NC DEPARTMENT OF TRANSPORTATION
 DIVISION OF HIGHWAYS
 STRUCTURE MANAGEMENT UNIT

ATTENTION: **PAR'S SUBMITTED FOR SPALLING WITH EXPOSED PRE-STRESSING AND CRACKING ON BEAMS**

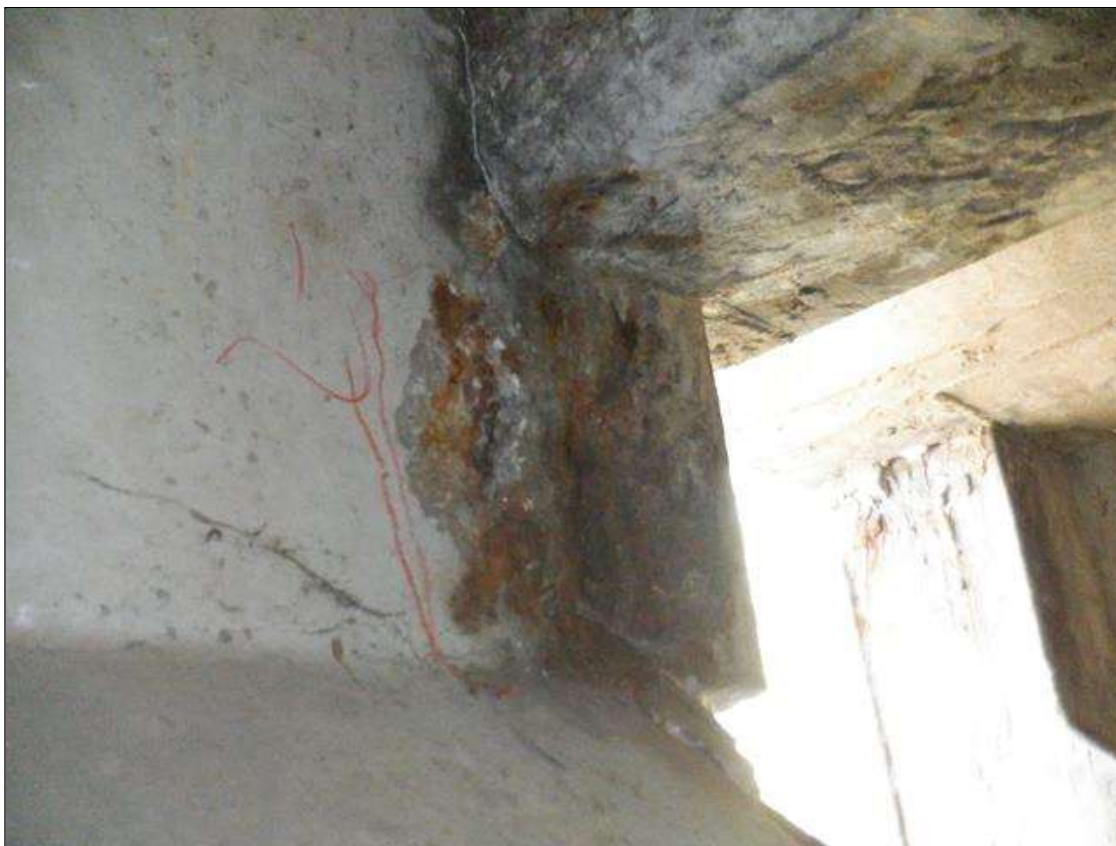
Span 2 Beam 8: 9 INCHES X UP TO 8 INCHES X 1 INCHES SPALL WITH EXPOSED REINFORCING ON WEST FACE OF WEB AT BENT 1.

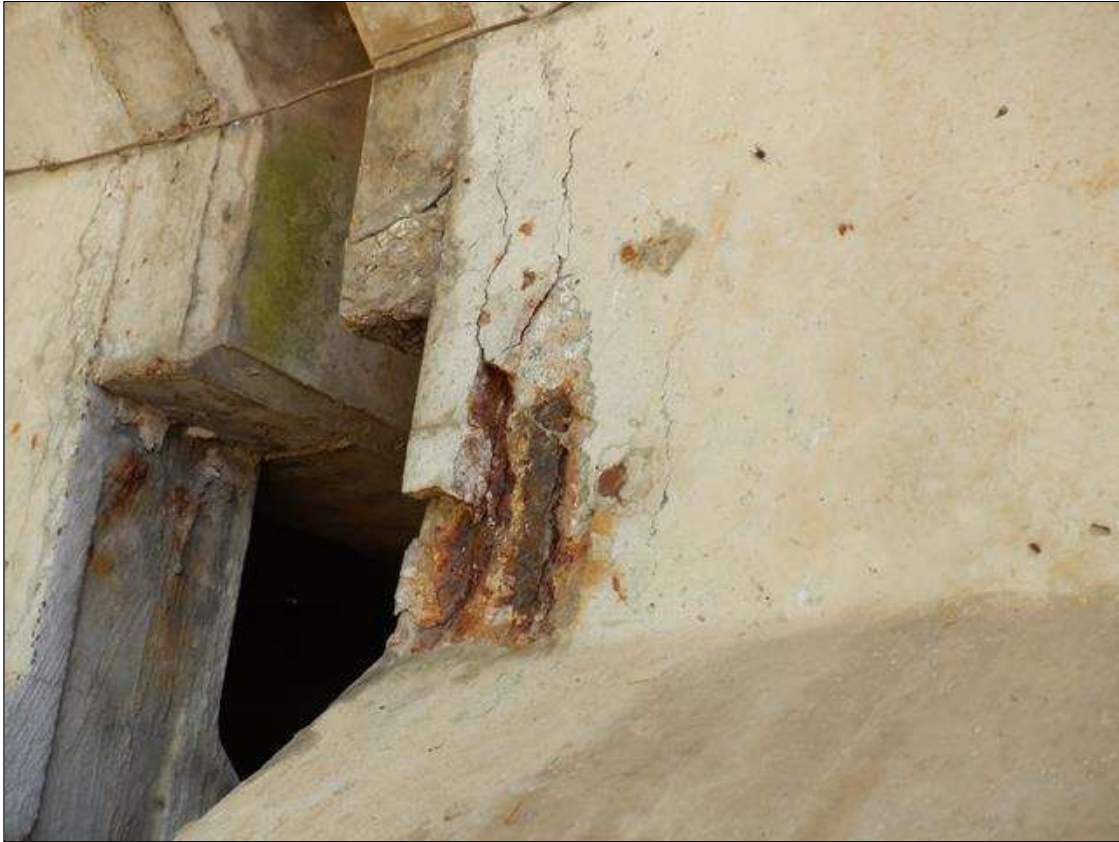
Span 2 Beam 8: 6 INCHES X 7 INCHES X UP TO 1 INCHES SPALL WITH EXPOSED REINFORCING WITH ADJACENT 9 INCHES X 14 INCHES DELAMINATION AND UP TO 0.008 INCHES VERTICAL CRACKS ON EAST FACE OF WEB AT BENT 1.

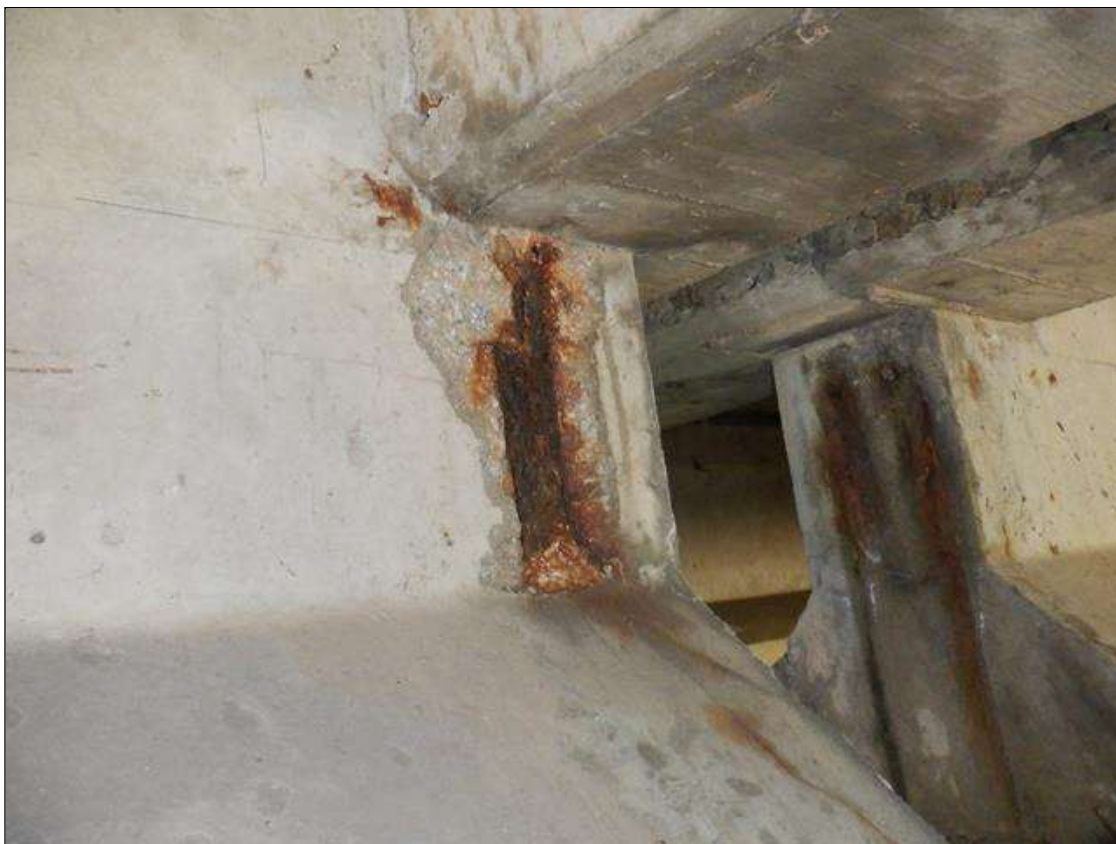
Span 2 Beam 3: 4 INCHES X UP TO 6 INCHES X 1 INCHES SPALL WITH EXPOSED REINFORCING ON WEST FACE AT BENT 1.

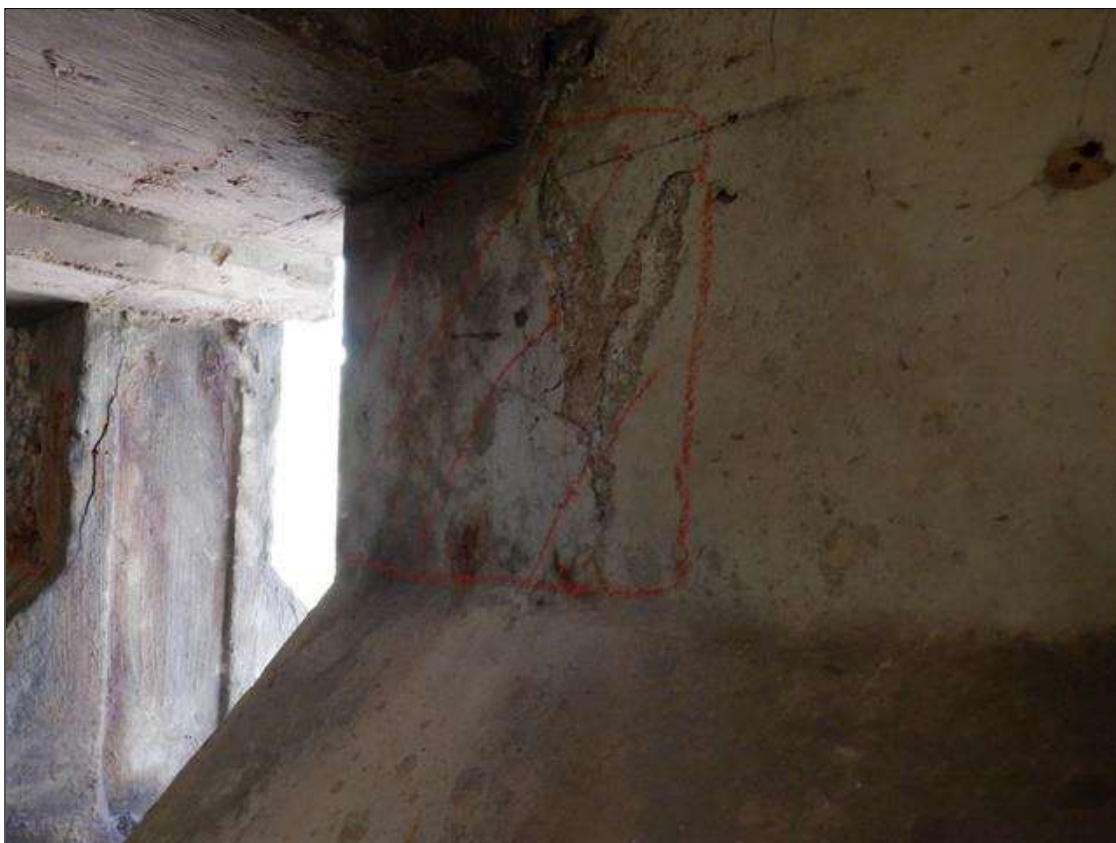
Span 2 Beam 1: 6 INCHES X UP TO 6 INCHES DELAMINATION/SURFACE SPALL WITH HAIRLINE MAP CRACKING AND RUST STAINING ON EAST FACE AT BENT 1.

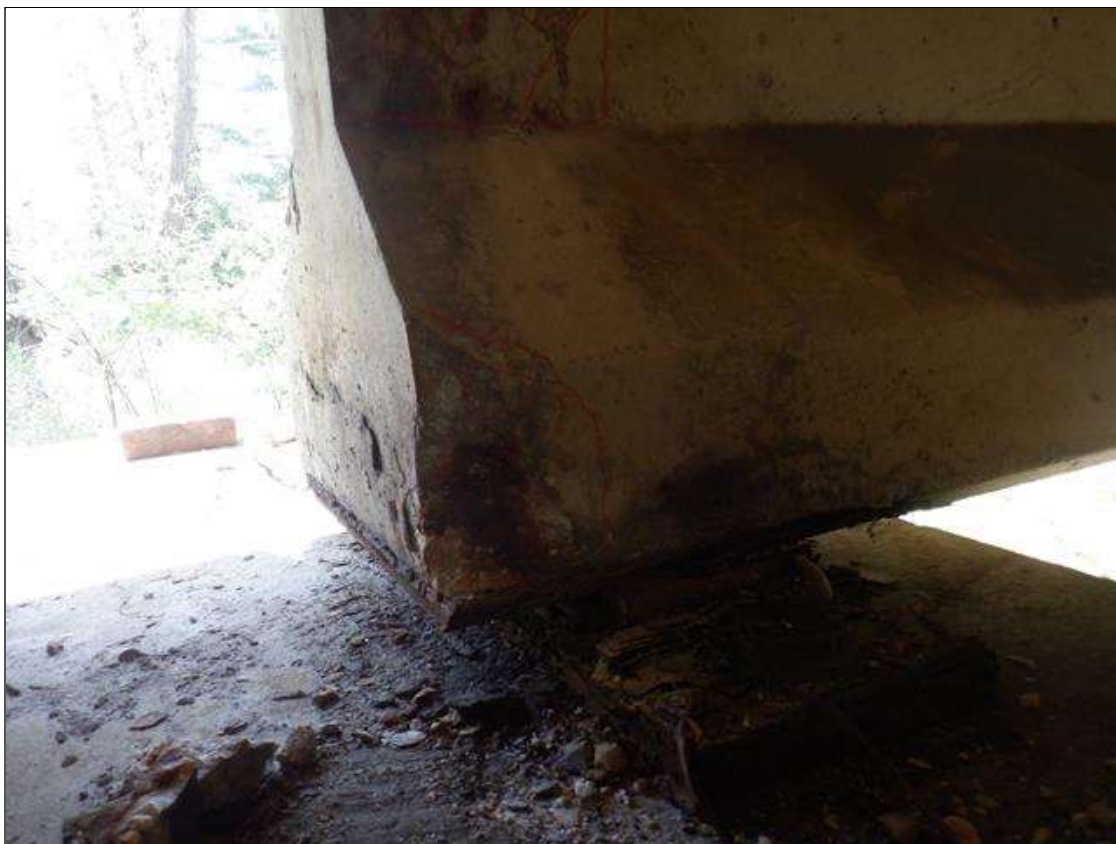
Span 2 Beam 1: 4 INCHES X 7 INCHES UP TO 1.5 INCHES SPALL WITH EXPOSED REINFORCING IN SOUTHEAST CORNER OF BOTTOM FLANGE AT BENT 1.

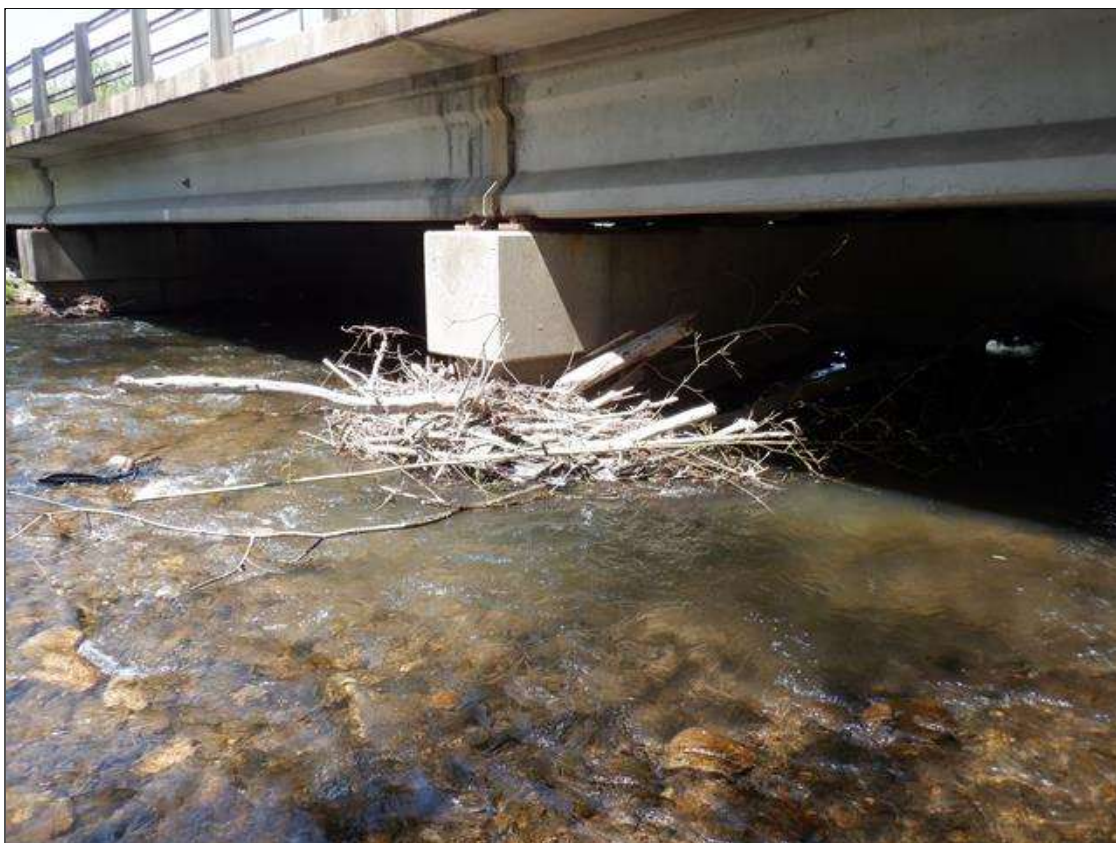
DRIFT: 45 FEET X UP TO 15 FEET X 4 FEET TIMBER DRIFT AND DEBRIS CAUGHT AT UPSTREAM END OF BENT 2.

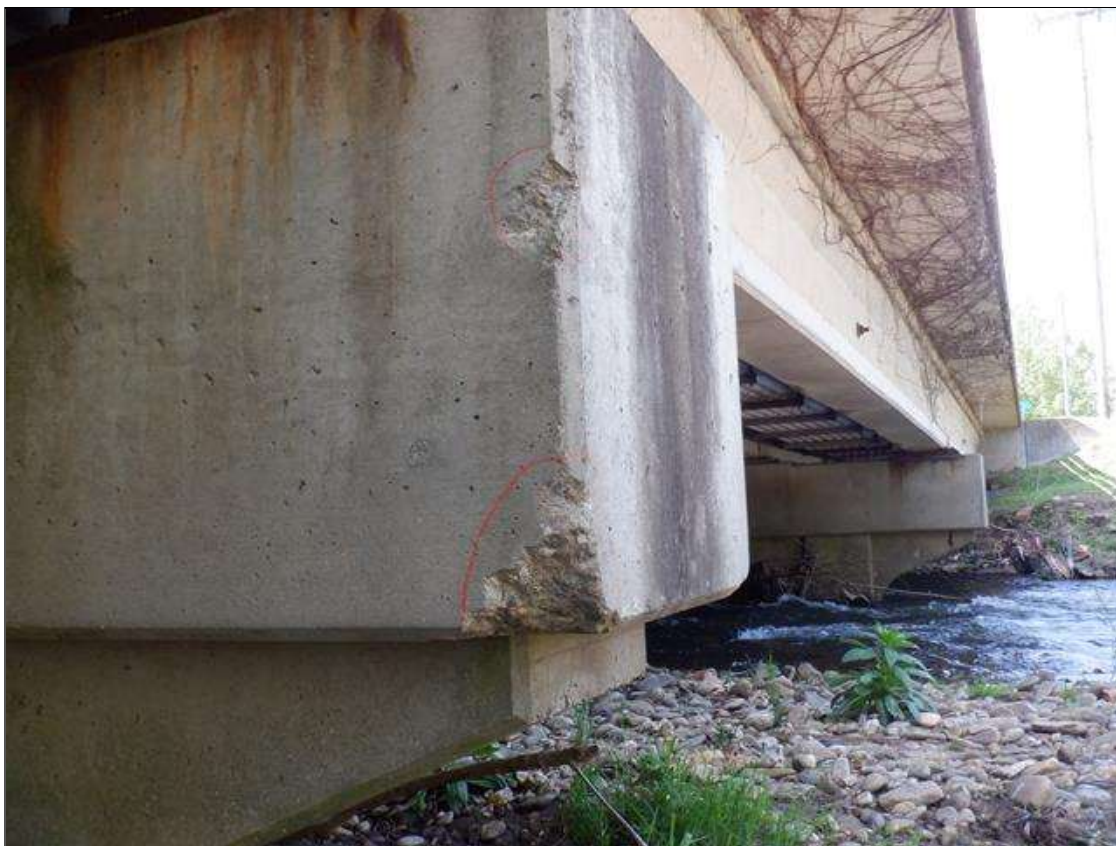
Bent 2 Cap 1: (2) UP TO 6 INCHES X 6 INCHES X 6 INCHES SPALLS ON SOUTHEAST CORNER AT EAST END.

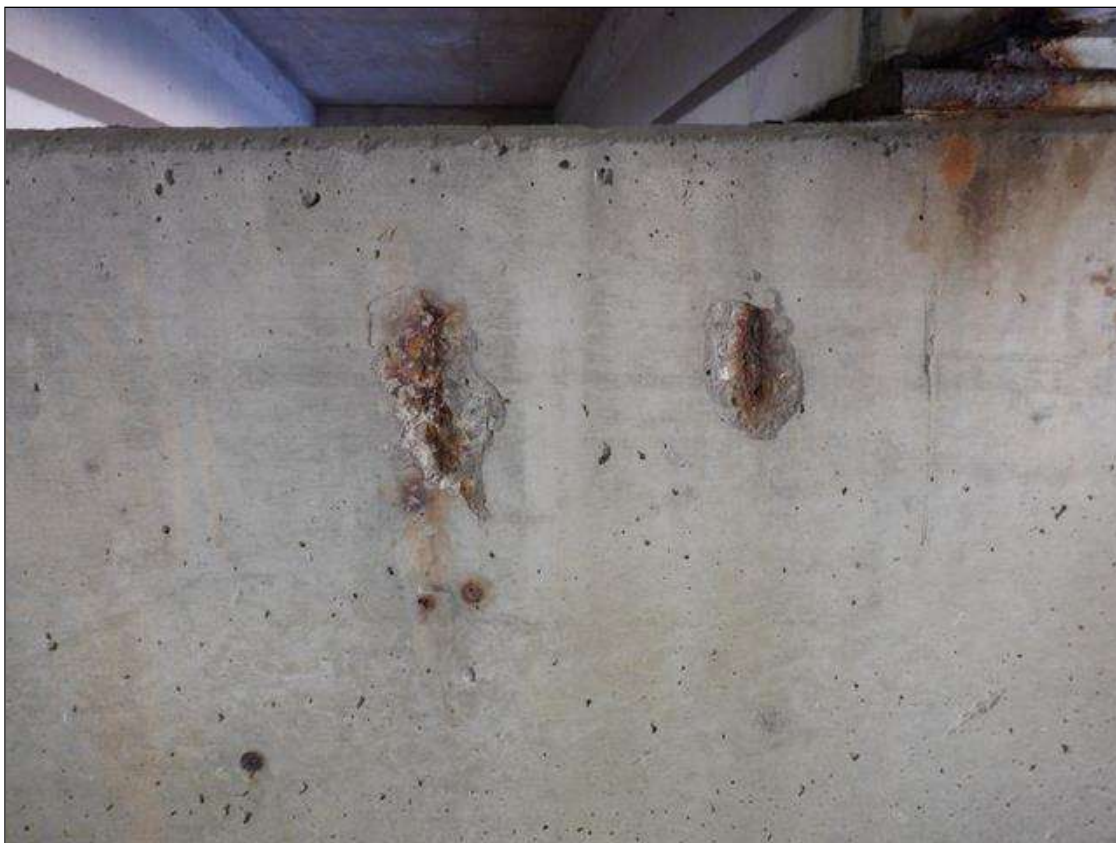
Bent 2 Cap 1: (2) UP TO 6 INCHES X 10 INCHES X 1 INCHES SPALLS WITH EXPOSED REINFORCING ON SOUTH FACE BETWEEN BEAMS 6 AND 7.

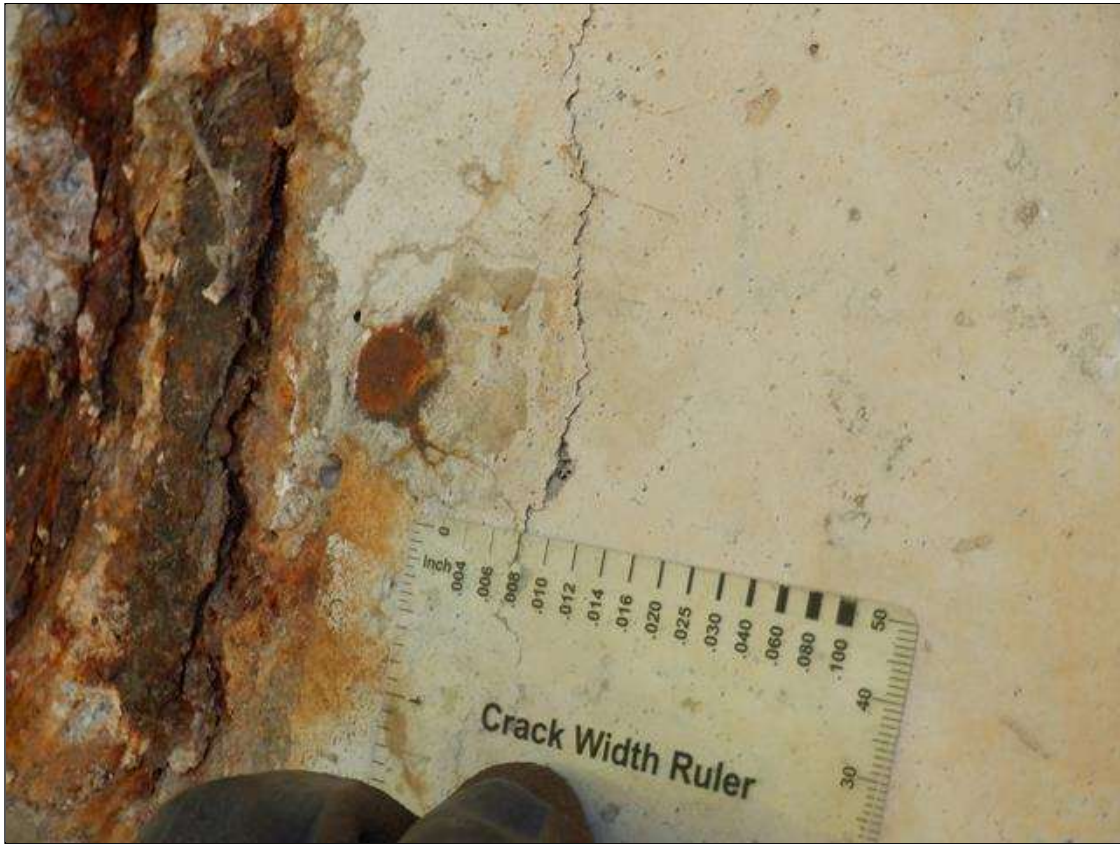
Span 2 Beam 8: 6 INCHES X 7 INCHES X UP TO 1 INCHES SPALL WITH EXPOSED REINFORCING WITH ADJACENT 9 INCHES X 14 INCHES DELAMINATION AND UP TO 0.008 INCHES VERTICAL CRACKS ON EAST FACE OF WEB AT BENT 1.

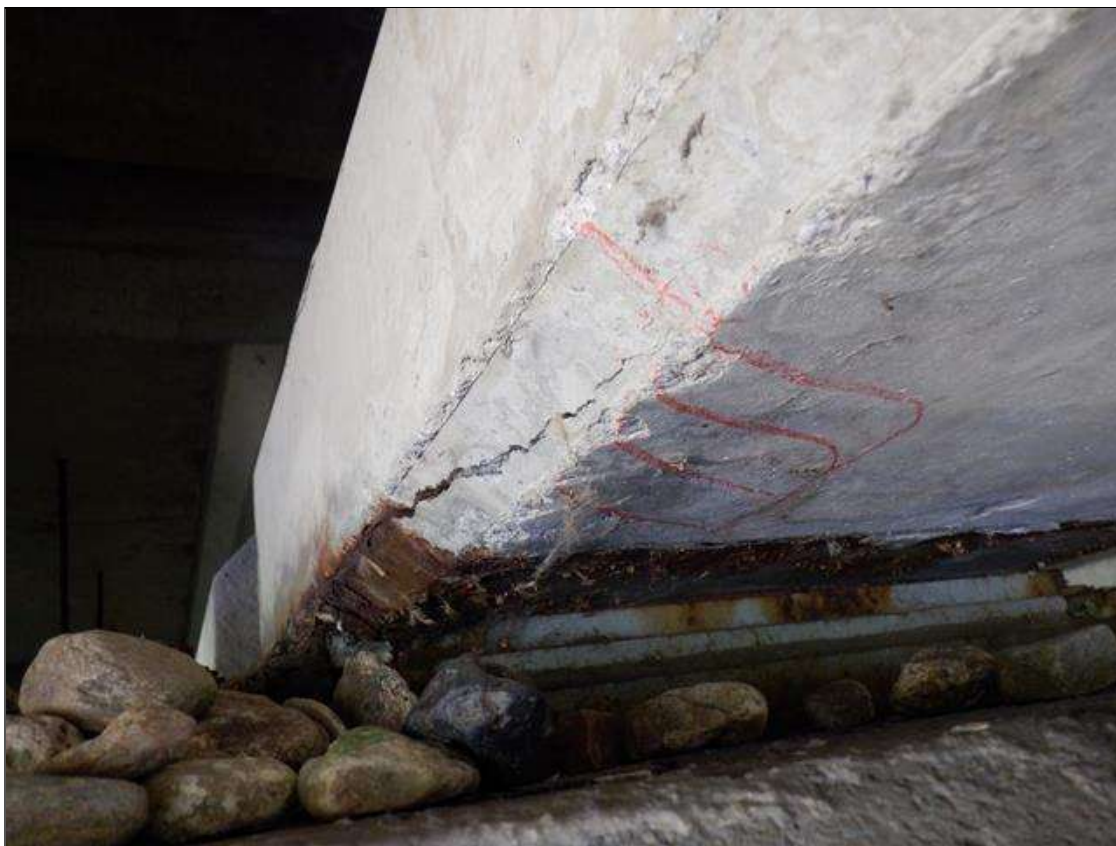
Span 2 Beam 7: (PAR) 8 INCHES X UP TO 0.1 INCHES LONGITUDINAL CRACK WITH ADJACENT 4 INCHES X UP TO 4 INCHES DELAMINATION ON THE EAST FACE OF THE BOTTOM FLANGE AND THE BOTTOM FACE AT BENT 1.

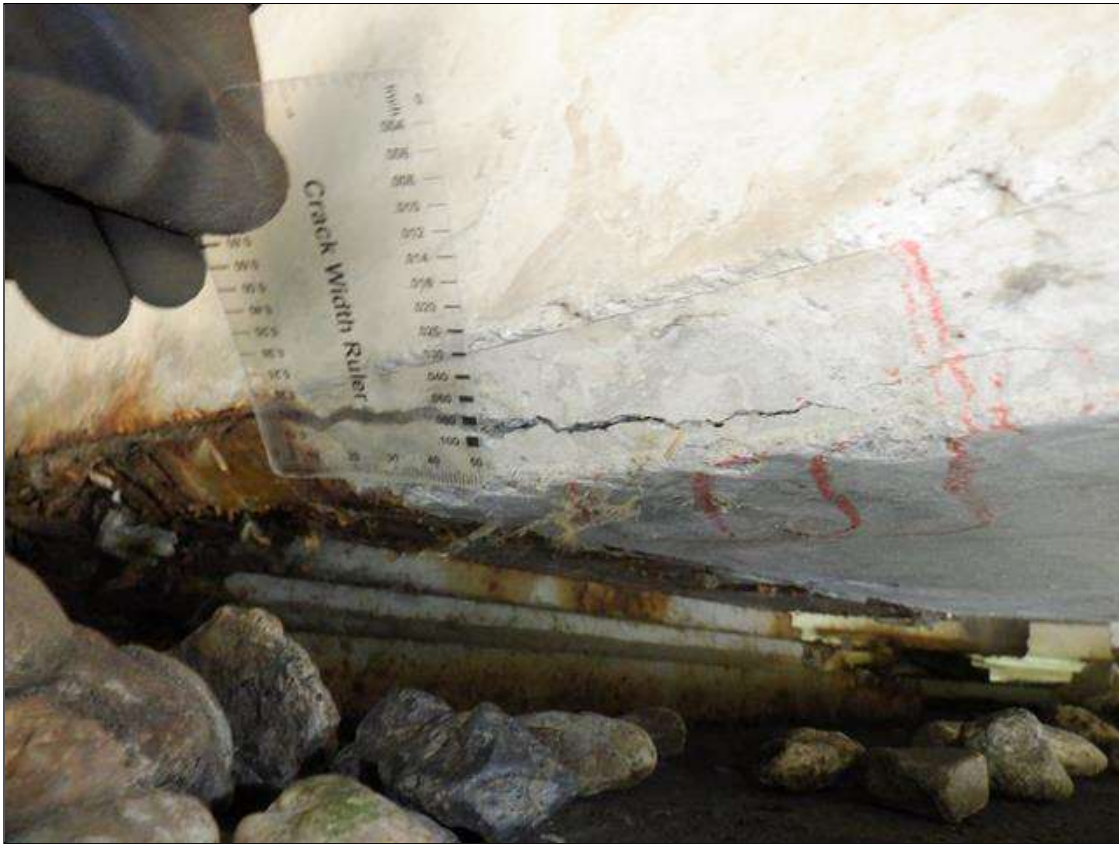
Span 2 Beam 7: (PAR) 8 INCHES X UP TO 0.1 INCHES LONGITUDINAL CRACK WITH ADJACENT 4 INCHES X UP TO 4 INCHES DELAMINATION ON THE EAST FACE OF THE BOTTOM FLANGE AND THE BOTTOM FACE AT BENT 1.

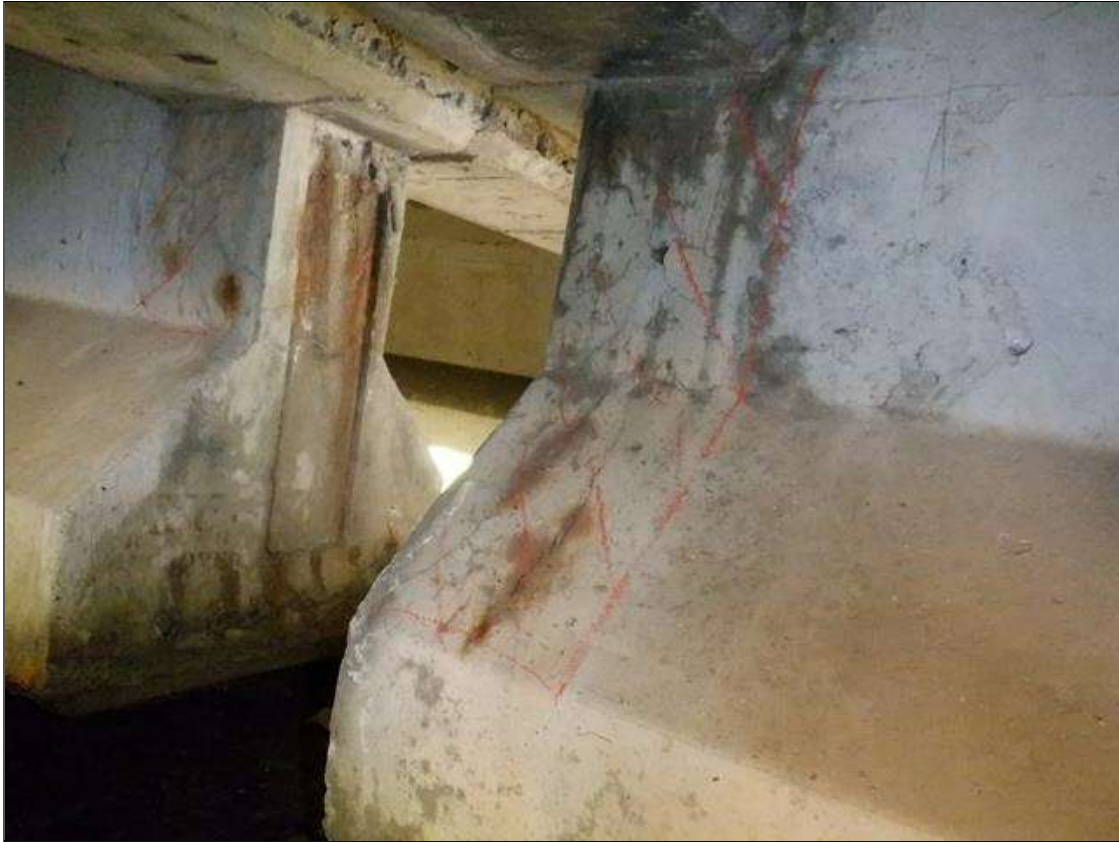
Span 2 Beam 3: (PAR) 7 INCHES X UP TO 0.016 INCHES VERTICAL CRACK WITH RUST STAINING AND ADJACENT 7 INCHES X 14 INCHES DELAMINATION AND HAIRLINE CRACKING IN THE EAST FACE OF THE WEB AND CHAMFER AT BENT 1.

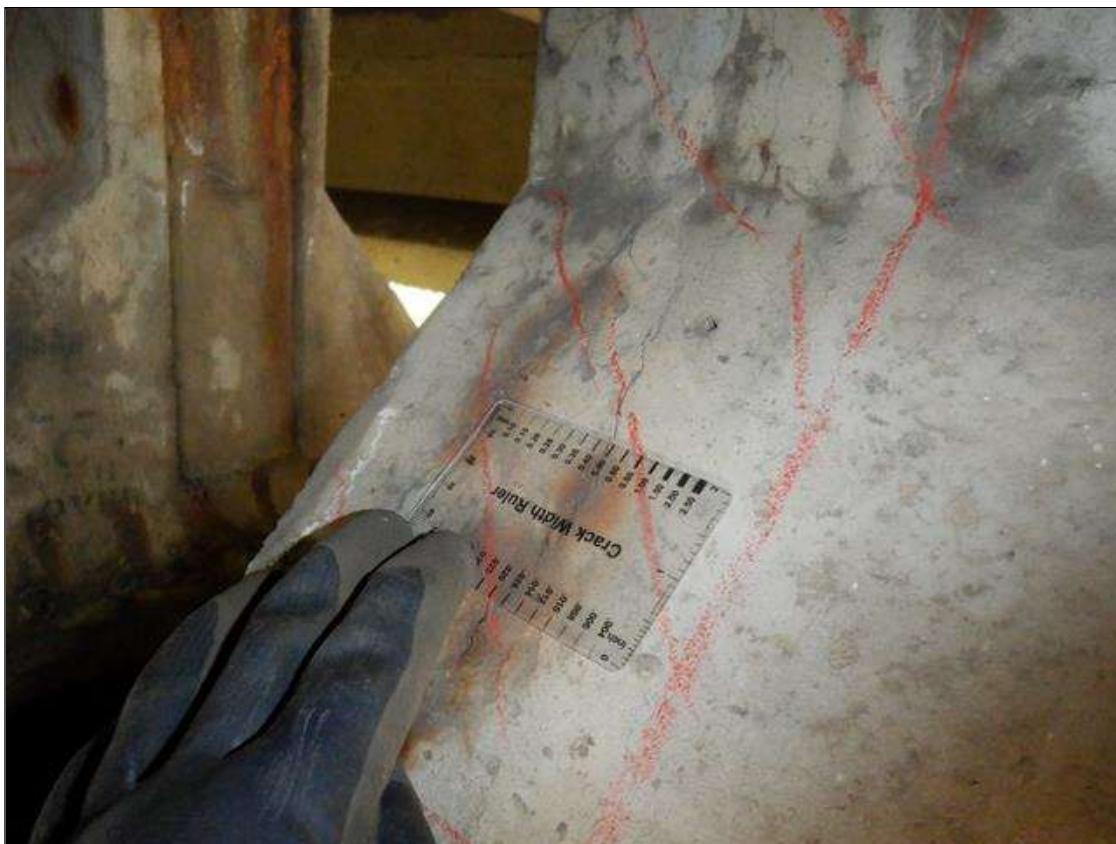
Span 2 Beam 3: (PAR) 7 INCHES X UP TO 0.016 INCHES VERTICAL CRACK WITH RUST STAINING AND ADJACENT 7 INCHES X 14 INCHES DELAMINATION AND HAIRLINE CRACKING IN THE EAST FACE OF THE WEB AND CHAMFER AT BENT 1.

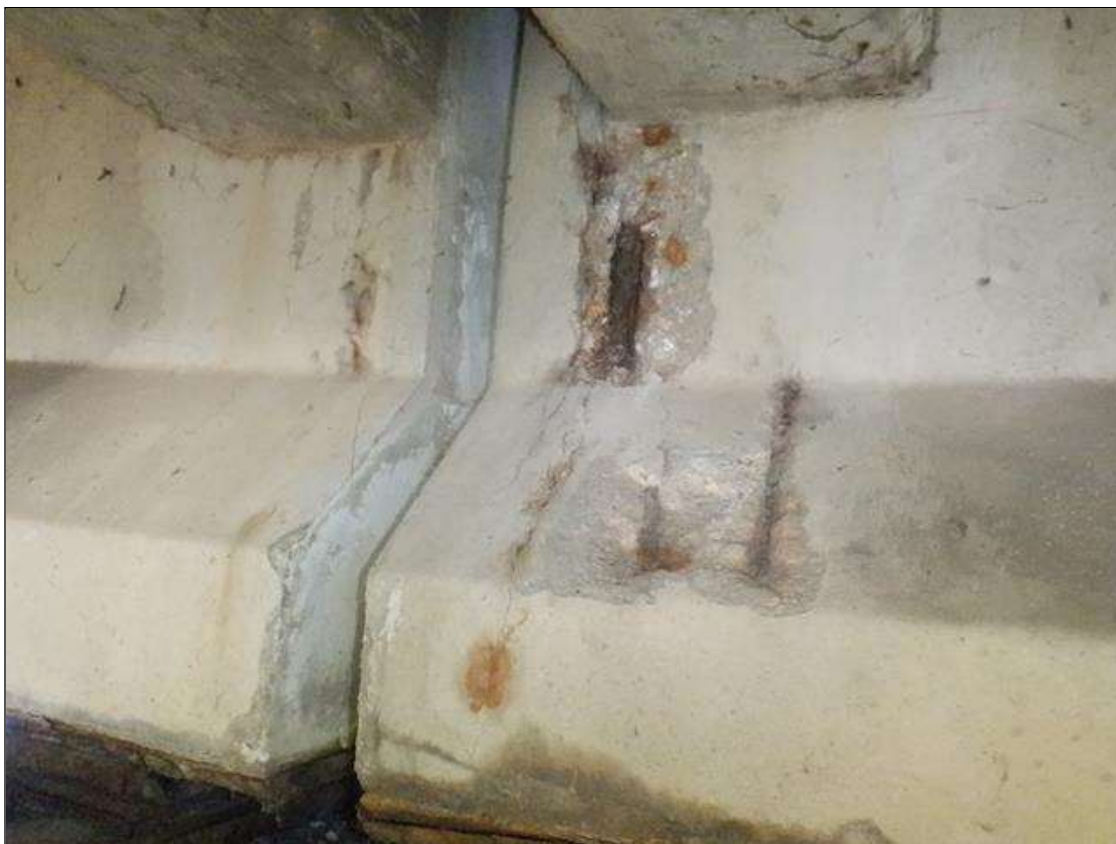
Span 2 Beam 7: (PAR) (5) UP TO 13 INCHES X 0.02 INCHES VERTICAL CRACKS WITH RUST STAINING ON WEST FACE OF THE WEB, CHAMFER, AND BOTTOM FLANGE AT BENT 2.

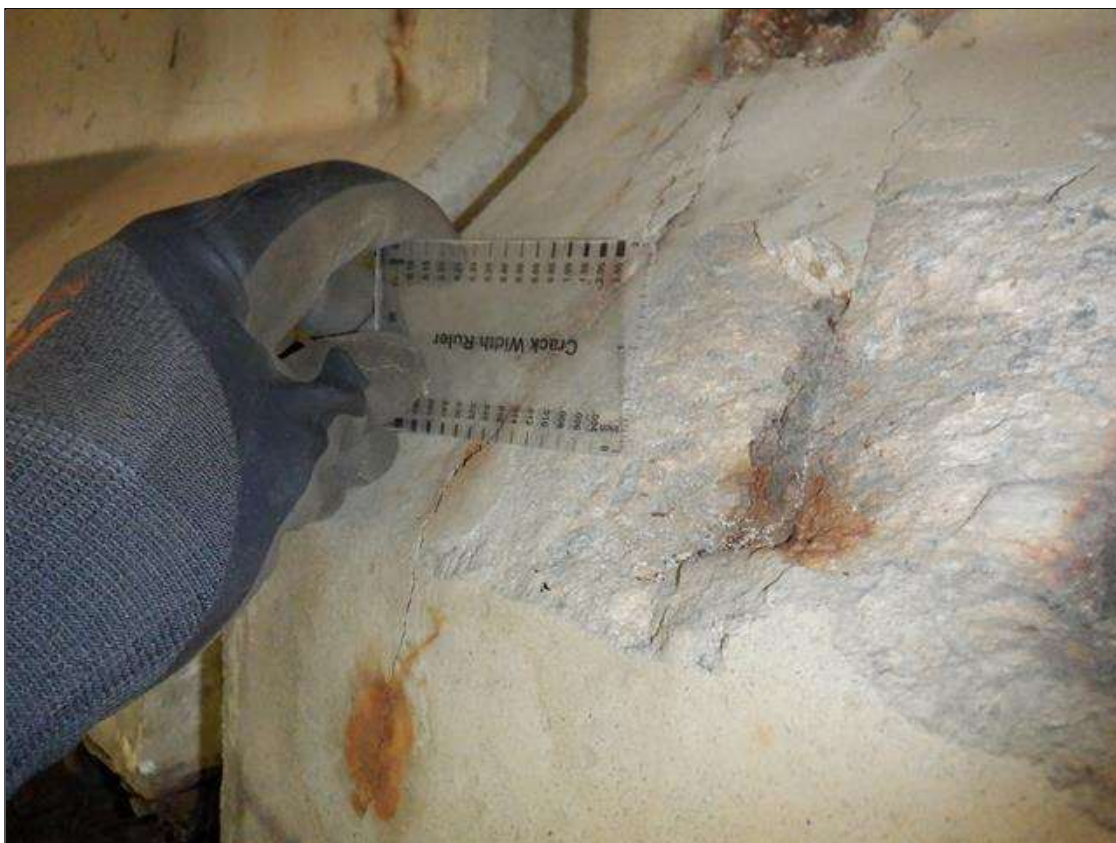
Span 2 Beam 7: (PAR) (5) UP TO 13 INCHES X 0.02 INCHES VERTICAL CRACKS WITH RUST STAINING ON WEST FACE OF THE WEB, CHAMFER, AND BOTTOM FLANGE AT BENT 2.

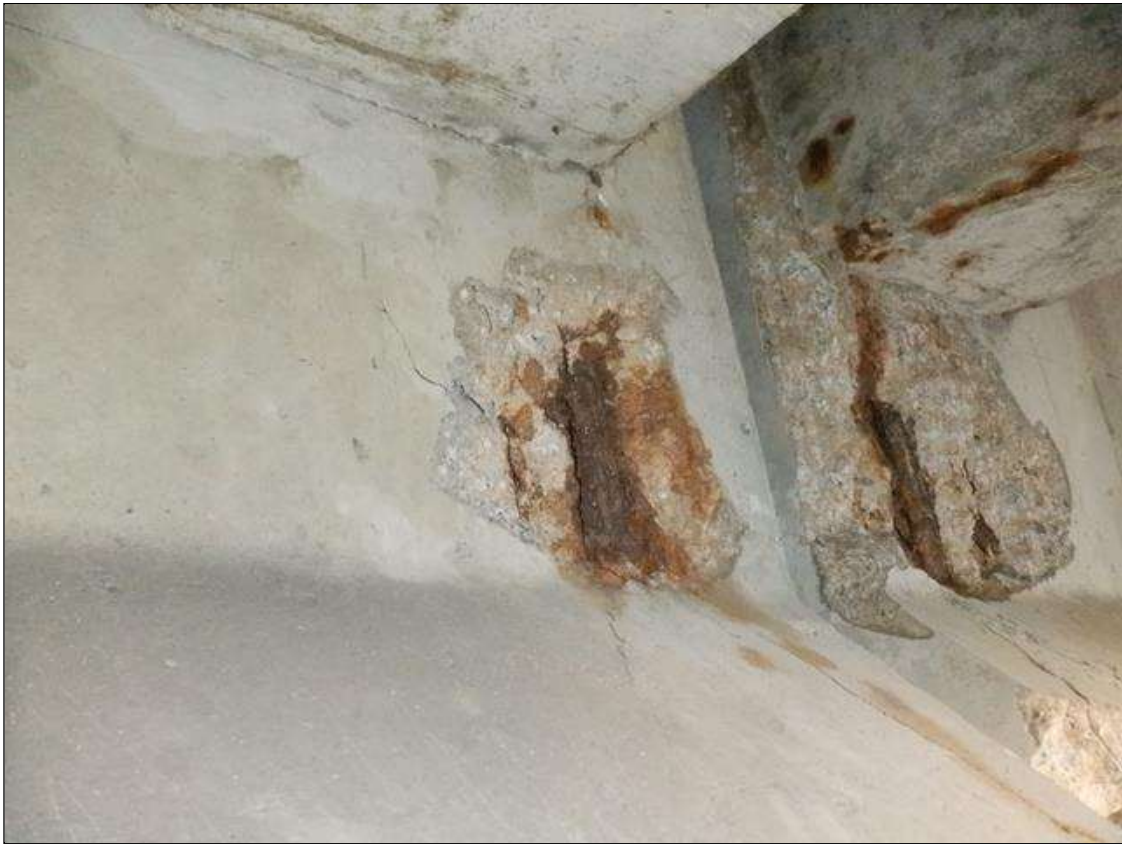
Span 2 Beam 7: (3) UP TO 7.5 INCHES X 9 INCHES X 1 INCHES SPALLS WITH EXPOSED REINFORCING ON EAST AND WEST FACES OF WEB AND CHAMFER AT BENT 2.

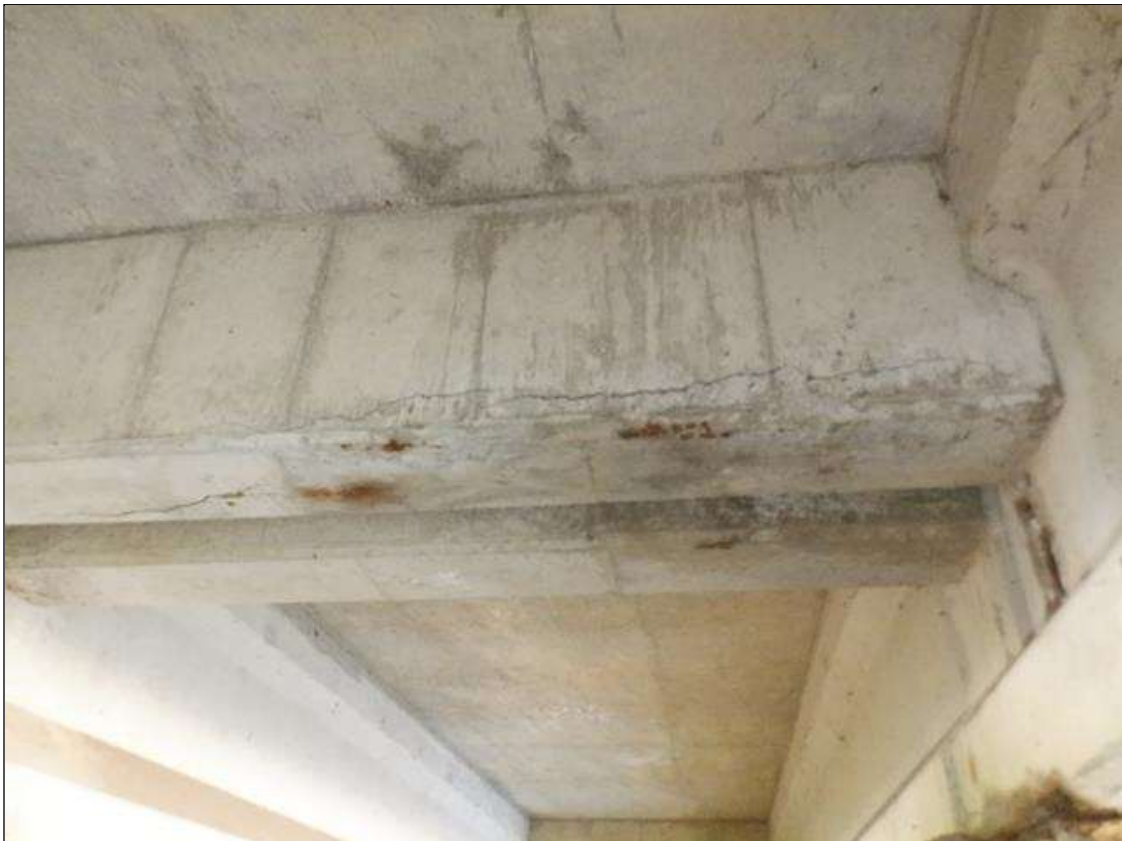
Span 2 Beam 7: 5 FEET X UP TO 10 INCHES CRACKED DELAMINATION WITH UP TO 1/4 INCHES CRACKING AND RUST STAINING ON BOTTOM FACE OF END DIAPHRAGM BETWEEN BEAMS 6 AND 7 AT BENT 2.

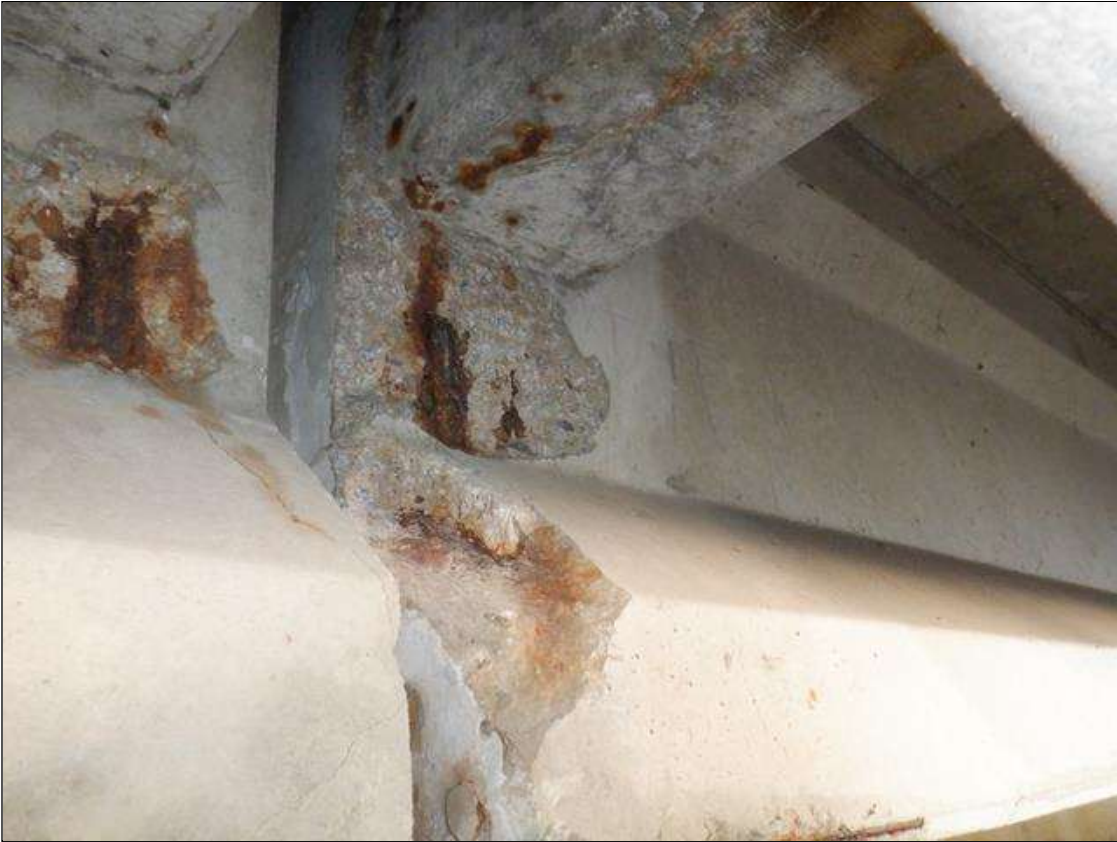
Span 3 Beam 7: (PAR) 12 INCHES X UP TO 20 INCHES X 4 INCHES SPALL WITH EXPOSED REINFORCING AND PRESTRESSED STRANDS ON THE EAST FACE AT BENT 2.

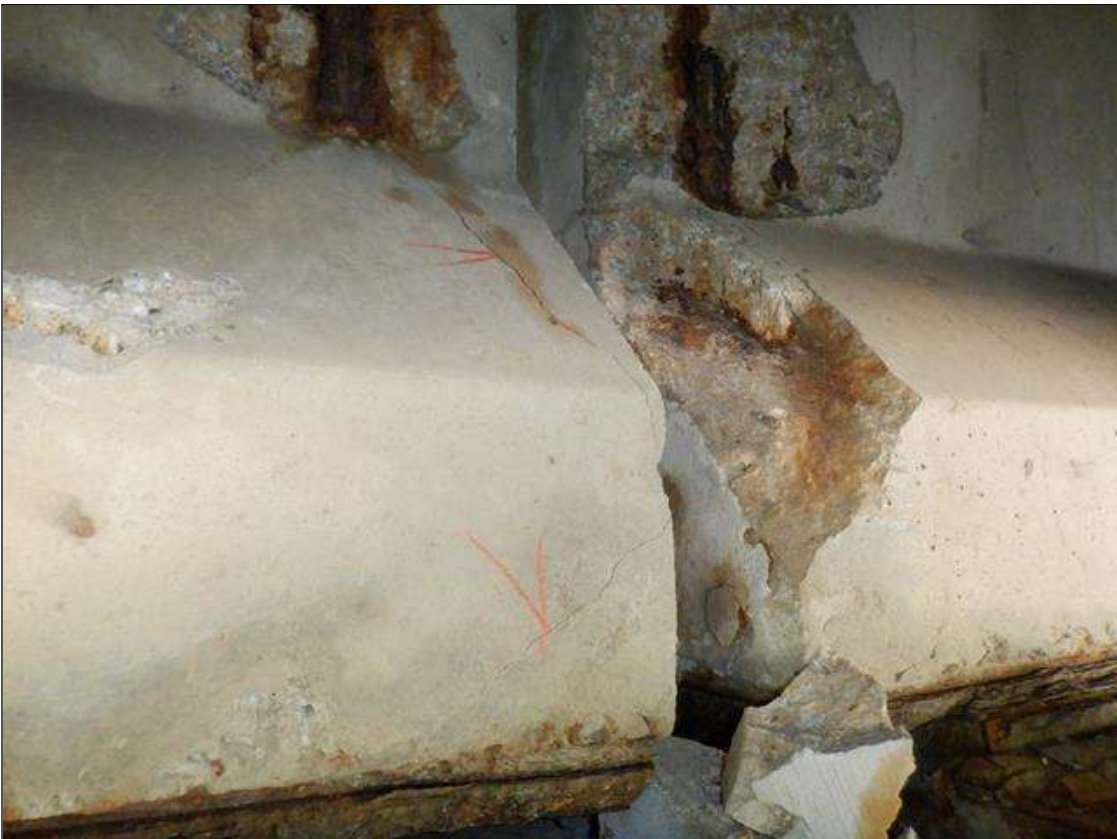
Span 2 Beam 7: (PAR) (2) UP TO 9 INCHES X 0.014 DIAGONAL CRACKS WITH RUST STAINING ON THE EAST FACE OF THE CHAMFER AND BOTTOM FLANGE AT BENT 2.

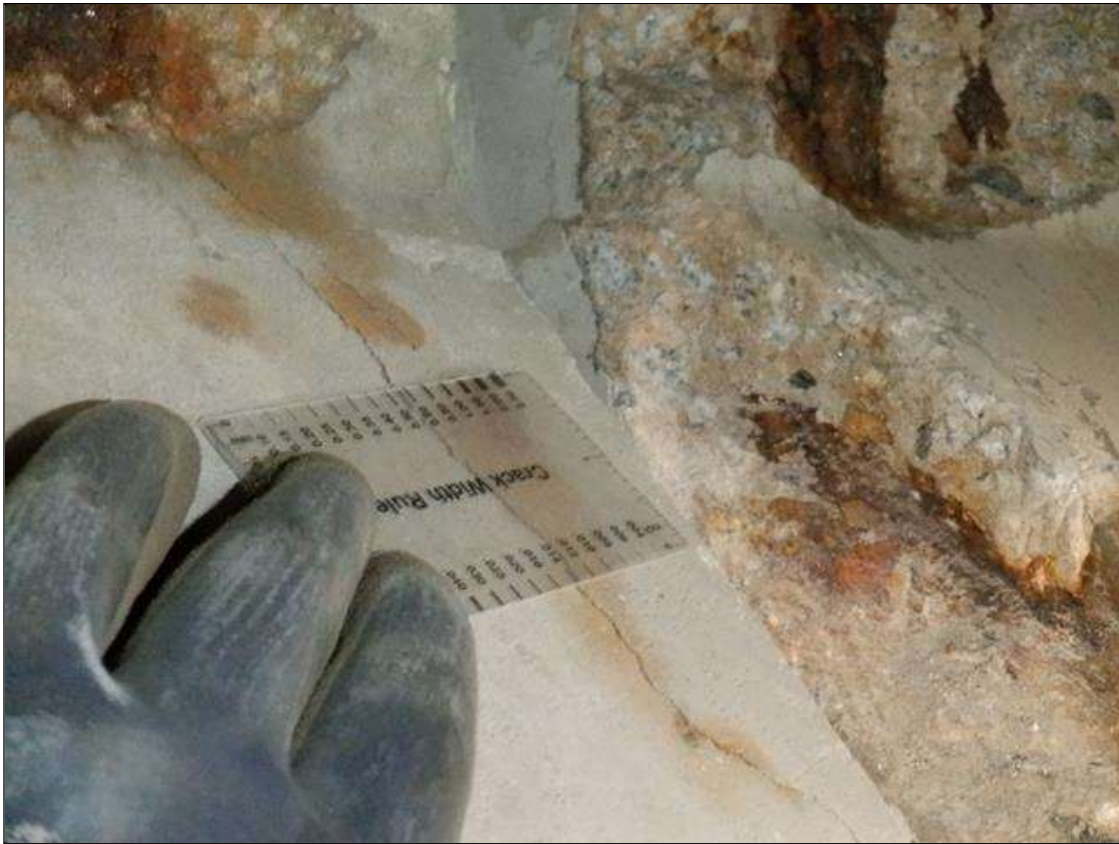
Span 2 Beam 7: (PAR) (2) UP TO 9 INCHES X 0.014 DIAGONAL CRACKS WITH RUST STAINING ON THE EAST FACE OF THE CHAMFER AND BOTTOM FLANGE AT BENT 2.

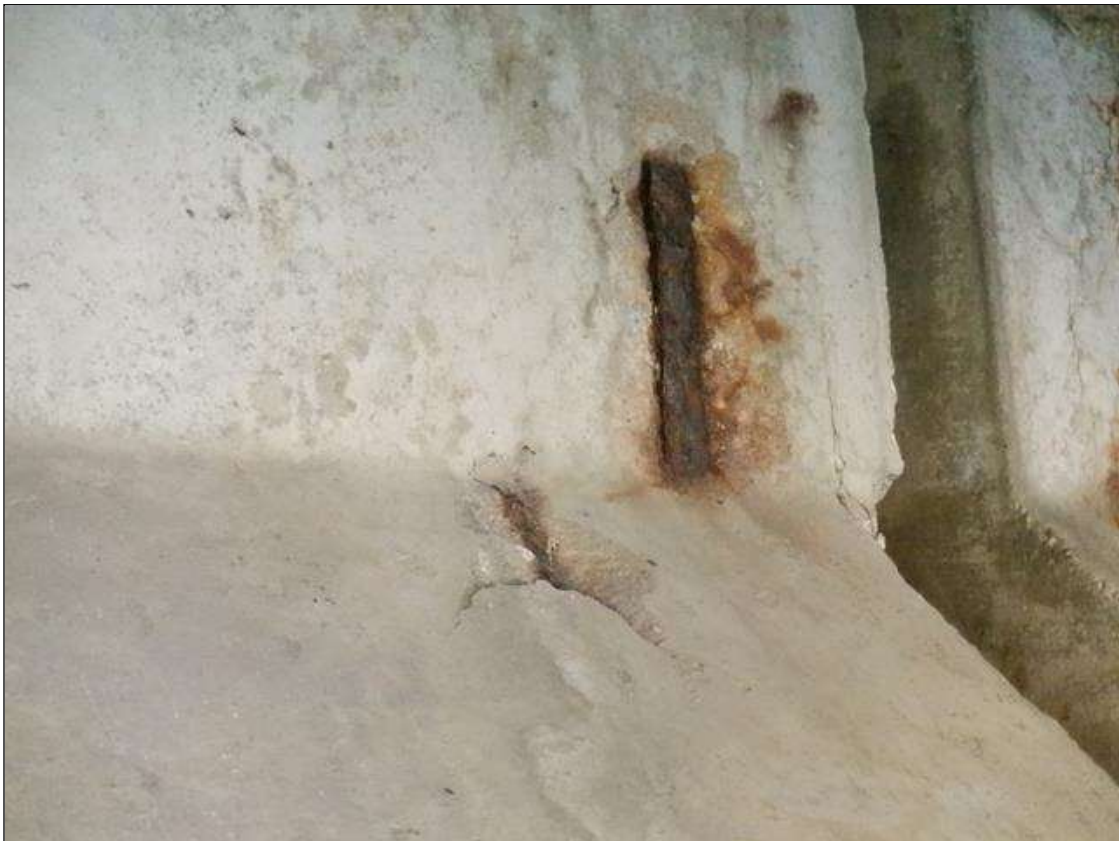
Span 2 Beam 6: (4) UP TO 6 INCHES X 4 INCHES X 1 INCHES SPALLS WITH EXPOSED REINFORCING ON EAST AND WEST FACES AT BENT 2.

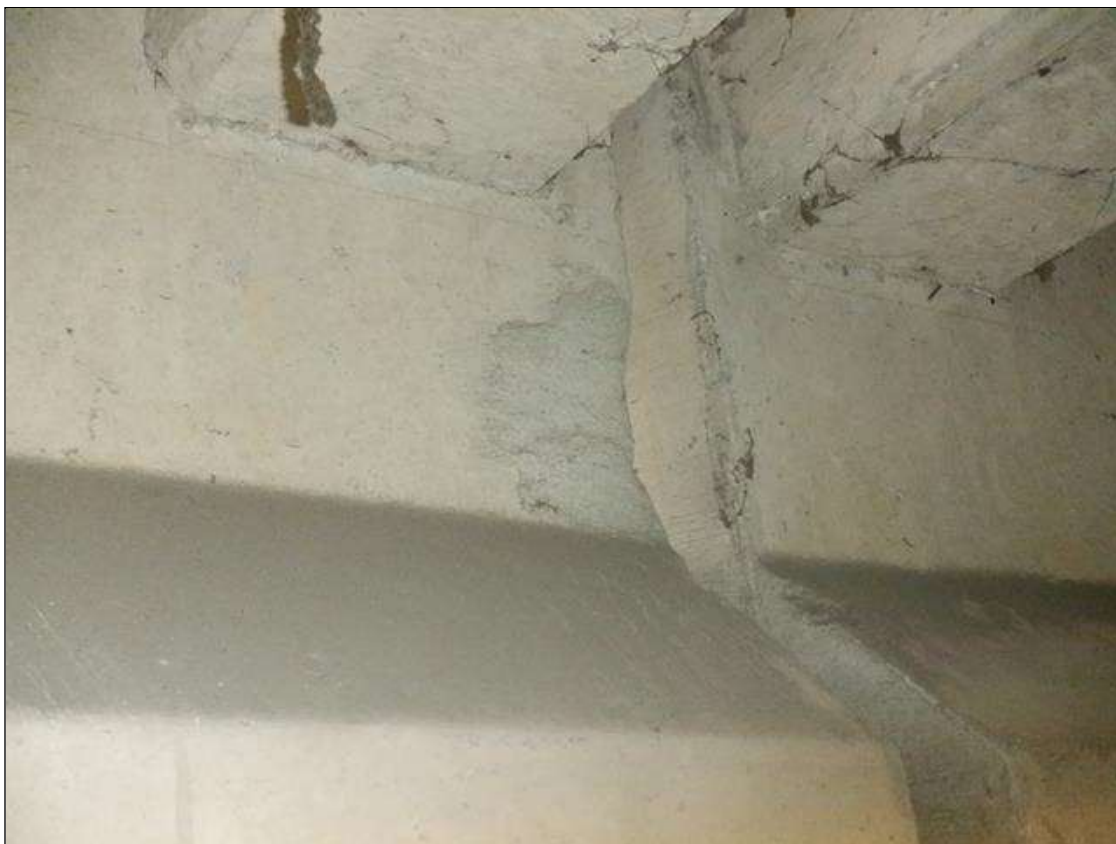
Span 2 Beam 4: 4 INCHES X UP TO 8 INCHES PATCHED AREA ON EAST FACE OF WEB AT BENT 2.

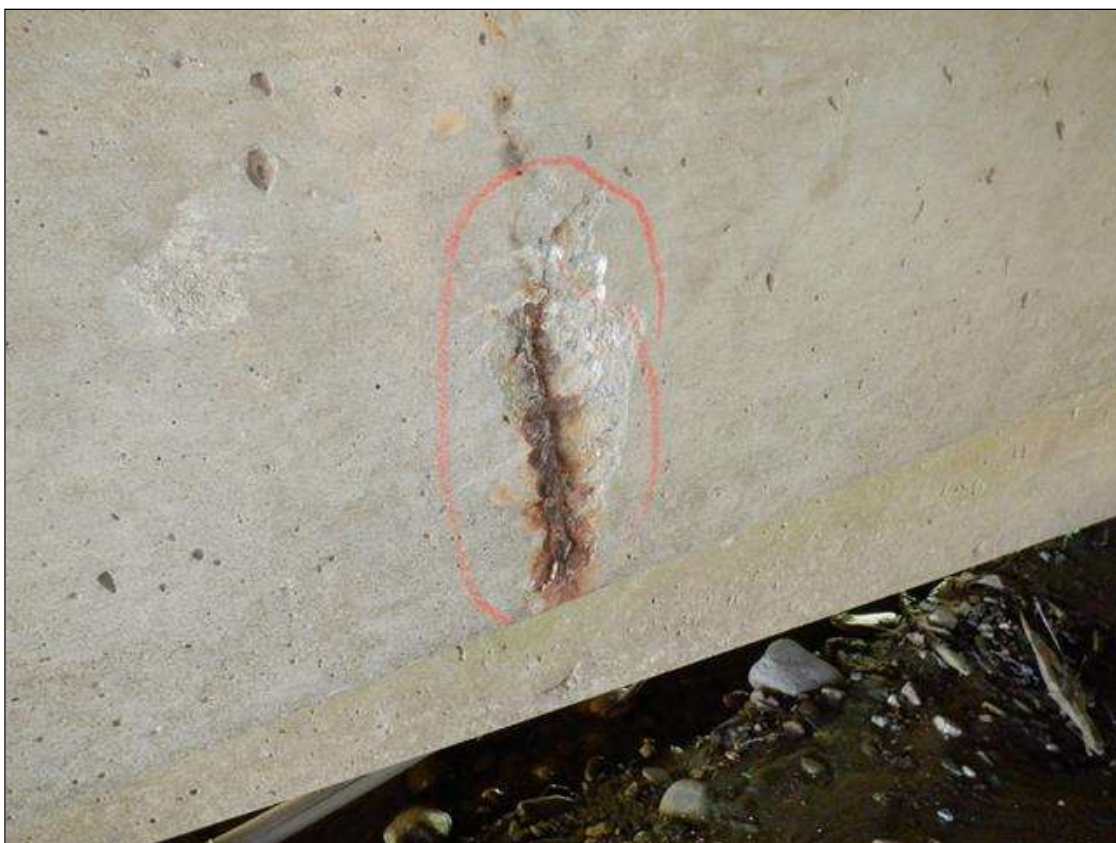
Bent 2 Cap 1: 3 INCHES X UP TO 6 INCHES X 1/2 INCHES SPALL WITH EXPOSED REINFORCING ON NORTH FACE BENEATH BEAM 6.
