NC DEPARTMENT OF TRANSPORTATION
 DIVISION OF HIGHWAYS
 STRUCTURE MANAGEMENT UNIT

ATTENTION: **PAR'S SUBMITTED FOR SPALLING WITH EXPOSED PRE-STRESSING AND CRACKING ON BEAMS**

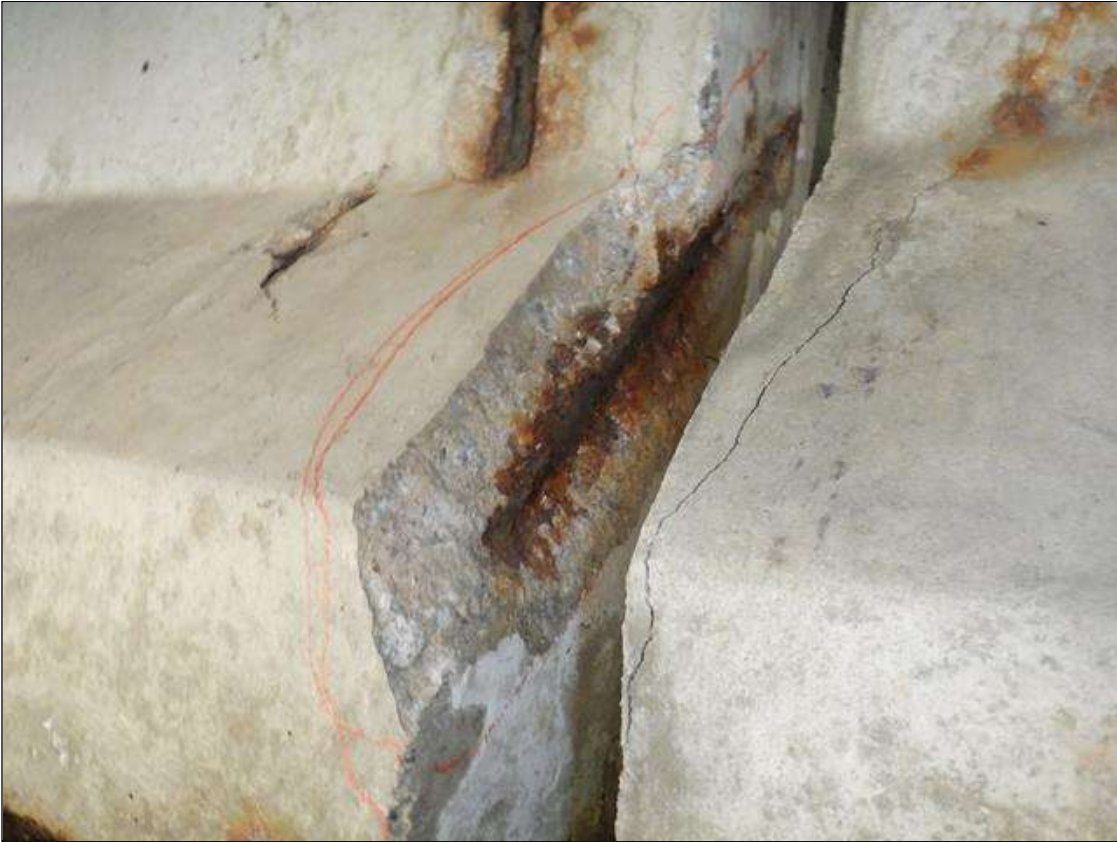
Span 2 Beam 6: 2 INCHES X UP TO 14 INCHES X 1.5 INCHES SPALL WITH EXPOSED REINFORCING IN NORTH FACE OF BOTTOM FLANGE AND CHAMFER AT BENT 2.

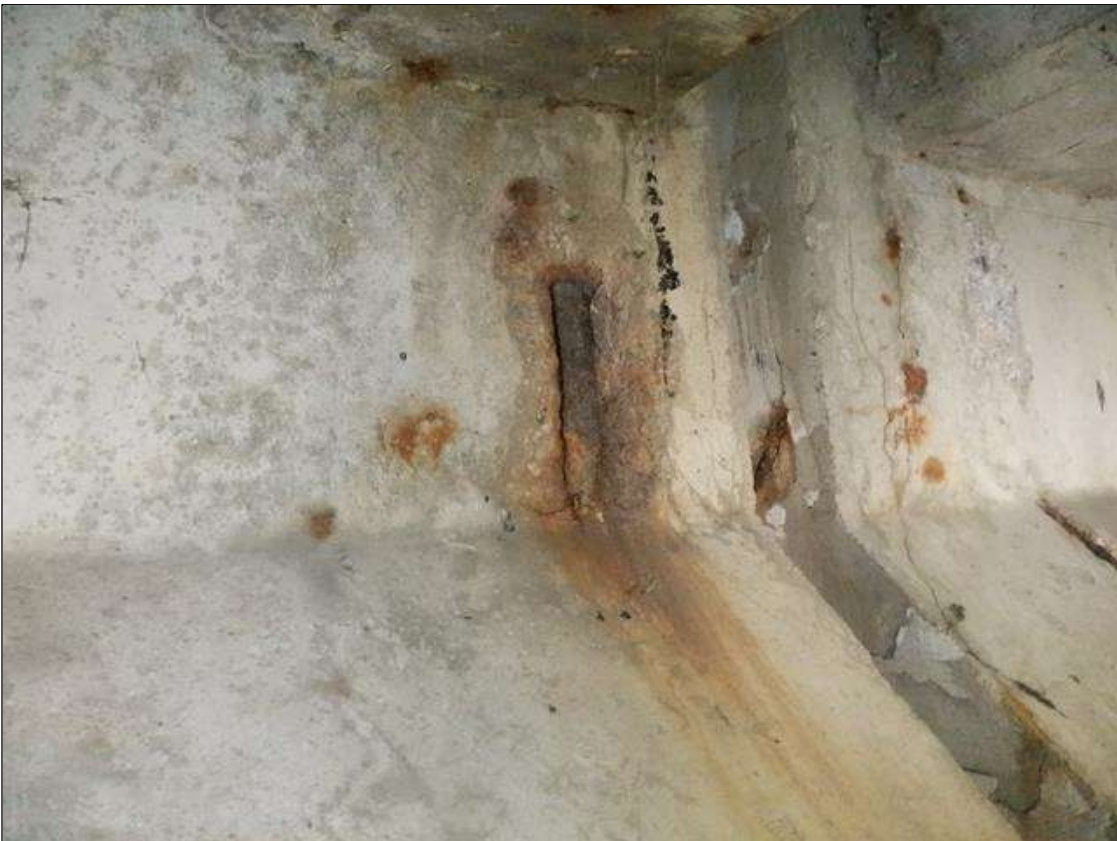
Span 3 Beam 6: (2) UP TO 4 INCHES X 7 INCHES X 1 INCHES SPALLS WITH EXPOSED REINFORCING ON EAST AND WEST FACES AT BENT 2.

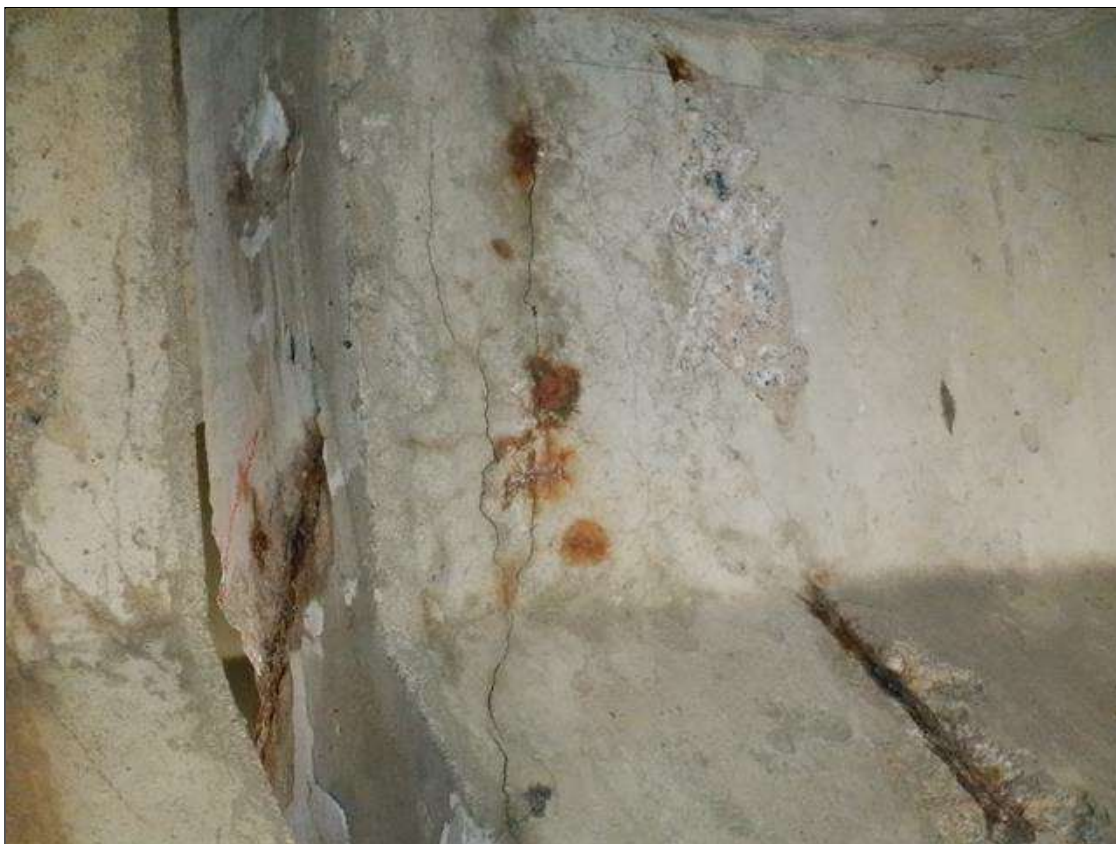
Span 2 Beam 6: (PAR) 5 INCHES X UP TO 11 INCHES AREA OF UP TO 0.014 INCHES MAP CRACKING WITH RUST STAINING ON THE WEST FACE OF THE WEB AND CHAMFER AT BENT 2.

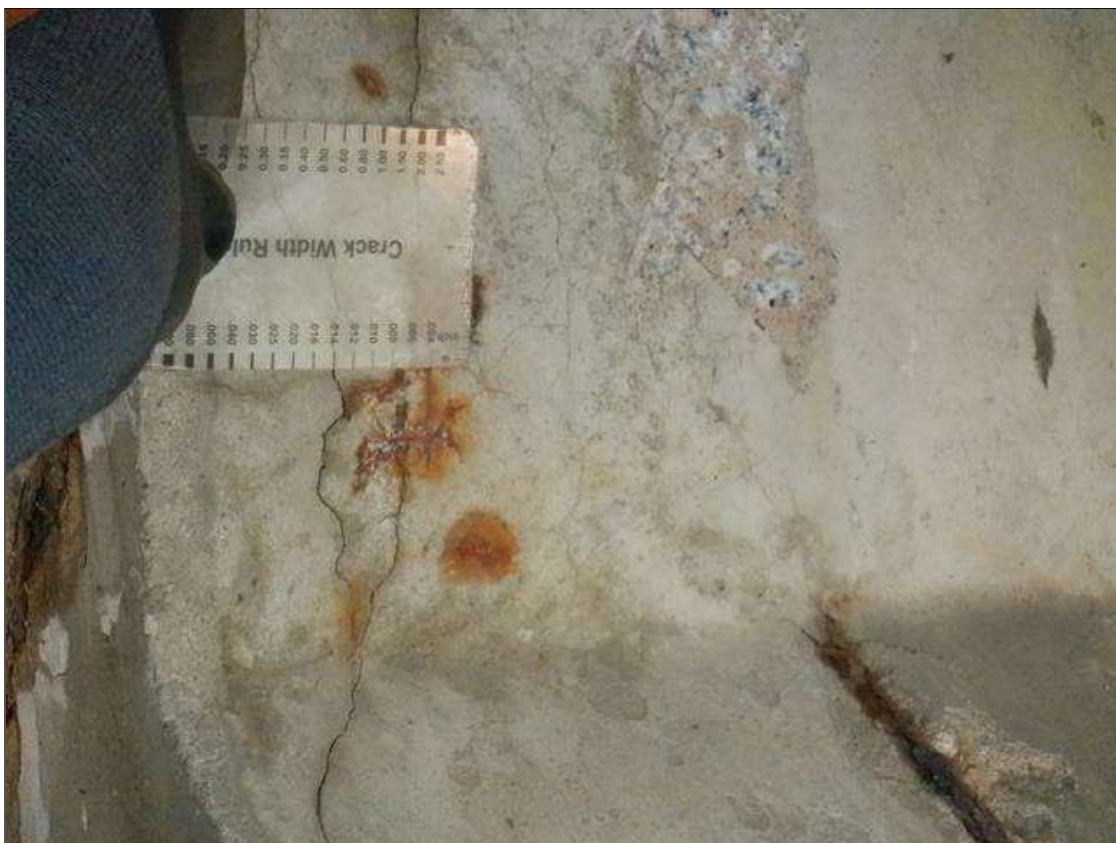
Span 2 Beam 6: (PAR) 5 INCHES X UP TO 11 INCHES AREA OF UP TO 0.014 INCHES MAP CRACKING WITH RUST STAINING ON THE WEST FACE OF THE WEB AND CHAMFER AT BENT 2.

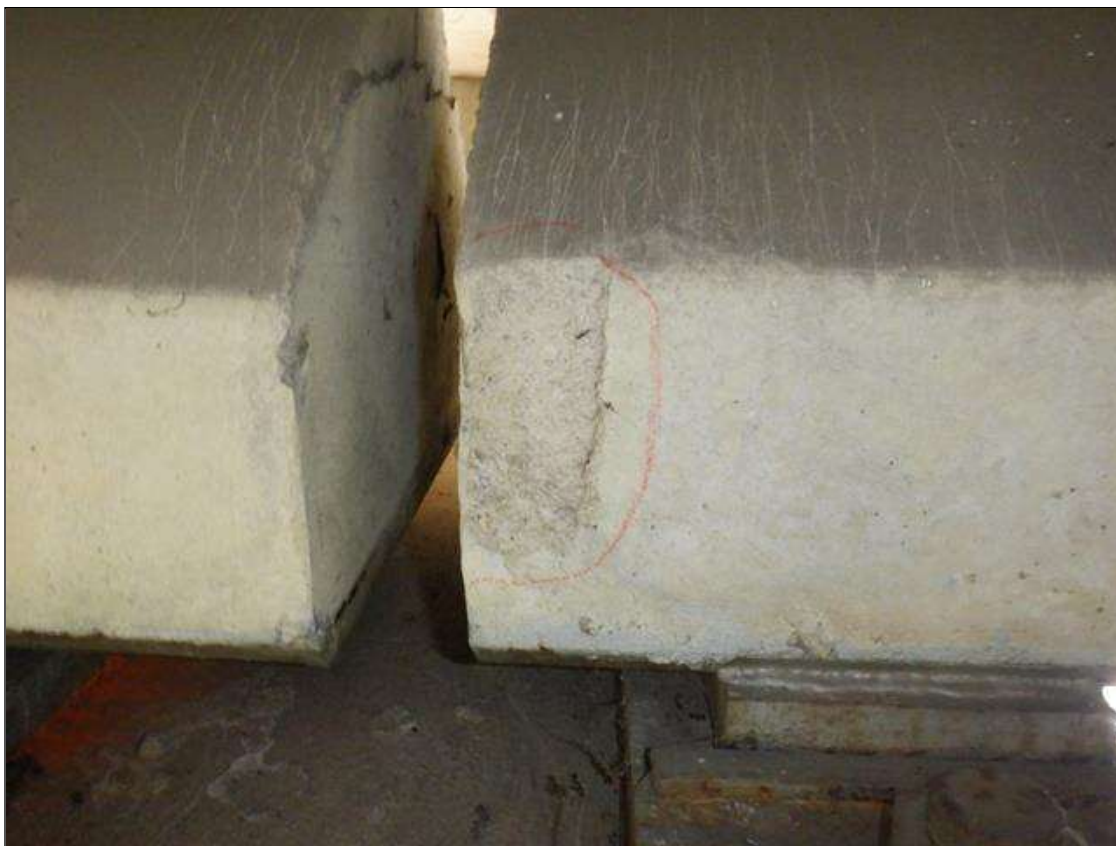
Span 3 Beam 2: 3 INCHES X 5 INCHES X 1/2 INCHES SPALL ON EAST FACE OF BOTTOM FLANGE AT BENT 2.

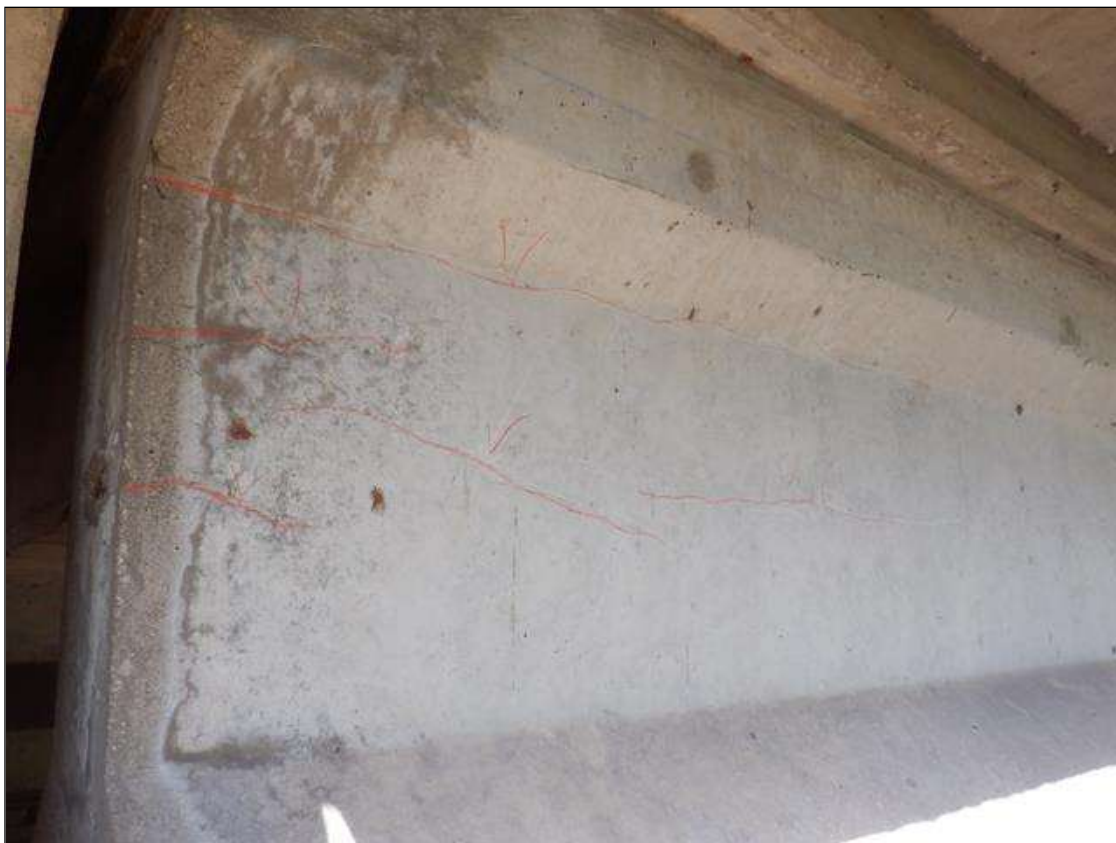
Span 2 Beam 1: (5) UP TO 4 FEET X 0.008 INCHES LONGITUDINAL CRACKS IN WEST WEB EXTENDING FROM BENT 2.

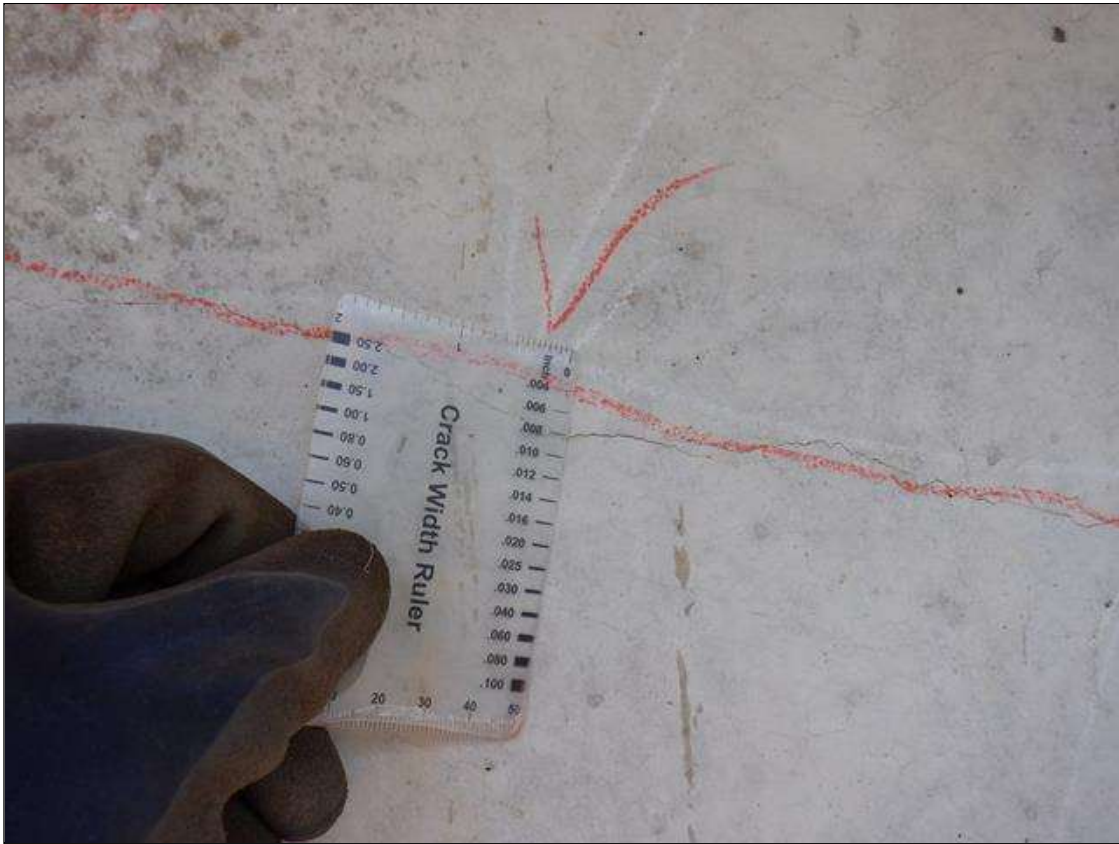
Span 2 Beam 1: (5) UP TO 4 FEET X 0.008 INCHES LONGITUDINAL CRACKS IN WEST WEB EXTENDING FROM BENT 2.

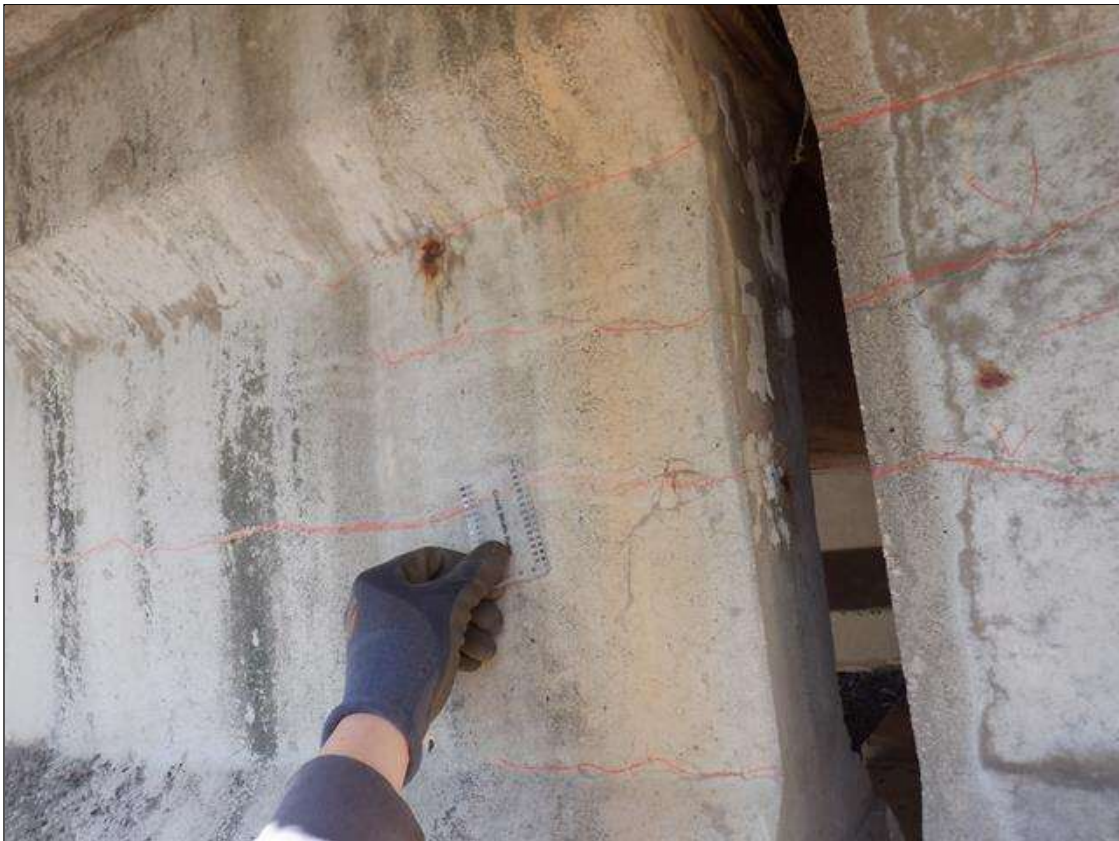
Span 3 Beam 1: (4) UP TO 3 FEET X 0.006 INCHES LONGITUDINAL CRACKS IN WEST FACE OF WEB EXTENDING FROM BENT 2.

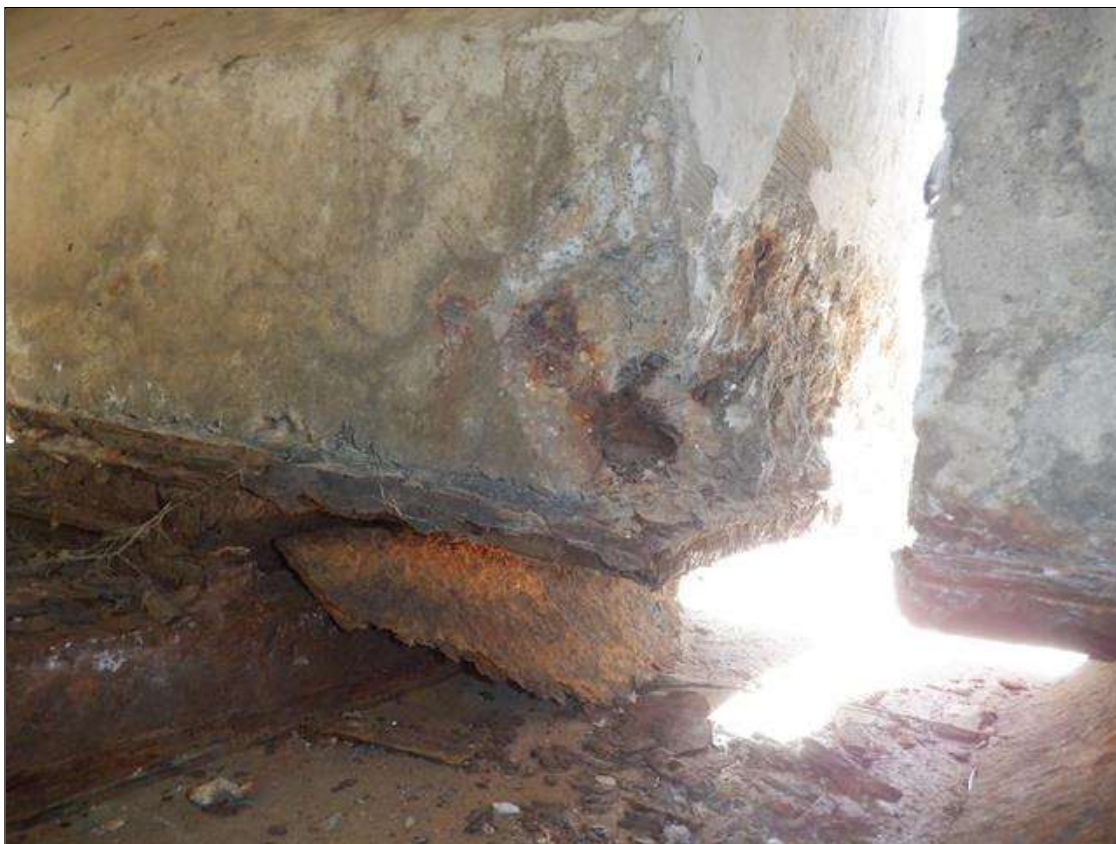
Span 2 Beam 1: (PAR) 3 INCHES X 5 INCHES X UP TO 18 INCHES SPALL WITH EXPOSED PRESTRESSED STRANDS ON THE NORTH FACE OF THE BOTTOM FLANGE AT BENT 2.

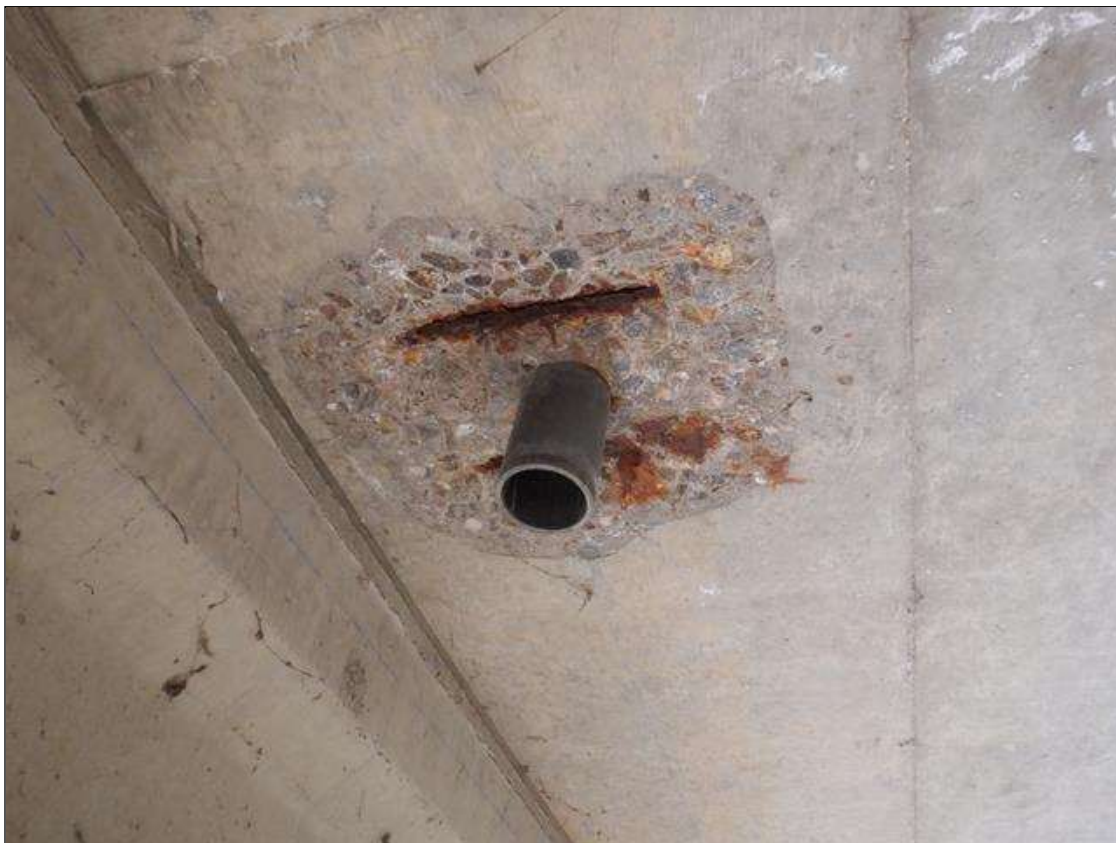
Span 3 Deck: 2 FEET X UP TO 2 FEET X 1 INCHES SPALL WITH EXPOSED REINFORCING ON DECK UNDERSIDE AROUND FIRST DRAIN BETWEEN BEAMS 1 AND 2 MEASURED FROM BENT 2.

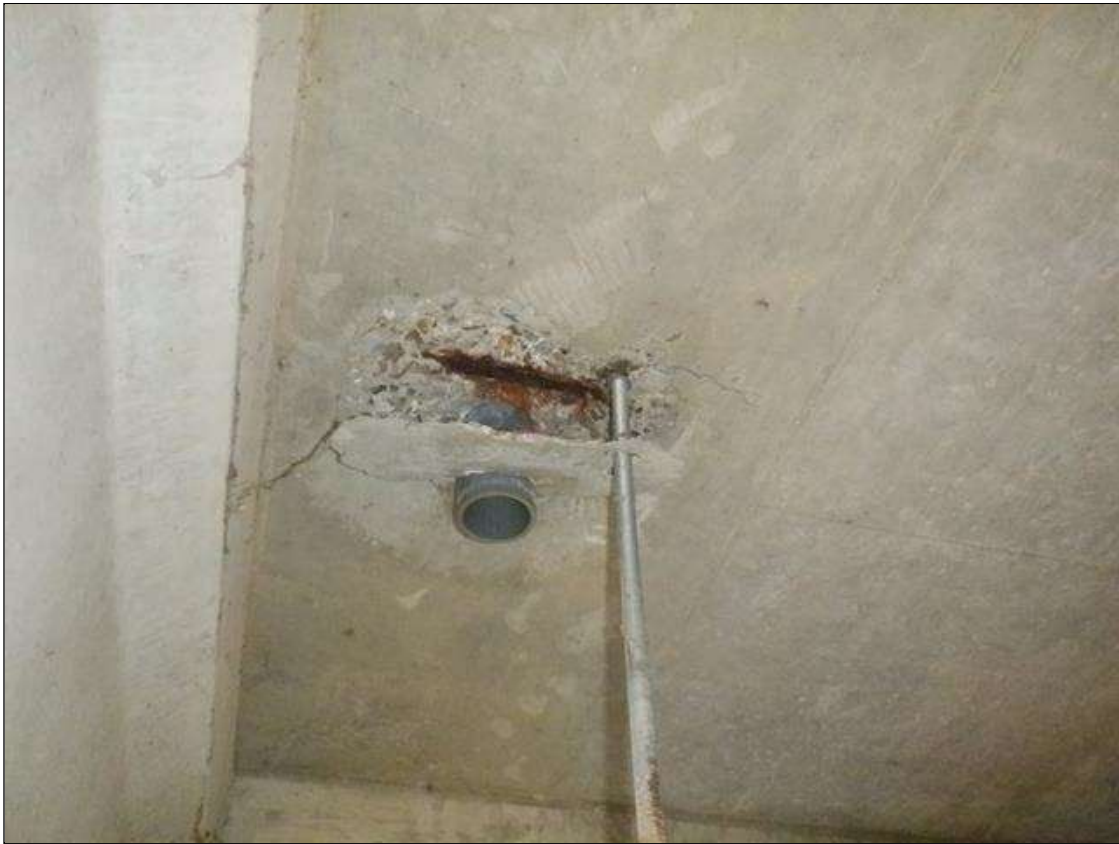
Span 3 Deck: 2 FEET X UP TO 1 FEET X 1 INCHES SPALL WITH EXPOSED REINFORCING ON DECK UNDERSIDE AROUND THIRD DRAIN BETWEEN BEAMS 7 AND 8 MEASURED FROM BENT 3.

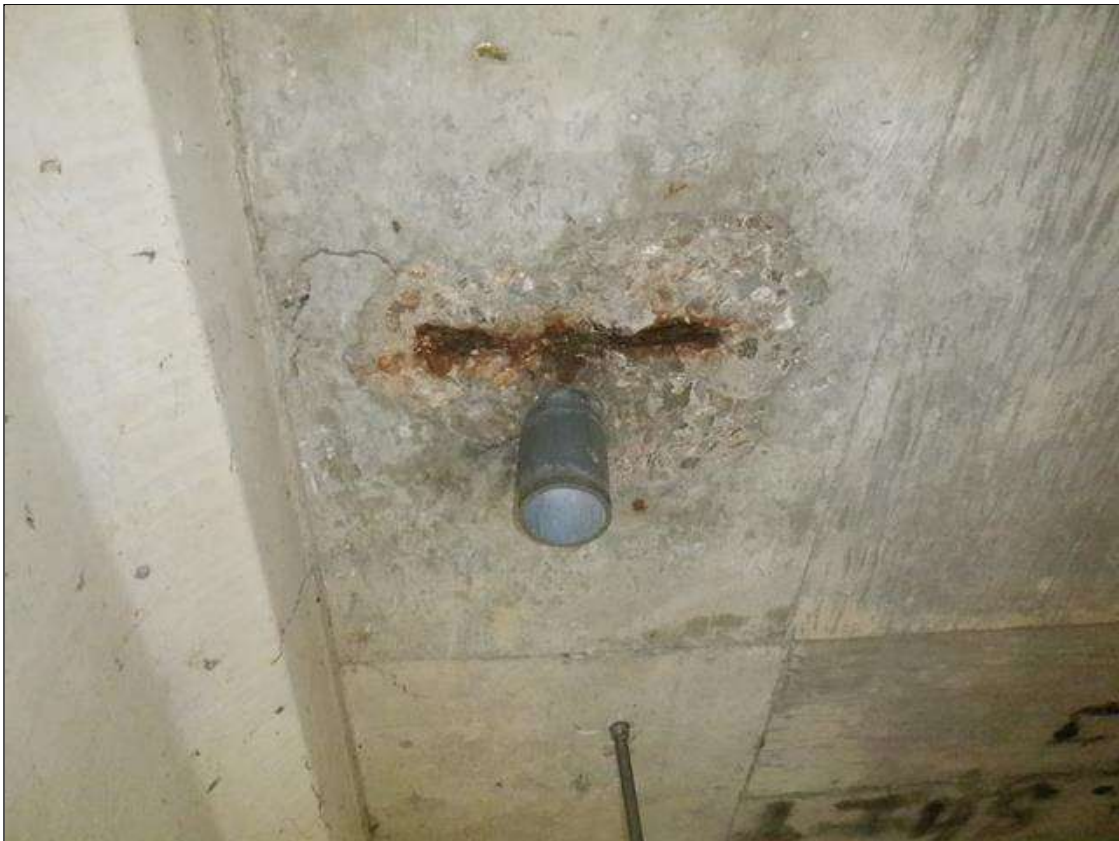
Span 2 Deck: 16 INCHES X UP TO 10 INCHES X 1 INCHES SPALL WITH EXPOSED REINFORCING ON DECK UNDERSIDE AROUND FIRST DRAIN BETWEEN BEAMS 7 AND 8 MEASURED FROM BENT 1.

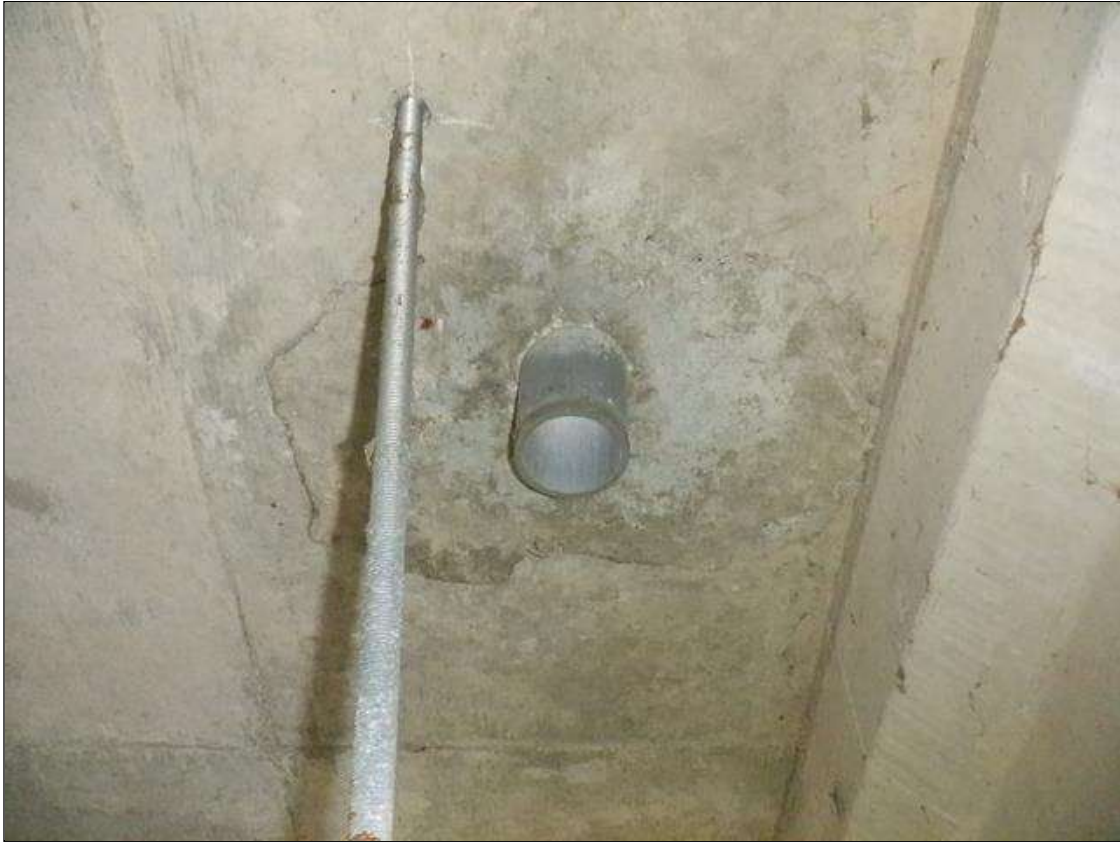
Span 2 Deck: 10 SQUARE FEET OF DELAMINATIONS ON DECK UNDERSIDE AT RANDOM THROUGHOUT DRAIN LOCATIONS BETWEEN BEAMS 7 AND 8.

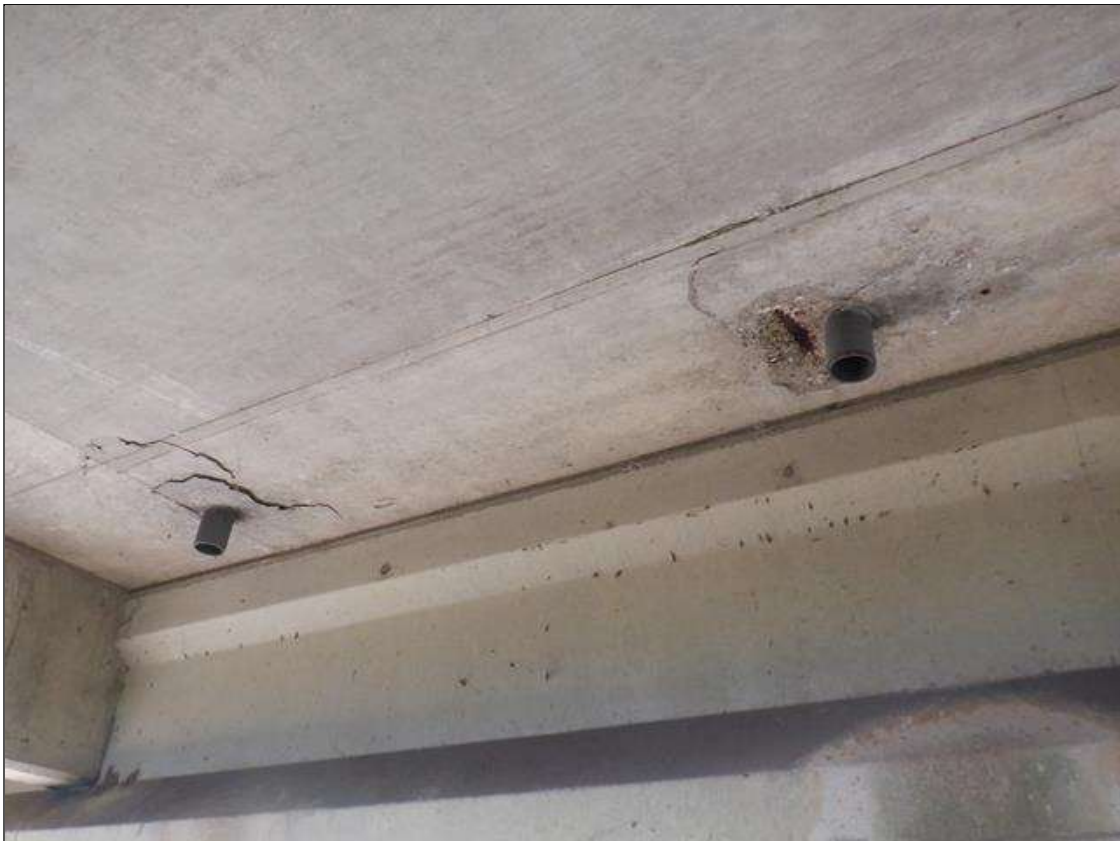
Span 2 Deck: 18 INCHES X UP TO 12 INCHES X 2 INCHES SPALL WITH EXPOSED REINFORCING ON DECK UNDERSIDE AROUND SECOND DRAIN BETWEEN BEAMS 1 AND 2 MEASURED FROM BENT 2.

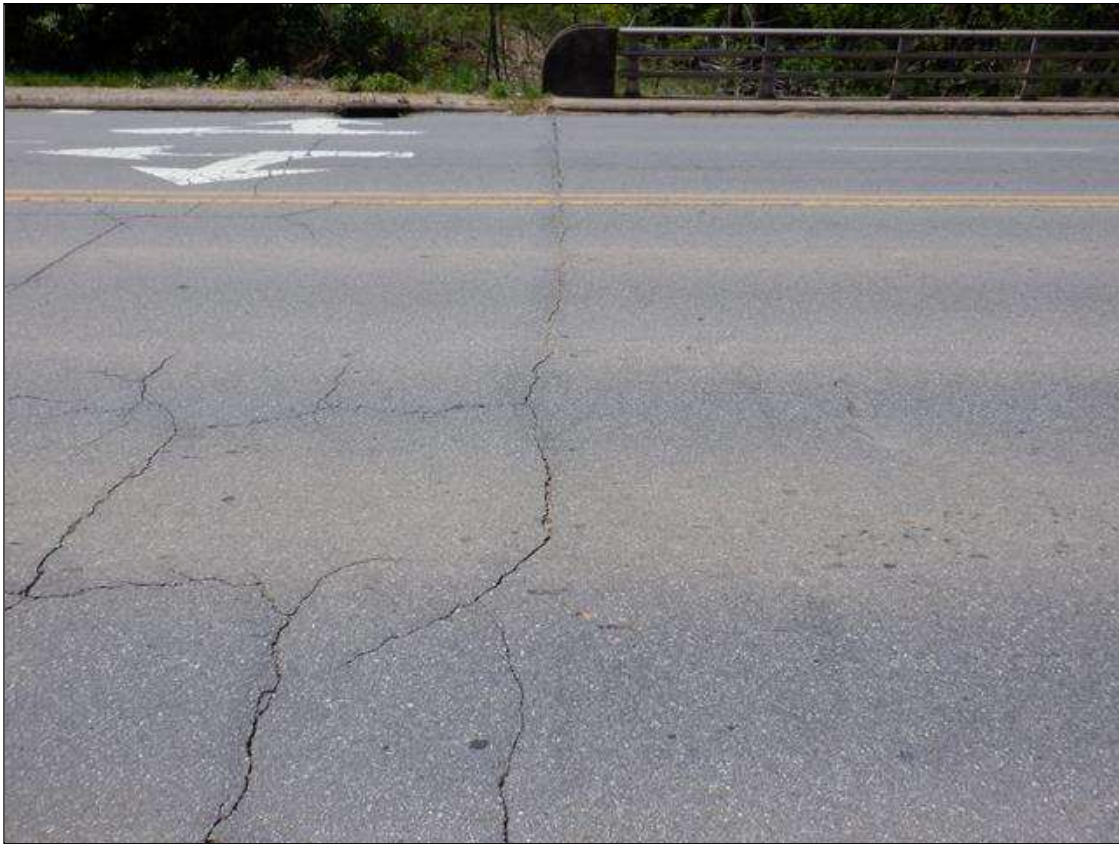
Span 1 Wearing Surface: 44 FEET X UP TO 1 INCHES TRANSVERSE CRACK AT END BENT 1.

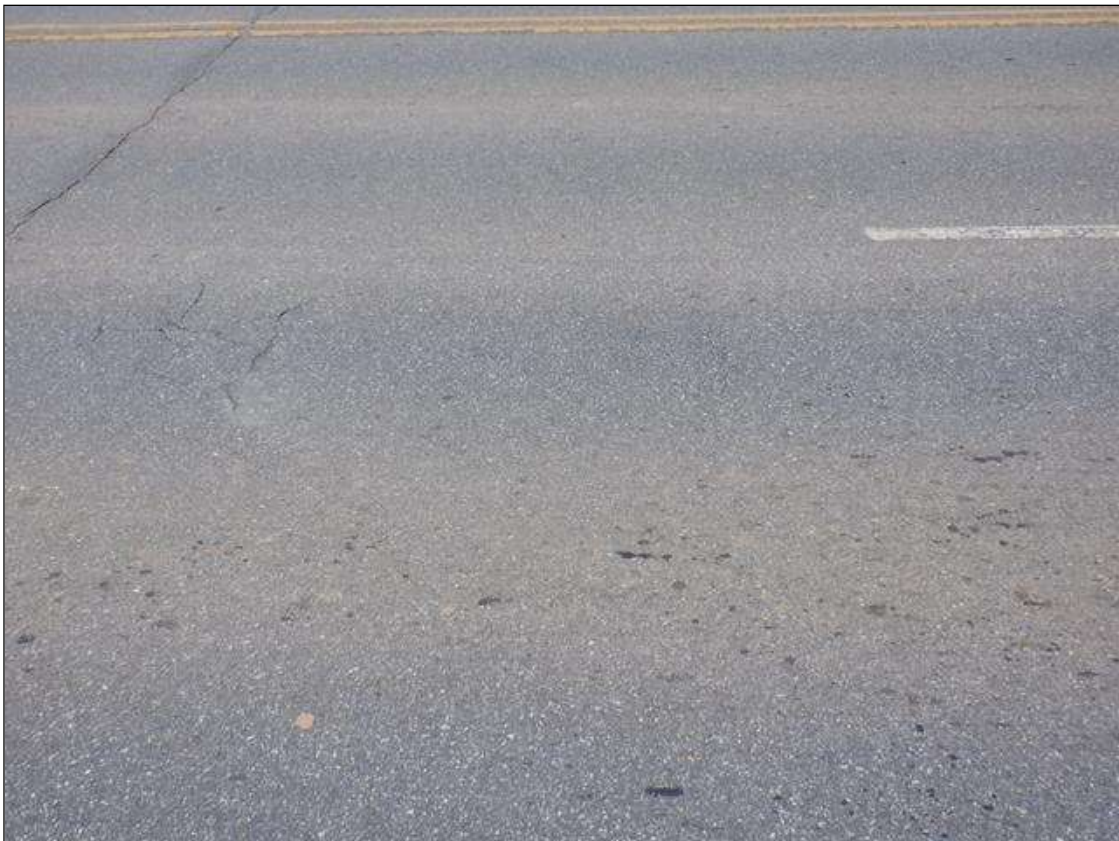
Span 1 Wearing Surface: 20 SQUARE FEET OF UP TO 1/16 INCHES MAP CRACKING AT RANDOM THROUGHOUT.

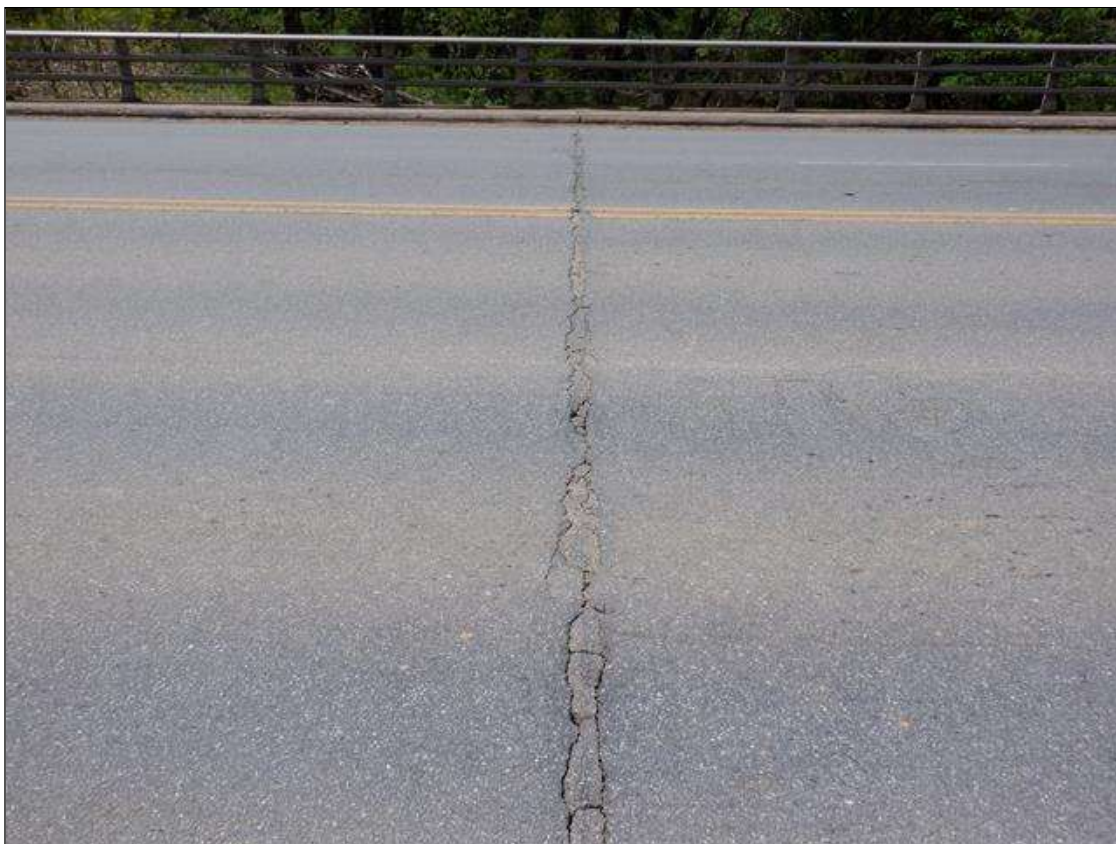
Span 2 Wearing Surface: 44 FEET X UP TO 3 INCHES TRANSVERSE CRACK AT BENT 1.

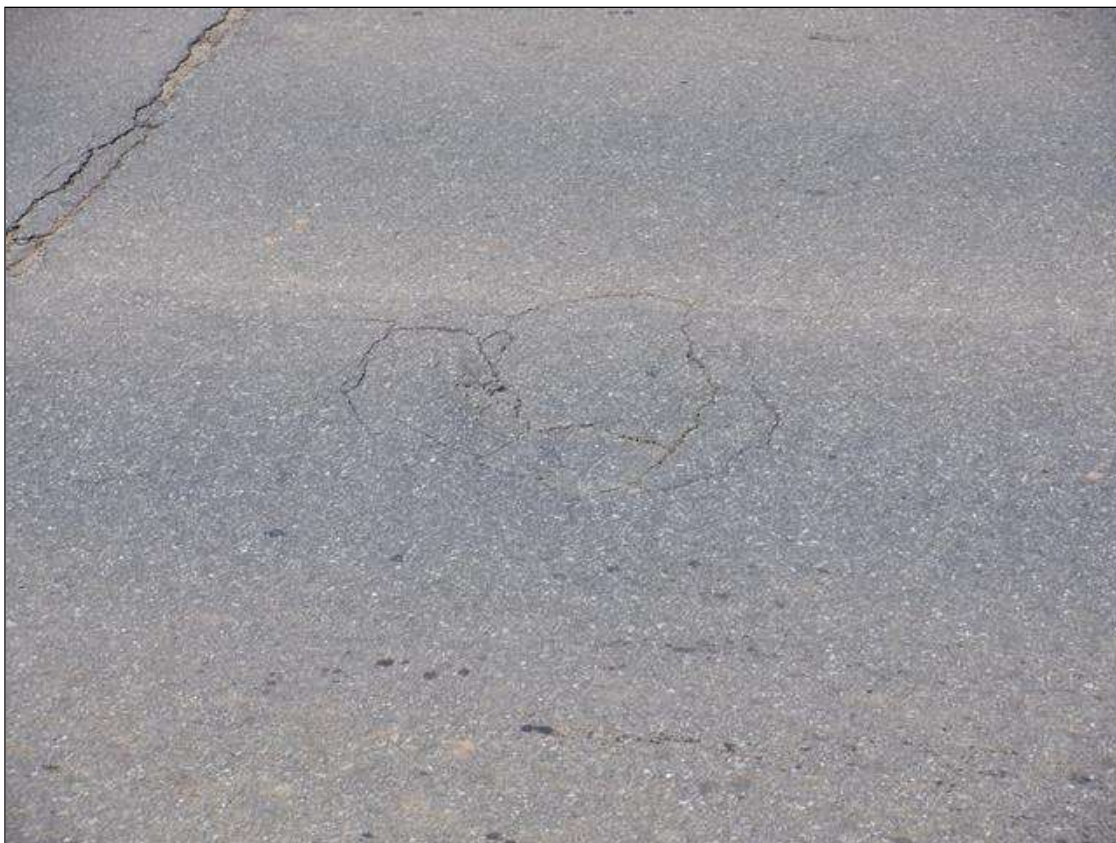
Span 2 Wearing Surface: 50 SQUARE FEET OF UP TO 1/16 INCHES MAP CRACKING AT RANDOM THROUGHOUT.

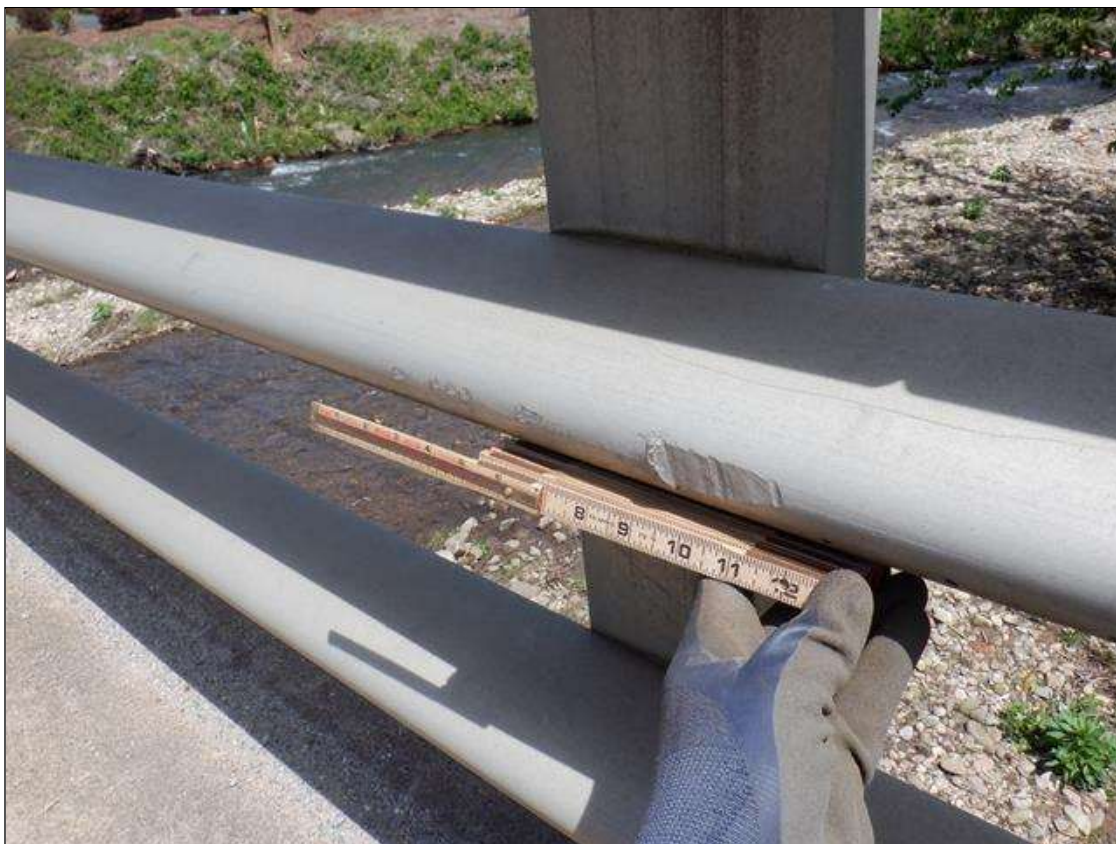
Span 2 Right Bridge Rail: 12 INCHES SCRAPE ON MID RAIL, 3 FEET FROM BENT 1.

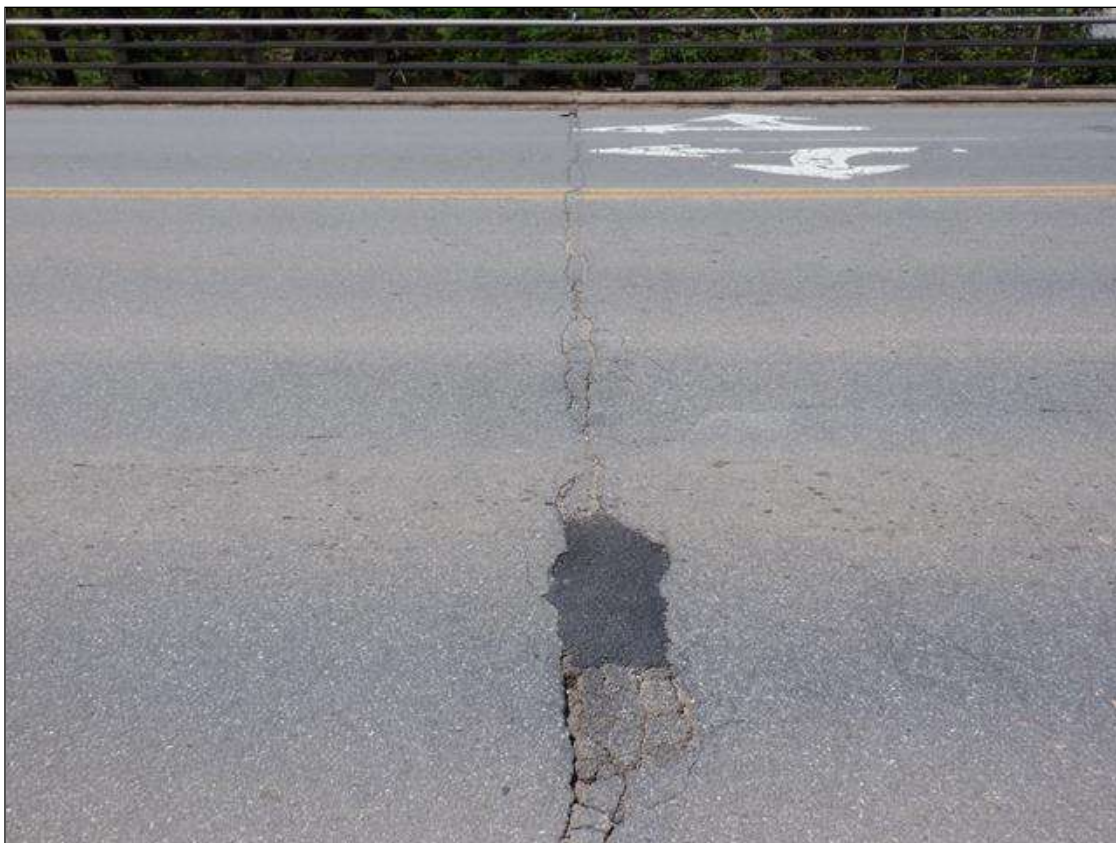
Span 3 Wearing Surface: 44 FEET X UP TO 2 INCHES TRANSVERSE CRACK AT BENT 2.

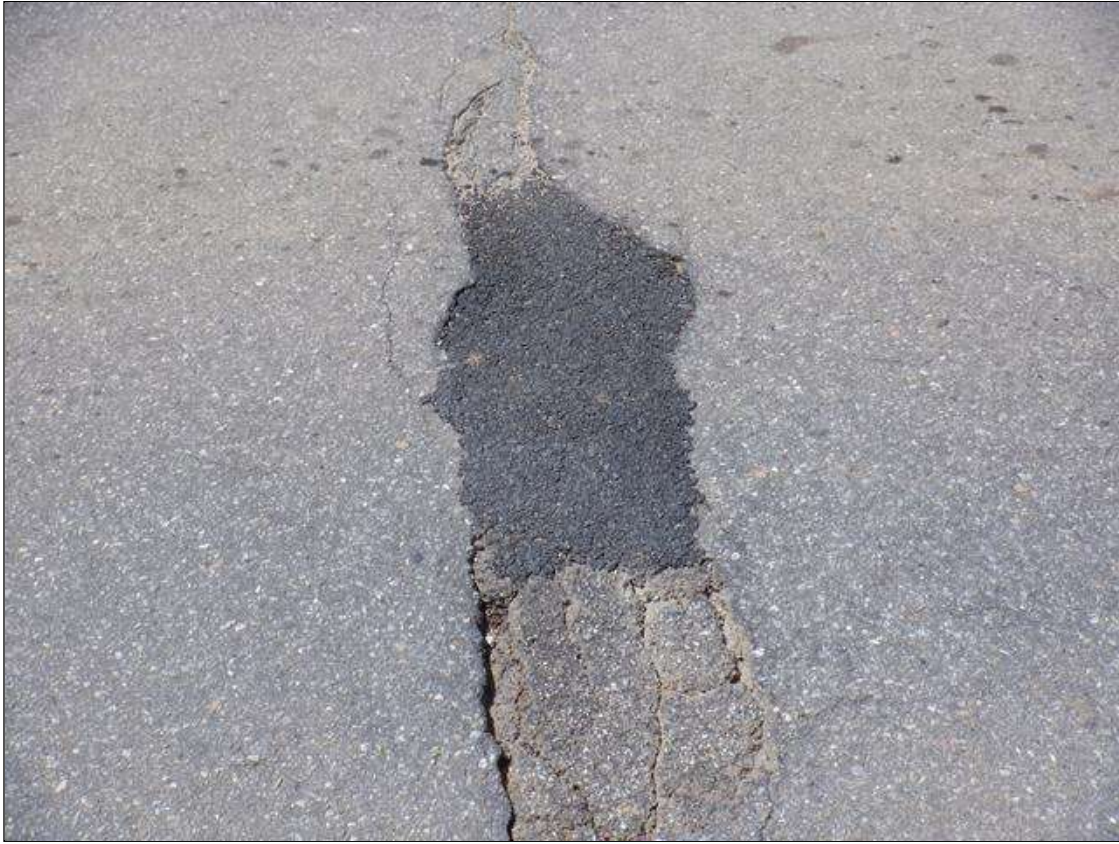
Span 3 Wearing Surface: 1 FEET X 3 FEET ASPHALT PATCH AT BENT 2, 5 FEET FROM EAST CURB

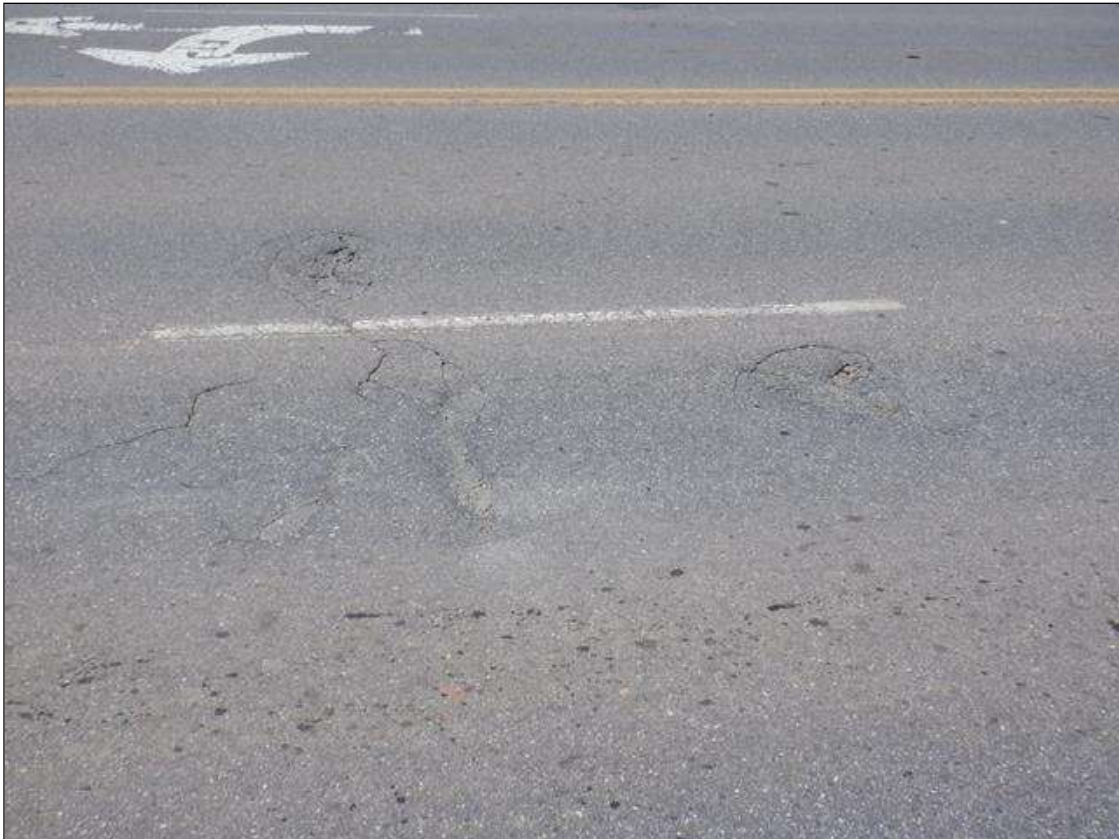
Span 3 Wearing Surface: (2) 2 FEET DIAMETER AREAS OF UP TO 1/2 INCHES ALLIGATOR CRACKING IN NORTHBOUND LANE.

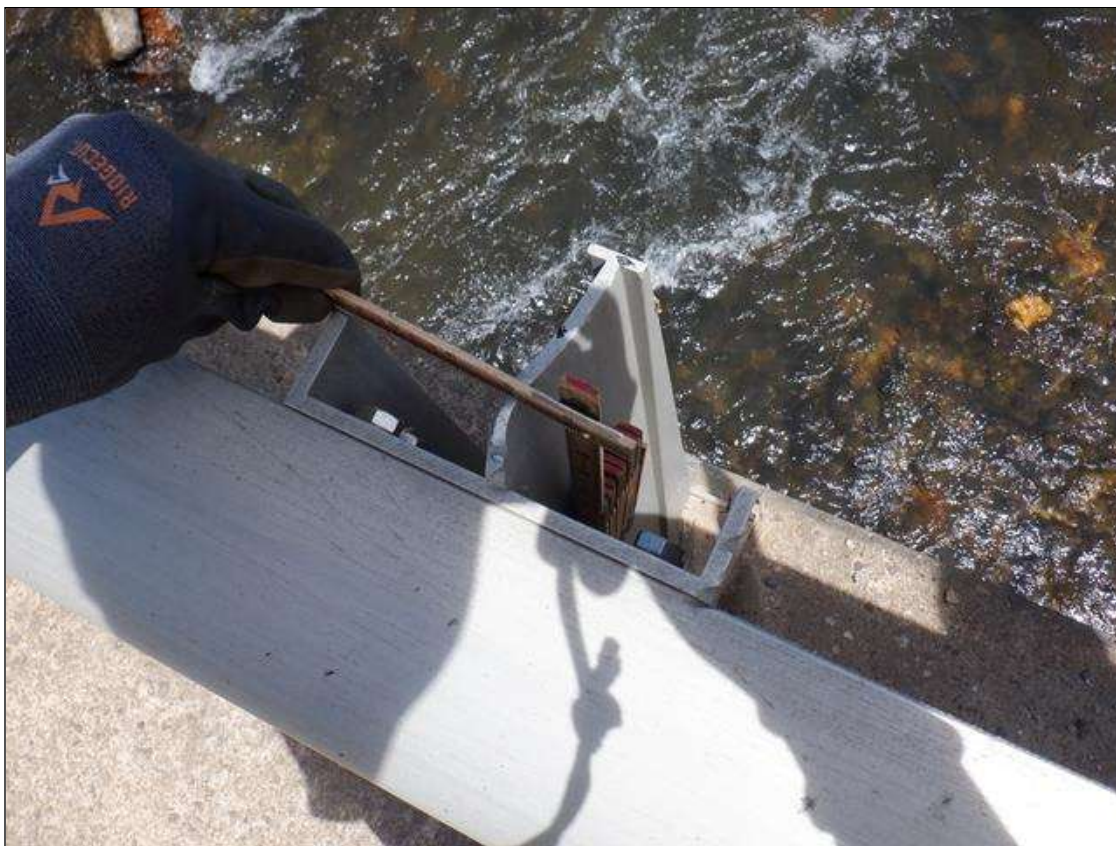
Span 3 Right Bridge Rail: UP TO 1/2 INCHES DISTORTION ON TOP OF SECOND RAIL POST MEASURED FROM BENT 3.
