NC DEPARTMENT OF TRANSPORTATION
 DIVISION OF HIGHWAYS
 STRUCTURE MANAGEMENT UNIT

ATTENTION: **PAR'S SUBMITTED FOR SPALLING WITH EXPOSED PRE-STRESSING AND CRACKING ON BEAMS**

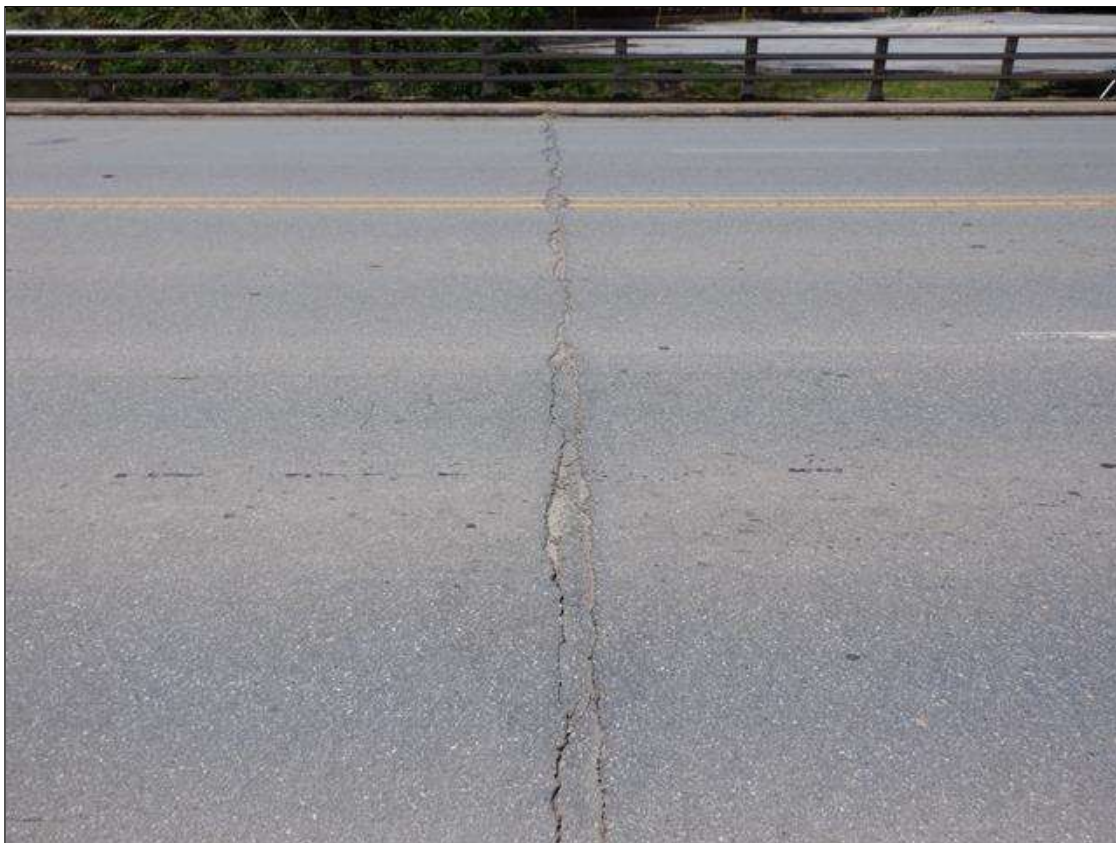
Span 4 Wearing Surface: 44 FEET X UP TO 3 INCHES TRANSVERSE CRACK AT BENT 3.

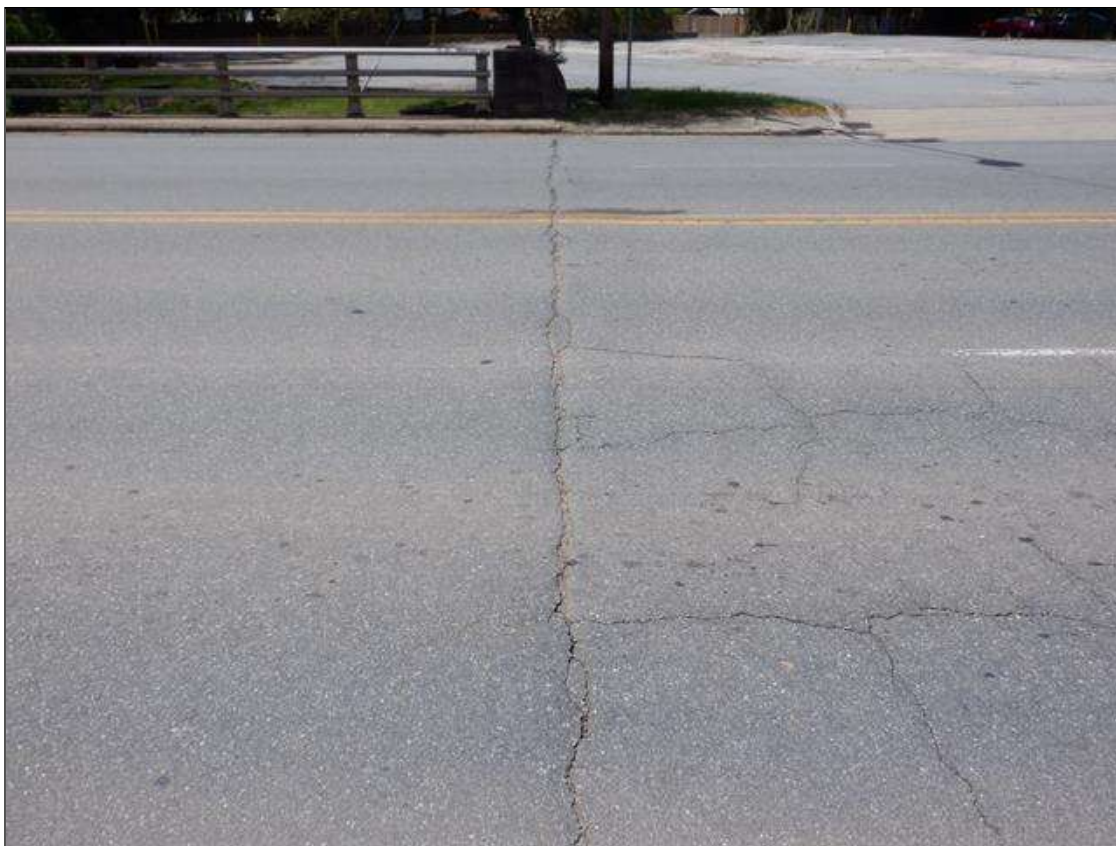
Span 4 Wearing Surface: 44 FEET X UP TO 1 INCHES TRANSVERSE CRACK AT END BENT 2.

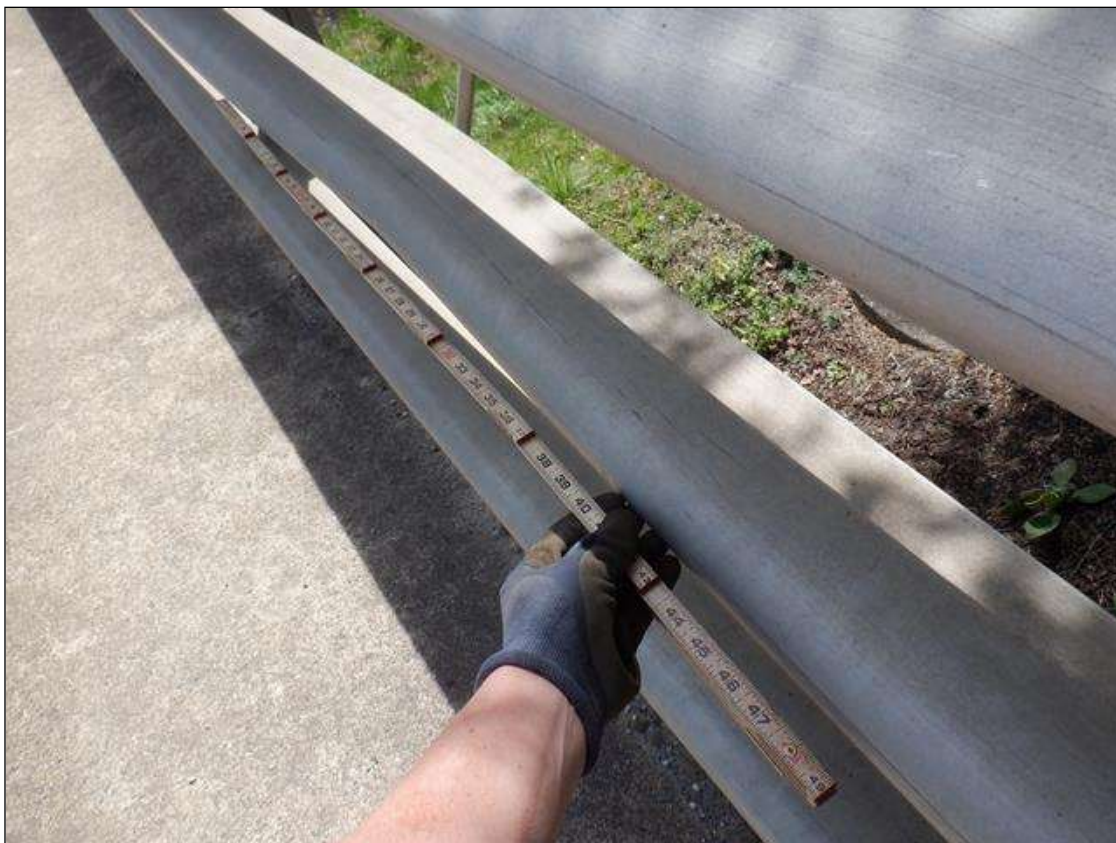
Span 4 Left Bridge Rail: 4 FEET X UP TO 1 INCHES DISTORTION OF THE MID RAIL, 5 FEET FROM END BENT 2.

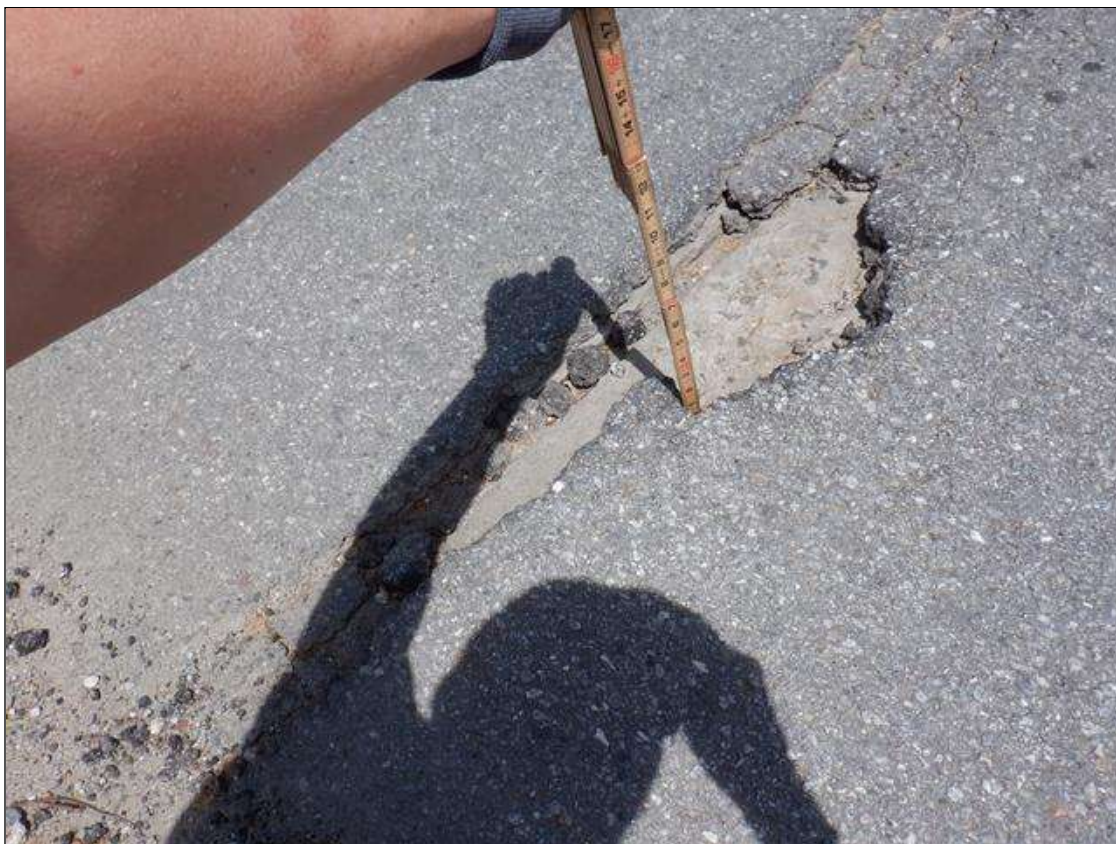
Span 3 Wearing Surface: 11 INCHES X UP TO 30 INCHES X FULL DEPTH POTHOLE IN SOUTHBOUND LANE AT BENT 2, 18 INCHES FROM WEST CURB.

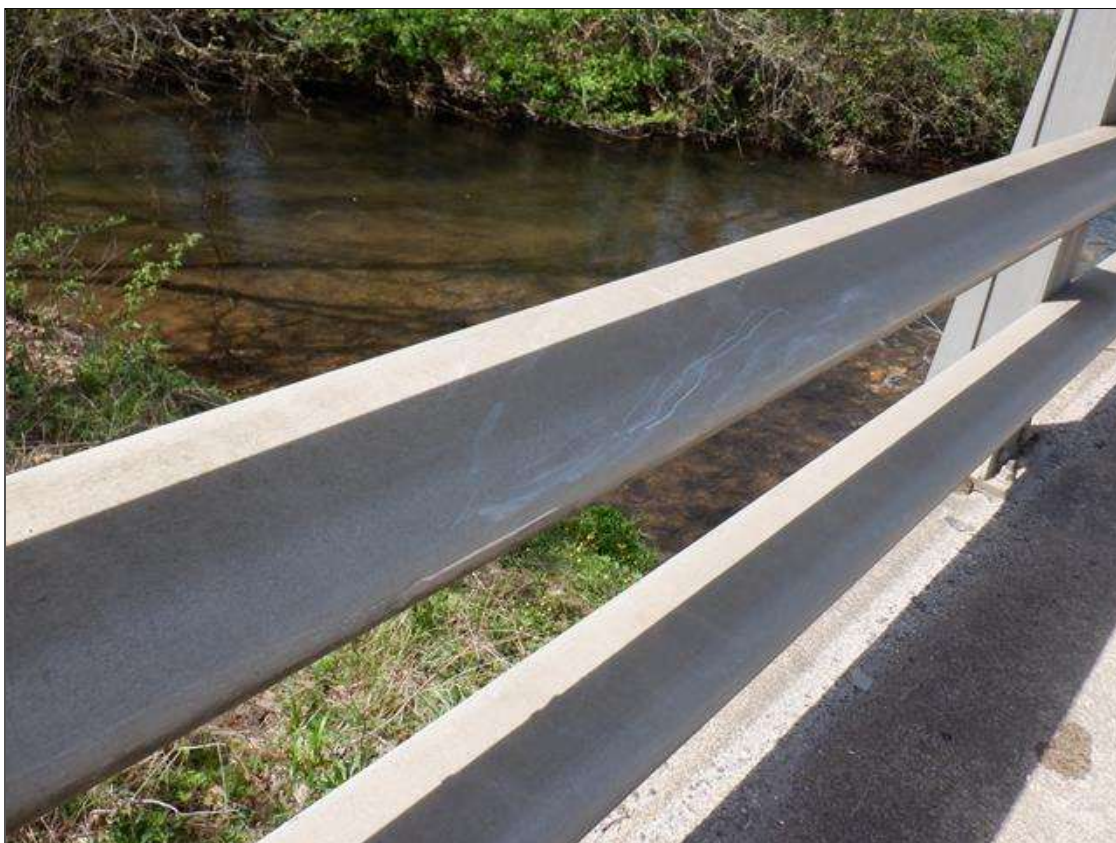
Span 2 Left Bridge Rail: (3) UP TO 2 FEET SCRAPES ON THE MID RAIL, 6 FEET FROM BENT 1.

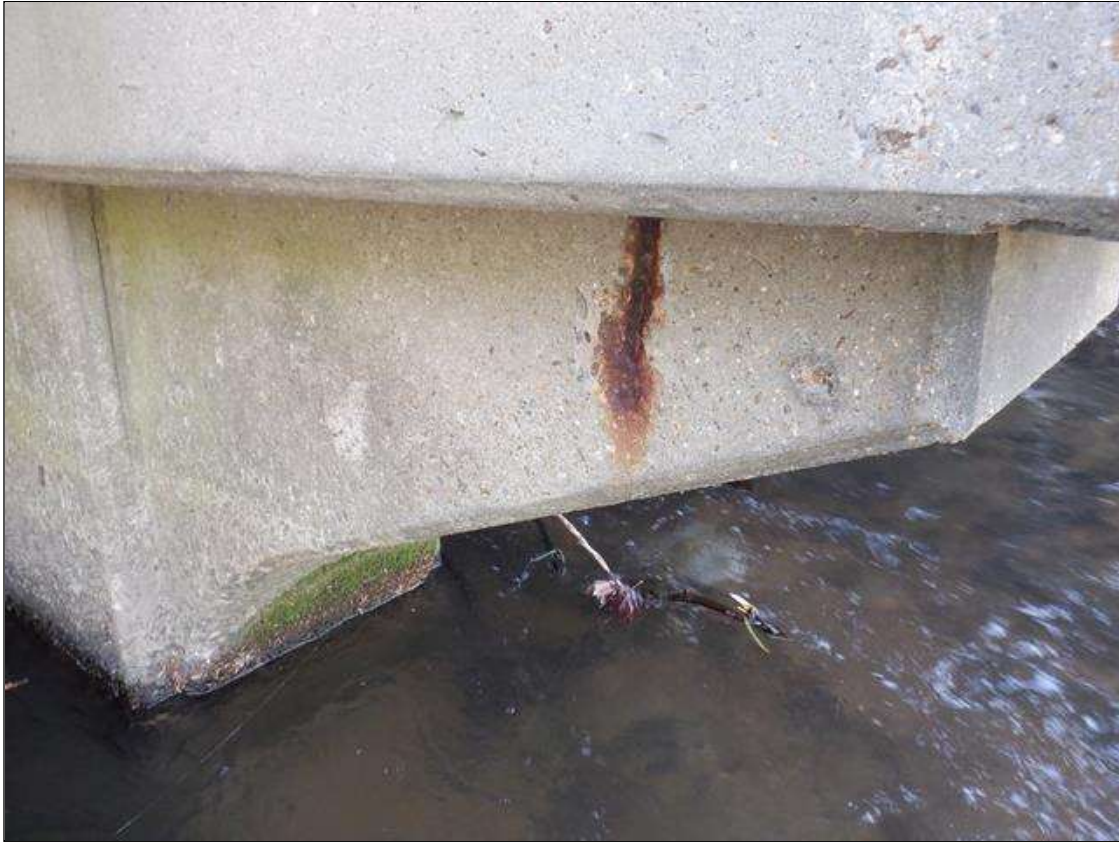
Bent 3 Cap 1: 2 INCHES X UP TO 6 INCHES X 1 INCHES SPALL WITH EXPOSED REINFORCING ON SOUTH FACE OF EAST OVERHANG.

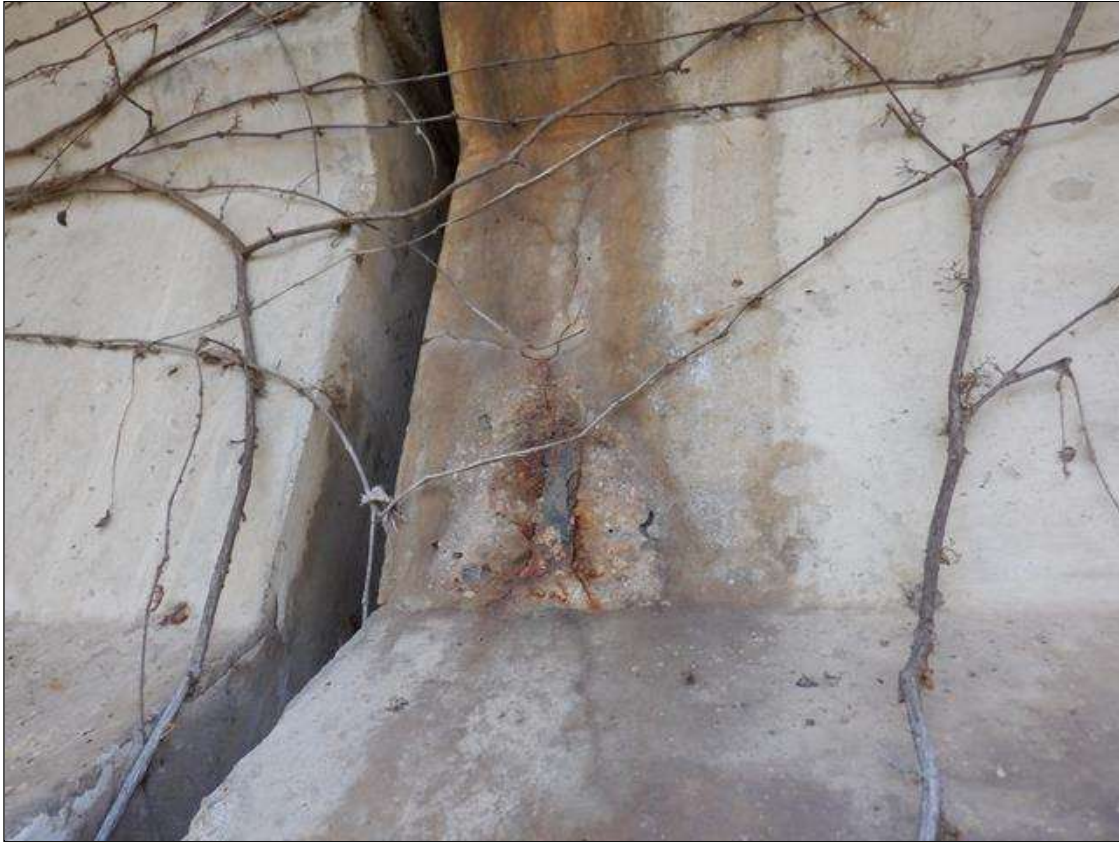
Span 4 Beam 8: 7 INCHES X 6 INCHES X UP TO 3/4 INCHES SPALL WITH EXPOSED REINFORCING WITH ADJACENT 8 INCHES X 10 INCHES AREA OF UP TO 0.008 INCHES MAP CRACKING ON EAST FACE OF WEB AT BENT 3.

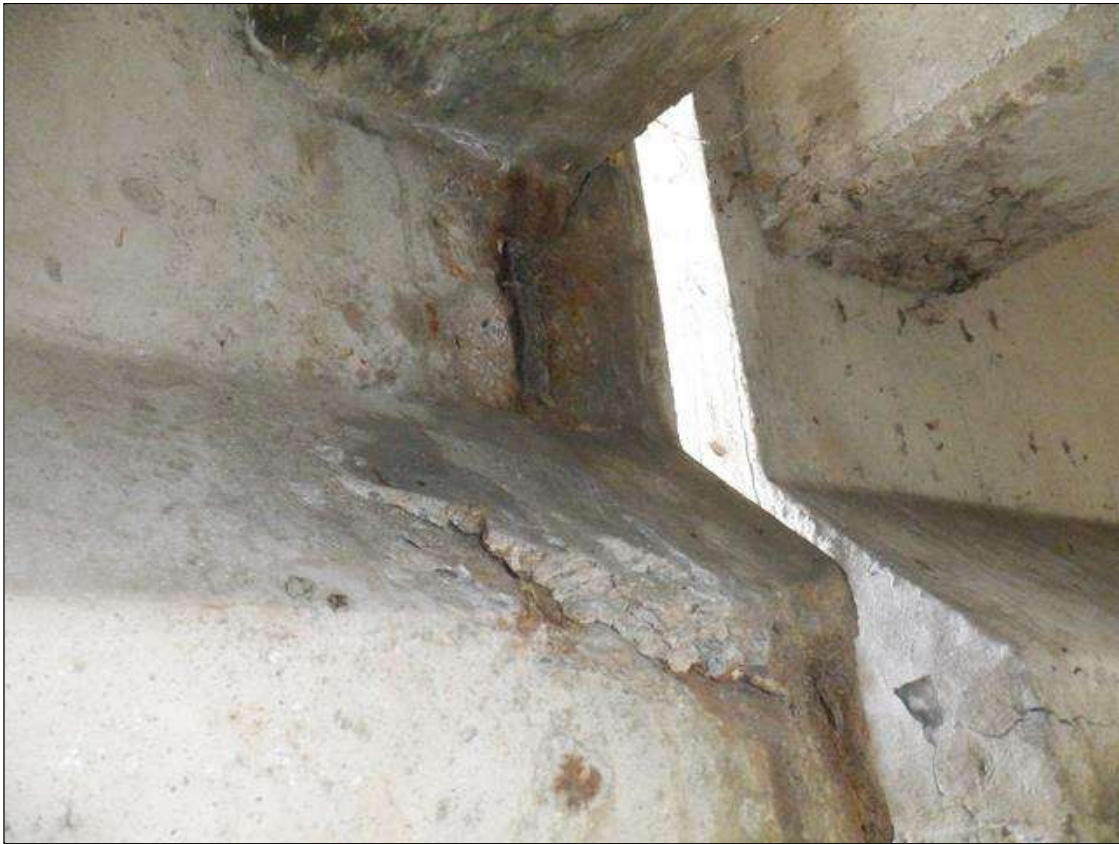
Span 4 Beam 8: (2) UP TO 14 INCHES X 16 INCHES X 1.5 INCHES SPALLS WITH EXPOSED REINFORCING ON WEST FACE OF BOTTOM FLANGE, CHAMFER, AND THE WEB AT BENT 3.

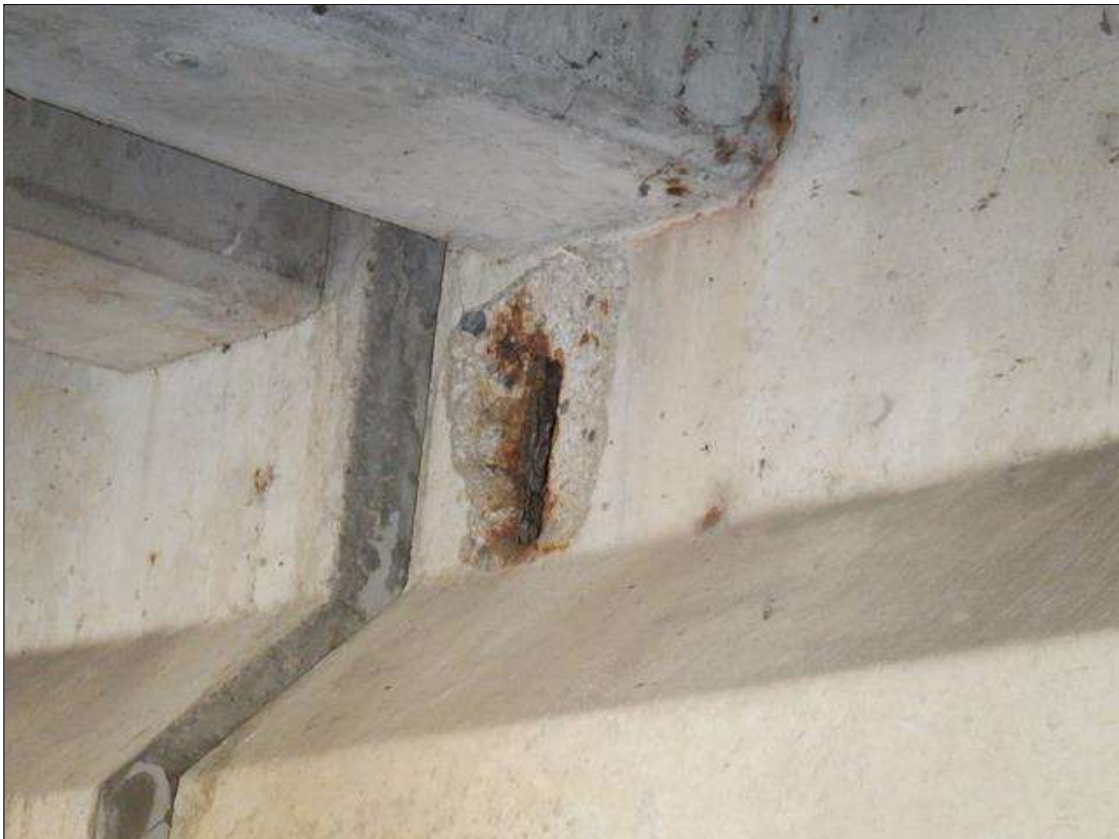
Span 4 Beam 6: 6 INCHES X UP TO 8 INCHES X 1 INCHES SPALL WITH EXPOSED REINFORCING ON EAST FACE AT BENT 3.

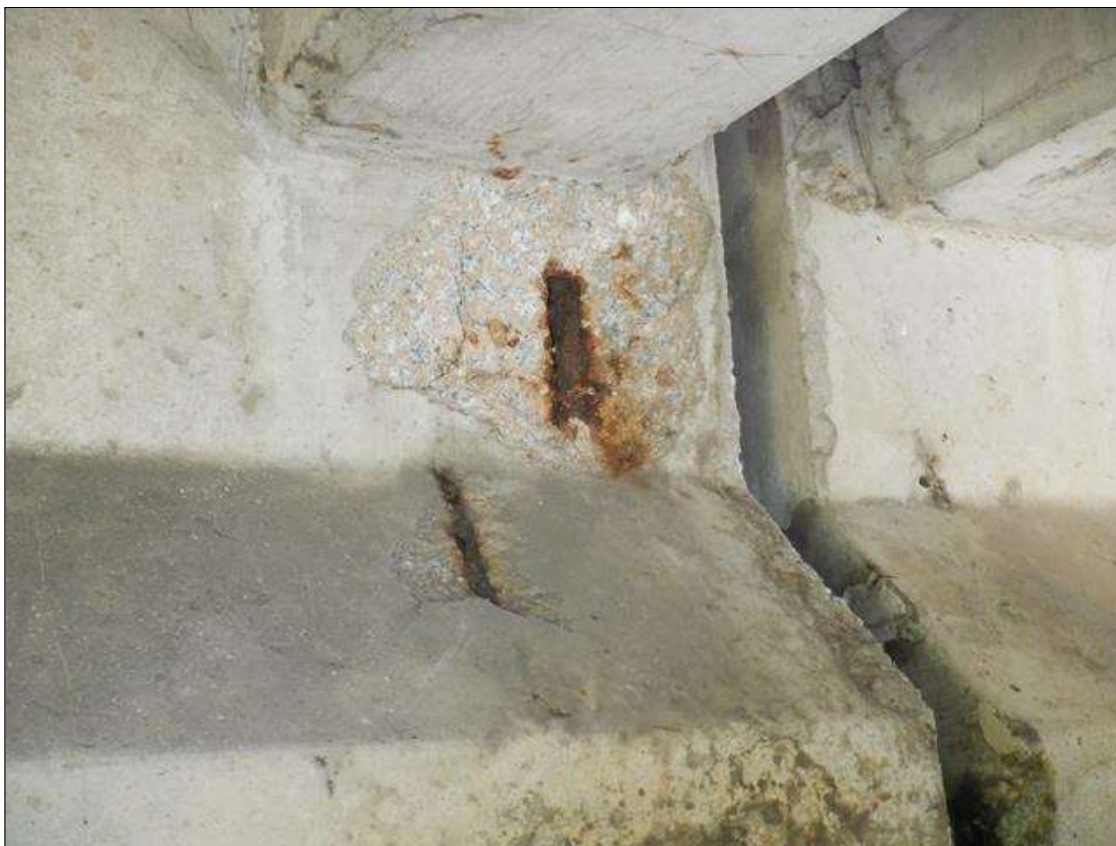
Span 4 Beam 2: (2) UP TO 10 INCHES DIAMETER X 1 INCHES SPALLS WITH EXPOSED REINFORCING ON WEST FACE AT BENT 3.

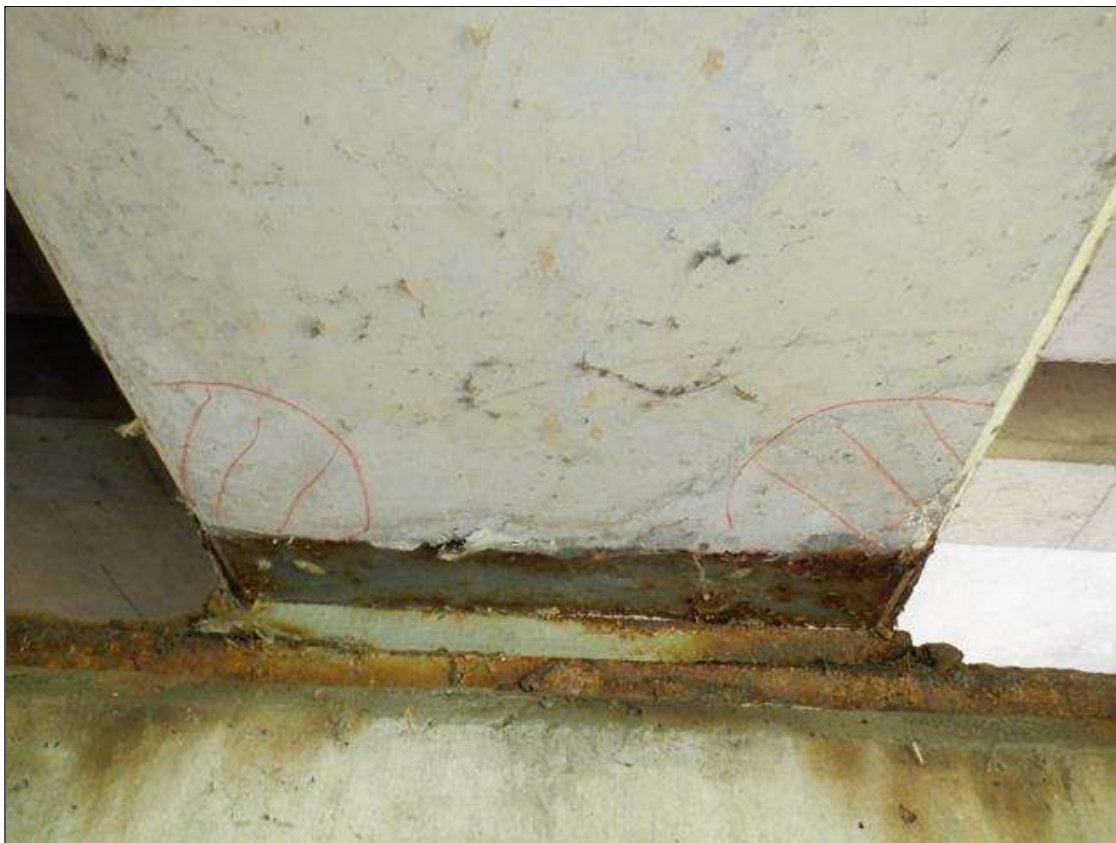
Span 4 Beam 2: (2) UP TO 3 INCHES DIAMETER DELAMINATIONS ON BOTTOM FACE, 2 FEET FROM BENT 3.

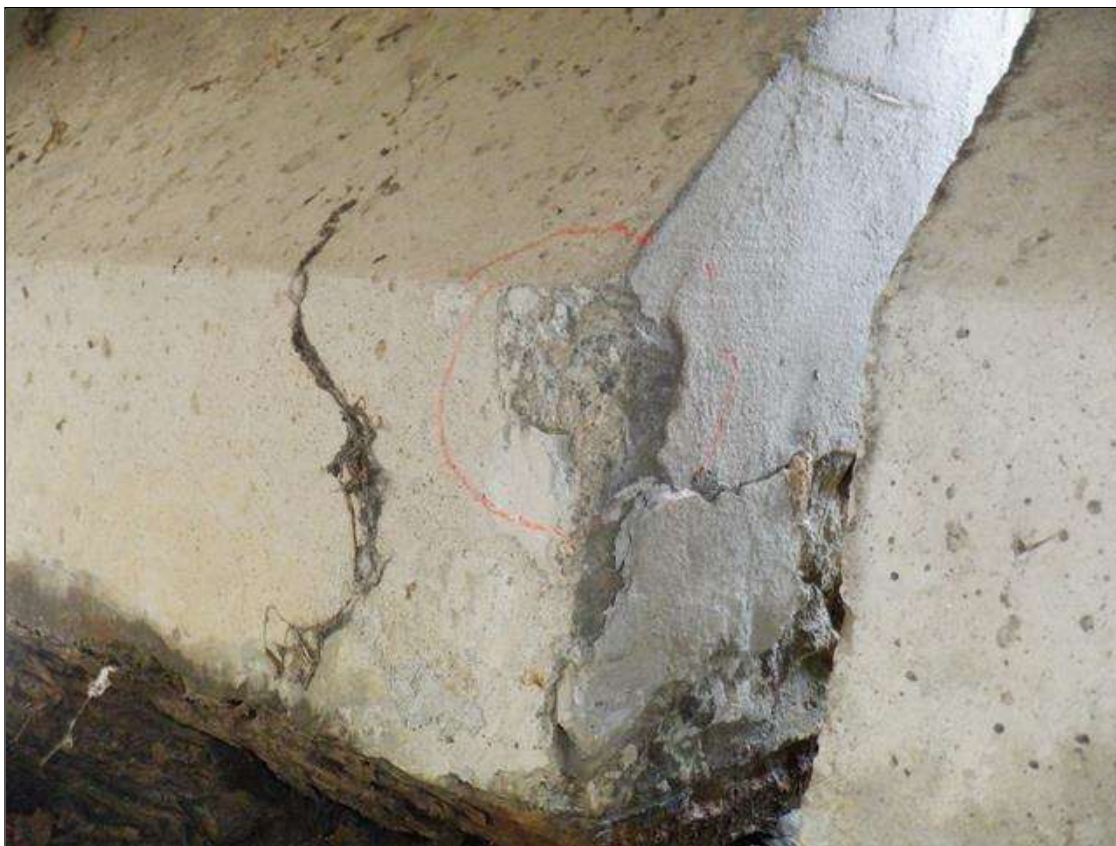
Span 3 Beam 1: 3 INCHES DIAMETER X 1/2 INCHES SPALL IN NORTHEAST CORNER OF BOTTOM FLANGE AT BENT 3

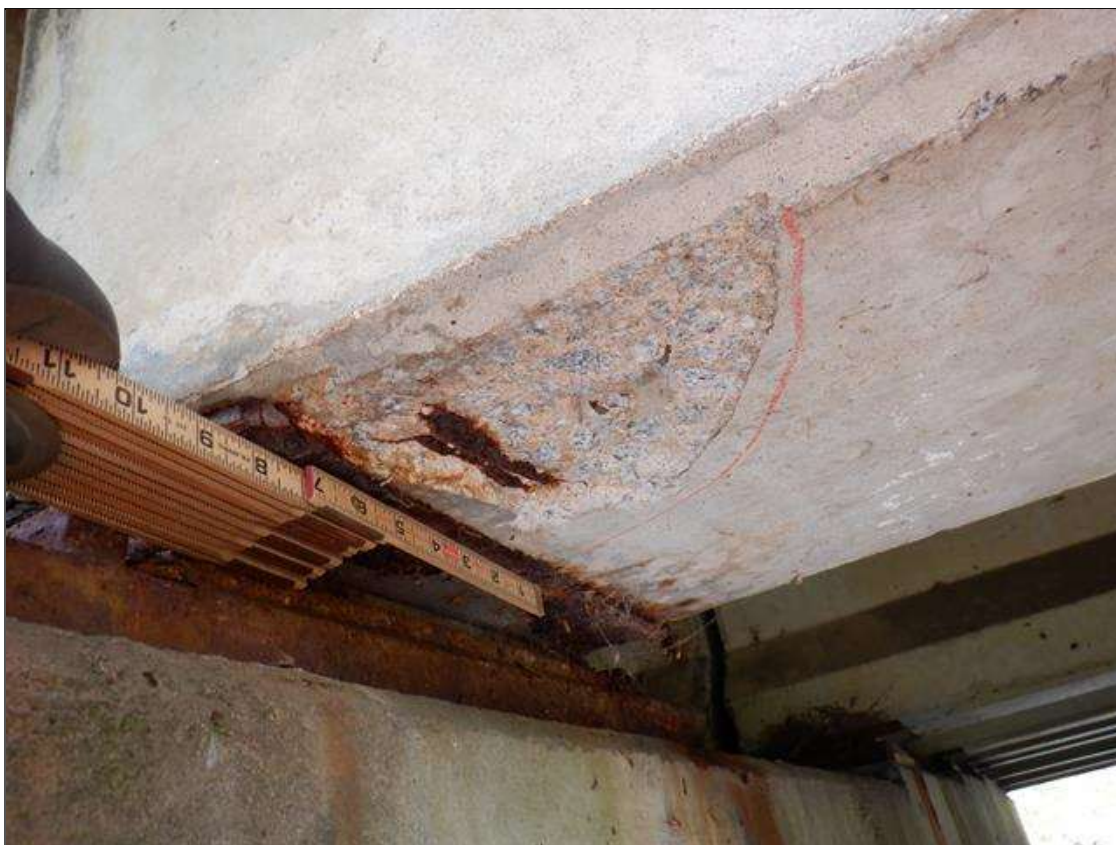
Span 3 Beam 1: 8 INCHES DIAMETER X UP TO 1/2 INCHES SPALL IN UNDERSIDE OF BOTTOM FLANGE, 15 INCHES FROM BENT 3.

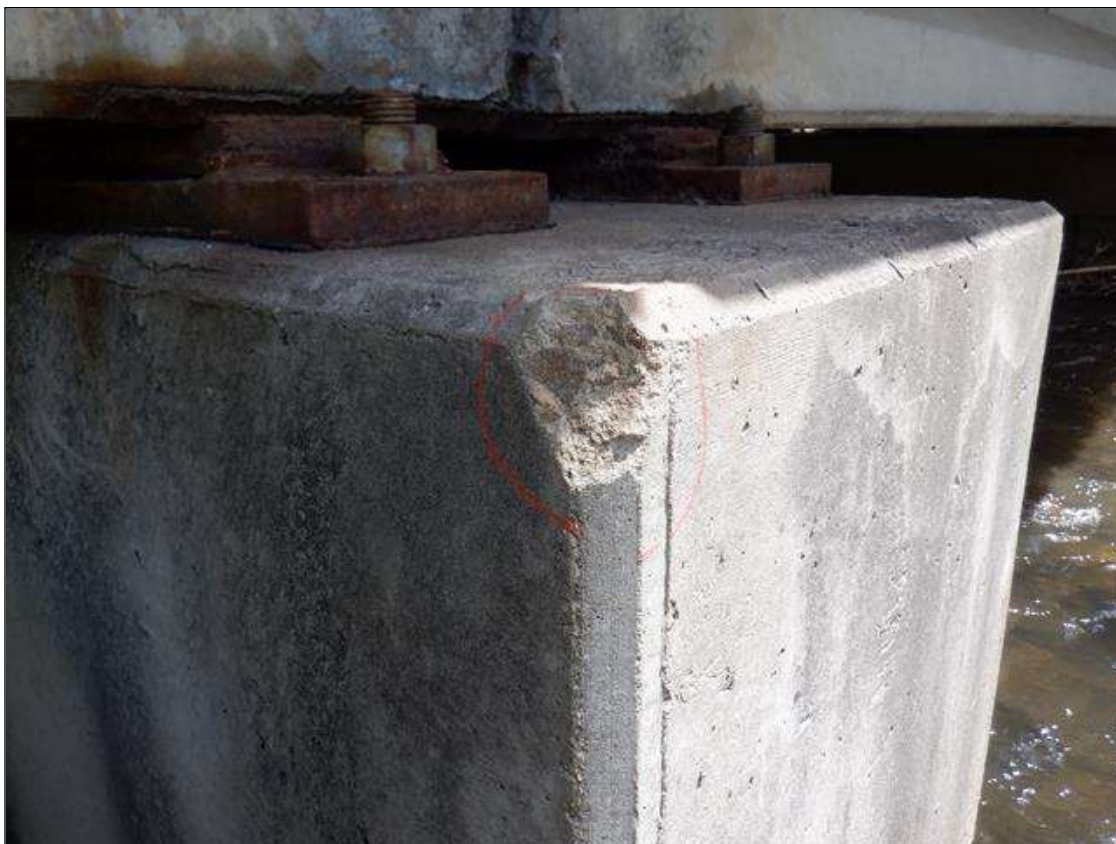
Bent 3 Cap 1: 3 INCHES DIAMETER X 1/2 INCHES SPALL IN TOP OF NORTHWEST CORNER.

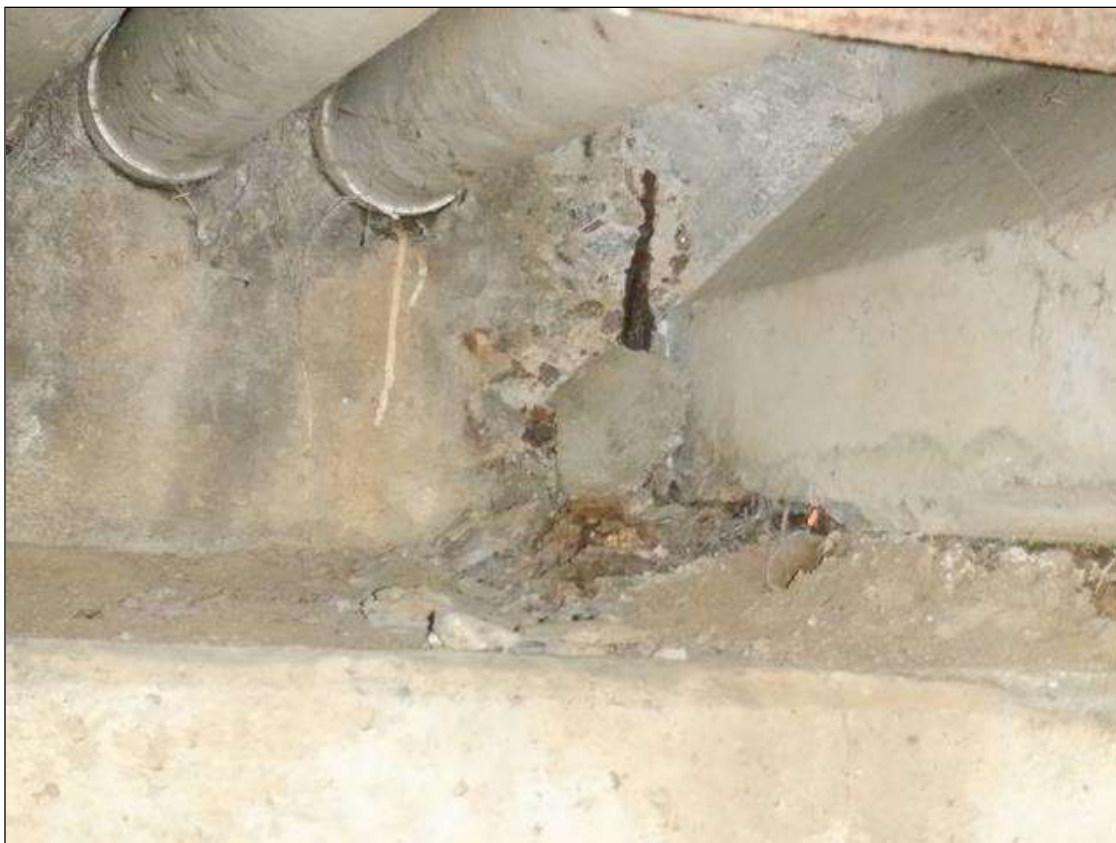
End Bent 2 Abutment: 6 INCHES X UP TO 12 INCHES X 1 INCHES SPALL WITH EXPOSED REINFORCING ON SOUTH FACE BETWEEN BEAMS 7 AND 8, NEAR BEAM 8.

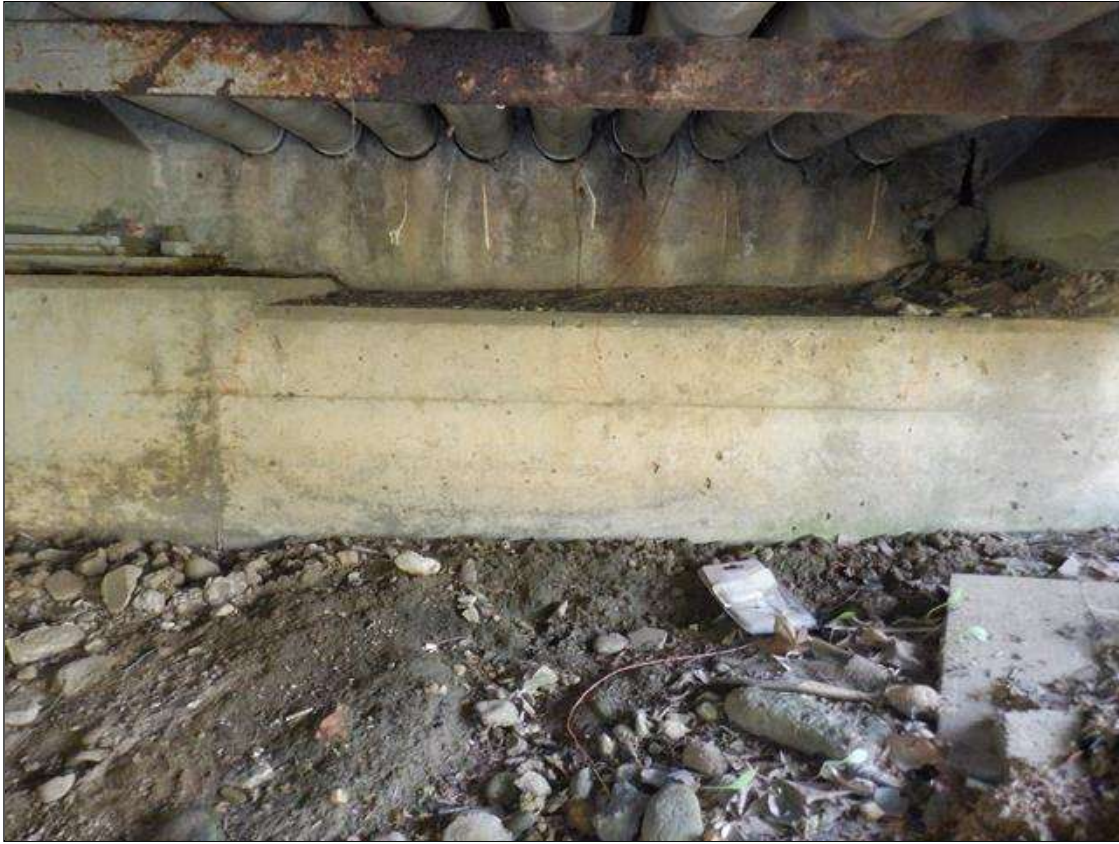
End Bent 2 Cap 1: (3) UP TO 10 INCHES X 1/64 INCHES VERTICAL CRACKS ON SOUTH FACE BETWEEN BEAMS 7 AND 8.

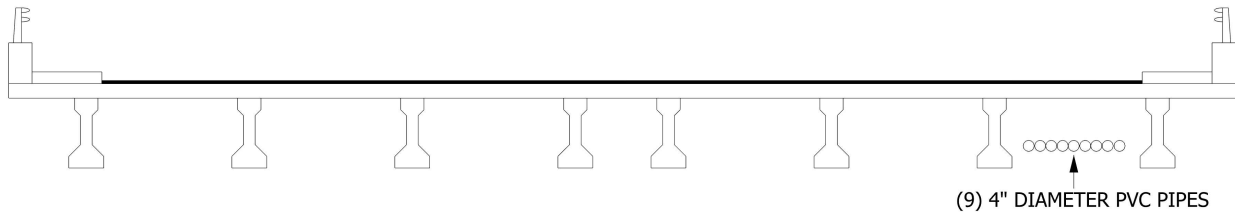
Measurements for Span #	1	Spans 2-4 Similar	
Deck Thickness	7.5in	Left Overhang	3.33ft
Top of Rail to Bottom of Beam (Avg)	8.58ft	Right Overhang	3.33ft

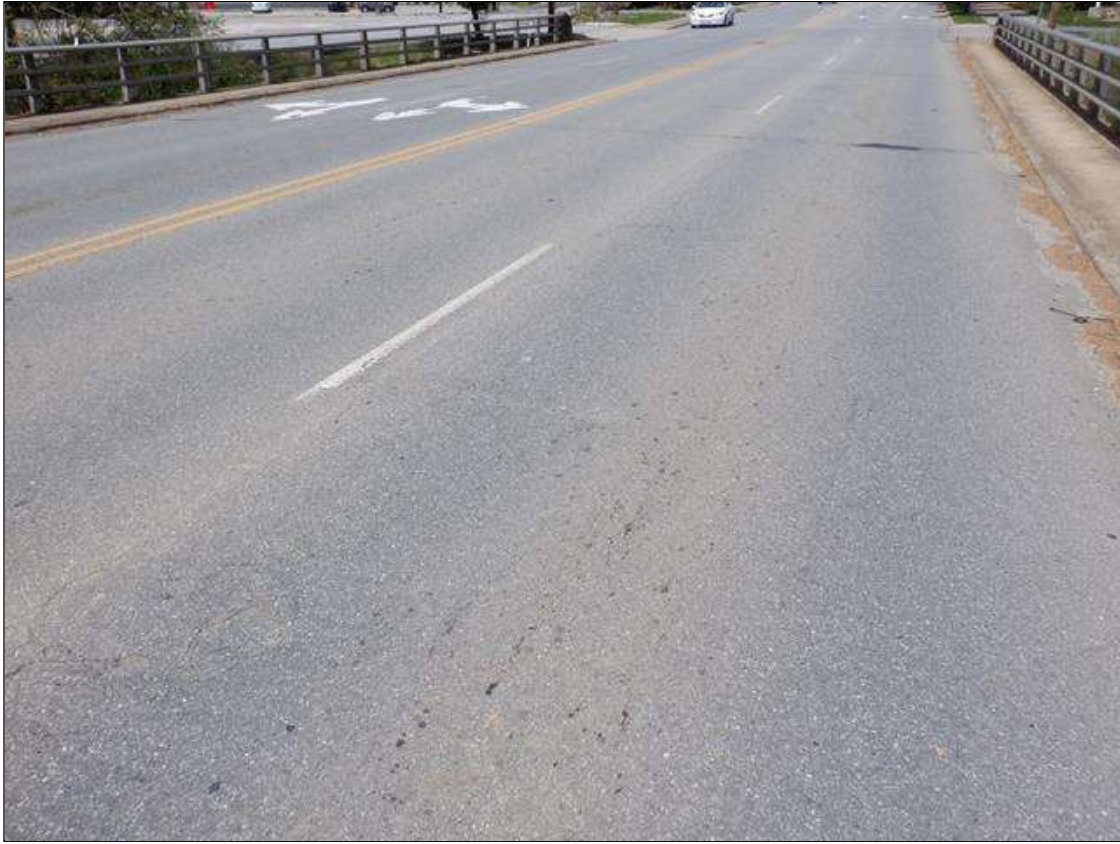
SPAN 2 ASPHALT WEARING SURFACE LOOKING NORTH

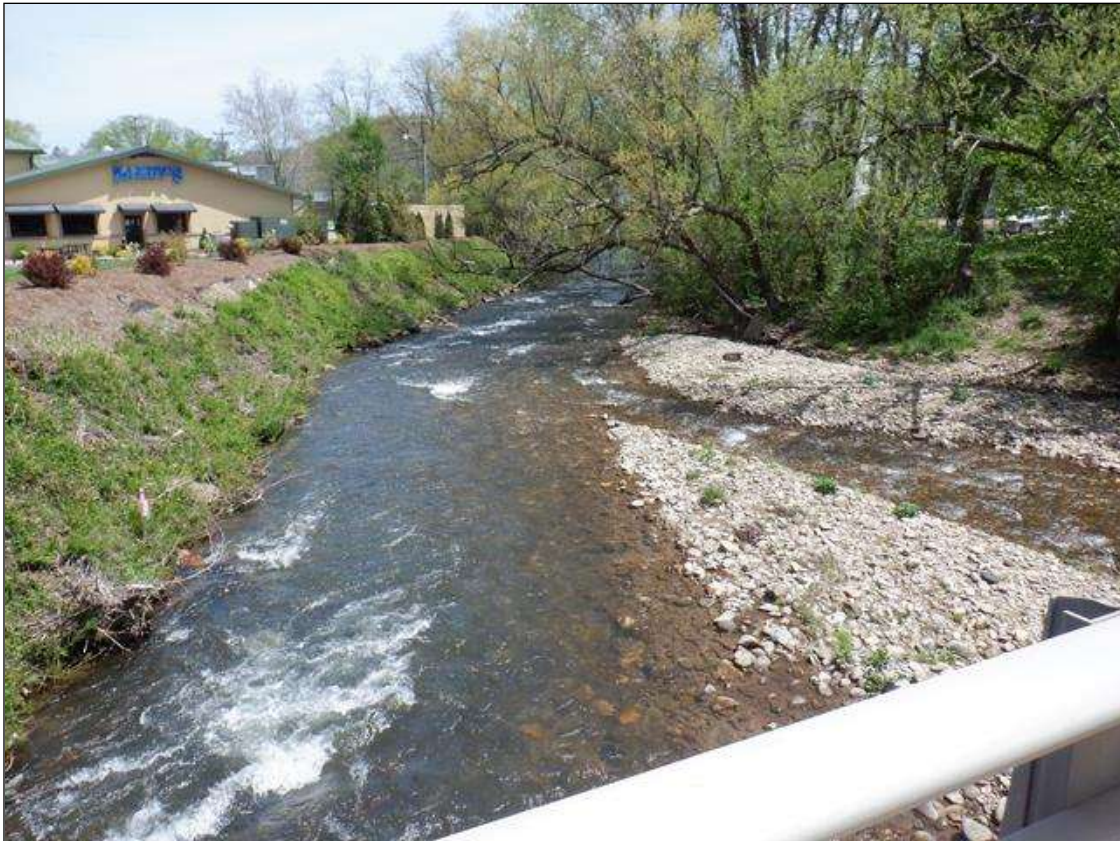
DOWNSTREAM VIEW FROM BRIDGE LOOKING EAST
