ATTENTION:

DIVISION OF HIGHWAYS

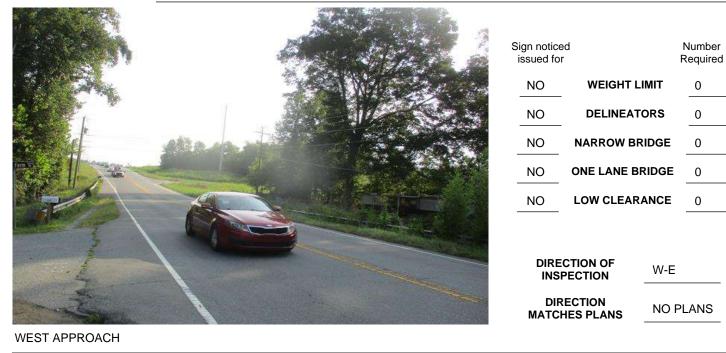
OTHER SIGNS PRESENT: NONE

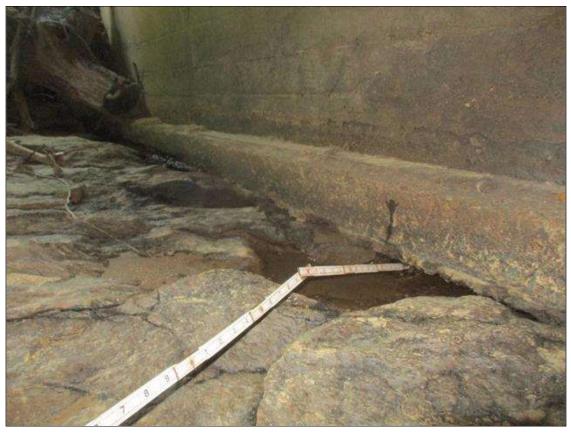
Span 2 Culvert Section 1: (PAR) 8 FEET LONG X 4 INCHES HIGH X FULL DEPTH UNDERMINING WITH WATER FLOW BENEATH THE EAST FOOTING BETWEEN BARREL 2 AND BARREL 3, 10 FEET FROM THE UPSTREAM END OF THE BARREL

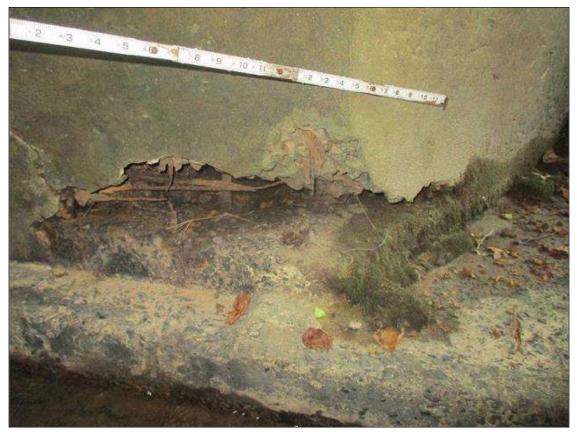
Span 3 Culvert Section 1: (PAR) 3 FEET LONG X 10 INCHES HIGH X 1 FEET WIDE SPALLED AREA WITH EXPOSED AND BROKEN REINFORCEMENT, 1 FEET DEEP UNDERMINING, AND EXPOSED FILL AT THE DOWNSTREAM END OF THE EAST WALL

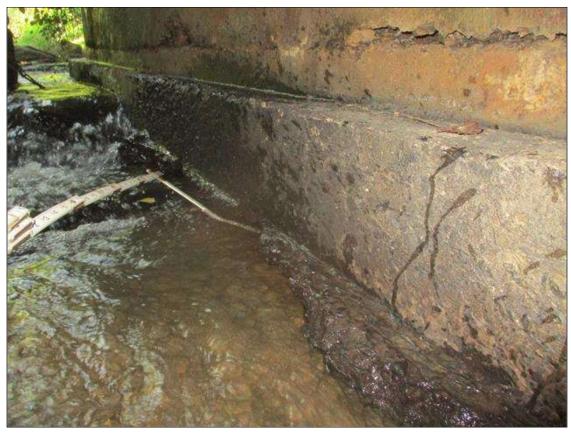
Span 3 Culvert Section 1: (PAR) 5 FEET LONG X 5 INCHES HIGH X 9 INCHES DEEP UNDERMINING OF THE EAST FOOTING, 9.5 FEET FROM THE UPSTREAM END OF THE BARREL

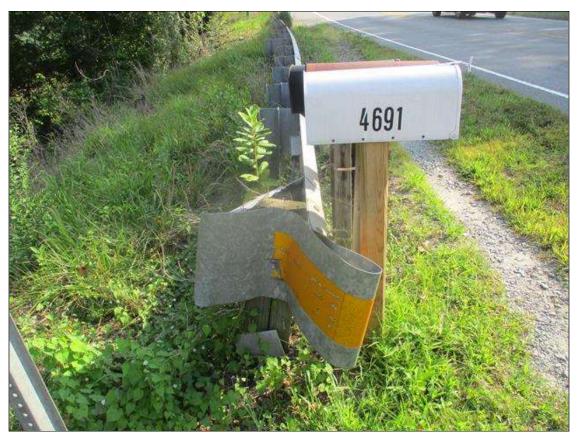
(PAR) IMPACT DAMAGE WITH SURFACE SCRAPES AT NORTHWEST GUARDRAIL TERMINAL END

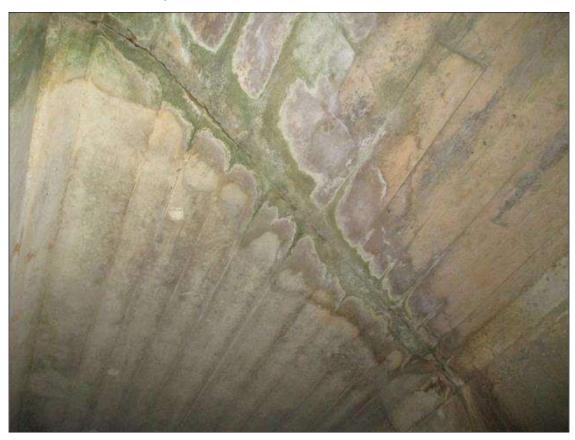
Span 1 Culvert Section 1: FULL HEIGHT X FULL WIDTH X UP TO 1/4 INCHES WIDE VERTICAL WRAP AROUND CRACK WITH EFFLORESCENCE AND SPALLED AND DELAMINATED AREAS UP TO 3 INCHES LONG X 4 INCHES HIGH X 1.5 INCHES DEEP IN THE WALLS AND TOP SLAB, 9.5 FEET FROM THE DOWNSTREAM END OF THE BARREL

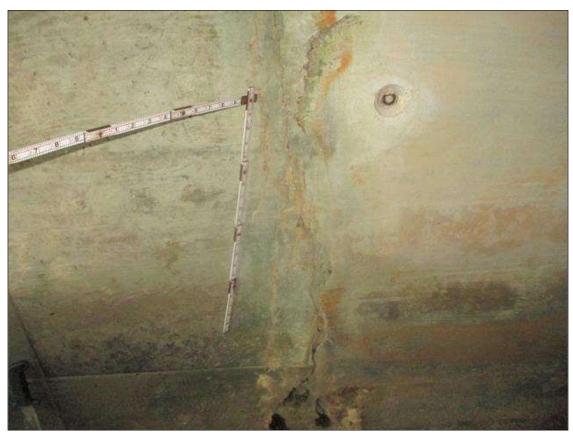
Span 1 Culvert Section 1: FULL HEIGHT X FULL WIDTH X UP TO 1/4 INCHES WIDE VERTICAL WRAP AROUND CRACK WITH EFFLORESCENCE AND SPALLED AND DELAMINATED AREAS UP TO 3 INCHES LONG X 4 INCHES HIGH X 1.5 INCHES DEEP IN THE WALLS AND TOP SLAB, 9.5 FEET FROM THE DOWNSTREAM END OF THE BARREL Structure: 330140

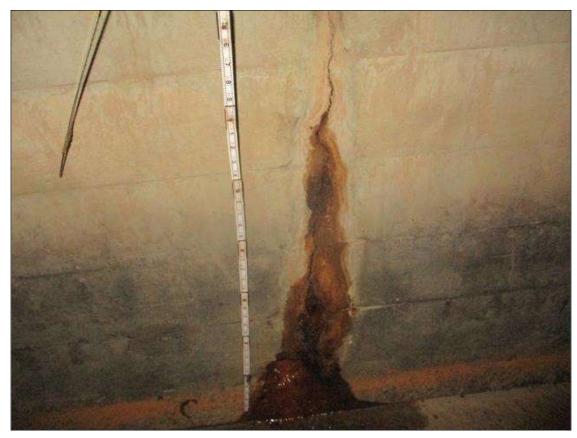
Span 1 Culvert Section 1: FULL HEIGHT X FULL WIDTH X UP TO 1/8 INCHES WIDE VERTICAL WRAP AROUND CRACKS WITH EFFLORESCENCE IN THE WALLS AND TOP SLAB AT GREATER THAN 3 FEET SPACING ALONG THE FULL LENGTH OF THE BARREL

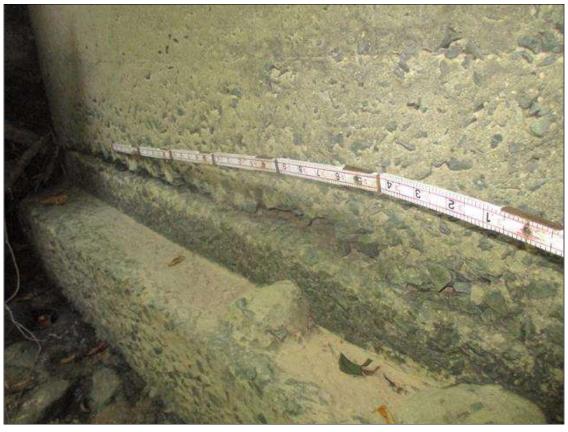
Span 1 Culvert Section 1: 4 FEET LONG X 4 INCHES HIGH X 2 INCHES DEEP SPALLED AREA IN THE EAST WALL AT THE FOOTING, AT THE UPSTREAM END OF THE BARREL

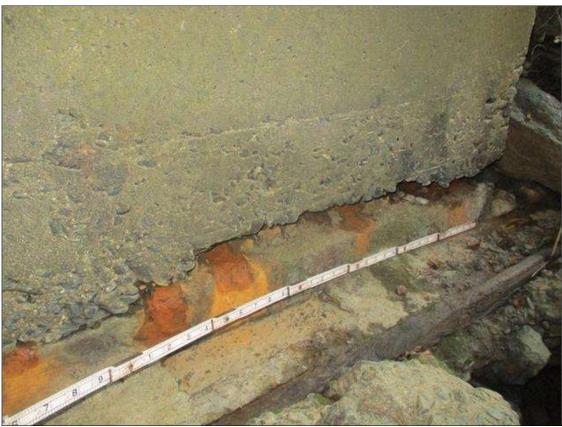
Span 1 Culvert Section 1: INTERMITTENT 14 FEET LONG X INTERMITTENT 10 INCHES HIGH X 3 INCHES DEEP SPALLED AREA IN THE WEST WALL AT THE FOOTING, AT THE UPSTREAM END OF THE BARREL

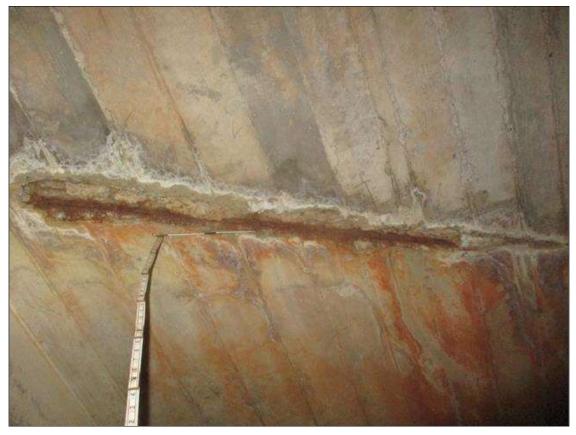
Span 1 Culvert Section 1: FULL WIDTH X 7 INCHES LONG X 3 INCHES DEEP SPALLED AREA WITH EXPOSED REINFORCEMENT AND EFFLORESCENCE IN THE TOP SLAB, 14 FEET FROM THE UPSTREAM END OF THE BARREL

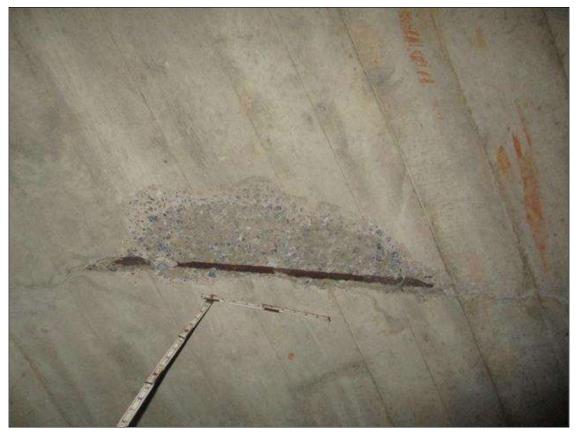
Span 1 Culvert Section 1: INTERMITTENT FULL WIDTH X 1.167 FEET LONG X 1.5 INCHES DEEP SPALLED AND DELAMINATED AREA WITH EXPOSED REINFORCEMENT IN THE TOP SLAB, 45 FEET FROM THE UPSTREAM END OF THE BARREL

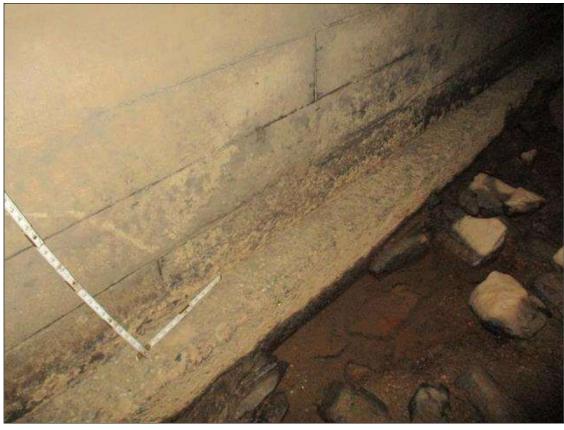
Span 1 Culvert Section 1: FULL LENGTH X FULL WIDTH X FULL HEIGHT SCALING THROUGHOUT THE EAST AND WEST FOOTINGS

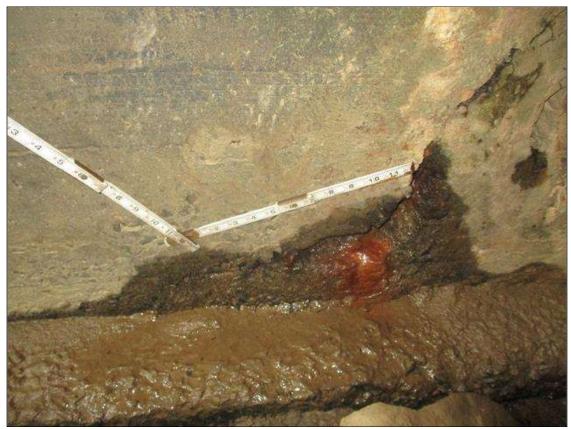
Span 1 Culvert Section 1: 8 INCHES LONG X 3 INCHES HIGH X 4 INCHES DEEP SPALLED AREA IN THE WEST WALL, 3 FEET FROM THE DOWNSTREAM END OF THE BARREL

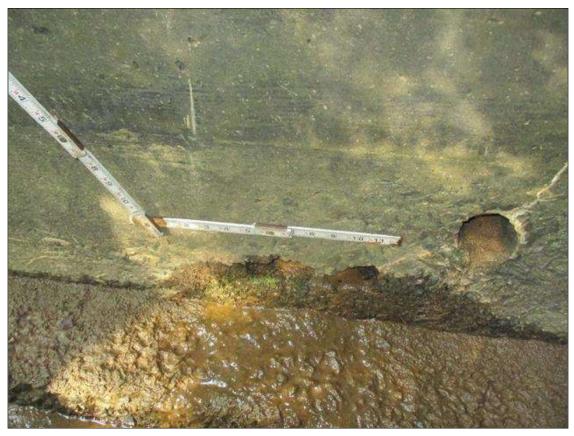
Span 1 Culvert Section 1: 8 INCHES LONG X 10 INCHES HIGH X UP TO 2 INCHES SPALLED AREA IN THE WEST WALL AT THE FOOTING, 9 FEET FROM THE DOWNSTREAM END OF THE BARREL

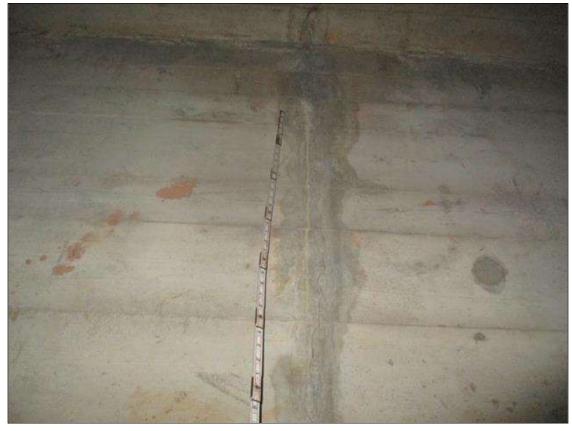
Span 2 Culvert Section 1: FULL HEIGHT X FULL WIDTH X UP TO 1/8 INCHES WIDE VERTICAL WRAP AROUND CRACKS WITH EFFLORESCENCE IN THE WALLS AND TOP SLAB AT GREATER THAN 3 FEET SPACING ALONG THE FULL LENGTH OF THE BARREL

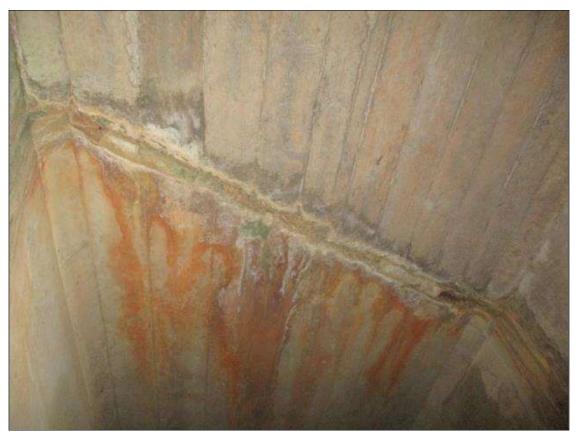
Span 2 Culvert Section 1: FULL HEIGHT X FULL WIDTH X UP TO 1/8 INCHES WIDE VERTICAL WRAP AROUND CRACK IN THE WALLS AND TOP SLAB WITH EFFLORESCENCE AND INTERMITTENT SPALLED AND DELAMINATED AREAS UP TO 12 INCHES X 18 INCHES X 4 INCHES IN THE WALLS AND TOP SLAB, 13.75 FEET FROM THE UPSTREAM END OF THE BARREL

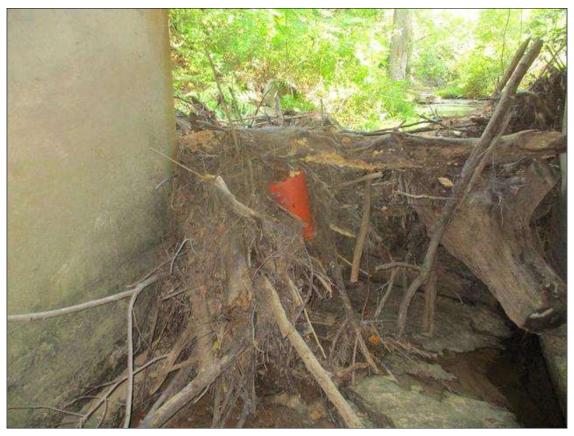
Span 2 Culvert Section 1: INTERIOR WALL 1 AT INLET, SPALL (15 INCHES X 7 INCHES X UP TO 3/4 INCH) (SCOUR WAS COVERED BY DRIFT DURING 2023 INSPECTION)

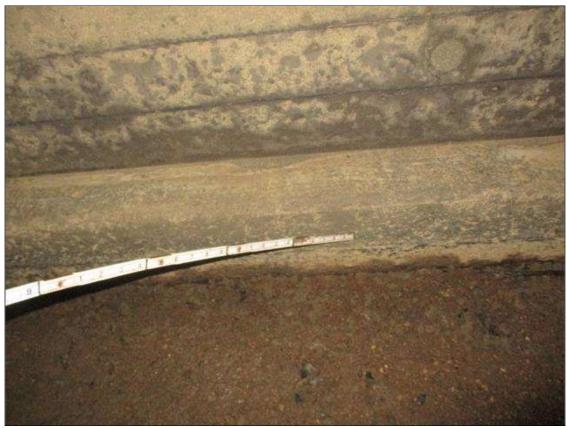
Span 2 Culvert Section 1: FULL LENGTH X FULL WIDTH X FULL HEIGHT SCALING THROUGHOUT THE EAST AND WEST FOOTINGS.

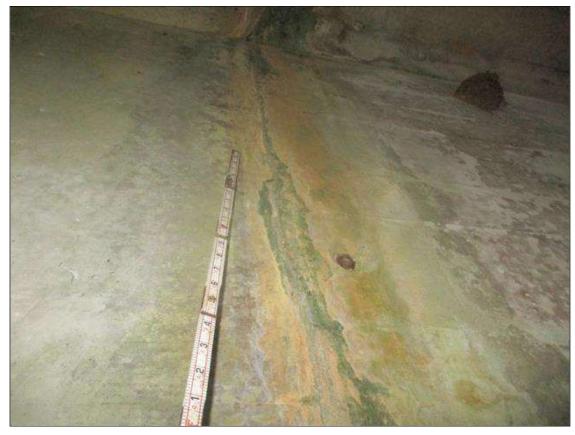
Span 2 Culvert Section 1: FULL HEIGHT X FULL WIDTH X UP TO 1/4 INCHES WIDE VERTICAL WRAP AROUND CRACK IN THE WALLS AND TOP SLAB WITH EFFLORESCENCE AND INTERMITTENT FULL WIDTH X 5 INCHES LONG DELAMINATION IN THE TOP SLAB AND UP TO 12 INCHES X 4 INCHES X 4 INCHES INTERMITTENT SPALLS, 9 FEET FROM THE DOWNSTREAM END OF THE BARREL

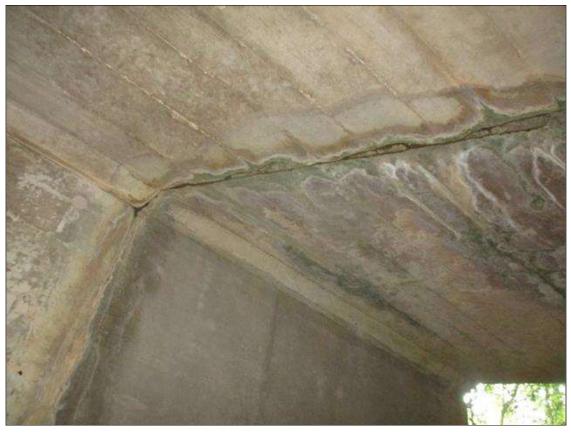
Span 2 Culvert Section 1: FULL HEIGHT X FULL WIDTH X UP TO 1/4 INCHES WIDE VERTICAL WRAP AROUND CRACK IN THE WALLS AND TOP SLAB WITH EFFLORESCENCE AND INTERMITTENT FULL WIDTH X 5 INCHES LONG DELAMINATION IN THE TOP SLAB AND UP TO 12 INCHES X 4 INCHES X 4 INCHES INTERMITTENT SPALLS, 9 FEET FROM THE DOWNSTREAM END OF THE BARREL

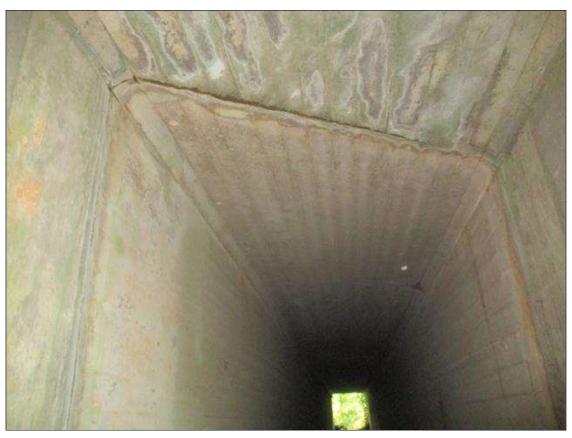
Span 3 Culvert Section 1: FULL HEIGHT X FULL WIDTH X UP TO 1/8 INCHES WIDE VERTICAL WRAP AROUND CRACKS WITH EFFLORESCENCE IN THE WALLS AND TOP SLAB AT GREATER THAN 3 FEET SPACING ALONG THE FULL LENGTH OF THE BARREL

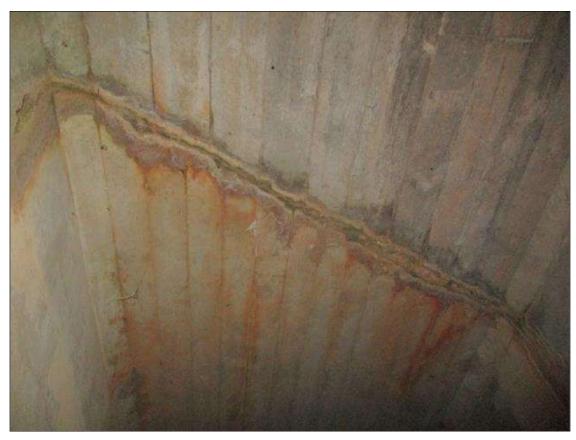
Span 3 Culvert Section 1: INTERMITTENT FULL WIDTH X 3 INCHES LONG DELAMINATED AREA WITH A FULL WIDTH X 1/4 INCHES WIDE TRANSVERSE CRACK IN THE TOP SLAB, 14.5 FEET FROM THE UPSTREAM END OF THE BARREL

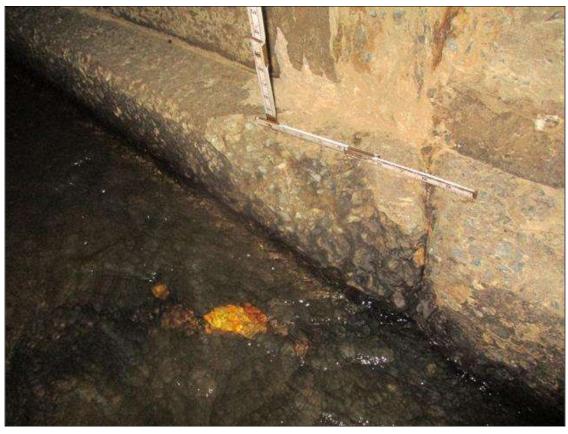
Span 3 Culvert Section 1: (8) UP TO 6 FEET X 5 INCHES X 5 INCHES SPALLS AT RANDOM THROUGHOUT EAST AND WEST FOOTINGS.

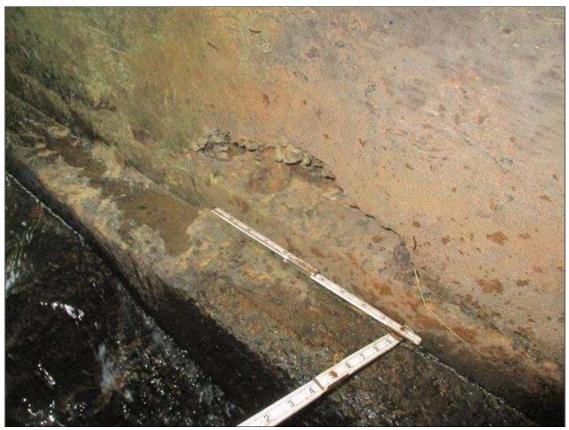
Span 3 Culvert Section 1: INTERMITTENT 14.5 FEET LONG X 7 INCHES HIGH X 5 INCHES DEEP SPALLED AREA 4 INCHES ABOVE THE FOOTING AT THE UPSTREAM END

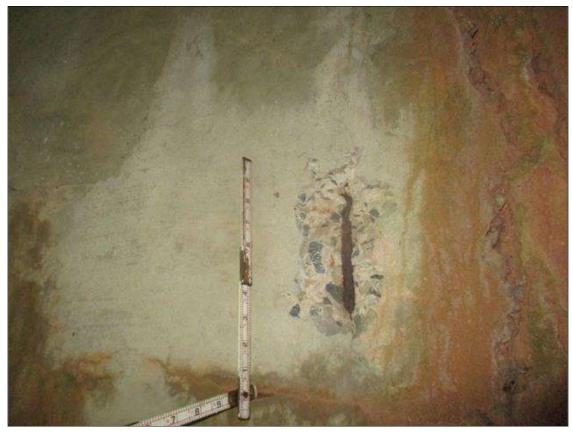
Span 3 Culvert Section 1: 8 INCHES HIGH X 4 INCHES LONG X 1 INCHES DEEP SPALLED AREA WITH EXPOSED REINFORCEMENT IN THE EAST WATERLINE, 4.5 FEET BELOW THE TOP SLAB, 13.5 FEET FROM THE UPSTREAM END OF THE BARREL

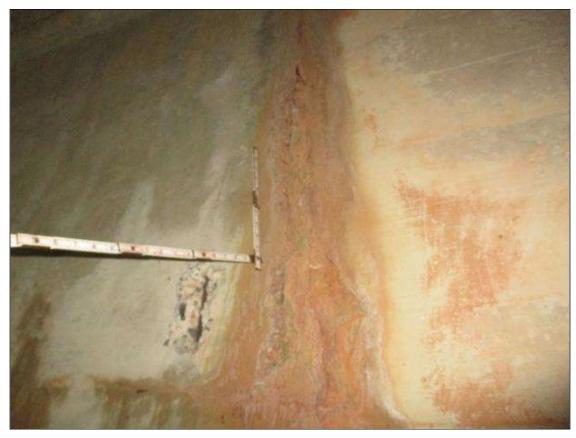
Span 3 Culvert Section 1: INTERMITTENT FULL HEIGHT X 1 FEET LONG X 1.5 INCHES DEEP SPALLED AND DELAMINATED AREA WITH A FULL HEIGHT X 1/8 INCHES WIDE VERTICAL CRACK IN THE EAST WALL, 14.5 FEET FROM THE UPSTREAM END OF THE BARREL

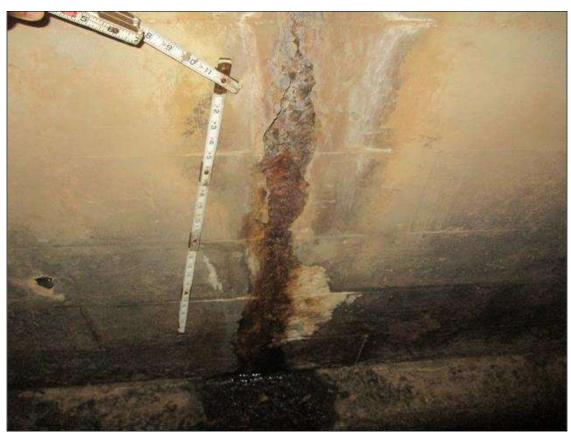
Span 3 Culvert Section 1: 1.25 FEET HIGH 3 INCHES LONG X 3/4 INCHES DEEP SPALLED AREA WITH A 6 FEET HIGH X 1/4 INCHES WIDE VERTICAL CRACK WITH EFFLORESCENCE AND HEAVY BUILDUP AND RUST STAINING ADJACENT TO 15 INCHES X 5 INCHES X 4 INCHES SPALL IN EAST FOOTING, 19 FEET FROM THE DOWNSTREAM END OF THE BARREL

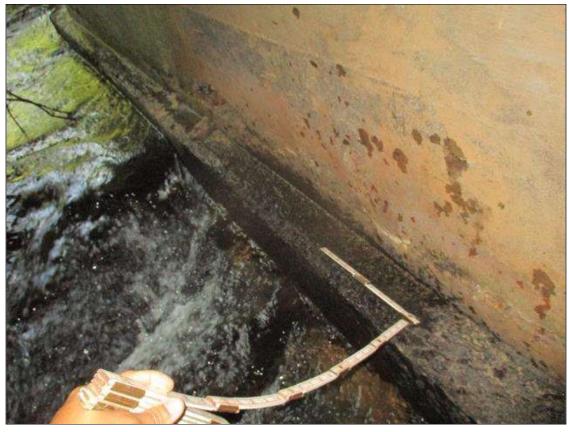
Span 3 Culvert Section 1: FULL LENGTH X FULL WIDTH X FULL HEIGHT SCALING THROUGHOUT THE EAST AND WEST FOOTINGS

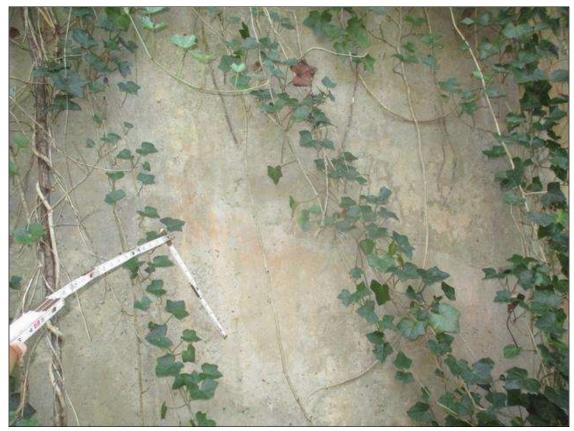
14 FEET X 10 FEET X UP TO 1/32 INCHES MAP CRACKING WITH RUST STAINING IN SOUTHWEST WINGWALL

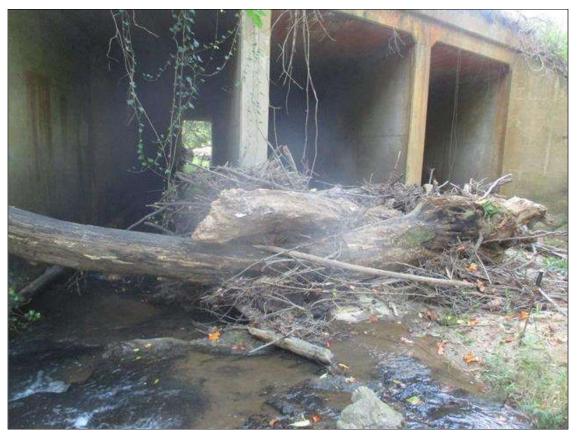
LARGE DRIFT ACCUMULATION AT INLET IN FRONT OF BARRELS 1 THROUGH 3

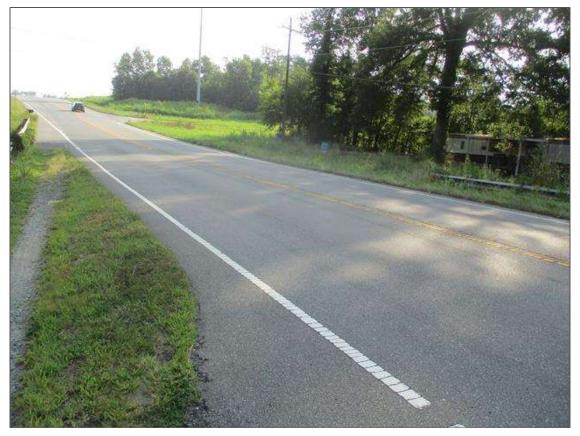
ASPHALT WEARING SURFACE
