NC DEPARTMENT OF TRANSPORTATION  
 DIVISION OF HIGHWAYS  
 STRUCTURE MANAGEMENT UNIT

ATTENTION: **PAR SUBMITTED  
 SNOOPER USED**

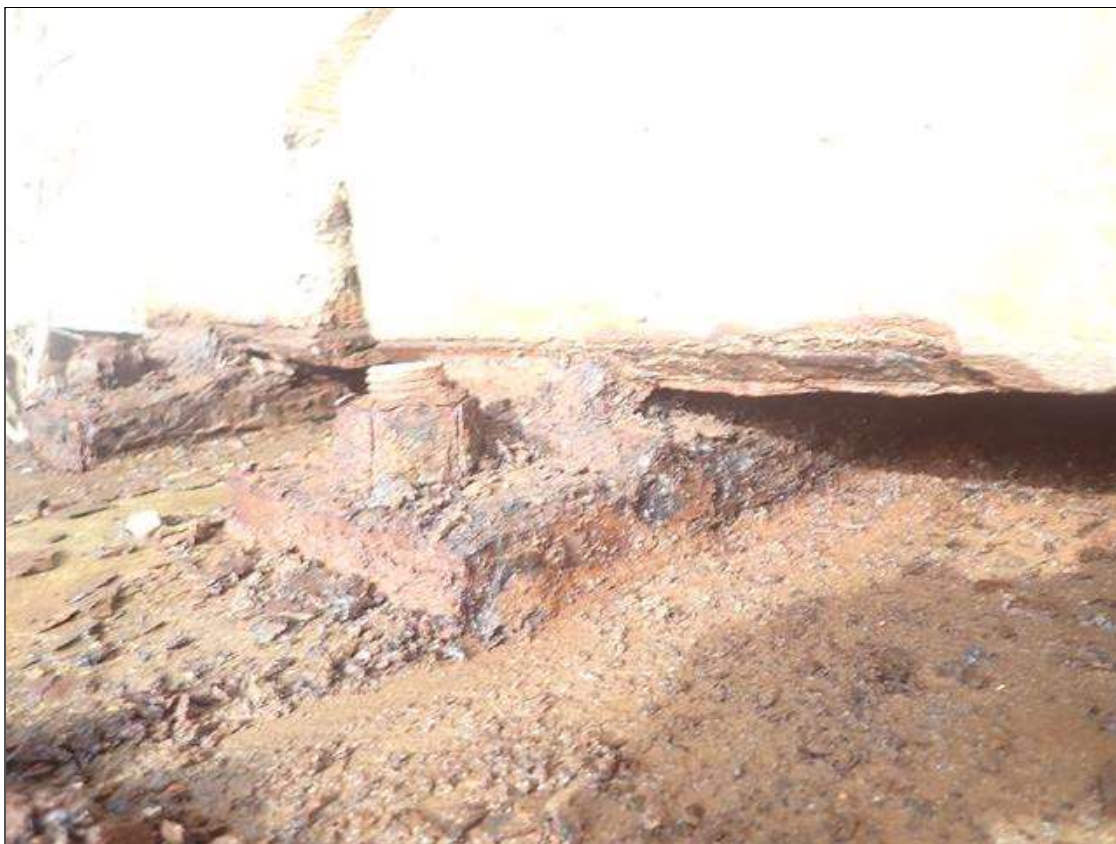
Span 5 Beam 4 - Near Bearing: RUST SCALE WITH SECTION LOSS (UP TO 1/8IN LOSS)

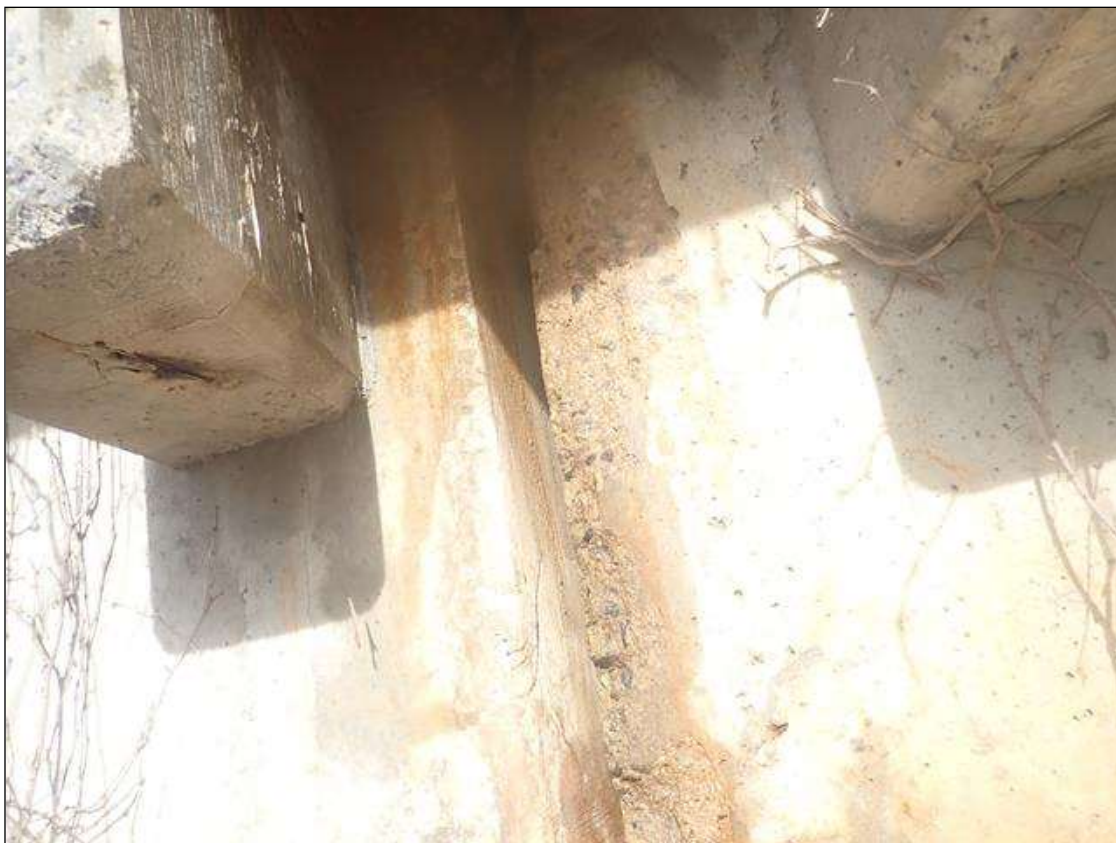
Span 5 Beam 4: 6 INCHES X 36 INCHES X UP TO 1-1/2 INCHES DEEP SPALL ON RIGHT SIDE OF WEB AT BENT 4  
(PHOTO 1 OF 2)

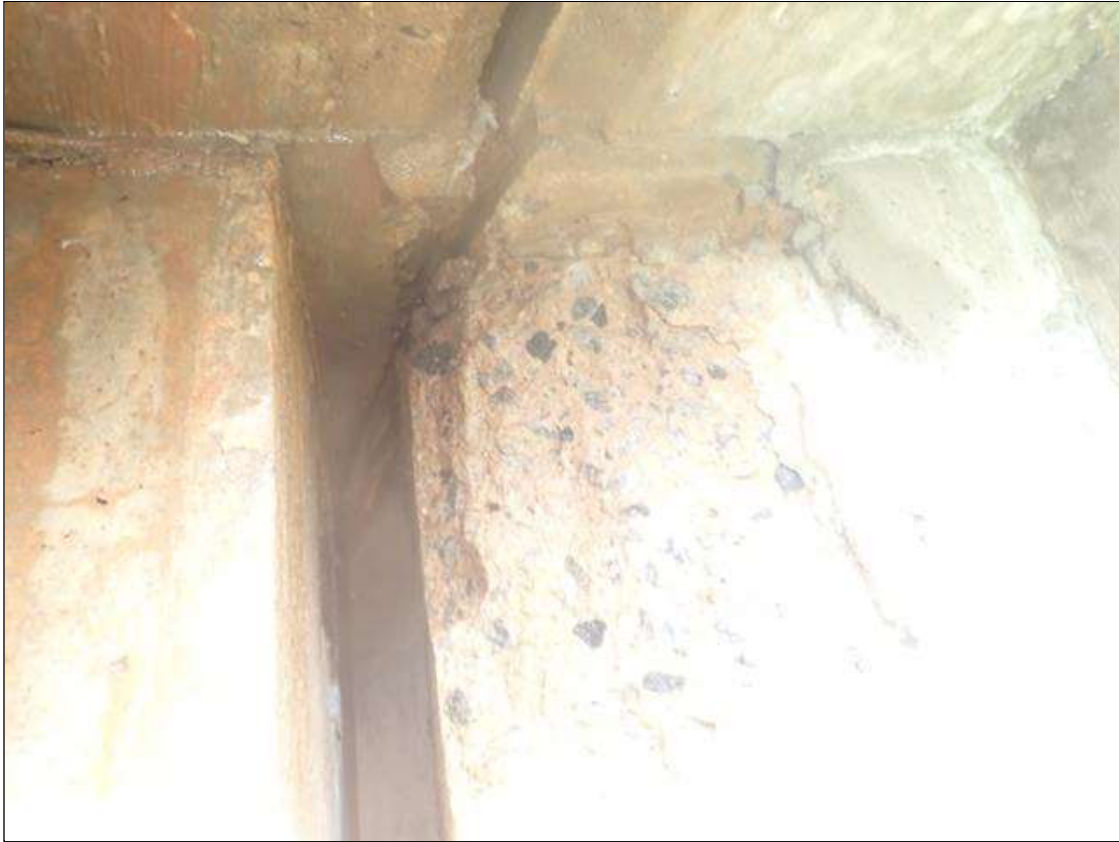
Span 5 Beam 4: 6 INCHES X 36 INCHES X UP TO 1-1/2 INCHES DEEP SPALL ON RIGHT SIDE OF WEB AT BENT 4  
(PHOTO 2 OF 2)

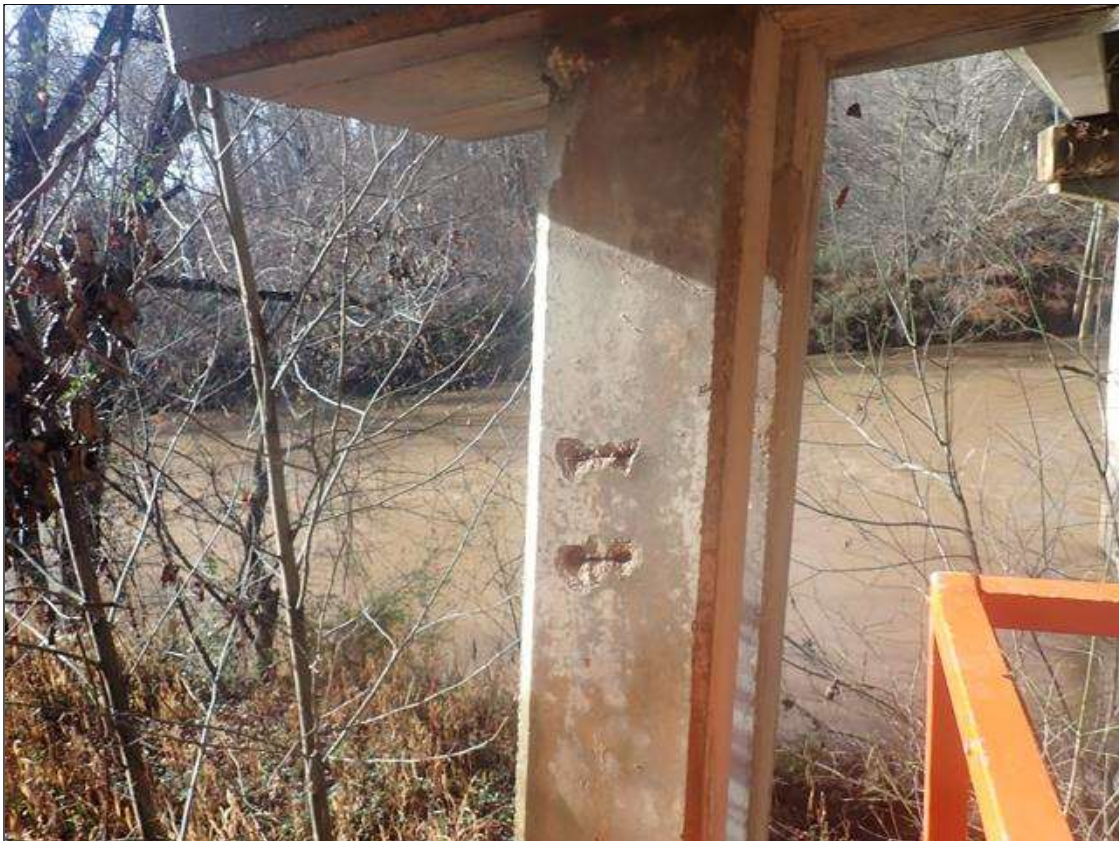
Bent 4 Row 2 Pile 5: EAST FACE BELOW CAP, (3) SPALLS (UP TO 9IN X 4IN X 1-1/2IN) WITH EXPOSED RUSTED REBAR

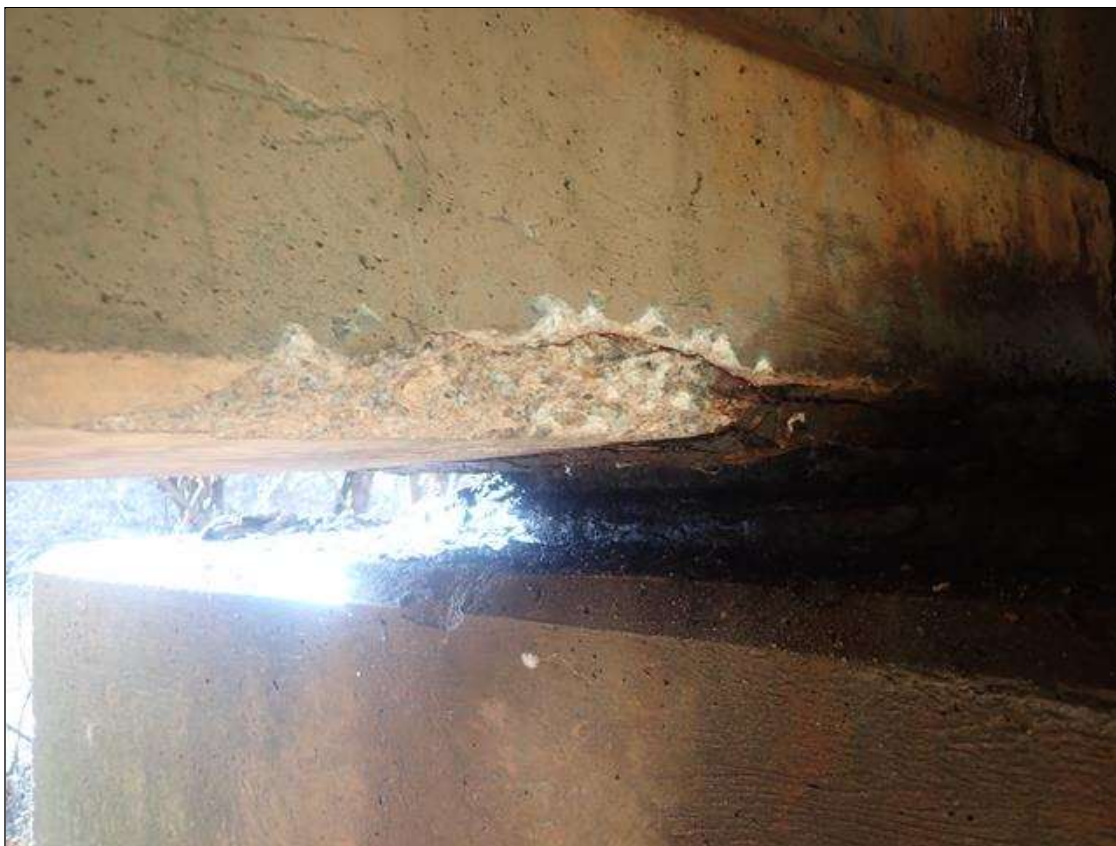
Span 5 Beam 4: BOTTOM FLANGE NORTH FACE AT BENT 4, SPALL (11IN X 3IN X 1-1/2IN)

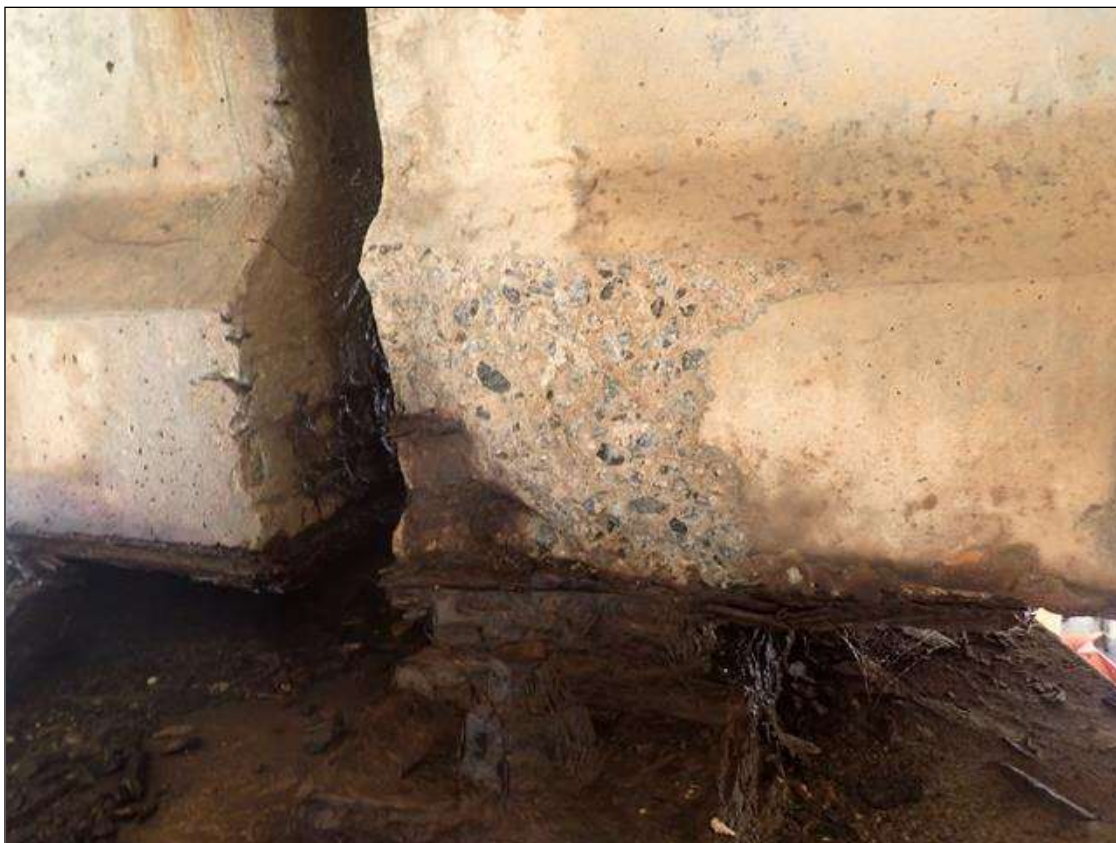
Span 5 Beam 3: (PAR) 18 INCHES X 8 INCHES X 2 INCHES DEEP SPALL WITH EXPOSED PRESTRESSING STRANDS ON RIGHT SIDE OF BOTTOM FLANGE AT BENT 4

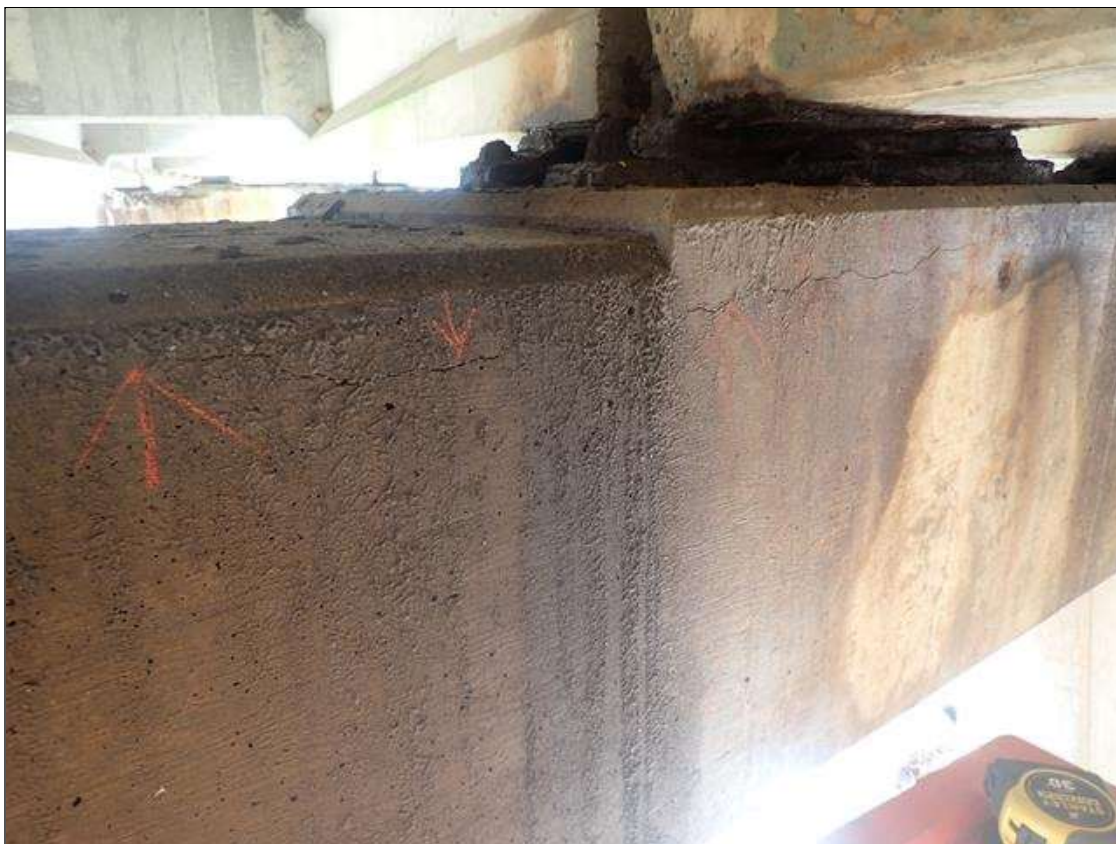
Bent 4 Cap 1: EAST FACE BELOW BEAM 3, HORIZONTAL CRACK (35IN X UP TO 1/16IN)

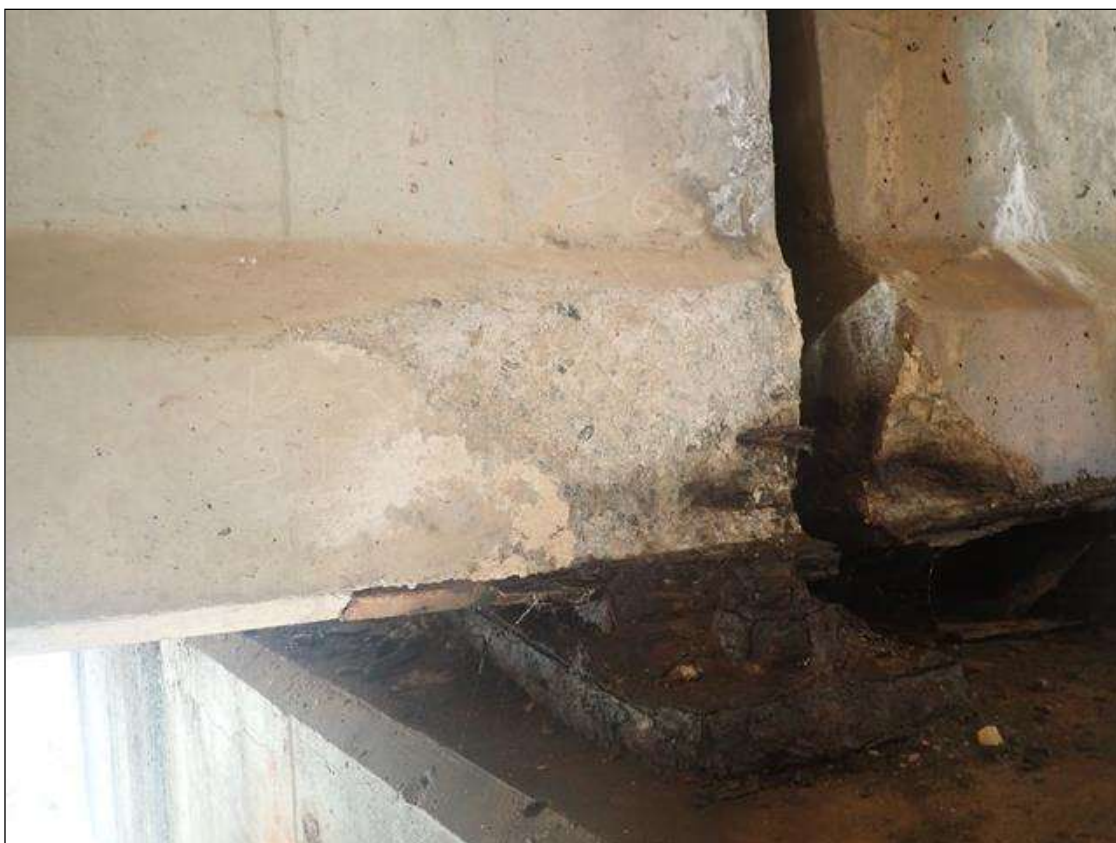
Span 5 Beam 3: (PAR) 16 INCHES X 9 INCHES X 2 INCHES DEEP SPALL WITH EXPOSED PRESTRESSING STRANDS ON LEFT SIDE OF BOTTOM FLANGE AT BENT 4

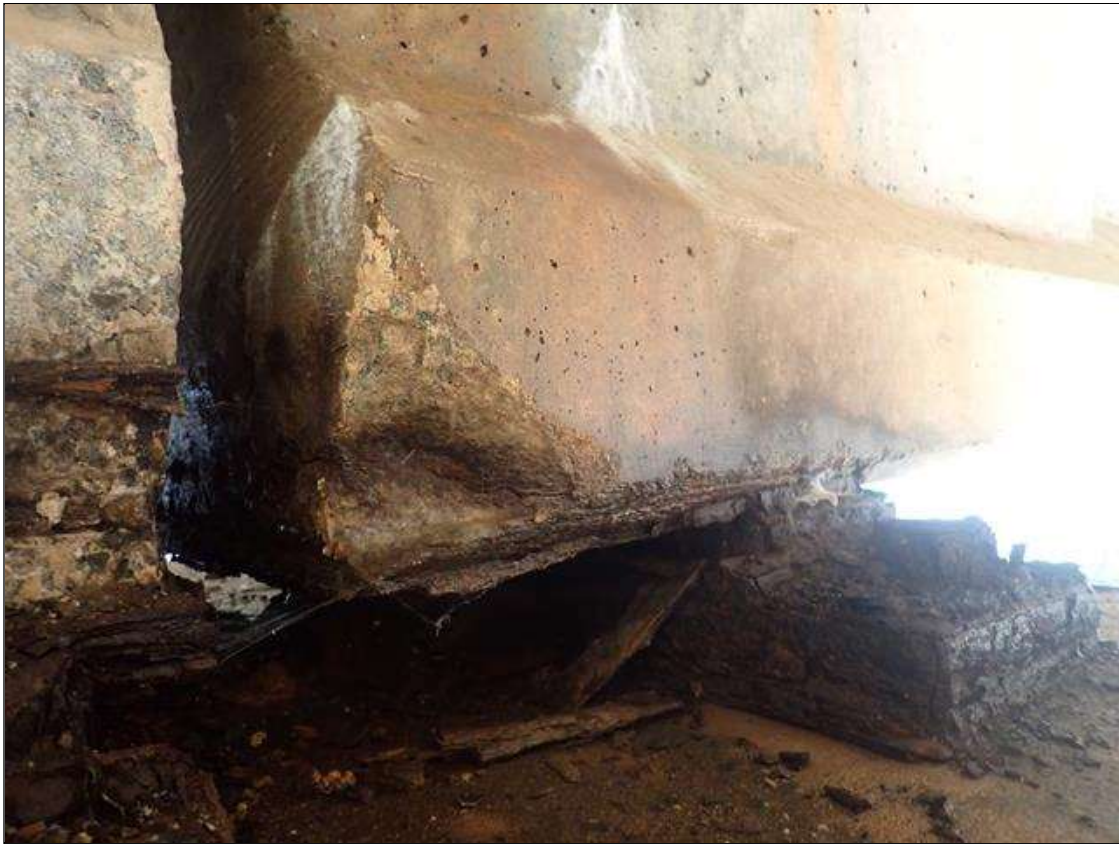
Span 4 Beam 3: LEFT SIDE OF BOTTOM FLANGE SPLIT AT BENT 4, SPALL (6IN X 6IN X 1-1/2IN) WITH RUST STAINING

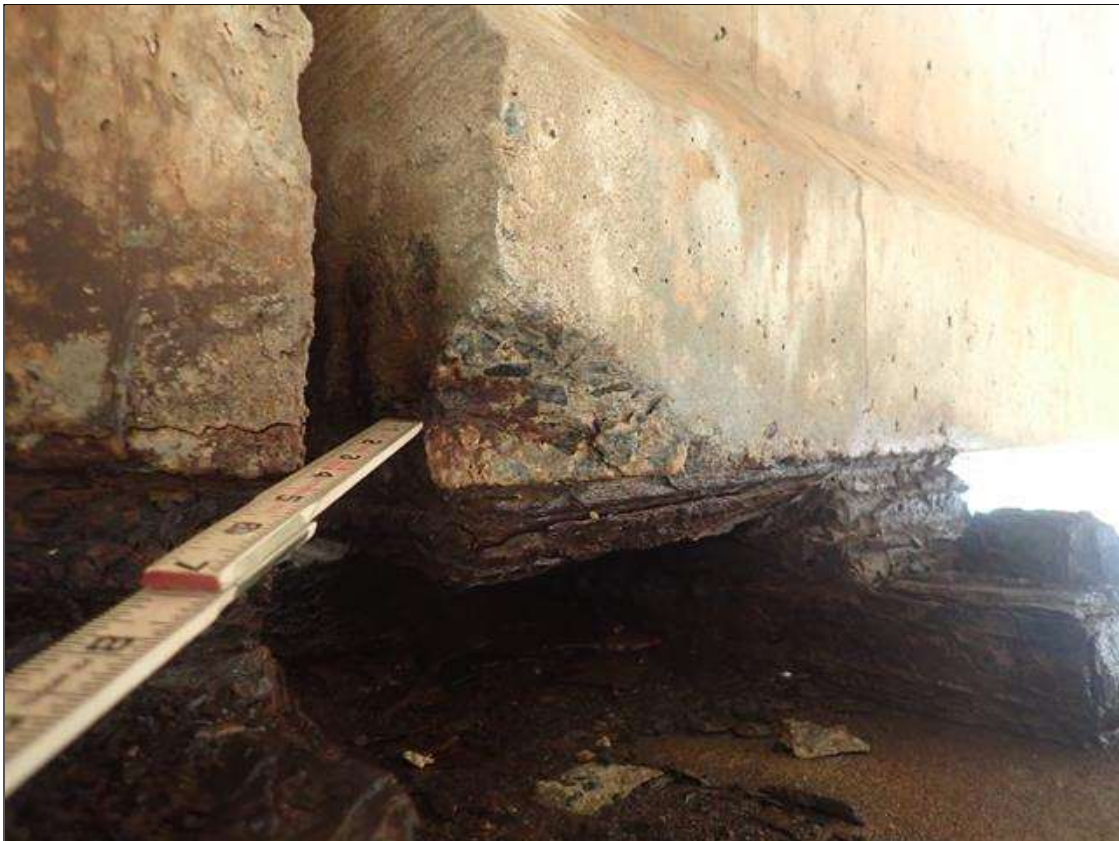
Span 4 Beam 2: (PAR) BOTTOM FLANGE LEFT SIDE AT BENT 4, SPALL (8IN X 4IN X 2IN) WITH EXPOSED PRESTRESSING STRAND

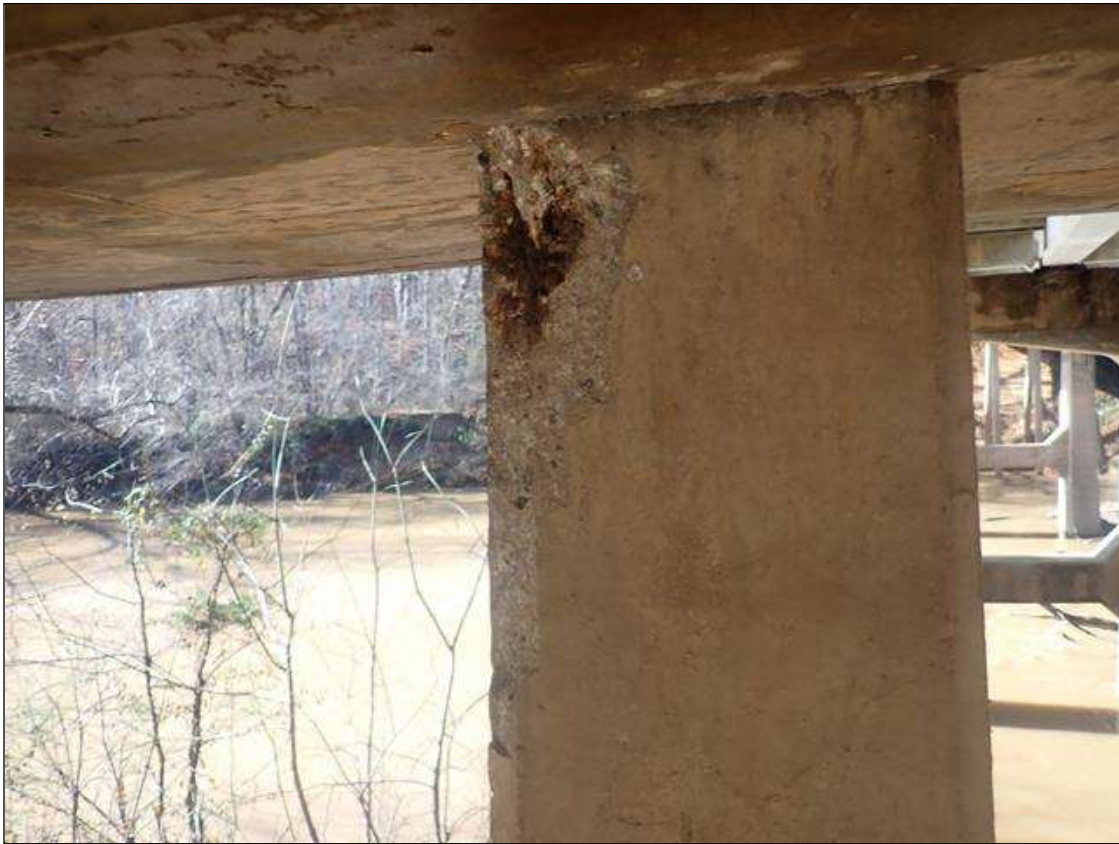
Bent 4 Row 2 Pile 3: (PAR) SOUTHEAST CORNER BELOW CAP, SPALL (16IN X 4-1/2IN X 2IN) WITH EXPOSED RUSTED STRAND

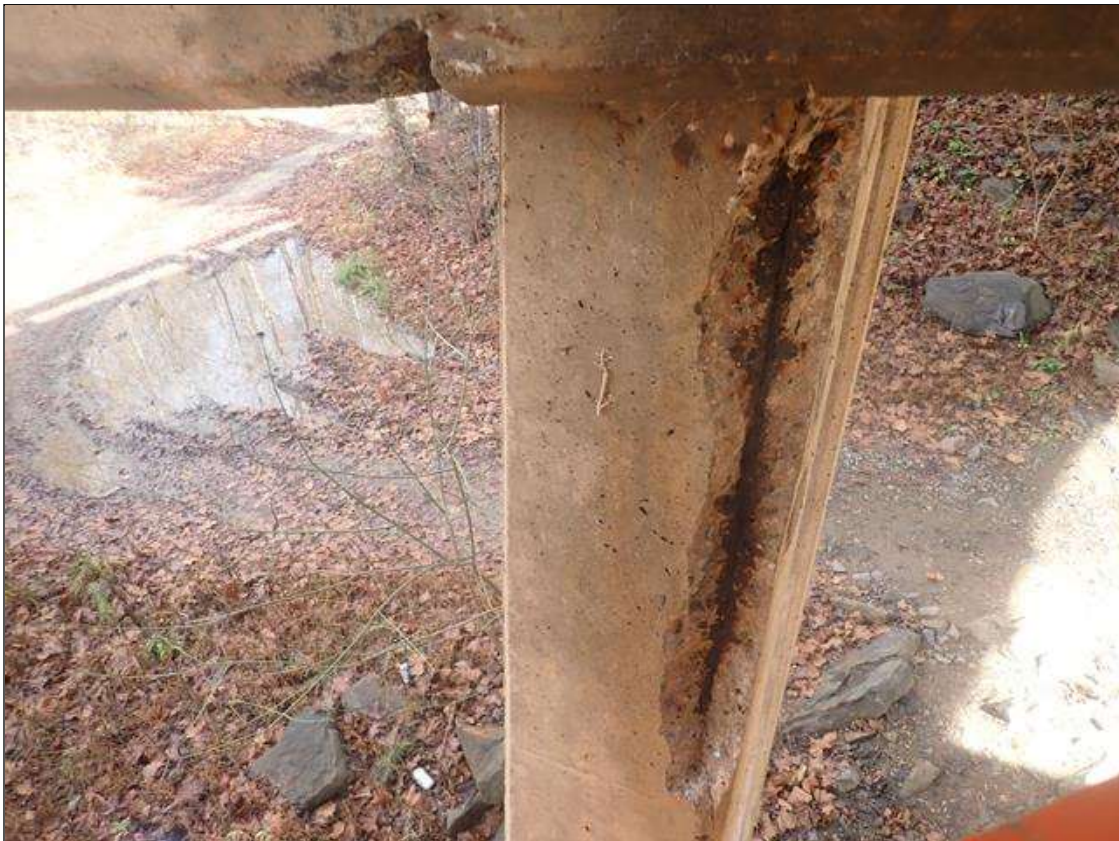
Bent 4 Row 1 Pile 1: (PAR) SOUTHWEST CORNER BELOW CAP, SPALL (3FT X 4IN X 2IN) WITH EXPOSED RUSTED STRAND

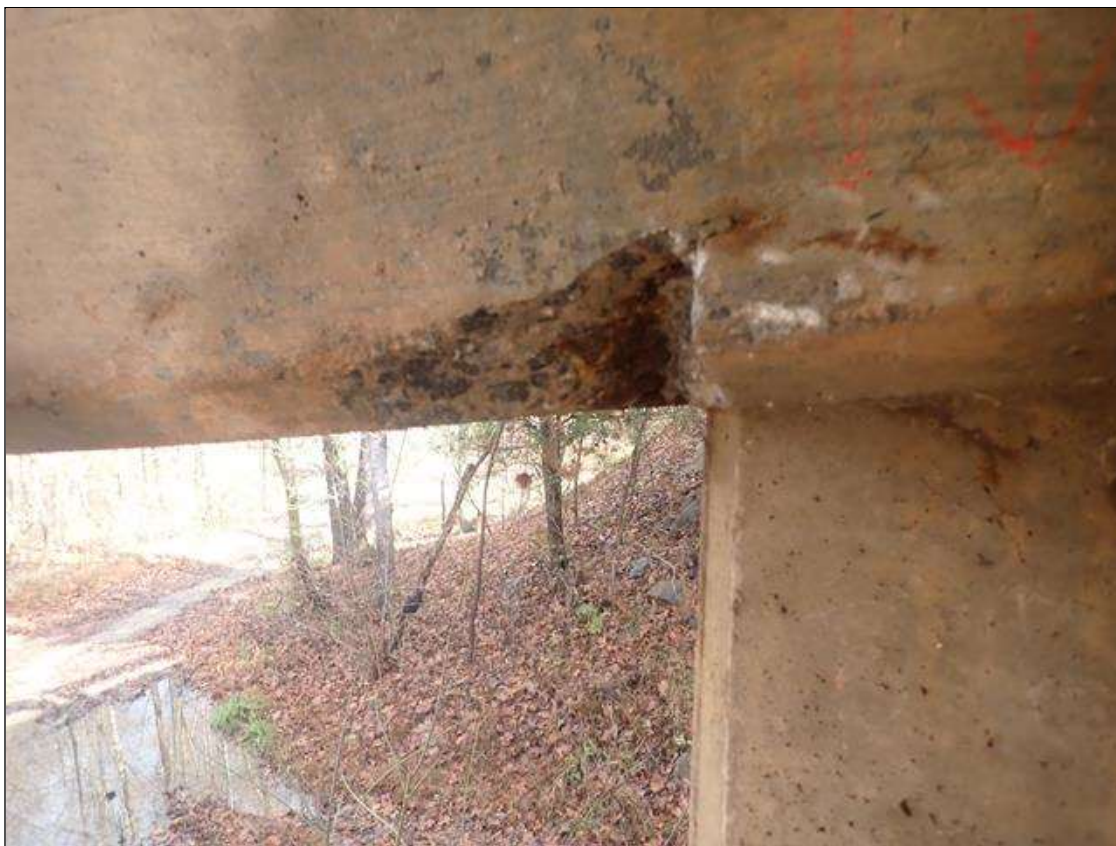
Bent 4 Cap 1: WEST FACE UNDER BEAM 1, SPALL (7IN X 4IN X1-1/2IN) WITH EXPOSED RUSTED REBAR

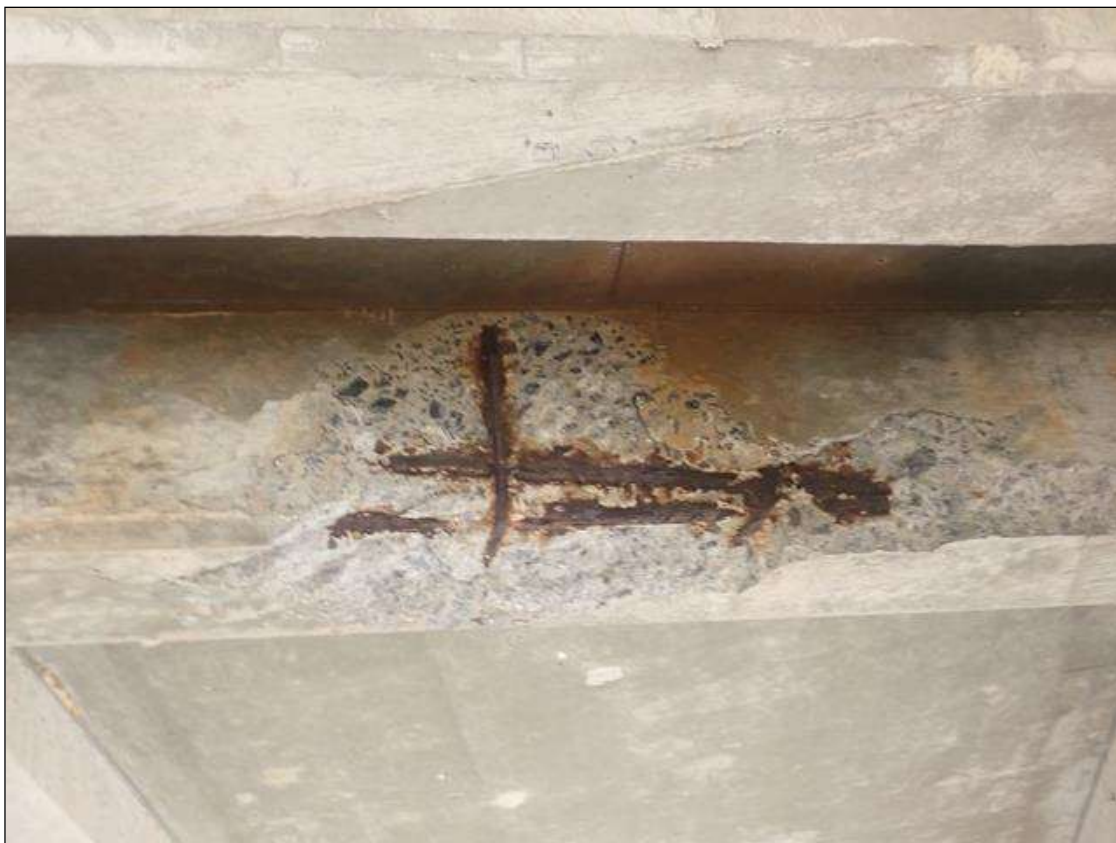
Span 5 Beam 2: 40 INCHES X 18 INCHES X 3 INCHES DEEP SPALL WITH EXPOSED REBAR ON BENT 4 DIAPHRAGM IN BAY 1

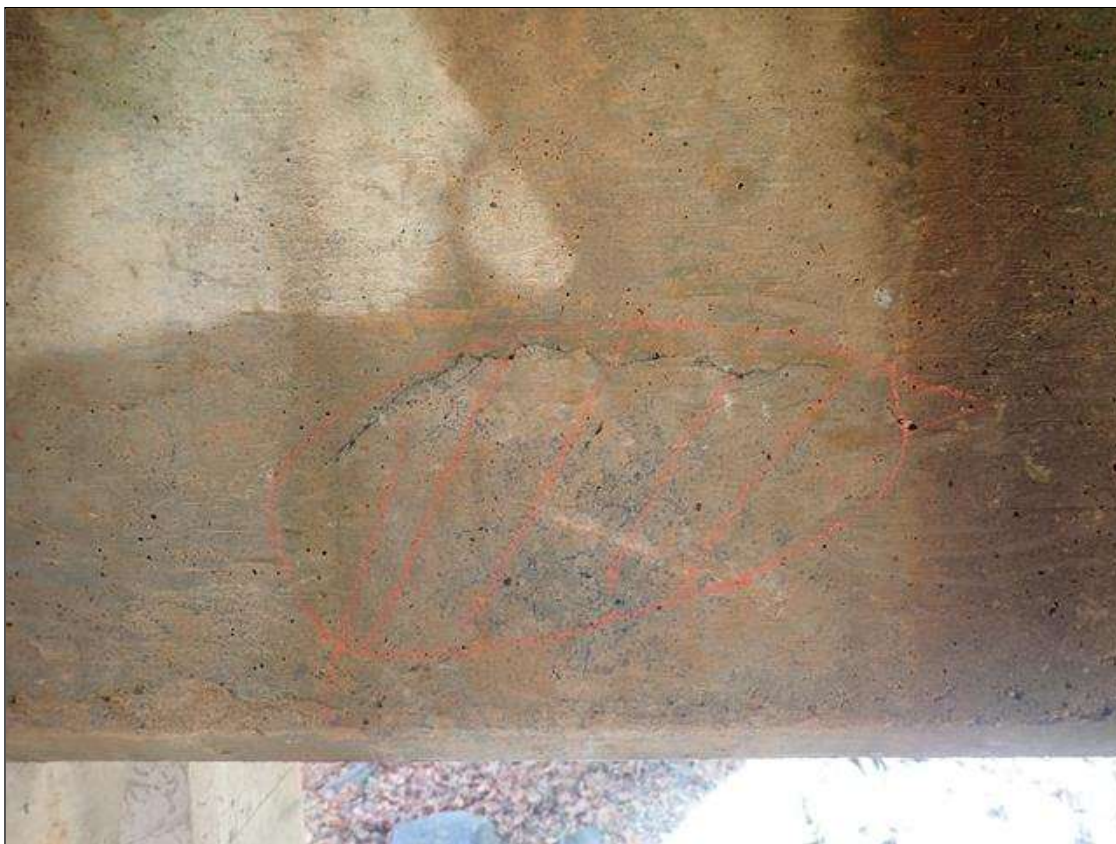
Bent 4 Cap 1: 13 INCHES X 5 INCHES AREA OF DELAMINATION IN WEST FACE UNDER BEAM 2

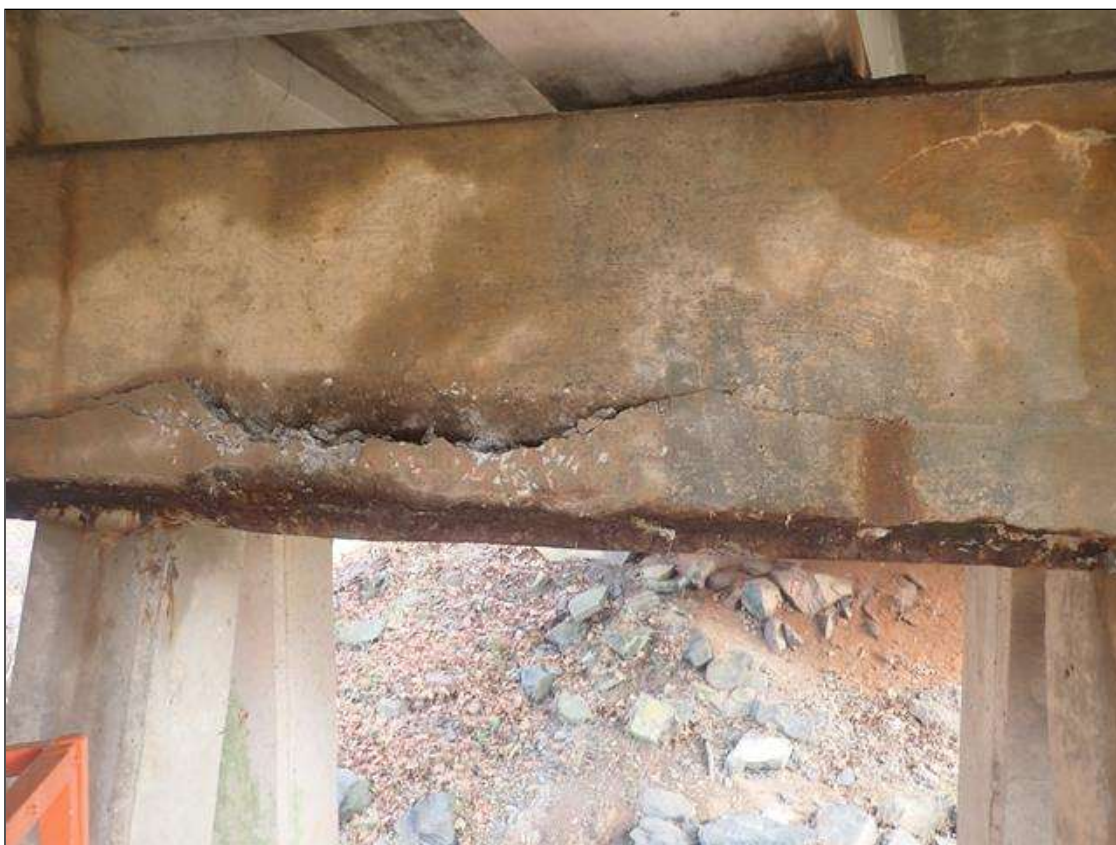
Bent 4 Cap 1: (PAR) WEST FACE UNDER BEAM 3, SPALL/DELAMINATION (95IN X 12IN X UP TO 2-1/2IN) WITH EXPOSED RUSTED REBAR

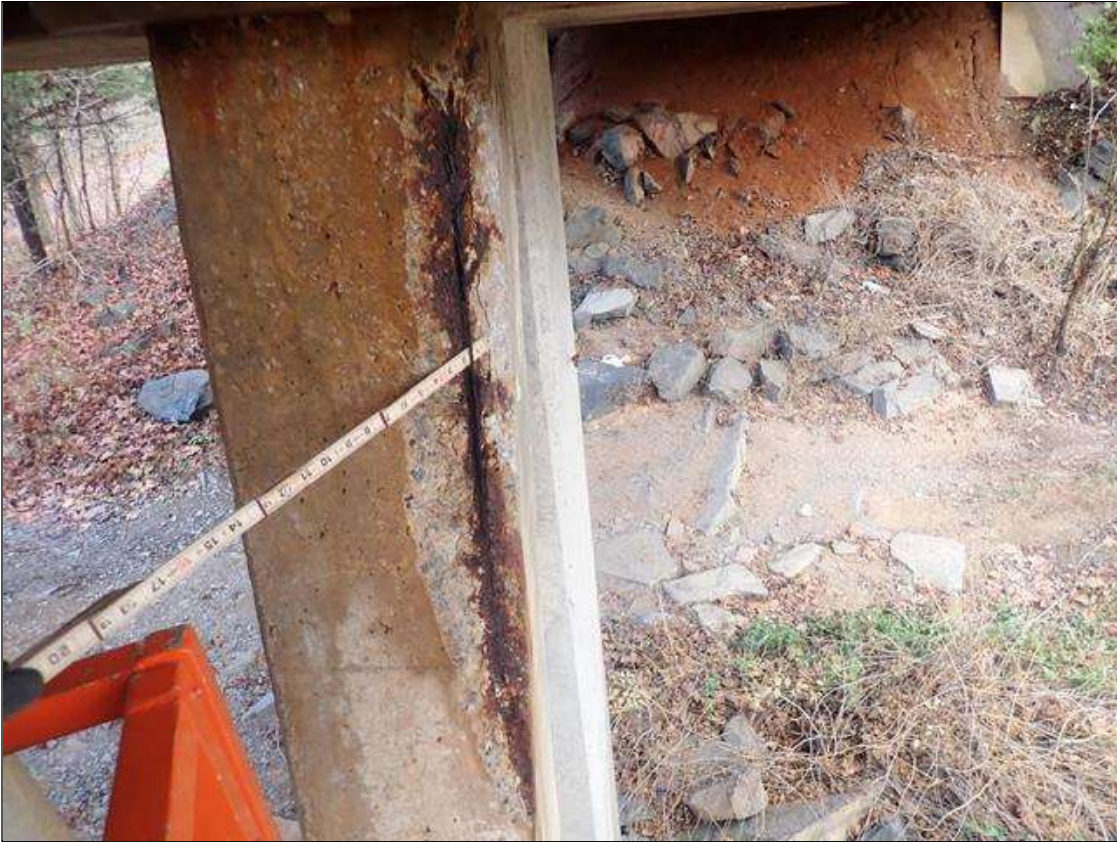
Bent 4 Row 1 Pile 4: (PAR) 36 INCHES X 6 INCHES X 2 INCHES DEEP SPALL WITH EXPOSED STRAND (UP TO 90% LOSS ON STRAND) ON SOUTHWEST CORNER

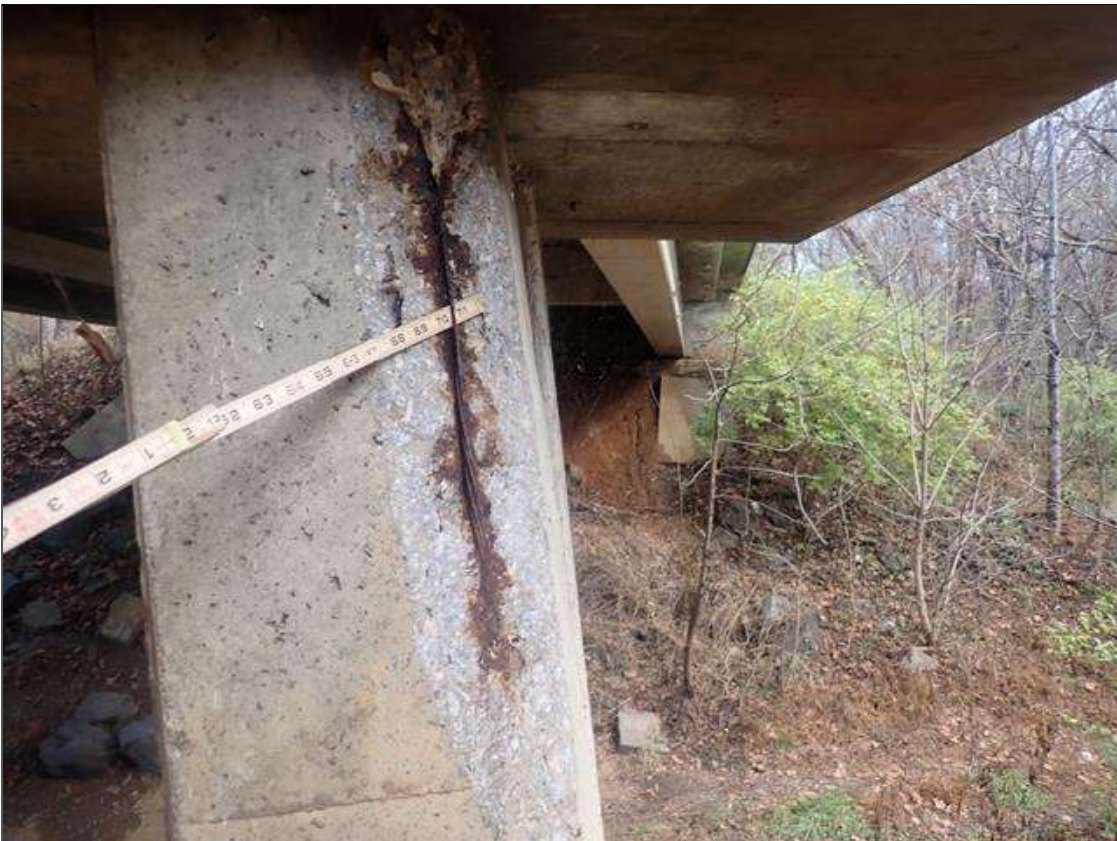
Bent 4 Row 1 Pile 5: (PAR) 31 INCHES X 5 INCHES X 5 INCHES DEEP SPALL WITH EXPOSED STRAND (UP TO 90% LOSS ON STRAND) ON SOUTHWEST CORNER

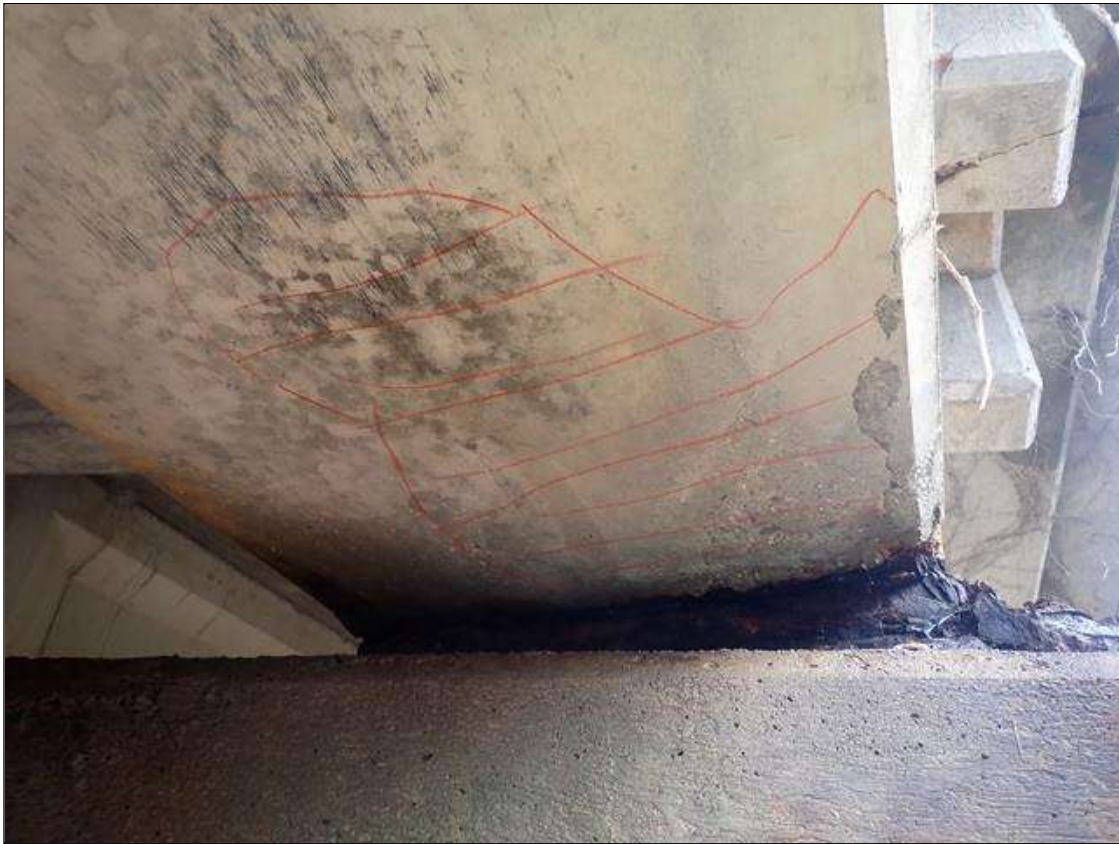
Span 4 Beam 4: 20 INCHES X 14 INCHES AREA OF DELAMINATION ON BOTTOM OF BEAM AT BENT 4

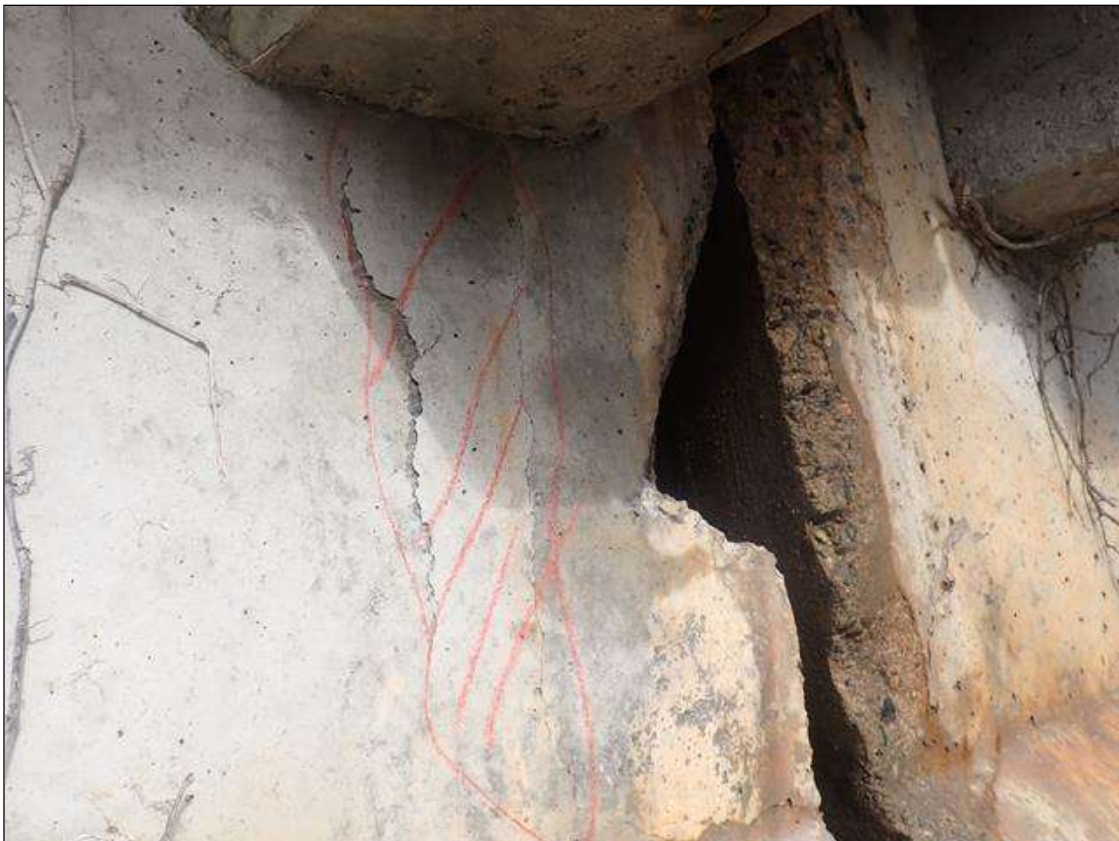
Span 4 Beam 4: EAST END OF WEB AT BENT 4, SPALL (18IN X 12IN X UP TO 3IN) WITH ADJACENT DELAMINATION (22IN X 5IN) ON SOUTH FACE (PHOTO 1 OF 2)

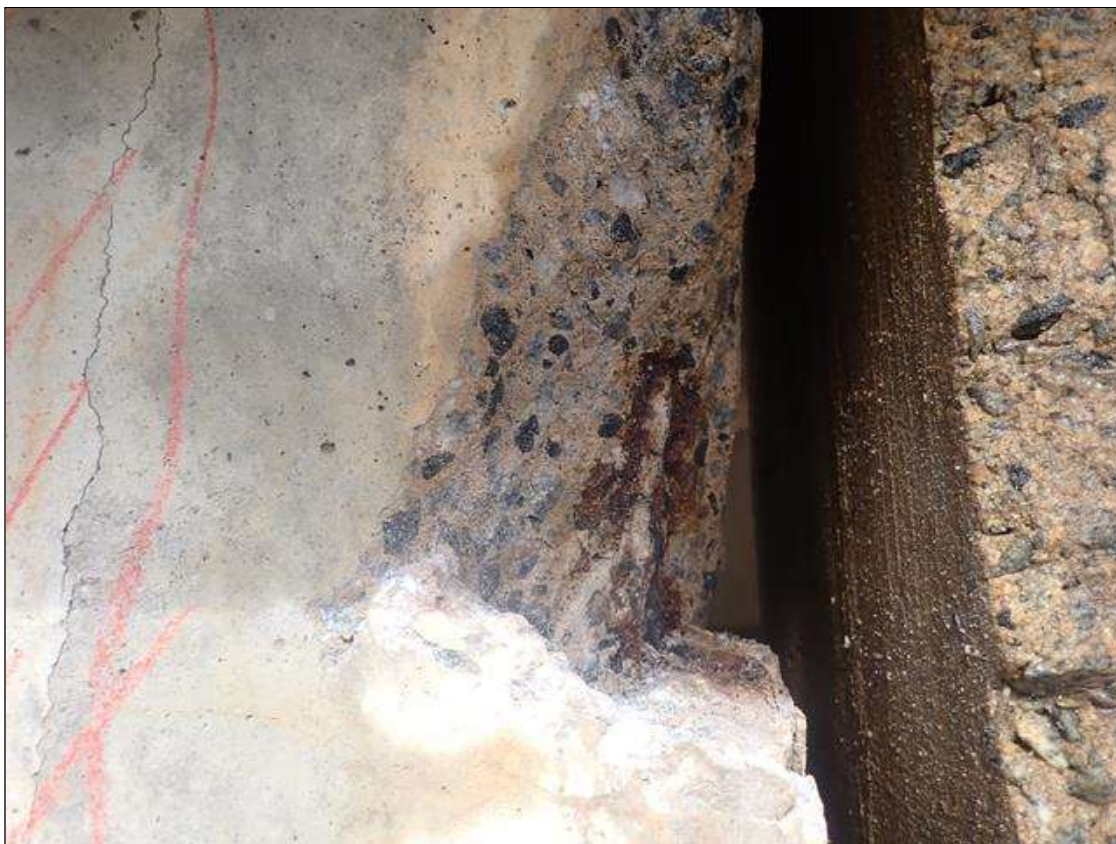
Span 4 Beam 4: EAST END OF WEB AT BENT 4, SPALL (18IN X 12IN X UP TO 3IN) WITH ADJACENT DELAMINATION (22IN X 5IN) ON SOUTH FACE (PHOTO 2 OF 2)

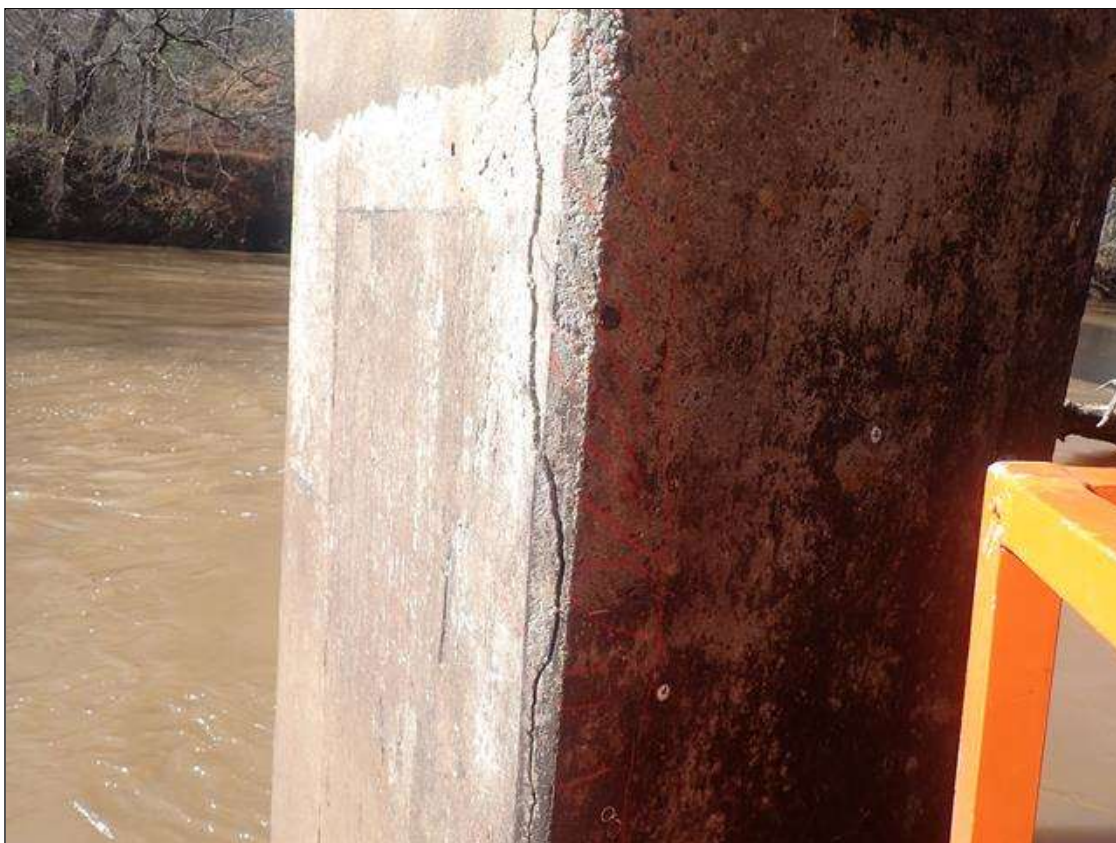
Bent 3 Pile 2: (PAR) 10 FEET X 8 INCHES X 2 INCHES DEEP SPALL/DELAMINATION WITH EXPOSED REBAR ON SOUTHEAST CORNER (PHOTO 1 OF 2)

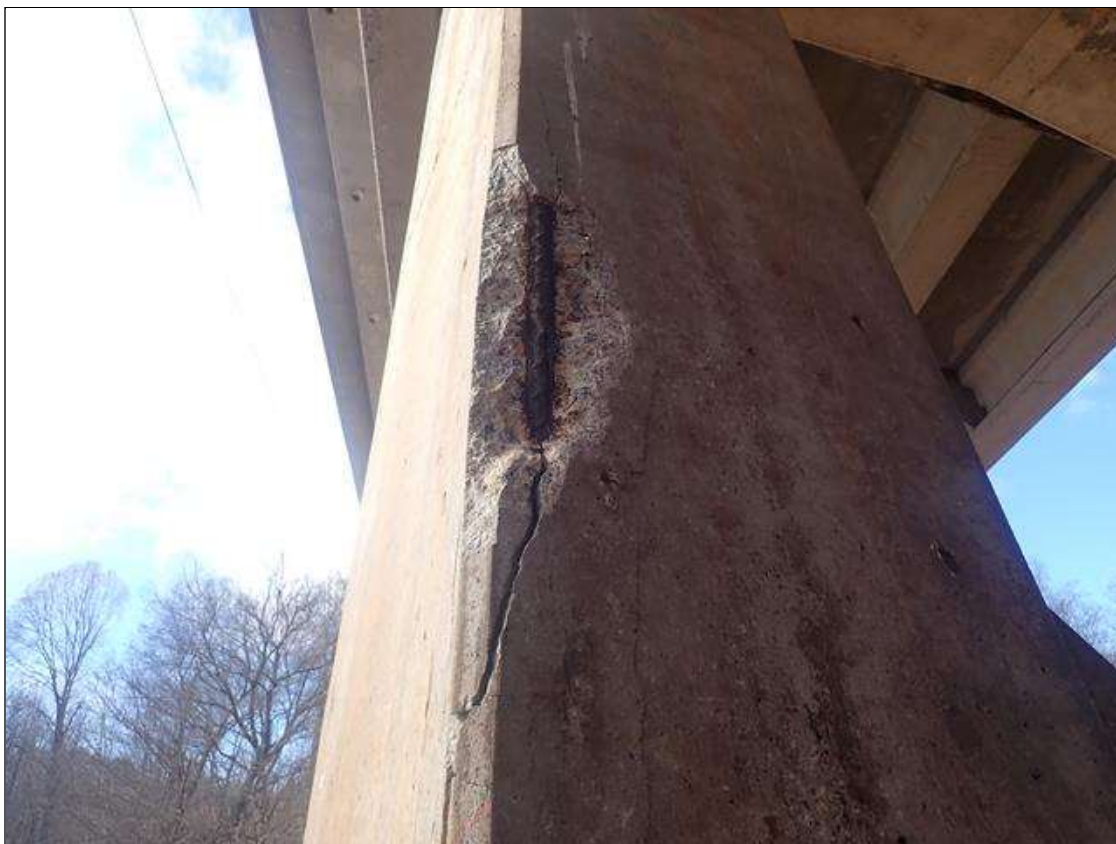
Bent 3 Pile 2: (PAR) 10 FEET X 8 INCHES X 2 INCHES DEEP SPALL/DELAMINATION WITH EXPOSED REBAR ON SOUTHEAST CORNER (PHOTO 2 OF 2)

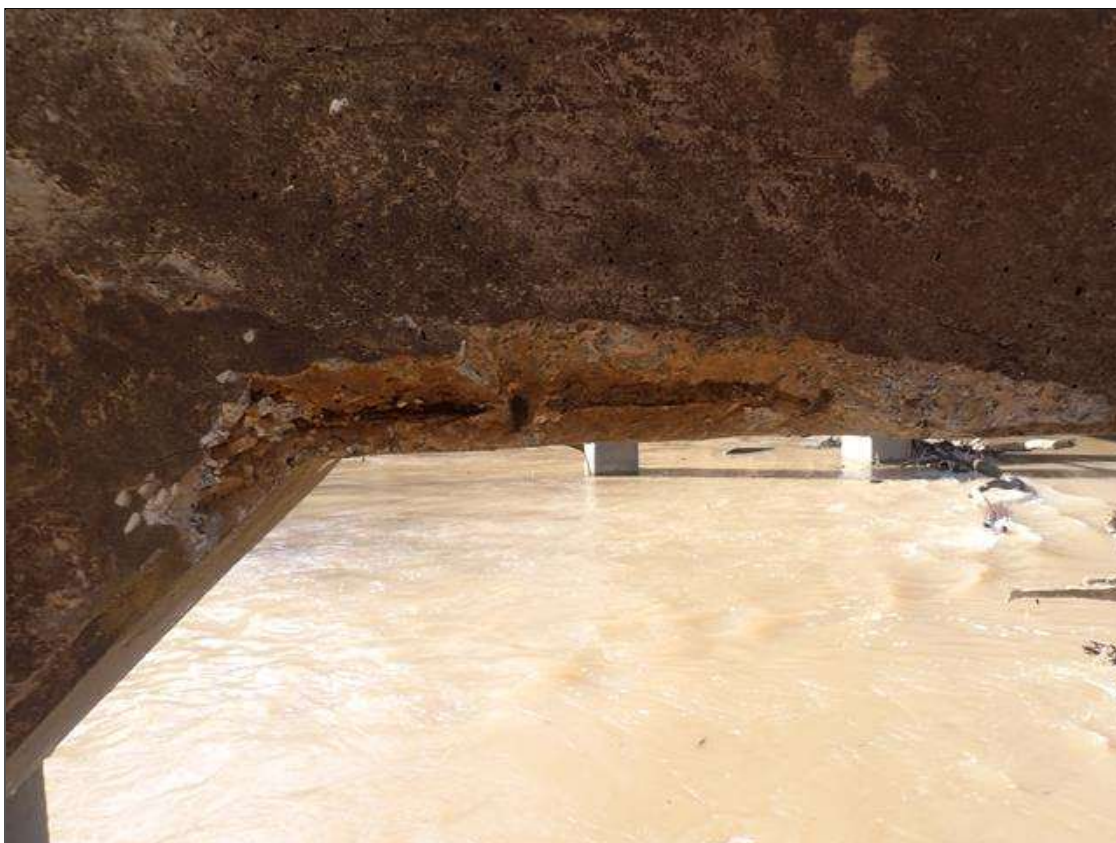
Bent 3 Pile 2: UNDERSIDE OF STRUT NEXT TO PILE 2, SPALL (3FT X 5IN X 3IN) WITH EXPOSED RUSTED REBAR
