NC DEPARTMENT OF TRANSPORTATION  
 DIVISION OF HIGHWAYS  
 STRUCTURE MANAGEMENT UNIT

ATTENTION: **PAR SUBMITTED  
 SNOOPER USED**

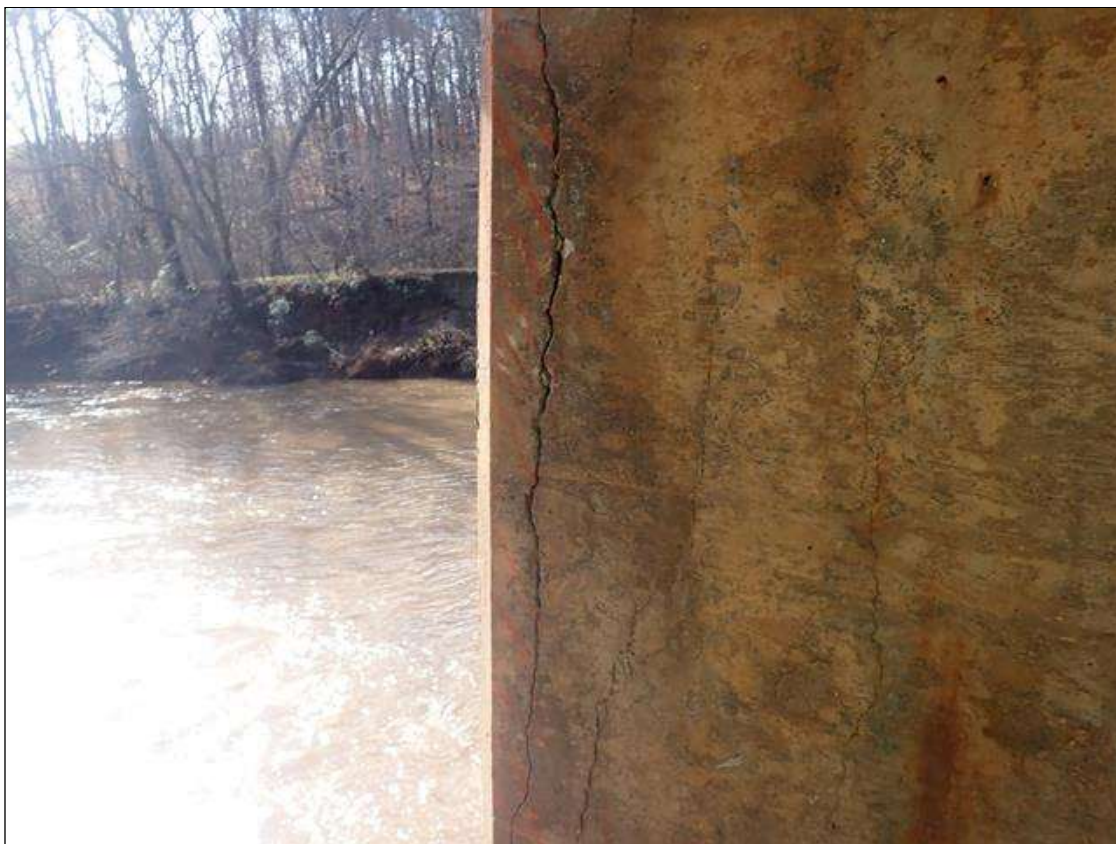
Bent 3 Pile 2: 7 FEET X 8 INCHES AREA OF DELAMINATION WITH 1/8 INCHES VERTICAL CRACK ON SOUTHEAST CORNER

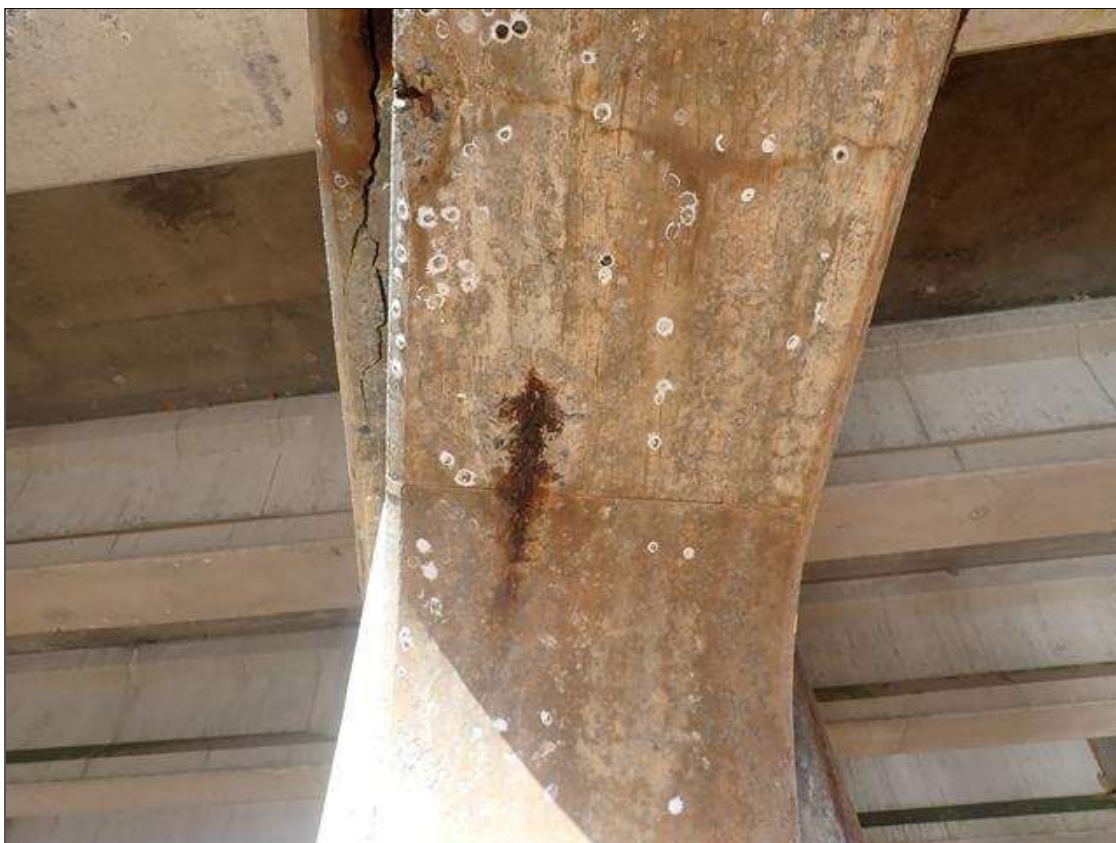
Bent 3 Pile 2: (2) UP TO 12 INCHES X 6 INCHES X 1 INCHES DEEP SPALL WITH EXPOSED REBAR ON BOTTOM OF CORBEL AT SOUTH END

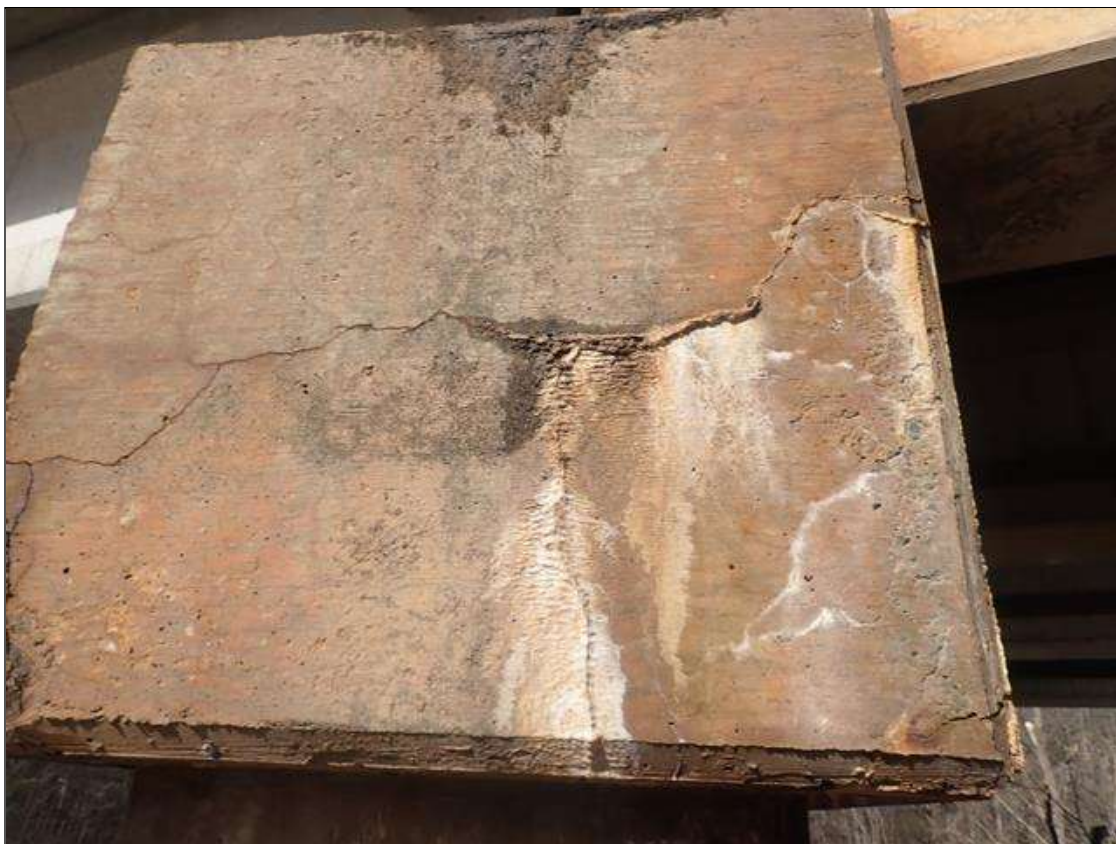
Bent 3 Cap 1: FULL HEIGHT X FULL WIDTH AREA OF VERTICAL (16IN X 1/32IN) AND HORIZONTAL (FULL WIDTH X 1/32IN) CRACKS WITH EFFLORESCENCE ON SOUTH FACE

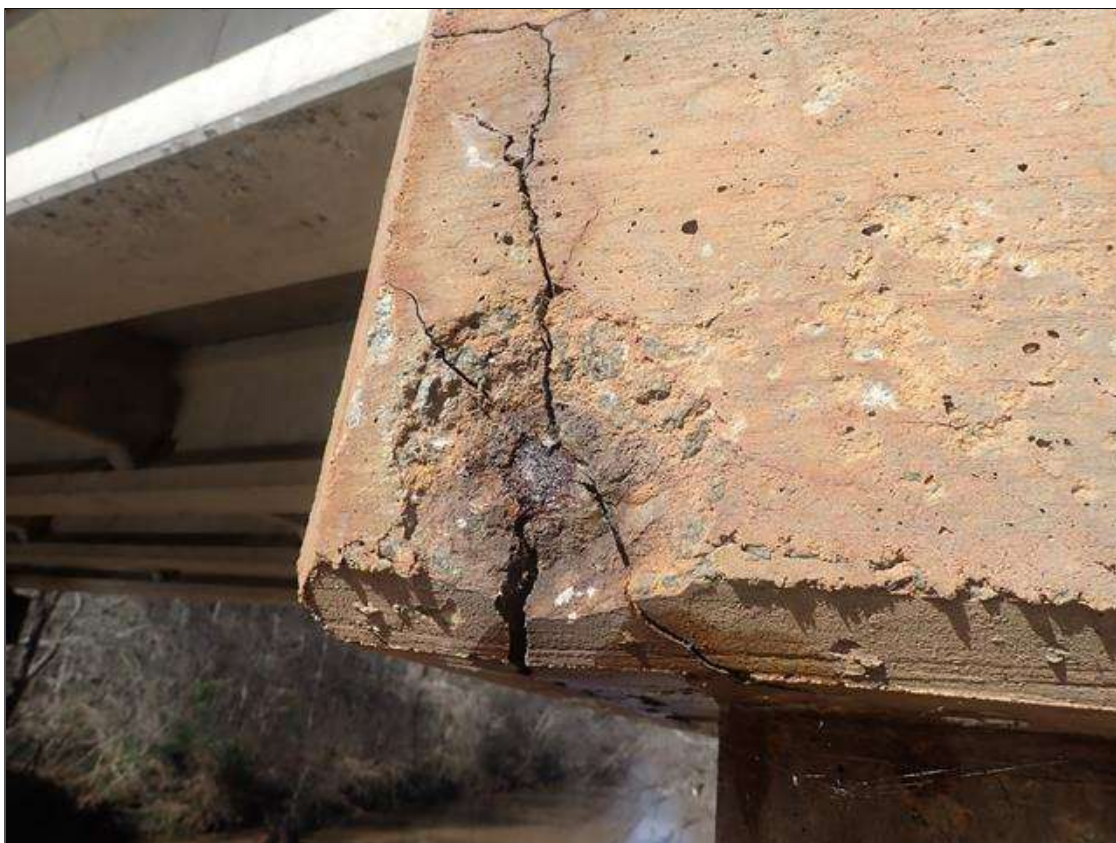
Bent 3 Cap 1: 6 INCHES DIAMETER X 1 INCHES DEEP SPALL WITH EXPOSED REBAR ON SOUTH FACE

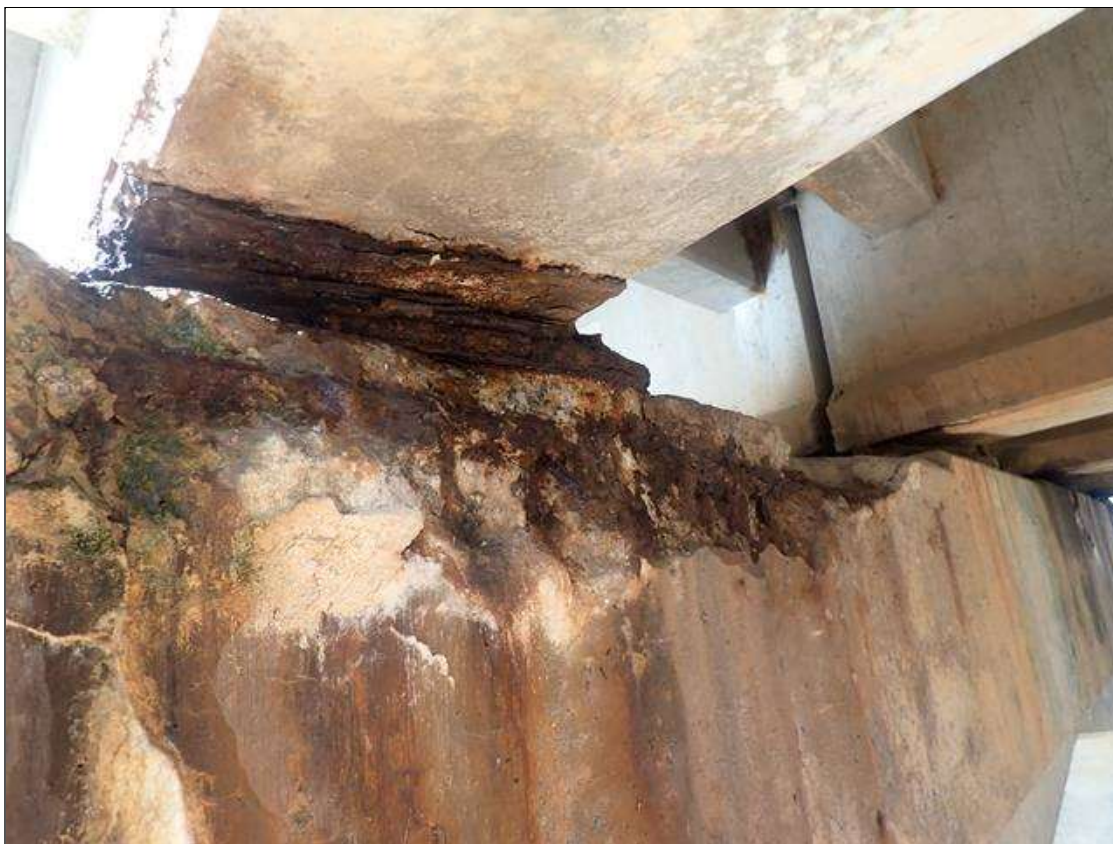
Bent 3 Cap 1: (PAR) 7FT X 12 INCHES X 2 INCHES DEEP SPALL WITH EXPOSED REBAR WITH 15 INCHES X 1 INCHES LOSS OF BEARING ON EAST FACE UNDER BEAM 4

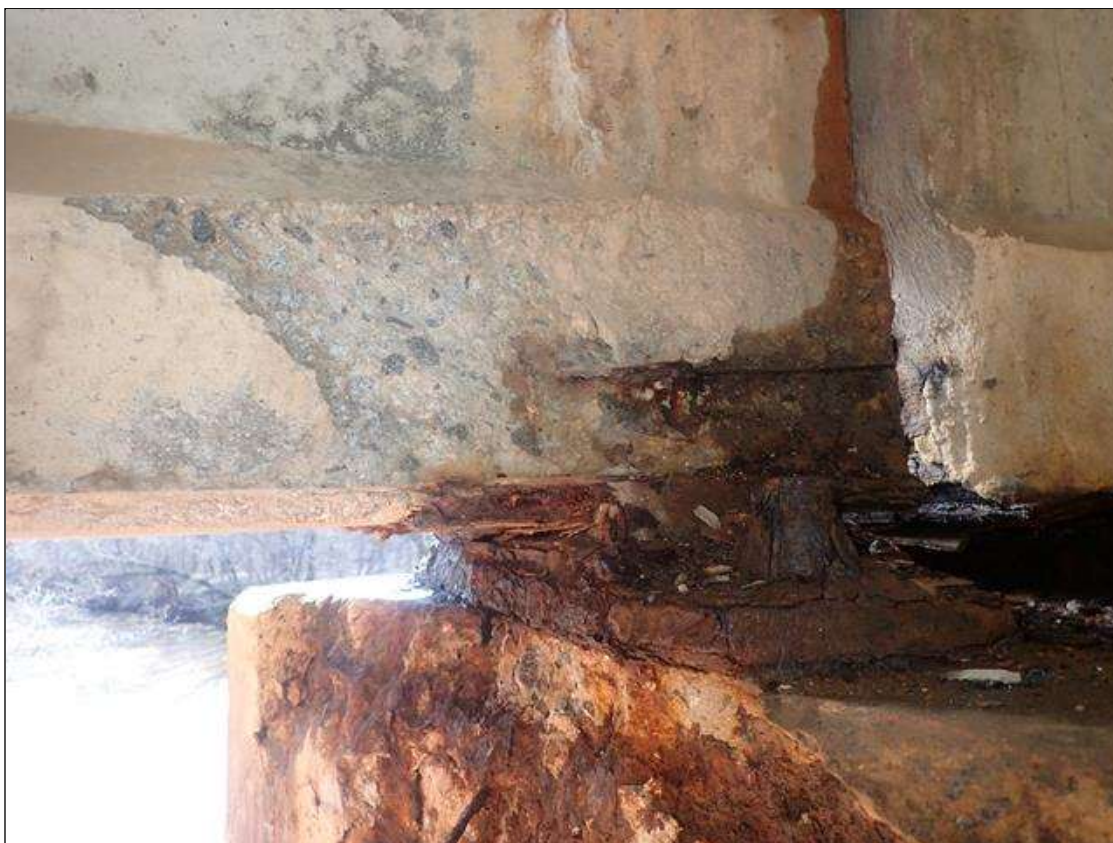
Span 4 Beam 4: (PAR) 24 INCHES X 8 INCHES X 2-1/2 INCHES DEEP SPALL WITH EXPOSED PRESTRESSING STRANDS ON LEFT SIDE OF BOTTOM FLANGE AT BENT 3

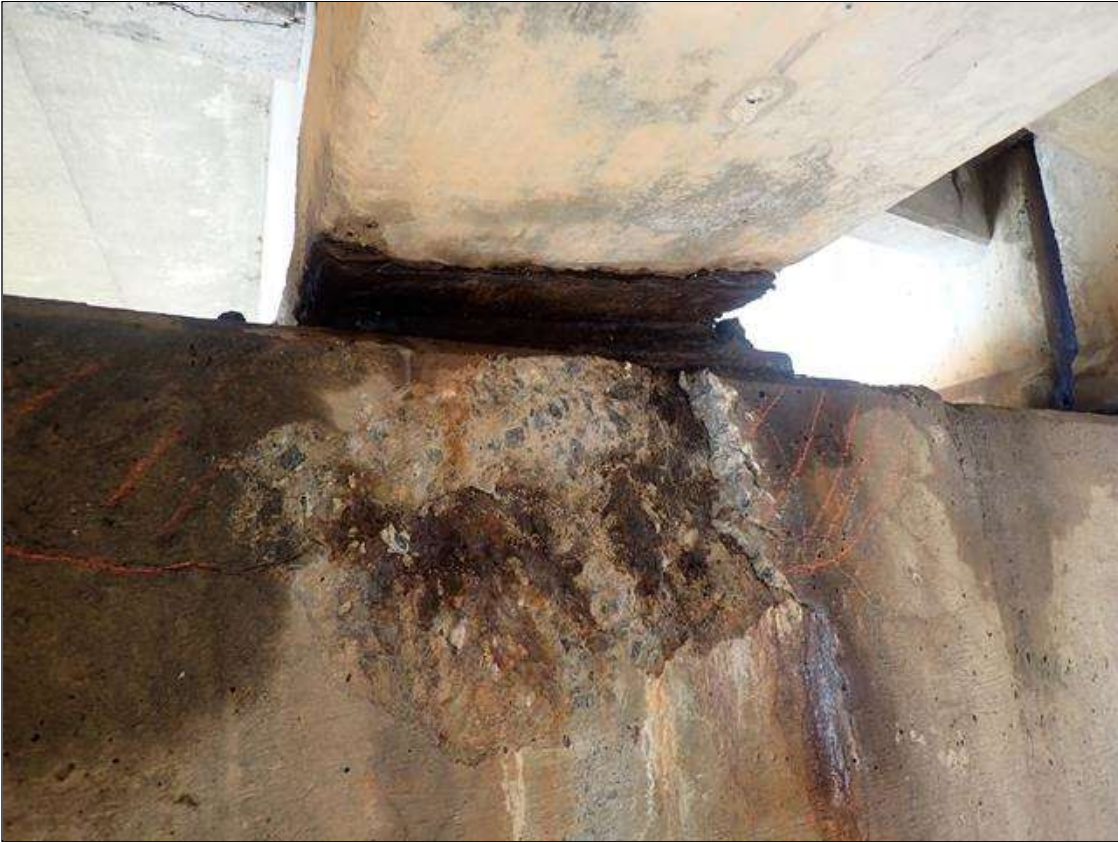
Bent 3 Cap 1: (PAR) 40 INCHES X 16 INCHES X 2 INCHES DEEP SPALL WITH EXPOSED REBAR AND AREA OF DELAMINATION ON EAST FACE UNDER BEAM 2

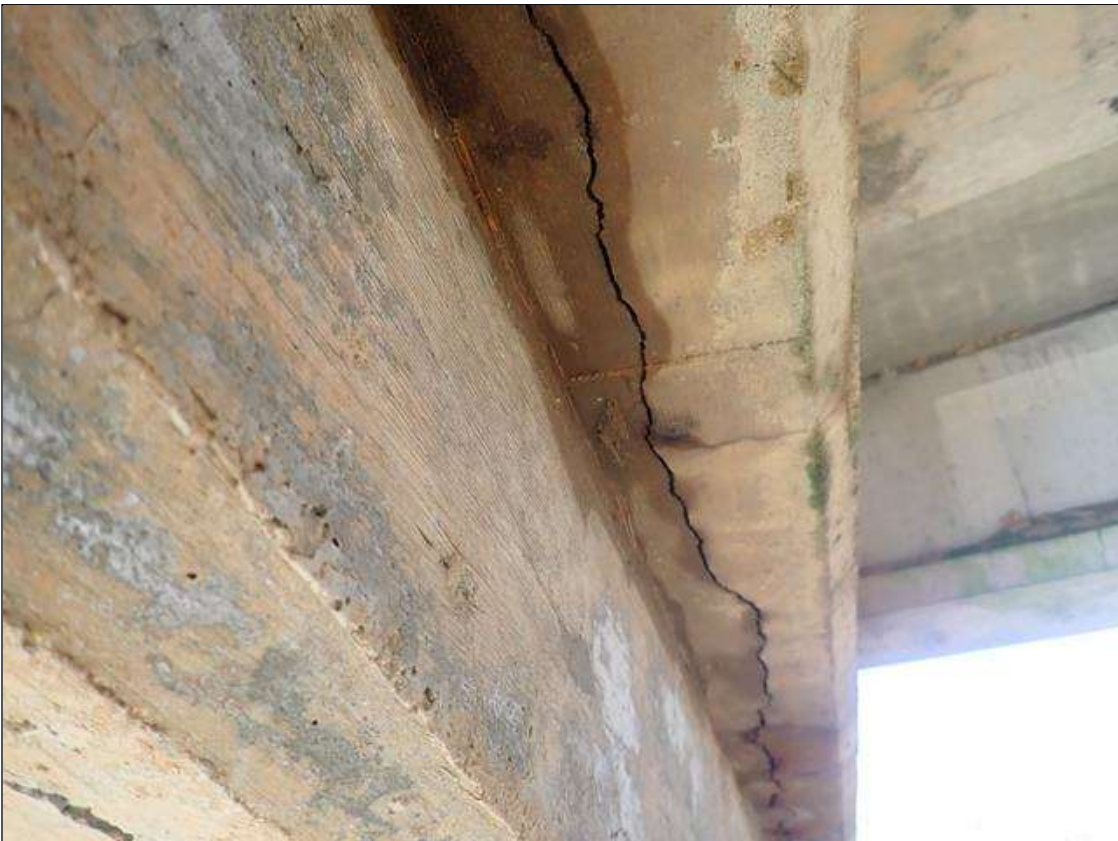
Bent 3 Cap 1: (19 FEET X UP TO 1/8 INCHES) TRANSVERSE CRACK WITH RUST STAINING ON BOTTOM OF CAP

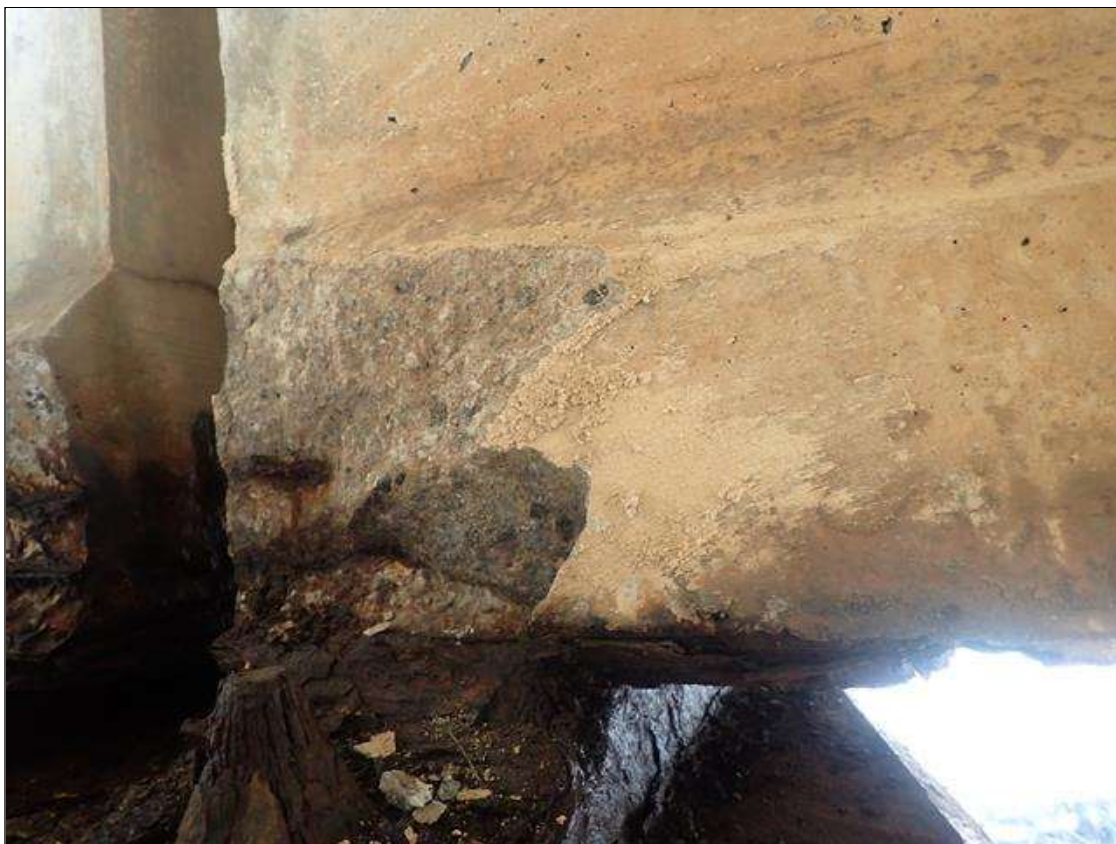
Span 4 Beam 2: (PAR) 11 INCHES X 9 INCHES X 2 INCHES DEEP SPALL WITH EXPOSED PRESTRESSING STRANDS ON RIGHT SIDE OF BOTTOM FLANGE AT BENT 3

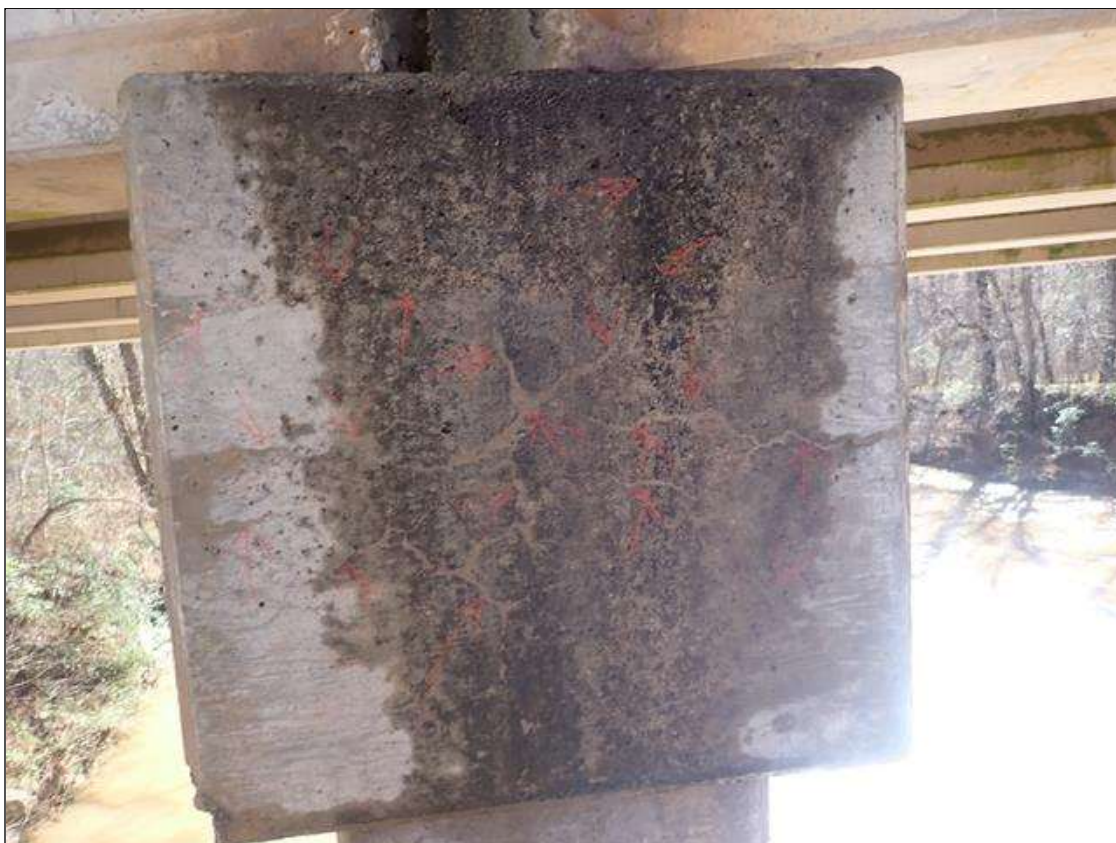
Bent 3 Cap 1: NORTH FACE, MAP CRACKING (FULL WIDTH X FULL HEIGHT X HAIRLINE) WITH EFFLORESCENCE

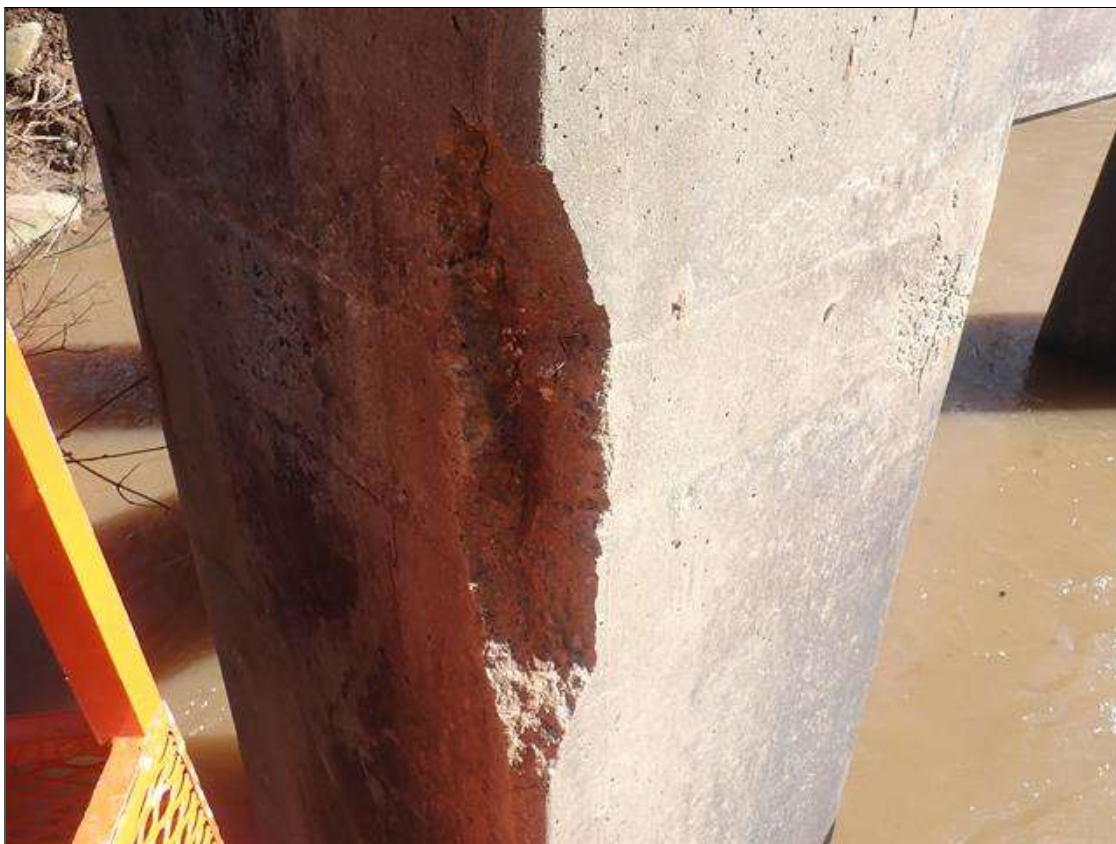
Bent 3 Pile 1: (PAR) 36 INCHES X 6 INCHES X 2 INCHES DEEP SPALL WITH EXPOSED REBAR AT NORTHWEST CORNER

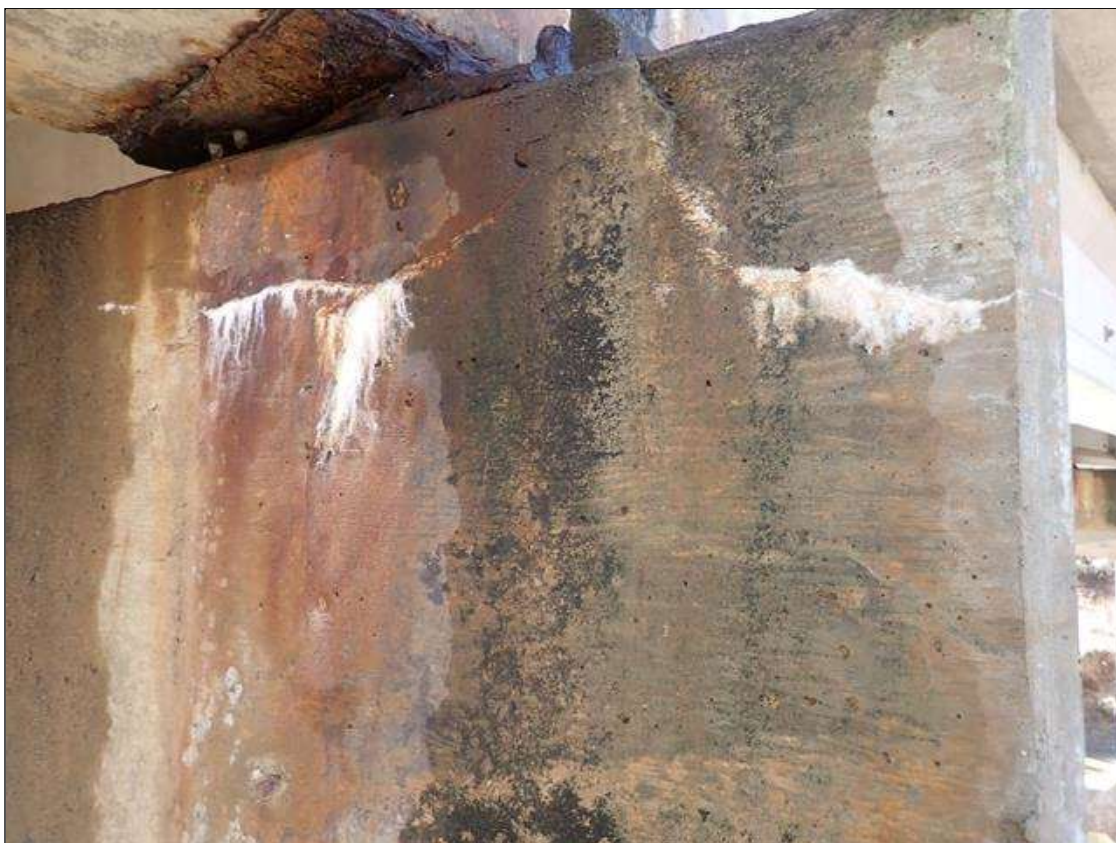
Bent 3 Cap 1: 3 FEET X 3 FEET AREA OF HAIRLINE VERTICAL AND HORIZONTAL CRACKS UP TO 1/32IN WITH EFFLORESCENCE ON EAST FACE AT NORTH END

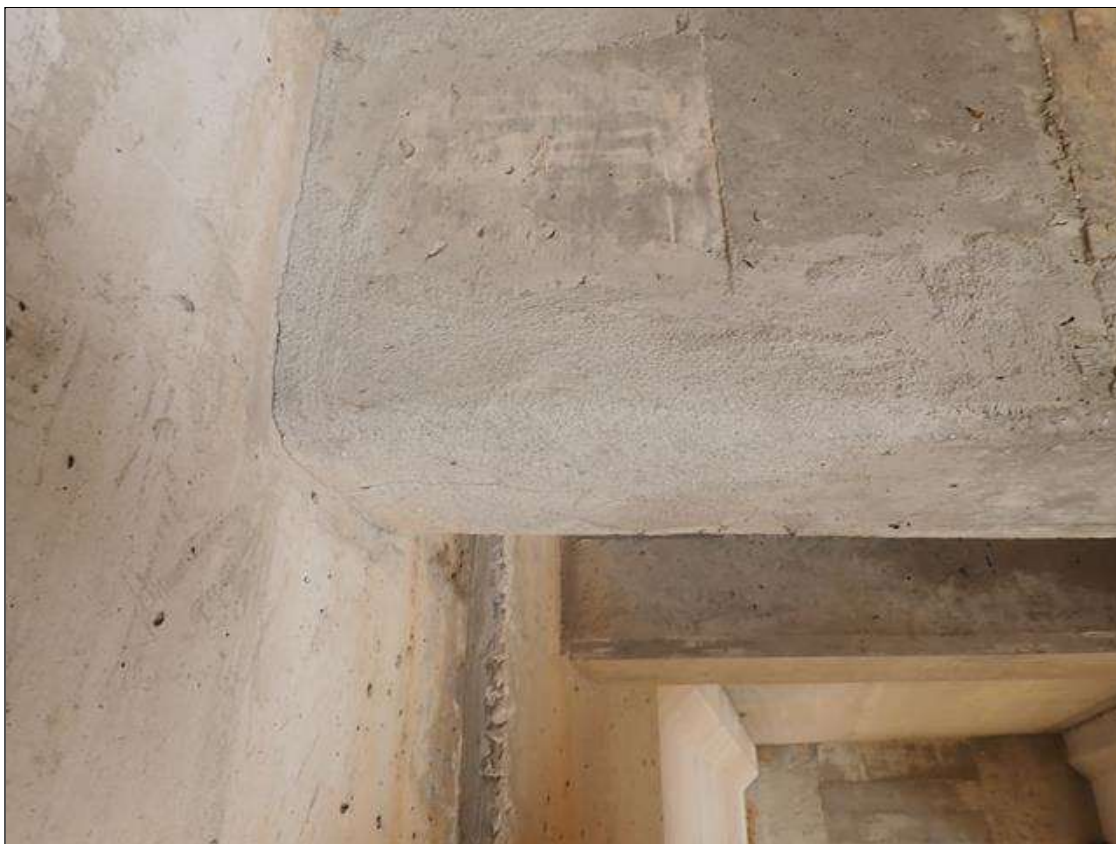
Span 3 Beam 1: 30 INCHES X 7 INCHES AREA OF SOUND PATCH ON BENT 3 DIAPHRAGM IN BAY 1

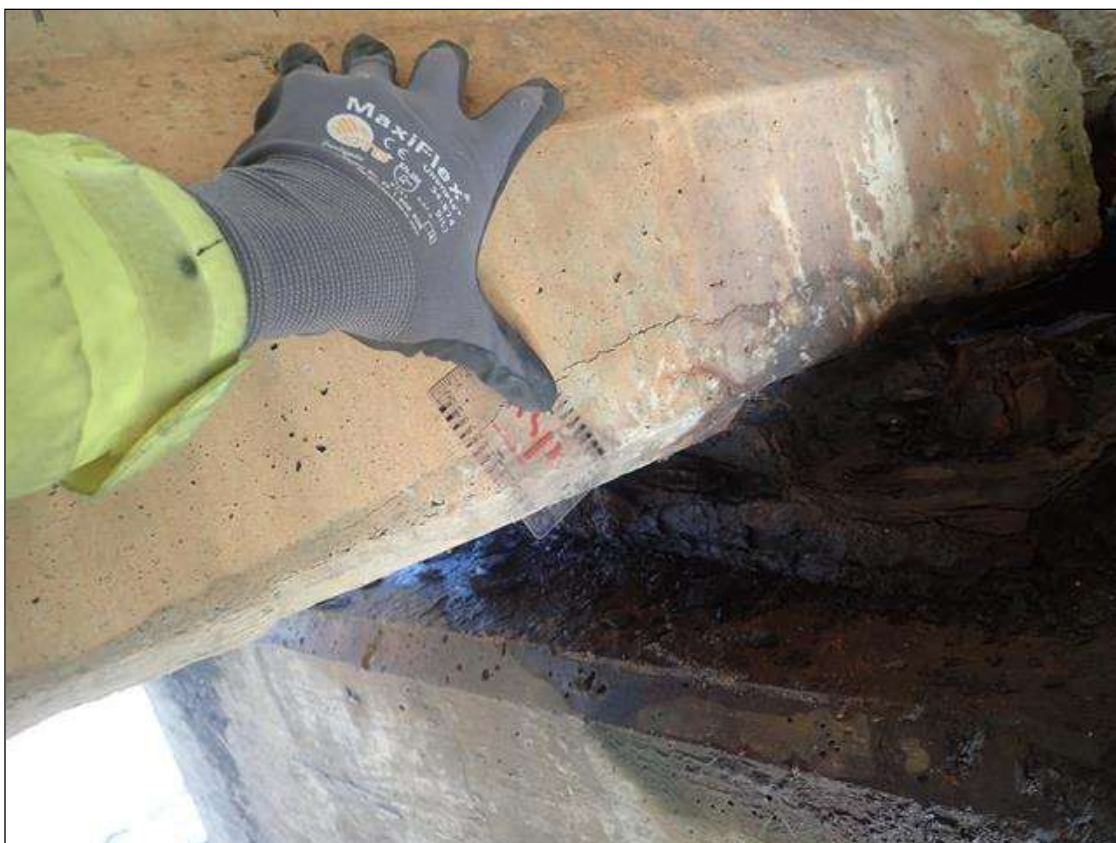
Span 3 Beam 1: BOTTOM FLANGE RIGH SIDE AT BENT 4, HORIZONTAL CRACK (12IN X UP TO 0.016IN)

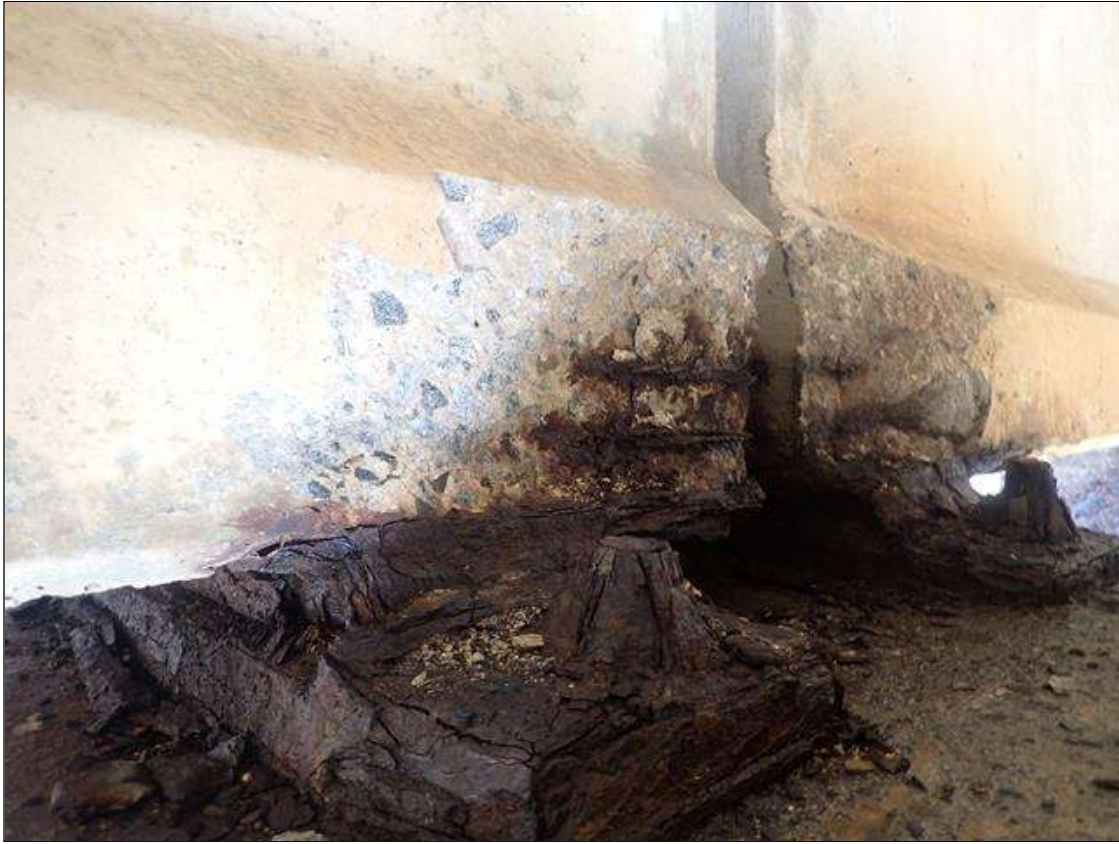
Span 3 Beam 2: (PAR) 16 INCHES X 8 INCHES X 2 INCHES DEEP SPALL WITH EXPOSED PRESTRESSING STRANDS ON RIGHT SIDE OF BOTTOM FLANGE AT BENT 3

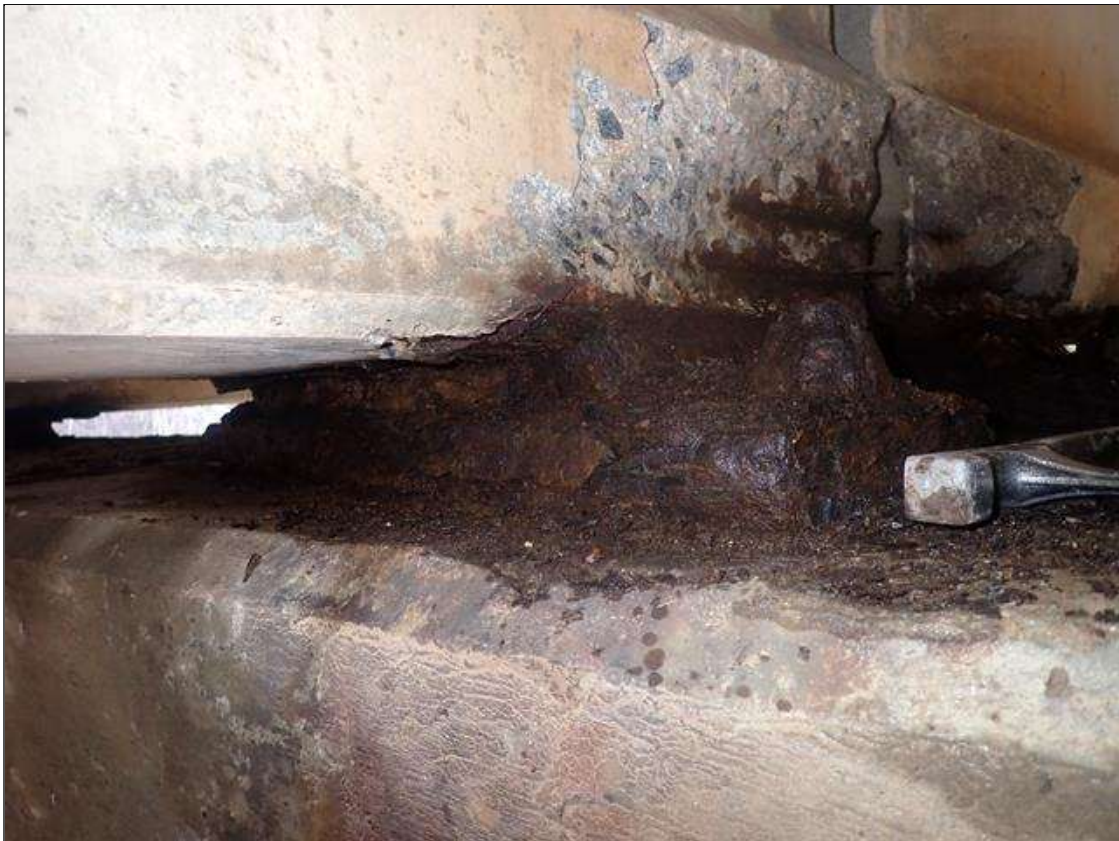
Span 3 Beam 2 - Far Bearing: RUST SCALE WITH SECTION LOSS (UP TO 1/8IN LOSS)

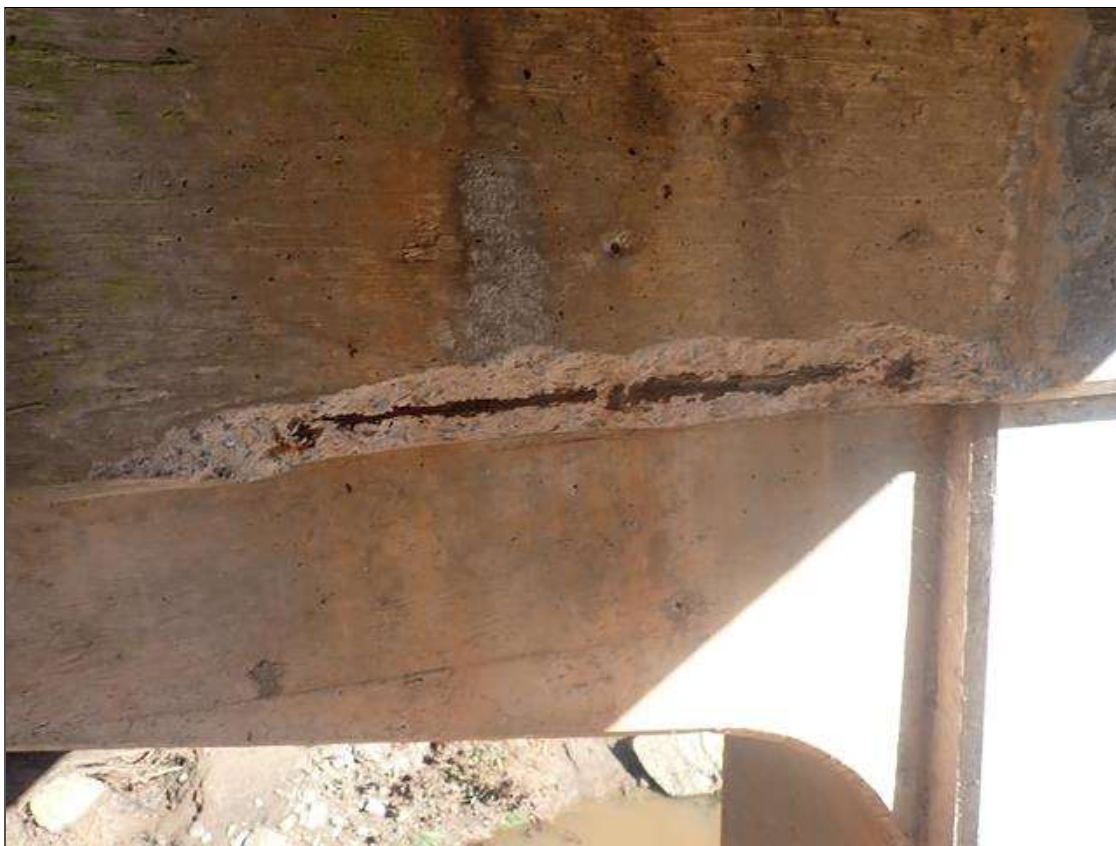
Bent 3 Cap 1: (PAR) 53 INCHES X 7 INCHES X 3 INCHES DEEP SPALL WITH EXPOSED REBAR ON WEST FACE UNDER BAY 3

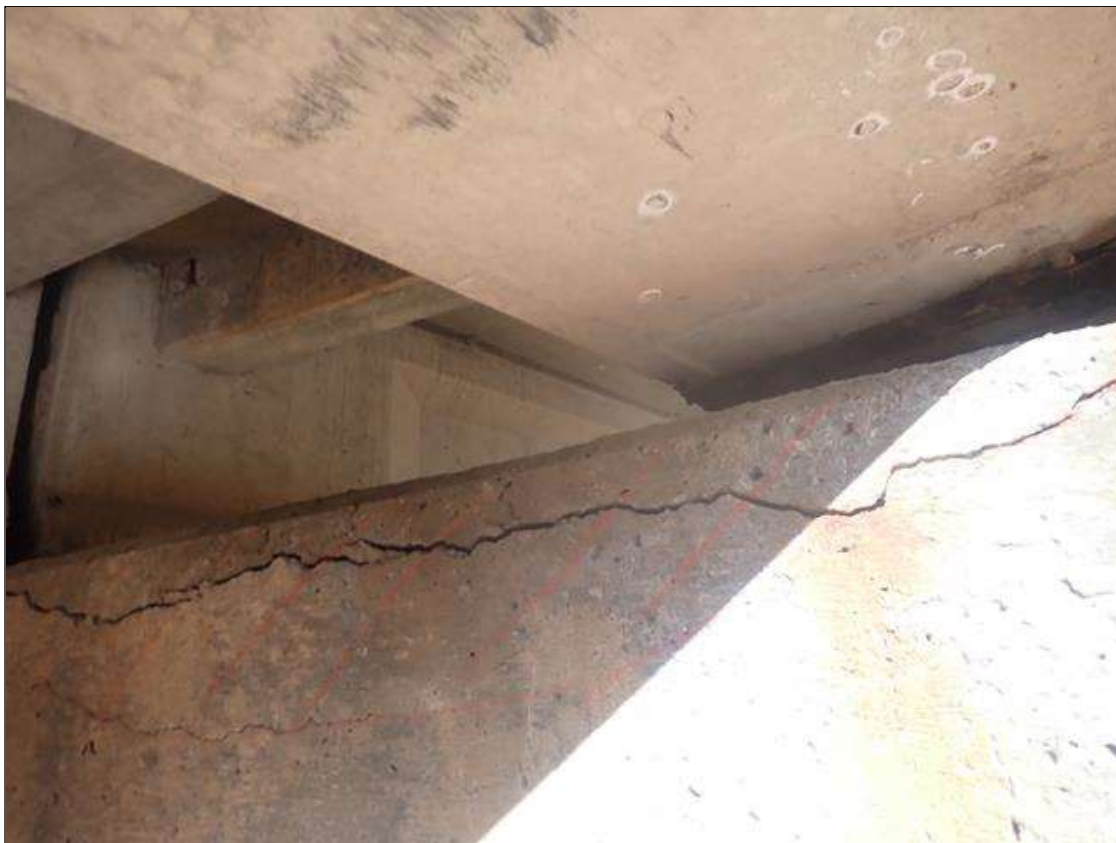
Bent 3 Cap 1: 6-1/2FT X UP TO 9IN DELAMINATION ON WEST FACE UNDER BAY 3

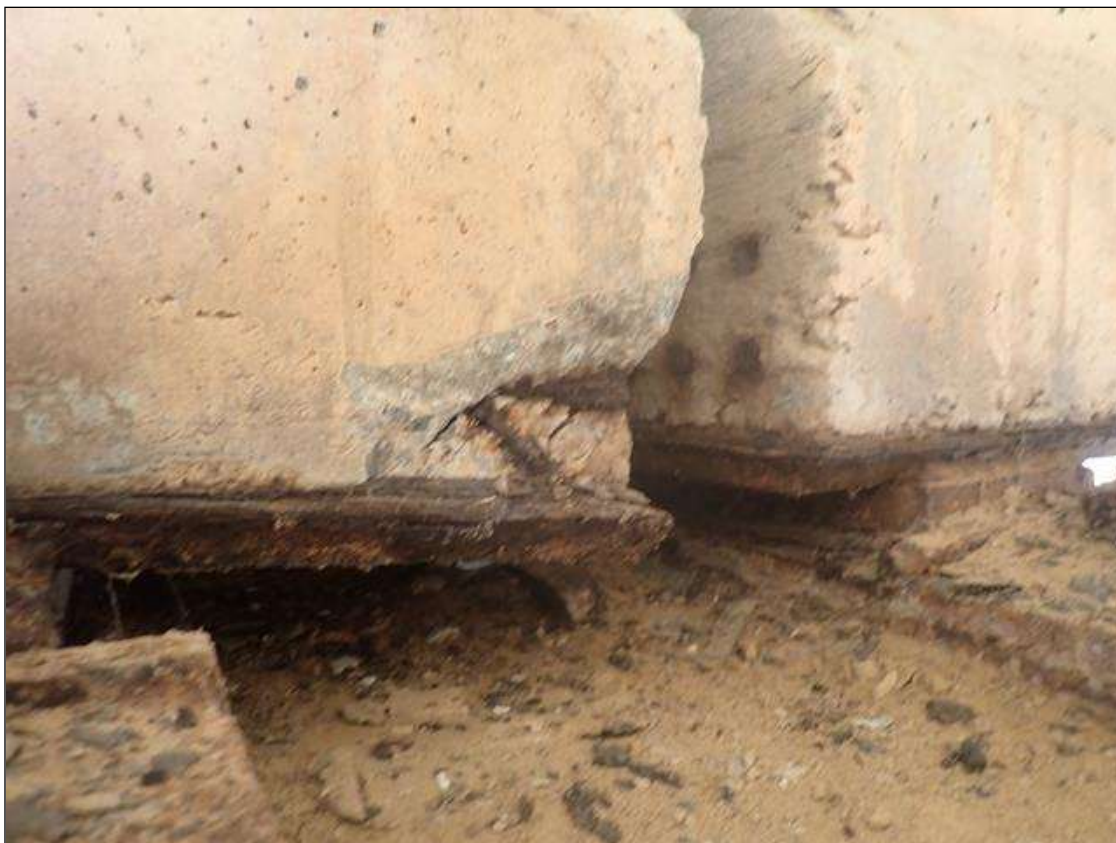
Span 3 Beam 3: (PAR) 5 1/2 INCHES X 3 INCHES X 2 INCHES DEEP SPALL WITH EXPOSED PRESTRESSING STRANDS ON RIGHT SIDE OF BOTTOM FLANGE AT BENT 3

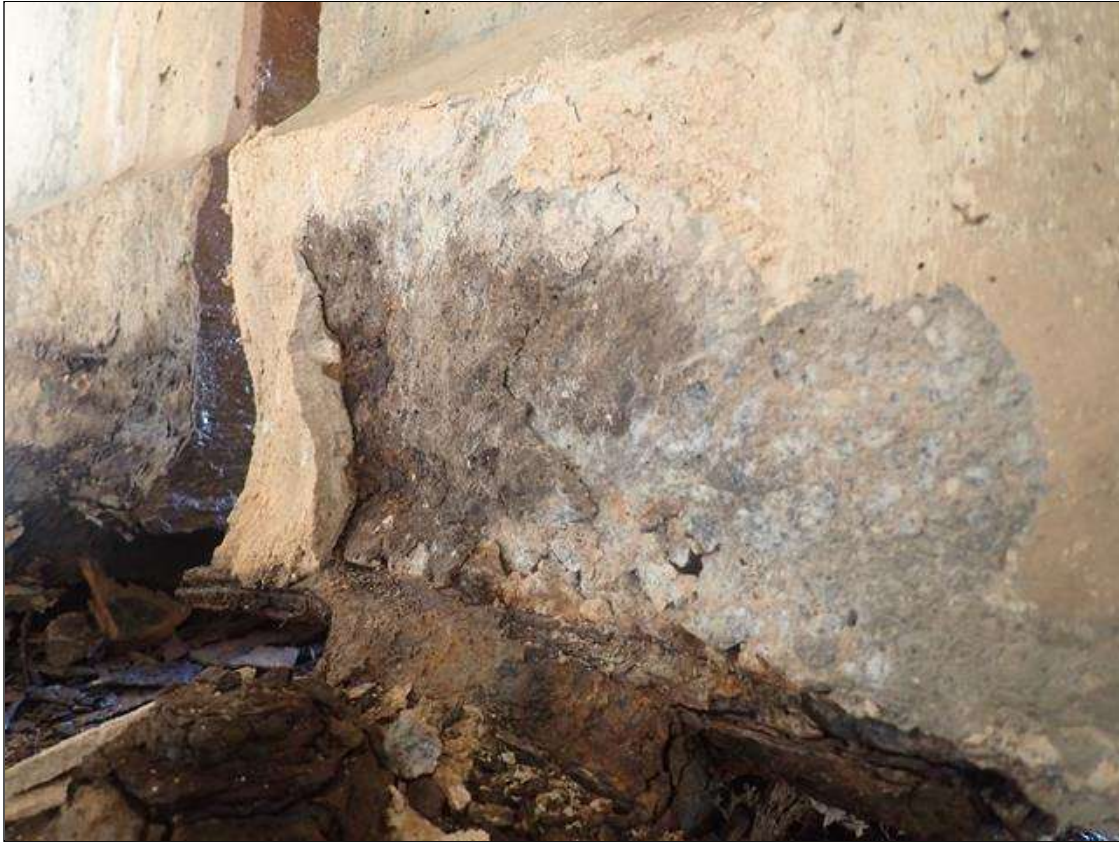
Span 3 Beam 4: (PAR) LEFT SIDE OF BOTTOM FLANGE AT BENT 3, SPALL (17IN X 6IN X UP TO 2IN) WITH EXPOSED RUSTED STRANDS AT FAILED PATCHED AREA

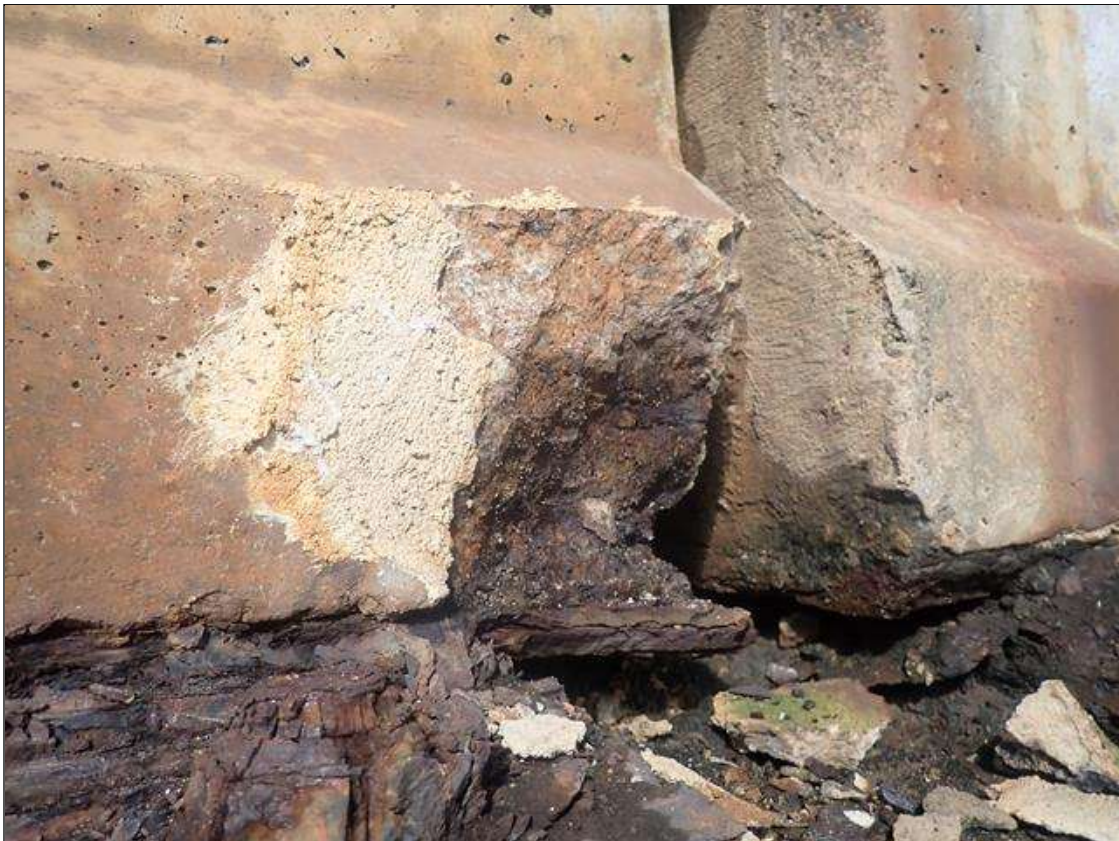
Span 3 Beam 4: (PAR) RIGHT SIDE OF BOTTOM FLANGE AT BENT 3, SPALL (17IN X 6IN X UP TO 2IN) WITH EXPOSED RUSTED STRANDS AT FAILED PATCHED AREA

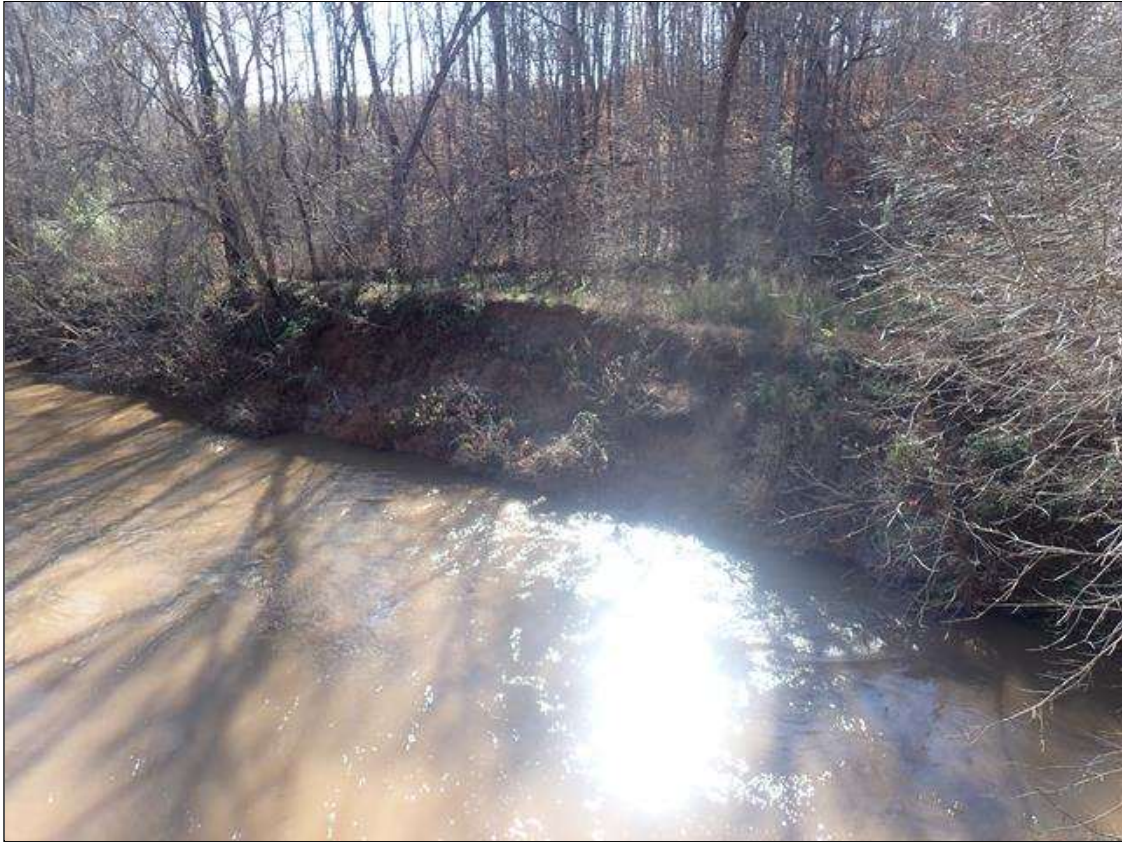
Channel and Channel Protection: southwest streambank 50ft from bridge, vertical cuts (70ft x 8ft x 12ft) with exposed tree roots

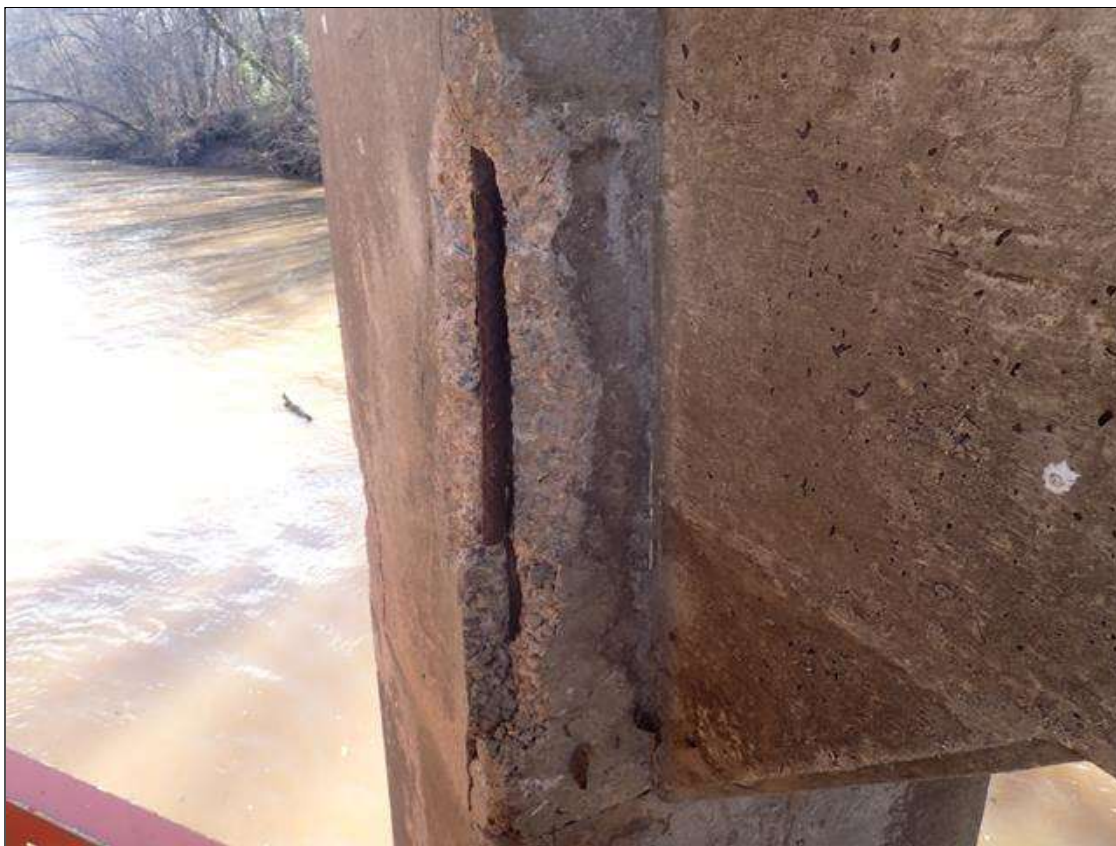
Bent 2 Pile 2: (PAR) 48 INCHES X 6 INCHES X 3-1/2 INCHES DEEP SPALL WITH EXPOSED REBAR ON NORTHEAST CORNER
