NC DEPARTMENT OF TRANSPORTATION  
 DIVISION OF HIGHWAYS  
 STRUCTURE MANAGEMENT UNIT

ATTENTION: **PAR SUBMITTED  
 SNOOPER USED**

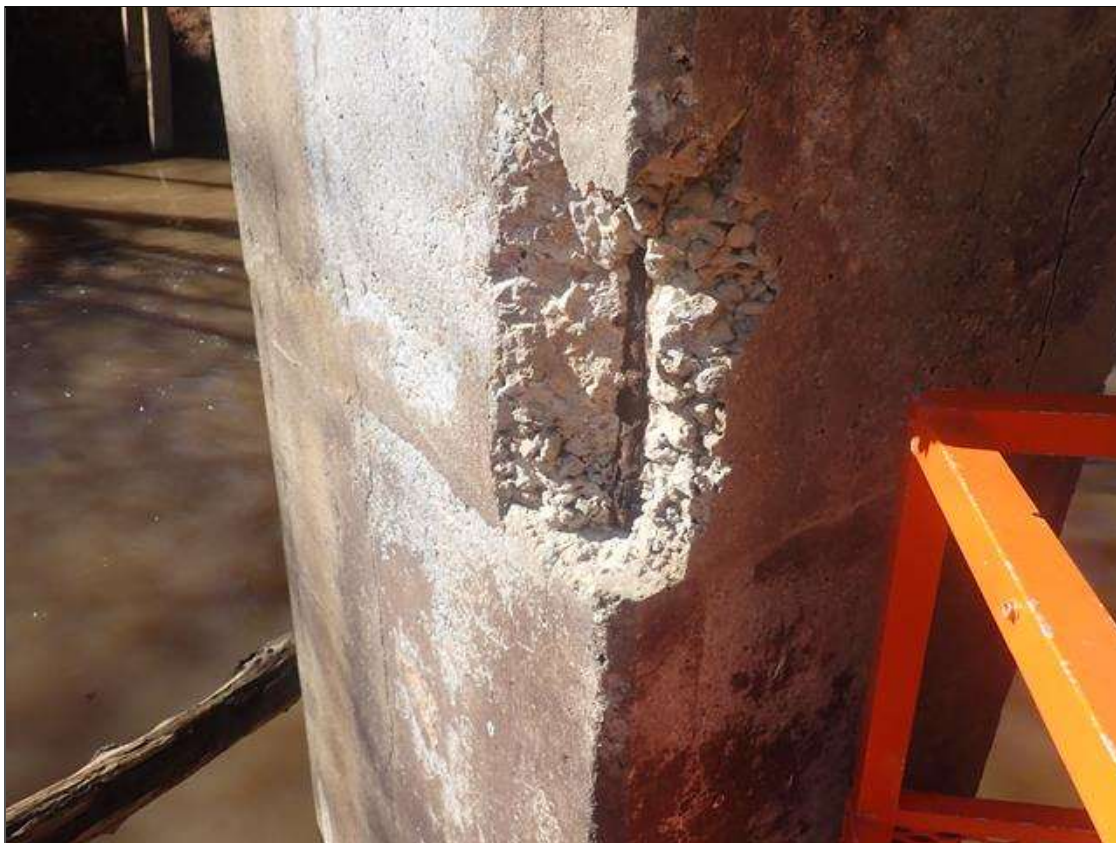
Bent 2 Pile 2: (PAR) 18 INCHES X 12 INCHES X 3 INCHES DEEP SPALL WITH EXPOSED REBAR ON SOUTHEAST CORNER

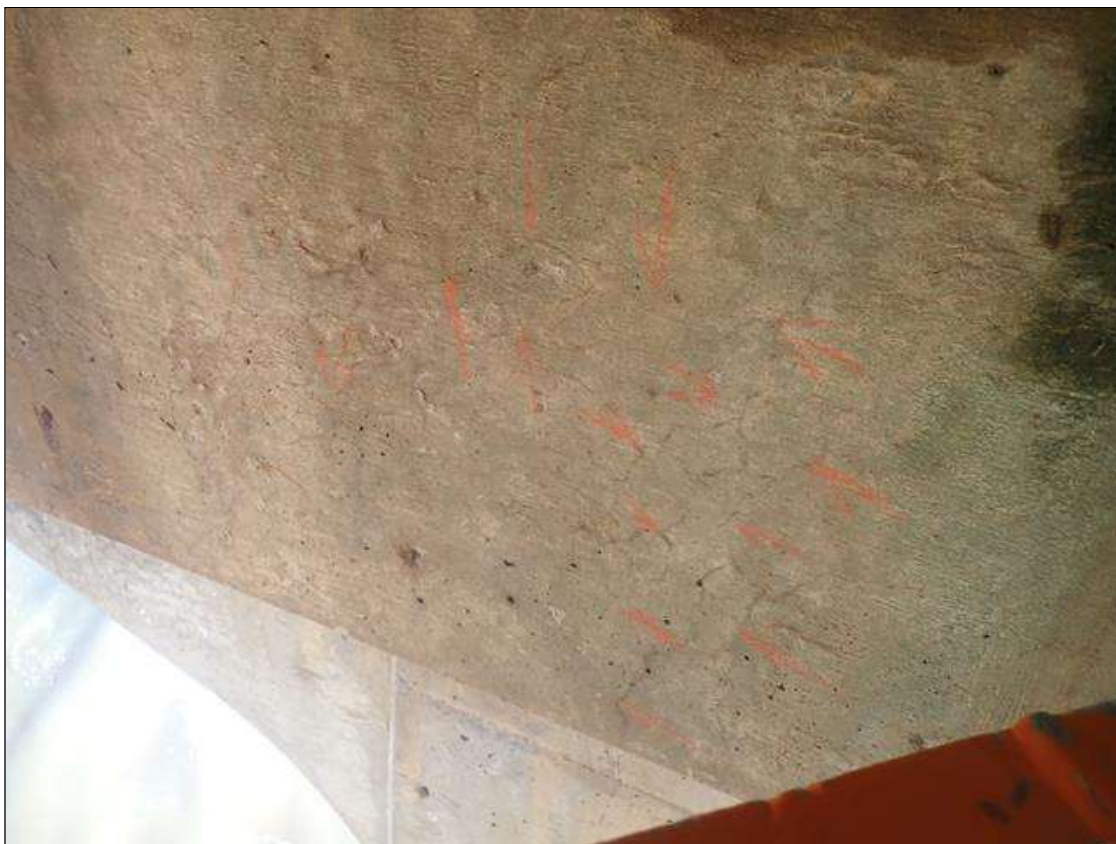
Bent 2 Cap 1: EAST FACE SCATTERED THROUGHOUT, MAP CRACKING (FULL HEIGHT X UP TO 4FT X HAIRLINE)

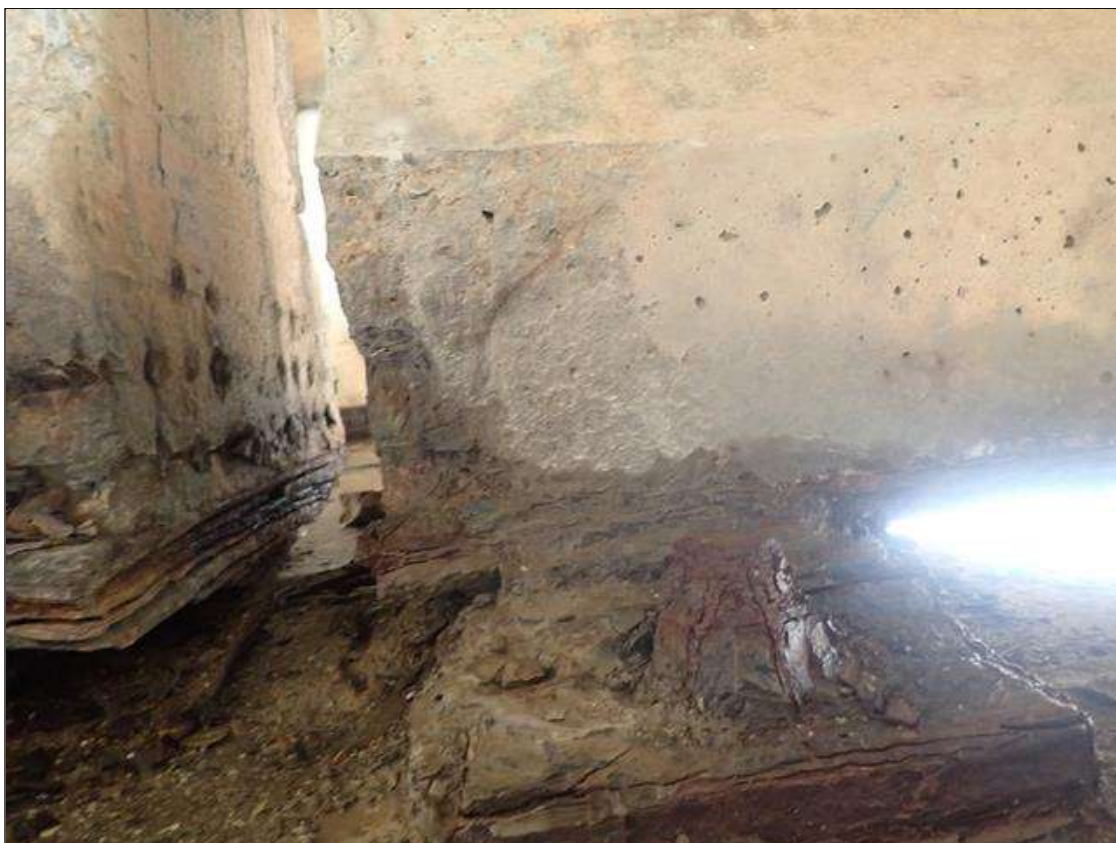
Span 3 Beam 3: (PAR) 7 INCHES X 7 INCHES X 2 1/2 INCHES DEEP SPALL WITH EXPOSED PRESTRESSING STRANDS ON RIGHT SIDE OF BOTTOM FLANGE AT BENT 2

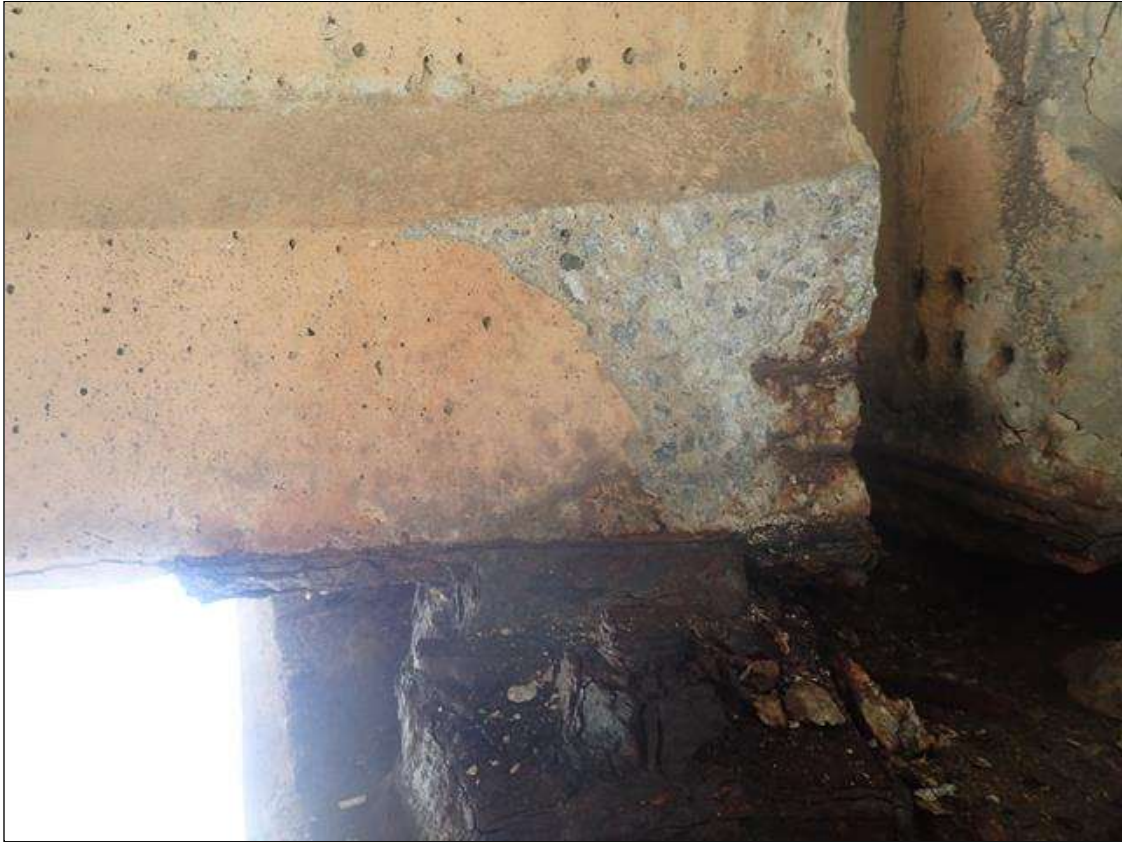
Span 3 Beam 3: (PAR) BOTTOM FLANGE LEFT SIDE AT BENT 2, SPALL (9IN X 8IN X 2-1/2IN) WITH EXPOSED RUSTED STRANDS

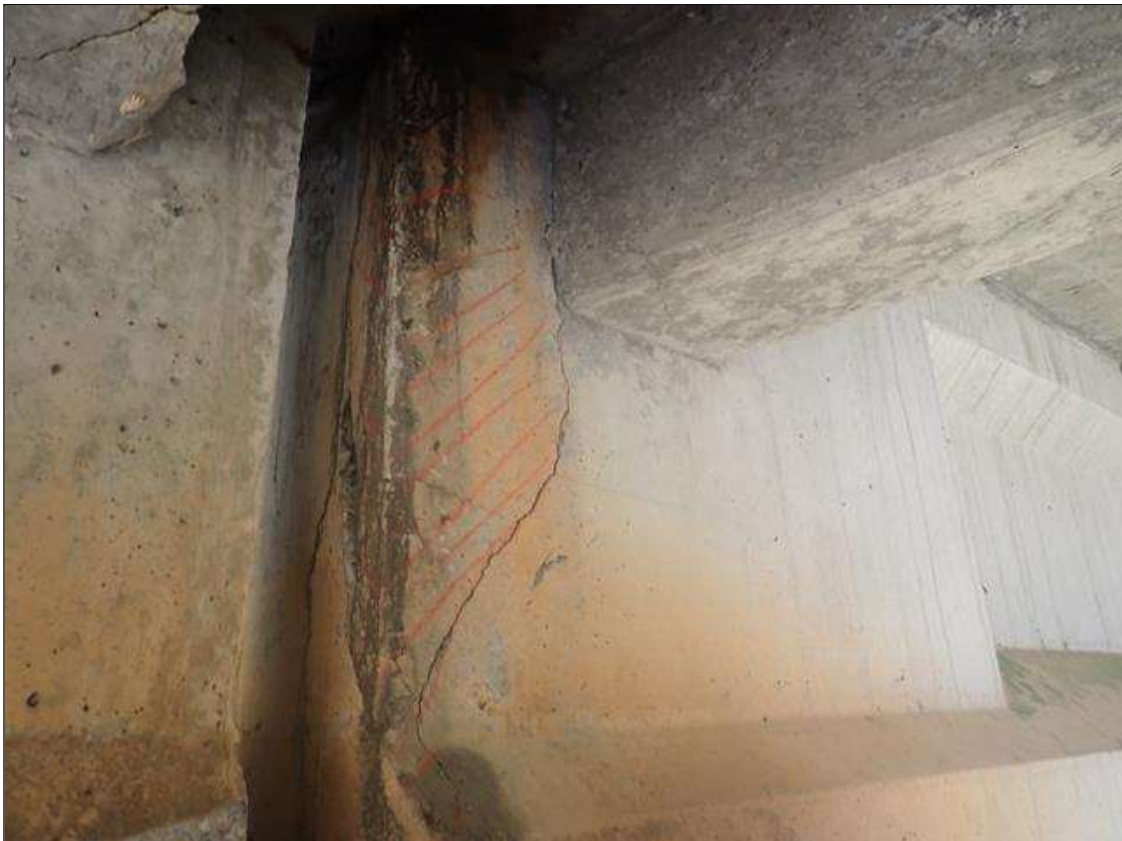
Span 2 Beam 3: 1 FEET X 30 INCHES X 4 INCHES DELAMINATION ON LEFT SIDE OF WEB AT BENT 2

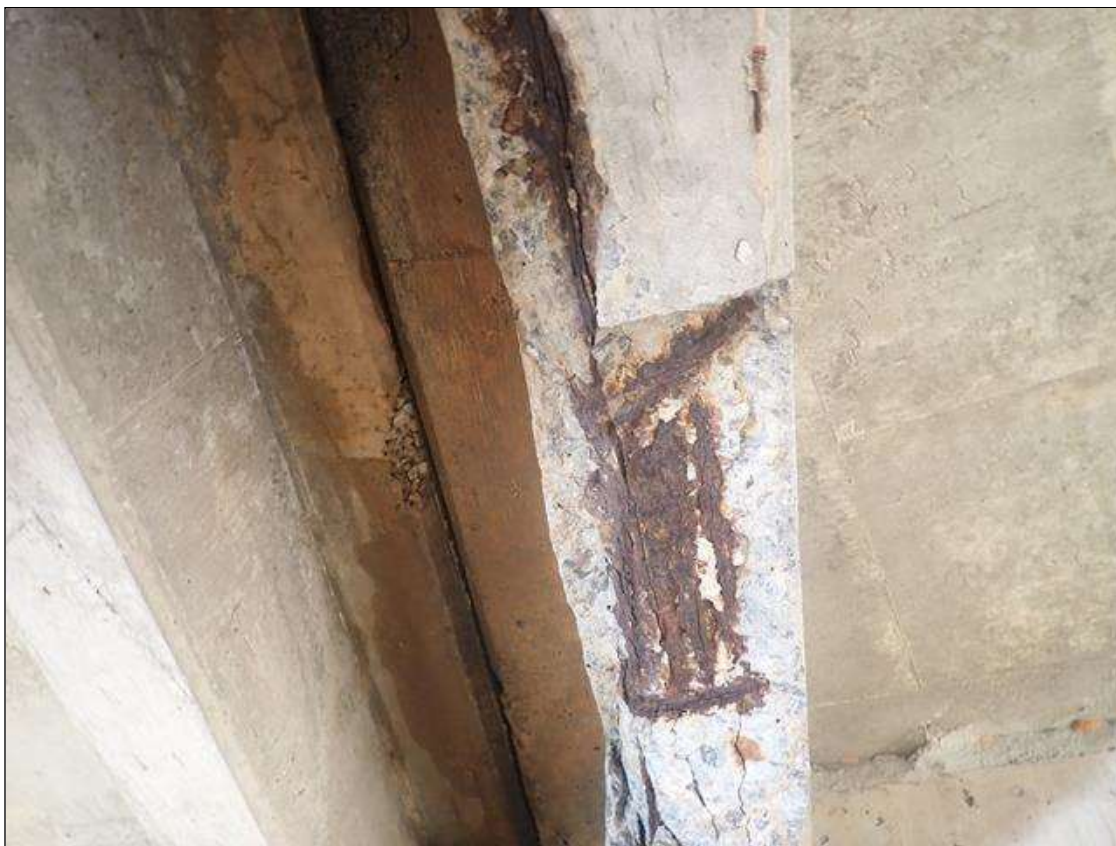
Span 3 Beam 3: 89 INCHES X 10 INCHES X 7 INCHES DEEP SPALL WITH EXPOSED REBAR ON BENT 2 DIAPHRAGM IN BAY 2

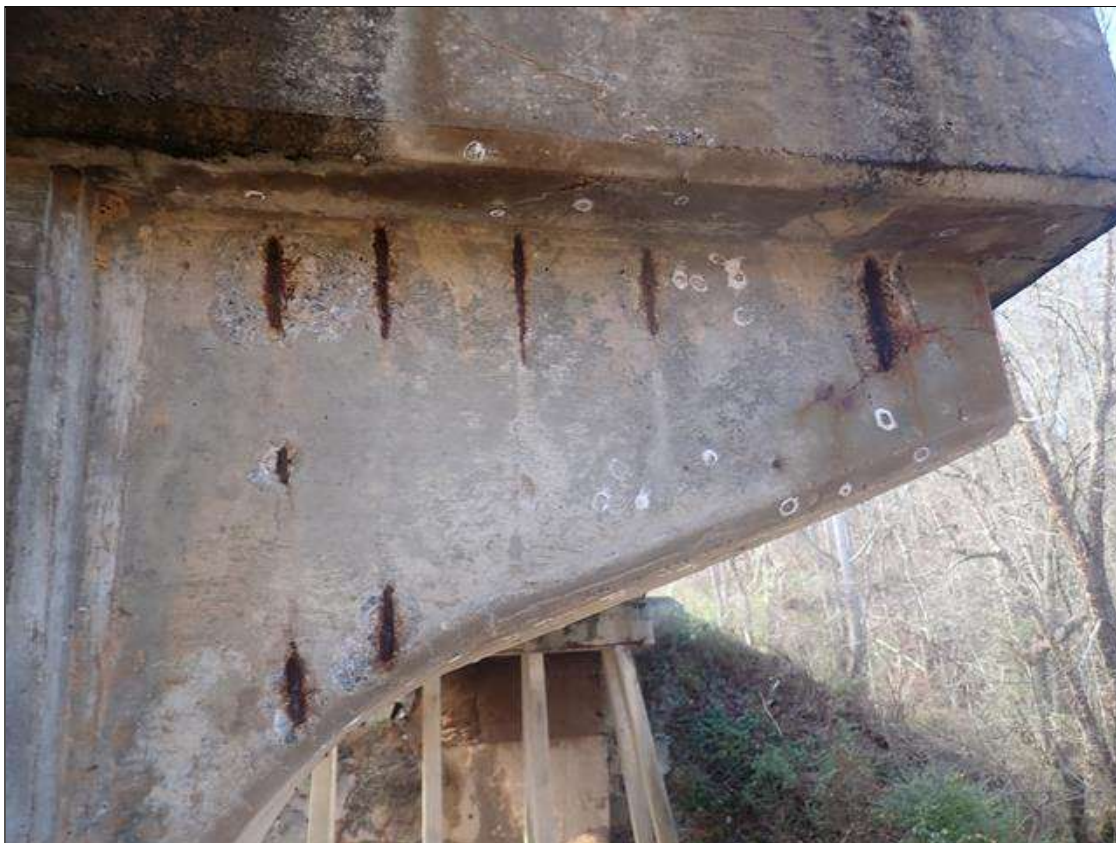
Bent 2 Cap 1: (8) UP TO 12 INCHES X 6 INCHES X 1/2 INCHES DEEP SPALLS WITH EXPOSED REBAR ON EAST FACE OF CORBEL AT NORTH END

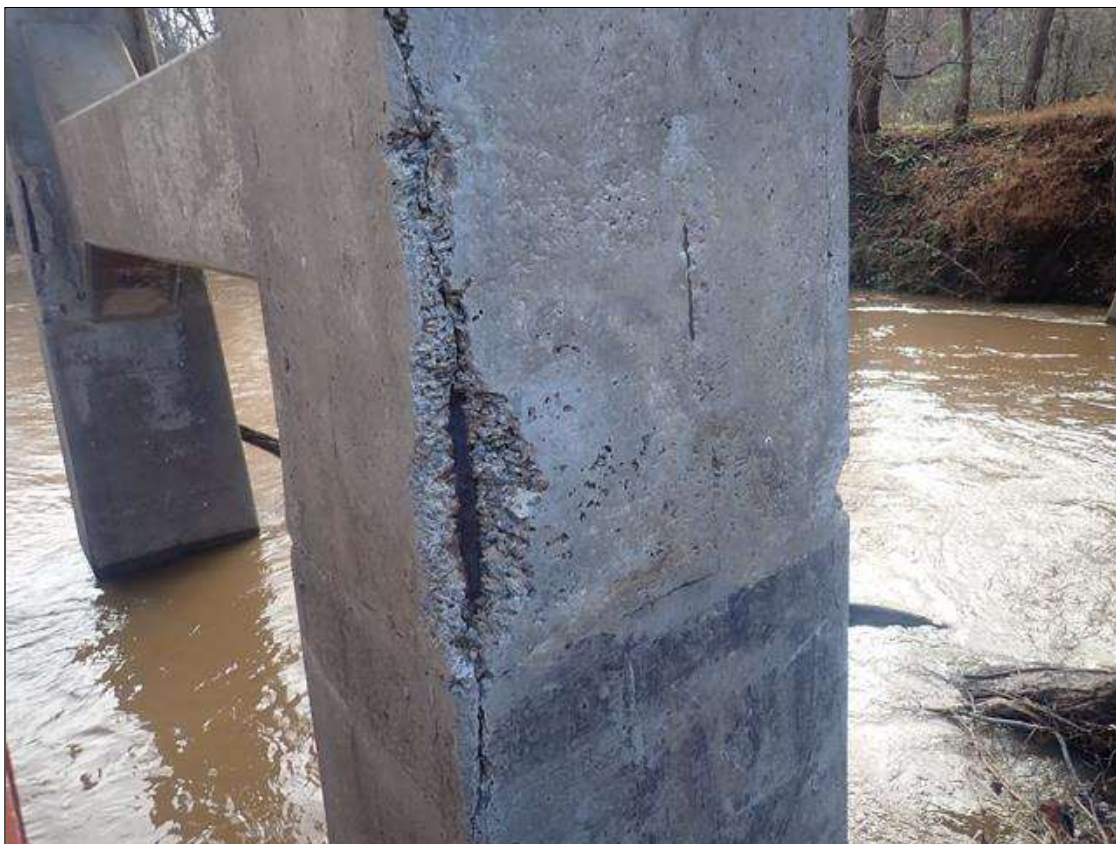
Bent 2 Pile 1: (PAR) 30 INCHES X 10 INCHES X 3 INCHES DEEP SPALL WITH EXPOSED REBAR ON NORTHEAST CORNER

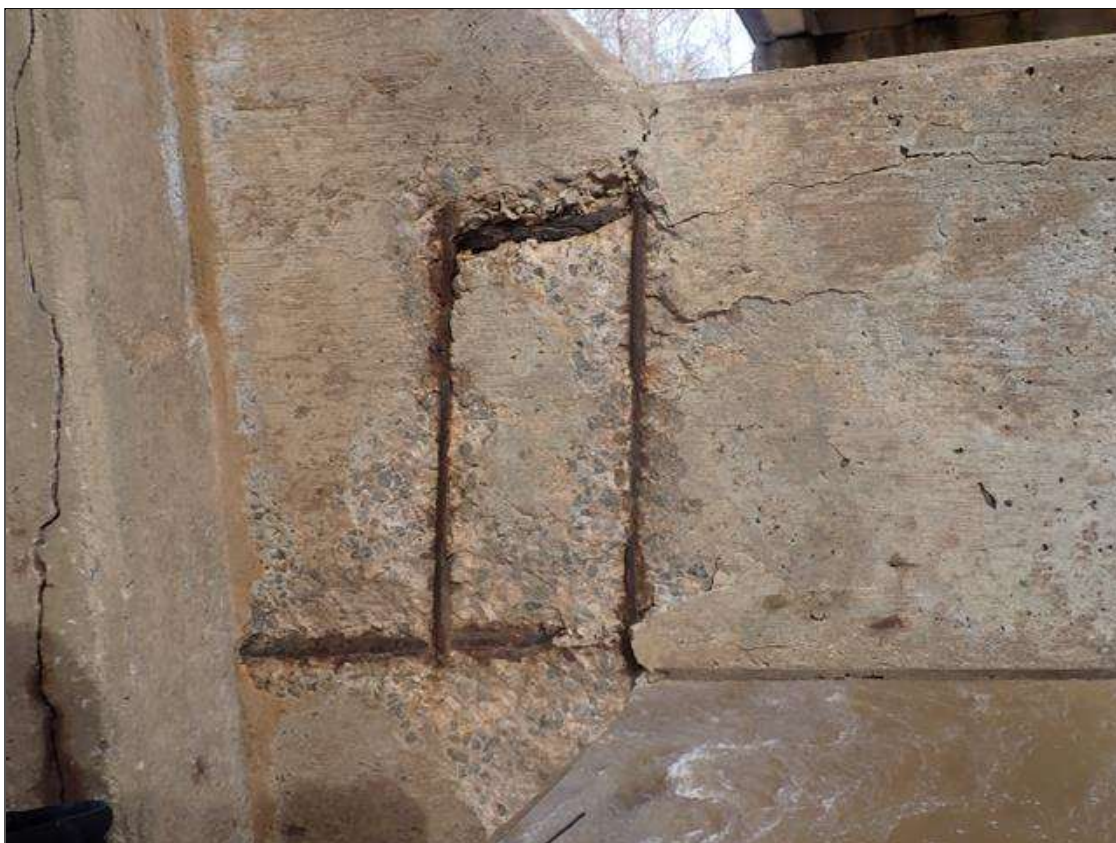
Bent 2 Pile 1: 32 INCHES X 30 INCHES X 1 1/2 INCHES DEEP SPALL WITH EXPOSED REBAR ON WEST FACE OF STRUT

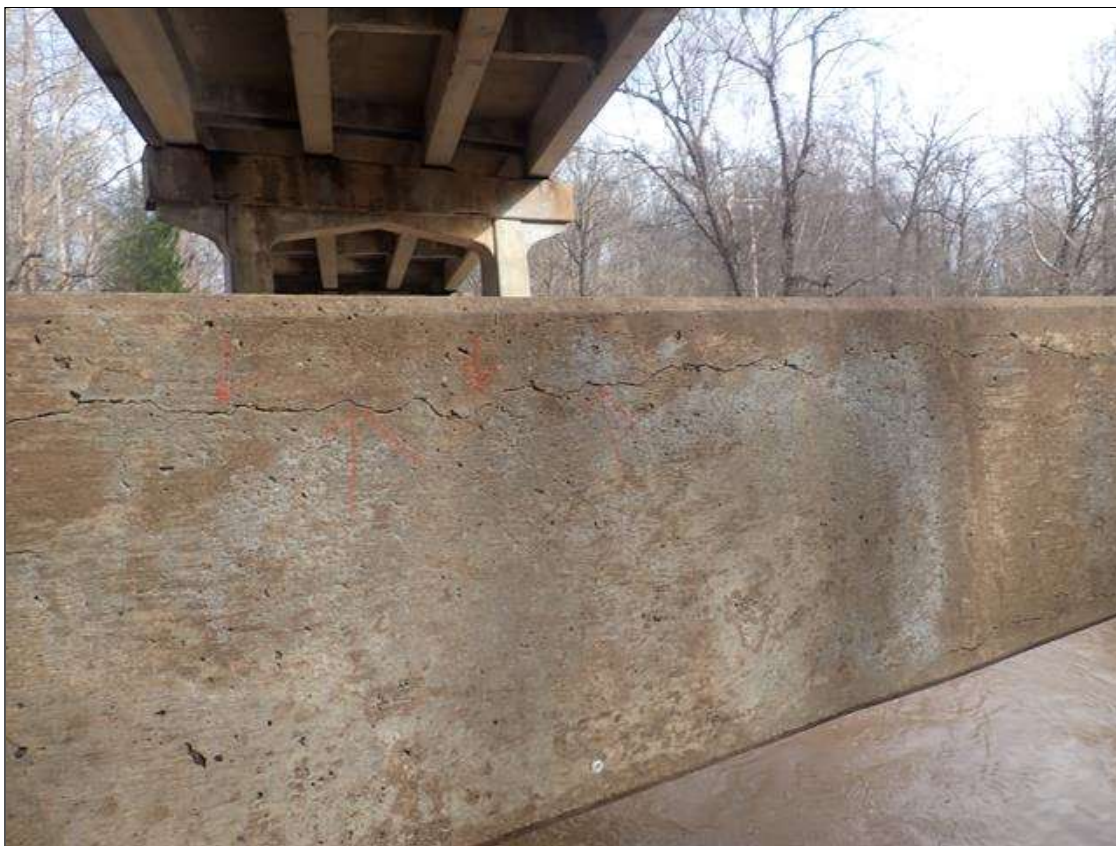
Bent 2 Pile 2: strut west face, horizontal crack (full length x up to 1/16in)

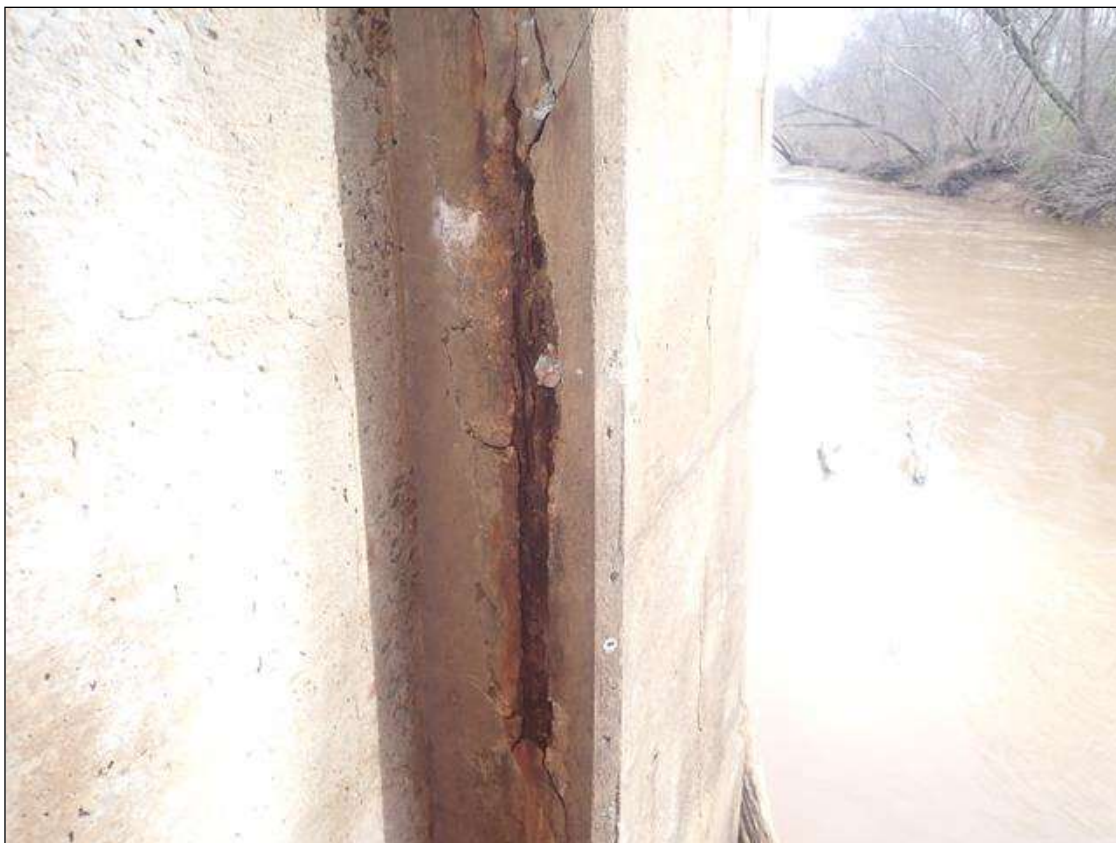
Bent 2 Pile 2: (PAR) 32 INCHES X 4 INCHES X 1 INCHES DEEP SPALL WITH EXPOSED REBAR ON NORTH FACE

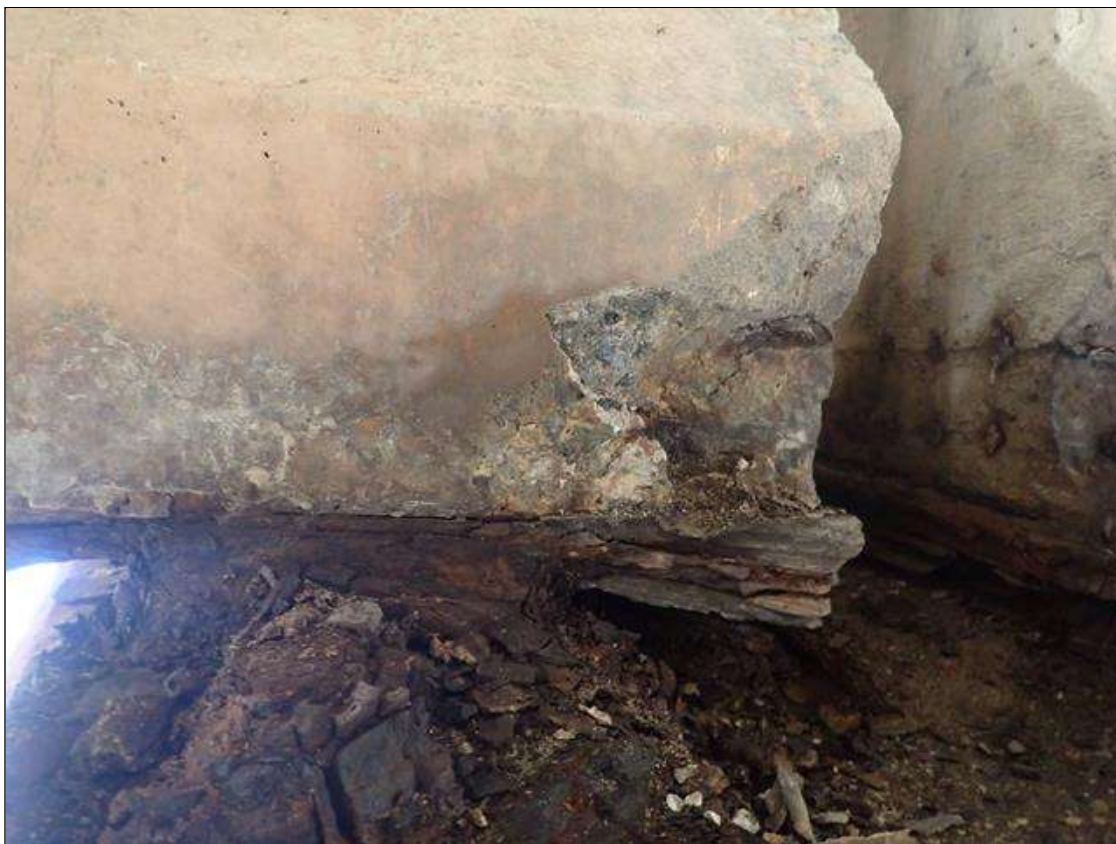
Span 2 Beam 3: (PAR) 8 INCHES X 7 INCHES X 2 1/2 INCHES DEEP SPALL WITH EXPOSED PRESTRESSING STRANDS ON RIGHT SIDE OF BOTTOM FLANGE AT BENT 2

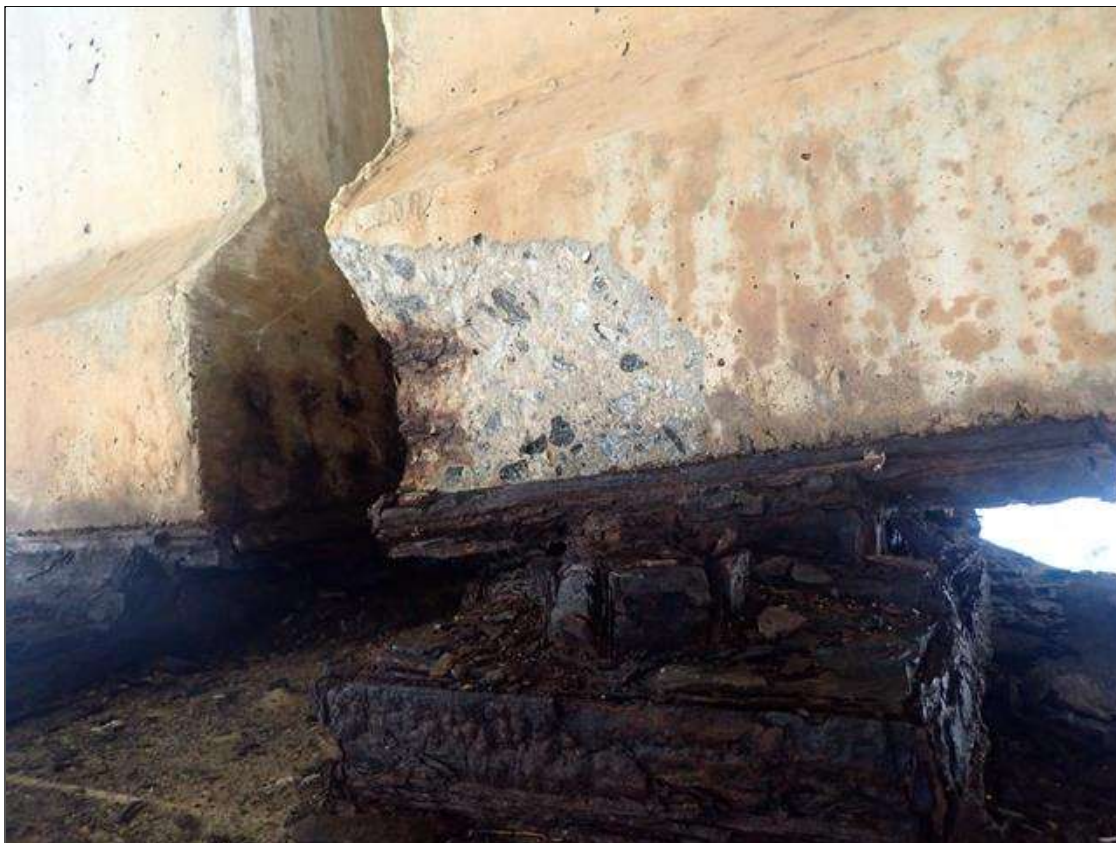
Span 2 Beam 2: (PAR) 9 INCHES X 7 INCHES X 2 1/2 INCHES DEEP SPALL WITH EXPOSED PRESTRESSING STRANDS ON LEFT SIDE OF BOTTOM FLANGE AT BENT 2

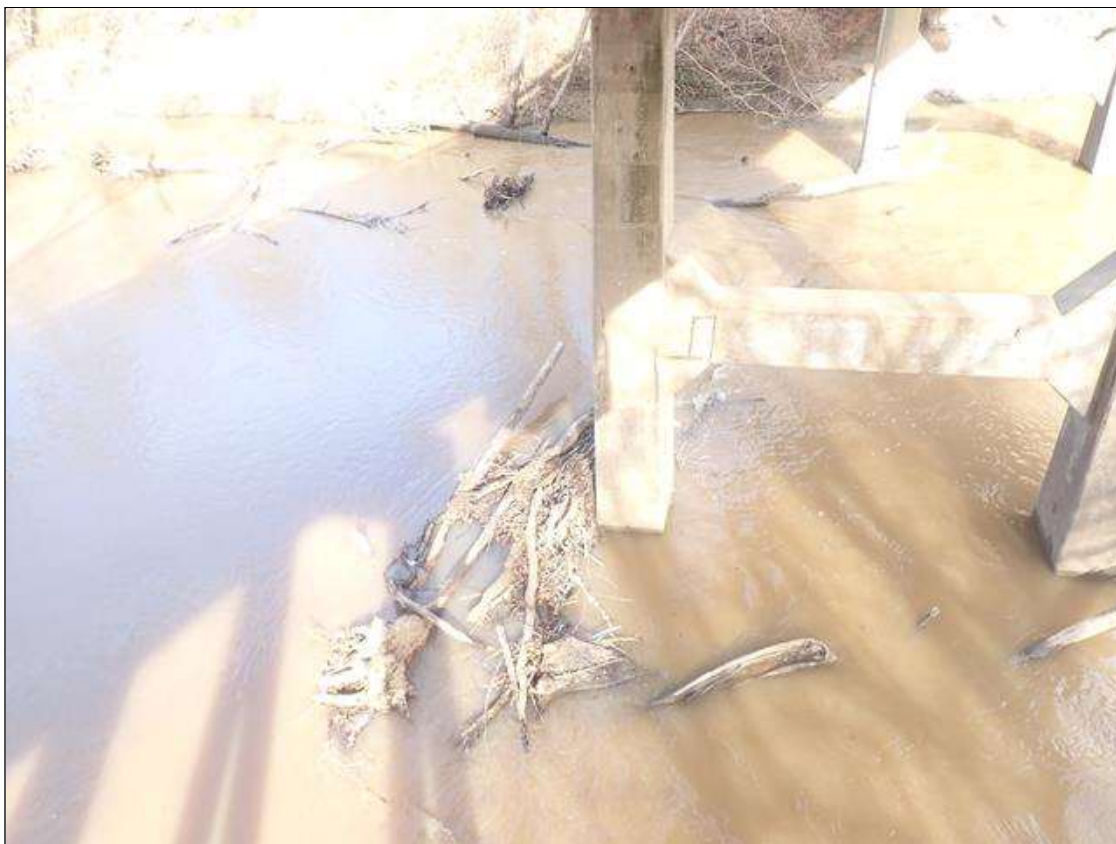
Drift: upstream at bent 2 pile 1, drift accumulation (2cy)

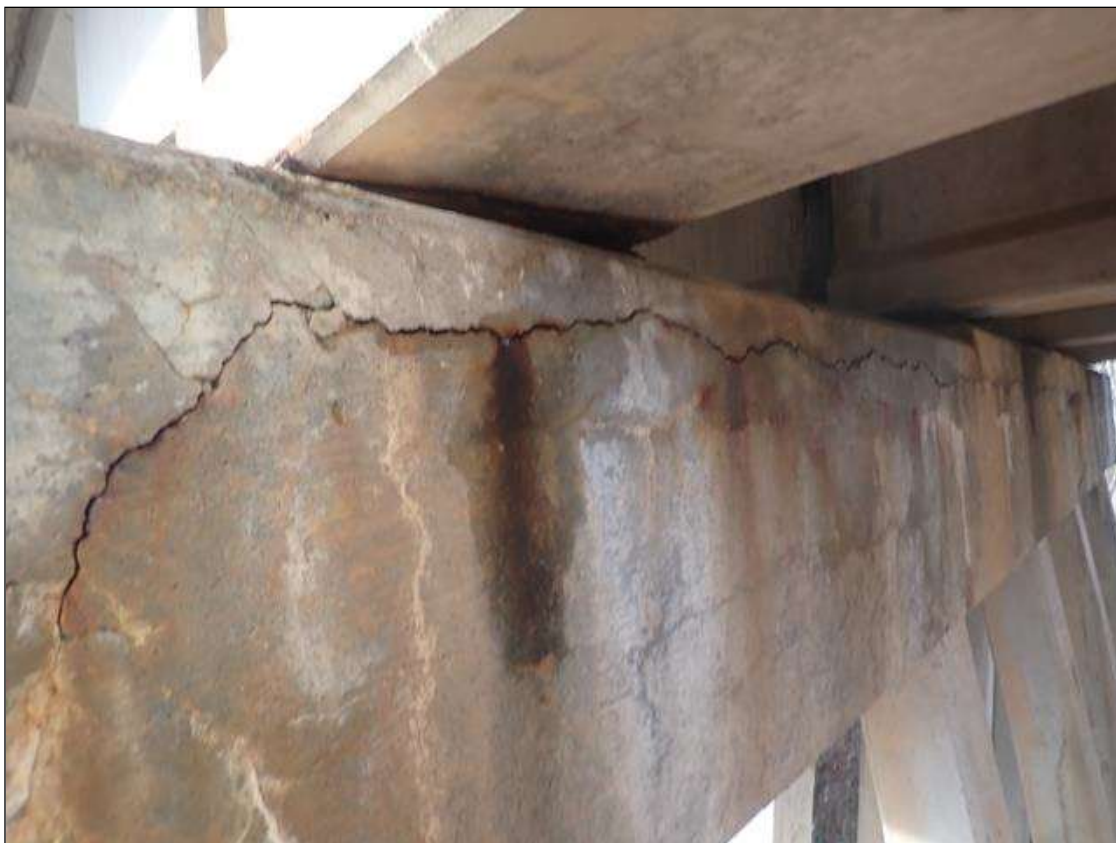
Bent 1 Cap 1: 12 FEET X 1 FEET AREA OF DELAMINATION WITH UP TO 3/16 INCHES HORIZONTAL CRACK WITH EFFLORESCENCE AND RUST STAINS ON EAST FACE AT SOUTH END

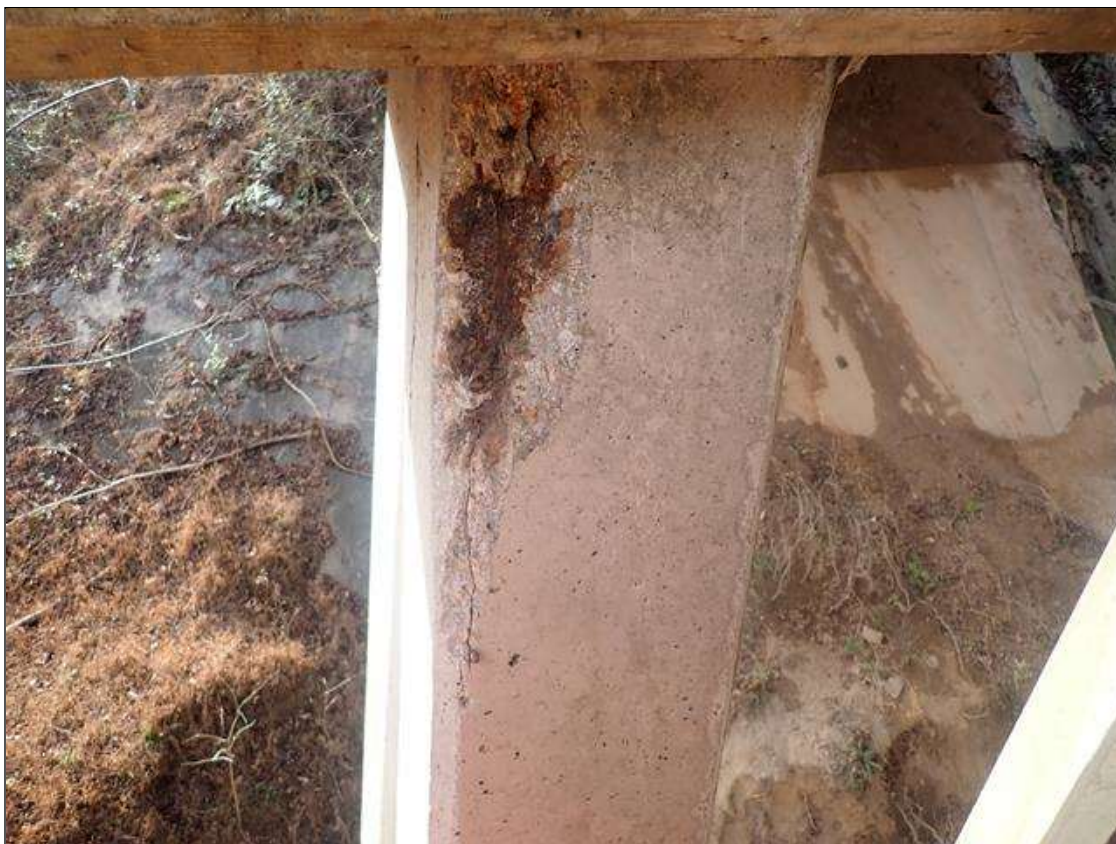
Bent 1 Row 2 Pile 5: (PAR) 18 INCHES X 5 INCHES X 3 INCHES DEEP SPALL WITH EXPOSED STRAND ON SOUTHEAST CORNER

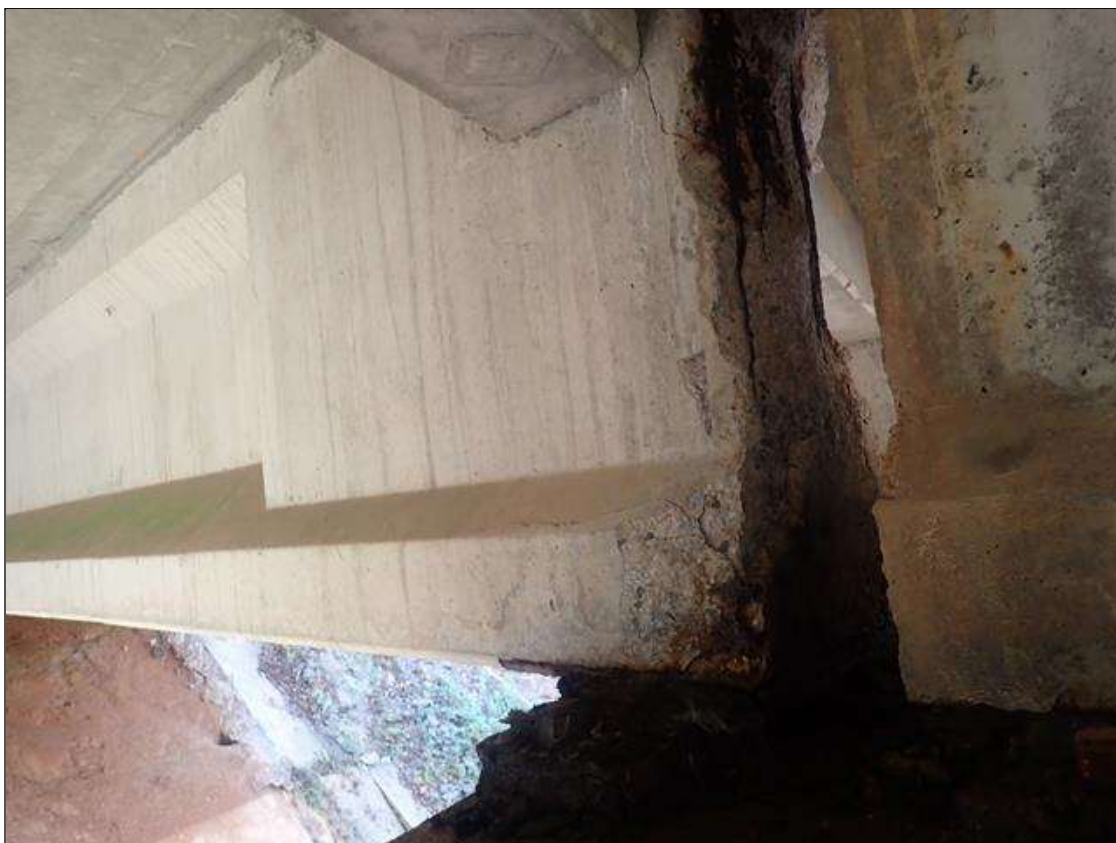
Span 1 Beam 3: (PAR) 16 INCHES X 41 INCHES X 2 INCHES DEEP SPALL WITH EXPOSED PRESTRESSING STRANDS ON BEAM END AT BENT 1

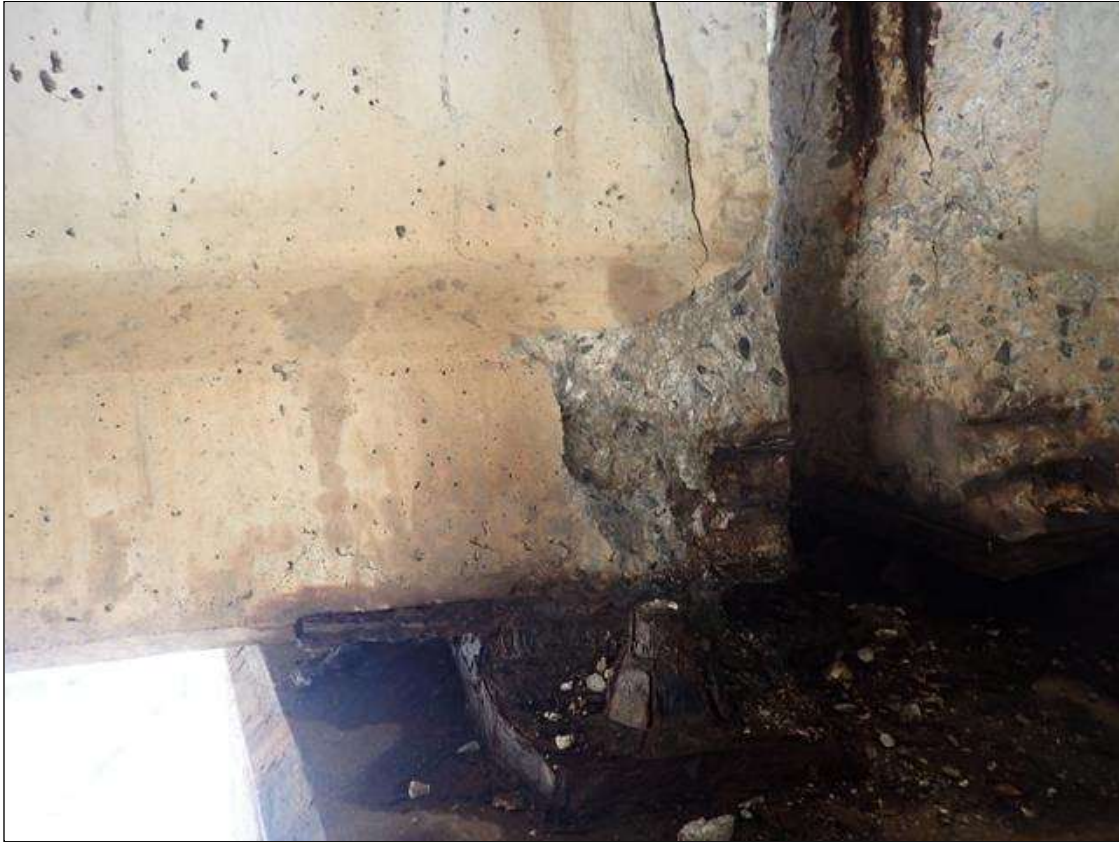
Span 2 Beam 3: (PAR) 10 INCHES X 10 INCHES X 2 1/2 INCHES DEEP SPALL WITH EXPOSED PRESTRESSING STRANDS ON LEFT SIDE OF BOTTOM FLANGE AT BENT 1

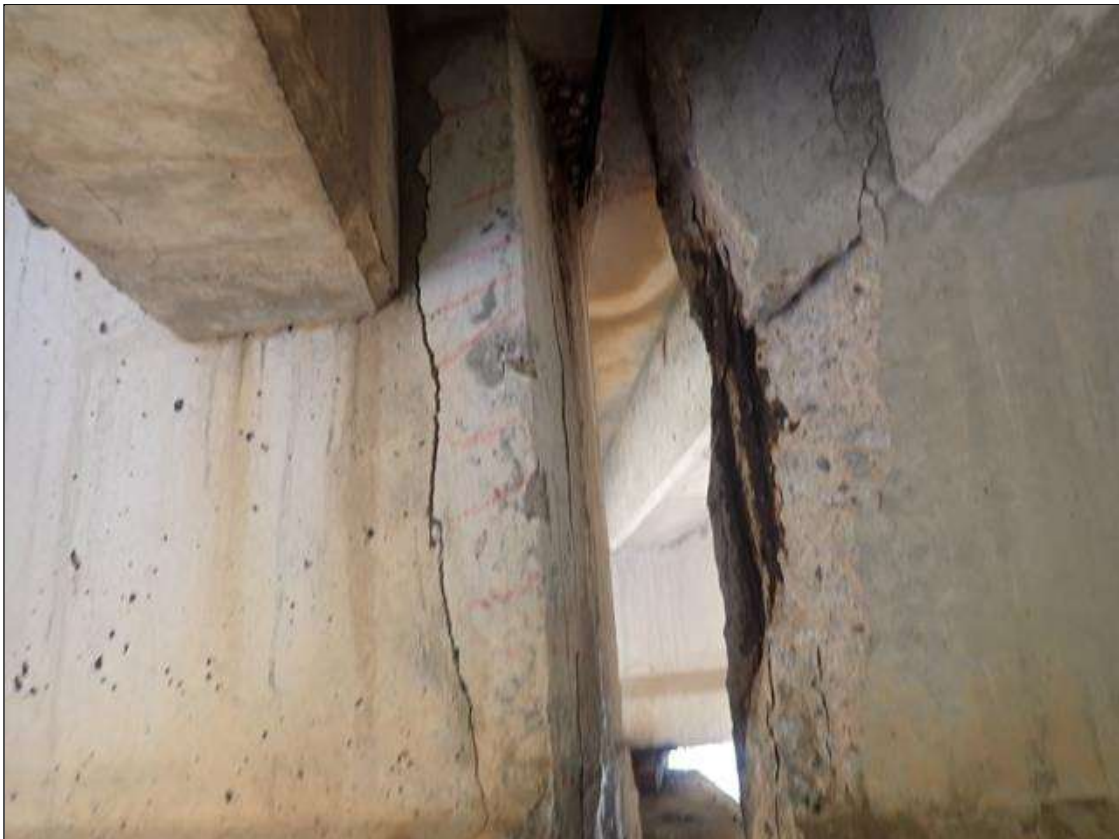
Span 2 Beam 3: 7 INCHES X 36 INCHES AREA OF DELAMINATION WITH 1/8 INCHES VERTICAL CRACK ON LEFT SIDE OF WEB AT BENT 1

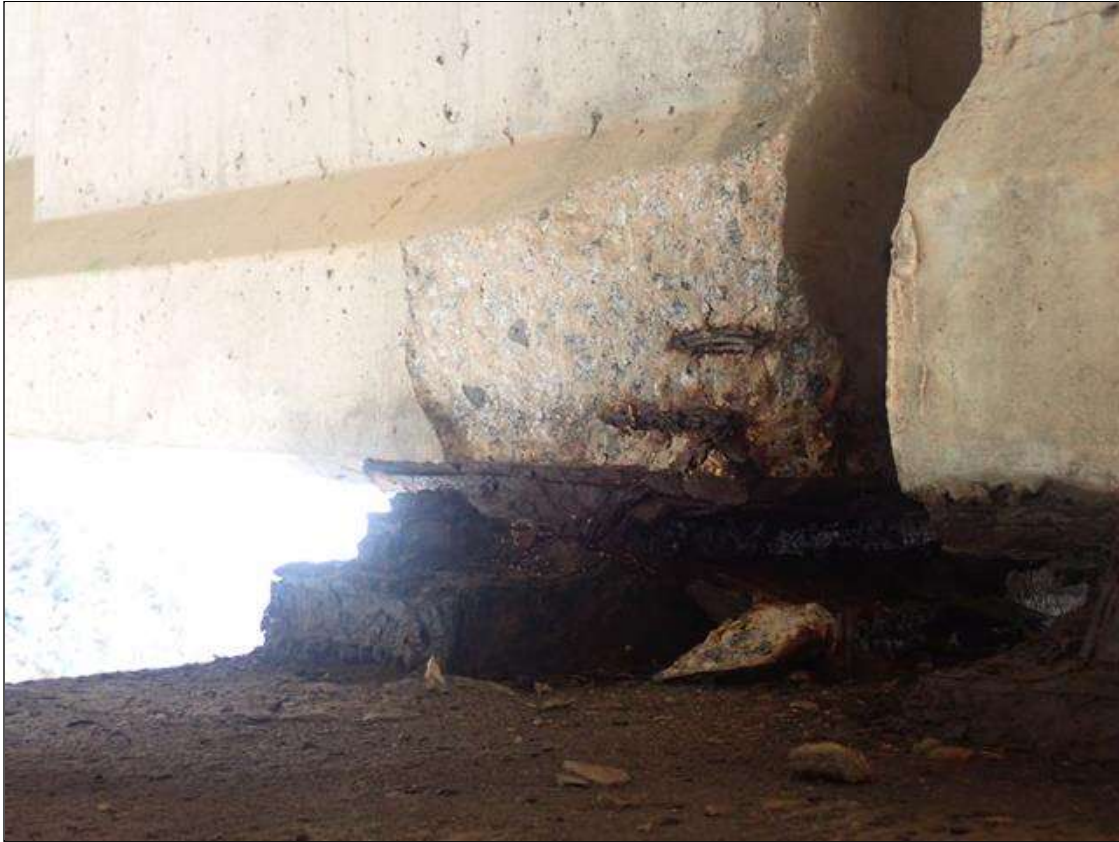
Span 1 Beam 2: (PAR) 12 INCHES X 9 INCHES X 2 INCHES DEEP SPALL WITH EXPOSED PRESTRESSING STRANDS ON RIGHT SIDE OF BOTTOM FLANGE AT BENT 1

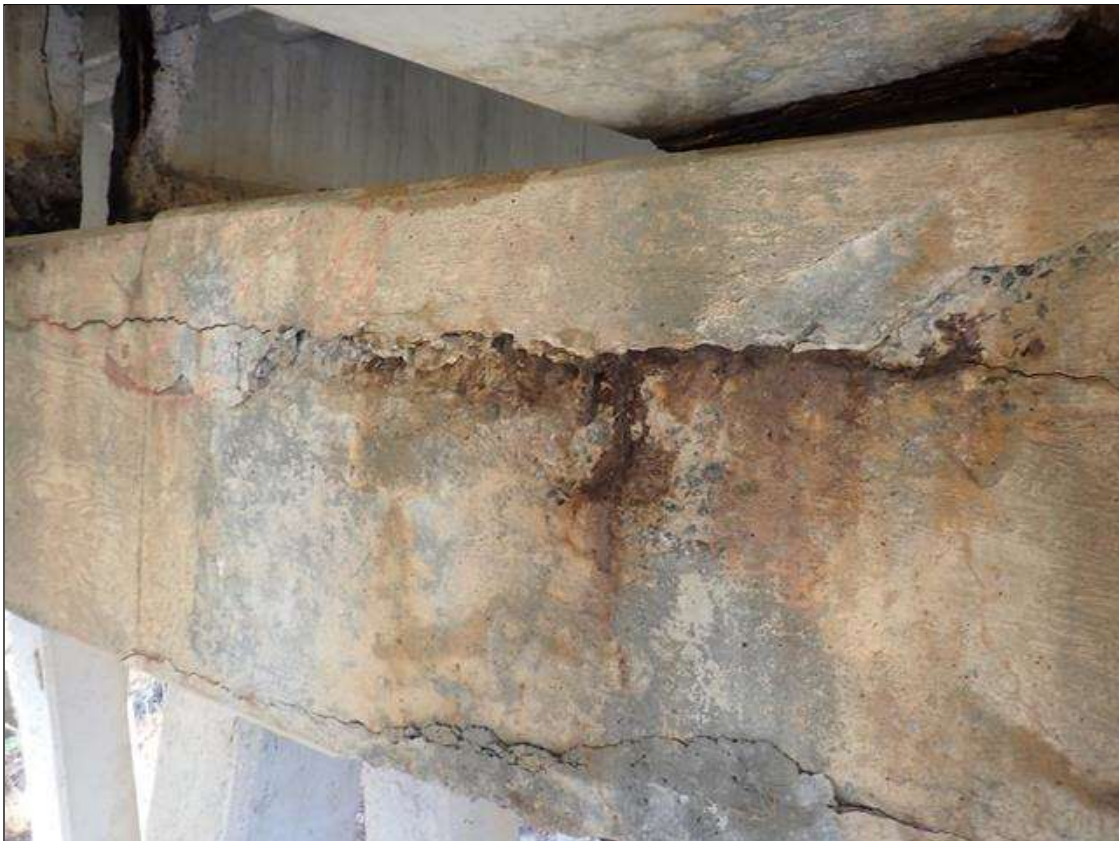
Bent 1 Cap 1: (PAR) 60 INCHES X 5 INCHES X 3 INCHES DEEP AND 48 INCHES X 10 INCHES X 2 INCHES DEEP SPALL WITH EXPOSED REBAR ON EAST FACE UNDER BEAM 2

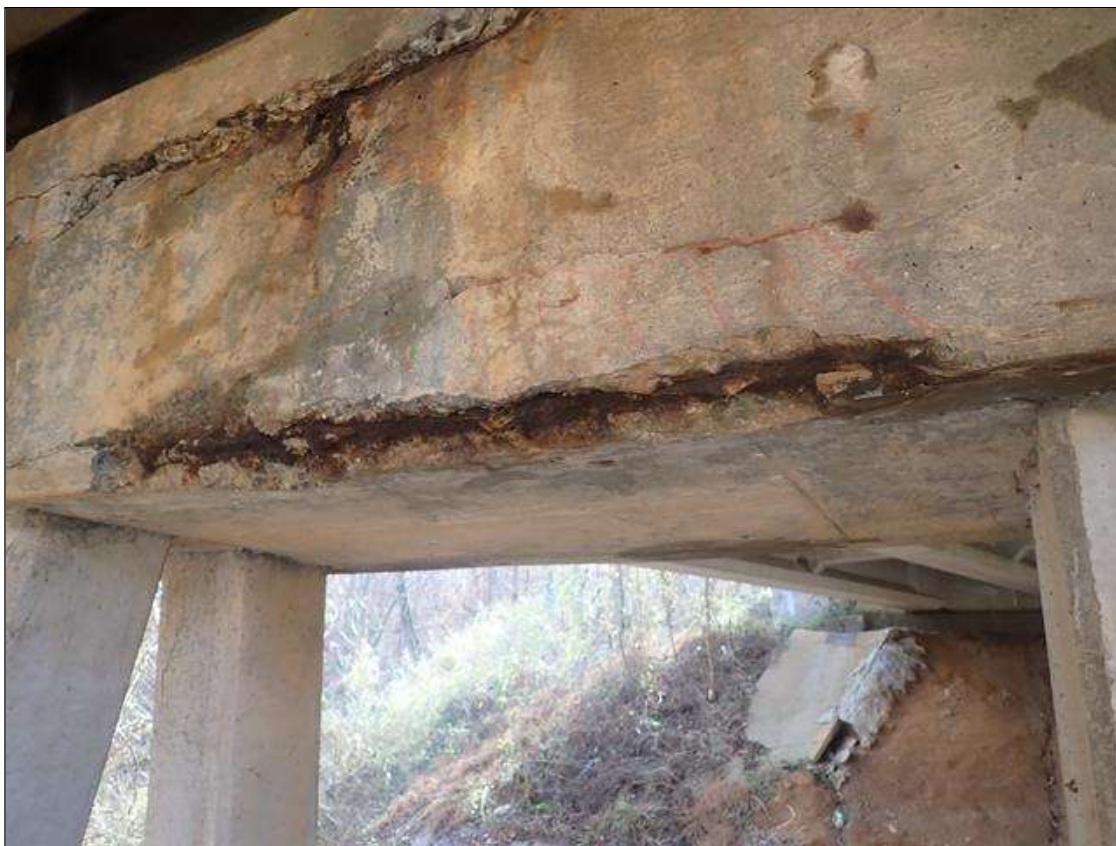
Bent 1 Cap 1: (PAR) EAST FACE BETWEEN PILES 2 AND 3, SPALL/DELMINATION (6FT X UP TO 10IN X 2-1/2IN) WITH EXPOSED RUSTED REBAR

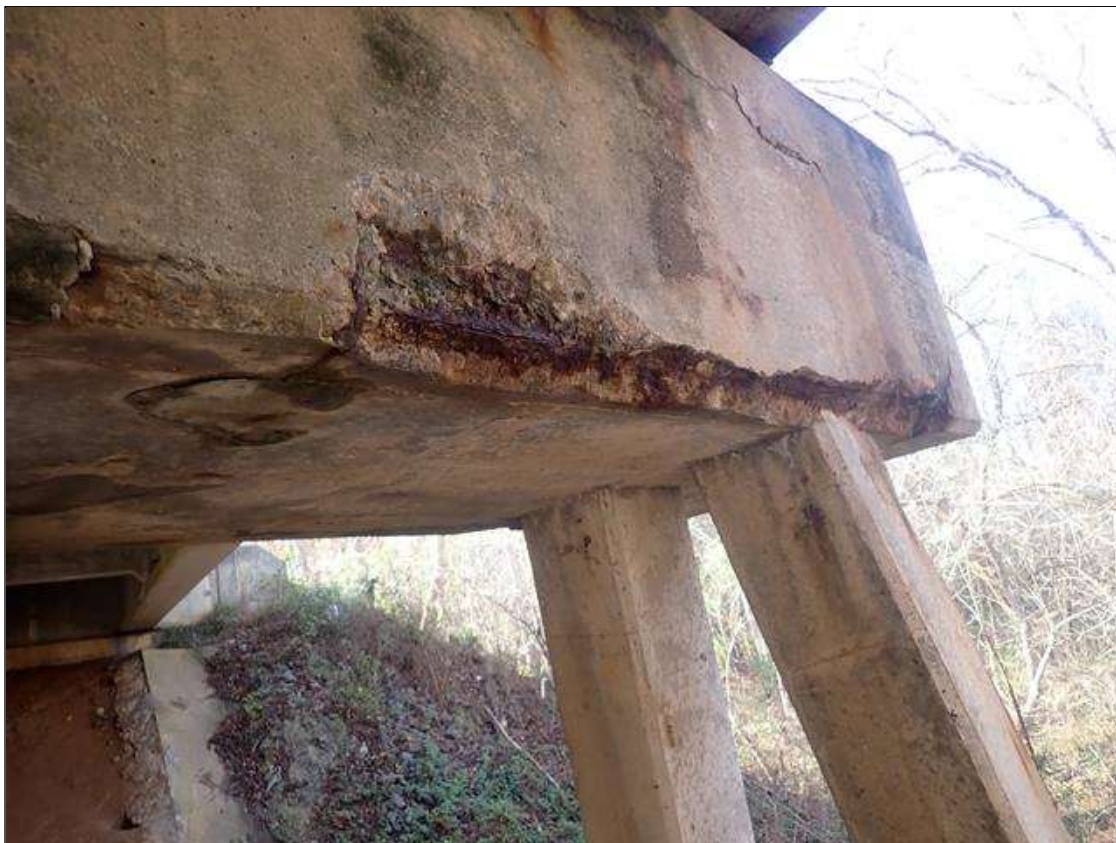
Bent 1 Cap 1: (PAR) 7 FEET X 9 INCHES X 3 INCHES DEEP SPALL WITH EXPOSED REBAR AND AREA OF DELAMINATION ON EAST FACE BETWEEN PILES 1 AND 2
