NC DEPARTMENT OF TRANSPORTATION  
 DIVISION OF HIGHWAYS  
 STRUCTURE MANAGEMENT UNIT

ATTENTION: **PAR SUBMITTED  
 SNOOPER USED**

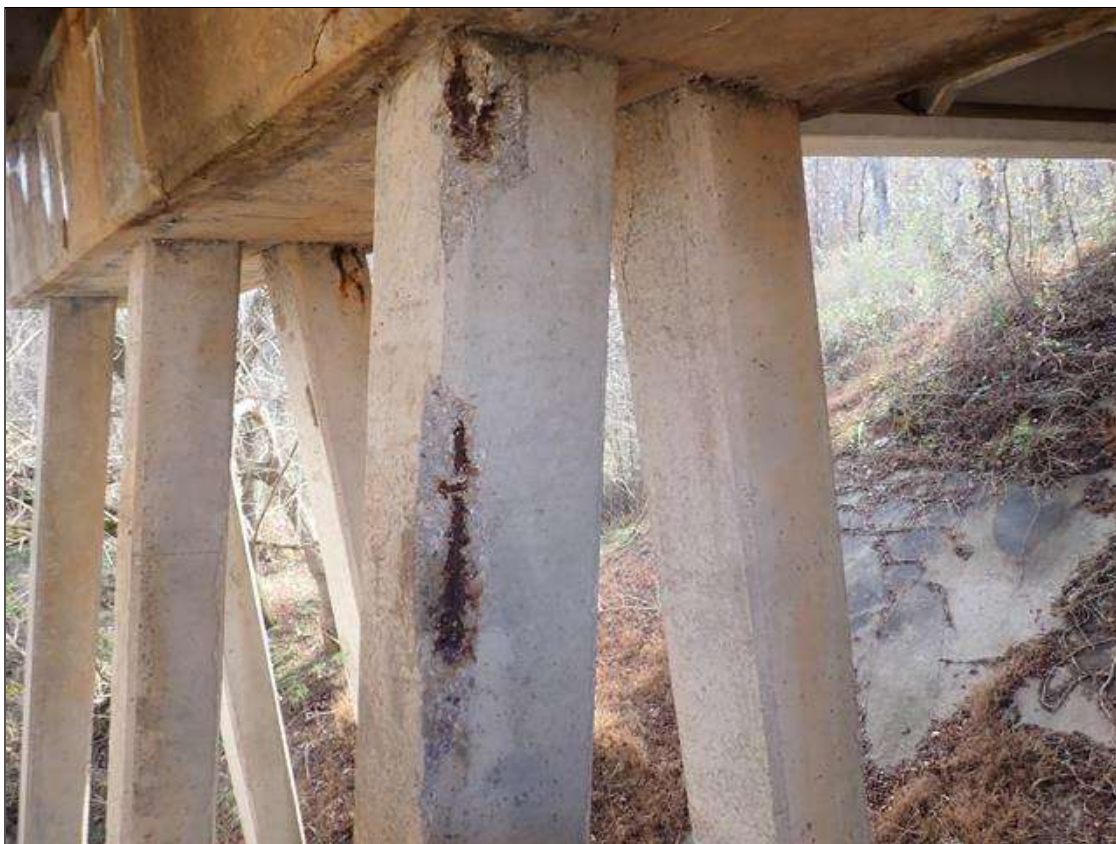
Bent 1 Row 2 Pile 3: (PAR) EAST FACE BELOW CAP, (2) SPALL/DELAMINATION (UP TO 27IN X 5IN X 2IN) WITH EXPOSED RUSTED STRAND

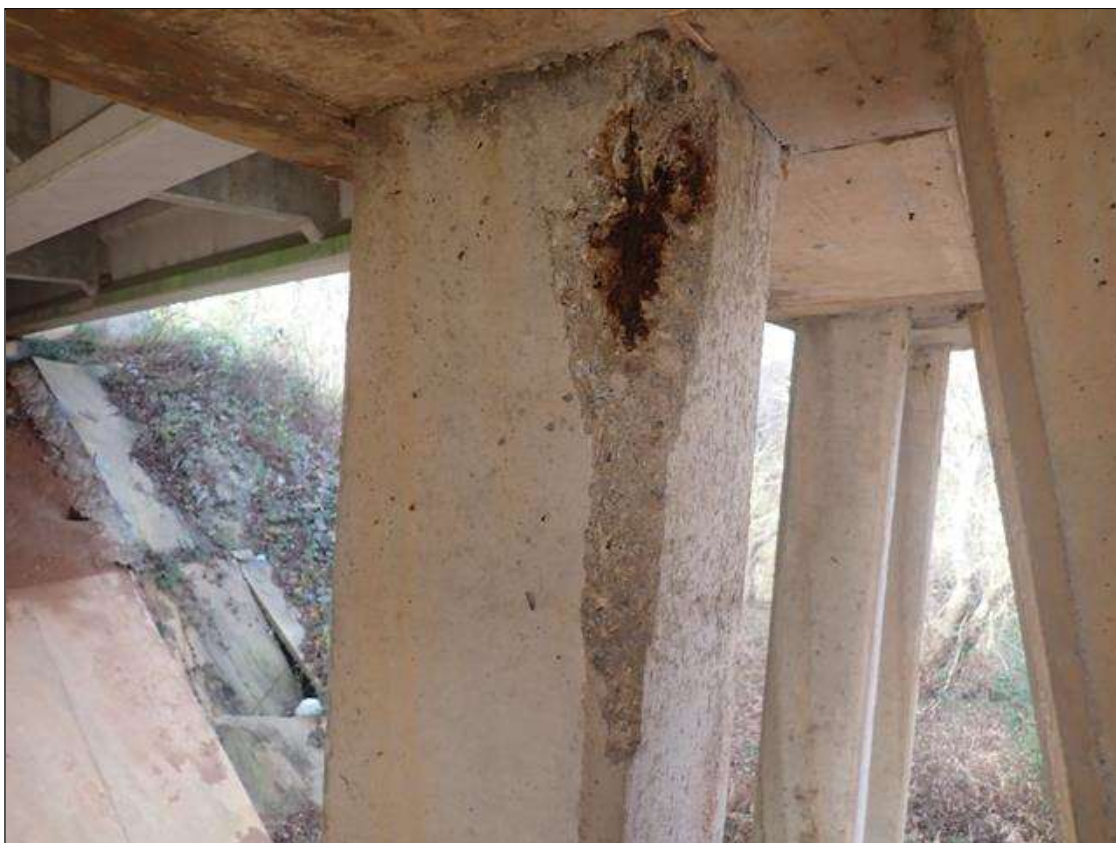
Bent 1 Row 1 Pile 3: (PAR) SOUTHEAST CORNER BELOW CAP, SPALL(21IN X 6IN X 2IN) WITH EXPOSED RUSTED STRAND

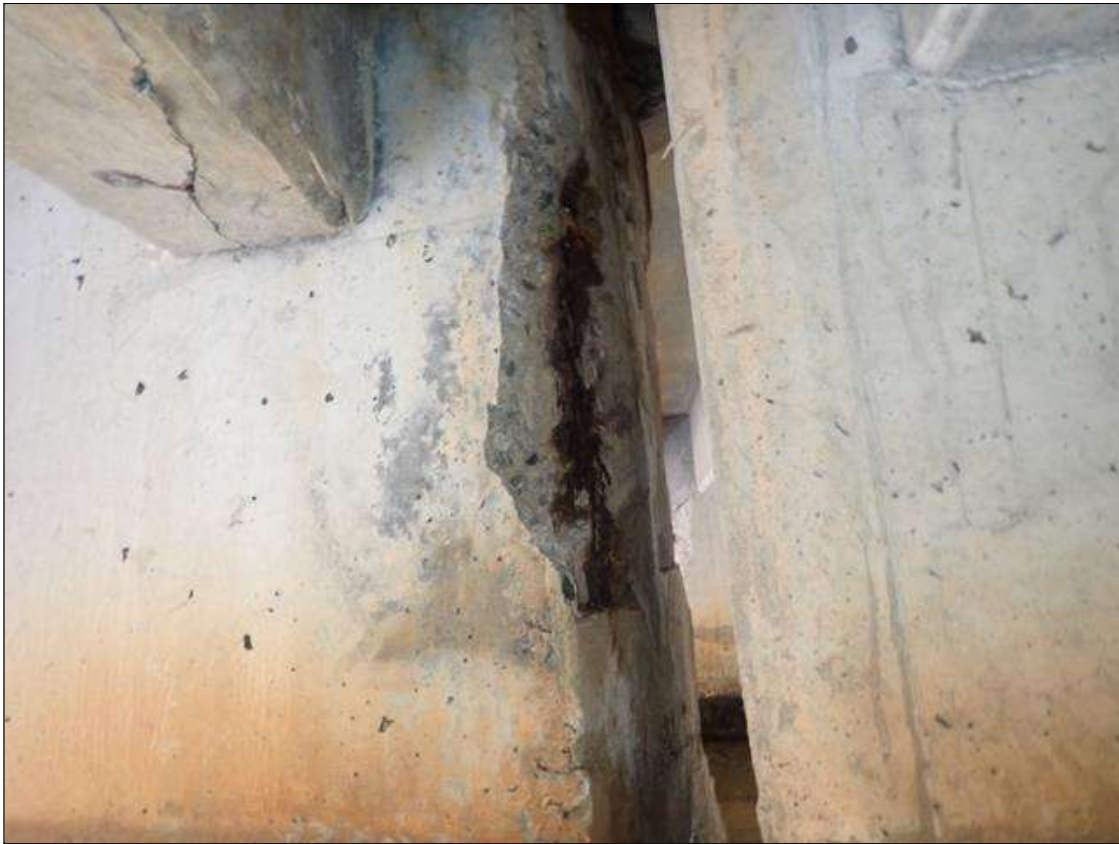
Span 2 Beam 2: (PAR) 24 INCHES X 16 INCHES X 4 INCHES DEEP SPALL WITH EXPOSED PRESTRESSING STRANDS ON BEAM END AT BENT 1

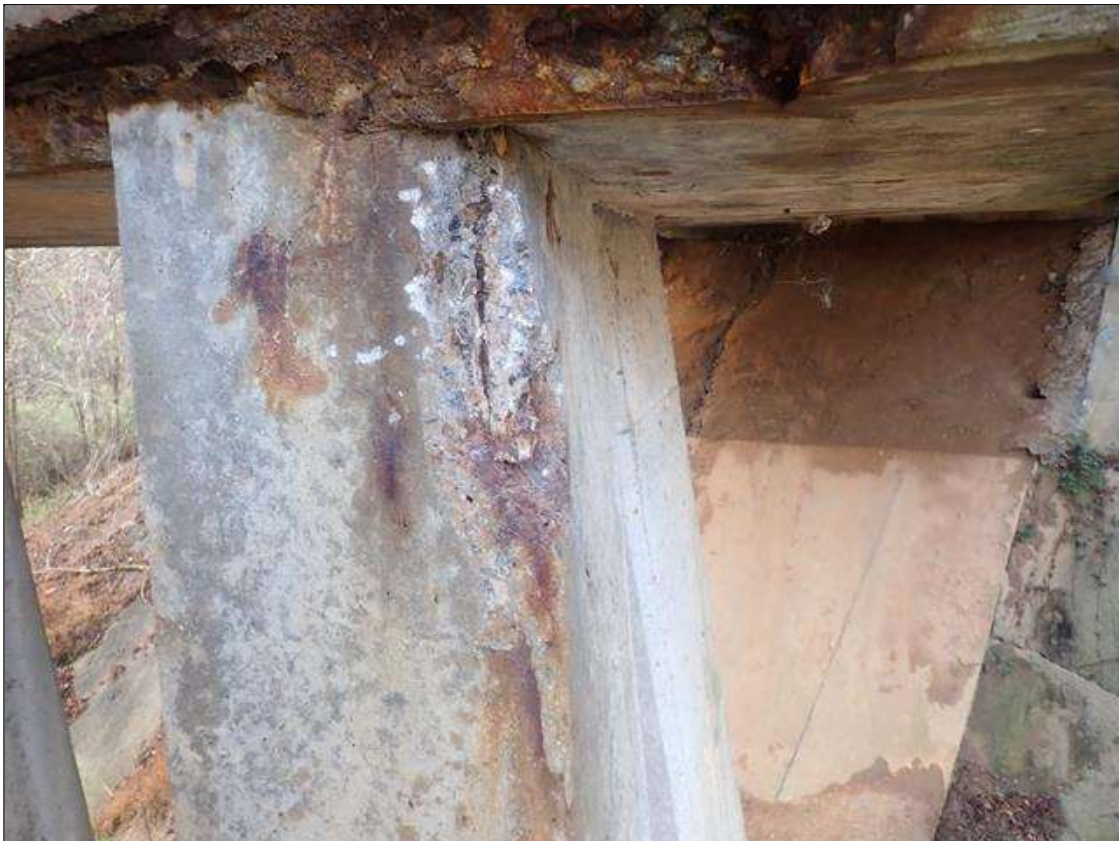
Bent 1 Row 2 Pile 1: (PAR) 16 INCHES X 3 INCHES X 4 INCHES DEEP SPALL WITH EXPOSED STRAND ON NORTHEAST CORNER

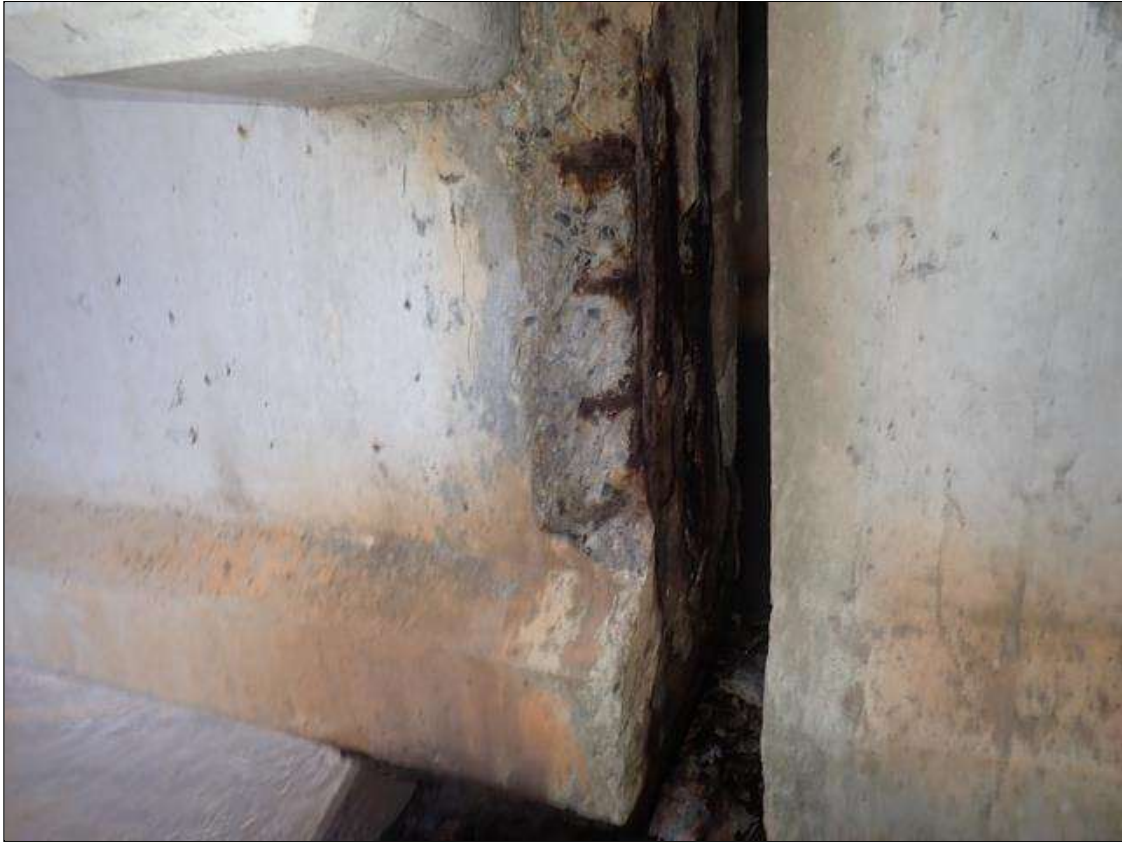
Span 2 Beam 1: (PAR) 16 INCHES X 28 INCHES X 6 INCHES DEEP SPALL WITH EXPOSED PRESTRESSING STRANDS ON BEAM END AT BENT 1

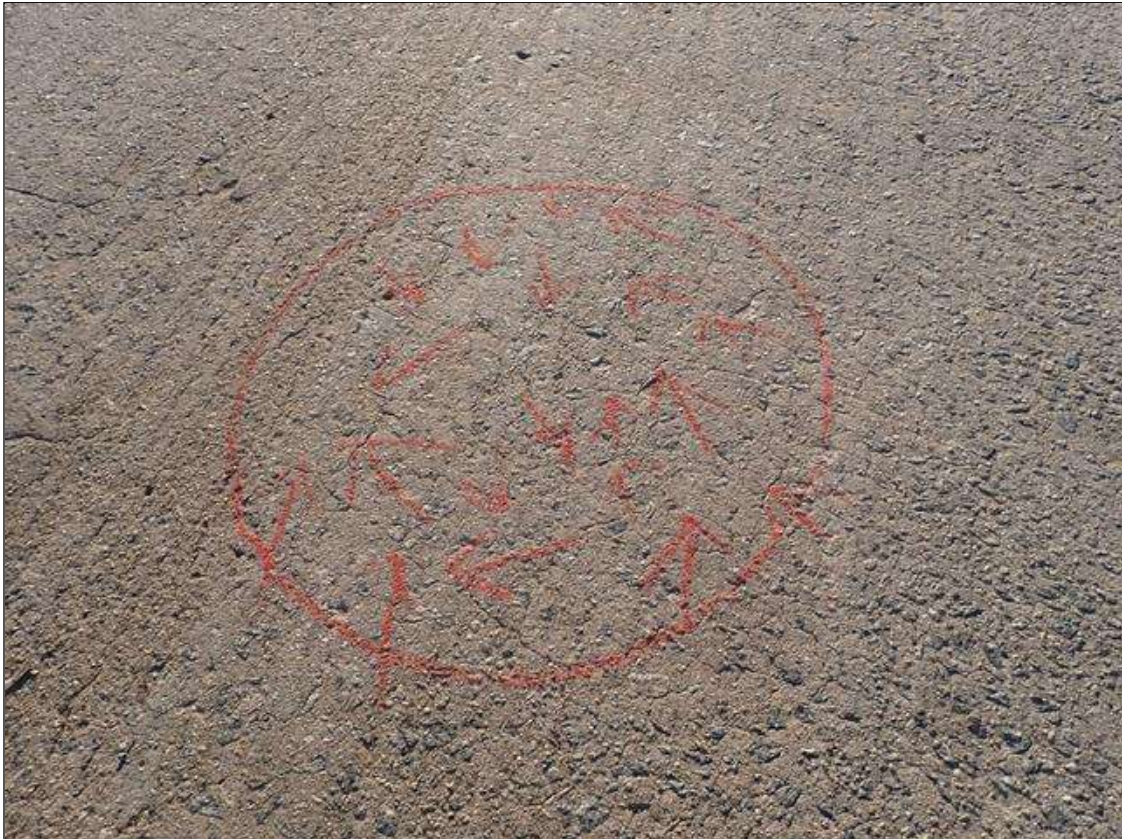
Span 5 Deck: 900 SQUARE FEET HAIRLINE MAP CRACKING

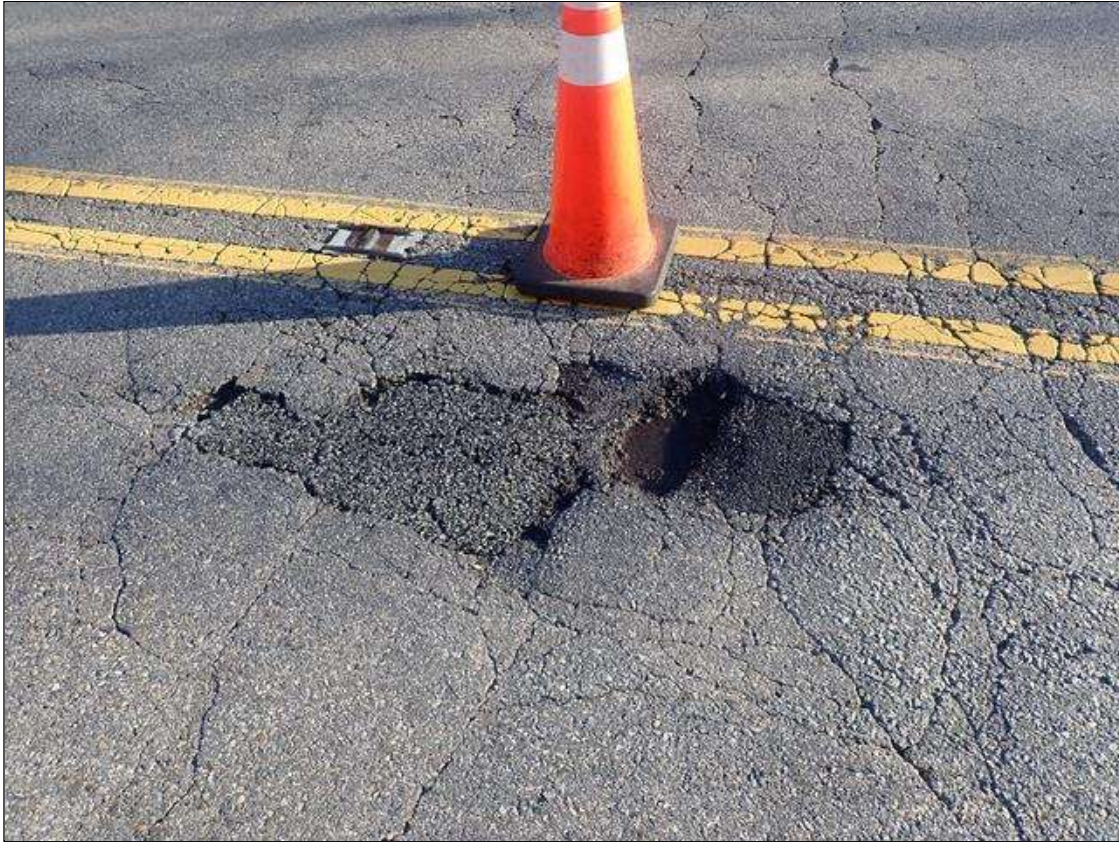
General Comments and Misc Items: west approach westbound lane at 9ft from end bent 1, pothole (9in x 15in x 3in)

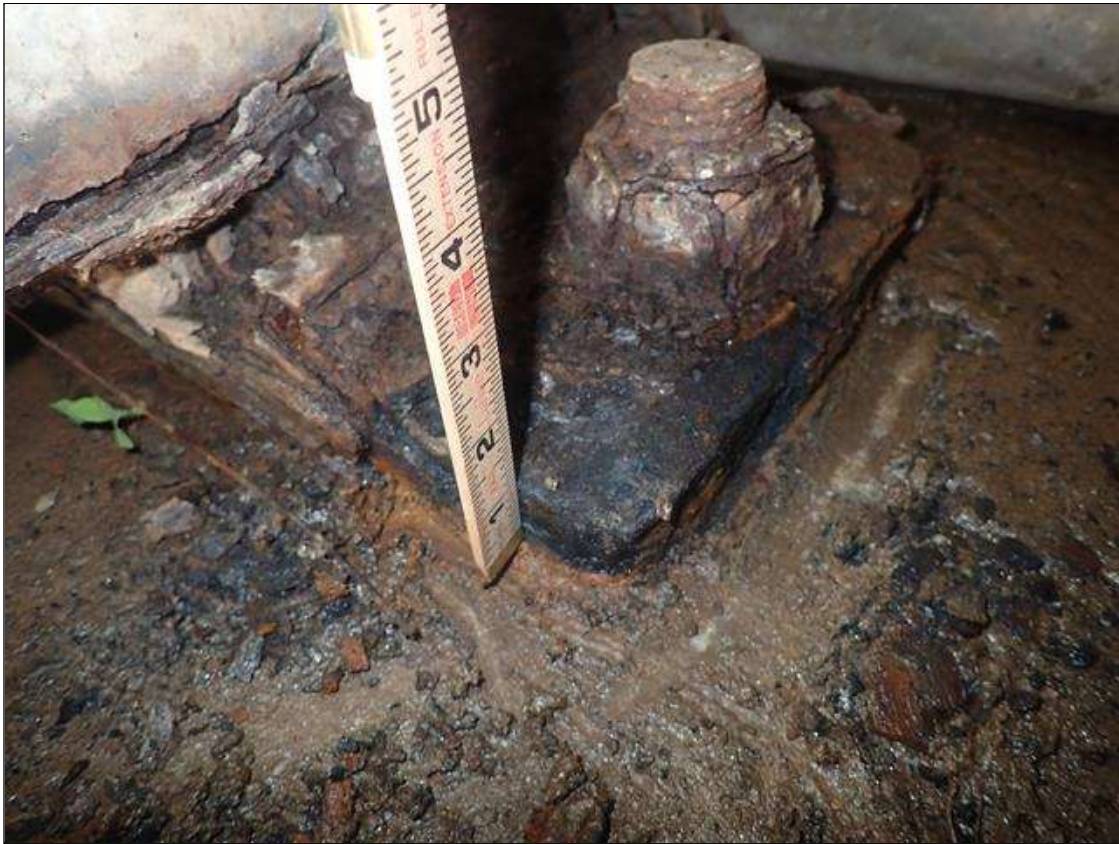
Span 1 Beam 4 - Near Bearing: RUST SCALE WITH SECTION LOSS (UP TO 1/8IN)

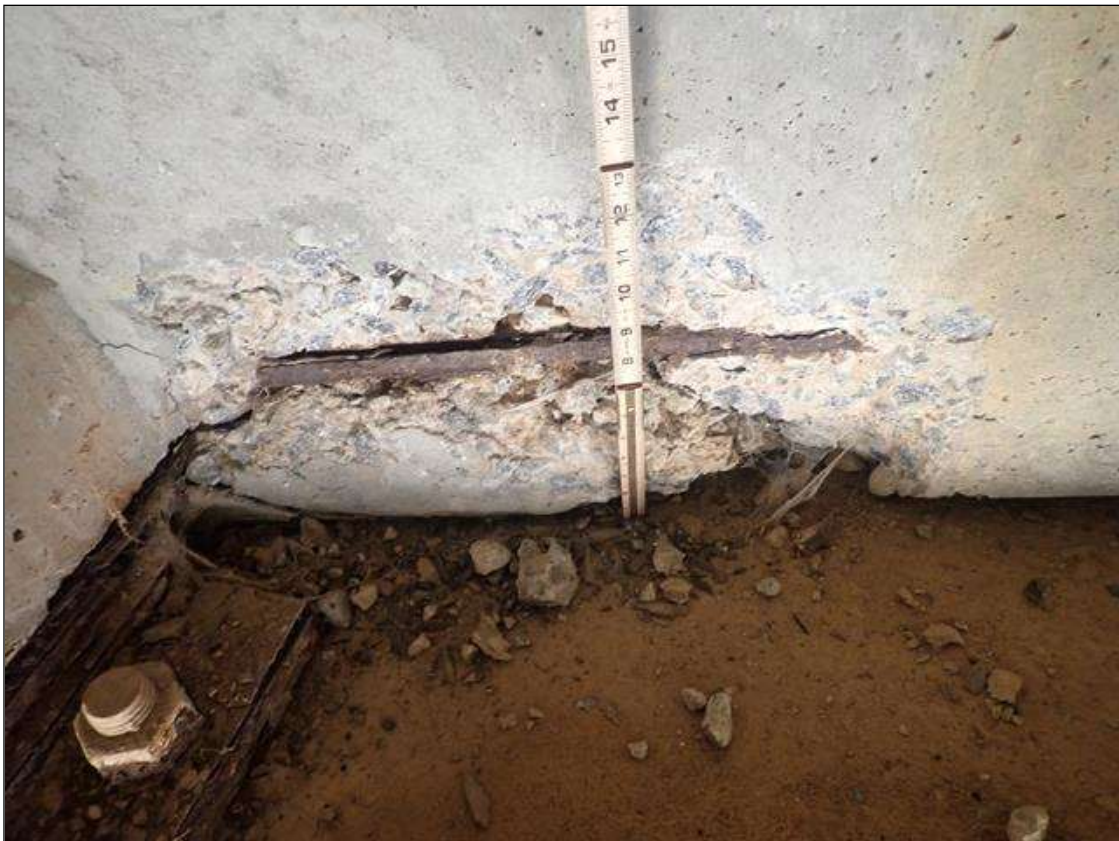
End Bent 1 Abutment: 21 INCHES X 13 INCHES X UP TO 2IN AREA OF SPALLING WITH EXPOSED RUSTED REBAR DEBONDED FROM COBCRETE IN BAY 3 ADJACENT TO BEAM 3

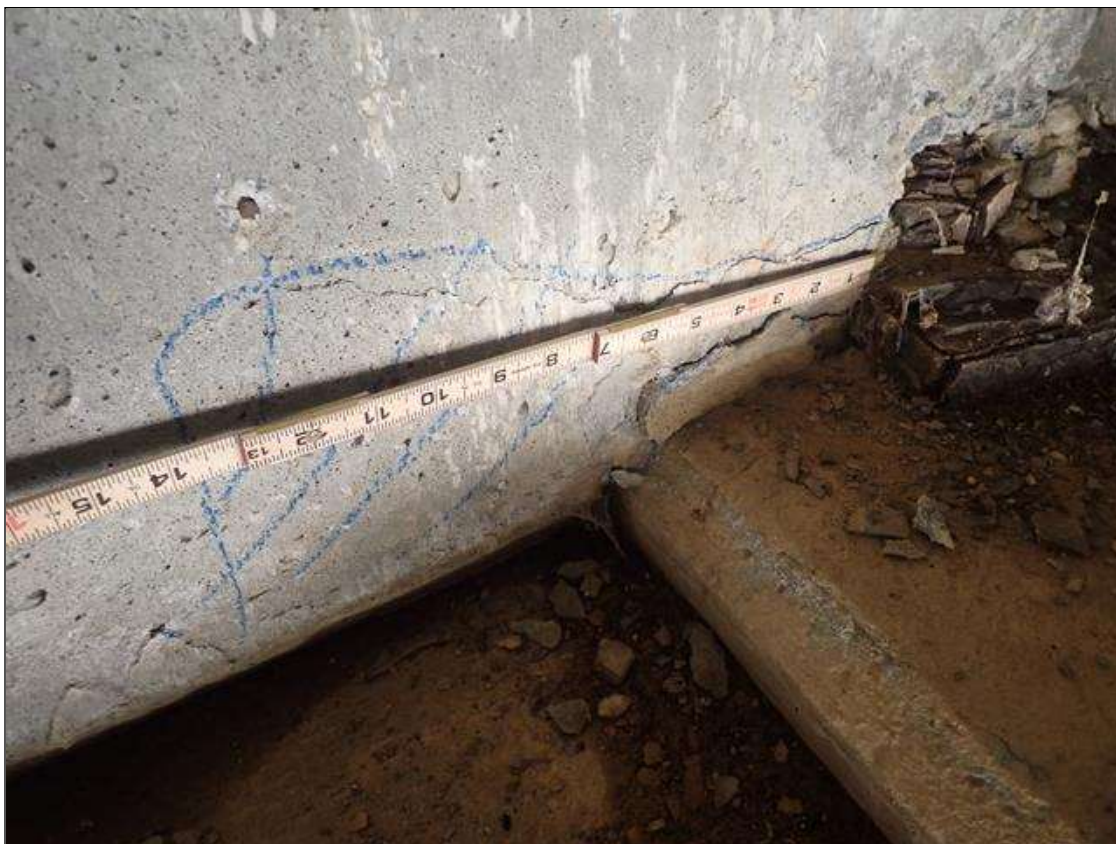
End Bent 1 Abutment: 14 INCHES X 8 INCHES AREA OF DELAMINATION IN BAY 3 ADJACENT TO BEAM 3

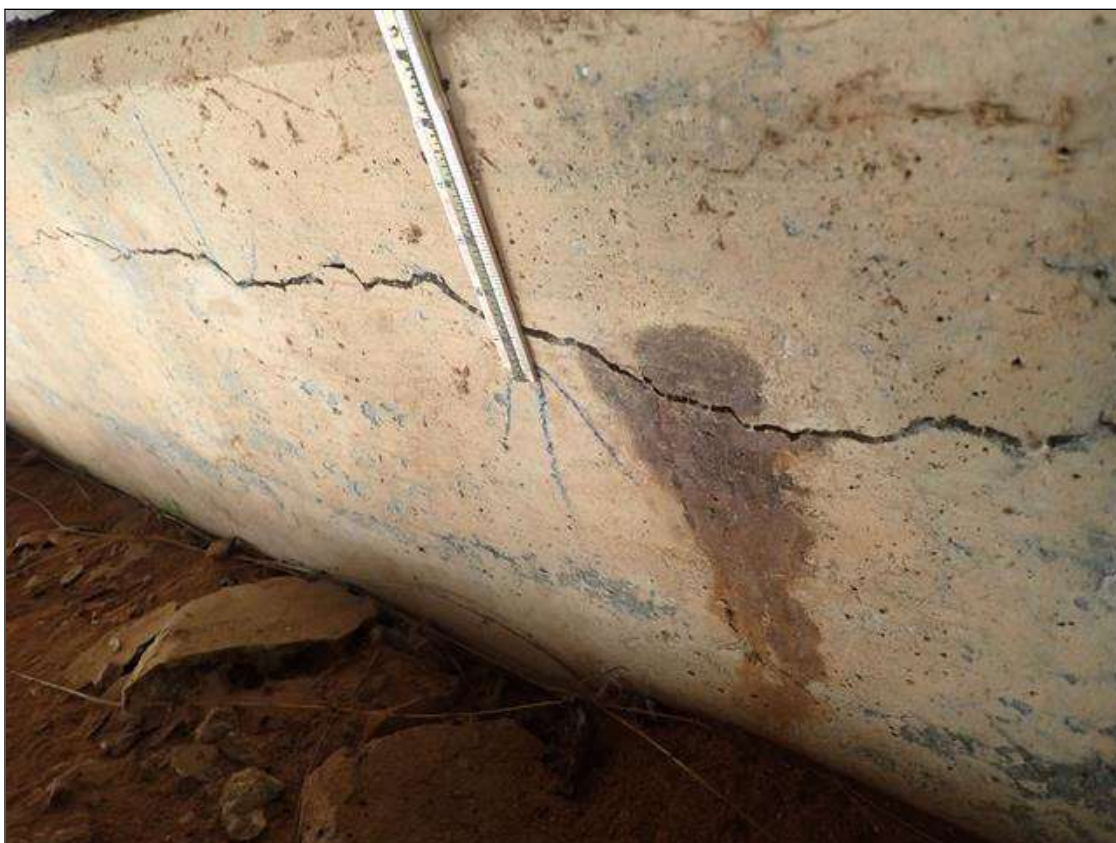
End Bent 1 Cap 1: 60 INCHES UP TO 1/8 INCHES AREA OF HAIRLINE HORIZONTAL CRACK UNDER BAYS 2 AND 3

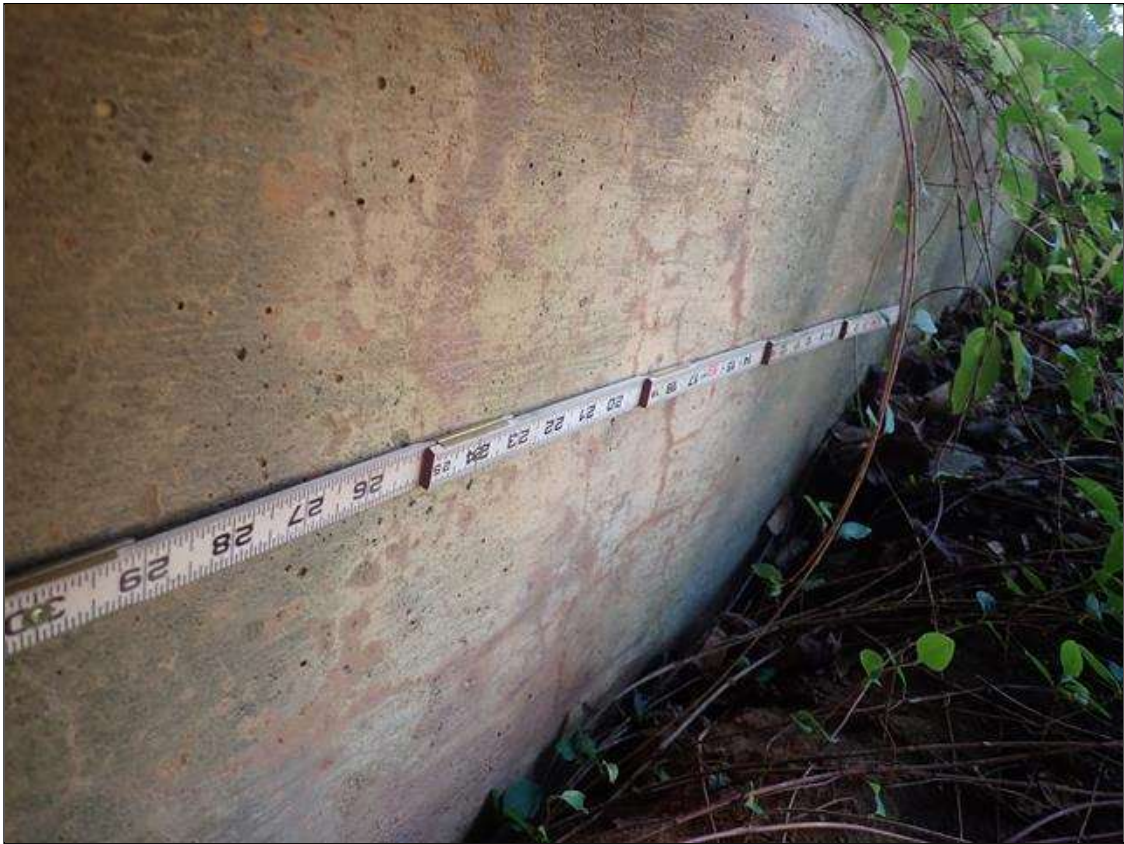
End Bent 1 Cap 1: 30 INCHES X 12 INCHES AREA OF HAIRLINE MAP CRACKING UNDER BEAM 1

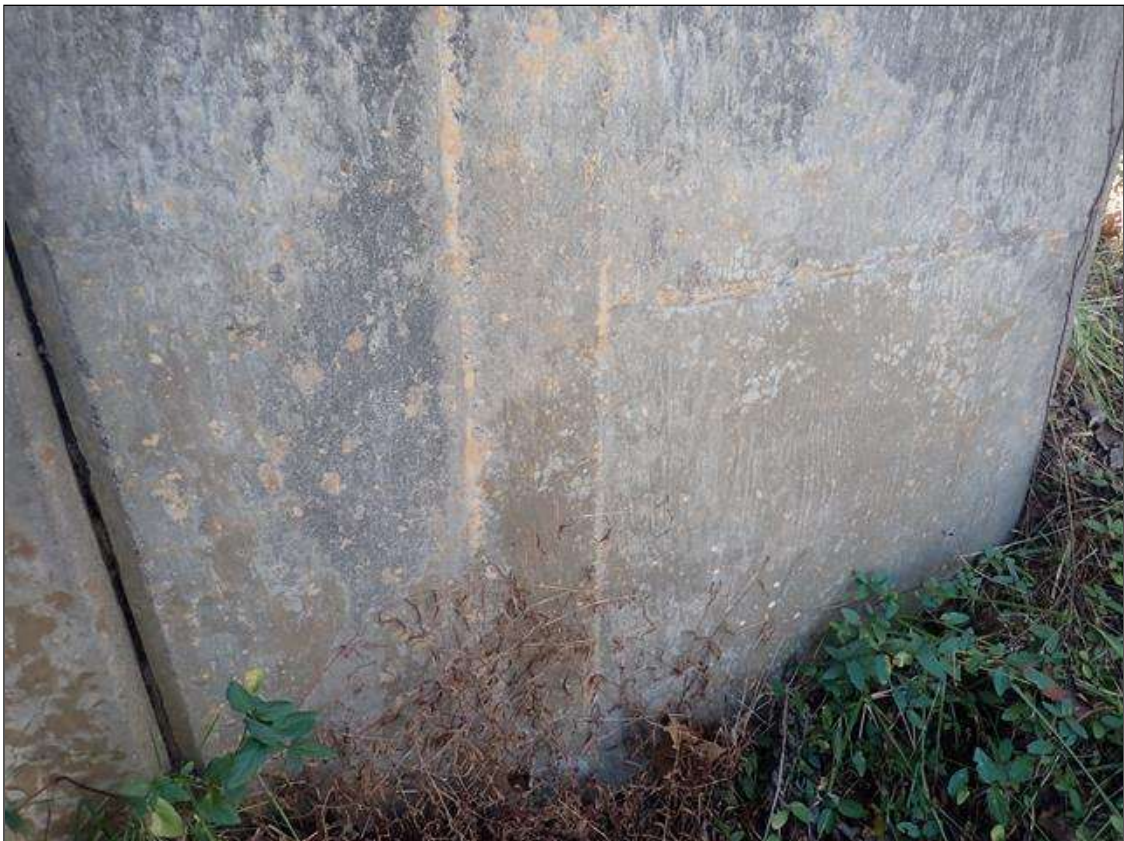
Wingwalls: southwest wingwall, map cracking (full width x up to full height x hairline) with efflorescence

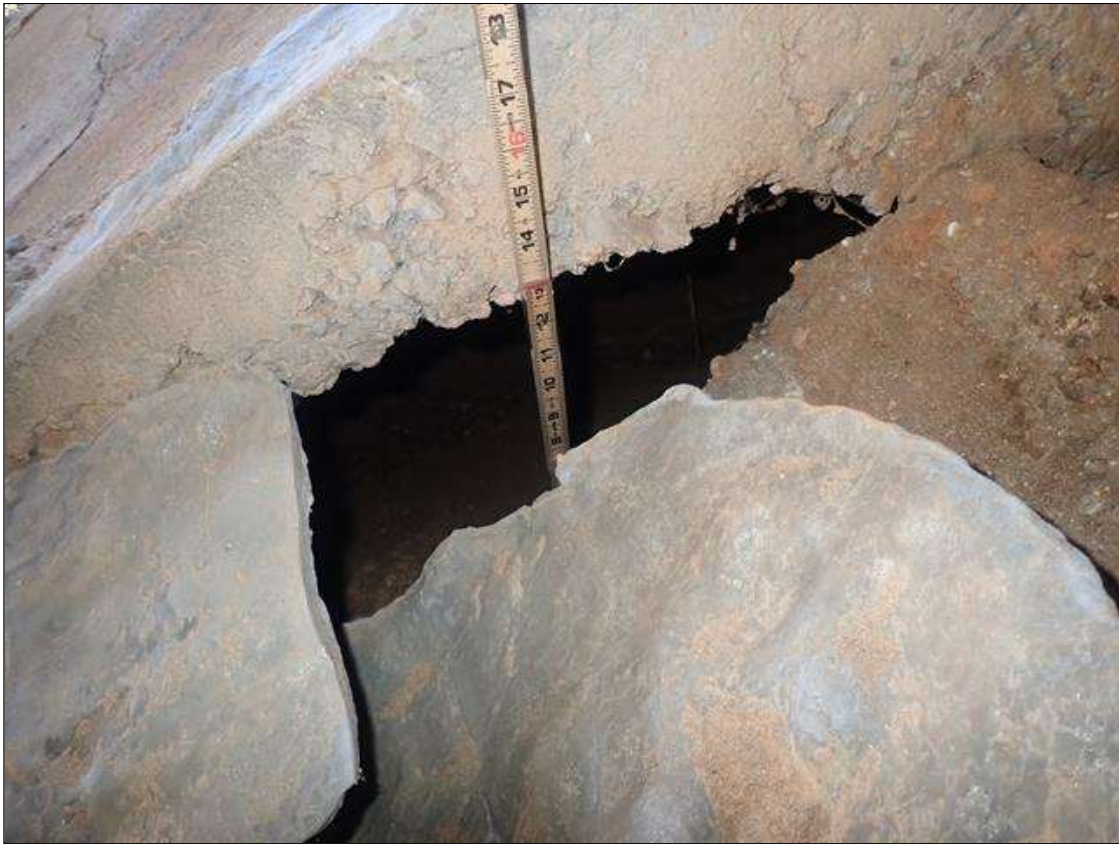
Slope Protection: end bent 1 slope protection under beam 4, failed repair with erosion causing undermining (up to 2ft x up to 1ft deep x full width) of the slope at top and below intermediate diaphragm (photo 1 of 2).

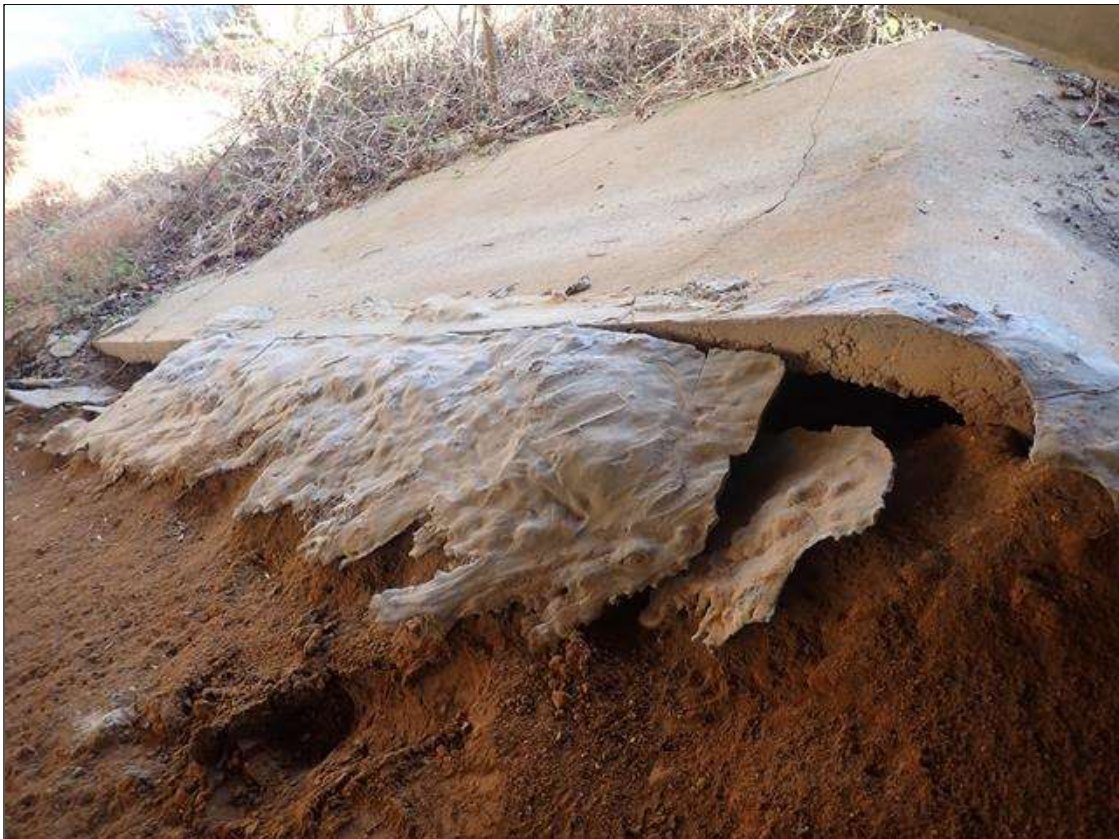
Slope Protection: end bent 1 slope protection under beam 4, failed repair with erosion causing undermining (up to 2ft x up to 1ft deep x full width) of the slope at top and below intermediate diaphragm (photo 2 of 2)

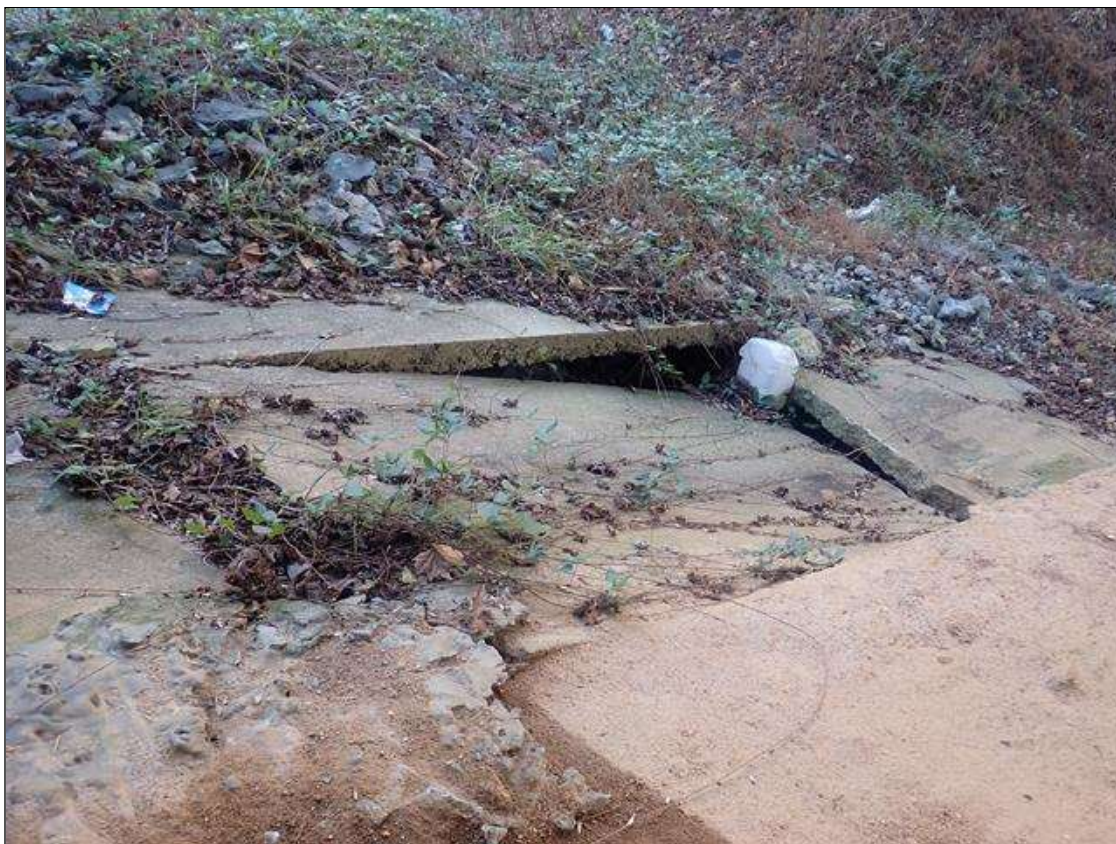
Slope Protection: end bent 1 slope protection north end at base, broken concrete and separation of slope allowing erosion with undermining (6ft x up to 1ft deep x full width) of the slope

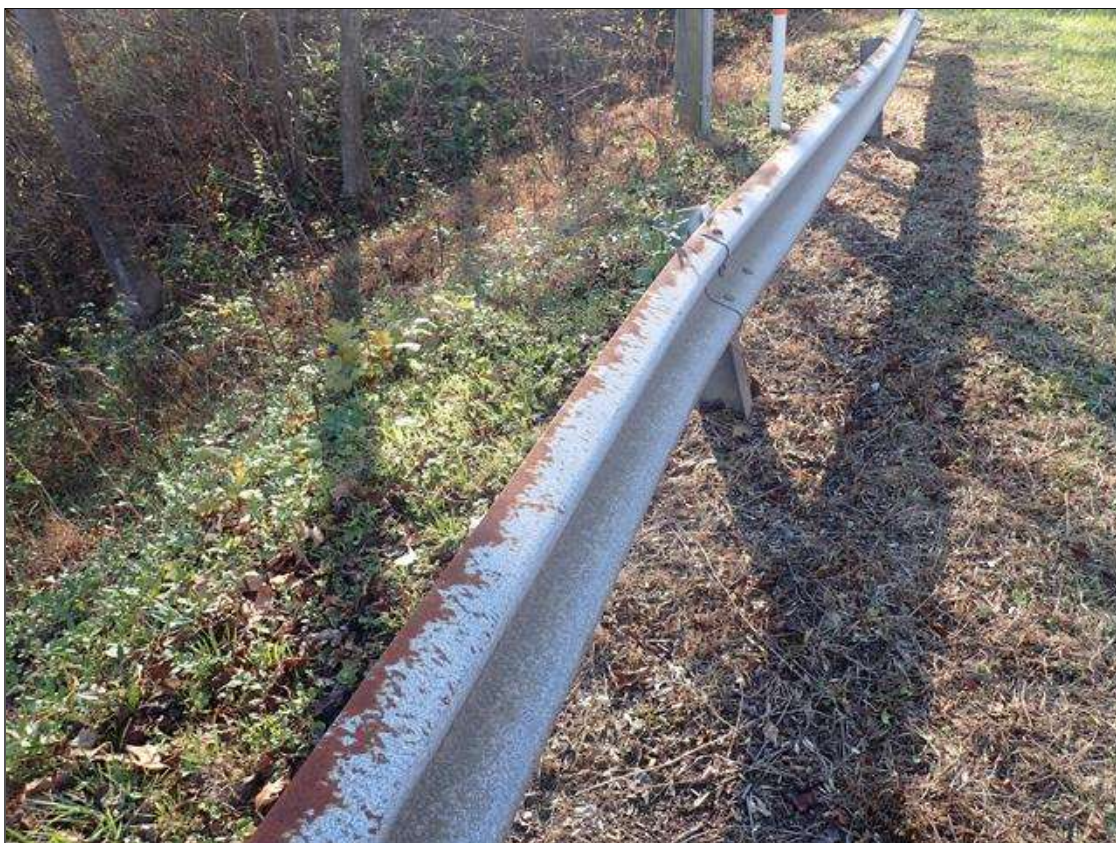
General Comments and Misc Items: southwest guardrail at 25ft from end bent 1, impact damage (12ft)

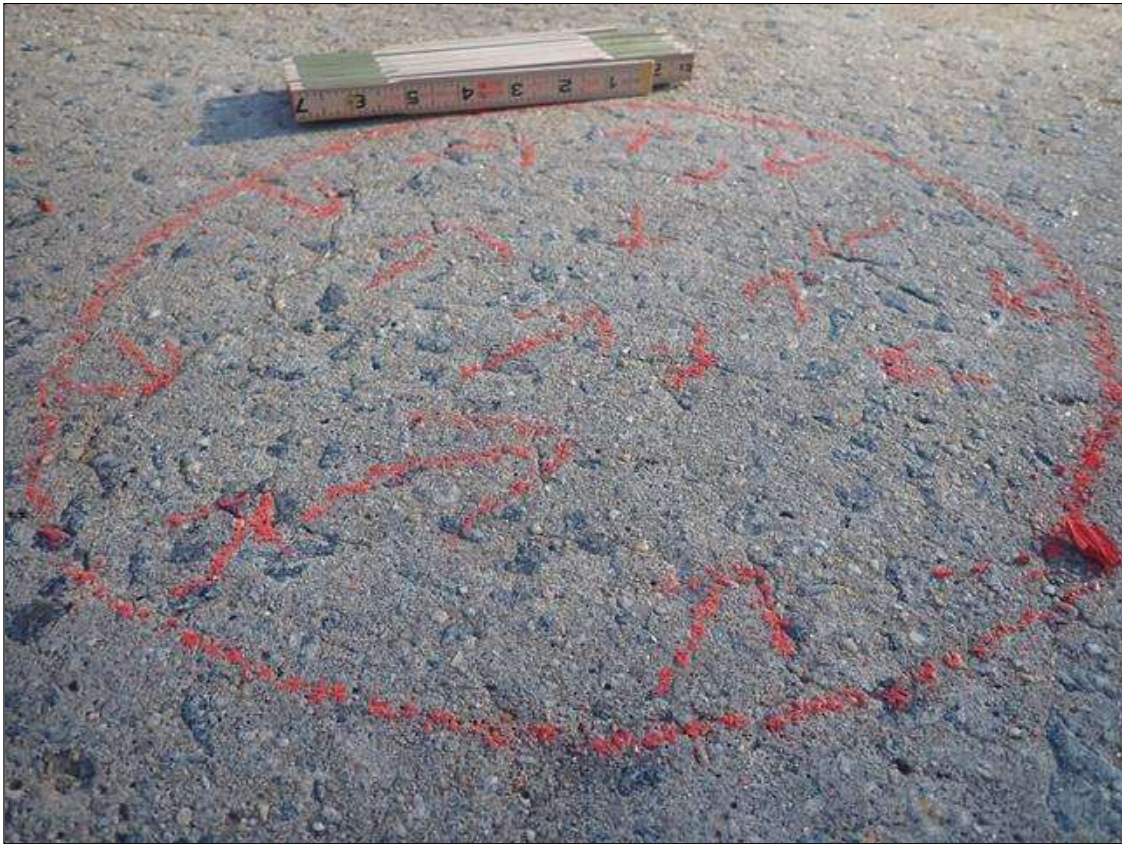
Span 1 Deck: 1008 SQUARE FEET HAIRLINE MAP CRACKING

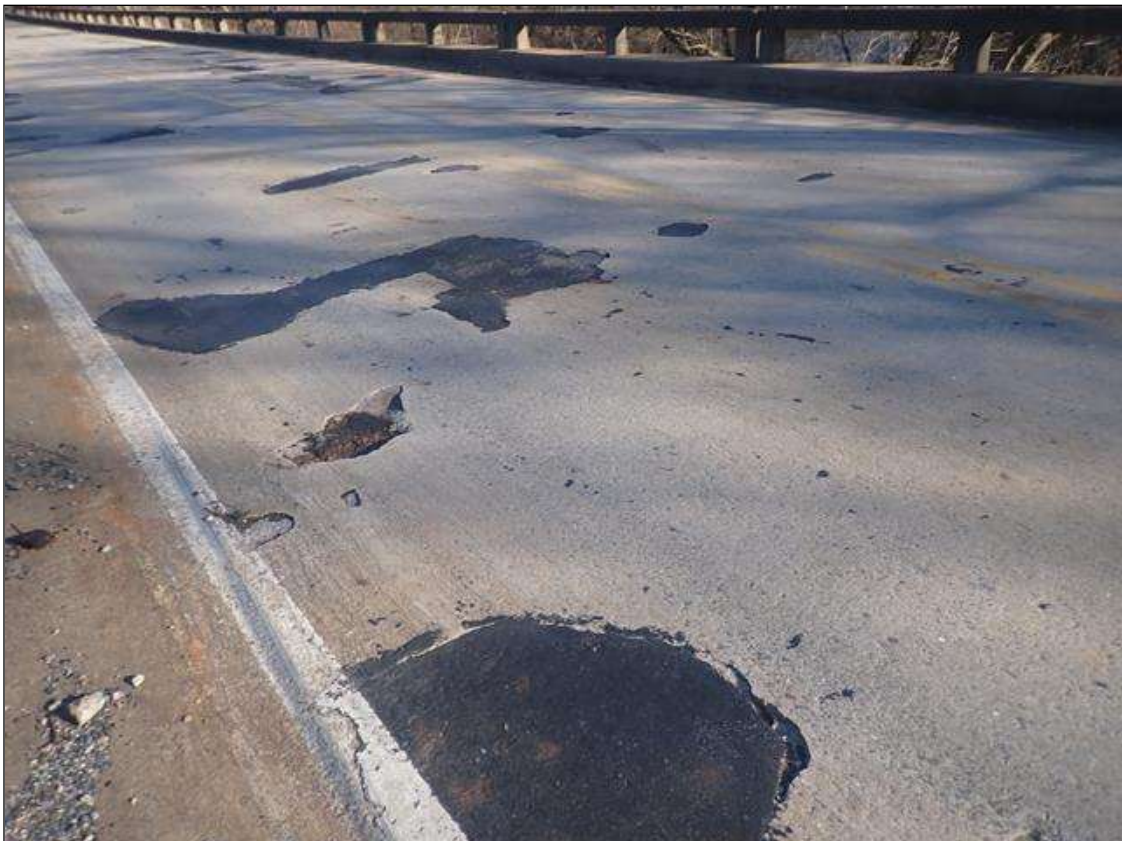
Span 1 Deck: both lanes scattered throughout, patched areas (up to 7ft x 4ft)

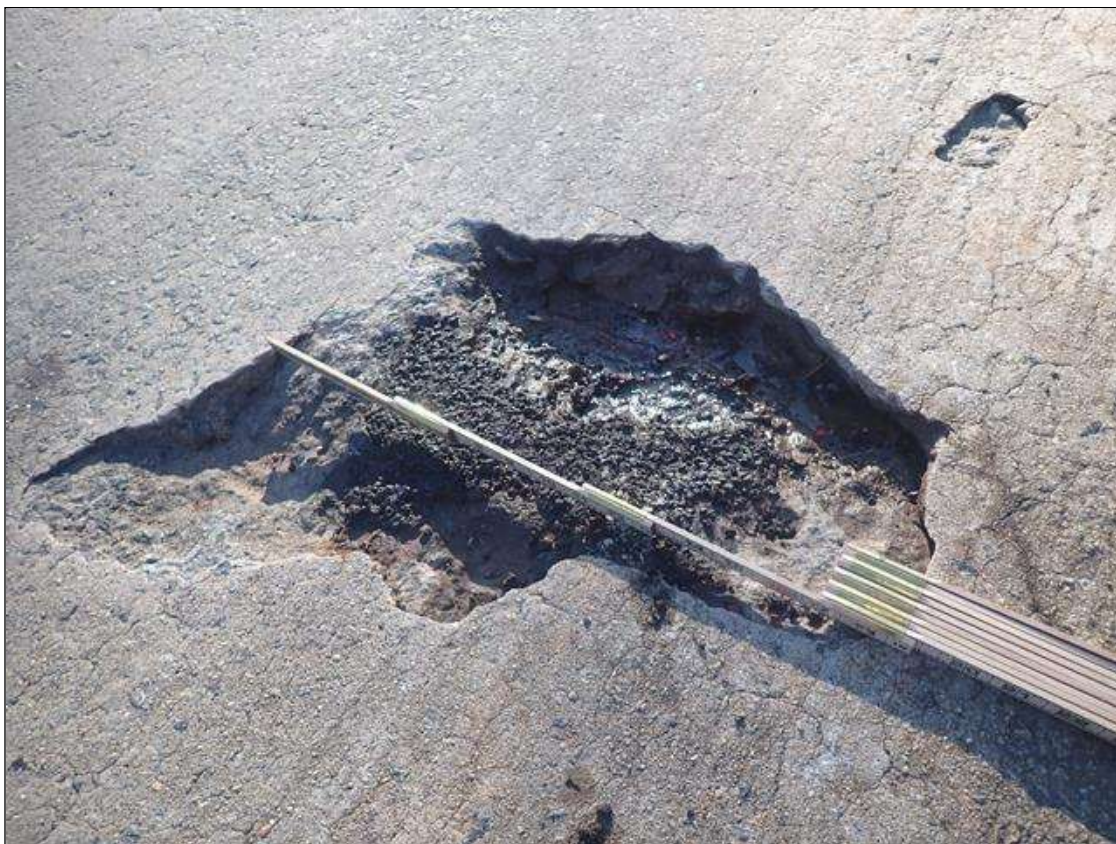
Span 1 Deck: (PAR) westbound lane at midspan, spall (2ft x up to 16in x 2in) with exposed rusted rebar

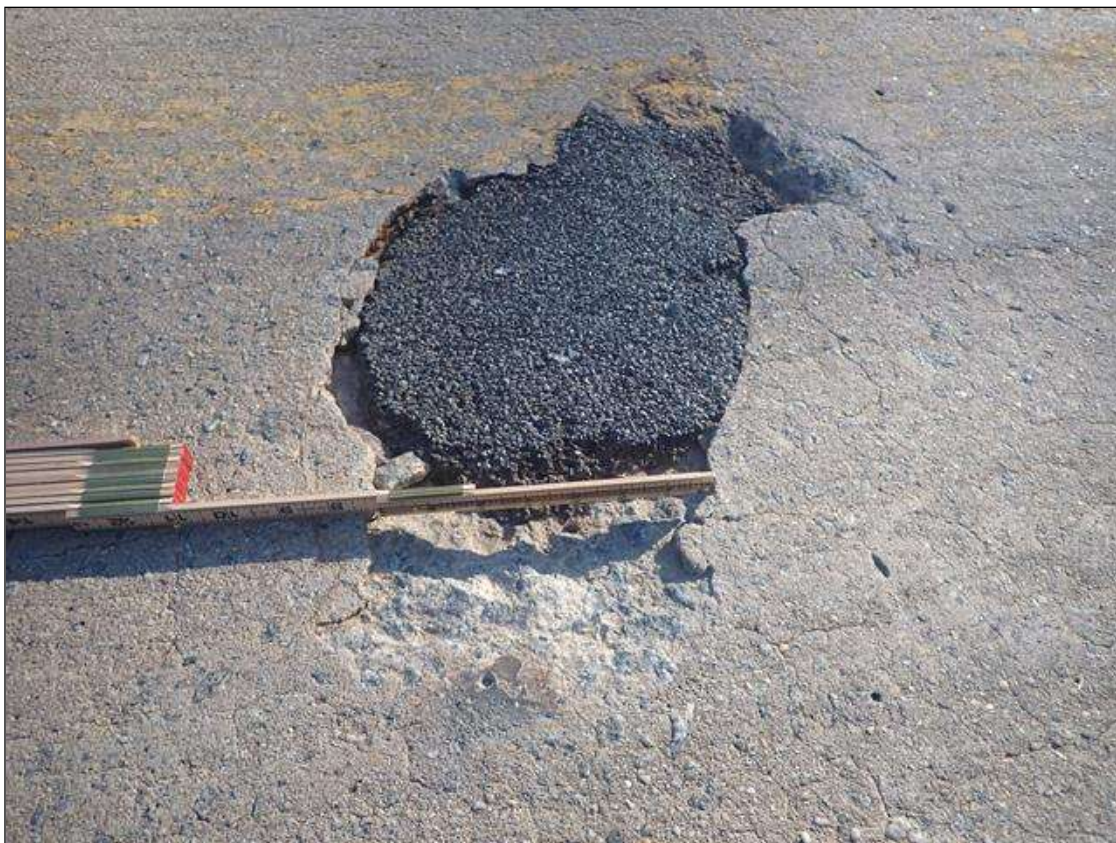
Span 1 Deck: both lanes scattered throughout, spalls (up to 10in x 6in x 1in) mainly at edges of previously patched area (photo 1 of 2)

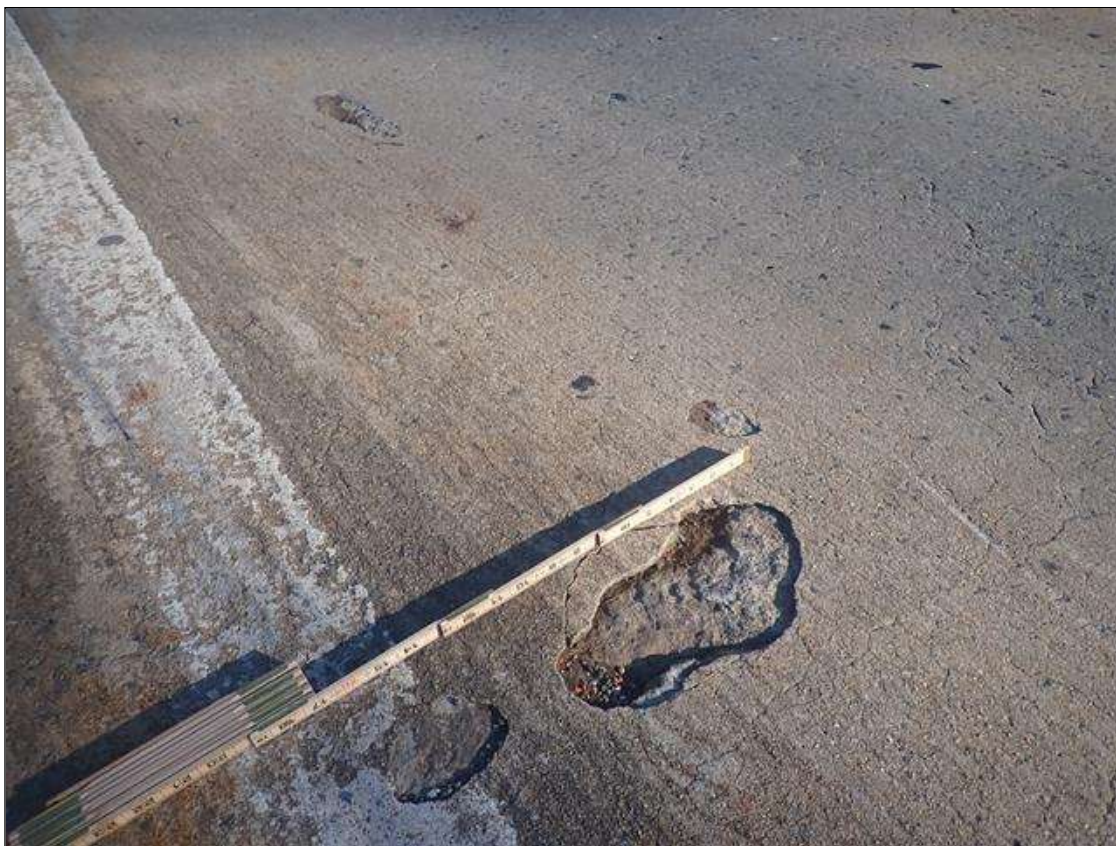
Span 1 Deck: both lanes scattered throughout, spalls (up to 10in x 6in x 1in) mainly at edges of previously patched area (photo 2 of 2)

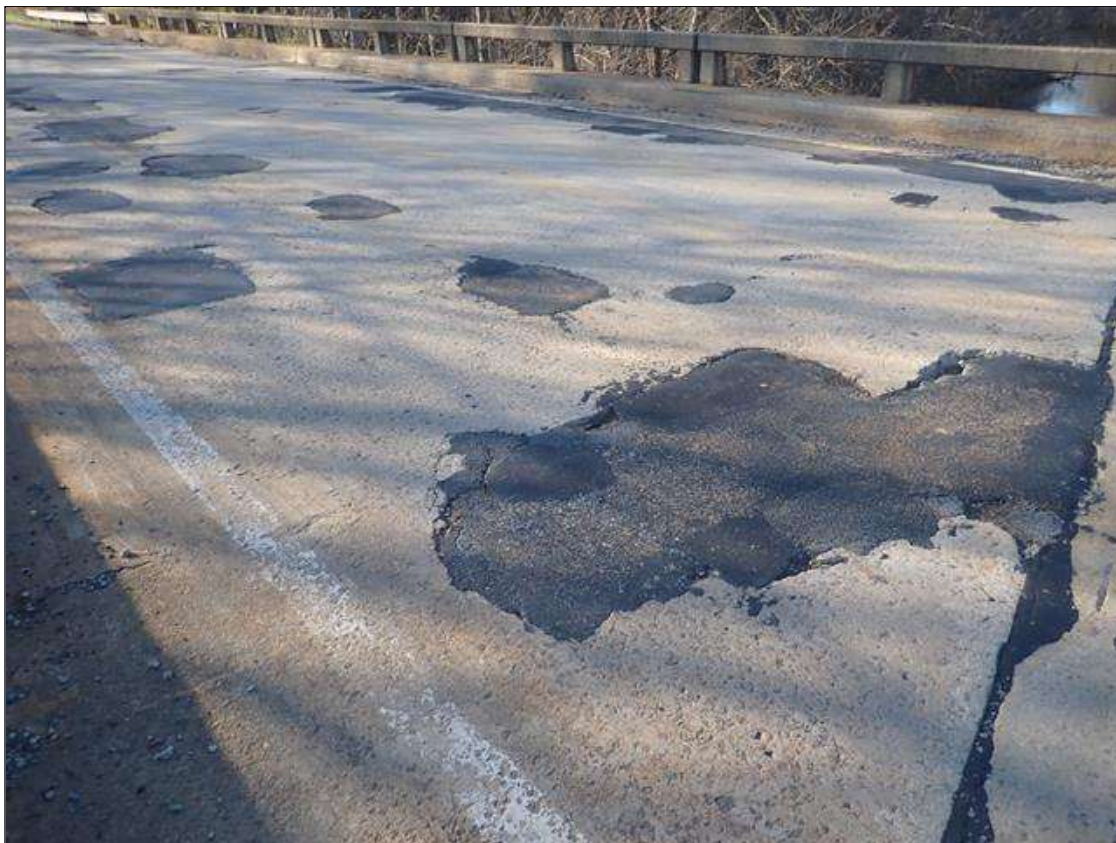
Span 2 Deck: both lanes scattered throughout, patched areas (up to 31ft x 4ft)
