NC DEPARTMENT OF TRANSPORTATION  
 DIVISION OF HIGHWAYS  
 STRUCTURE MANAGEMENT UNIT

ATTENTION: **PAR SUBMITTED  
 SNOOPER USED**

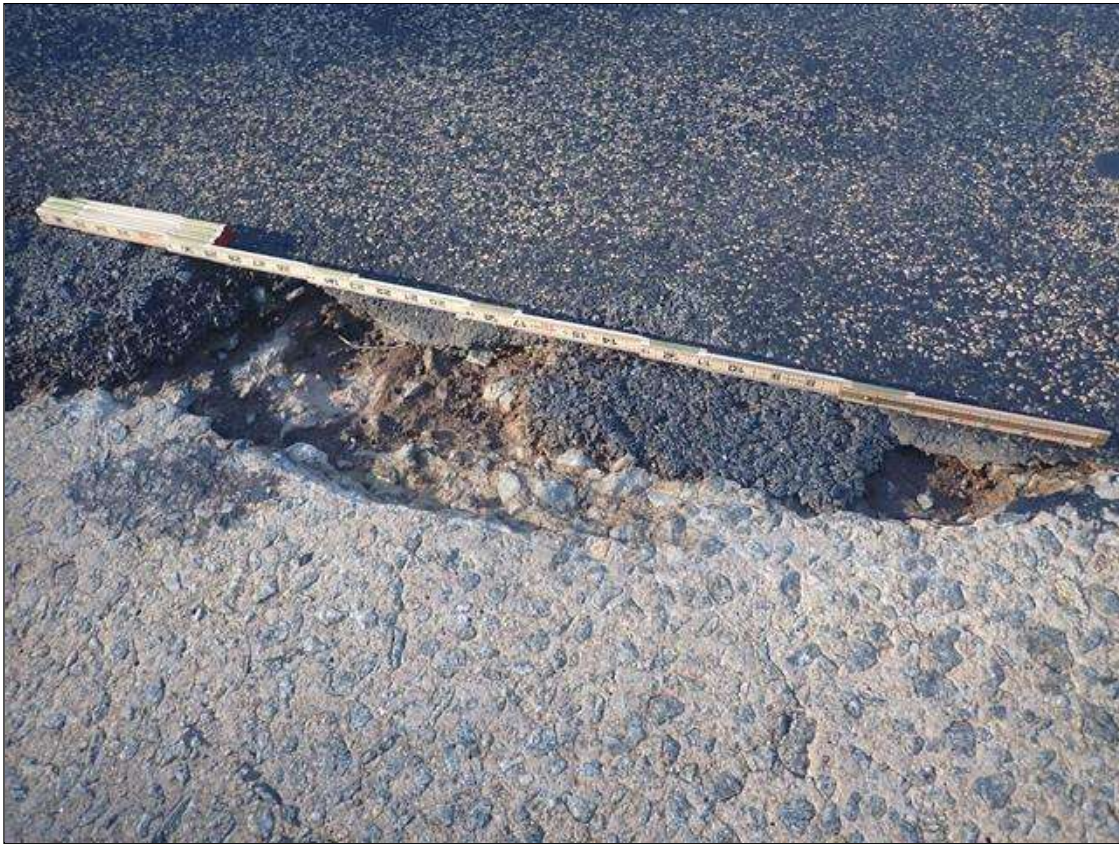
Span 2 Deck: (PAR) 30 INCHES X 12 INCHES X 2 INCHES DEEP SPALL WITH EXPOSED REBAR AND AREA OF DELAMINATION IN EASTBOUND LANE, 11 FEET FROM BENT 1

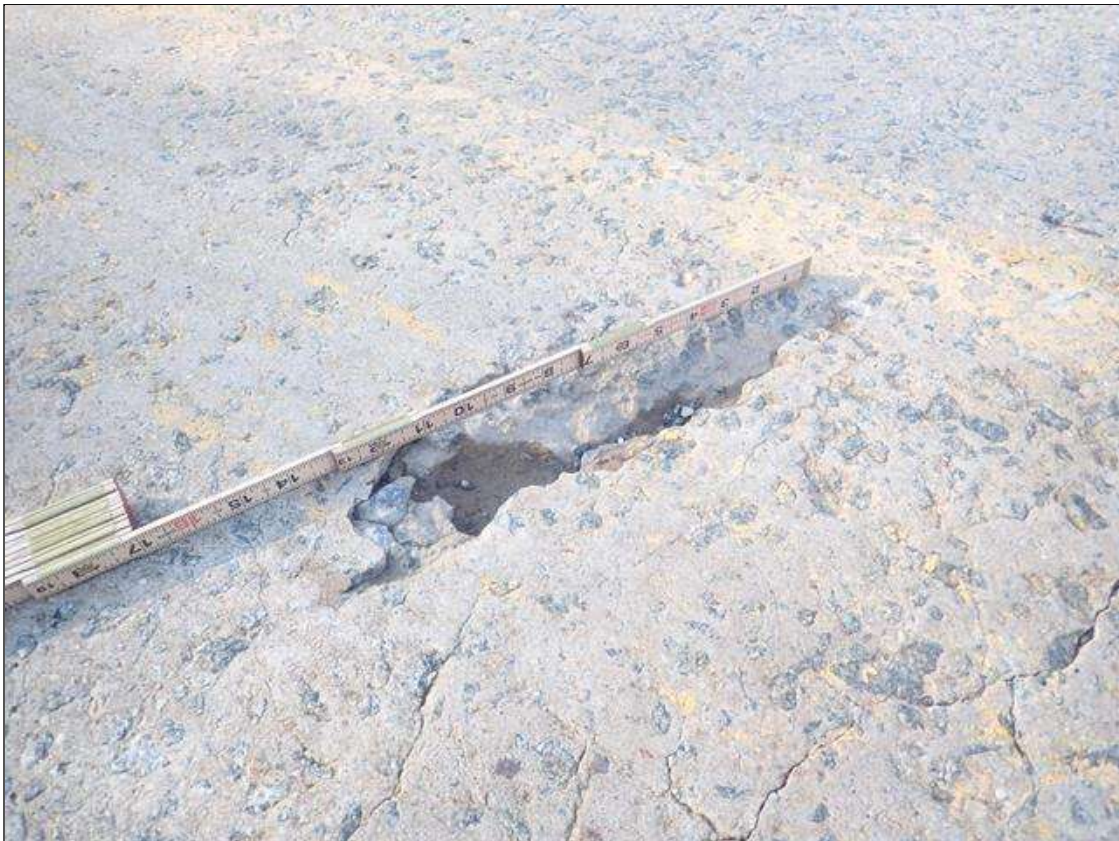
Span 2 Deck: both lanes scattered throughout, spalls (up to 3ft x up to 12in x 1in) mainly at edges of previously patched areas (photo 1 of 2)

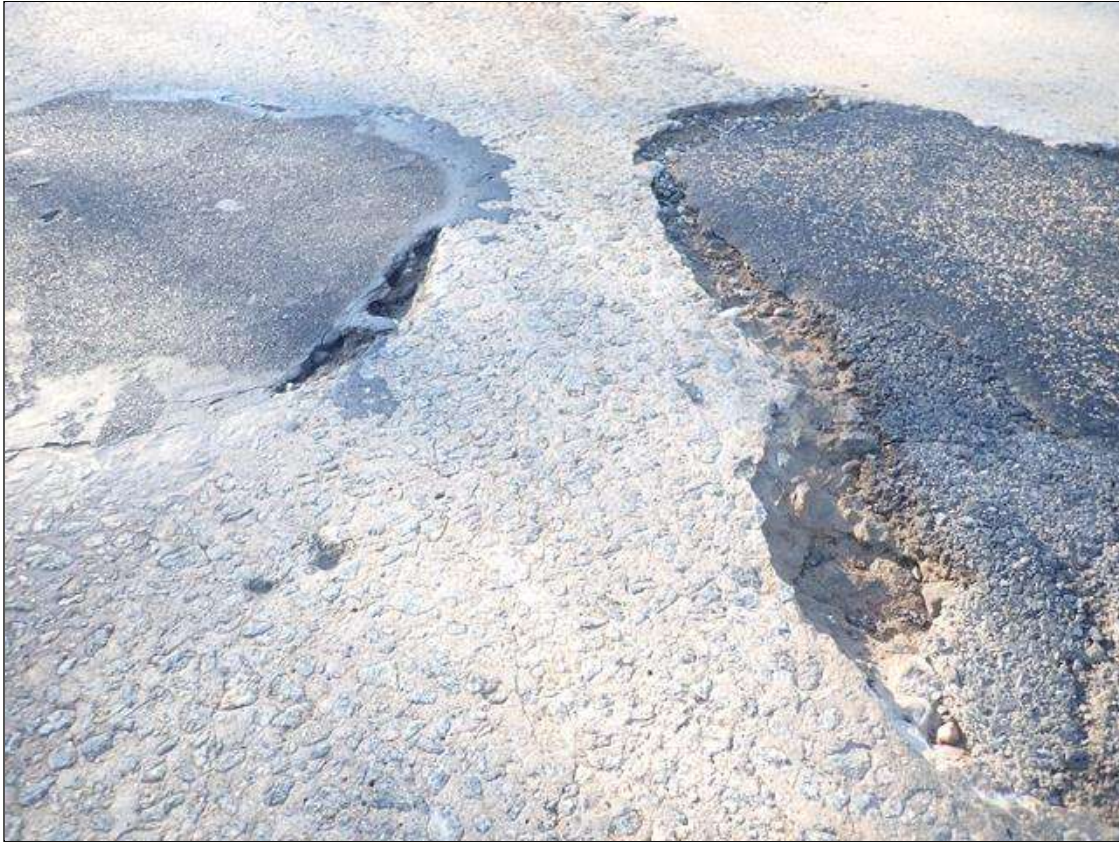
Span 2 Deck: both lanes scattered throughout, spalls (up to 3ft x up to 12in x 1in) mainly at edges of previously patched areas (photo 2 of 2)

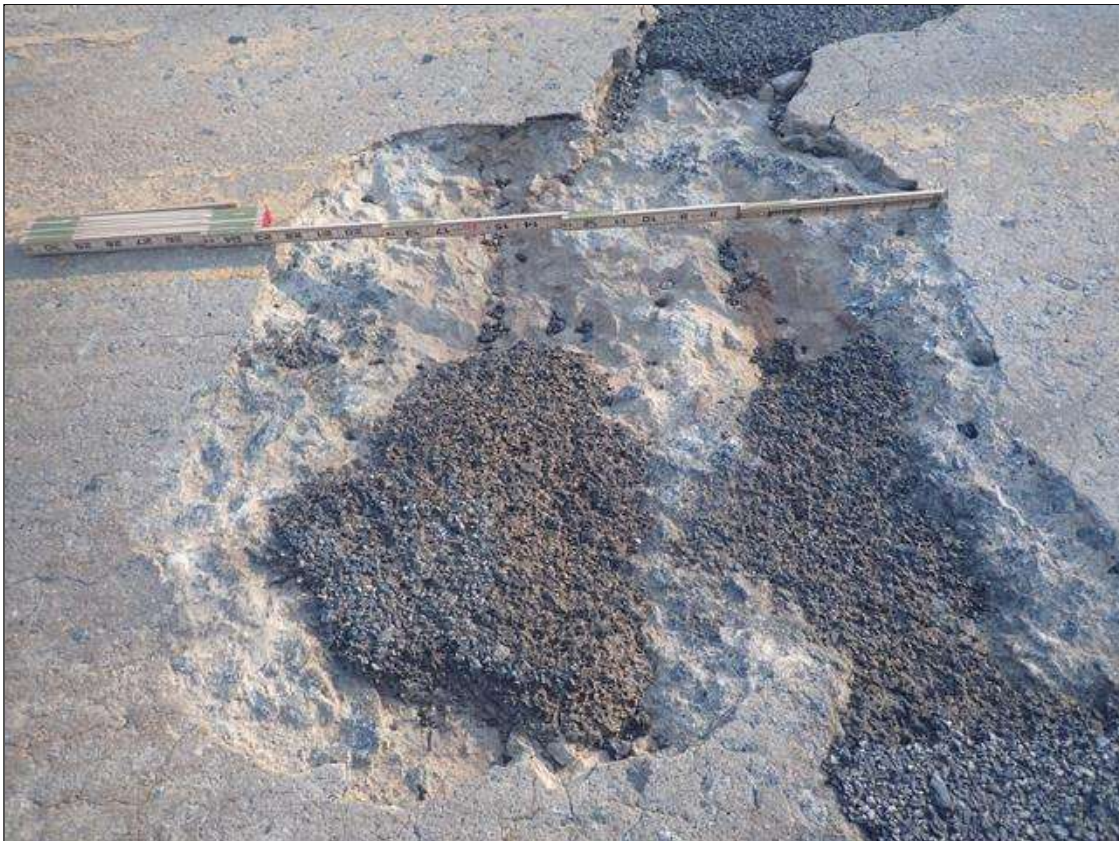
Span 3 Deck: (PAR) WESTBOUND LANE AT 9FT FROM BENT 2 JOINT, SPALL (30IN X 2FT X 2-1/2IN) WITH EXPOSED RUSTED REBARS

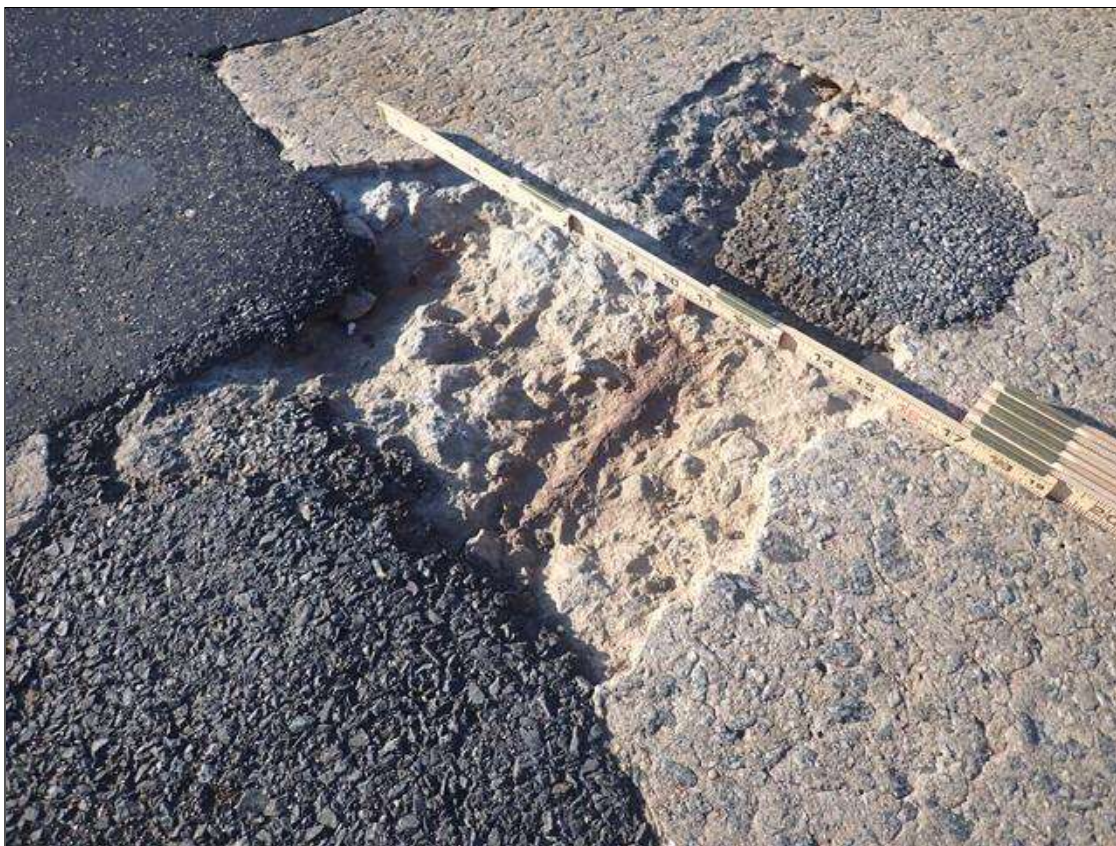
Span 4 Deck: (PAR) EASTBOUND LANE AT 9FT FROM BENT 3 JOINT, SPALL (2FT X 16IN X UP TO 2IN) WITH EXPOSED RUSTED REBARS

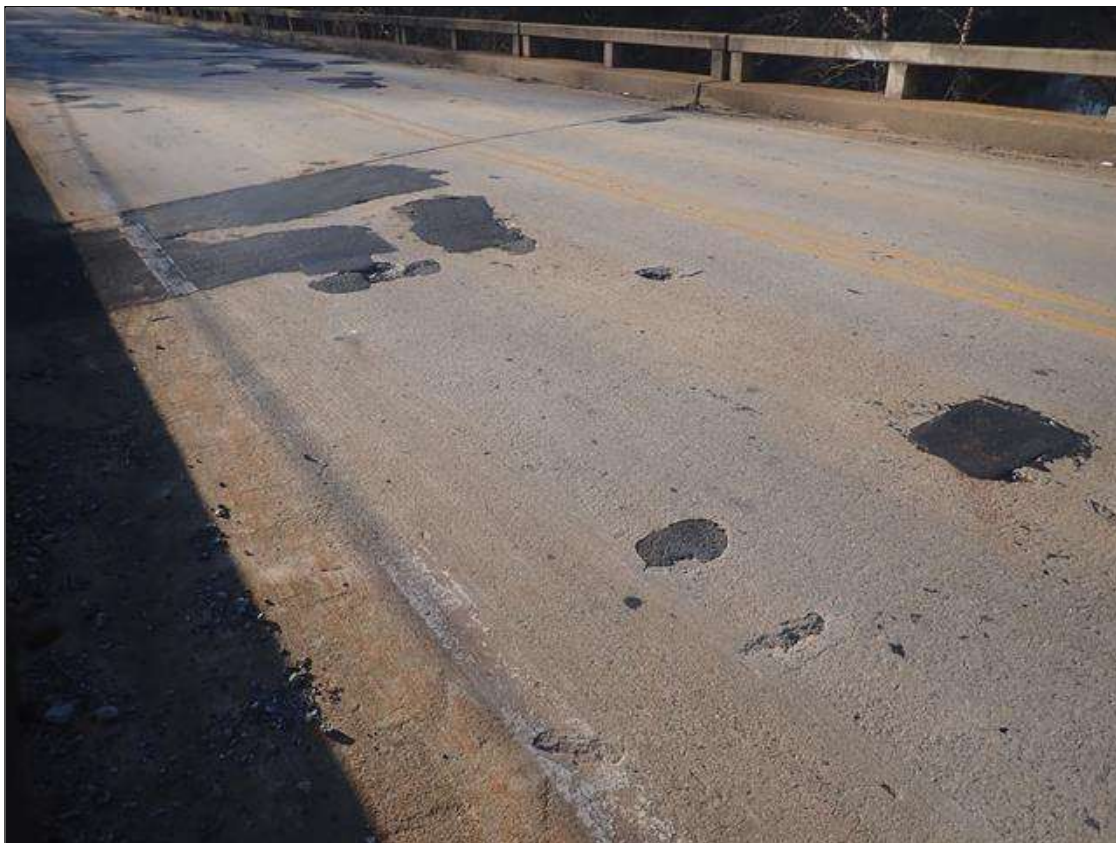
Span 4 Deck: BOTH LANES SCATTERED THROUGHOUT, PATCHED AREAS (UP TO 7FT X UP TO 12 FT)

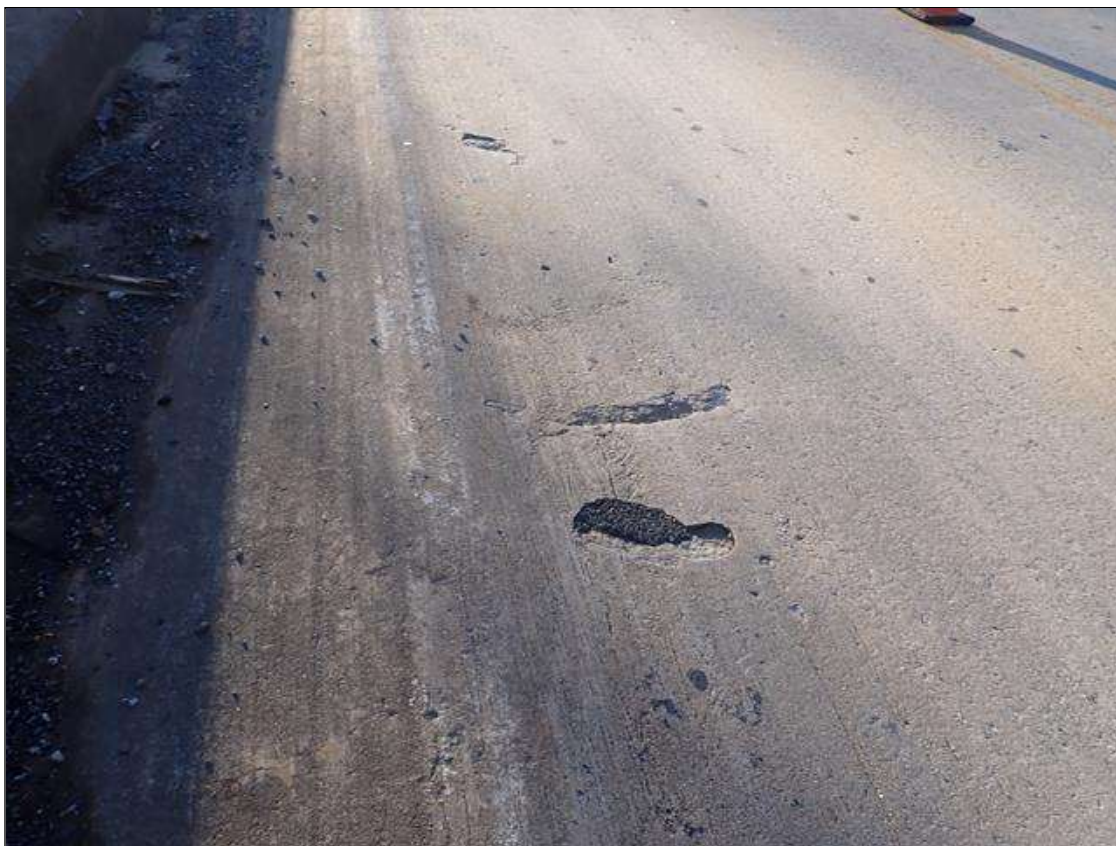
Span 5 Deck: (4) UP TO 18 INCHES X 24 INCHES X 1 INCHES DEEP SPALLS AND AREA OF DELAMINATION SCATTERED THROUGHOUT EASTBOUND LANE

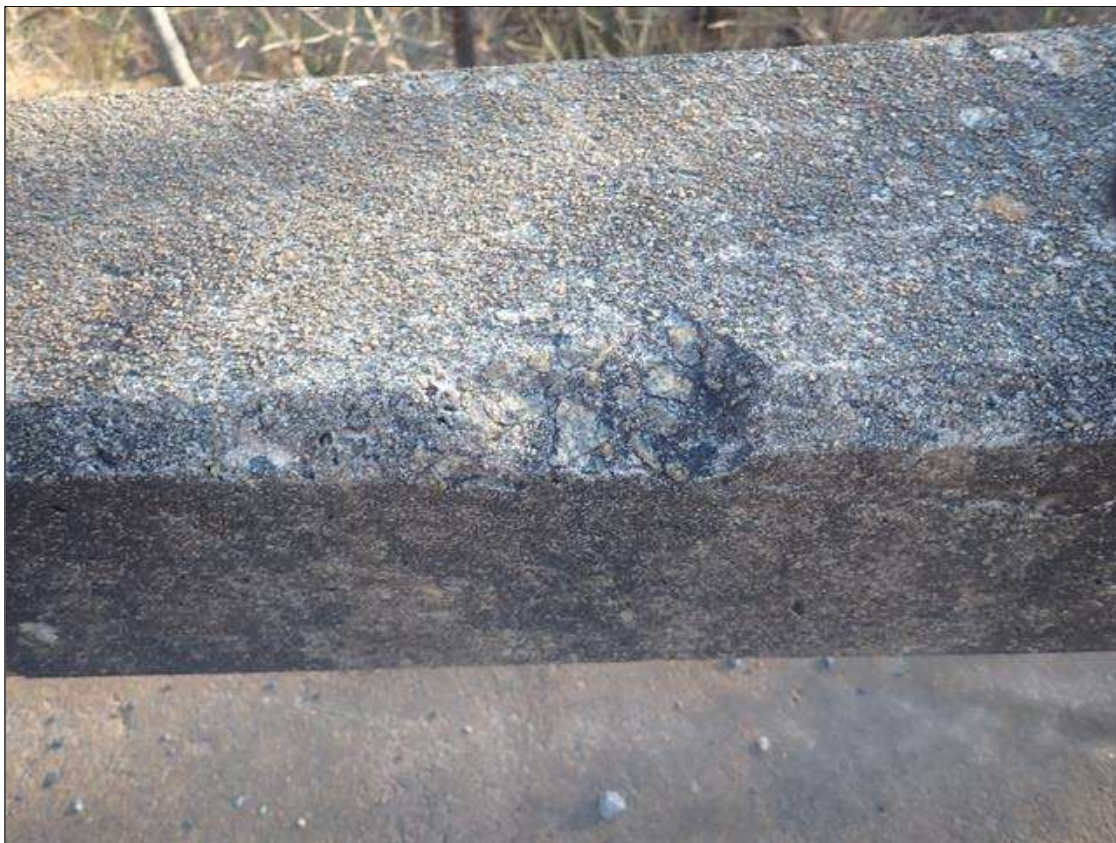
Span 5 Right Bridge Rail: 4 INCHES X 3 INCHES X 1/2 INCHES DEEP SPALL ON RAIL NEAR POST 5

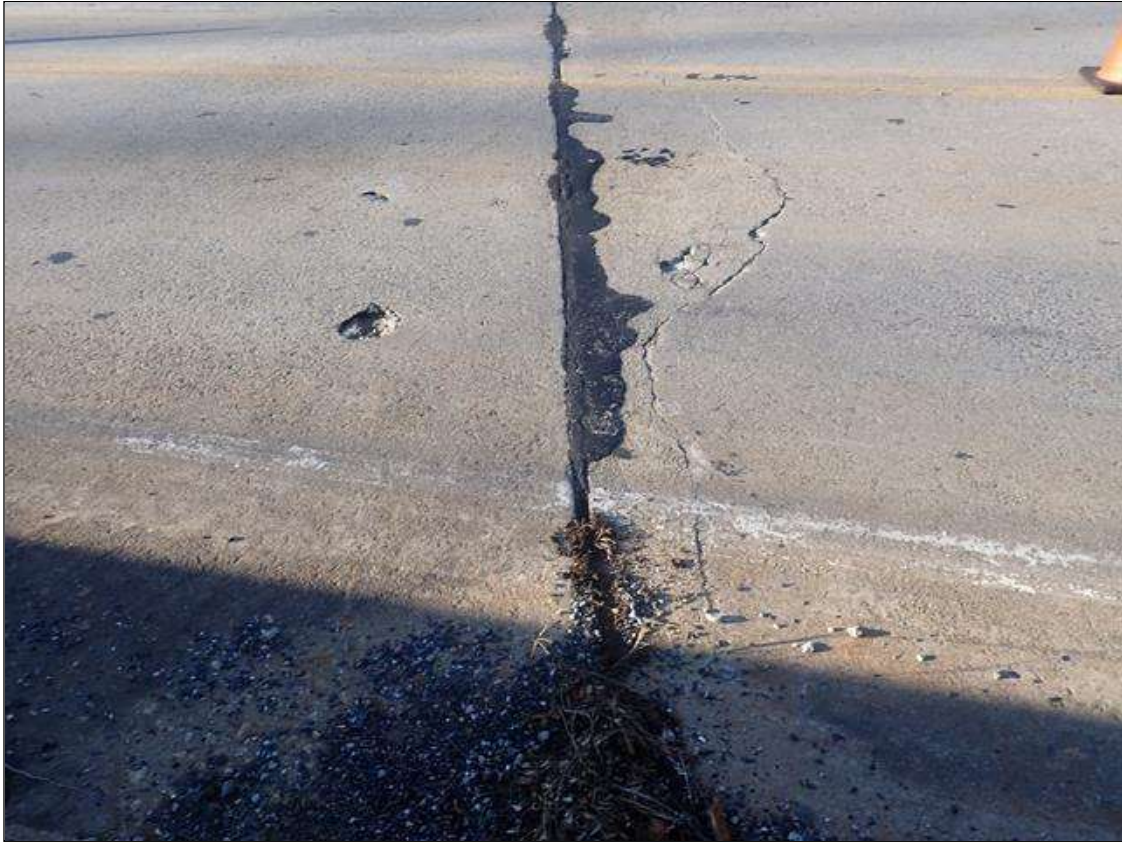
Span 5 Expansion Joint: 25 FEET WEARING SURFACE IN JOINT

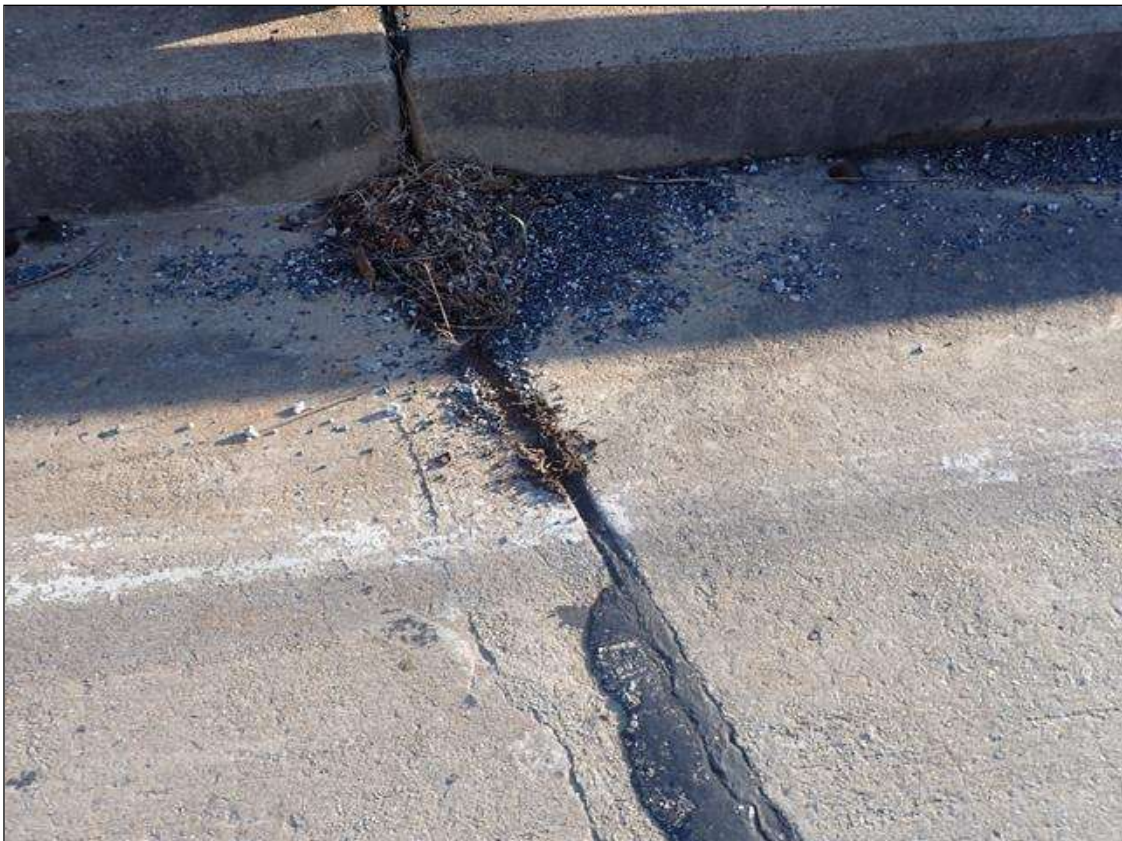
Span 5 Expansion Joint: 4 FEET DIRT AND DEBRIS IN SOUTH GUTTER

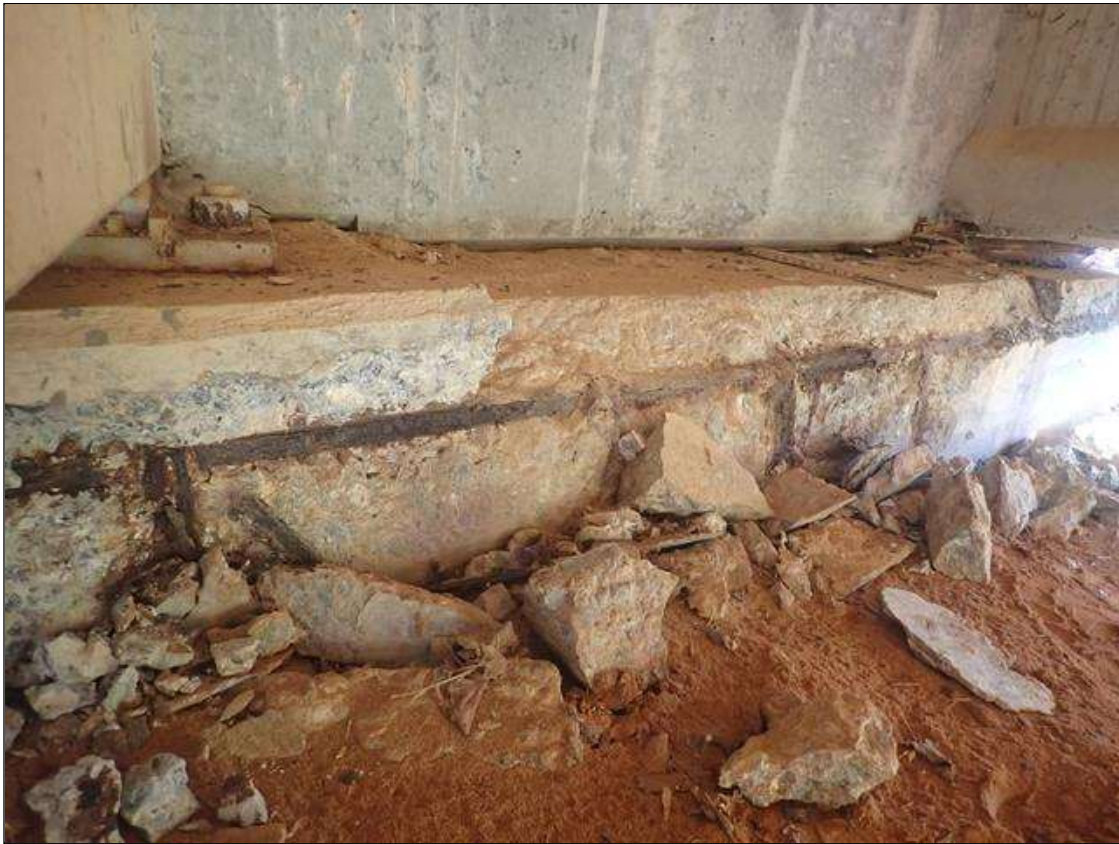
End Bent 2 Cap 1: (PAR) 9 FEET X 14 INCHES X 5 INCHES DEEP SPALL WITH EXPOSED REBAR AND AREA OF DELAMINATION UNDER BAY 3

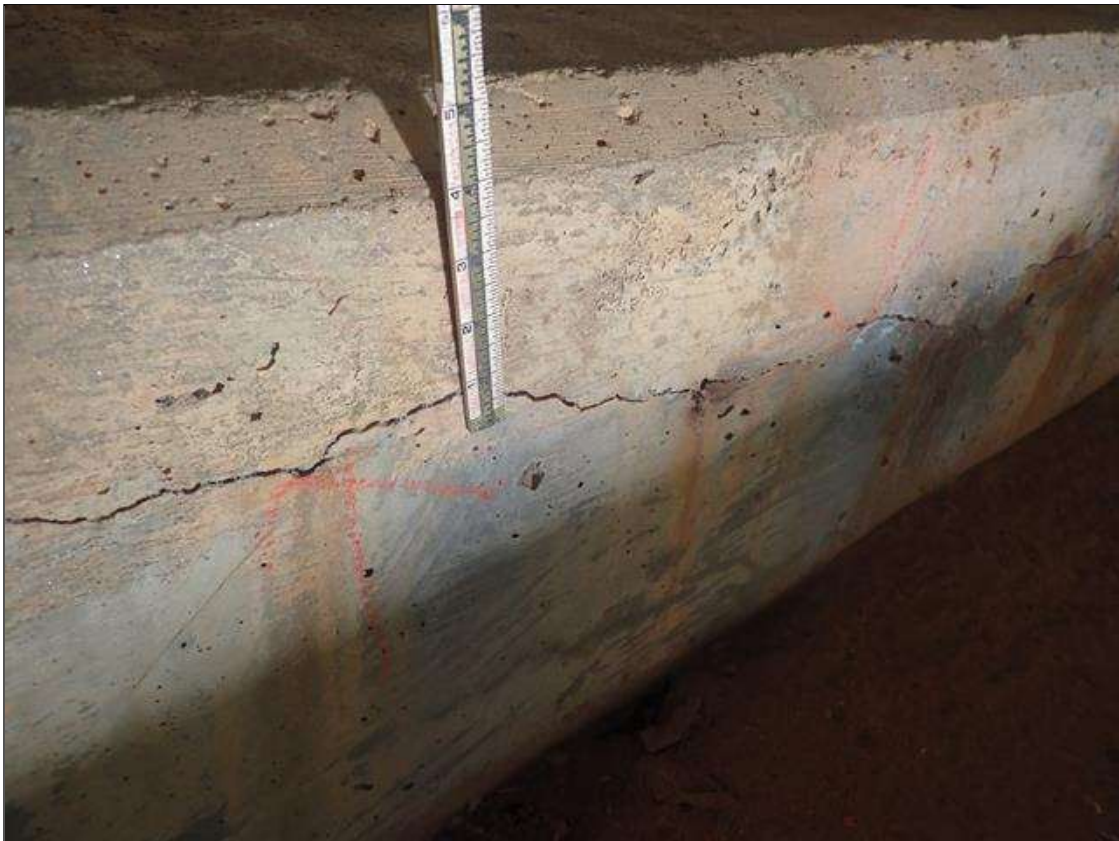
End Bent 2 Cap 1: 5 FEET UP TO 1/8 INCHES HORIZONTAL CRACK WITH RUST STAINS UNDER BAYS 1 AND 2

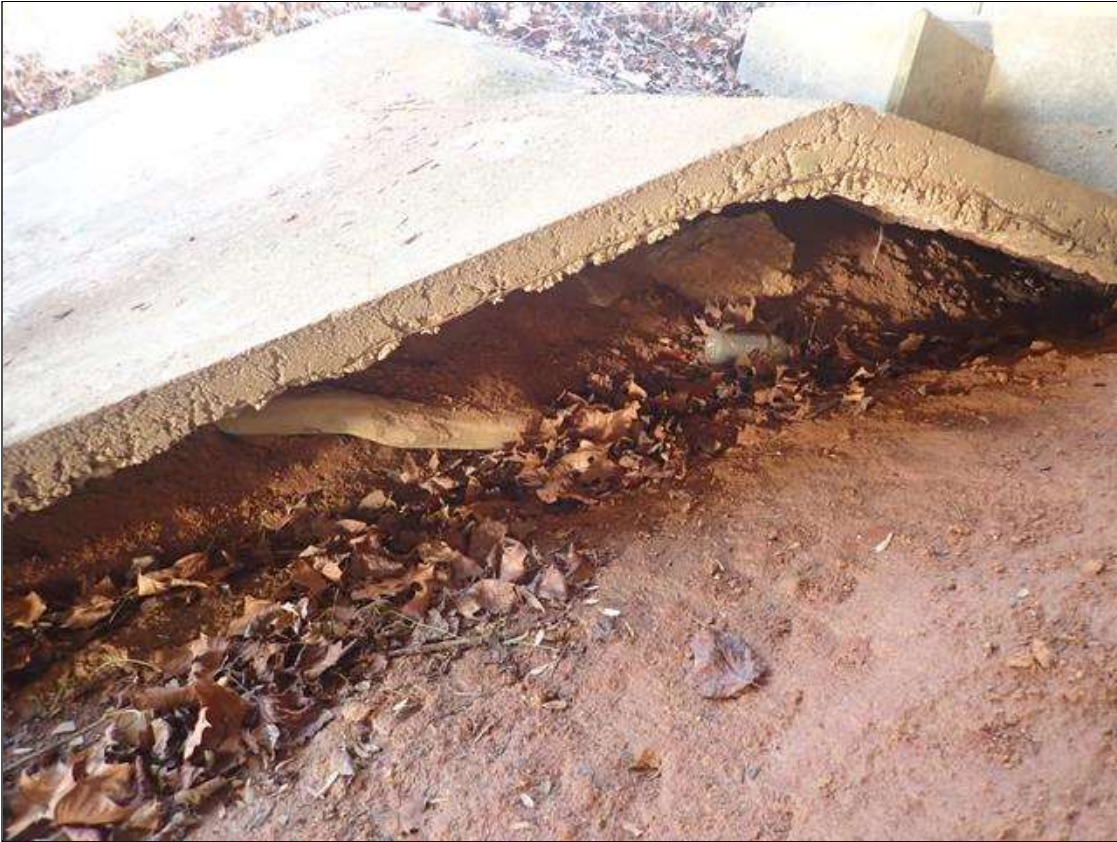
Slope Protection: end bent 2 slope protection north end, erosion with undermining (12ft x 2ft x full width)

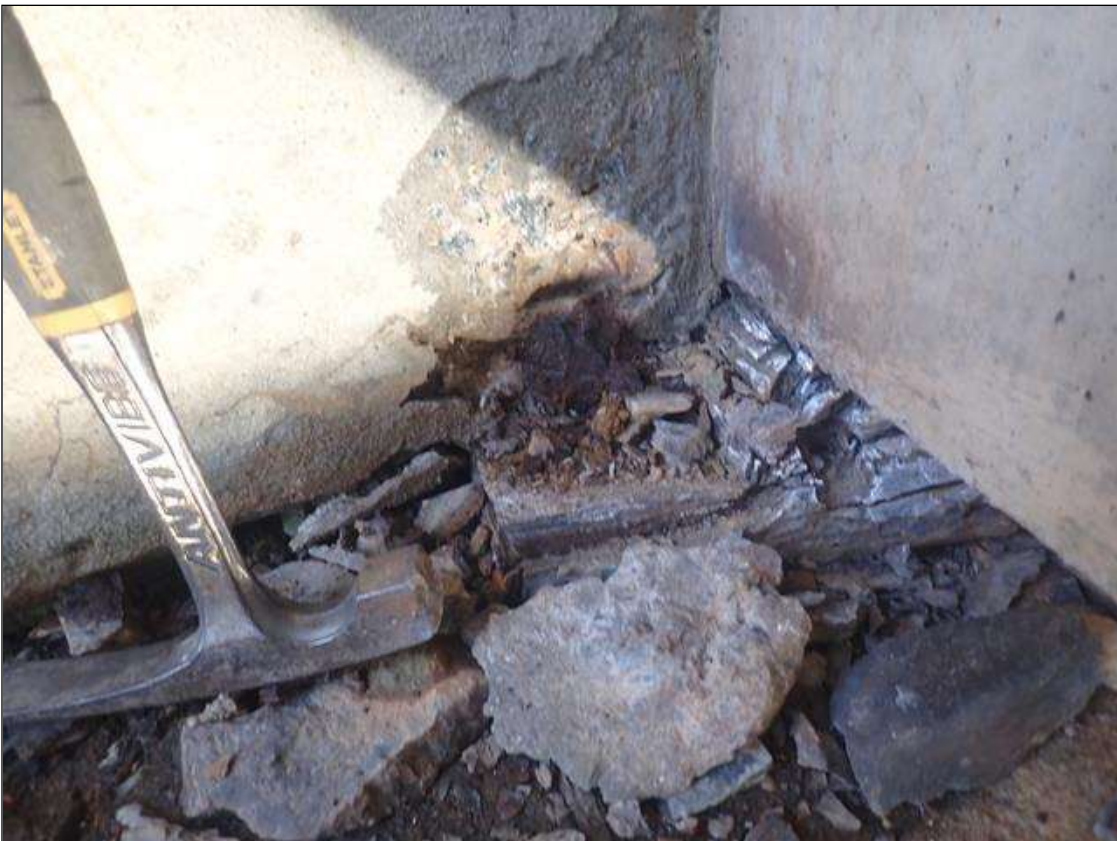
End Bent 2 Abutment: 22 INCHES X 12 INCHES AREA OF PATCH WITH 6 INCHES X 5 INCHES X 1 INCHES DEEP SPALL WITH EXPOSED REBAR AT NORTH END ADJACENT TO BEAM 1

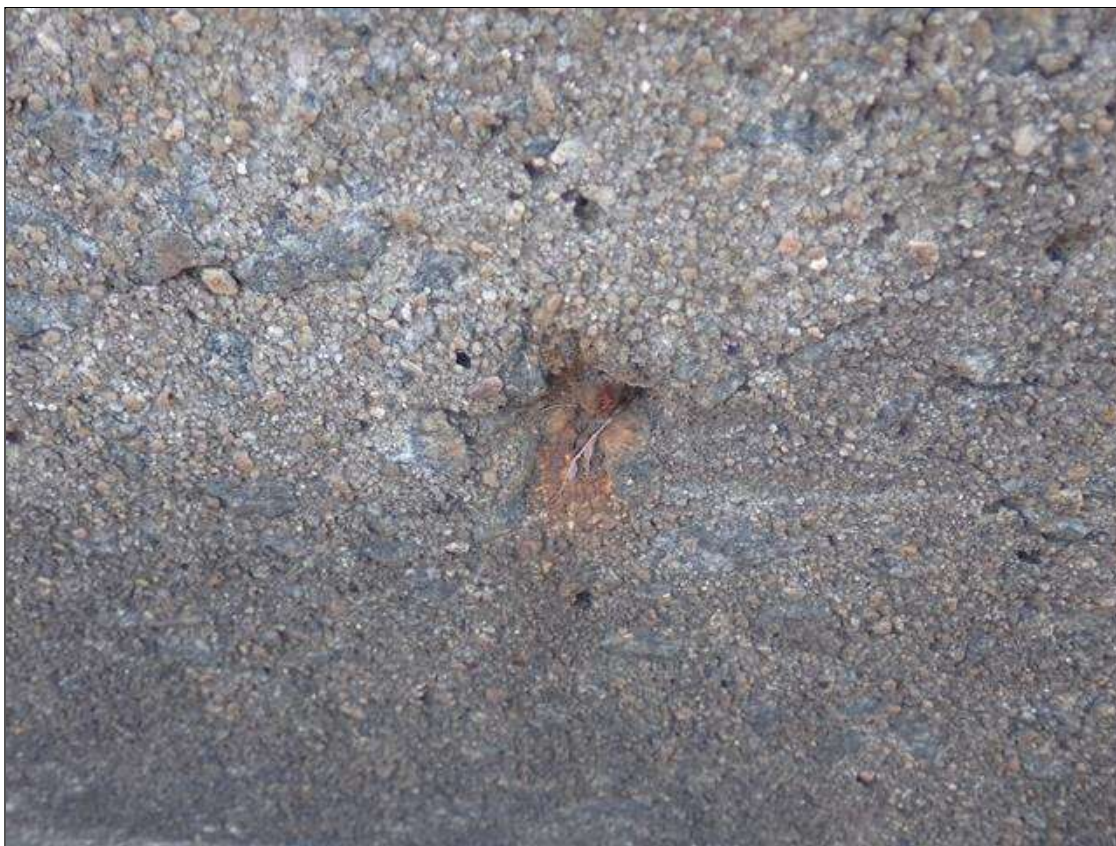
Span 1 Right Bridge Rail: 1 INCHES X 1 INCHES X 1/2 INCHES DEEP SPALL WITH EXPOSED REBAR ON CURB AT POST 4

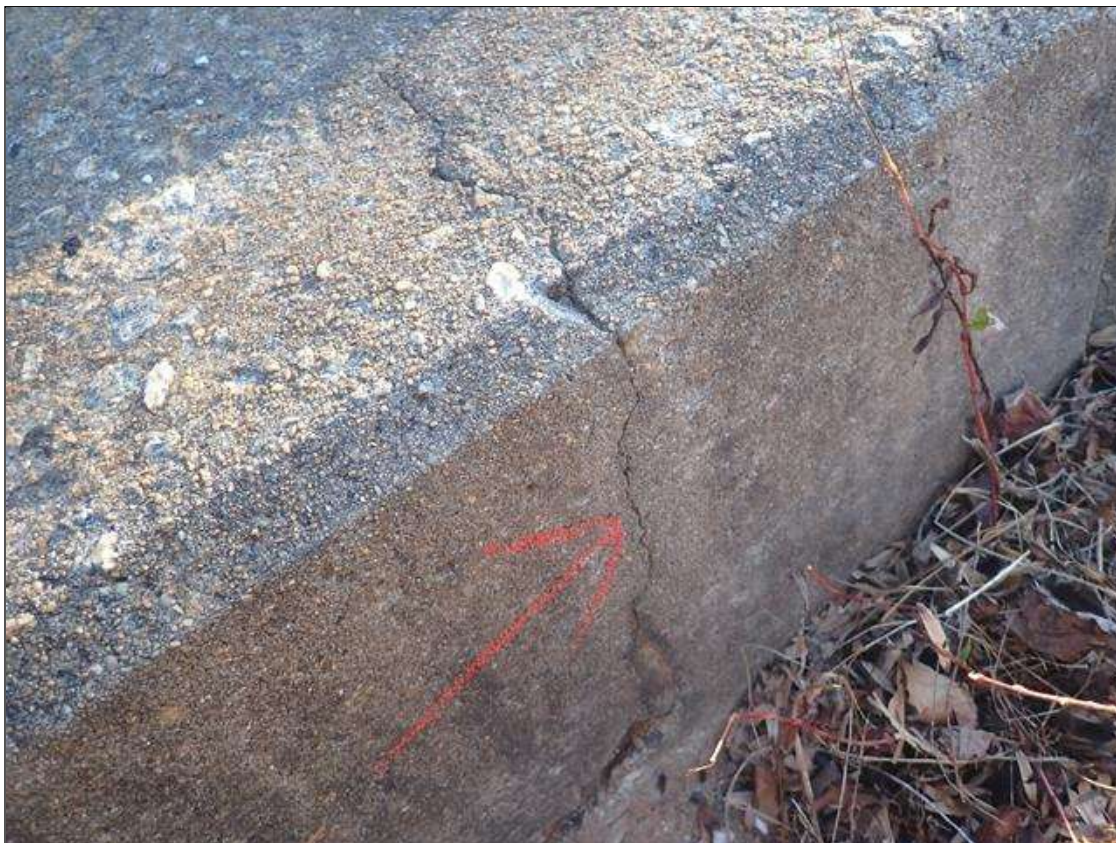
Span 1 Right Bridge Rail: (12 FEET X UP TO 1/32IN) LONGITUDINAL AND TRANSVERSE CRACKS ON CURB

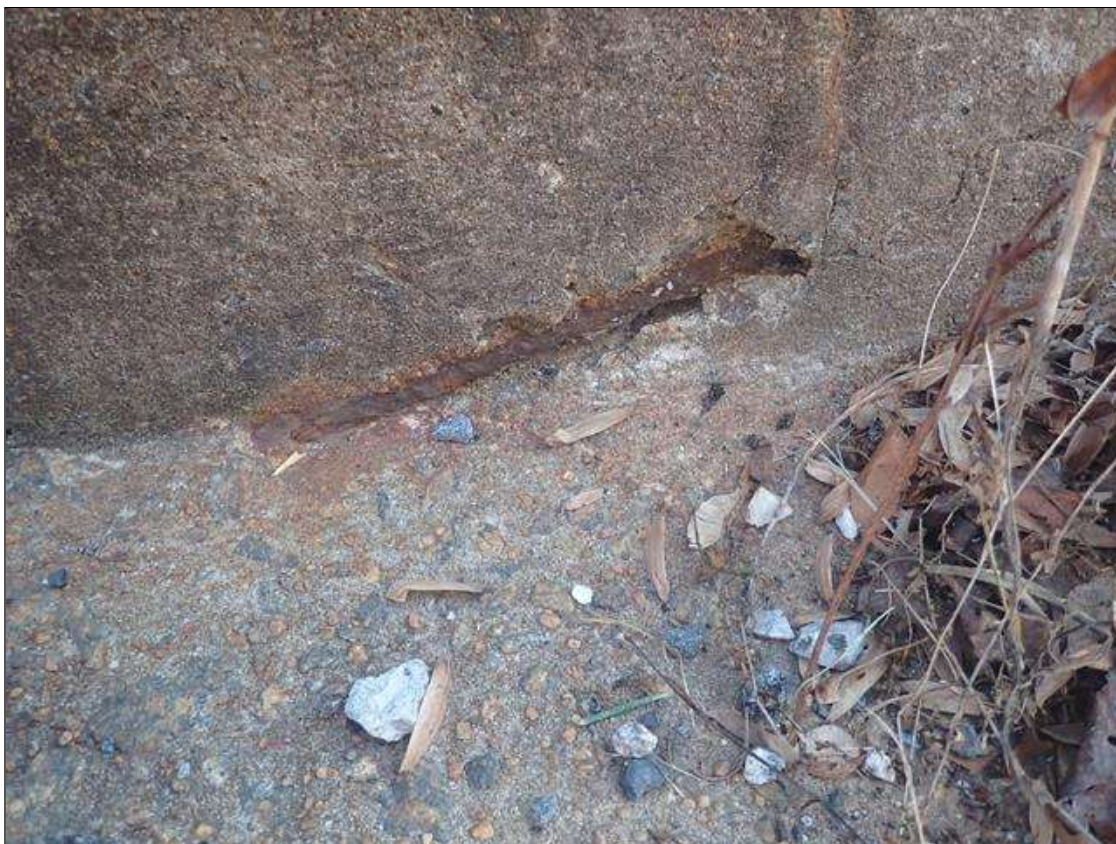
Span 1 Left Bridge Rail: END POST EAST FACE AT END BENT 1, SPALL (6IN X 4IN X 1-1/2IN) WITH EXPOSED RUSTED REBAR

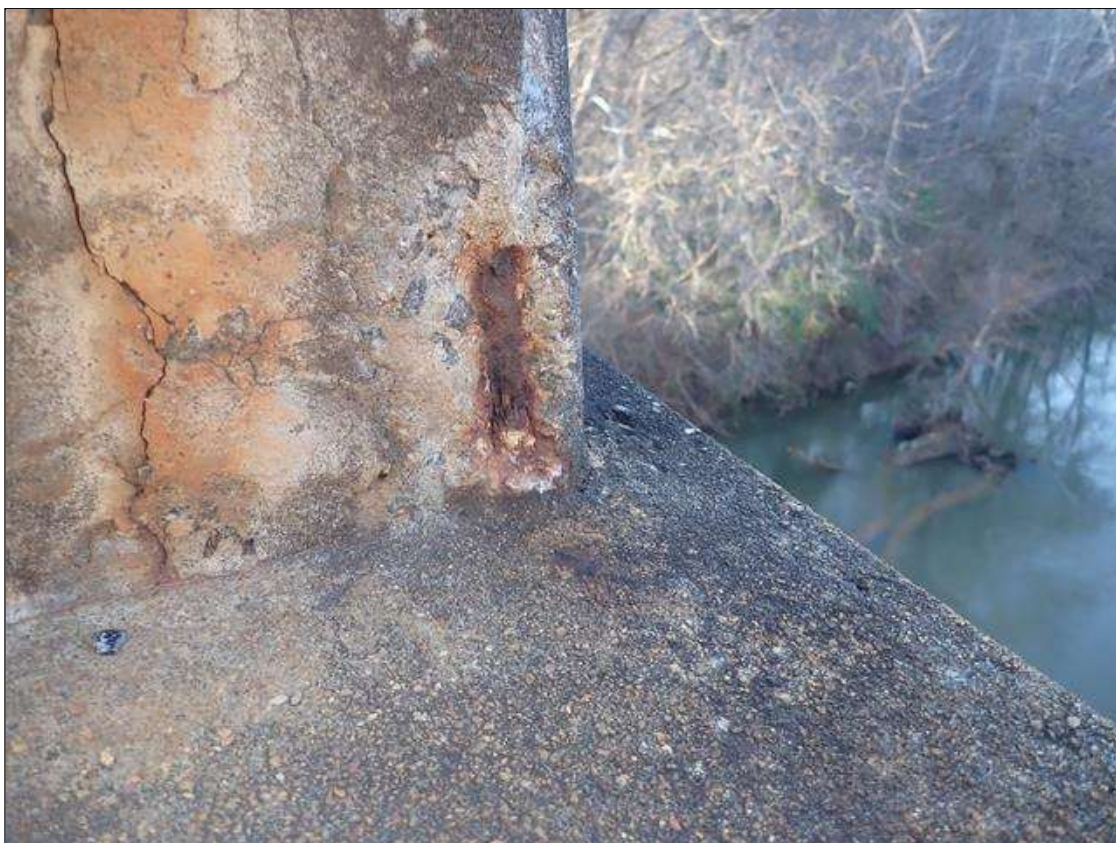
Span 3 Left Bridge Rail: 4 INCHES X 2 INCHES X 1/2 INCHES DEEP SPALL ON RAIL AT POST 1

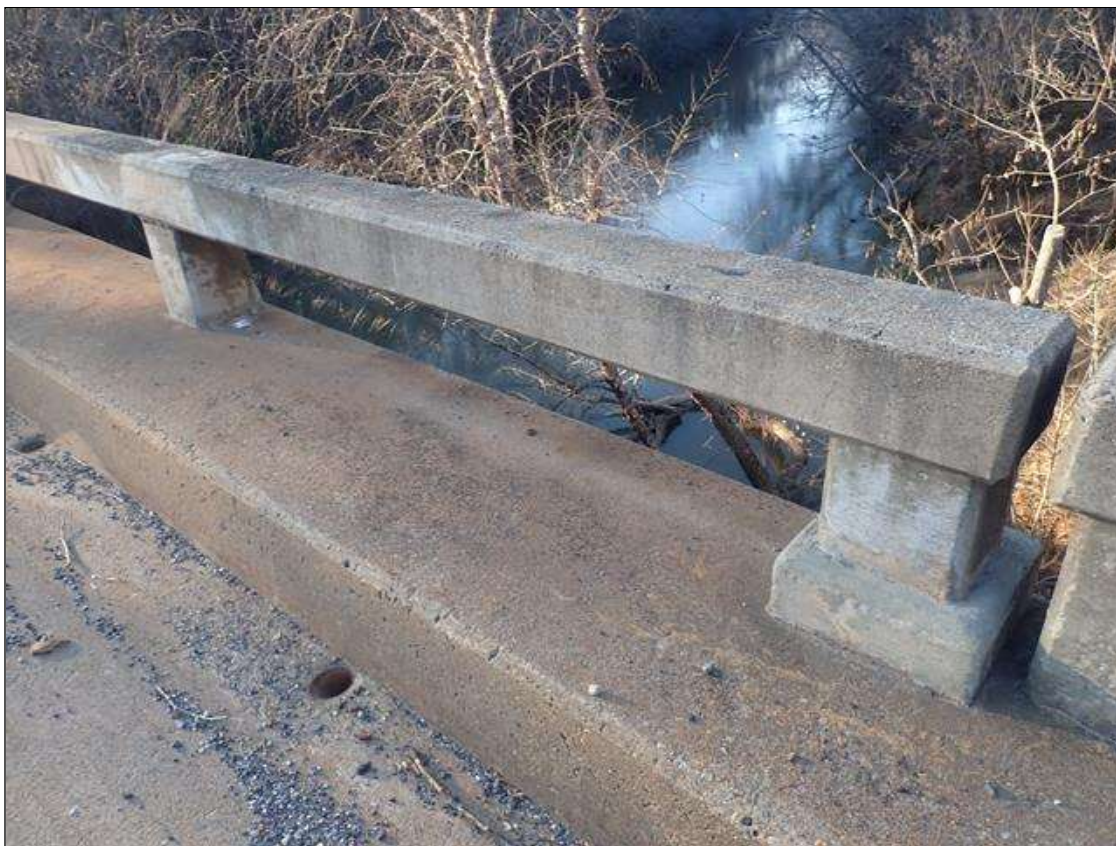
Span 4 Left Bridge Rail: 6 FEET REPLACED RAIL SECTION AT POST 2

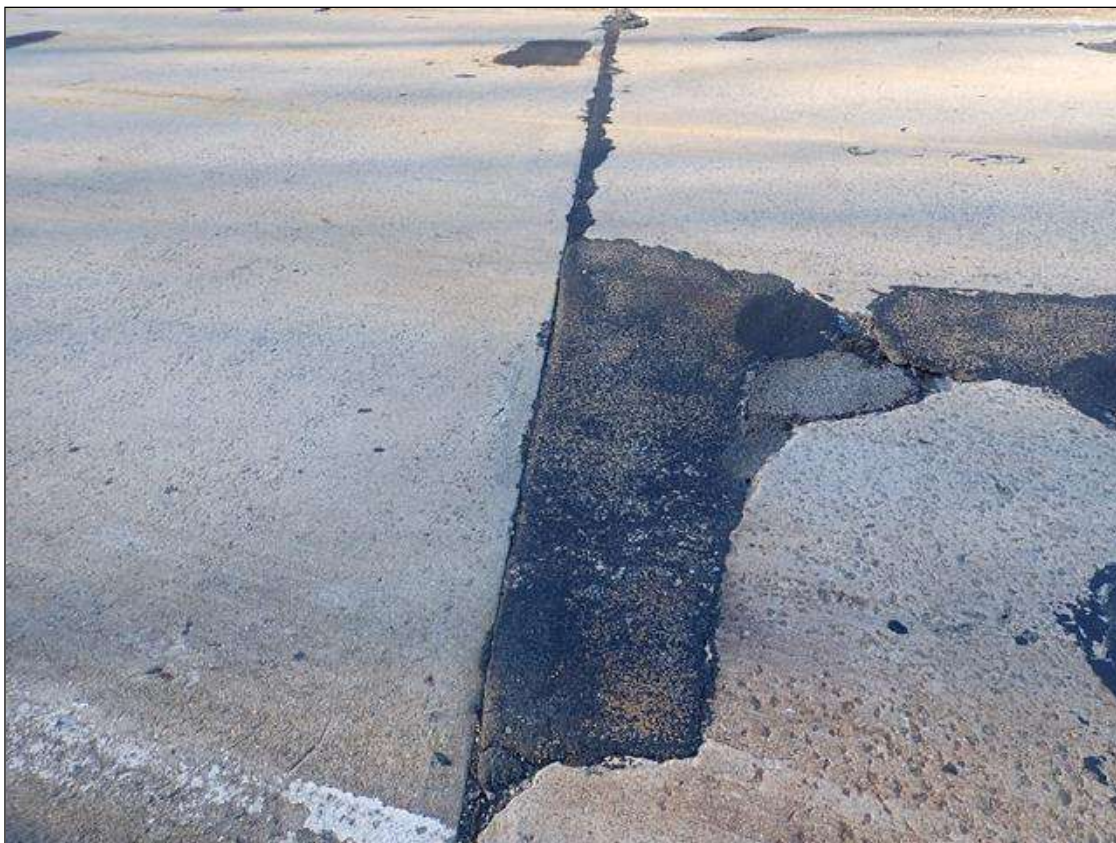
Span 2 Expansion Joint: (NOT OBSERVED AS OF 2022-11-18) 10 INCHES X 6 INCHES X 2 1/2 INCHES DEEP SPALL WITH EXPOSED REBAR IN EASTBOUND LANE ALONG BENT 1 JOINT

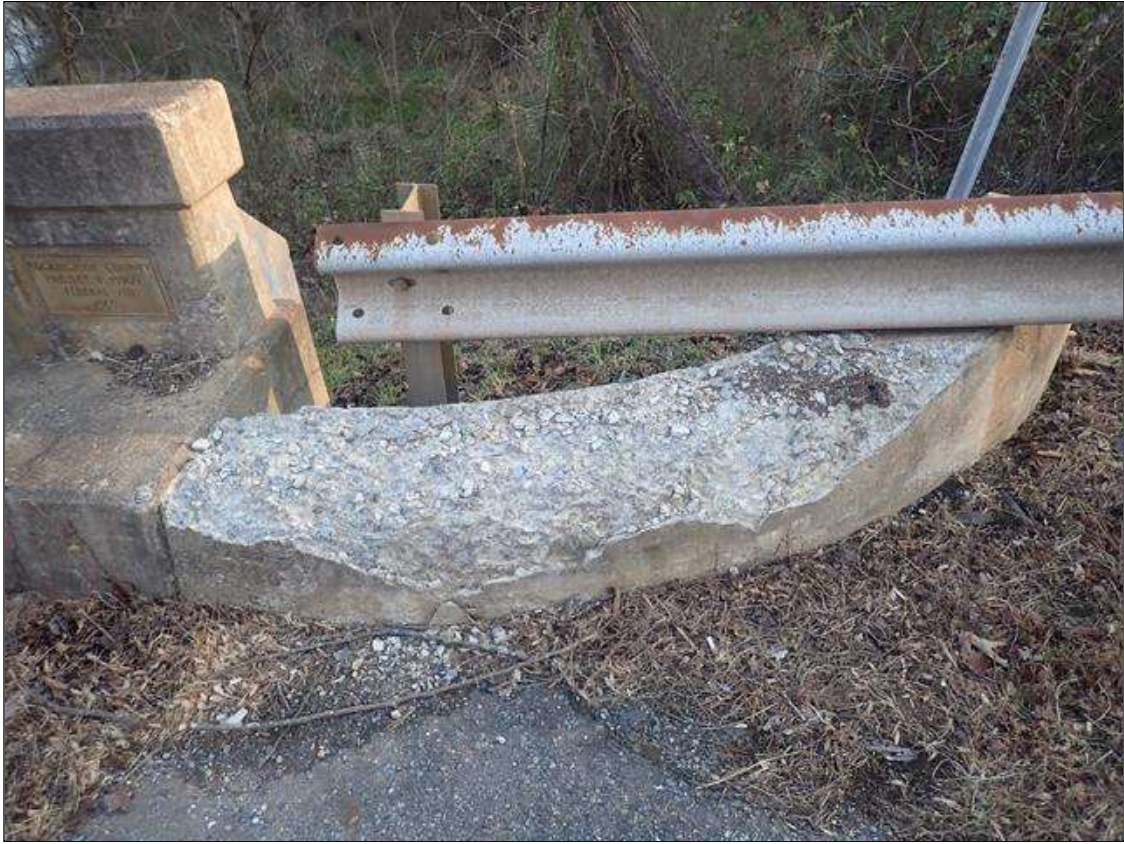
Span 1 Right Bridge Rail: RAIL EXTENSION AT END BENT 1, SPALL (6-1/2FT X FULL WIDTH X UP TO 1IN)

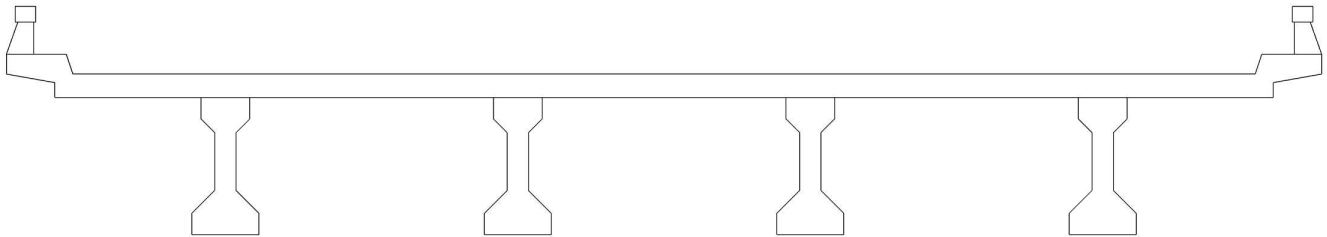
Measurements for Span #	1		
Deck Thickness	7.75in	Left Overhang	4.667ft
Top of Rail to Bottom of Beam (Avg)	7.229ft	Right Overhang	4.667ft

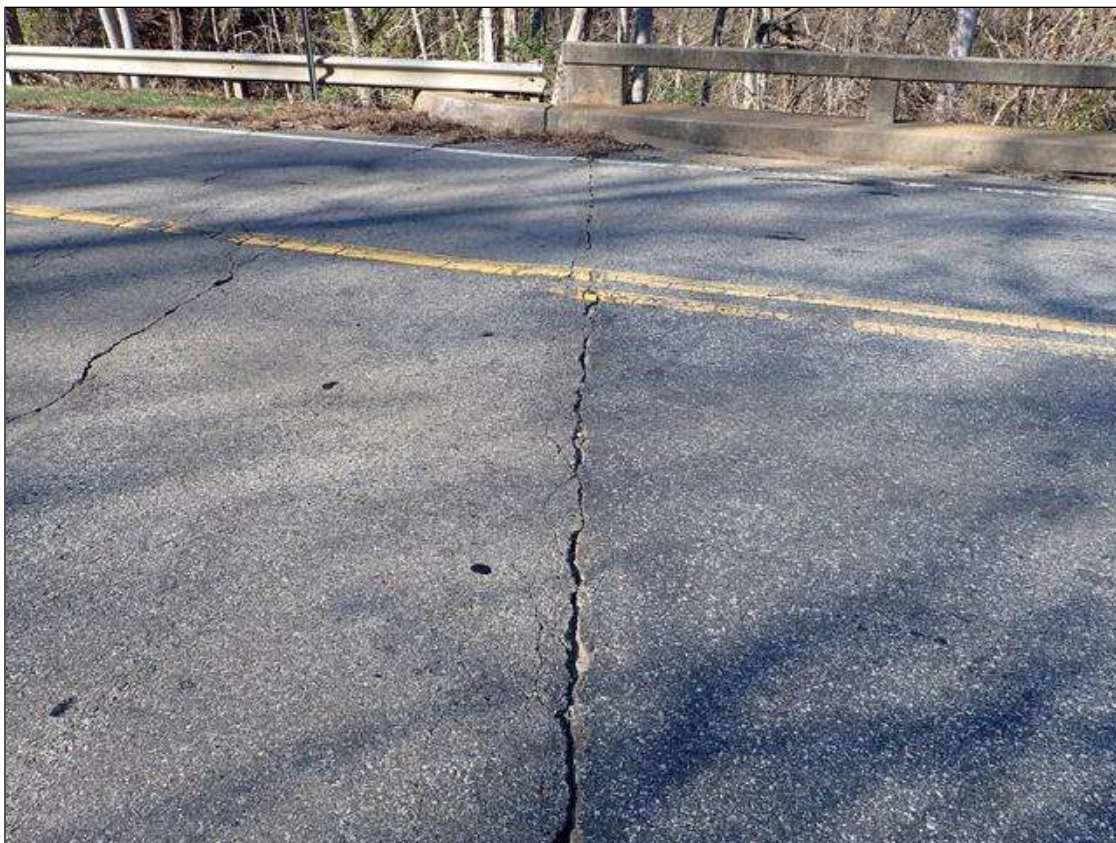
asphalt wearing surface over end bent 1

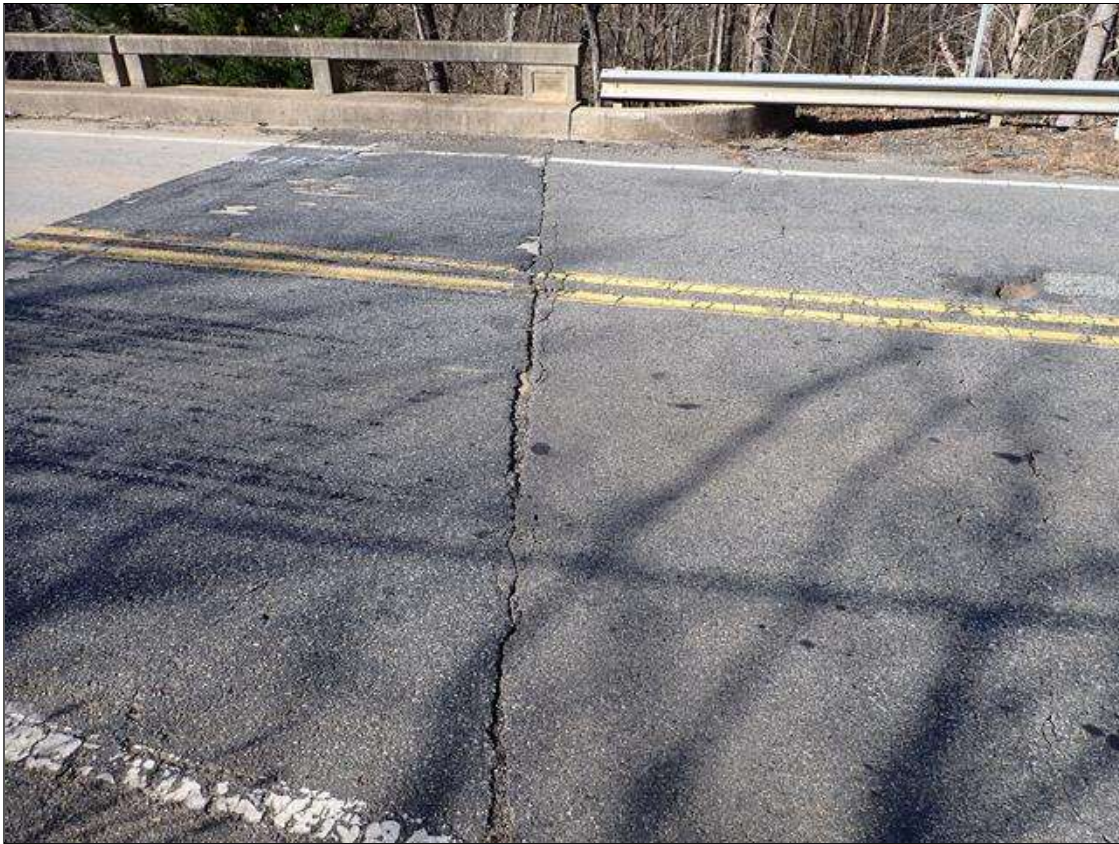
asphalt wearing surface over end bent 2
