NC DEPARTMENT OF TRANSPORTATION  
 DIVISION OF HIGHWAYS  
 STRUCTURE MANAGEMENT UNIT

ATTENTION: **PAR SUBMITTED  
 SNOOPER USED**

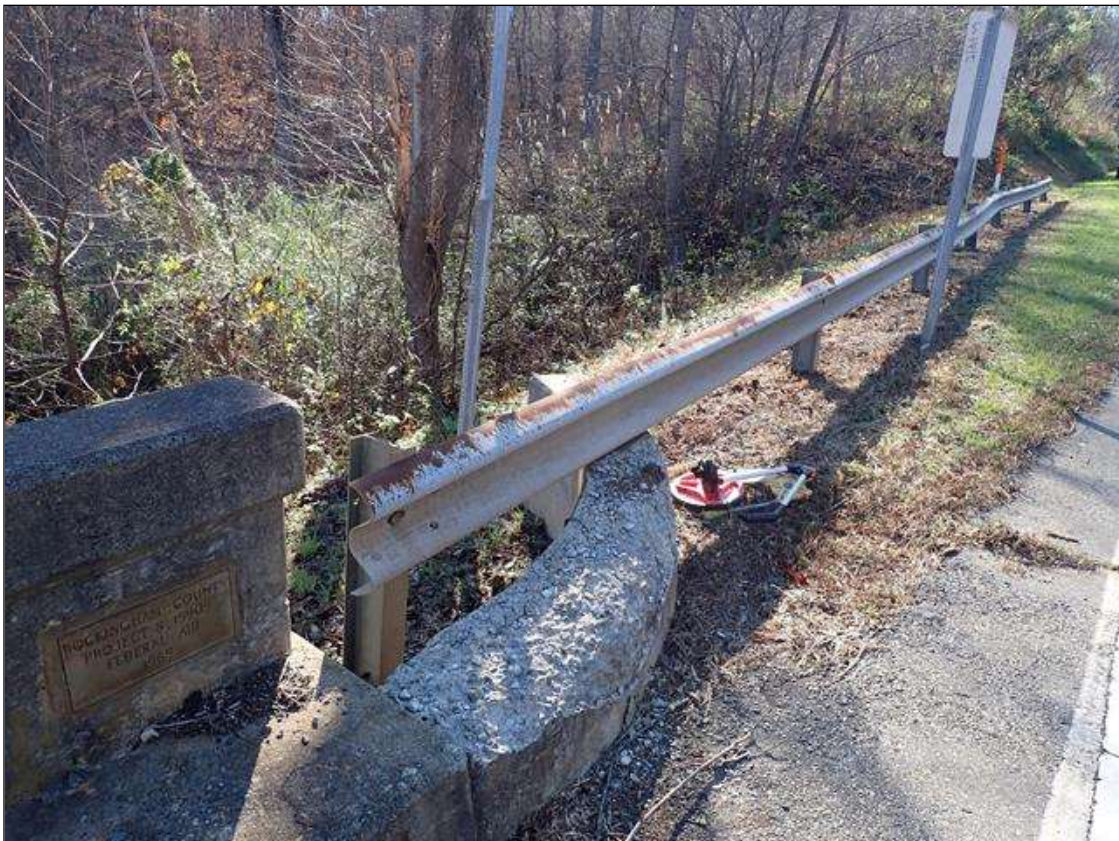
southwest guardrail and post spacing
