NC DEPARTMENT OF TRANSPORTATION ATTENTION
DIVISION OF HIGHWAYS
BRIDGE MAINTENANCE UNIT

BRIDGE INSPECTION REPORT

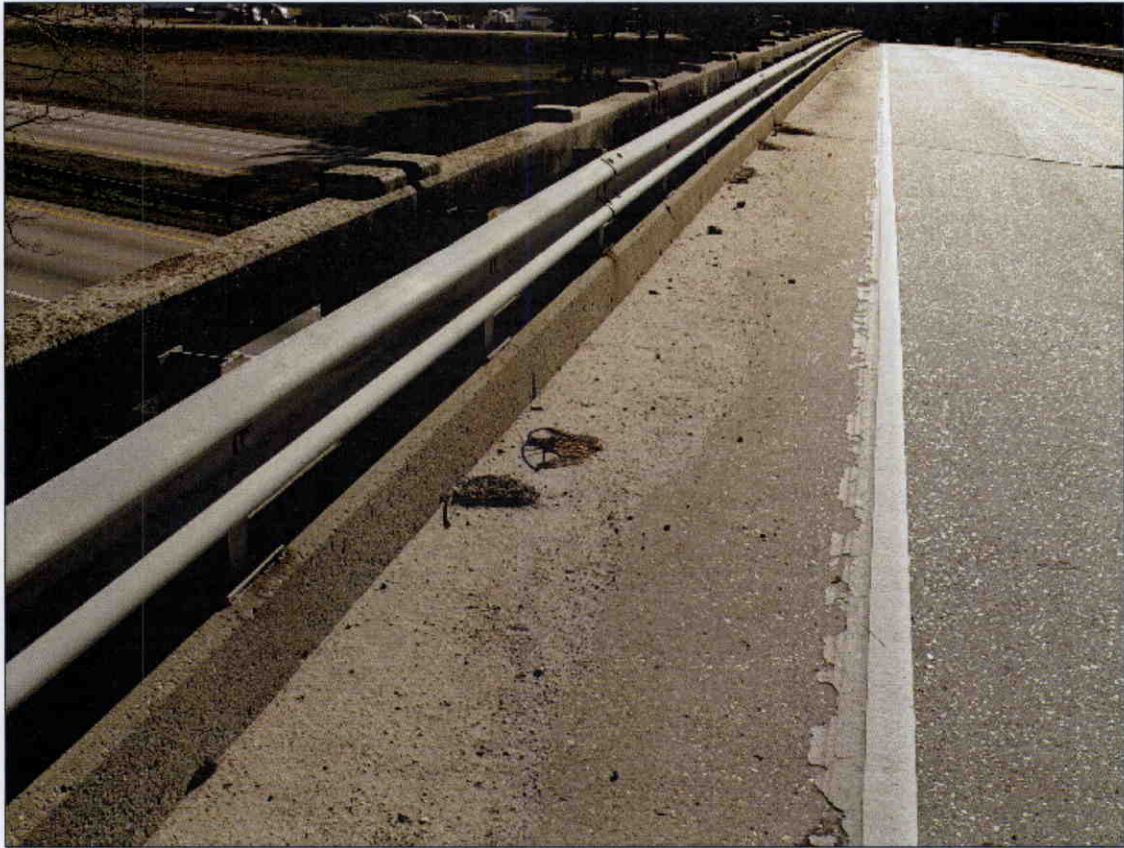
DIRT AND DEBRIS WITH VEGETATION GROWING ALONG NORTH CURB, SIMILAR CONDITION AT SOUTH CURB

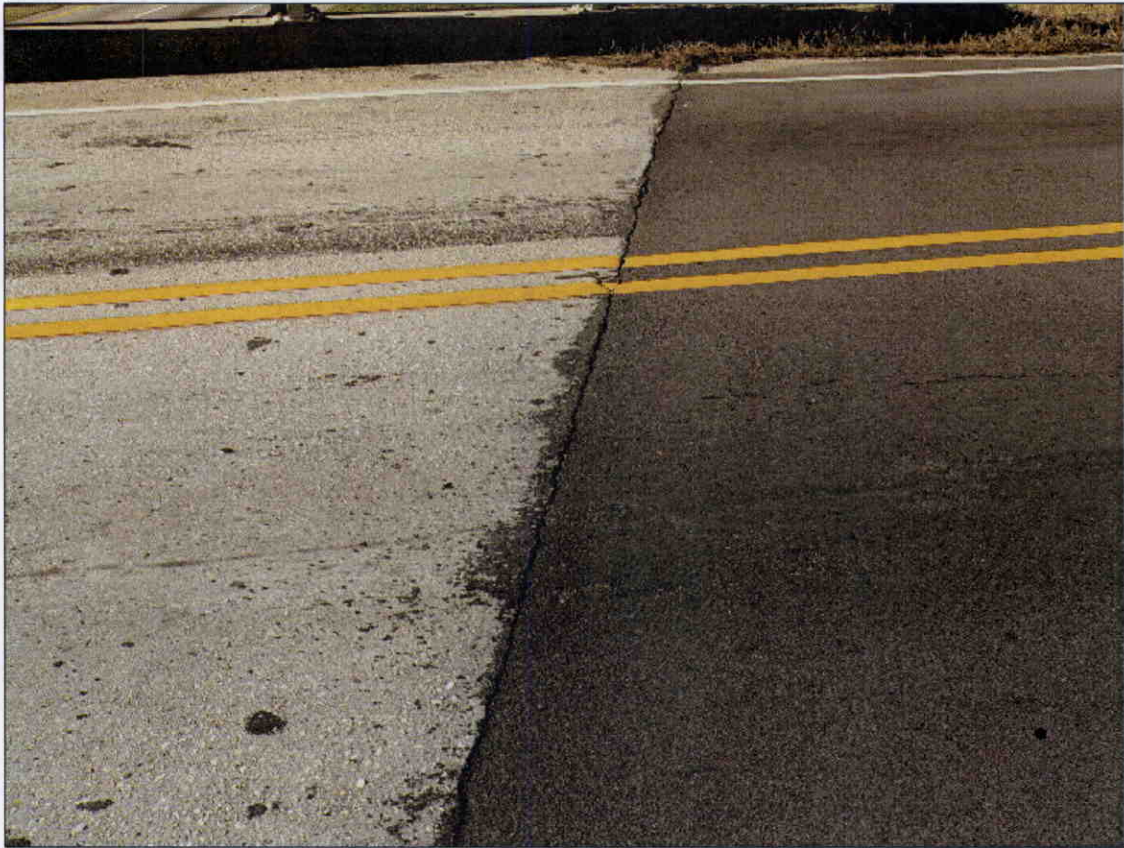
TRANSVERSE CRACK IN ASPHALT WEARING SURFACE ALONG END BENT 1 FILL FACE WITH 1/4 IN OF SETTLEMENT

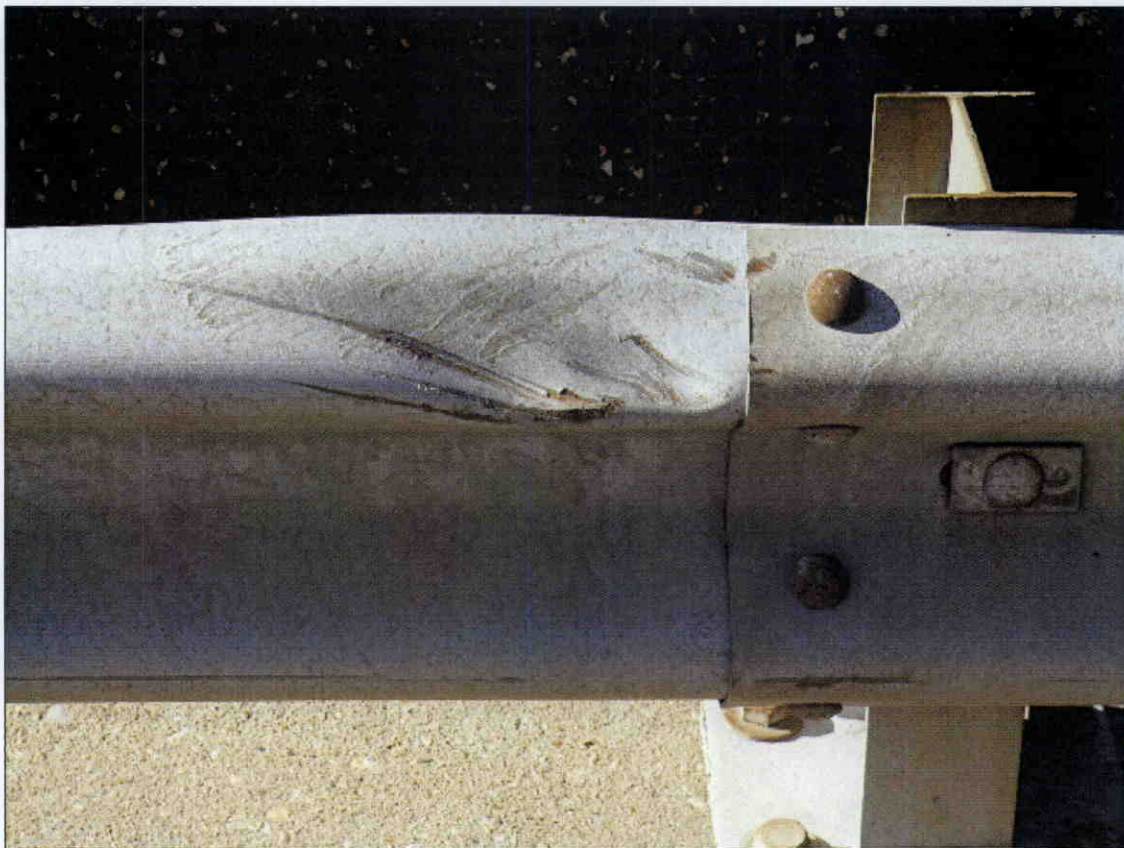
IMPACT DAMAGE TO SOUTH STEEL BRIDGE RAIL, 18 FT FROM END BENT 1

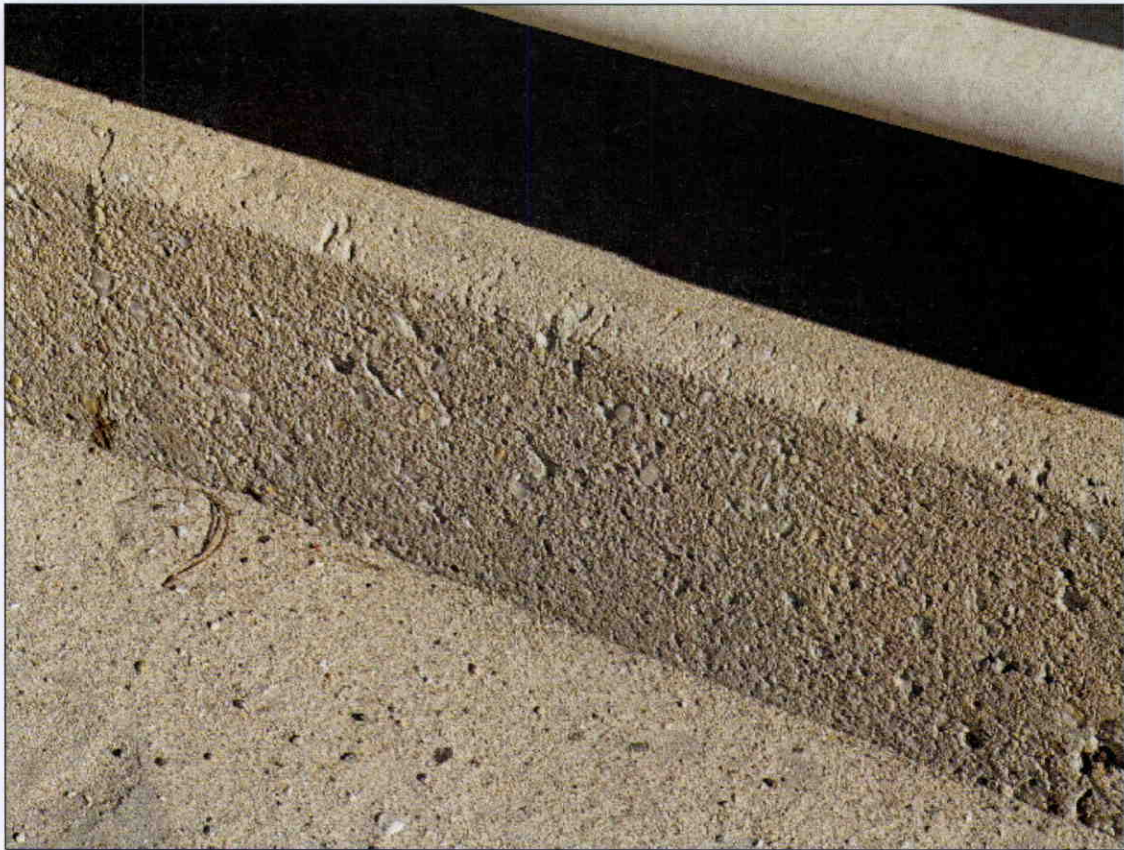
WEATHERING AND SCALING OF CURB WITH EXPOSED AGGREGATE

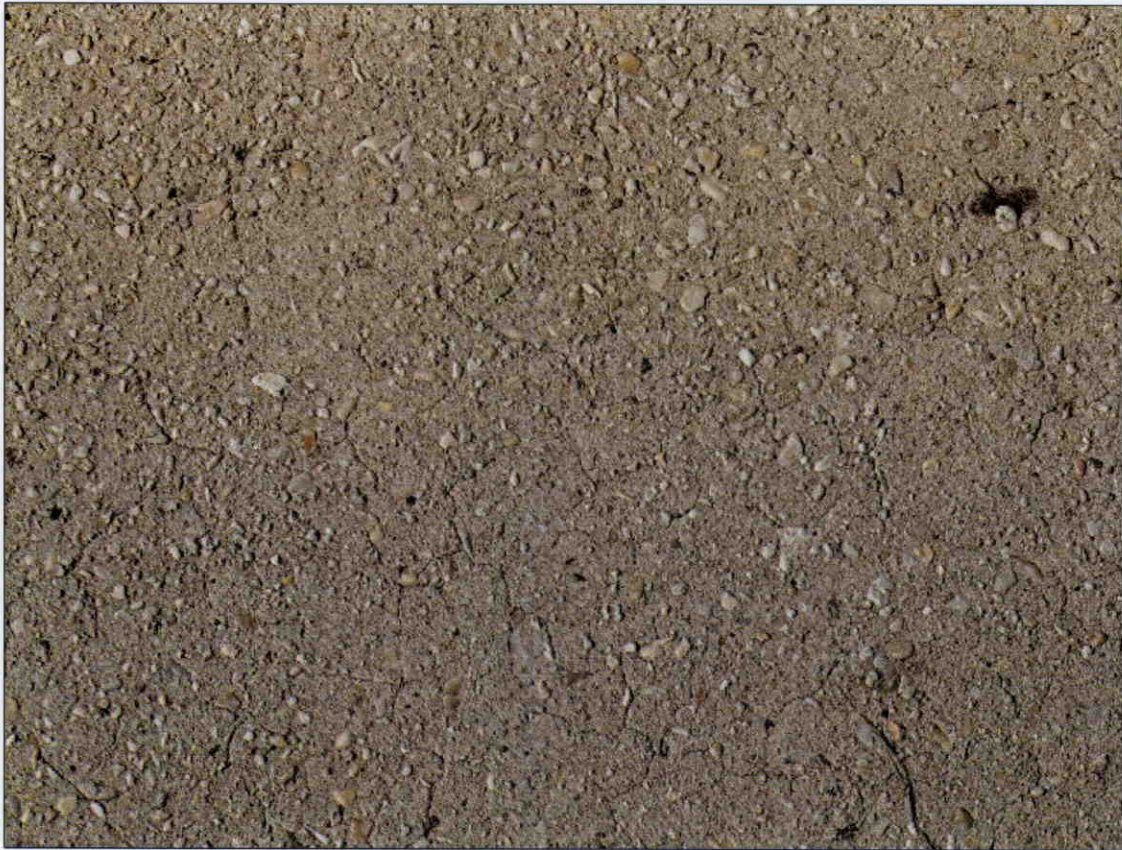
ROUGH AND WORN SURFACE WITH EXPOSED AGGREGATE AND HAIRLINE MAP CRACKING IN TOP OF DECK, SPAN 1 SHOWN, SIMILAR CONDITION THROUGHOUT

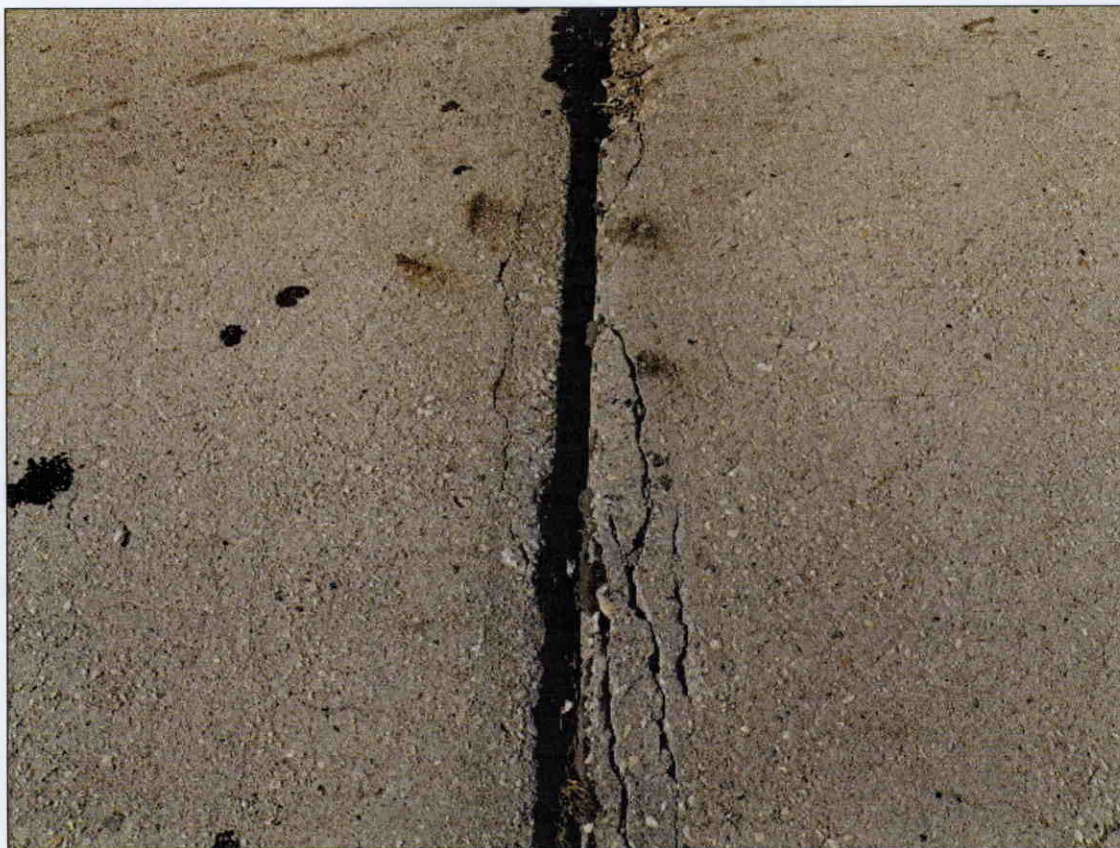
DRIED AND MISSING JOINT MATERIAL AND JOINT SEALER ALONG DECK EXPANSION JOINT AT BENT 1,
SIMILAR CONDITION AT DECK EXPANSION JOINT AT BENTS 2 AND 3

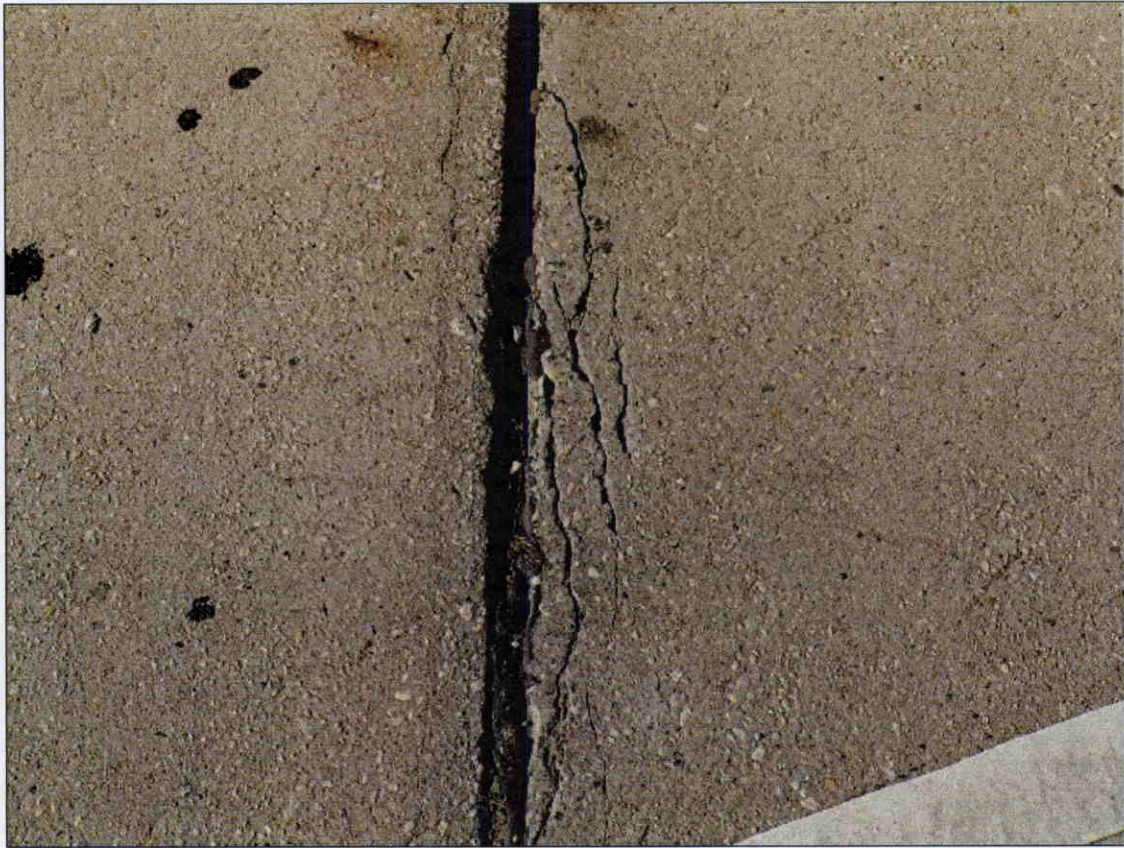
1/8 IN TRANSVERSE CRACKS WITH IMMINENT SPALL IN TOP OF DECK AT DECK EXPANSION JOINT AT BENT

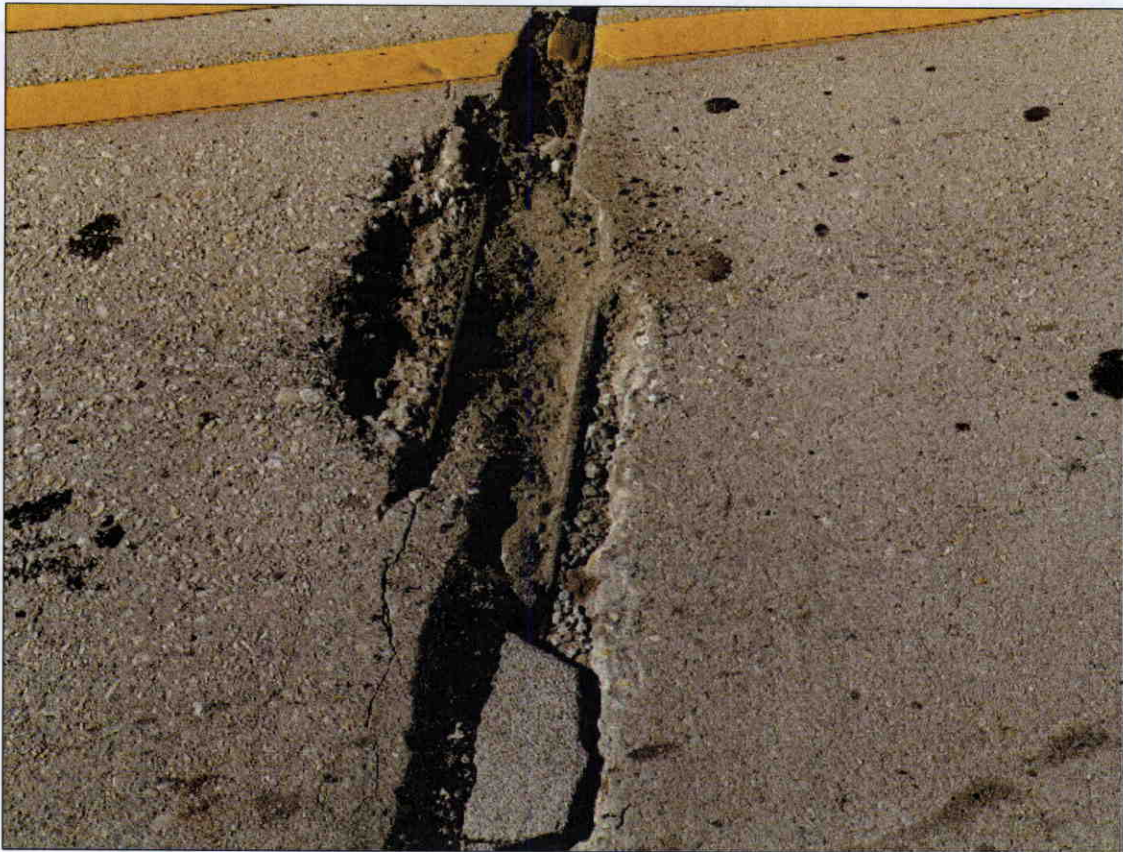
14 IN X 36 IN X 3 IN DEEP SPALL WITH EXPOSED REBAR IN TOP OF DECK AT DECK EXPANSION JOINT AT BENT 1

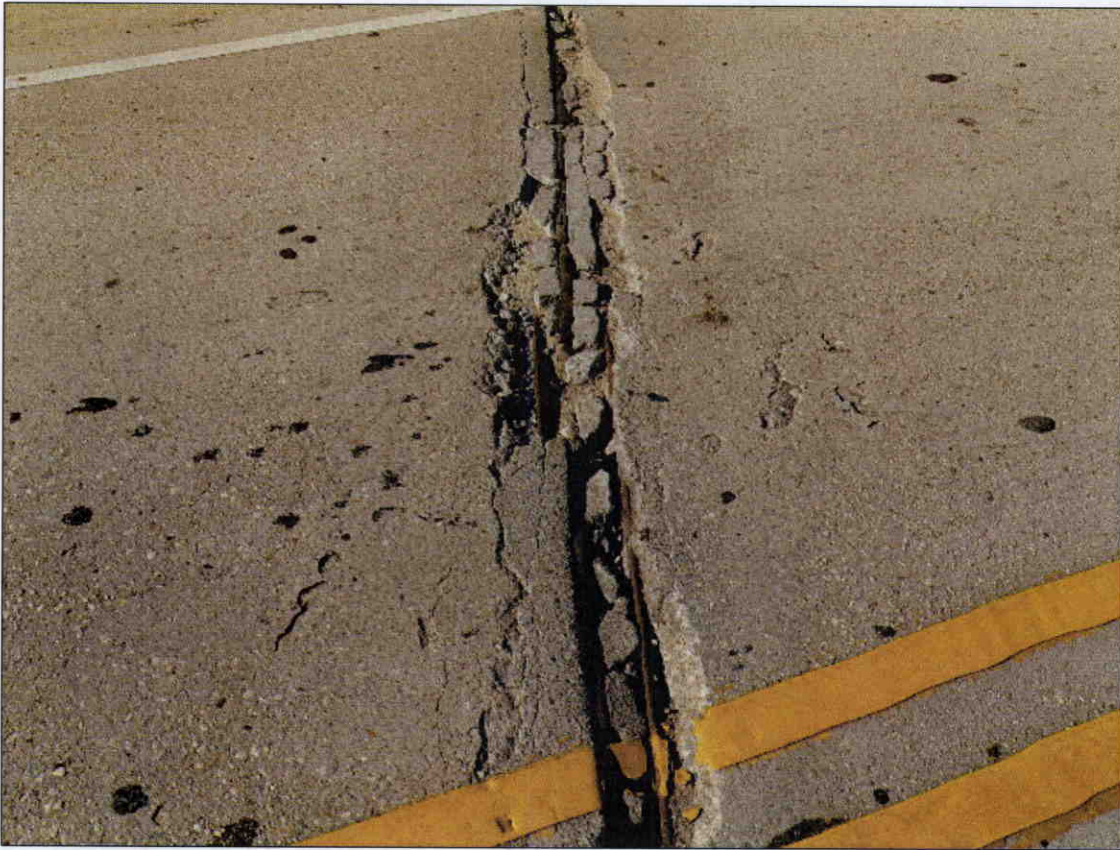
9 IN X 12 FT X 3 IN DEEP SPALL WITH EXPOSED REBAR IN TOP OF DECK WITH ADDITIONAL AREAS OF
BROKEN CONCRETE AT DECK EXPANSION JOINT AT BENT 2

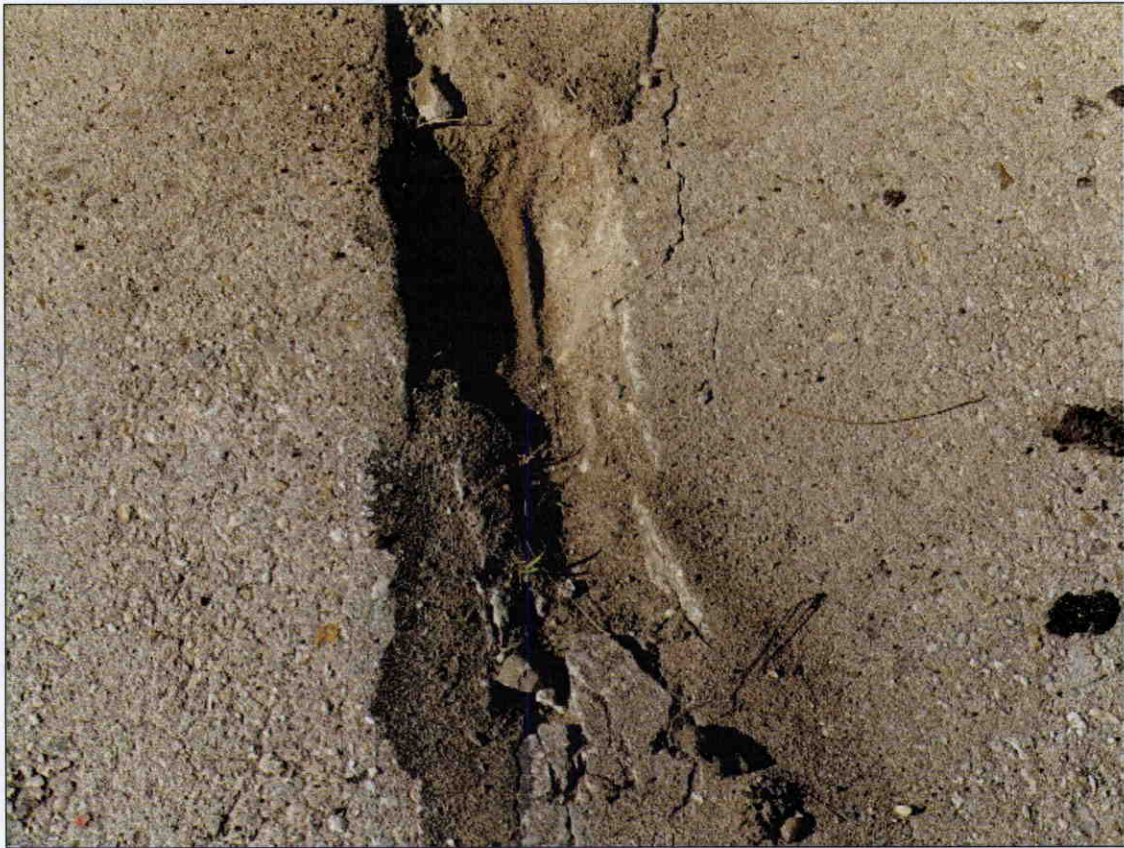
6 IN X 24 IN X 3 IN DEEP SPALL WITH EXPOSED REBAR IN TOP OF DECK AT DECK EXPANSION JOINT AT BENT 2

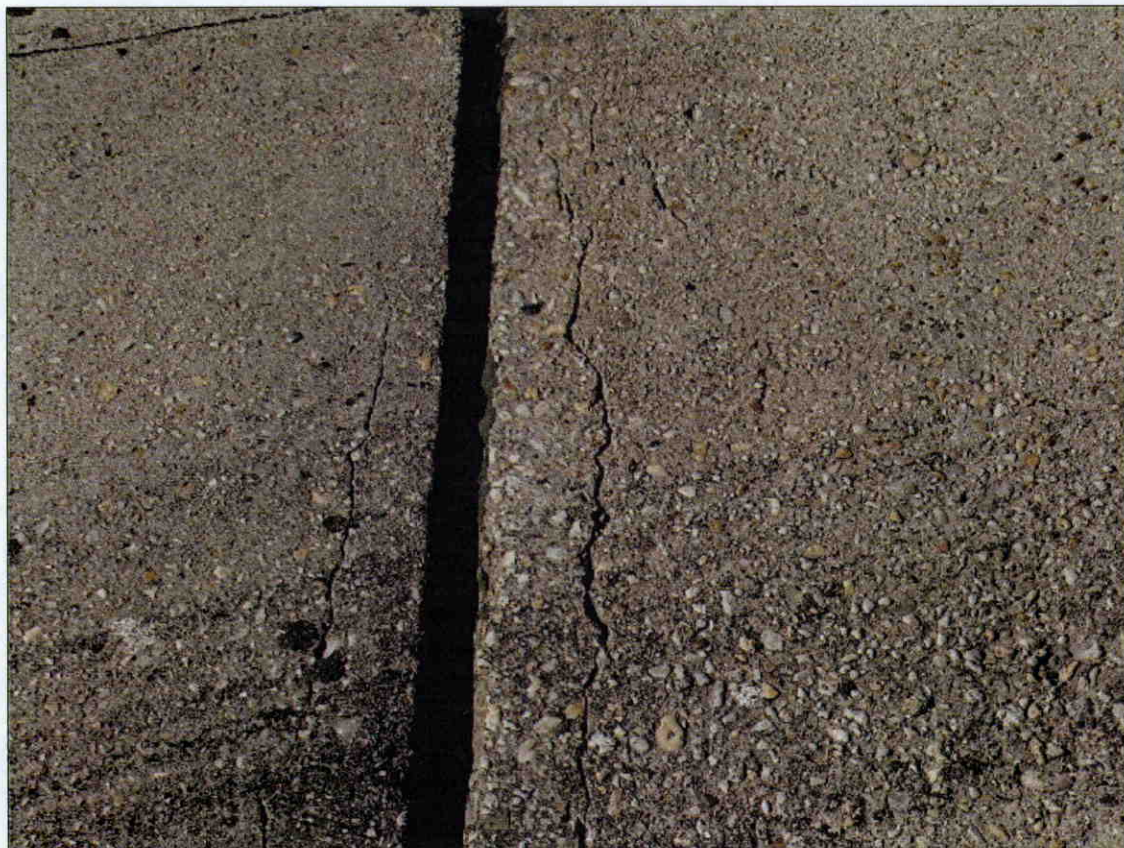
HAIRLINE TO 1/8 IN TRANSVERSE CRACKS IN TOP OF DECK AT DECK EXPANSION JOINT AT BENT 3

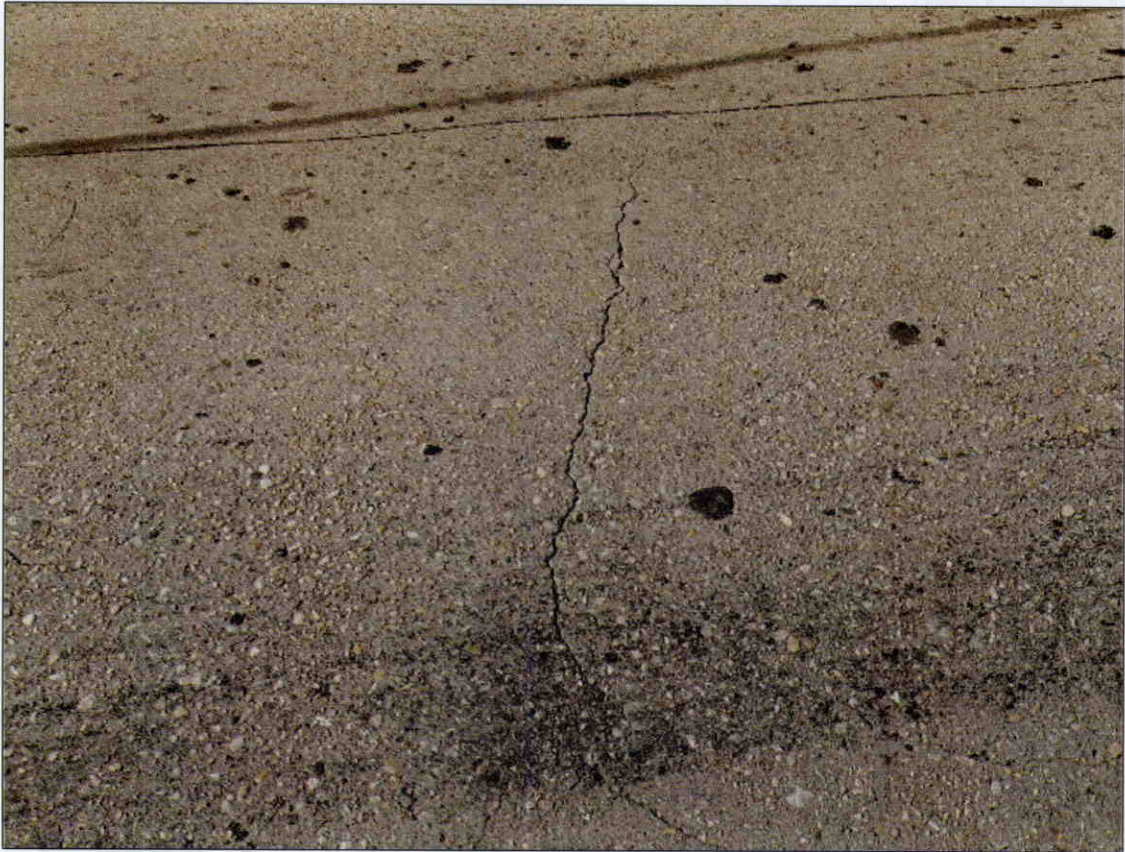
HAIRLINE TO 1/8 IN TRANSVERSE CRACKS IN TOP OF DECK THROUGHOUT SPAN 4

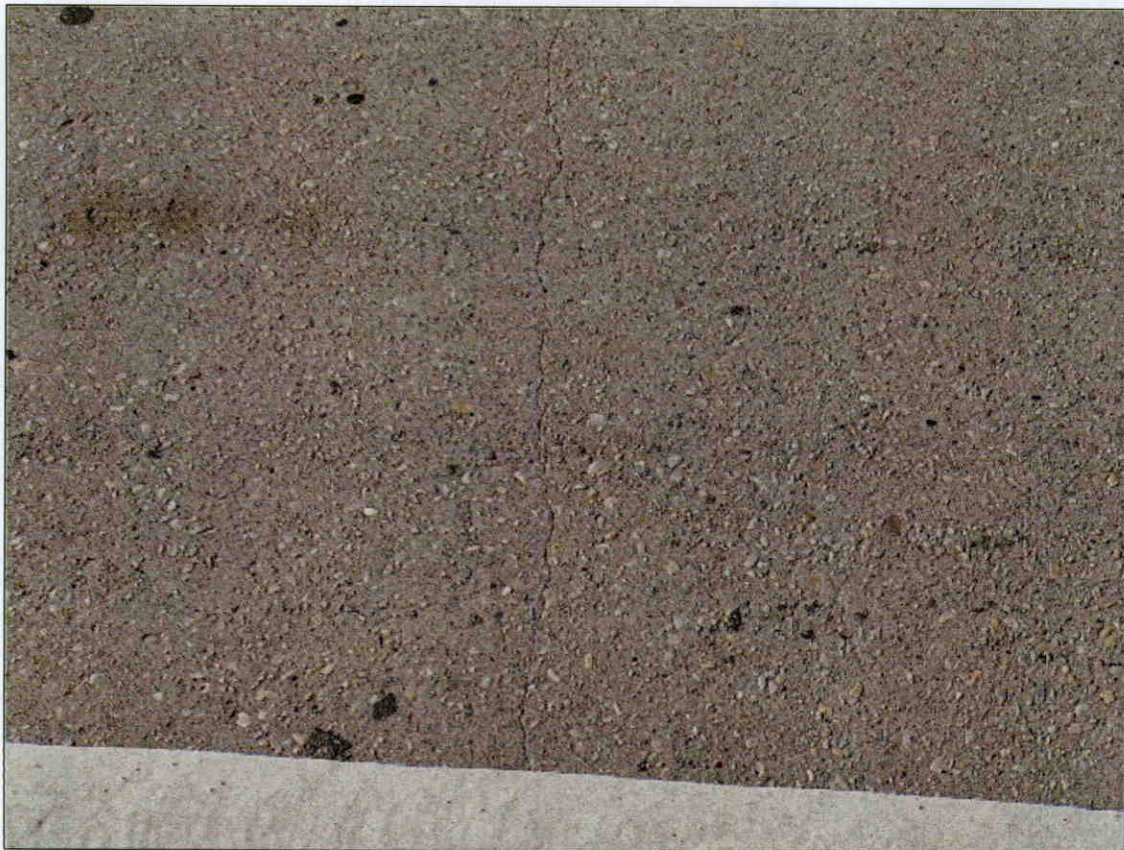
TRANSVERSE HAIRLINE CRACKS IN TOP OF DECK THROUGHOUT SPANS 1 AND 2, SPAN 2 SHOWN

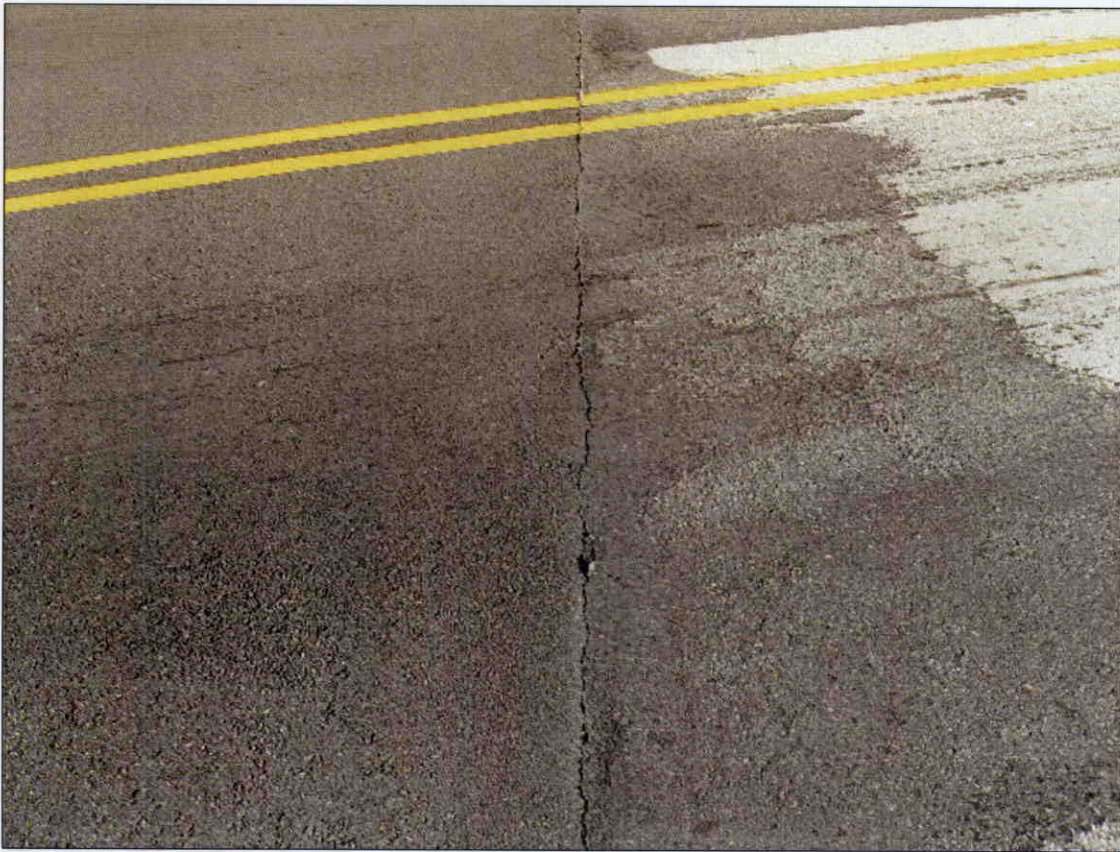
TRANSVERSE CRACK IN ASPHALT WEARING SURFACE ALONG END BENT 2 FILL FACE WITH 1/4 IN OF SETTLEMENT

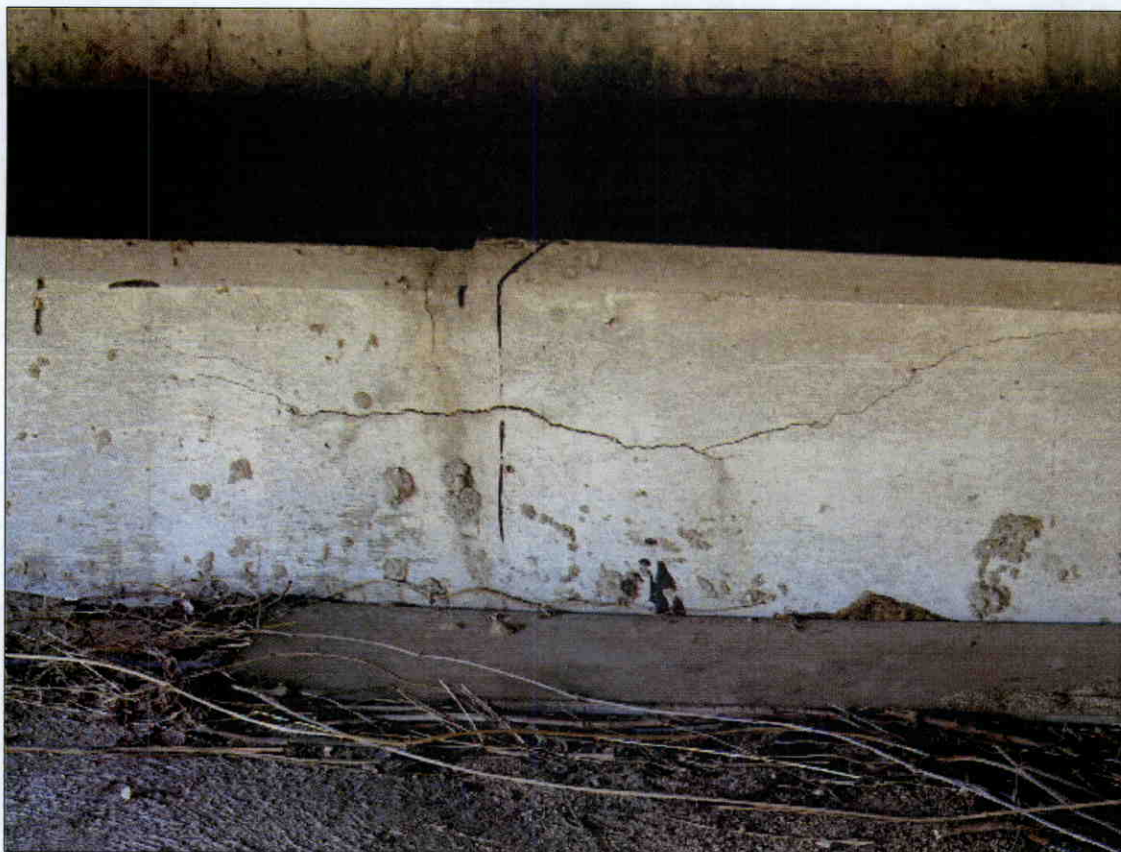
HAIRLINE TO 1/16 IN HORIZONTAL CRACK IN FACE OF END BENT 2 CAP BAY 1

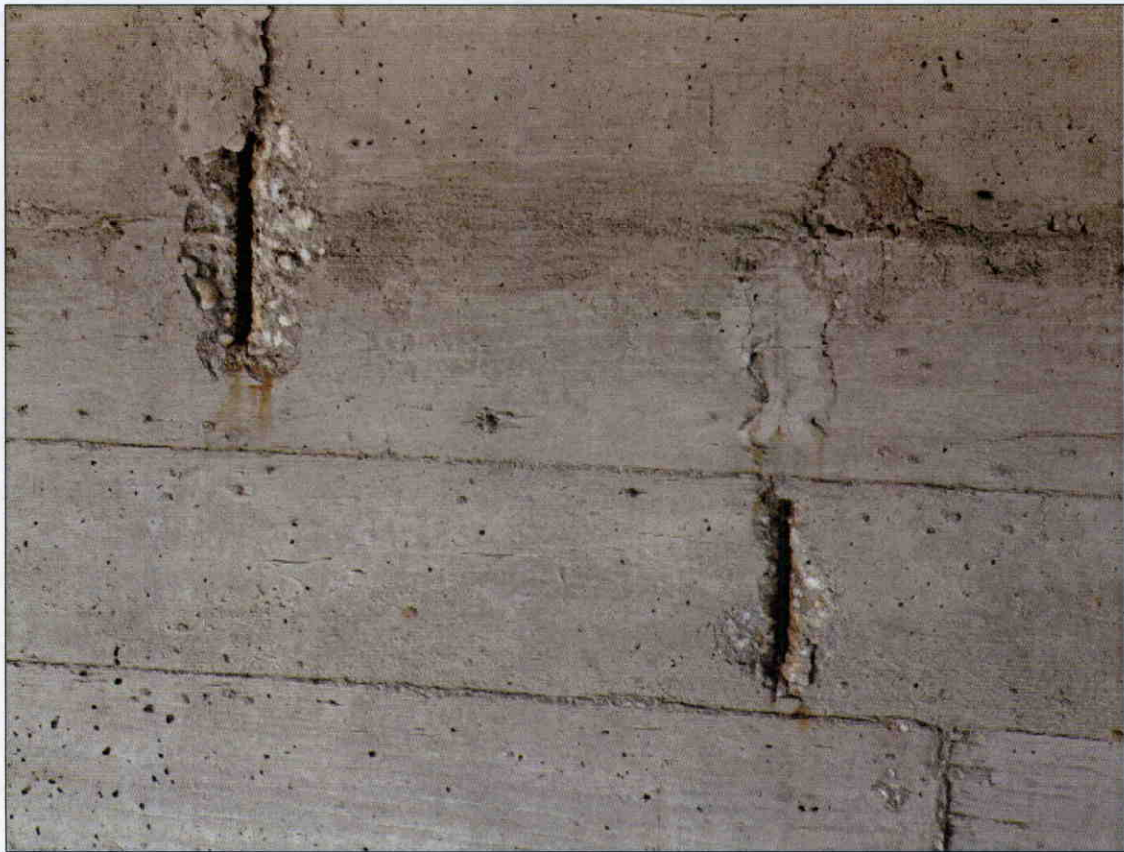
4 IN X 12 IN X 1/2 IN DEEP AND 2 IN X 5 IN X 1/2 IN DEEP SPALLS WITH EXPOSED REBAR IN FACE OF GIRDER 1, SPAN 4 NEAR END BENT 2

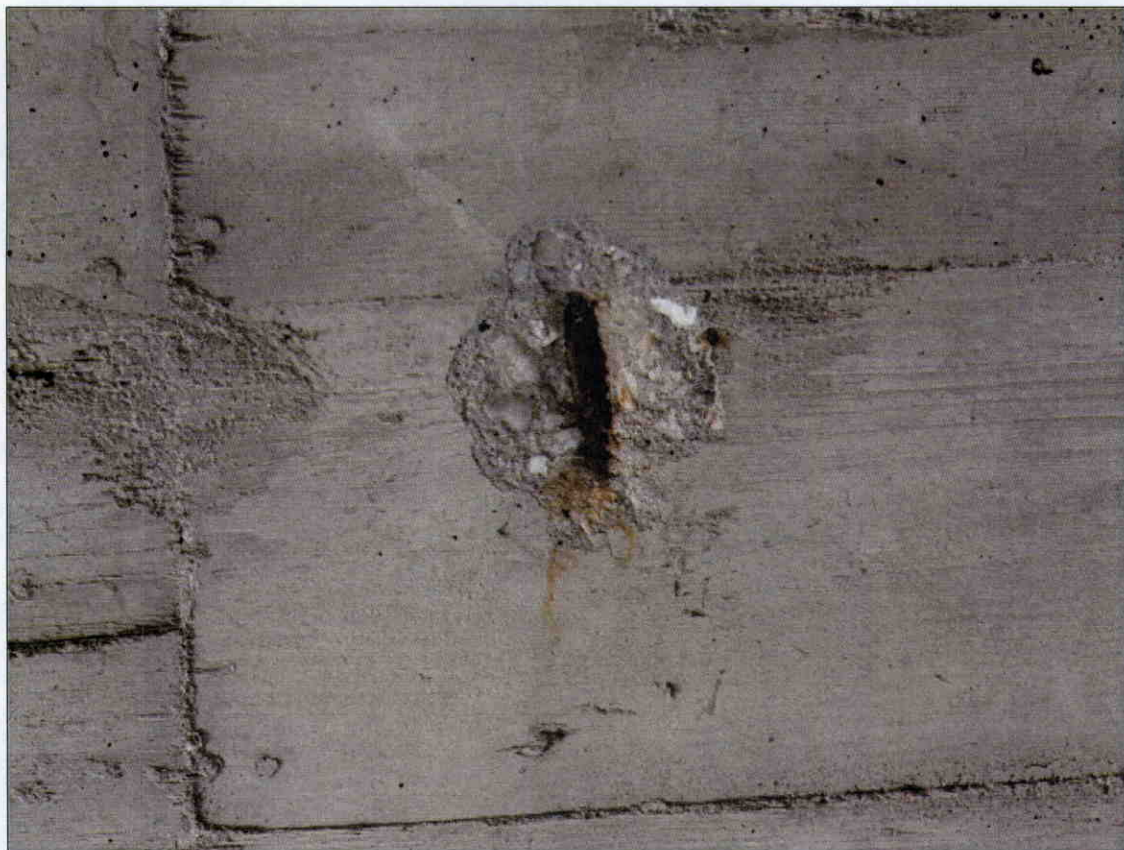
4 IN X 4 IN X 1/2 IN DEEP SPALL WITH EXPOSED REBAR IN FACE OF GIRDER 1, SPAN 4 NEAR END BENT 2

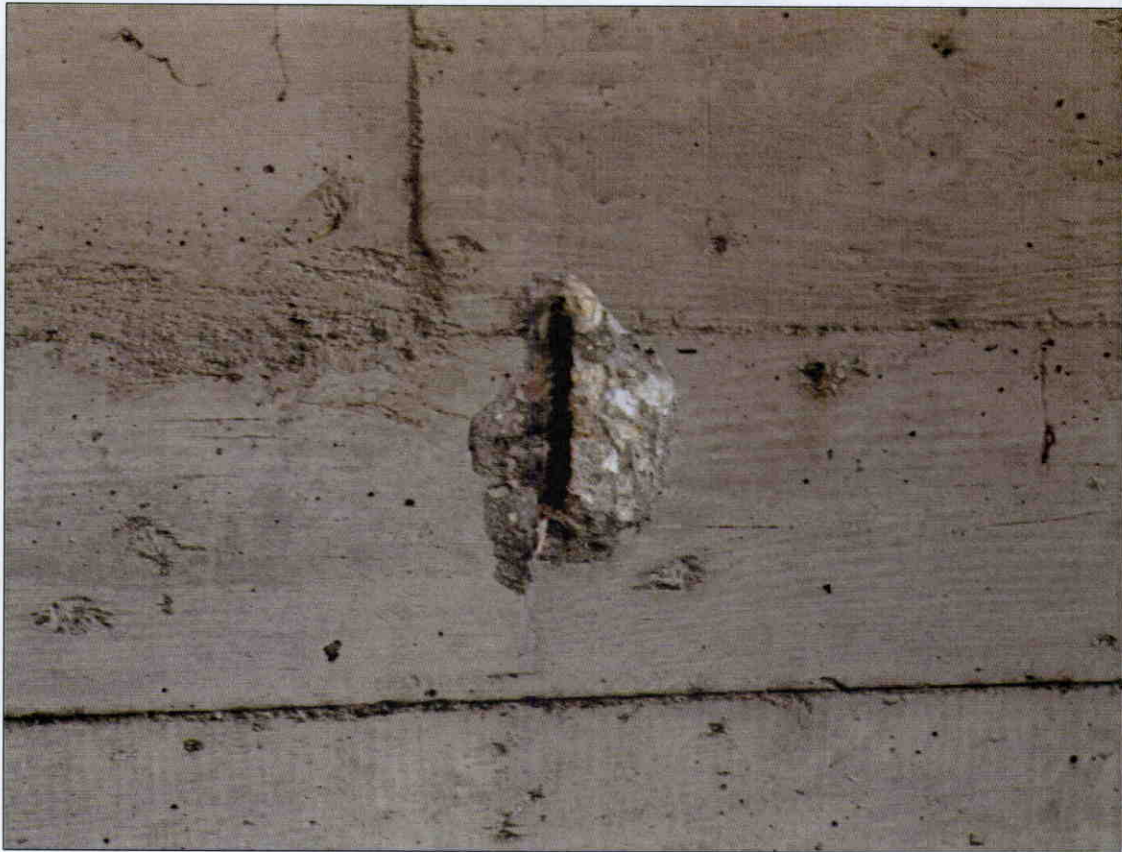
4 IN X 6 IN X 1/2 IN DEEP SPALL WITH EXPOSED REBAR IN FACE OF GIRDER 1, SPAN 4 NEAR END BENT 2

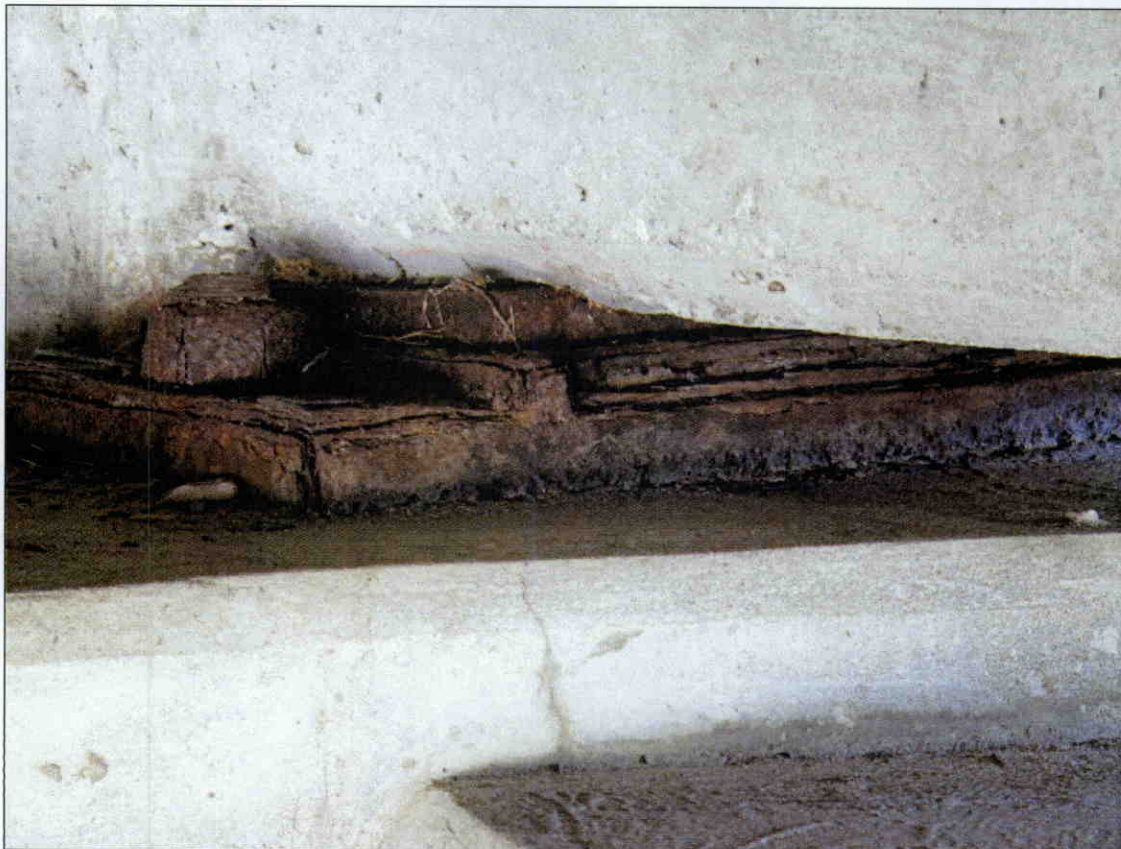
RUST AND DELAMINATION OF BEARING AT GIRDER 4, END BENT 2, SIMILAR CONDITION AT GIRDER 1

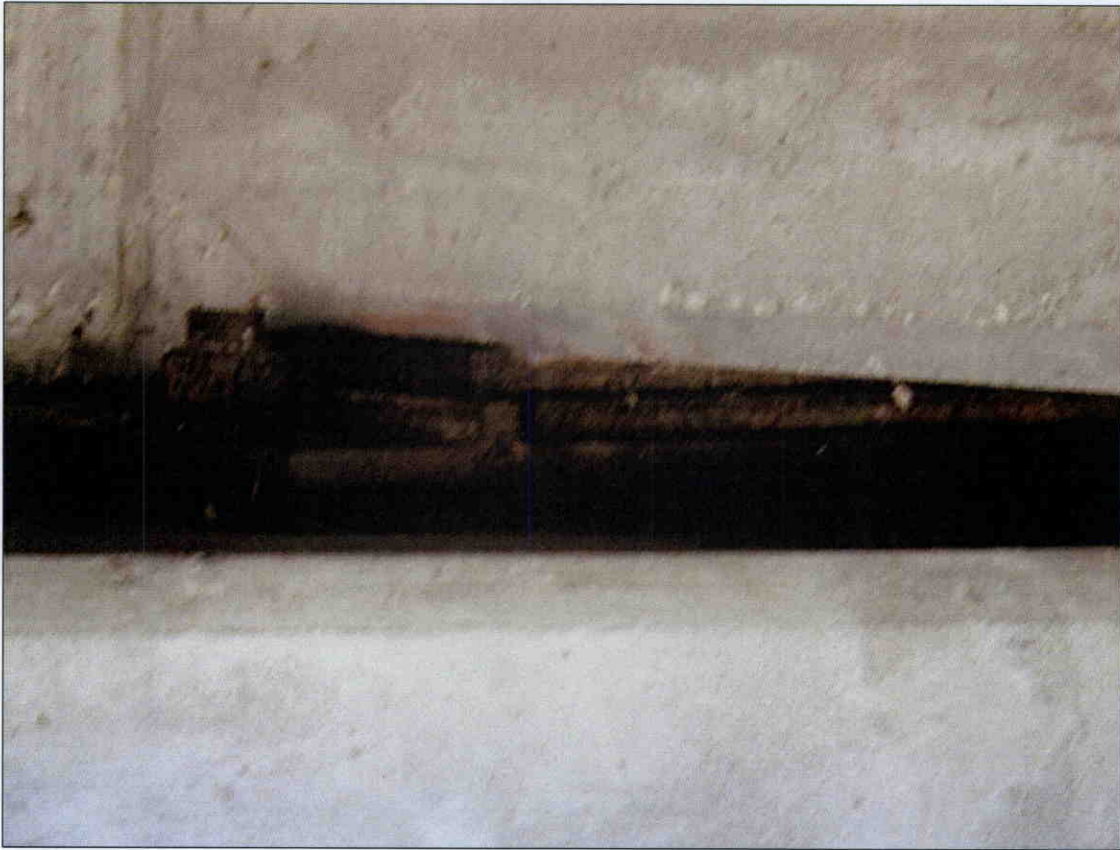
RUSTED BEARING AT GIRDER 2, END BENT 2, SIMILAR CONDITION AT GIRDER 3

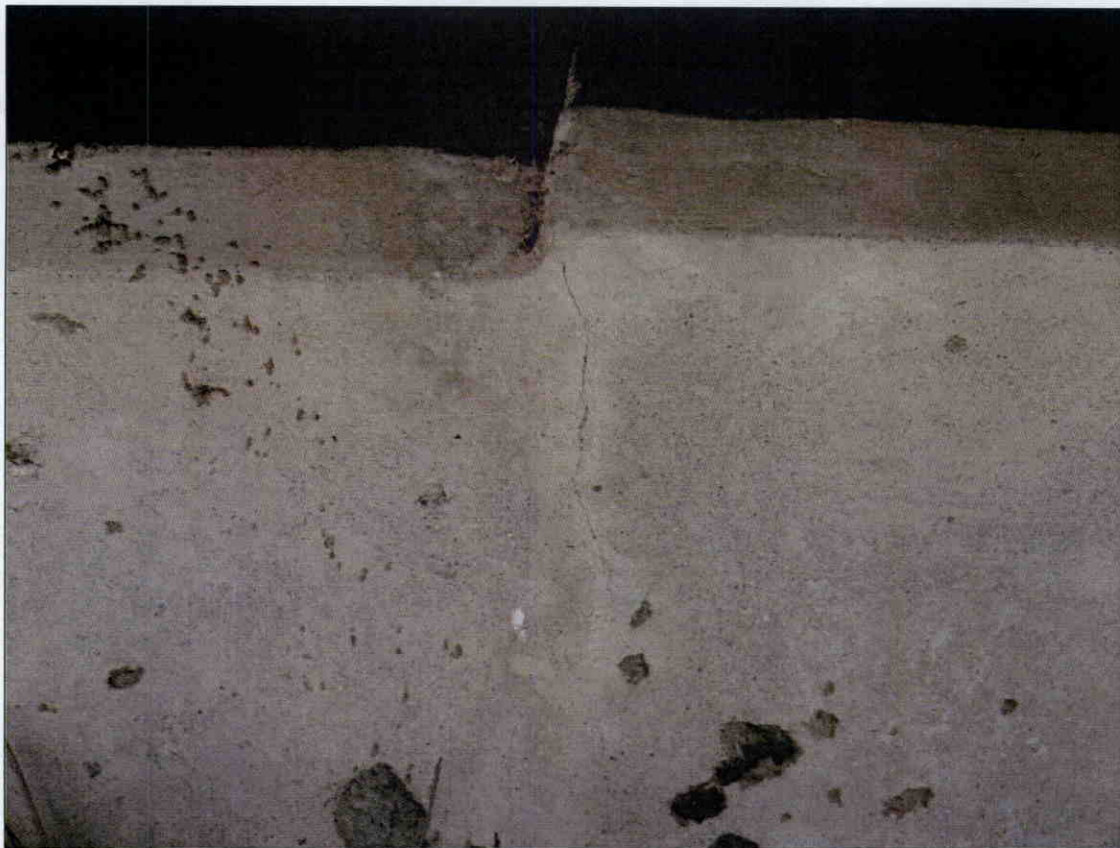
VERTICAL HAIRLINE CRACK IN FACE OF END BENT 2 CAP AT STEP, SIMILAR CONDITION AT END BENT 1

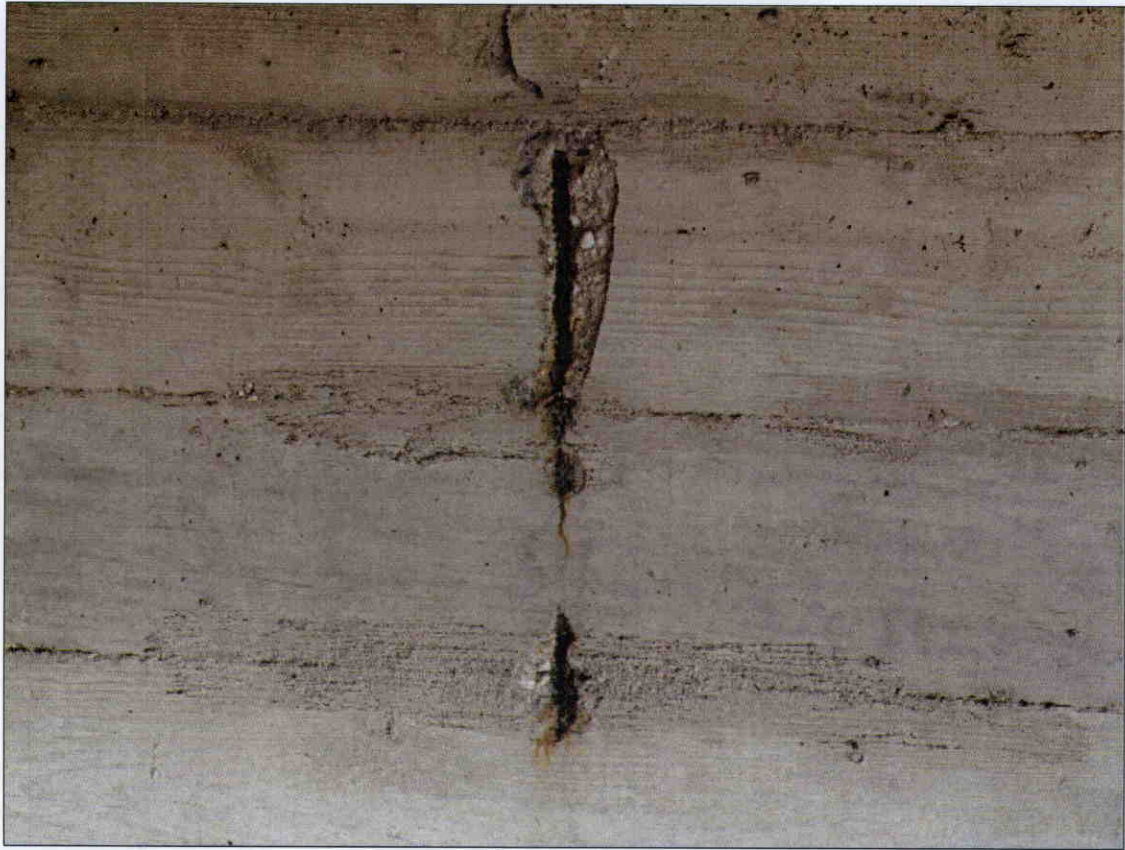
2 IN X 9 IN X 1/2 IN DEEP AND 2 IN X 3 IN X 1/2 IN DEEP SPALLS WITH EXPOSED REBAR IN FACE OF GIRDER
3, SPAN 4 NEAR END BENT 2

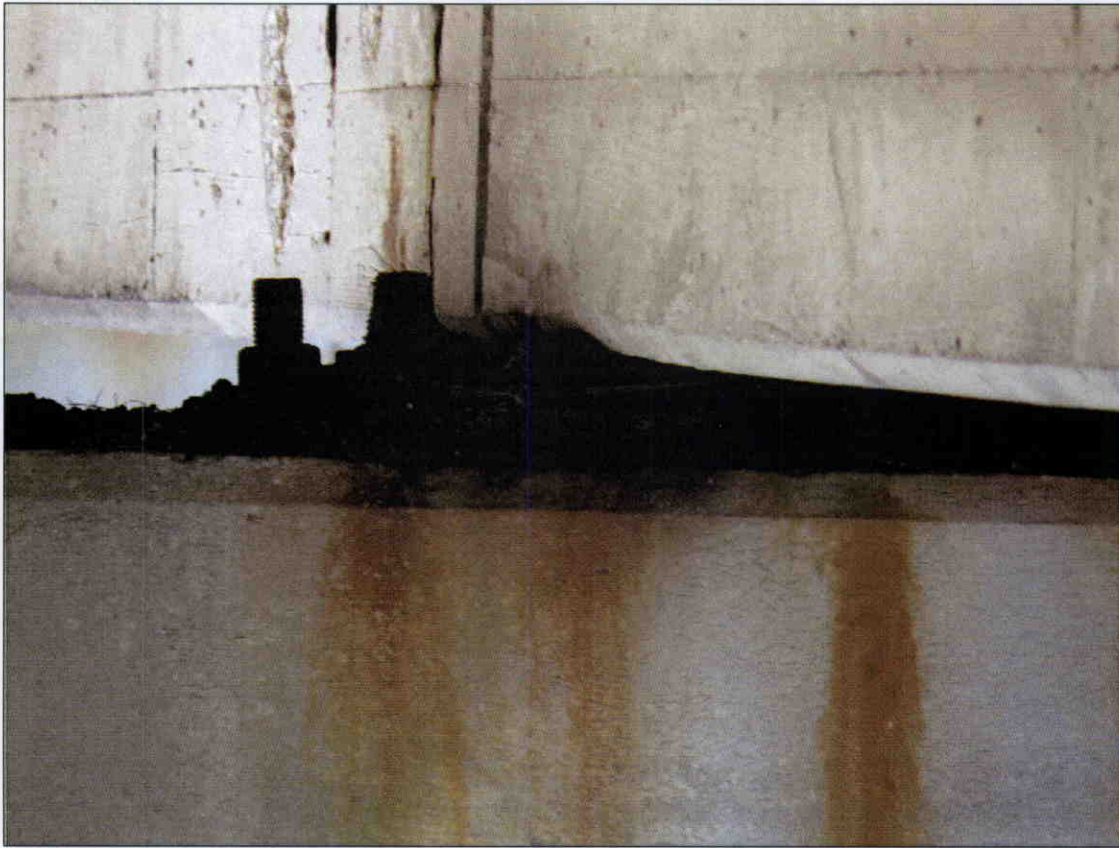
RUST AND DELAMINATION OF BEARING AT GIRDER 2, BENT 3, SIMILAR CONDITION AT ALL INTERIOR BENT BEARINGS
