NC DEPARTMENT OF TRANSPORTATION ATTENTION
DIVISION OF HIGHWAYS
BRIDGE MAINTENANCE UNIT

BRIDGE INSPECTION REPORT

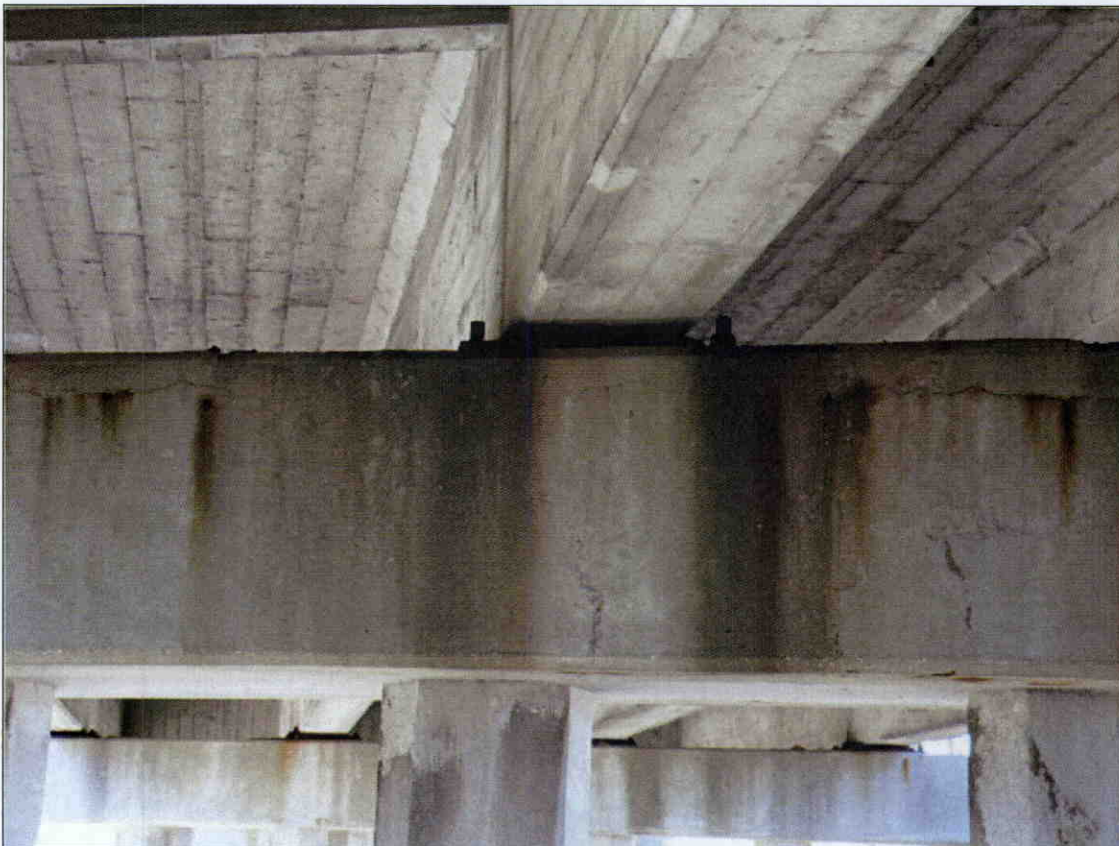
HAIRLINE TO 1/16 IN HORIZONTAL CRACK IN FACE OF BENT 3 CAP BETWEEN PILES 4 AND 6, SPAN 4 SIDE

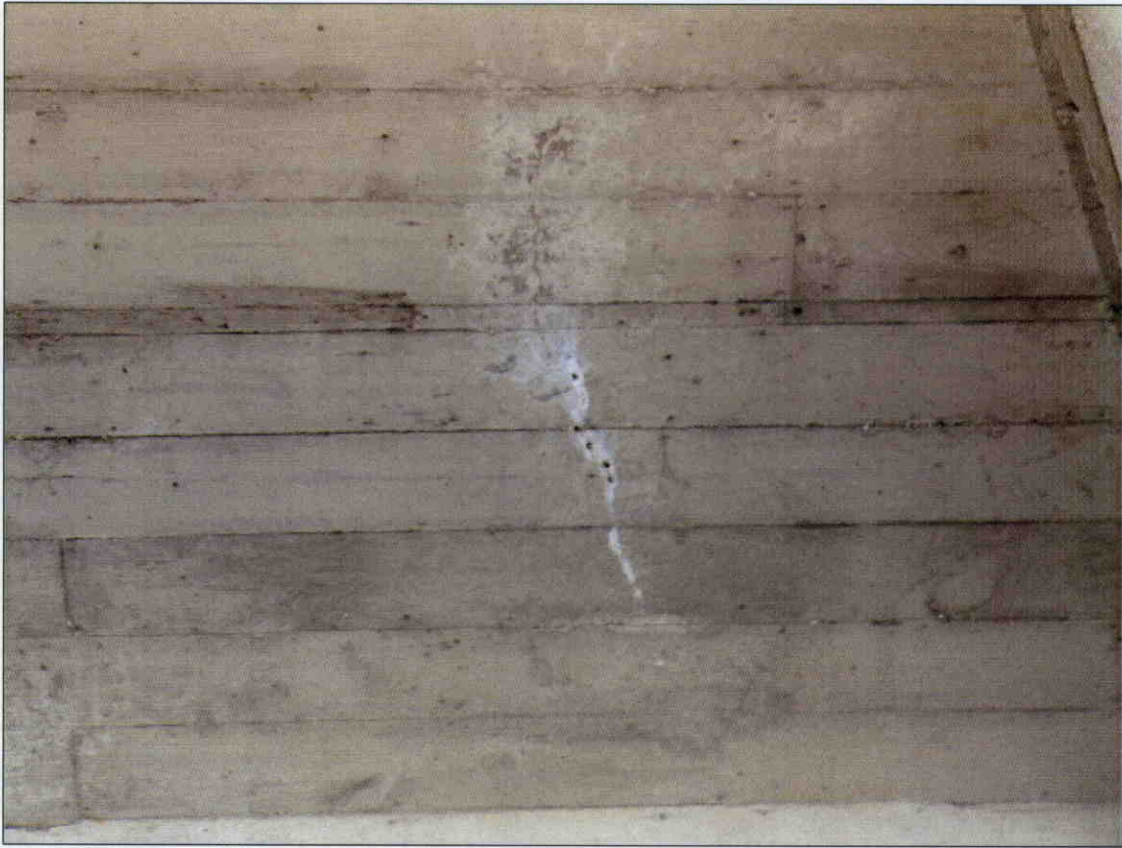
TRANSVERSE HAIRLINE CRACK WITH EFFLORESCENCE IN BOTTOM OF DECK THROUGHOUT SPAN 4

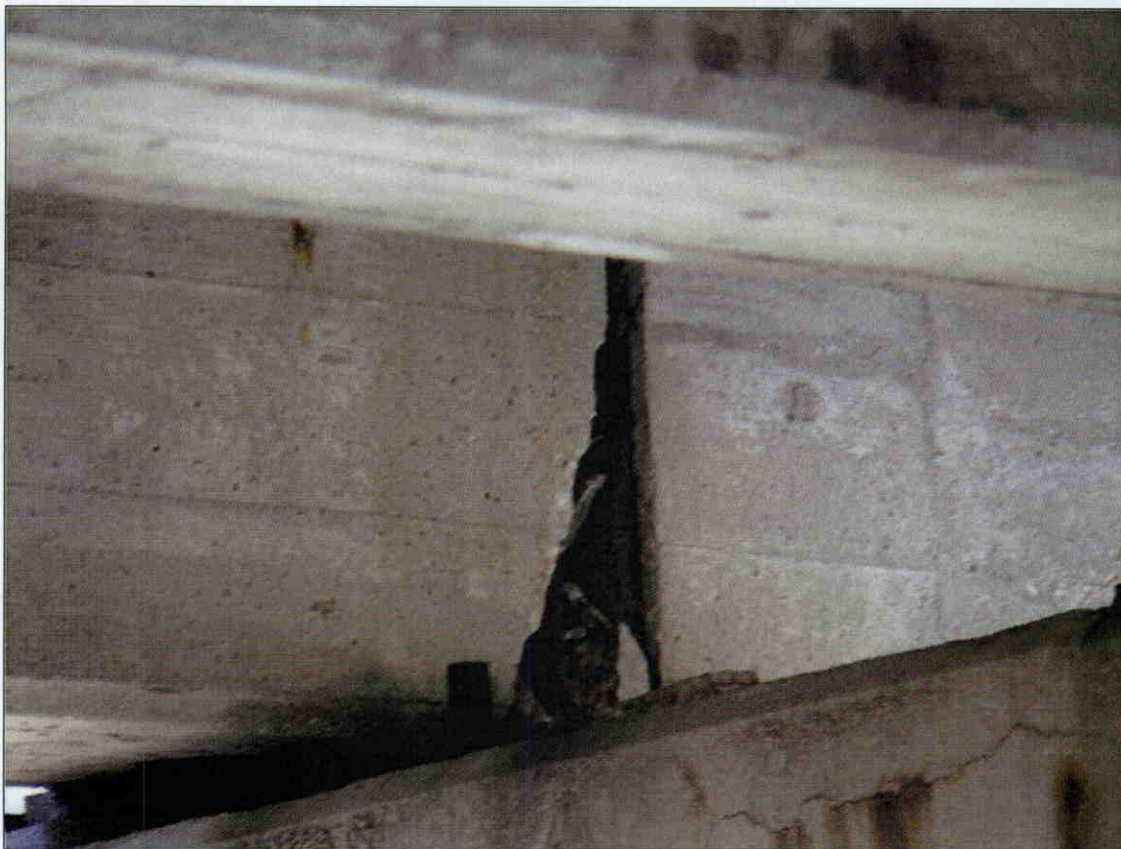
19 IN X 5 IN X 3 IN DEEP SPALL IN FACE OF GIRDER 4, SPAN 4 AT BENT 3, SIMILAR SPALL AT GIRDER 1, SPAN 2 AT BENT 2 AND GIRDER 1, SPAN 3 AT BENT 3

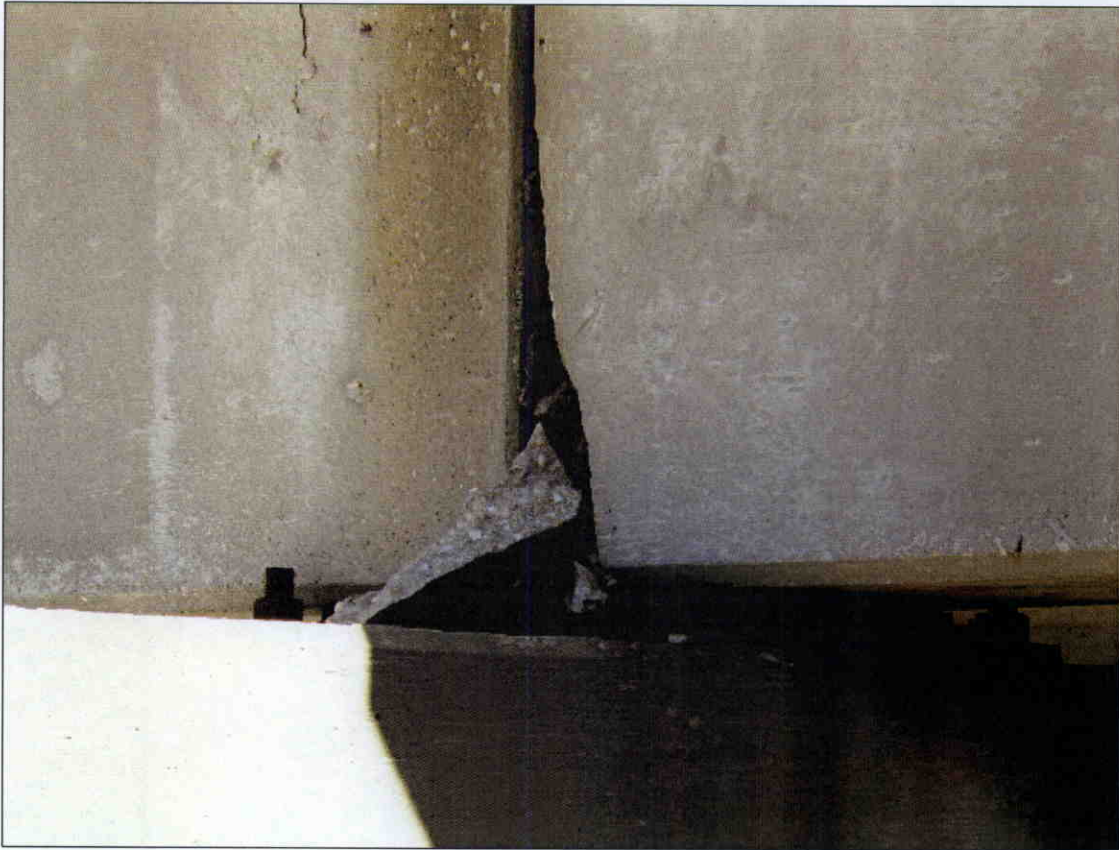
19 IN X 5 IN X 3 IN DEEP SPALL IN OUTSIDE FACE OF GIRDER 4, SPAN 4 AT BENT 3

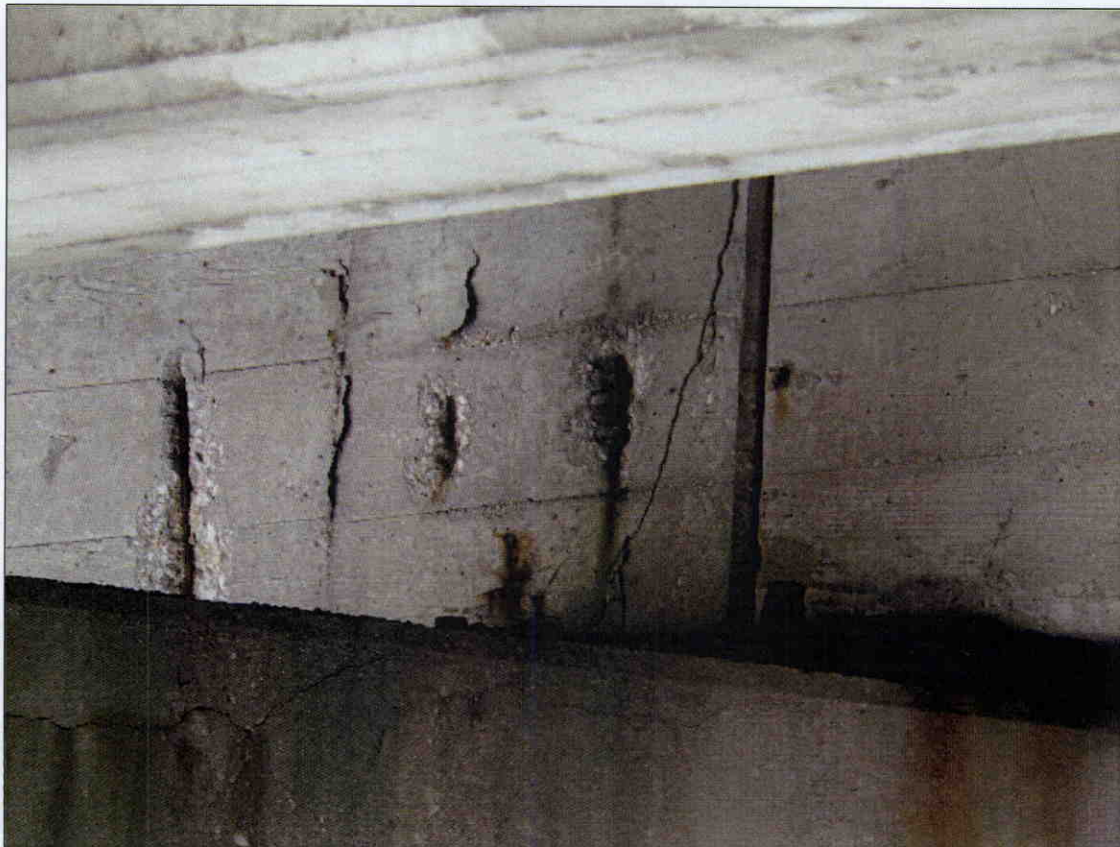
3 IN X 12 IN X 1/2 IN DEEP SPALL WITH EXPOSED REBAR IN FACE OF GIRDER 1, SPAN 3 AT BENT 3, 3 TOTAL

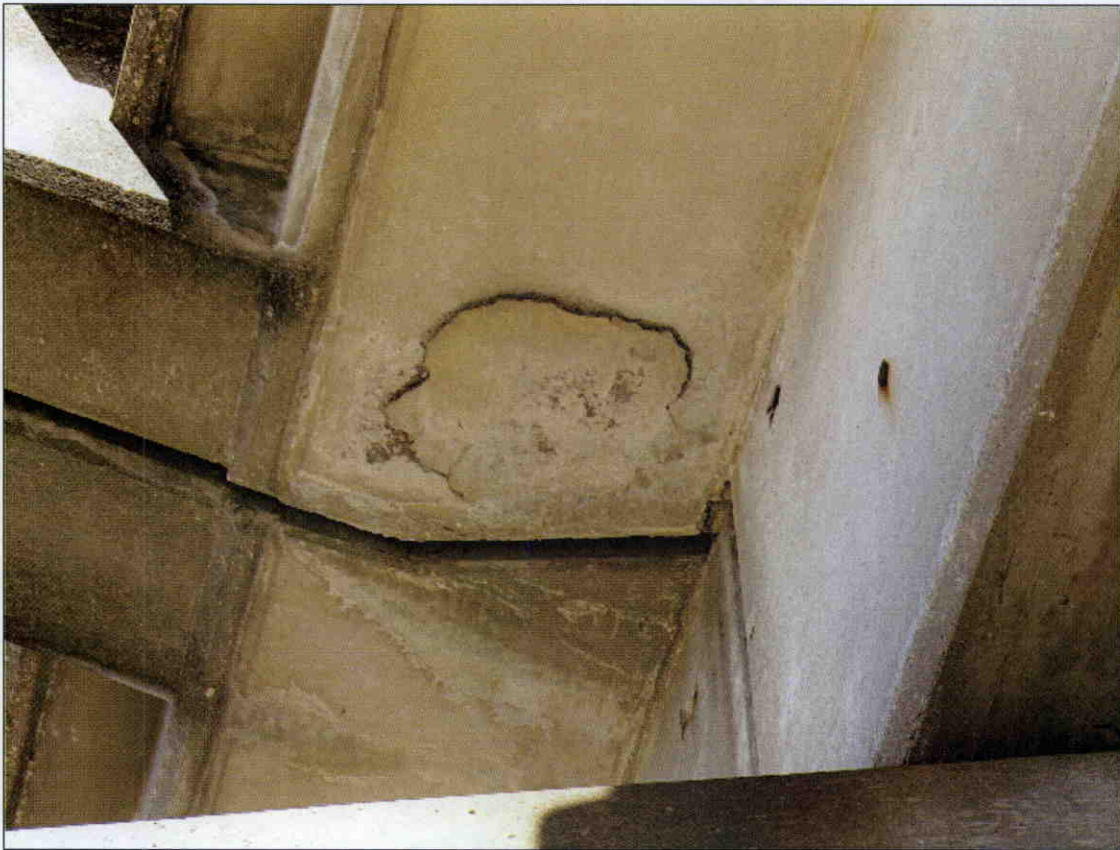
18 IN X 18 IN IMMINENT SPALL IN BOTTOM OF OUT SOUTH DECK OVERHANG AT BENT 2

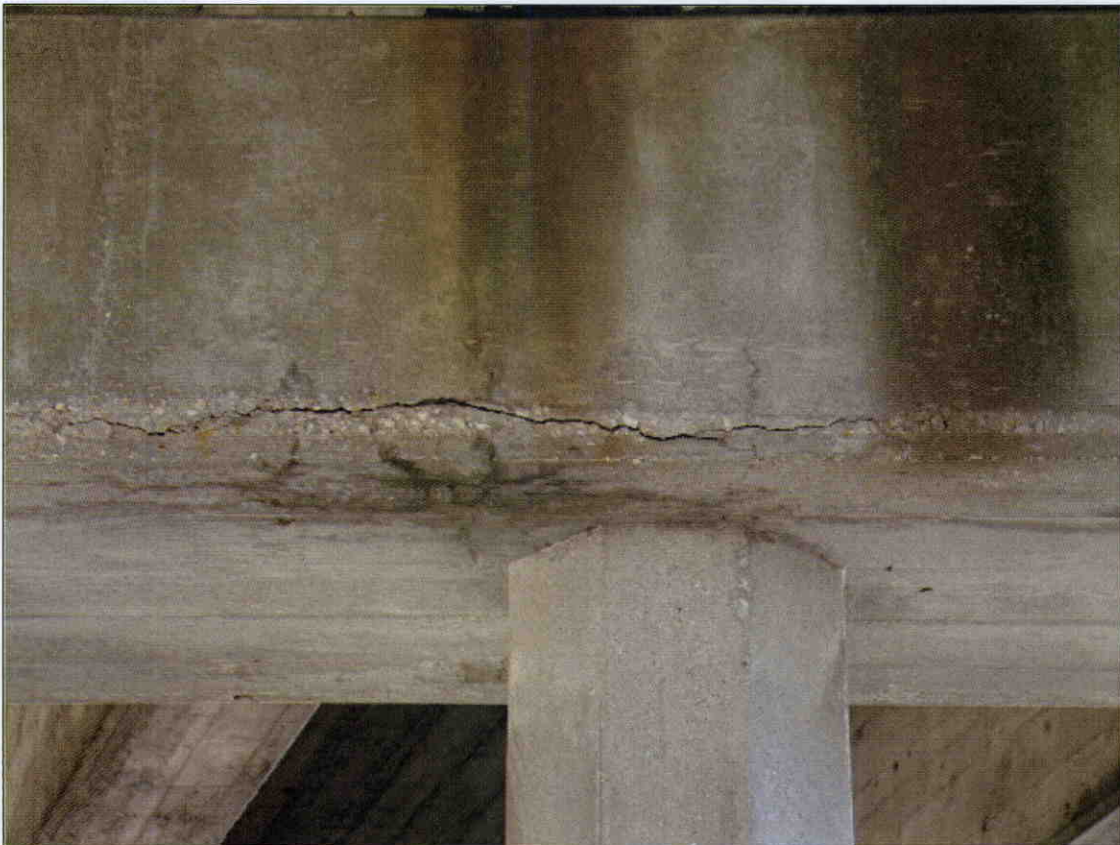
HAIRLINE TO 1/4 IN HORIZONTAL CRACK IN FACE OF BENT 2 CAP BETWEEN PILES 3 AND 4, SPAN 3 SIDE

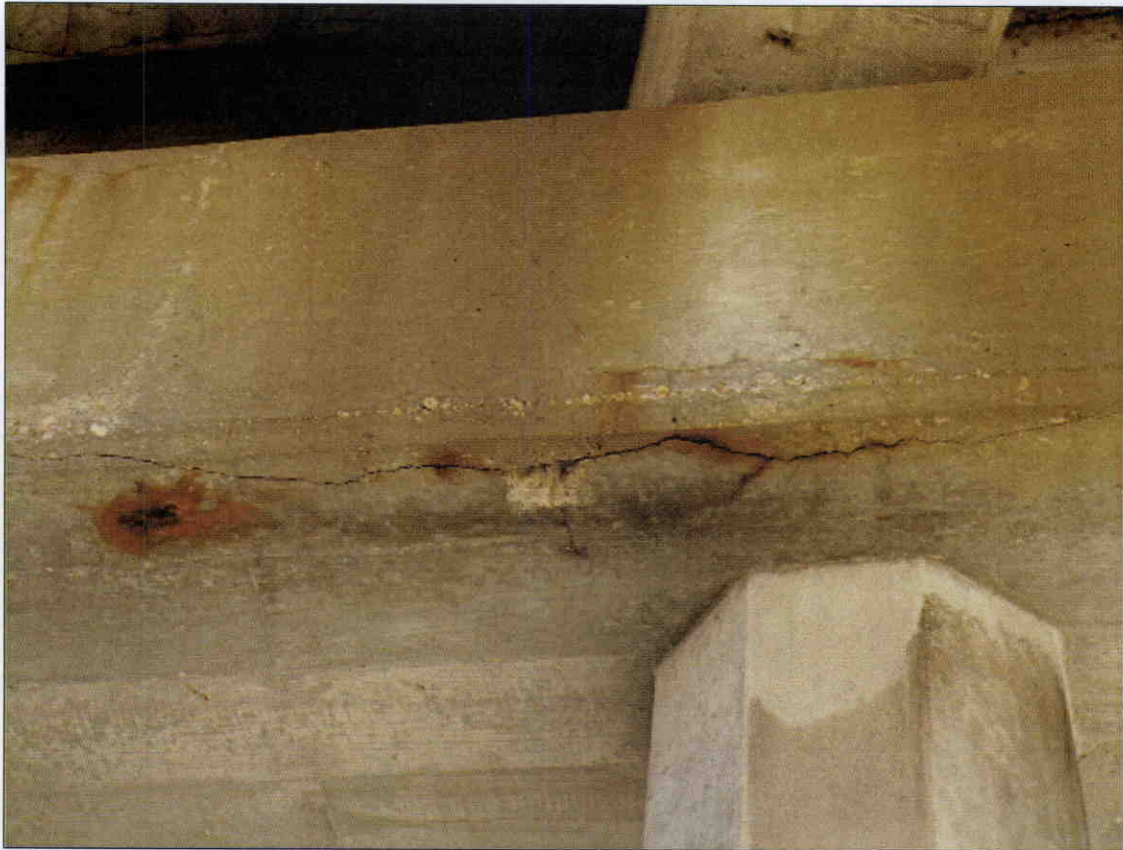
HAIRLINE TO 1/8 IN LONGITUDINAL CRACK IN BOTTOM OF BENT 2 CAP AT PILE 7, SIMILAR CRACKS IN BOTTOM OF ALL BENT CAPS

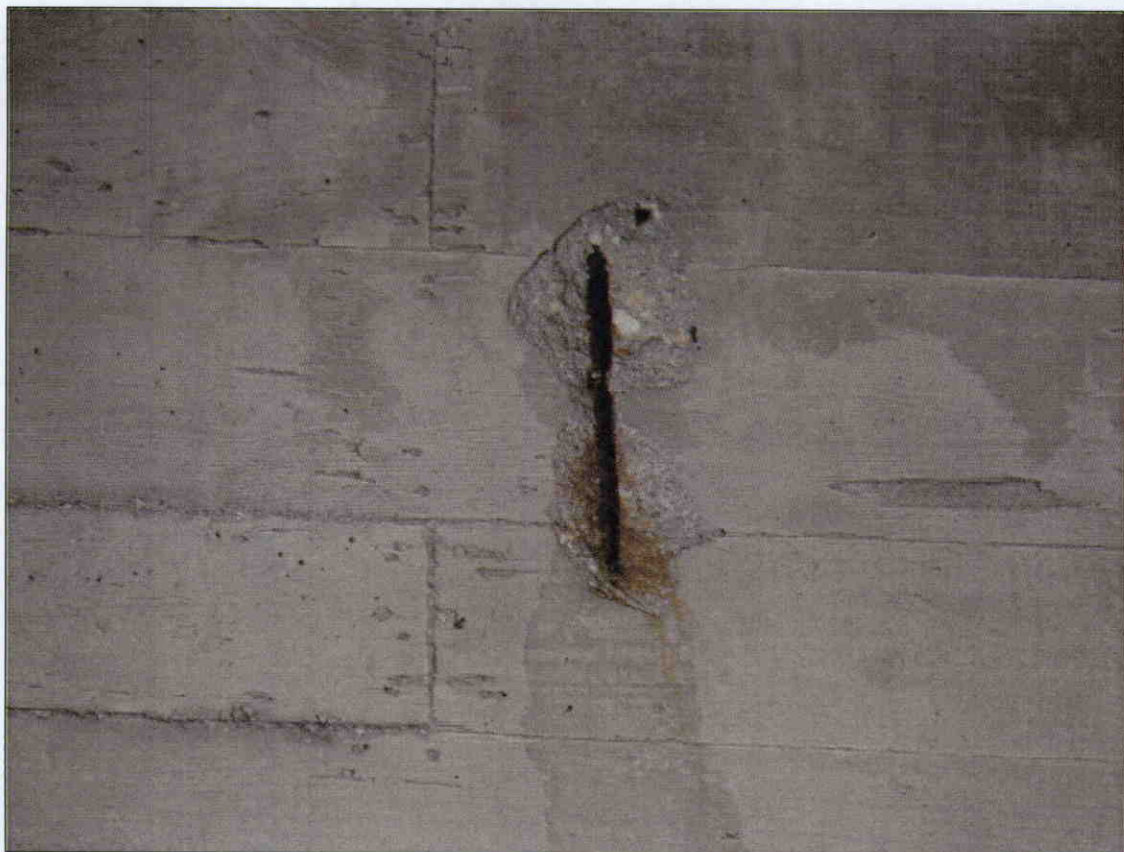
4 IN X 9 IN X 1/2 IN DEEP SPALL WITH EXPOSED REBAR IN RIGHT FACE OF GIRDER 1, SPAN 2 NEAR BENT 2

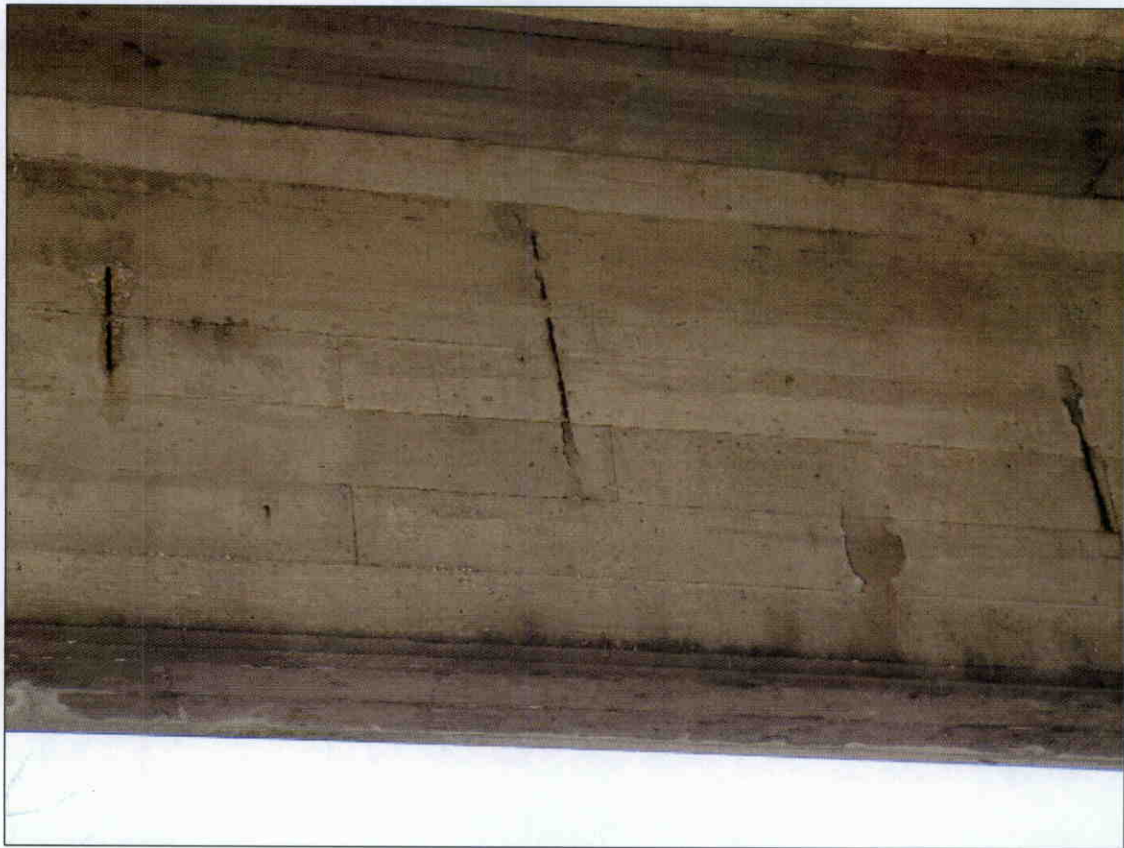
2 IN X 15 IN X 1/2 IN DEEP SPALL WITH EXPOSED REBAR IN RIGHT FACE OF GIRDER 1, SPAN 2 NEAR BENT
1, 3 TOTAL

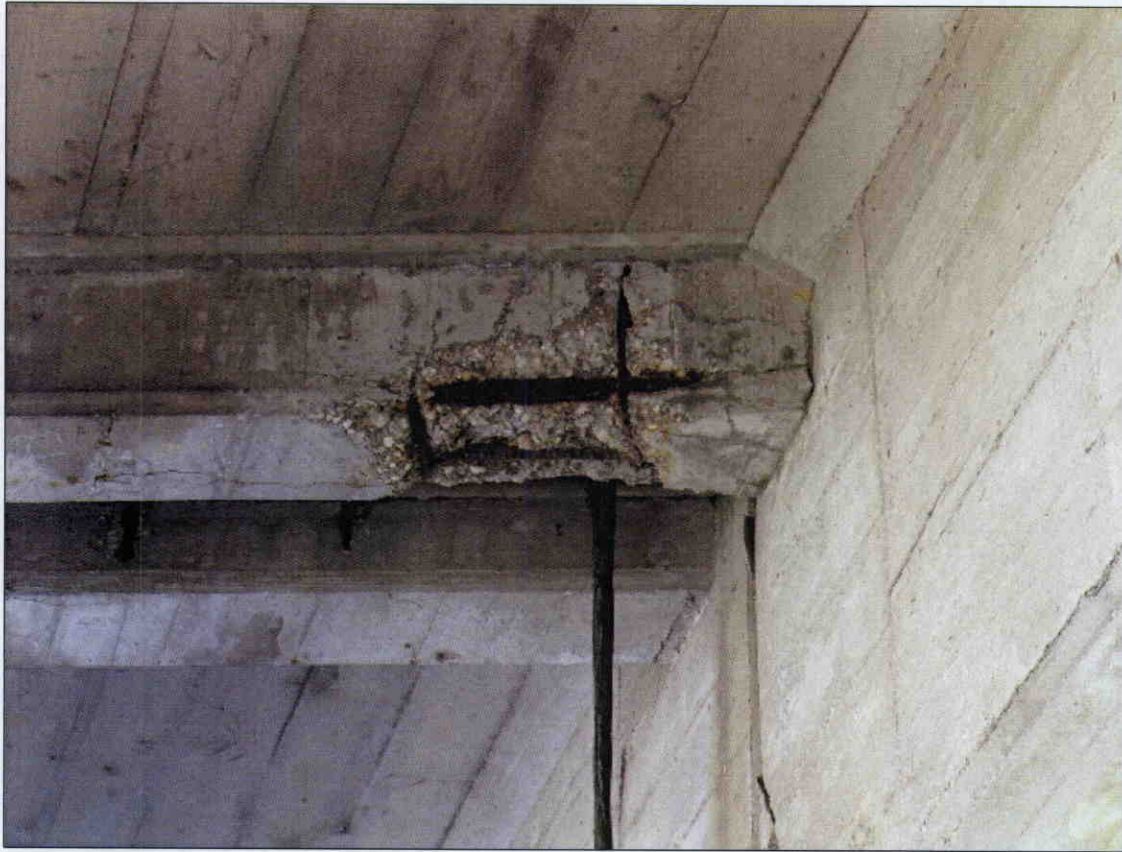
9 IN X 20 IN X 2 IN DEEP SPALL WITH EXPOSED REBAR IN BOTTOM OF END DIAPHRAGM AT BENT 1, BAY 1, SPAN 1

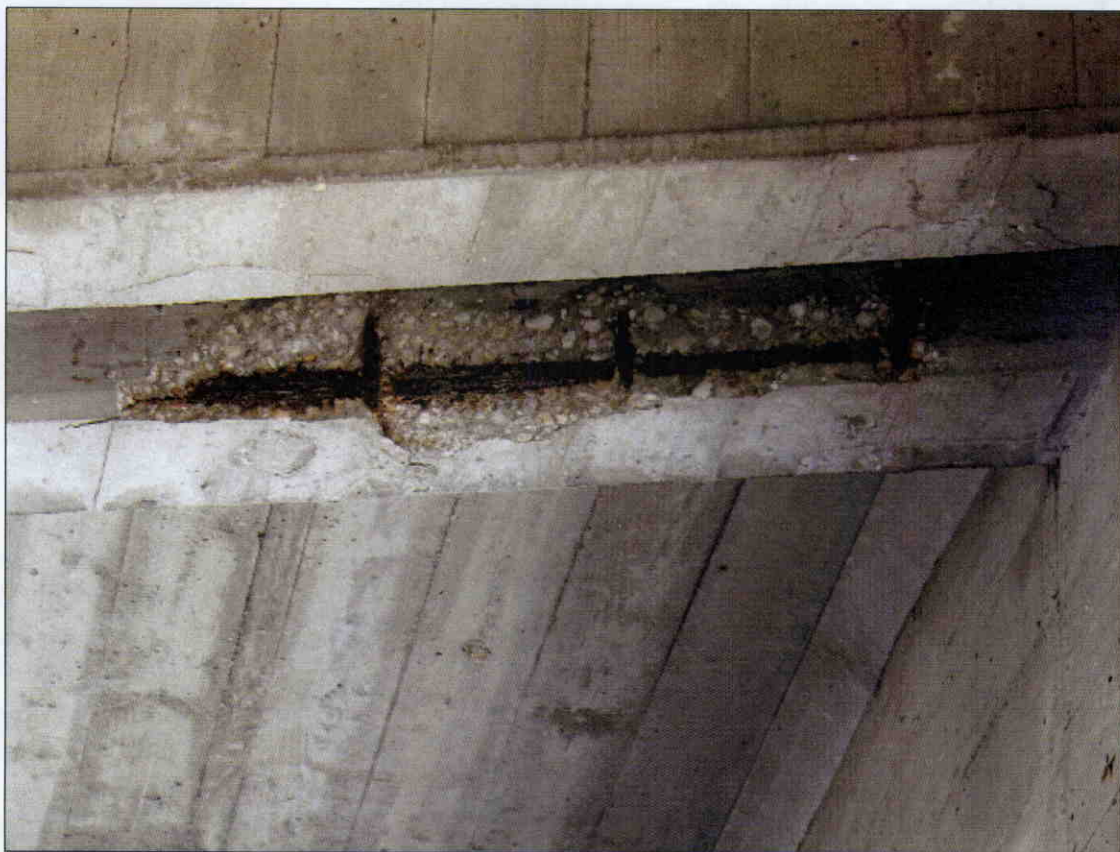
10 IN X 40 IN X 2 IN DEEP SPALL WITH EXPOSED REBAR IN BOTTOM OF END DIAPHRAGM AT BENT 1, BAY 2, SPAN 2

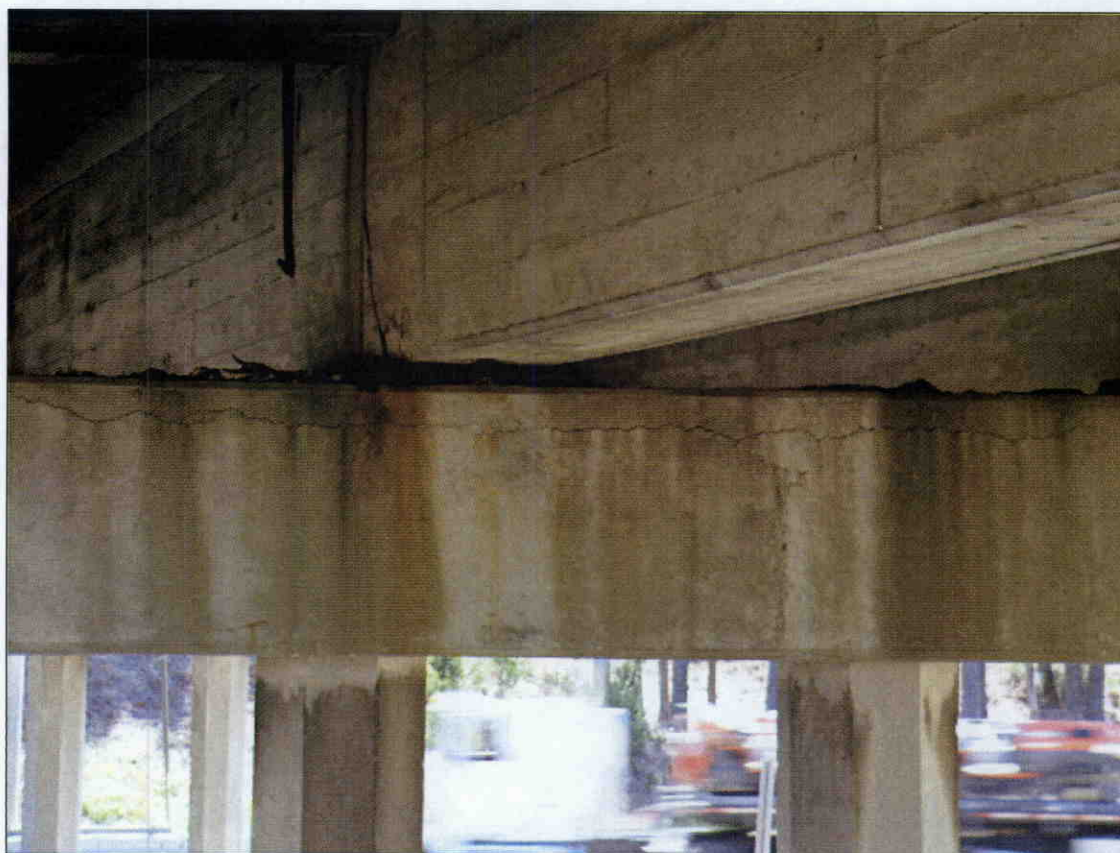
HAIRLINE TO 1/8 IN HORIZONTAL CRACK IN FACE OF BENT 1 CAP BETWEEN PILES 2 AND 6, SPAN 1 SIDE

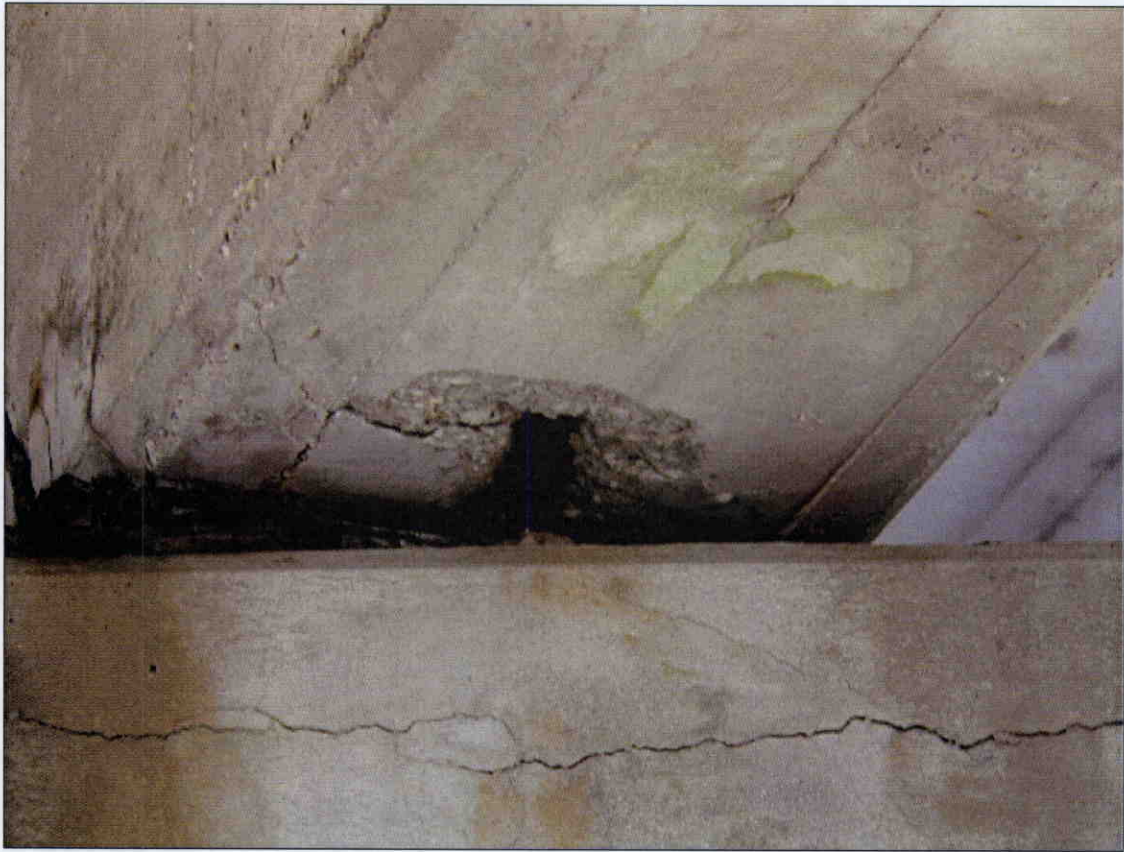
9 IN X 9 IN X 1 IN DEEP SPALL WITH EXPOSED REBAR IN BOTTOM OF GIRDER 2, SPAN 1 AT BENT 1, SIMILAR SPALLS GIRDERS 3 AND 4

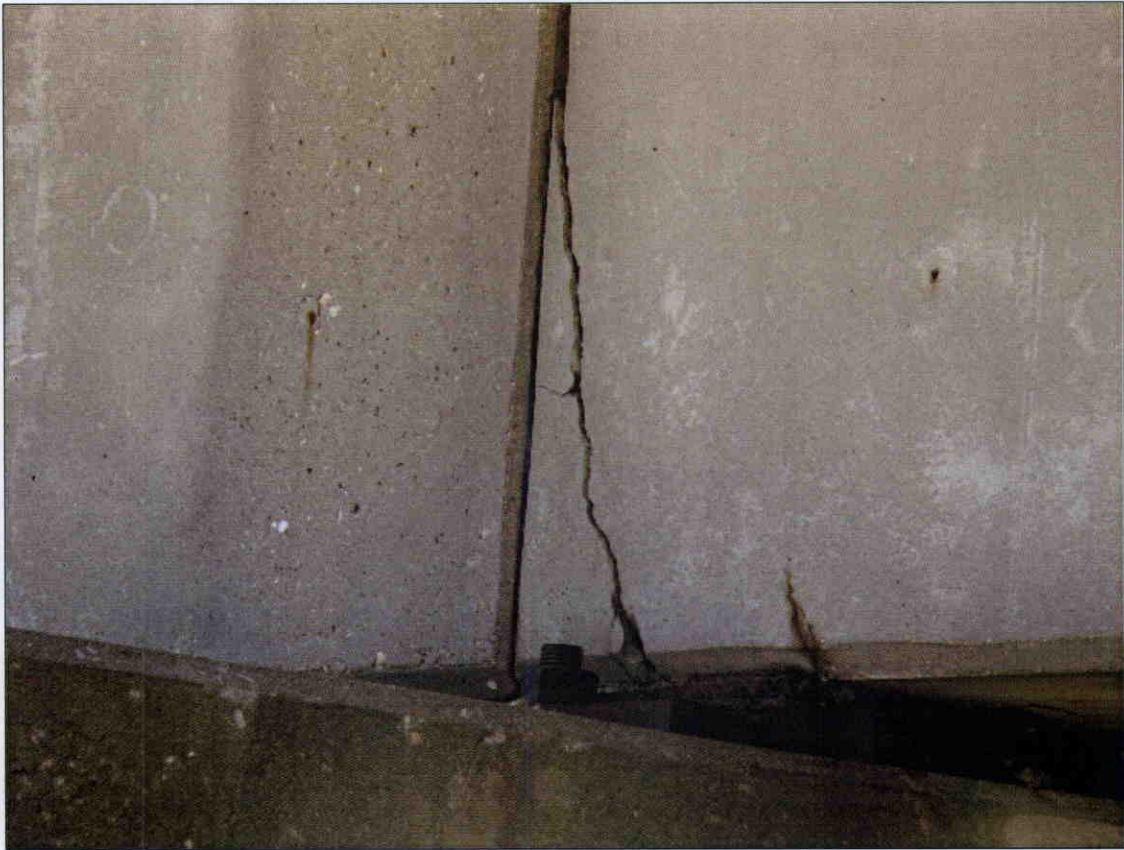
24 IN LONG X 1/4 IN VERTICAL CRACK IN END OF GIRDER 1 AT BENT 1, SPAN 1 SIDE, SIMILAR CRACKS AT ENDS OF GIRDERS AT OTHER BENTS

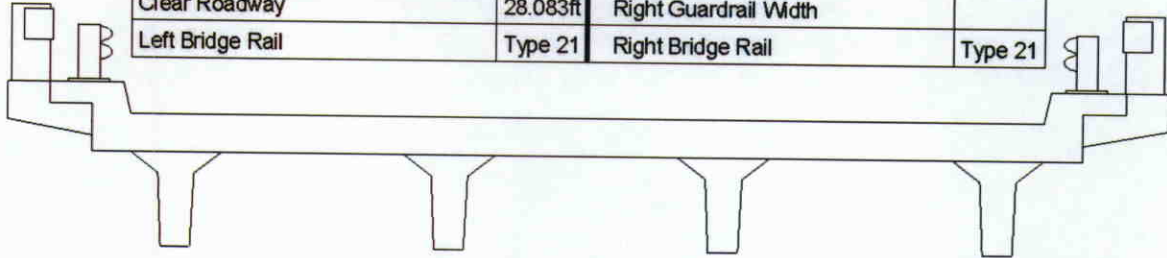
Measurements for Span #	1		
Deck Thickness	0.604	Left Overhang	3.75
Top of Rail to Bottom of Beam	7.312	Right Overhang	3.75
