NC DEPARTMENT OF TRANSPORTATION ATTENTION
 DIVISION OF HIGHWAYS
 BRIDGE MANAGEMENT UNIT

BRIDGE INSPECTION REPORT

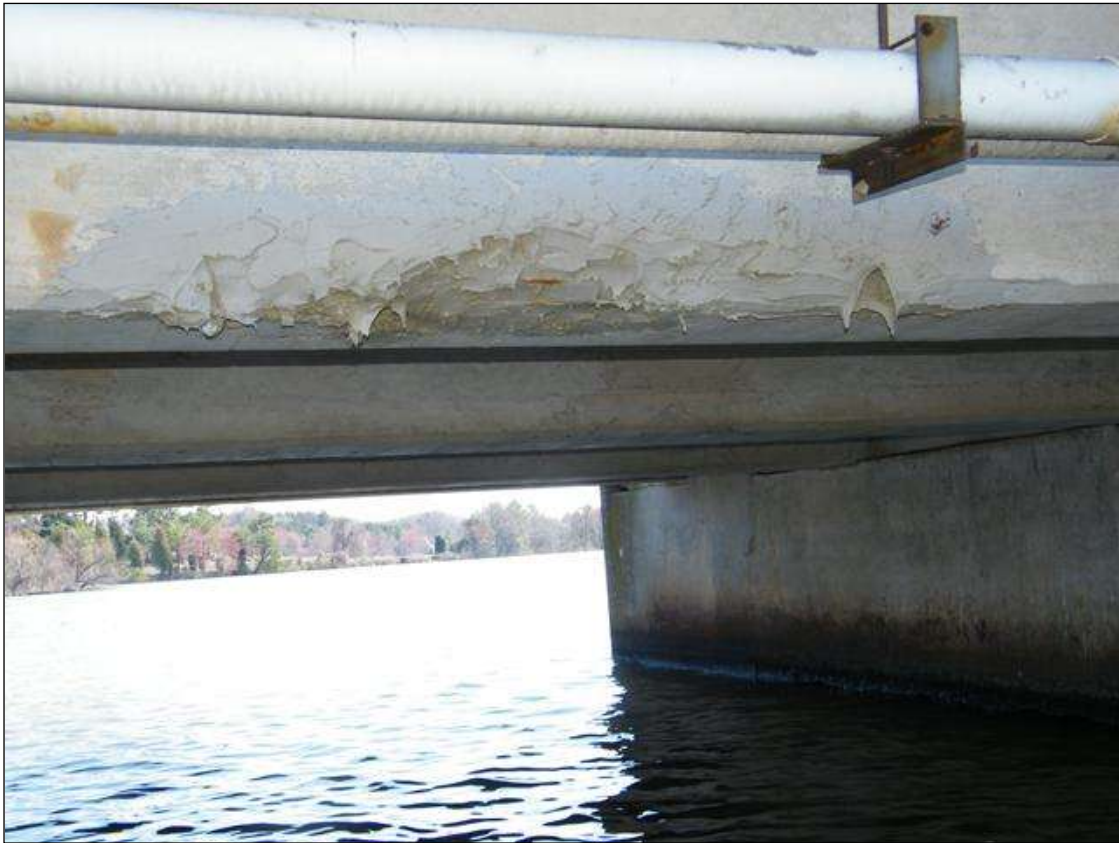
GIRDER 1 IN SPAN 1 HAS A CONCRETE REPAIR, 10 FEET FROM ABUTMENT 1.

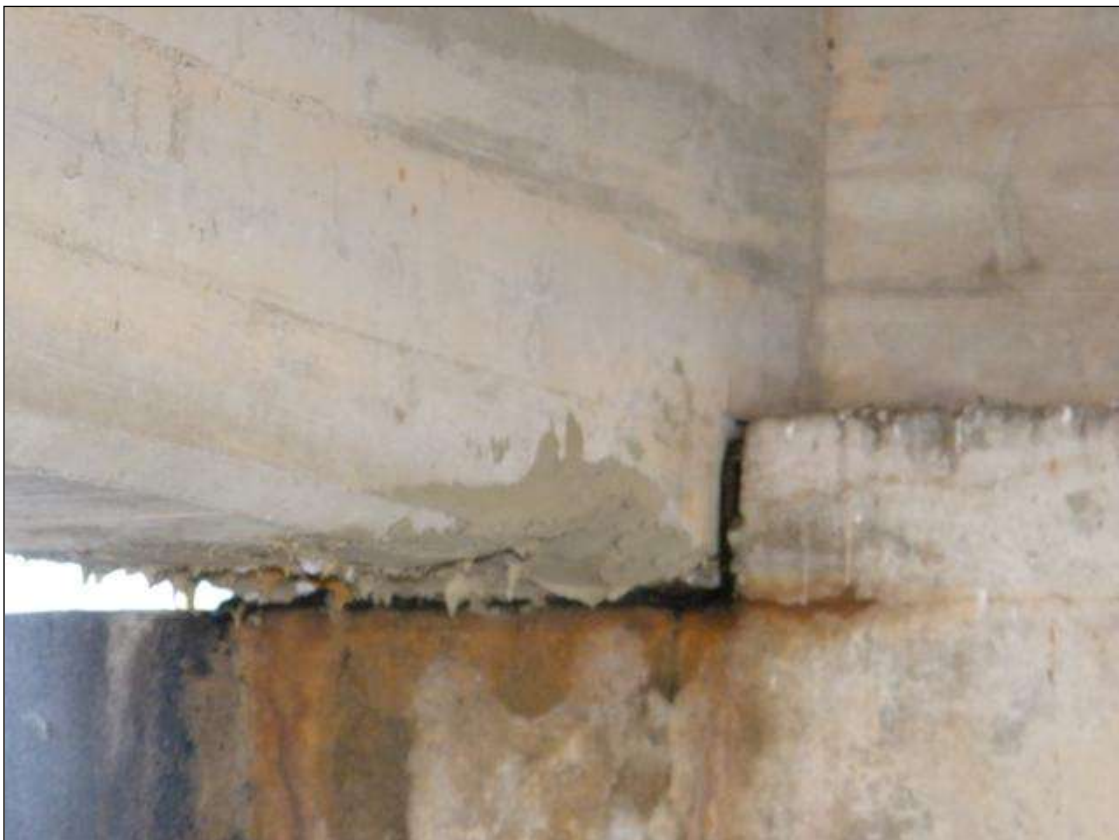
GIRDER 1, SPAN 1 HAS A CONCRETE REPAIR AT PIER 1.

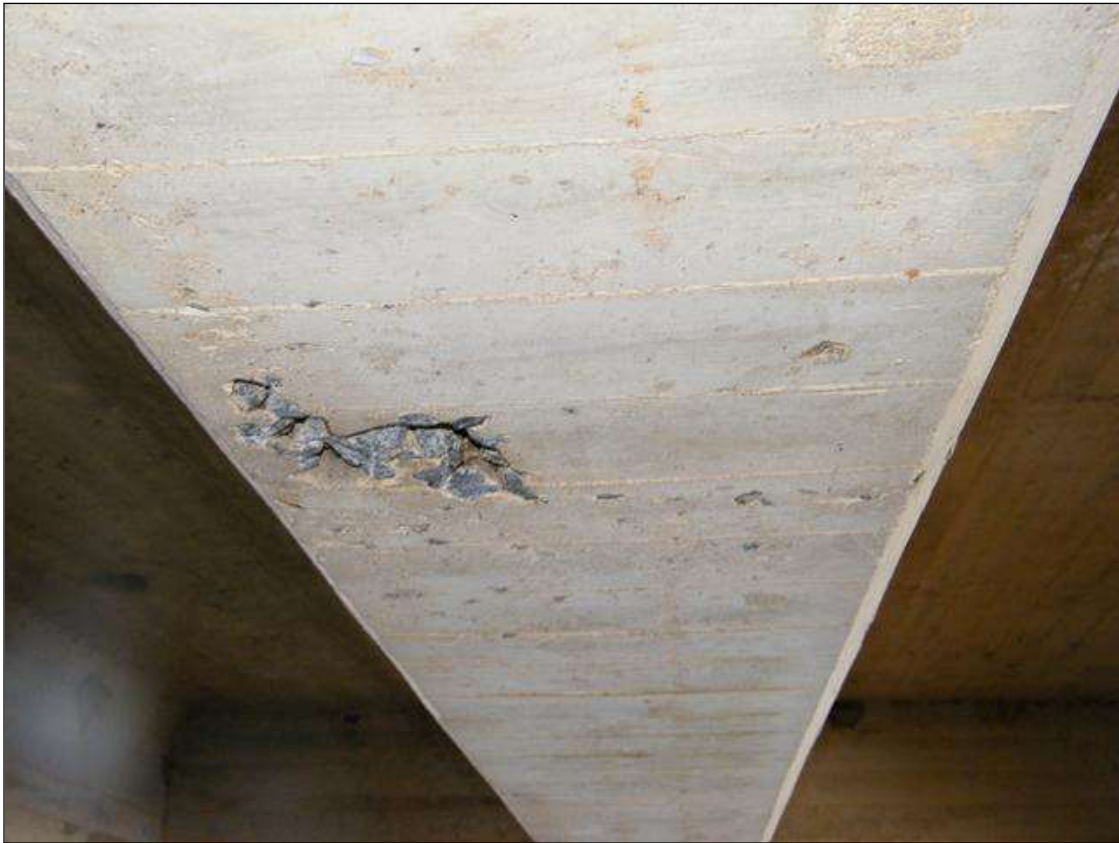
GIRDER 2 IN SPAN 1 HAS 2 INCH DEEP AREA OF HONEYCOMBING NEAR MID-SPAN .

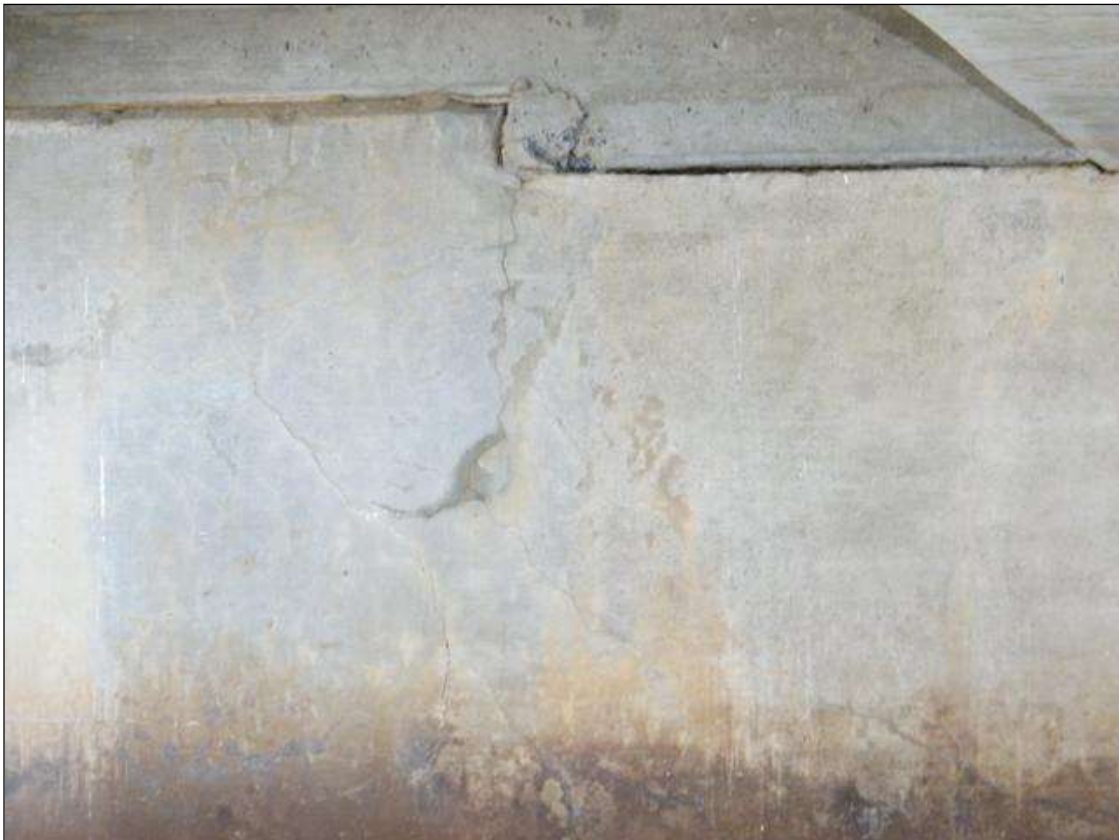
ABUTMENT 1 CAP MAP CRACKING ON FACE AT BAY 3

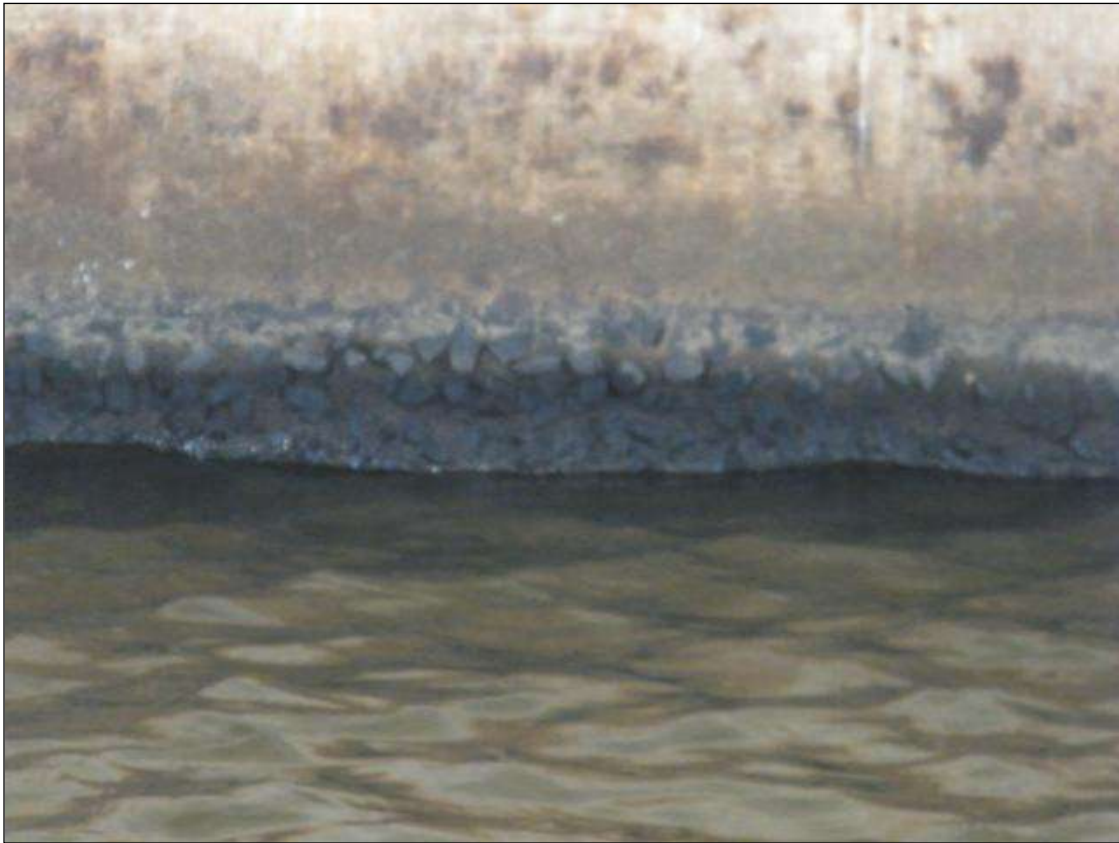
ABUTMENT 1 BREASTWALL AND COLUMNS ARE PITTING UP TO 1" DEEP ALONG THE WATERLINE.

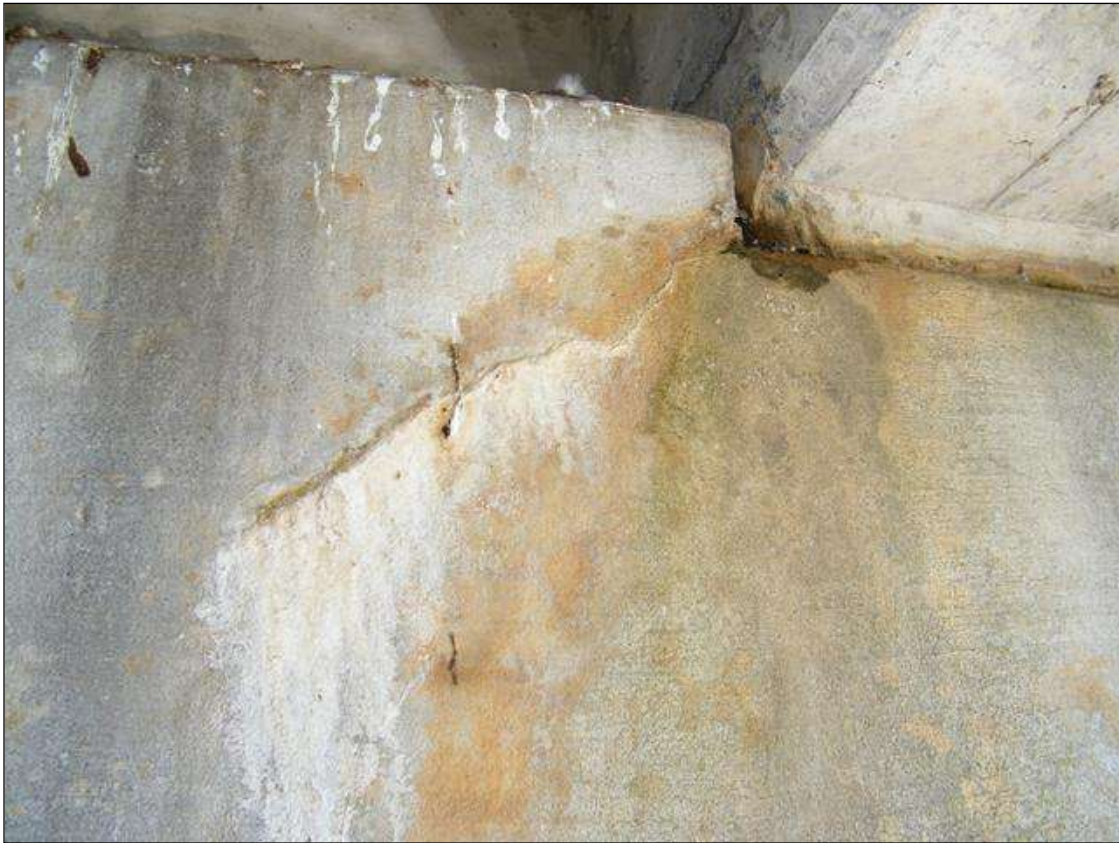
PIER 1 CAP ON SOUTH FACE HAS DIAGONAL EFFLORESCENCE CRACKS AT STEP-UP LEFT OF GIRDER 4

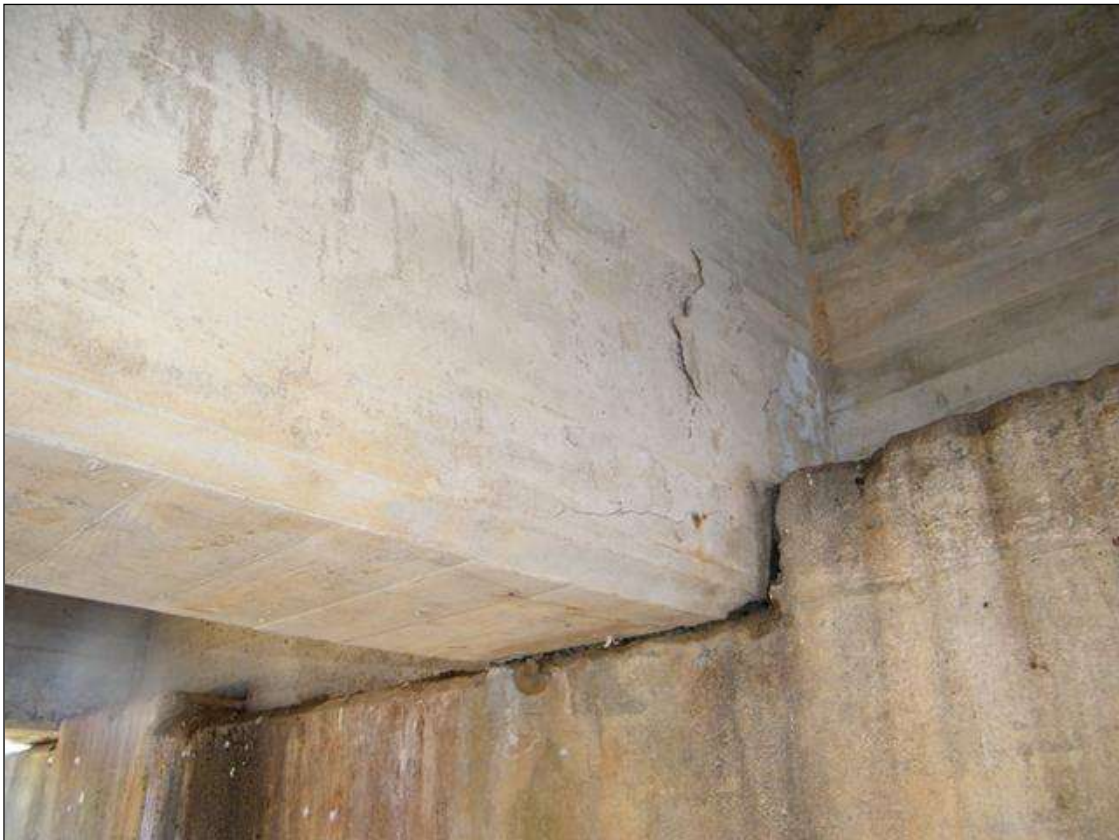
GIRDER 3 IN SPAN 2 IS DELAMINATED ON LEFT SIDE AT PIER 1 .

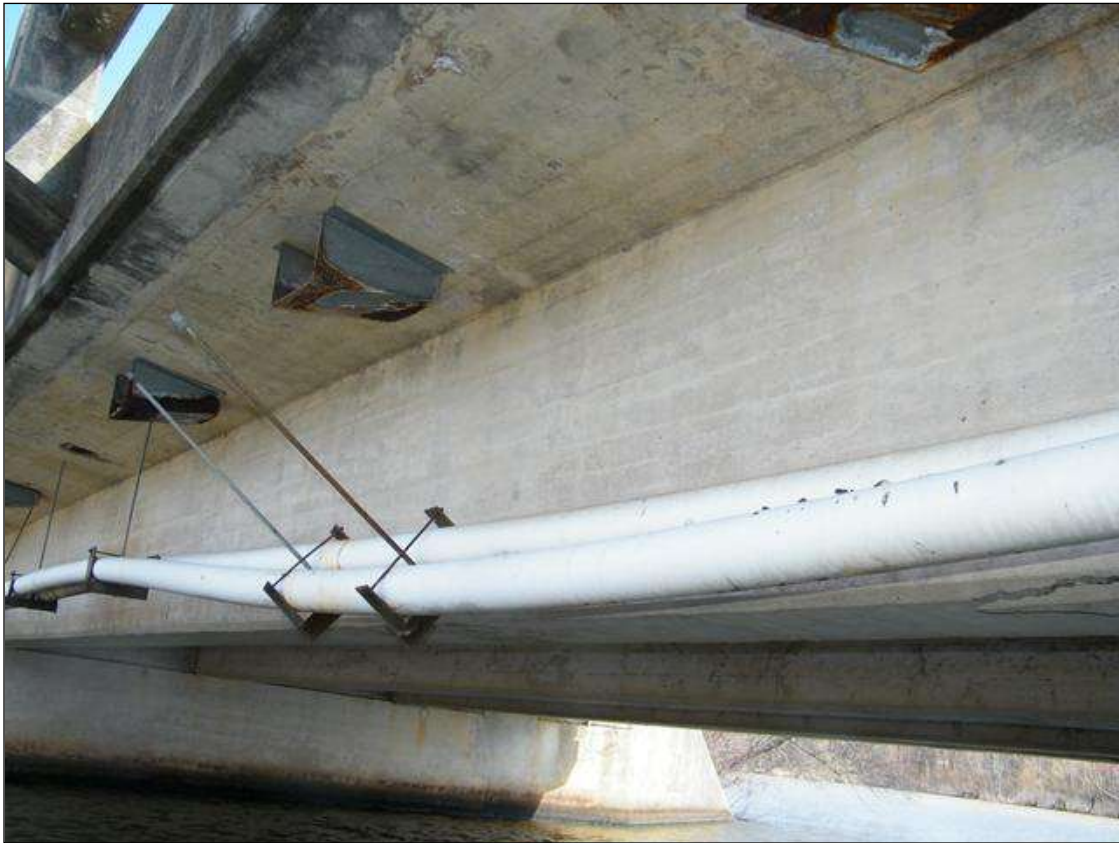
UTILITY BRACKETS BROKEN IN SPAN 3, UTILITY LINES SAGGING .

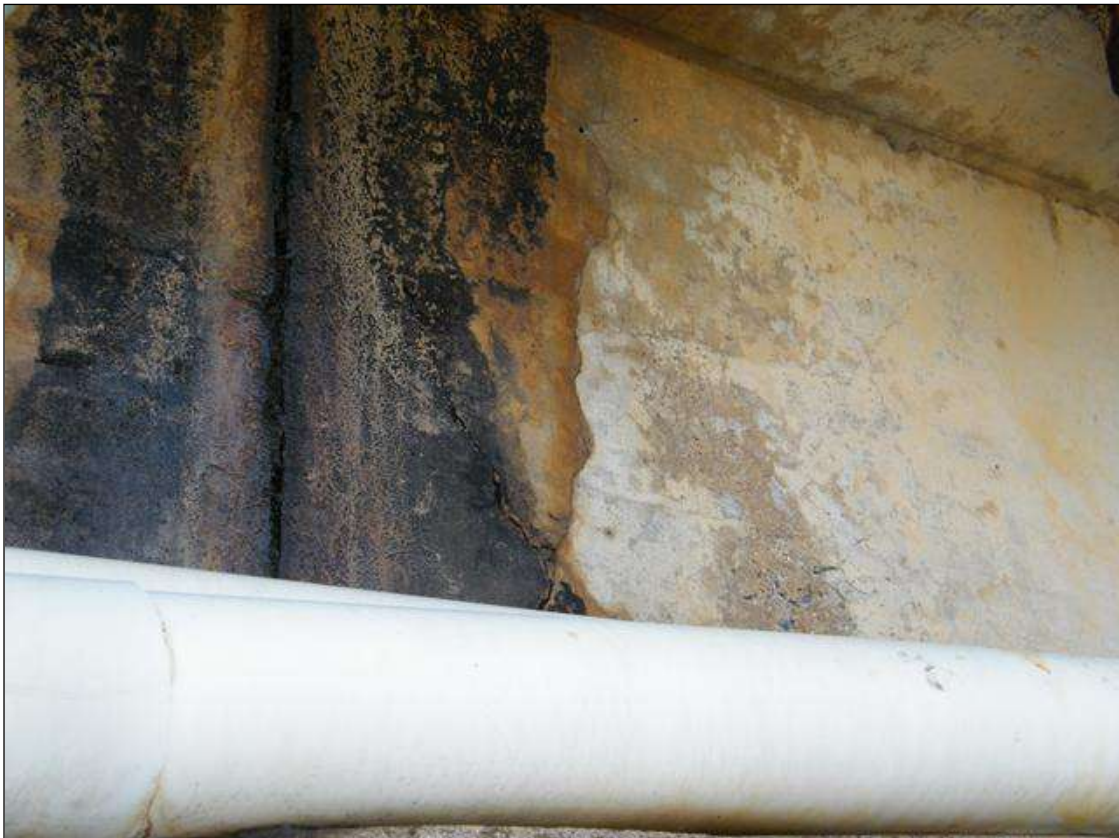
GIRDER 1 IN SPAN 2 HAS 1/2 CRACK ON RIGHT SIDE AT PIER 2 .

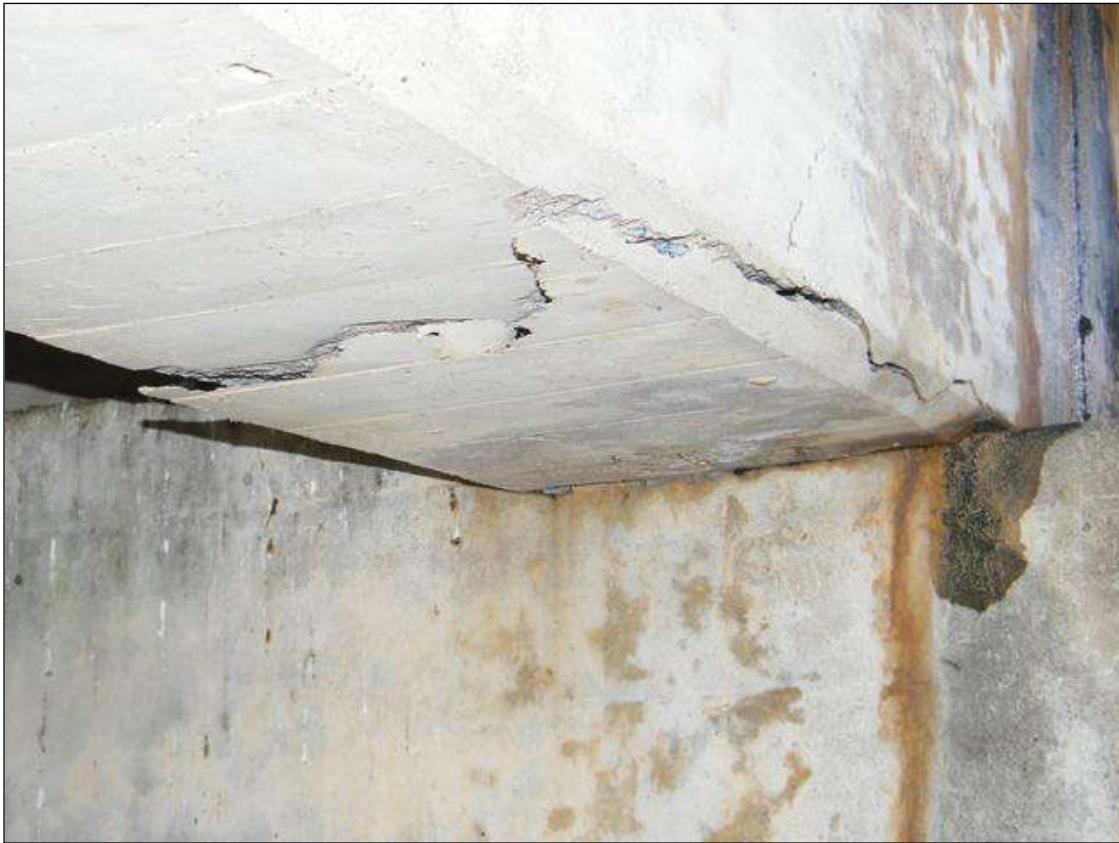
GIRDER 1, SPAN 3 IS DELAMINATED 1" DEEP ALONG BOTTOM FROM PIER 2 BACK 1' LONG X WIDTH.

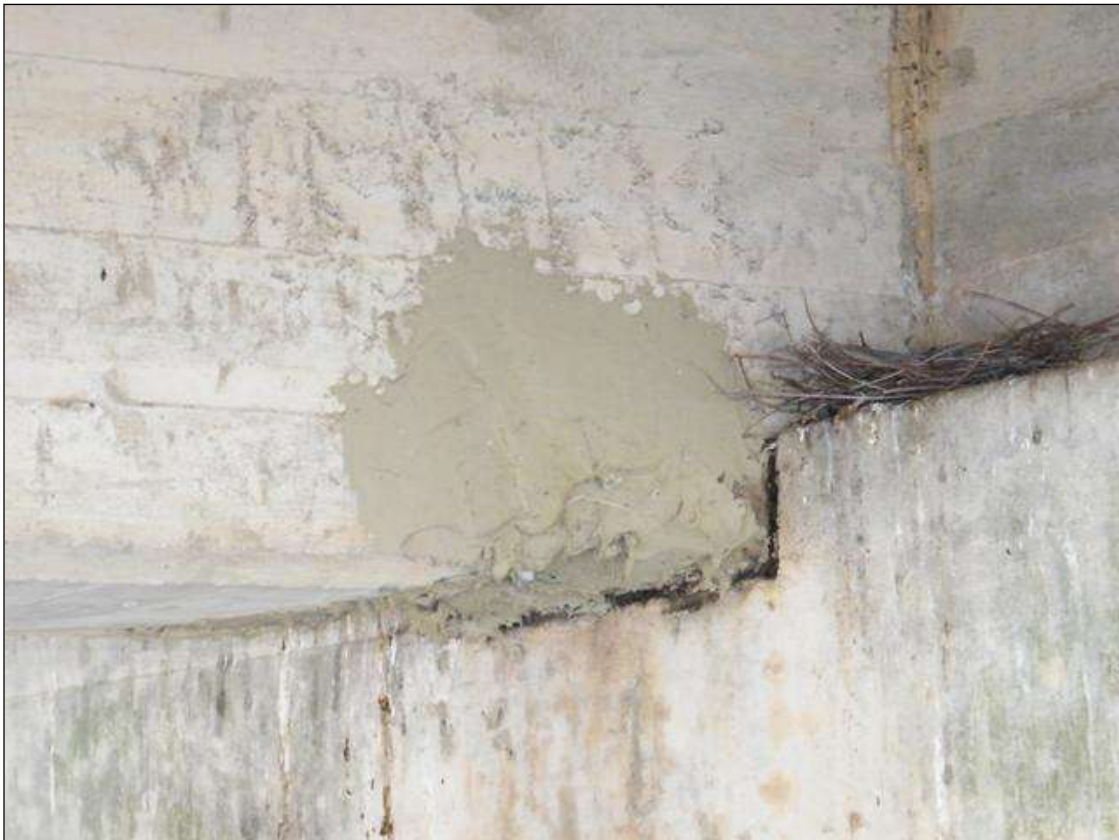
GIRDER 2, SPAN 3 HAS A CONCRETE REPAIR ALONG BOTTOM AT PIER 2

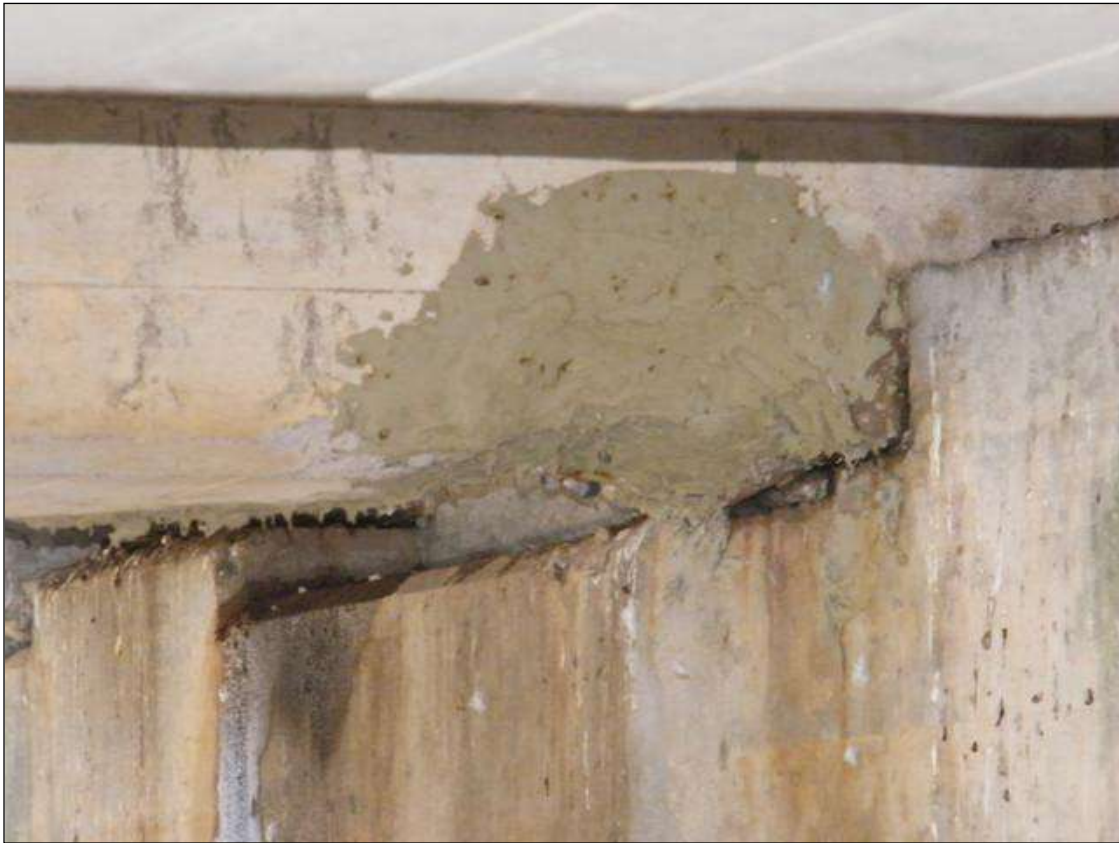
GIRDER 3, SPAN 3 HAS A CONCRETE REPAIR ALONG BOTTOM AT PIER 2

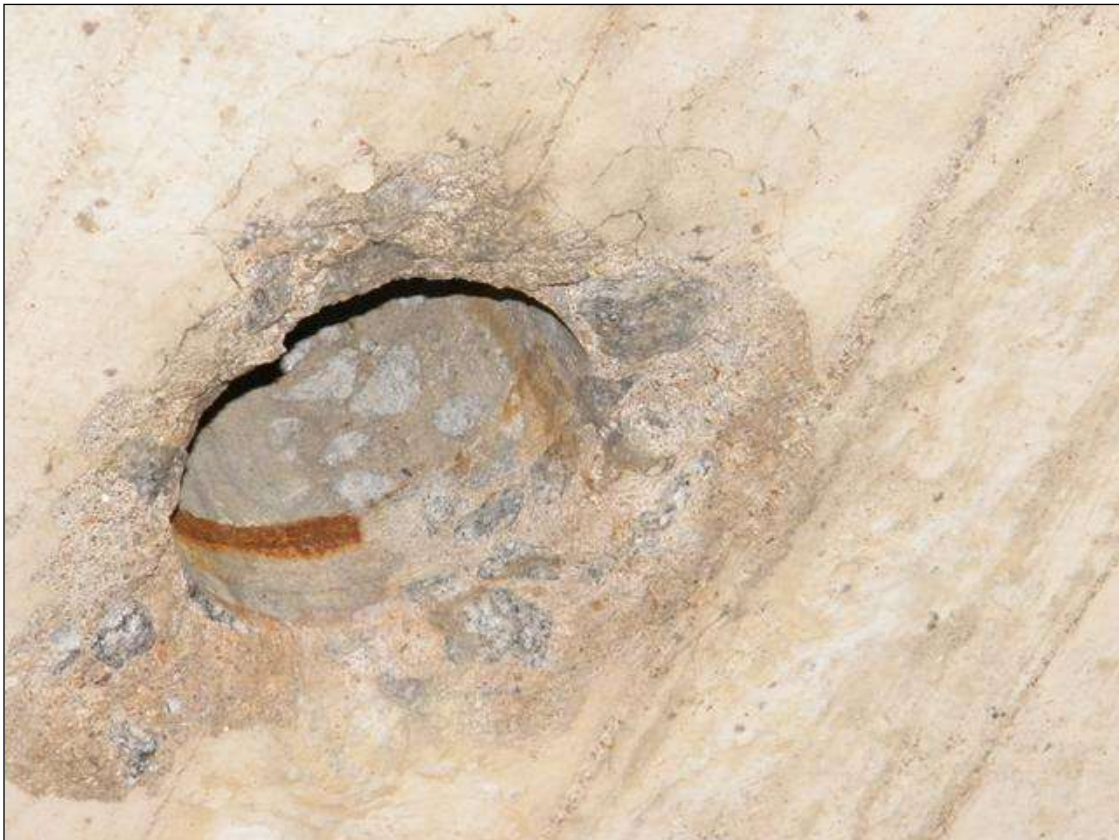
DECK HAS BEEN CORED IN SPAN 3, BAY 1

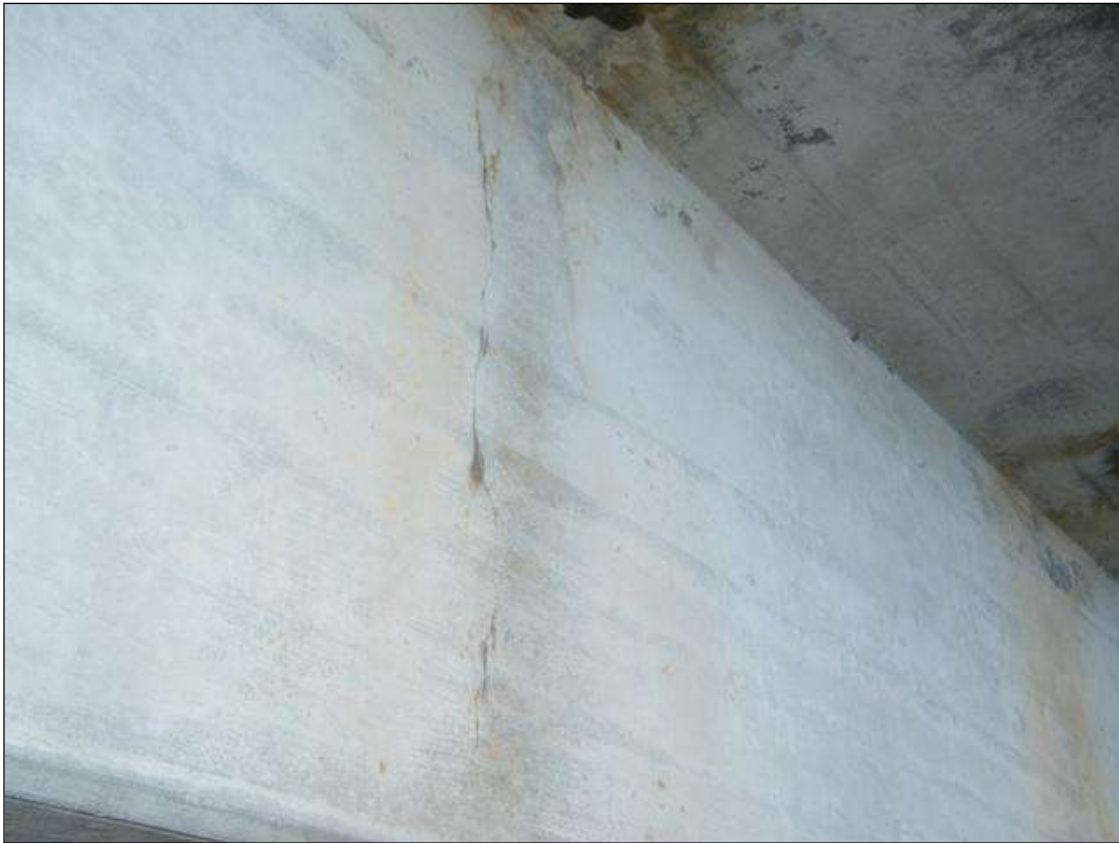
GIRDER 4 IN SPAN 3 HAS VERTICAL H/L CRACK ON RIGHT SIDE FROM TOP TO BOTTOM NEAR MID-SPAN AT 10 FEET FROM ABUTMENT 2 .

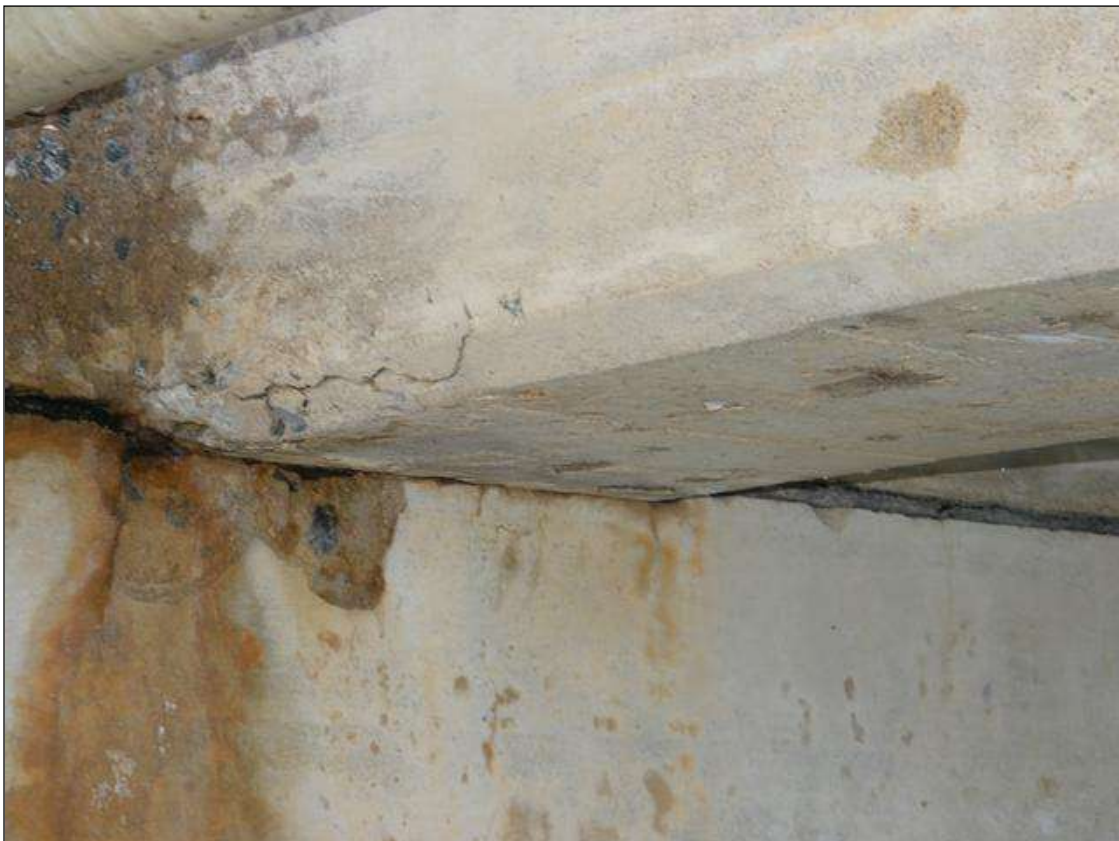
GIRDER 1, SPAN 3 HAS A 1/8" LONGITUDINAL CRACK FROM ABUTMENT 2 BACK 6" ALONG BOTTOM.

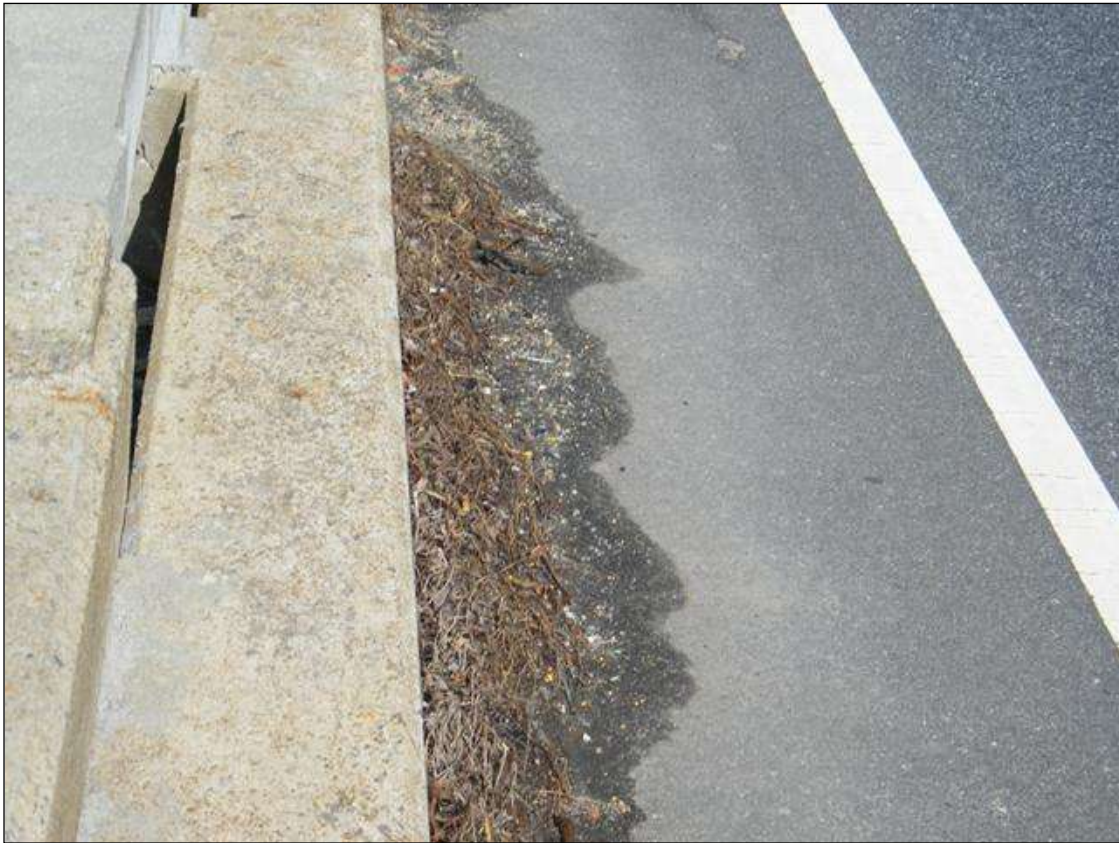
DIRT ALONG CURBS PARTIALLY BLOCKING DRAIN HOLES

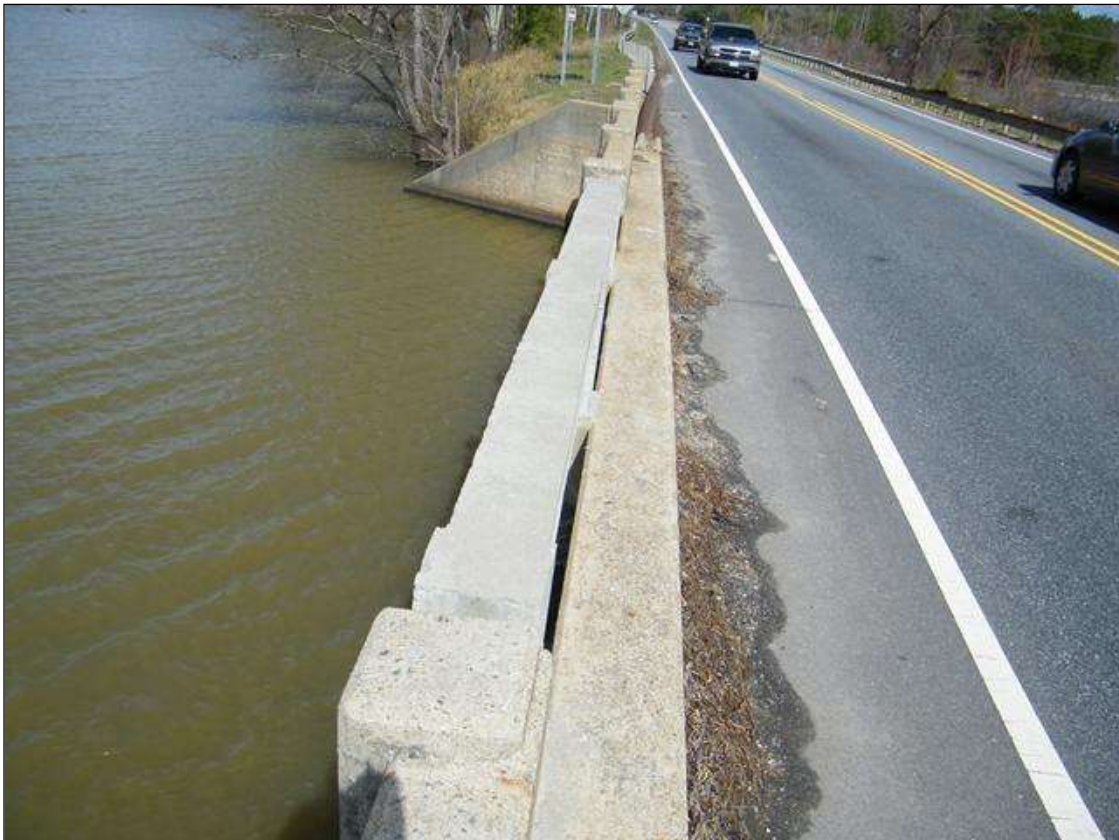
LEFT RAIL HAS BEEN REPAIRED IN SPAN 3

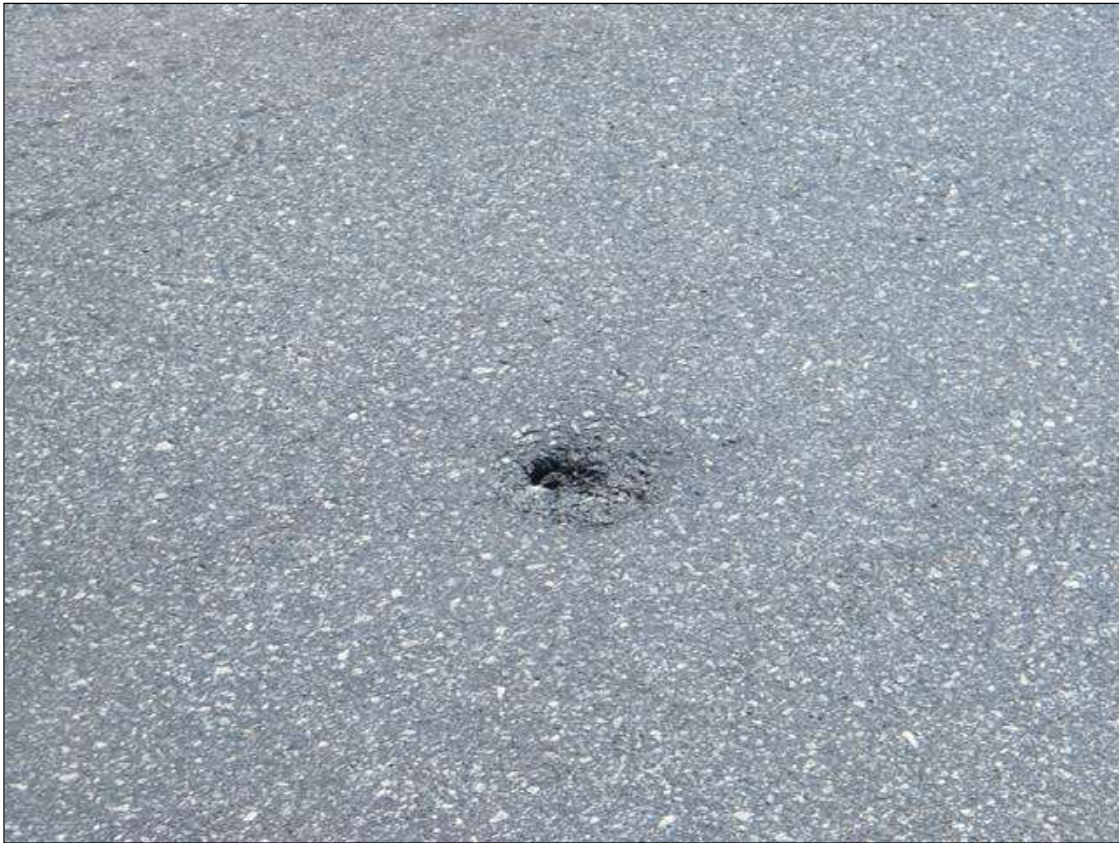
DECK WAS CORED IN SPAN 3, HOLE IN WEARING SURFACE.

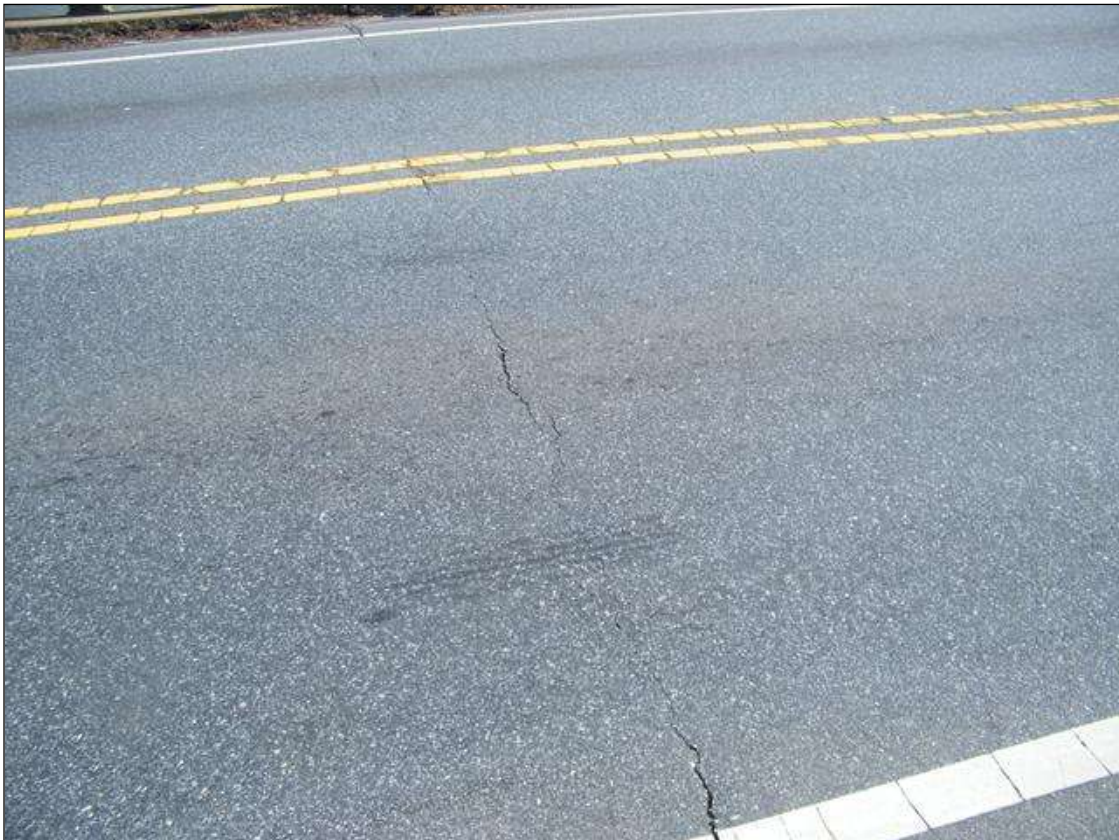
WEARING SURFACE CRACKED AT PIERS AND ABUTMENTS.

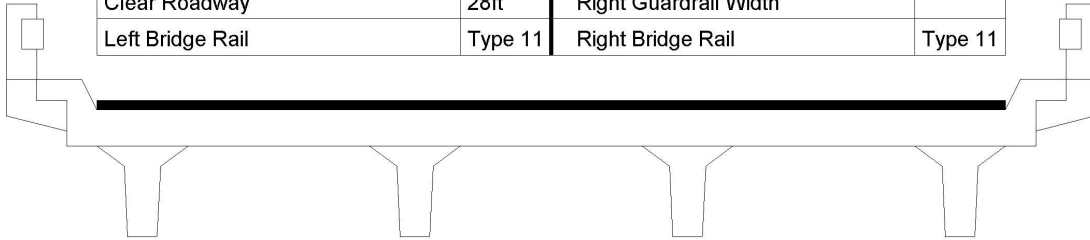
Measurements for Span #	1	spans 2 & 3 similar	
Deck Thickness	0.583	Left Overhang	3.75
Top of Rail to Bottom of Beam	6.917	Right Overhang	3.75
