N.C. DEPARTMENT OF TRANSPORTATION
 DIVISION OF HIGHWAYS
 BRIDGE MAINTENANCE UNIT

Attention:

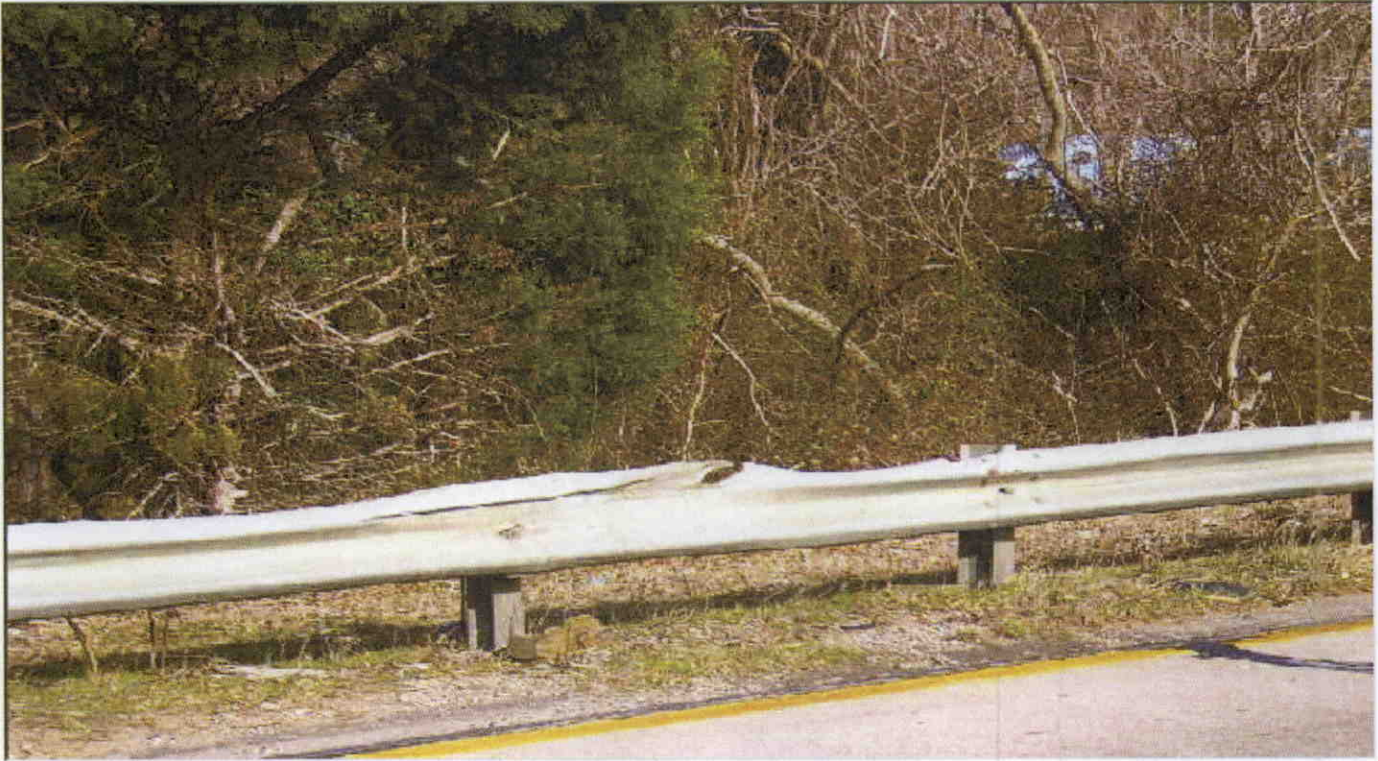
GUARDRAIL DAMAGE AT LEFT SIDE OF APPROACH 1

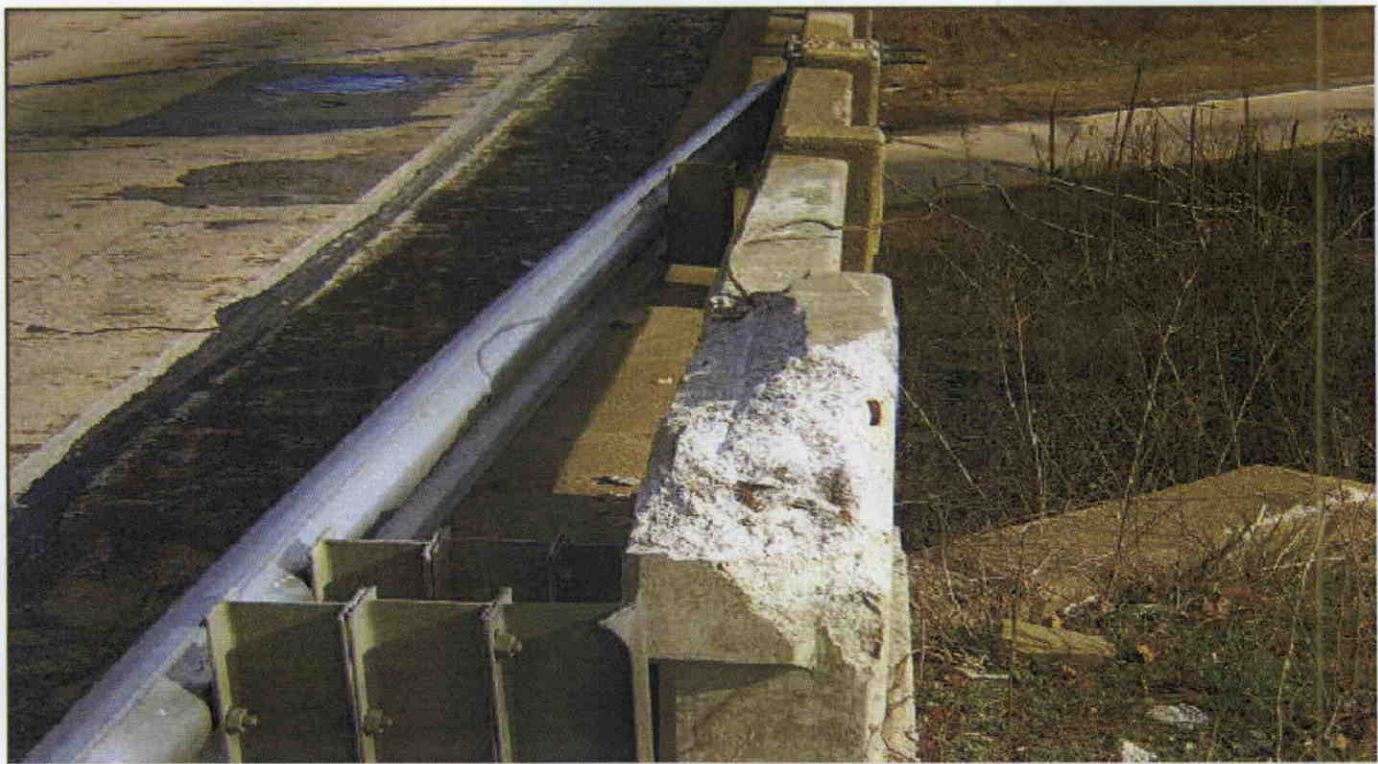
COLLISION DAMAGE AT RIGHT ENDPOST OF END BENT 1

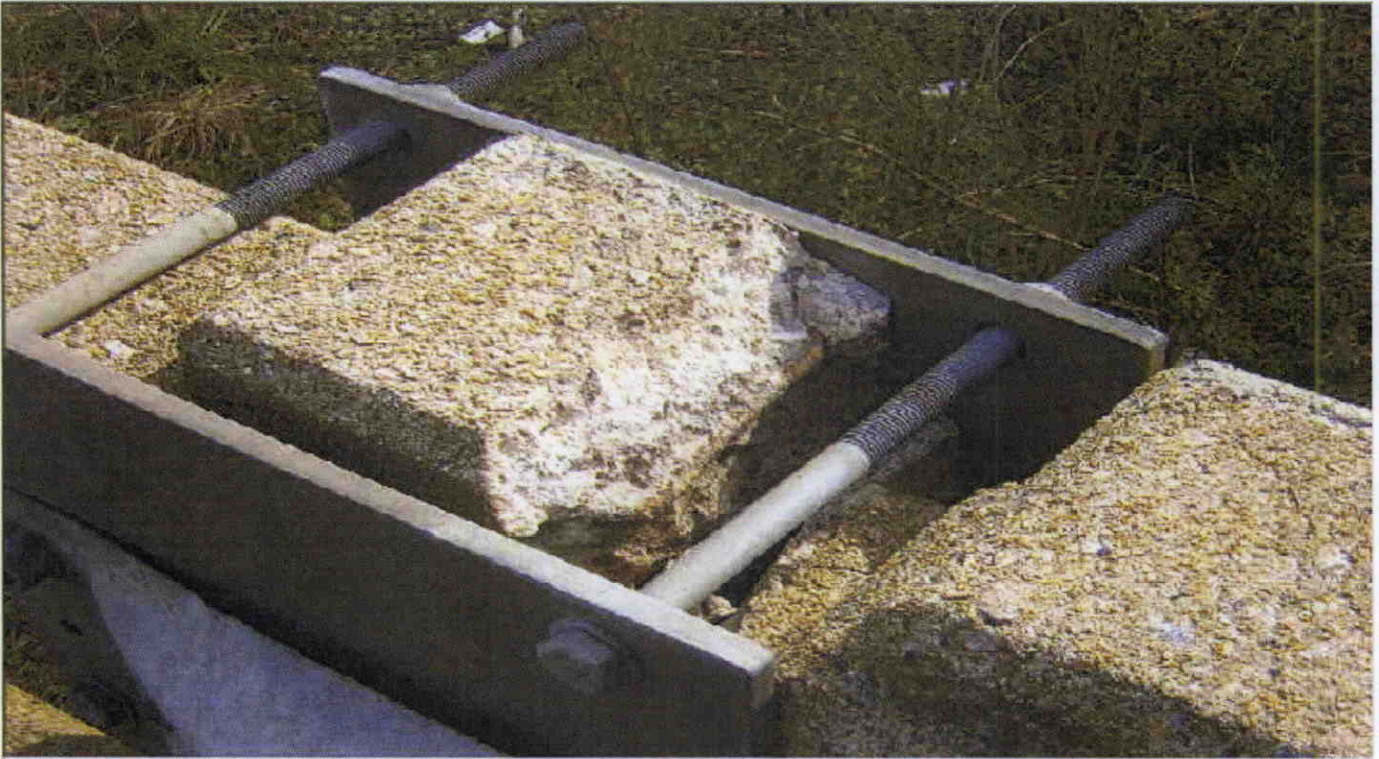
SPALL IN GUARDRAIL POST AT RIGHT SIDE ATTACHMENT END BENT 1

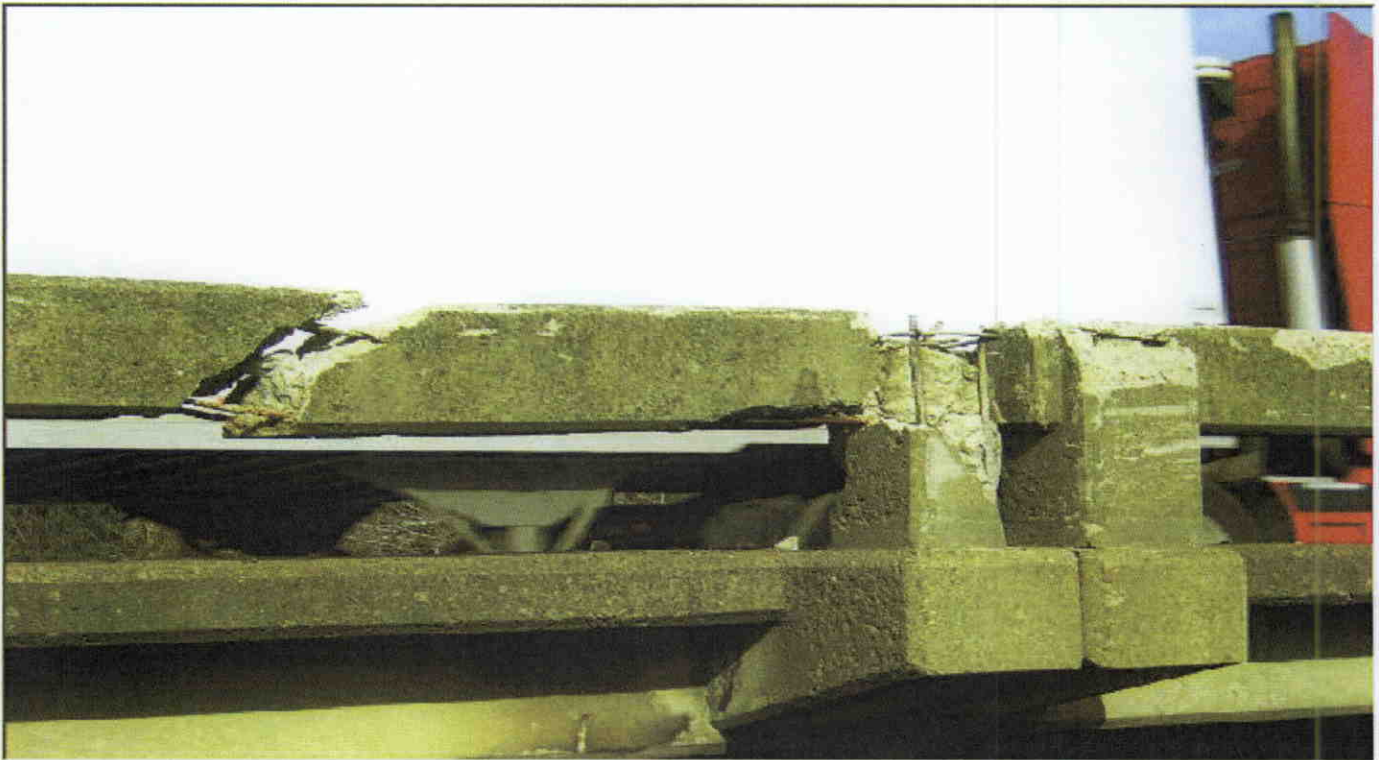
GUARDRAIL DAMAGE AT RIGHT SIDE OF SPAN 1 AT BENT 1

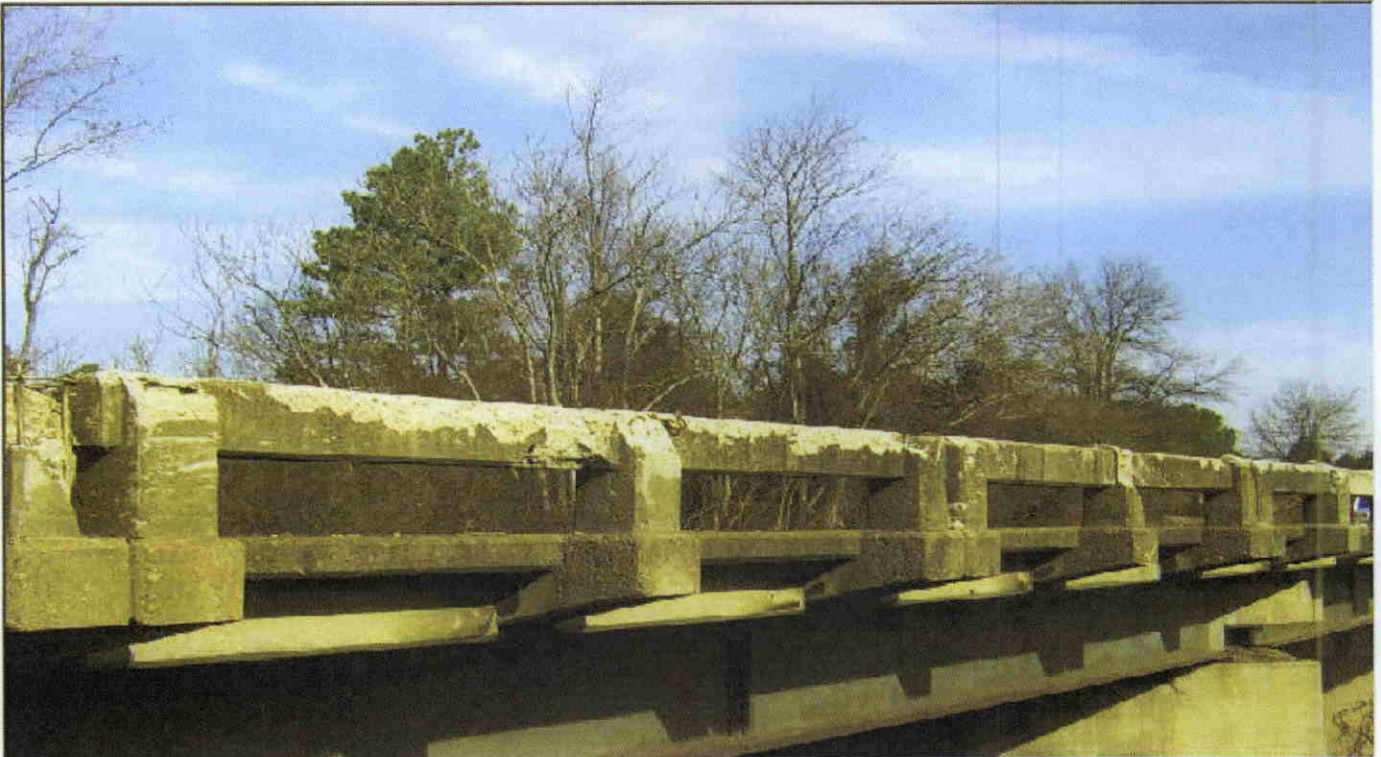
GUARDRAIL DAMAGE AT RIGHT SIDE OF SPAN 2

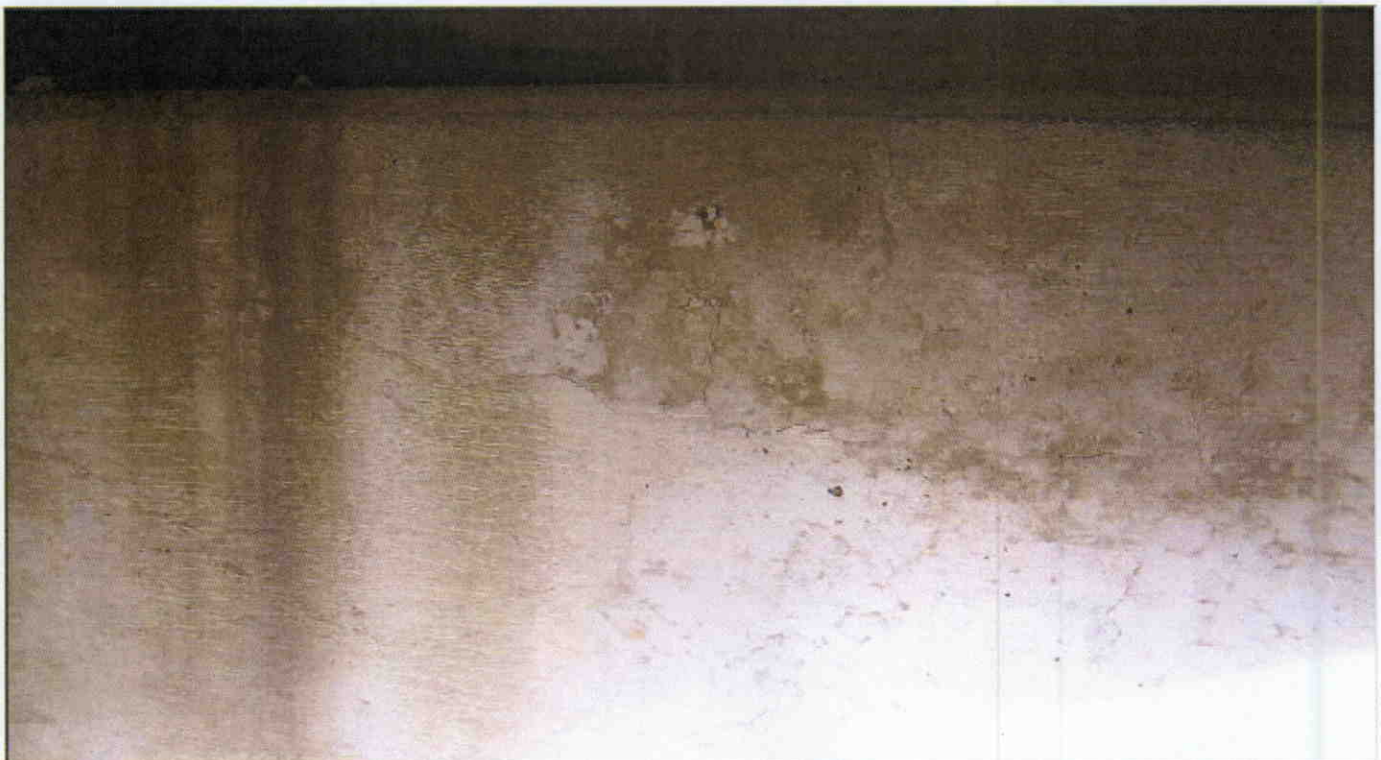
HAIRLINE CRACKS IN SPAN 1 SIDE FACE OF BENT 1 BAY 3

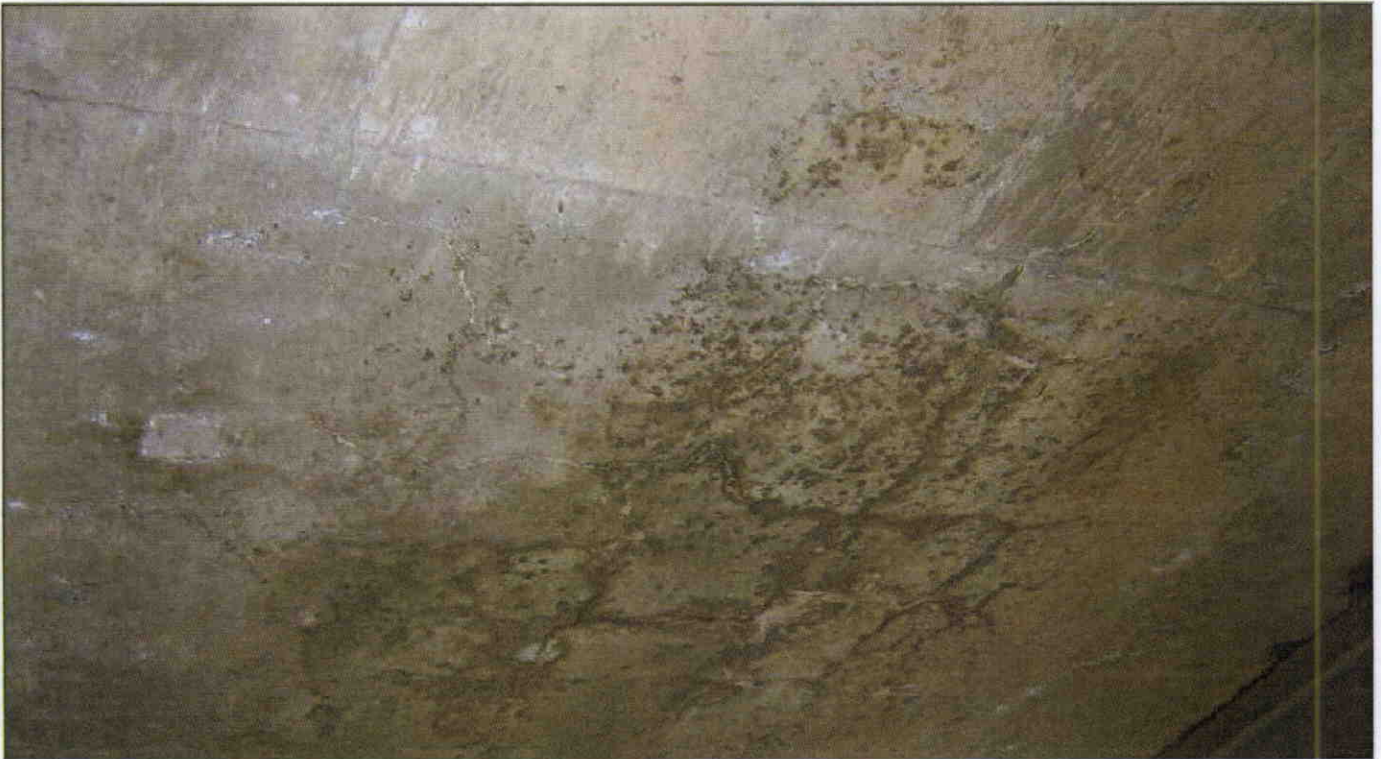
CRACKS WITH EFFLO LEAKAGE IN BOTTOM OF DECK BAY 3 SPAN 1

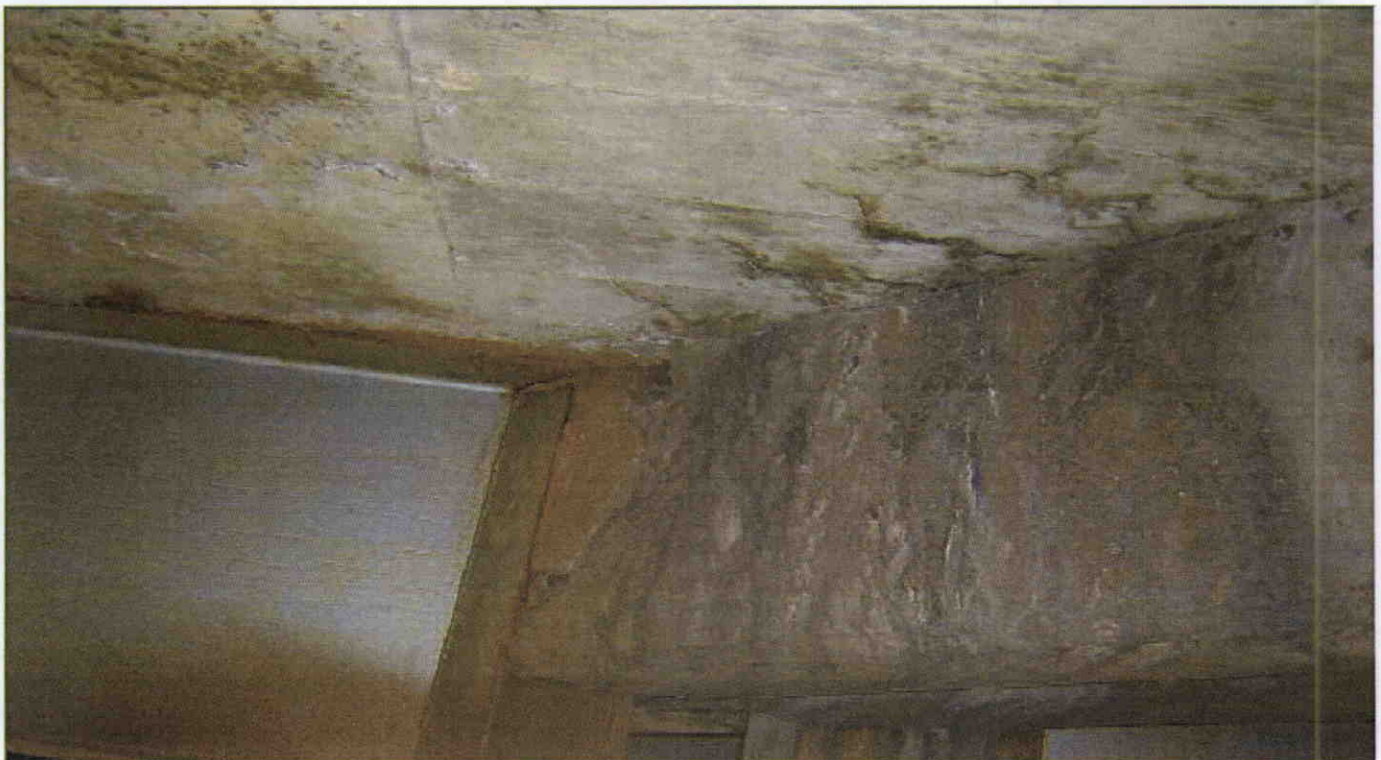
CRACKS AND SPALLS IN BAY 3 DIAPHRAGM OF SPAN 1 AT BENT 1

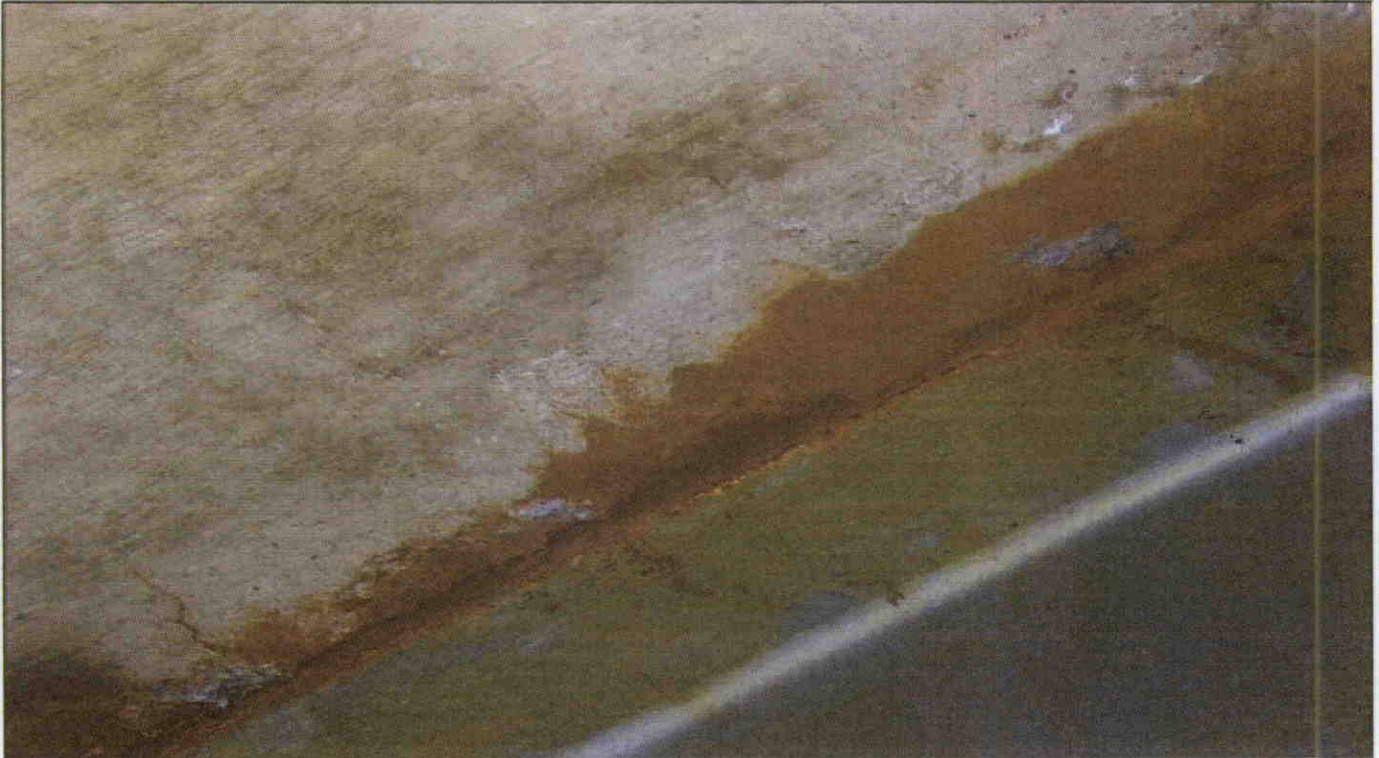
RUST POWDER STAIN IN BOTTOM OF DECK AT BEAM 3 SPAN 1 AT BENT 1

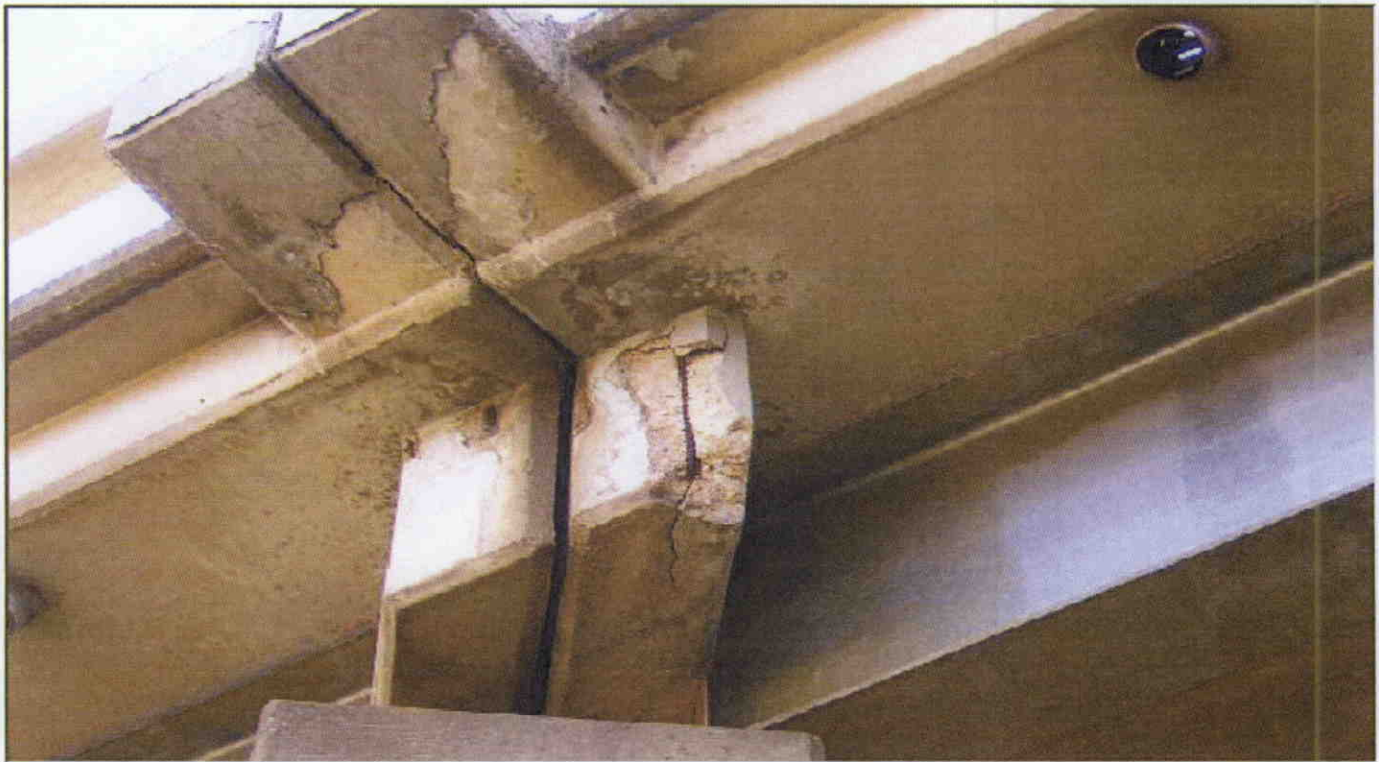
SPALL WITH EXPOSED REBAR IN LEFT DIAPHRAGM AT BENT 2

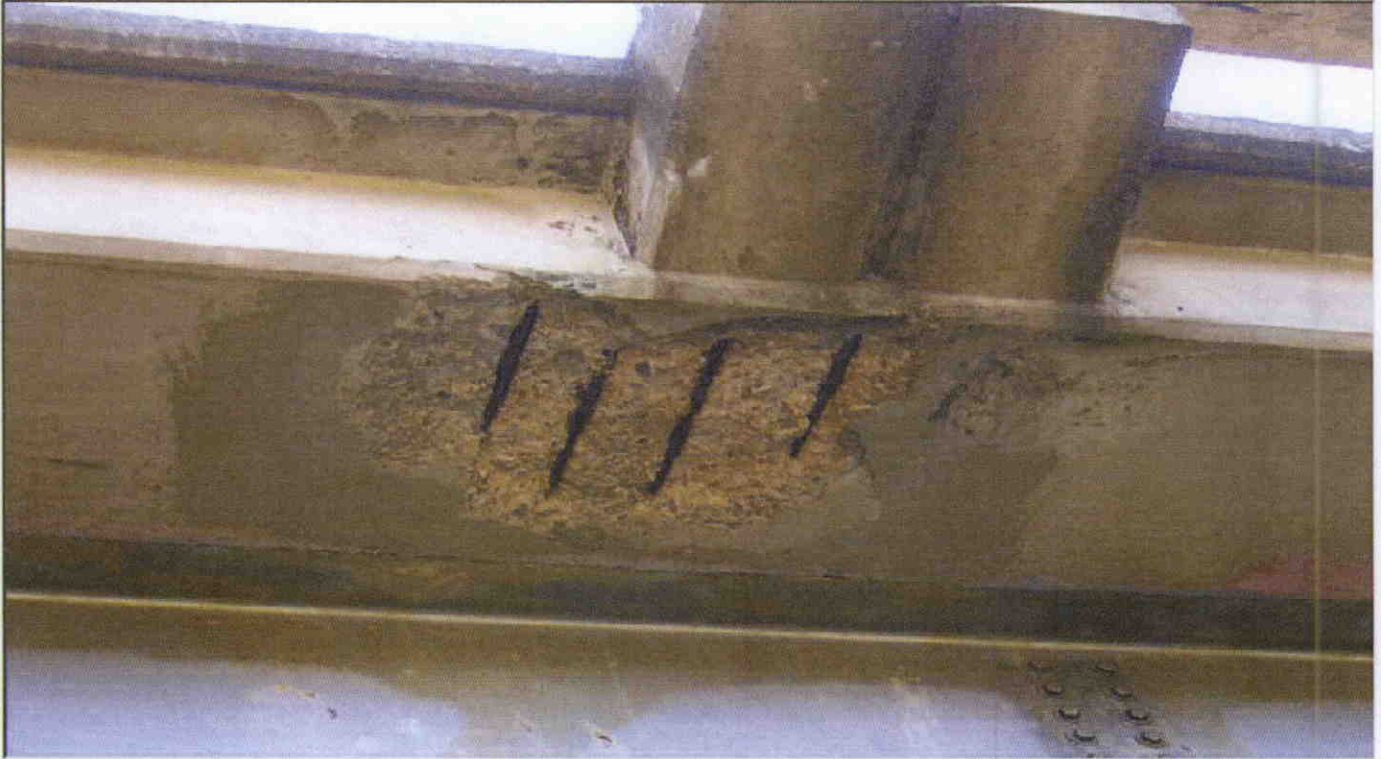
SPALL WITH EXPOSED REBAR IN BOTTOM OF LEFT OVERHANG SPAN 2

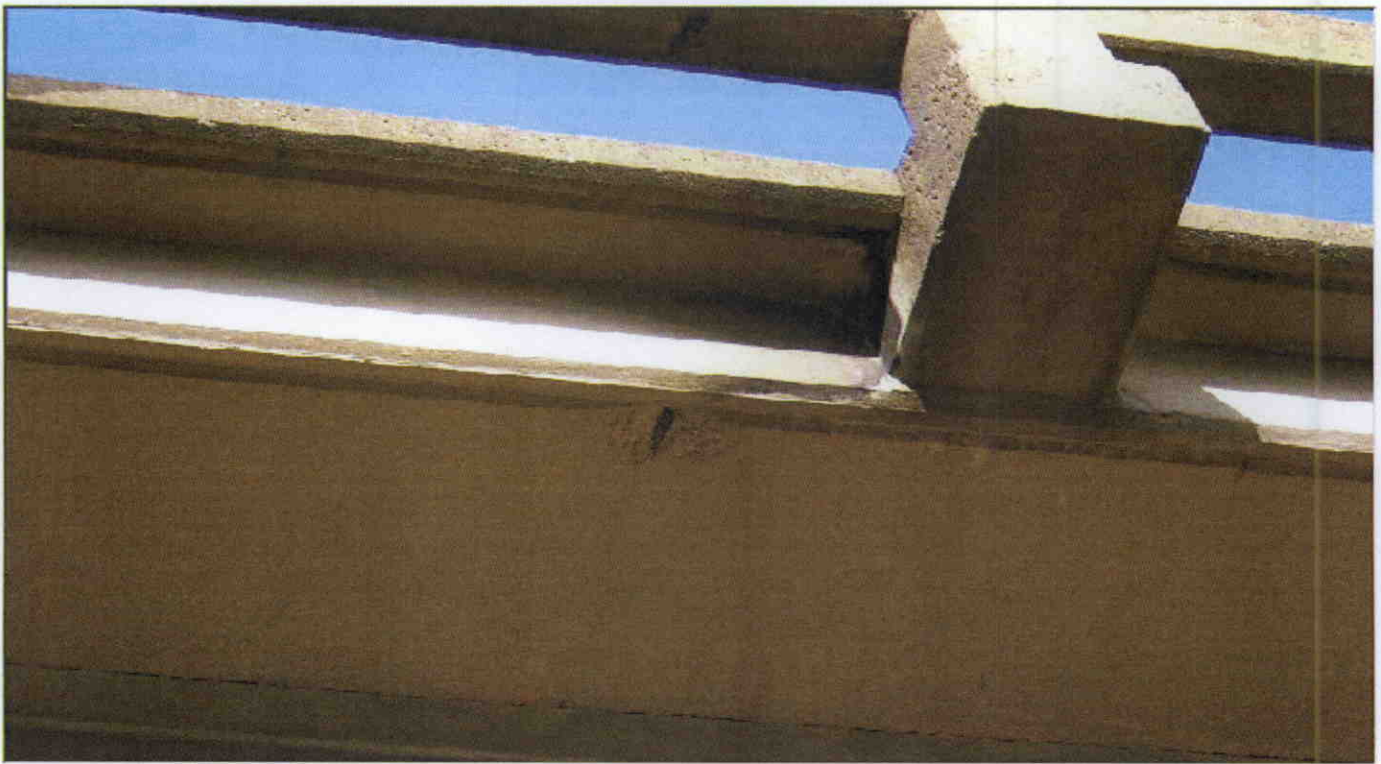
SPALL WITH EXPOSED REBAR IN BOTTOM OF RIGHT OVERHANG SPAN 3

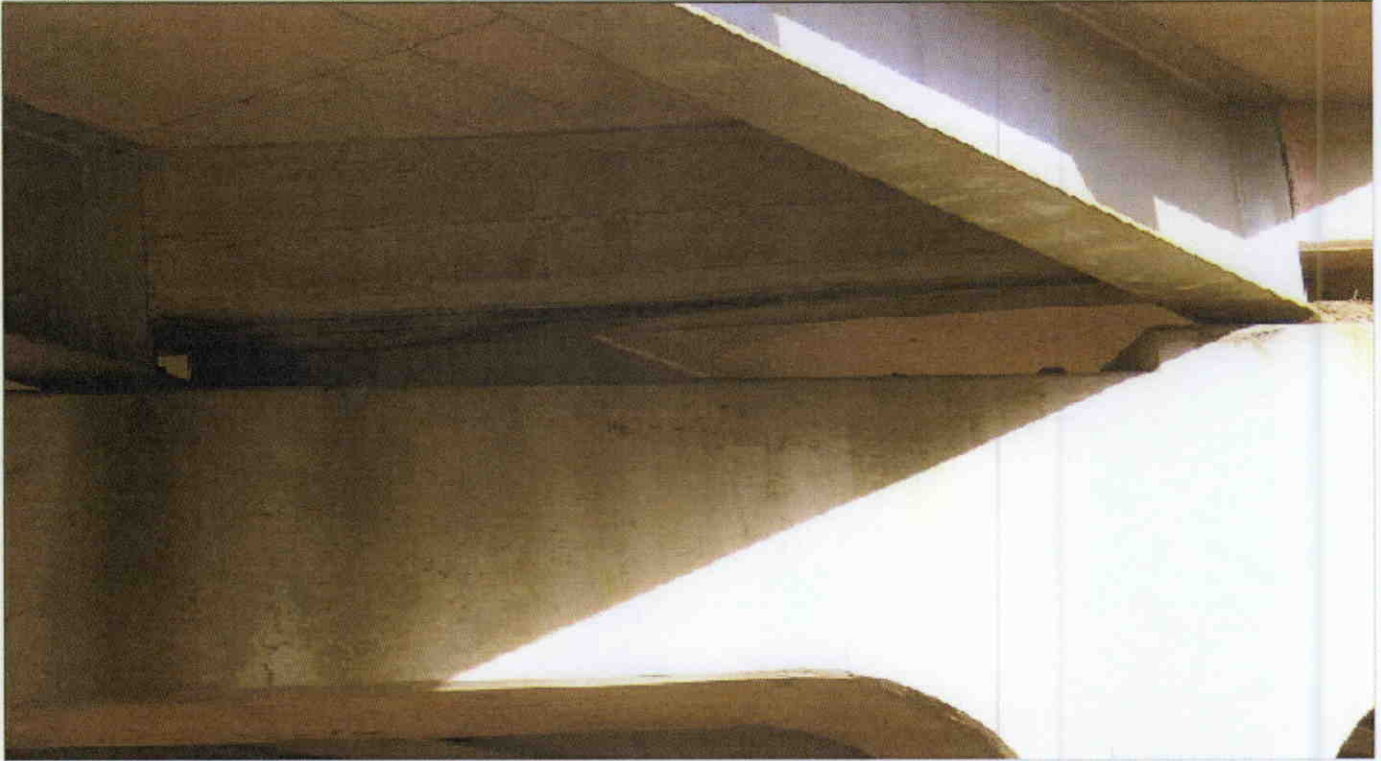
LONGITUDINAL CRACK IN FACE OF SPAN 3 SIDE OF BENT 3 CAP AT BAY 3

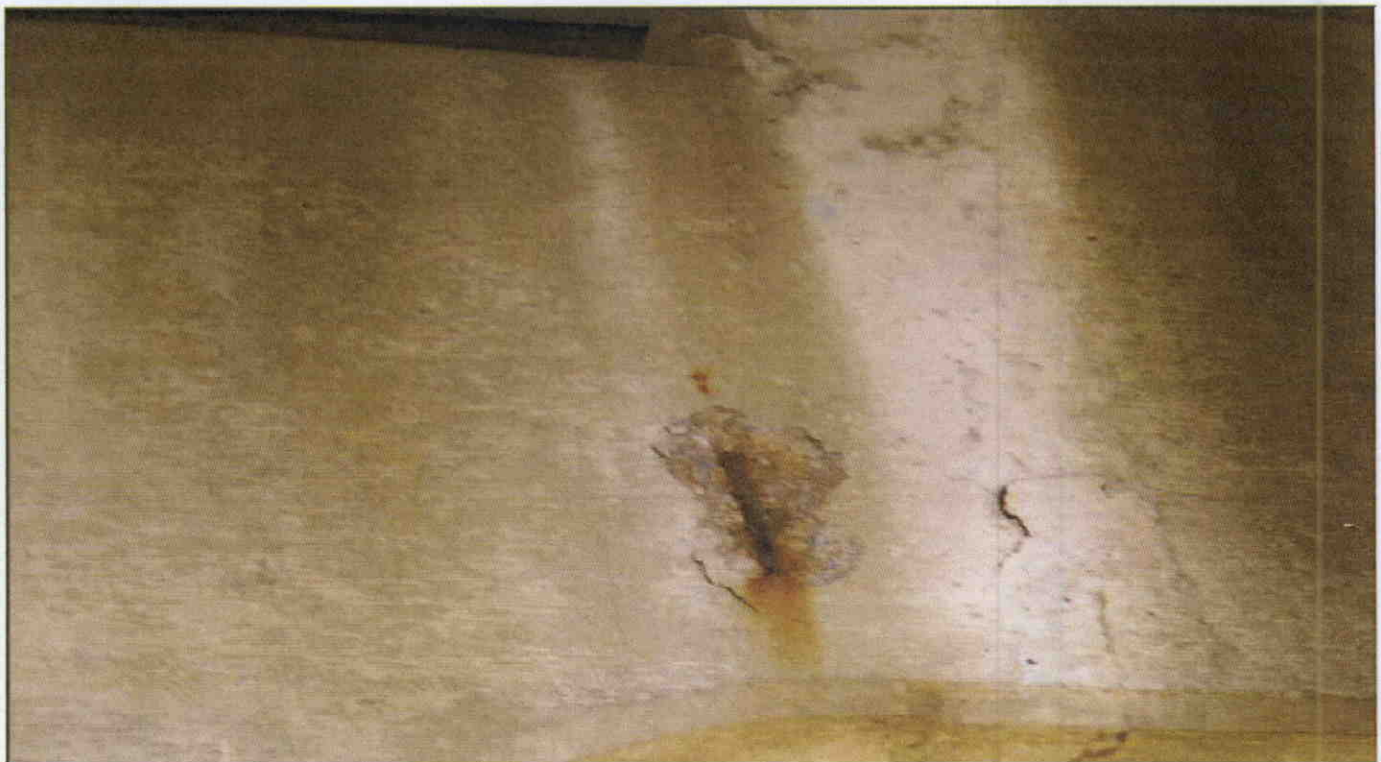
SPALL WITH EXPOSED REBAR IN FACE OF SPAN 3 SIDE OF BENT 3 AT BEAM 3

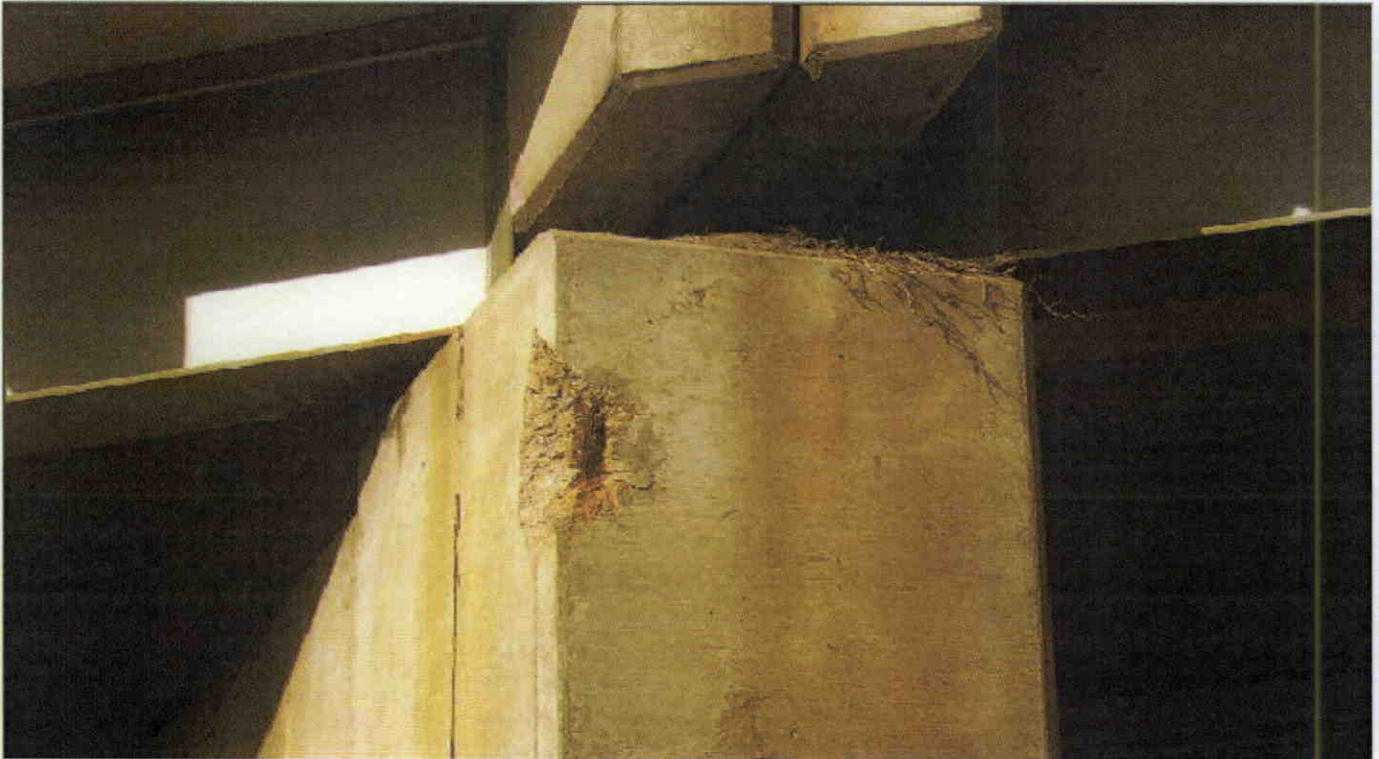
SPALL WITH EXPOSED REBAR IN RIGHT END OF BENT 3 CAP

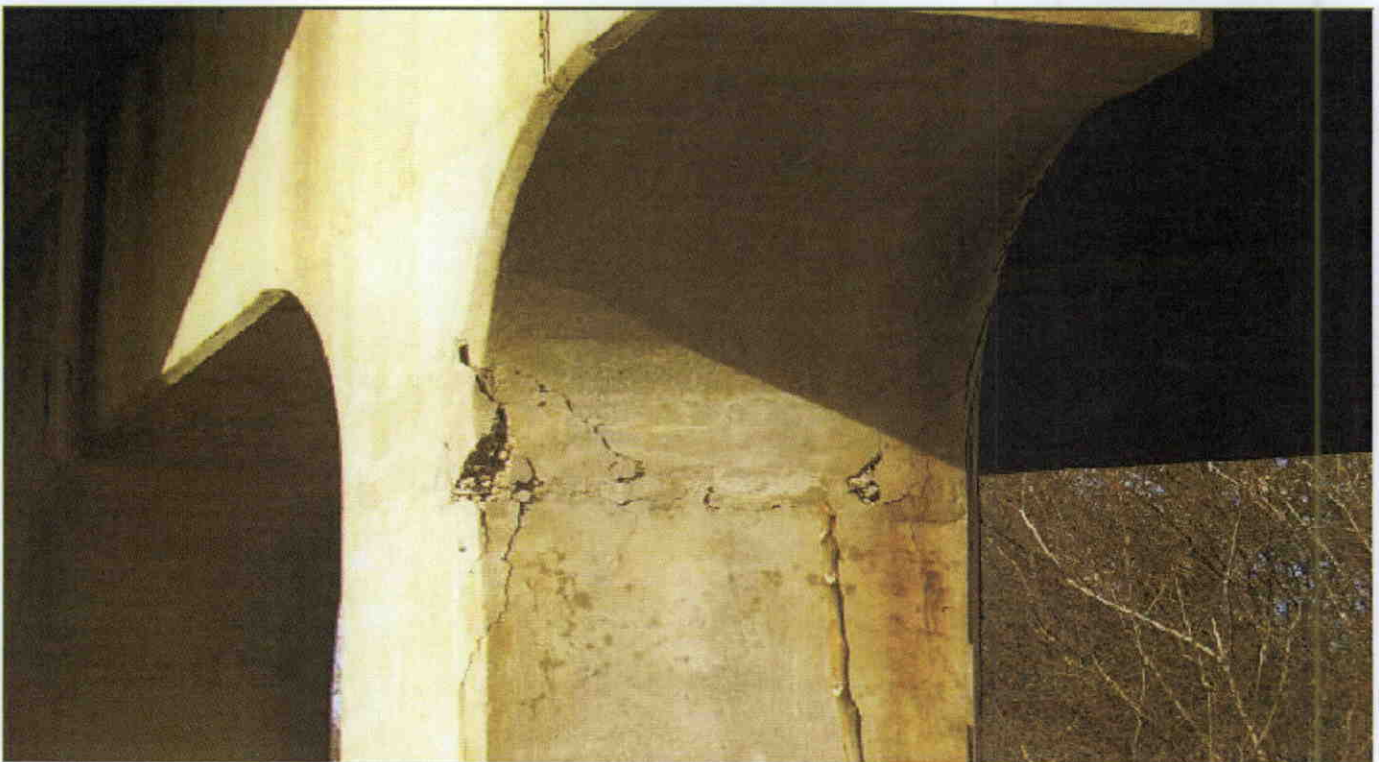
SPALLS CRACKS AND DELAMINATION IN RIGHT SIDE OF COLUMN 3 BENT 3

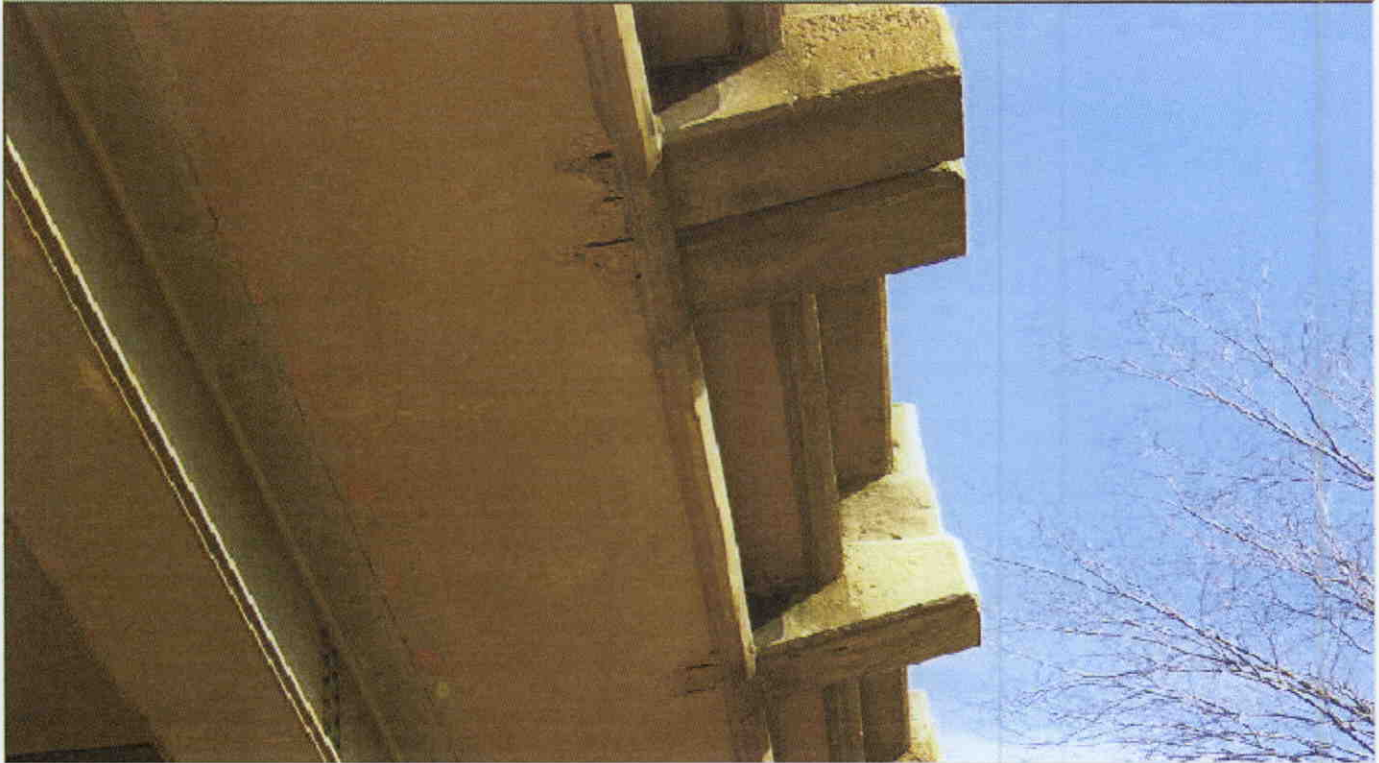
SPALLS WITH EXPOSED REBAR IN BOTTOM OF RIGHT OVERHANG OF SPAN 4

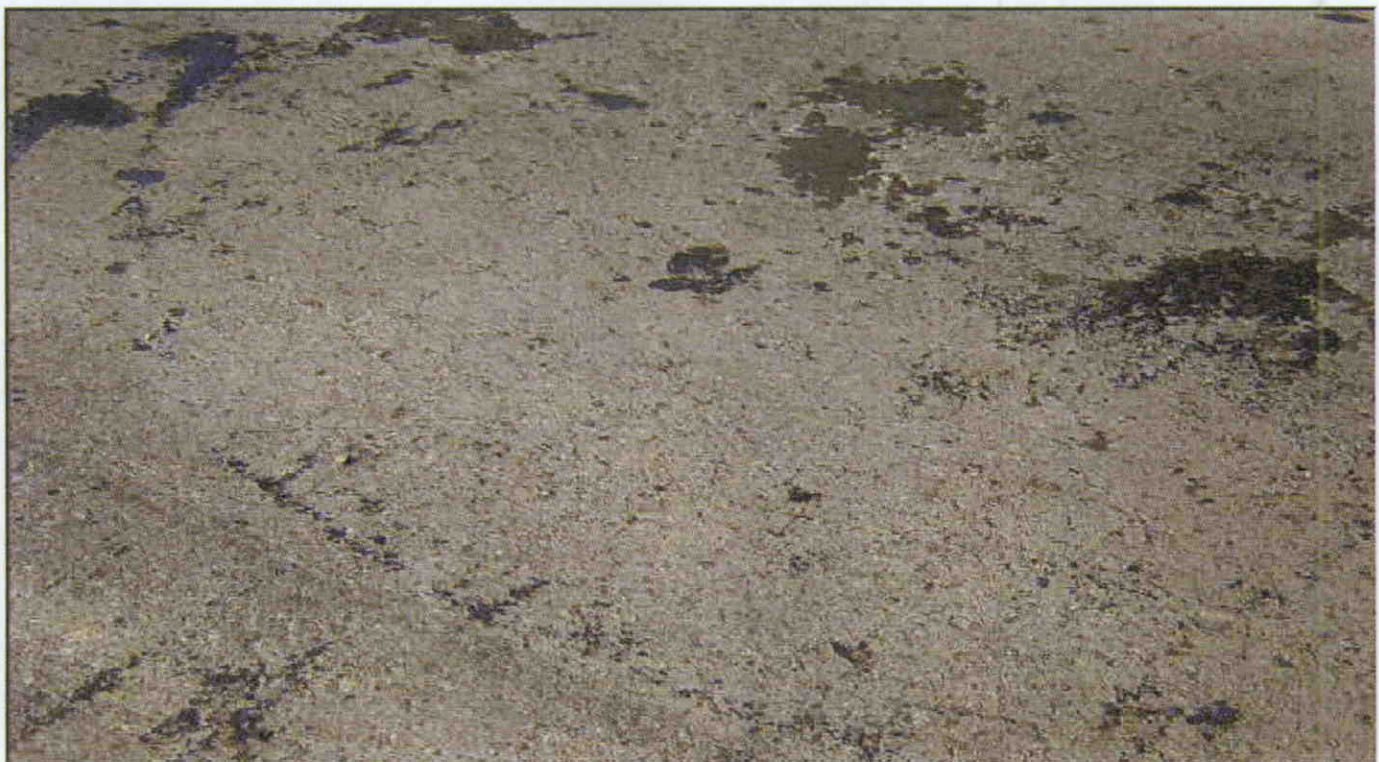
MAP CRACK IN TOP OF DECK SPAN 4

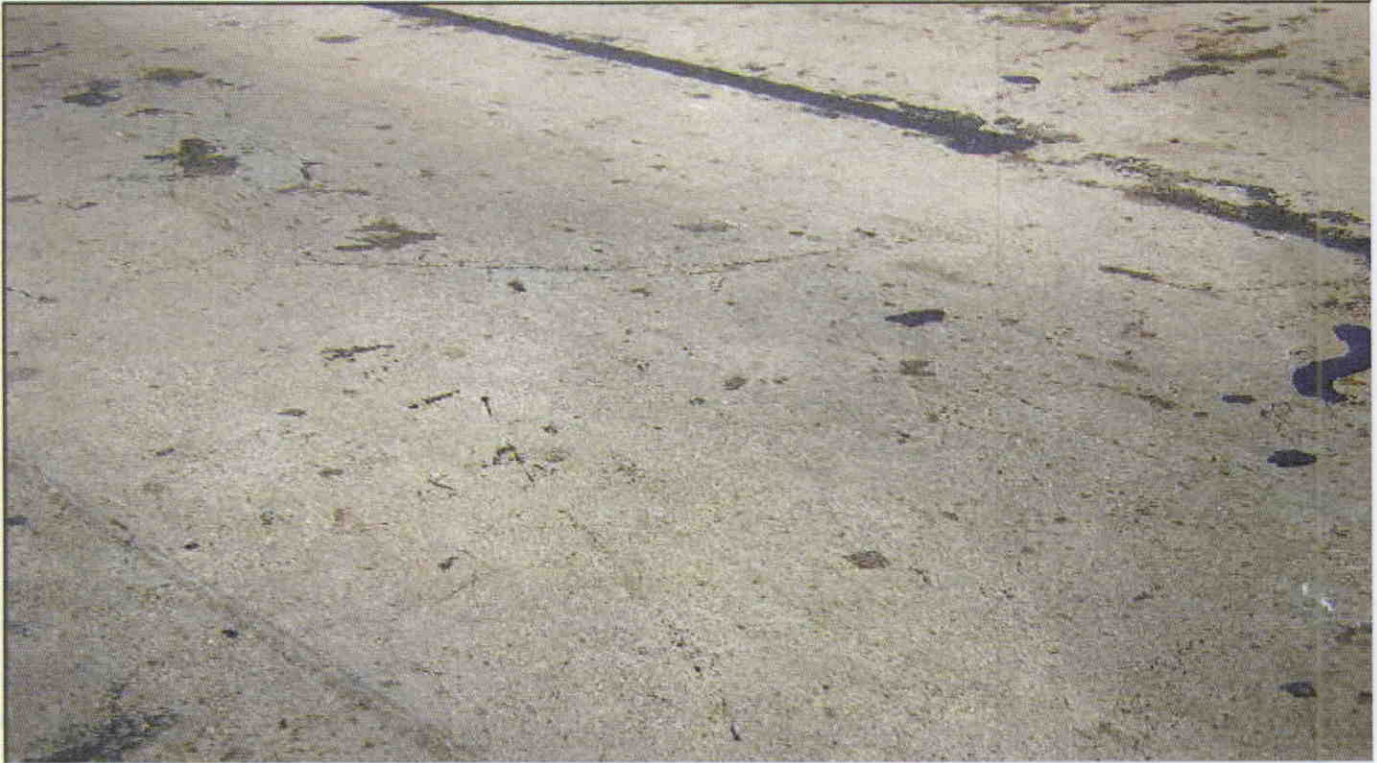
TRANSVERSE AND MAP CRACKS AND SCALING WITH EXPOSED COARSE AGGREGATE IN TOP OF DECK SPAN 3

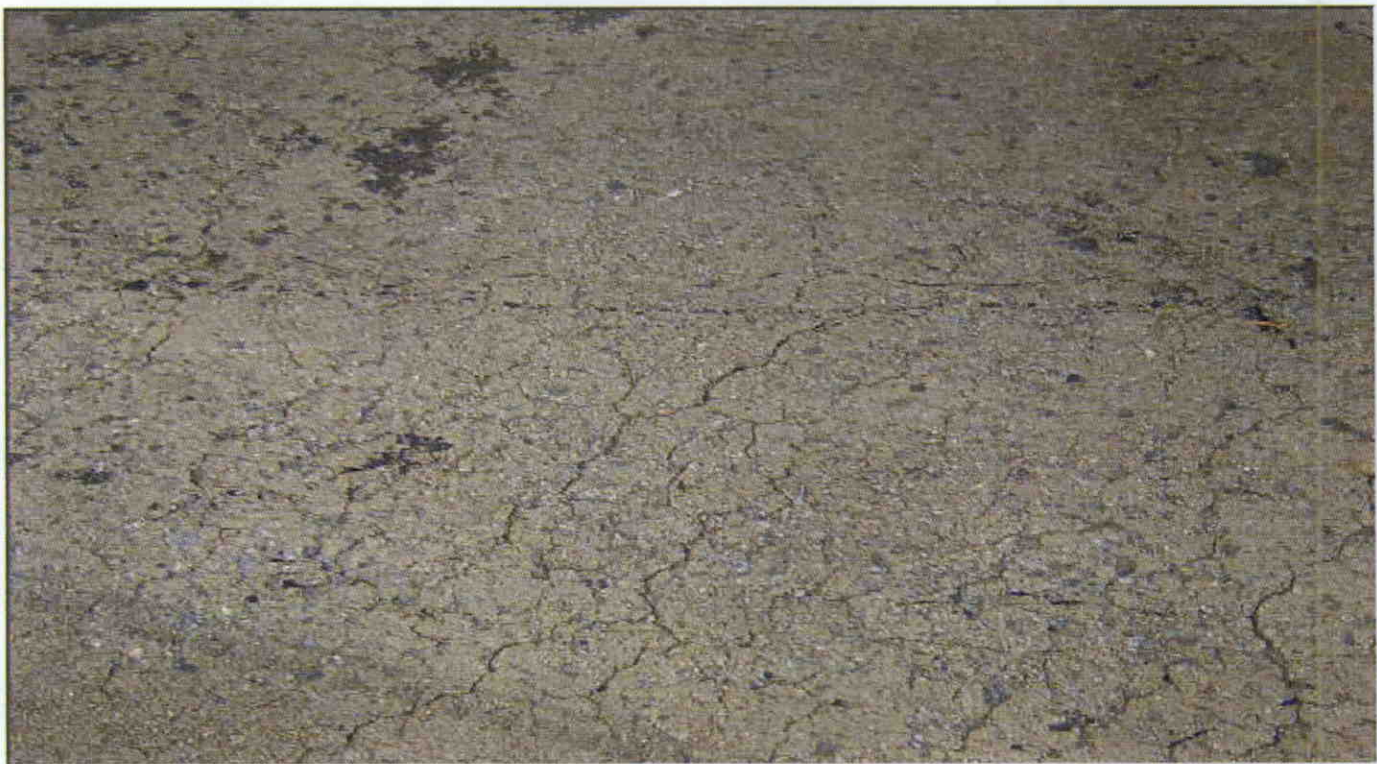
MAP CRACKS AND SCALING WITH EXPOSED COARSE AGGREGATE IN TOP OF DECK SPAN 2

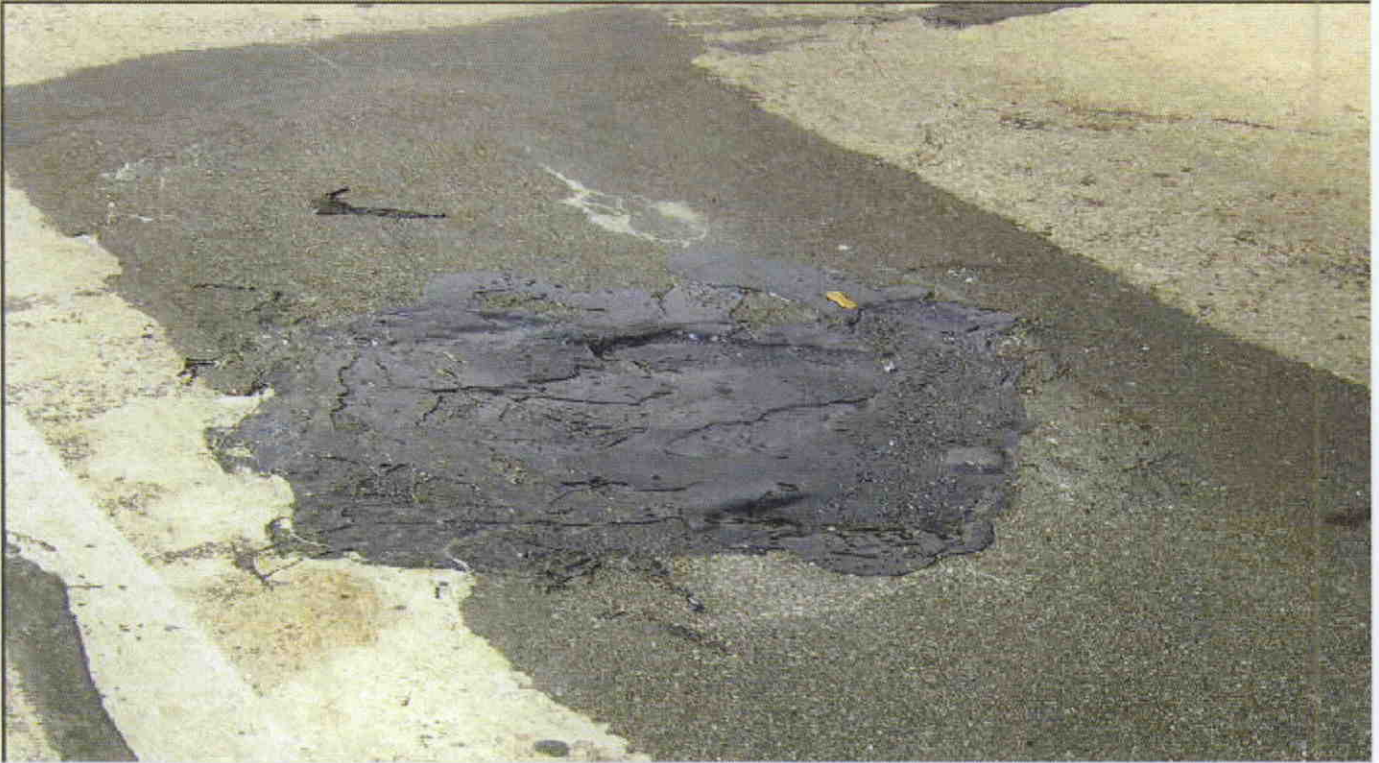
PATCH AND SETTLEMENT IN TOP OF DECK SPAN 1
