N.C. DEPARTMENT OF TRANSPORTATION
 DIVISION OF HIGHWAYS
 BRIDGE MAINTENANCE UNIT

Attention:

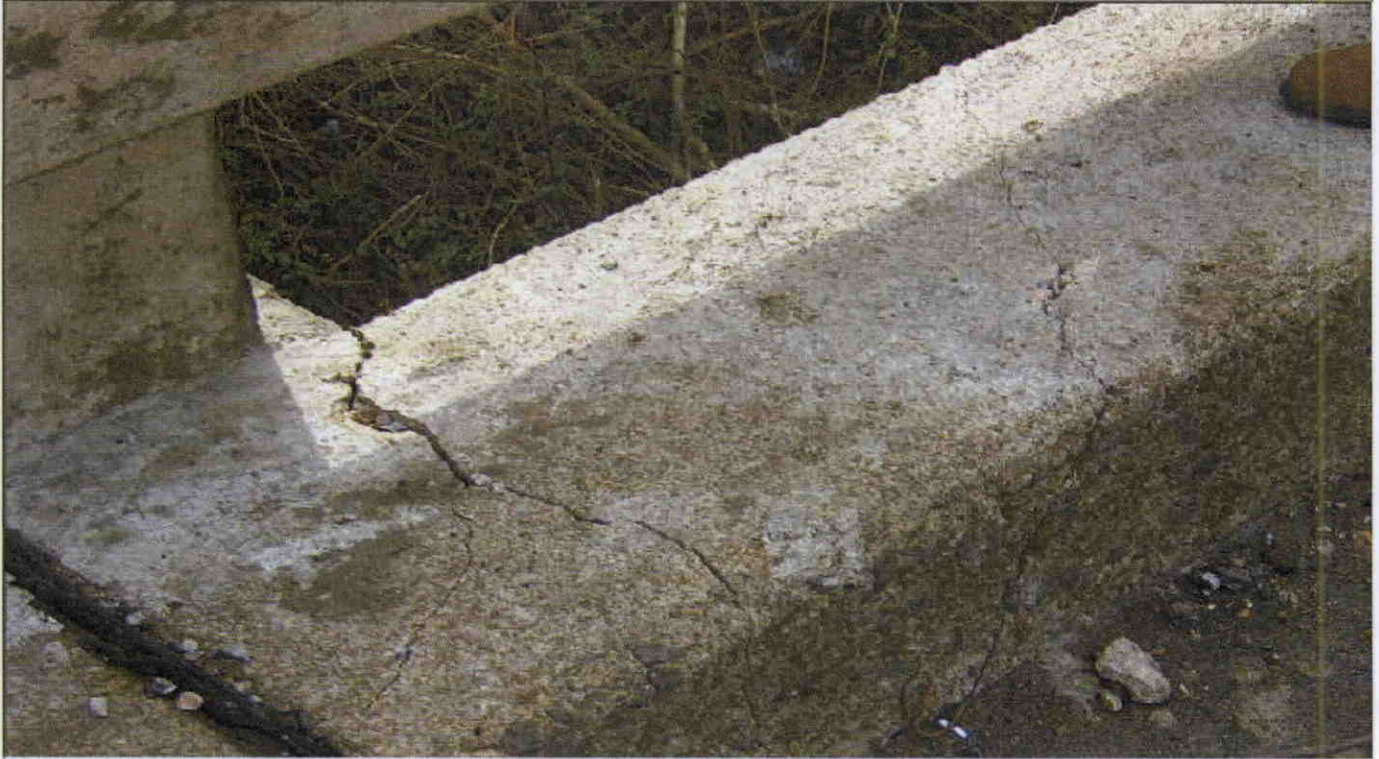
CRACKED CURB AT RIGHT SIDE OF SPAN 2 AT BENT 2

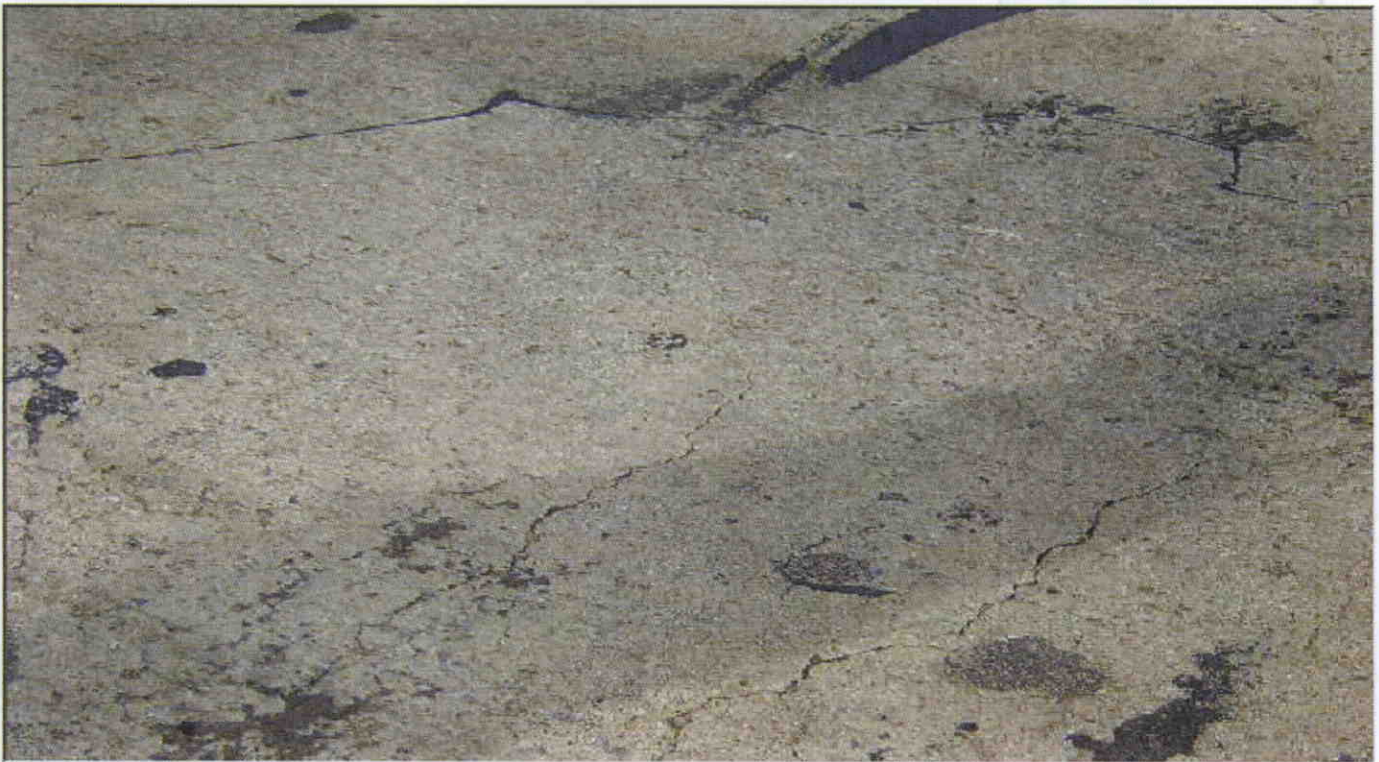
TRANSVERSE CRACKS IN TOP OF DECK SPAN 1

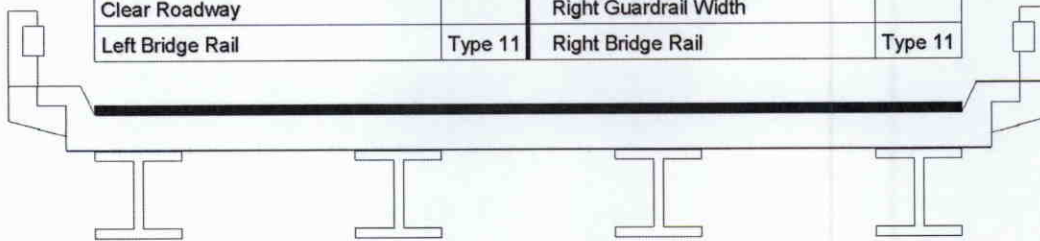
Measurements for Span #	1	ALL SPANS SIMILAR	
Deck Thickness	.604	Left Overhang	3.833
Top of Rail to Bottom of Beam	6.333	Right Overhang	3.833

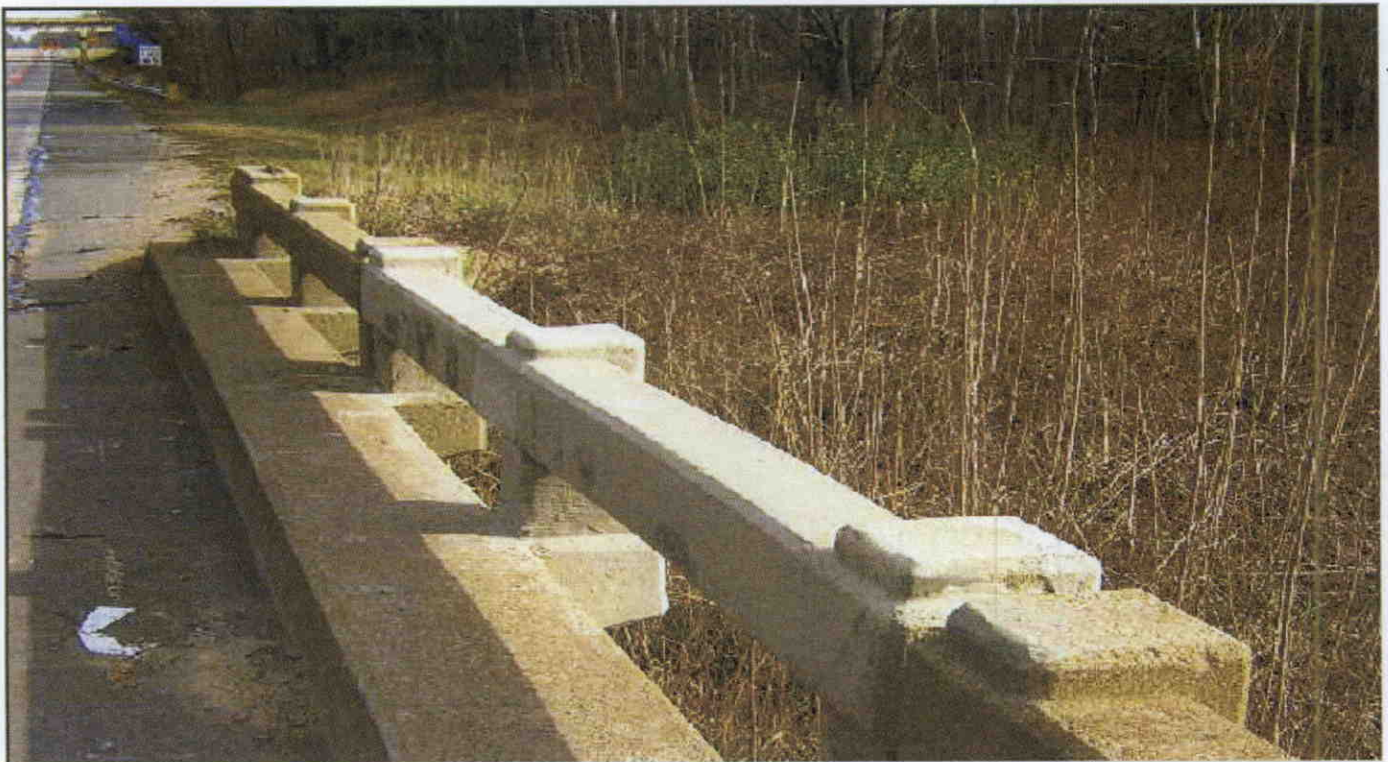
GUARDRAIL REPAIR AT RIGHT SIDE OF SPAN 4

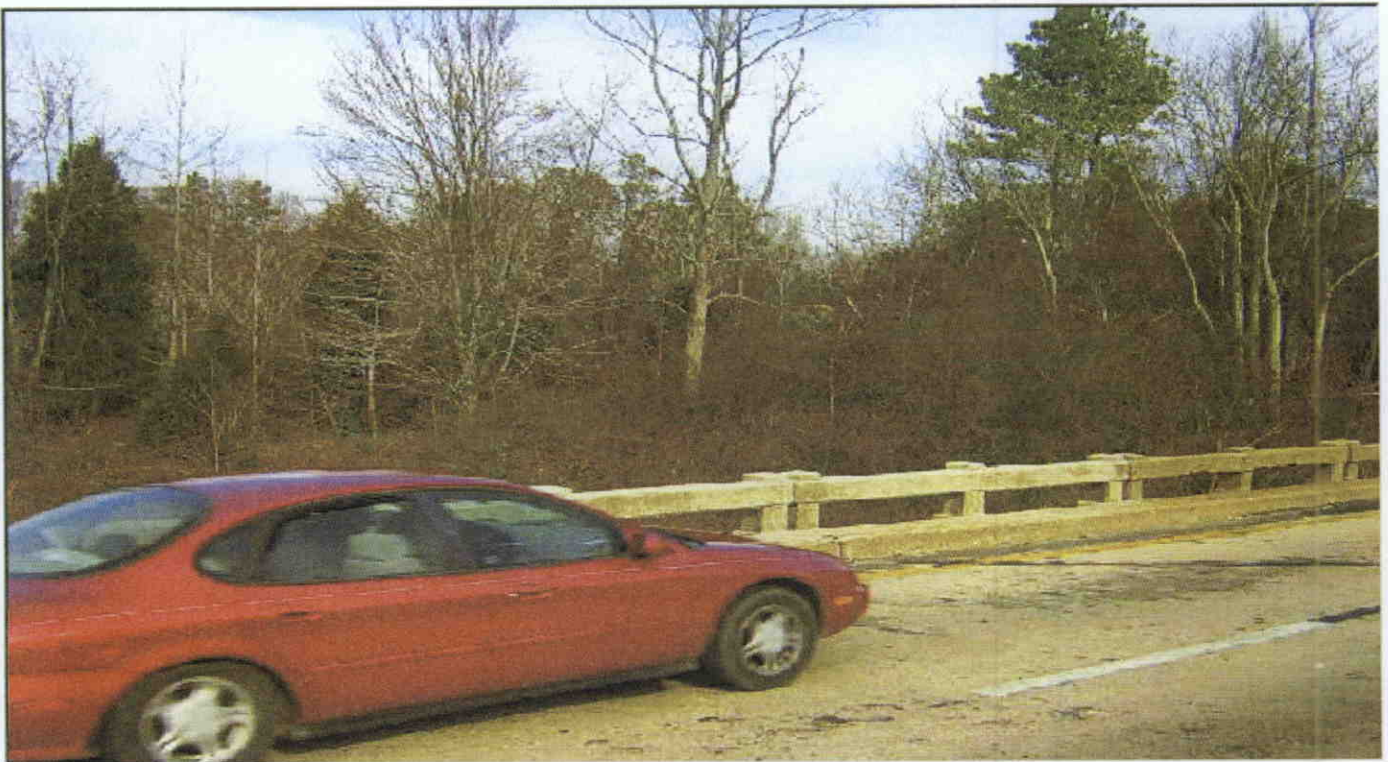
GUARDRAIL REPAIR AT LEFT SIDE OF END BENT 2
