PROJECT NO. <u>I-5788</u> <u>CUMBERLAND</u> COUNTY BRIDGE NO. <u>157</u> SHEET 2 OF 5					
STATE OF NORTH CAROLINA DEPARTMENT OF TRANSPORTATION					
SUPERSTRUCTURE					
REPAIR					
SPAN B					
NBL					
REVISIONS SHEET NO.					
NO. BY: DATE: NO. BY: DATE: S-26					
1 3 TOTAL SHEETS 72 4					
<b>2 4</b> 72

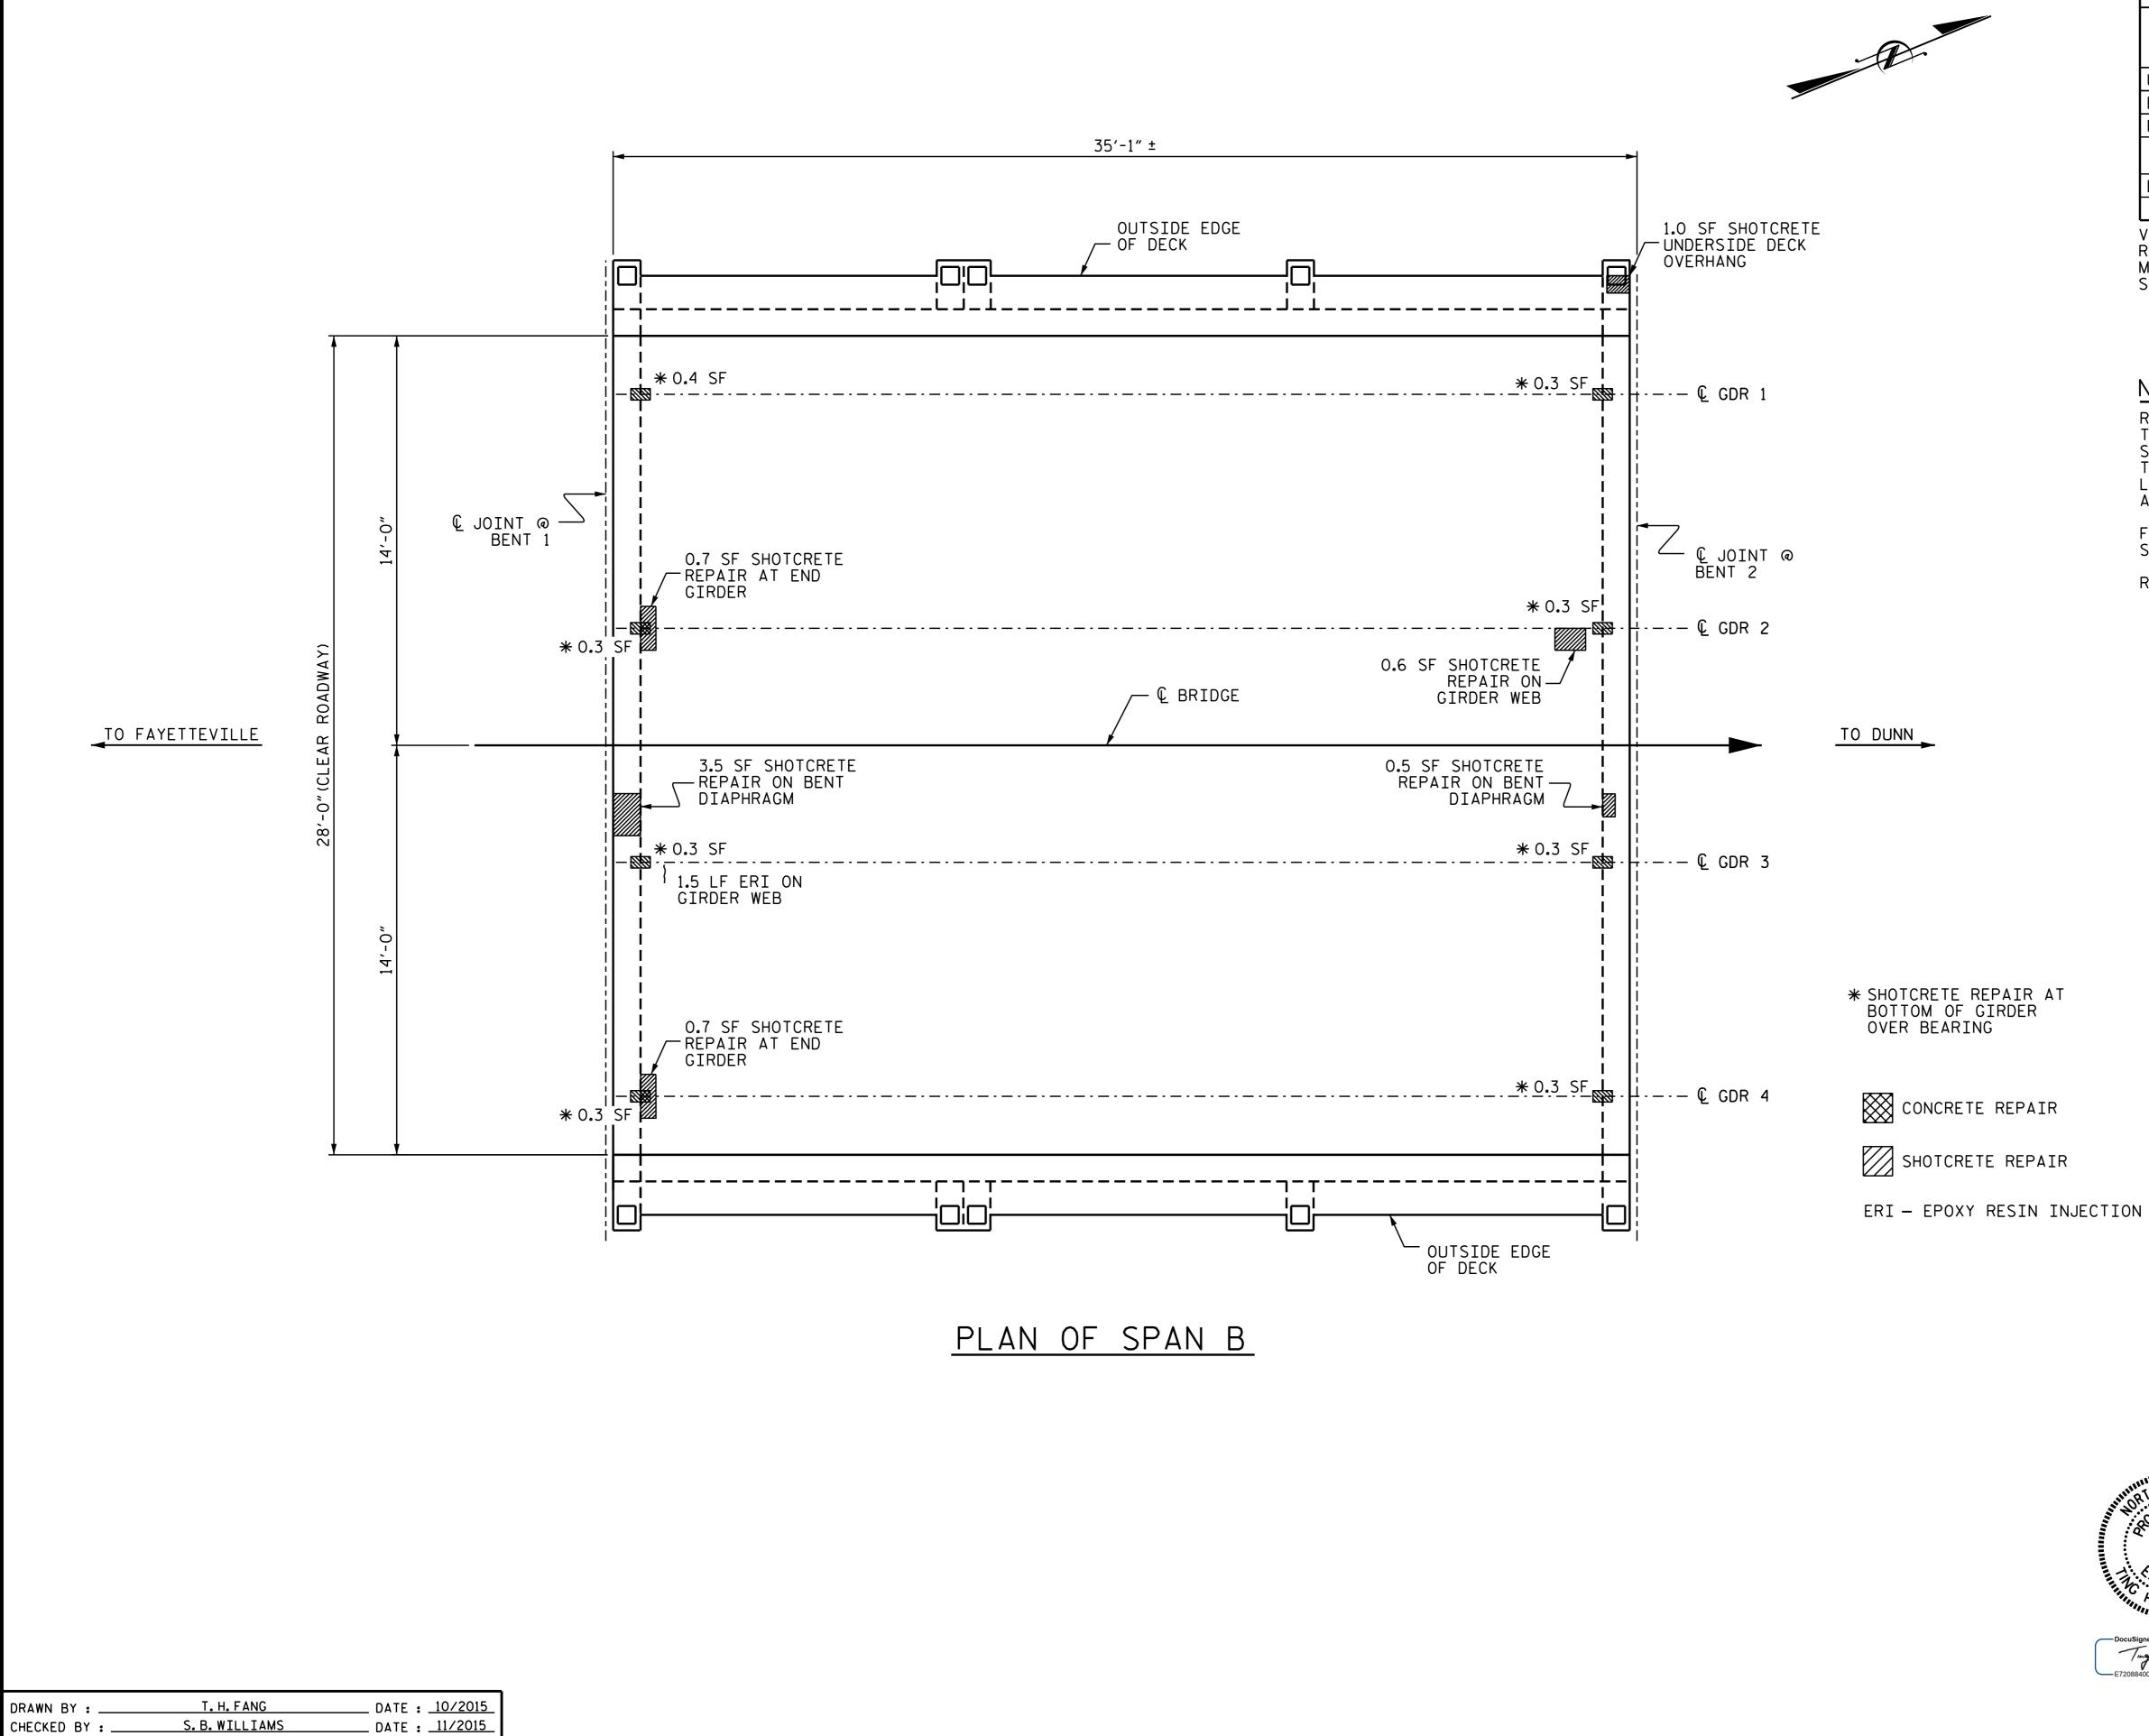
REPAIR QUANTI	ΤΥ Τ.	ABLE			
UNDERSIDE OF DECK REPAIRS					
	ESTIMATE		ACTUAL		
SHOTCRETE REPAIRS	AREA SF	VOLUME CF	AREA SF	VOLUME CF	
UNDERSIDE OF DECK & OVERHANGS	1.0	0.3			
BENT DIAPHRAGMS	4.0	1.0			
RC DECK GIRDERS	4.5	1.2			
	ESTIMATE		ACTUAL		
EPOXY RESIN INJECTION	1.5 LF

VALUES IN CHARTS REPRESENT ESTIMATED UNDERSIDE OF DECK REPAIR TOTALS AFTER REMOVAL OF UNSOUND CONCRETE, MIN.OF 1" BEHIND REBAR AND MIN.1" CLEAR TO SAWCUT. SEE REPAIR DETAILS.

REPAIR LOCATIONS AND ESTIMATE OF QUANTITIES ARE GIVEN WITH THE BEST INFORMATION AVAILABLE. IF ADDITIONAL REPAIRS NOT SHOWN ON THE DRAWINGS ARE DEEMED NECESSARY BY THE ENGINEER, THE ENGINEER SHALL NOTE ON THE DRAWINGS THE APPROXIMATE LOCATION AND DESCRIPTION OF THE REPAIRS AND ADJUST THE ACTUAL QUANTITIES ENTERED INTO THE REPAIR QUANTITY TABLE. FOR BENT DIAPHRAGM AND RC DECK GIRDER REPAIR DETAILS SEE SHEET S-24. REPAIR CONCRETE BENT DIAPHRAGMS AS DIRECTED BY THE ENGINEER.
