BENT 14 CRACKED AND DELAMINATED AREA ON THE NW SIDE OF PILE 4 STARTS 10" BELOW CAP AND GOES DOWN 8' 4" X 12" WIDE.

BENT 17 PILE 3 UNDER SUBCAP 1 HAS SAPLLED AREA 10' 2" LONG X 2 1/2" DEEP ON SW SIDE WITH CABLES EXPOSED AND BROKEN.PM

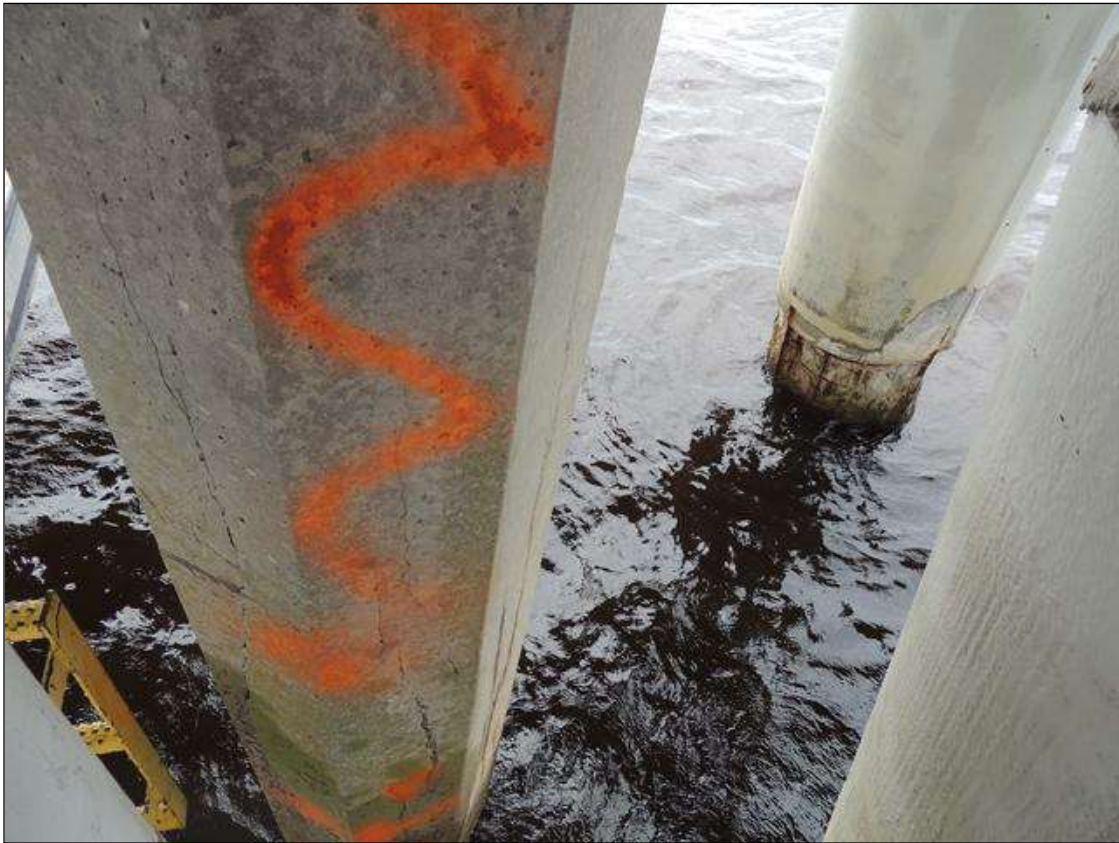
BENT 17 P5 UNDER SUBCAP 2 IS HEAVILY CRACKED AND DELAMINATED 10' 2" LONG X 33" AROUND PILE ON WEST SIDE.PM

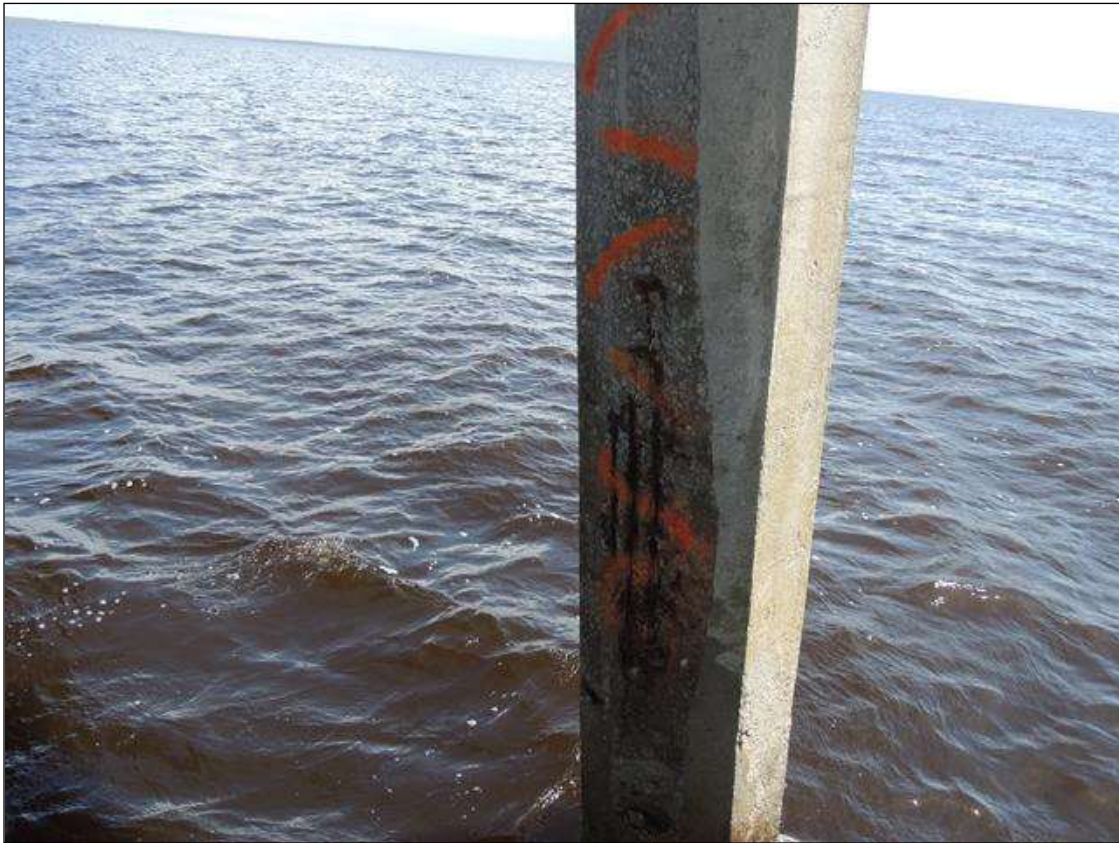
BENT 28 DELAMINATED AND SPALLED AREA ON NORTH FACE OF P4 FROM WL UP 10' 8" TO BOT OF CAP 18" WIDE CABLES EXPOSED PM

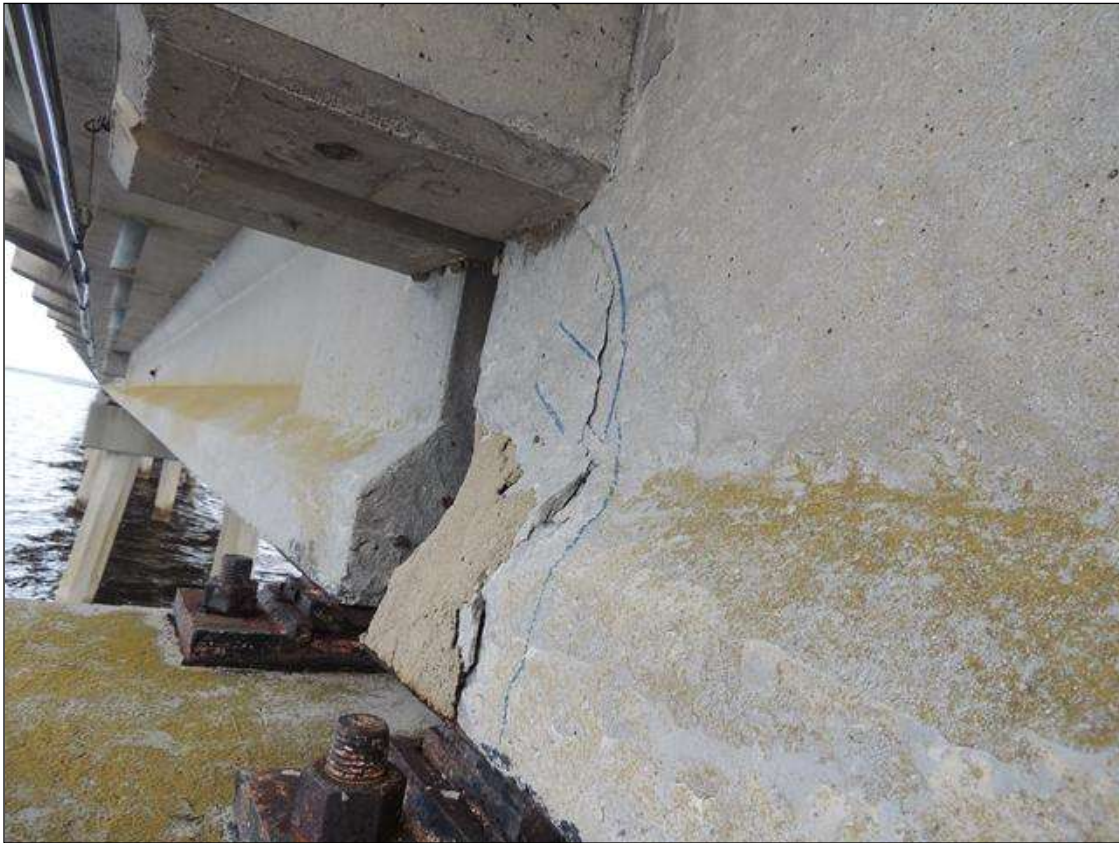
BENT 36 SPAN 36 SIDE PATCHED AND DELAMINATED AREA ALONG BOT LT END OF G1 18" H X 12" FROM END BACK.

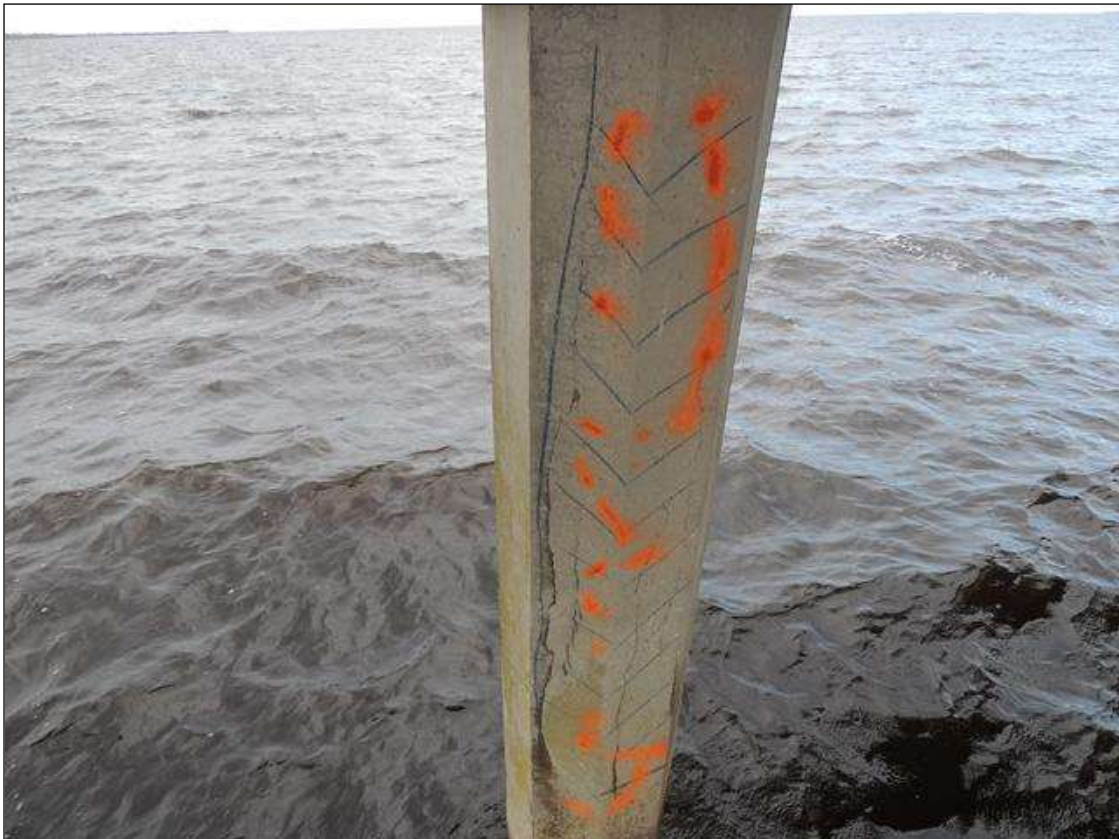
BENT 36 P1 SOUTH FACE CRACKED AND DELAMINATED AREA FROM WL UP TO BOT OF CAP 10' 4".

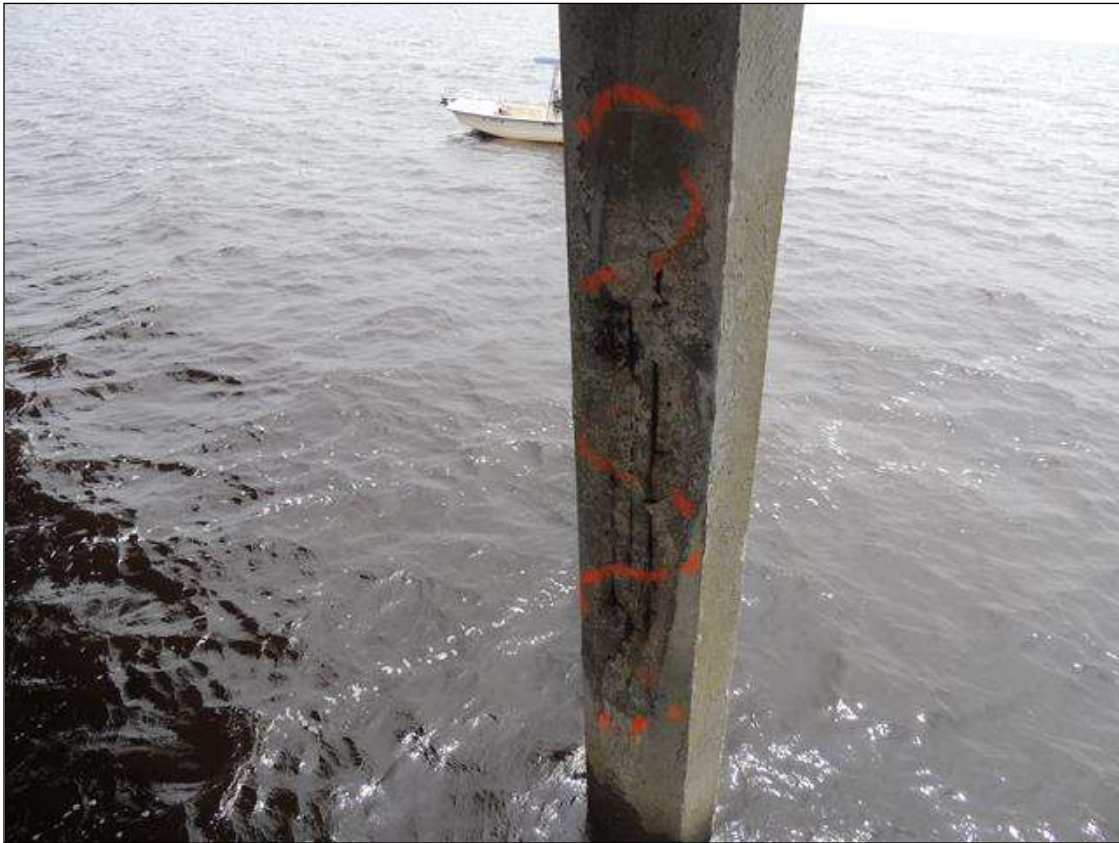
BENT 120 PILE 6 IS CRACKED, DELAMINATED AND SPALLED FROM BOTTOM CAP DOWN 127" AND 18" W WITH 3 CABLES EXPOSED. PM

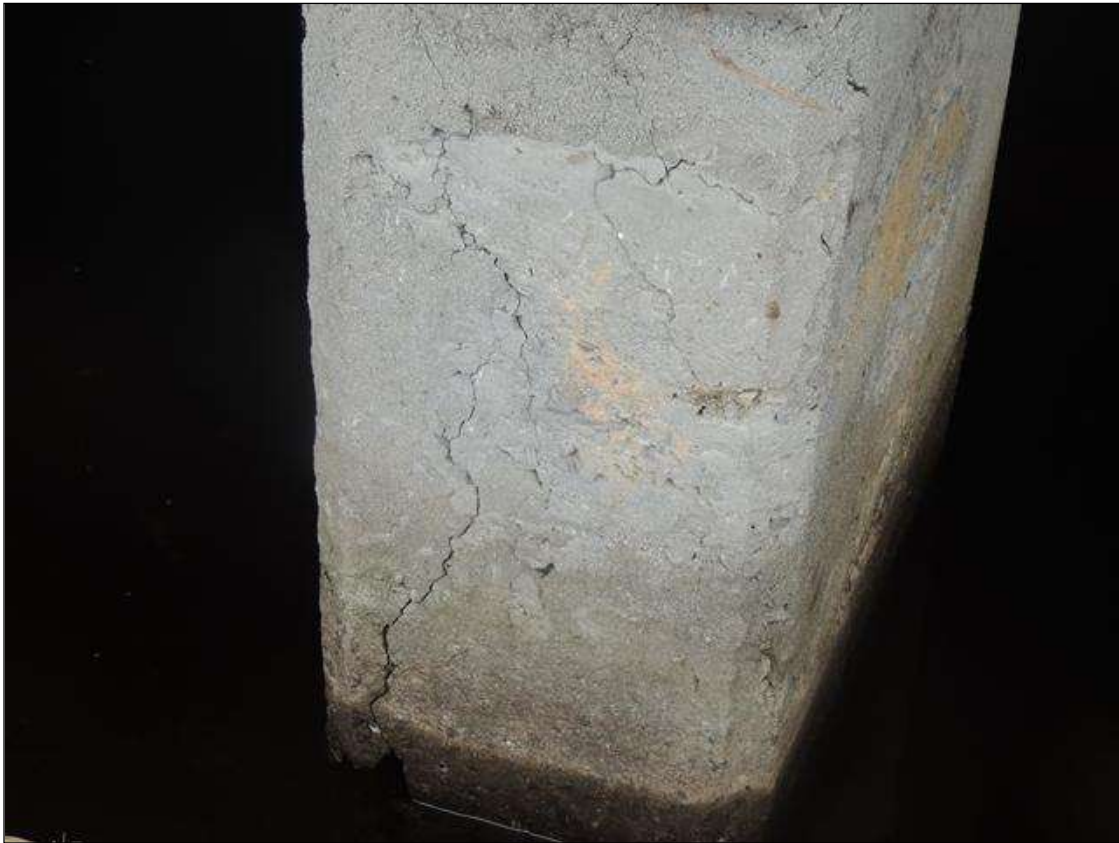
BENT 305 COL 4 CRACKED AND DELAMINATED ALONG RT OUTSIDE EDGE 12" W X 2' H .

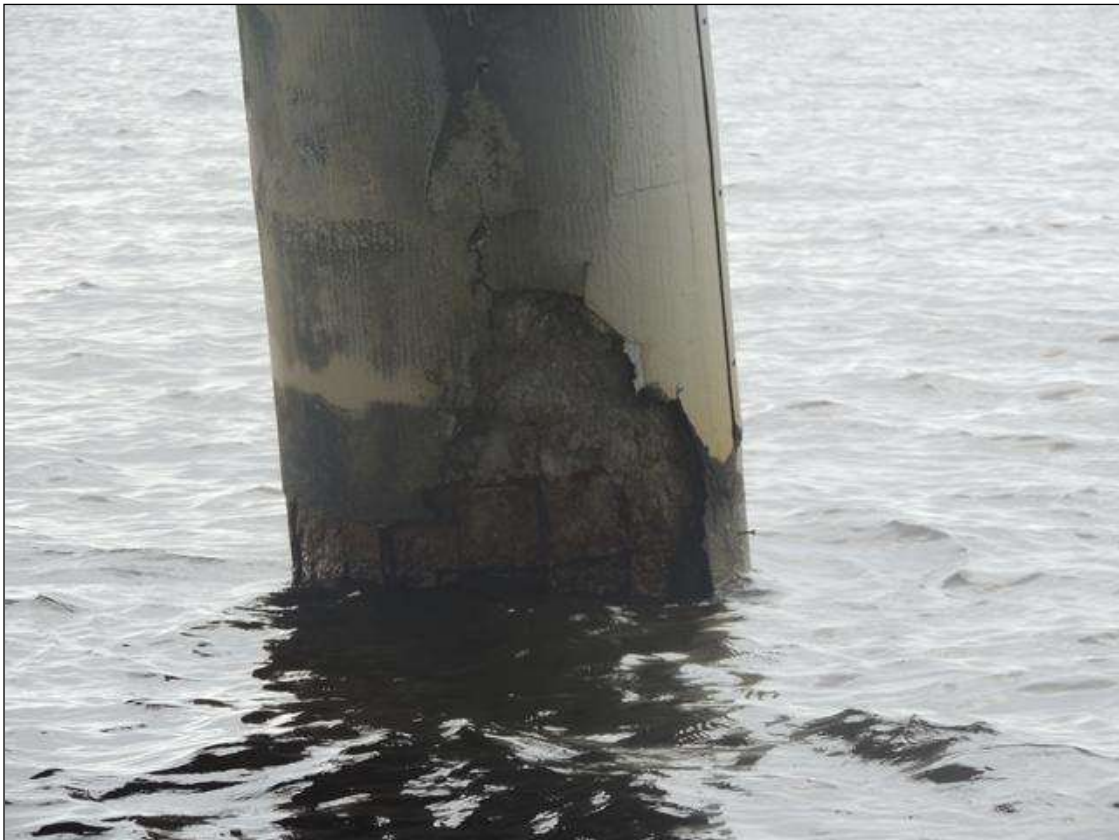
BENT 10 P4 CONCRETE REPAIRED AREA HAS FAILED AND HAS SOME EXPOSED REBAR.

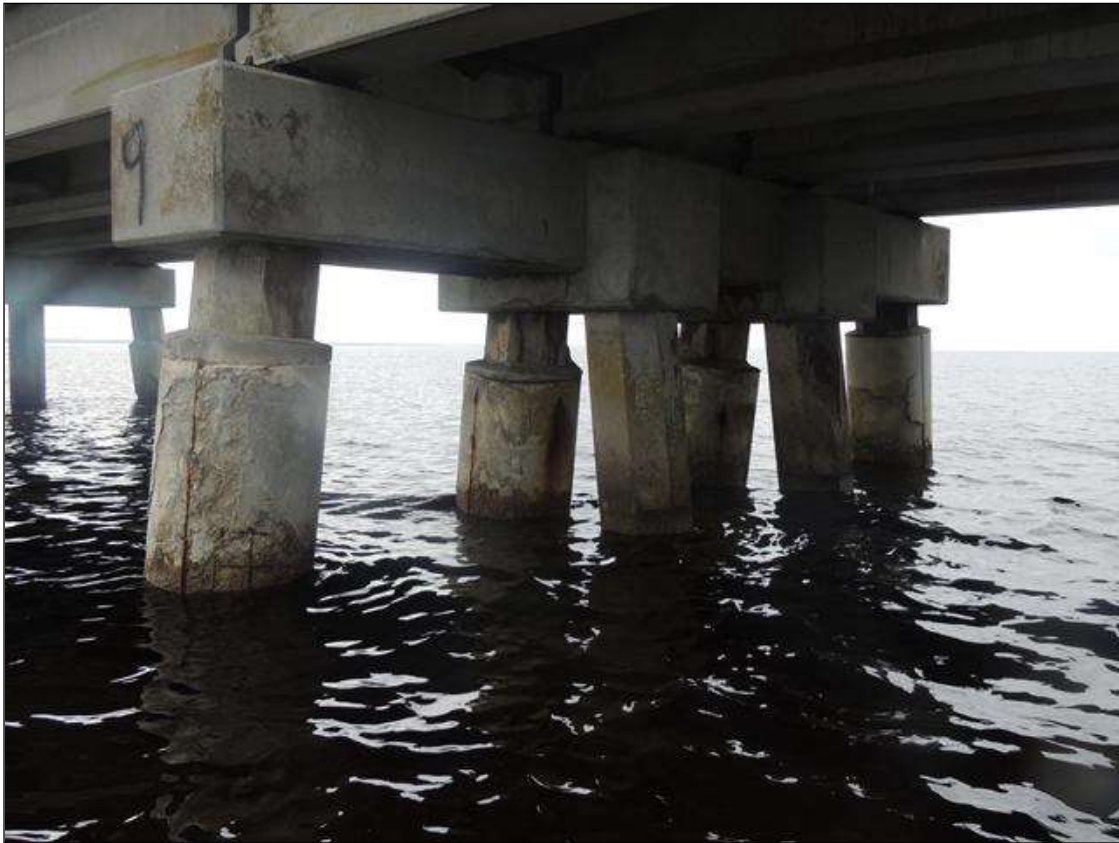
BENT 10 THE CASING AROUND REPAIRED PILES IS BREAKING OFF AROUND PILE.AND MISSING IN SPOTS.

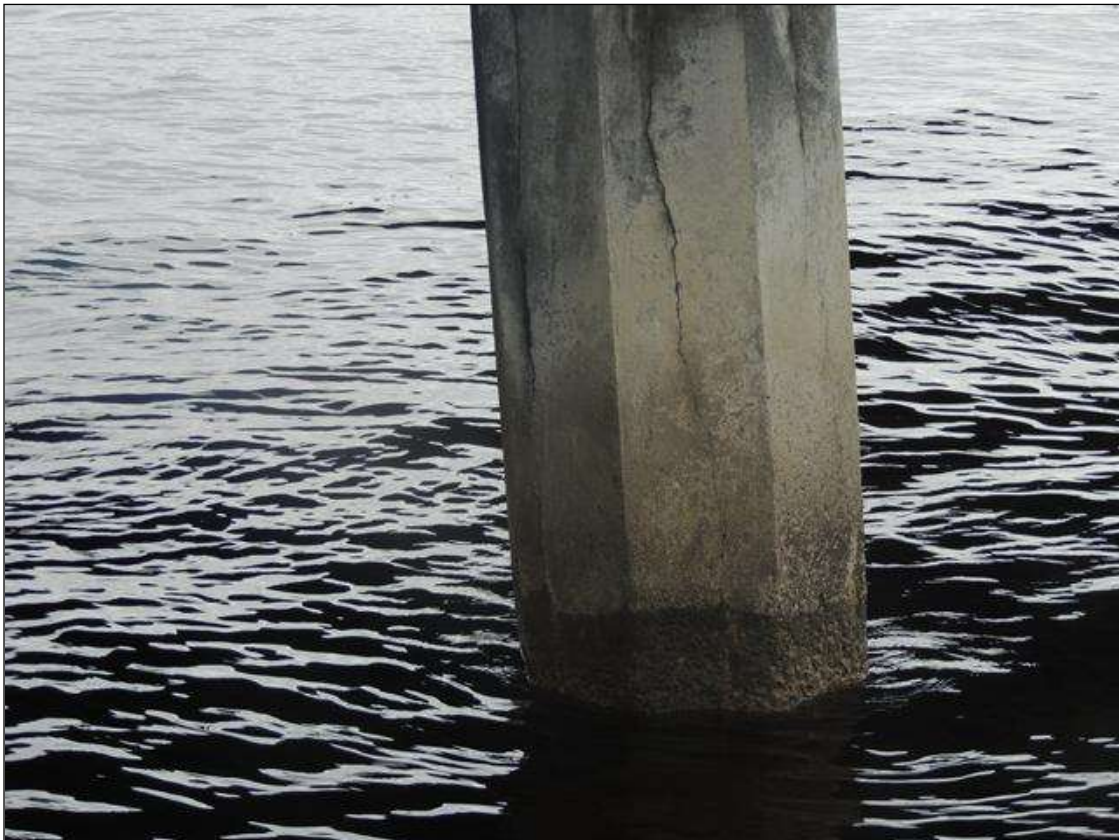
BENT 8 P4 CRACKED AND DELAMINATED AREA IN FACE OF PILE FROM WL TO BOTTOM OF CAP WITH P2 AND 3 SIMILAR.

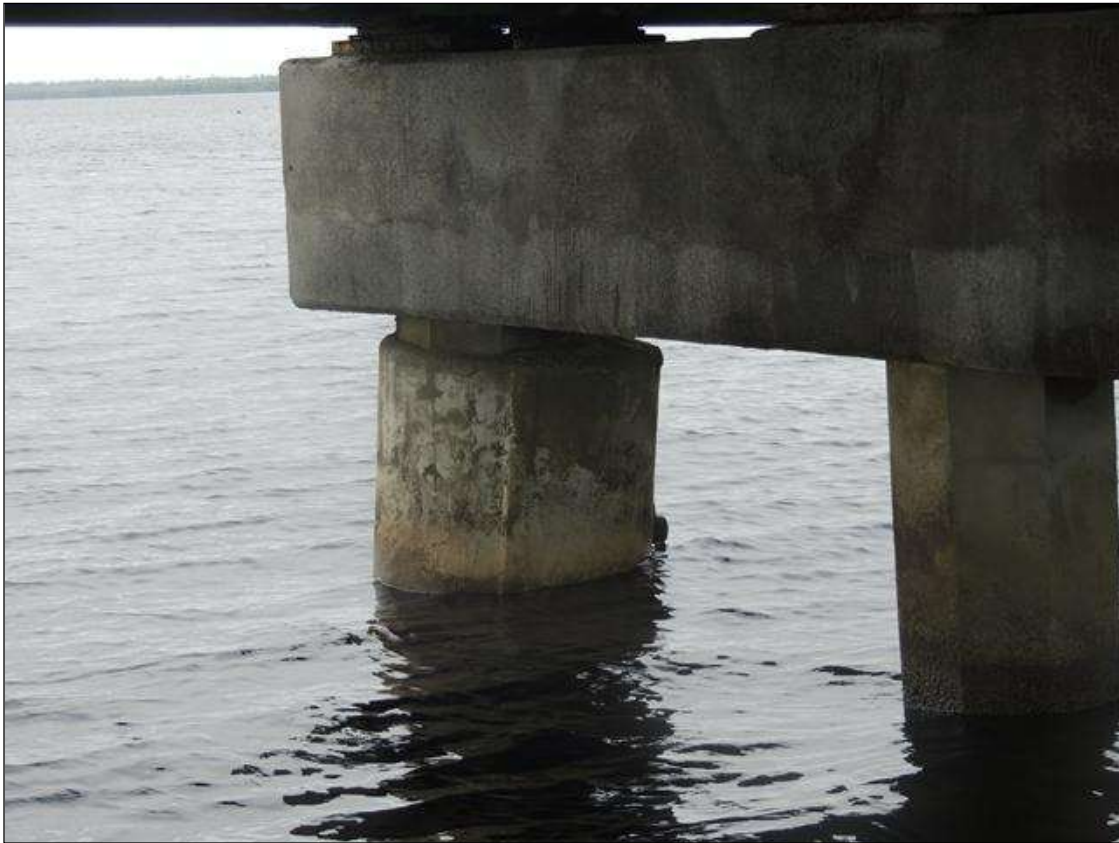
BENT 6 P4 HAS BEEN REPAIRED .

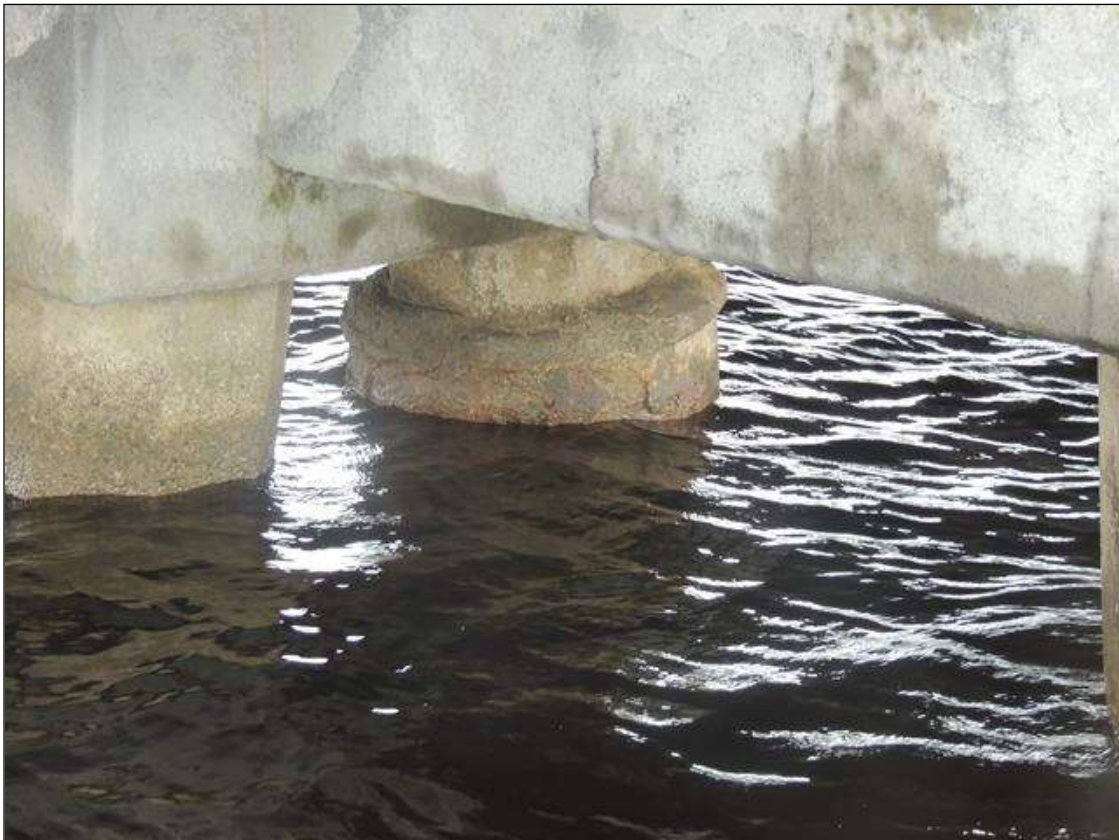
BENT 5 PILE 3 HAS BEEN REPAIRED.

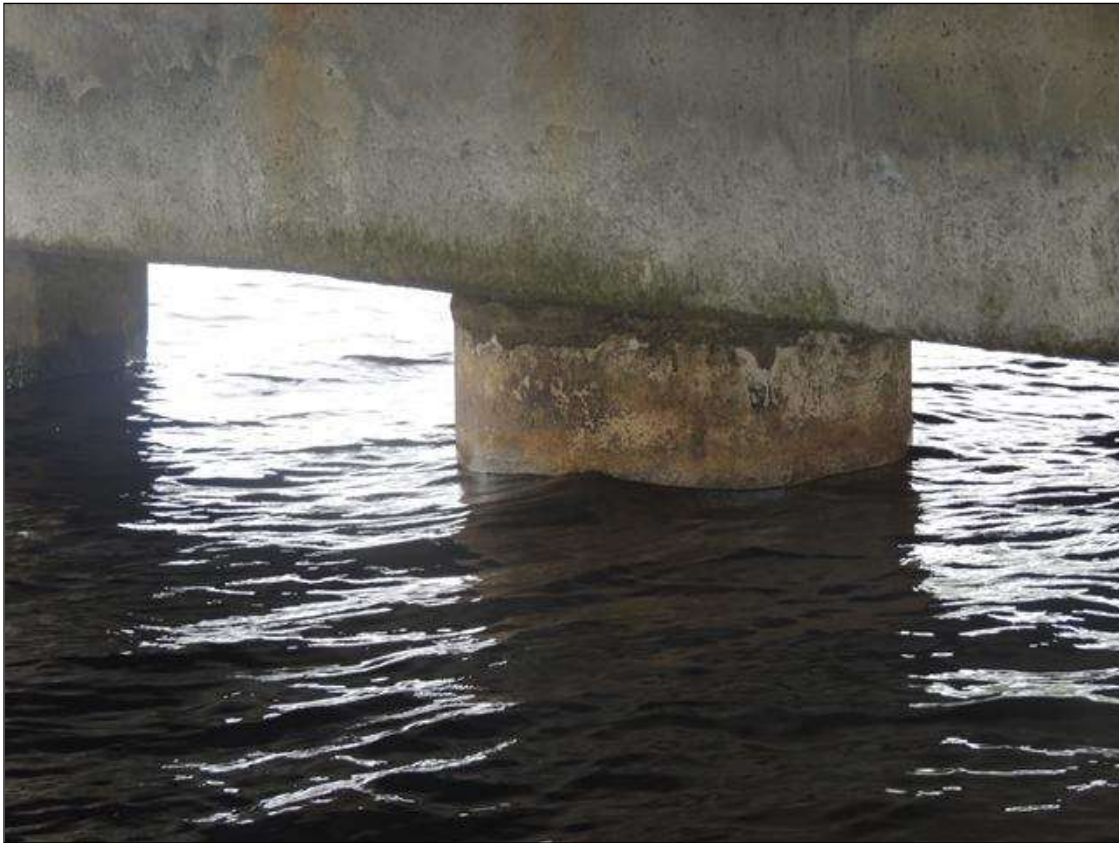
BENT 4 P3 HAS BEEN REPAIRED.

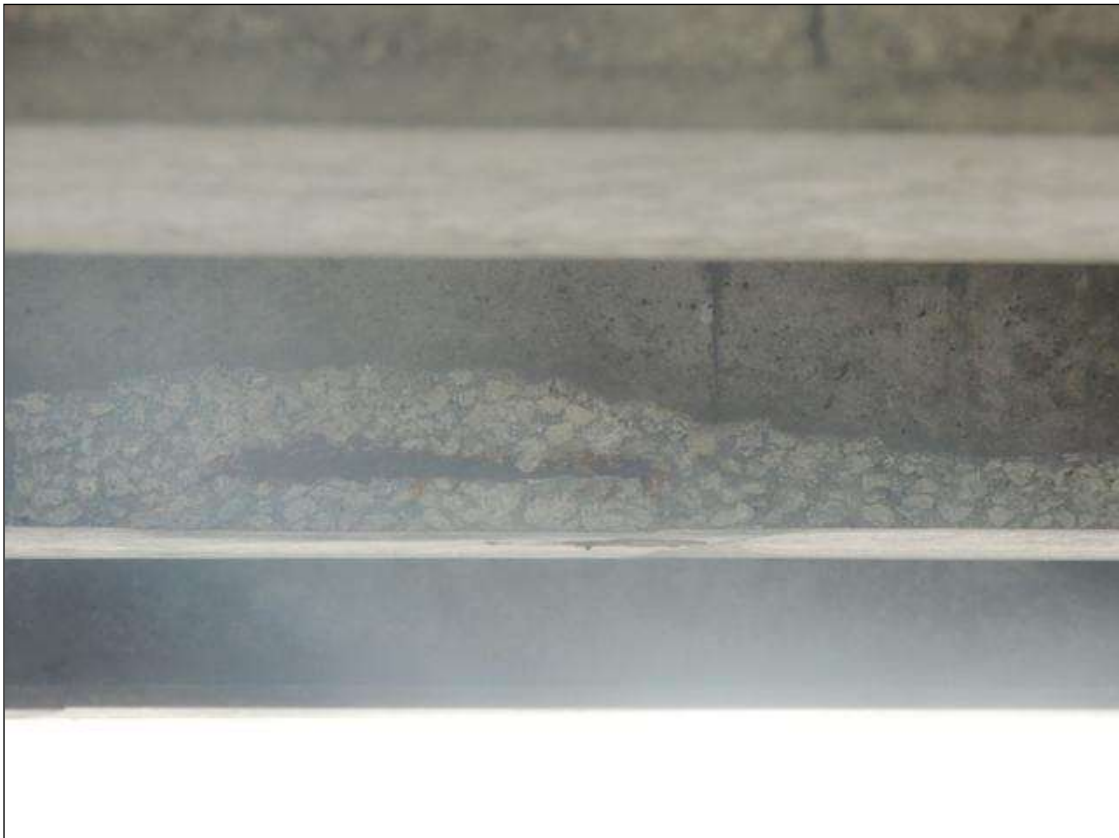
SPAN 4 LT BOTTOM SIDE OF G3 SPALLED ALONG BOTTOM EDGE 4" X 28" X 3" WITH EXPOSED CABLE NEAR MIDSPAN PM

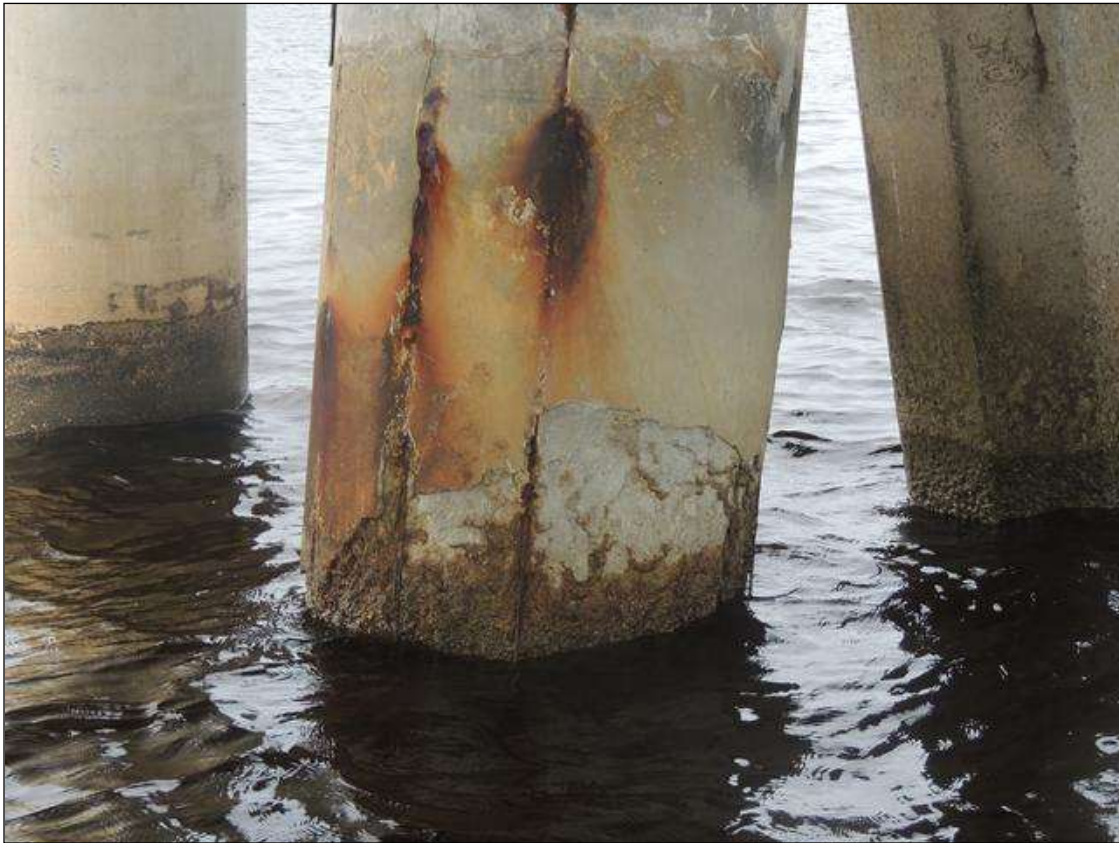
BENT 13 PILE 5 PATCHED AREA IS DETERIORATED AT WL AND HAS REBAR EXPOSED.

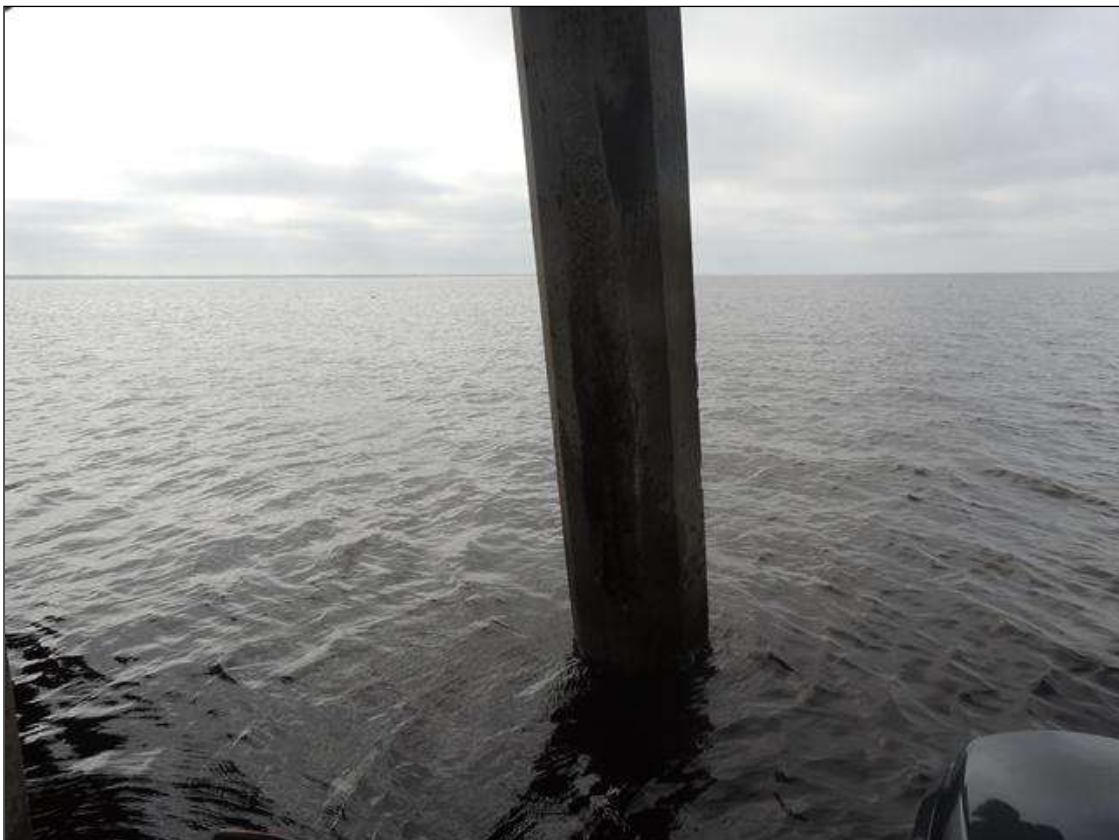
BENT 14 P4 SPALLED AREA FROM BOTTOM OF CAP TO WL 108" X 14" WIDE REBAR EXPOSED PM

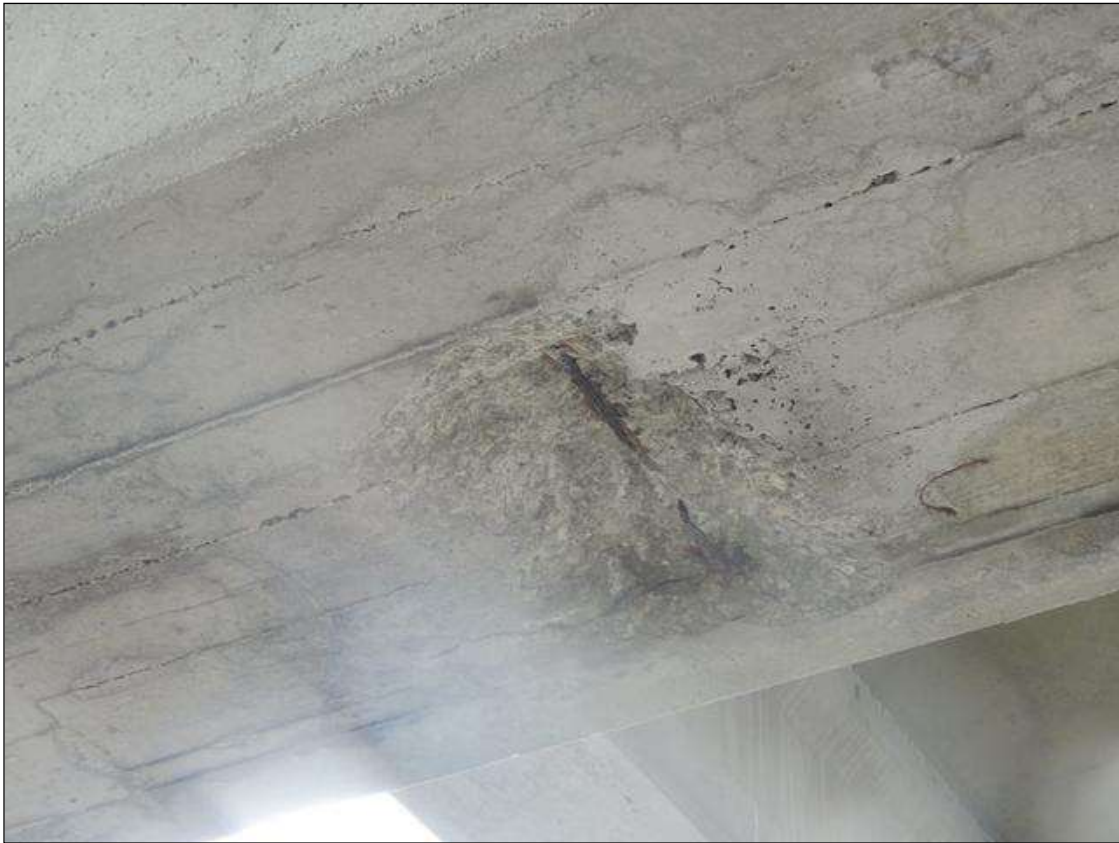
BENT 15 BOTTOM OF THE CAP BETWEEN P1 AND P2 IS SPALLED 18" X 24" X 4" DEEP WITH EXPOSED REBAR.

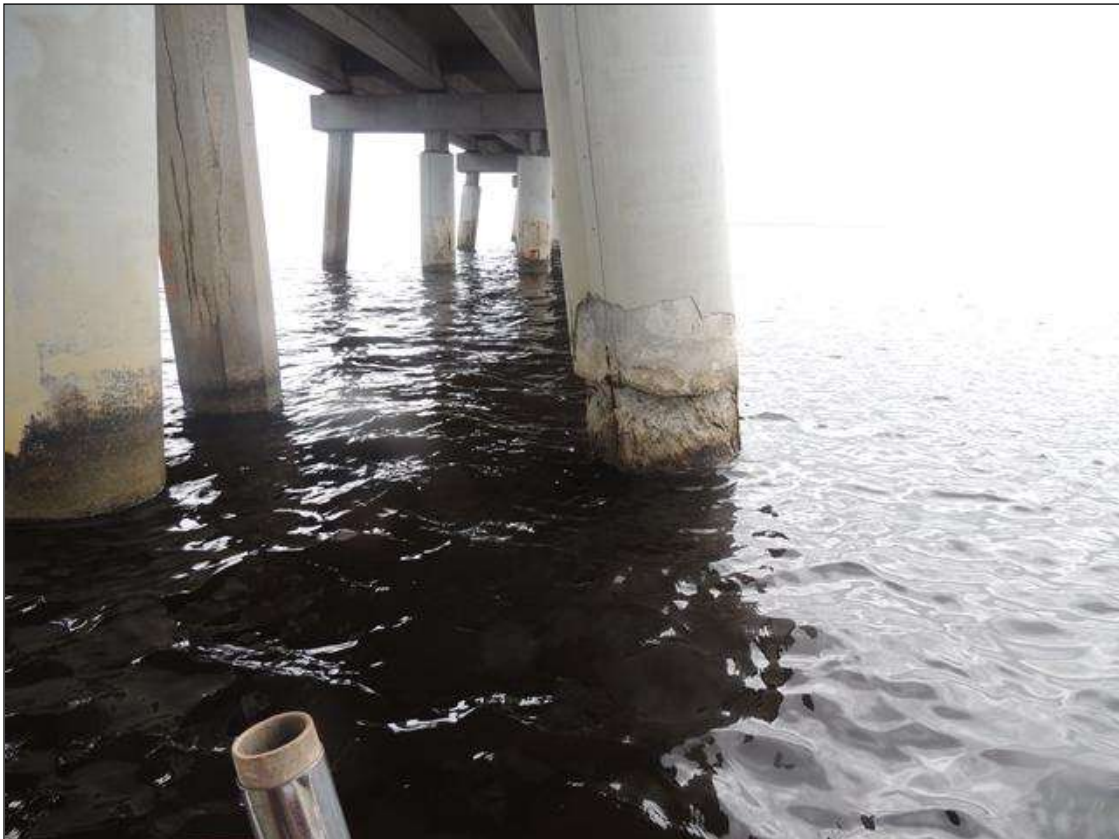
BENT 17 HAS REPAIRED AREA THAT HAS SPALLED 4" DEEP ALL AROUND PILE FROM WL UP 2'.

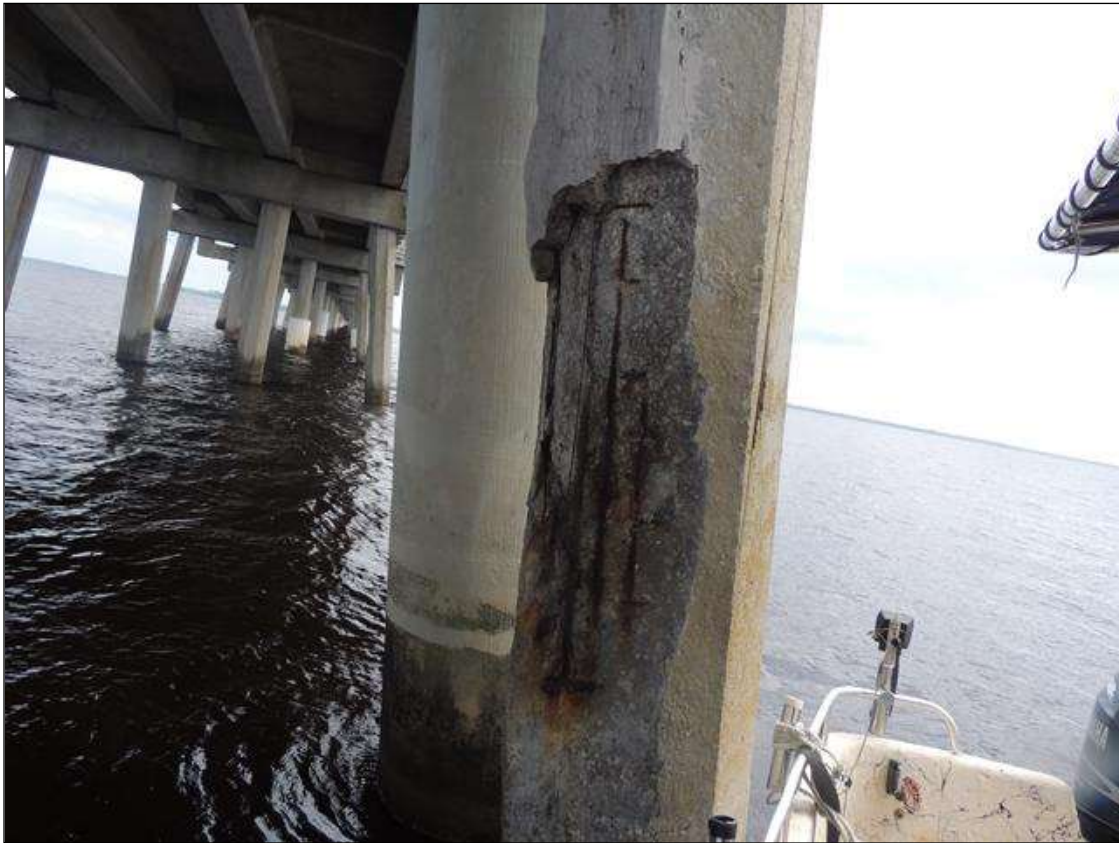
BENT 116 CRACKED AND SPALLED AND DELAMINATED AREA ON P7 WITH CABLES EXPOSED 6' 6" H X 28" AROUND PILE PM

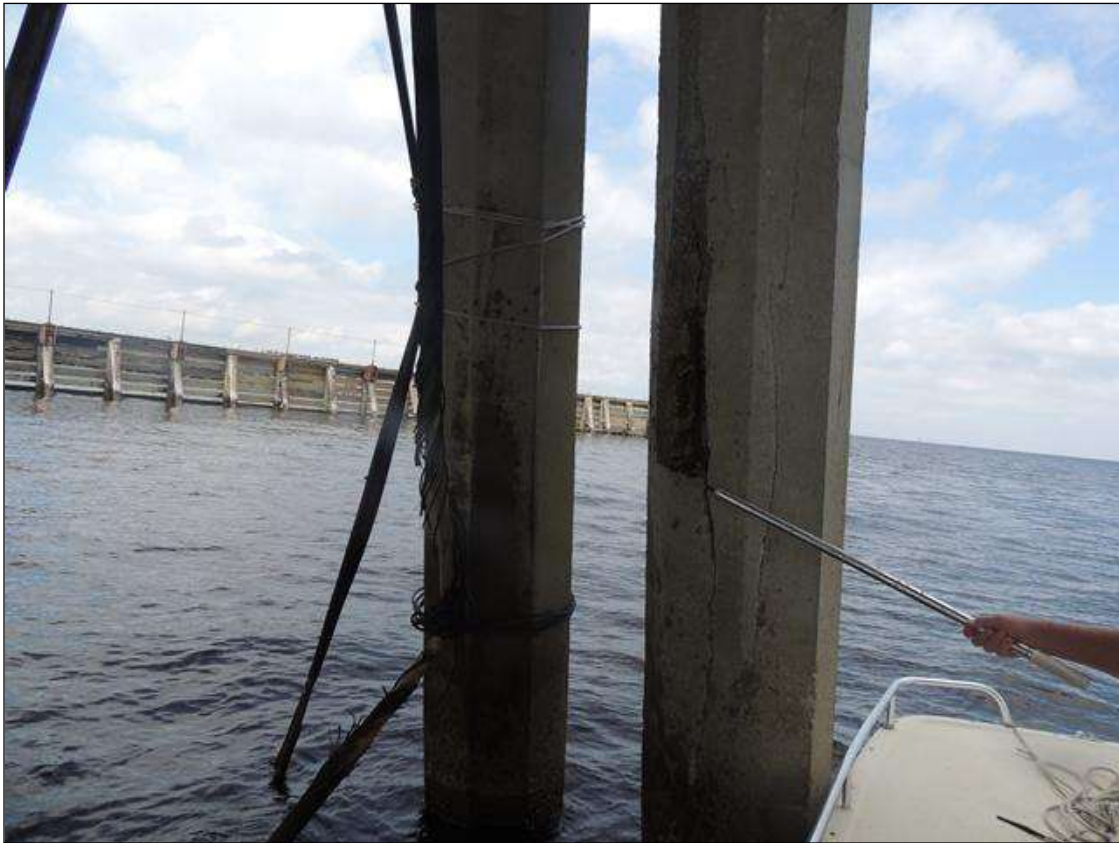
BENT 116 P2 DELAMINATED AND CRACKED AND SPALLED AREA WITH 3 CABLES EXPOSED 9' 4" H X 24" AROUND PILE ON SOUTH FACE.PM

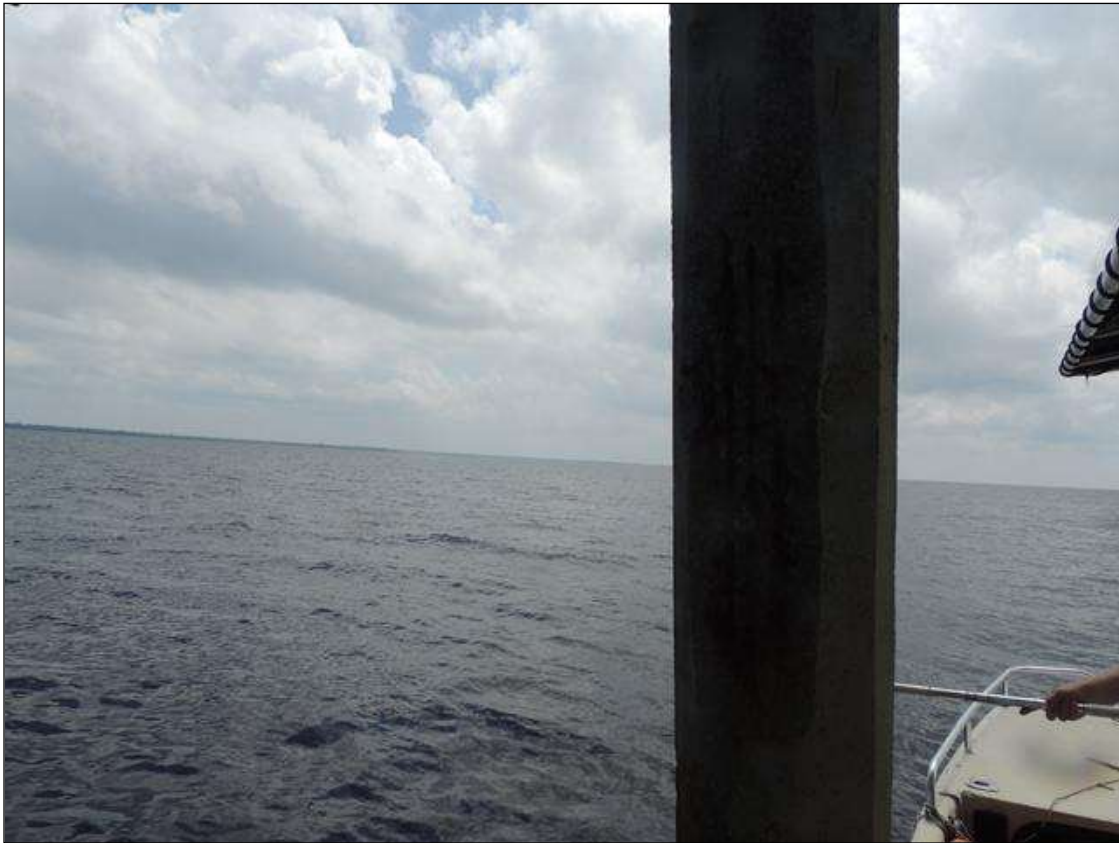
BENT 118 P5 CRACKED AND SPALLED AND DELAMINATED AREA WITH 5 CABLES EXPOSED 10' 10" H X 20" AROUND PILE.PM

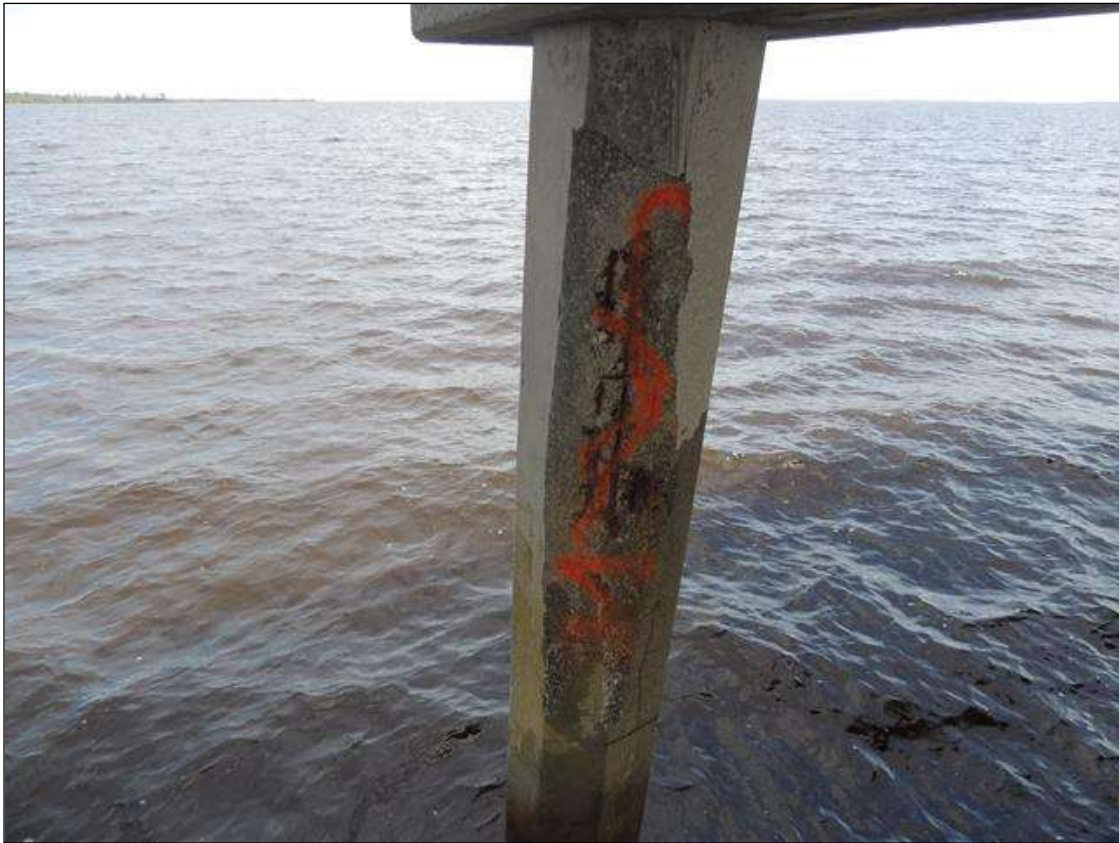
BENT 22 PILE 1 CR ACKED AND SPALLED AREA FROM WL TO BOTTOM OF CAP 11' X 16" AROUND PILE CABLES AND REBAR EXPOSED PM.

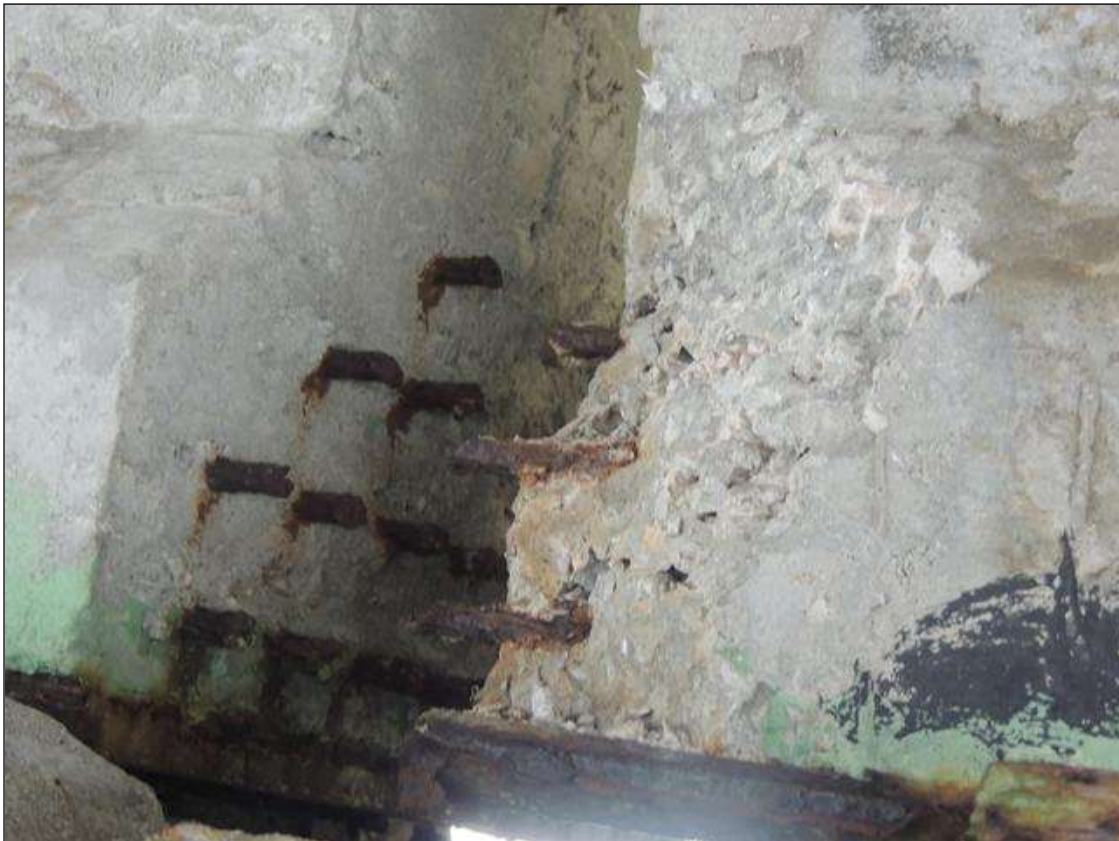
BENT 22 SPAN 22 SIDE SPALLED AREA ALONG BOTTOM LT END OF G2 4" X 9" X 2" DEEP CABLE EXPOSED.

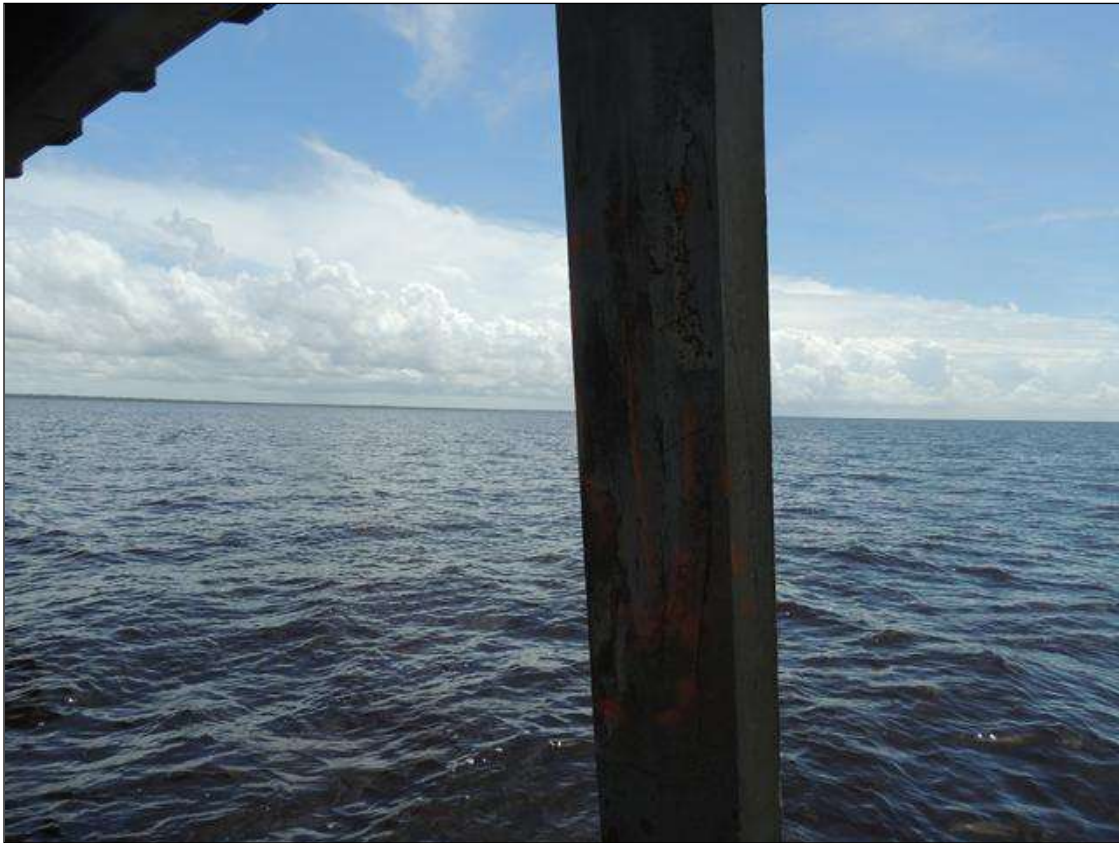
BENT 24 P4 CRACKED AND DELAMINATED AREA FROM THE BOT OF CAP DOWN 8' 3" 29" AROUND PILE.

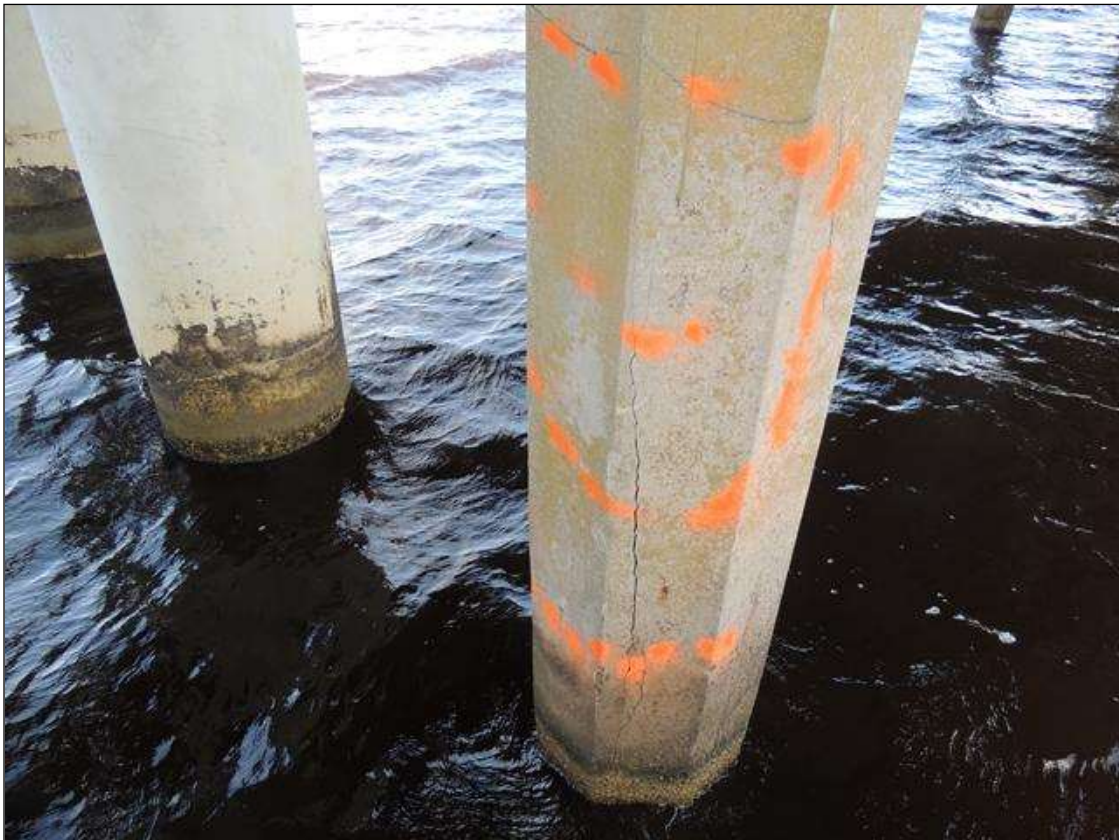
BENT 24 PILE 3 SW FACE IS CRACKED AND DELAMINATED STARTING 5' BELOW BOTTOM CAP EXTENDS TO WL 69" 28" AROUND PILE.
