BENT 14 CRACKED AND DELAMINATED AREA ON THE NW SIDE OF PILE 4 STARTS 10" BELOW CAP AND GOES DOWN 8' 4" X 12" WIDE.

BENT 17 PILE 3 UNDER SUBCAP 1 HAS SAPLLED AREA 10' 2" LONG X 2 1/2" DEEP ON SW SIDE WITH CABLES EXPOSED AND BROKEN.PM

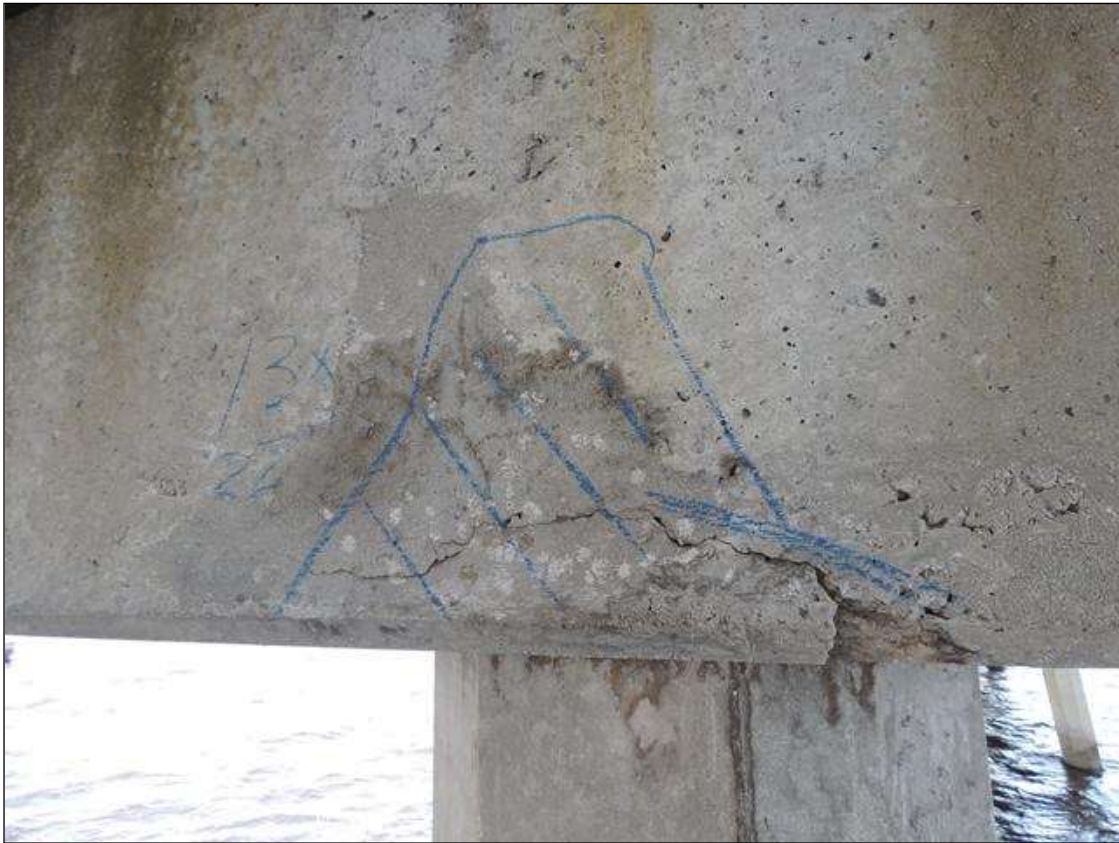
BENT 24 SPAN 25 SIDE CRACKED AND DELAMINATED AREA IN FACE OF CAP UNDER G2 13" X 22",,

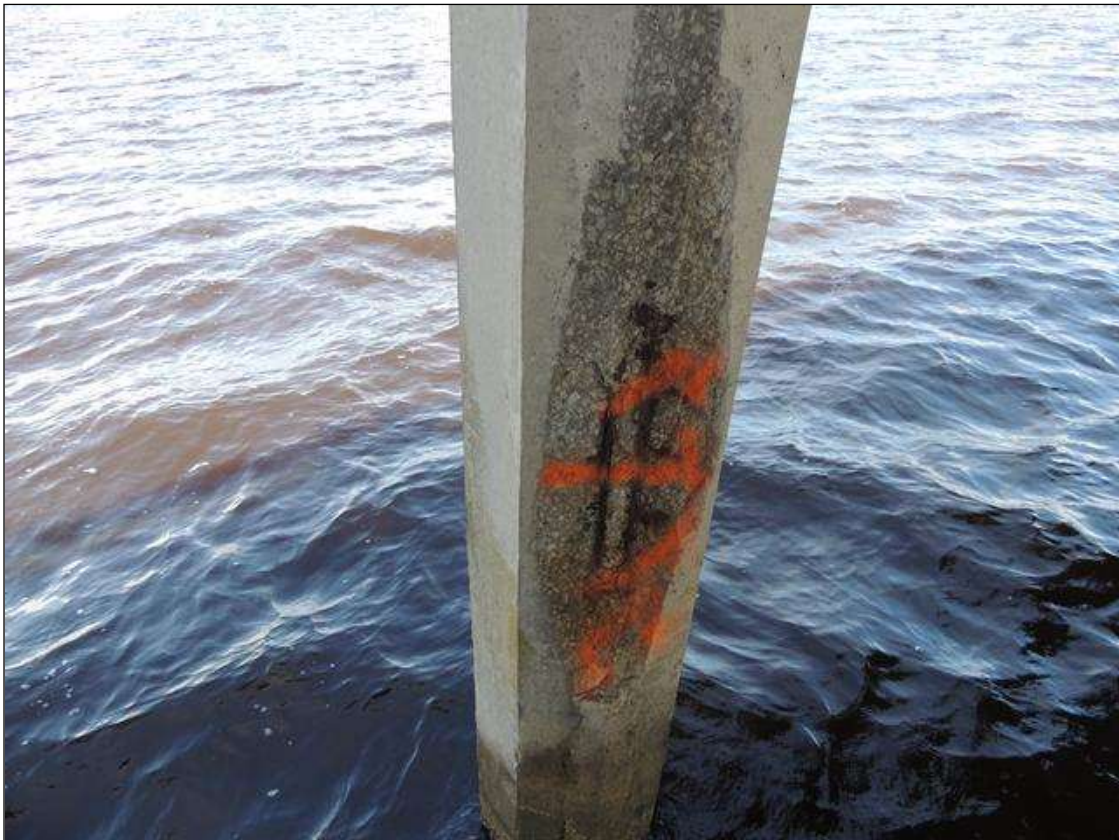
BENT 25 SOUTH FACE OF P1 SPALLED AND CRACKED AND DELAMINATED AREA STARTS 1' BELOW BOT OF CAP AND GOES DOWN TO WL 9' X 16" AROUND X 2" DEEP CABLES PM

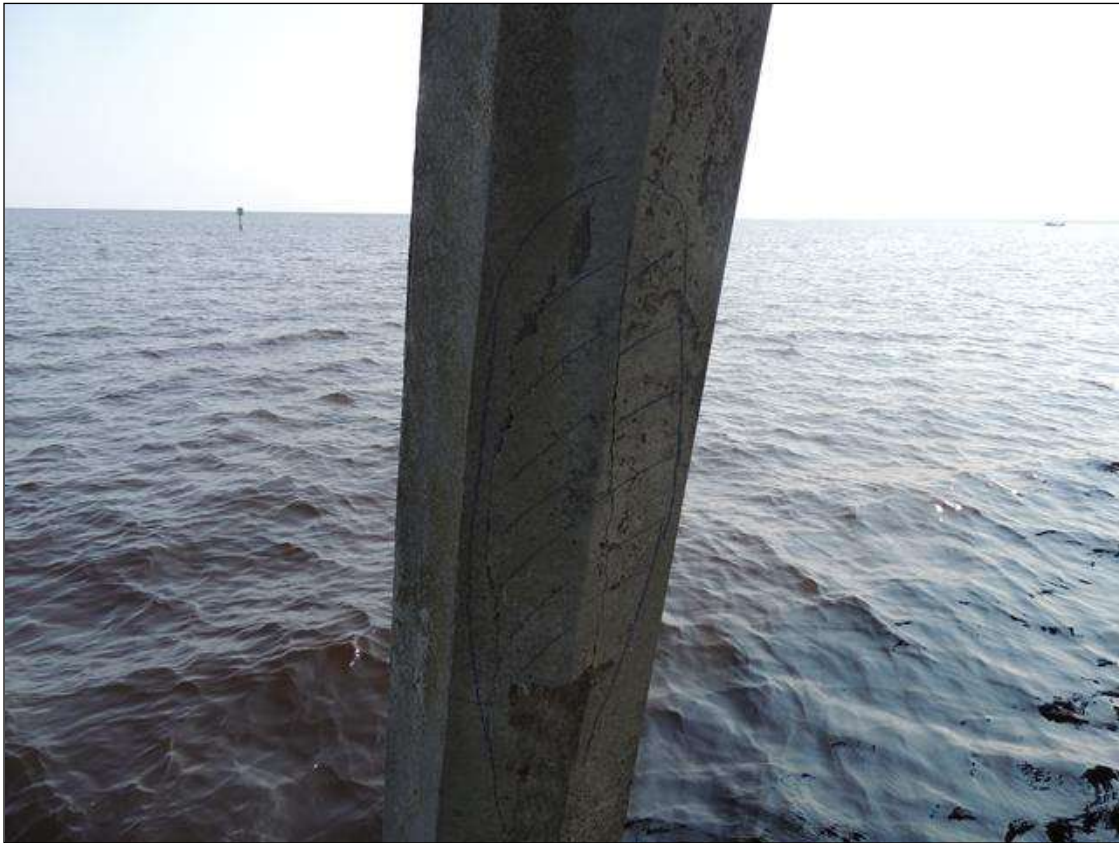
BENT 52 P1 CRACKED AND SPALLED AND DELAMINATED AREA ON SOUTH FACE OF PILE STARTS 33" BELOW BOT CAP AND EXTENDS 68" X 17" W X 1 3/4" DEEP.

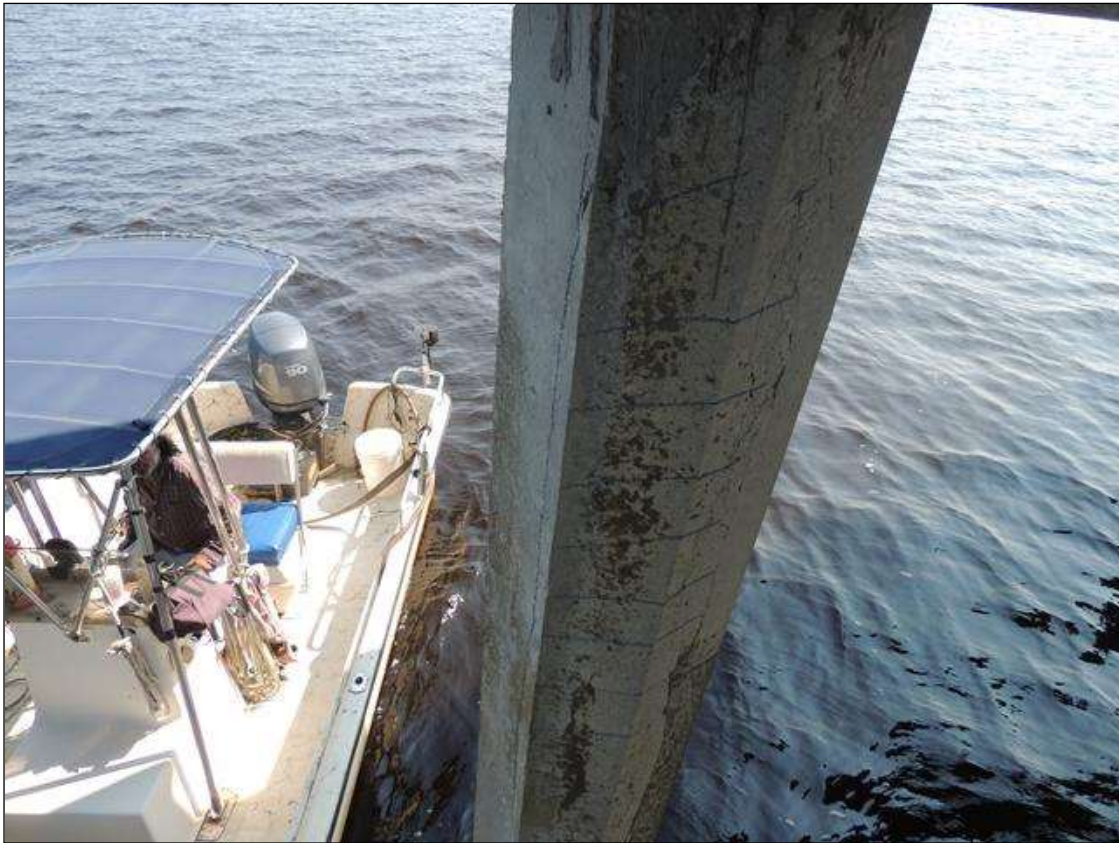
BENT 53 P1 CRACKED AND DELAMINATED AREA ON THE SOUTH FACE OF PILE FROM BOTTOM CAP TO WL  
10' 6" X 17" AROUND PILE.

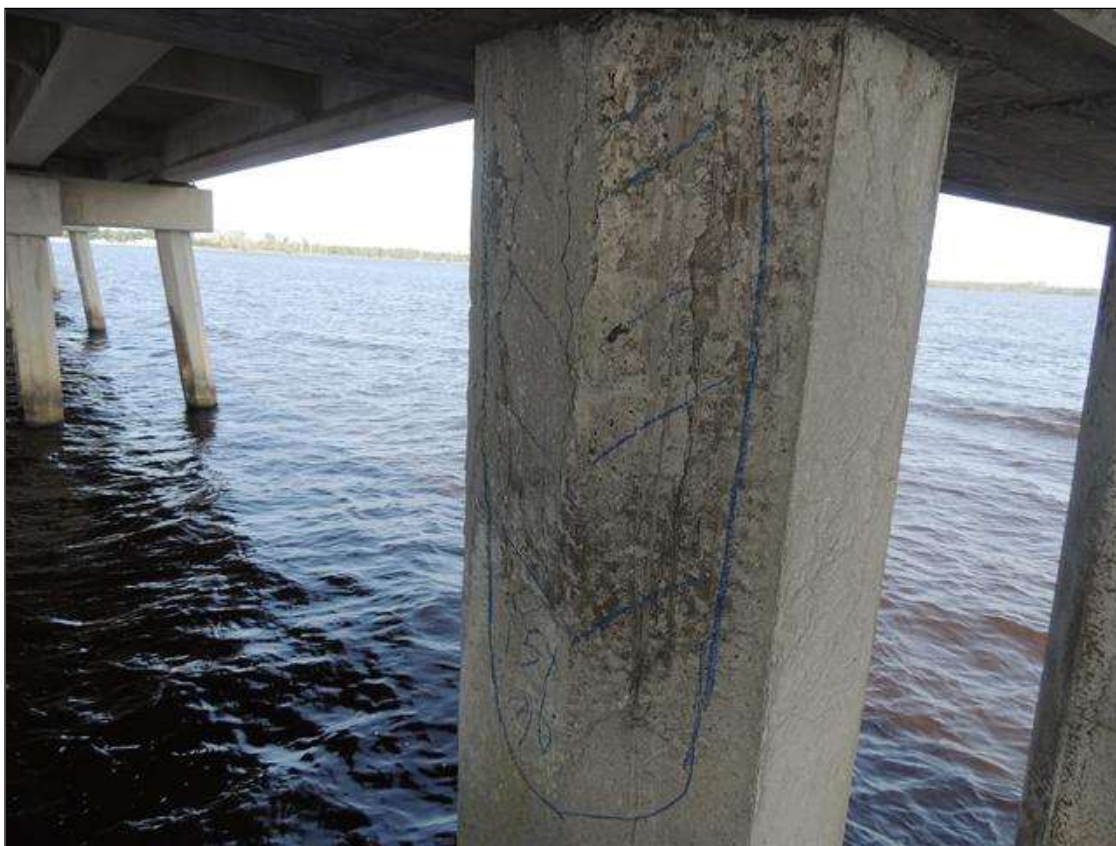
BENT 54 P2 CRACKED AND DELAMINATED AREA AROUND SE CORNER OF PILE FROM BOTTOM OF CAP DOWN 36" X 15" AROUND PILE.

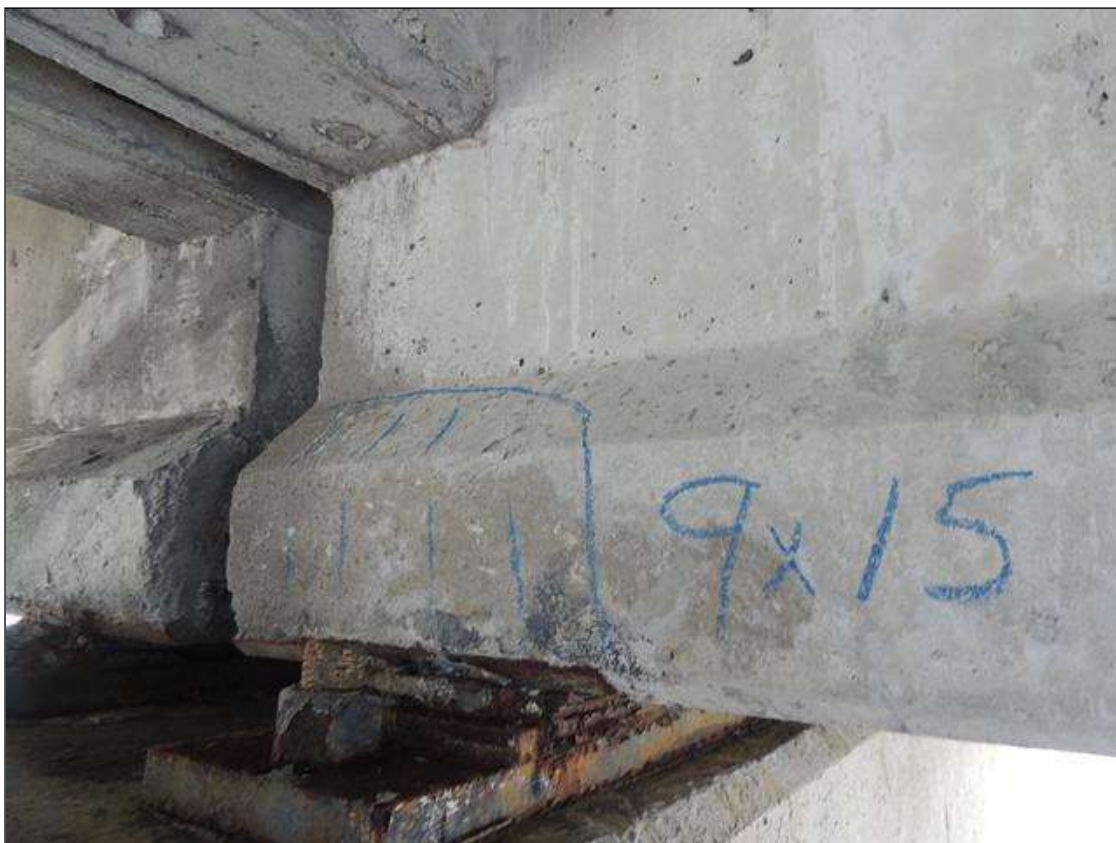
BENT 55 SPAN 55 SIDE CRACKED AND DELAMINATED AREA ALONG THE BOTTOM SIDE OF G3 9" X 15".

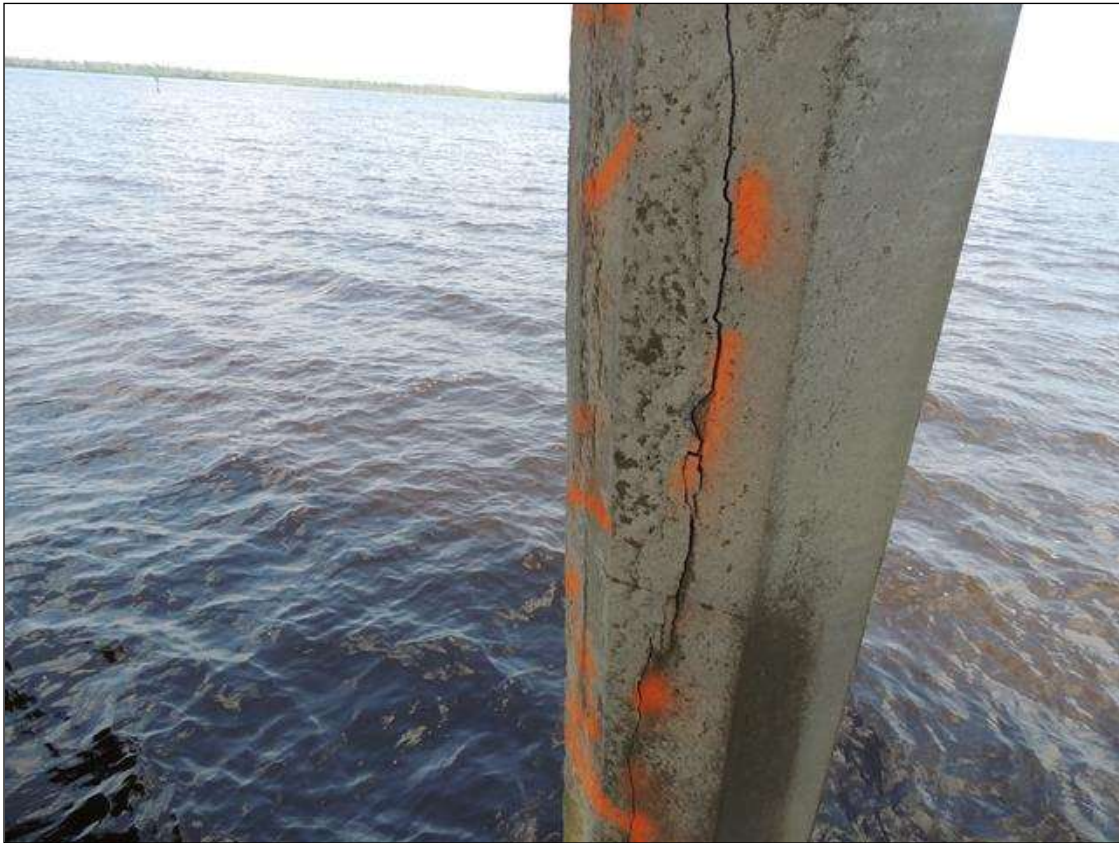
BENT 63 P1 IS CRACKED AND DELAMINATED ON SOUTH FACE FROM BOTTOM CAP TO WL 10' 8" X 21" AROUND PILE.

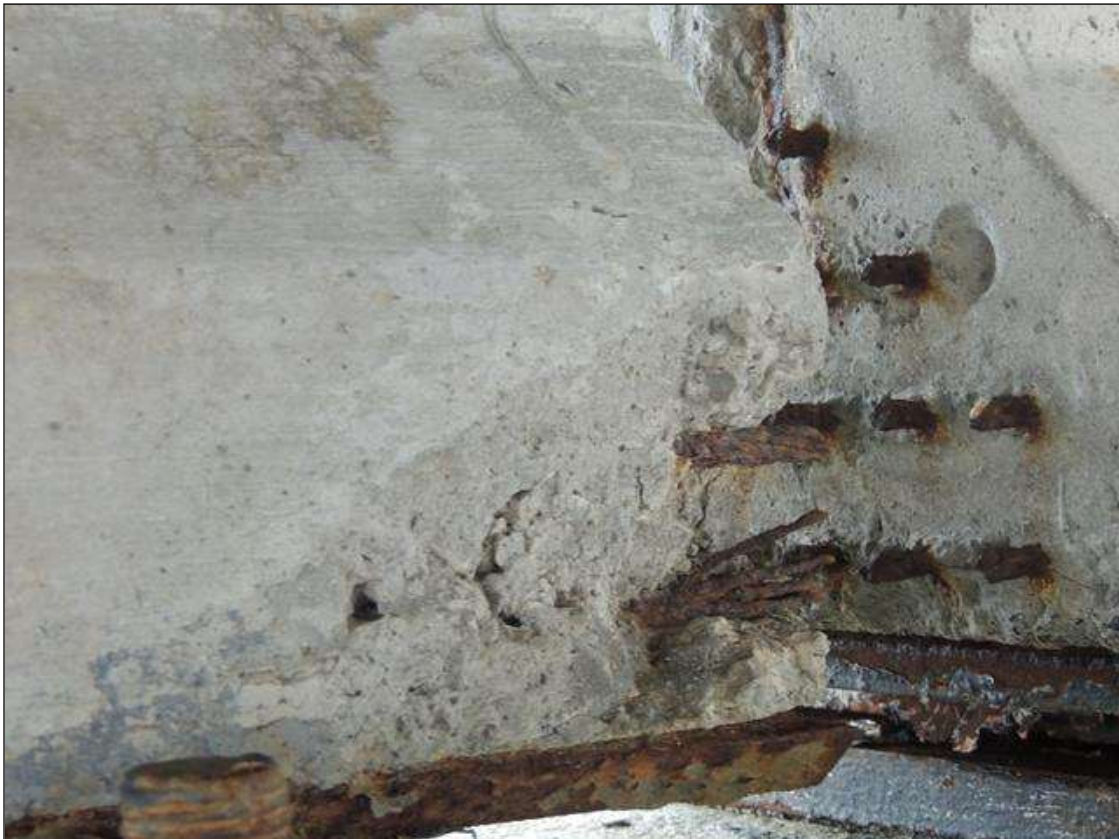
BENT 65 SPAN 65 SIDE SPALLED AREA ON THE BOTTOM RT END OF G1 6" X 8" X 2" DEEP

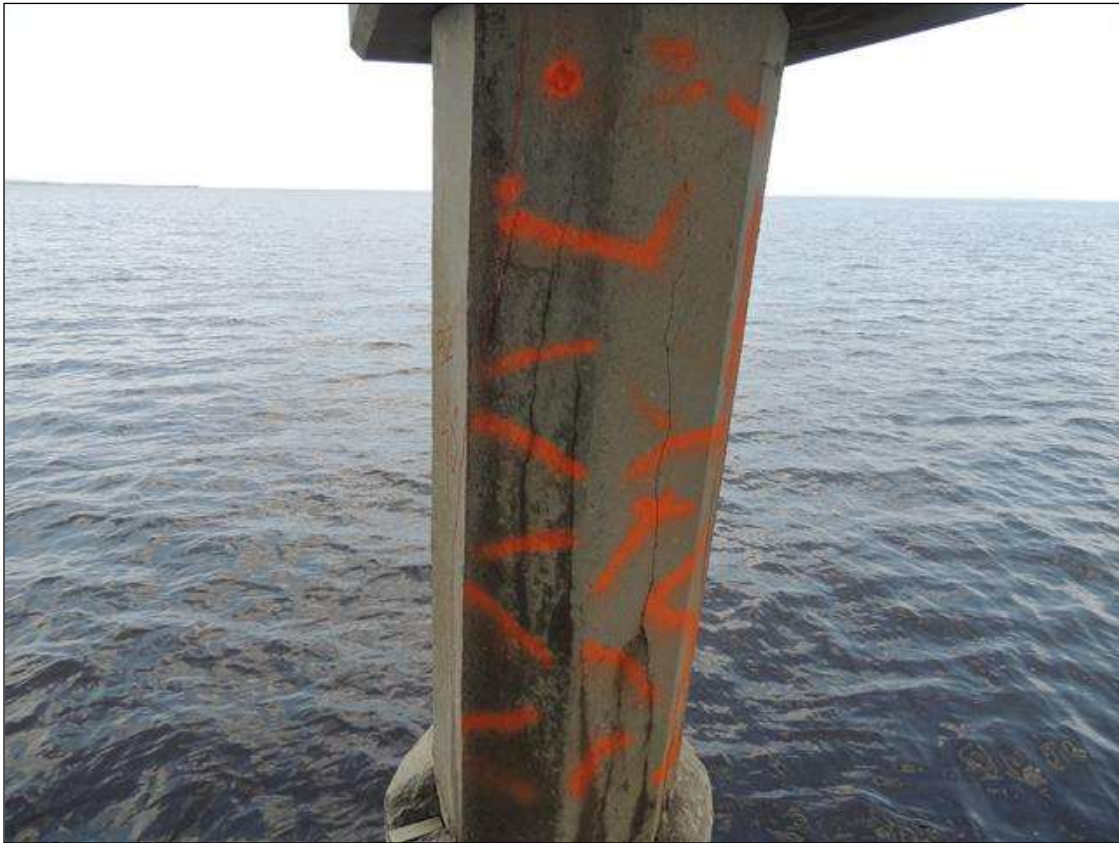
BENT 66 PILE 1 CRACKED AND DELAMINATED AREA ABOVE THE PILE REPAIR FROM BOTTOM OF CAP DOWN 70" X 32" AROUND PILE.

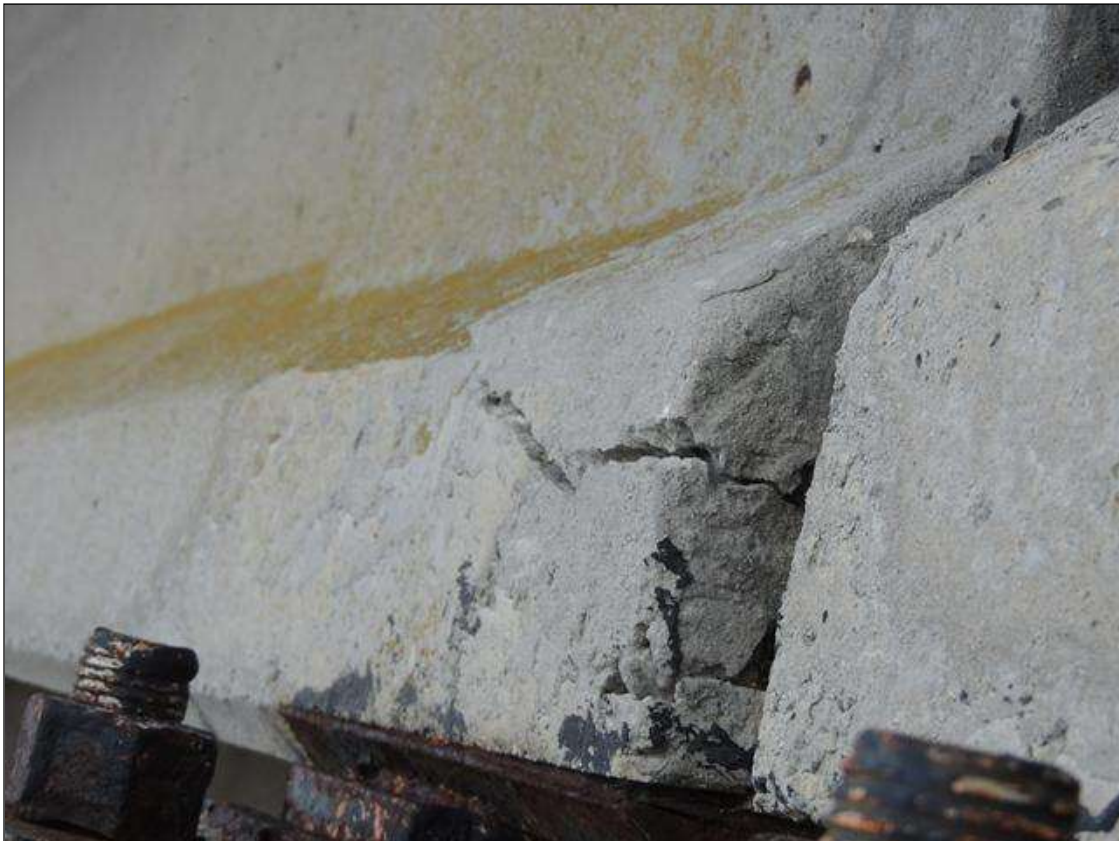
BENT 67 SPAN 68 SIDE BOTTOM LT END OF G1 IS CRACKED AND DELAMINATED 9" X 10".

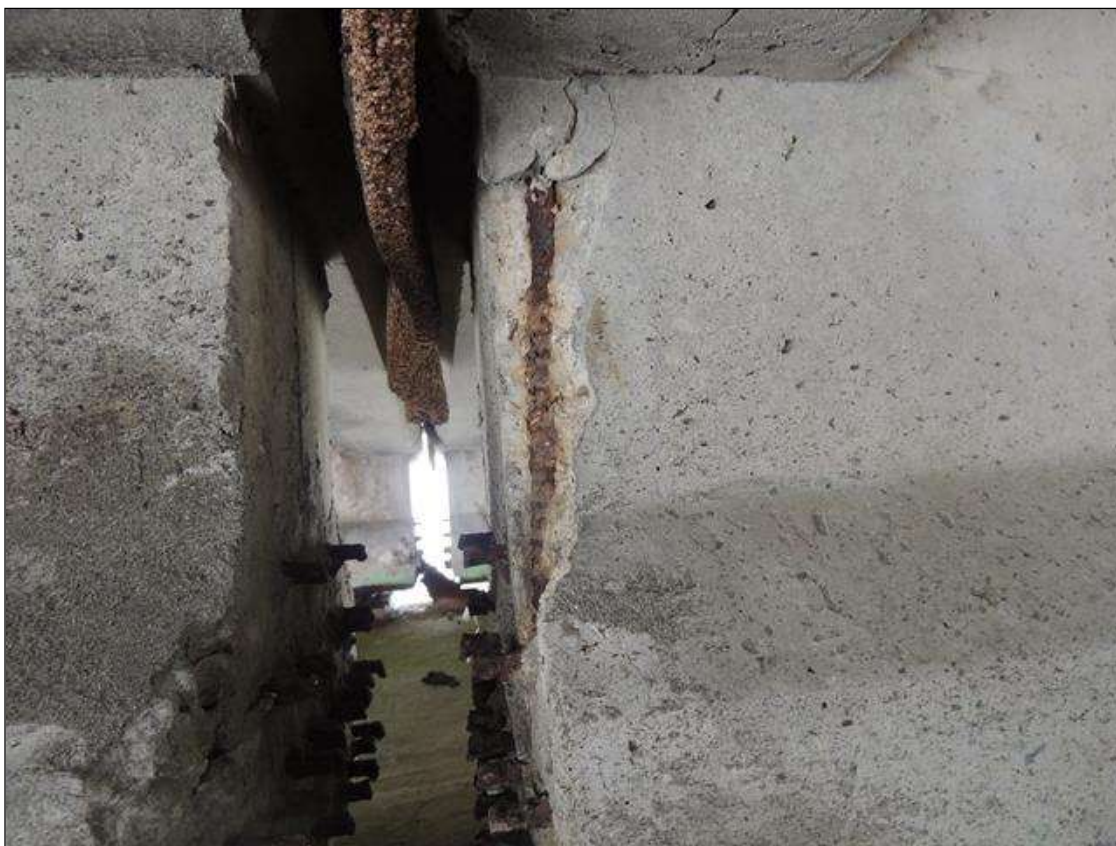
BENT 9 SPAN 9 SIDE SPALLED AREA ALONG END OF G3 4" W AND FROM DIAPHRAGM DOWN 10" X 1 1/2" DEEP REBAR EXPOSED.

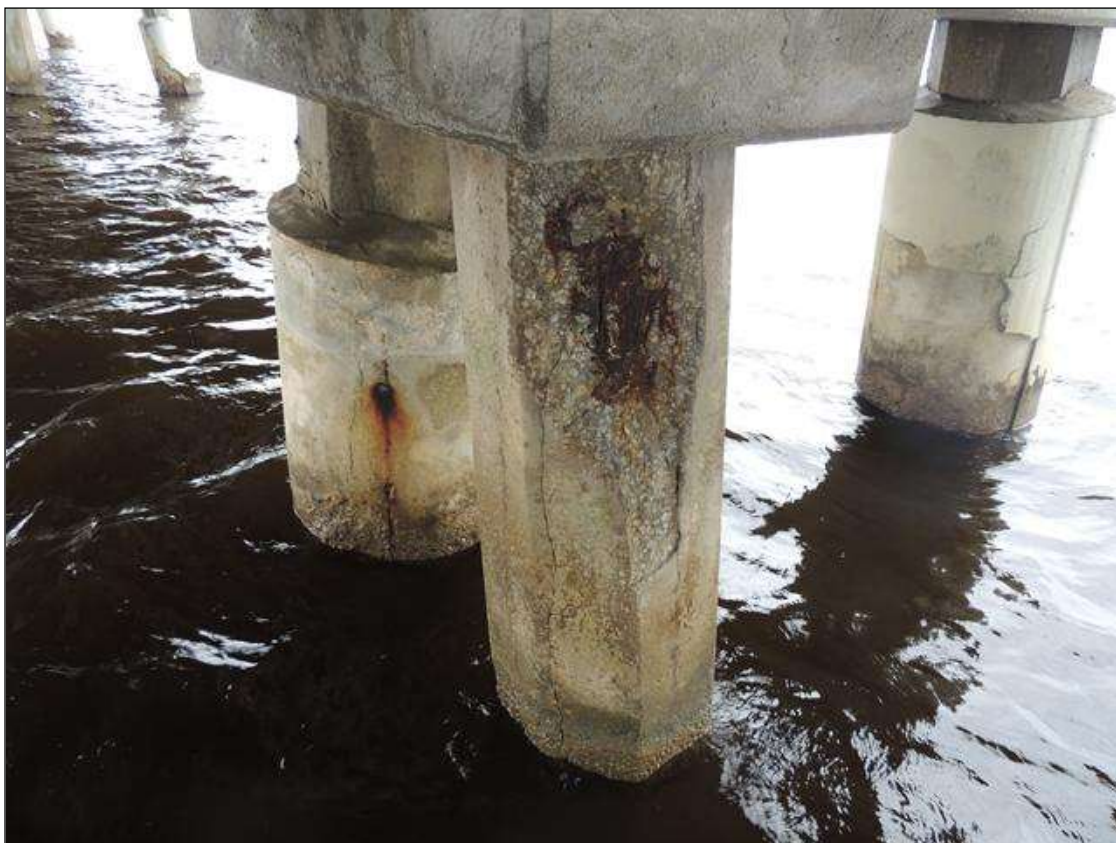
BENT 9 PILE HAS A CRACKED AND SPALLED AREA UNDER G3 17" X 39" X 3" DEEP WITH CABLES EXPOSED.

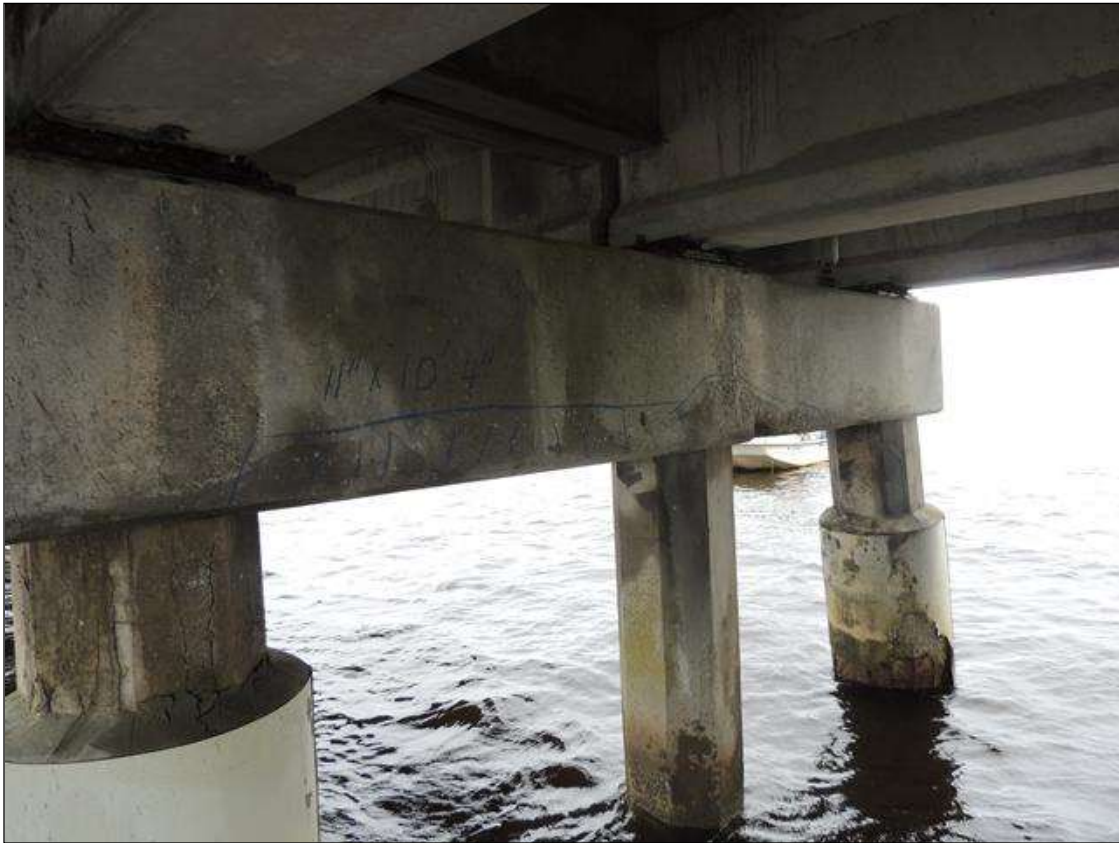
BENT 10 SPAN 10 SIDE DELAMINATED AND SPALLED AND CRACKED AREA ALONG THE BOTTOM FACE OF CAP FROM G2 TO RT SIDE G3 11" X 10' 4".

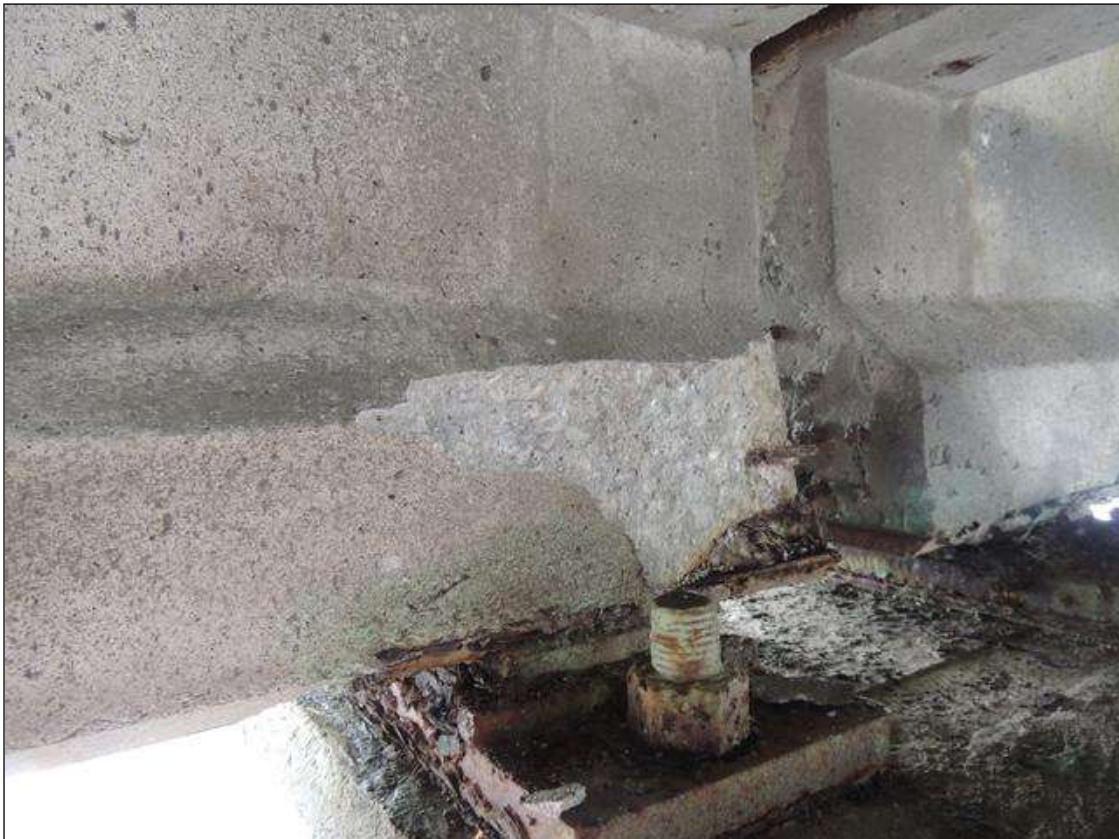
BENT 10 SPAN 10 SIDE SPALLED AREA ON THE RT SIDE OF G1 7" X 14" X 2" DEEP.

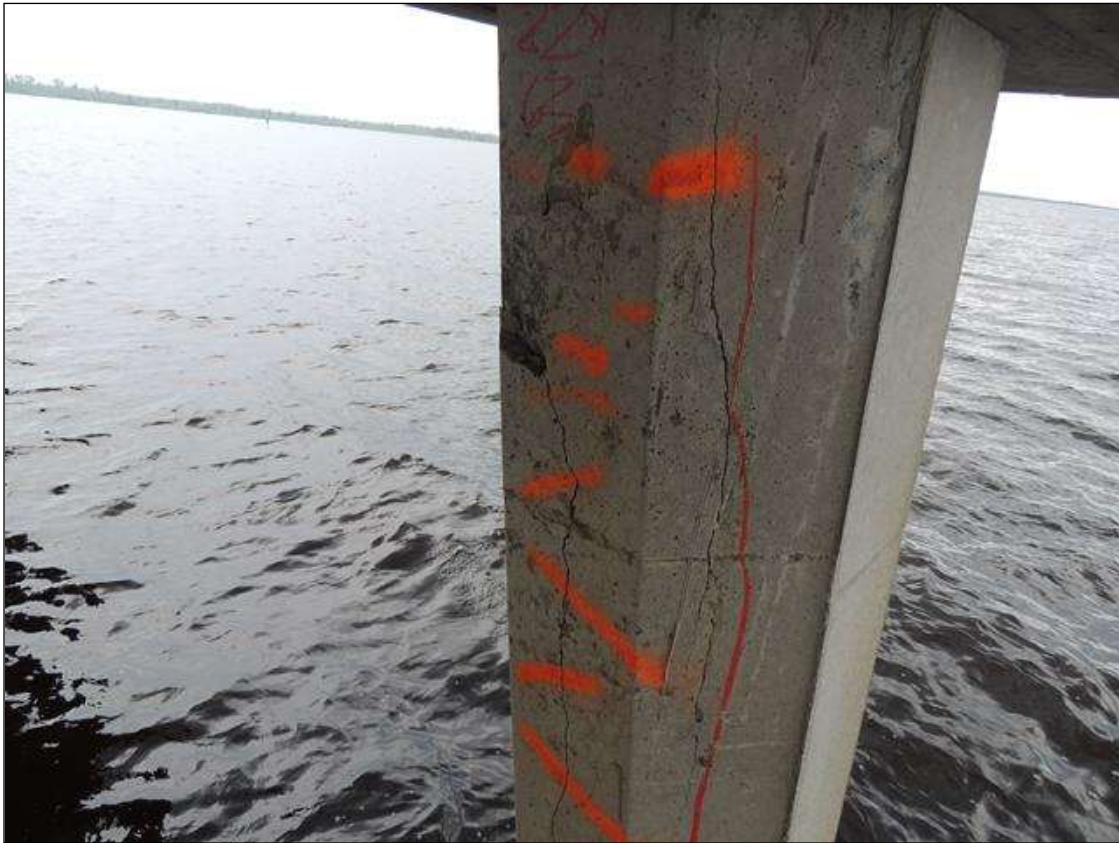
BENT 69 PILE 1 CRACKED AND DELAMINATED AREA ON SOUTH FACE OF PILE FROM BOTTOM OF CAP DOWN 63" X 22" AROUND.

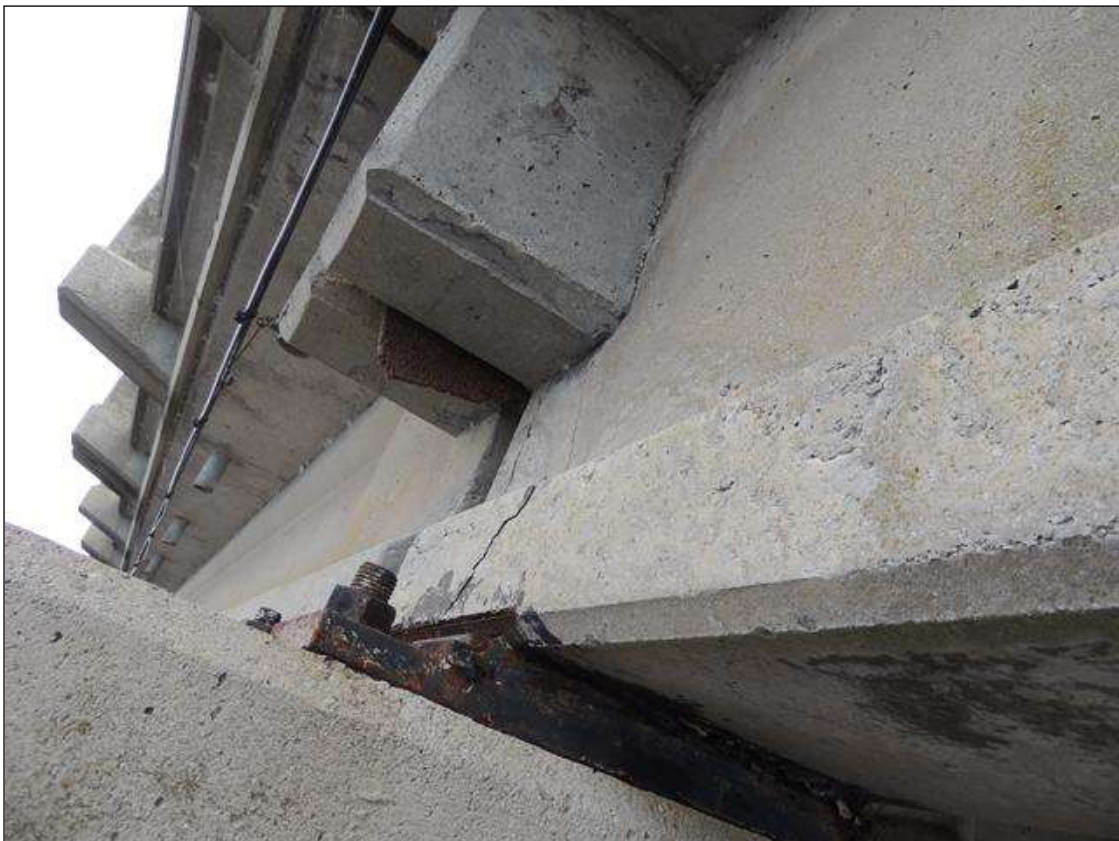
BENT 70 LT END OF G1 IS CRACKED AND DELAMINATED 17" H X 12" FROM END BACK.

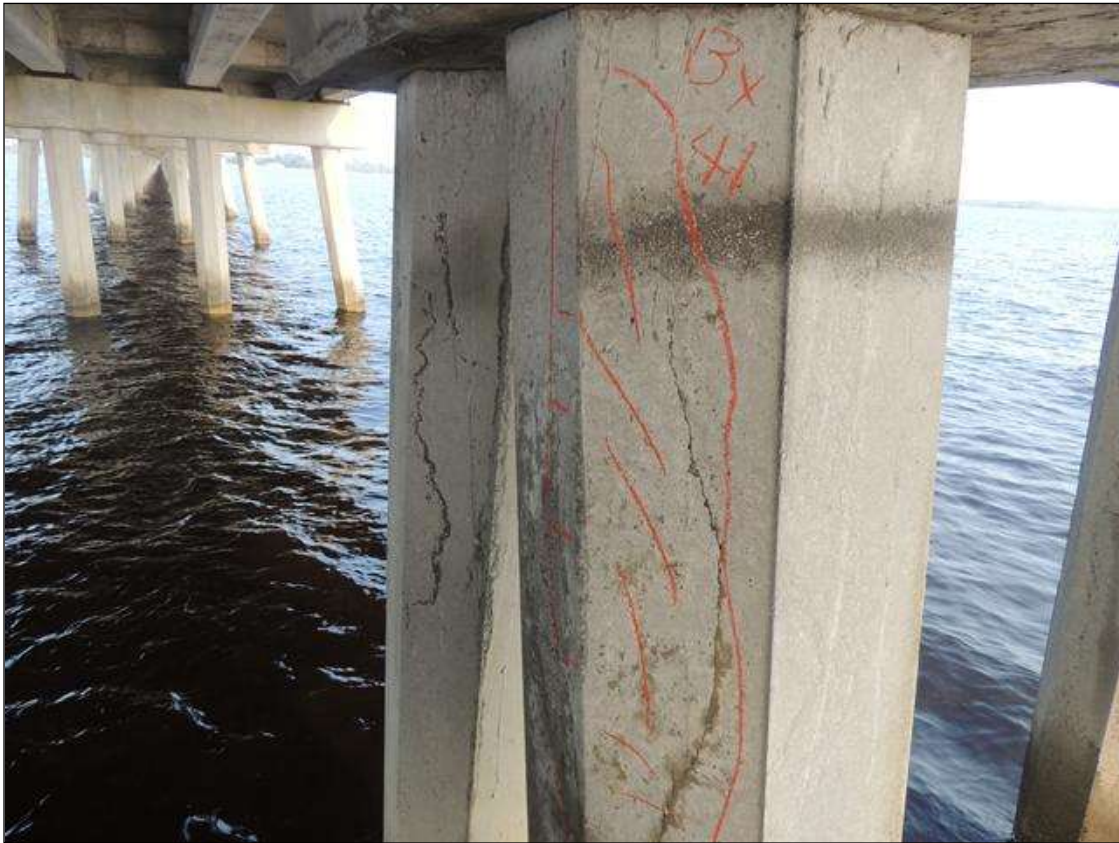
BENT 81 DELAMINATED AREA ON SOUTH FACE OF P3 UNDER BOTTOM OF CAP 13" X 41".

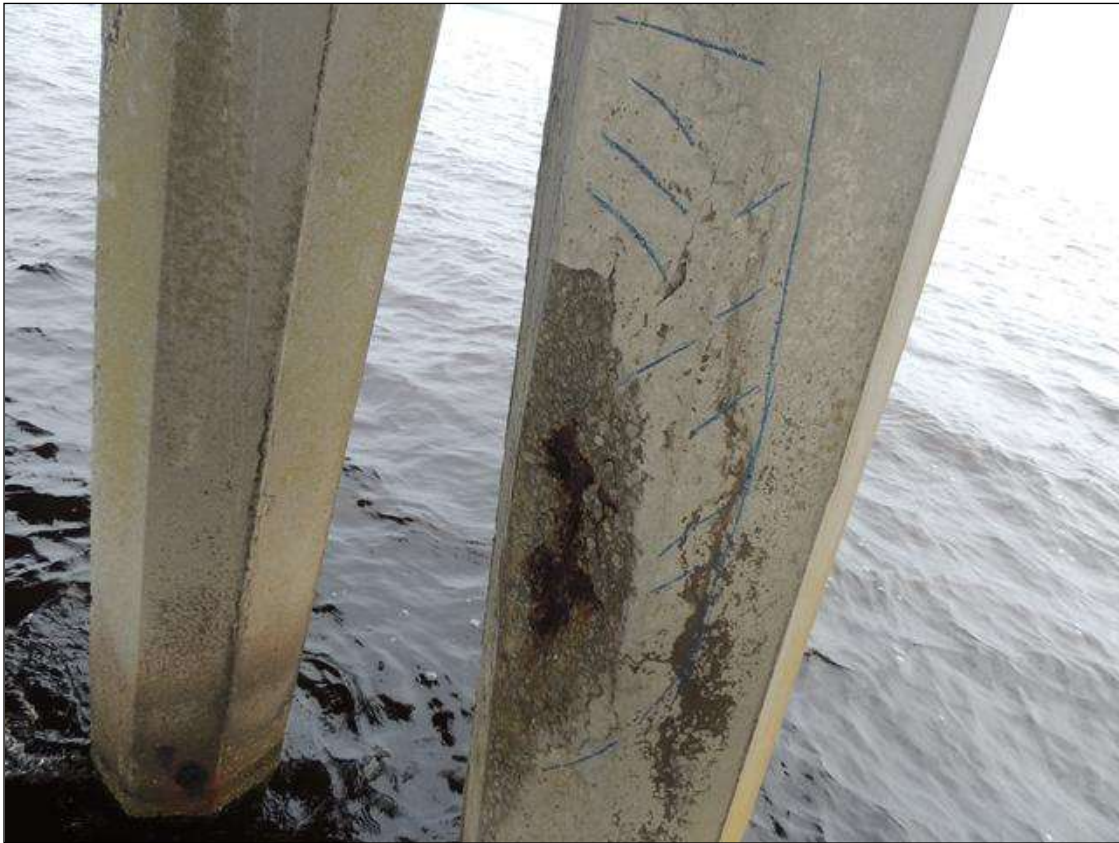
BENT 93 PILE 3 IS SPALLED AND DELAMINATED UNDER BOTTOM SUBCAP 1 STARTS 23" UNDER CAP 59" LONG X 17" W X 2" DEEP REBAR EXPOSED PM.

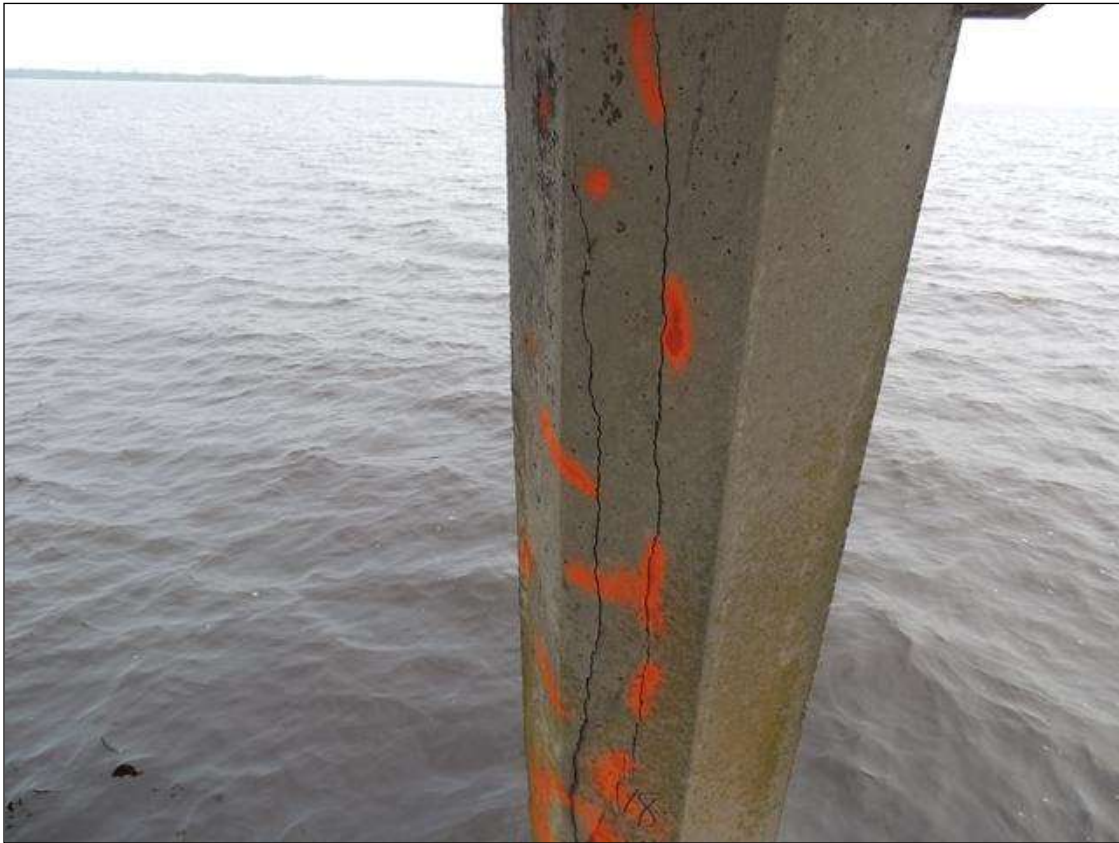
BENT 98 PILE 1 CRACKED AND DELAMINATED AREA ON THE SOUTH FACE OF PILE FROM BOTTOM CAP DOWN 75" X 18" AROUND PILE.

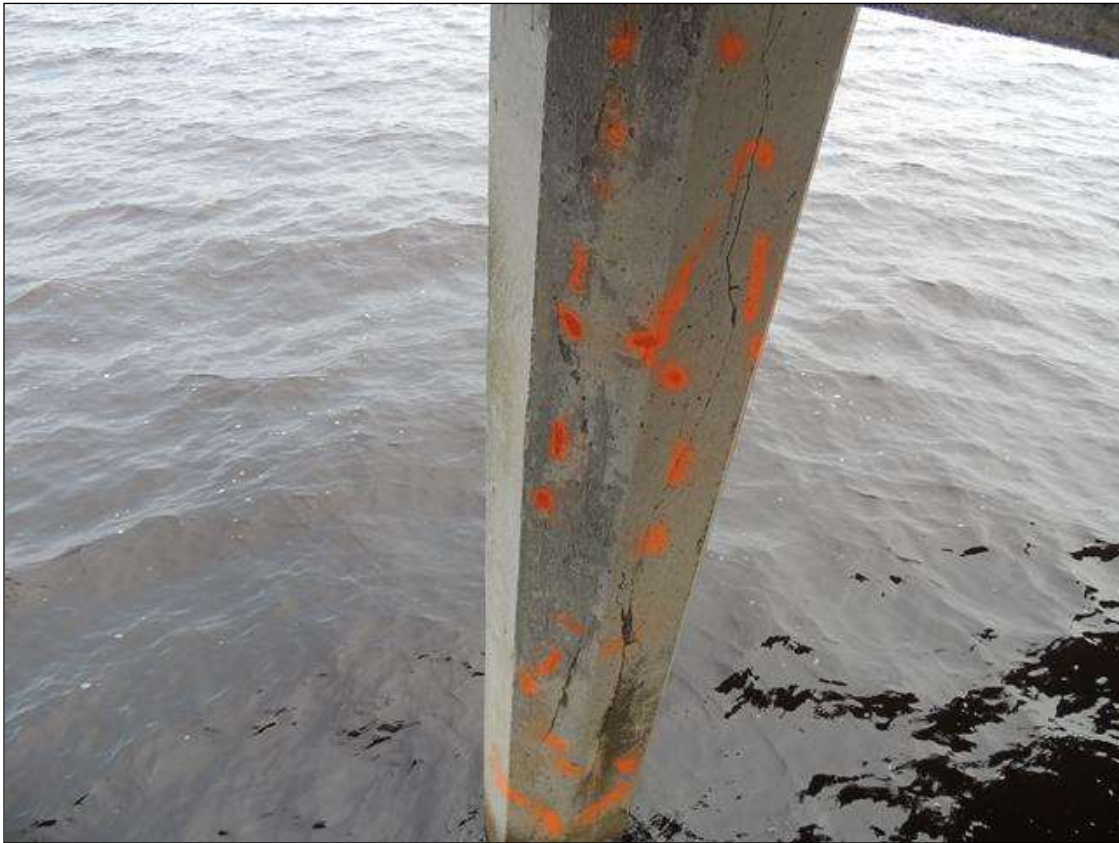
BENT 101 PILE 1 IS CRACKED AND DELAMINATED AND SURFACE SPALLED AREA SOUTH FACE FROM BOTTOM OF CAP DOWN 11' 5" X 23" AROUND PILE.

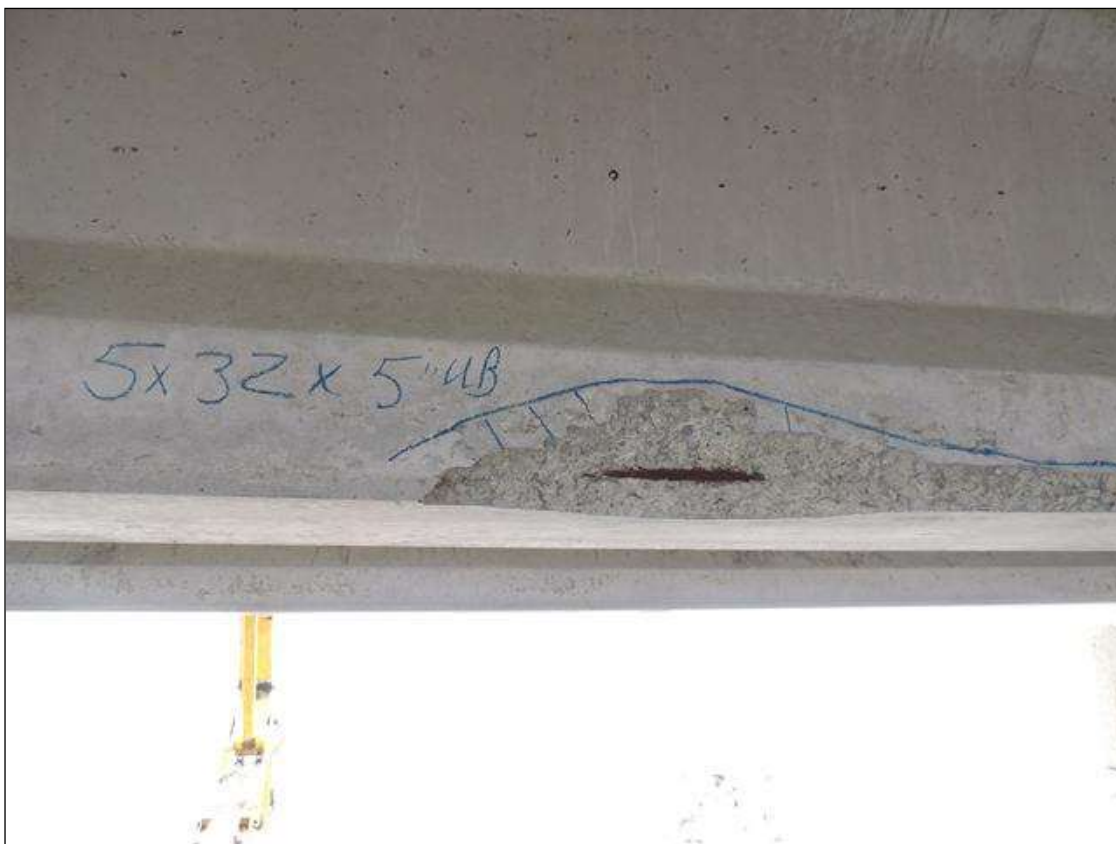
SPAN 103 G3 SPALLED AREA ALONG THE BOTTOM LT SIDE 5" X 32" X 5" UNDER BOTTOM 10' FROM BENT 102 MCABLE EXPOSED PM

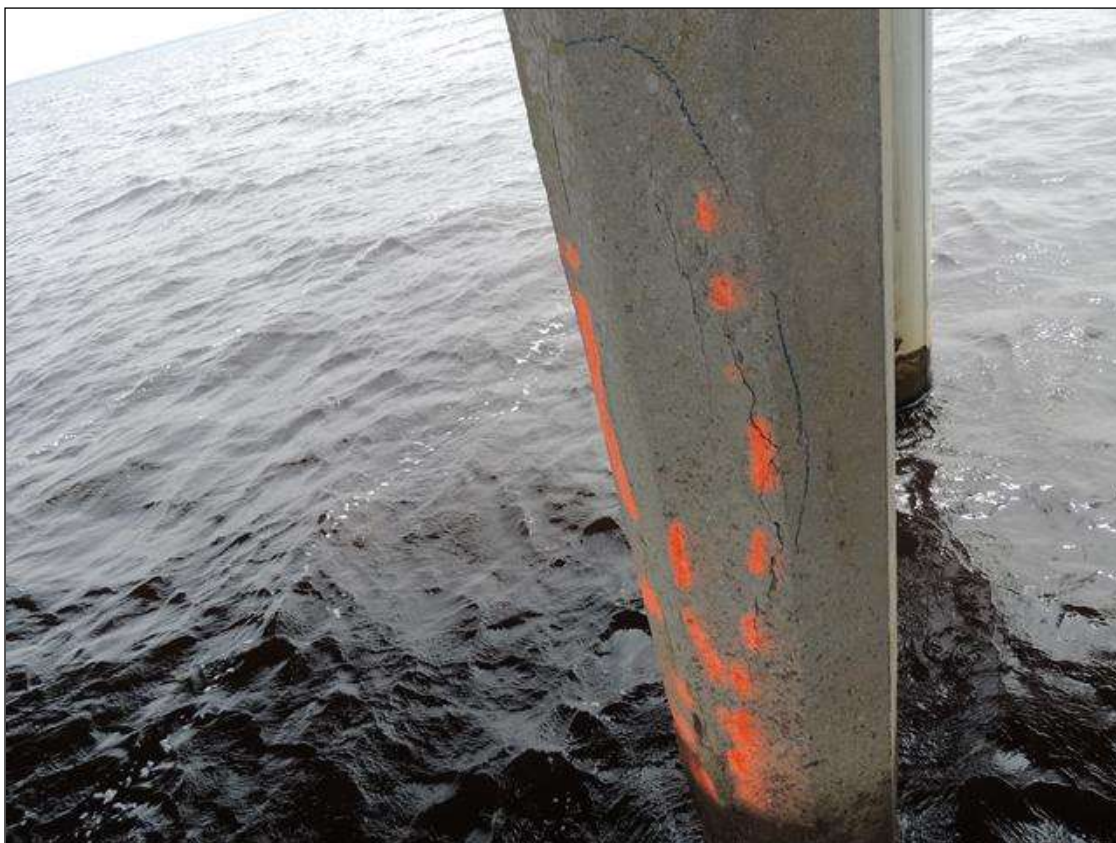
BENT 125 PILE 3 IS CRACKED AND DELAMINATED ON N FACE OF PILE FROM THE WL UP 90" .

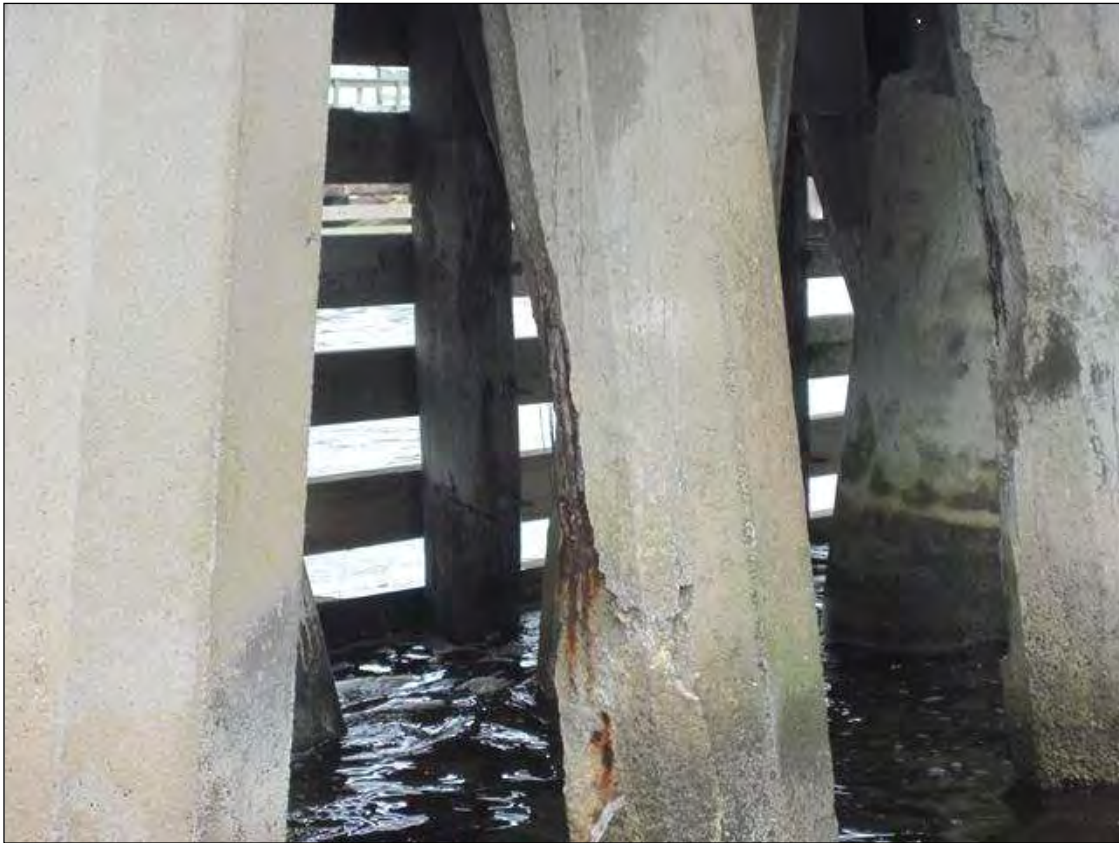
REST BENT 2 PILES POOR

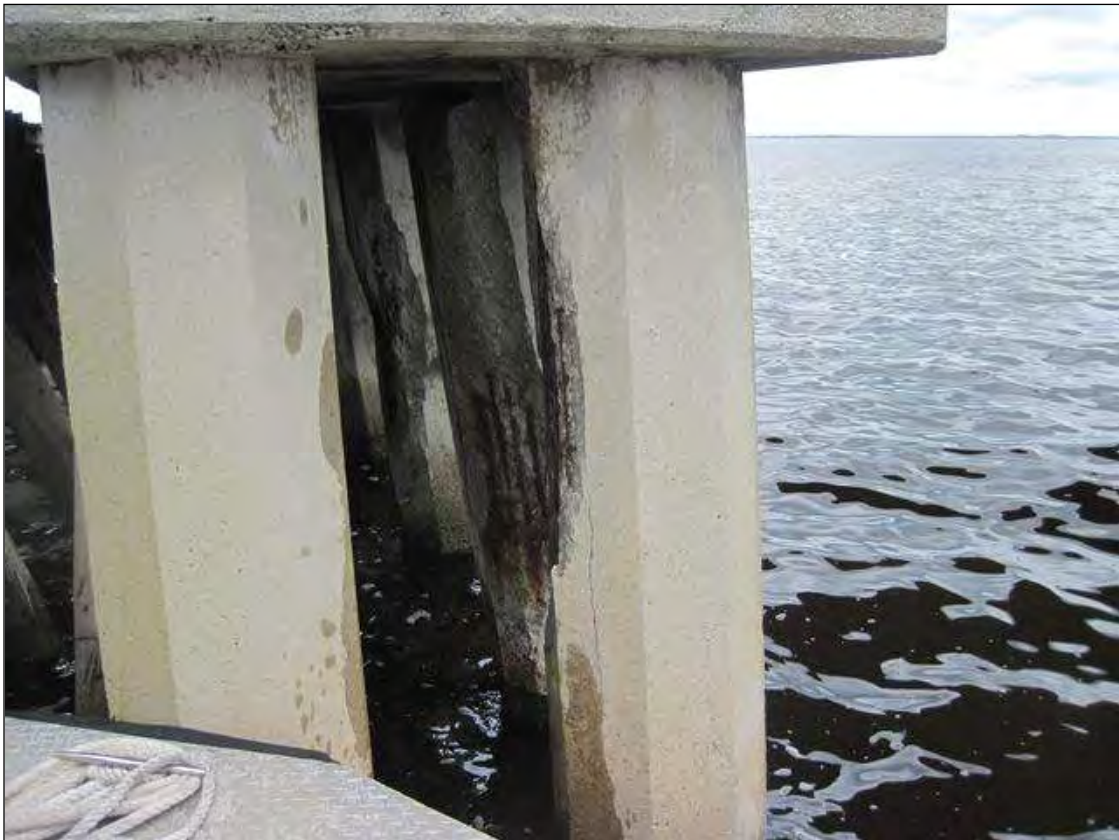
REST BENT 2, P-14, SPALLED W/ EXPOSED STRANDS (50%-100% LOSS) FROM CAP TO W/L, FACES 1,2,8.
