BENT 14 CRACKED AND DELAMINATED AREA ON THE NW SIDE OF PILE 4 STARTS 10" BELOW CAP AND GOES DOWN 8' 4" X 12" WIDE.

BENT 17 PILE 3 UNDER SUBCAP 1 HAS SAPLLED AREA 10' 2" LONG X 2 1/2" DEEP ON SW SIDE WITH CABLES EXPOSED AND BROKEN.PM

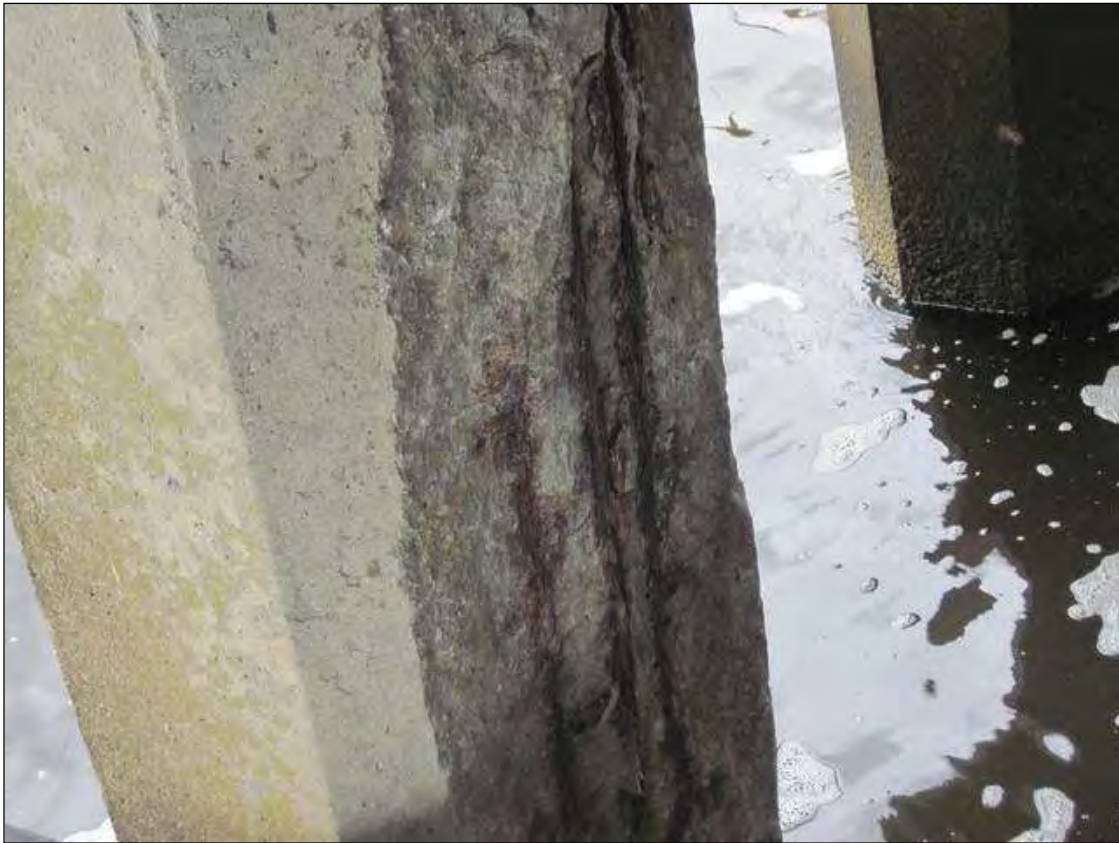
REST BENT 2, P-12, SPALLED W/ EXPOSED STRANDS (50%-100% LOSS) FROM CAP TO W/L, FACES 1,2,3,6,7,8.

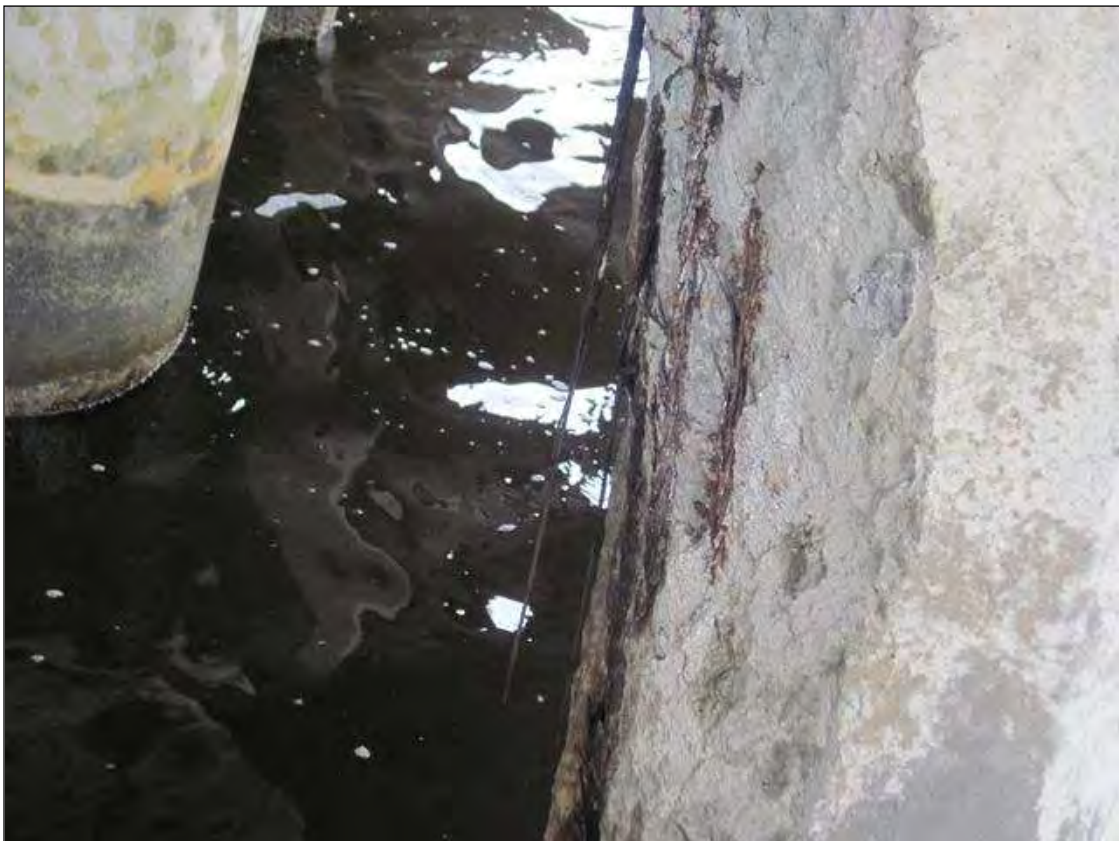
REST BENT 2, P-10, SPALLED W/ EXPOSED STRANDS (50%-100% LOSS) FROM CAP TO W/L, FACES 1,2,7,8.

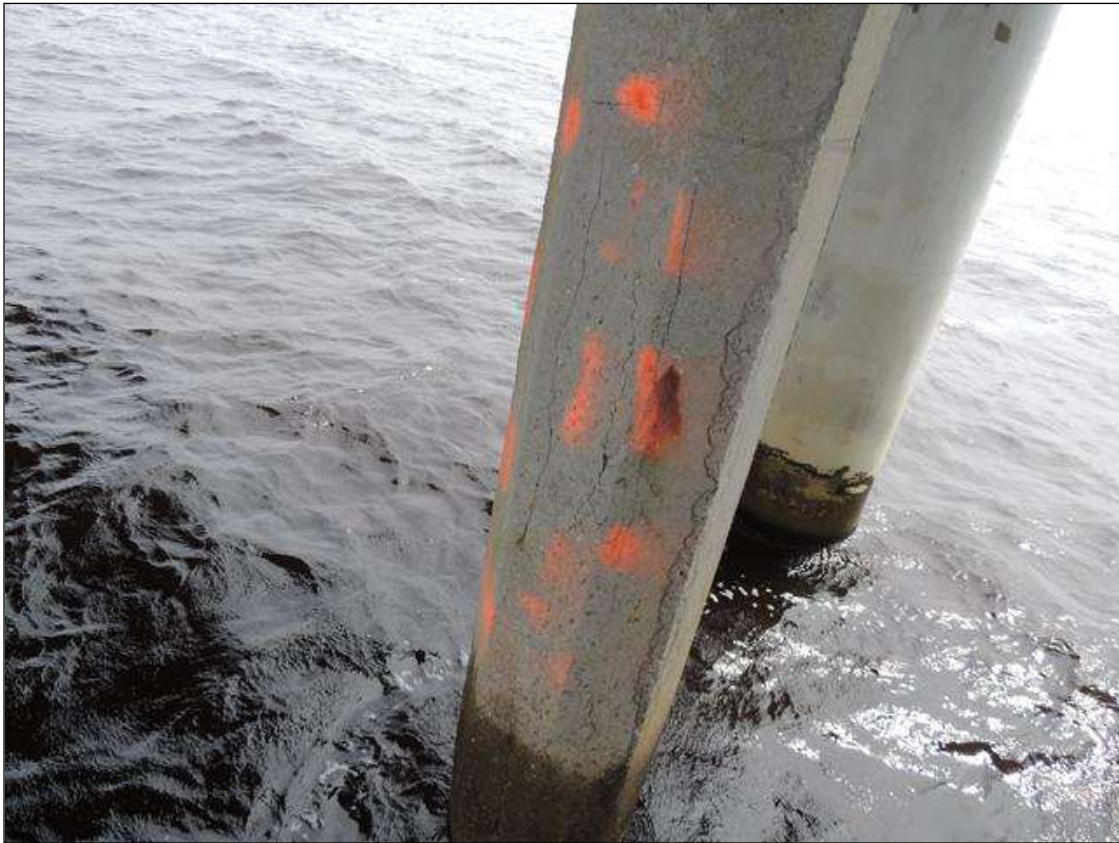
BENT 126 PILE 3 CRACKED AND DELAMINATED AREA ON THE N FACE OF PILE STARTS 3' ABOVE WL AND GOES UP 4' AND 16" AROUND PILE.

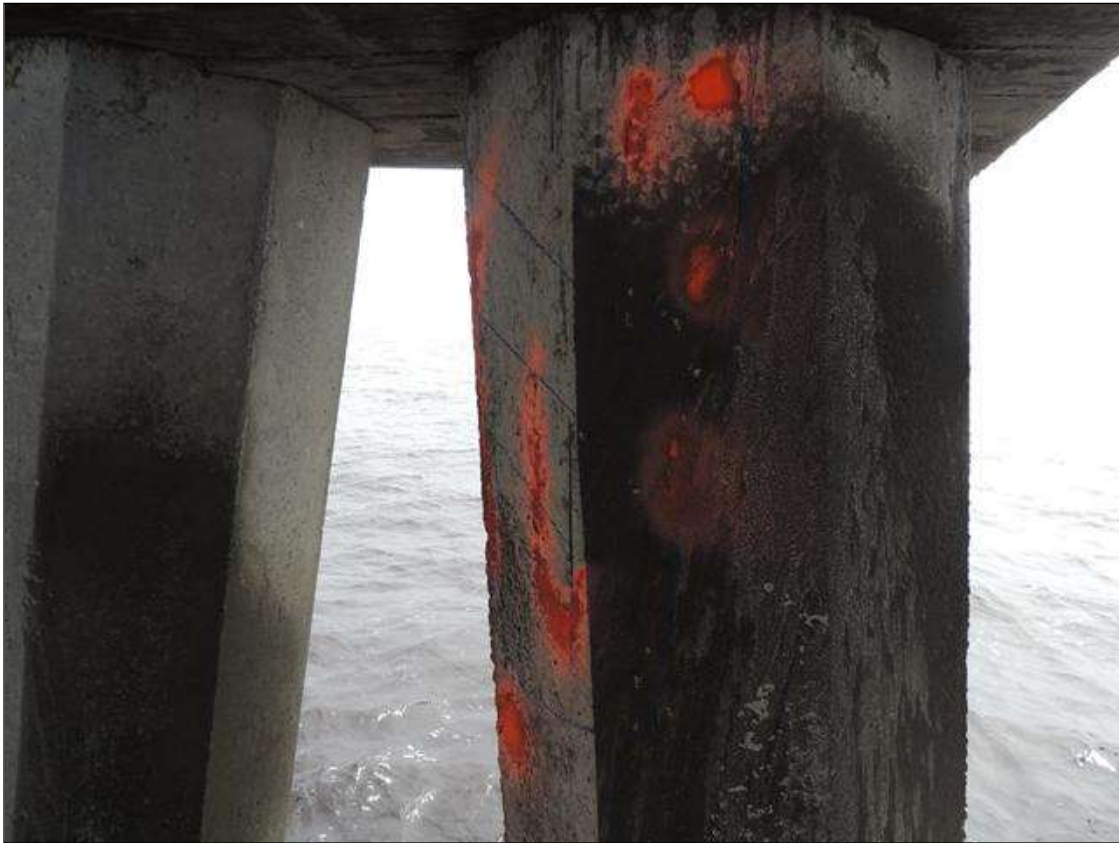
BENT 128 PILE 4 DELAMINATED AREA ON THE N FACE OF THE PILE FROM BOTTOM OF CAP DOWN 29" X 15" AROUND PILE.

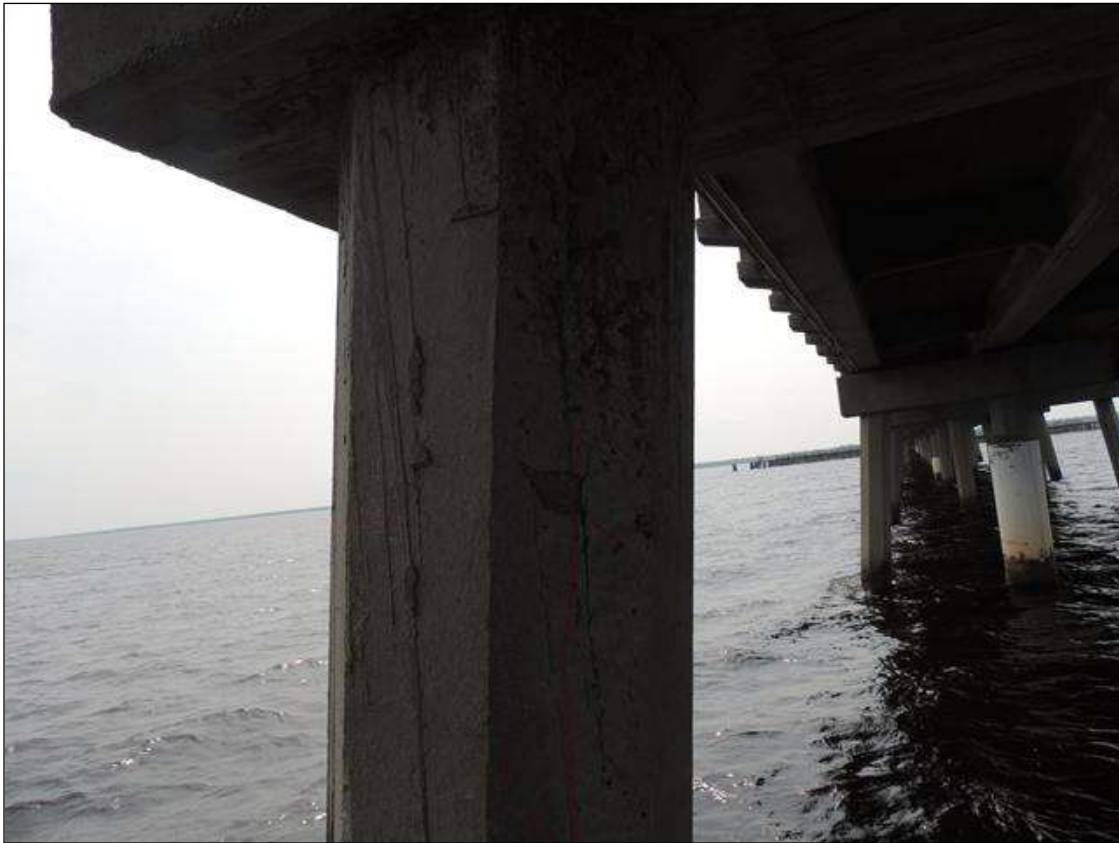
BENT 132 CRACKED AND DELAMINATED AREA ON THE NORTH FACE OF P6 FROM BOTTOM OF CAP DOWN 49" X 12" AROUND PILE.

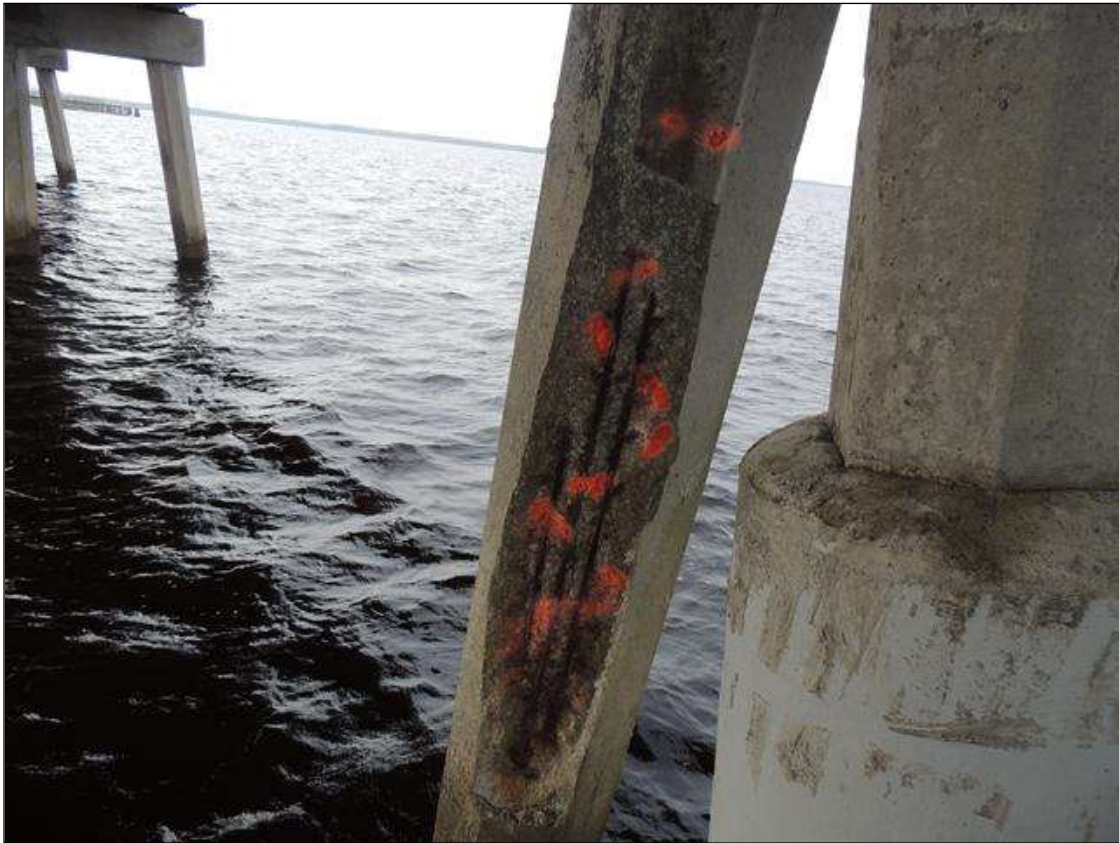
BENT 132 P2 IS CRACKED AND DELAMINATED AND SPALLED FROM THE BOTTOM OF SUBCAP TO WL 124" AND 15" AROUND PILE 3 CABLES EXPOSED PM.

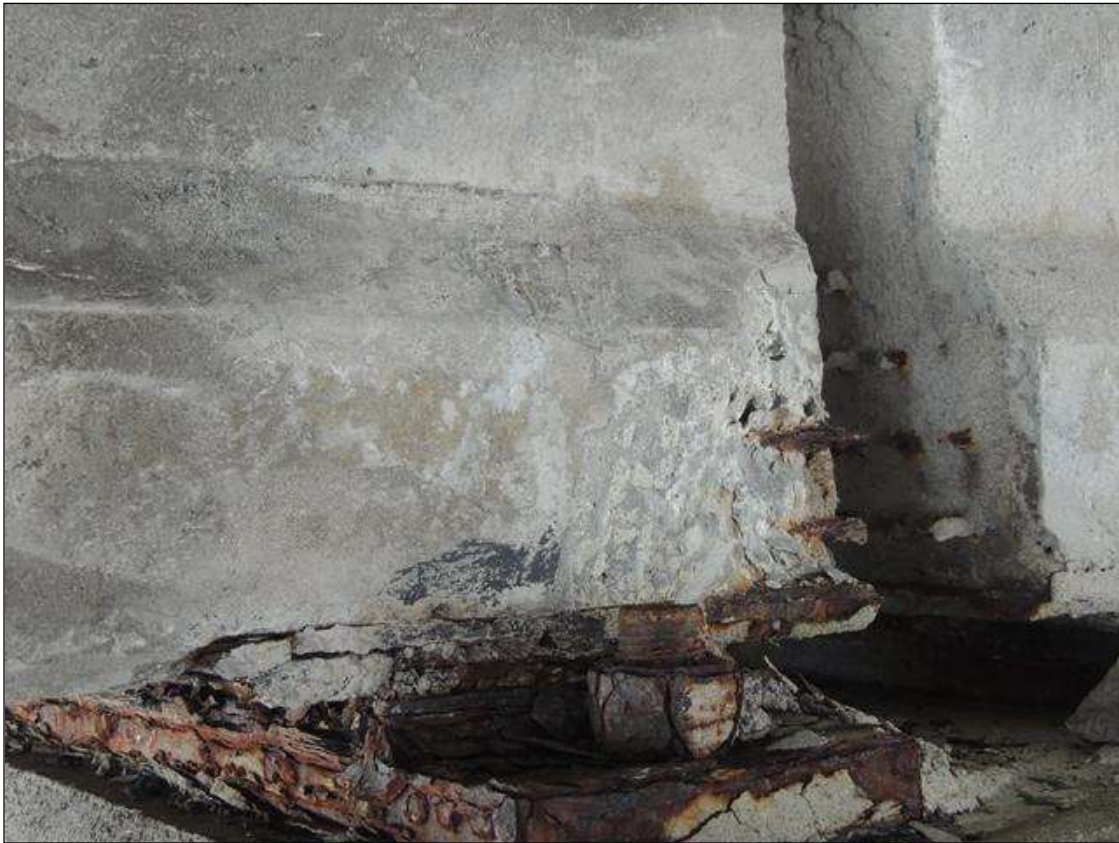
BENT 132 SPAN 133 SIDE SPALLED AREA ALONG THE BOTTOM LT END OF G2 8" X 9" X 2" DEEP CABLE EXPOSED PM.

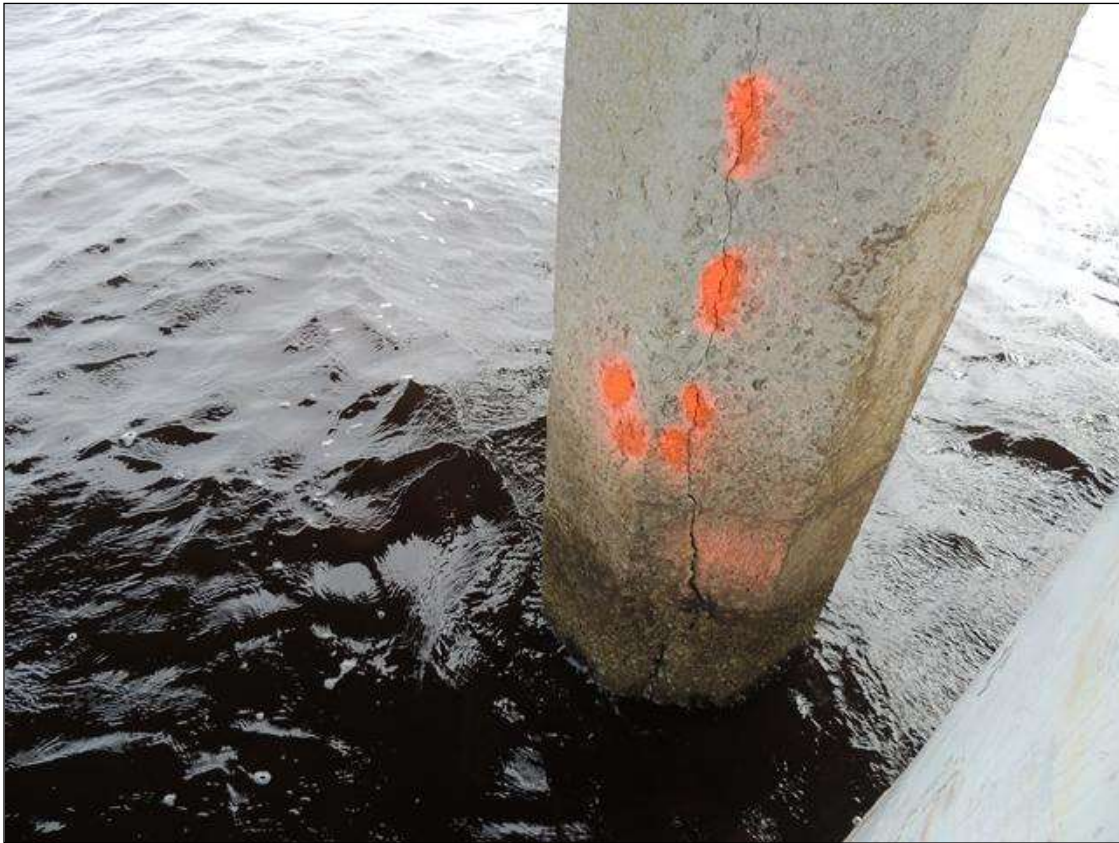
BENT 134 LARGE CRACK AND DELAMINATED AREA ON THE N FACE OF P3 48" FROM WL UP AND 12" AROUND PILE.

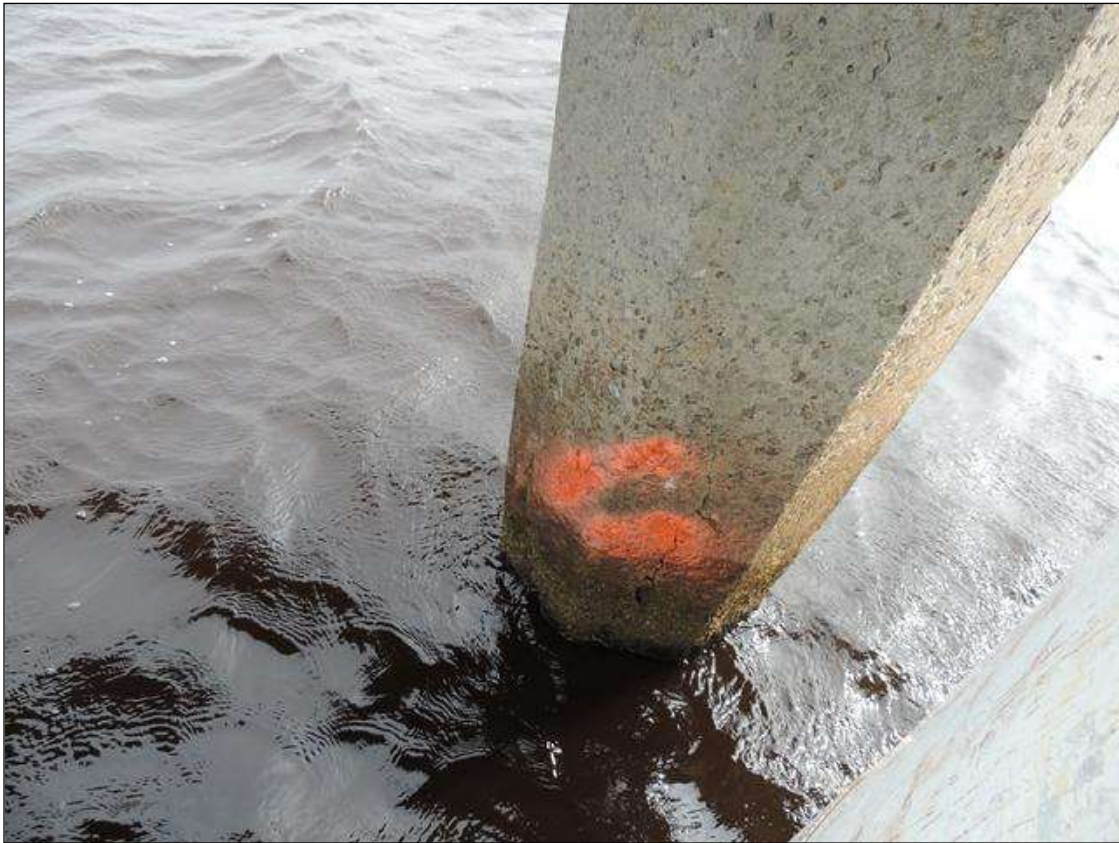
BENT 134 LARGE CRACK AND DELAMINATED AREA ON THE N FACE OF P4 28" FROM WL UP AND 14" AROUND PILE.

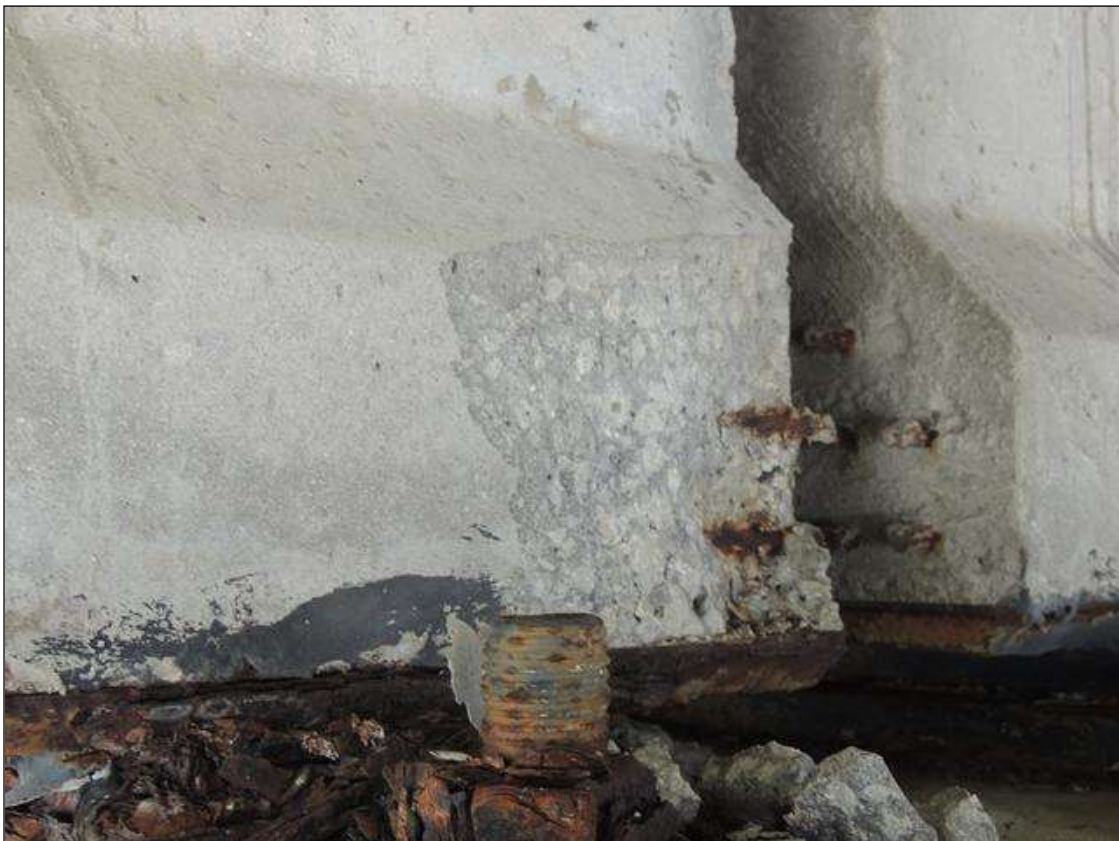
BENT 134 SPAN 134 SIDE SPALLED AREA ALONG THE BOTTOM RT END OF G3 7" X 9" X 1 1/2" DEEP.

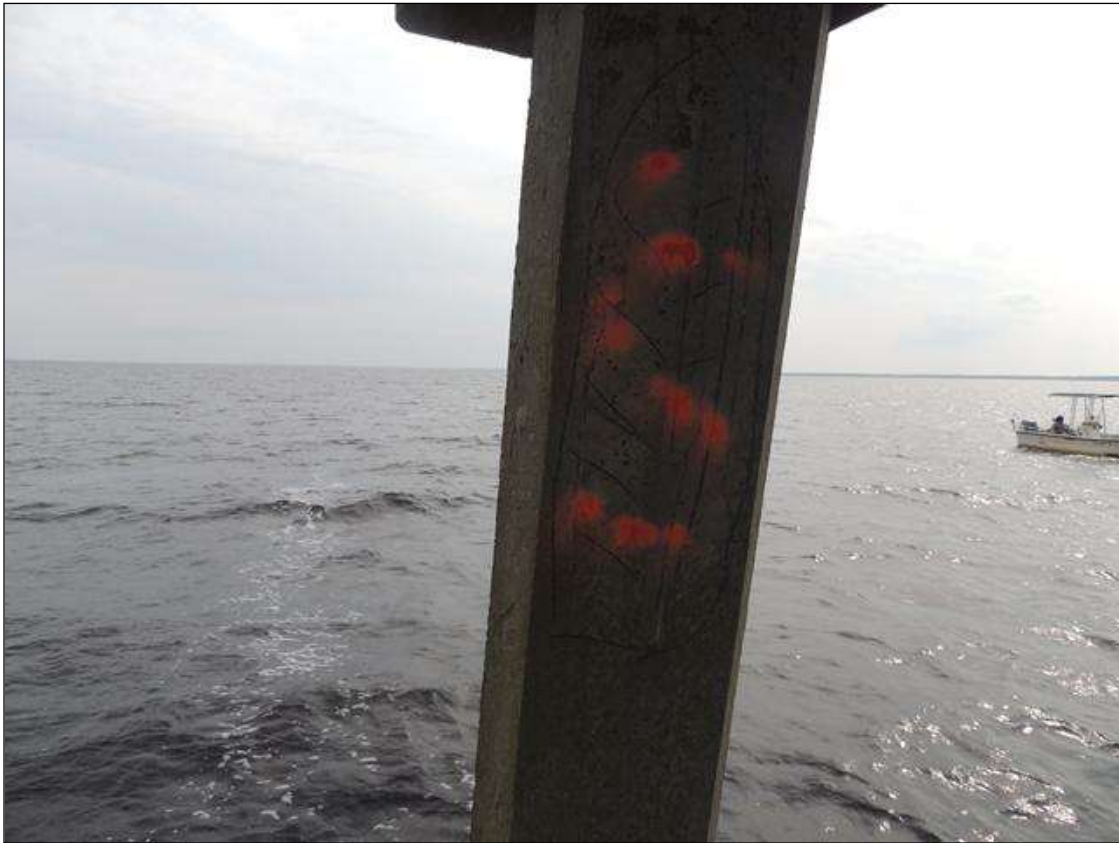
BENT 134 PILE 4 HAS DELAMINATED AREA STARTING 10" BELOW BOTTOM OF CAP AND GOES DOWN 44" X 16" AROUND PILE.

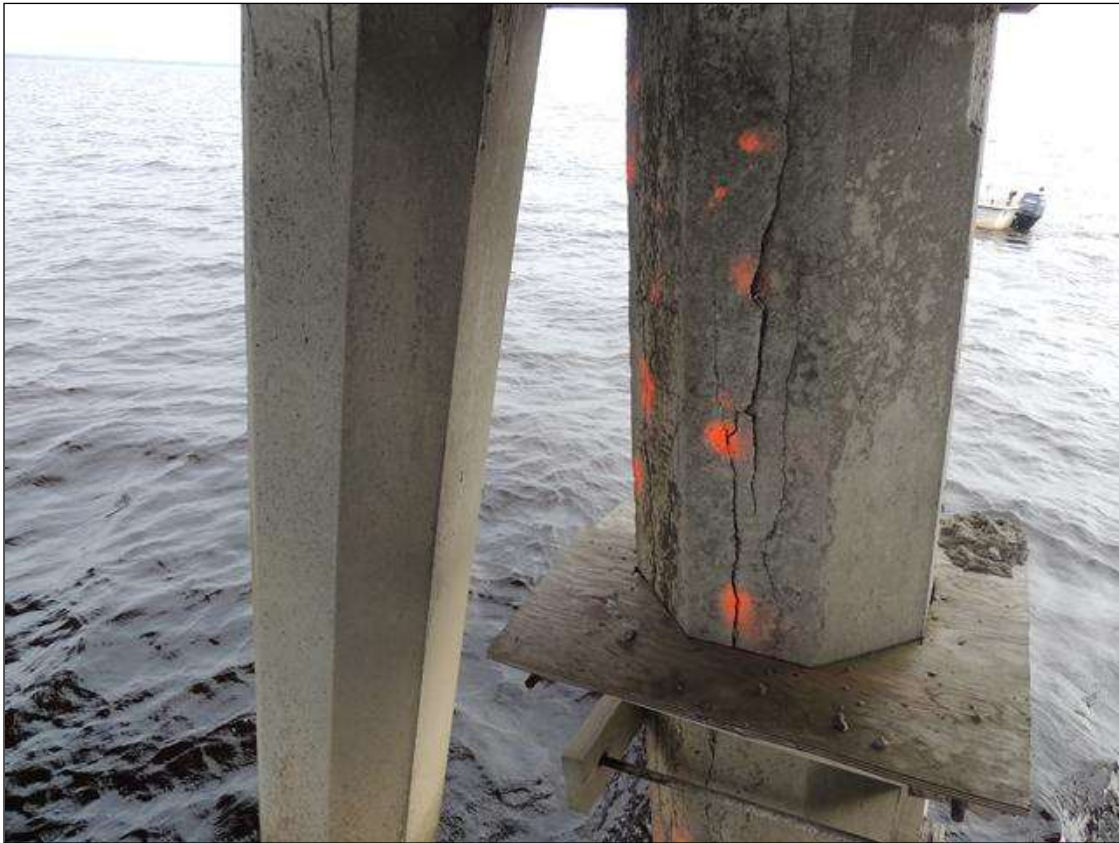
BENT 136 P4 LARGE CRACKED AND DELAMINATED AREA FROM BOTTOM OF CAP TO WL 10' X 28" AROUND PILE ON N FACE.

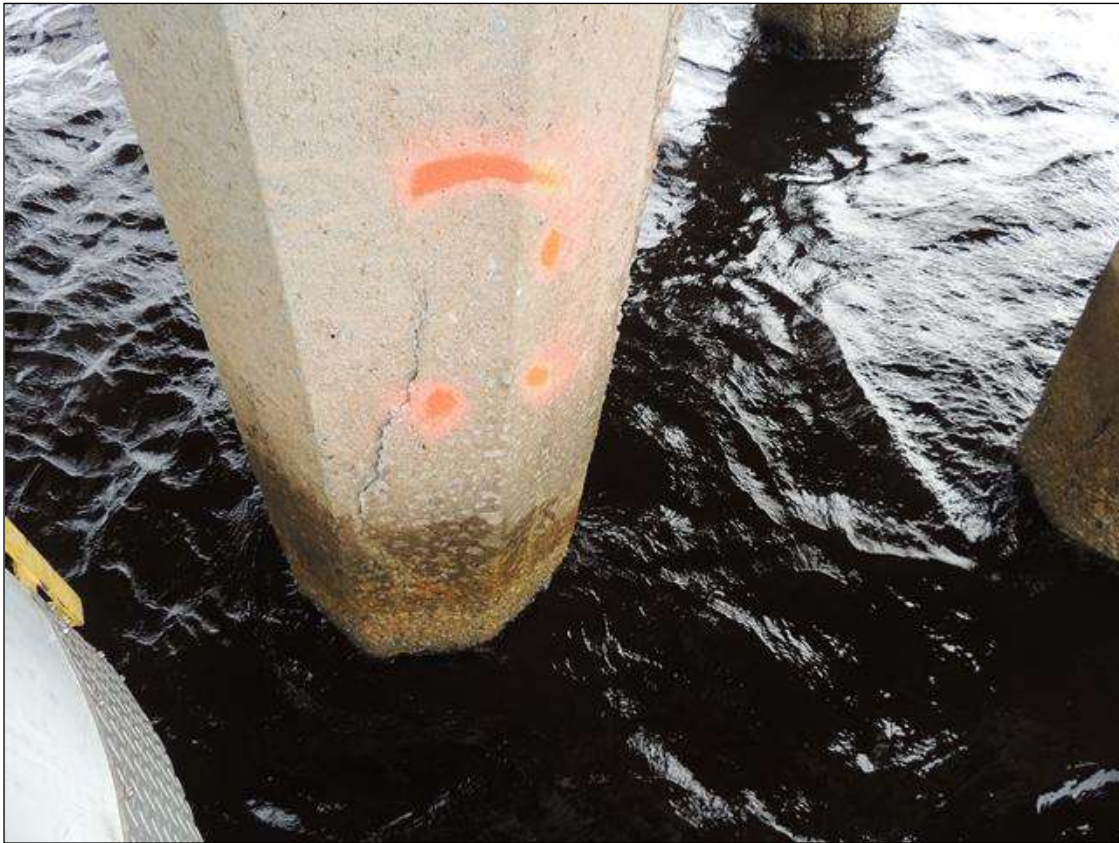
BENT 136 P3 CRACKED AND DELAMINATED AREA ON THE N FACE OF PILE FROM WL UP 41" X 16" AROUND PILE.

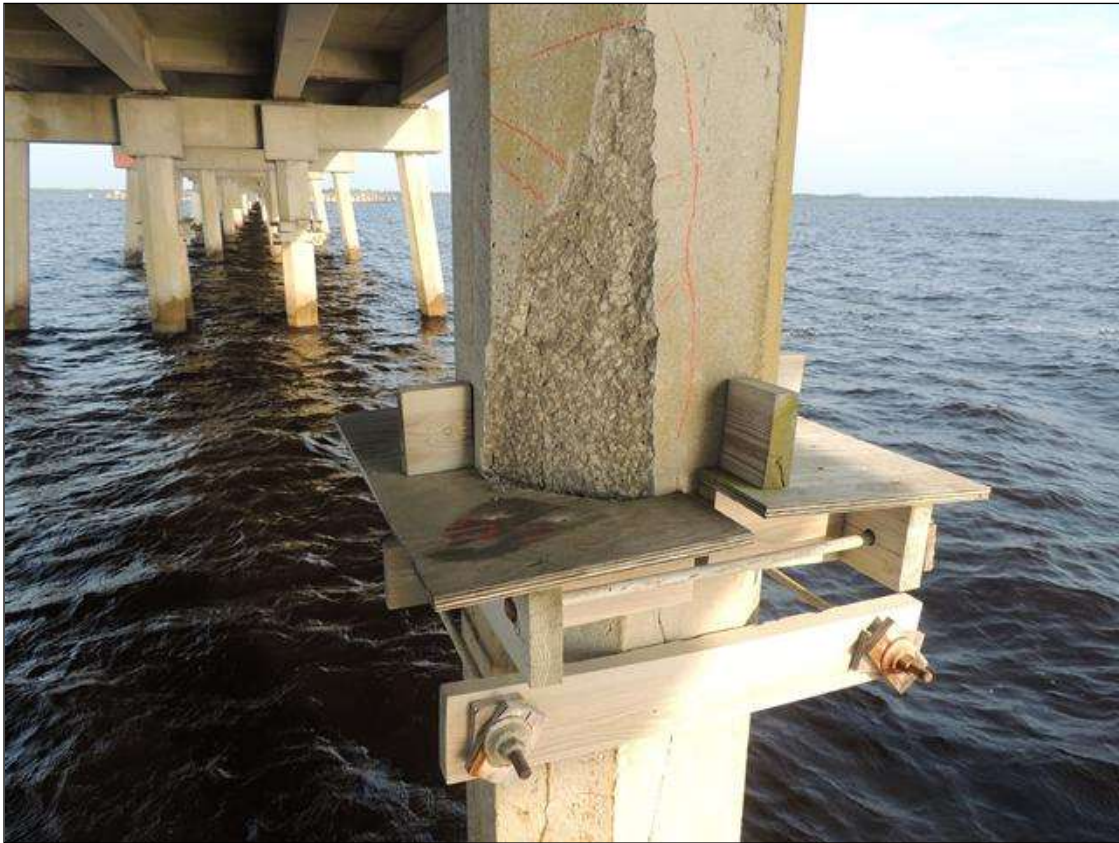
BENT 137 PILE 2 CRACKED AND DELAMINATED AREA ON THE NE FACE OF THE PILE 18" AROUND, 9' 2" FROM THE WATERLINE UP

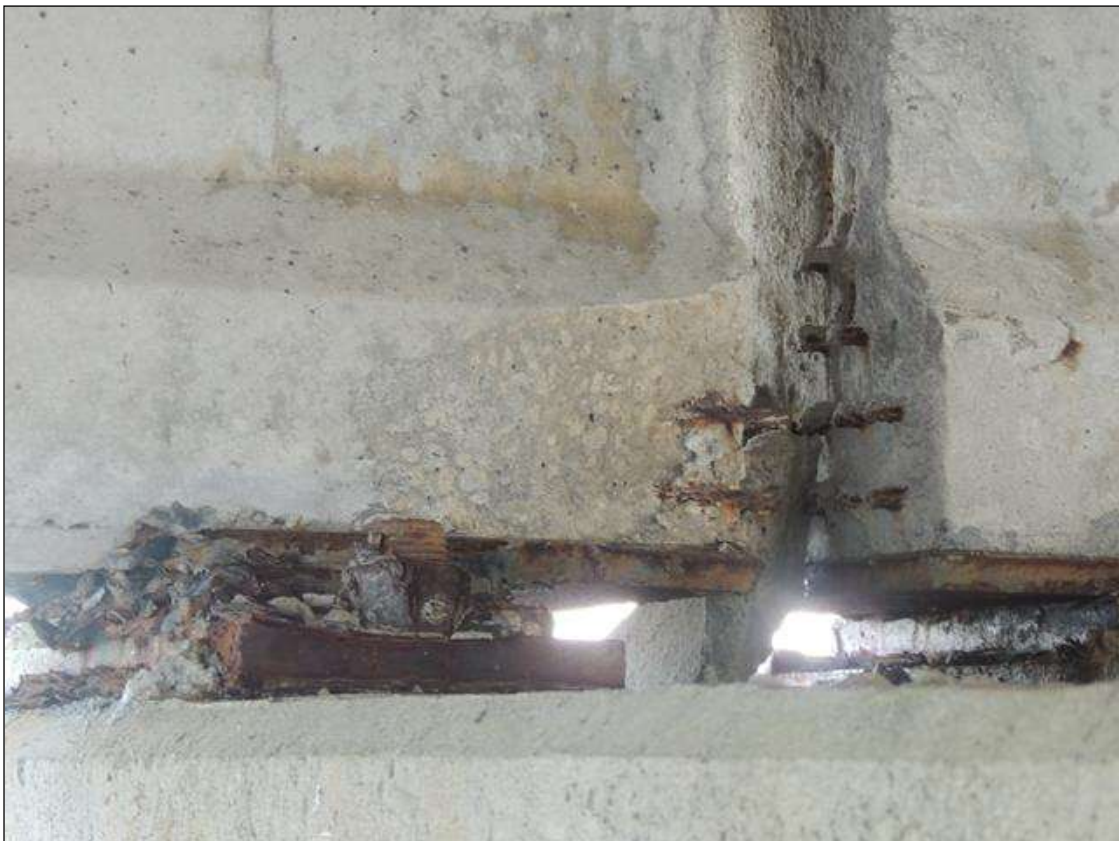
BENT 138 SPAN 138 SIDE SPALLED AREA ALONG THE BOTTOM RT END OF G1 7" X 11" 1 1/2" DEEP

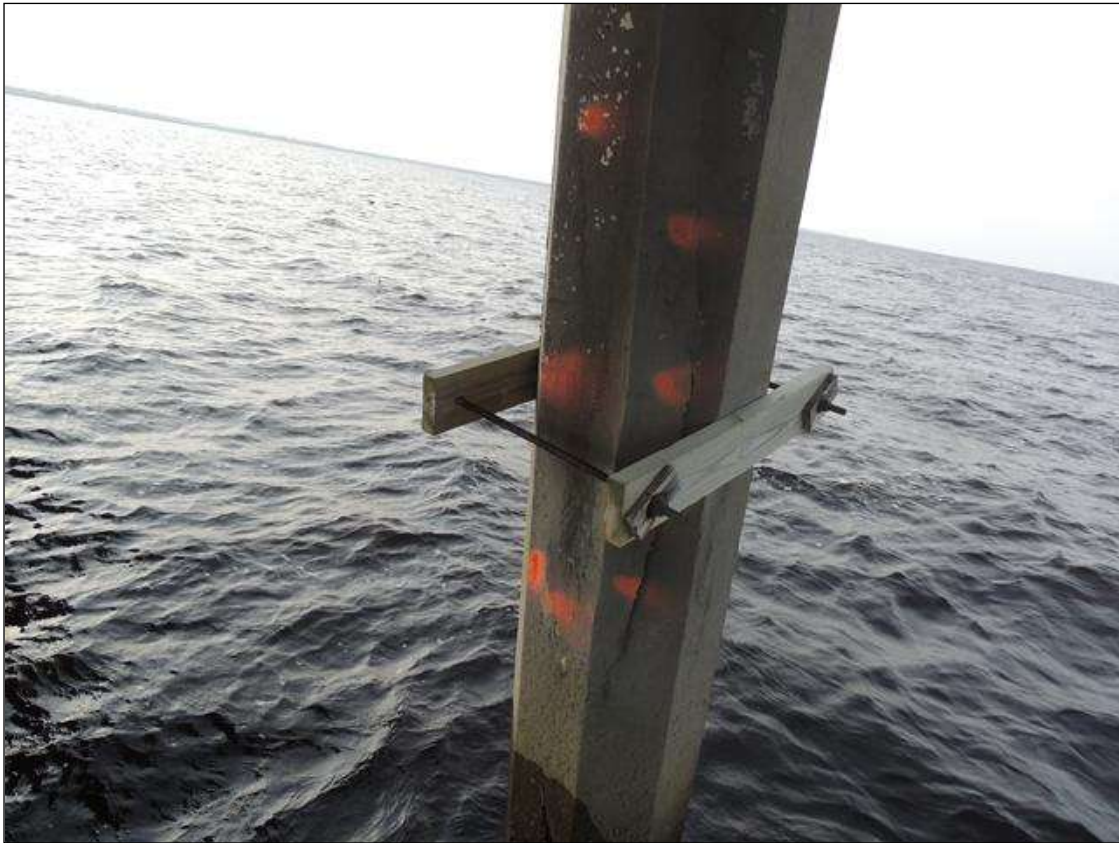
BENT 139 P4 CRACKED AND DELAMINATED AREA ON THE N FACE OF THE PILE 8' 1" FROM THE WATERLINE  
UP, 18" AROUND THE PILE

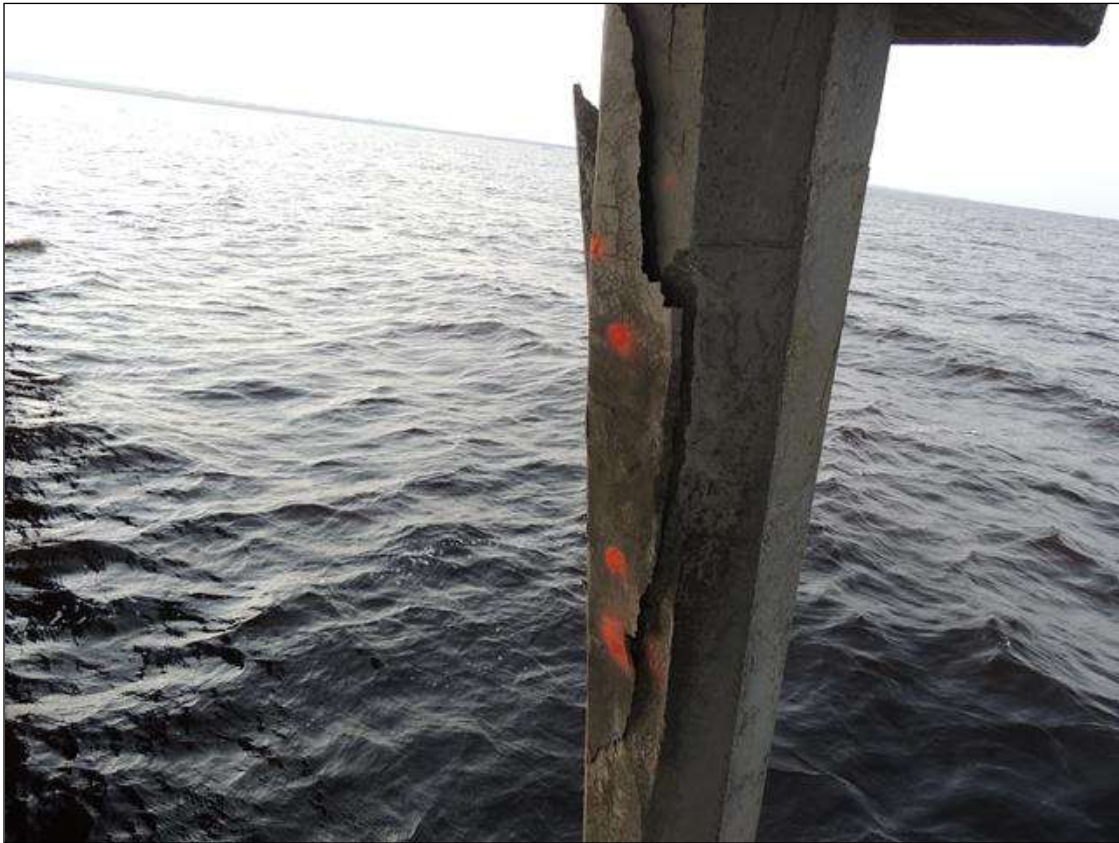
BENT 140 P6 CRACKED, SPALLED, AND DELAMINATED AREA, 10' X 6" FROM THE BOTTOM OF CAP TO WL,  
26" AROUND THE PILE, REBAR AND CABLES EXPOSED

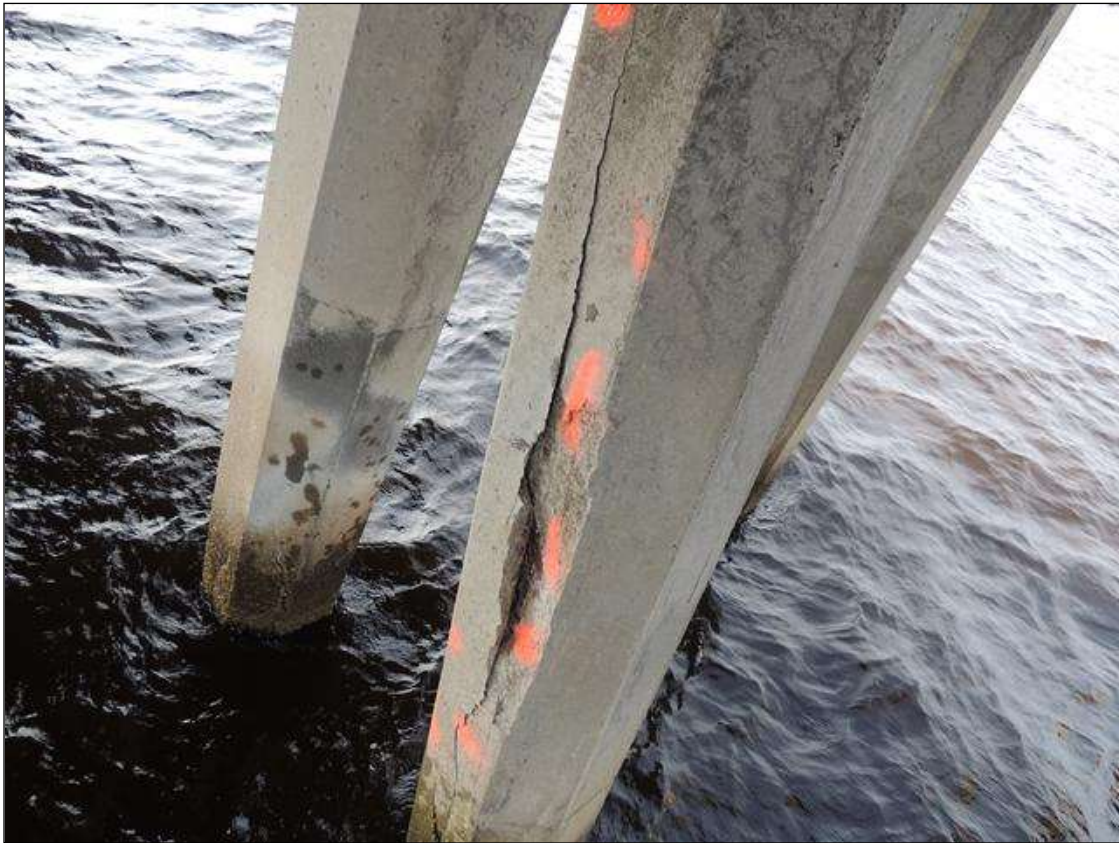
BENT 144 P4 CRACKED AND DELAMINATED AREA 20" AROUND THE PILE 9' 10" FROM THE BOTTOM OF THE CAP DOWN

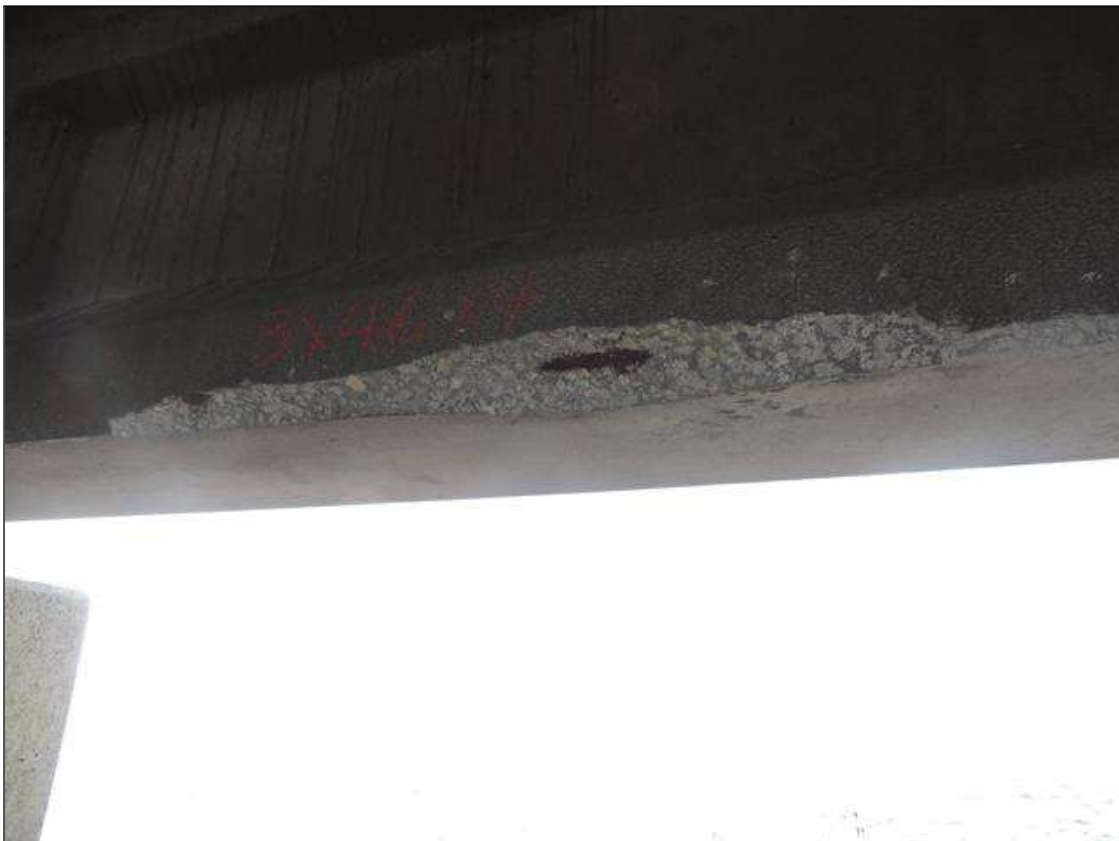
SPAN 144 SPALLED AREA ALONG THE BOTTOM LT SIDE OF G4 3' FROM BENT 144, 3" X 46" X 4"

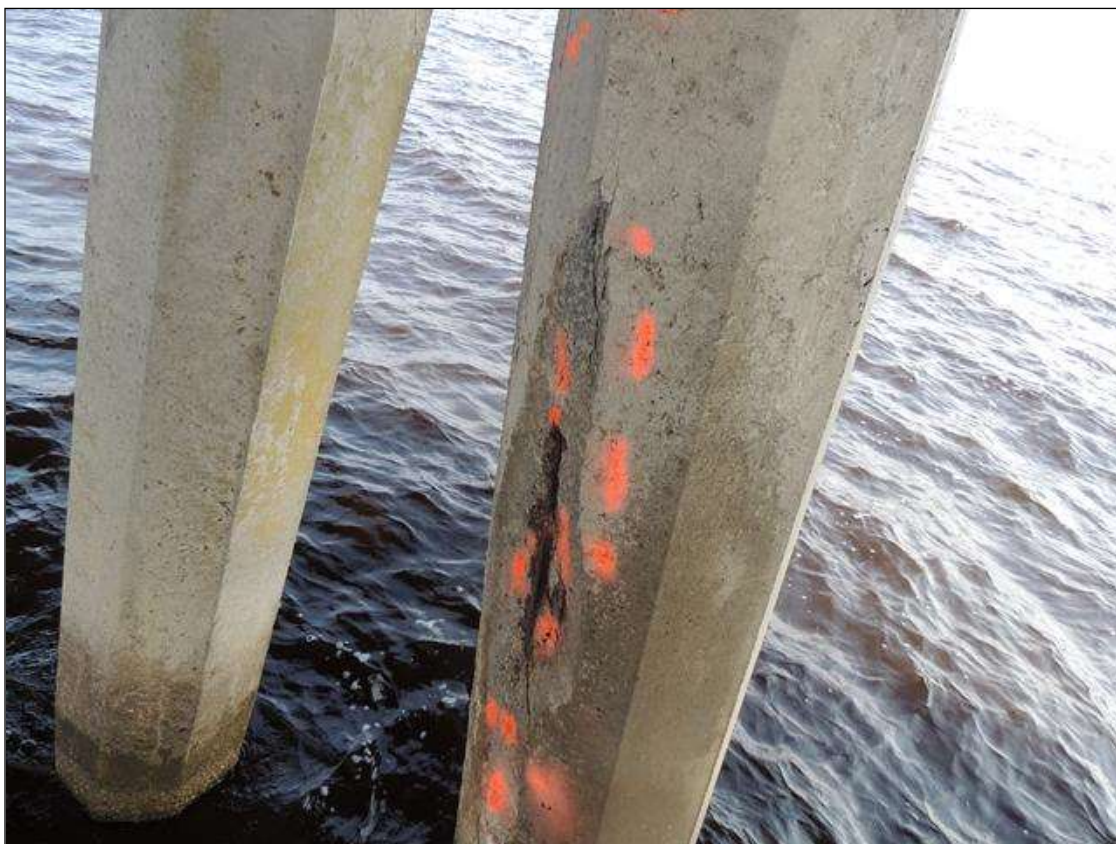
BENT 144 P2 CRACKED, SPALLED AND DELAMINATED AREA FROM THE BOTTOM OF CAP TO WL 9' 8" AND 23" AROUND PILE REBAR EXPOSED PM

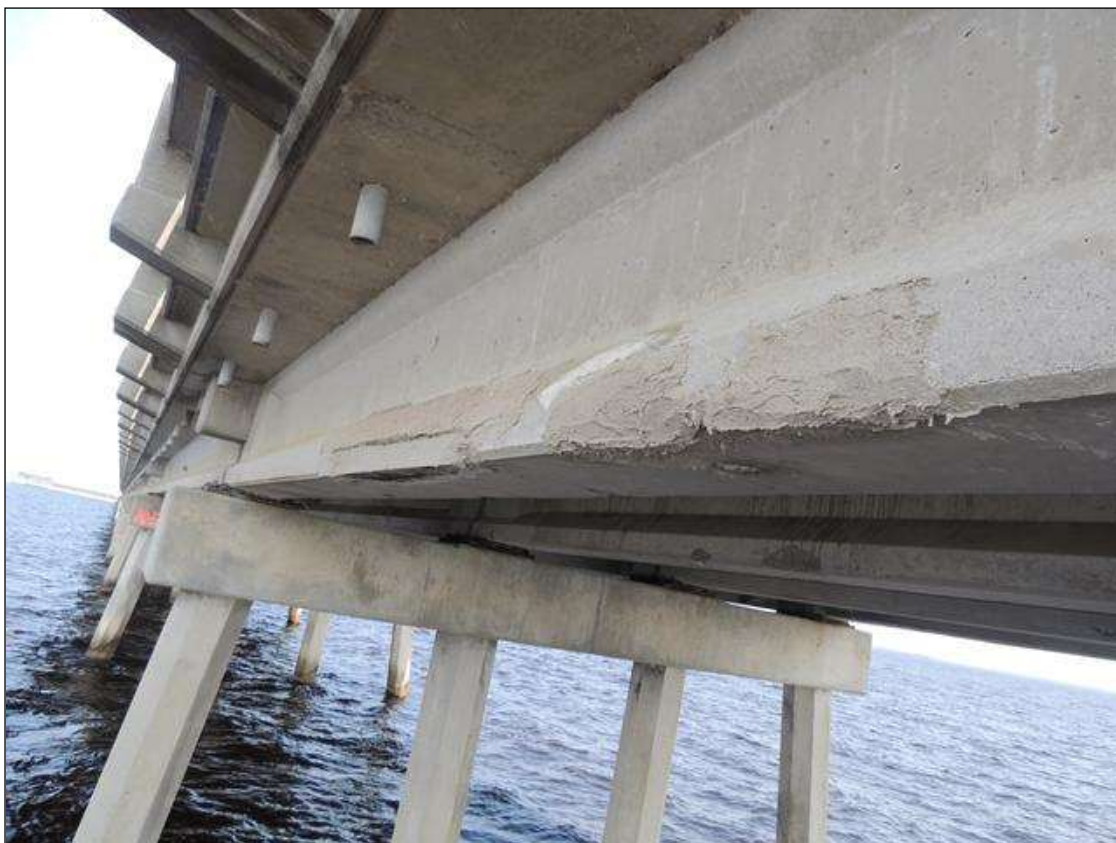
SPAN 147 SCATTERED PATCHED AREAS ALONG BOTOM R SIDE OF G4.

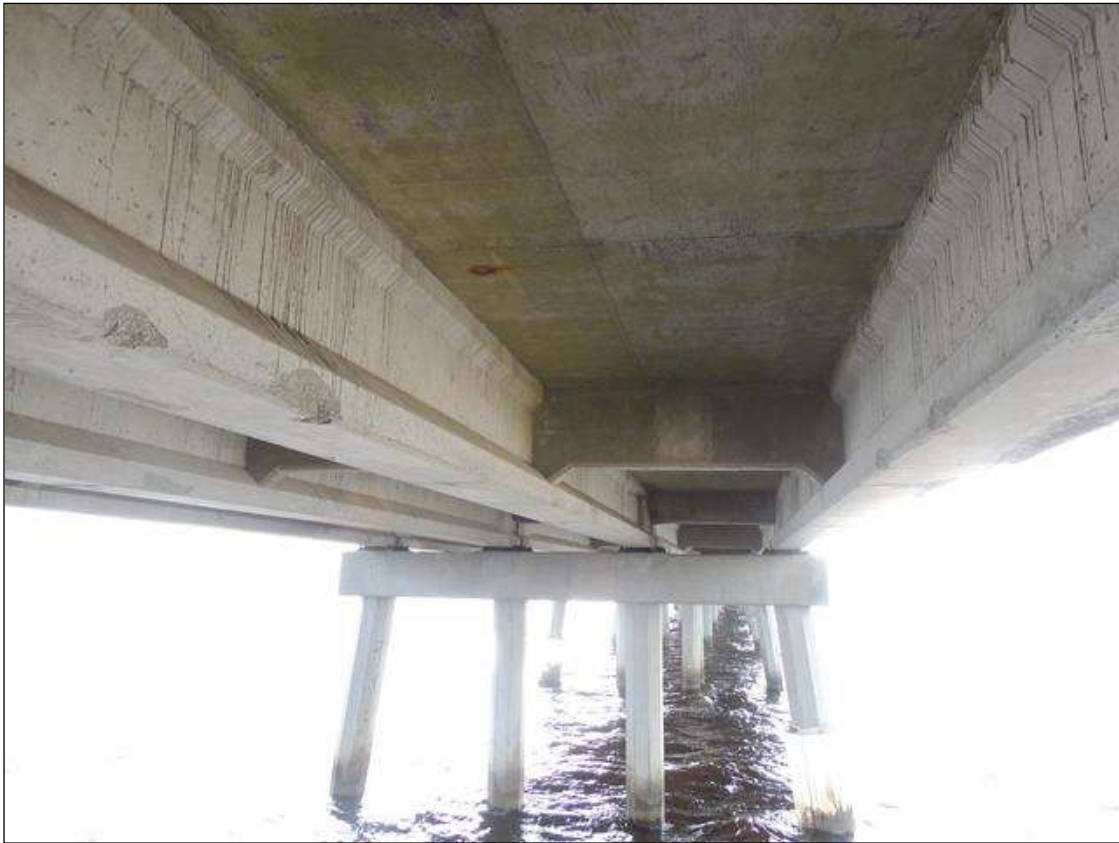
SPAN 147 SCATTERED SURFACE SPALLED AREAS ON BOOM EDGES OF G2 , G3 AND G4 .

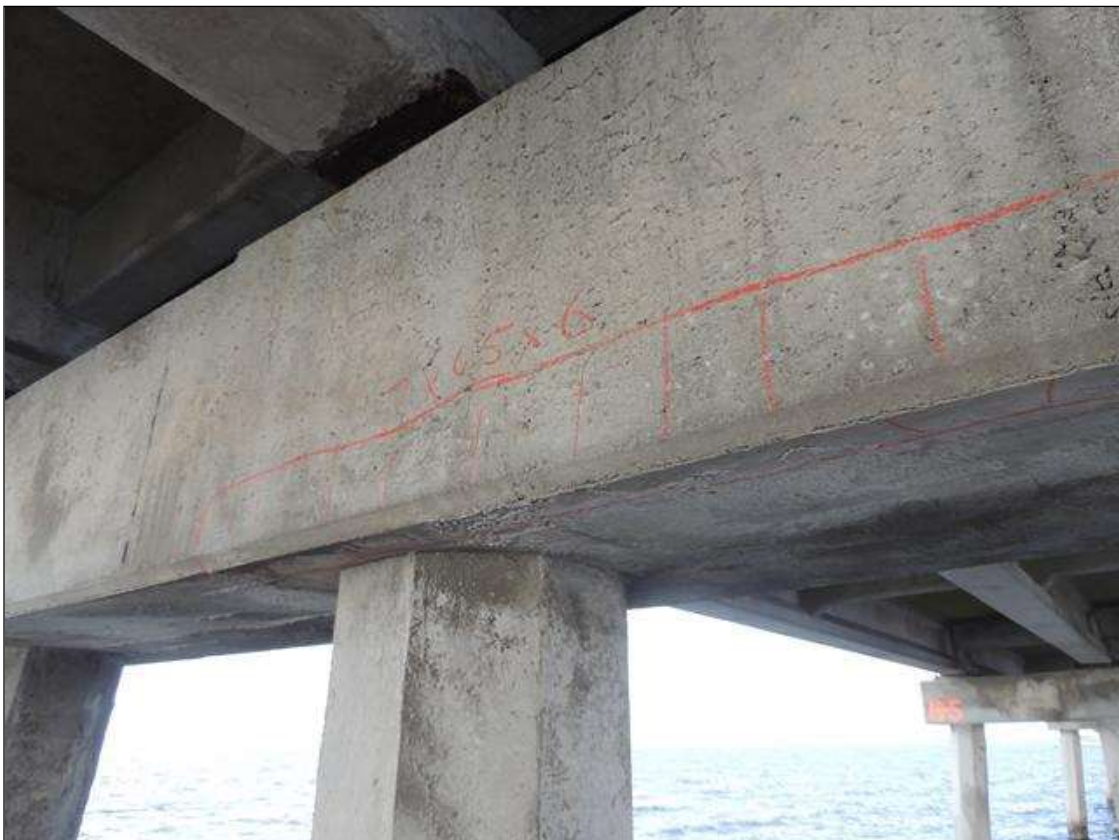
BEN 146 SPAN 147 SIDE CRACKED AND DELAMINATED AREA ALONG THE BOTTOM FACE AND BOTTOM OF THE CAP UNDER G3 7' X 65" X 12" UNDER BOTOM.

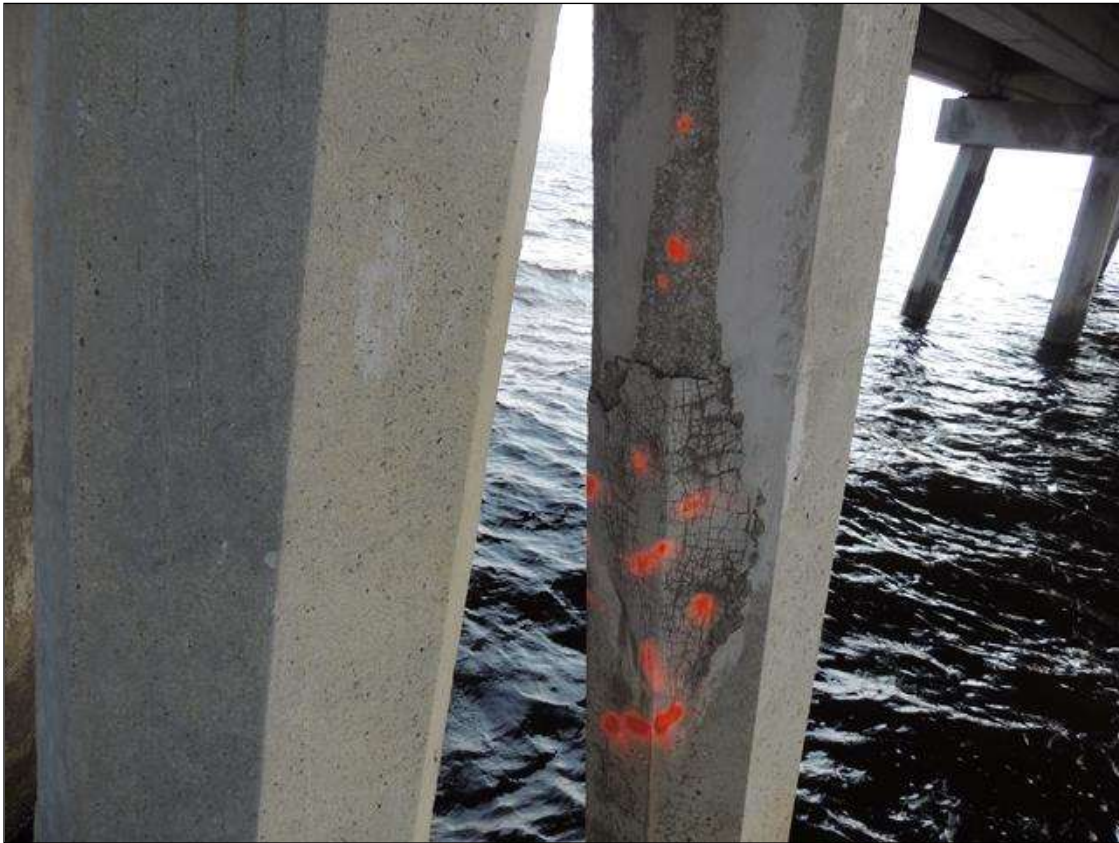
BENT 148 P5 IS CRACKED , DELAM AND SPALLED ON THE WEST FACE FROM BOTTOM OF CAP DOWN 72" AND 21" AROUND PILE.
