BENT 14 CRACKED AND DELAMINATED AREA ON THE NW SIDE OF PILE 4 STARTS 10" BELOW CAP AND GOES DOWN 8' 4" X 12" WIDE.

BENT 17 PILE 3 UNDER SUBCAP 1 HAS SAPLLED AREA 10' 2" LONG X 2 1/2" DEEP ON SW SIDE WITH CABLES EXPOSED AND BROKEN.PM

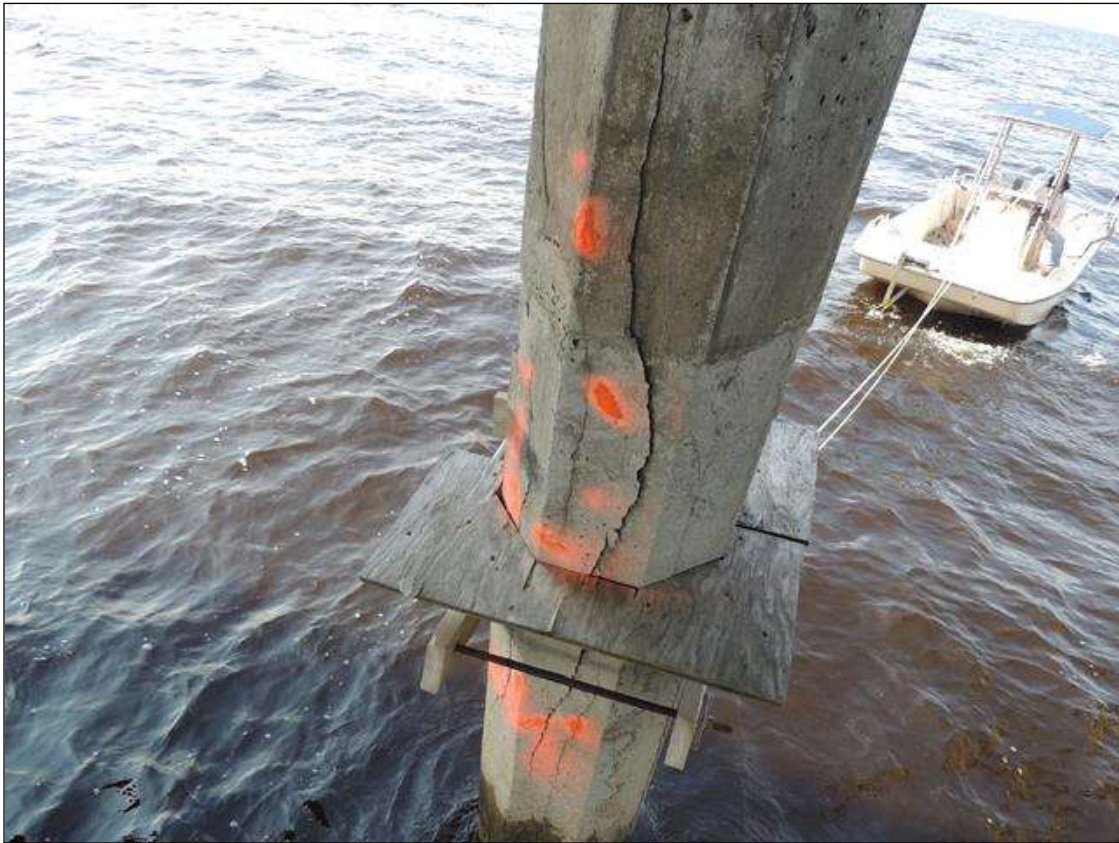
BEN 149 P4 ON THEW NE FACE HAS CRACKED , DELAMINATED AND SPALLED AREA FROM WL TO BOTTOM OF CAP 10' 3" AND 21" AROUND PILE.

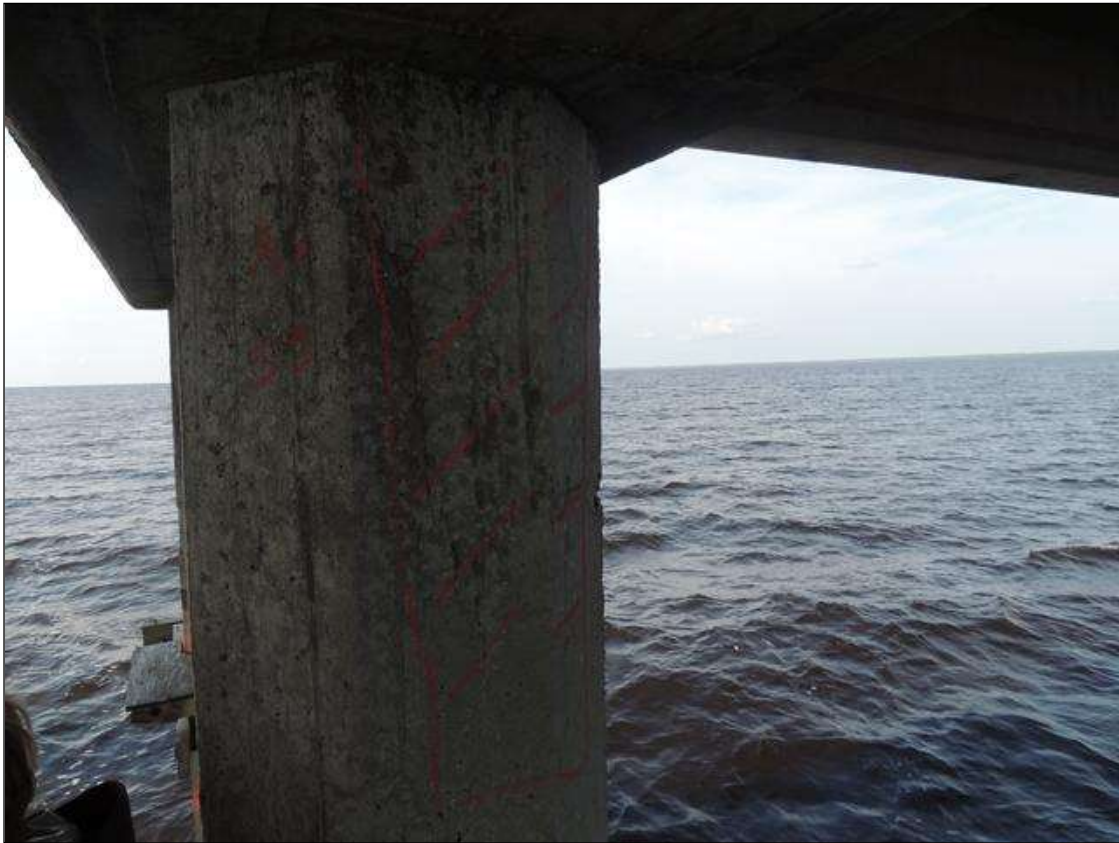
BENT 149 P3 CRACKED AND DELAMINATED AREA ON THE NORTH FACE OF THE PILE FROM BOTTOM OF CAP DOWN 33" X 16" AROUND PILE.

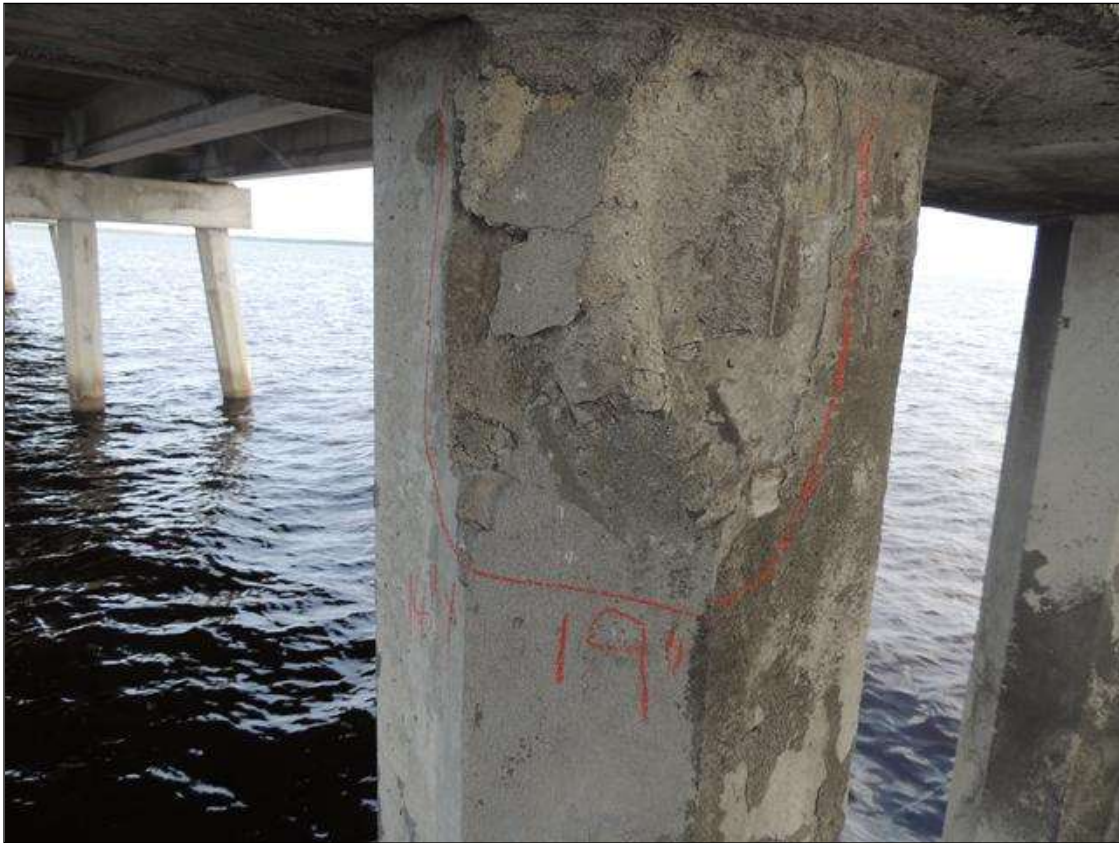
BENT 166 P3 EAST FACE SPALLED AND DELAMINATED AREA 19" FROM THE BOTTOM OF THE CAP DOWN X 18" AROUND X 2" DEEP

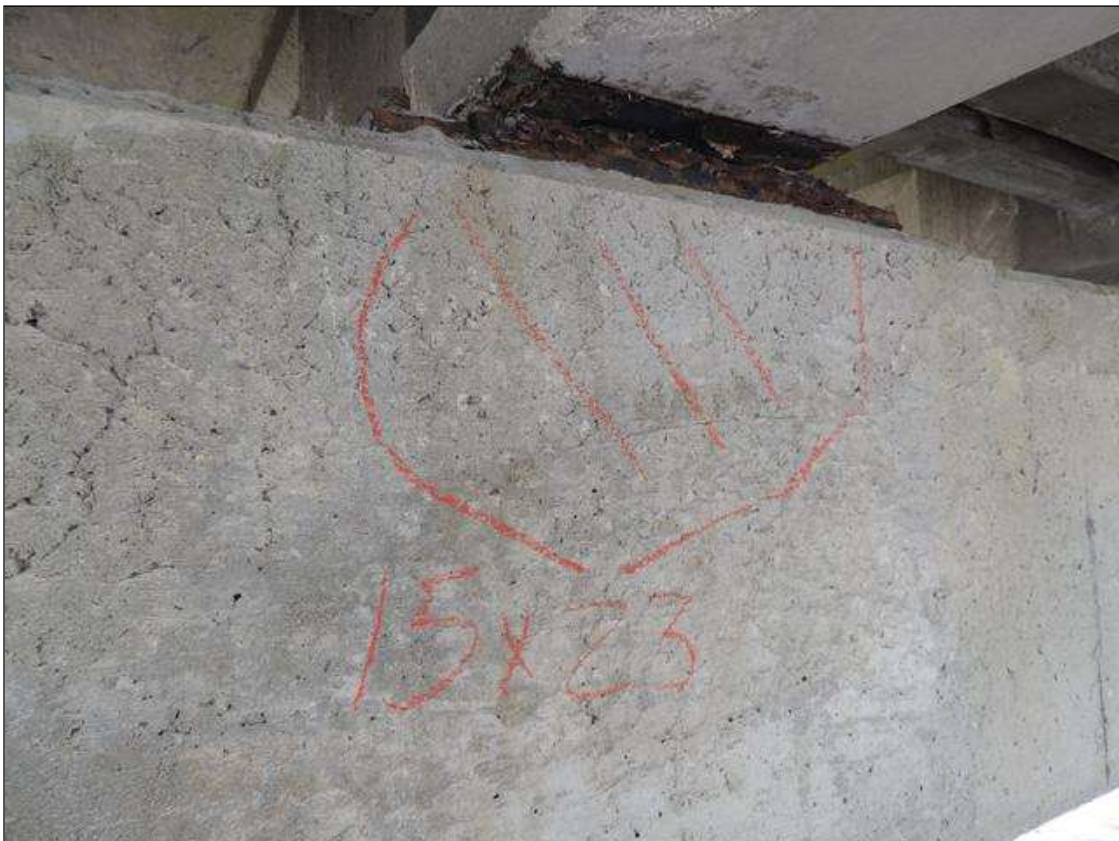
BENT 167 SPAN 167 SIDE CRACKED AND DELAMINATED AREA ALONG THE CAP UNDER G3 15" X 23"

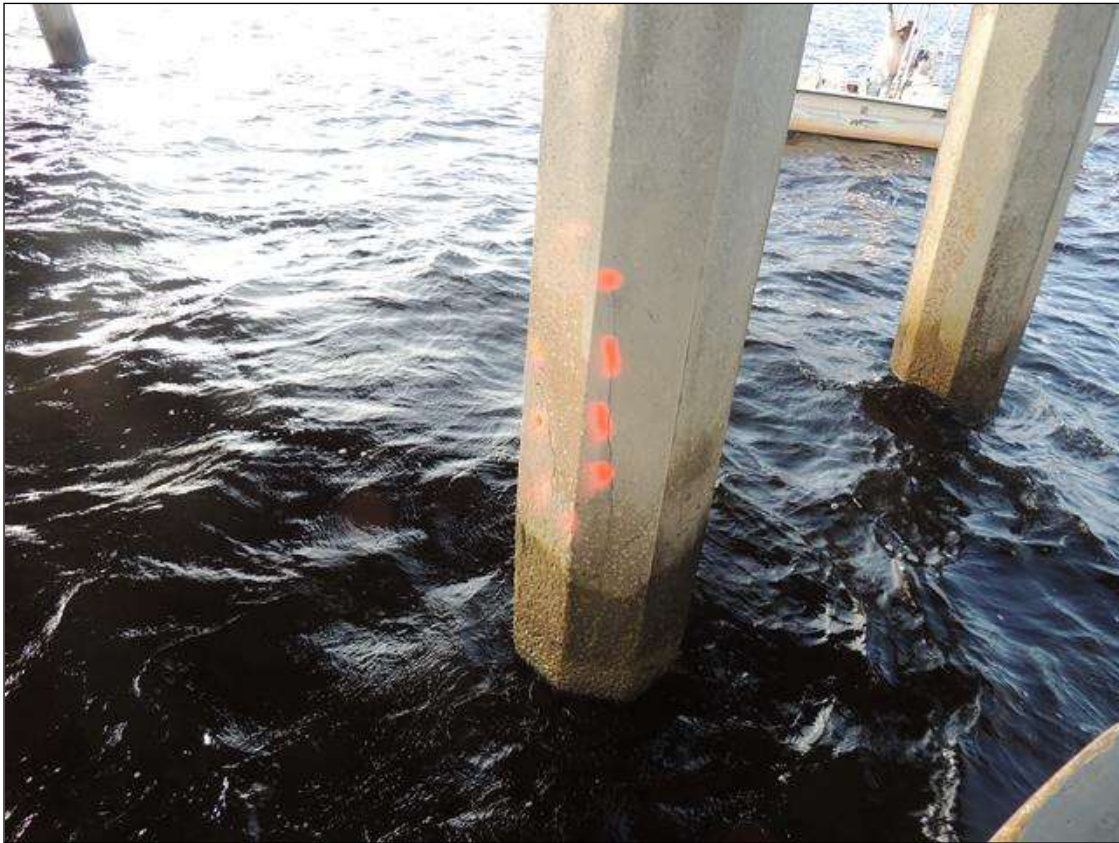
BENT 213 P3 CRACKED AND DELAMINATED AREA ON THE N FACE OF THE PILE, 55" FROM THE WATERLINE  
UP 14" AROUND THE PILE

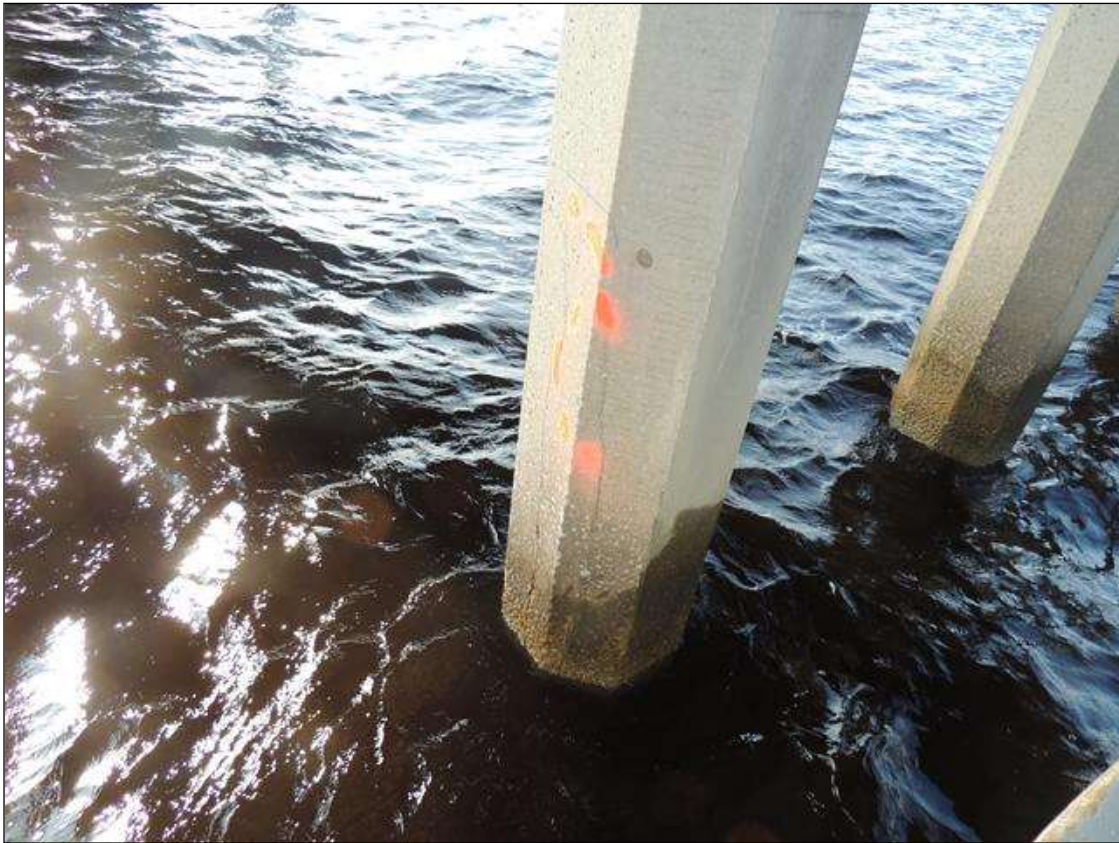
BENT 215 P2 CRACKED AND DELAMINATED AREA ON THE N FACE OF THE PILE 58" FROM THE WATERLINE  
UP 10" AROUND THE PILE

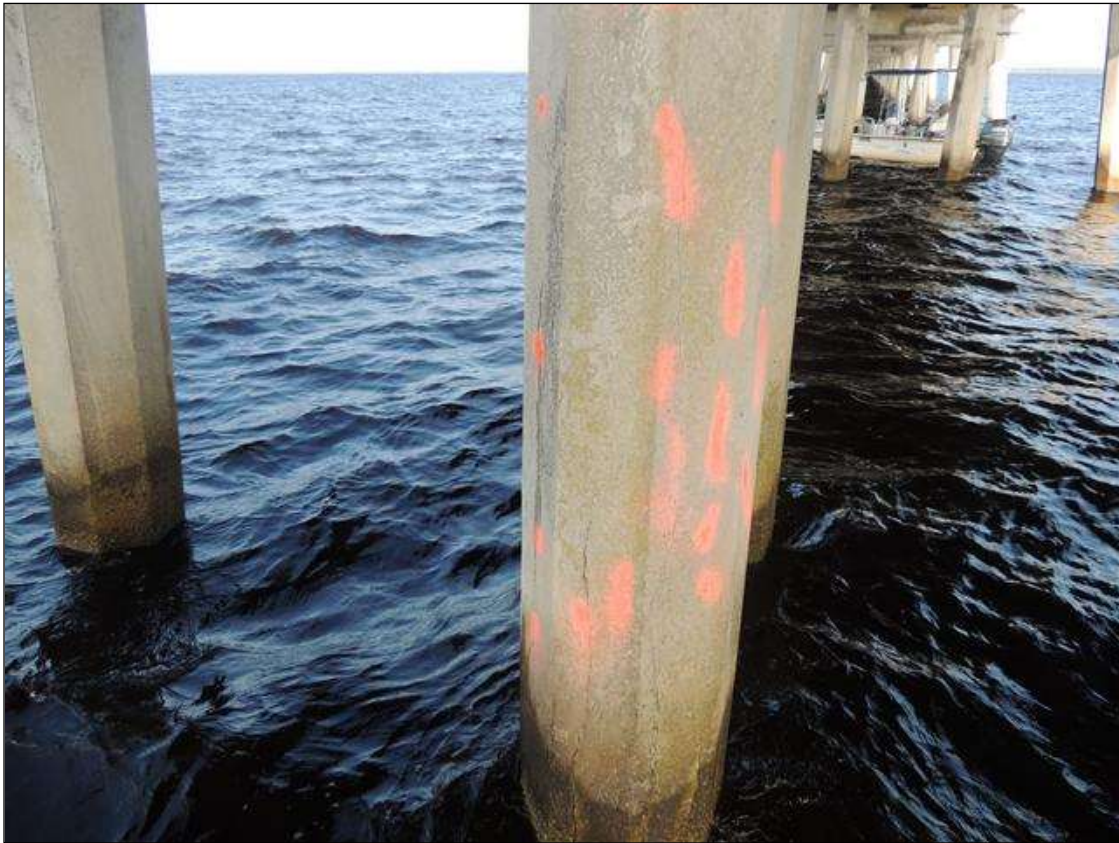
BENT 216 P5 CRACKED AND DELAMINATED AREA ALONG THE E FACE OF THE PILE 78" FROM THE WATERLINE UP 32" AROUND THE PILE

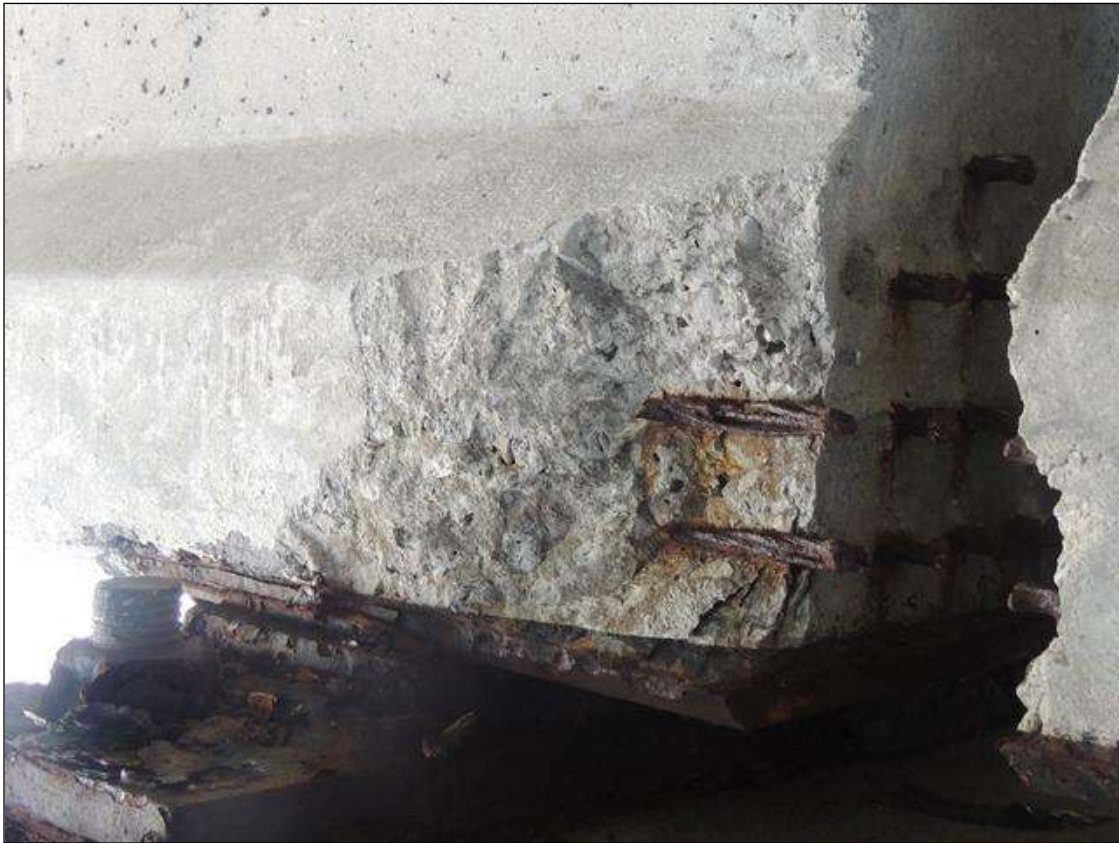
BENT 217 SPAN 218 SIDE SPALLED AREA ALONG THE BOTTOM LT END OF G2 8" X 10" X 2" DEEP CABLE EXPOSED PM.

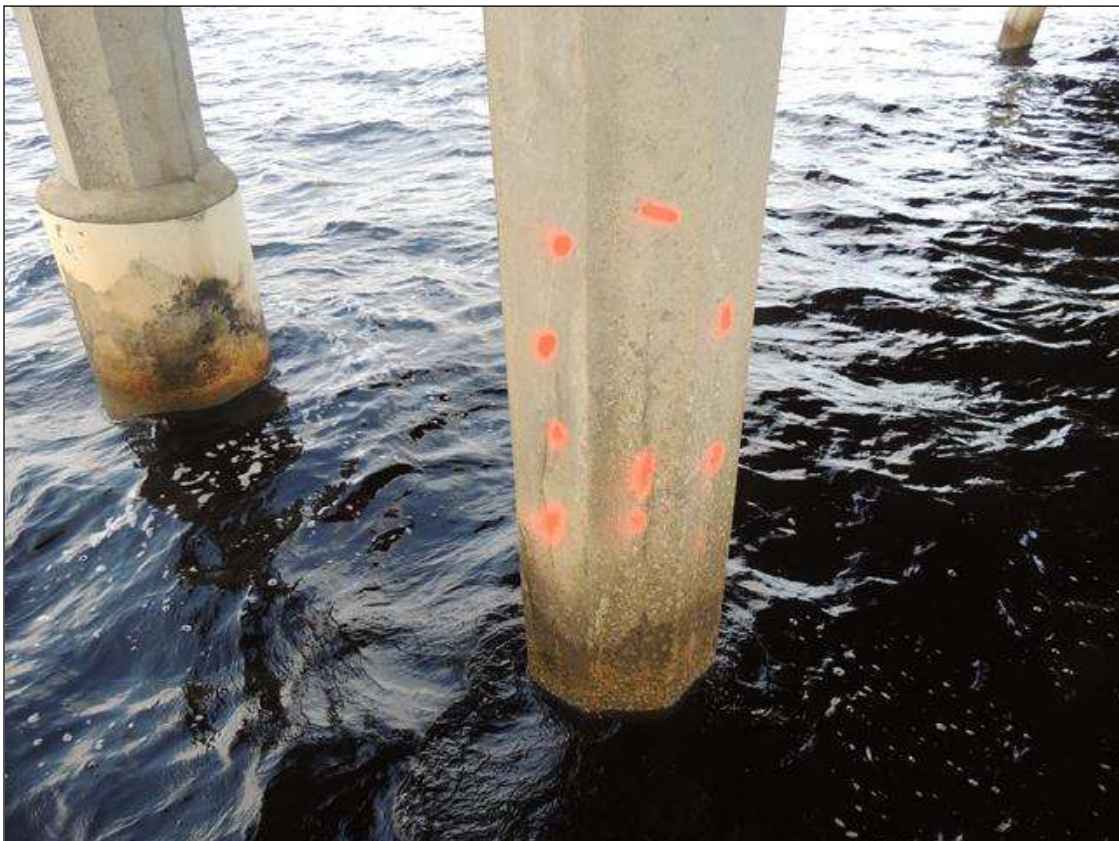
BENT 218 P3 CRACKED AND DELAMINATED AREA 58" FROM THE WATERLINE UP 20" AROUND THE PILE.

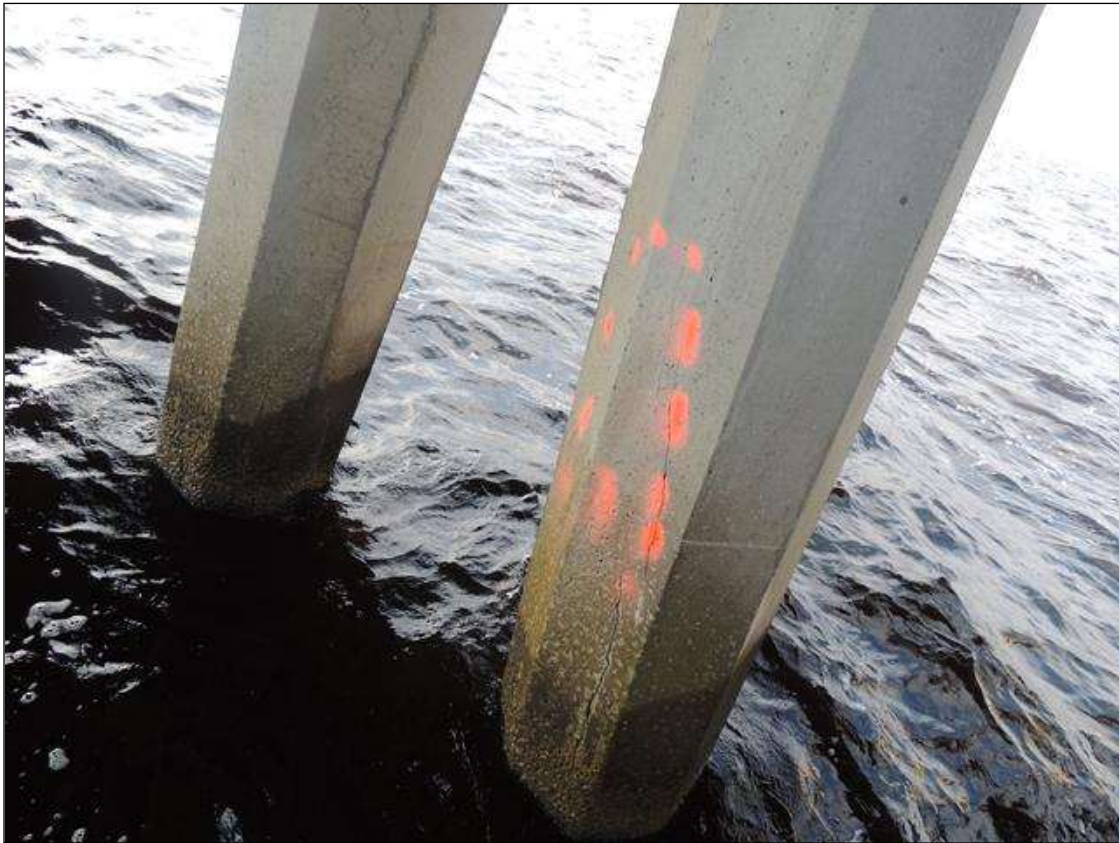
BENT 220 P4 CRACKED AND DELAMINATED AREA ON THE N FACE OF THE PILE 57" FROM THE WATERLINE UP 16" AROUND THE PILE.

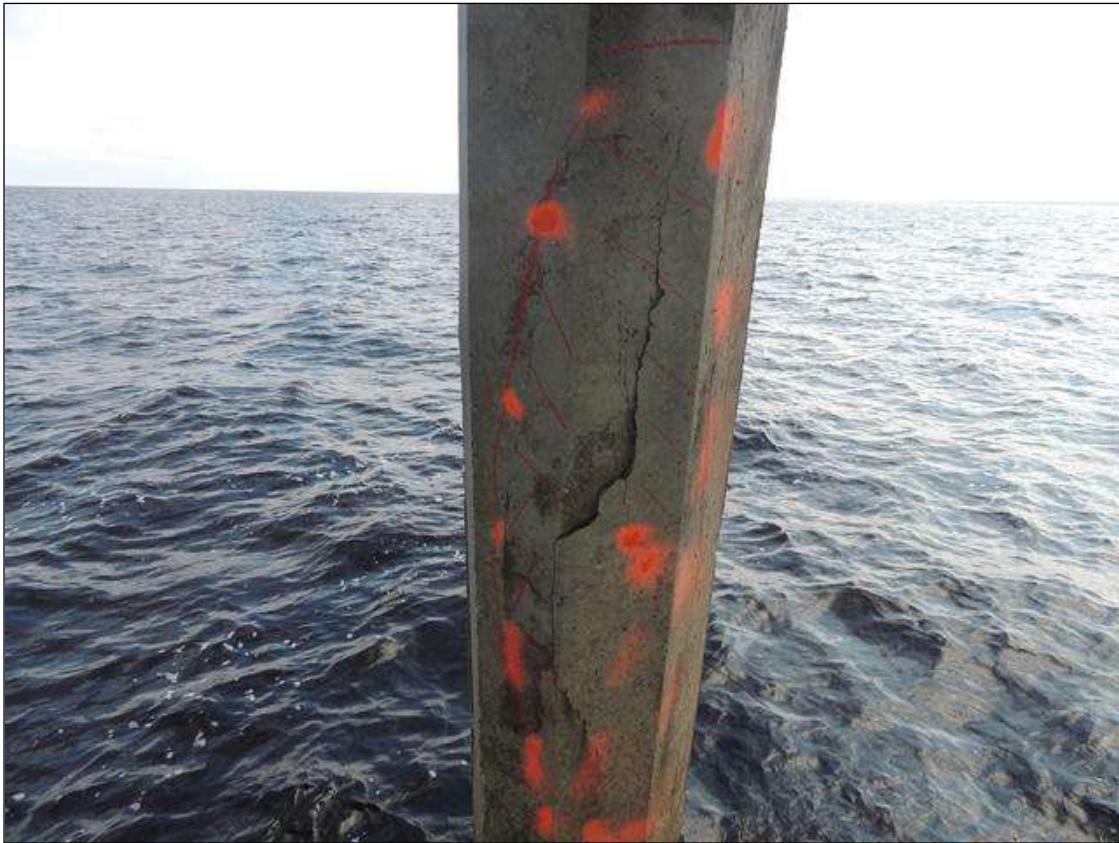
BENT 221 P1 SPALLED CRACKED AND DELAMINATED AREA ALONG THE S FACE OF THE PILE 101" FROM THE WATERLINE UP 21" AROUND THE PILE.

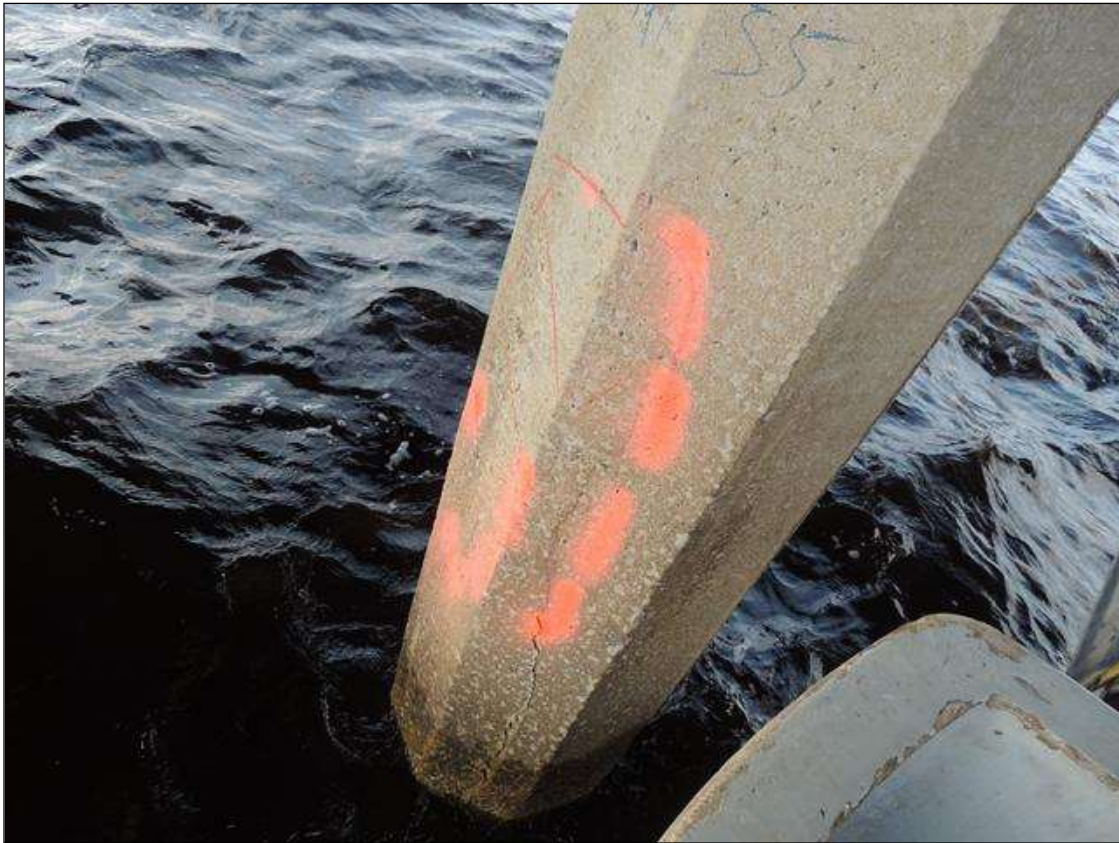
BENT 221 P2 CRACKED AND DELAMINATED AREA ON THE N FACE OF THE PILE 55" FROM THE WATERLINE UP 14" AROUND THE PILE.

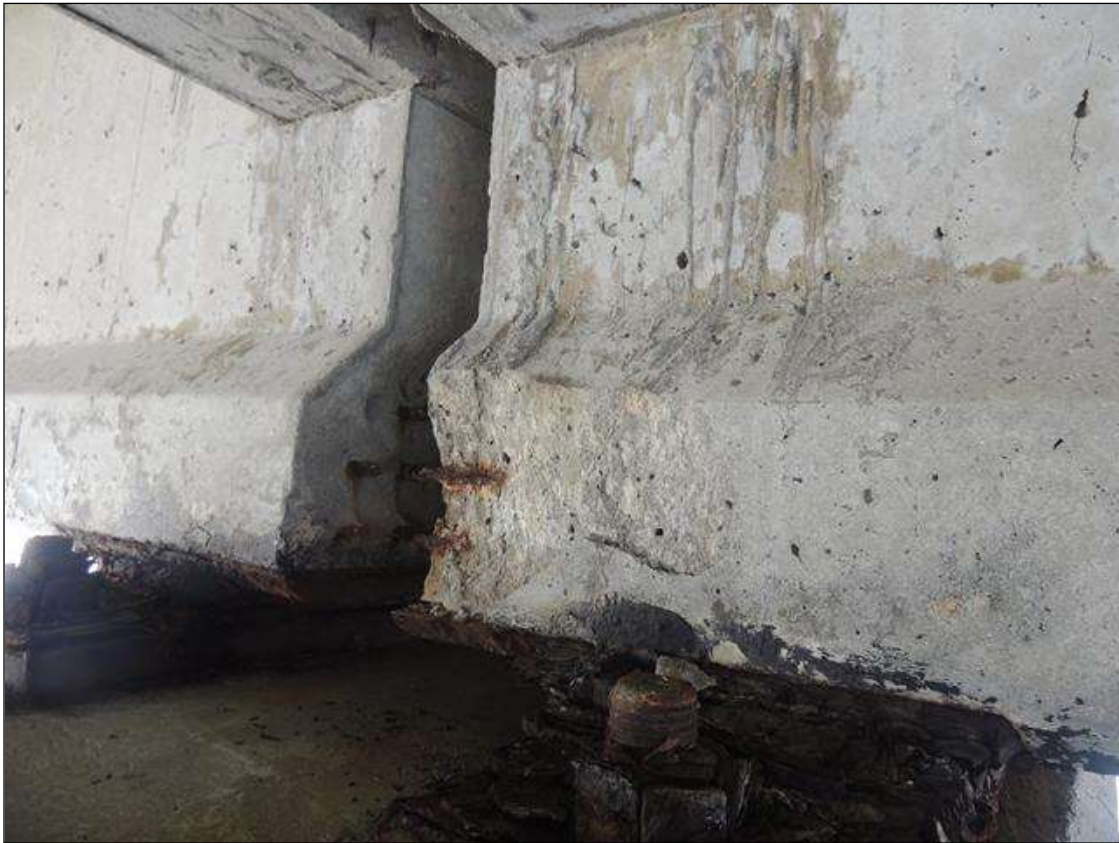
BENT 222 SPAN 222 SIDE SPALLED AREA ALONG THE LT BOTTOM END OF G3 7" X 9" X 2" DEEP CABLE EXPOSED PM.

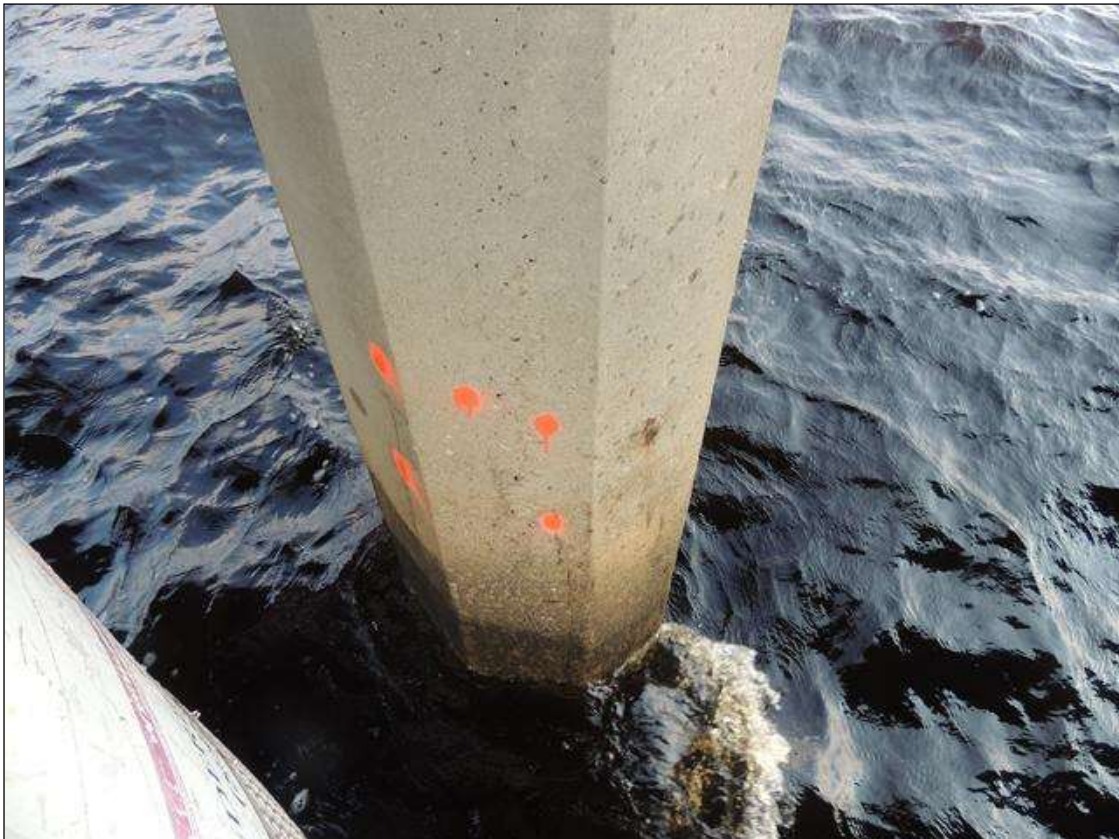
BENT 222 P2 CRACKED AND DELAMINATED AREA 40" FROM THE WATERLINE UP 15" AROUND THE PILE

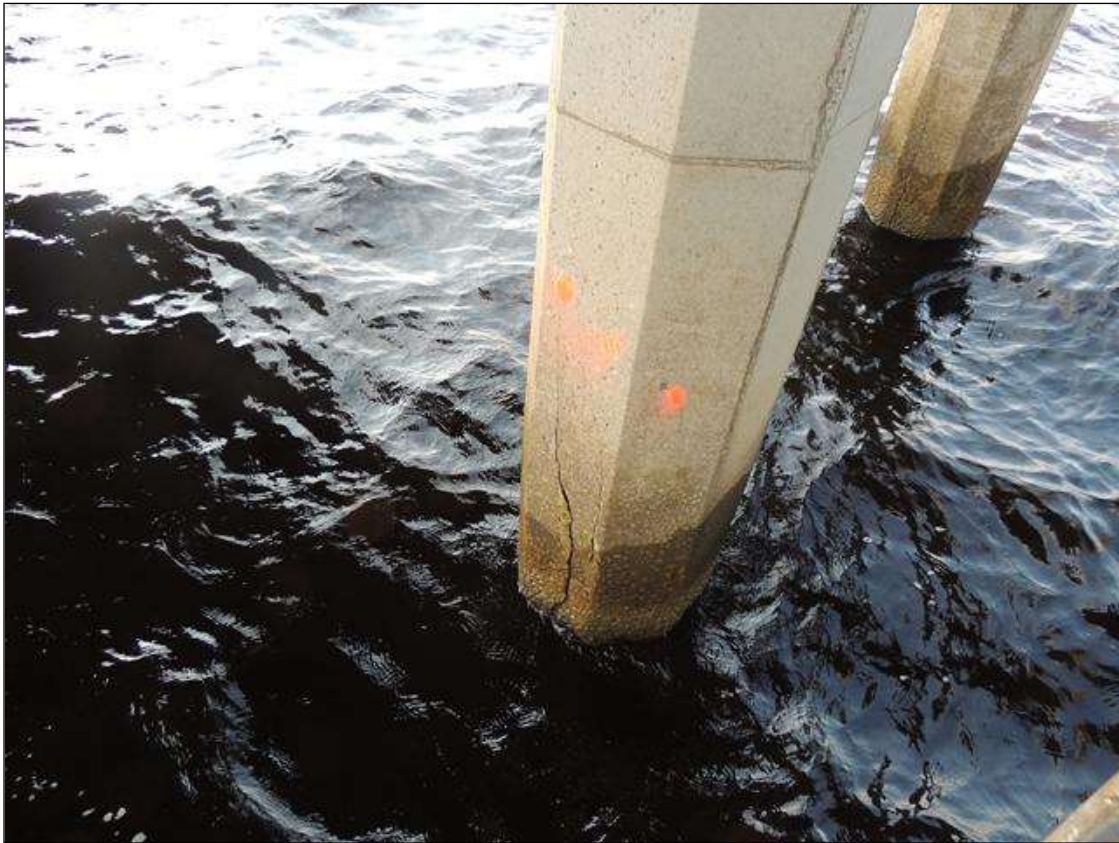
BENT 222 P3 CRACKED AND DELAMINATED AREA 42" FROM THE WATERLINE UP 22" AROUND THE PILE.

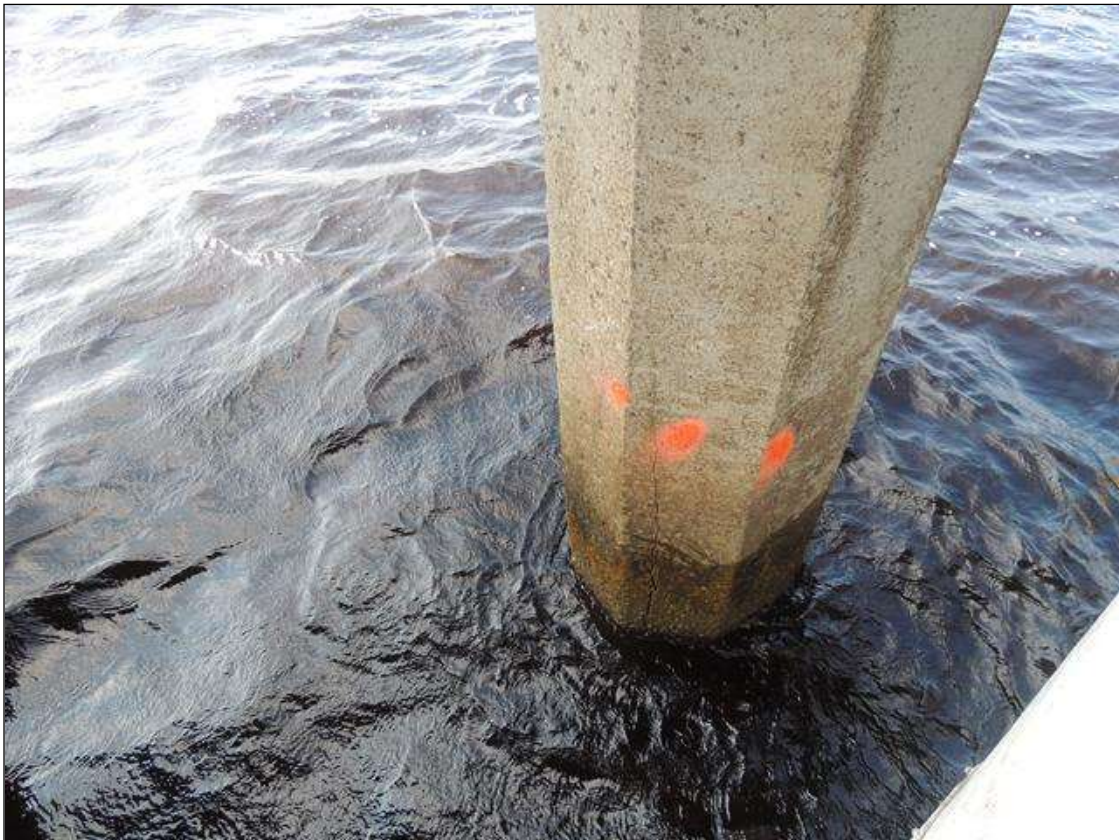
BENT 222 P4 CRACKED AND DELAMINATED AREA 30" FROM THE WATERLINE UP 18" AROUND THE PILE.

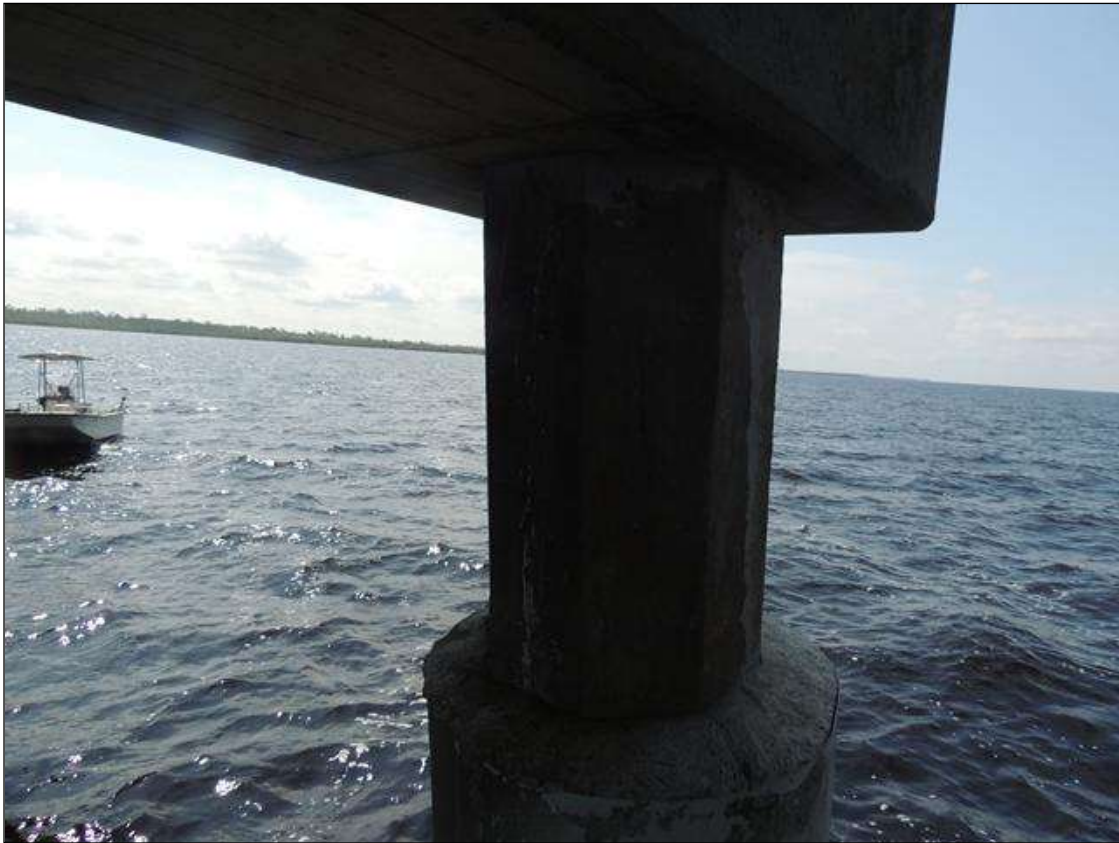
BENT 230 P4 CRACKED AND DELAMINATED AREA ABOVE THE REPAIR 39" FROM THE BOTTOM OF THE REPAIR TO THE CAP 25" AROUND THE PILE

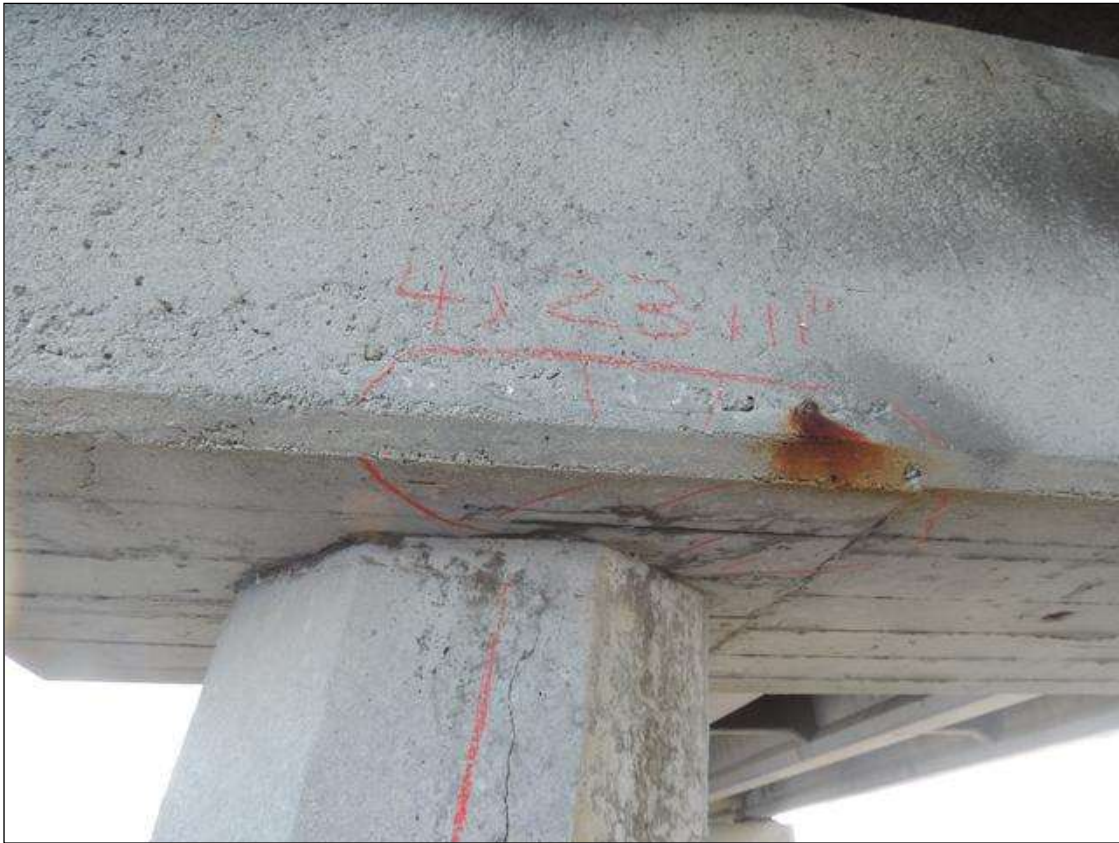
BENT 231 SPAN 231 SIDE CRACKED AND DELAMINATED AREA ALONG THE BOTTOM FACE OF THE CAP AT P1 4" X 23" X 11" UB.

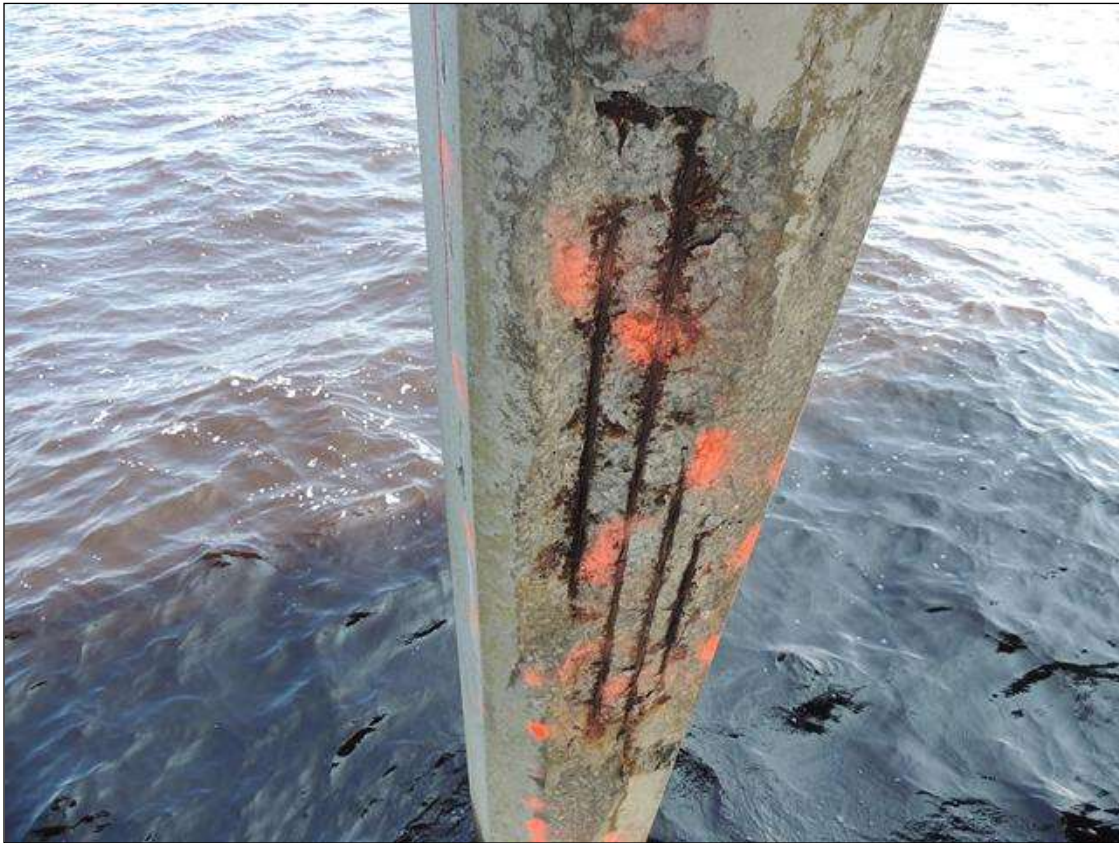
BENT 231 CRACKED SPALLED AND DELAMINATED AREA ALONG THE S FACE OF P1 10'2" FROM THE WATERLINE TO THE BOTTOM OF THE CAP 4 CABLES EXPOSED 3 BROKEN CABLE

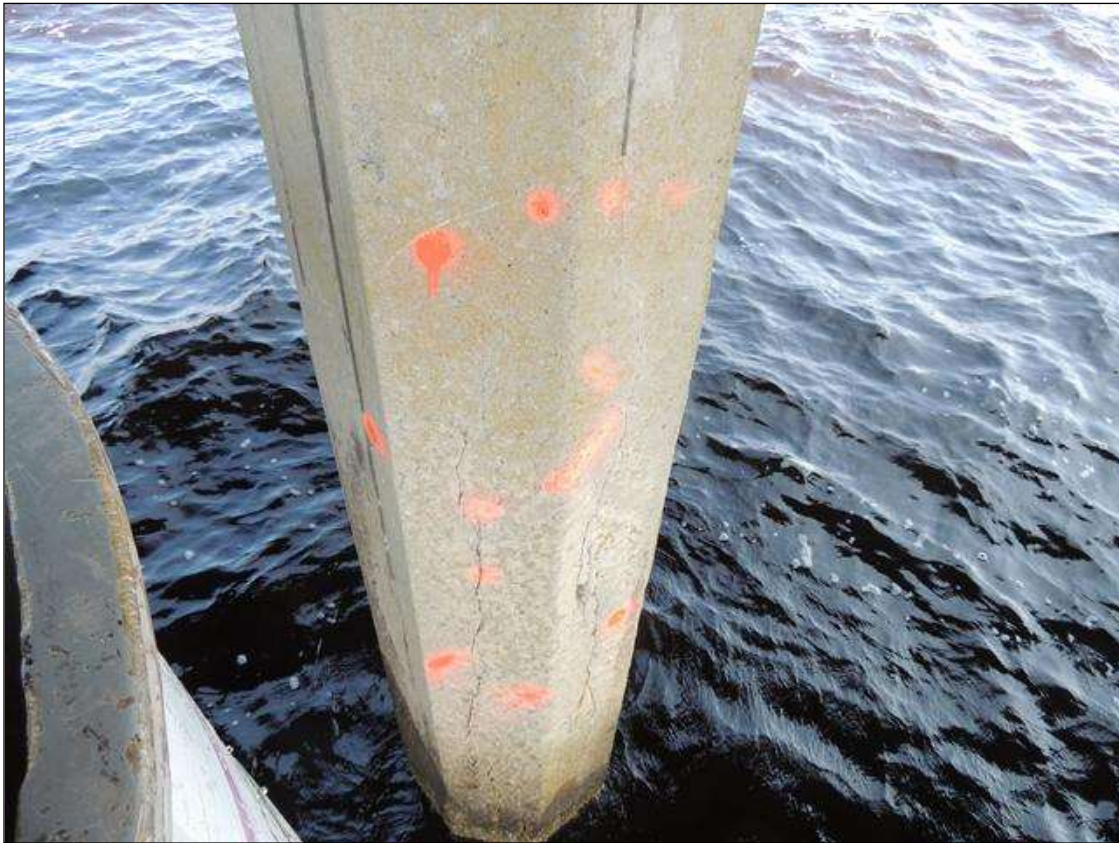
BENT 231 P2 CRACKED AND DELAMINATED AREA ON THE SE FACE OF THE PILE 75" FROM THE WATERLINE  
UP 30" AROUND THE PILE

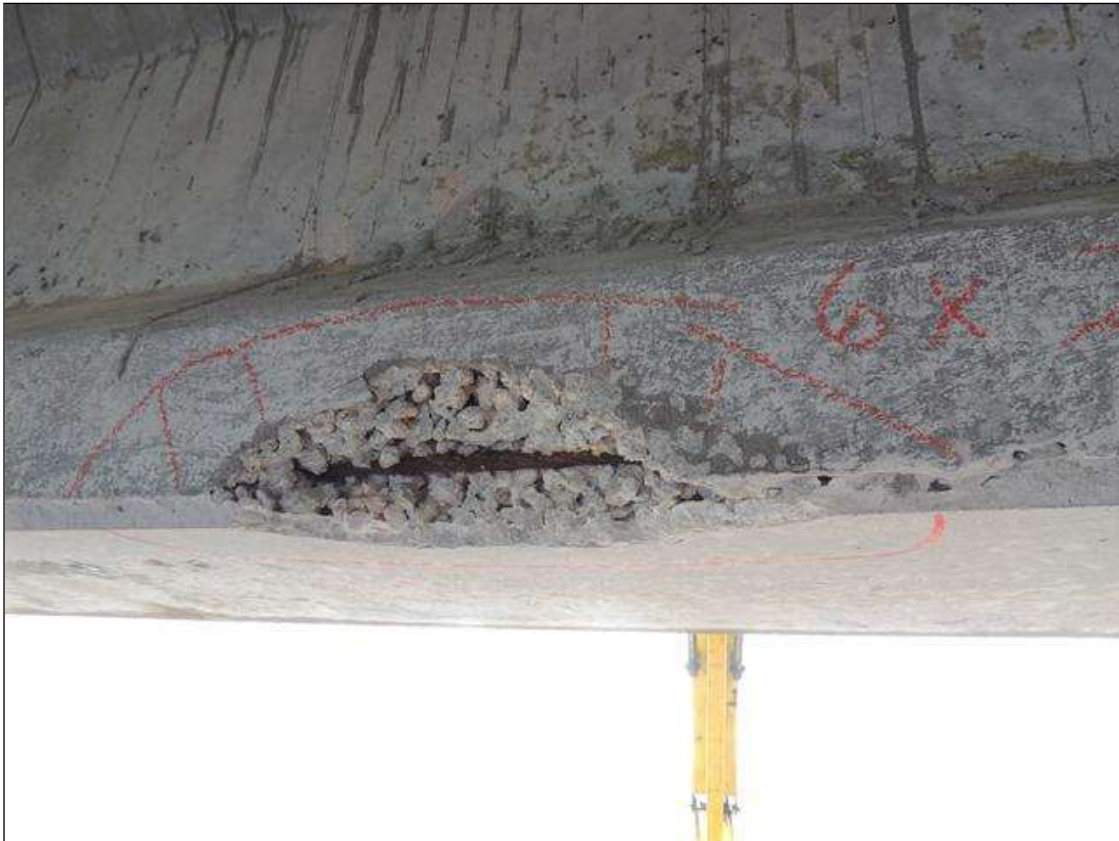
SPAN 233 SPALLED AND HONEYCOMBE AREA ALONG LT SIDE G4 11' FROM BENT 232 6" X 23" X 4" DEEP WITH CABLES EXPOSED PM

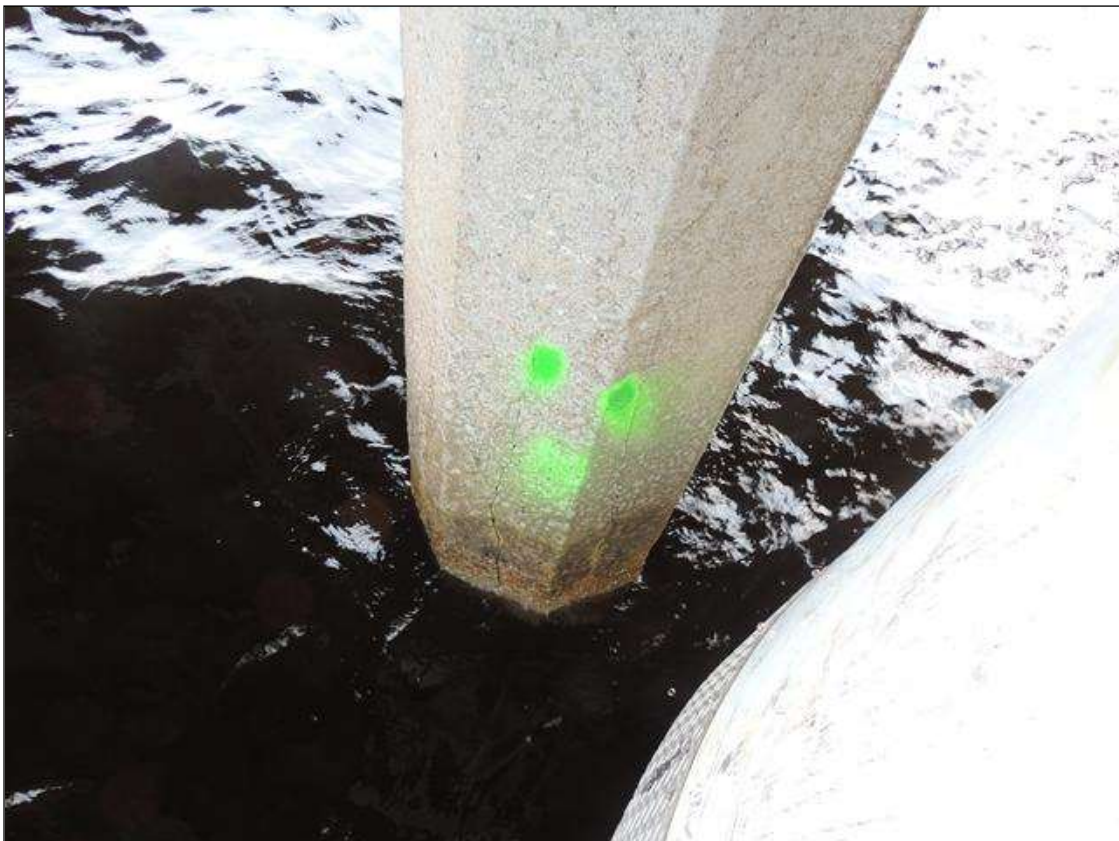
BENT 234 CRACKED AND DELAMINATED AREA ON PILE 2 FROM WL UP 36" AND 24" AROUND PILE.

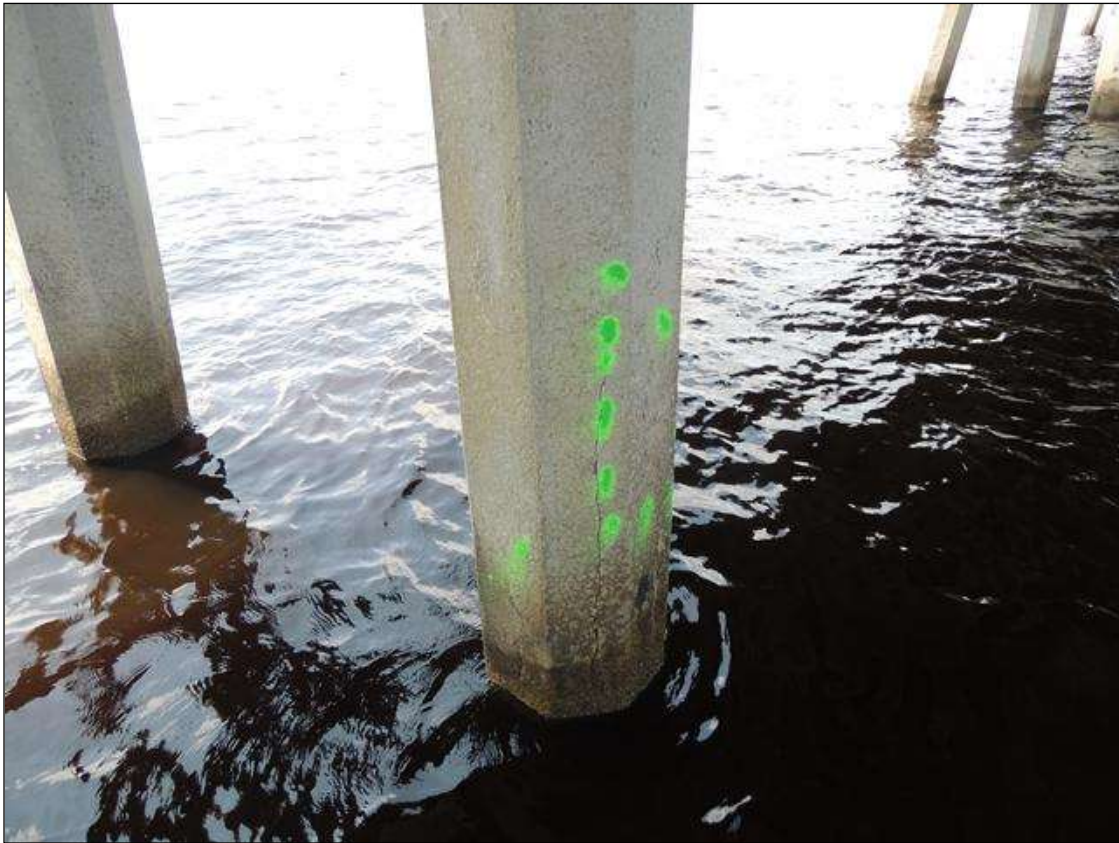
BENT 234 CRACKED AND DELAMINATED AREA ON PILE 3 FROM THE WL UP 53" X 28" AROUND PILE.

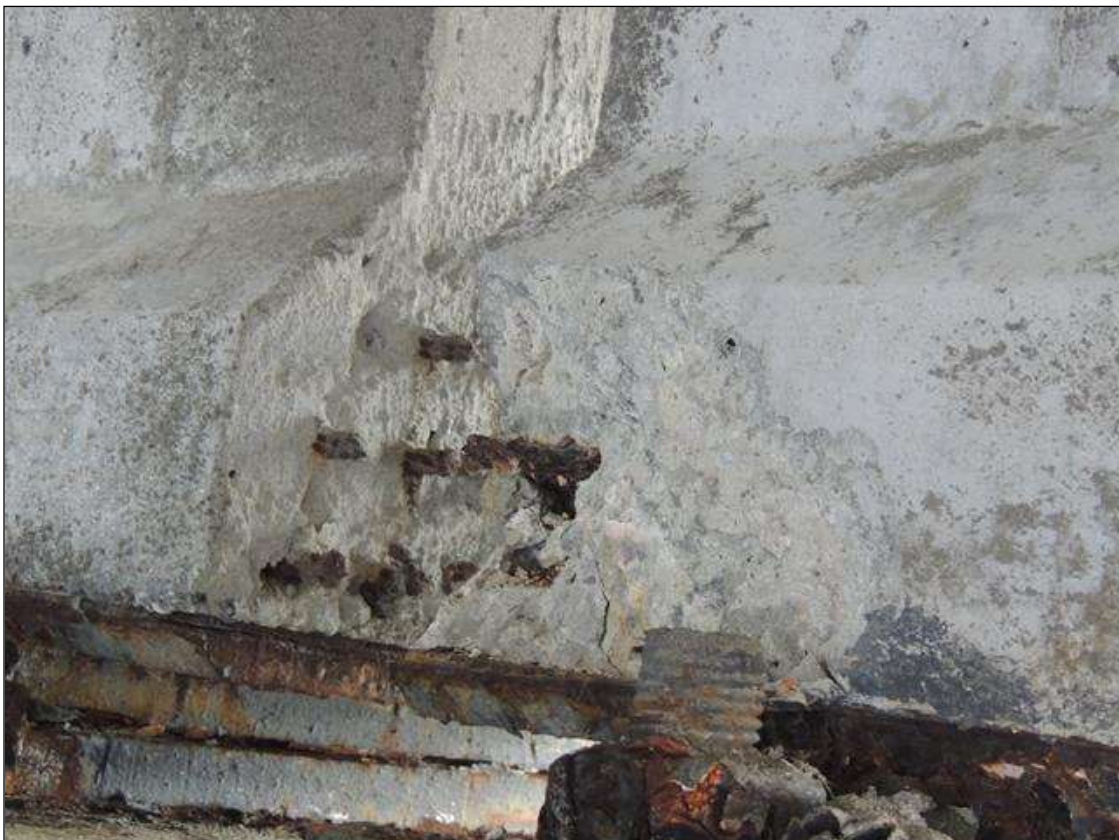
BENT 235 SPAN 235 SIDE SPALLED AREA ALONG THE BOTTOM LT END OF G4 7" X 9" X 3" DEEP CABLES EXPOSED PM.
