BENT 14 CRACKED AND DELAMINATED AREA ON THE NW SIDE OF PILE 4 STARTS 10" BELOW CAP AND GOES DOWN 8' 4" X 12" WIDE.

BENT 17 PILE 3 UNDER SUBCAP 1 HAS SAPLLED AREA 10' 2" LONG X 2 1/2" DEEP ON SW SIDE WITH CABLES EXPOSED AND BROKEN.PM

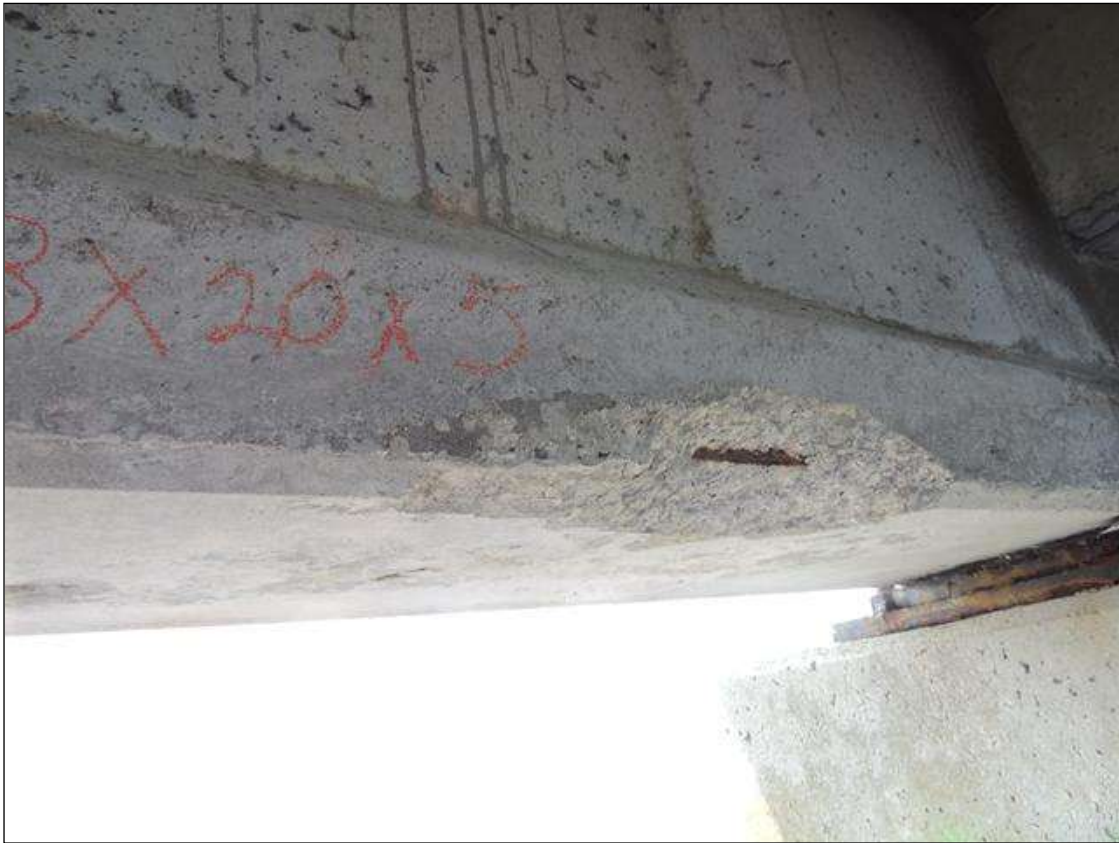
BENT 235 SPAN 236 SIDE SPALLED AREA ON LT SIDE OF G4 3" X 20" X 5" WITH CABLE EXPOSED 14" FROM BENT 235.

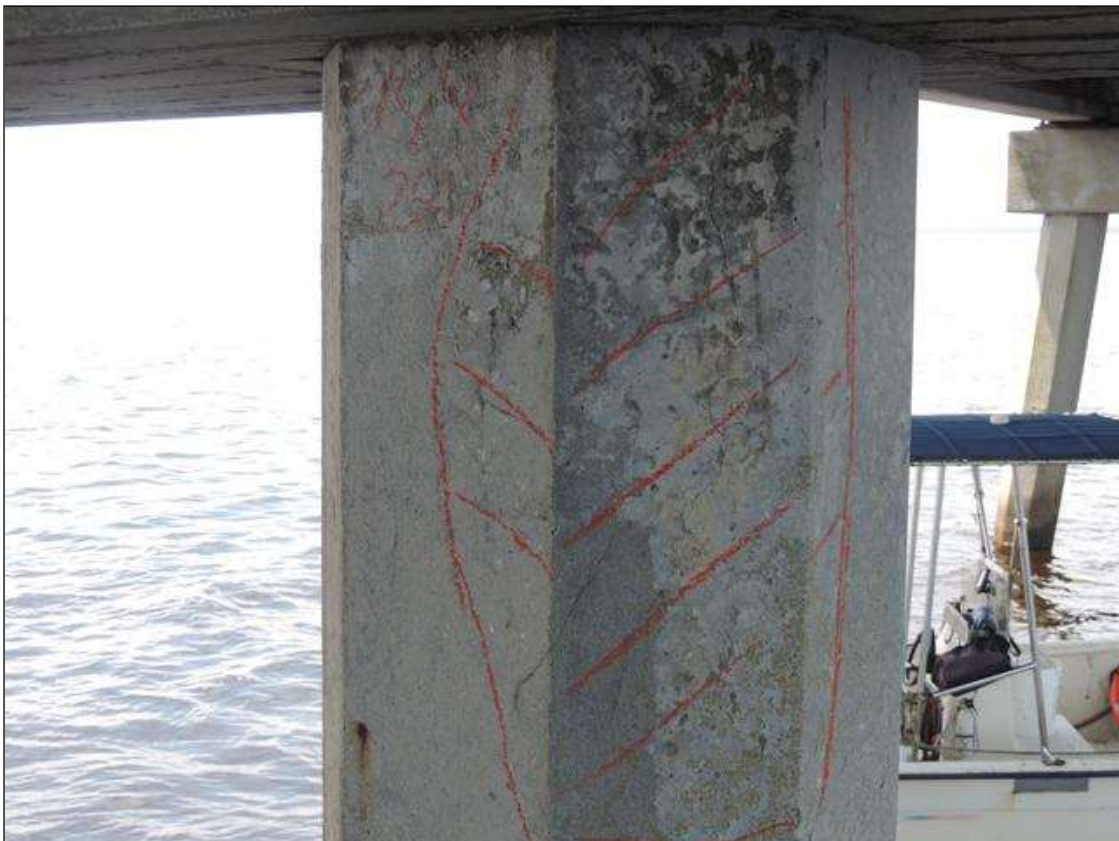
BENT 235 CRACKED AND DELAMINATED AREA ALONG THE TOP FACE OF PILE 2 ON NE FACE 18" X 28".

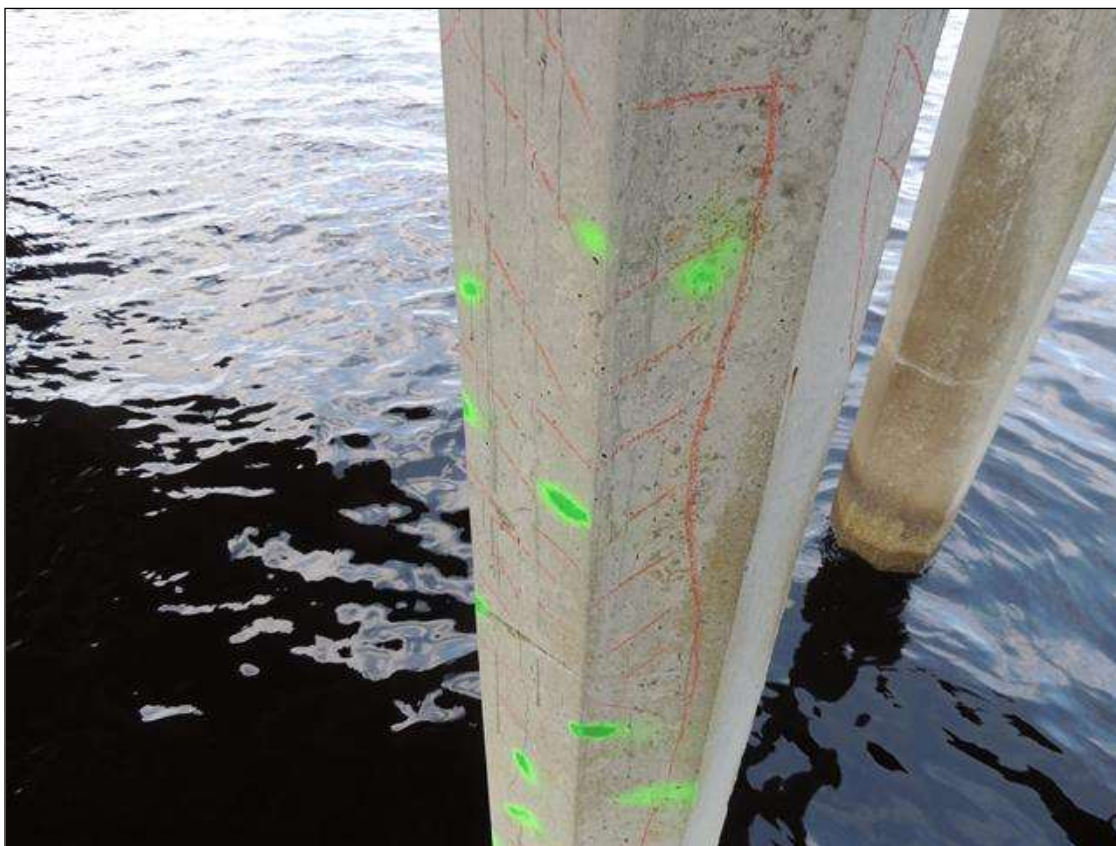
BENT 235 CRACKED AND DELAMINATED AREA ON THE SOUTH FACE OF P2 FROM BOTTOM OF CAP DOWN 7' 9" X 21" AROUND PILE.

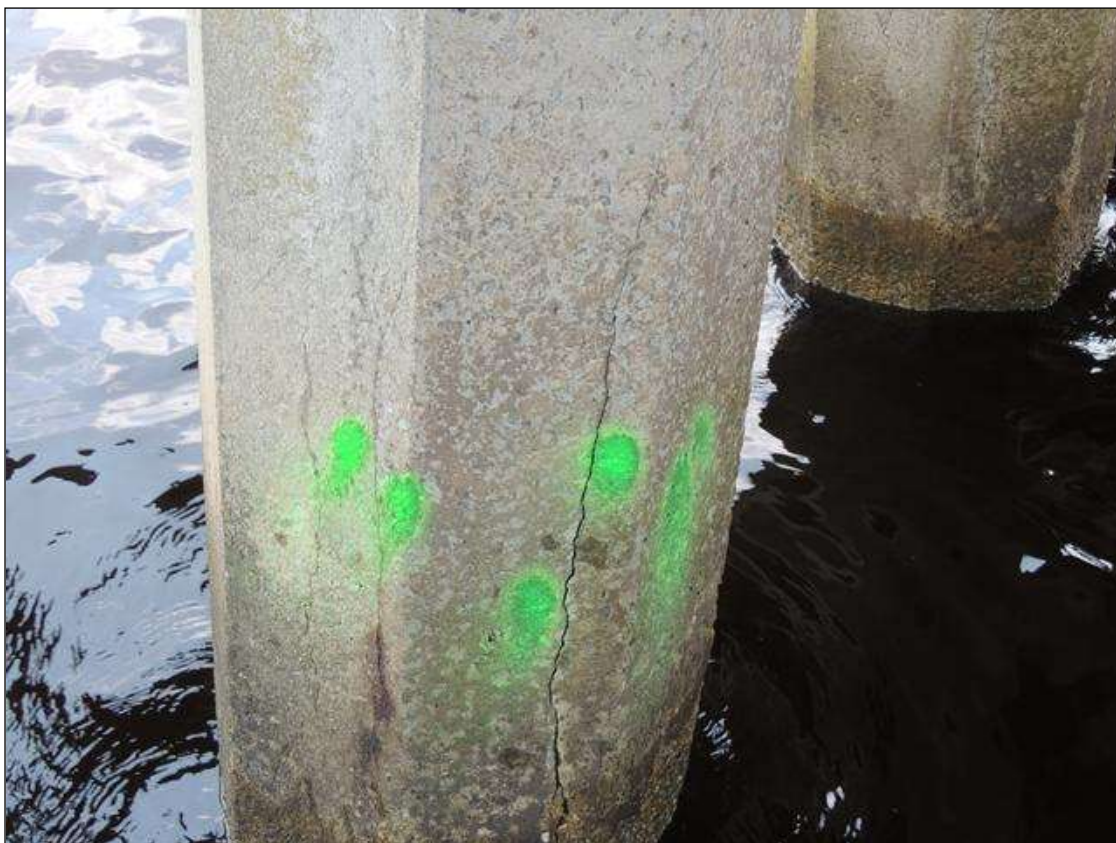
BENT 237 CRACKED AND DELAMINATED AREA ON P5 ON NE FACE FROM WL UP 46" AND 29" AROUND PILE.

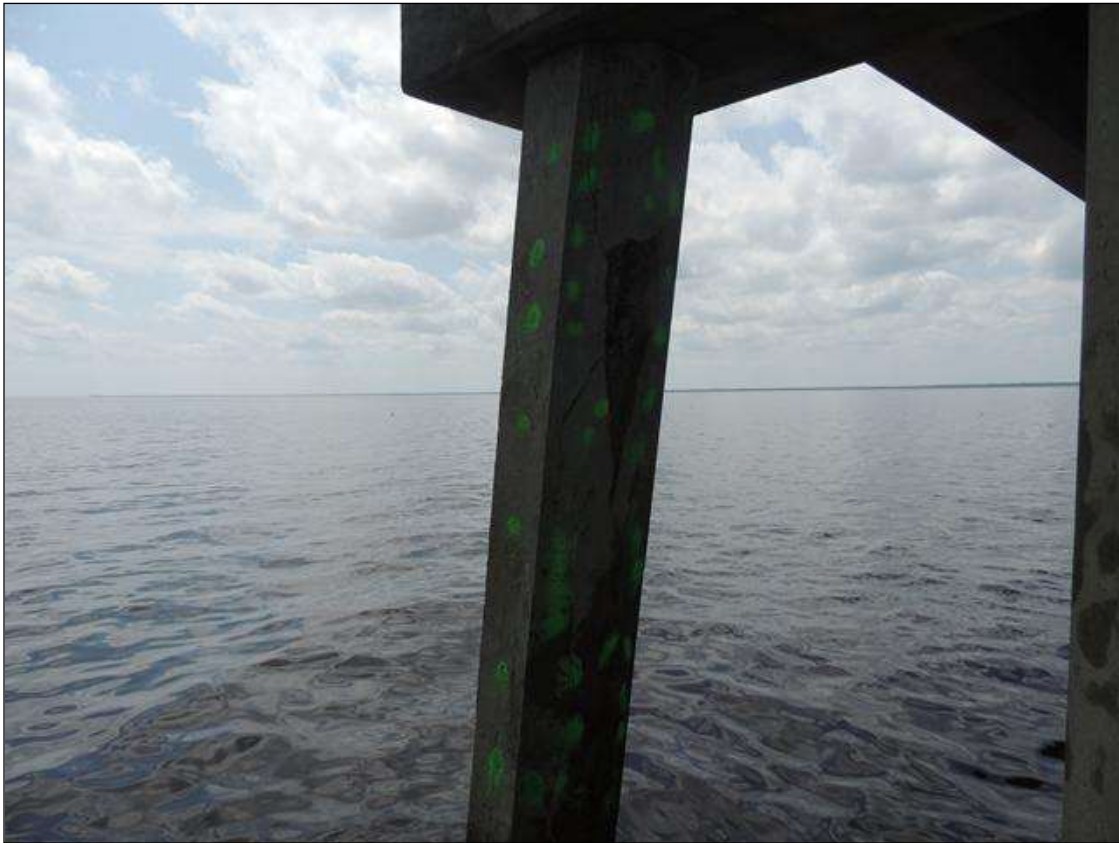
BENT 237 P5 CRACKED, DELAM, SPALLED AREA FROM BOT CAP TO WL 10' 4" X 25" AROUND PILE WITH 2 CABLES EXPOSED AND 3" DEEP NORTH FACE PM.

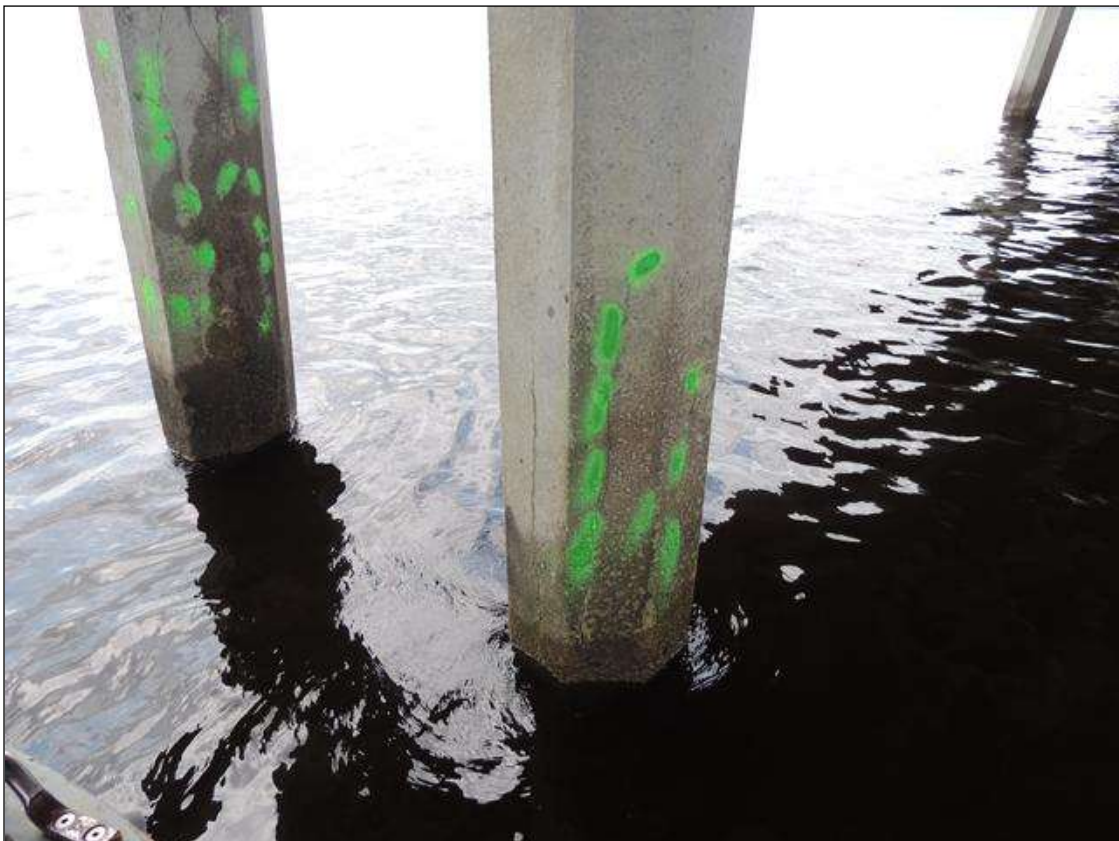
BENT 237 P4 CRACKED AND DELAMINATED AREA FROM THE WL UP 50" X 14" AROUND PILE ON NE FACE.

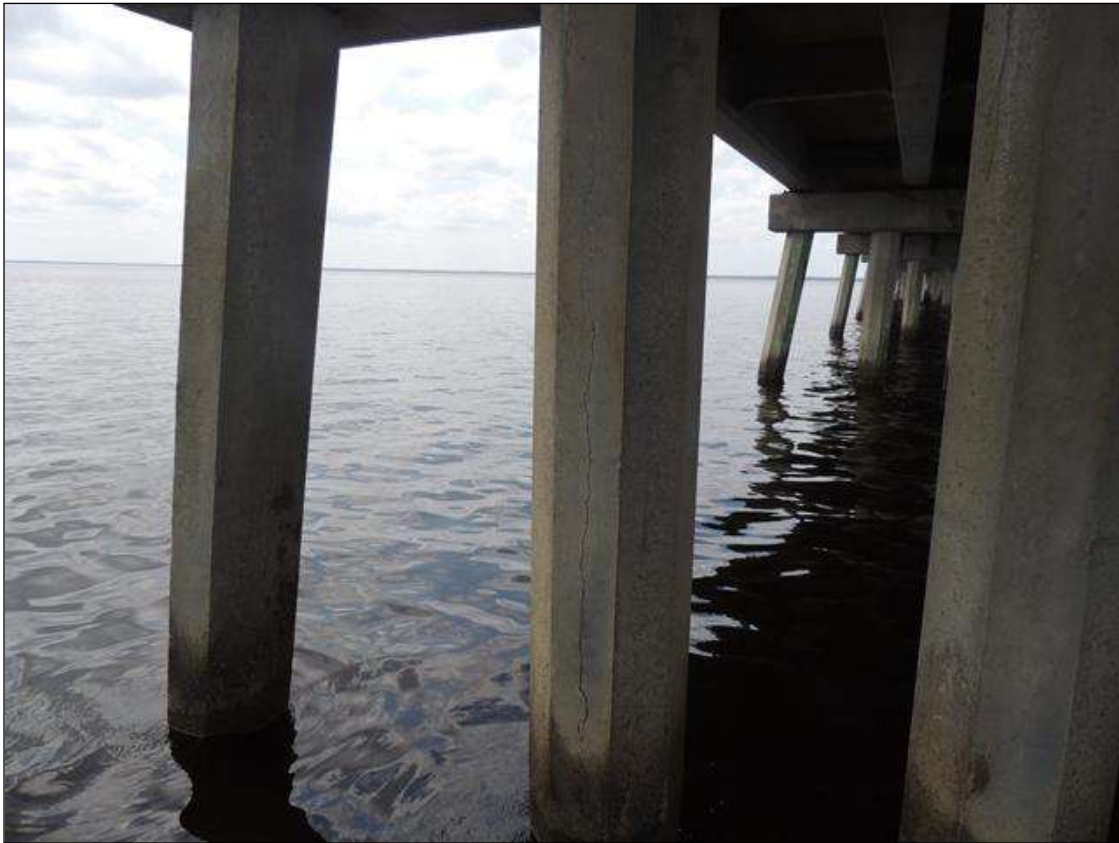
BENT 238 P4 VERTICAL CRACK IN THE EAST FACE OF PILE FROM BOT OF CAP TO WL CRACK AROUND 1/8" WIDE.

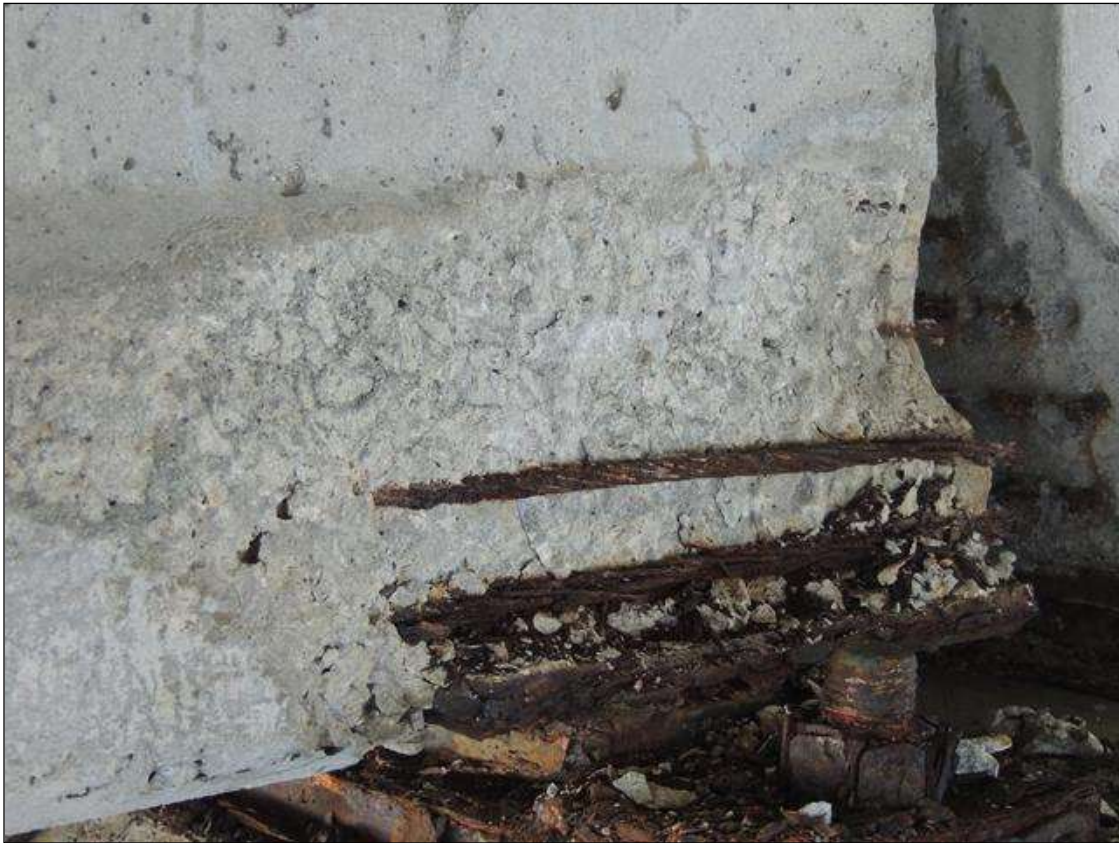
BENT 240 SPAN 241 SIDE SPALLED AREA ALONG THE LT BOTTOM END OF G2 10" X 24" L X 2 1/2" DEEP CABLES EXPOSED PM.

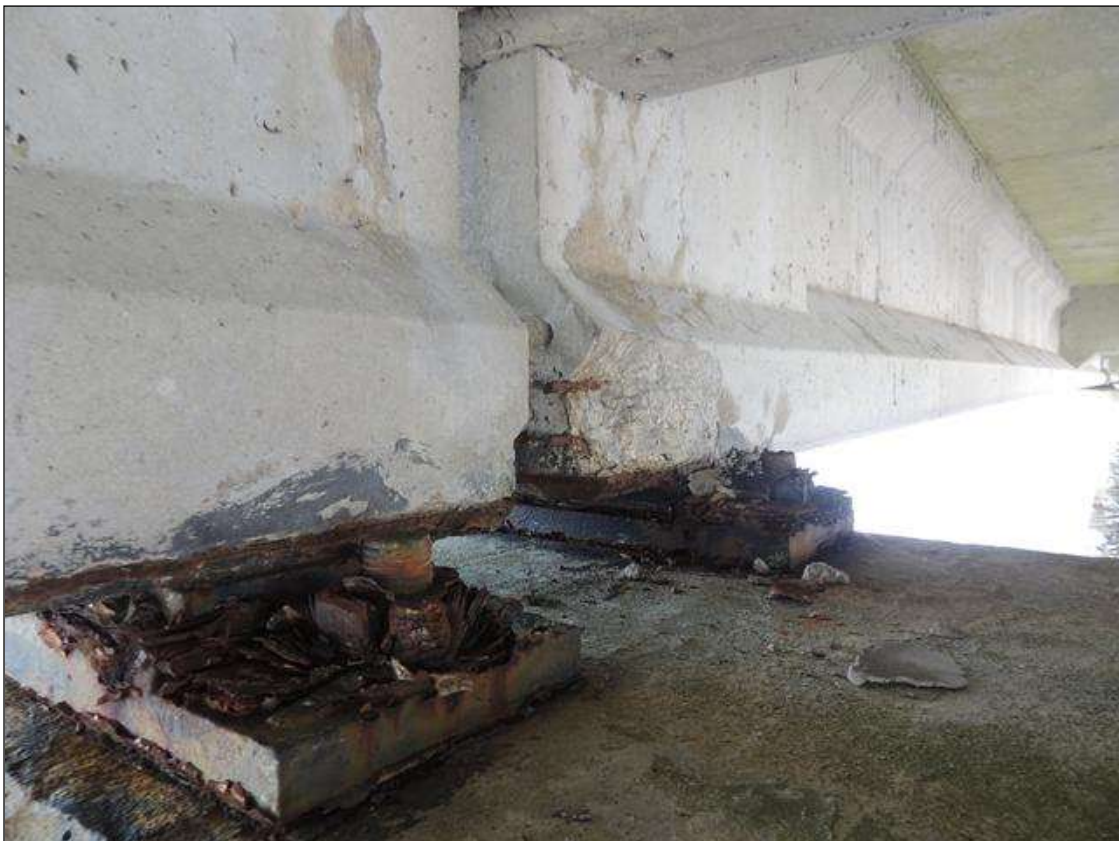
BENT 244 SPAN 245 SIDE SPALLED AREA ALONG THE LT BOTTOM SIDE OF G1 6" X 9" X 1 1/2" DEEP .

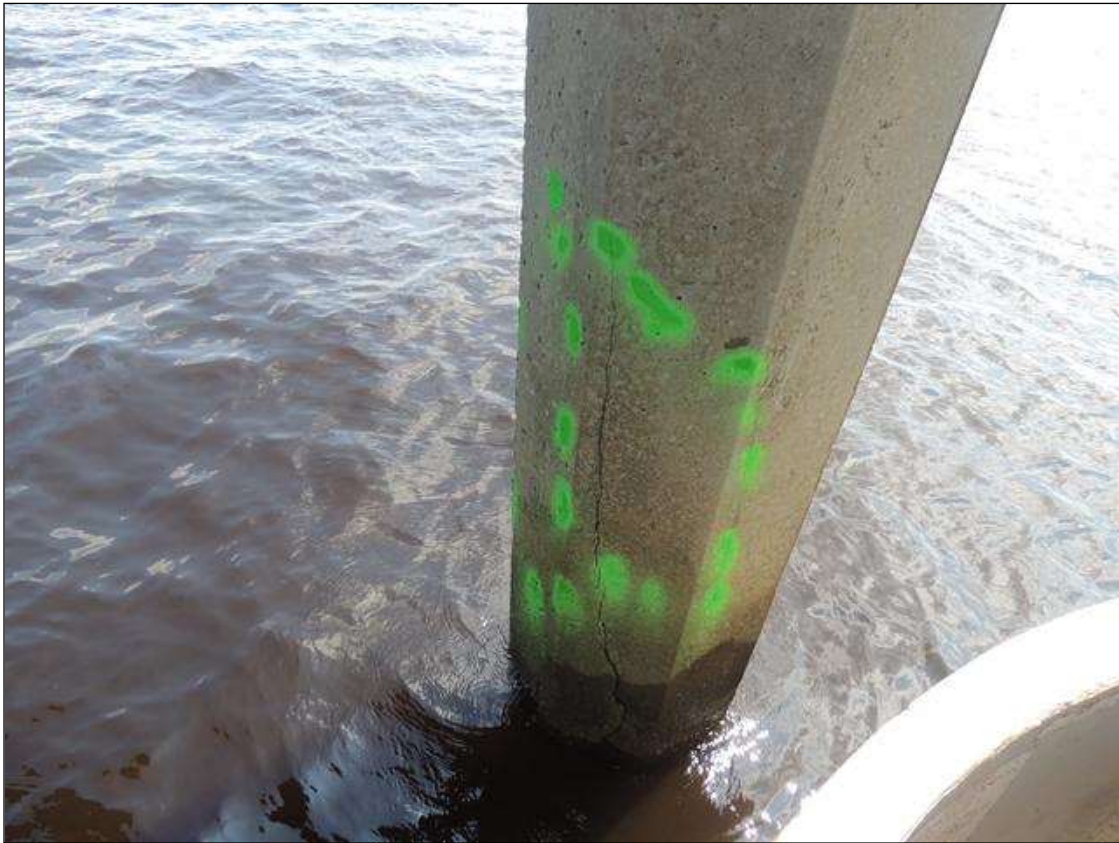
BENT 244 P6 CRACKED AND DELAMINATED AREA ALONG NE FACE FROM WL UP 41" X 21" AROUND PILE.

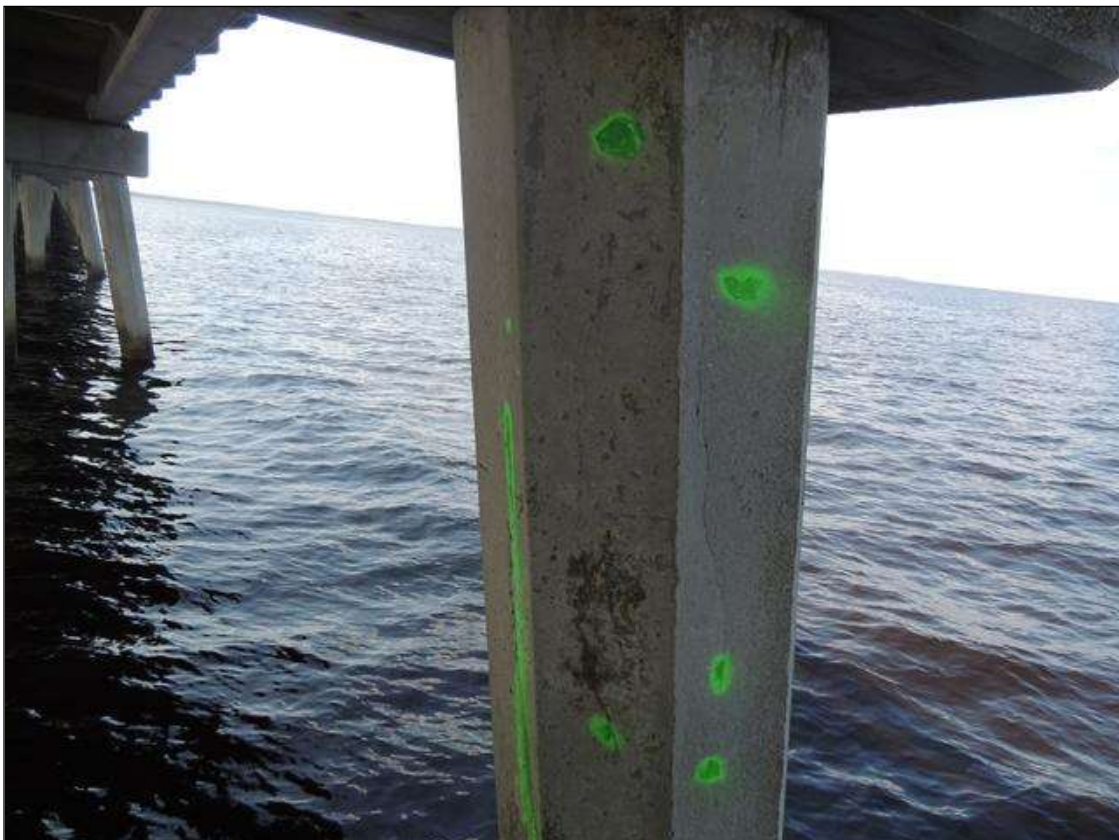
BENT 244 P1 CRACKED AND DELAMINATED AREA ALONG SE FACE OF PILE FROM BOTTOM OF CAP DOWN 61" X 16" AROUND PILE.

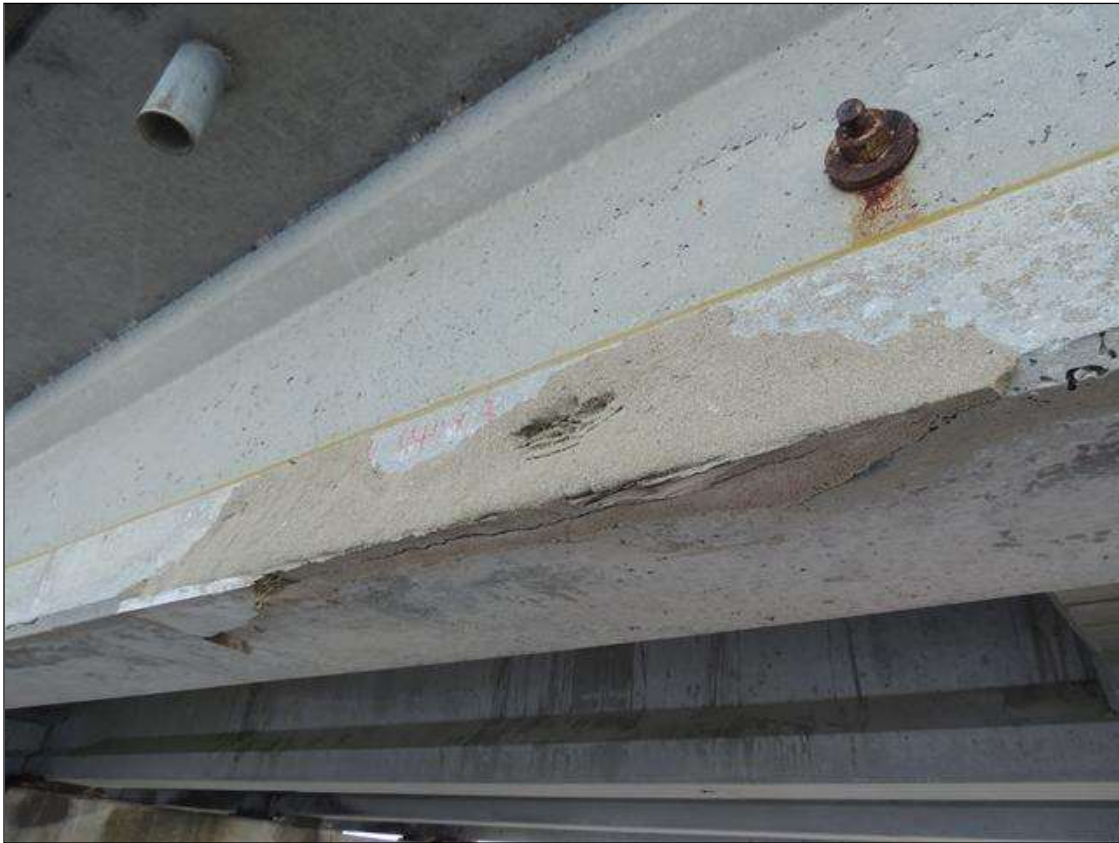
SPAN 246 PATCHED AREA ALONG THE LT BOTTOM SIDE OF G1 6" X 44" X 3".

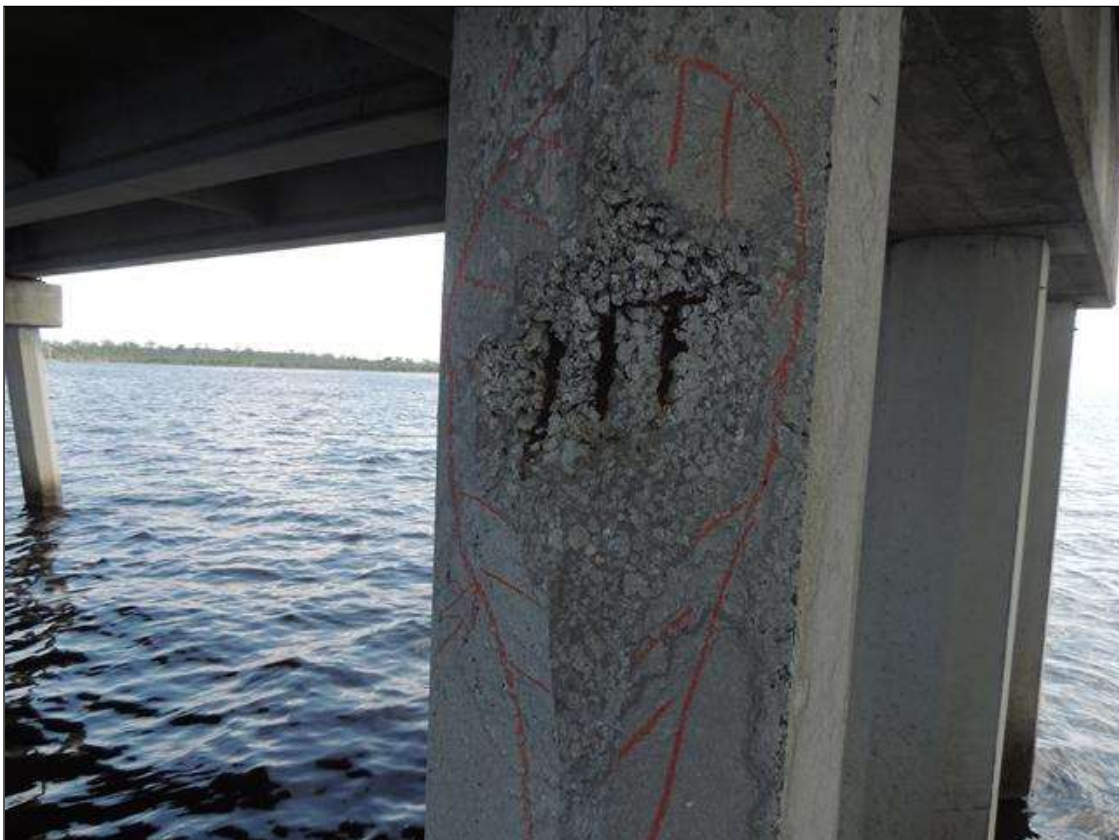
BENT 246 P2 SPALLED AND DELAM AREA ON THE NORTH FACE OF PILE STARTS 7" BELOW BOT OF CAP GOES DOWN 37" X 17" AROUND PILE W 3 CABLES EXPOSED PM

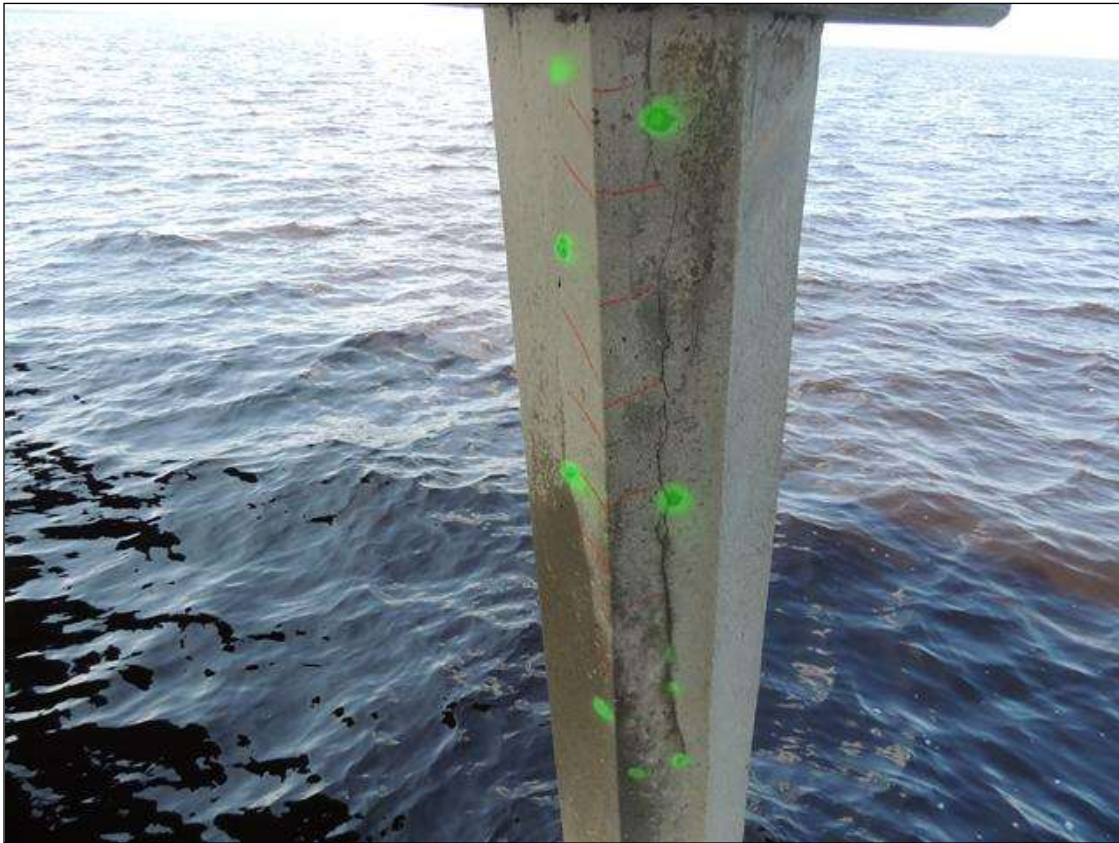
BENT 246 P1 CRACKED AND DELAMINATED AREA ON THE SOUTH FACE OF PILE FROM BOTTOM OF CAP DOWN 61" X 10" AROUND PILE..

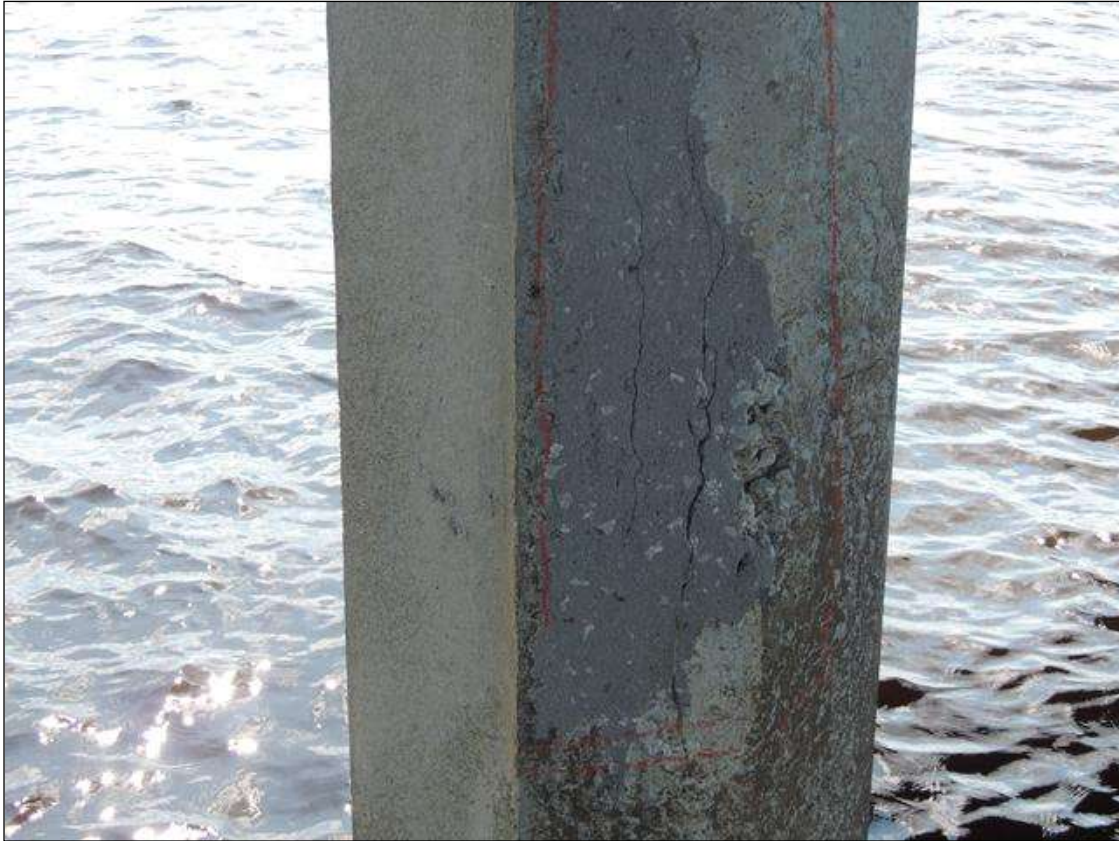
BENT 249 P3 PATCHED AREA IS CRACKED AND DELAM AND HONEYCOMBED STARTING 55" BELOW BOT OF CAP GOES 30" DOWN AND 14" WIDE ON NORTH FACE.

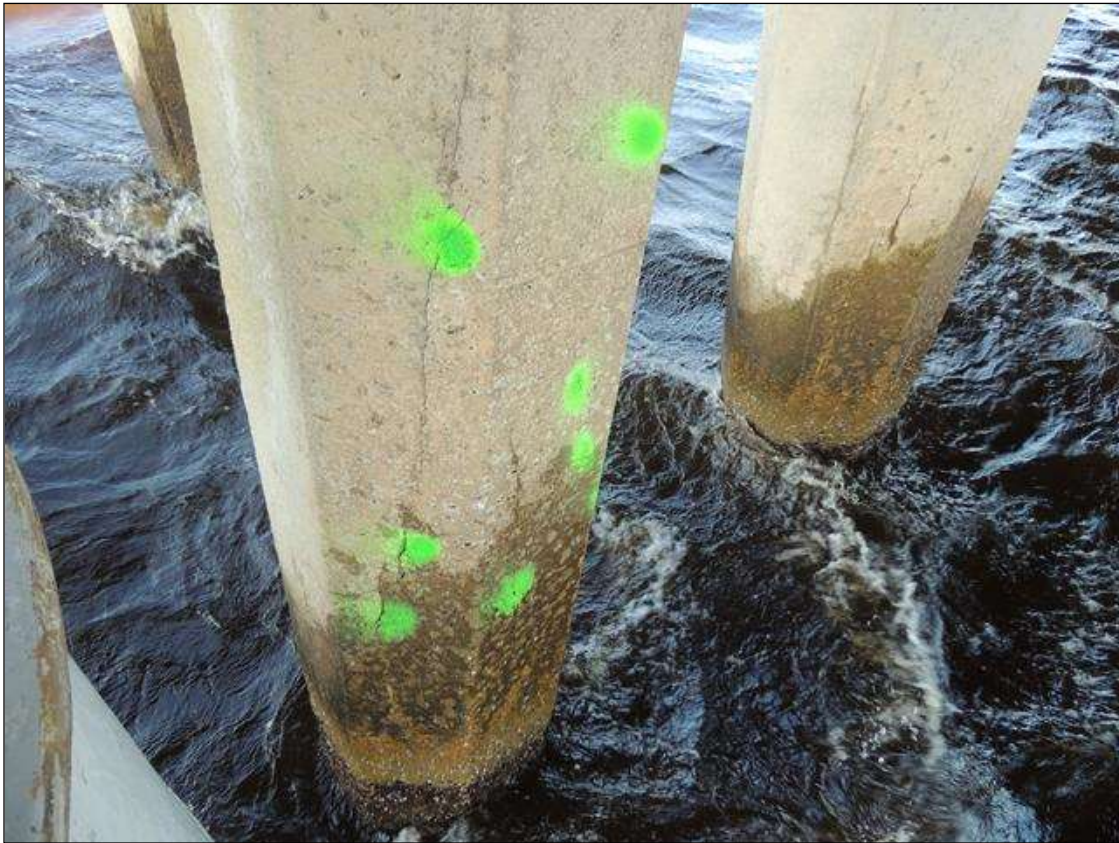
BENT 260 P5 CRACKED AND DELAMINATED AREA FROM THE WATER LINE UP 50" AND 18" AROUND PILE ON NORTH SIDE..

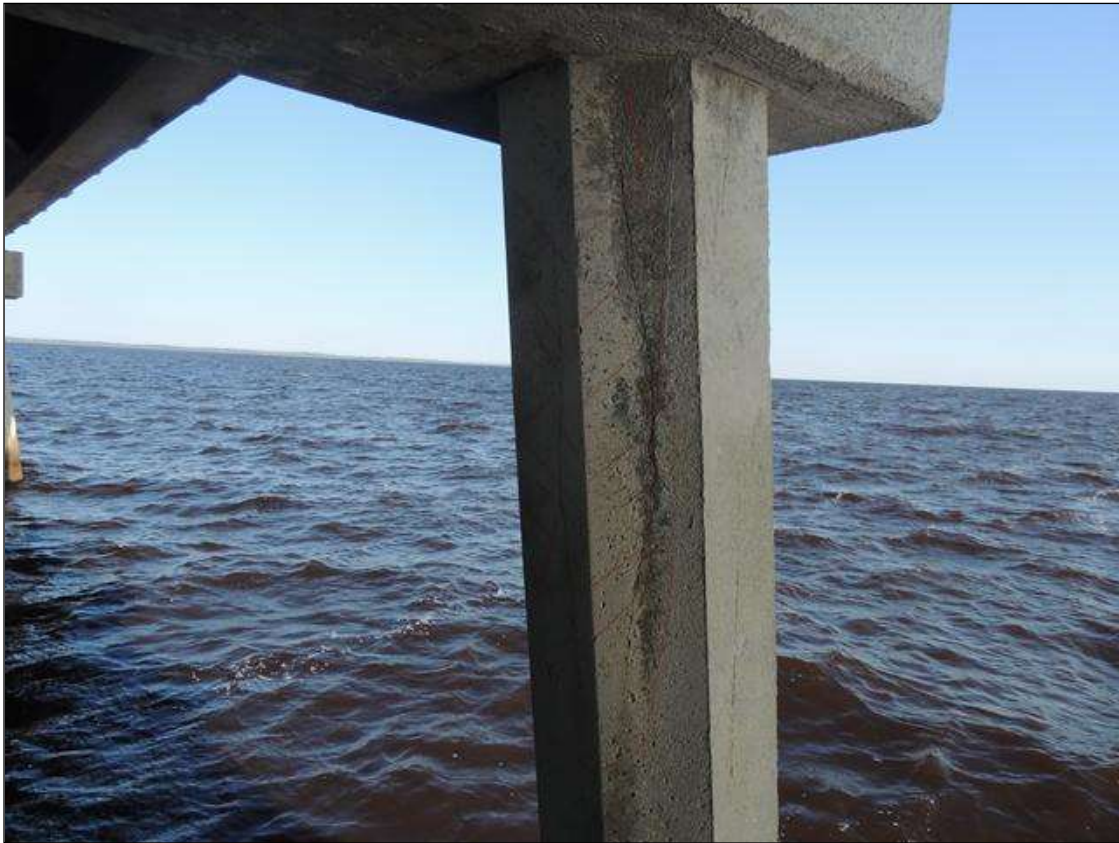
BENT 260 PILE 1 CRACKED AND DELAMINATED AREA FROM THE BOTTOM OF CAP DOWN 58" AND 18" AROUND PILE ON SOUTH FACE.

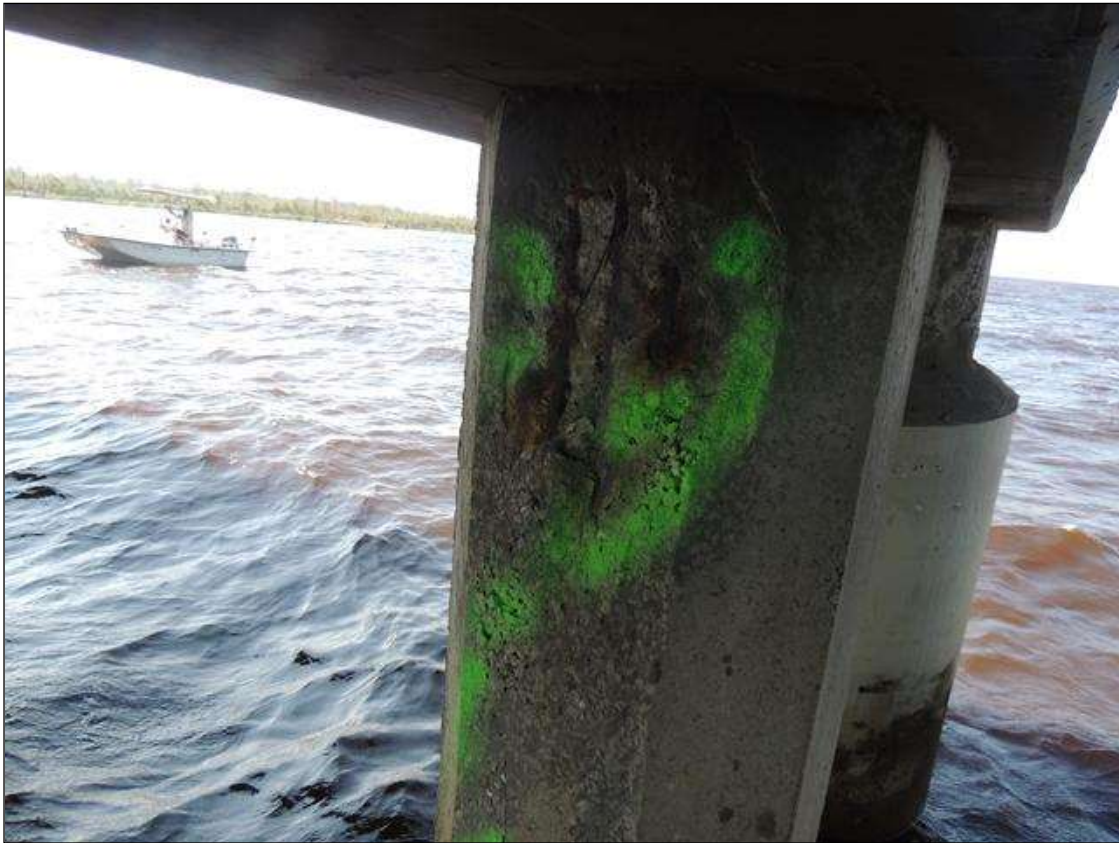
BENT 265 P5 CRACKED, SPALLED AND DELAMINATED AREA ON NORTH FACE OF PILE FROM BOTTOM CAP DOWN TO WL 75" X 18" AROUND PILE WITH 3 CABLES EXPOSE PM

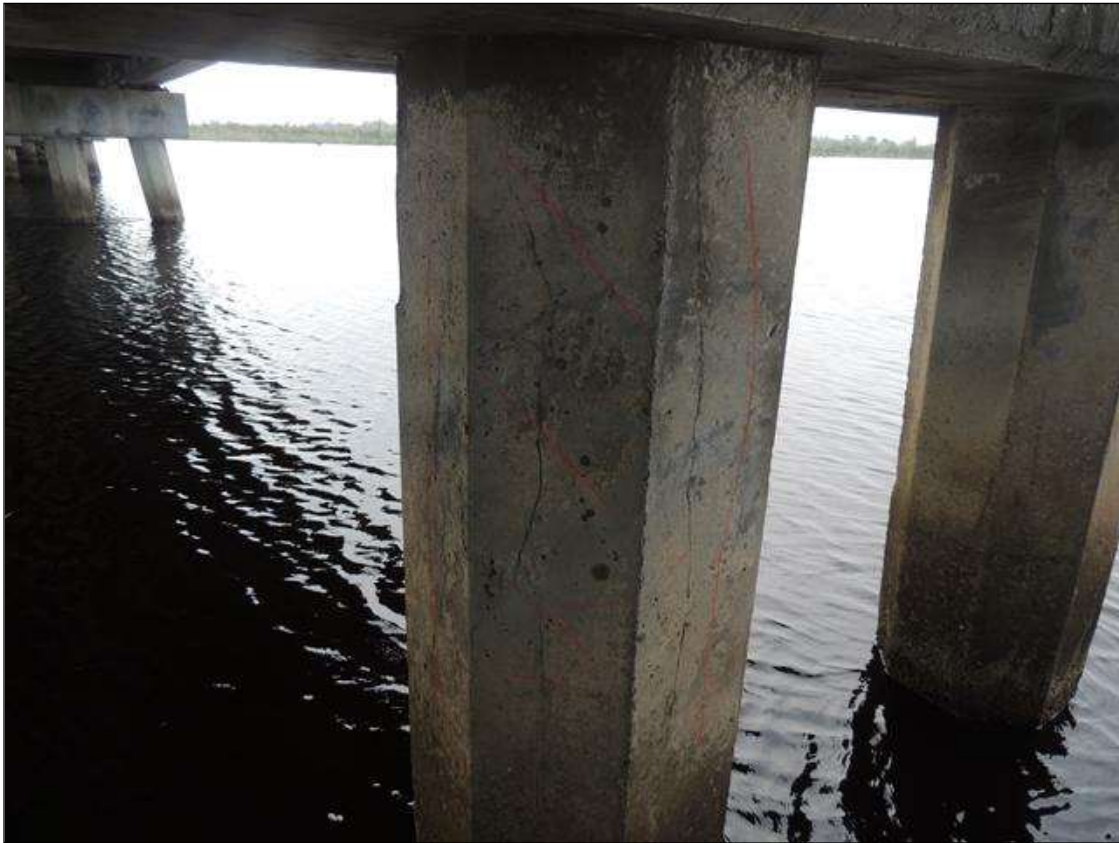
BENT 266 CRACKED AND DELAMINATED AREA ON THE WEST FACE OF PILE FROM BOT CAP TO WL 75" X 18" AROUND PILE.

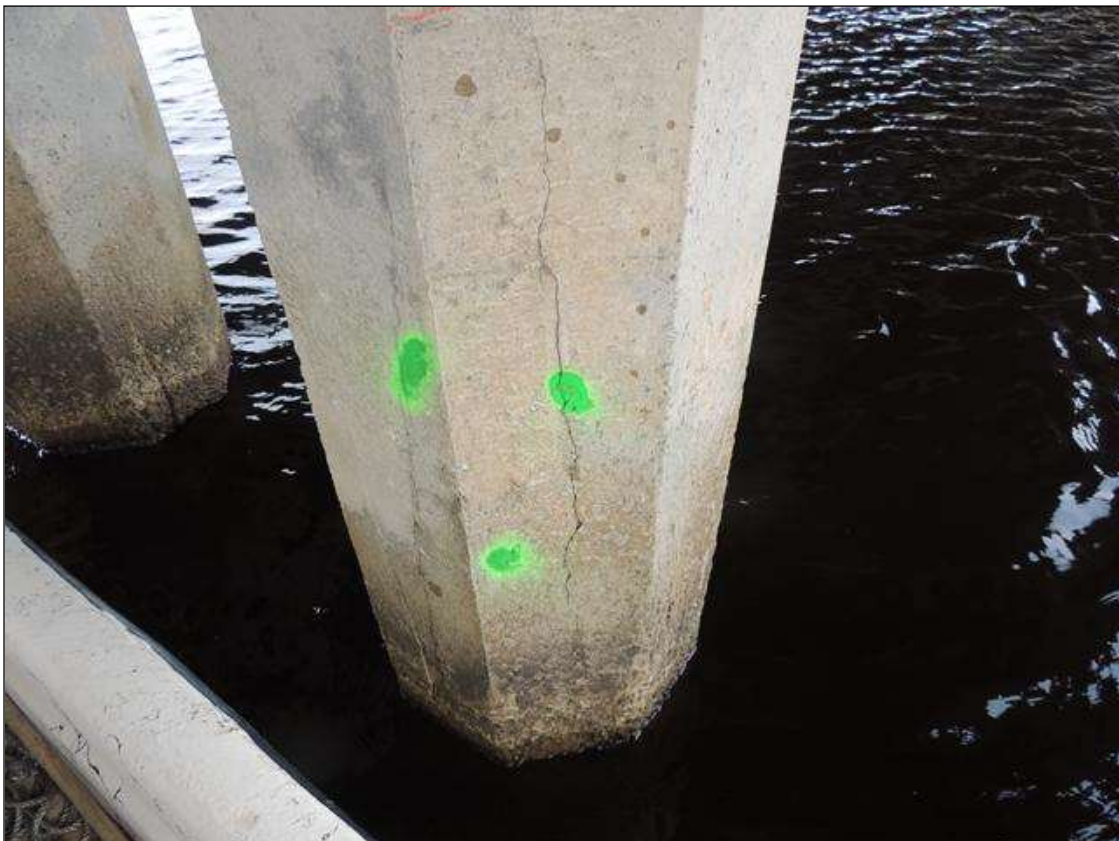
BENT 266 P2 EAST FACE CRACKED AND DELAMINATED AREA FROM WL UP 46" X 16" AROUND PILE.

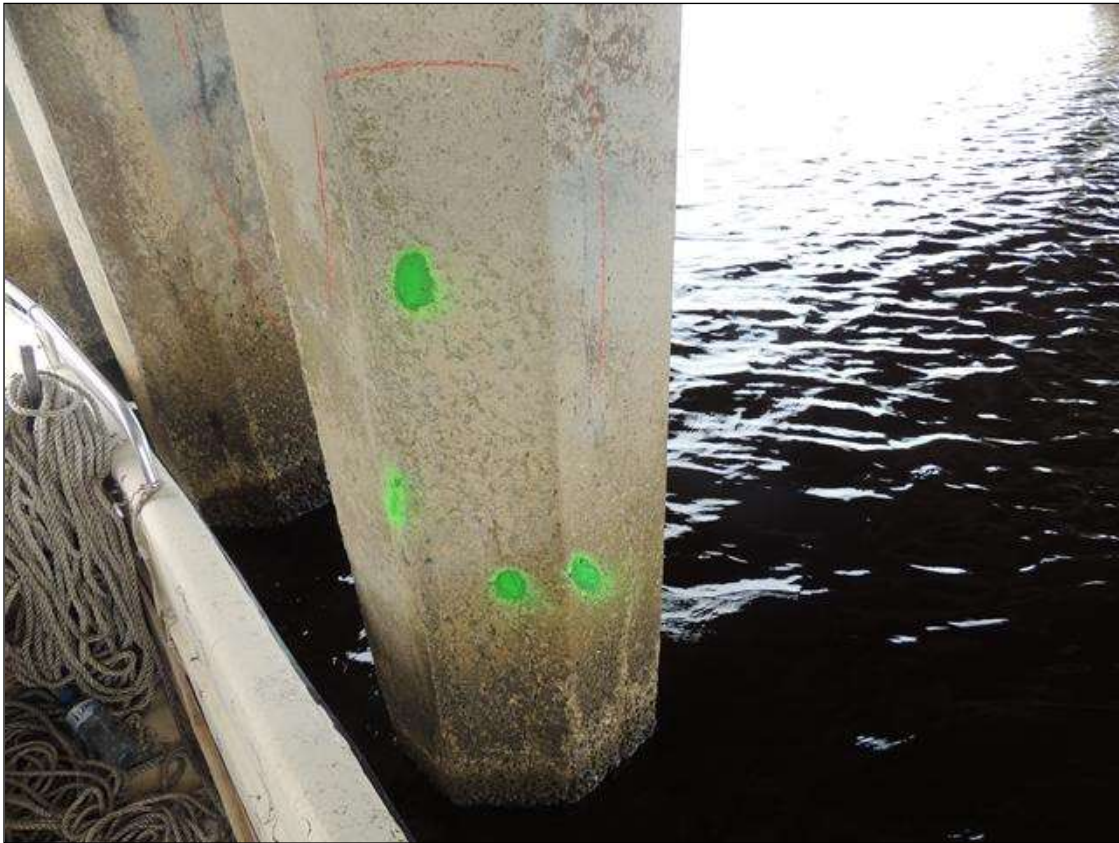
BENT 266 N EAST FACE OF P4 CRACKED AND DELAMINATED AREA FROM WL UP 52" X 18" AROUND PILE.

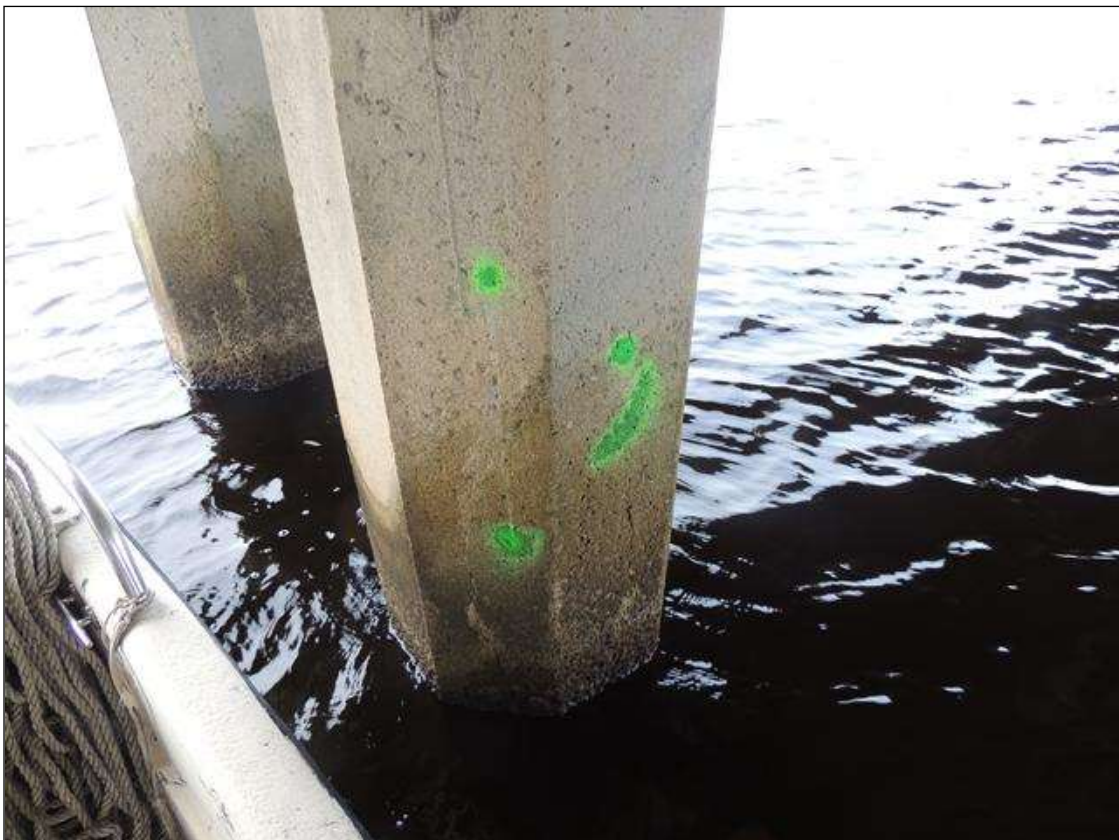
BENT 267 P5 CRACKED AND DELAMINATED AREA ON SPAN 268 SIDE FROM WL UP 48" X 16" AROUND PILE.

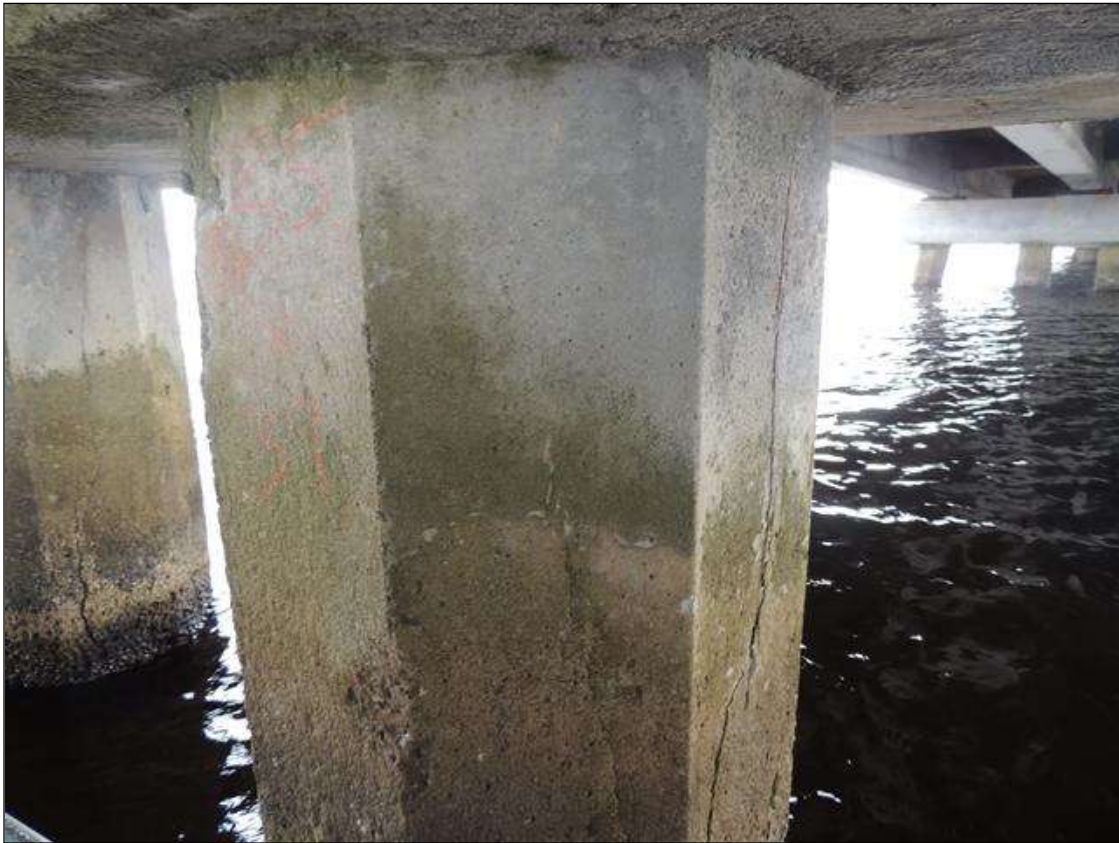
BENT 269 P3 CRACKED AND DELAMINATED FROM TOP DOWN TO WL 32" AROUND PILE AND 39" DOWN PILES 1 AND 2 AND 4 AND 5 SIMILAR.

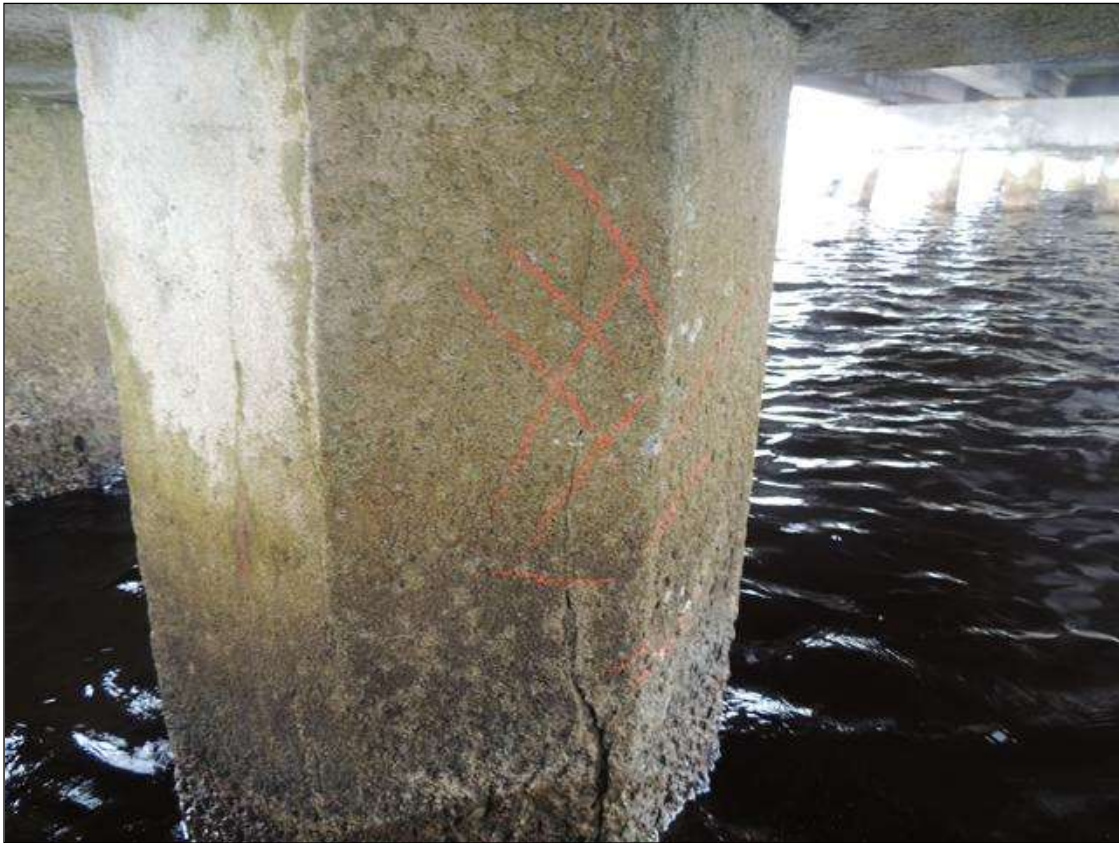
BENT 270 P3 CRACKED AND DELAMINATED AREA 14" AROUND PILE AND 27" FROM TOP TO WL WITH PILES 1,2,5 AND 6 SIMILAR.
