PROJECT NO. I-5839  
HALIFAX COUNTY  
 BRIDGE NO. 131 & 132

STATE OF NORTH CAROLINA  
 DEPARTMENT OF TRANSPORTATION  
 RALEIGH  
 SUBSTRUCTURE  
 TYPICAL CAP AND COLUMN  
 REPAIR DETAILS

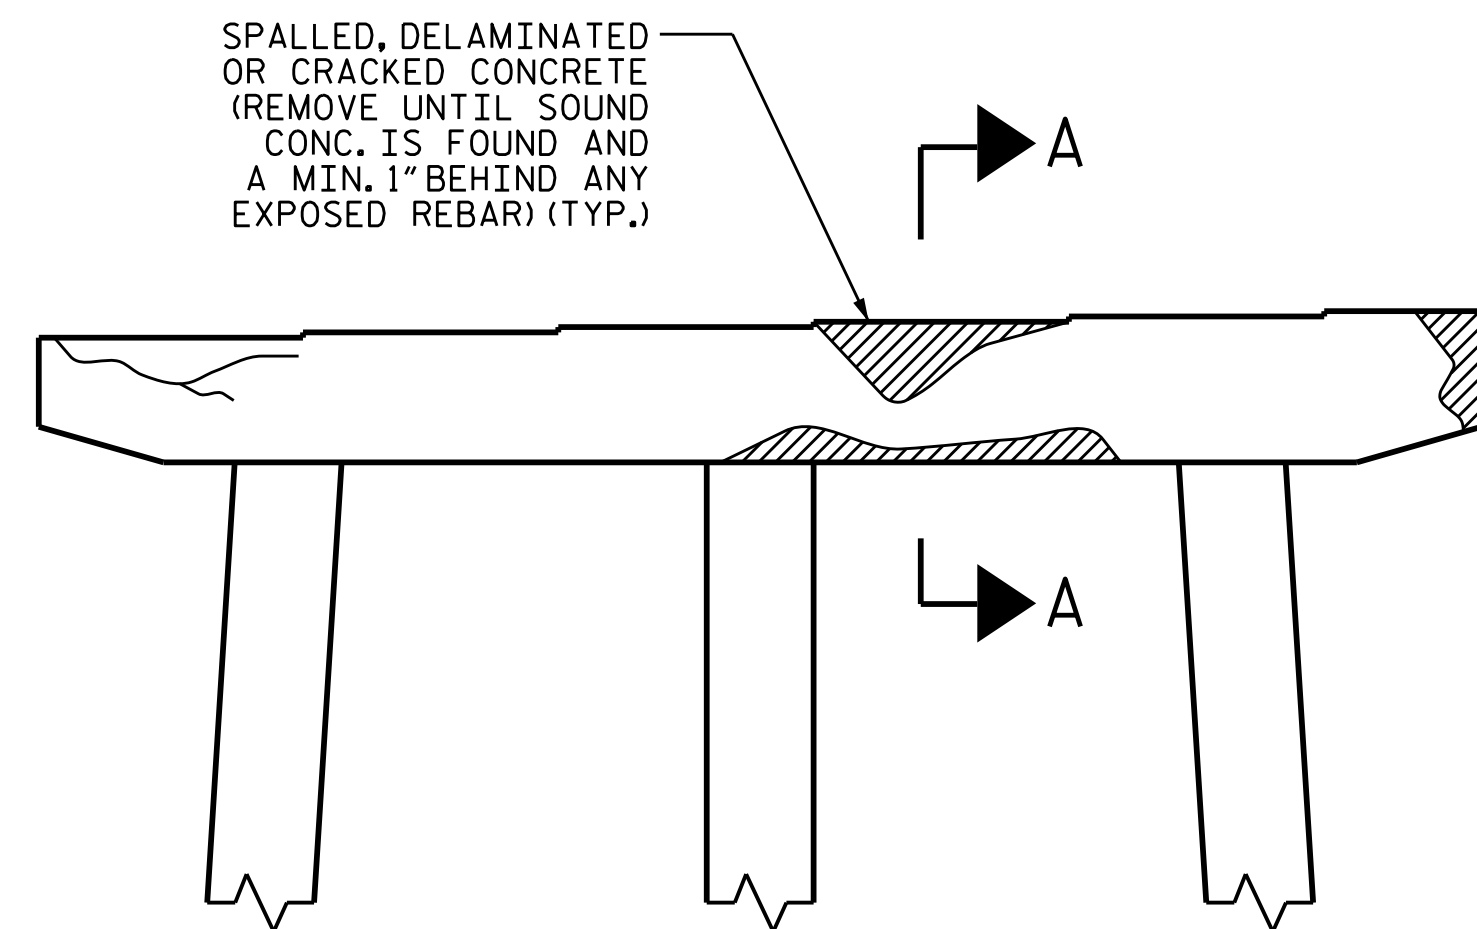
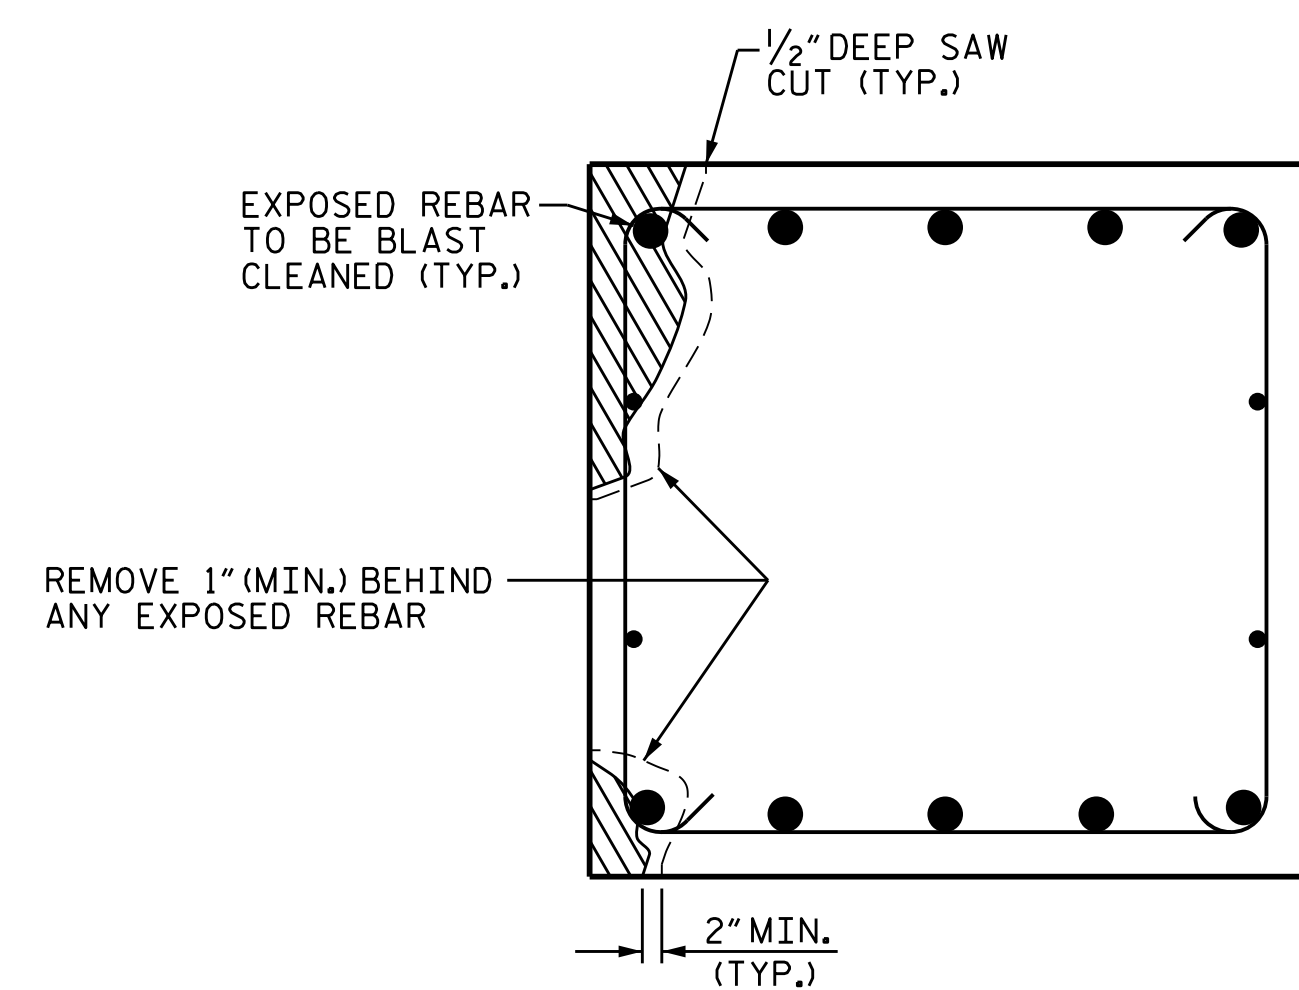
CAP REPAIR

BENT CAP REPAIRS

SECTION THRU CAP

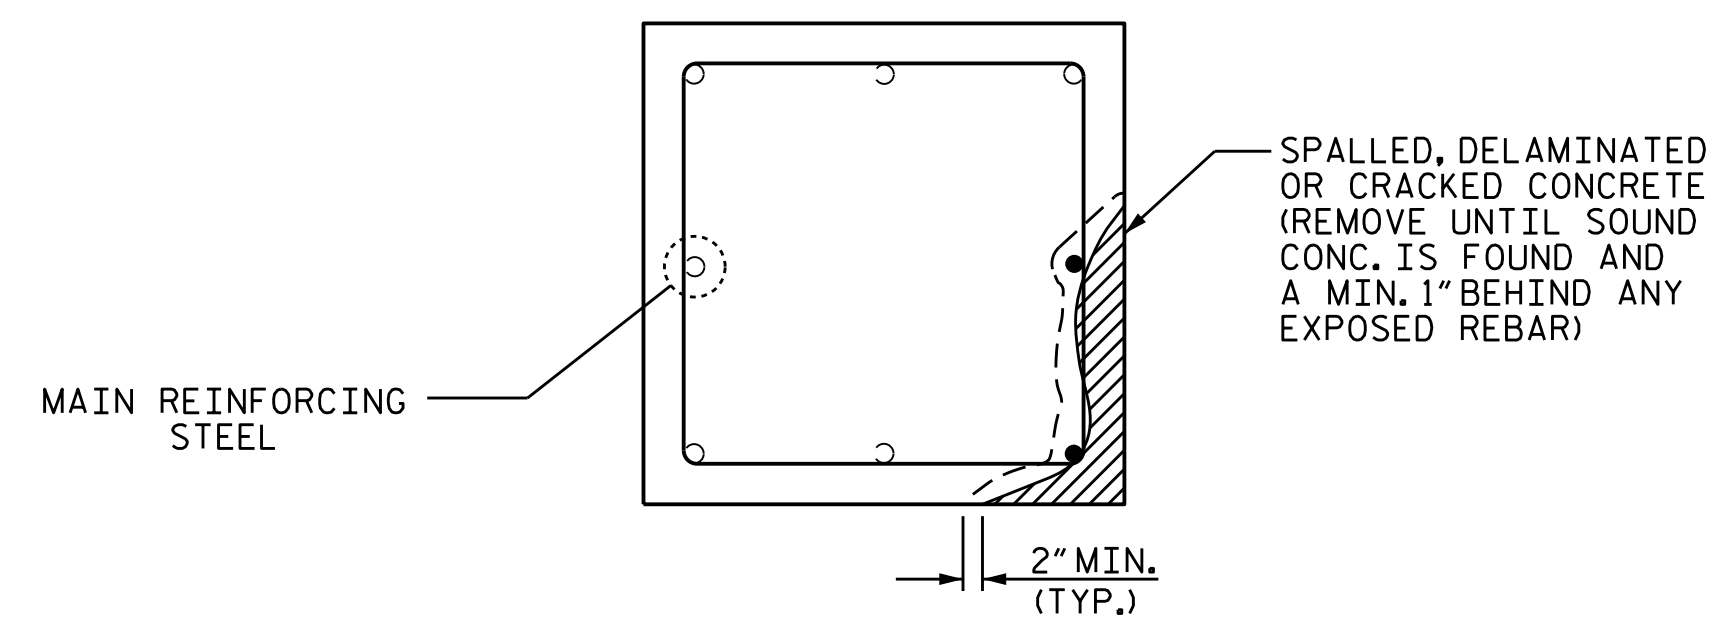
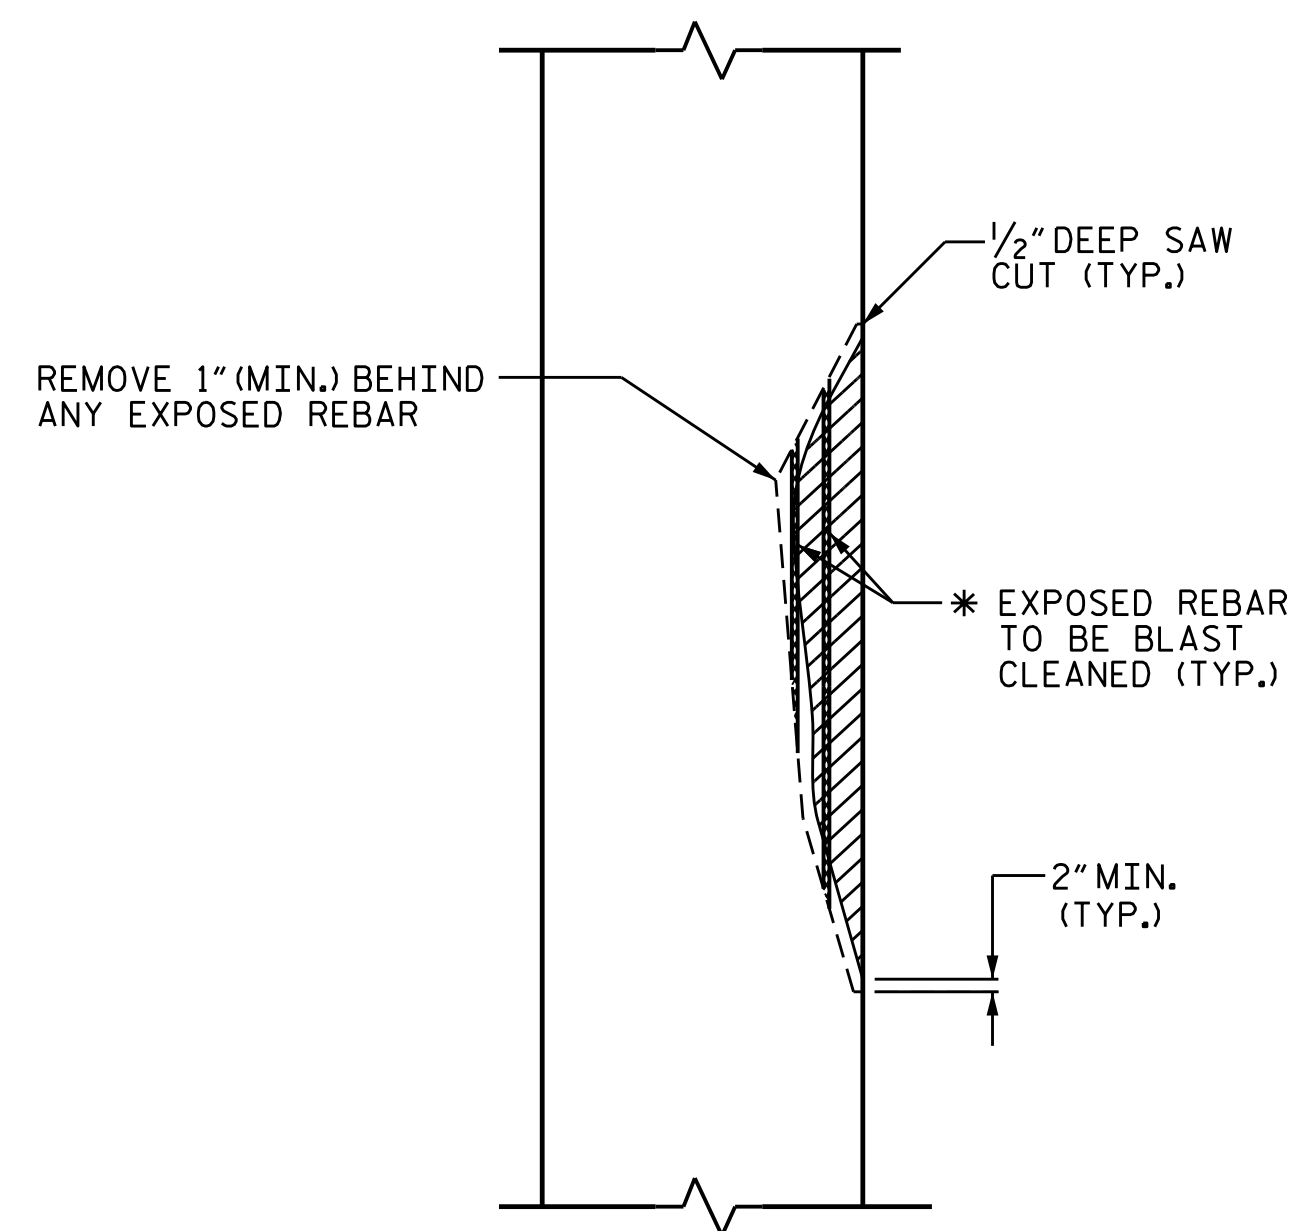
COLUMN REPAIR

PLAN OF COLUMN

ELEVATION OF COLUMN

\* DUE TO LACK OF CONFINEMENT STEEL, REPAIR LENGTH SHALL NOT EXCEED 10'-0" AT ONE TIME, UNLESS APPROVED BY THE ENGINEER.
