NC DEPARTMENT OF TRANSPORTATION
 DIVISION OF HIGHWAYS
 STRUCTURE MANAGEMENT UNIT

ATTENTION: **PM's ISSUED**

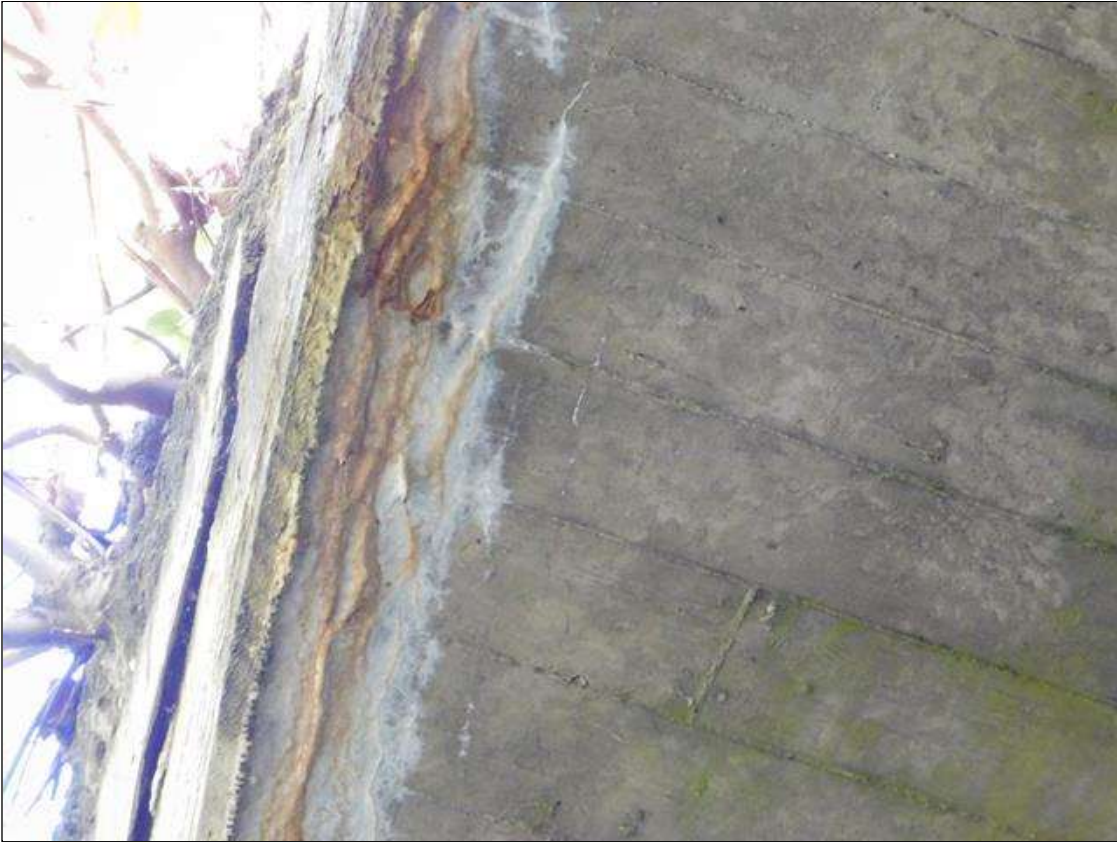
Barrel 1 Section 1: BARREL 1 BOTTOM OF TOP SLAB AND NORTHWEST CORNER. HAS A LARGE AREA THAT IS CRACKED/DELAMINATED AND SPALLED WITH REBAR AND HEAVY EFFLO VISIBLE. A "PM" HAS BEEN ISSUED FOR THIS CONDITION.

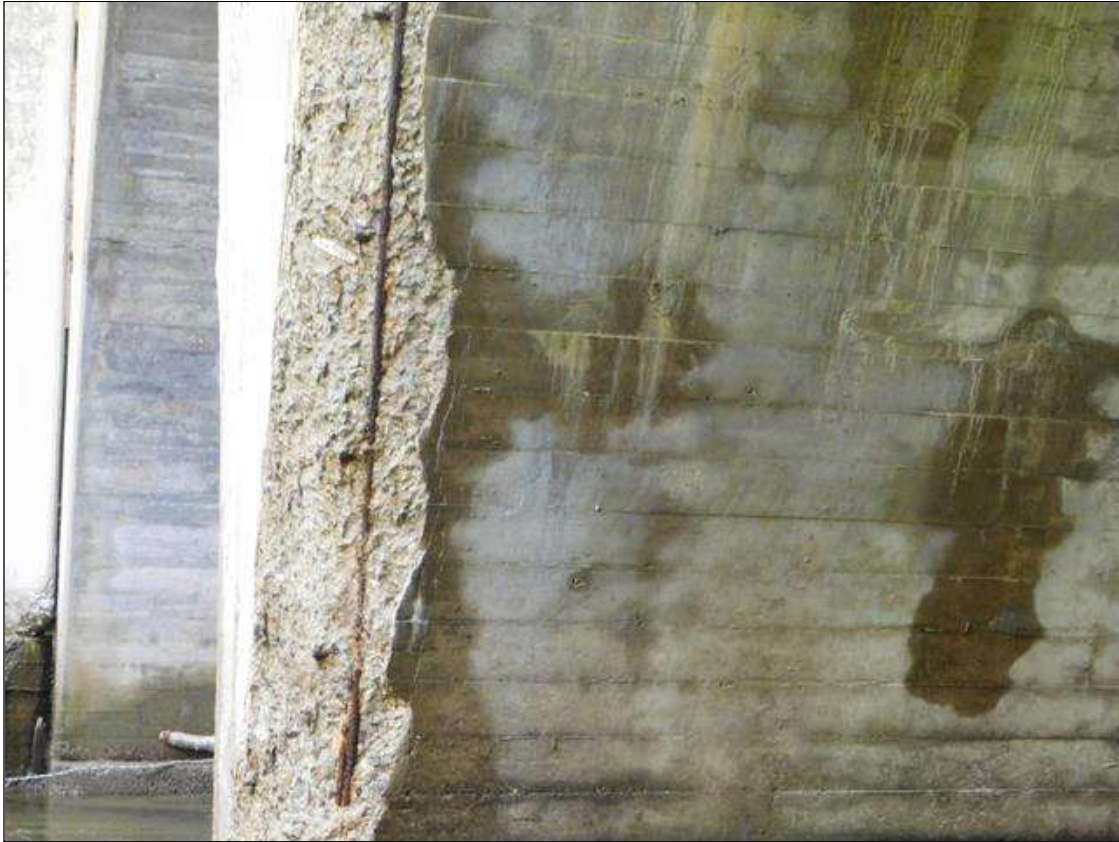
Barrel 1 Section 1: BARREL 1 BOTTOM OF TOP SLAB AND NORTHWEST CORNER. HAS A LARGE AREA THAT IS CRACKED/DELAMINATED AND SPALLED WITH REBAR AND HEAVY EFFLO VISIBLE. A "PM" HAS BEEN ISSUED FOR THIS CONDITION.

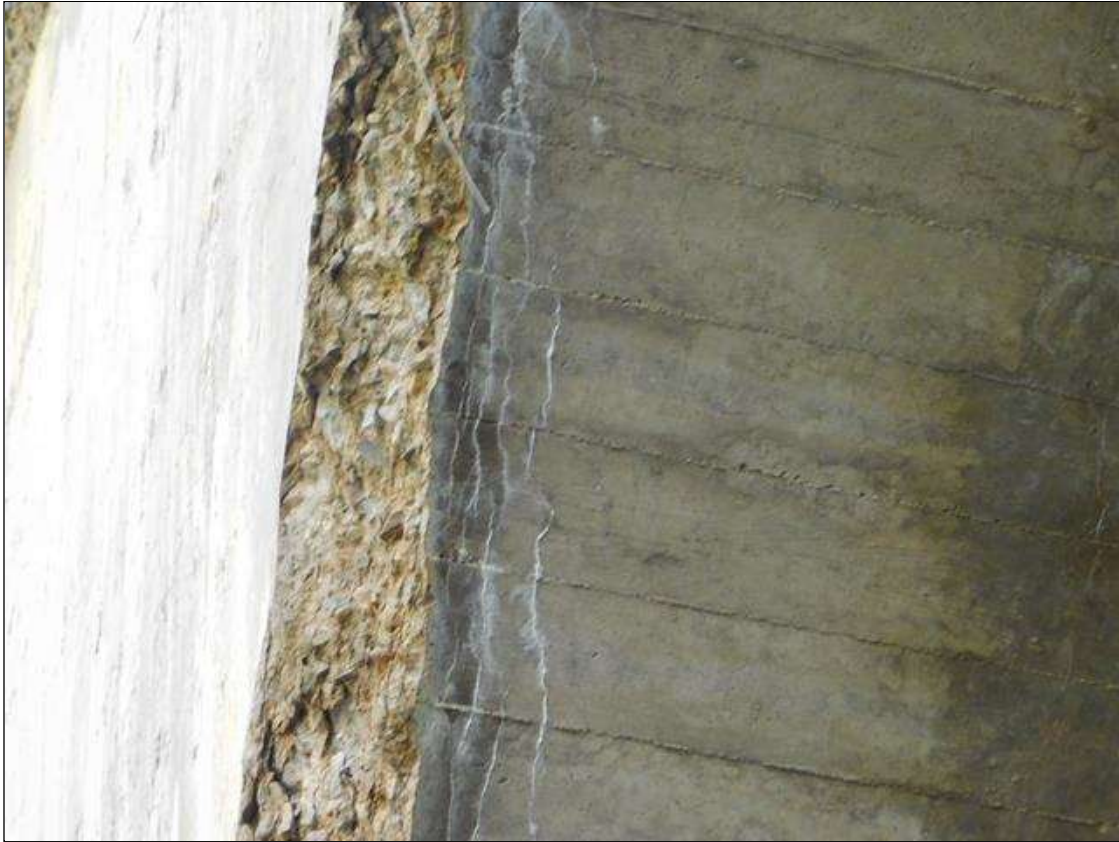
Barrel 1 Section 1: BARREL 1 BOTTOM OF TOP SLAB AND NORTHWEST CORNER. HAS A LARGE AREA THAT IS CRACKED/DELAMINATED AND SPALLED WITH REBAR AND HEAVY EFFLO VISIBLE. A "PM" HAS BEEN ISSUED FOR THIS CONDITION.

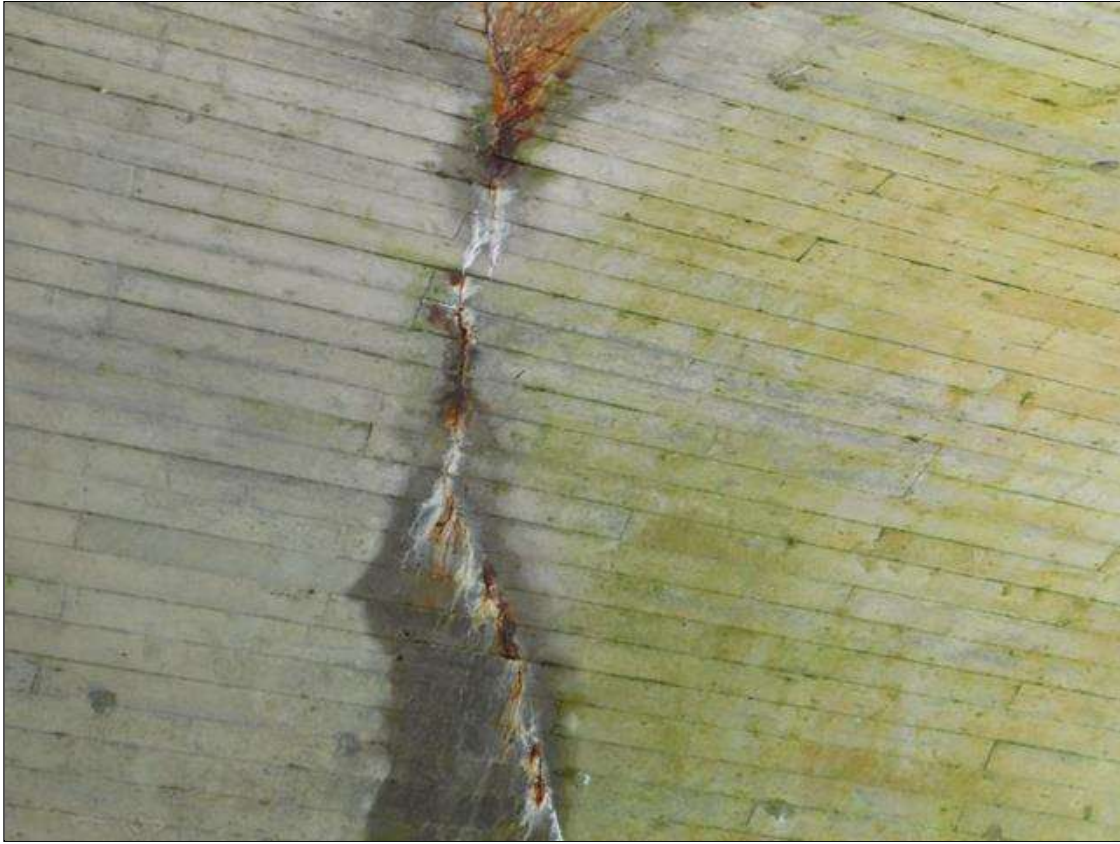
Barrel 1 Section 1: BARREL 1 HAS 2 CRACKS WITH HEAVY RUST STAINS AND EFFLO VISIBLE IN BOTTOM OF TOP SLAB AND DOWN BOTH INTERIOR WALLS. LOCATED AT: 27' AND 39' FROM UPSTREAM END.

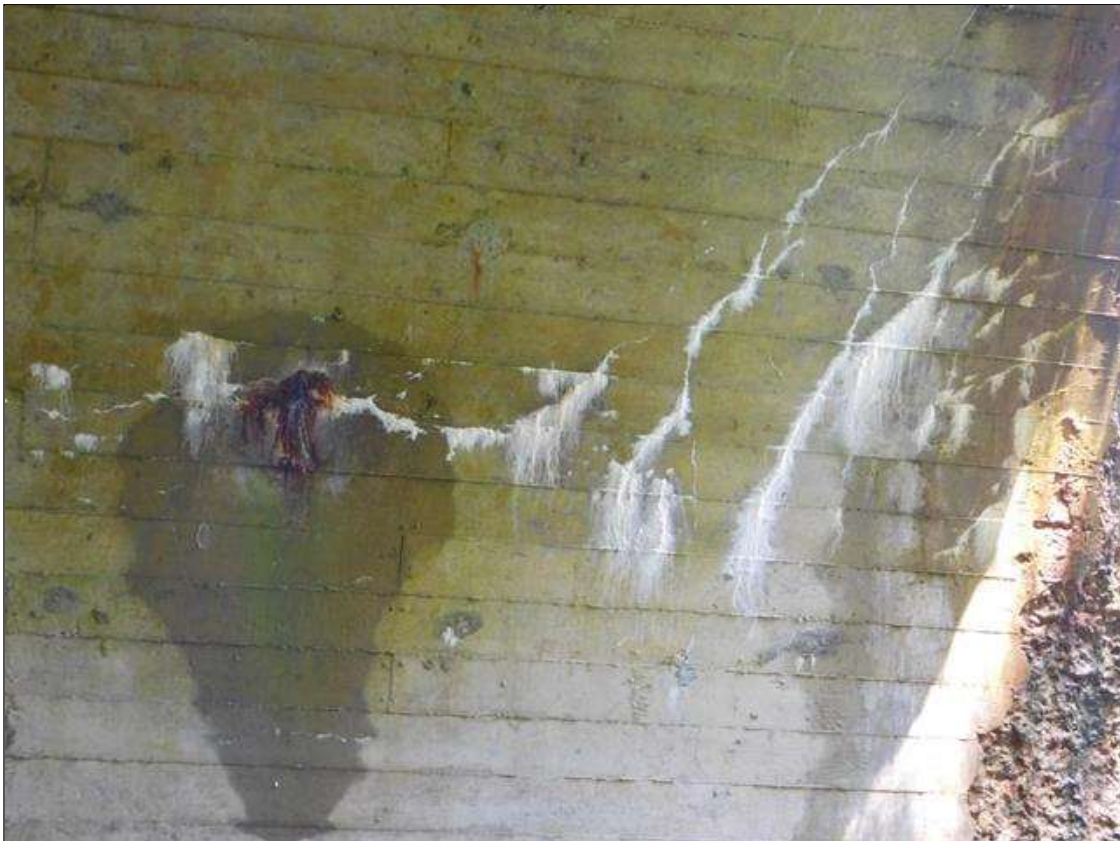
Barrel 1 Section 1: BARREL 1 HAS SCATTERED HORIZONTAL AND DIAGONAL CRACKS WITH HEAVY RUST STAINS AND EFFLO VISIBLE. LOCATED AT: 50' FROM UPSTREAM END.

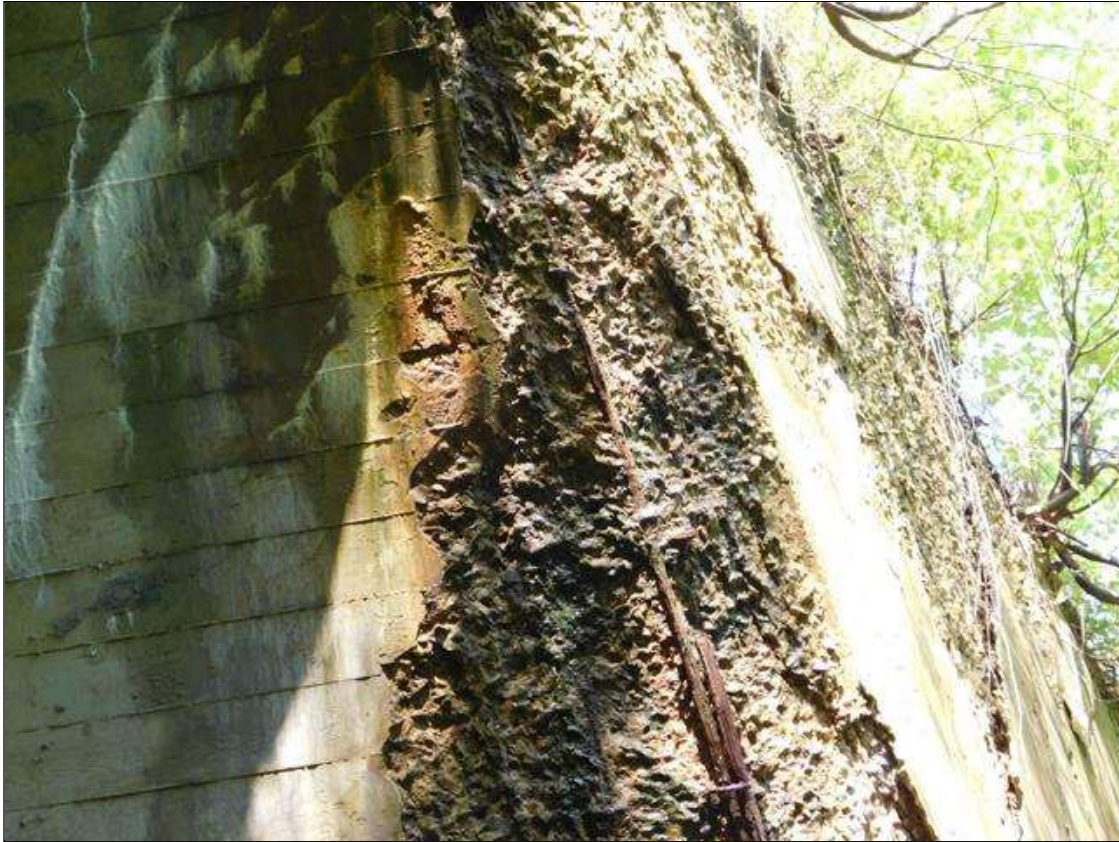
Barrel 1 Section 1: BARREL 1 DOWNSTREAM END HAS A LARGE AREA OF HEAVY DELAMINATION AND SPALL WITH REBAR EXPOSED. AREA IS: FULL CIRCUMFERENCE OF BARREL. A "PM" HAS BEEN ISSUED FOR THIS CONDITION.

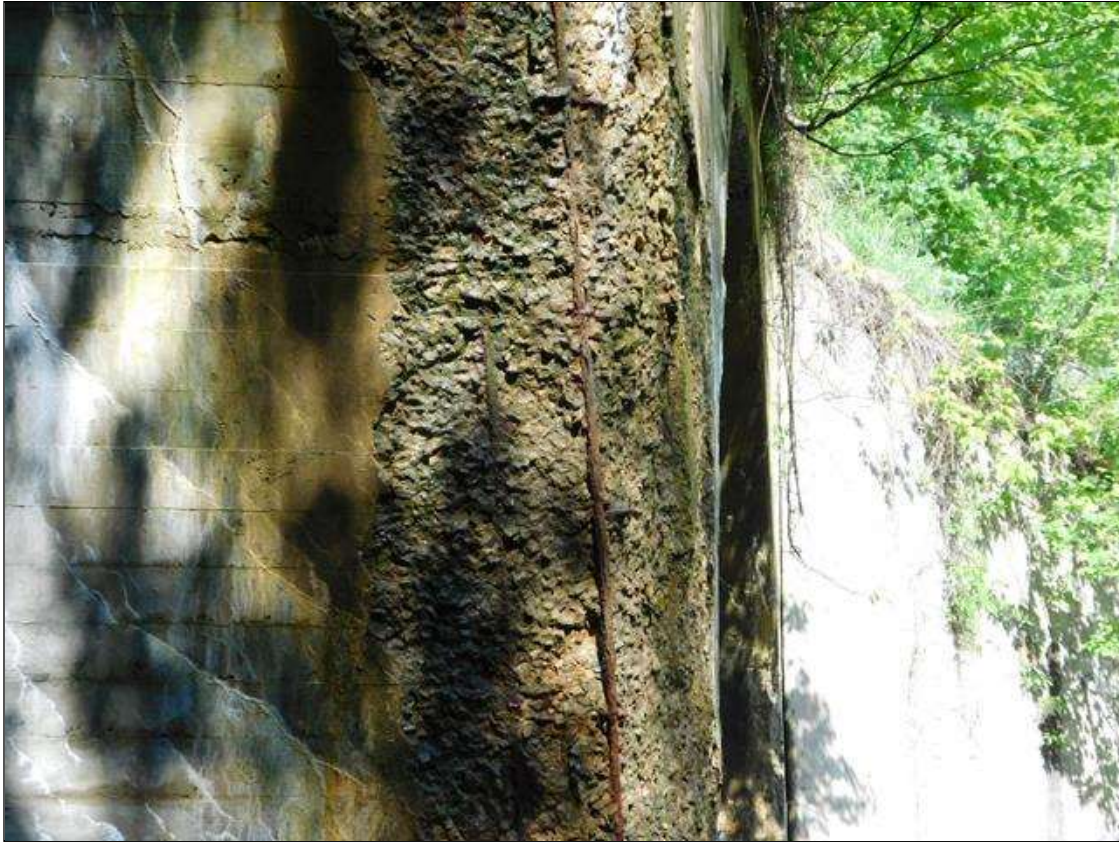
Barrel 1 Section 1: BARREL 1 DOWNSTREAM END HAS A LARGE AREA OF HEAVY DELAMINATION AND SPALL WITH REBAR EXPOSED. AREA IS: FULL CIRCUMFERENCE OF BARREL. A "PM" HAS BEEN ISSUED FOR THIS CONDITION.

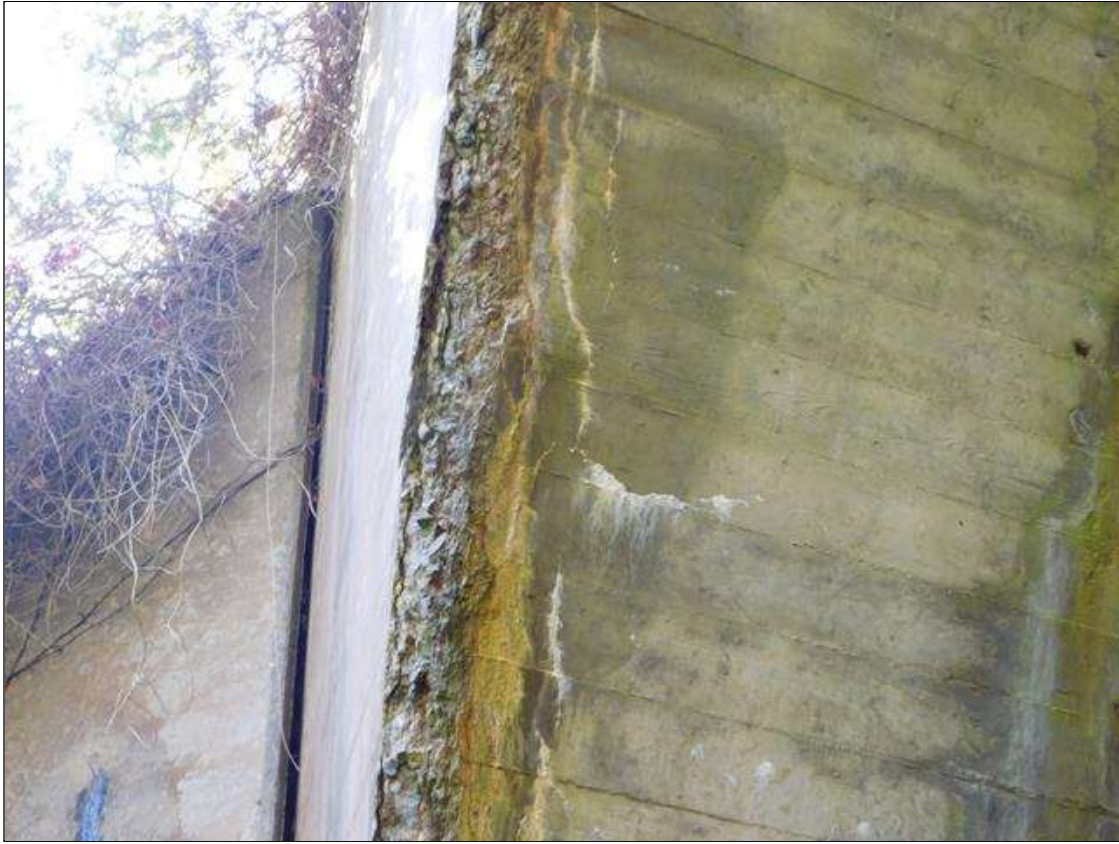
Barrel 1 Section 1: BARREL 1 DOWNSTREAM END HAS A LARGE AREA OF HEAVY DELAMINATION AND SPALL WITH REBAR EXPOSED. AREA IS: FULL CIRCUMFERENCE OF BARREL. A "PM" HAS BEEN ISSUED FOR THIS CONDITION.

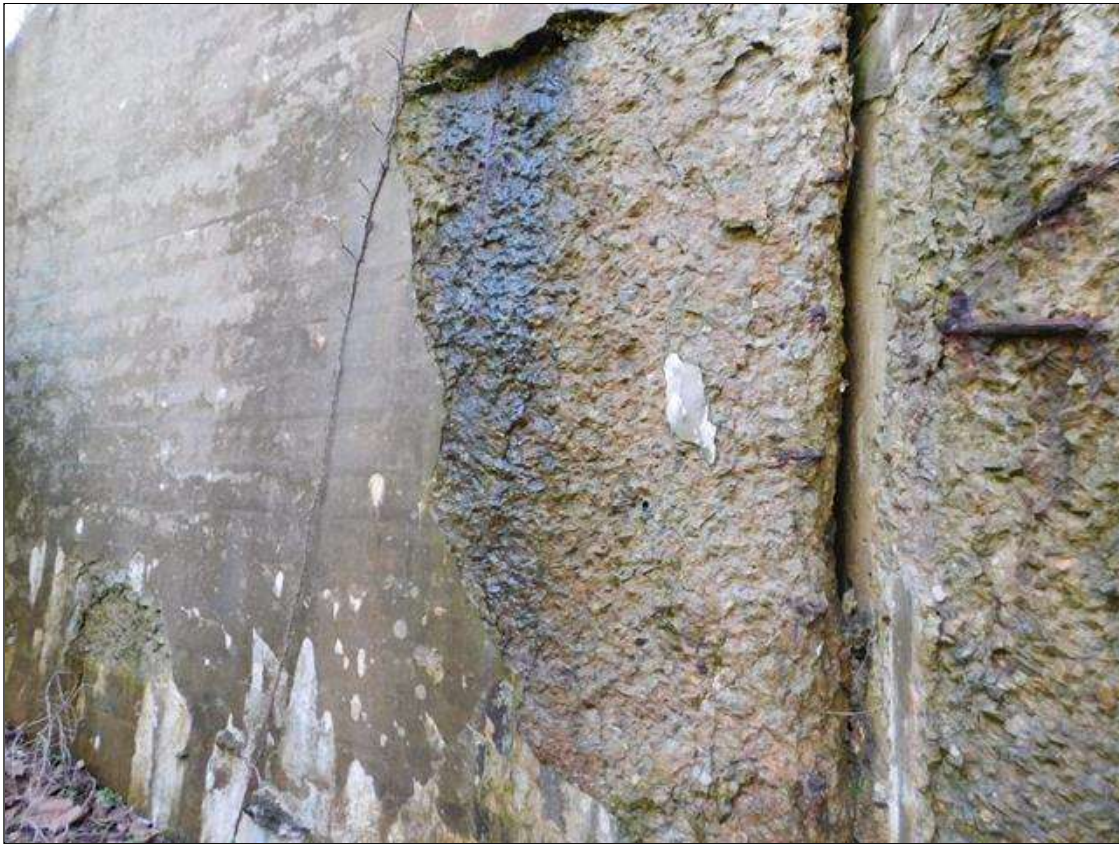
SOUTHEAST WING WALL HAS A AREA OF HEAVY SPALL AND DELAMINATION WITH REBAR EXPOSED. AREA IS: 3' x 7' x 4" DEEP. A "PM" HAS BEEN ISSUED FOR THIS CONDITION.

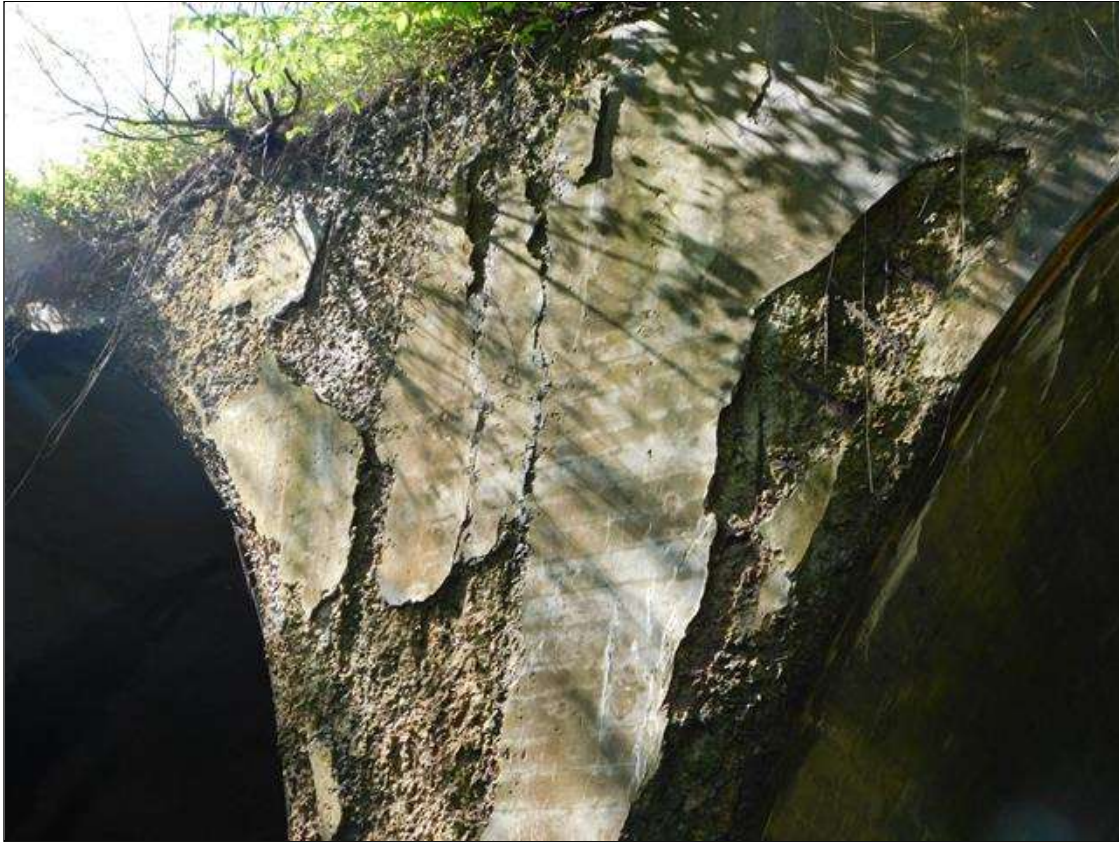
EAST HEADWALL HAS A LARGE AREA OF HEAVY SPALL AND DELAMINATION WITH REBAR AND EFFLO EXPOSED. AREA IS: 20' x 45'. TOTAL MAINTENANCE QUANTITY IS: 900 SQ FEET. A "PM" HAS BEEN ISSUED FOR THIS CONDITION.

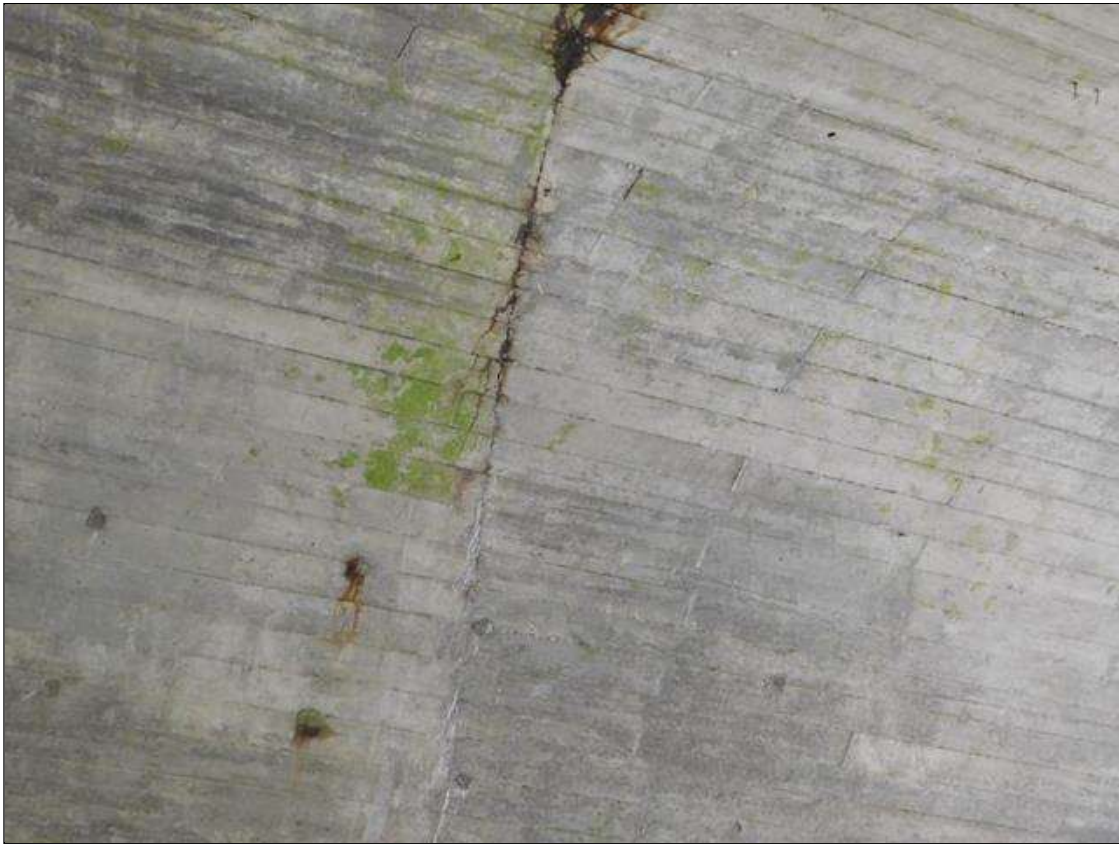
Barrel 2 Section 1: BARREL 2 INTERIOR WALL 2 AND BOTTOM OF ARCH HAS A CRACK WITH HEAVY RUST STAINS AND SOME EFFLO VISIBLE. LOCATED AT: 26' FROM UPSTREAM END.

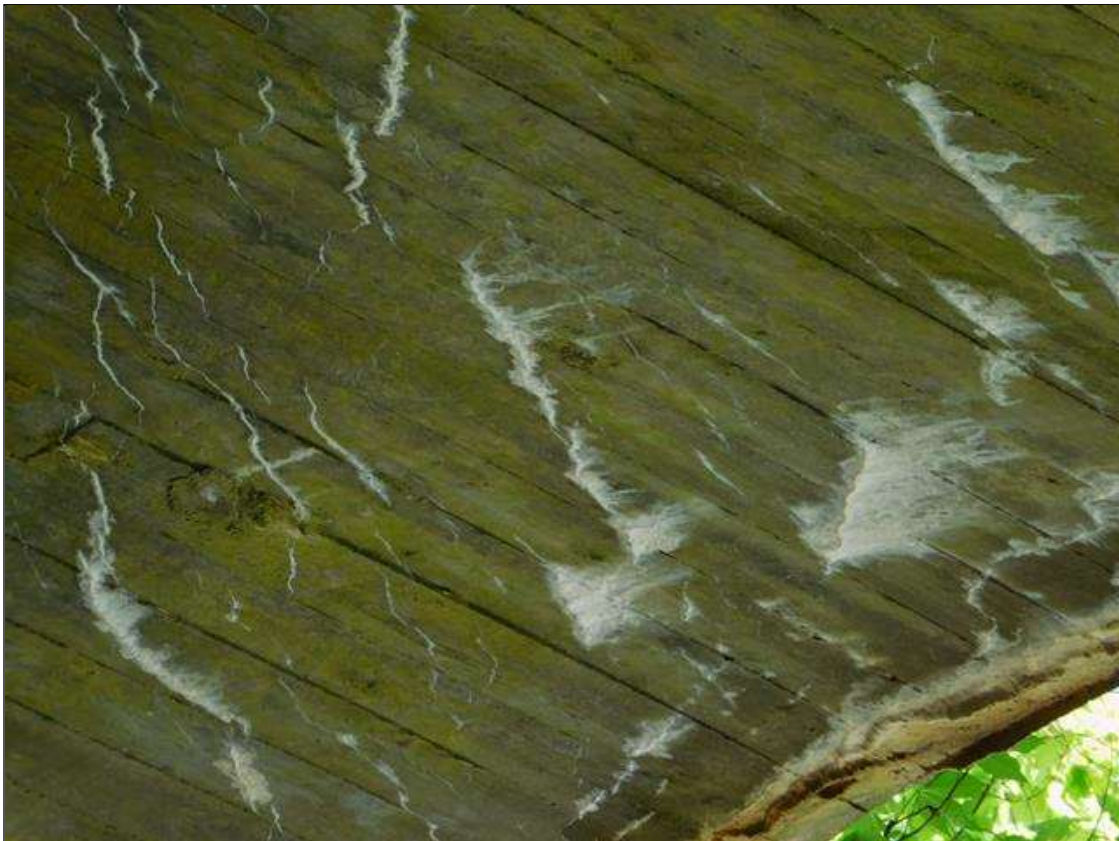
Barrel 2 Section 1: BARREL 2 INTERIOR WALL 1 AND 2 AND BOTTOM OF ARCH HAS SCATTERED DIAGONAL CRACKS WITH HEAVY EFFLO VISIBLE.

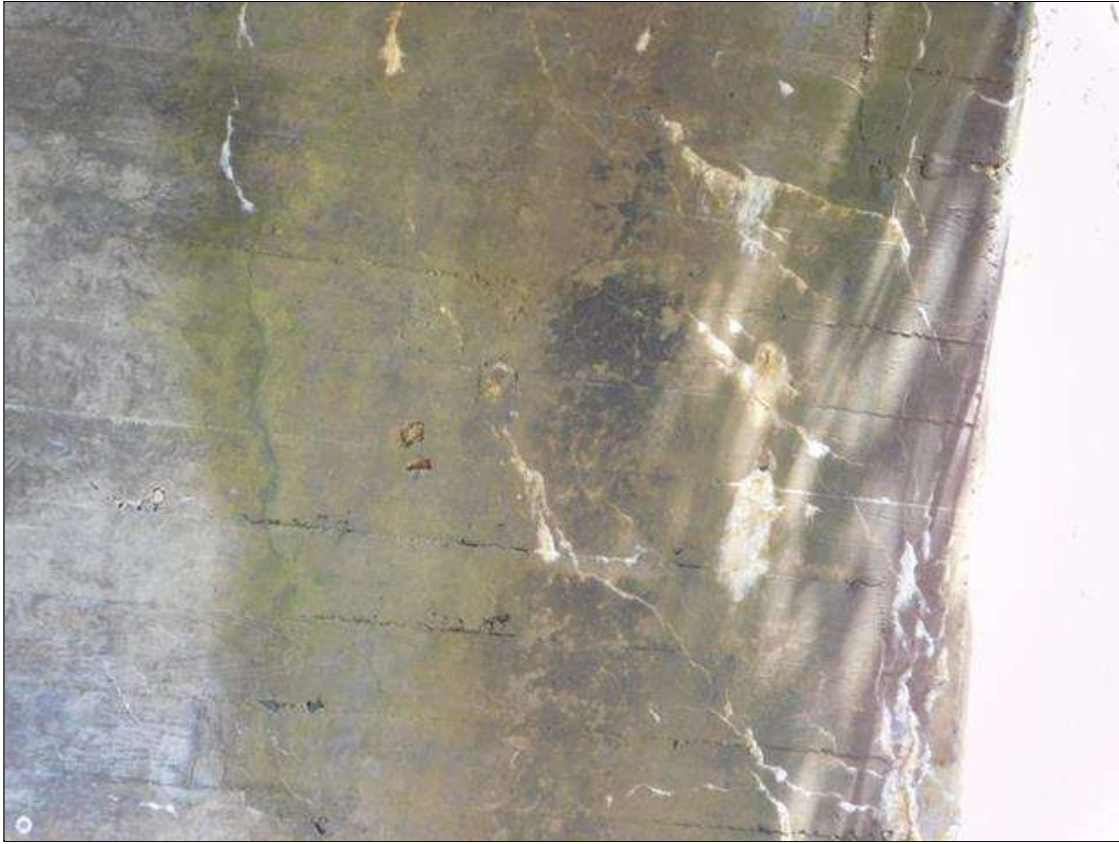
Barrel 2 Section 1: BARREL 2 INTERIOR WALL 1 AND 2 AND BOTTOM OF ARCH HAS SCATTERED DIAGONAL CRACKS WITH HEAVY EFFLO VISIBLE.

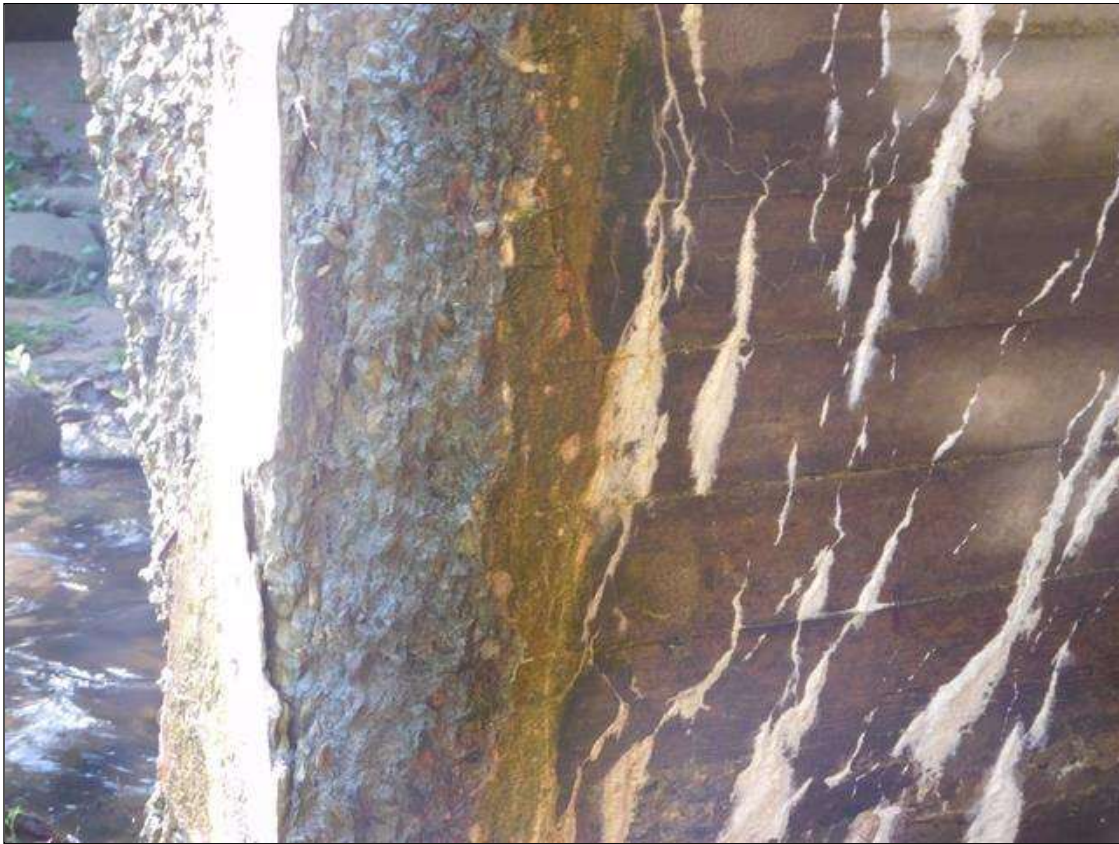
Barrel 2 Section 1: BARREL 2 DOWNSTREAM END OF BOTH INTERIOR WALLS AND BOTTOM OF ARCH HAS SCATTERED AREAS OF HEAVY SPALL AND DELAMINATION WITH REBAR EXPOSED. A "PM" HAS BEEN ISSUED FOR THIS CONDITION.

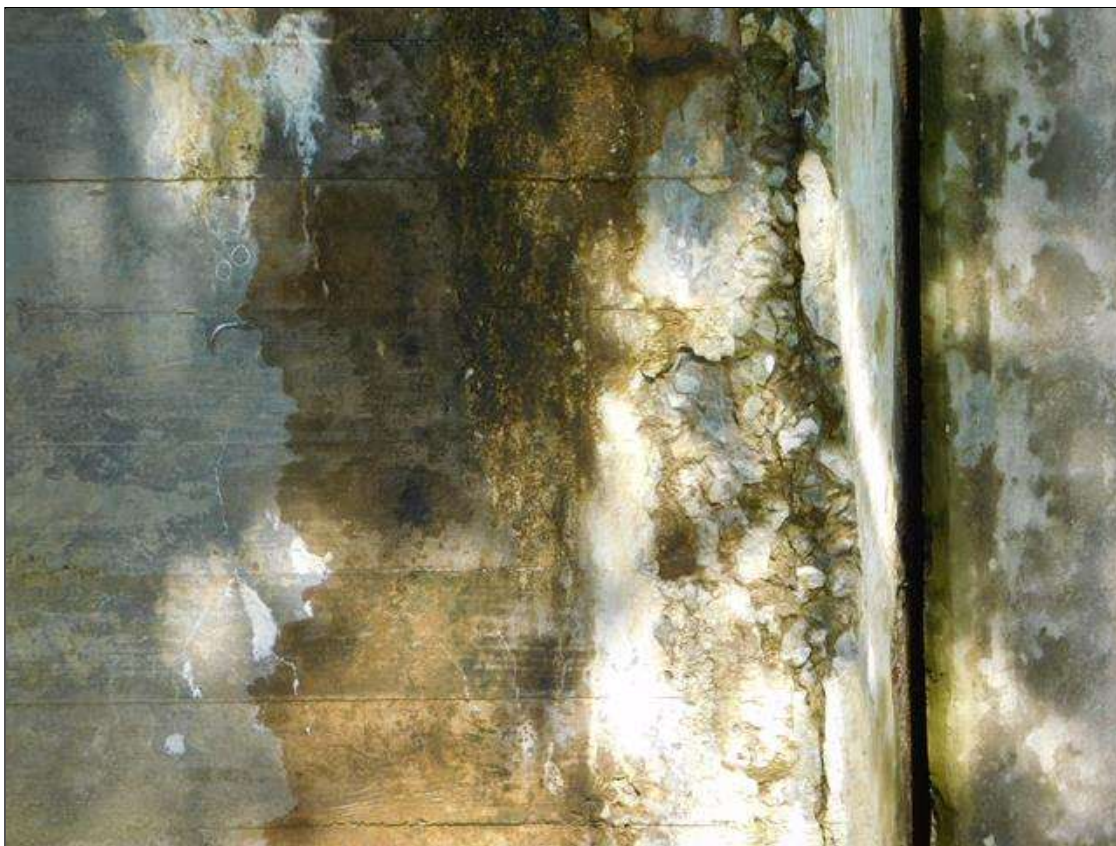
Barrel 2 Section 1: BARREL 2 DOWNSTREAM END OF BOTH INTERIOR WALLS AND BOTTOM OF ARCH HAS SCATTERED AREAS OF HEAVY SPALL AND DELAMINATION WITH REBAR EXPOSED. A "PM" HAS BEEN ISSUED FOR THIS CONDITION.

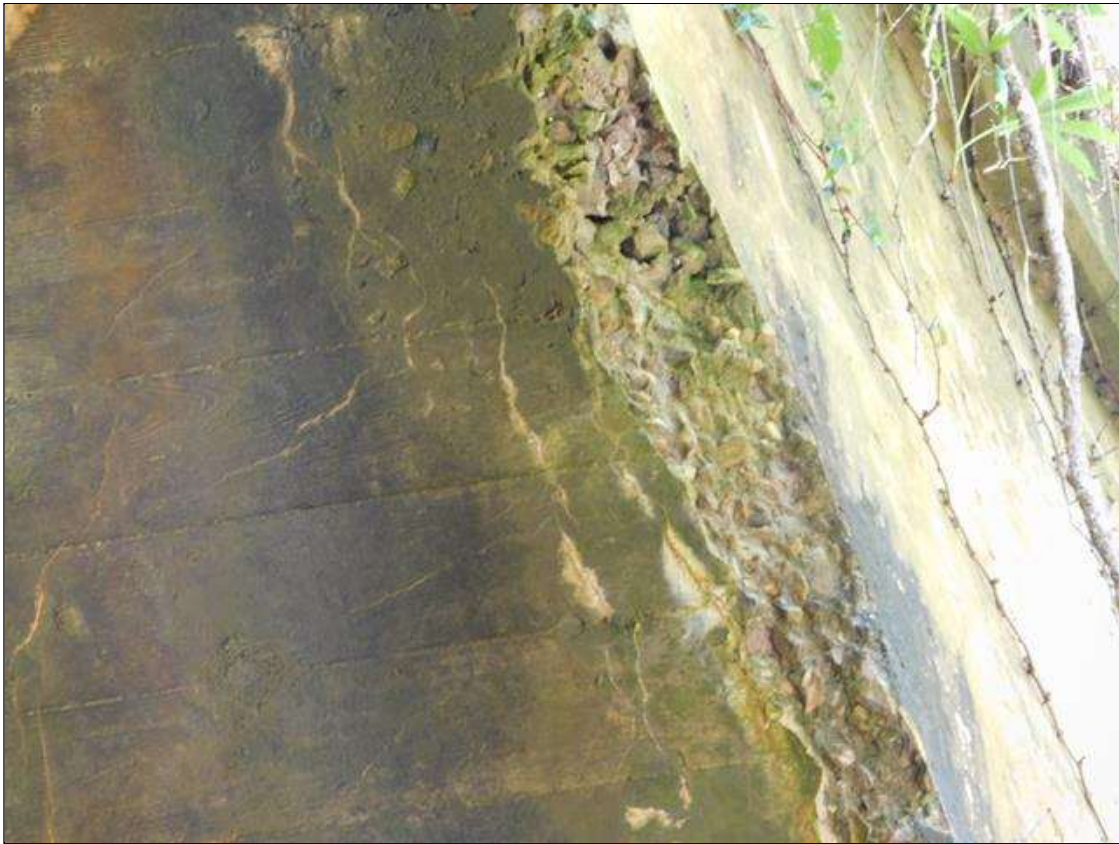
Barrel 2 Section 1: BARREL 2 DOWNSTREAM END OF BOTH INTERIOR WALLS AND BOTTOM OF ARCH HAS SCATTERED AREAS OF HEAVY SPALL AND DELAMINATION WITH REBAR EXPOSED. A "PM" HAS BEEN ISSUED FOR THIS CONDITION.

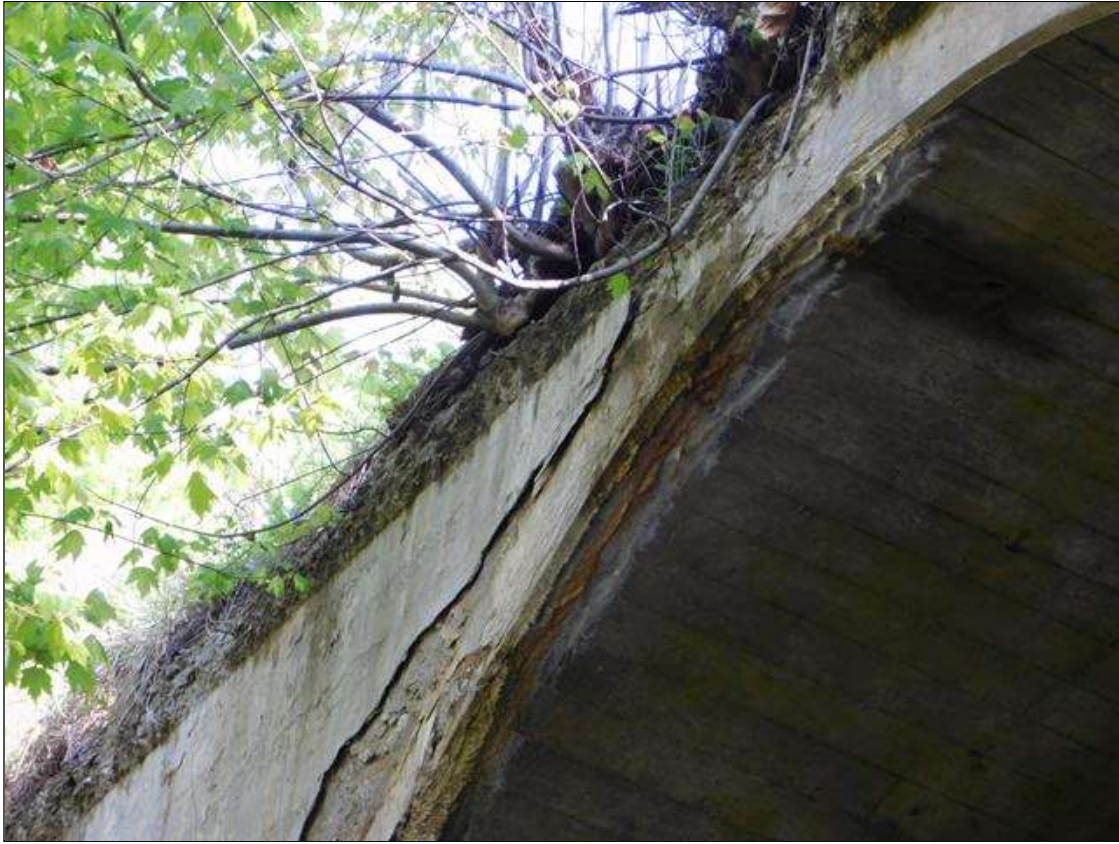
WEST HEADWALL HAS A LARGE AREA THAT IS CRACK/SPALL AND DELAMINATED WITH HEAVY EFFLO
VISIBLE. AREA IS: FROM TOP EDGE DOWN 16' x 40' LONG x 6" DEEP. TOTAL SQ FEET IS 640. A "PM" HAS
BEEN ISSUED FOR THIS CONDITION.

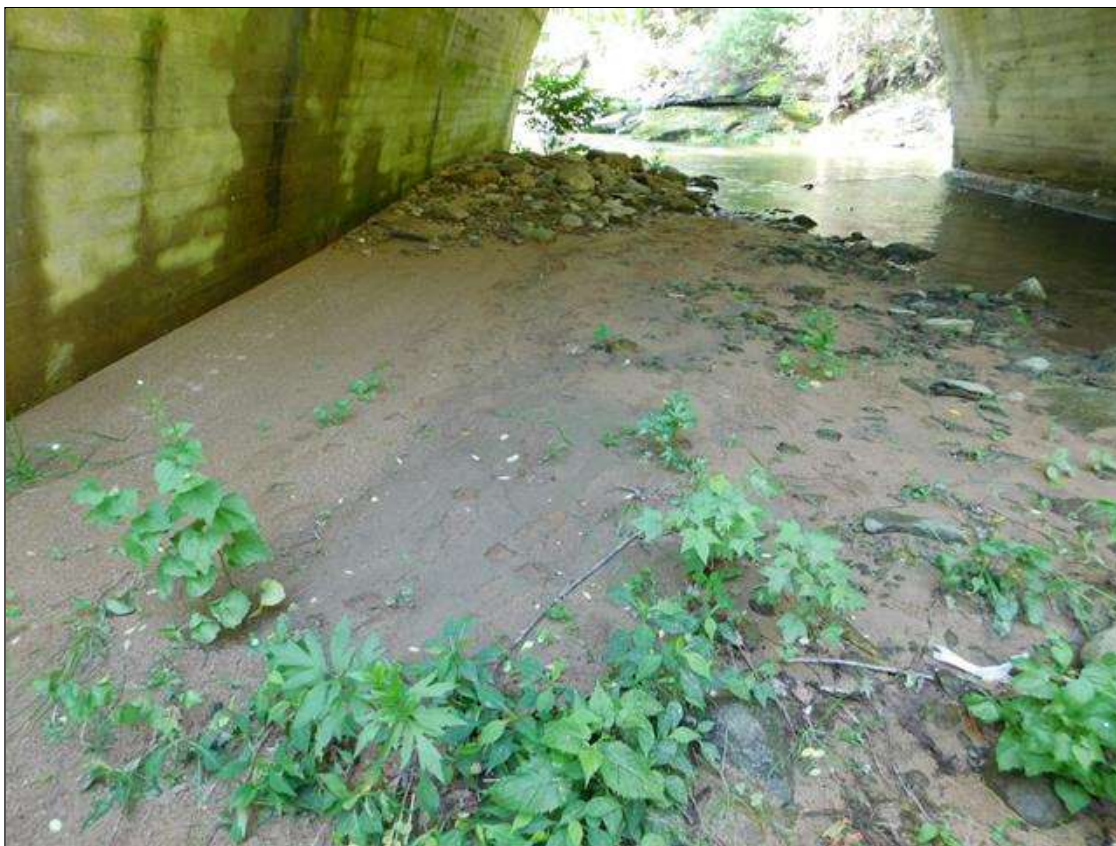
EXCESS SAND AND ROCKS IN BARREL 1. AREA IS: 15' x 56' x UP TO 3' HIGH. TOTAL MAINTENANCE QUANTITY IS 840' SQ FEET

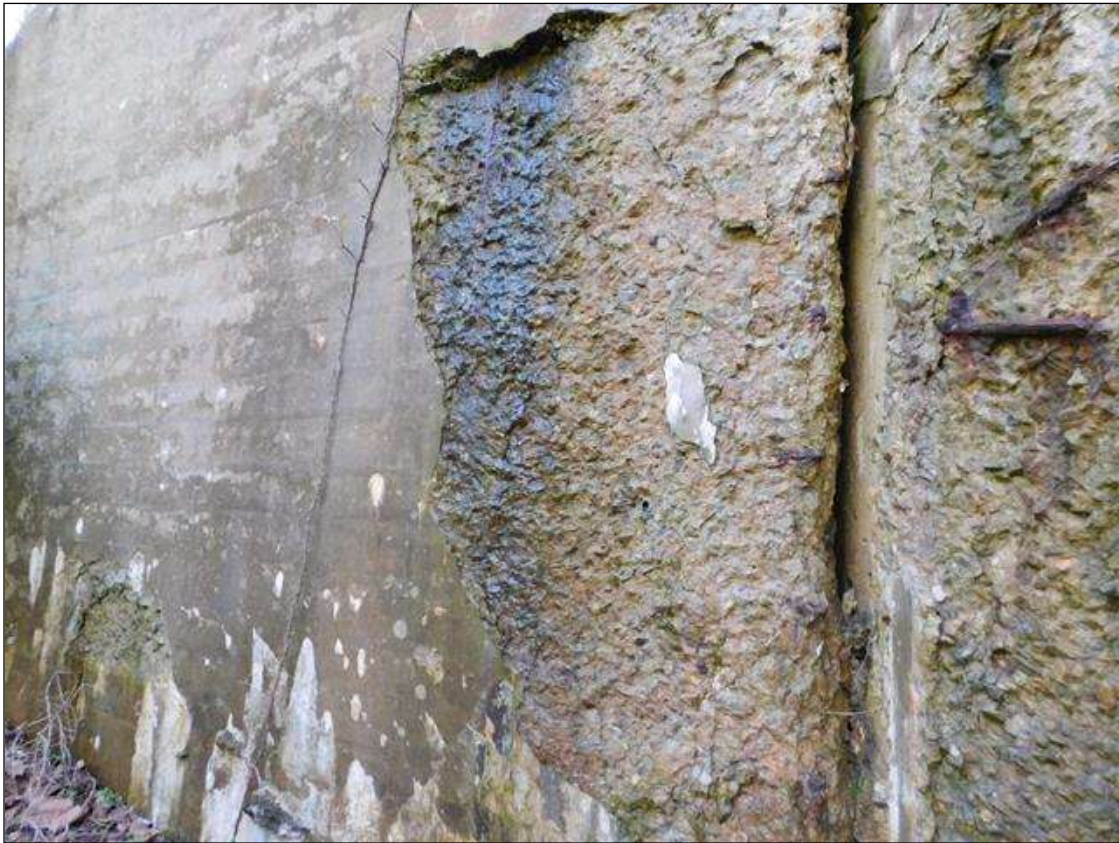
SOUTH EAST WINGWALL HEAVY SPALL & DELAMINATION WITH RE-BAR EXPOSED AREA IS 3' X 7' X 4" DEEP

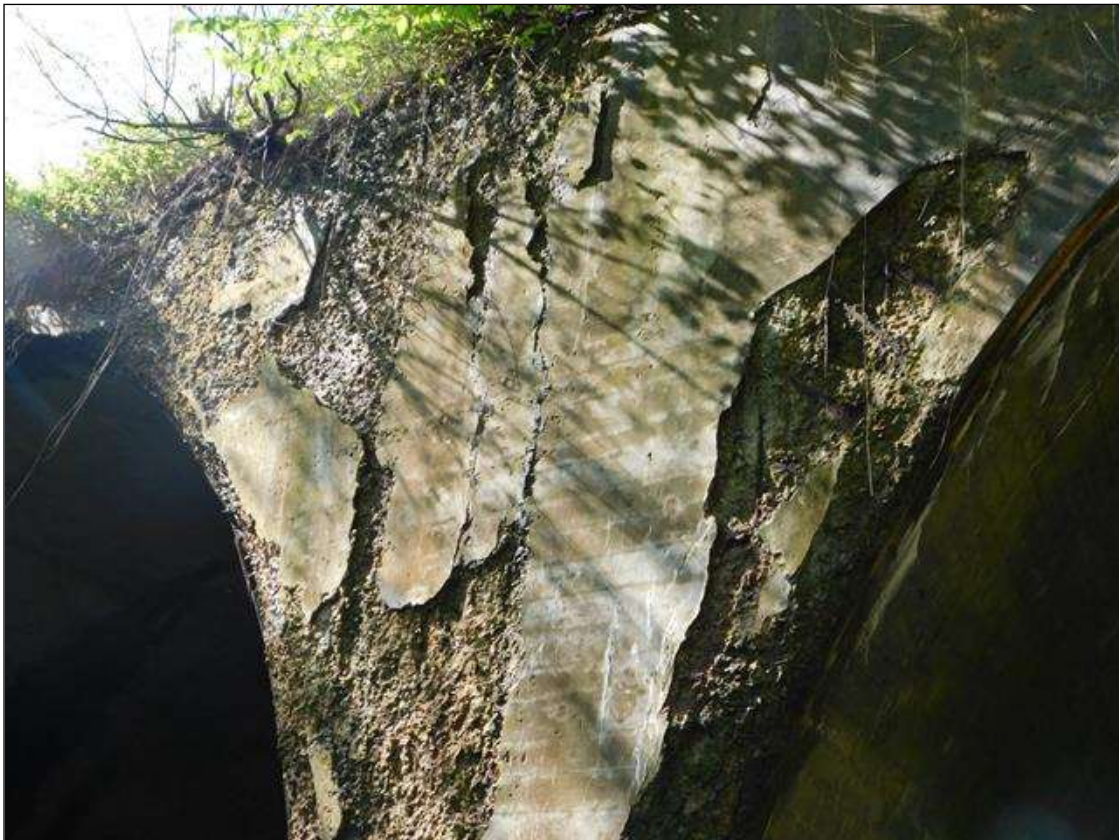
EAST HEADWALL HAS A LARGE AREA WITH HEAVY SPALL & DELAMINATION WITH RE-BAR & EFFLO EXPOSED. AREA IS 20' X 45' X 3" DEEP.

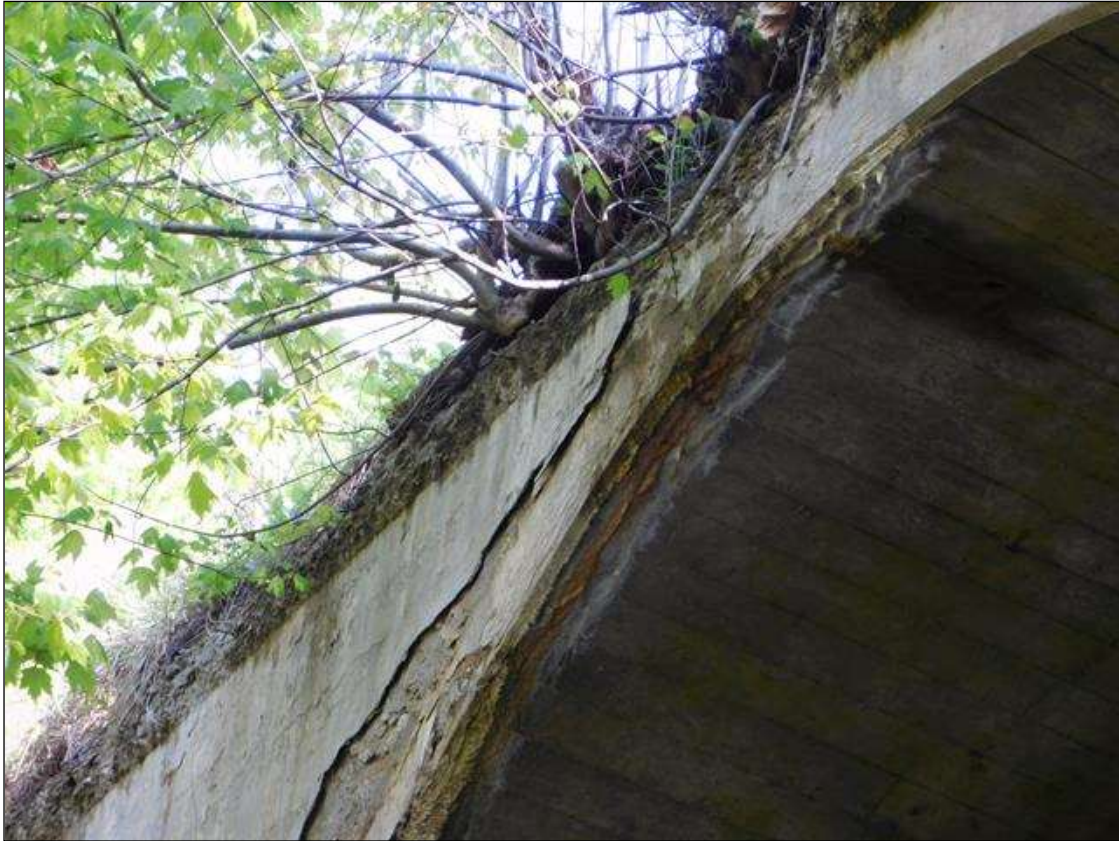
WEST HEADWALL HAS A LARGE AREA THAT IS CRACKED, SPALLED & DELAMINATED WITH RE-BAR & EFFLO EXPOSED. AREA IS 16' X 40' X 6" DEEP.
