NC DEPARTMENT OF TRANSPORTATION  
 DIVISION OF HIGHWAYS  
 STRUCTURE MANAGEMENT UNIT

ATTENTION: **PRIORITY ACTION REQUEST SUBMITTED  
 DATA CHANGES TO SKETCHES  
 NON NBIS STRUCTURE (NBIS = 18ft)**

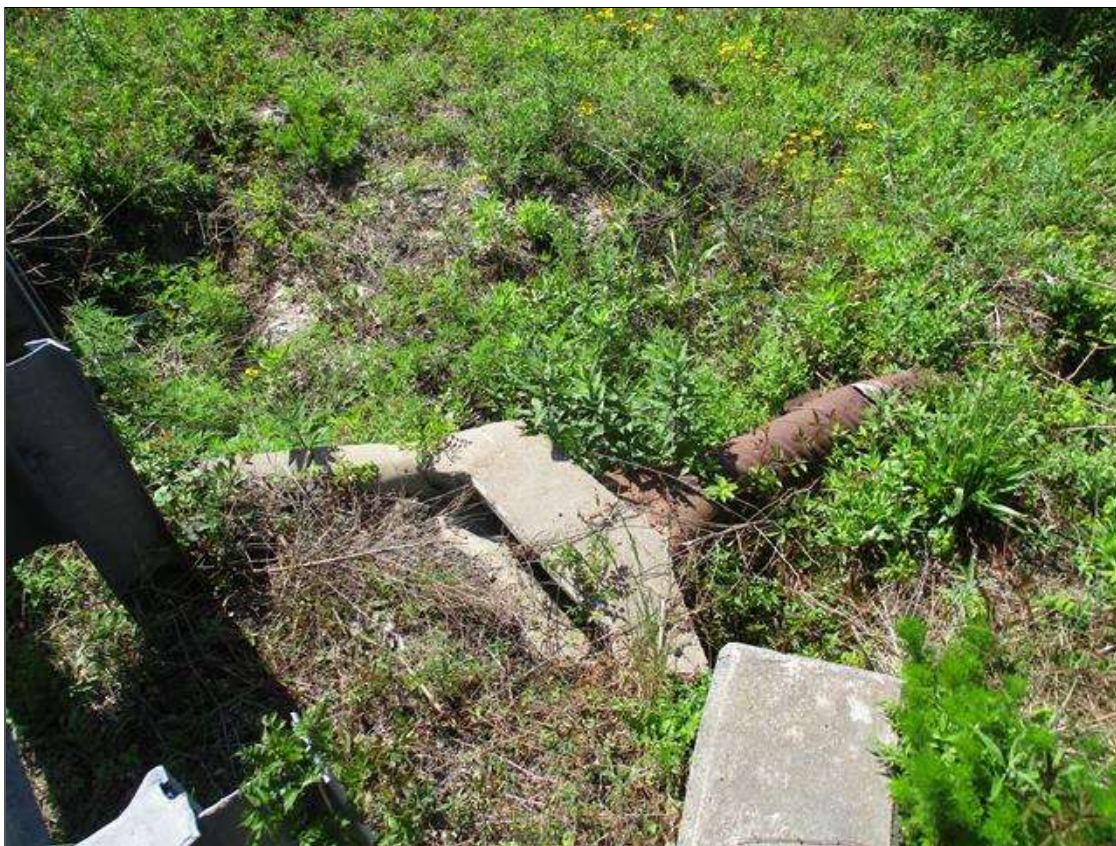
EROSION ( 8' LONG X 10' WIDE X 1.5' DEEP ) @ SOUTHWEST APPROACH CORNER DRAIN

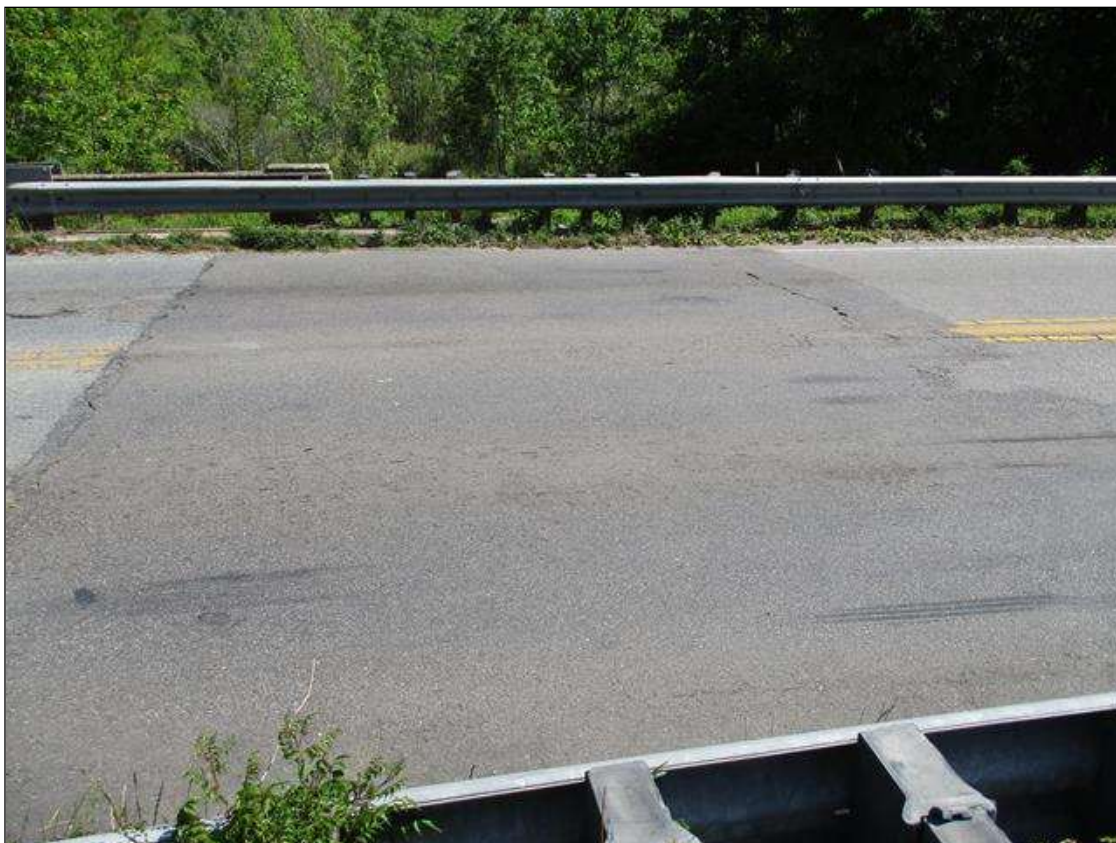
ASPHALT WEARING SURFACE SETTLED @ SOUTH END UP TO ( .5" TO 1" )

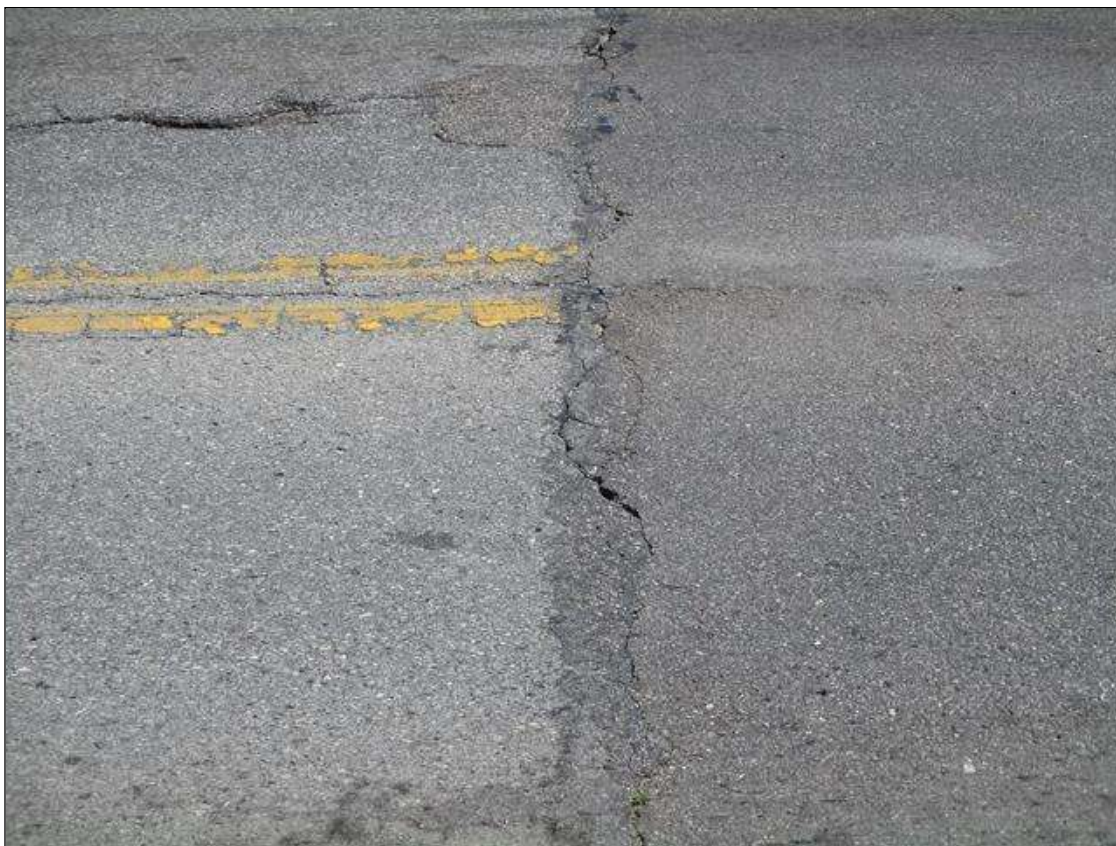
TRANSVERSE CRACKING IN ASPHALT WEARING SURFACE (.250" WIDE) OVER END BENT 1

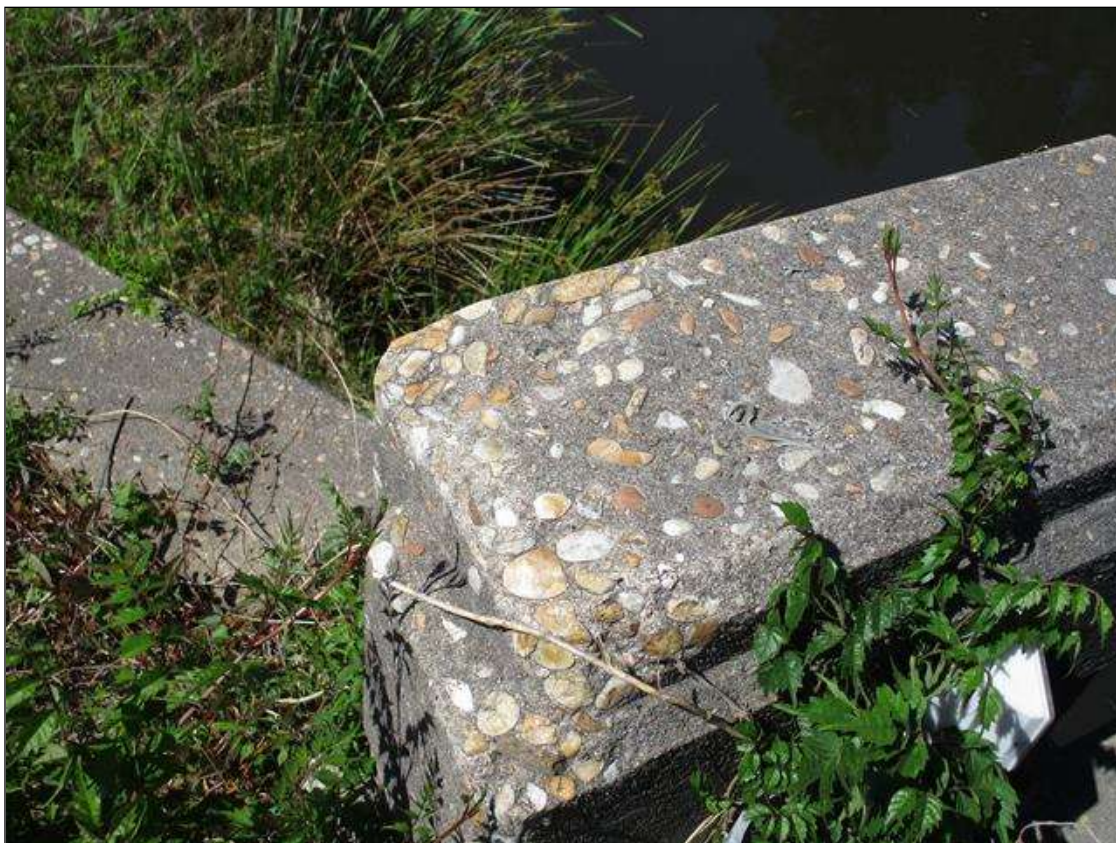
Span 1 Left Bridge Rail: SPALLED AREA (8" LONG X 5" WIDE X 1" HIGH) IN THE TOP PORTION OF THE SOUTHEAST RAIL POST

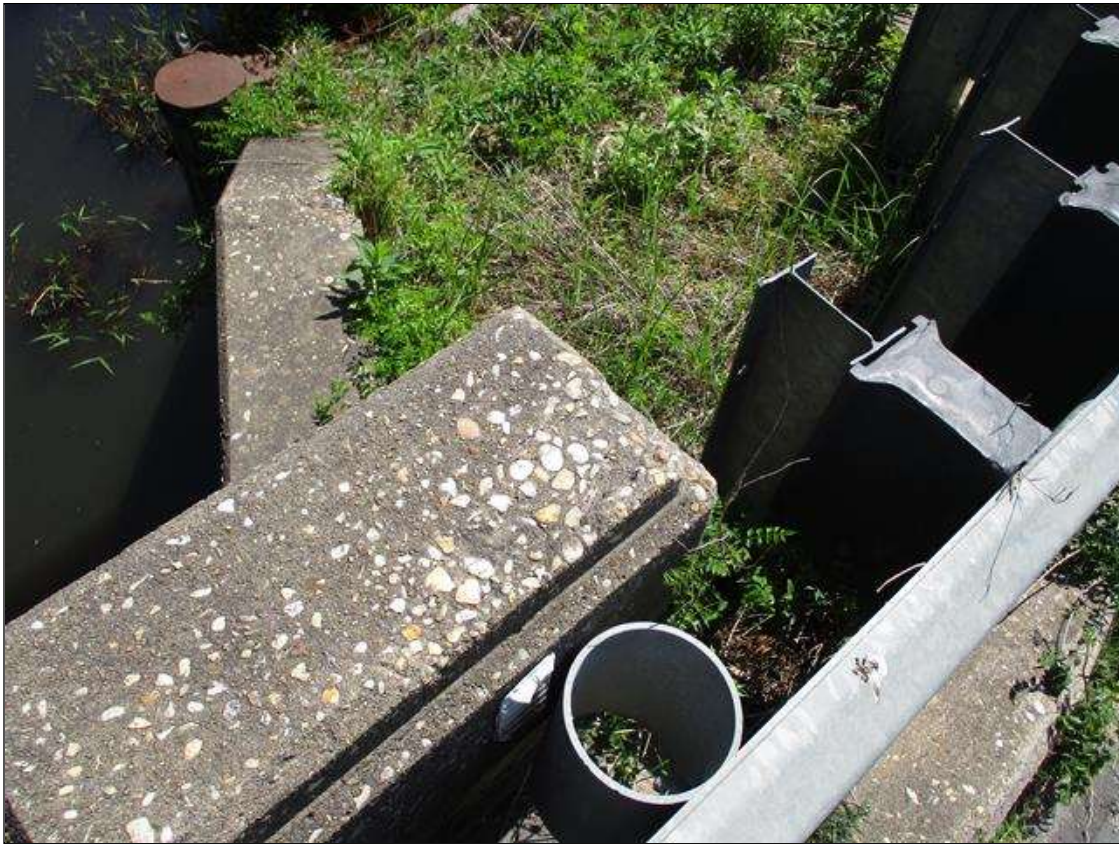
Span 1 Right Bridge Rail: SPALLED AREA (6" LONG X 3" WIDE X 1" HIGH) THE TOP PORTION OF THE SOUTHWEST RAIL POST.

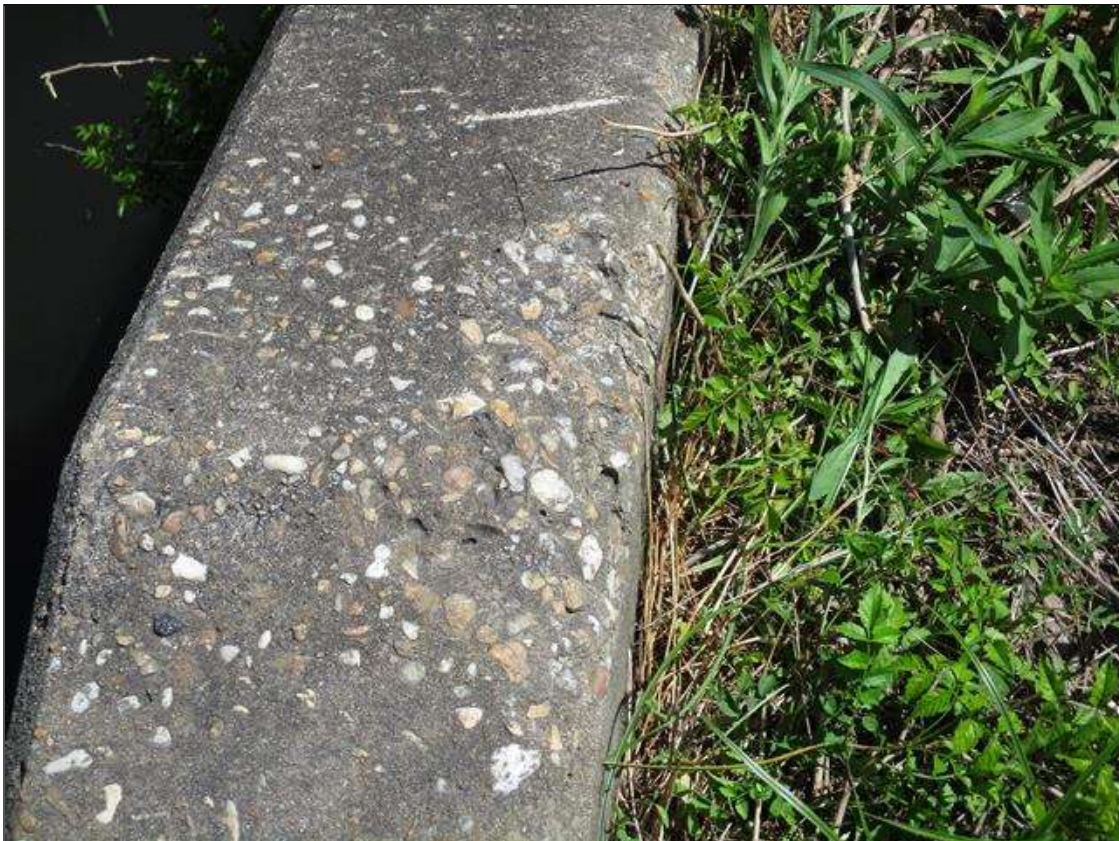
End Bent 1 Abutment: SPALLED AREA ( 1' LONG X 4" WIDE X 1" HIGH ) WITH NO EXPOSED REBAR AT EAST END TOP PORTION

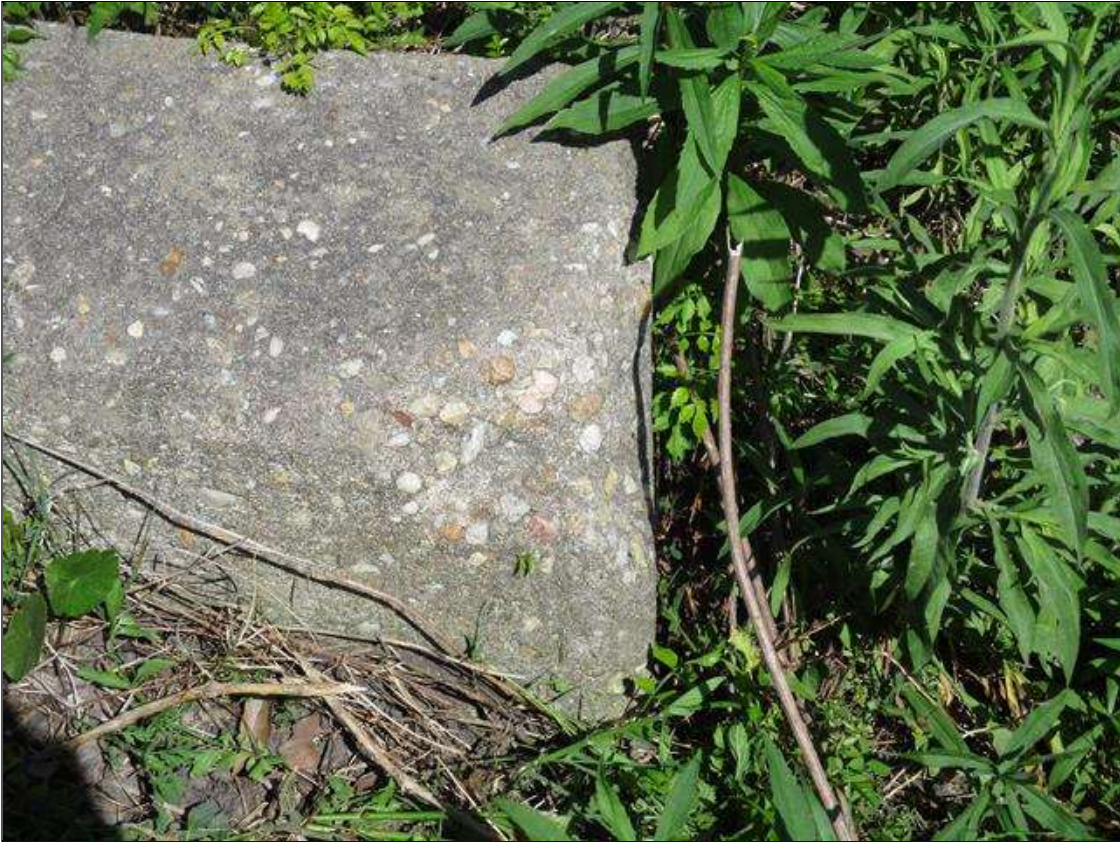
SPALL AREA ( 6" LONG X 4" WIDE X 4 " HIGH ) IN EAST CURB AT SOUTH END WITH NO EXPOSED REBAR

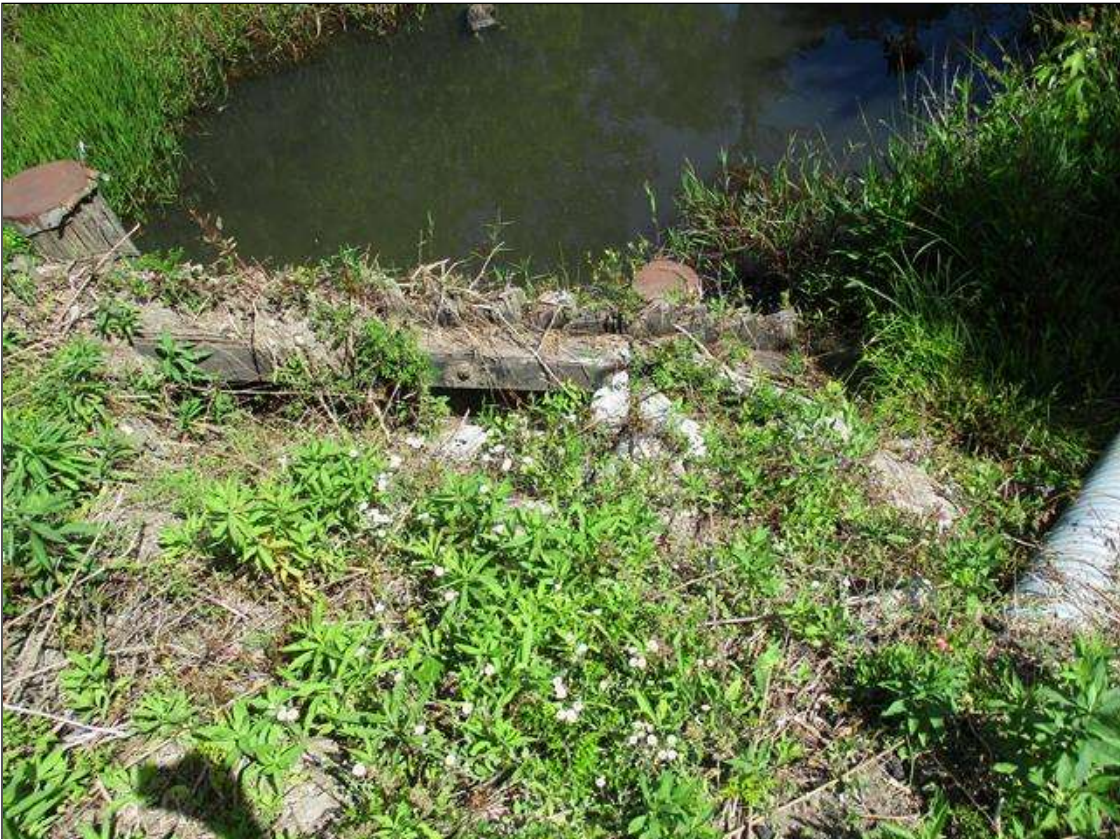
EROSION ( 8" LONG X 10' WIDE 1' TO 1.5' DEEP ) AT SOUTHEAST CORNER WING WALL

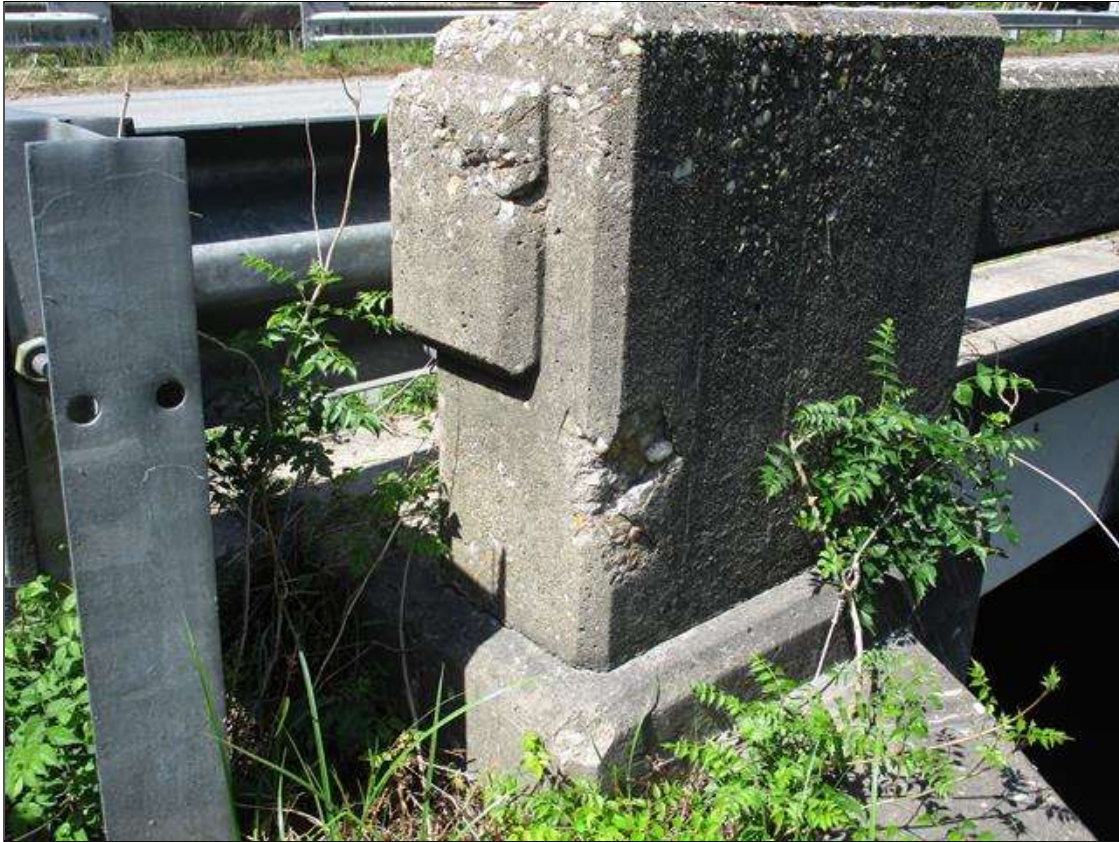
Span 1 Right Rail: SPALLED AREA ( 3" LONG X 5" WIDE X 5" HIGH ) NO EXPOSED REBAR IN POST # 1 EXTERIOR SIDE AT LOWER PORTION

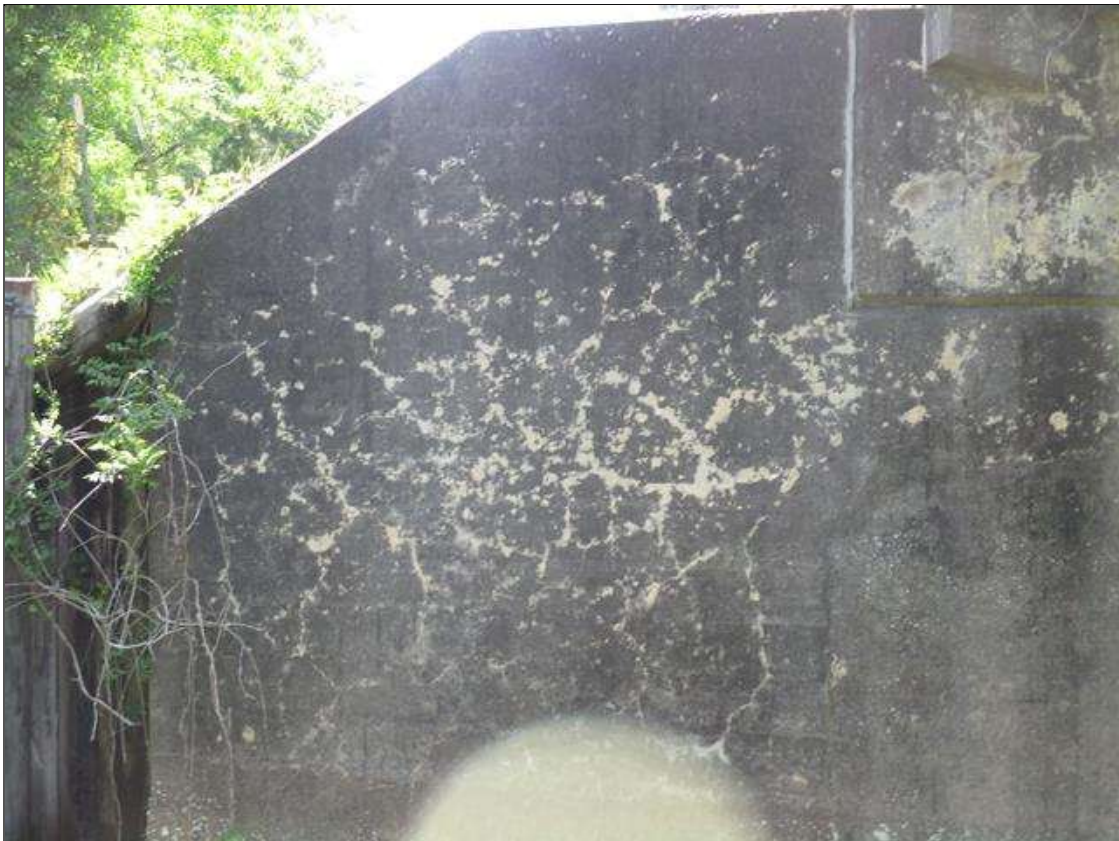
MAP CRACKING ( .020" WIDE ) WITH EFFLORESCENCE IN WEST AND EAST ENDS OF SOUTH AND NORTH ABUTMENTS ( EAST END OF SOUTH ABUTMENT SHOWN )

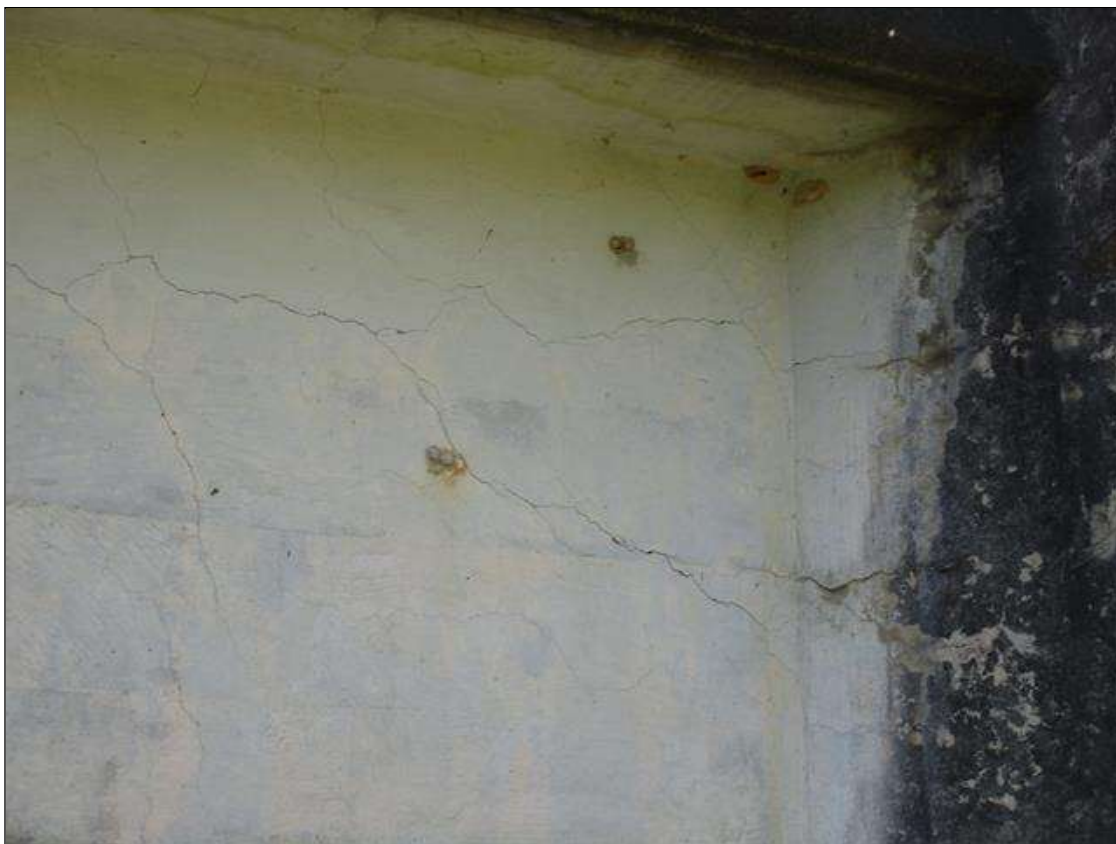
Span 1 Deck: MAP CRACKING ALONG EXTERIOR SIDES OF DECK UP TO .025" WIDE

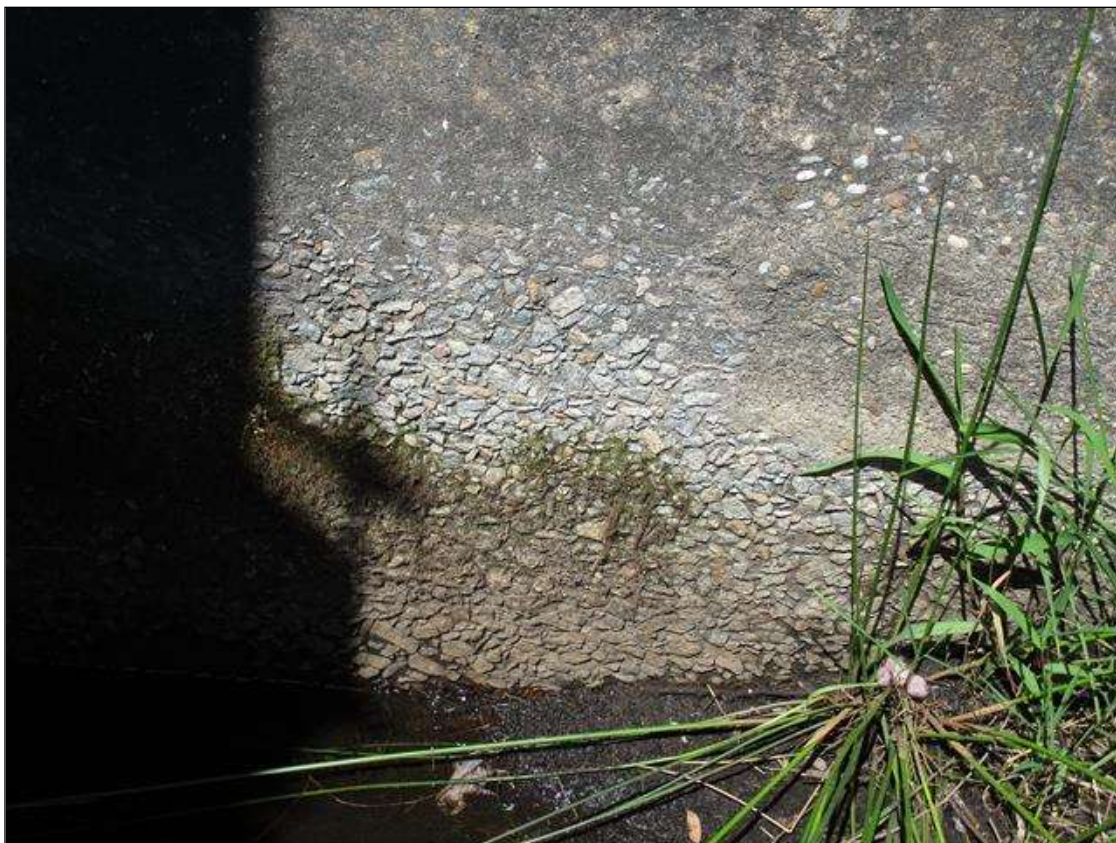
End Bent 1 Abutment: LOWER PORTION OF ABUTMENTS WORN WITH EXPOSED AGGREGATE

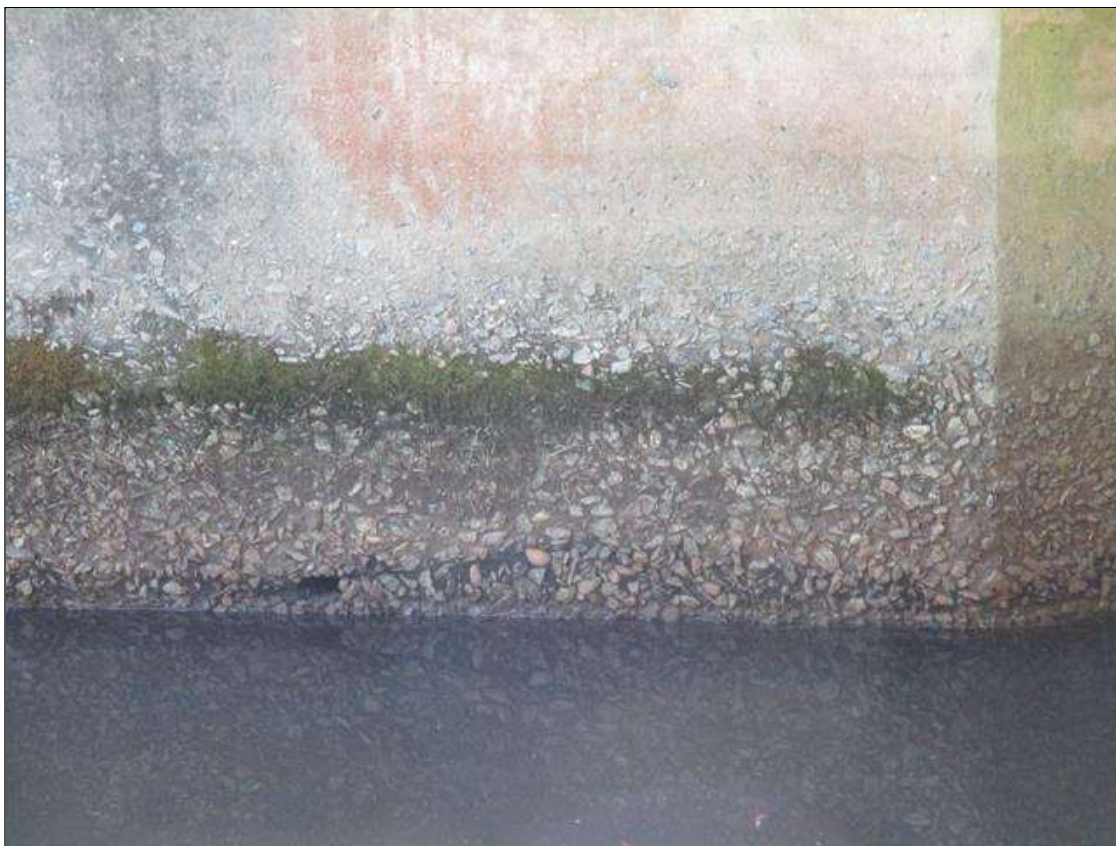
End Bent 2 Abutment: LOWER PORTION OF ABUTMENTS WORN WITH EXPOSED AGGREGATE

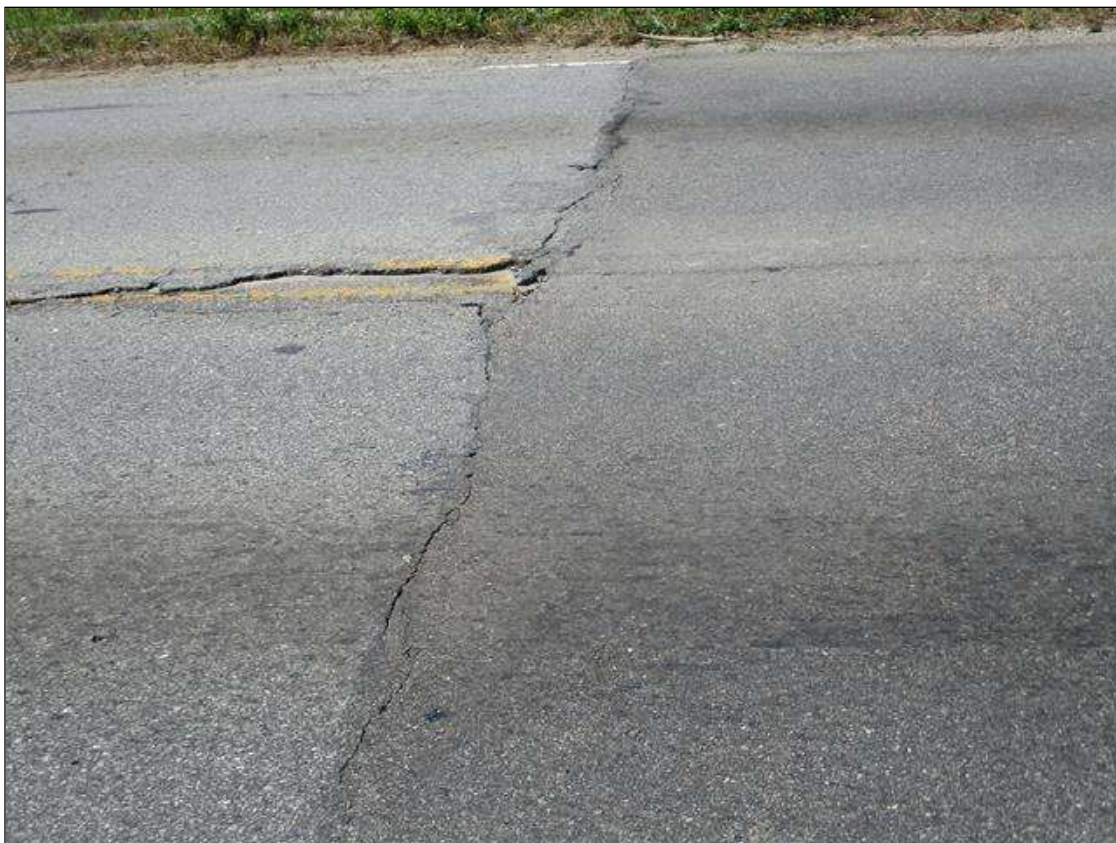
TRANSVERSE CRACKING IN ASPHALT WEARING SURFACE (.250" WIDE) OVER END BENT 2

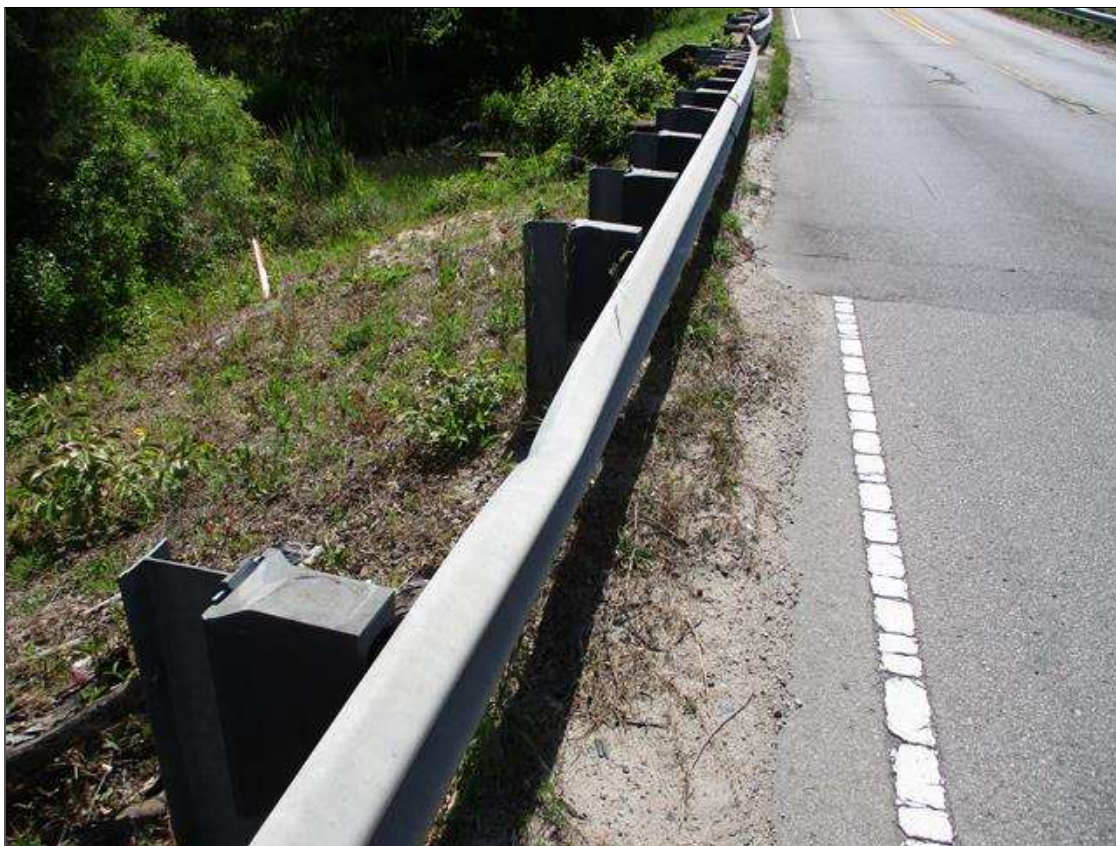
NORTHEAST APPROACH RAIL DAMAGED ( 25' LONG ) 75' FROM END BENT 2 ( PRIORITY ACTION REQUEST SUBMITTED )

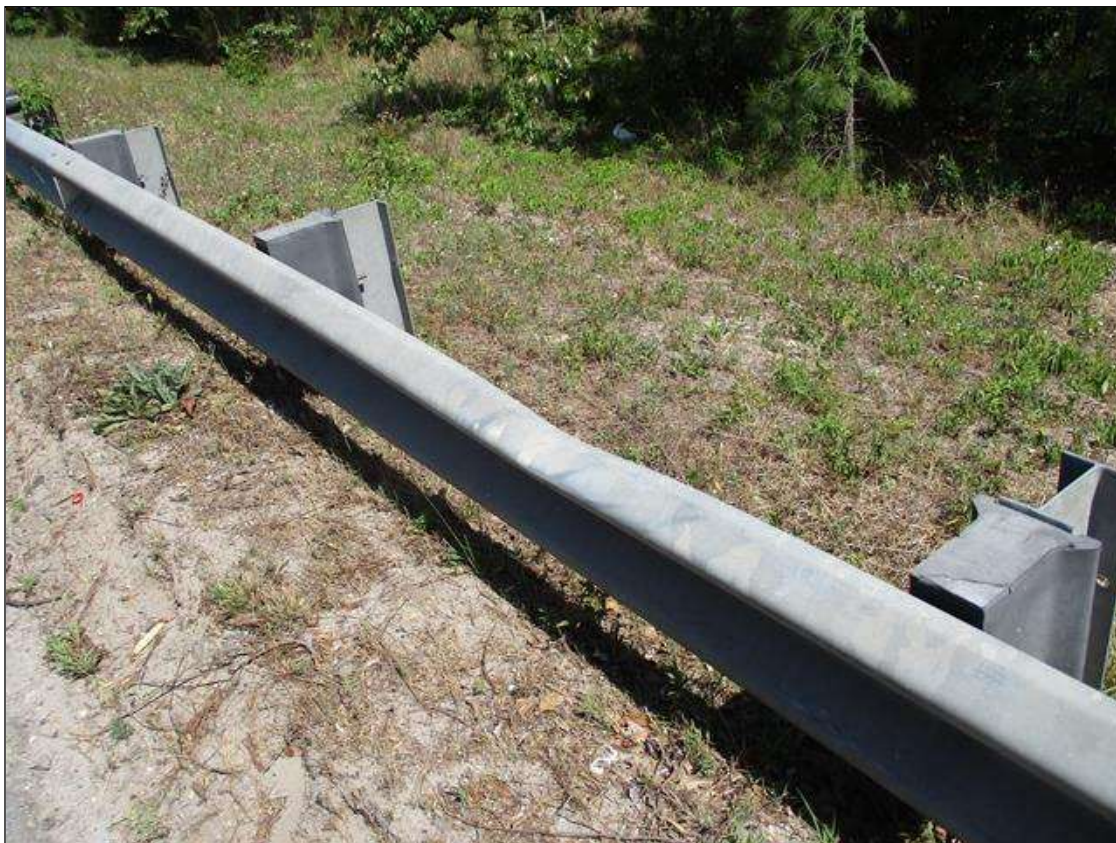
NORTHEAST APPROACH RAIL DAMAGED ( 25' LONG ) 40' FROM END BENT 2 ( PRIORITY ACTION REQUEST SUBMITTED )

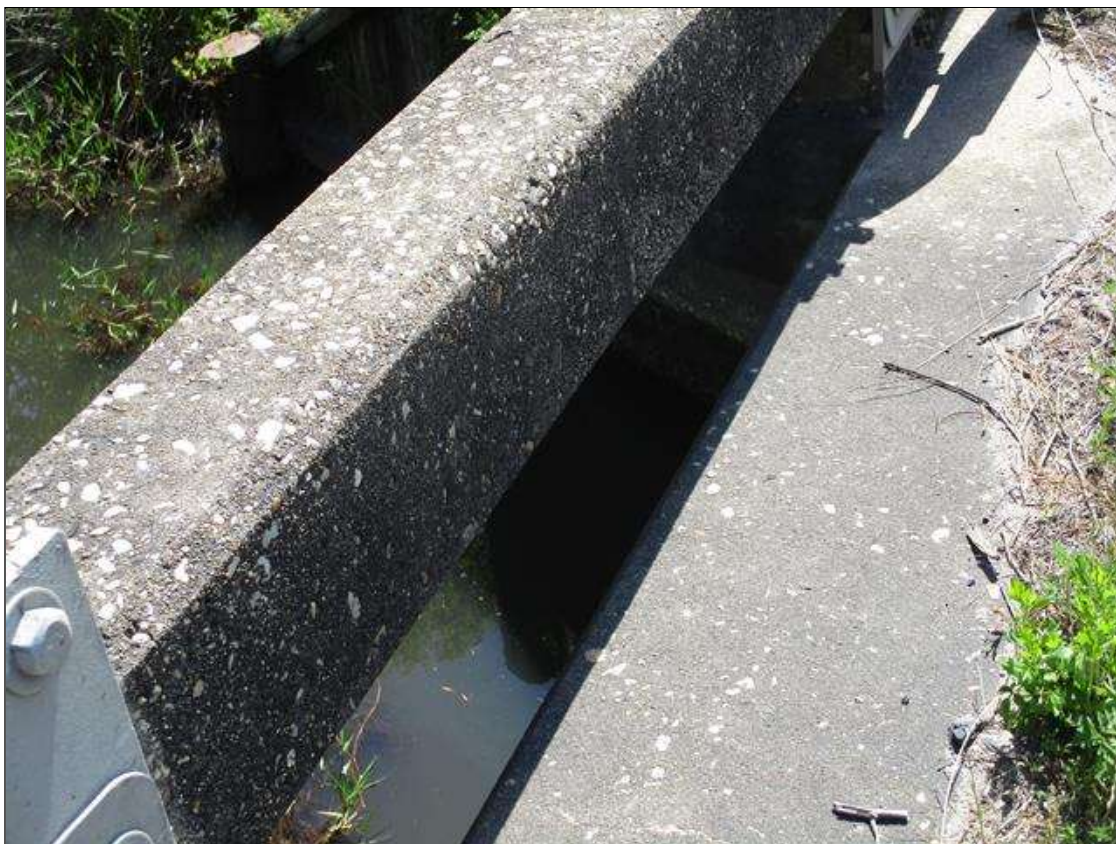
MODERATE WEAR WITH EXPOSED AGGREGATE THROUGHOUT WEST AND EAST RAILS

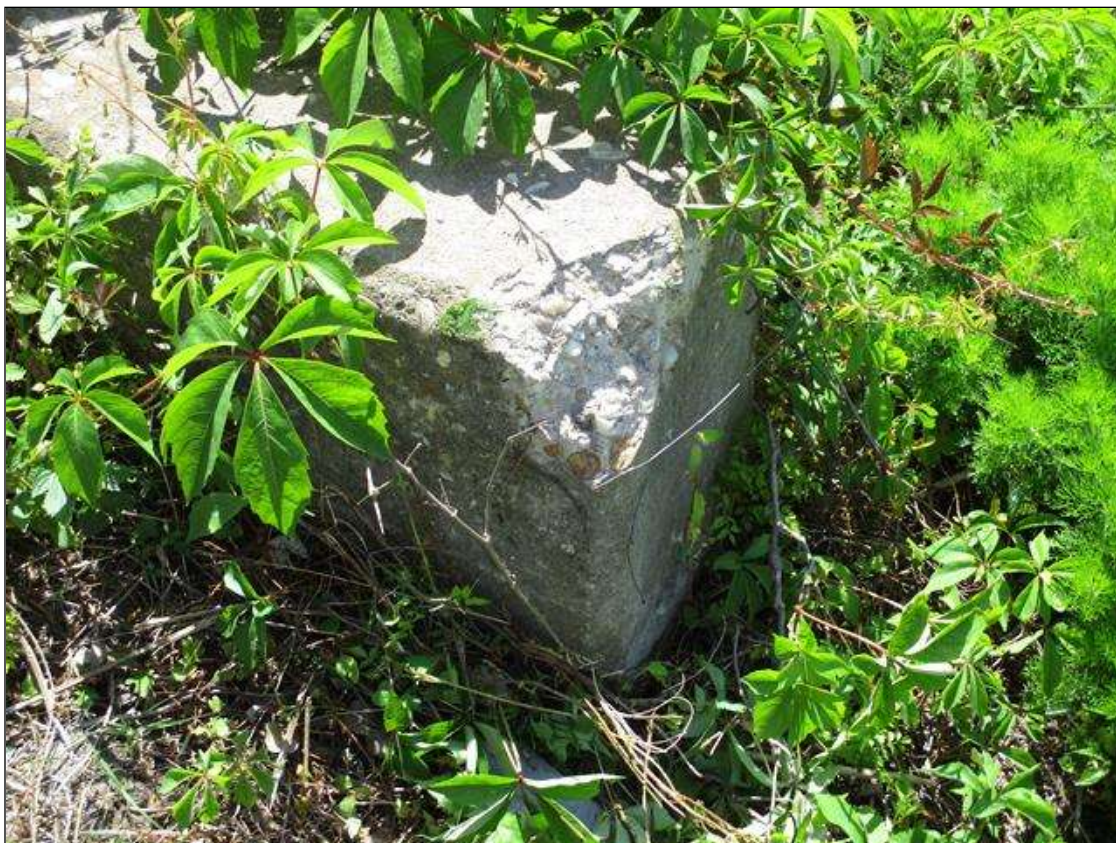
SPALL AREA ( 4" LONG X 6" WIDE X 4" HIGH ) IN WEST CURB AT NORTH END WITH NO EXPOSED REBAR

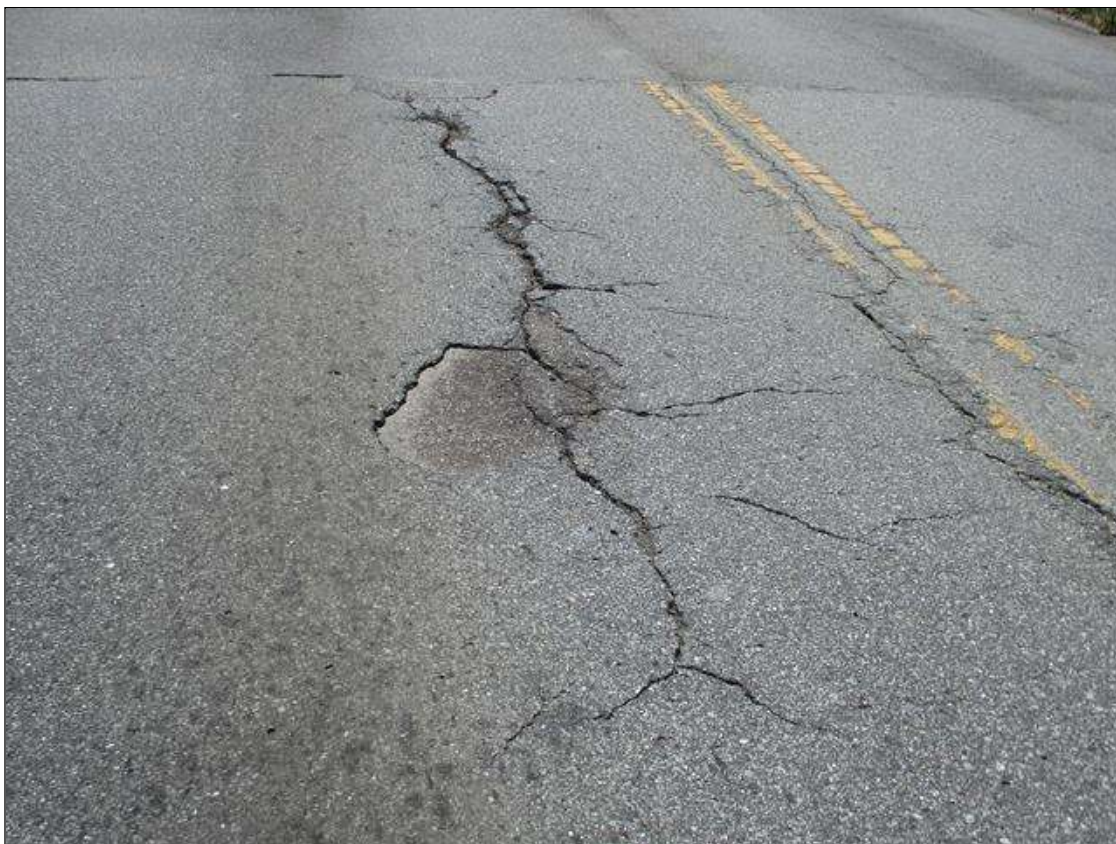
Wearing Surface: LONGIDUTINAL CRACKING (1" WIDE ) IN RIGHT LANE

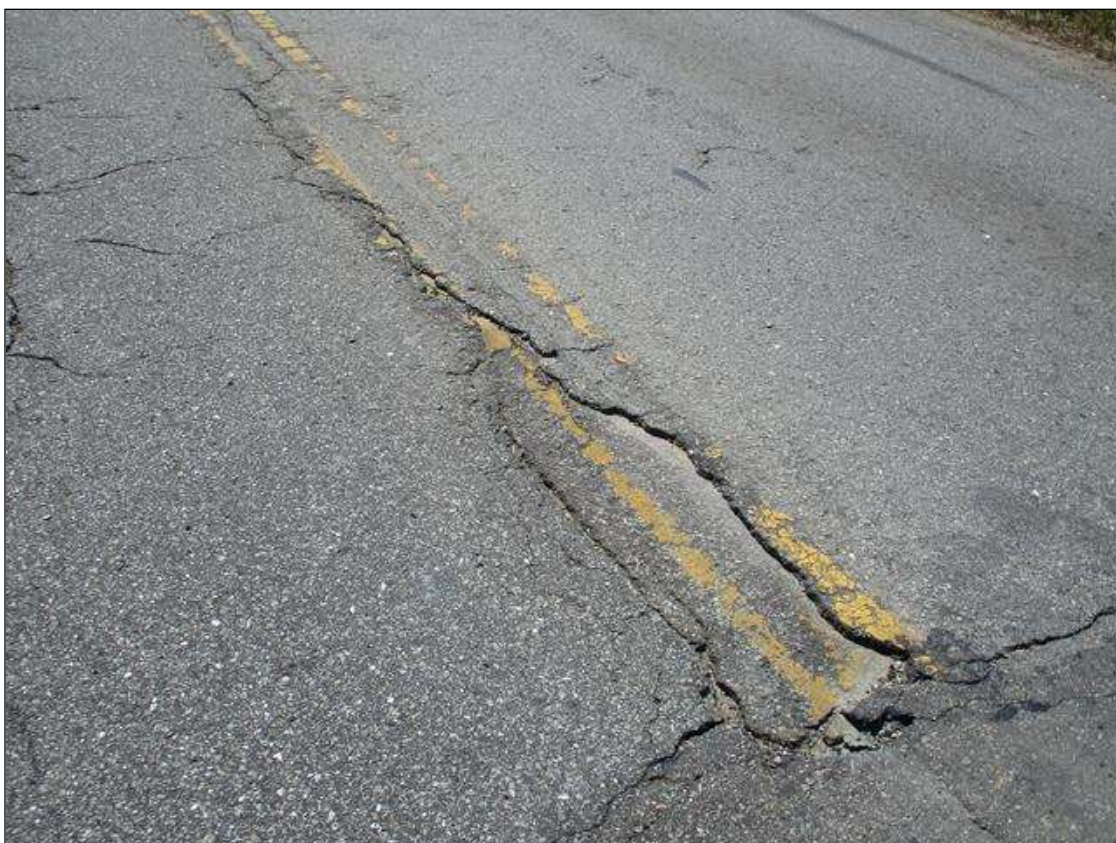
Span 1 Wearing Surface: SPALL (6' LONG X 1' WIDE X .5" DEEP ) AT CENTERLINE AT NORTH END.

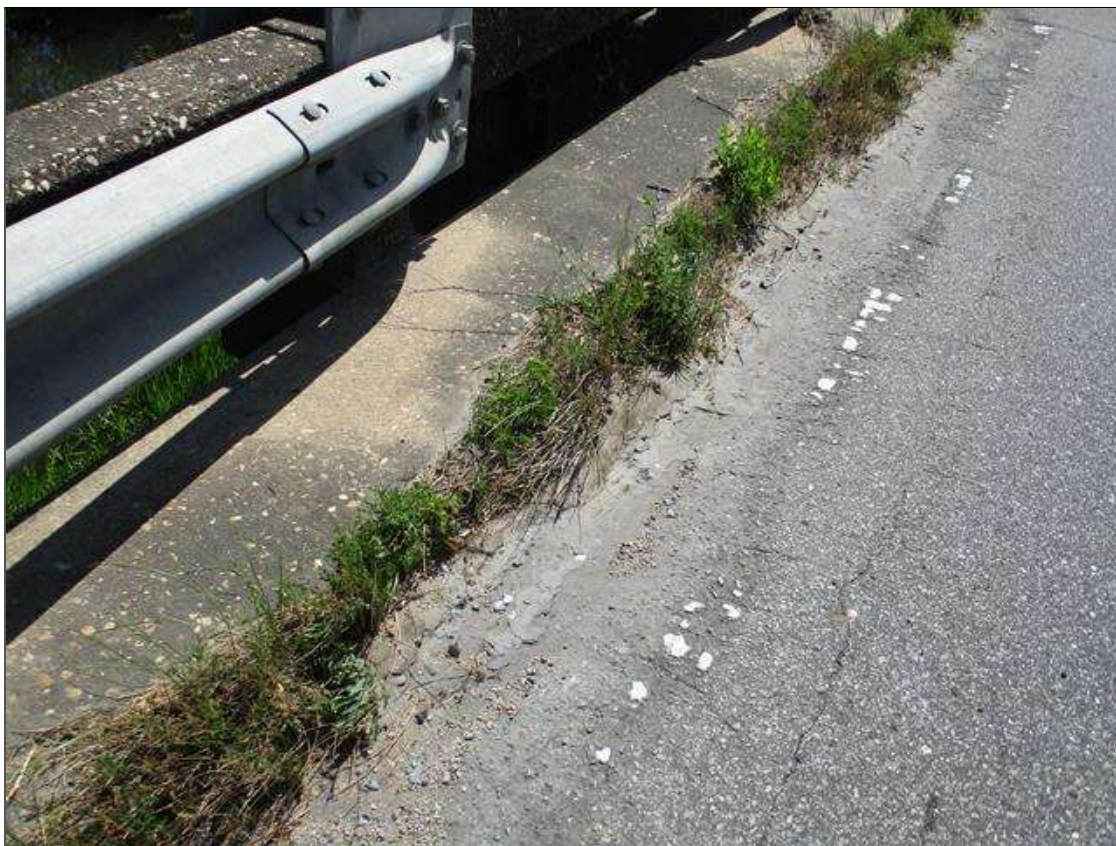
GROWTH AND DEBRIS ALONG WEST AND EAST RAILS BLOCKING DRAINS

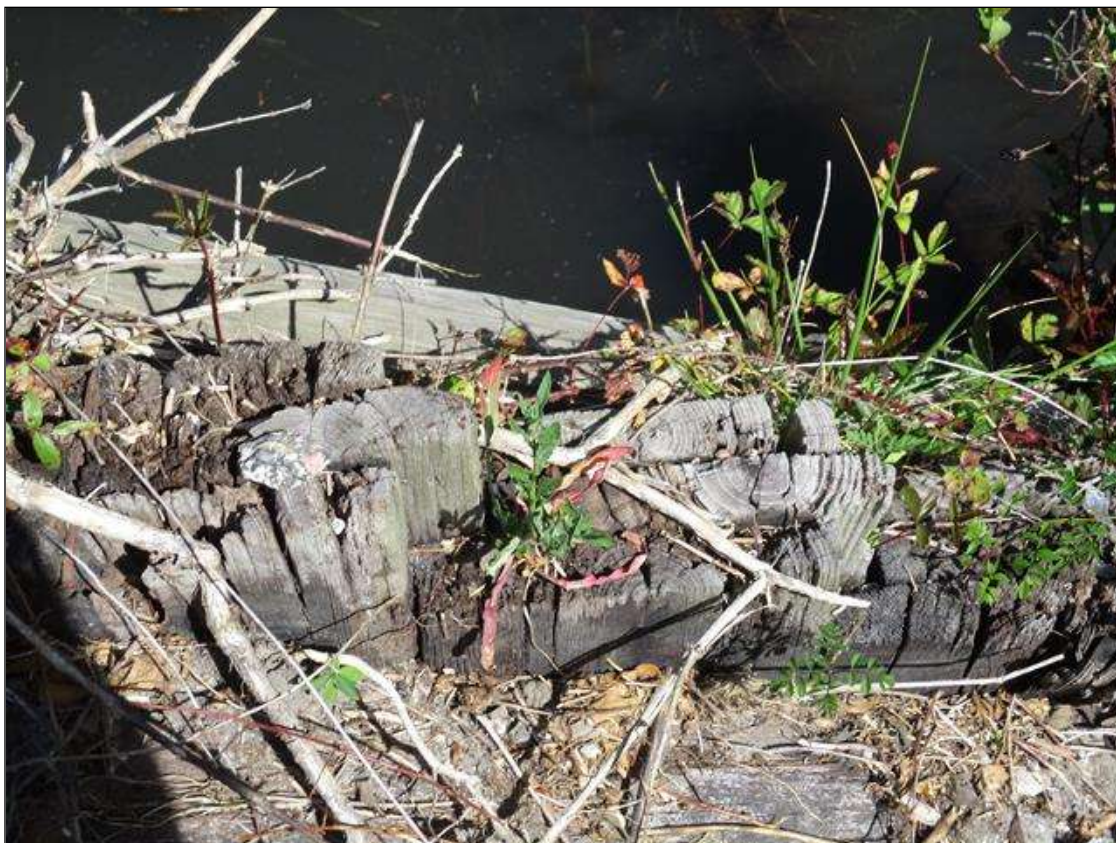
DECAY IN TOP PORTION OF VERTICAL WING WALL BOARDS ( 4" HIGH ) ( SOUTHEAST CORNER SHOWN )

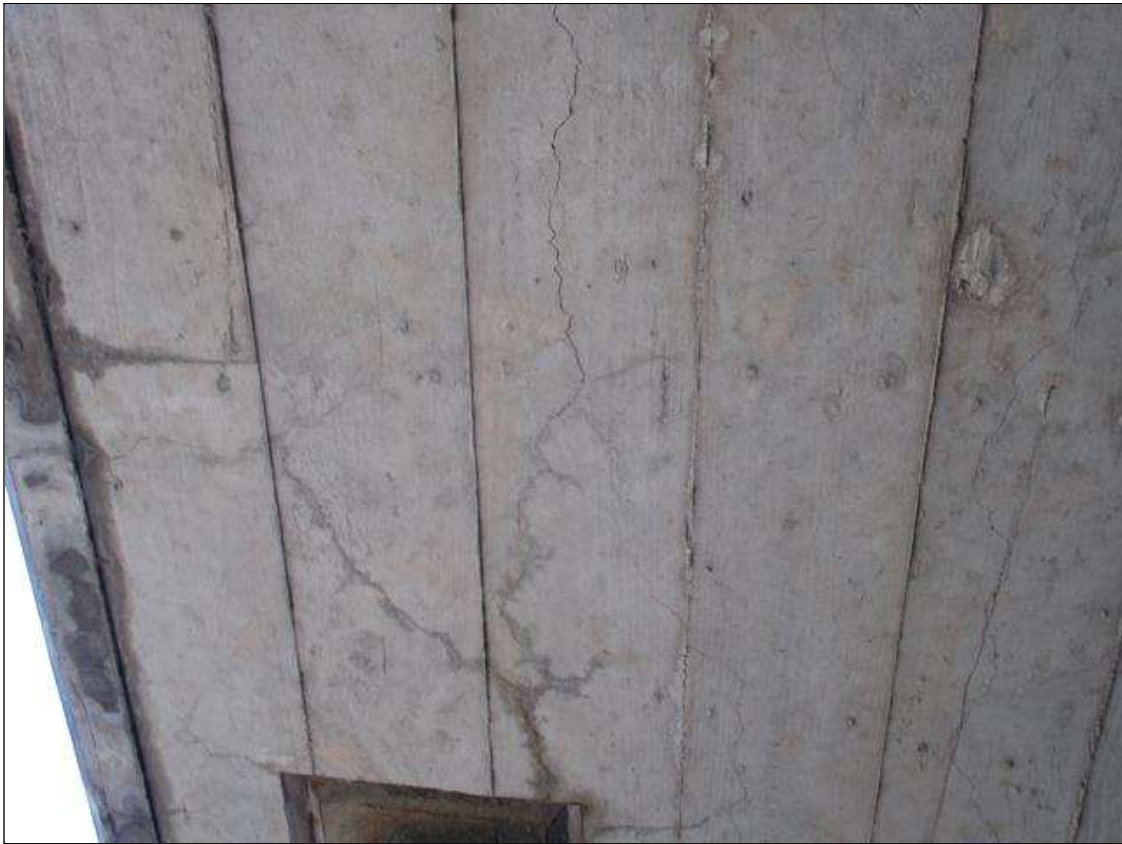
SCATTERED LONGITUDINAL CRACKING / MAP CRACKING ALONG UNDERSIDE OF DECK

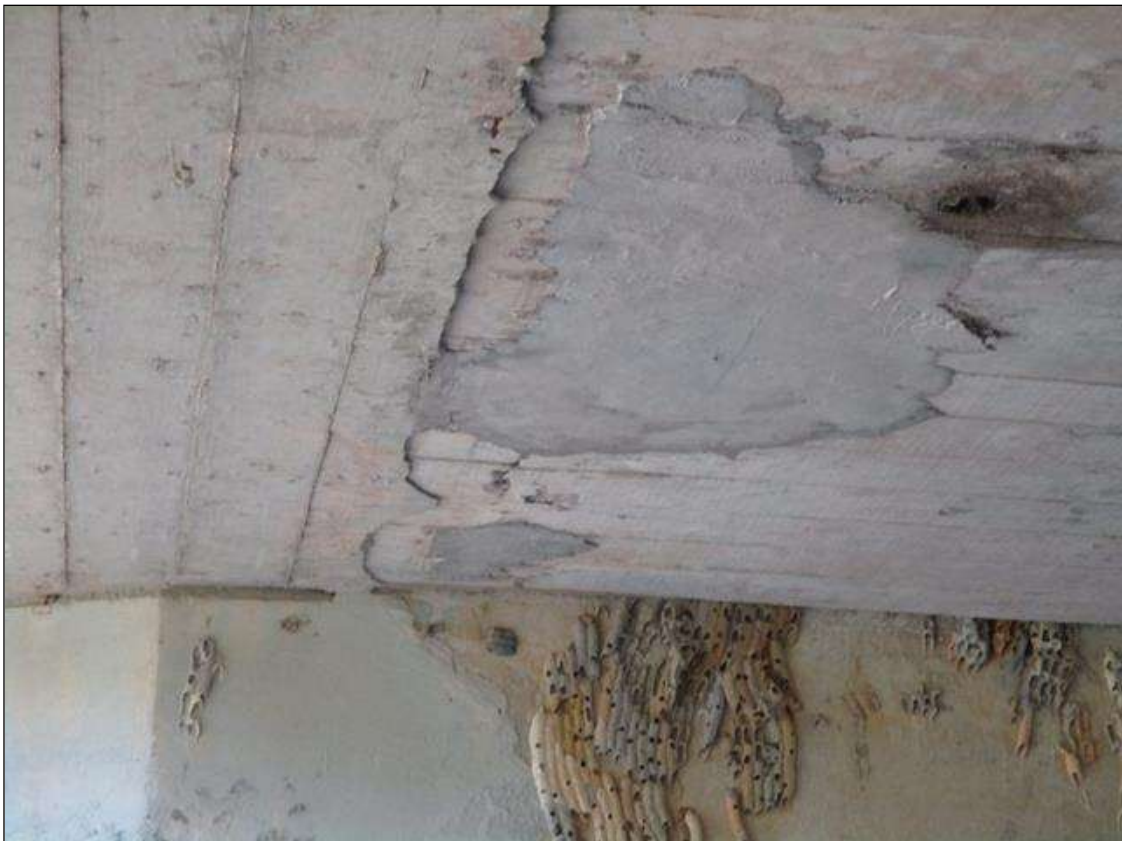
2 SOUND PATCHES TO UNDERSIDE AT NORTH END WEST SIDE
