NC DEPARTMENT OF TRANSPORTATION  
 DIVISION OF HIGHWAYS  
 STRUCTURE MANAGEMENT UNIT

ATTENTION: **PRIORITY ACTION REQUEST SUBMITTED  
 DATA CHANGES TO SKETCHES  
 NON NBIS STRUCTURE (NBIS = 18ft)**

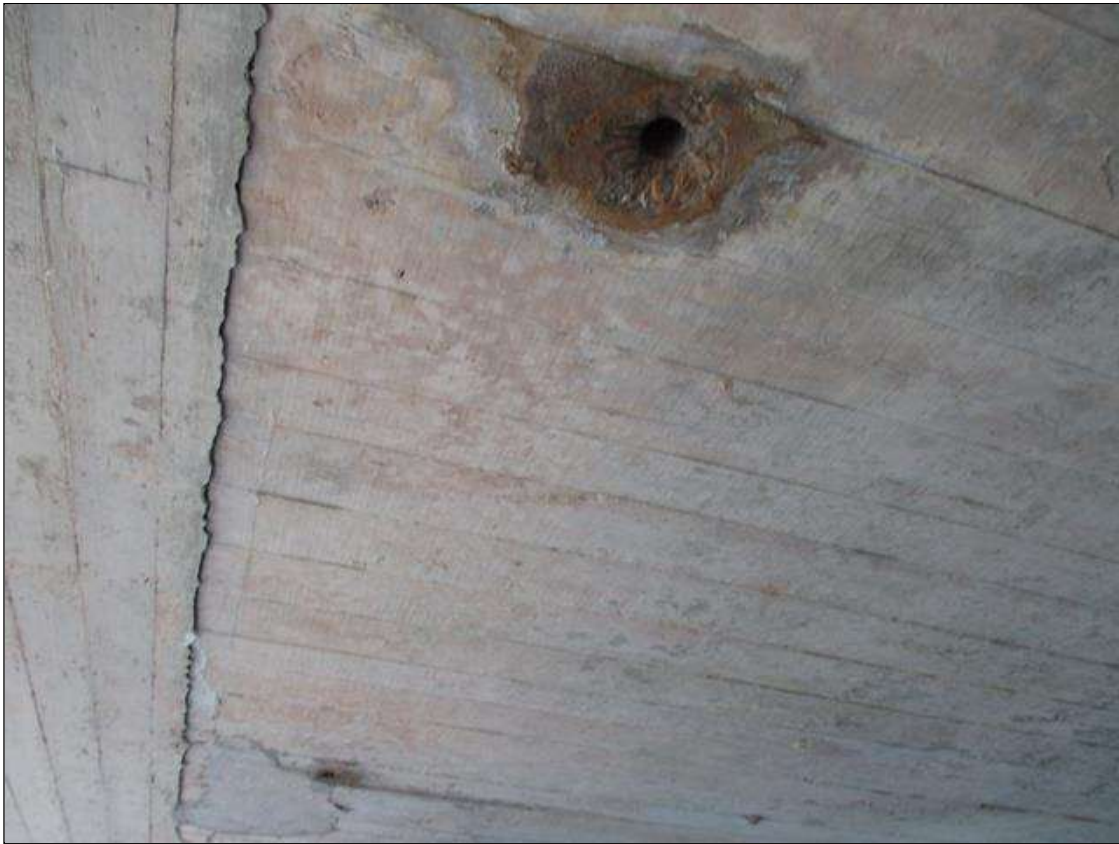
Span 1 Deck: 2 ( 2" ) SPALLED AREAS IN UNDERSIDE ( 6' FROM WEST SIDE )

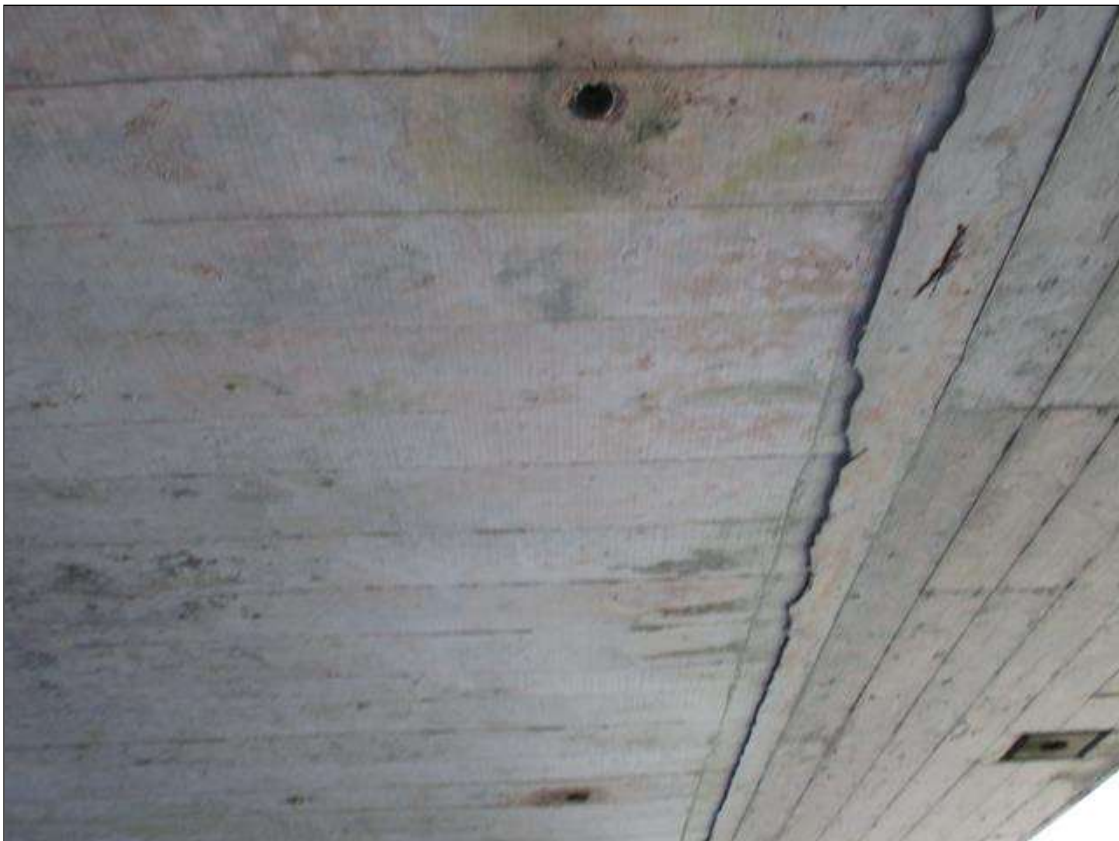
Span 1 Deck: 2 ( 2" ) SPALLED AREAS IN UNDERSIDE ( 6' FROM EAST SIDE )

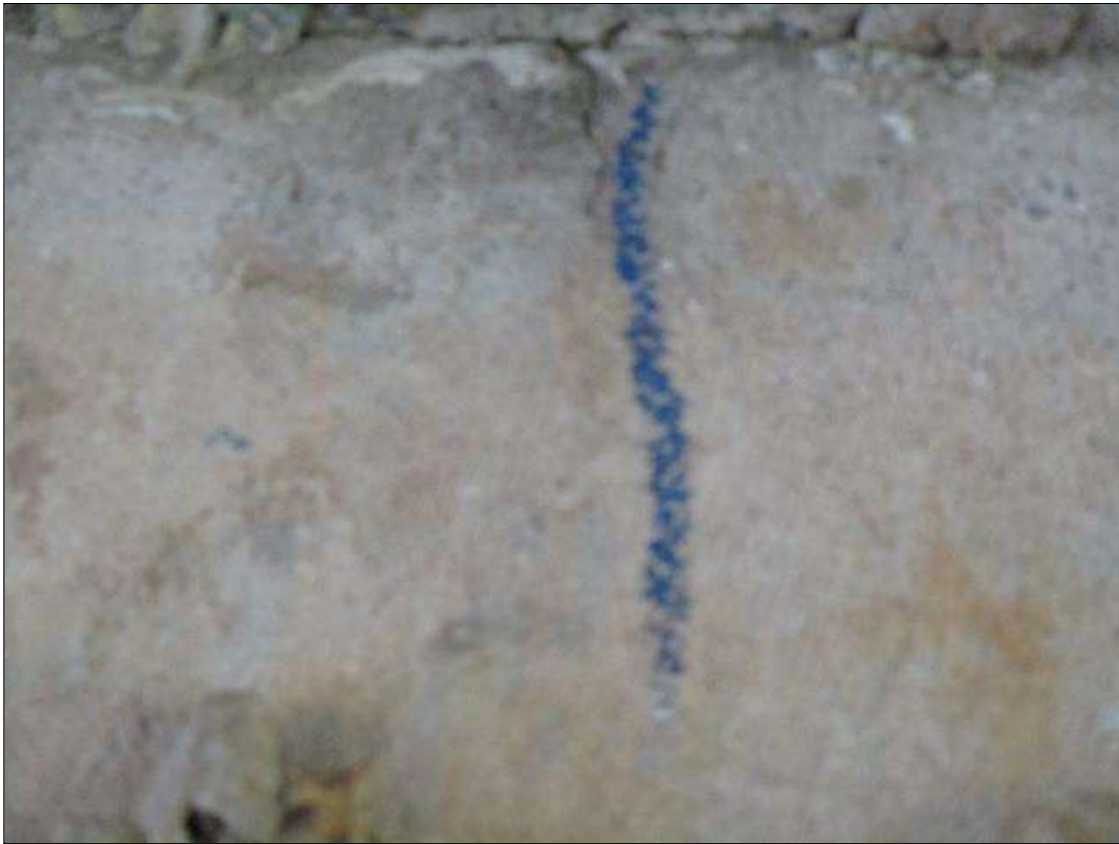
End Bent 2 Abutment: HAIRLINE VERTICAL CRACKING

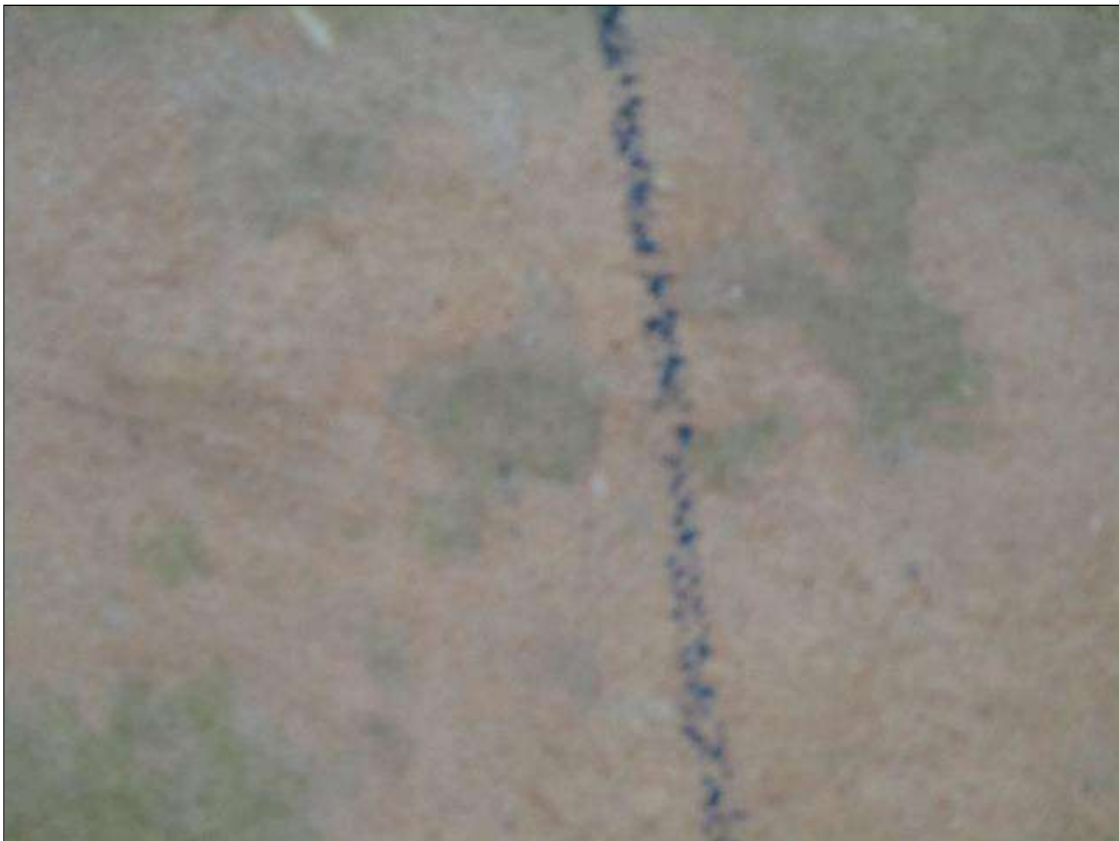
End Bent 1 Abutment: HAIRLINE VERTICAL CRACKING

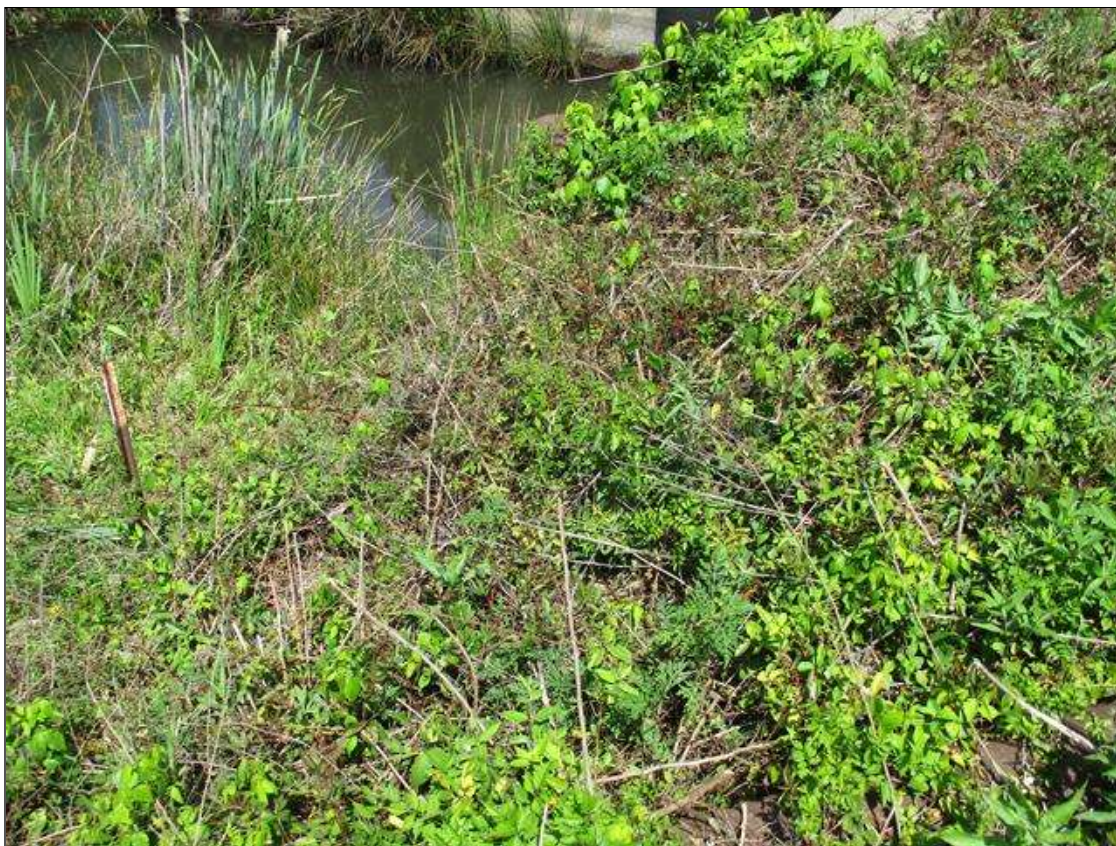
SINK HOLE ( 2' DIAMETER 1' DEEP ) BEHIND SOUTHWEST WING WALL

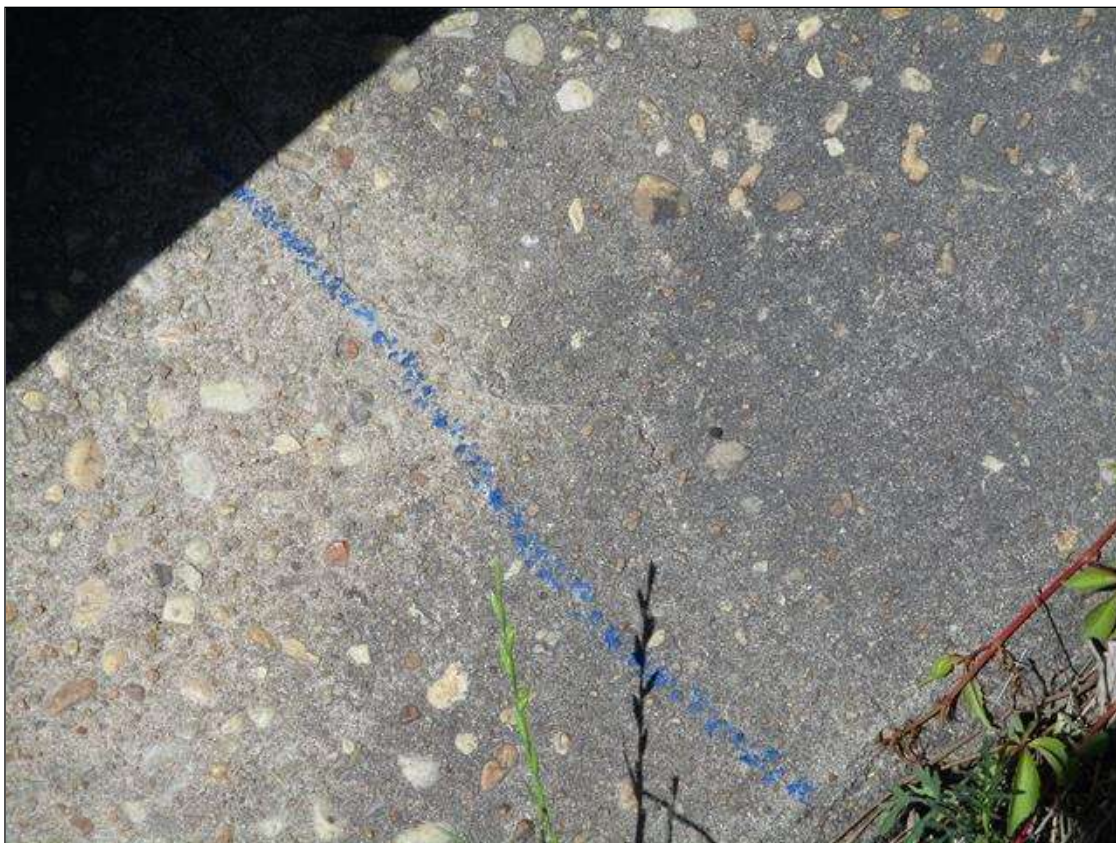
Span 1 Left Bridge Rail: SCATTERED CRACKING IN CURBS (.062" WIDE)

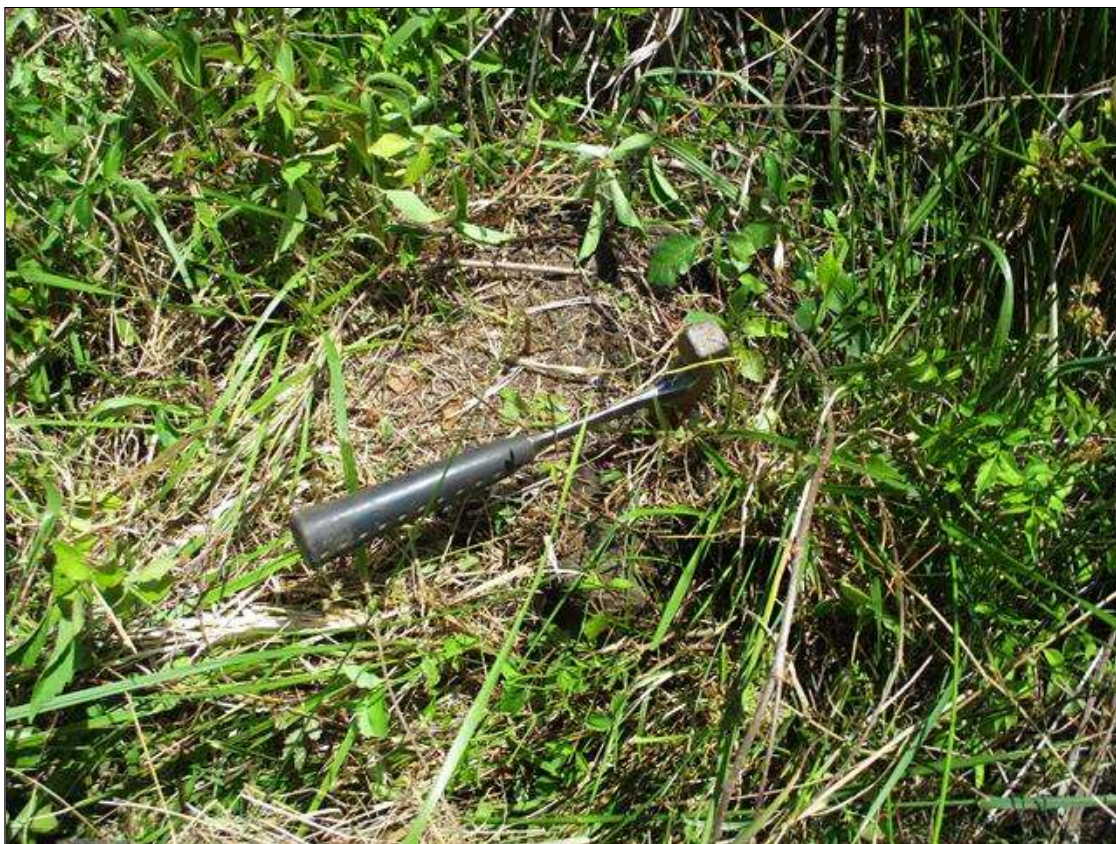
NORTHWEST WING PILE #2 DECAYED ( 1/2 CIRCUMFERENCE X 6" HIGH )

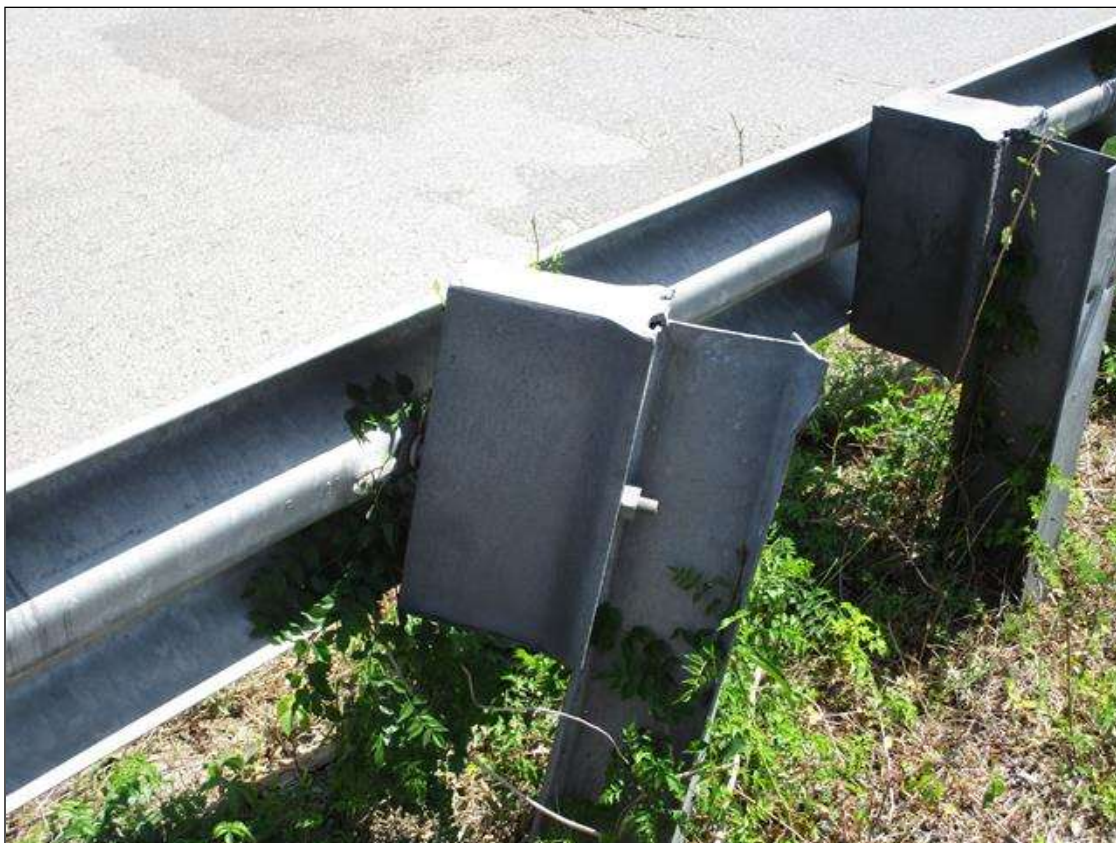
NORTHWEST GUARDRAIL POST DAMAGED ( 25' FROM END BENT 2 ) ( PRIORITY ACTION REQUEST SUBMITTED )

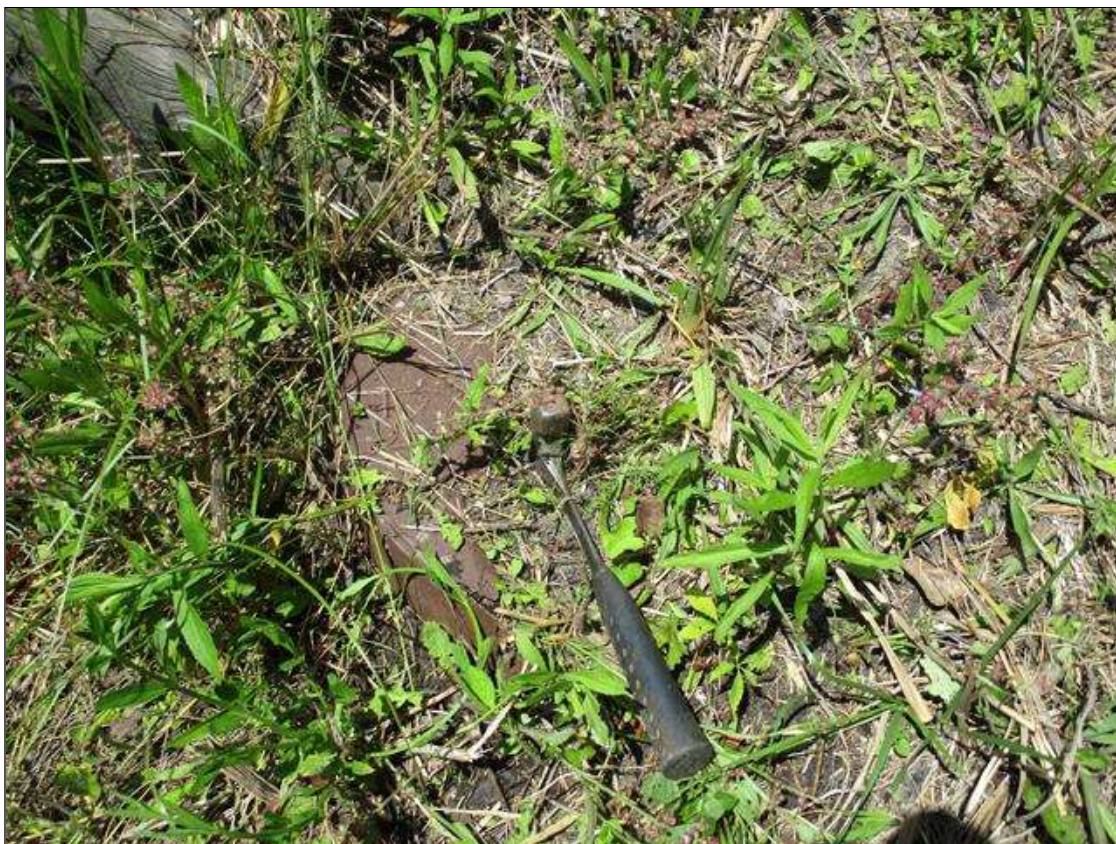
NORTHEAST WING PILE #2 DECAYED ( 1/2 CIRCUMFERENCE X 6" HIGH )

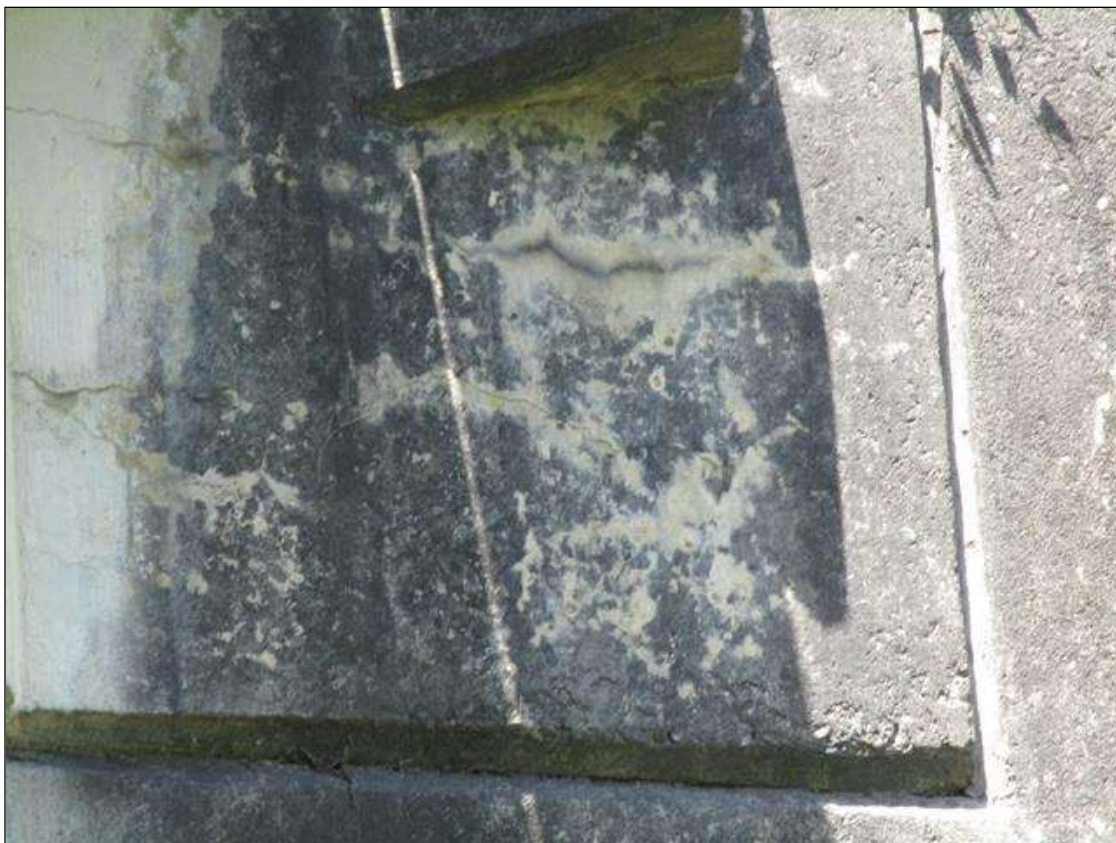
HORIZONTAL CRACKING (HAIRLINE TO 1/32IN) AND MAP CRACKING AT WEST AND EAST ENDS OF SOUTH AND NORTH ABUTMENTS ( NORTH ABUTMENT EAST END SHOWN )

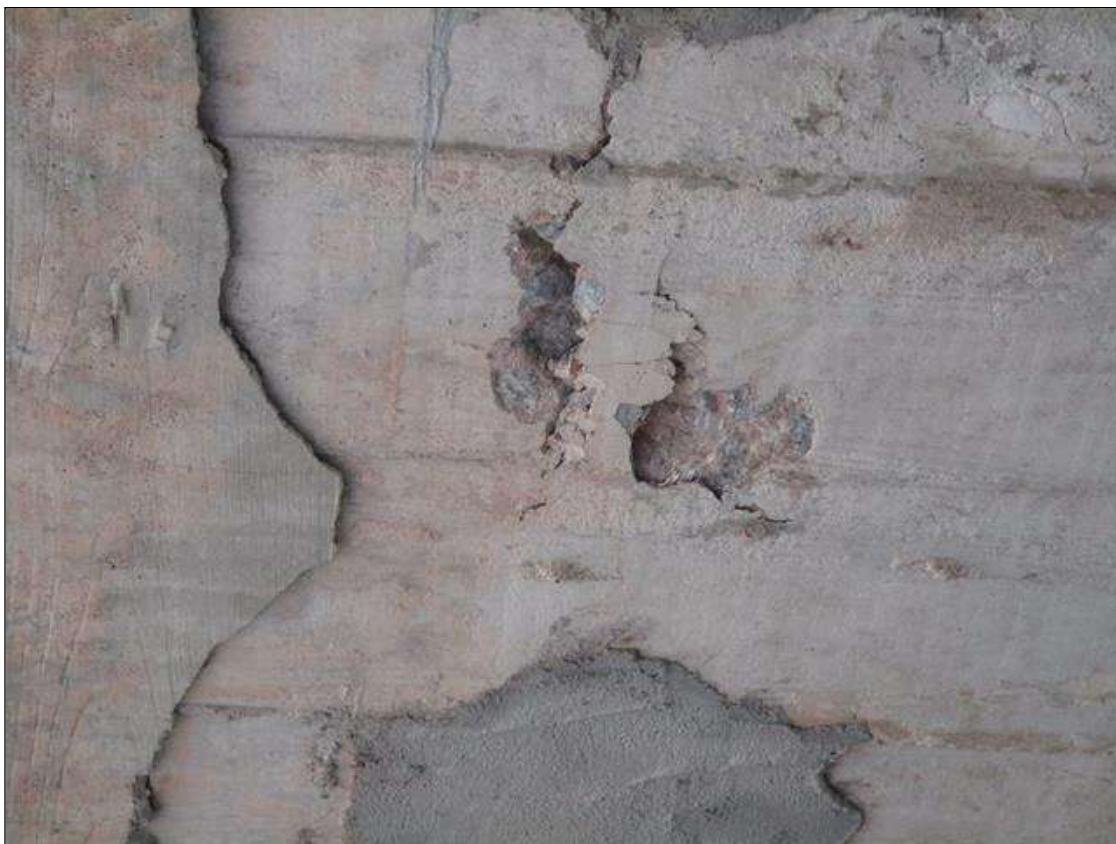
Span 1 Deck: SHALLOW SPALL/DELAMINATION ( 6" DIAMETER ) TO UNDERSIDE AT NORTH END WEST SIDE  
BETWEEN SOUND PATCHES
