NC DEPARTMENT OF TRANSPORTATION  
 DIVISION OF HIGHWAYS  
 STRUCTURE MANAGEMENT UNIT

ATTENTION: DATA CHANGES

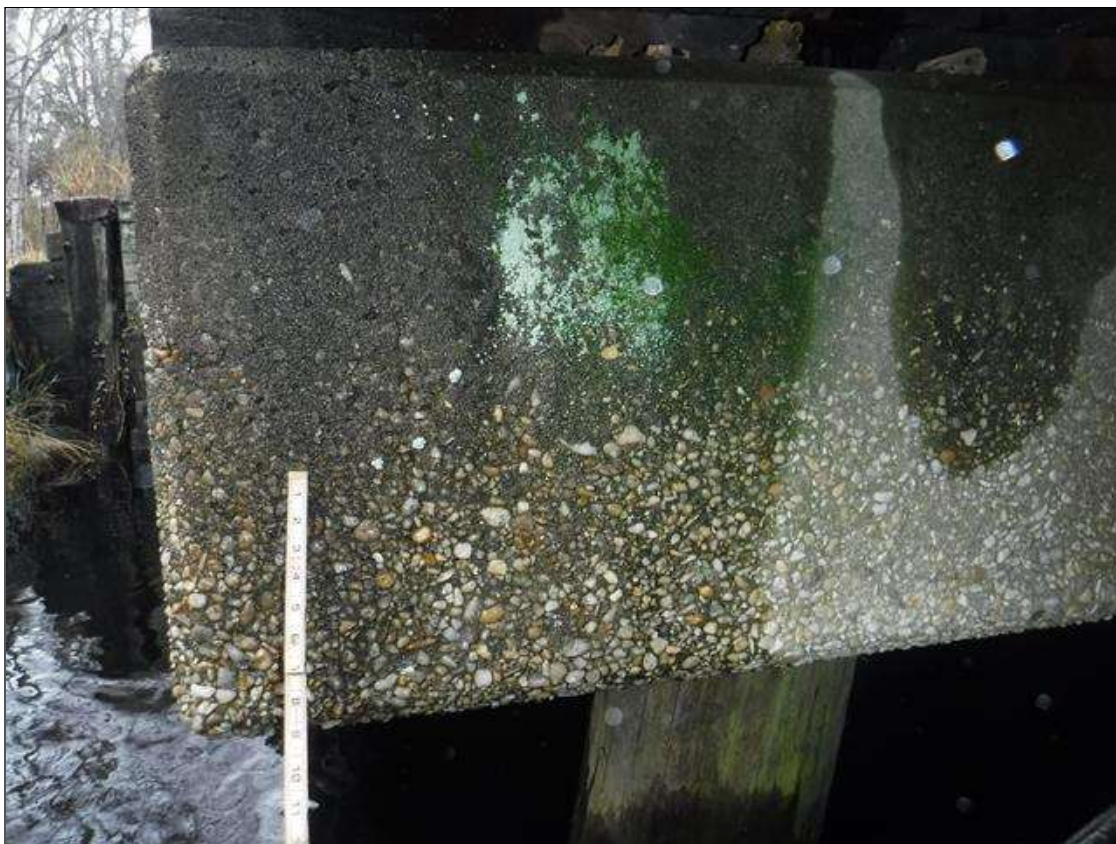
abrasion up to 1/4" deep, exposing aggregate, 12" high.

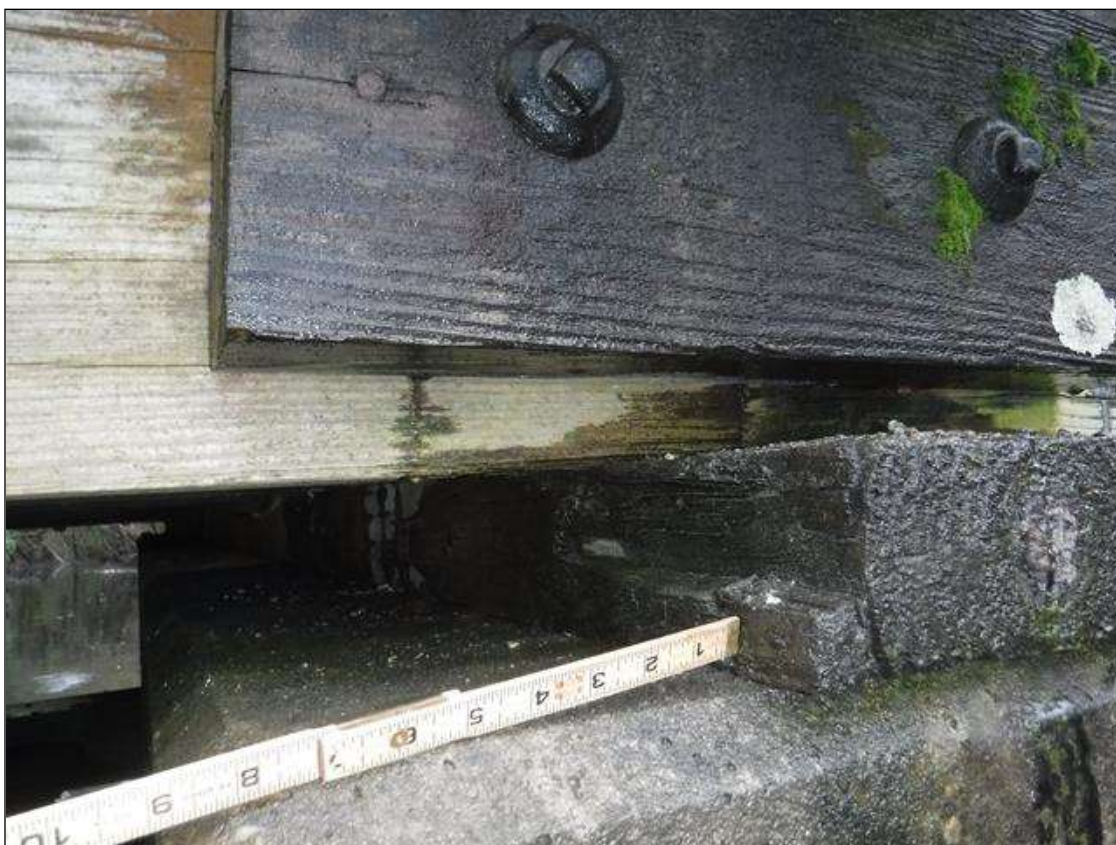
Timber Crown Strip at right end of cap, decay / Section Loss (10" long x 2-1/2" x 1-1/2".)

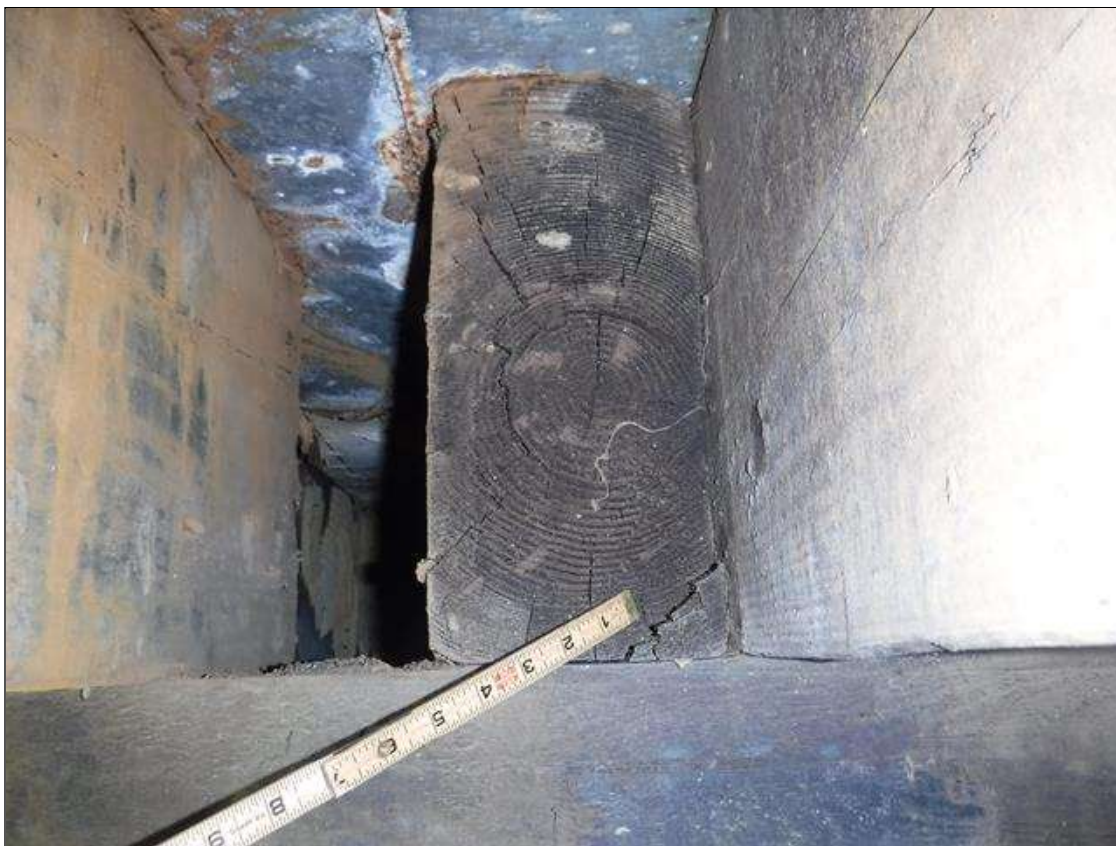
Span 1 Beam 7: 16" X 3" X 3" AREA OF DELAMINATION IN BOTTOM LEFT CORNER OF JOIST AT BENT 1

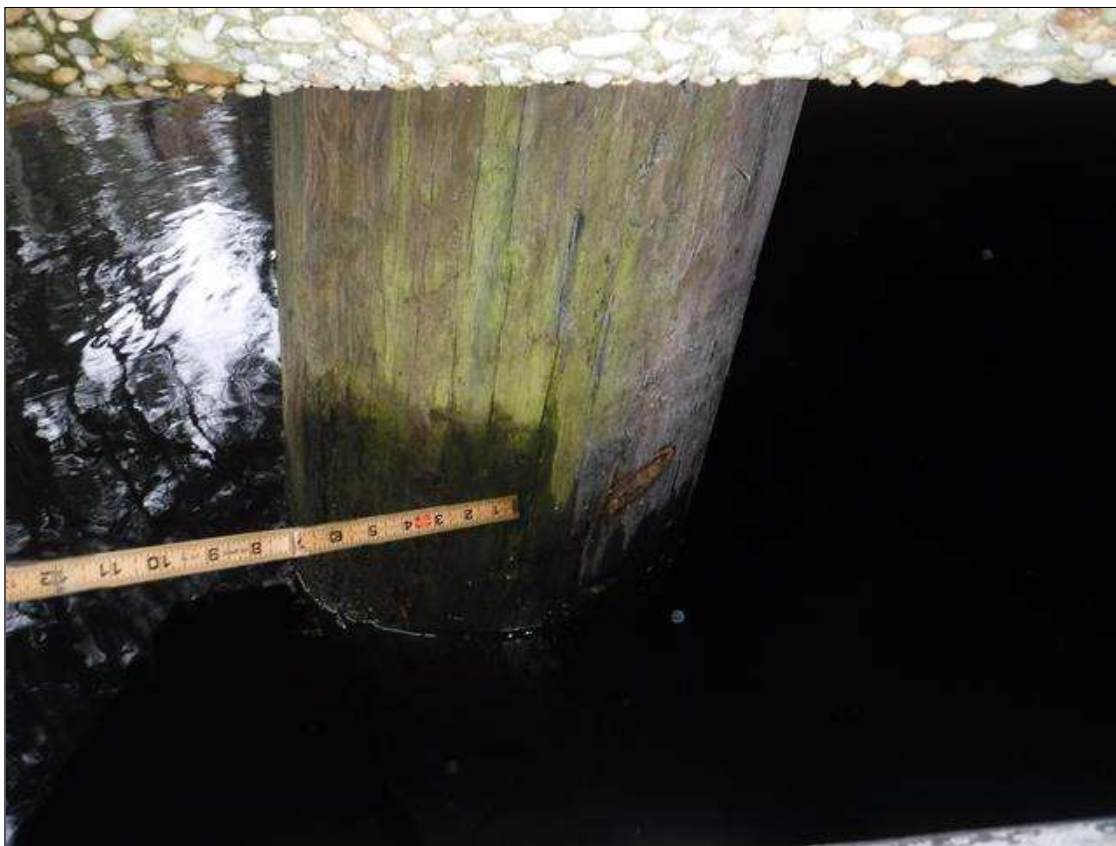
Decay, (1/2" deep x 12" x 12".)

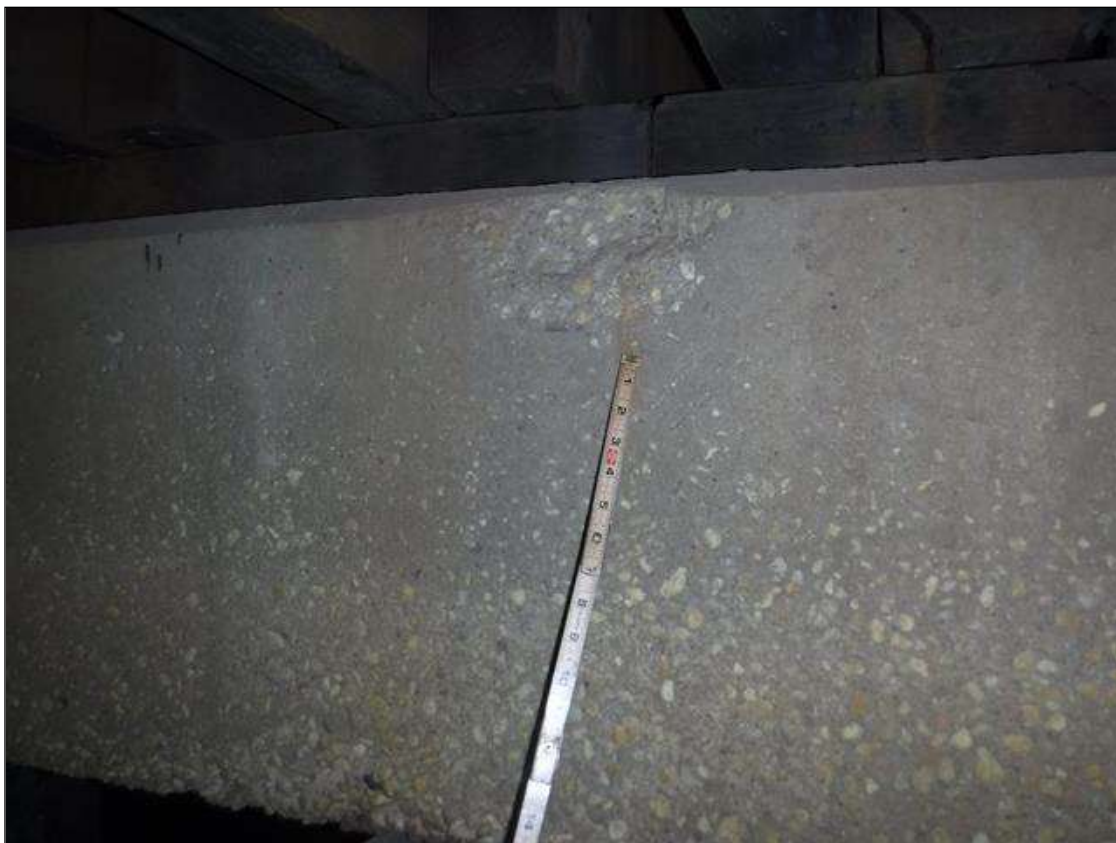
South face at top, above Steel Cross cap crutch, Spall no exposed steel (6" diameter x 1" deep.)

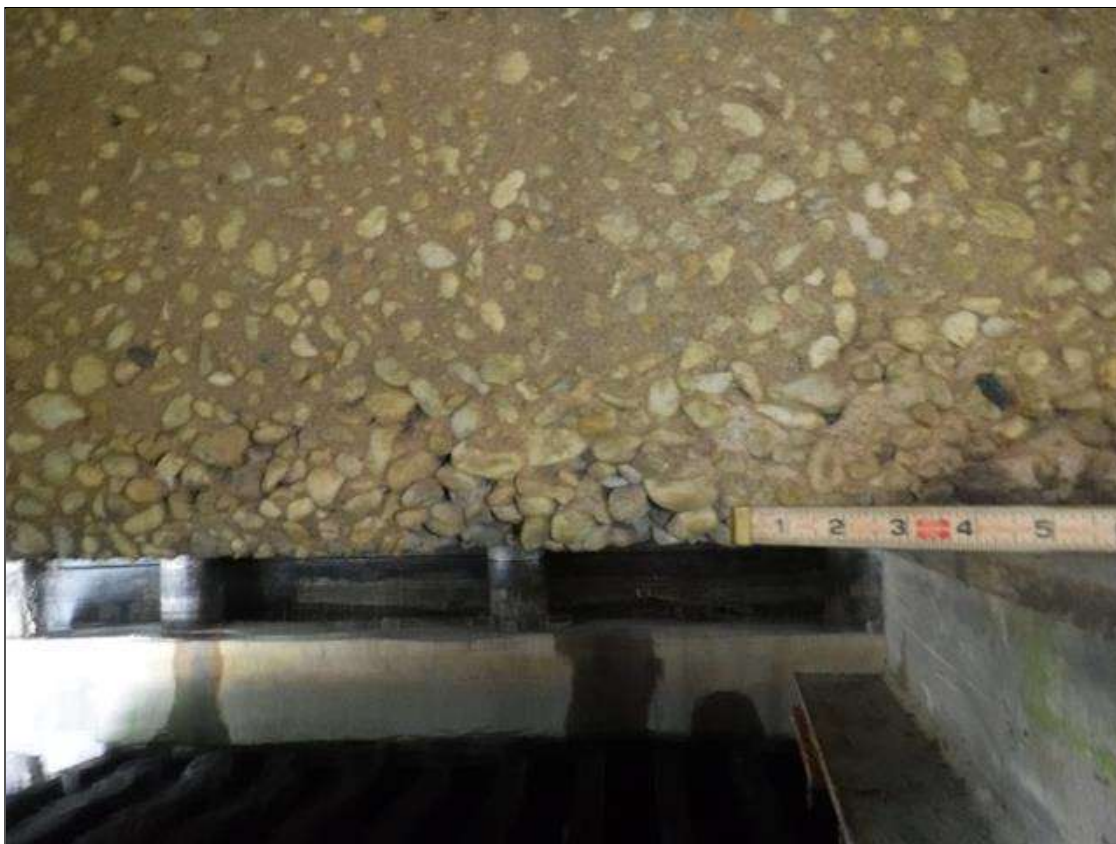
Bent 2 Cap 1: ABRASION UP TO 1" DEEP, EXPOSING AGGREGATE, 12" HIGH

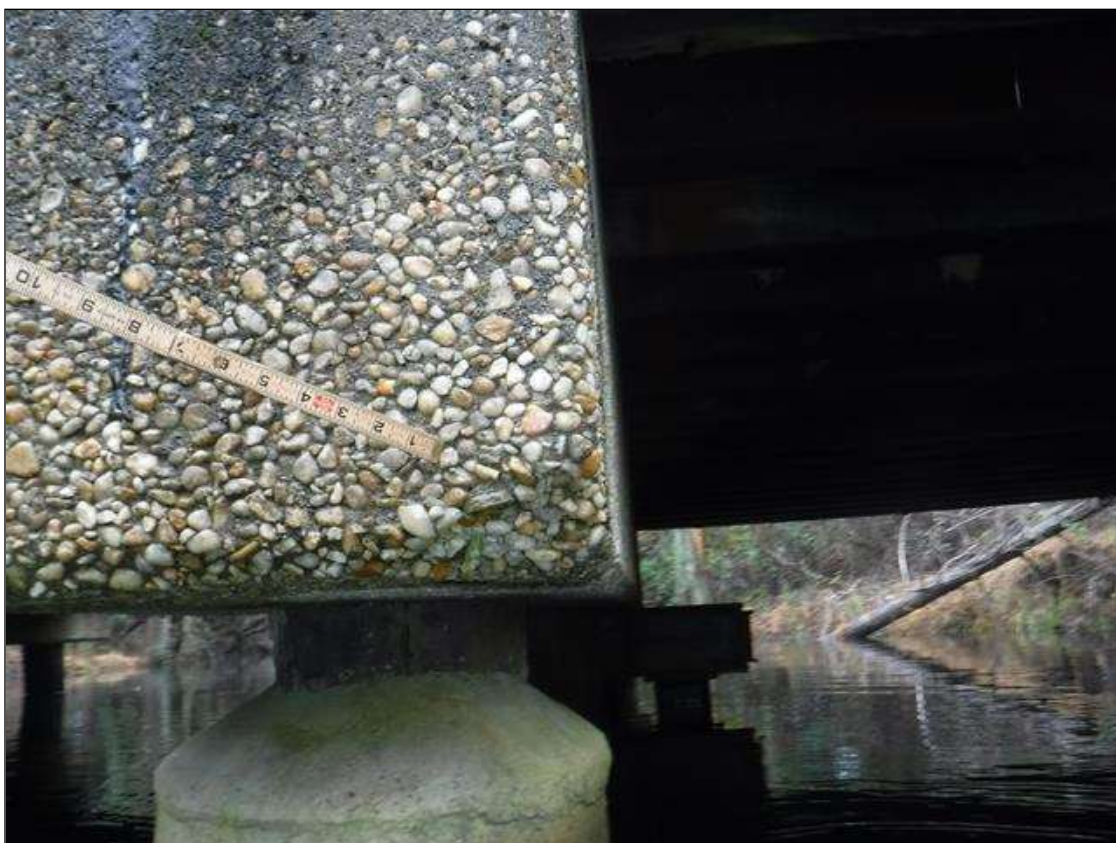
EAST END AT LOWER CORNER SPALLED AREA, no exposed steel, (5"LONG X 6"WIDE X 6"HIGH)

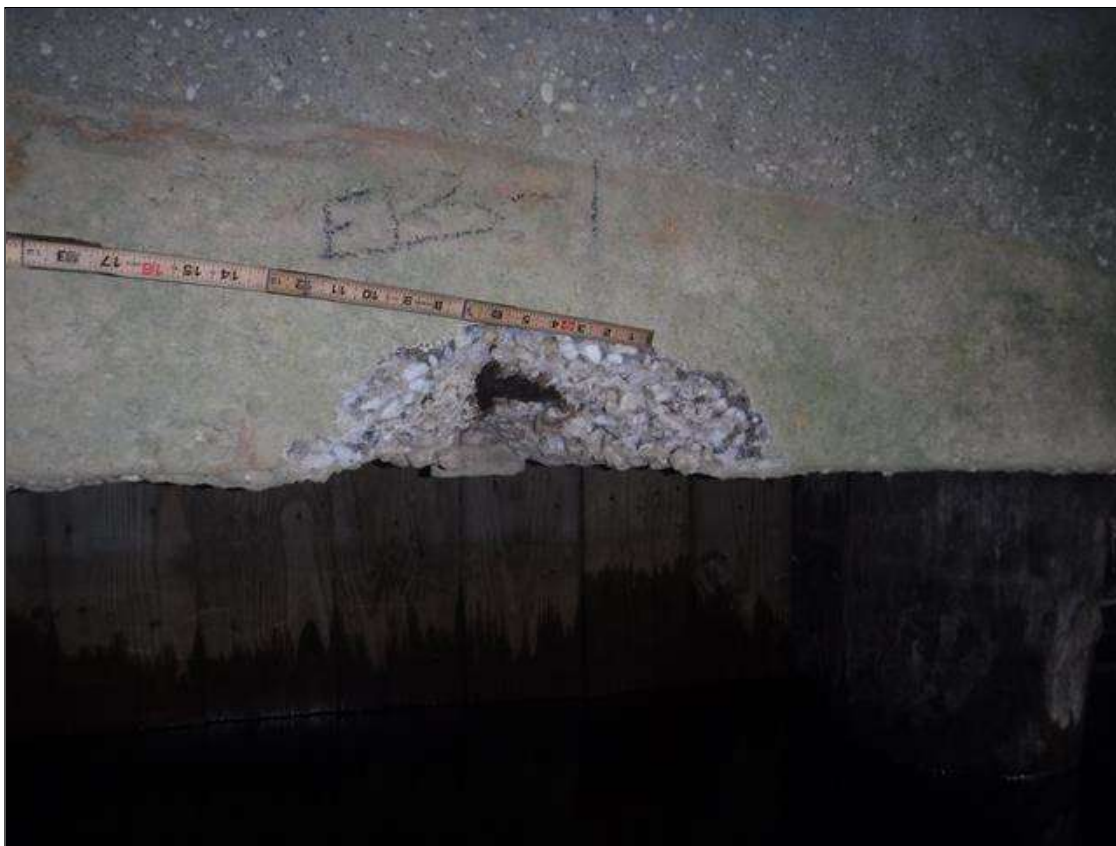
Between piles 1 and 2, Bottom of cap, Spall with Exposed Steel (15" x 7" x 8".)

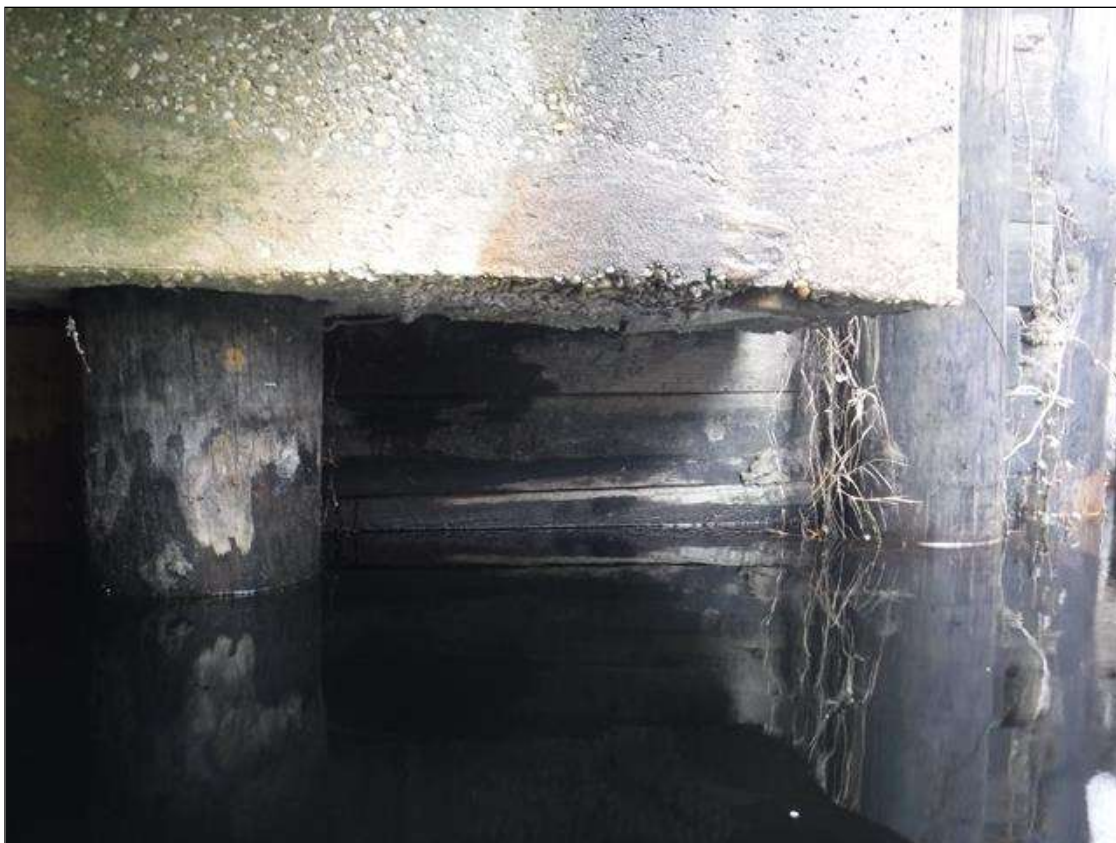
PRIORITY ACTION REQUEST: Pile 1 to left end, scour (6' long x 6" h.) at bottom of Bulkhead Boards exposing embankment fill 3" deep, fill spilling out. (2021 INSPECTION: UNABLE TO VERIFY DUE TO HIGH WATER)

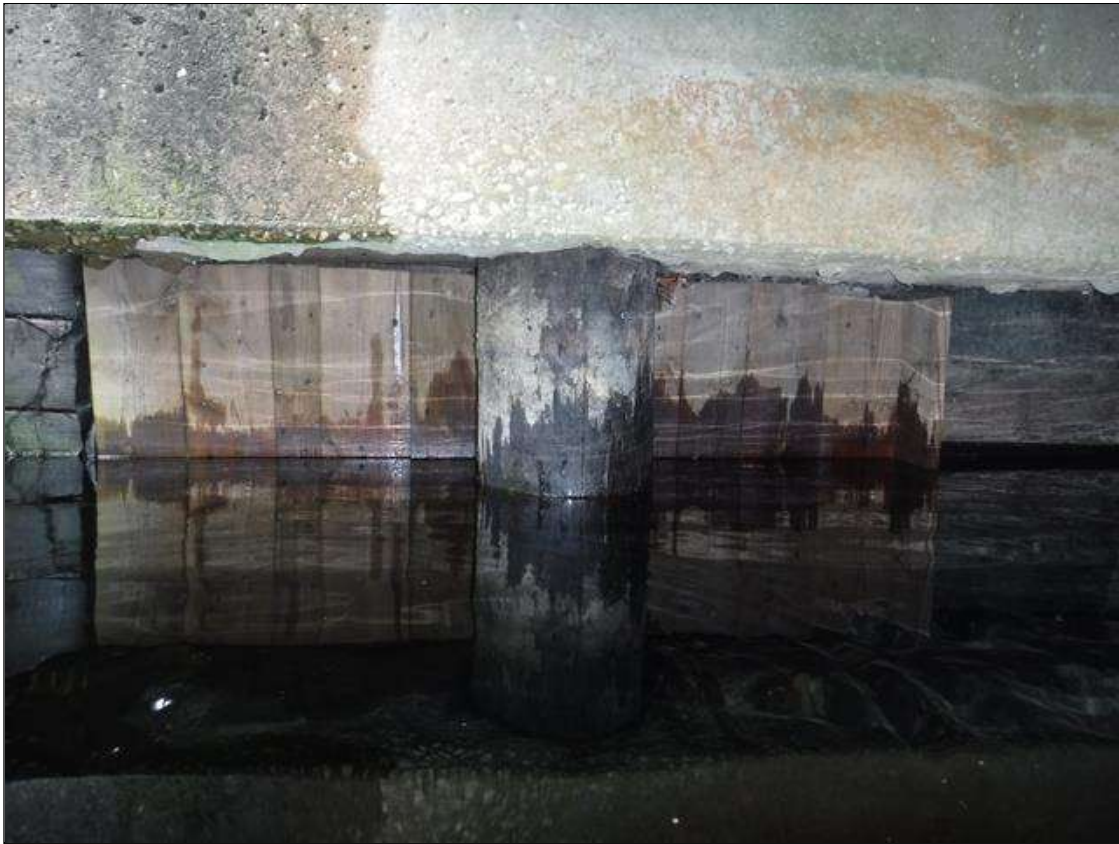
BOTH SIDES OF PILE 4, TIMBER BULKHEAD BOARDS REPLACED (PREVIOUS REPAIR) (6' LONG)

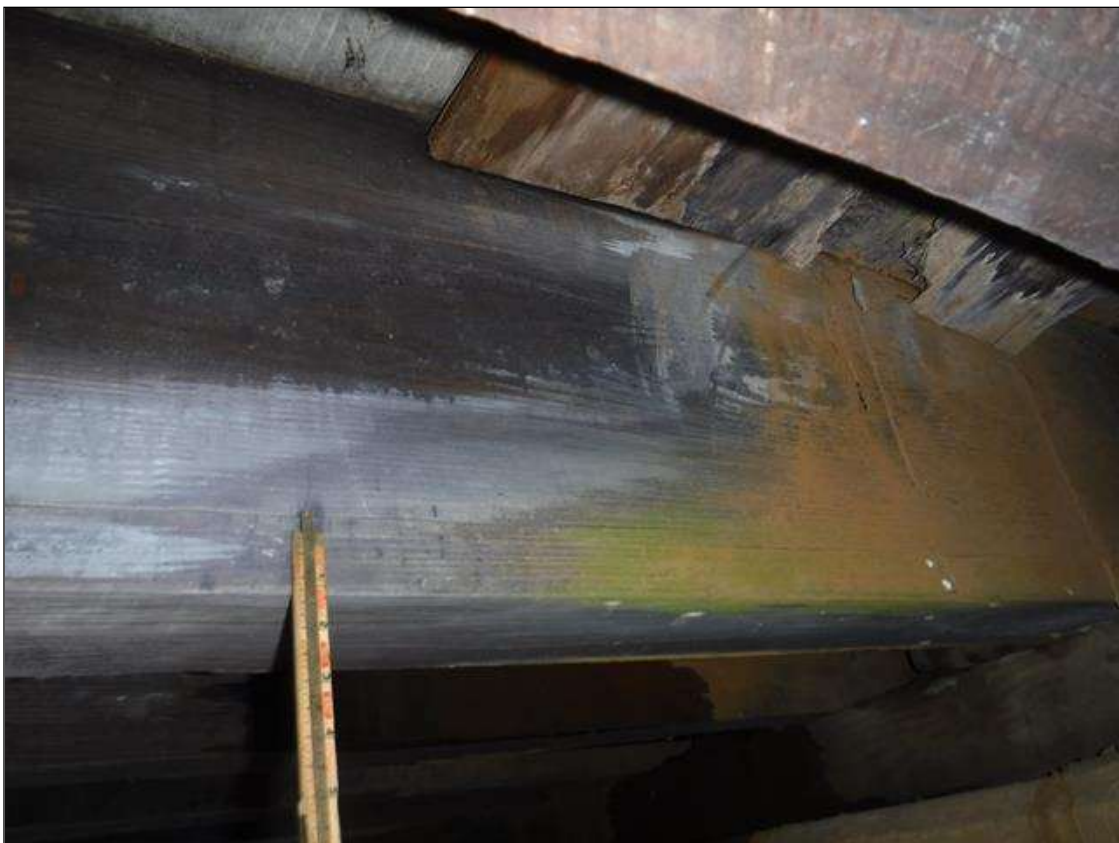
CHECKS ALONG THE JOIST UP TO .062" WIDE

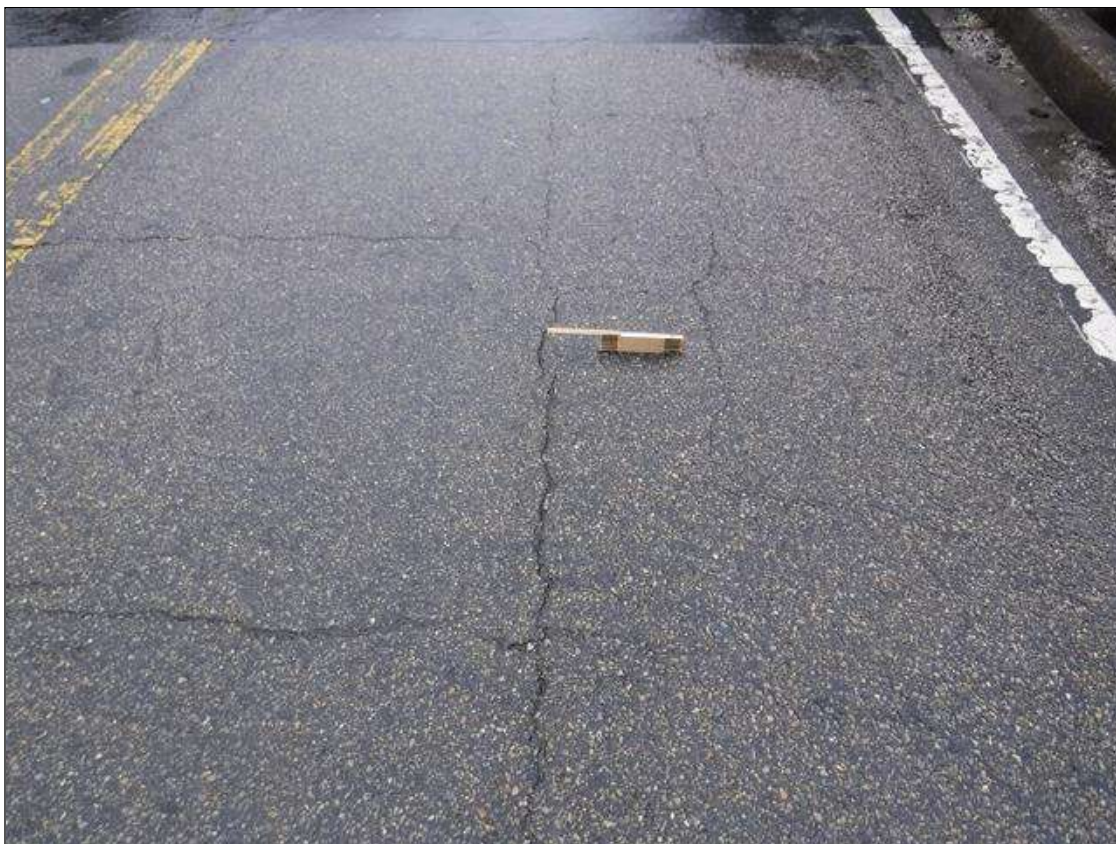
SCATTERED TRANSVERSE CRACKING / LONGITUDINAL CRACKING IN ASPHALT WEARING SURFACE UP TO AN .125" WIDE.

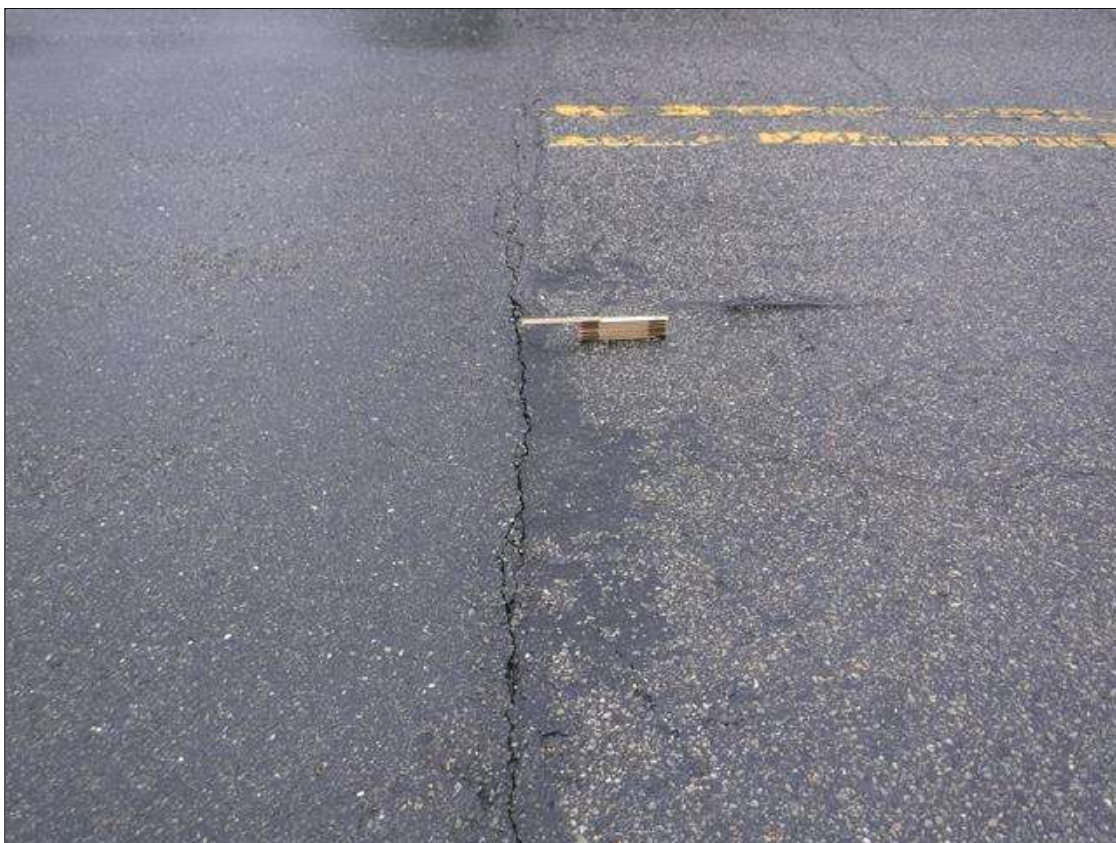
Span 1 Wearing Surface: UP TO 1/4" TRANSVERSE CRACK ALONG END BENT 1 FILL FACE

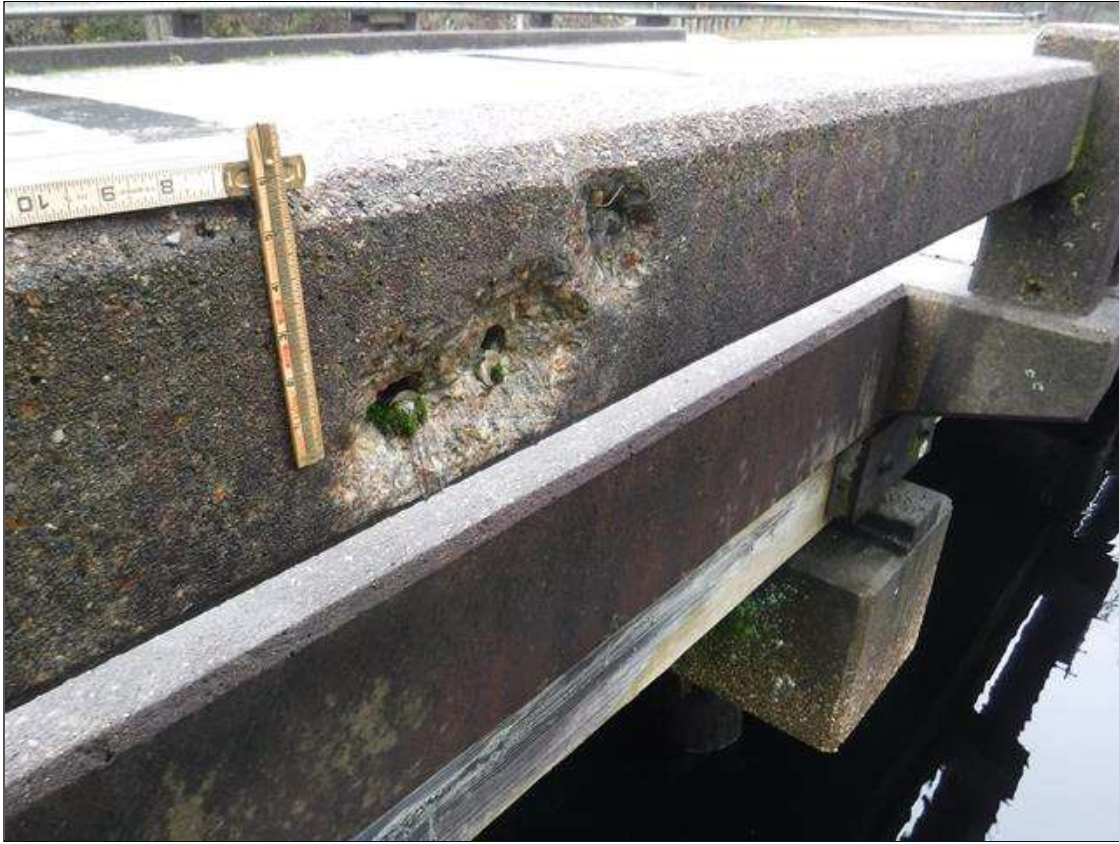
SPALL NO EXPOSED STEEL, (15" X 4" X 1") EXTERIOR SIDE OF RAIL AT PREVIOUS GUARDRAIL CONNECTION.

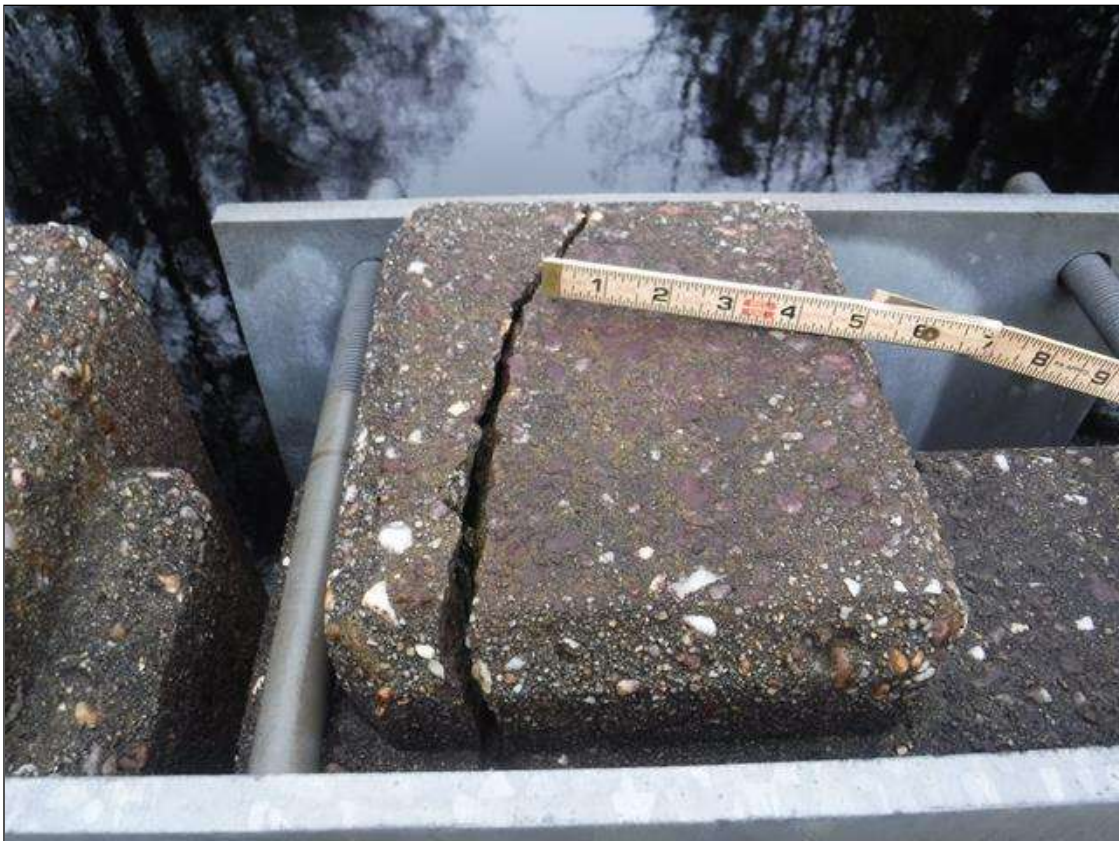
POST #3 CRACKED AREA (UP TO 3/8" WIDE X FULL WIDTH)

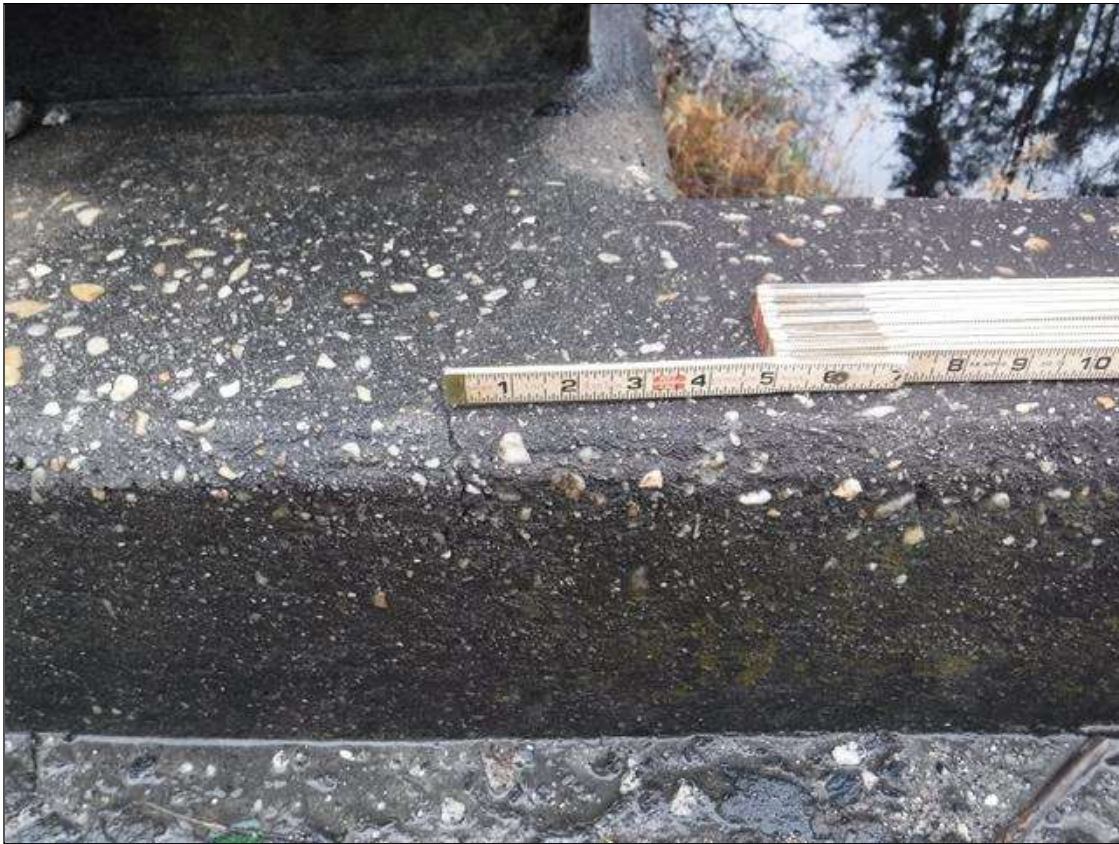
HAIRLINE TRANSVERSE CRACKING SCATTERED ALONG CURBS

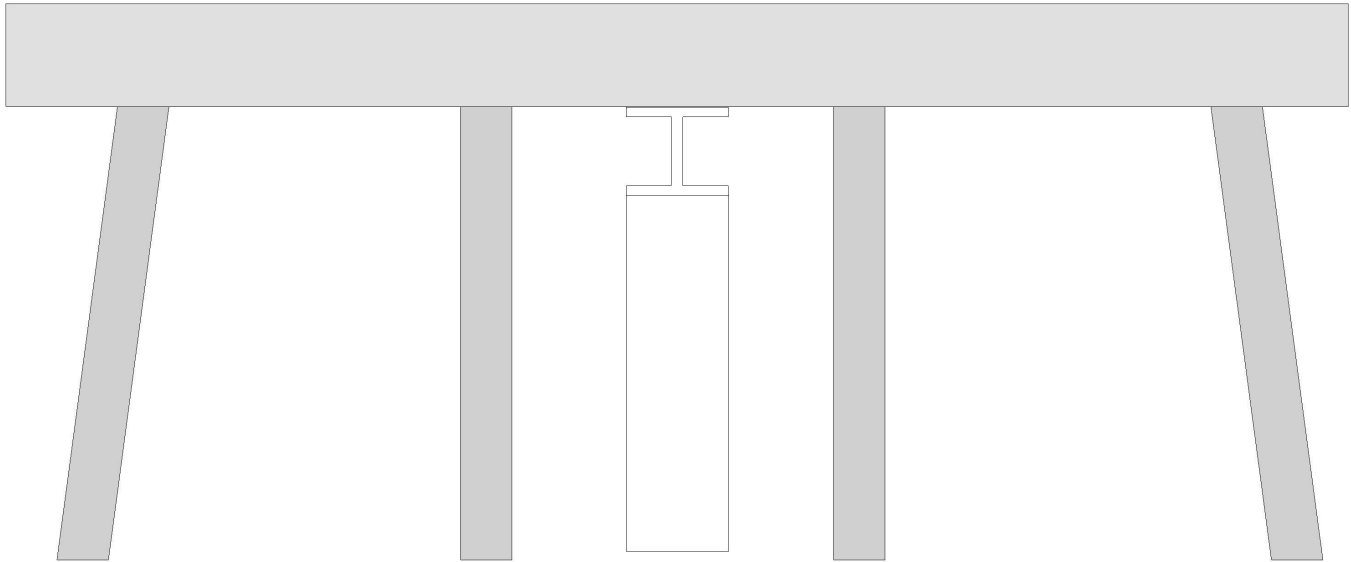
<b>Cap Information</b>			<b>Material</b> Cast in Place Concrete							
Length	Width	Height	Left Overhang	Right Overhang	Left Beam to End of Cap.	Right Beam to End of Cap.				
26.083 ft.	2.25 ft.	2.00 ft.	2.667 ft.	2.167 ft.	0.771 ft.	0.791 ft.				
<b>Subcap Information</b>			<b>Material</b>							
Length	Width	Height	Left Overhang	Right Overhang	Left Pile to Splice.					
<b>Sill Information</b>			<b>Material</b>							
Length	Width	Height								
Pile #	Material	Spacing	Width/Dia.	Height	Length	Orientation	Driven?	Replacement?	Removed?	Collar?
1	Timber	6.667 ft.	1.00 ft.			Battered	Yes	No	No	No
2	Timber	3.50 ft.	1.00 ft.			Vertical	Yes	No	No	No
3	Steel	3.75 ft.	1.00 ft.	1.00 ft.		Vertical	Yes	No	No	No
4	Timber	7.333 ft.	1.00 ft.			Vertical	Yes	No	No	No
5	Timber		1.00 ft.			Battered	Yes	No	No	No
<b>Bent: 1</b>

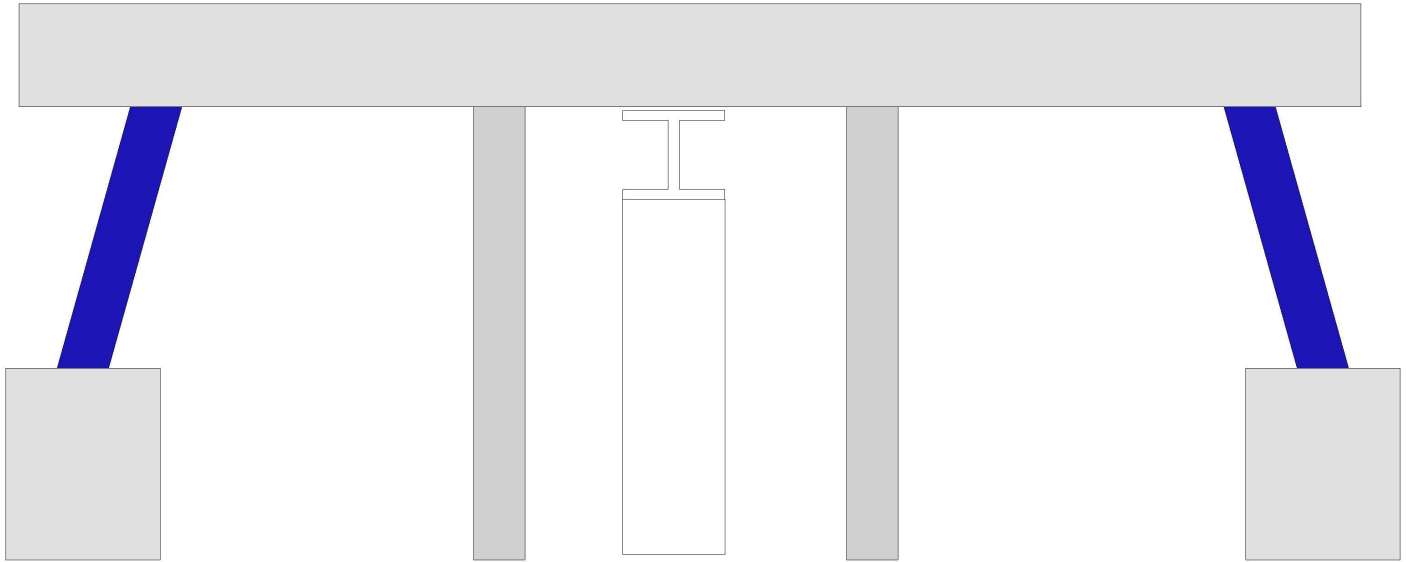
<b>Cap Information</b>			Material Cast-in-Place Concrete							
Length	Width	Height	Left Overhang	Right Overhang	Left Beam to End of Cap.	Right Beam to End of Cap.				
26.083 ft.	2.25 ft.	2.00 ft.	2.667 ft.	2.167 ft.	0.771 ft.	0.792 ft.				
<b>Subcap Information</b>			Material							
Length	Width	Height	Left Overhang	Right Overhang	Left Pile to Splice.					
<b>Sill Information</b>			Material							
Length	Width	Height								
Pile #	Material	Spacing	Width/Dia.	Height	Length	Orientation	Driven?	Replacement?	Removed?	Collar?
1	Timber	6.667 ft.	1.00 ft.			Battered	Yes	Yes	No	Yes
2	Timber	3.50 ft.	1.00 ft.			Vertical	Yes	No	No	No
3	Steel	3.75 ft.	1.00 ft.	1.00 ft.		Vertical	Yes	No	No	No
4	Timber	7.333 ft.	1.00 ft.			Vertical	Yes	No	No	No
5	Timber		1.00 ft.			Battered	Yes	Yes	No	Yes
<b>Bent: 2</b>

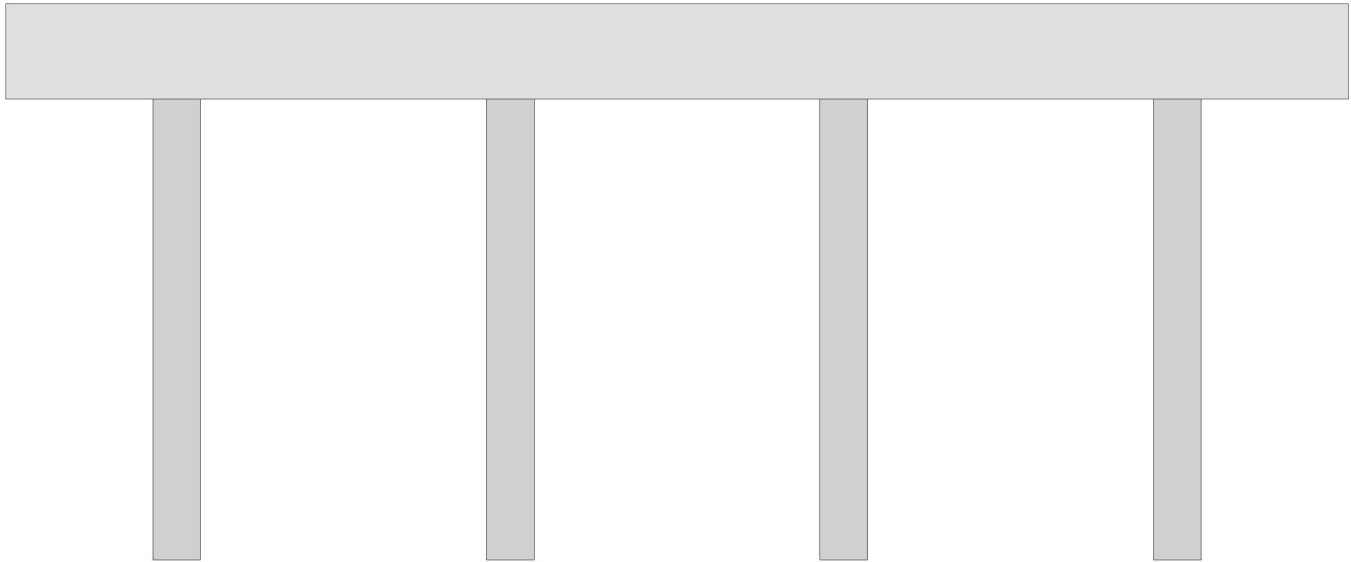
<b>Cap Information</b>			<b>Material</b> Cast-in-Place Concrete							
Length	Width	Height	Left Overhang	Right Overhang	Left Beam to End of Cap.	Right Beam to End of Cap.				
28.167 ft.	2.25 ft.	2.00 ft.	3.583 ft.	3.583 ft.	1.833 ft.	2.00 ft.				
<b>Subcap Information</b>			<b>Material</b>							
Length	Width	Height	Left Overhang	Right Overhang	Left Pile to Splice.					
<b>Sill Information</b>			<b>Material</b>							
Length	Width	Height								
Pile #	Material	Spacing	Width/Dia.	Height	Length	Orientation	Driven?	Replacement?	Removed?	Collar?
1	Timber	7.00 ft.	1.00 ft.			Vertical	Yes	No	No	No
2	Timber	7.00 ft.	1.00 ft.			Vertical	Yes	No	No	No
3	Timber	7.00 ft.	1.00 ft.			Vertical	Yes	No	No	No
4	Timber		1.00 ft.			Vertical	Yes	No	No	No
END BENT: 1
