NC DEPARTMENT OF TRANSPORTATION
 DIVISION OF HIGHWAYS
 STRUCTURE MANAGEMENT UNIT

ATTENTION: **PAR'S ISSUED: SPALLING THROUGHOUT BENTS, SIDEWALKS, BEAM & DRIFT UNDER SPAN 4. SNOOPER USED. CHANGES TO TYP. SECTION SKETCH. CHANGE TO AWS THICKNESS.**

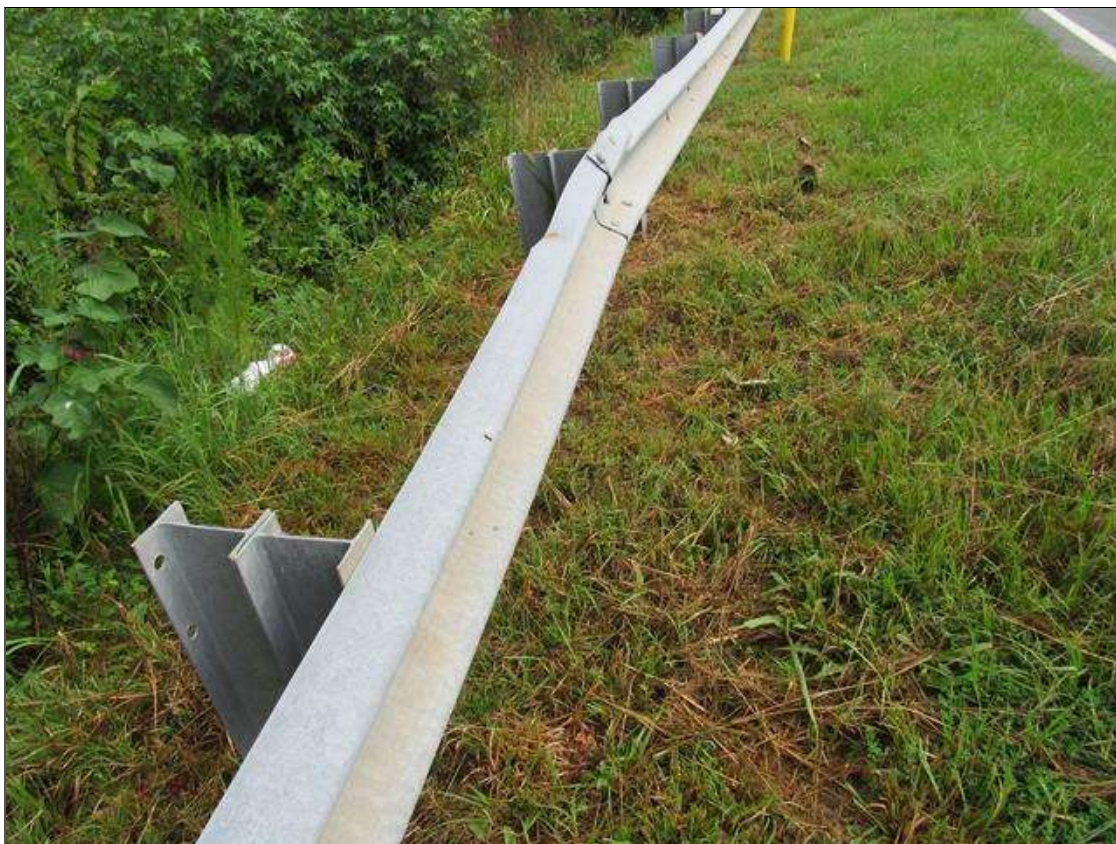
FAR LEFT GUARDRAIL - MODERATE DAMAGE (30FT), STARTING 50 FT FROM BRIDGE

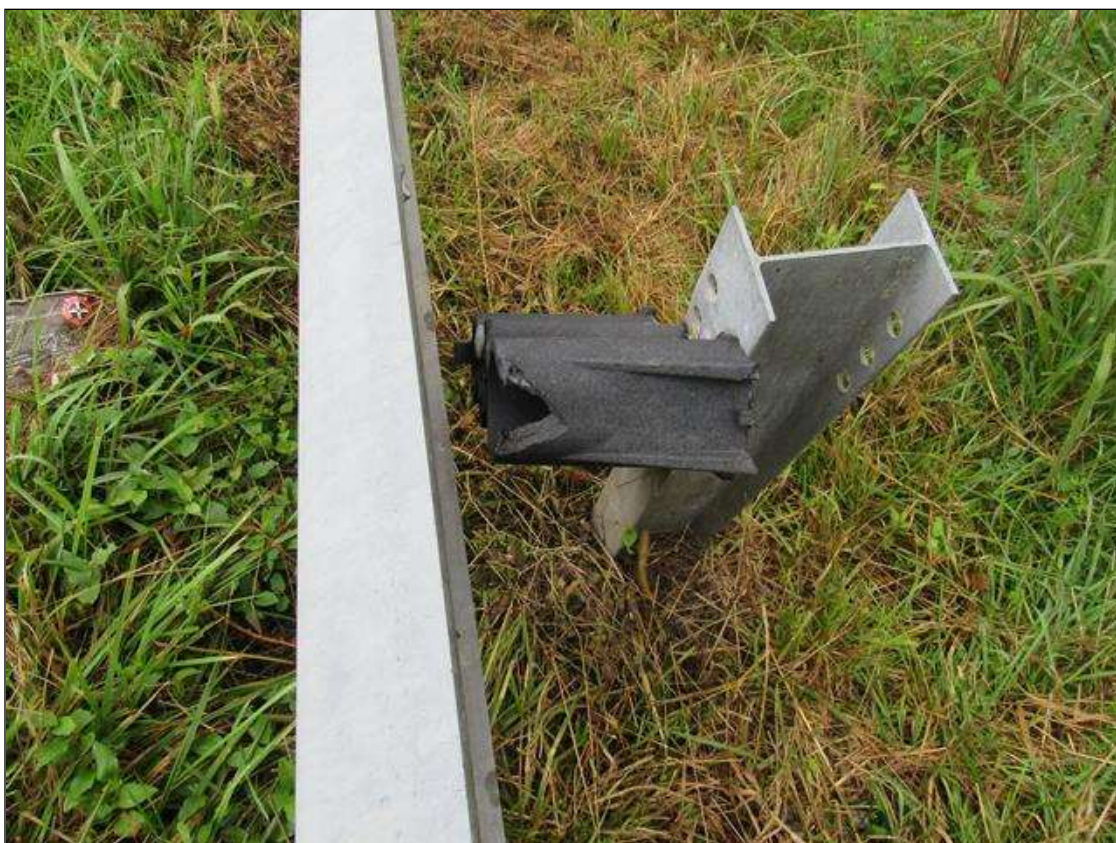
NEAR RIGHT GUARDRAIL POST - POST NOT ATTACHED, POST 8 FROM END TREATMENT, POST 3 & 5 SIMILAR

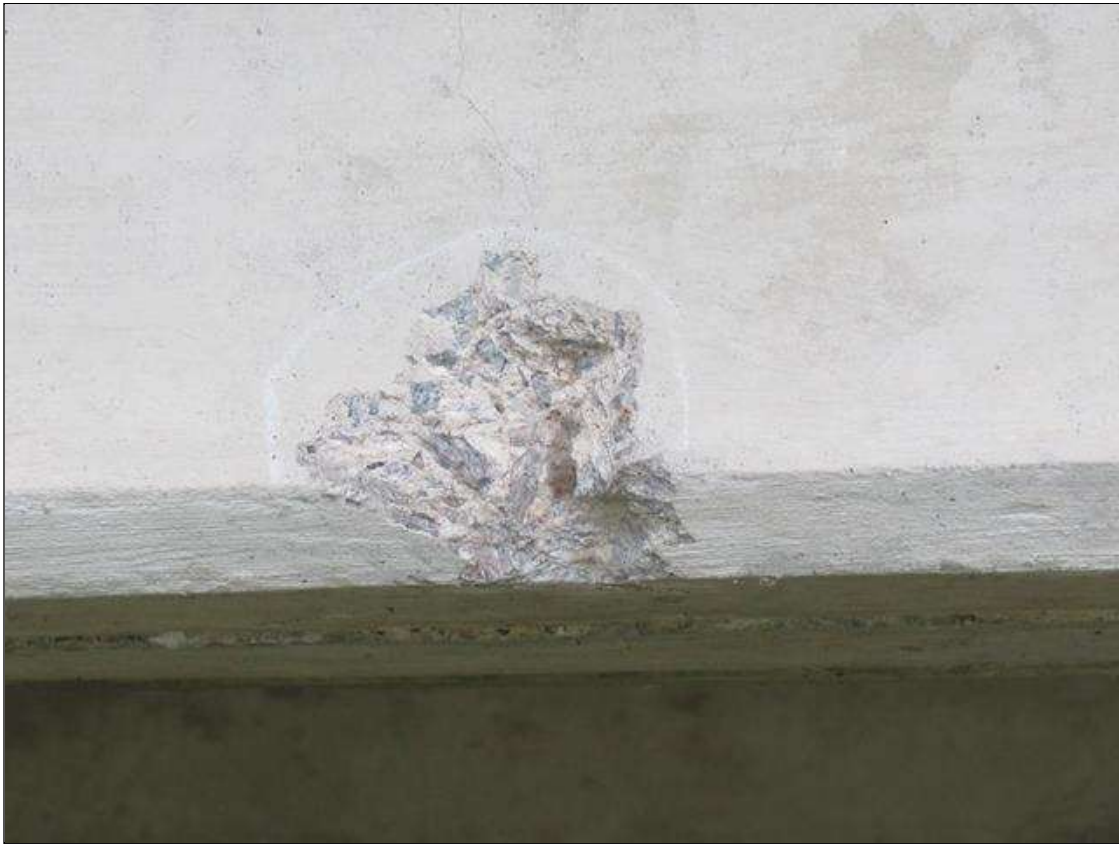
SPAN 1 BEAM 5 - SPALL (4IN X 4IN X 1IN) RIGHT SIDE AT BOTTOM, 15FT FROM NEAR END

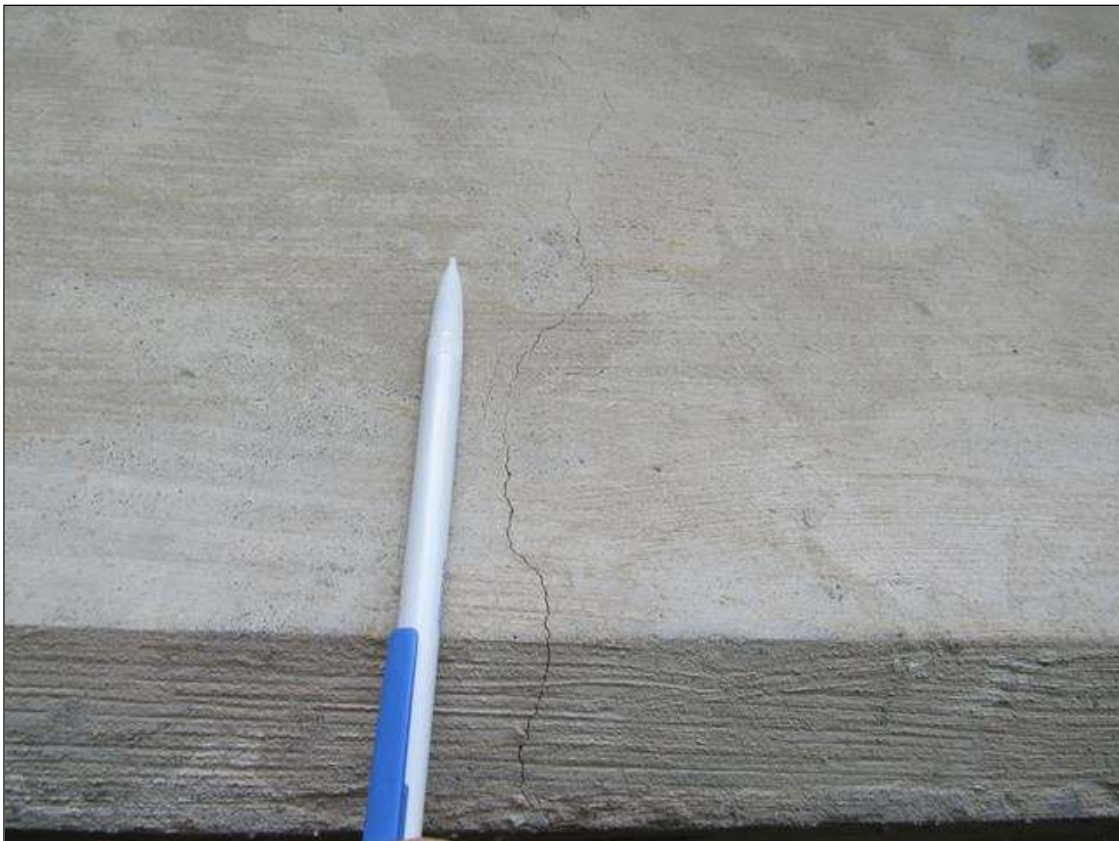
TYPICAL INTERMITTENT VERTICAL HAIRLINE CRACKING, (UP TO FULL HT.) SPACED UP TO 2FT O.C. THROUGHOUT BEAMS, SPAN 1 BEAM 5 MID-SPAN

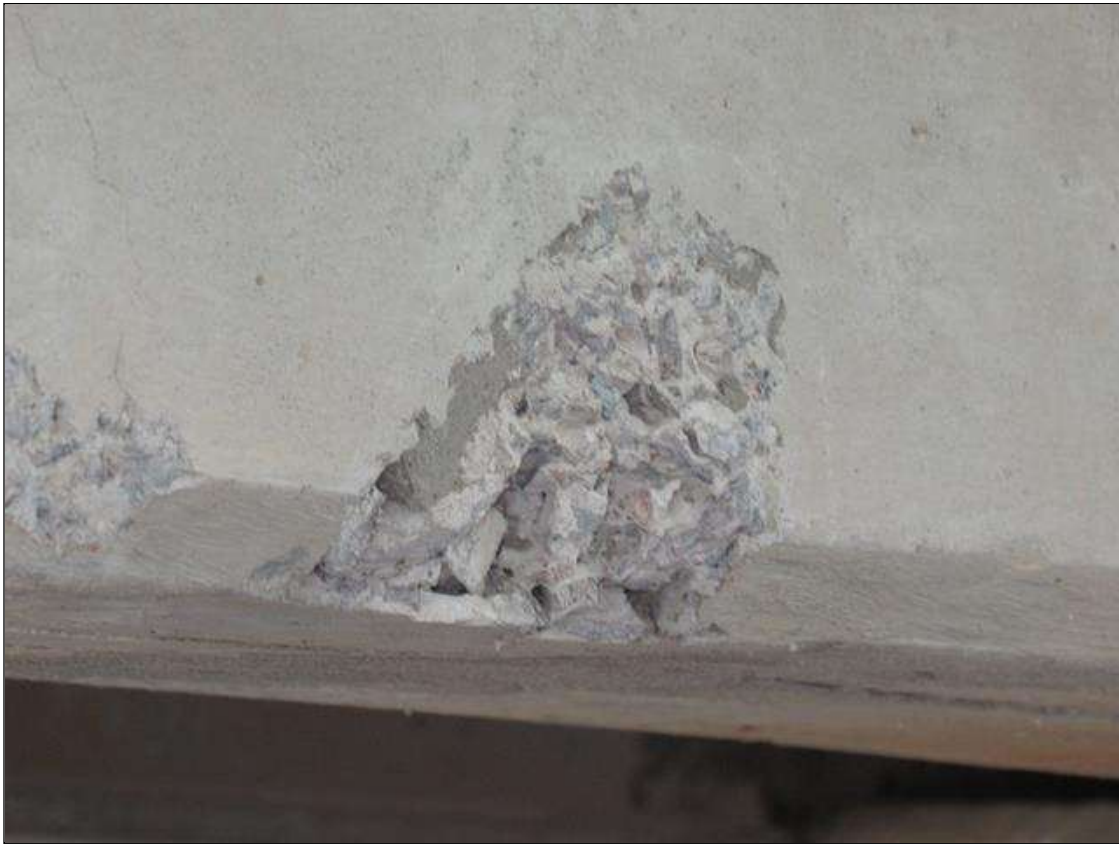
SPAN 1 BEAM 1 - SPALL (8IN X 8IN X 2IN) BOTTOM LEFT EDGE, 8FT FROM NEAR END

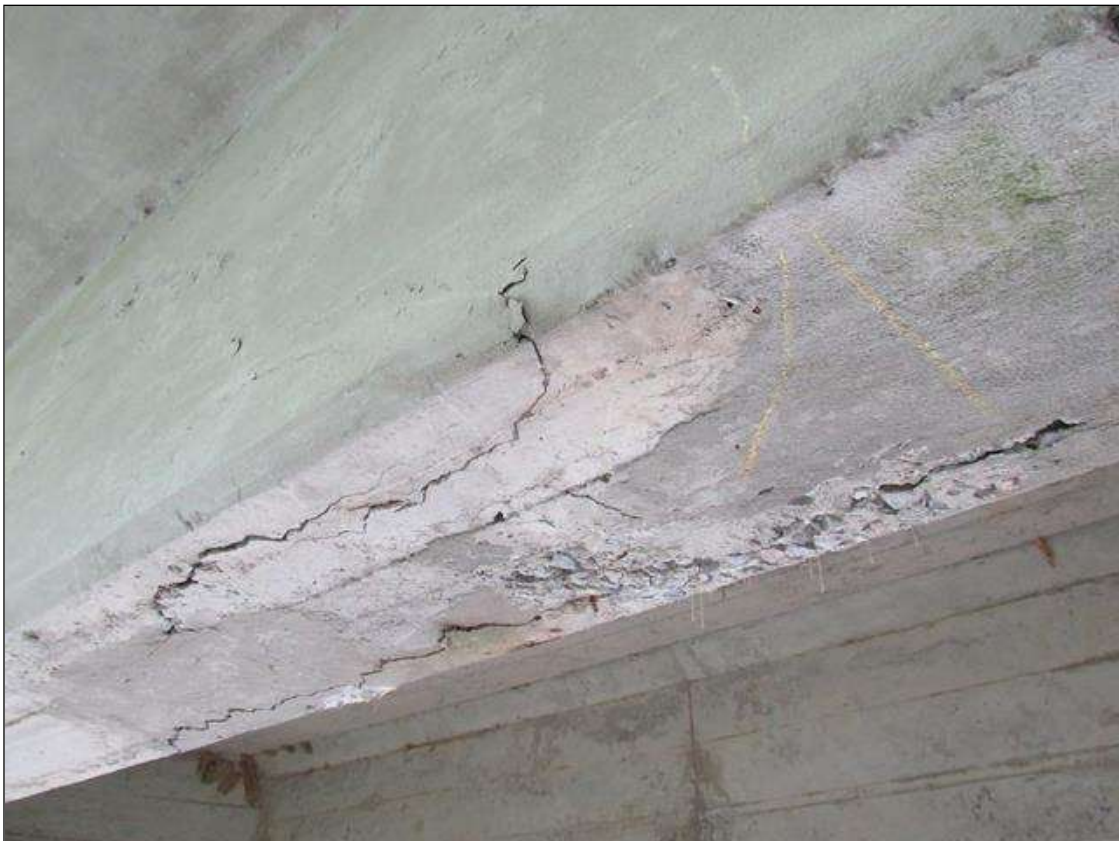
SPAN 1 BEAM 1 - DELAM (5FT L. X FULL W.) TO BOTTOM, 12FT FROM FAR END

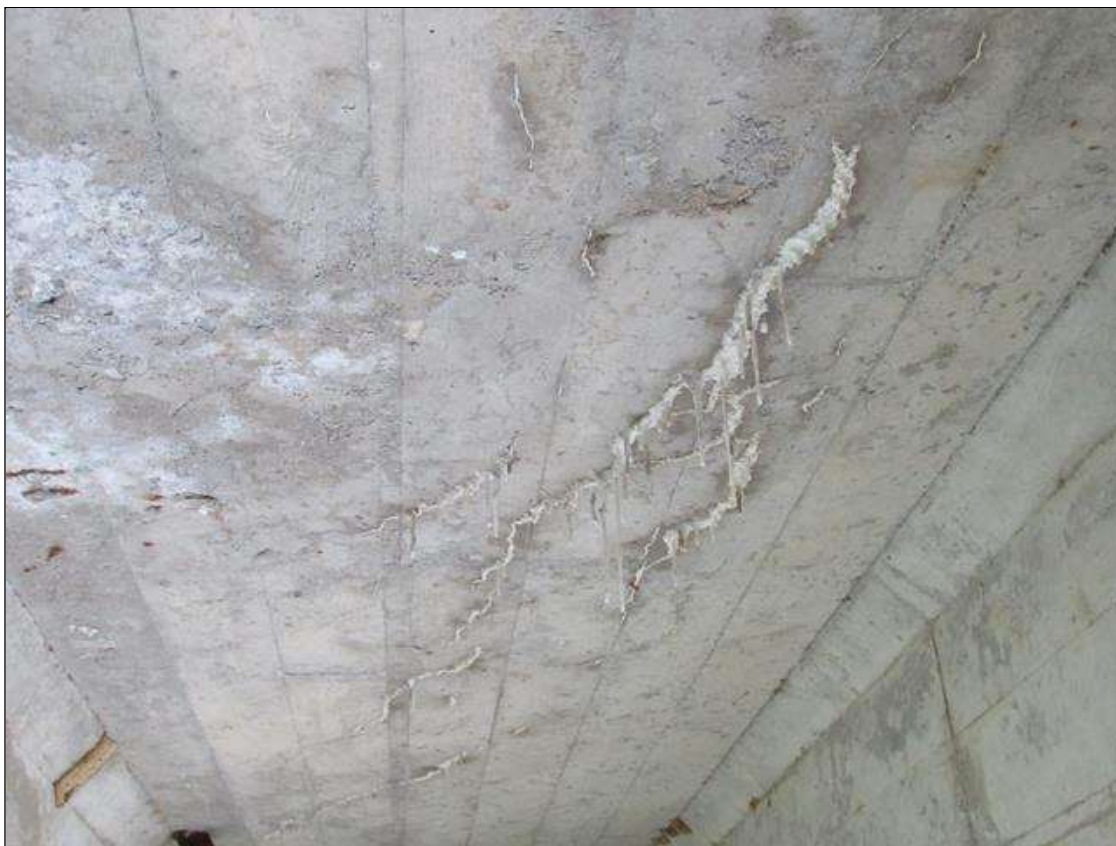
TYPICAL INTERMITTENT HAIRLINE TO 1/32IN LONGITUDINAL CRACKING WITH MODERATE TO HEAVY EFFLO. THROUGHOUT UNDERSIDE OF DECK, SPAN 1 BAY 1

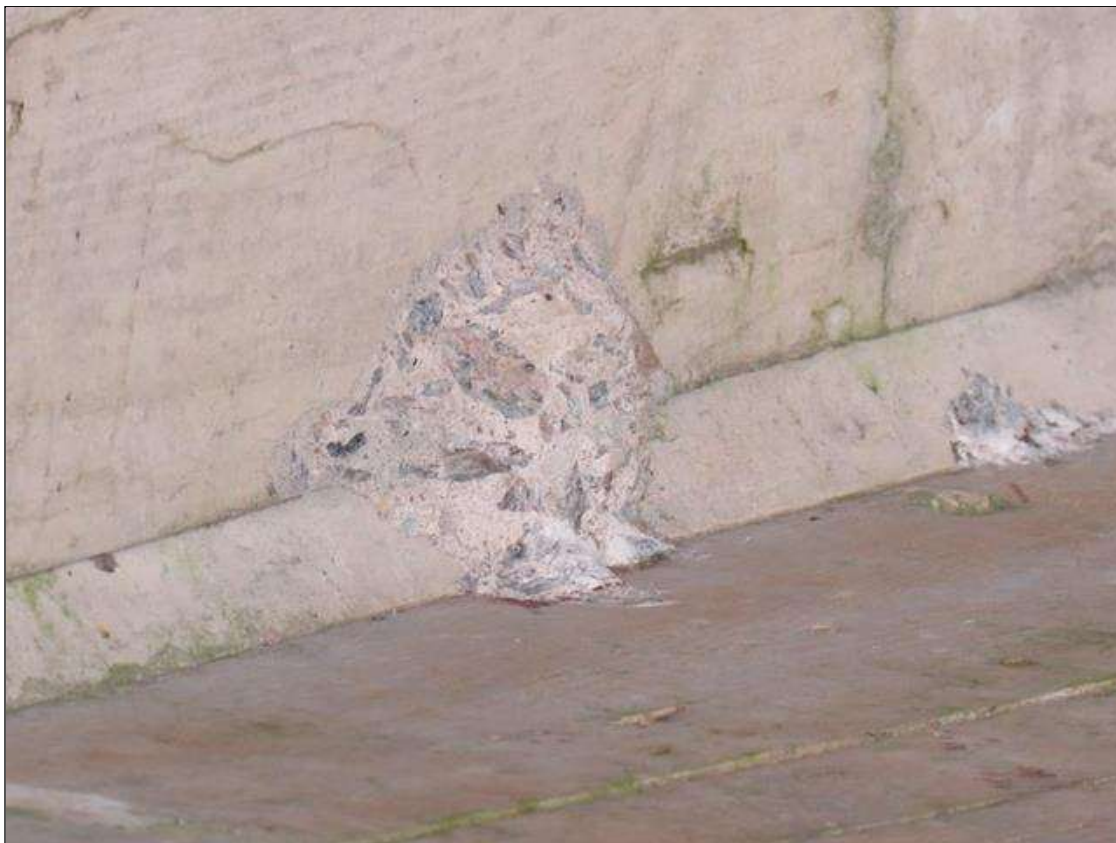
SPAN 1 BEAM 2 - SPALL (5IN X 4IN X 1IN) BOTTOM RIGHT, 10FT FROM NEAR END

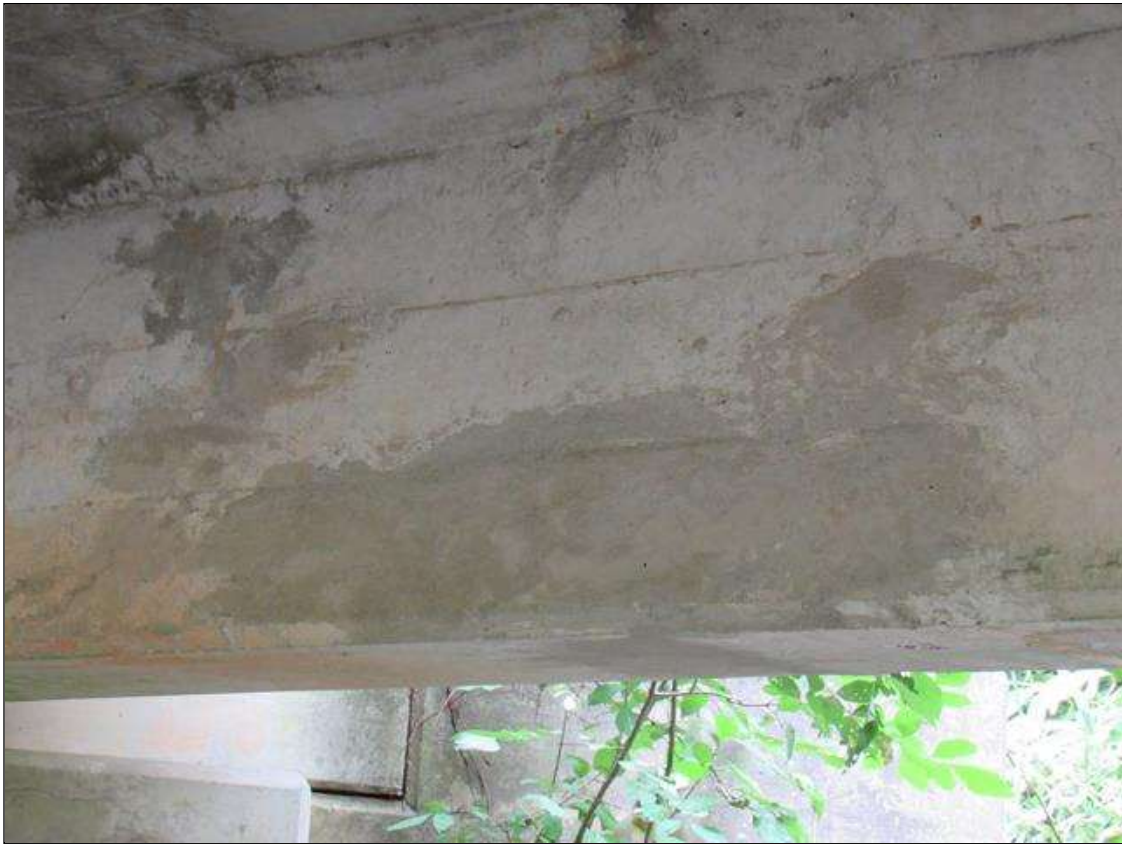
TYPICAL INTERMITTENT SOUND PATCH, (UP TO 3SF) THROUGHOUT BEAMS, SPAN 1 BEAM 1 RIGHT SIDE, 5FT FROM NEAR END

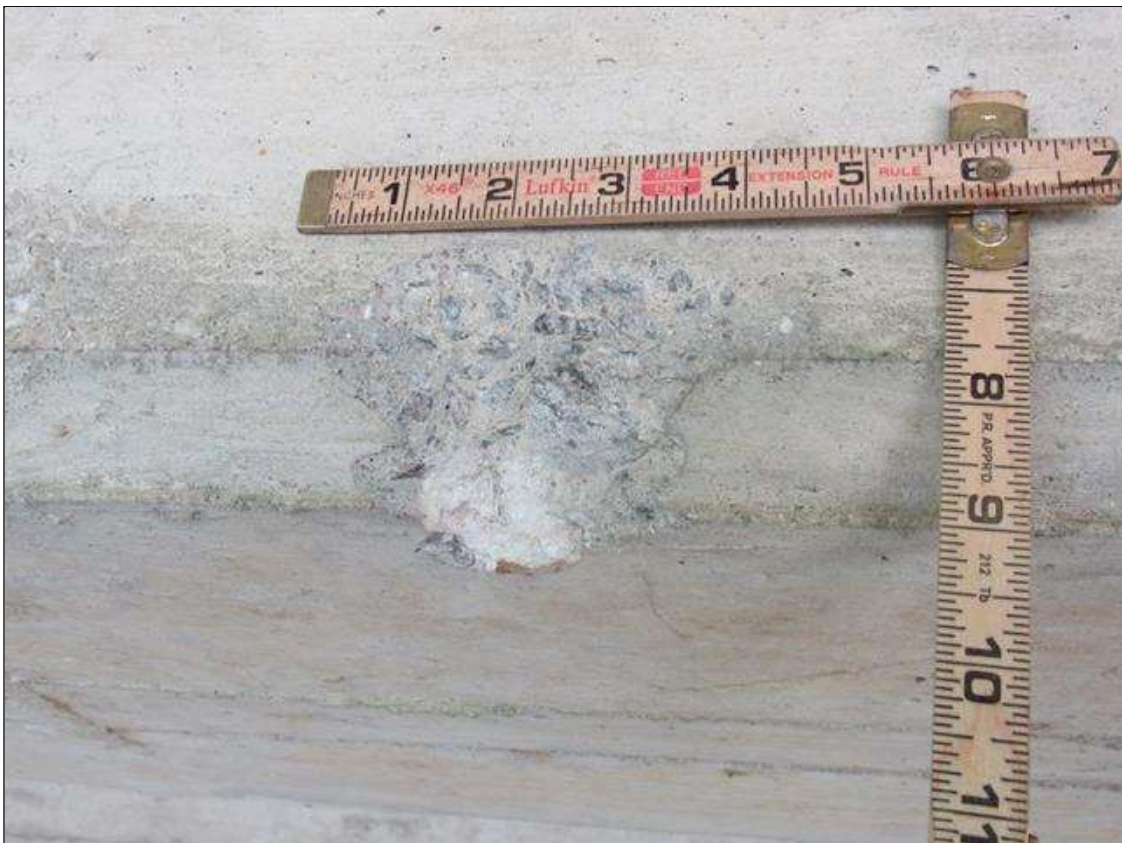
SPAN 1 BEAM 3 - SPALL (3IN X 3IN X 1/2IN) BOTTOM RIGHT, MID-SPAN

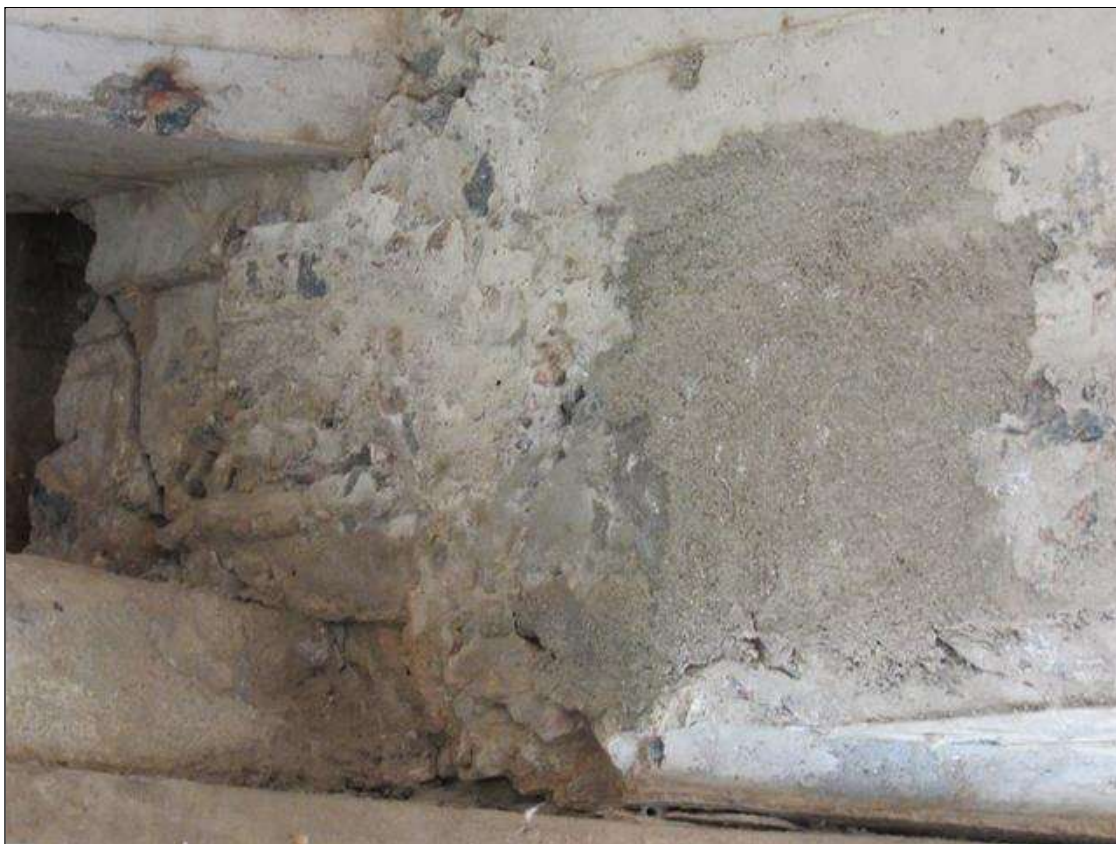
SPAN 1 BEAM 4 - SOUND PATCH (8IN DIAM) & DIAGONAL OPEN CRACK, (UP TO 1/8IN X 5IN L.) LEFT SIDE AT FAR END

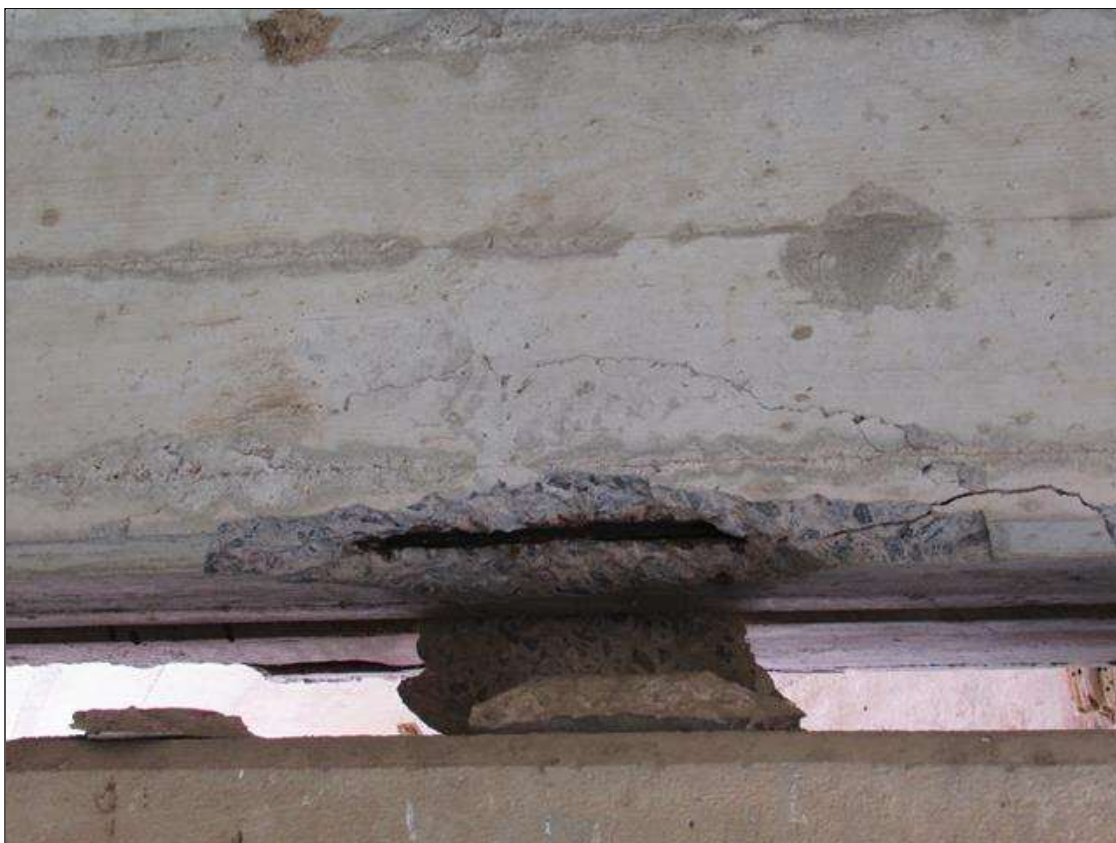
SPAN 1 FAR END DIAPHRAGM - SPALL/DELAM (3FT X 1FT X 3IN) WITH EXPOSED REBAR, LEFT OF BEAM 4

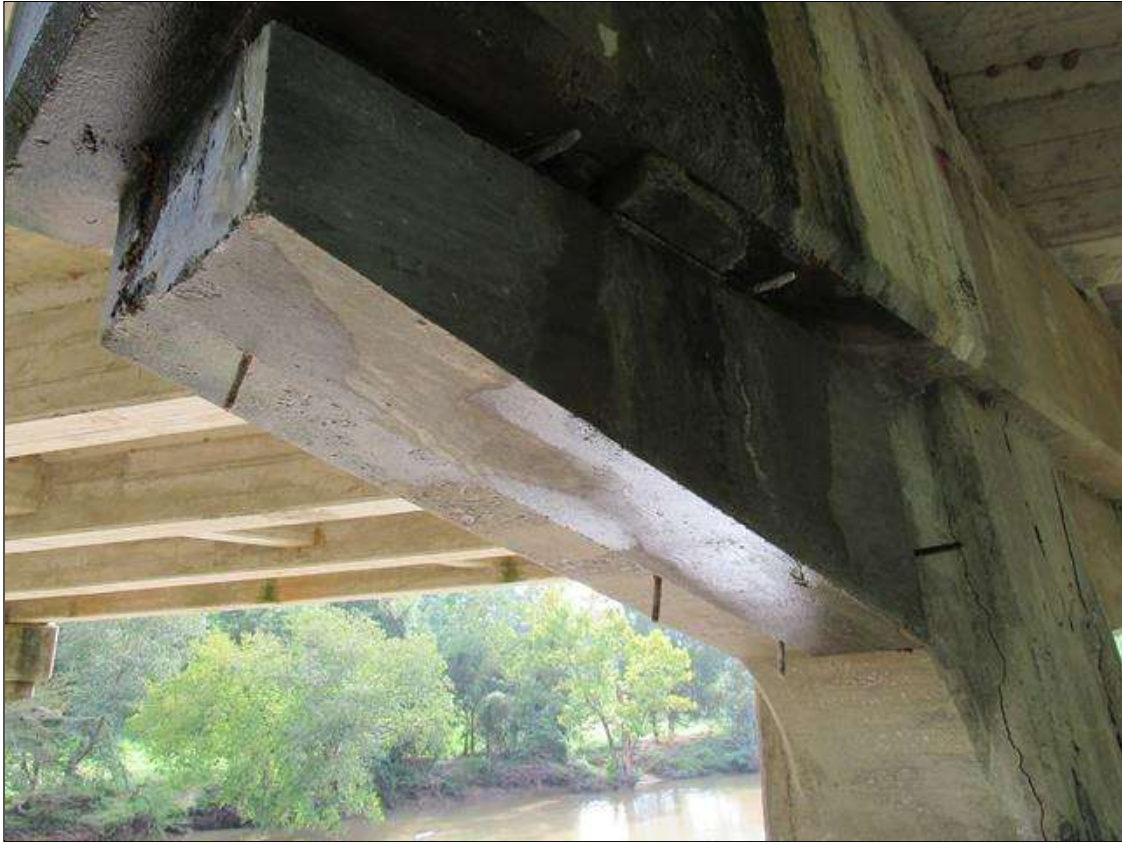
BENT 1 NEAR FACE - PARTIALLY DELAMINATED PATCH, (1SF) AT LEFT END

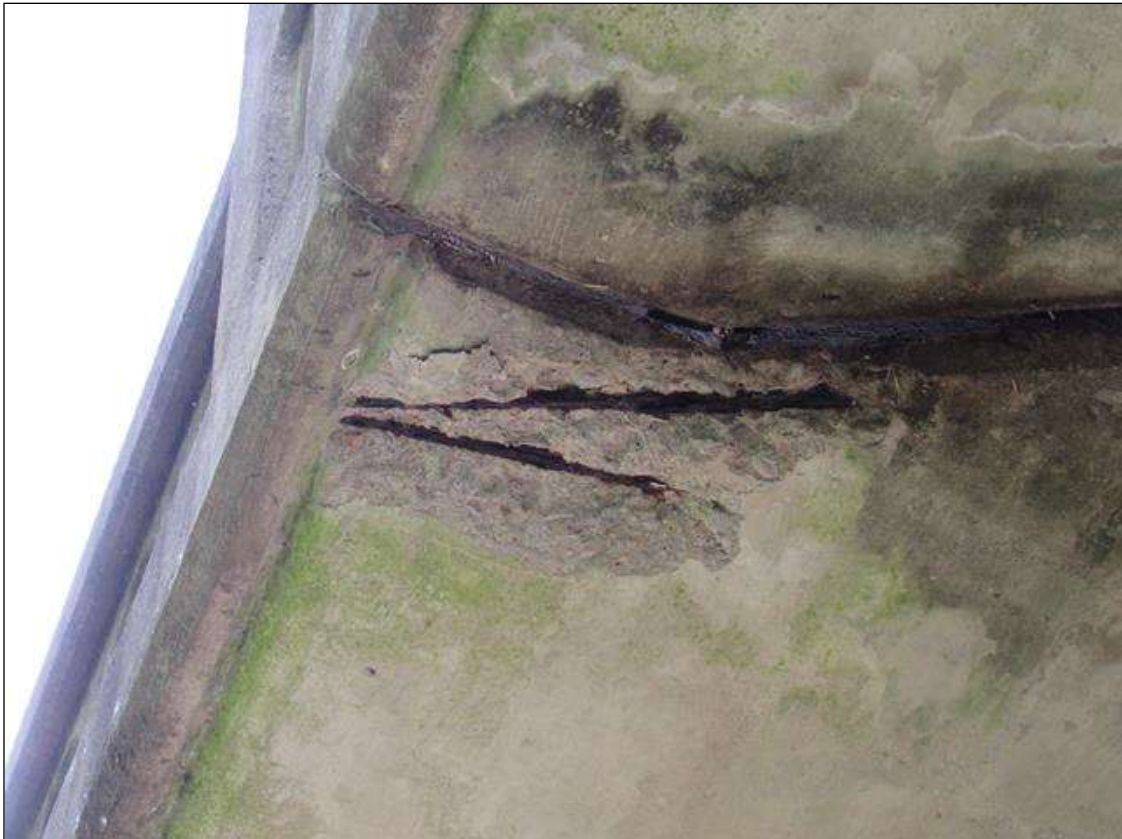
TYPICAL SPALL (UP TO 18IN X 12IN X 2IN) WITH EXPOSED REINFORCING TO UNDERSIDE OF DECK OVERHANG, SPAN 2 NEAR END

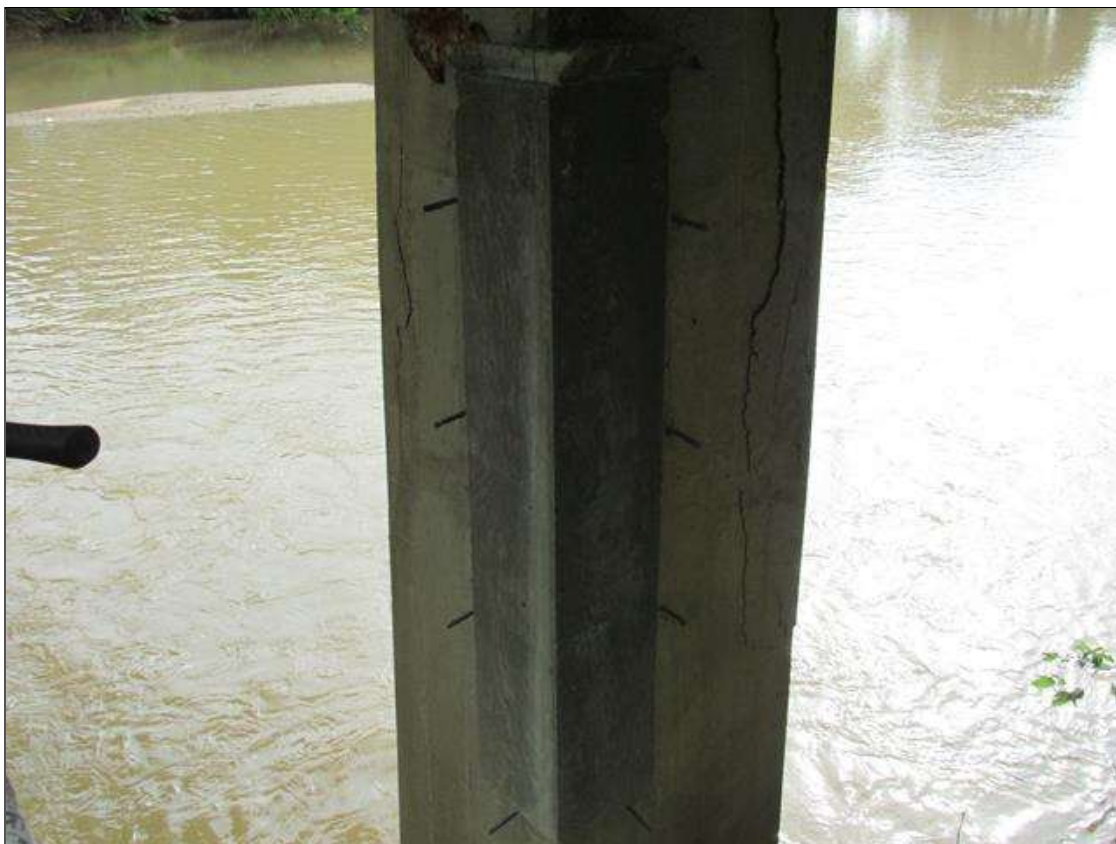
BENT 1 COLUMN 1 - SOUND PATCH (6FT X 2FT) NEAR LEFT CORNER, 3FT FROM BOTTOM OF CAP

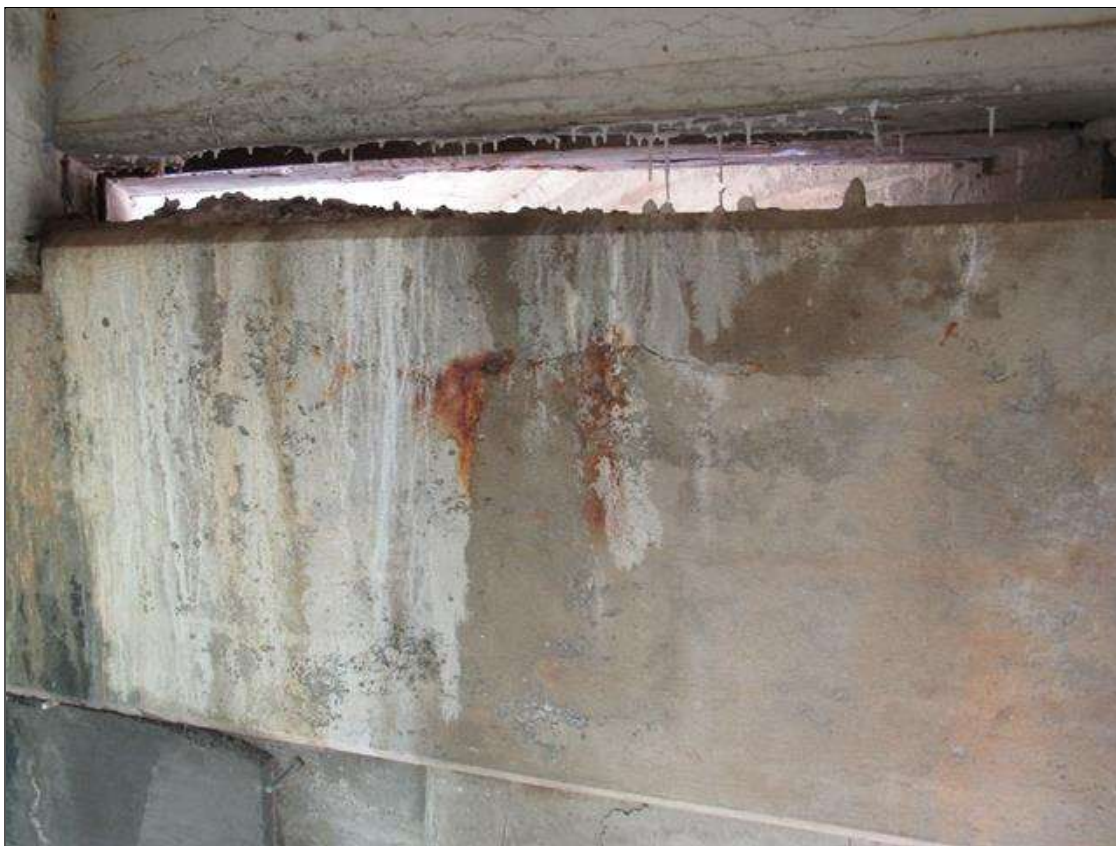
BENT 1 CAP, NEAR FACE - HORIZONTAL 1/32IN CRACK, (4FT L.) WITH EFFLO. & RUST STAINING, ABOVE COLUMN 1

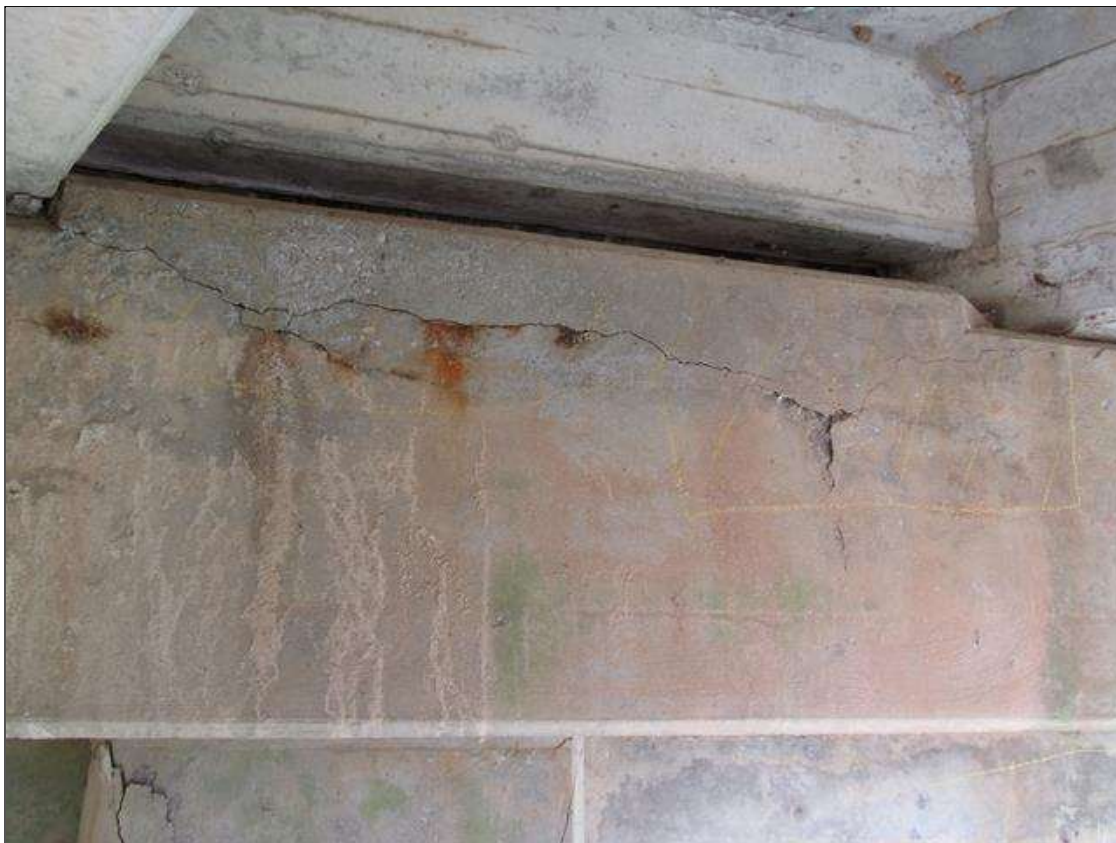
BENT 1 NEAR FACE - DELAM (5SF) ABOVE COLUMN 2

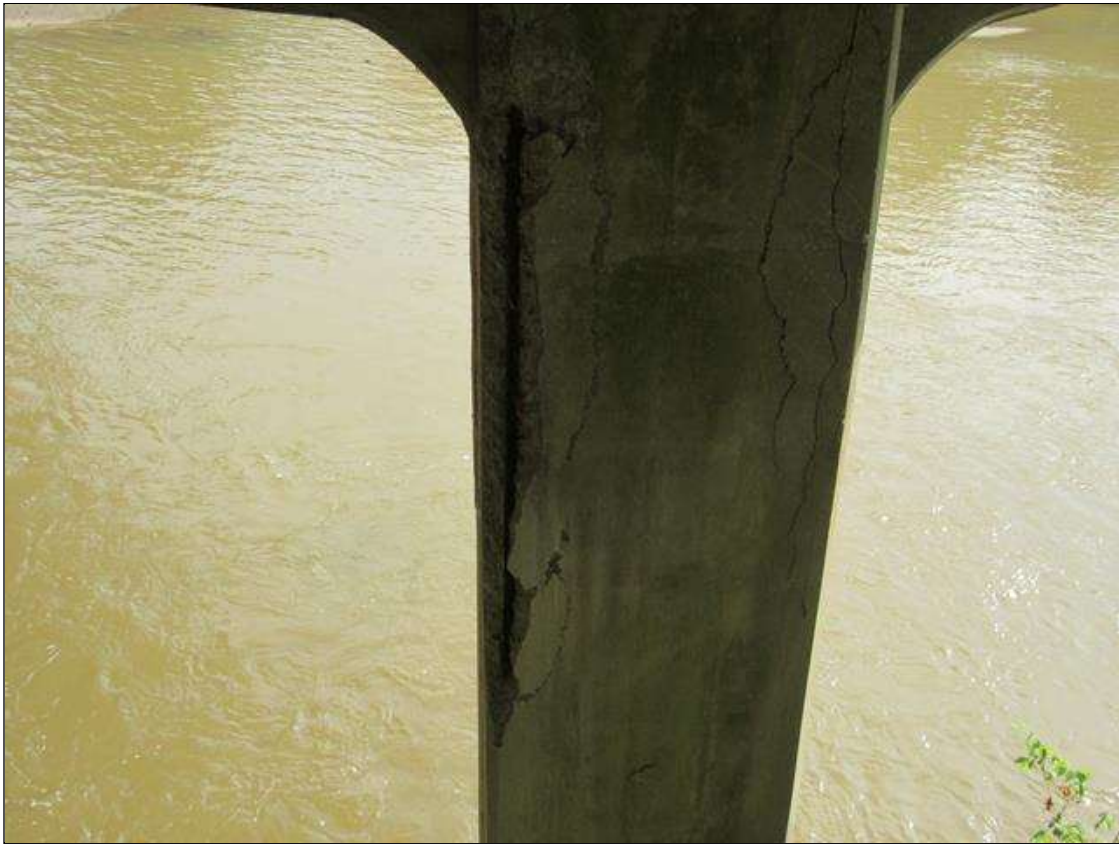
BENT 1 COLUMN 2 - SPALL/DELAM (7FT X 1FT X 4IN) WITH EXPOSED REINFORCING, NEAR LEFT CORNER STARTING AT TOP OF COLUMN. (PAR PHOTO)

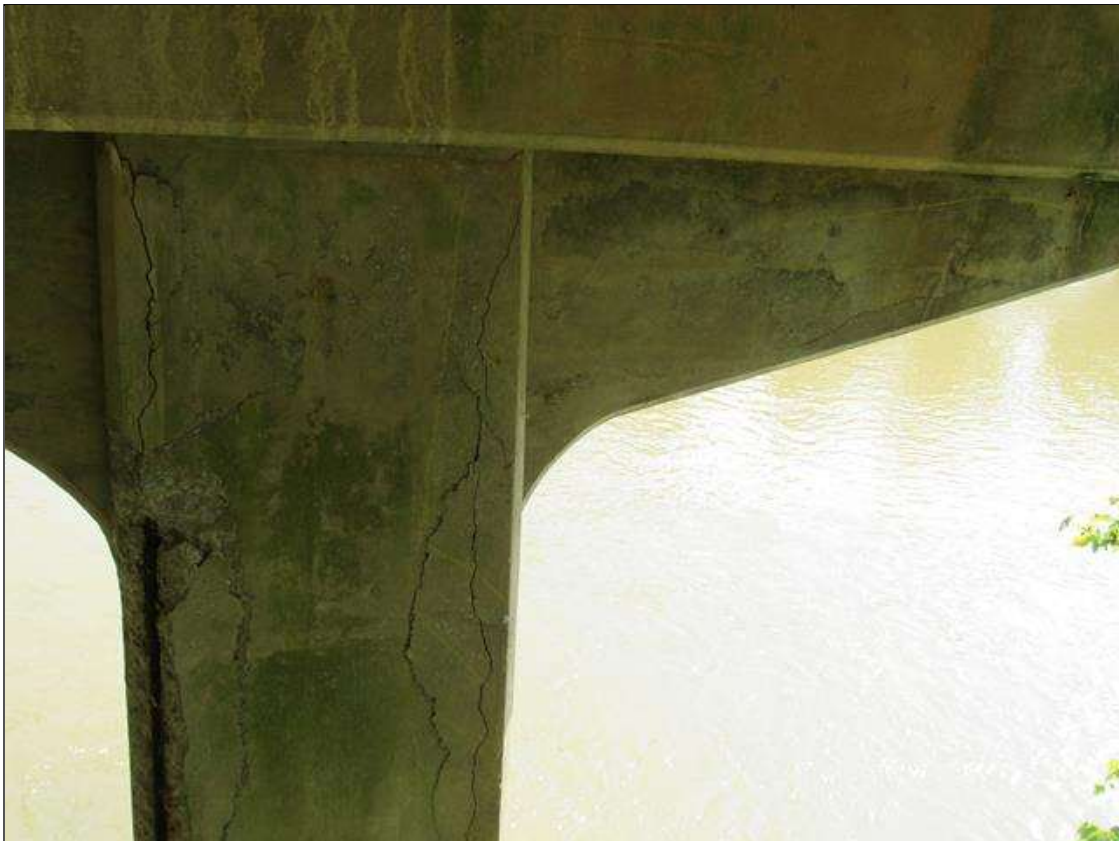
BENT 1 CAP & COLUMN , NEAR FACE - DELAM (6FT X 1FT) NEAR RIGHT CORNER & (3SF) AT RIGHT GUSSET

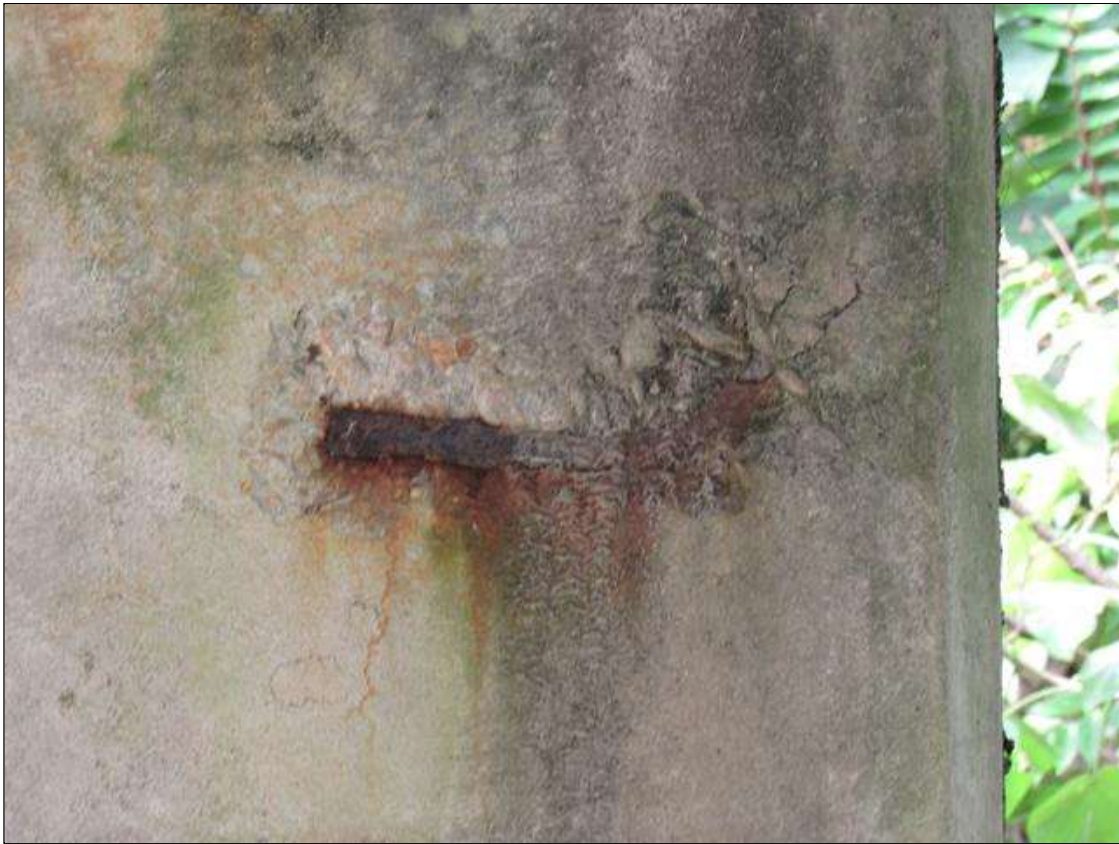
BENT 1 CAP, FAR FACE - SPALL (1FT X 6IN X 1IN) WITH EXPOSED REINFORCING, UNDER BEAM 1

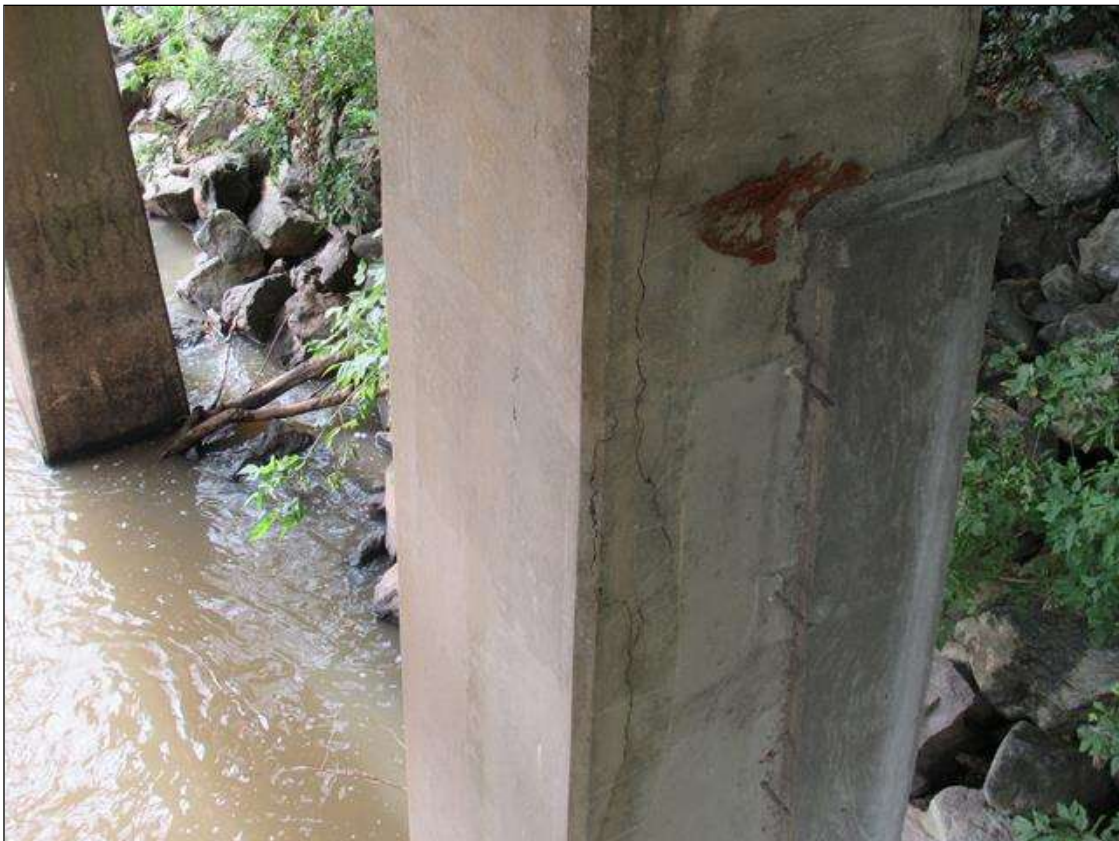
BENT 1 COLUMN 1 - DELAM (6FT X 8IN) FAR LEFT CORNER, STARTING 2FT FROM BOTTOM OF CAP

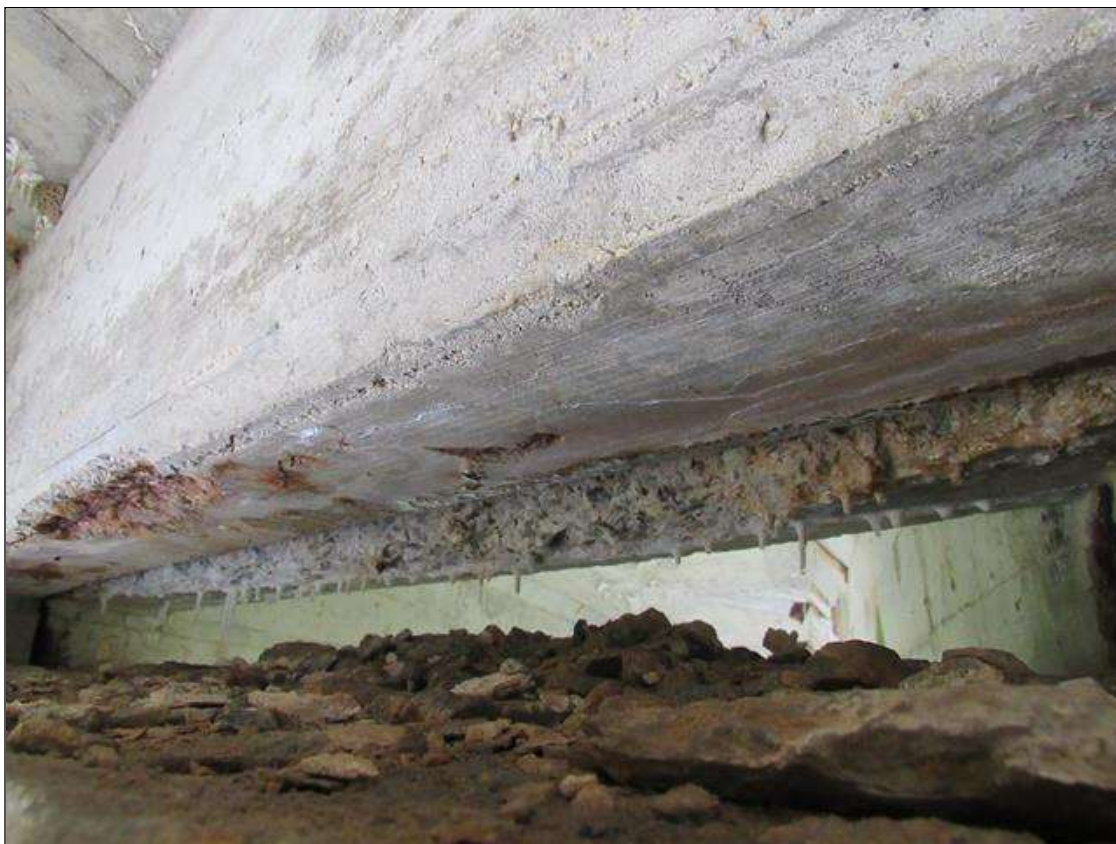
SPAN 1 FAR END, SPAN 2 NEAR END DIAPHRAGM, BAY 1 - SPALL (5FT X 6IN X 3IN) WITH EXPOSED REINFORCING & HEAVY EFFLO.

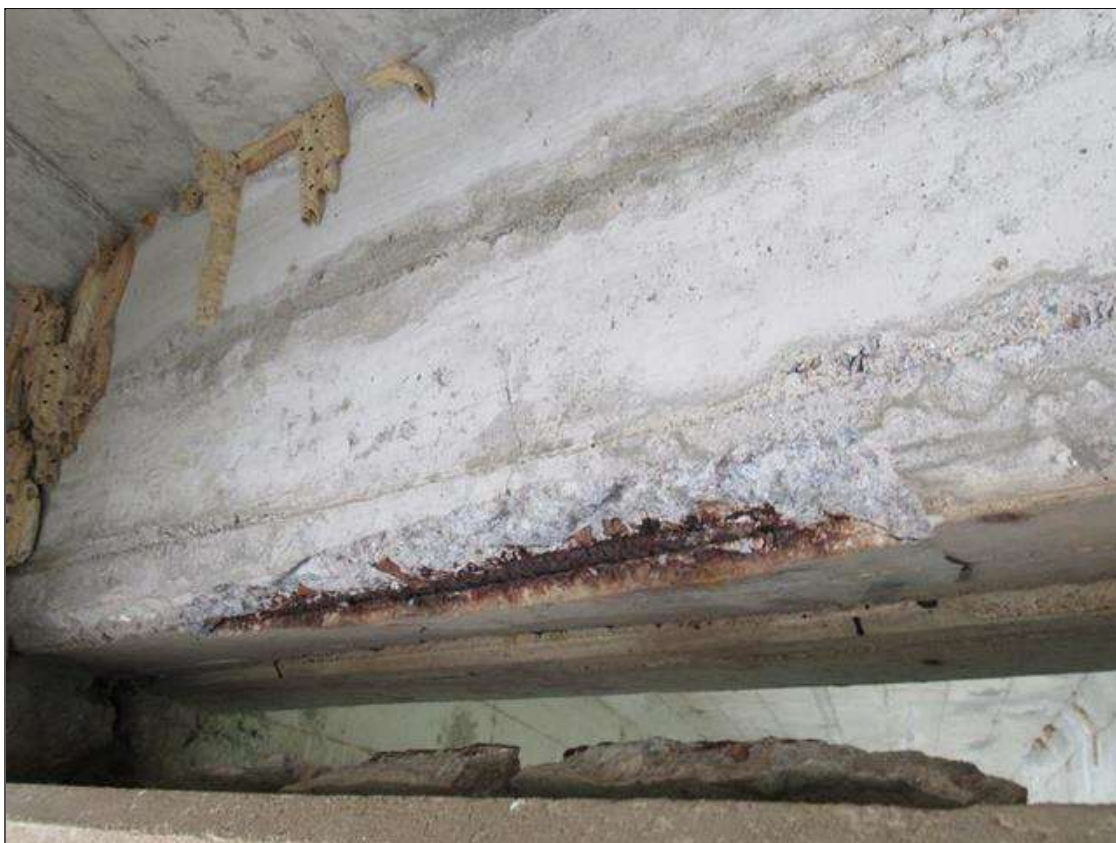
SPAN 2 NEAR END DIAPHRAGM, BAY 2 - SPALL (28IN X 4IN X 2IN) WITH EXPOSED REINFORCING

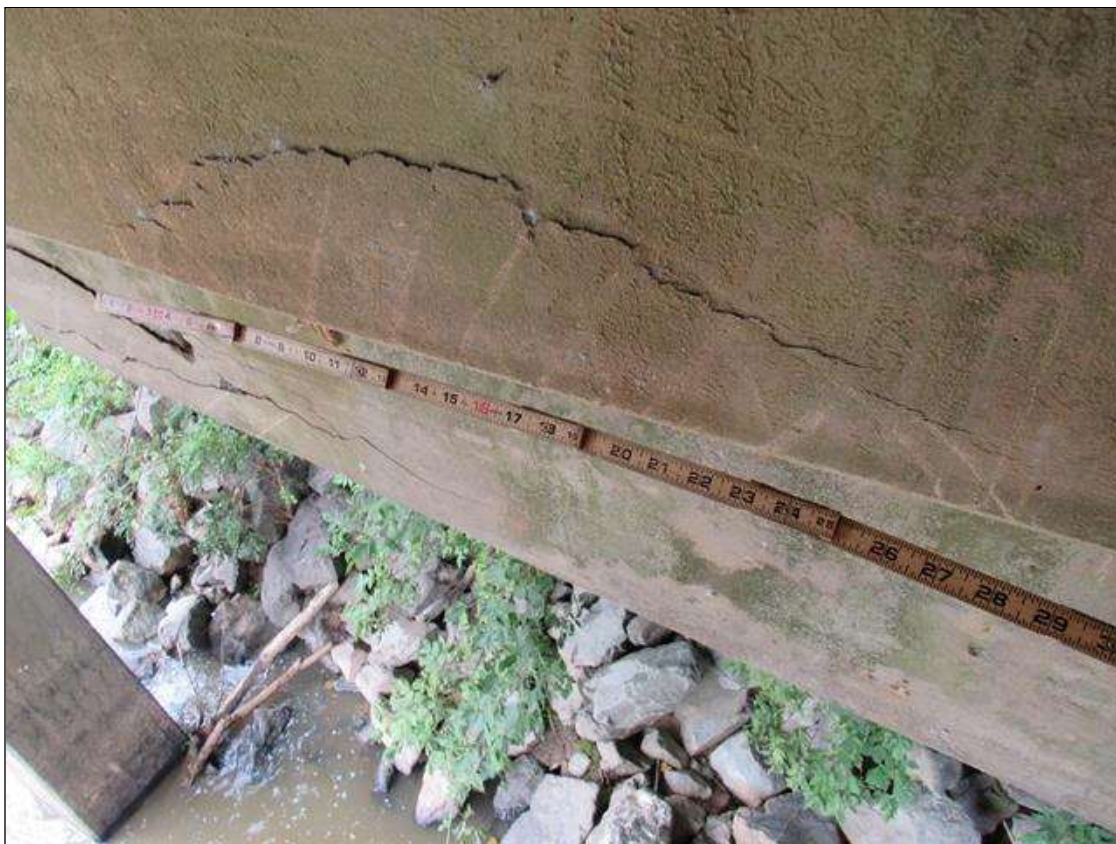
BENT 1 CAP, FAR FACE - DELAM (30IN X 7IN) BOTTOM EDGE UNDER BAY 2
