NC DEPARTMENT OF TRANSPORTATION
 DIVISION OF HIGHWAYS
 STRUCTURE MANAGEMENT UNIT

ATTENTION: **PAR'S ISSUED: SPALLING THROUGHOUT BENTS, SIDEWALKS, BEAM & DRIFT UNDER SPAN 4. SNOOPER USED. CHANGES TO TYP. SECTION SKETCH. CHANGE TO AWS THICKNESS.**

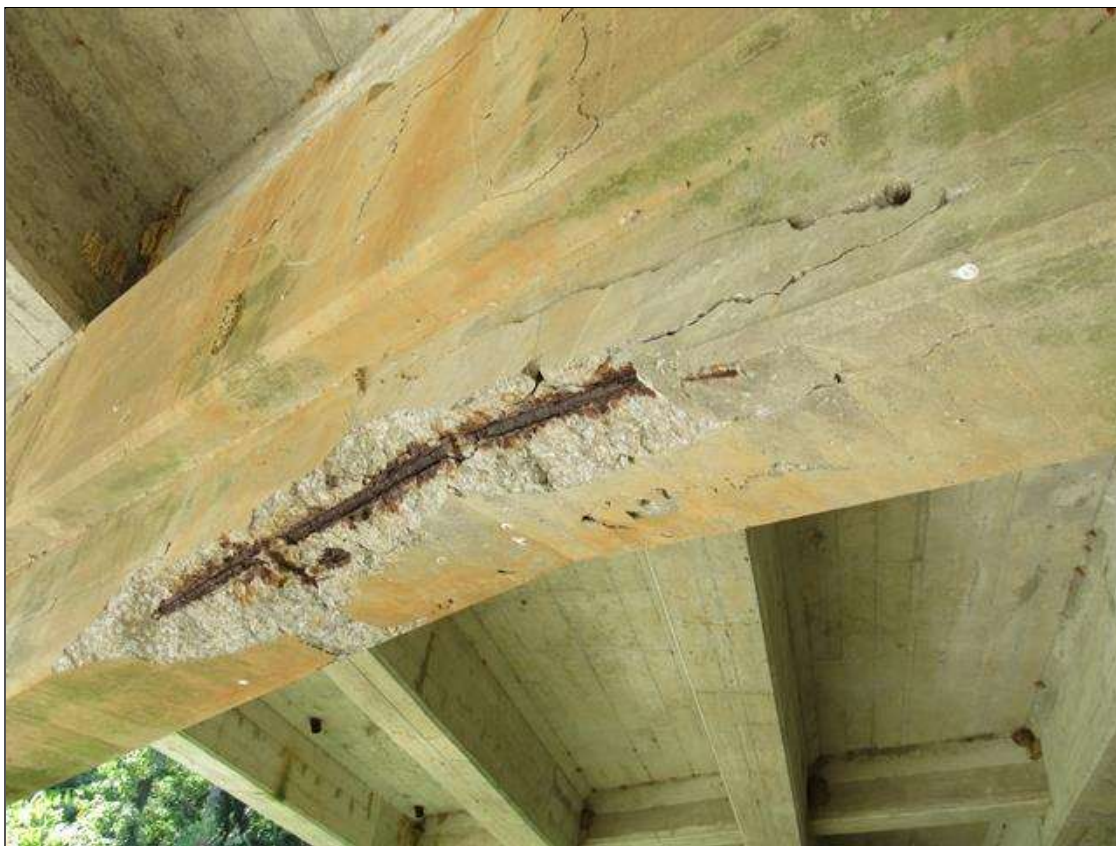
BENT 1 CAP, UNDERSIDE - SPALL/DELAM (9FT X 2FT X 5IN) WITH EXPOSED REINFORCING, UNDER BEAM 3. (PAR PHOTO)

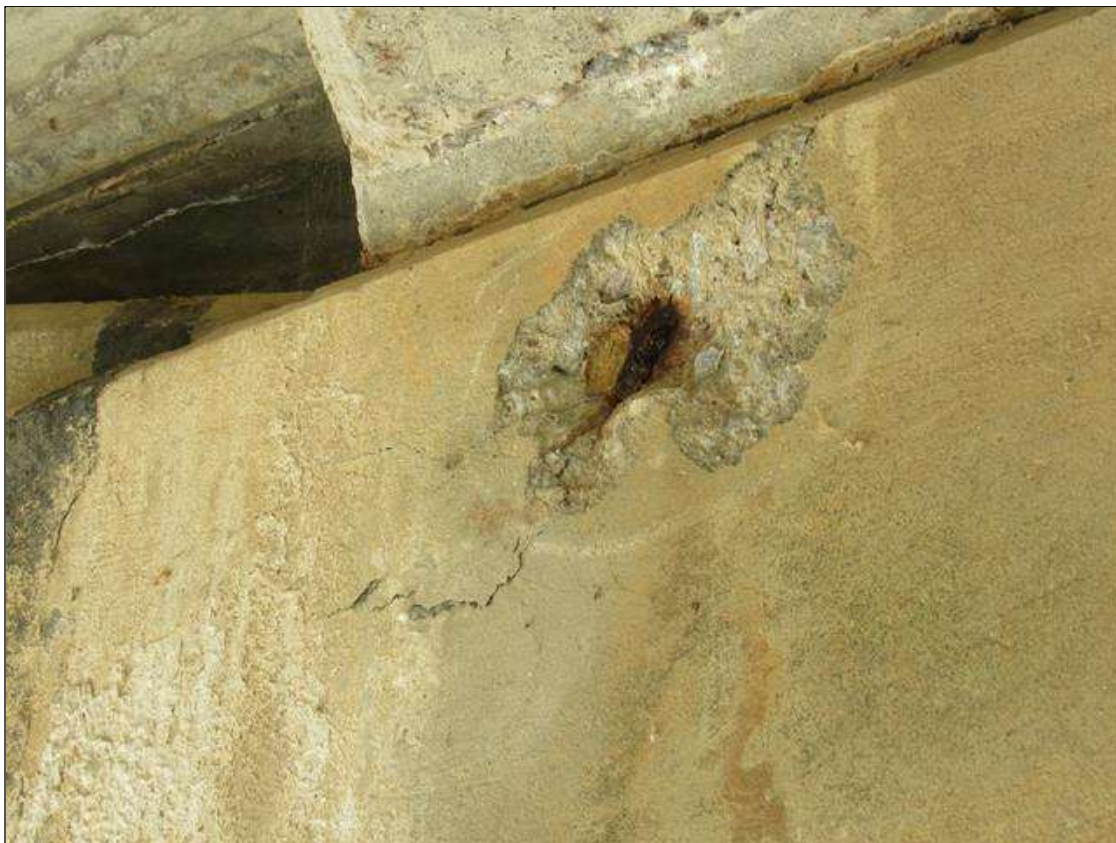
BENT 1 CAP, FAR FACE - SPALL (6IN X 1IN) WITH EXPOSED REINFORCING, UNDER BEAM 4

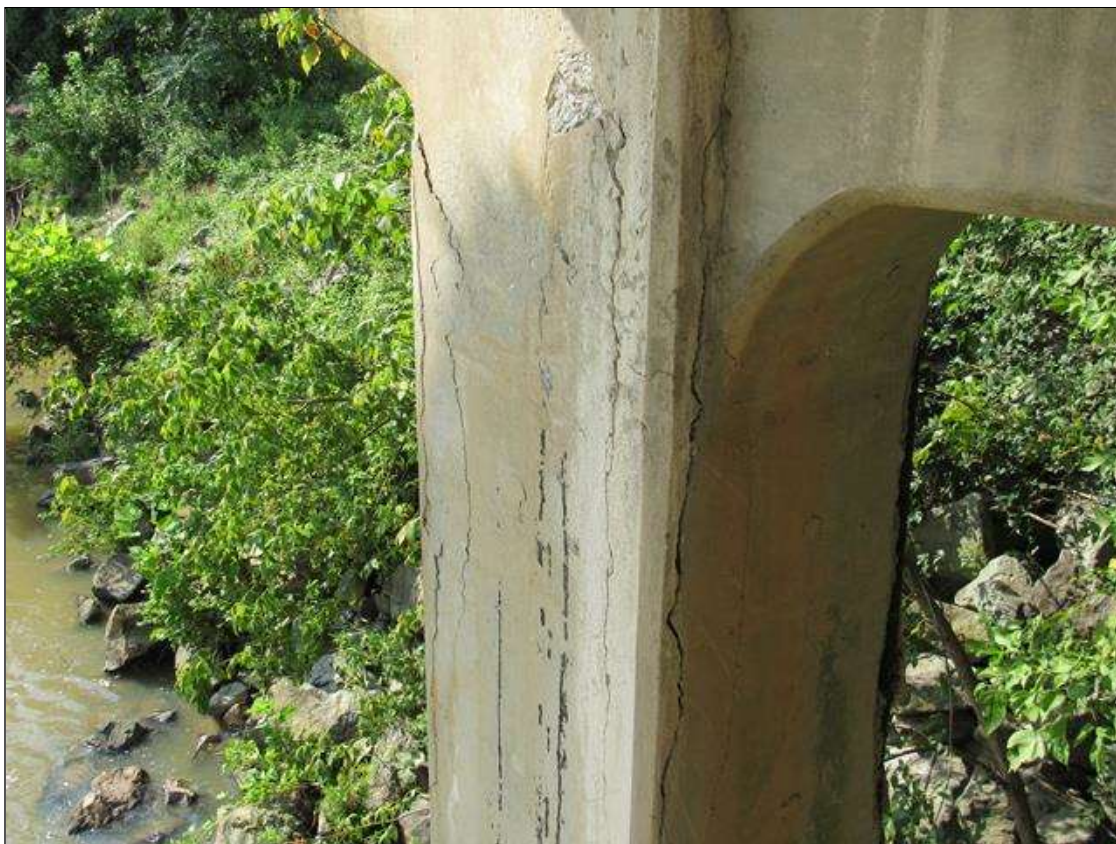
BENT 1 COLUMN 2, FAR FACE - (X2) DELAM (UP TO 7FT X 1FT) FAR LEFT & RIGHT CORNERS, STARTING AT BOTTOM OF CAP

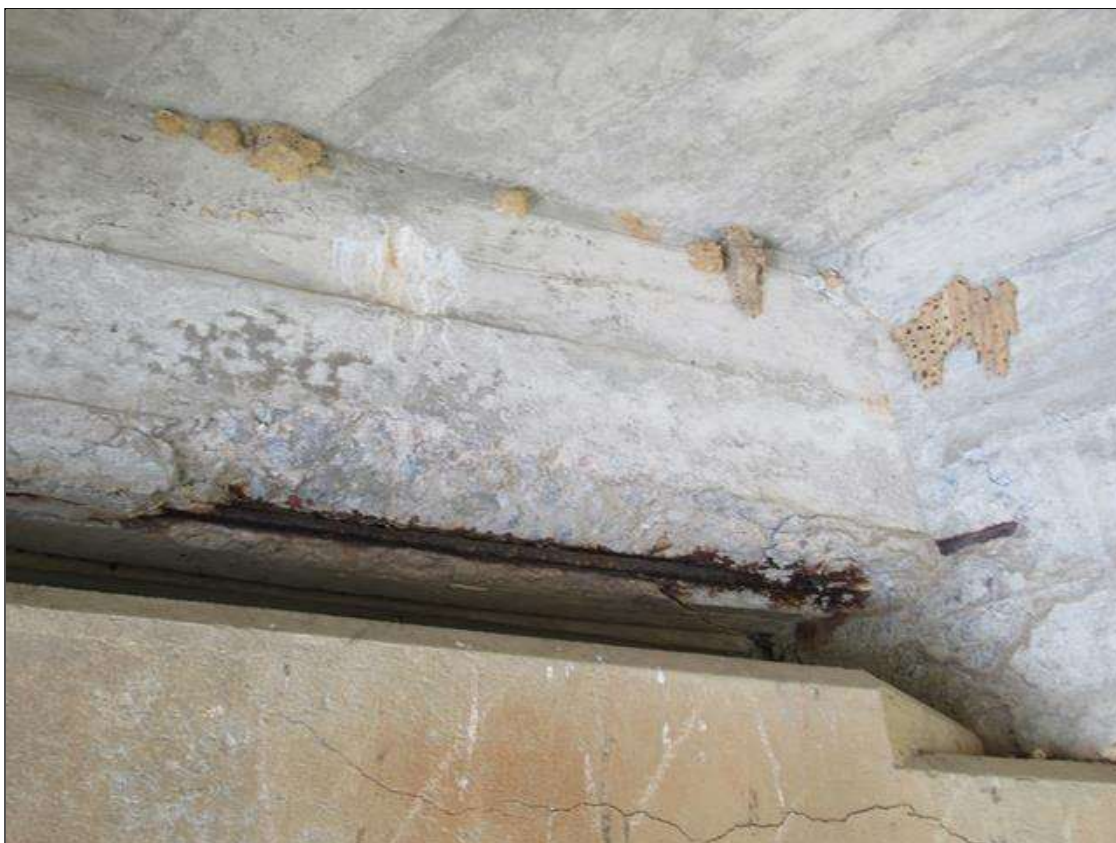
SPAN 2 NEAR END DIAPHRAGM - SPALL (3FT X 6IN X 3IN) WITH EXPOSED REINFORCING, RIGHT OF BEAM 3

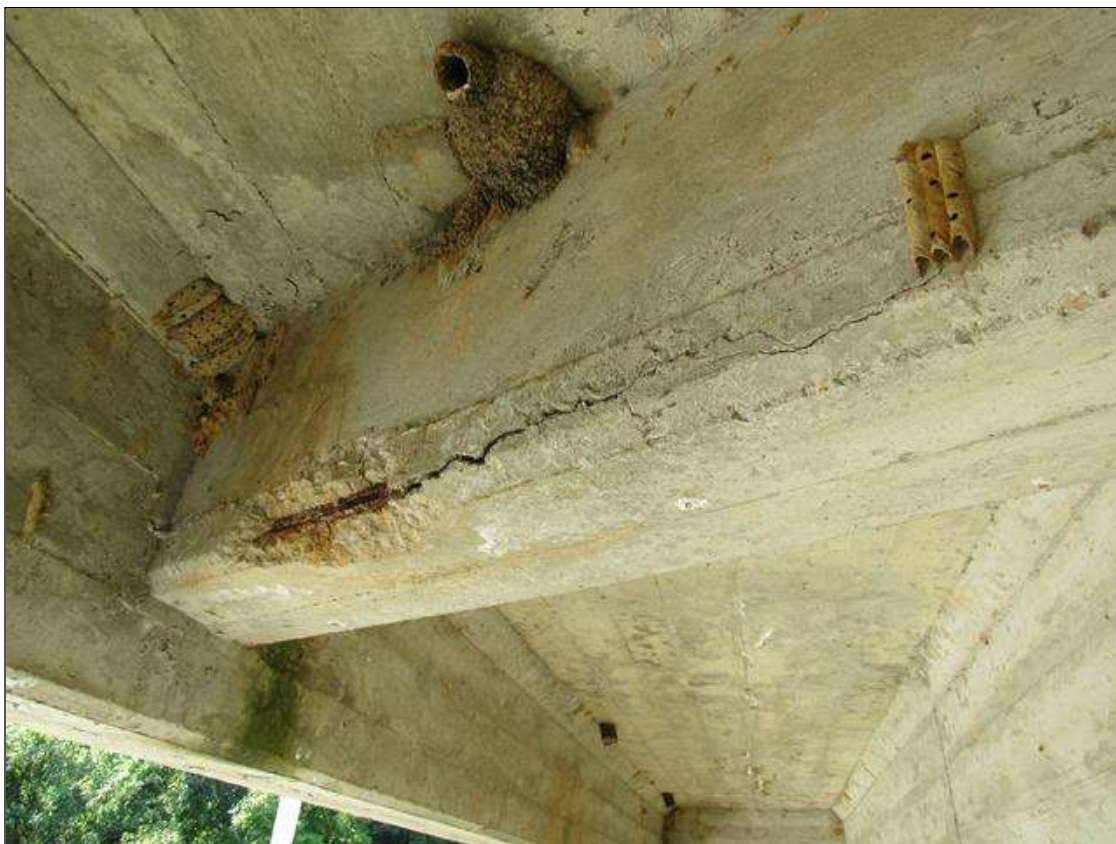
SPAN 2 BAY 4 MID-SPAN DIAPHRAGM - SPALL/DELAM (3FT X 6IN X 3IN) WITH REINFORCING EXPOSED

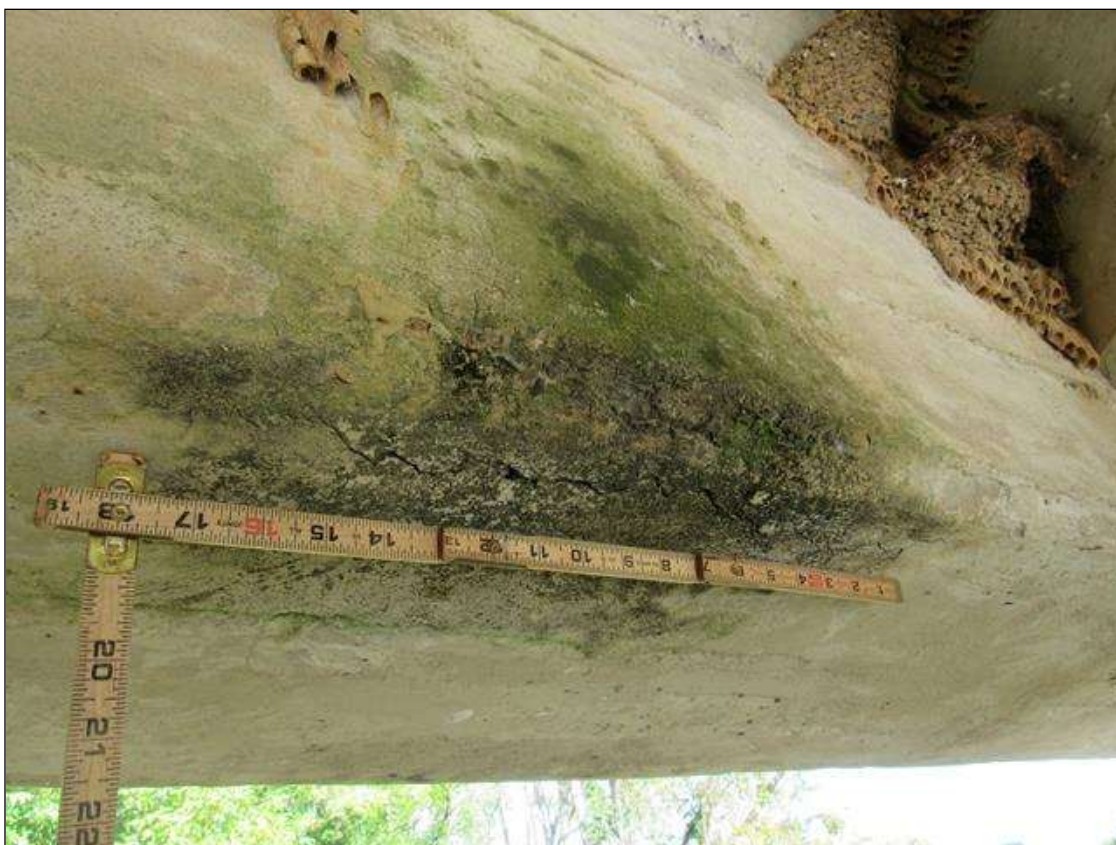
SPAN 2 BEAM 1 - DELAM (16IN X 8IN) BOTTOM RIGHT AT MID-SPAN

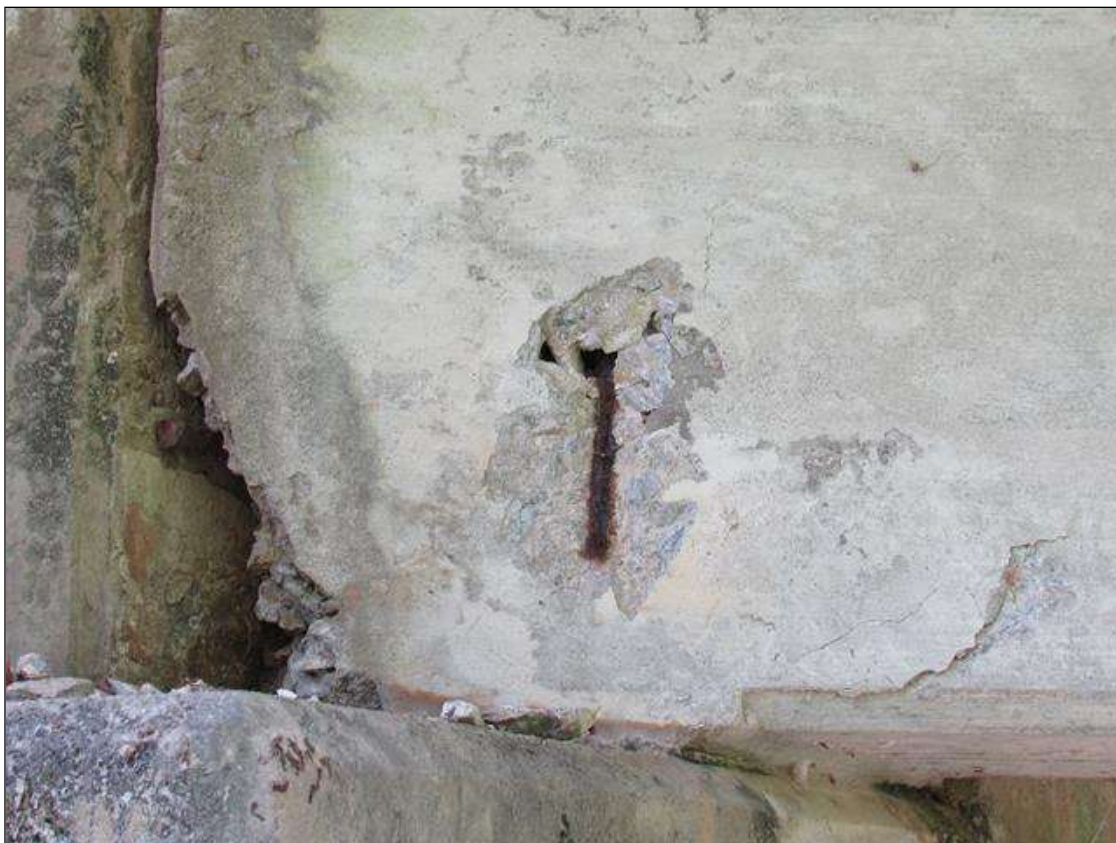
SPAN 2 BEAM 1 - SPALL/DELAM (2SF X 5IN) WITH EXPOSED REINFORCING, LEFT SIDE FAR END

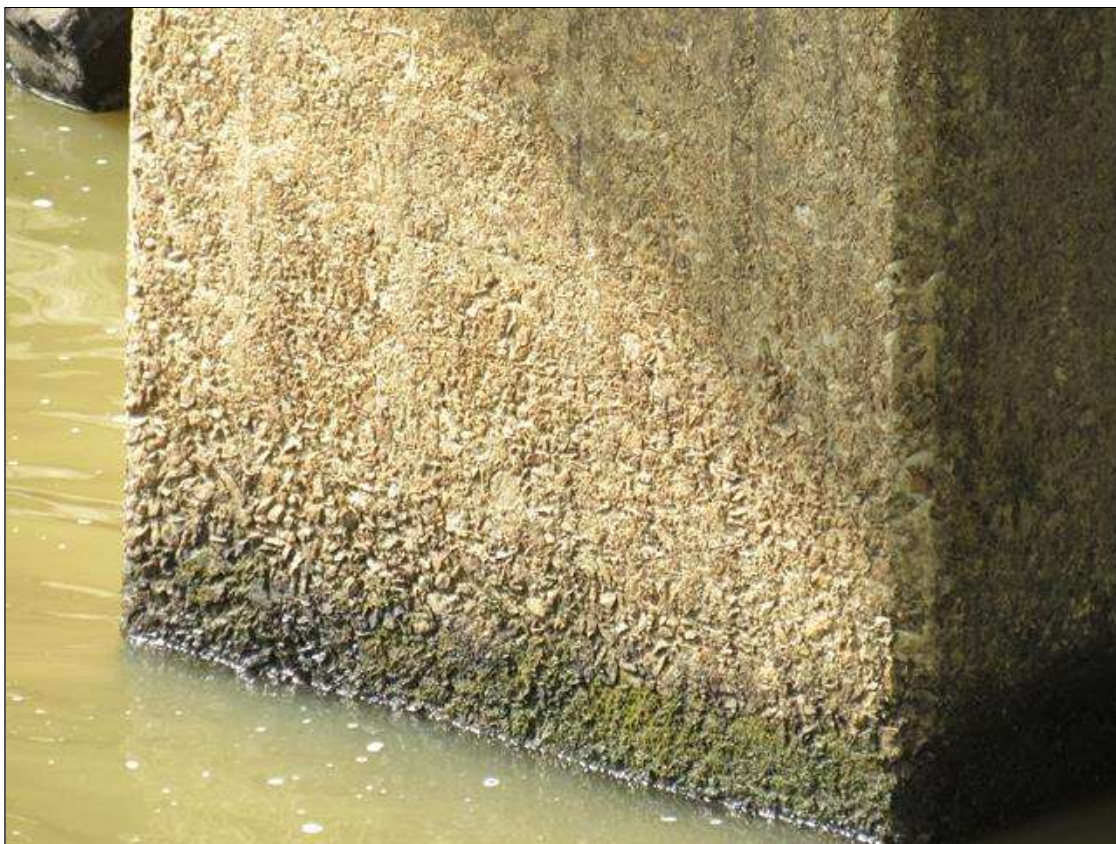
TYPICAL WATER SCALING, (UP TO 2FT H.) THROUGHOUT COLUMNS AT WATERLINE, BENT 1 COLUMN 1 FAR FACE

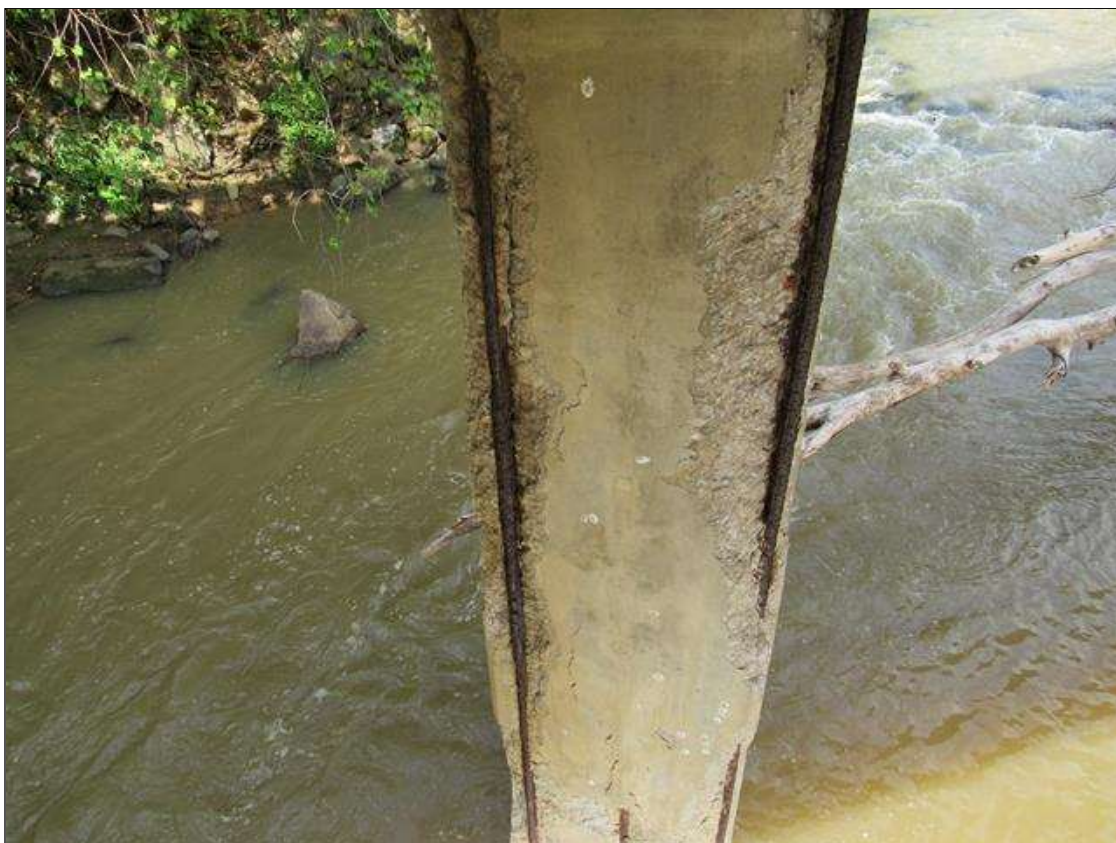
BENT 2 COLUMN 1, RIGHT SIDE - SPALL/DELAM (UP TO 25FT L. X 3FT W. X 6IN D.) WITH EXPOSED REINFORCING. (PAR PHOTO)

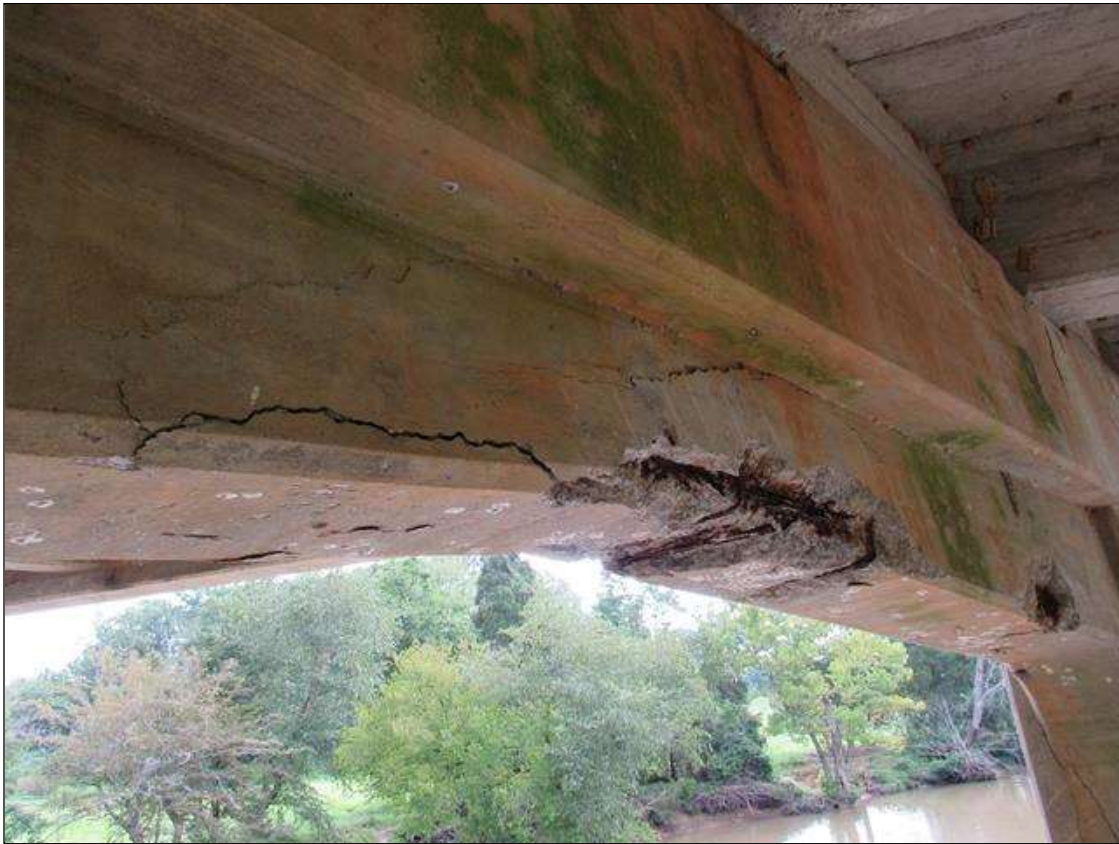
BENT 2 CAP, NEAR FACE - SPALL/DELAM (UP TO 7FT X 2FT X 5IN) WITH EXPOSED REINFORCING. (PAR PHOTO)

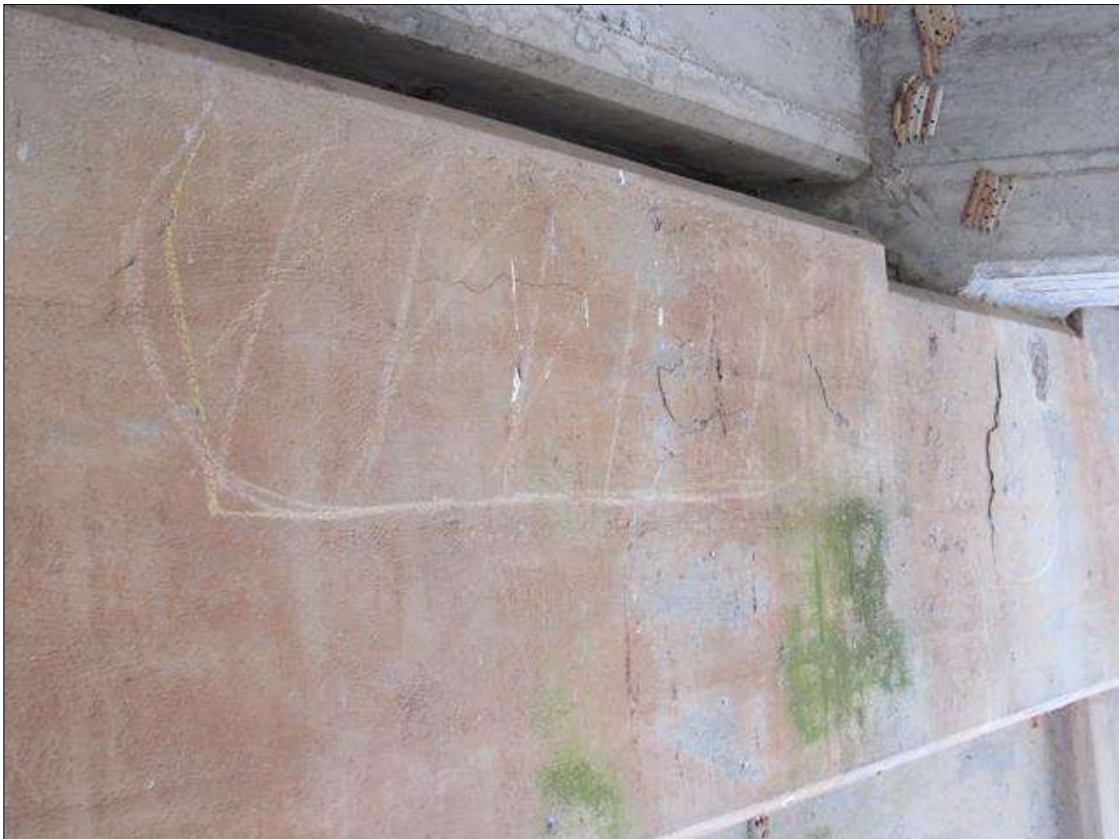
BENT 2 CAP, NEAR FACE - DELAM (5SF) UNDER BAY 3

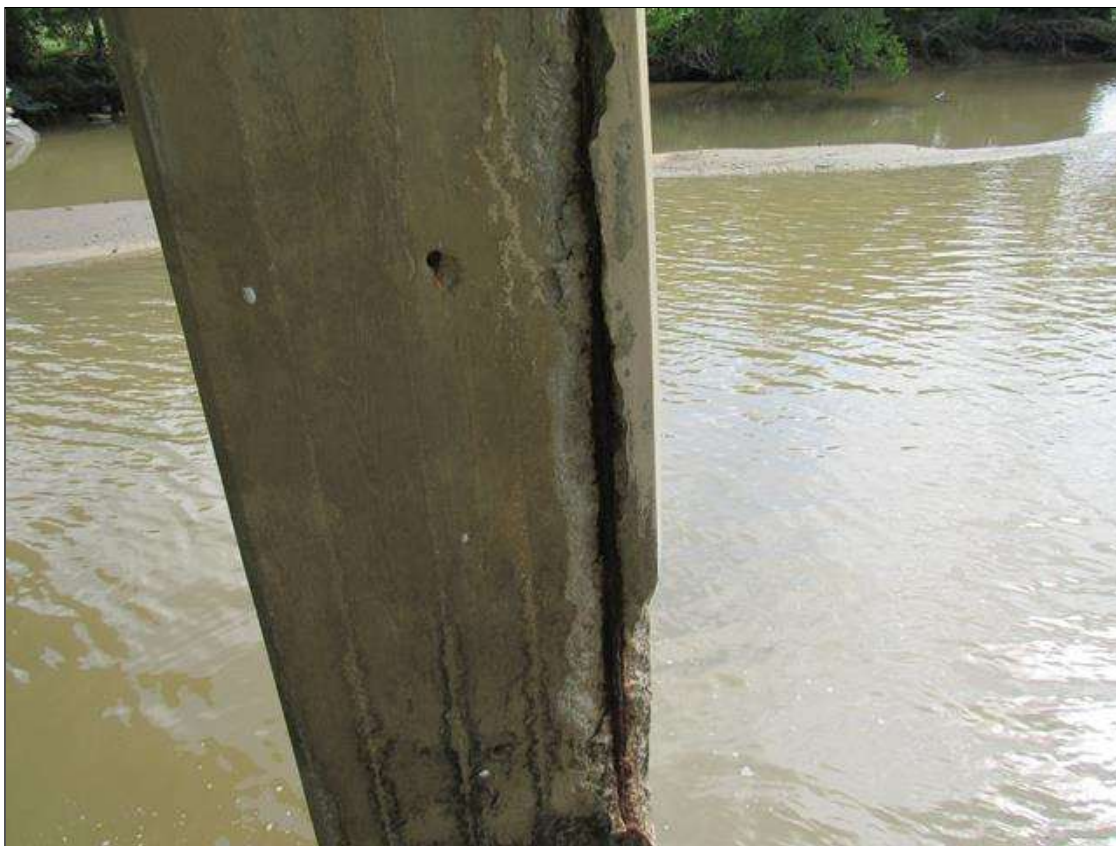
BENT 2 COLUMN 2 - SPALL/DELAM (10FT X 1FT X 4IN) WITH EXPOSED REINFORCING, NEAR RIGHT CORNER, STARTING 6FT DOWN FROM CAP. (PAR PHOTO)

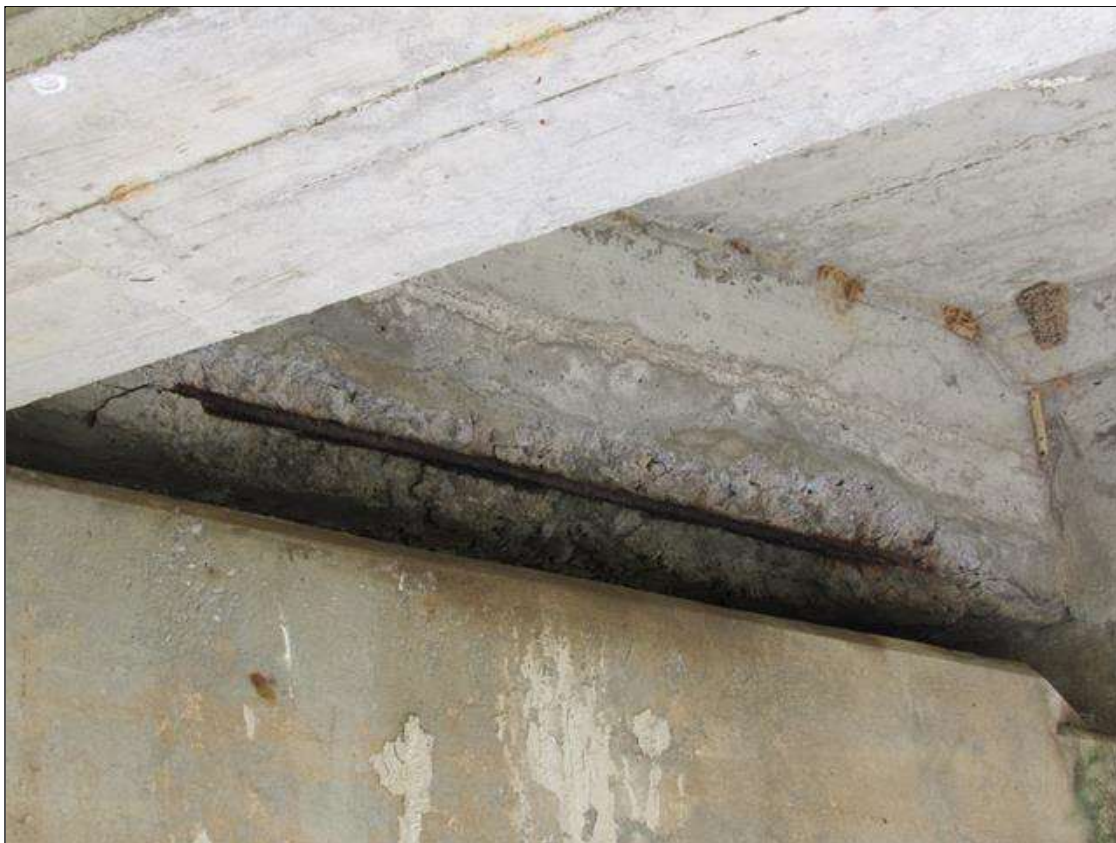
SPAN 2 FAR END DIAPHRAGM, BAY 4 - SPALL (4FT X 6IN X 3IN) WITH EXPOSED REINFORCING

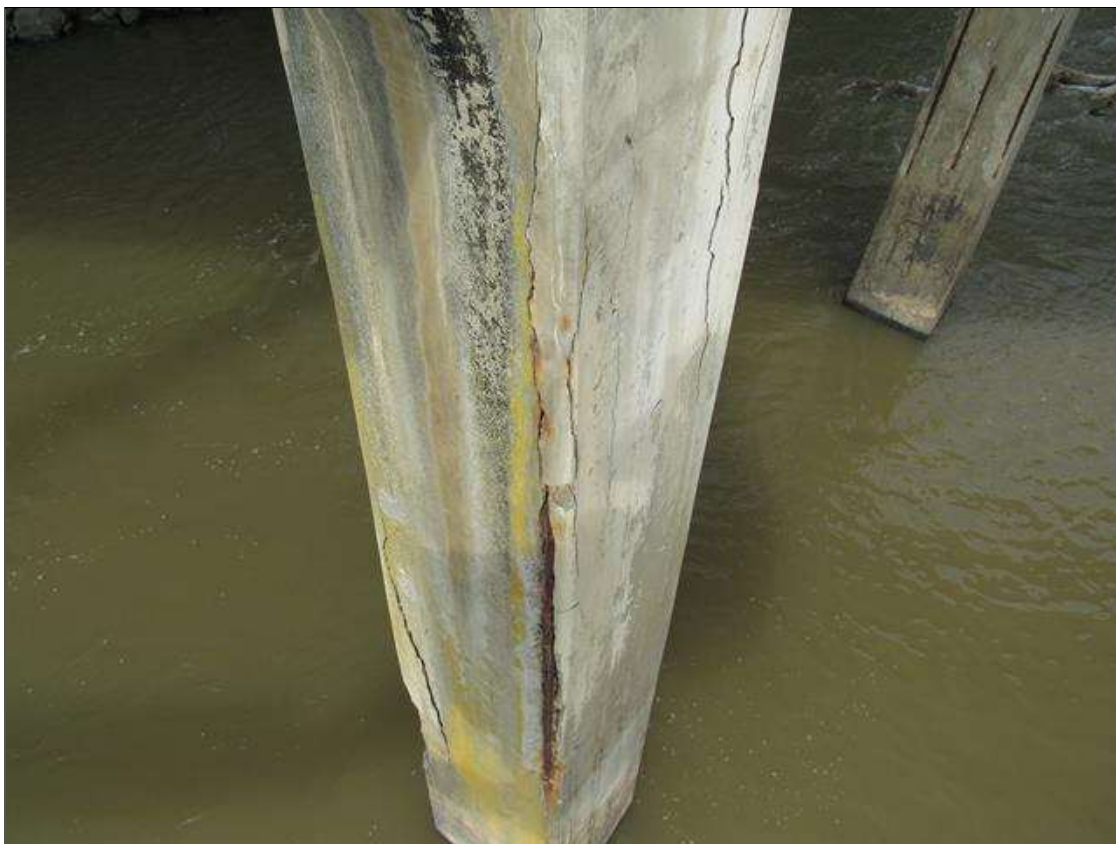
BENT 2 COLUMN 2 - SPALL/DELAM (15FT L. X 1FT W. X 6IN D.) WITH EXPOSED REINFORCING, FAR RIGHT CORNER STARTING AT CAP. (PAR PHOTO)

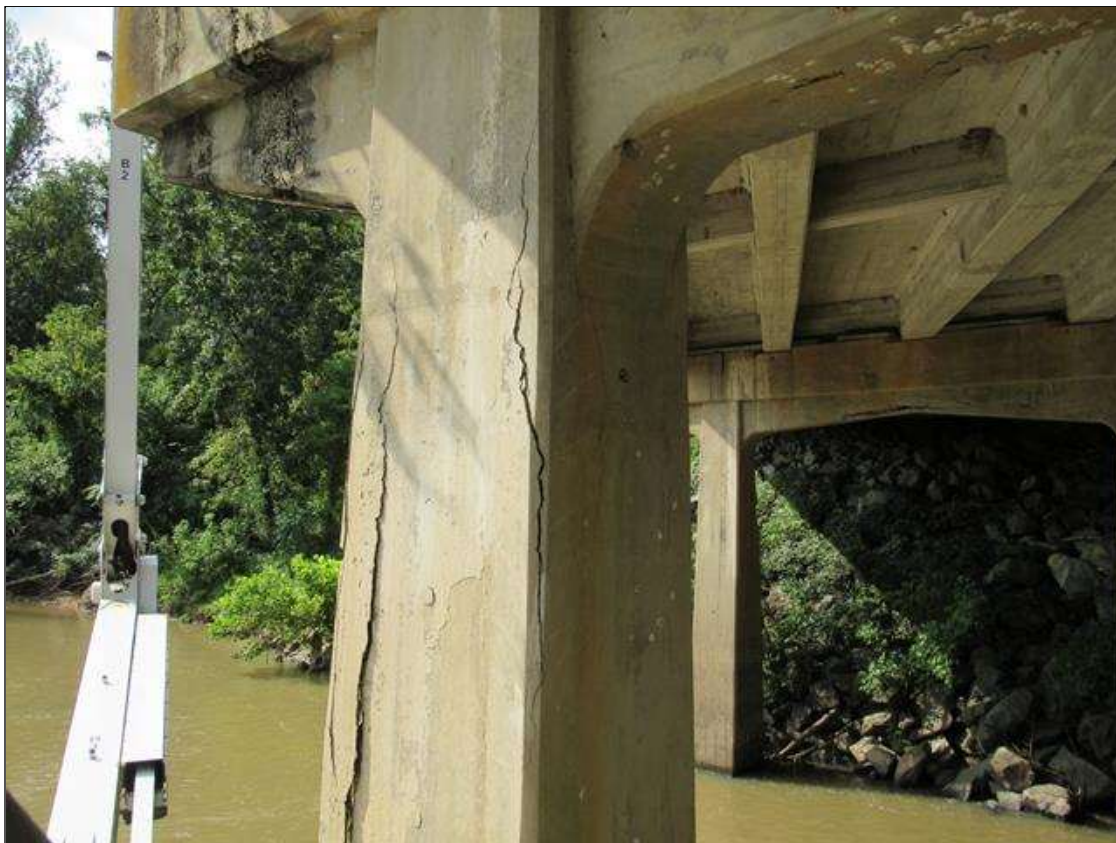
BENT 2 COLUMN 2 - DELAM (6FT X 1FT) FAR LEFT CORNER STARTING AT CAP

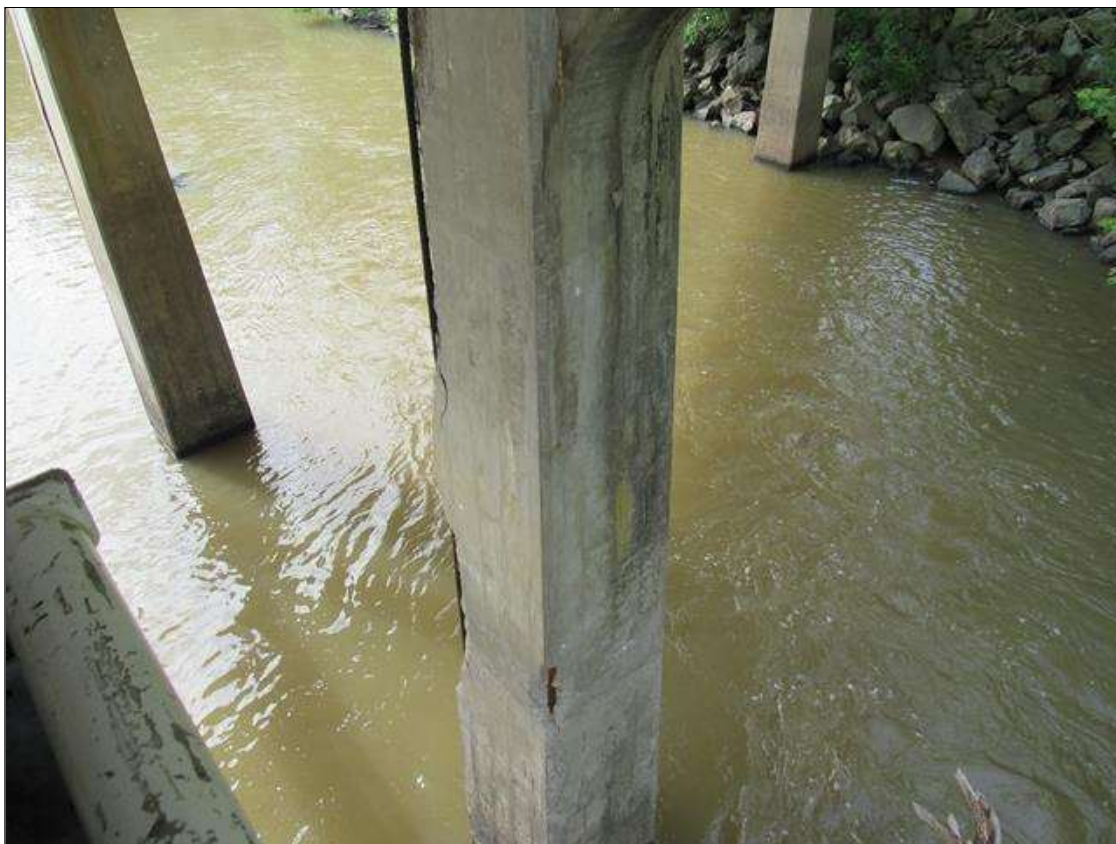
BENT 2 COLUMN 1 - DELAM/SPALL (8FT X 8IN X 3IN) WITH EXPOSED REINFORCING, STARTING 3FT FROM CAP, FAR LEFT CORNER

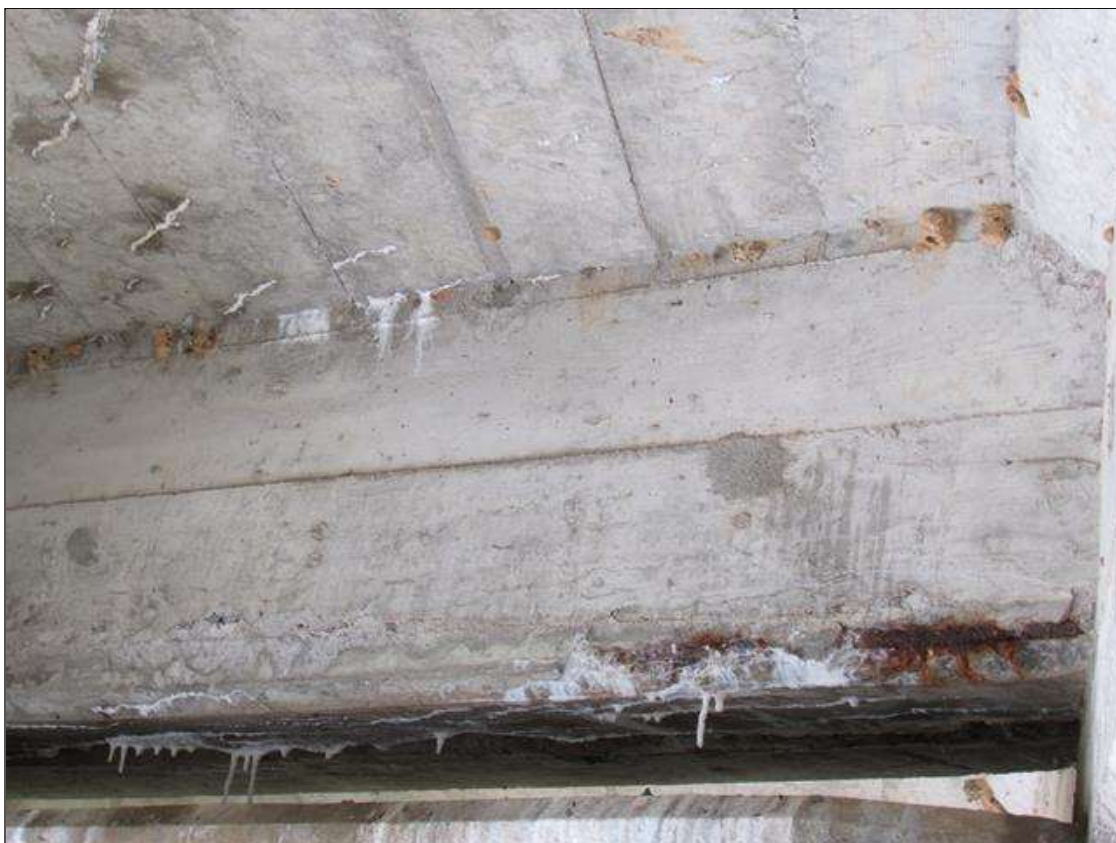
SPAN 3 NEAR END DIAPHRAGM, BAY 1 - SPALL (2FT X 4IN X 1IN) WITH EXPOSED REINFORCING & EFFLO.

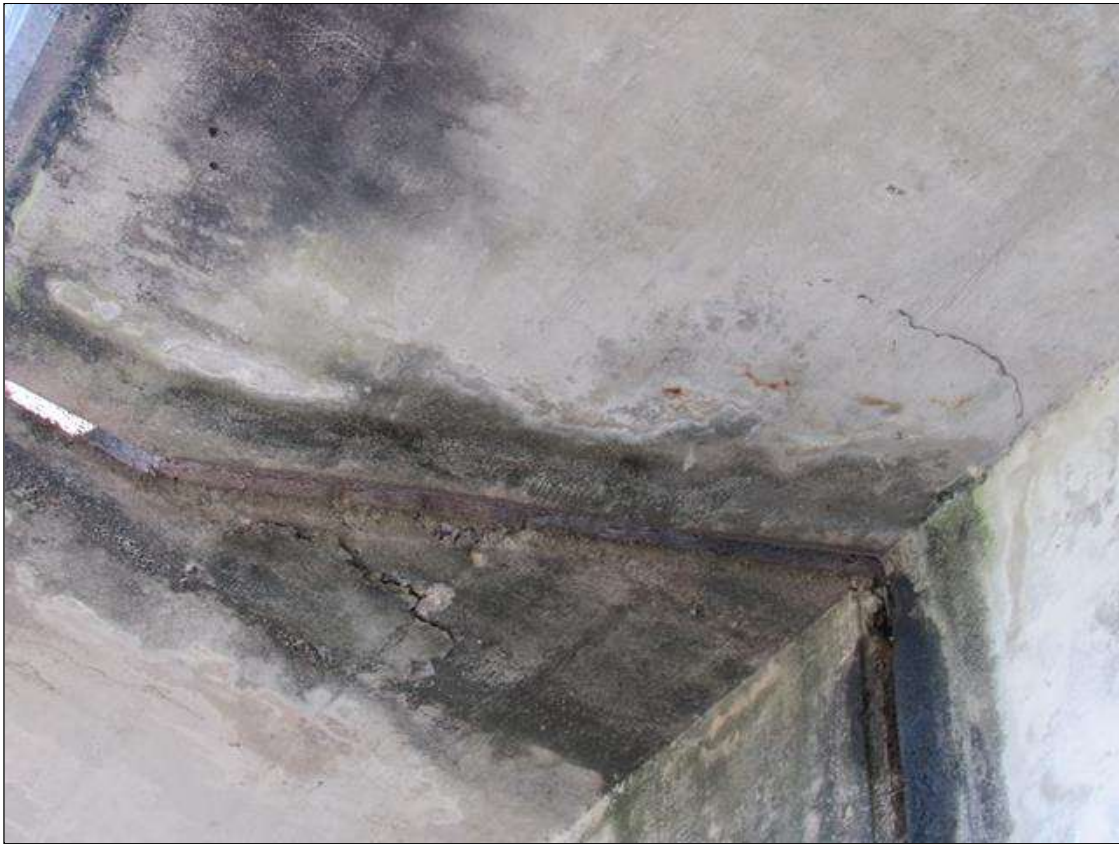
SPAN 3 FAR END & SPAN 4 NEAR END UNDESIDE OF DECK OVERHANG - DELAM (2SF), LEFT SIDE

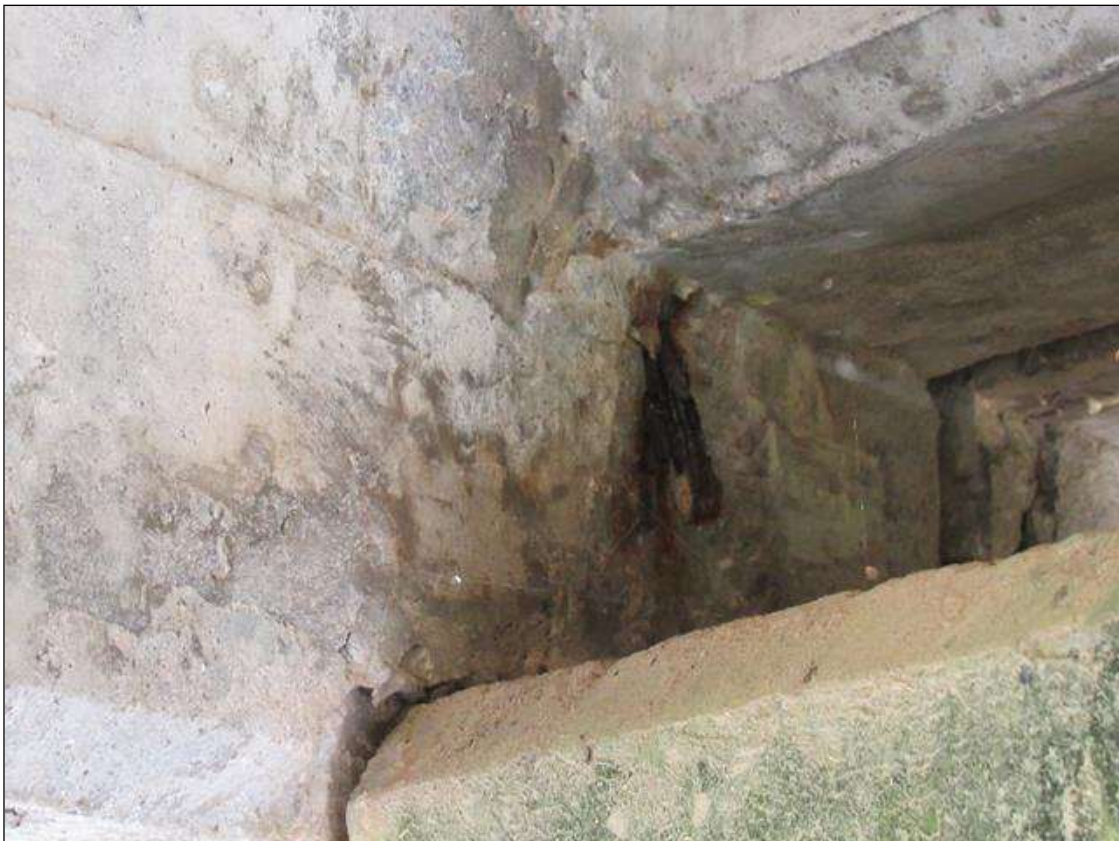
SPAN 3 BEAM 1 - SPALL (6IN X 1IN) WITH EXPOSED REINFORCING, RIGHT SIDE FAR END

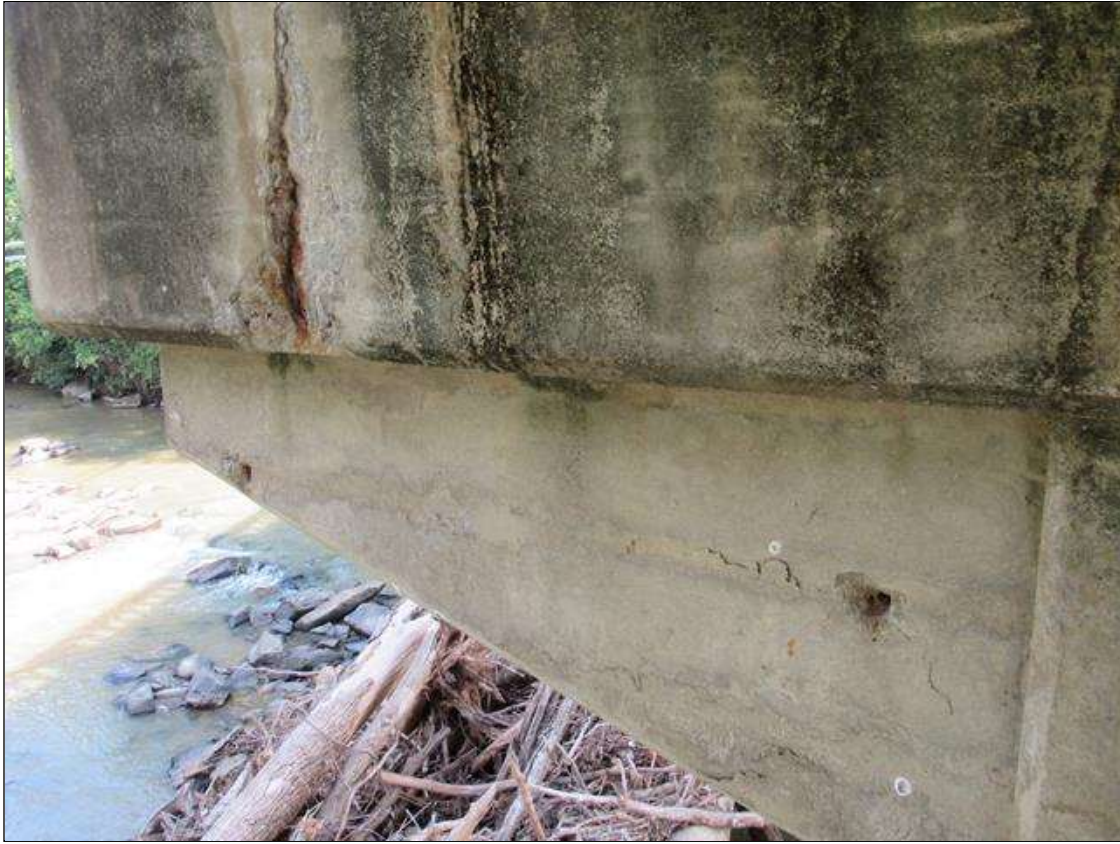
BENT 3 NEAR FACE - SPALL (18IN X 10IN X 2IN) WITH EXPOSED REINFORCING & DELAM (2SF) TO GUSSET UNDER BEAM 1

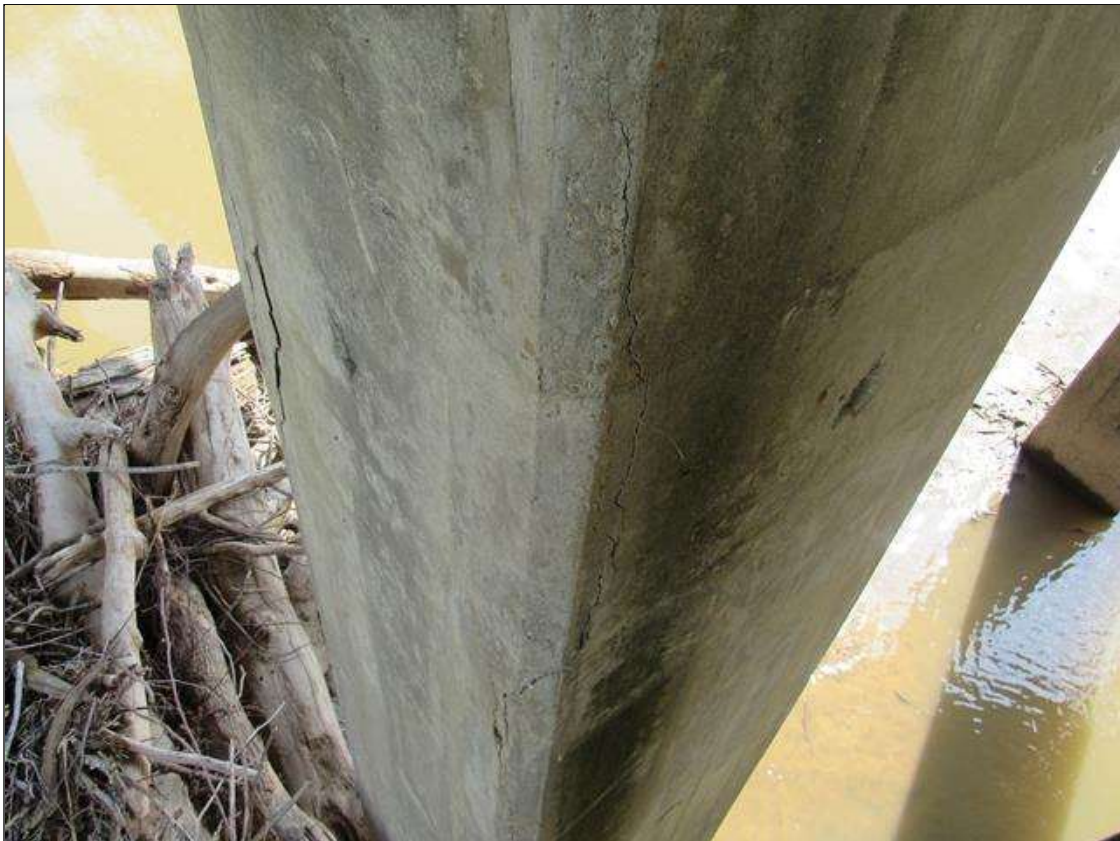
BENT 3 COLUMN 1 - DELAM (2.5FT X 6IN) NEAR LEFT CORNER, STARTING 2FT FROM CAP

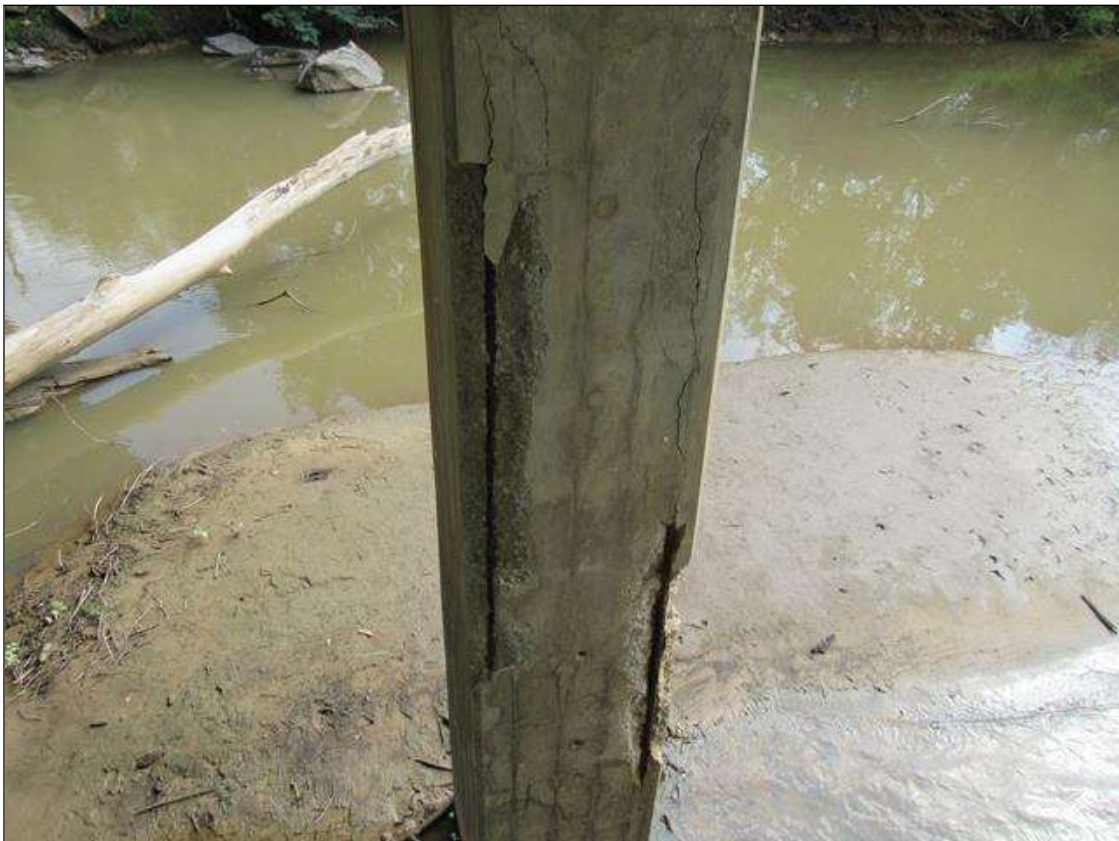
BENT 3 COLUMN 2 - (X2) SPALL/DELAM (UP TO 18FT L. X 1FT W. X 5IN D.) WITH EXPOSED REINFORCING, NEAR FACE LEFT & RIGHT CORNERS. (PAR PHOTO)

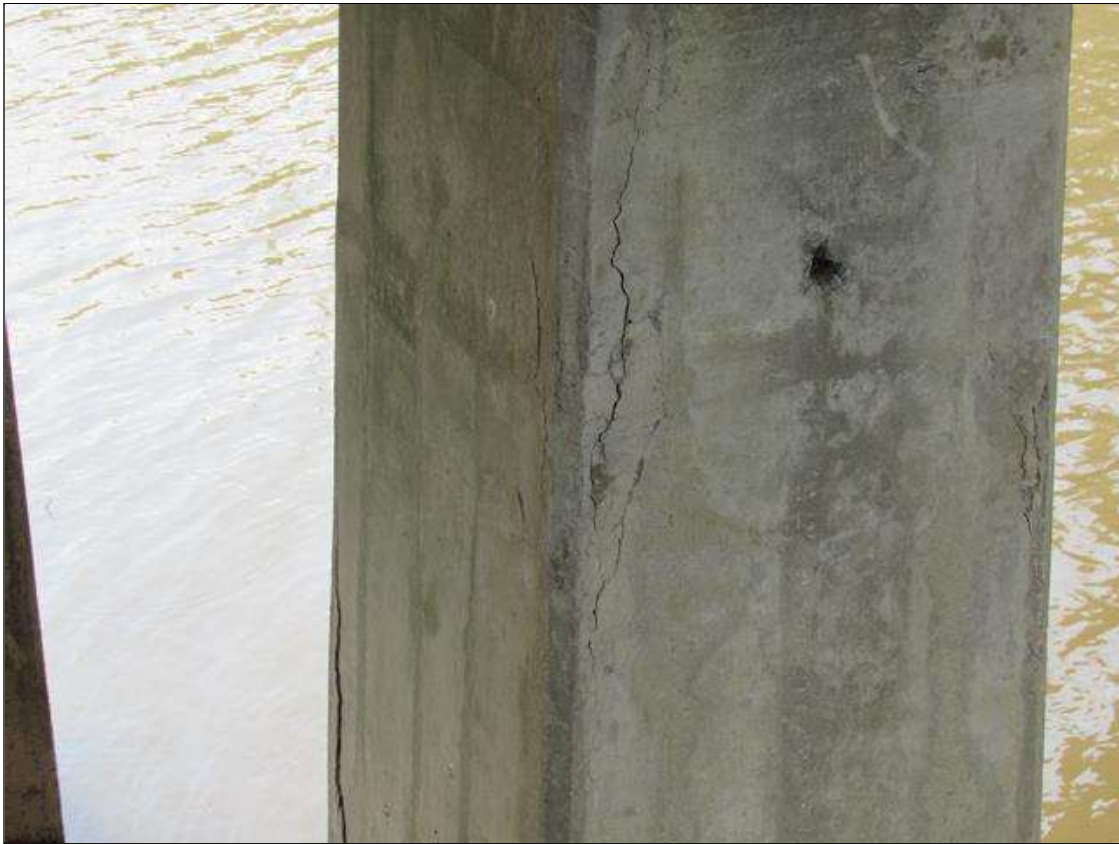
BENT 3 COLUMN 1 - DELAM (3FT X 6IN) FAR LEFT CORNER STARTING 4FT FROM CAP

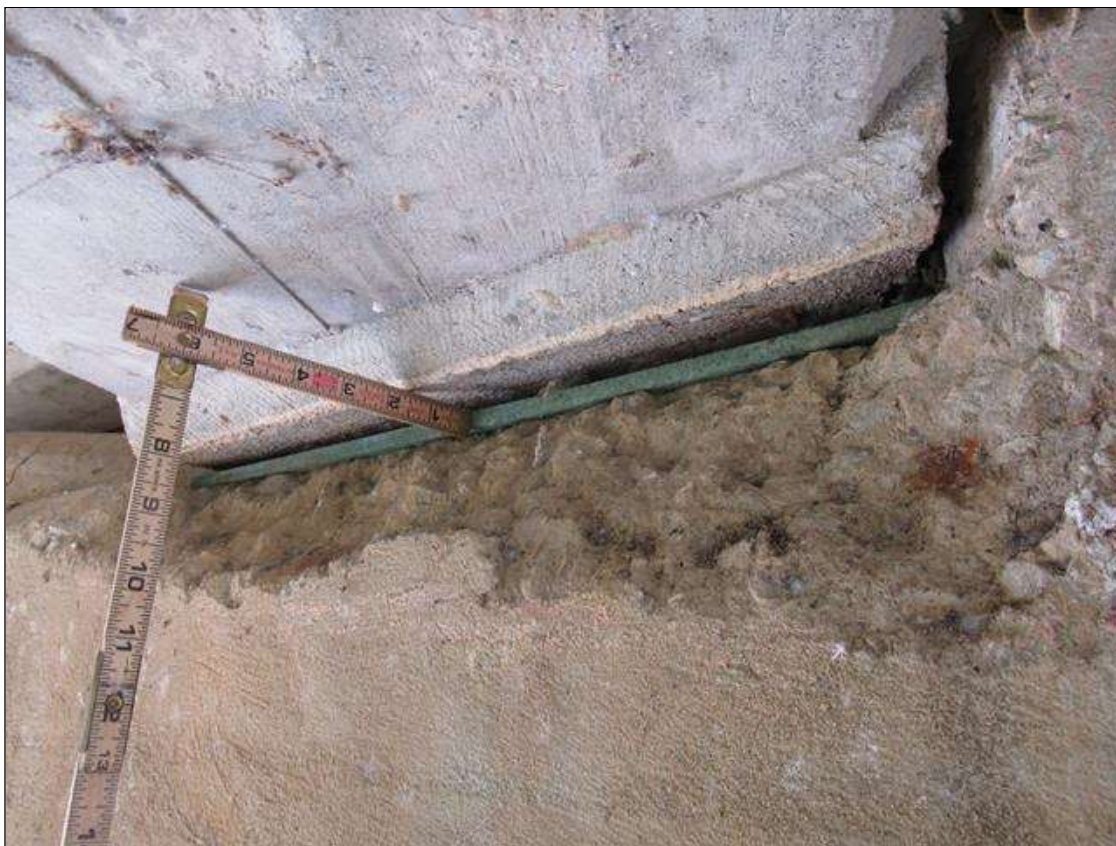
BENT 3 CAP, FAR FACE - SPALL (2FT X 6IN X 4IN) WITH BEARING LOSS, (UP TO 1.5IN X FULL W.) UNDER BEAM 2. REMAINING CONCRETE IS SOUND. (PAR PHOTO)
