NC DEPARTMENT OF TRANSPORTATION
 DIVISION OF HIGHWAYS
 STRUCTURE MANAGEMENT UNIT

ATTENTION: **PAR'S ISSUED: SPALLING THROUGHOUT BENTS, SIDEWALKS, BEAM & DRIFT UNDER SPAN 4. SNOOPER USED. CHANGES TO TYP. SECTION SKETCH. CHANGE TO AWS THICKNESS.**

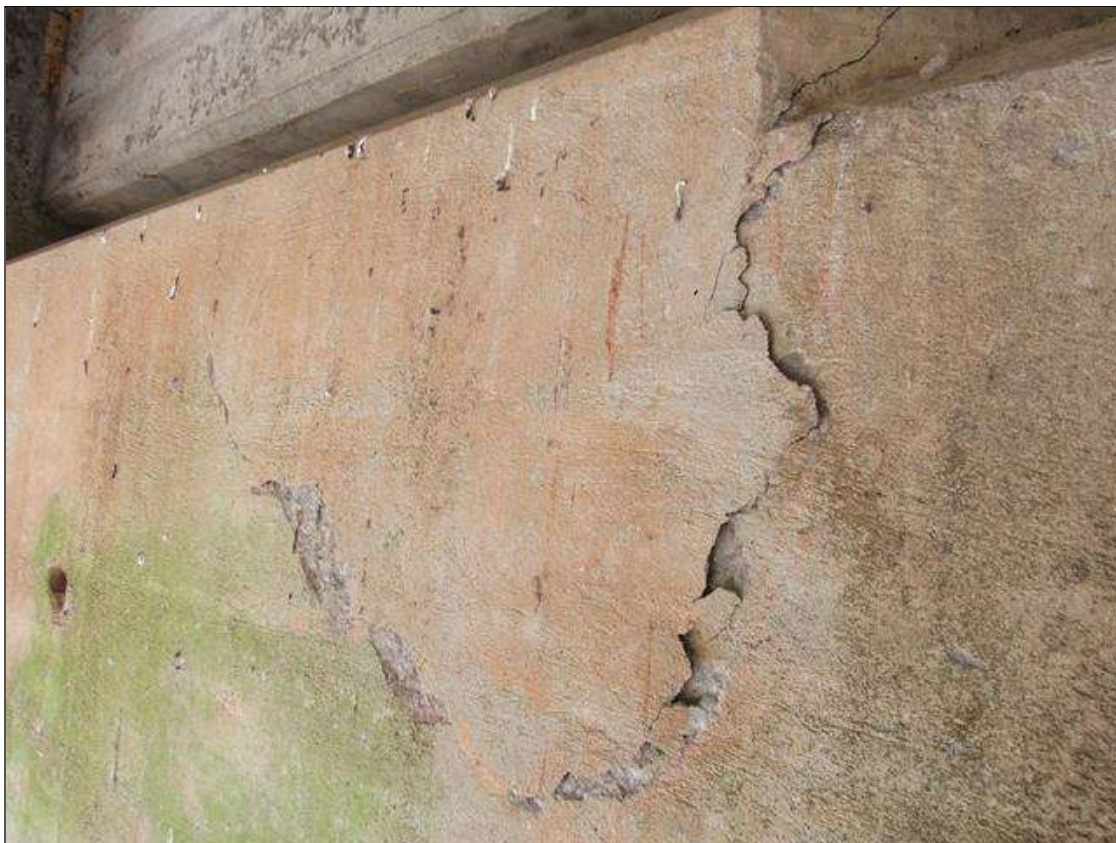
BENT 3 CAP FAR FACE - DELAM (2SF) RIGHT OF BEAM 2

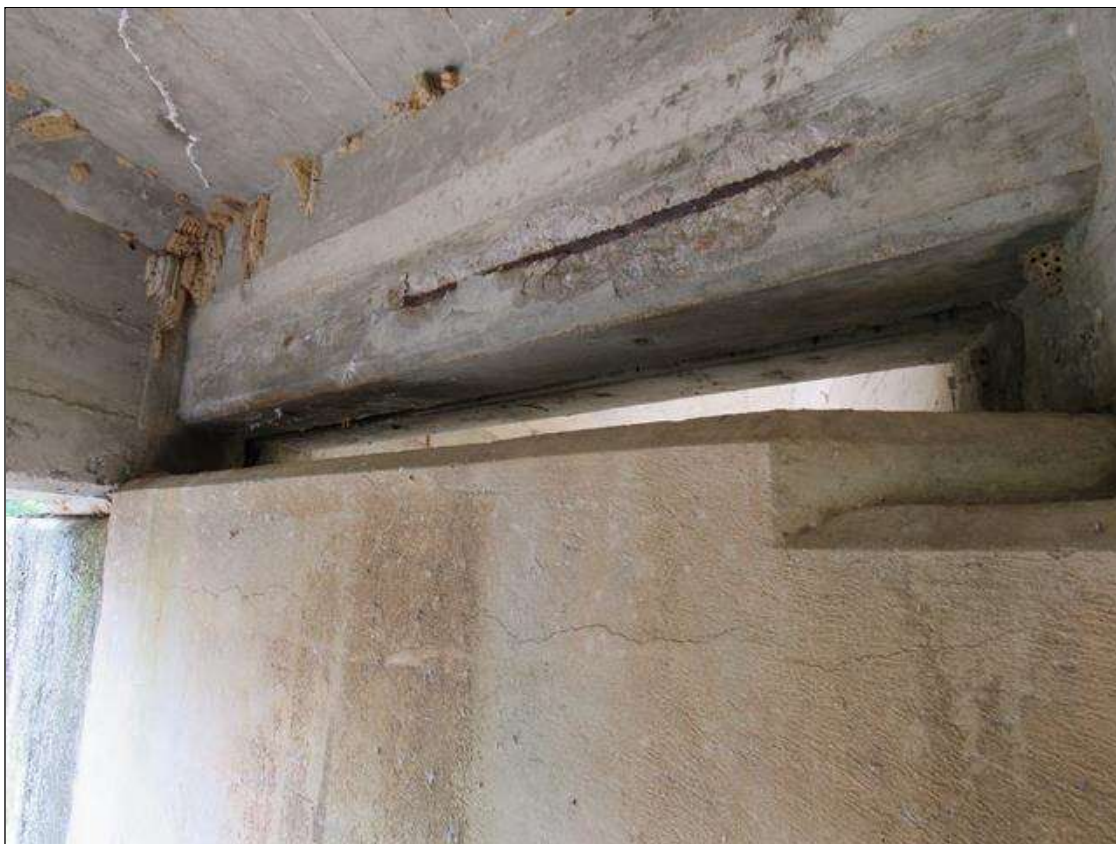
BENT 3 CAP FAR FACE - DELAM (5FT X 8IN) & SPALL (28IN X 6IN X 1IN) WITH EXPOSED REINFORCING, SPAN 4 NEAR END DIAPHRAGM, BAY 4

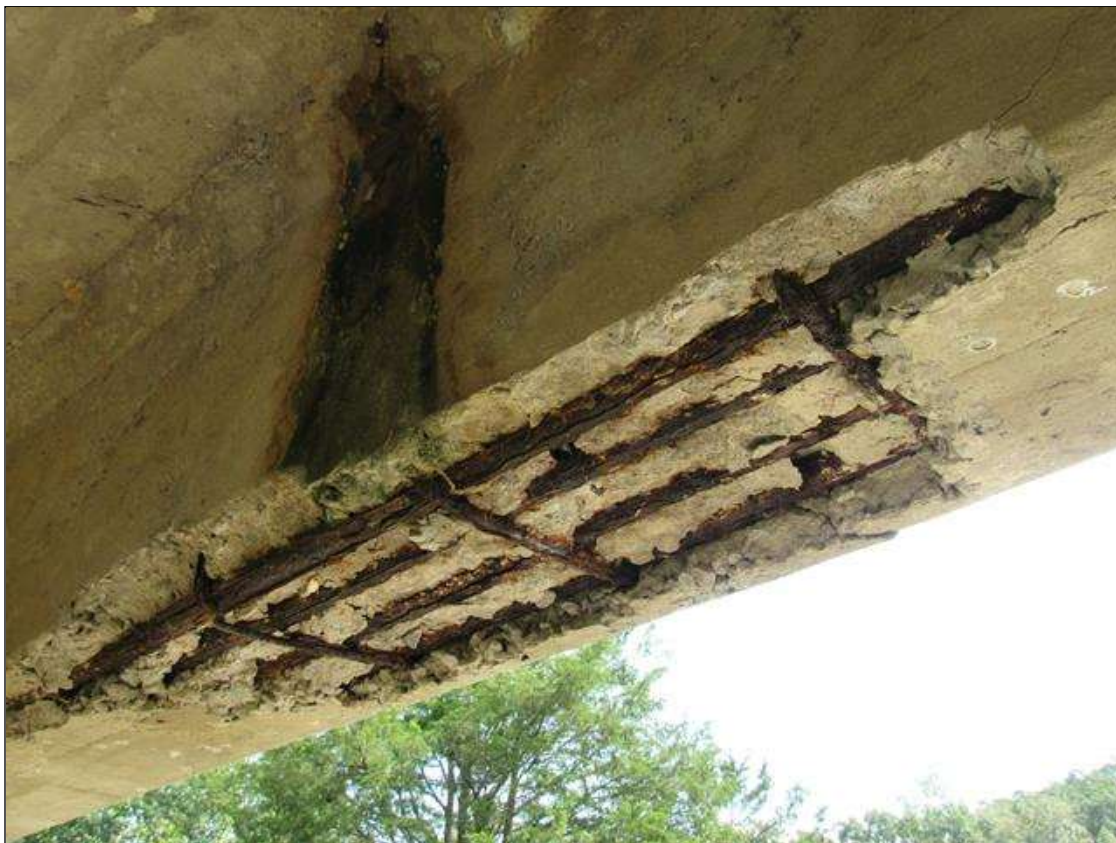
SPAN 4, BEAM 5 - SPALL (5FT X FULL W. X 5IN D.) WITH EXPOSED & CORRODED REINFORCING, BOTTOM OF BEAM AT MID-SPAN. (PAR PHOTO)

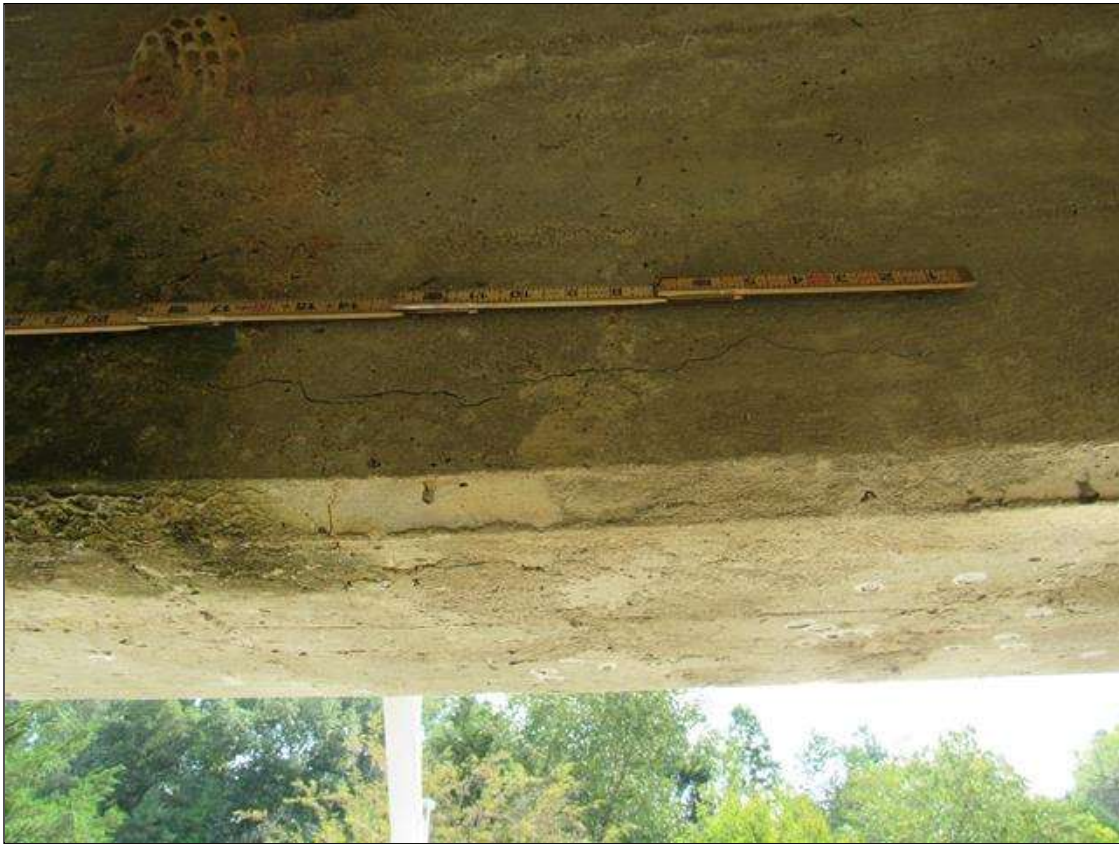
SPAN 4, BEAM 5 - DELAM (20IN X 5IN) BOTTOM LEFT EDGE NEAR MID-SPAN

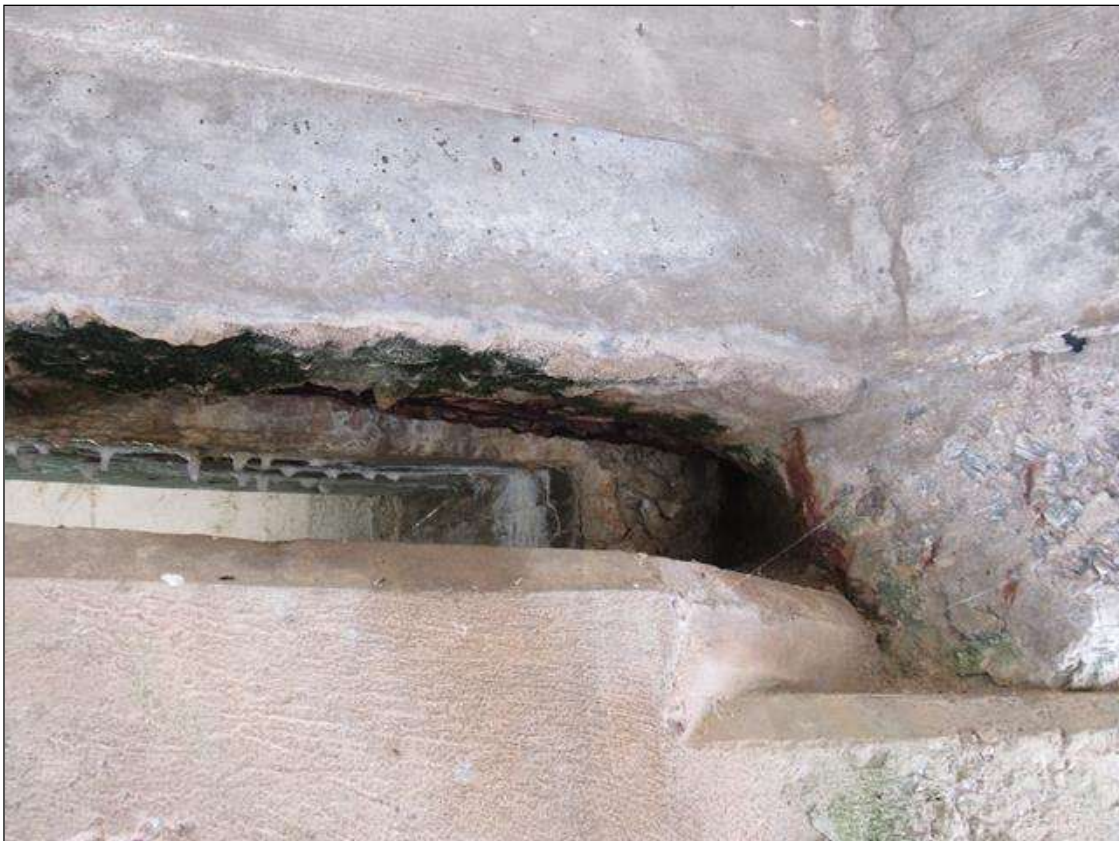
SPAN 4 BEAM 5 - SPALL (2FT X 6IN X 4IN) WITH EXPOSED REINFORCING, FAR END LEFT SIDE

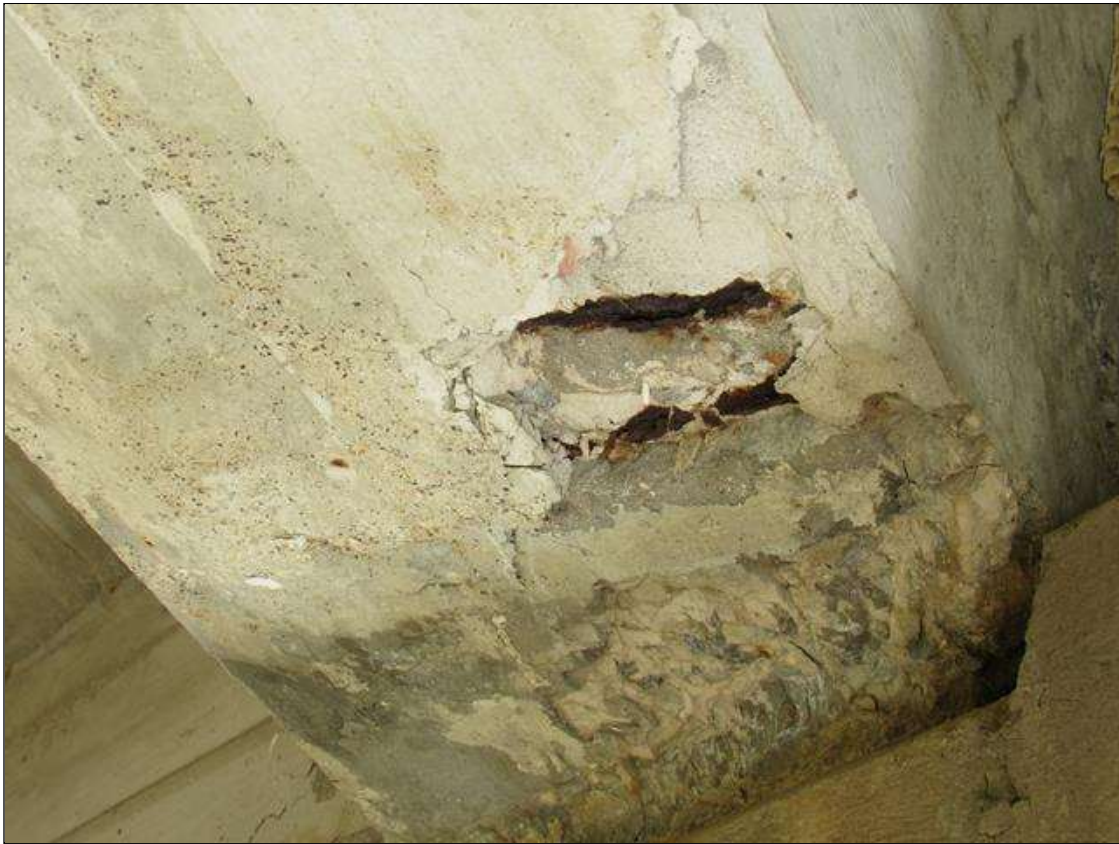
SPAN 4 BEAM 4 - SPALL (1FT X 8IN X 1.5IN) WITH EXPOSED REINFORCING TO BOTTOM AT FAR END

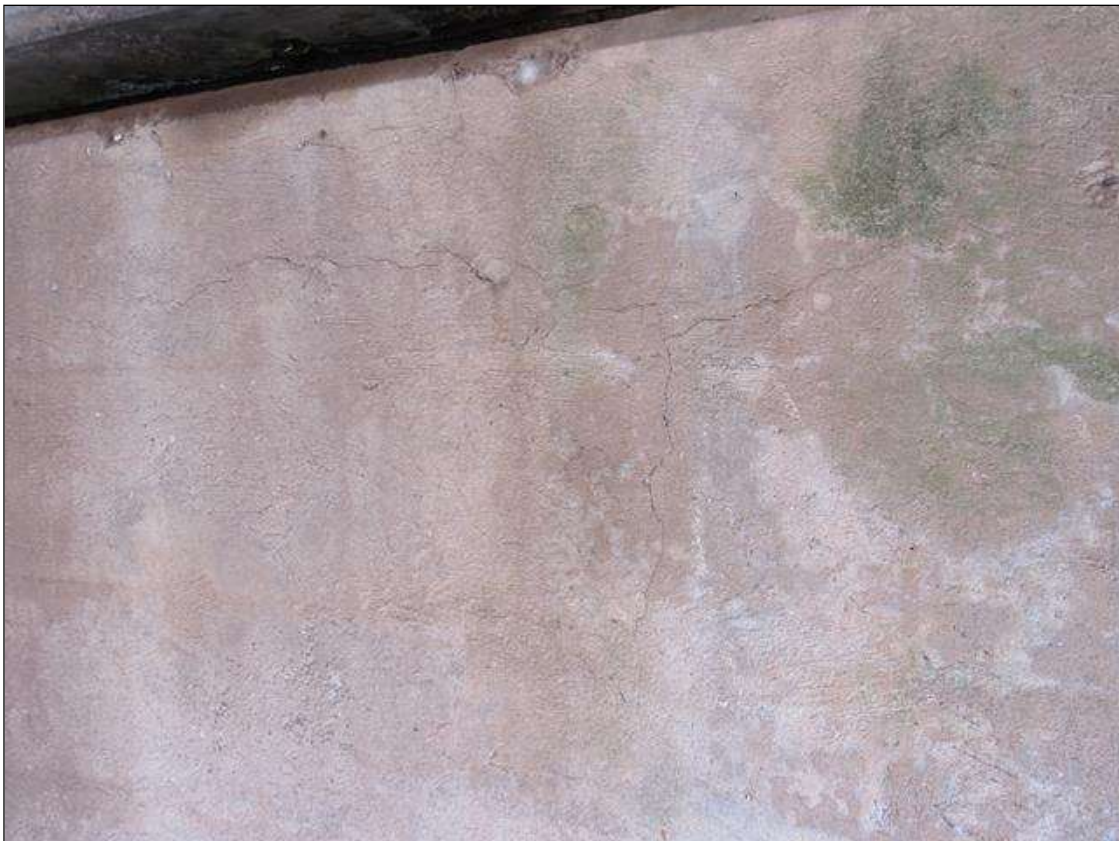
BENT 4 CAP, NEAR FACE - DELAM (1SF) ABOVE COLUMN 2

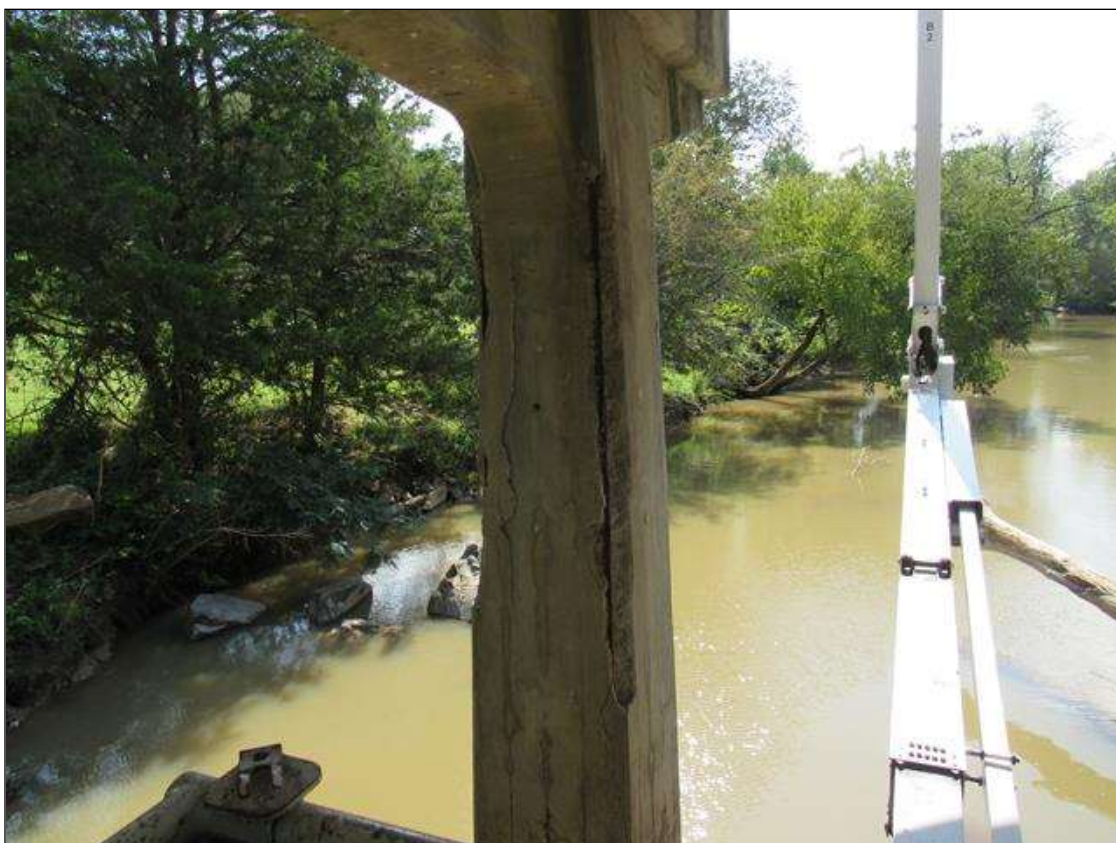
BENT 4 COLUMN 2 - SPALL/DELAM (13FT L. X 1FT W. X 5IN D.) WITH EXPOSED REINFORCING, NEAR LEFT CORNER. (PAR PHOTO)

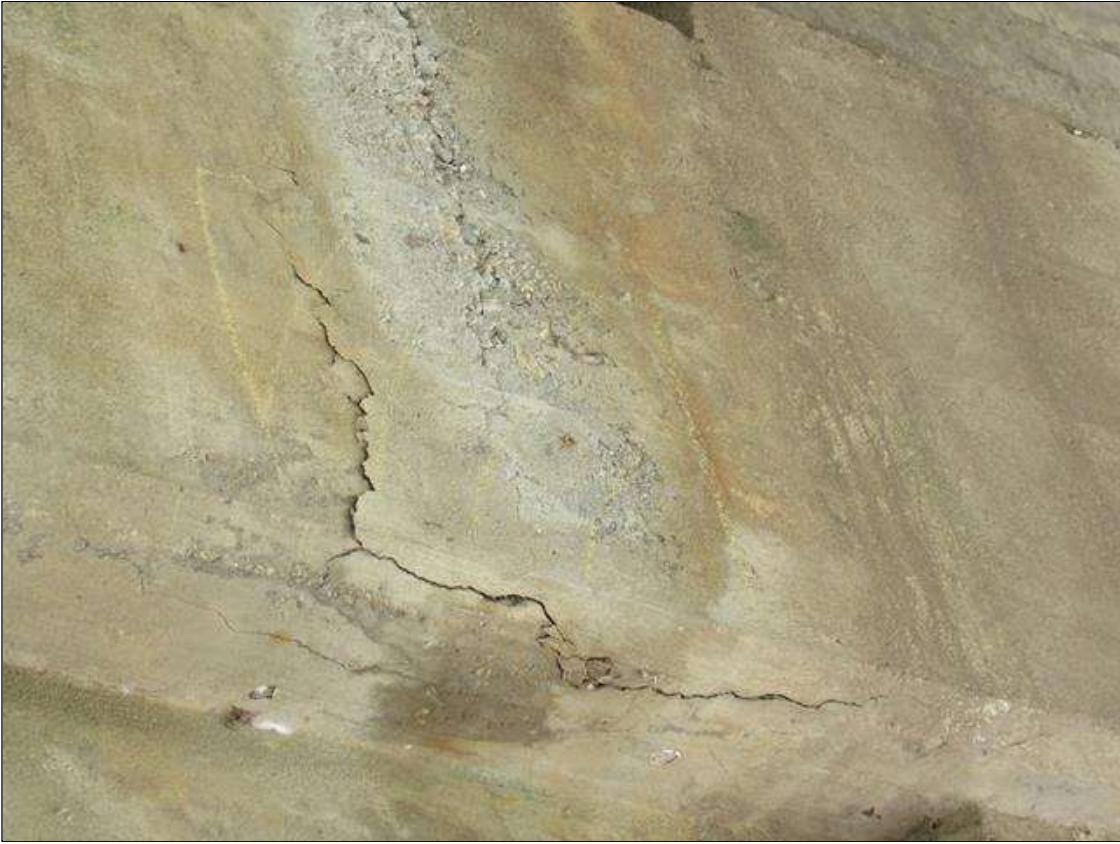
BENT 4 CAP, NEAR FACE - DELAM (1SF) UNDER BEAM 4

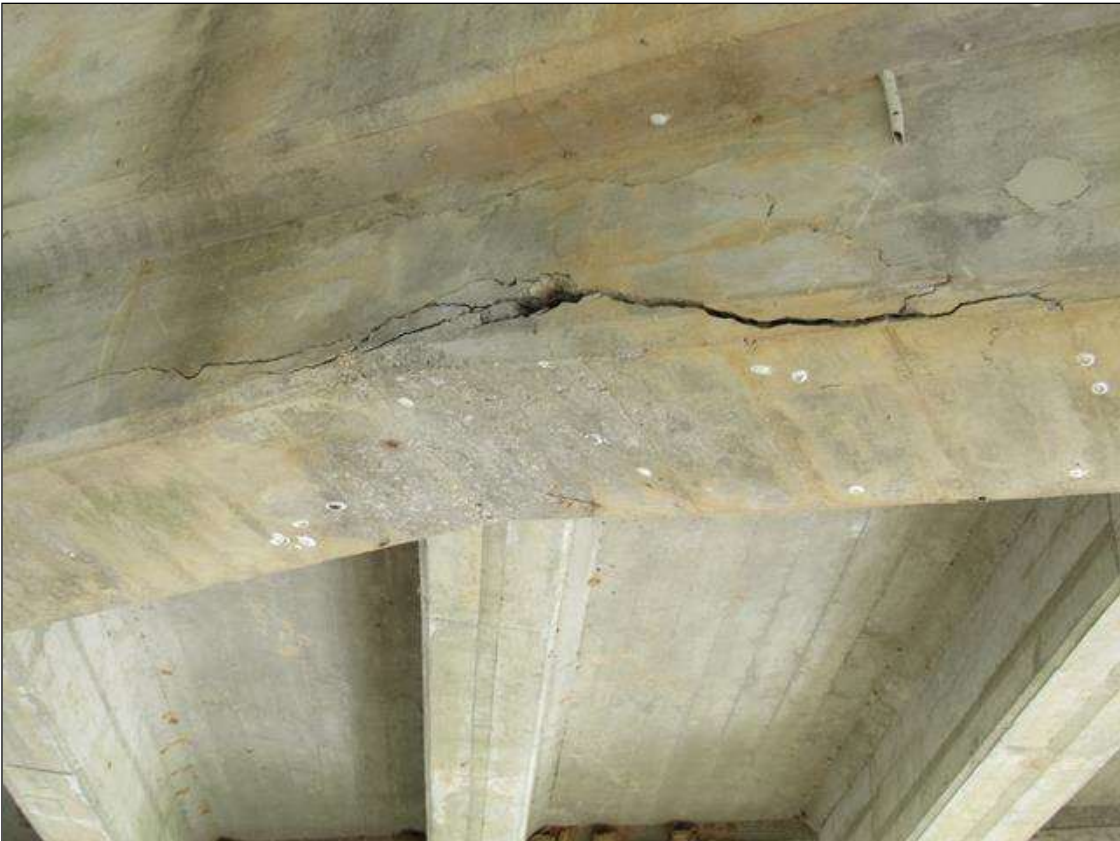
BENT 4 CAP NEAR FACE - DELAM/SPALL (4SF X 3IN D.) WITH EXPOSED REINFORCING, UNDER BEAM 3 TO GUSSET

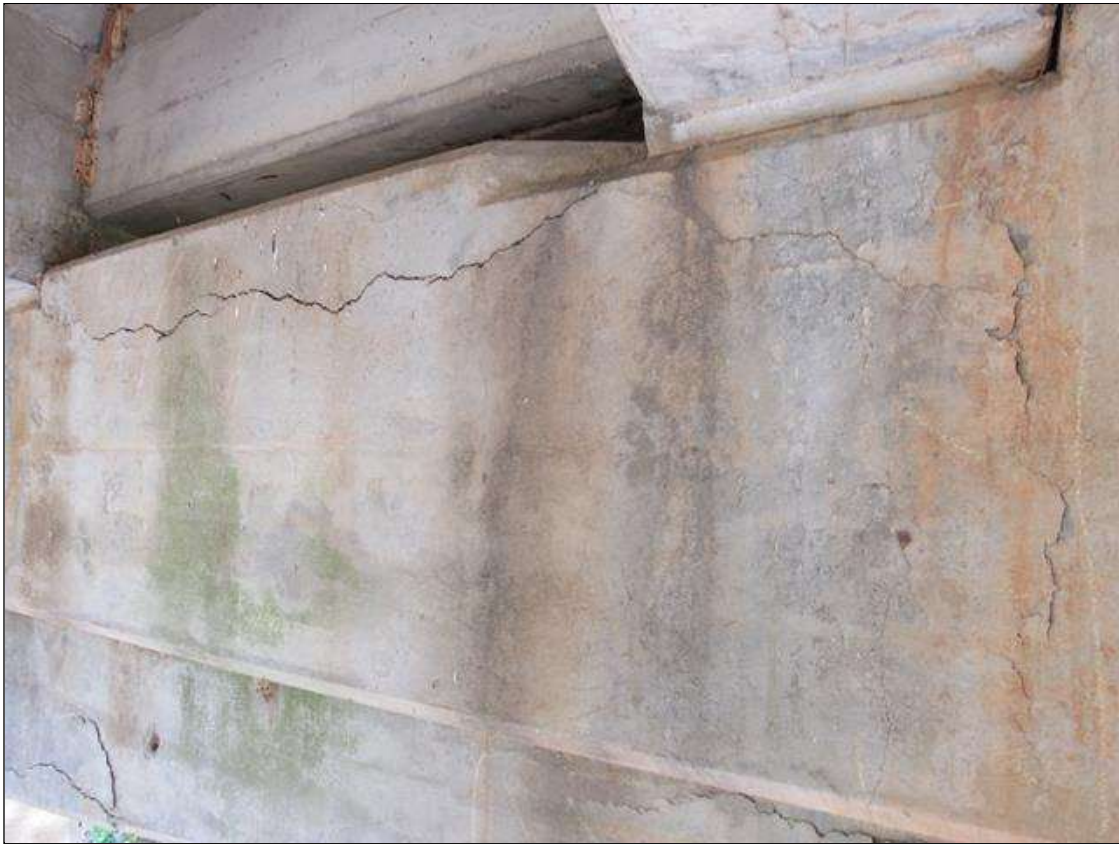
BENT 4 CAP, NEAR FACE - DELAM (UP TO 10SF) BETWEEN BEAMS 2 & 3

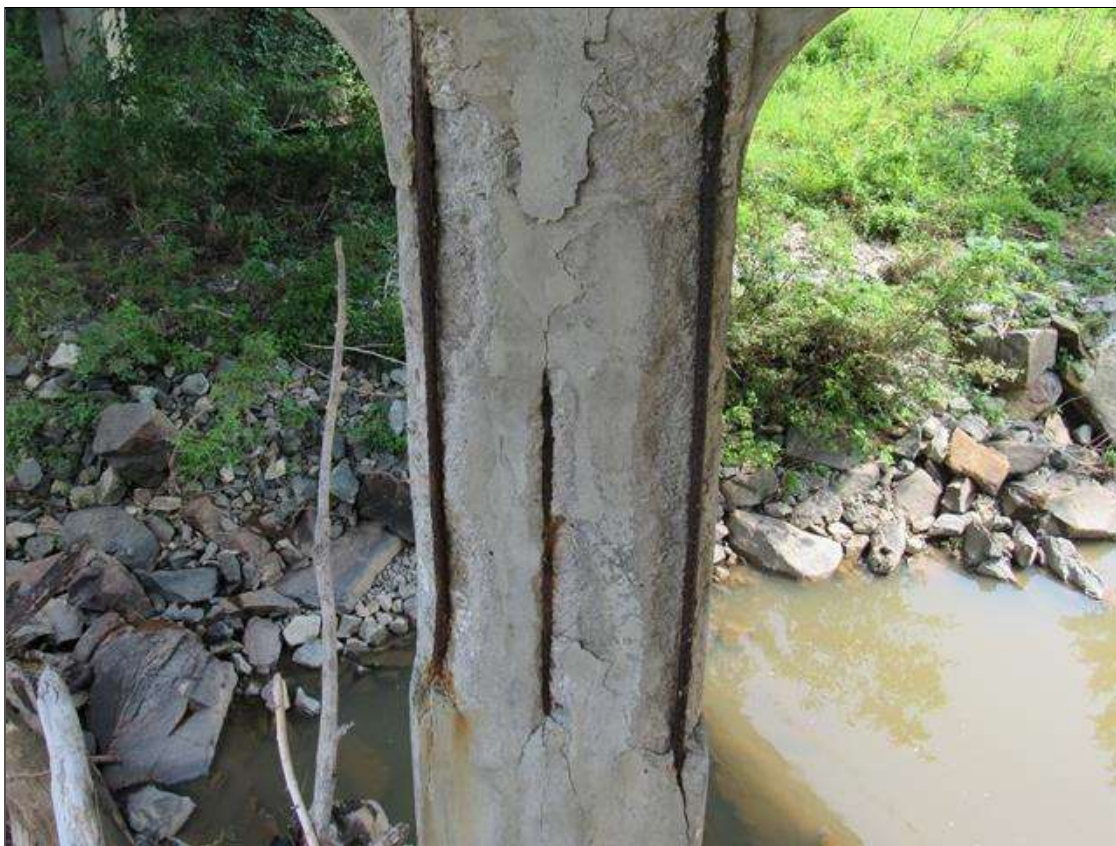
BENT 4 COLUMN 1 - SPALL/DELAM (13FT L. X FULL W. X 6IN D.) WITH EXPOSED REINFORCING, NEAR FACE.
(PAR PHOTO)

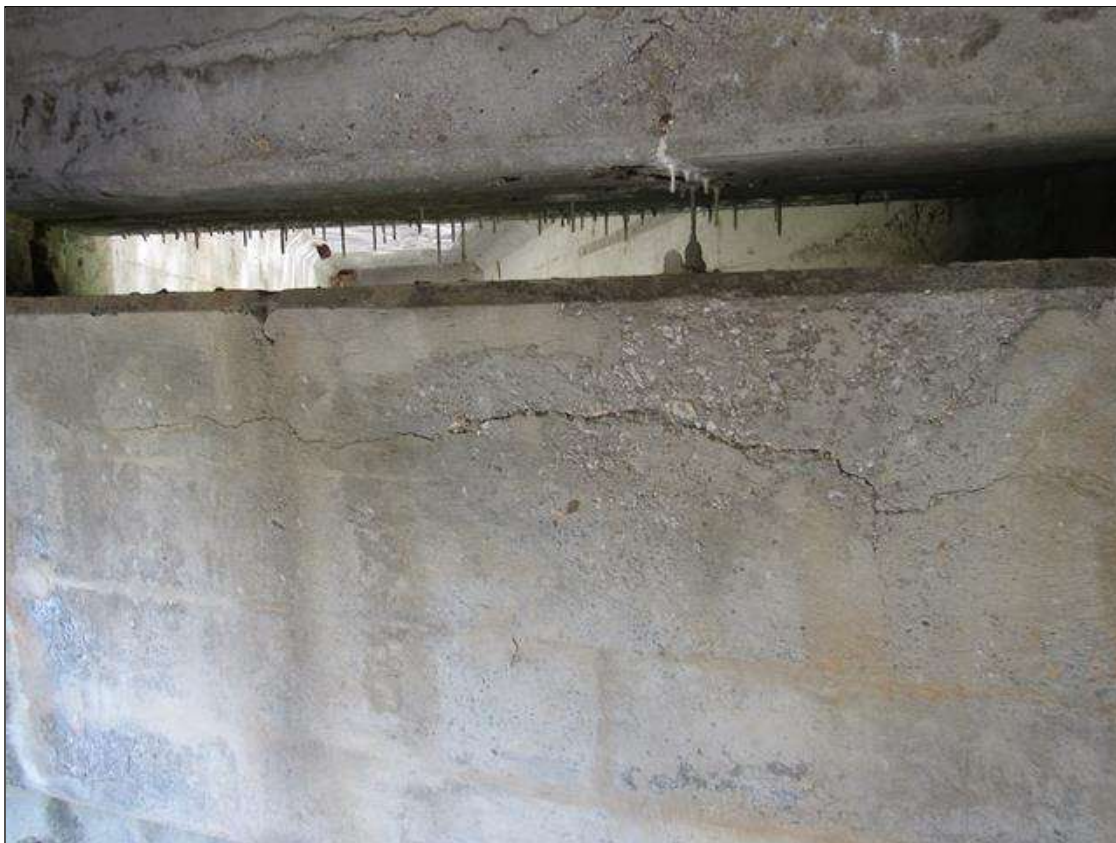
BENT 4 CAP, NEAR FACE - DELAM (5FT X 8IN) BAY 1

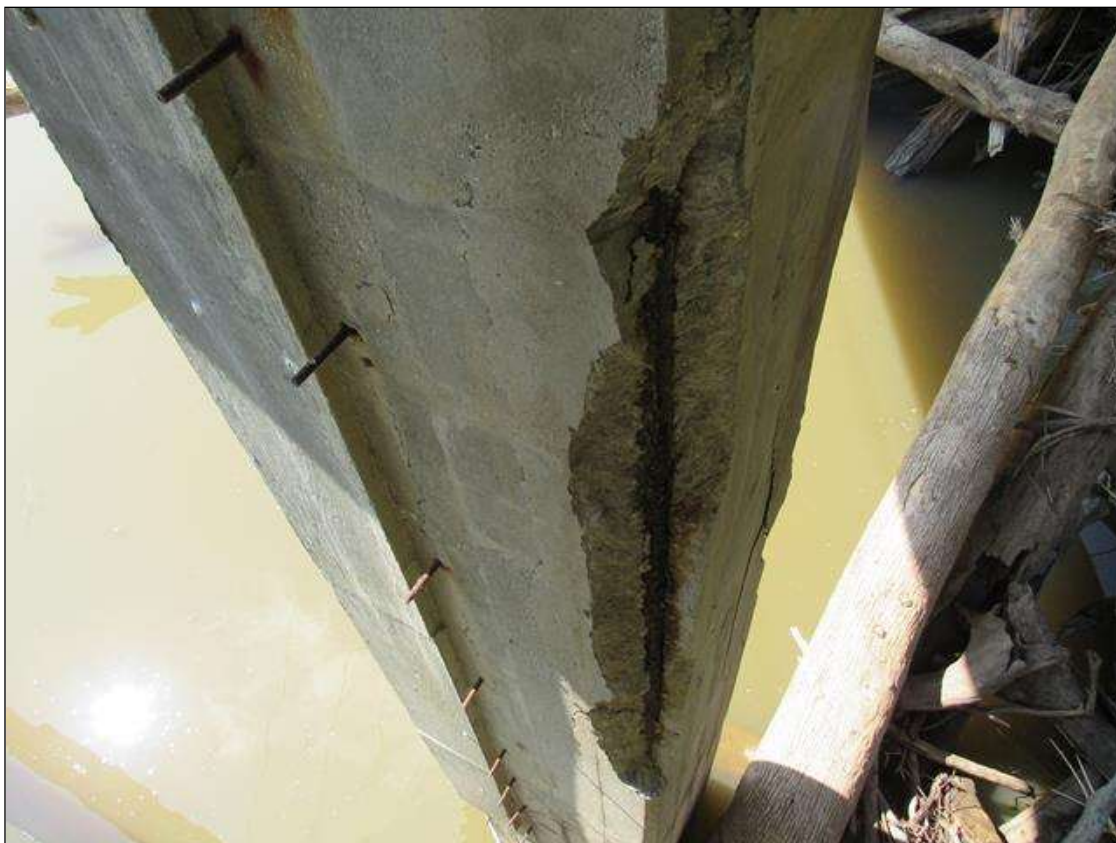
BENT 4 COLUMN 2 - SPALL/DELAM (12FT L. X 1FT W. X 5IN D.) WITH EXPOSED REINFORCING, FAR LEFT CORNER. (PAR PHOTO)

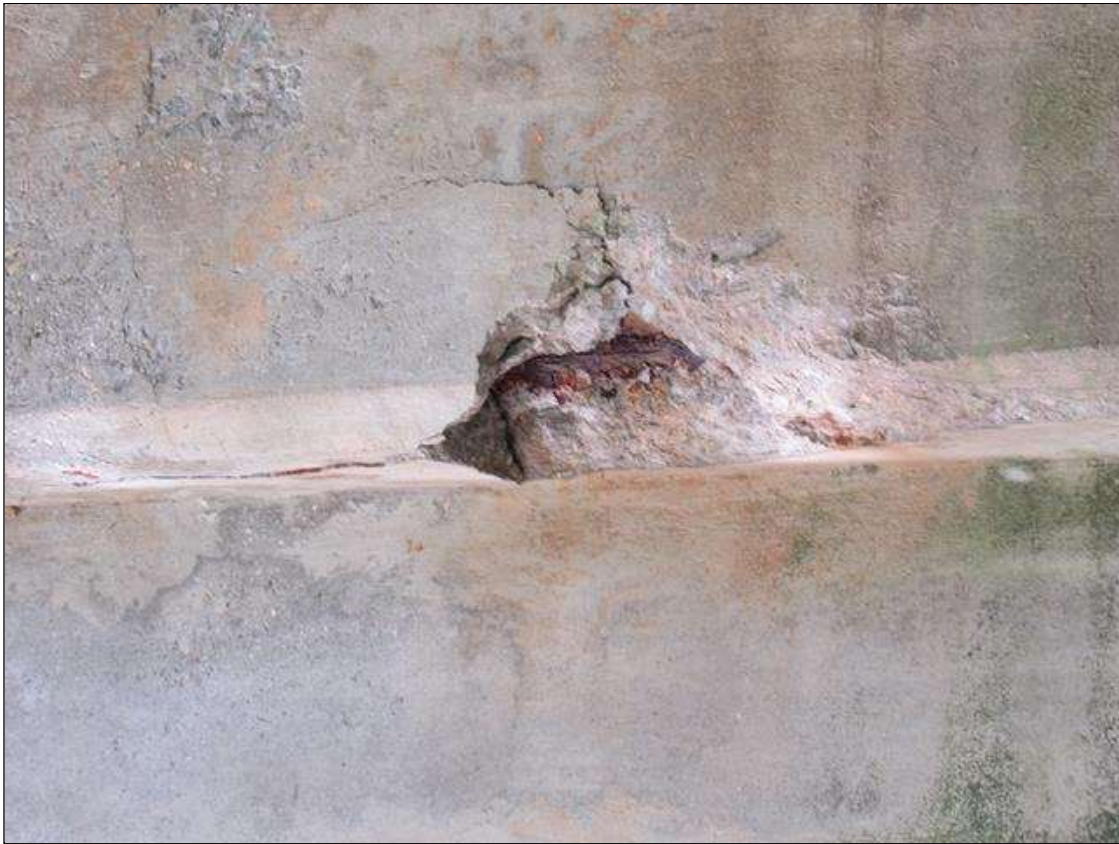
BENT 4 CAP, FAR FACE - SPALL (2FT X 8IN X 4IN) WITH EXPOSED REINFORCING, UNDER BEAM 4

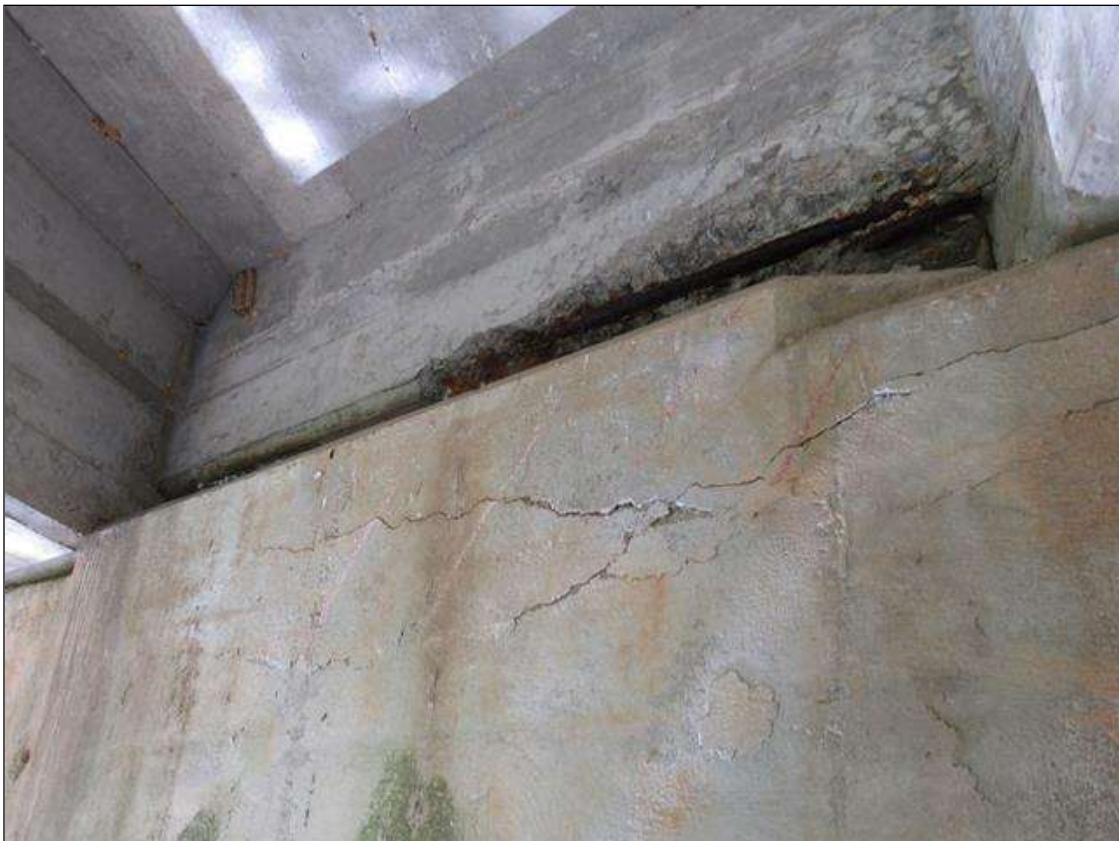
BENT 4 CAP, FAR FACE - DELAM (5SF) BAY 3 & SPALL (2.5FT X 8IN X 3IN) WITH EXPOSED REINFORCING TO SPAN 5 NEAR END DIAPHRAGM, BAY 3

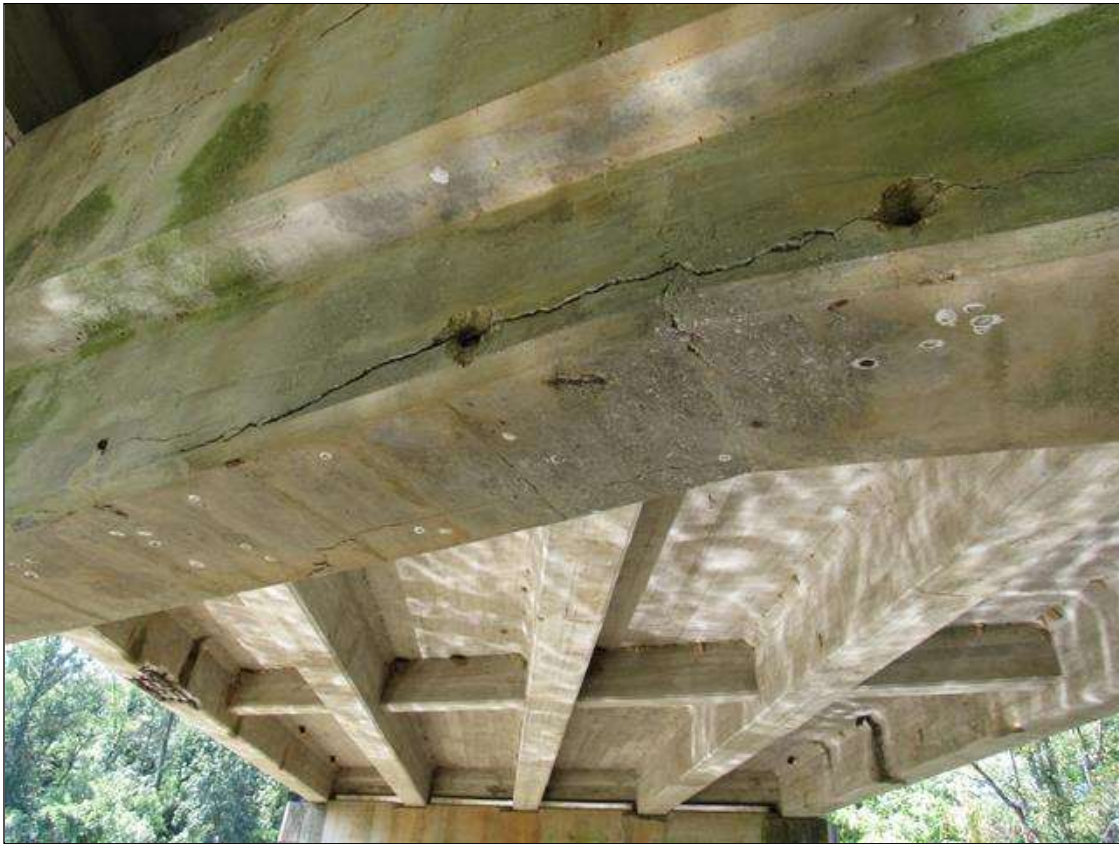
BENT 4 CAP, FAR FACE - DELAM (5FT X FULL W.) TO BOTTOM UNDER BEAM 3

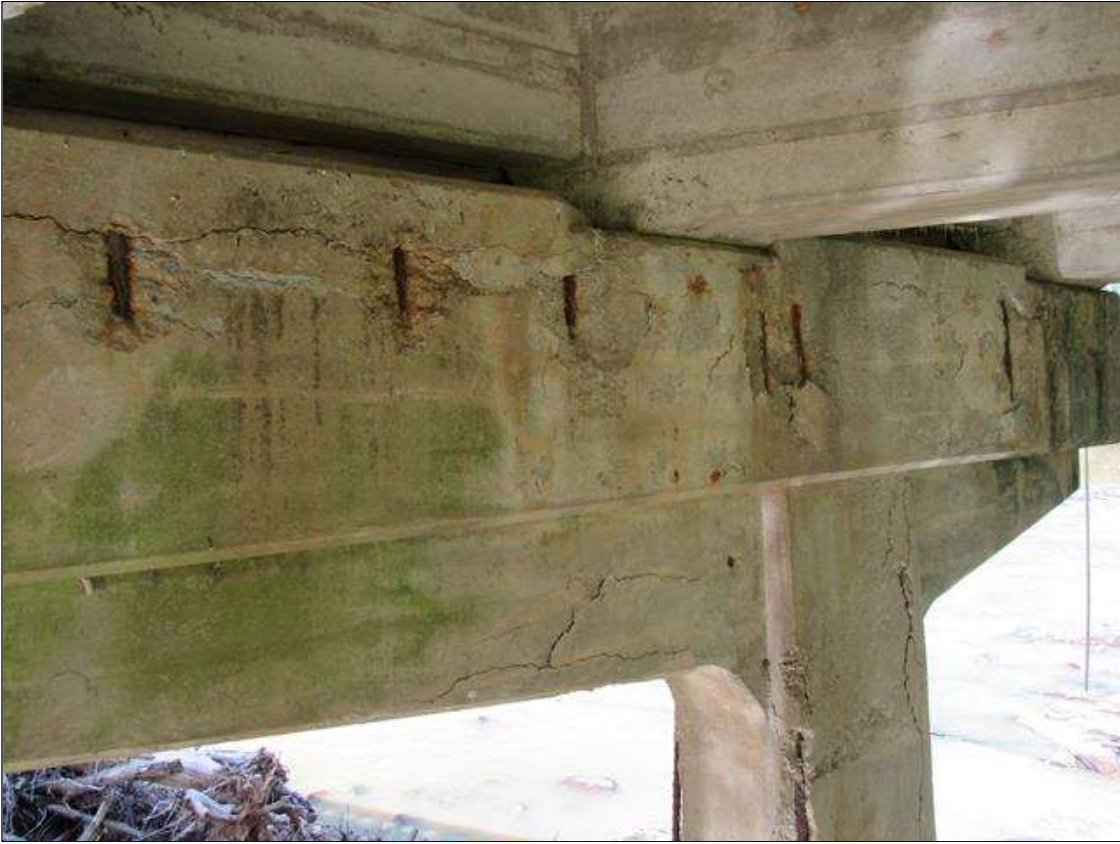
BENT 4 CAP, FAR FACE - INTERMITTENT SPALLING/DELAM, (UP TO 2SF X 2IN D.) WITH EXPOSED REINFORCING, BETWEEN BEAMS 1 & 3

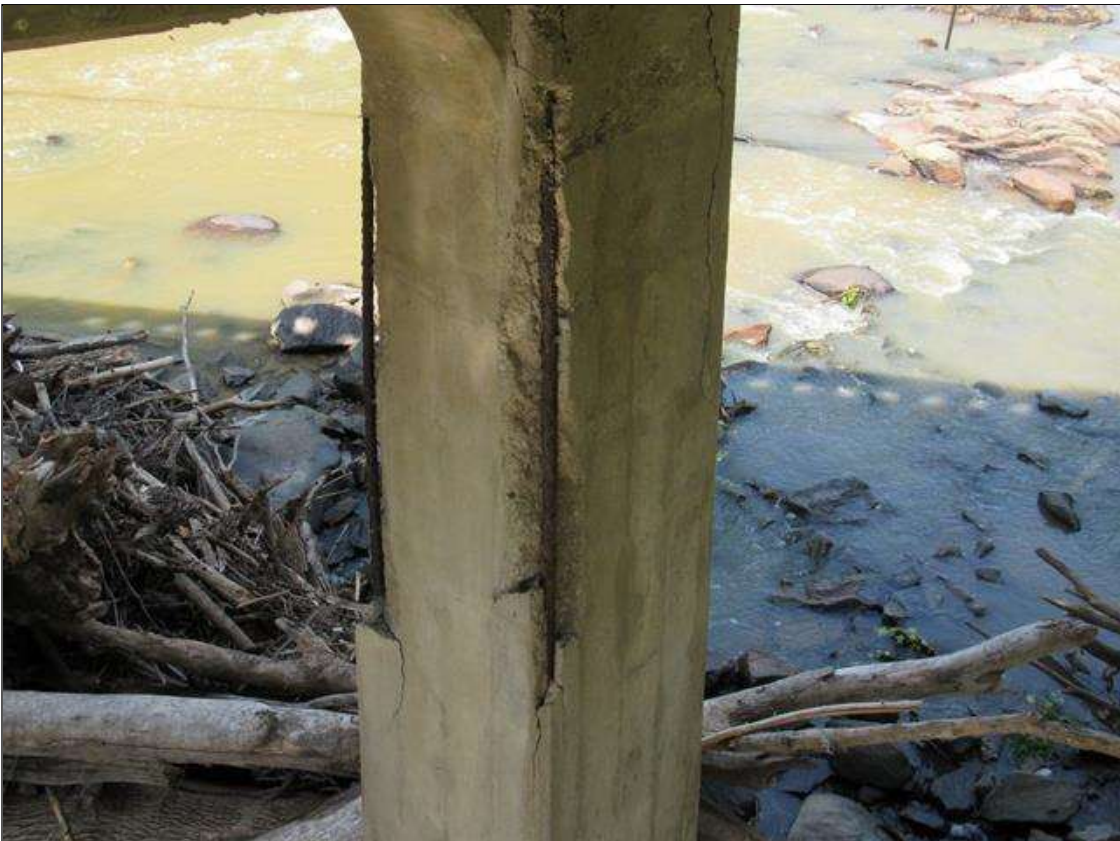
BENT 4 COLUMN 1 - SPALLING/DELAM (10FT L. X 1FT W. X 4IN D.) WITH EXPOSED REINFORCING, FAR & NEAR RIGHT CORNER. (PAR PHOTO)

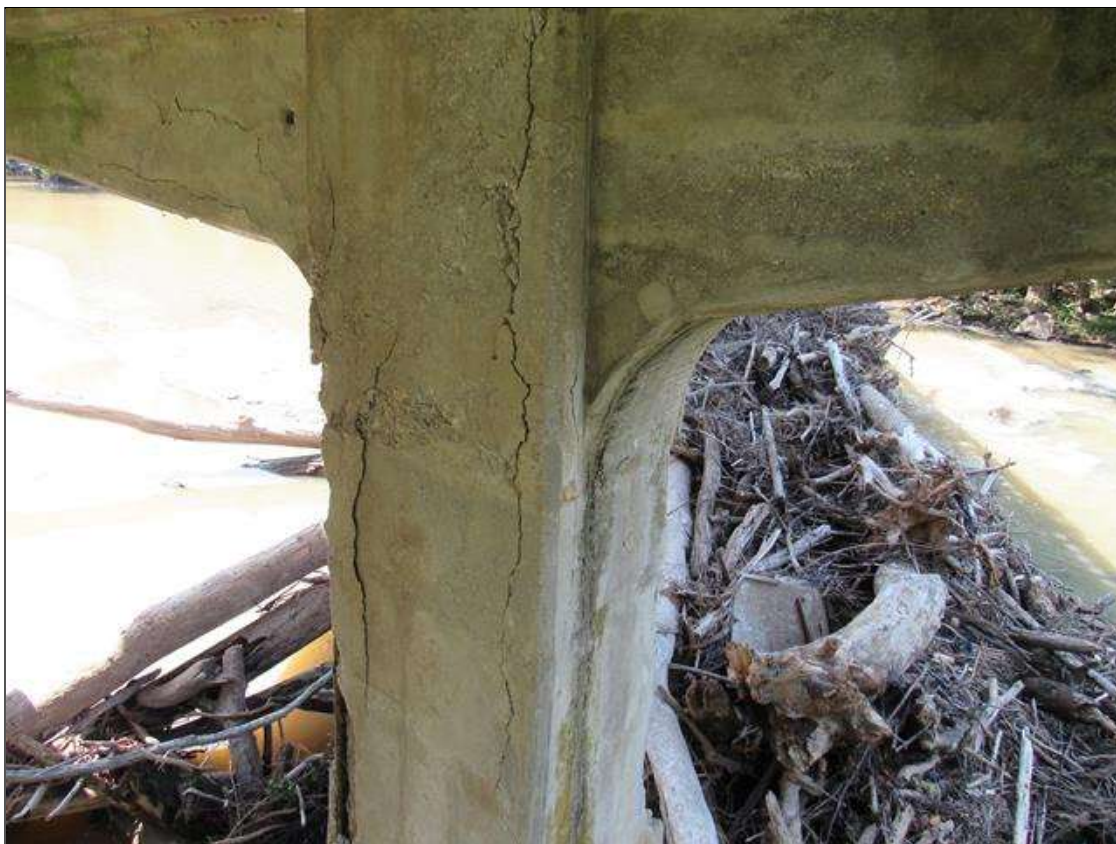
BENT 4 COLUMN 1 - DELAM (12FT X 10IN) FAR LEFT CORNER STARTING AT TOP OF COLUMN

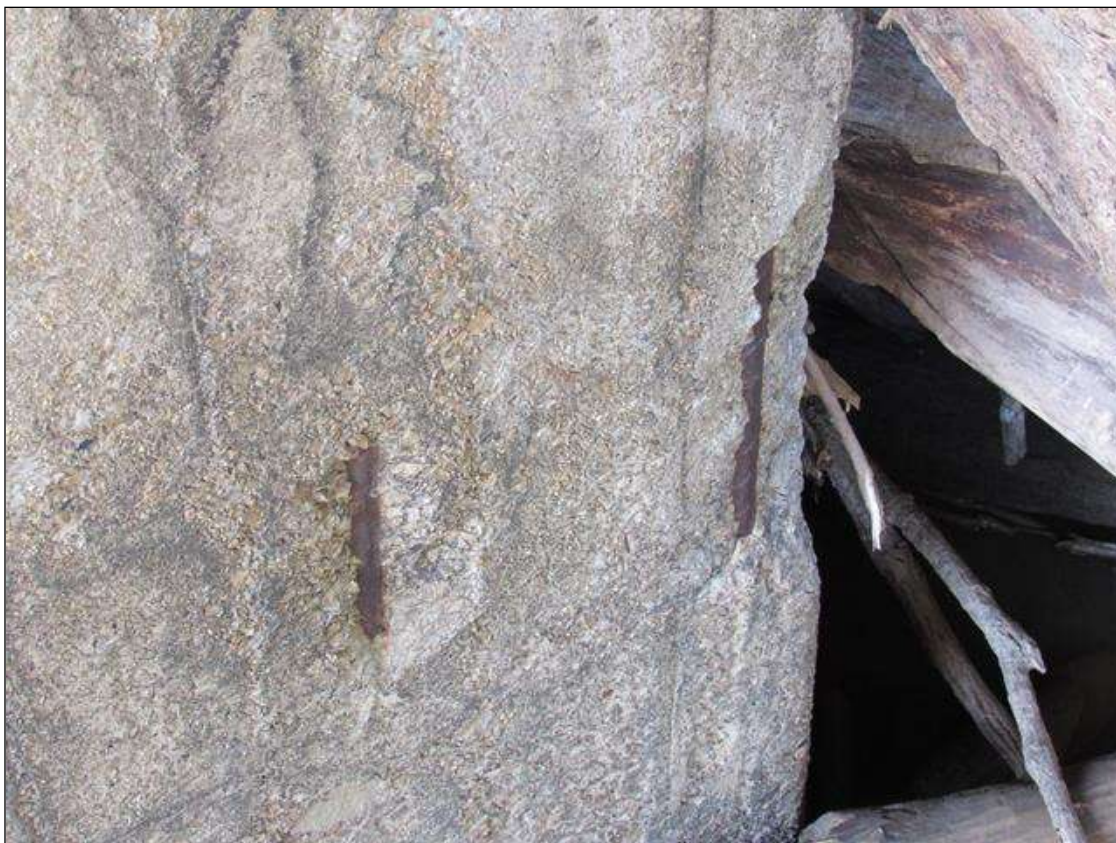
BENT 4 COLUMN 1 - (X2) SPALLS (UP TO 3FT X 8IN X 3IN) WITH EXPOSED REINFORCING, FAR LEFT CORNER 4FT FROM WATERLINE

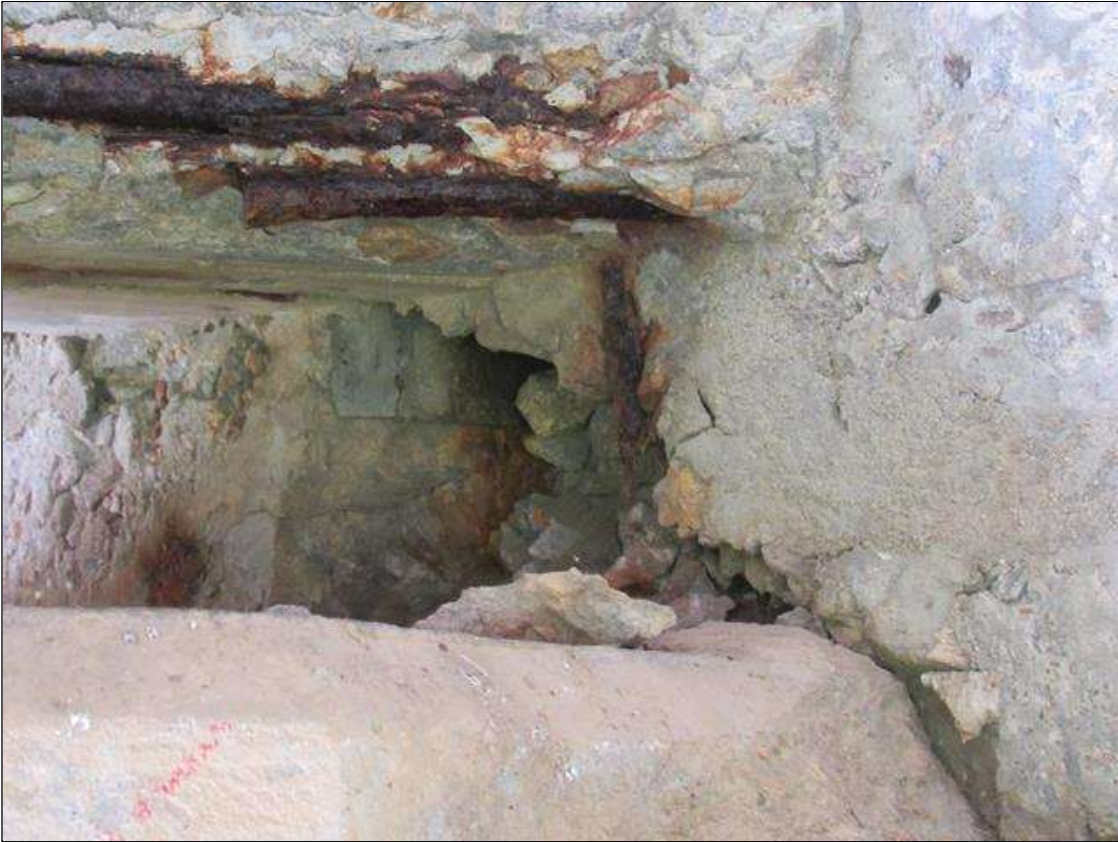
SPAN 5 BEAM 3 - SPALL (8IN X 6IN X 5IN) WITH EXPOSED REINFORCING, RIGHT SIDE NEAR END

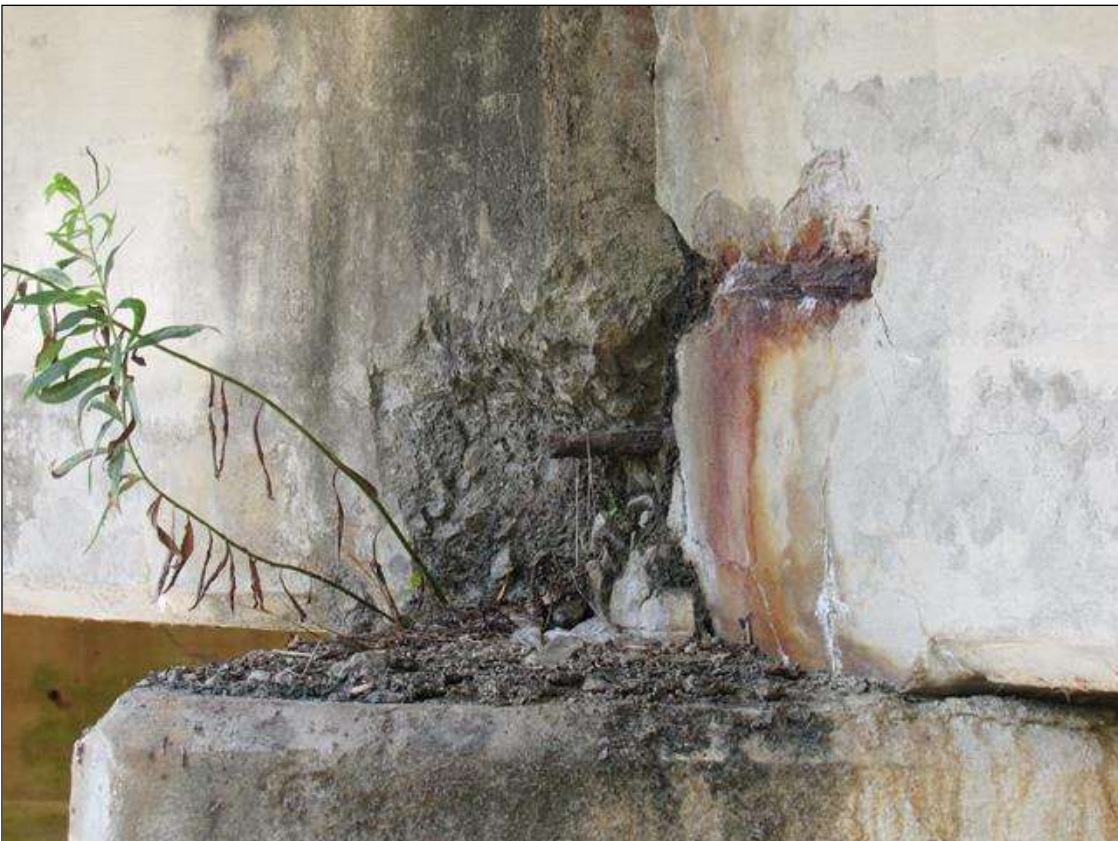
SPAN 4 FAR END, SPAN 5 NEAR END, BEAM 5 - SPALL/DELAM (UP TO 1SF X 4IN D.) WITH EXPOSED REINFORCING & BEARING LOSS TO SPAN 4 BEAM 5 ONLY (12IN X 4IN), RIGHT SIDE FAR END. (PAR PHOTO)

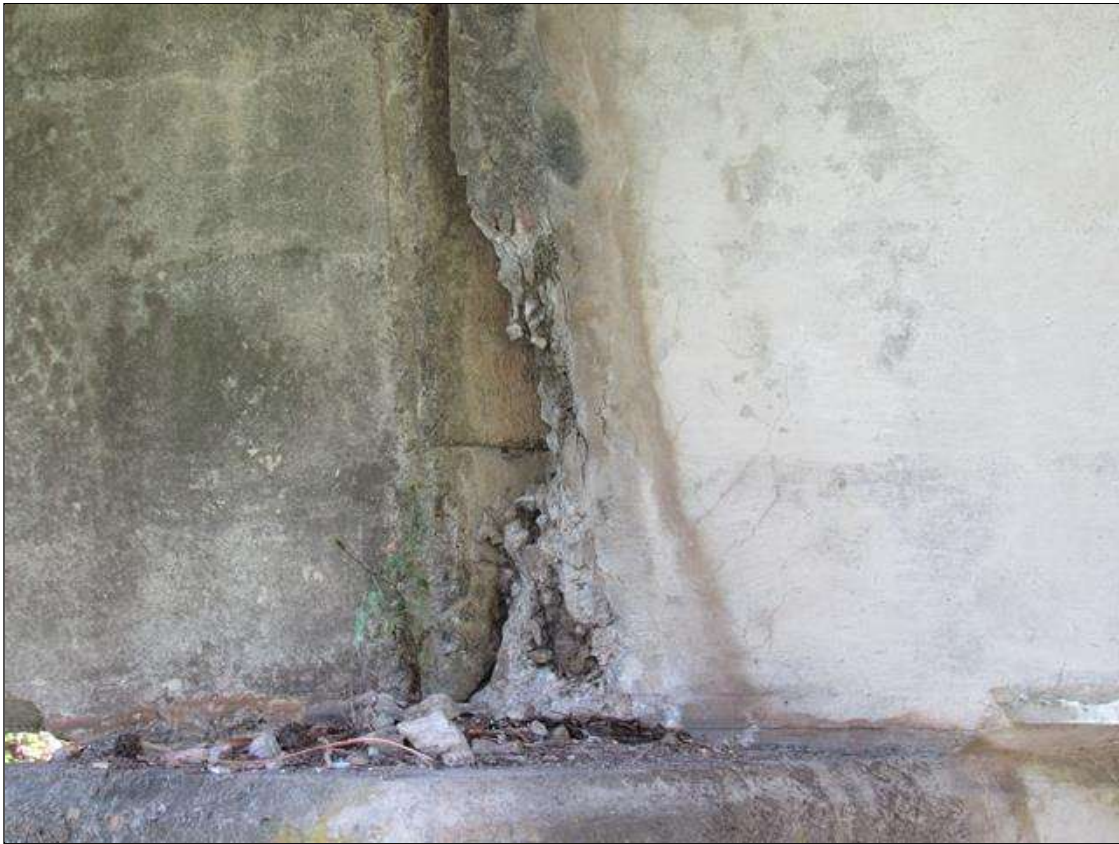
SPAN 5 BEAM 1 - SPALL (18IN X 6IN X 3IN) NO EXPOSED REINFORCING, FAR END LEFT SIDE
