NC DEPARTMENT OF TRANSPORTATION
 DIVISION OF HIGHWAYS
 STRUCTURE MANAGEMENT UNIT

ATTENTION: **PAR'S ISSUED: SPALLING THROUGHOUT BENTS, SIDEWALKS, BEAM & DRIFT UNDER SPAN 4. SNOOPER USED. CHANGES TO TYP. SECTION SKETCH. CHANGE TO AWS THICKNESS.**

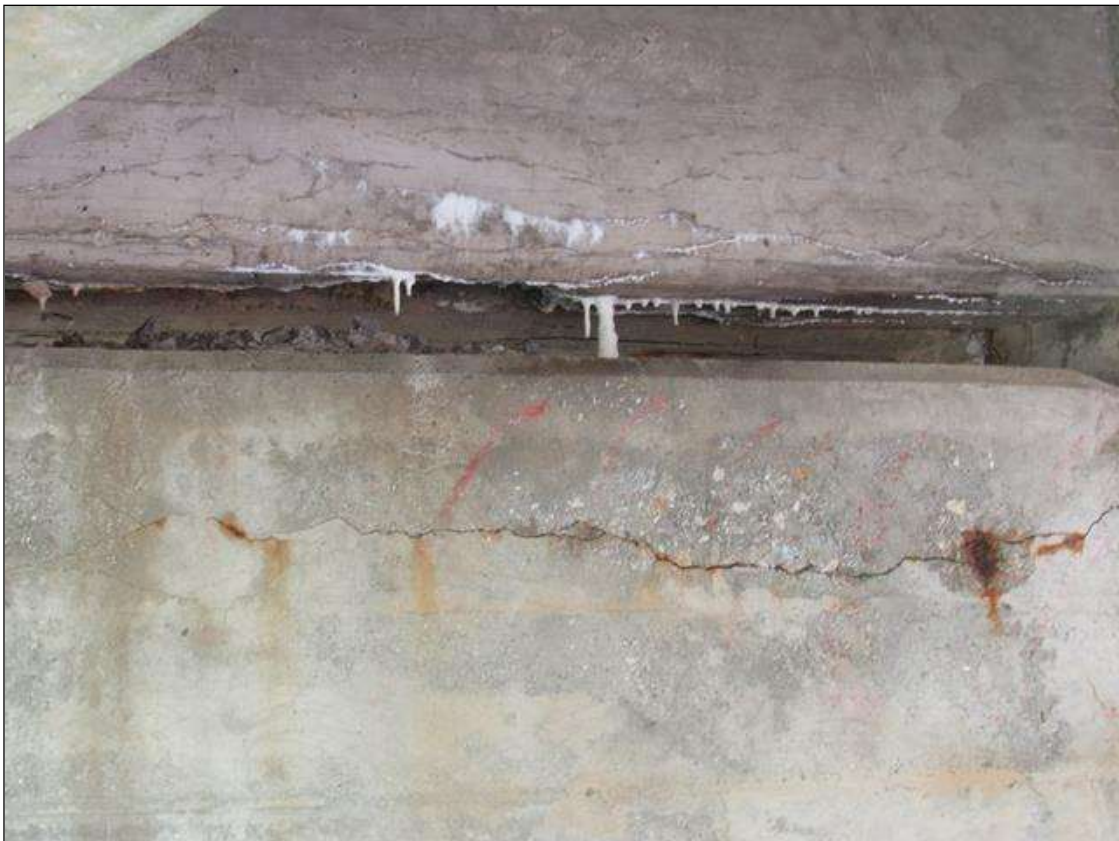
BENT 5 CAP, NEAR FACE - DELAM (5FT X 1FT) BAY 1

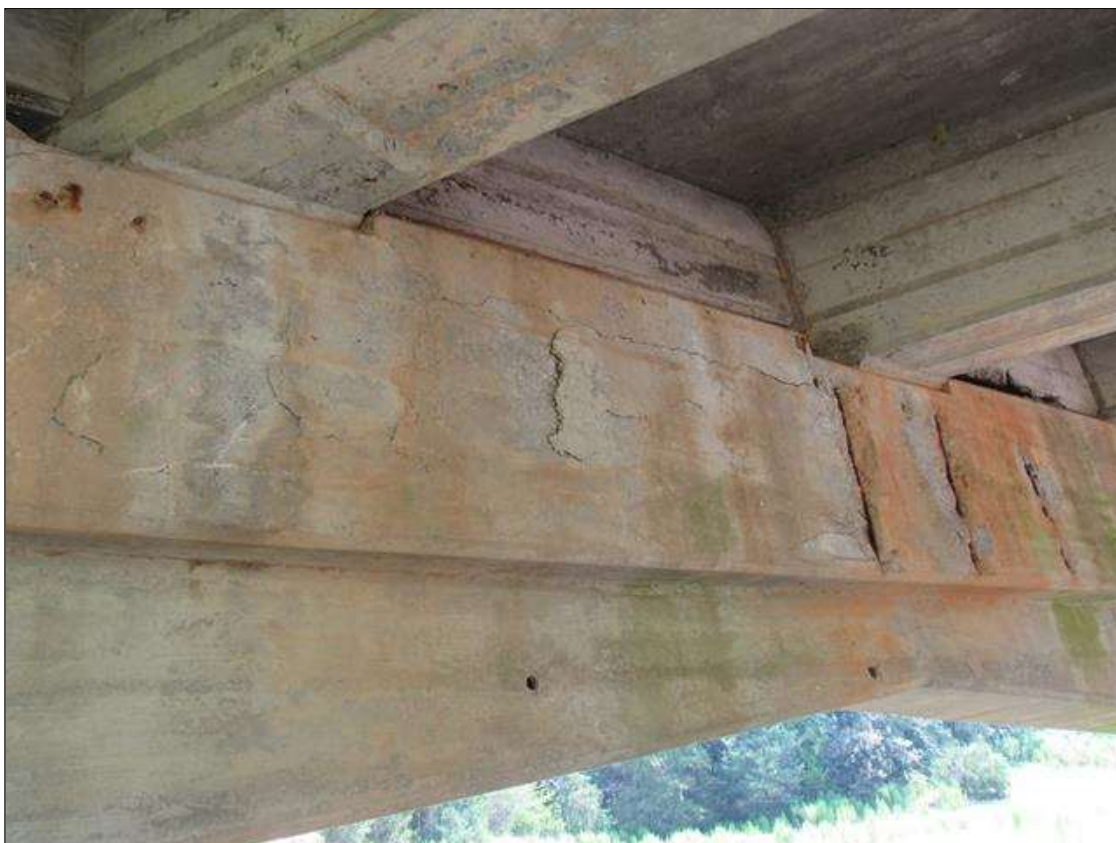
BENT 5 CAP, NEAR FACE - INTERMITTENT DELAM/SPALLING, (UP TO 3SF X 2IN D.) WITH EXPOSED REINFORCING, BETWEEN BEAMS 2 & 3

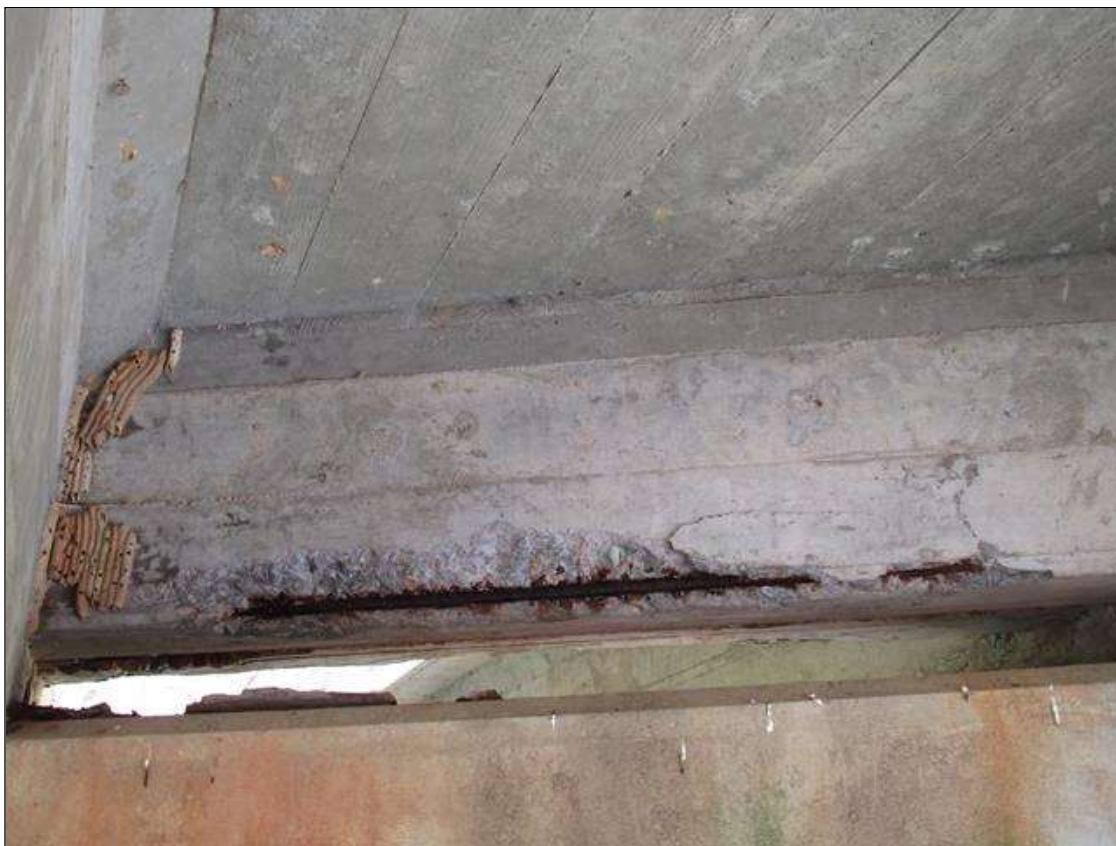
SPAN 5 FAR END DIAPHRAGM, BAY 3 - SPALL (4FT X 6IN X 3IN) WITH EXPOSED REINFORCING

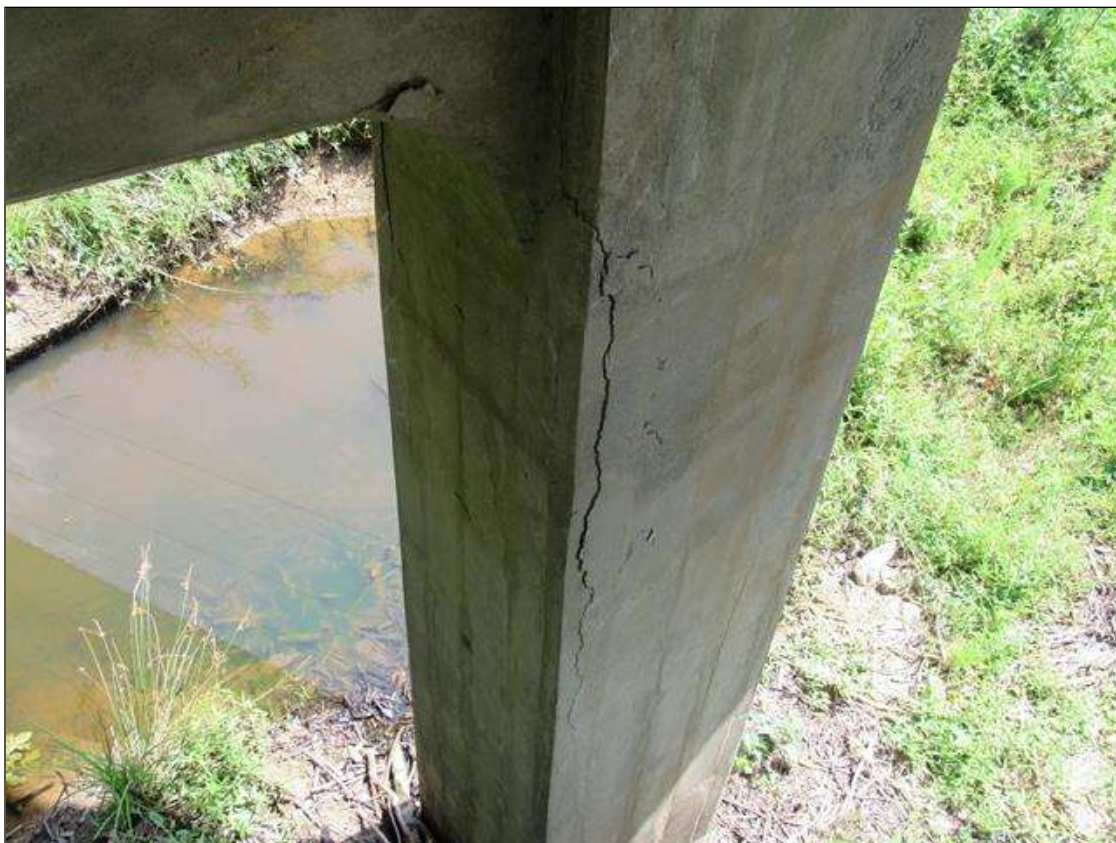
BENT 5 COLUMN 2 - DELAM (10FT X 1FT) NEAR LEFT CORNER STARTING AT TOP OF COLUMN

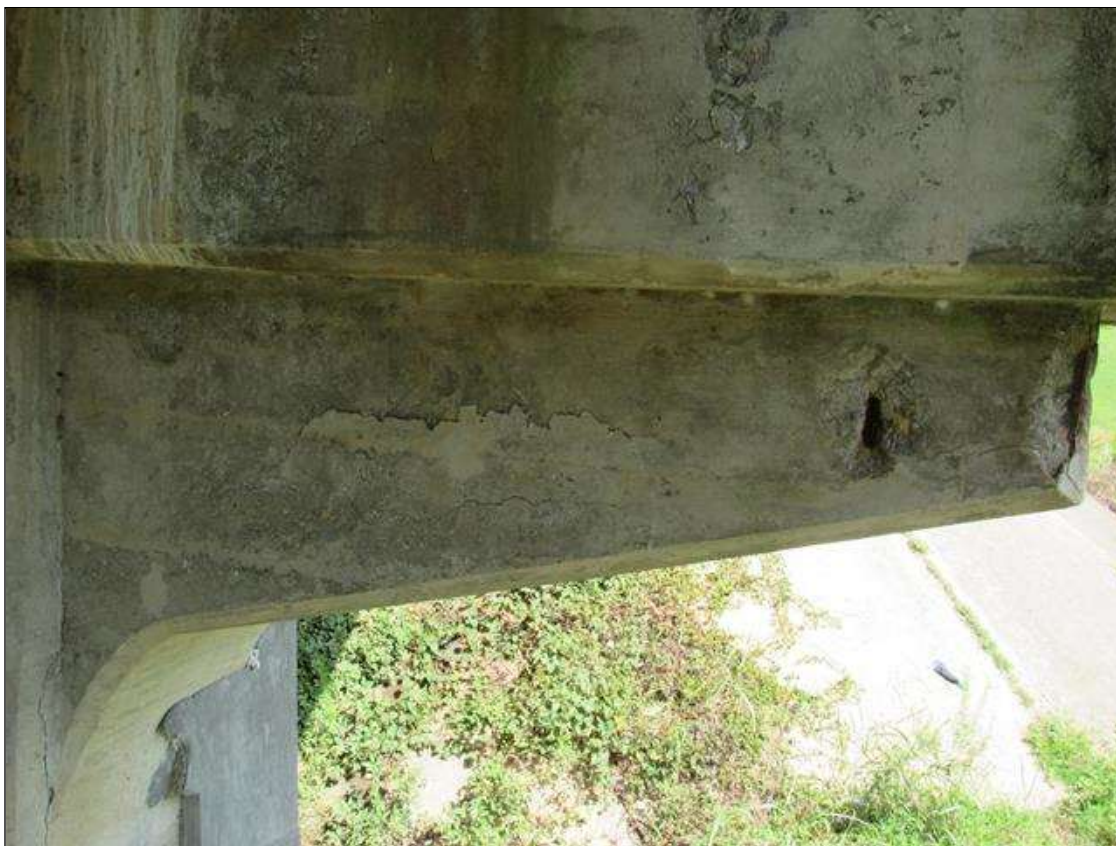
BENT 5 CAP, NEAR FACE - DELAM (2SF) & SPALLING (UP TO 6IN DIAM. X 1IN D.) WITH EXPOSED REINFORCING TO GUSSET UNDER BEAM 5

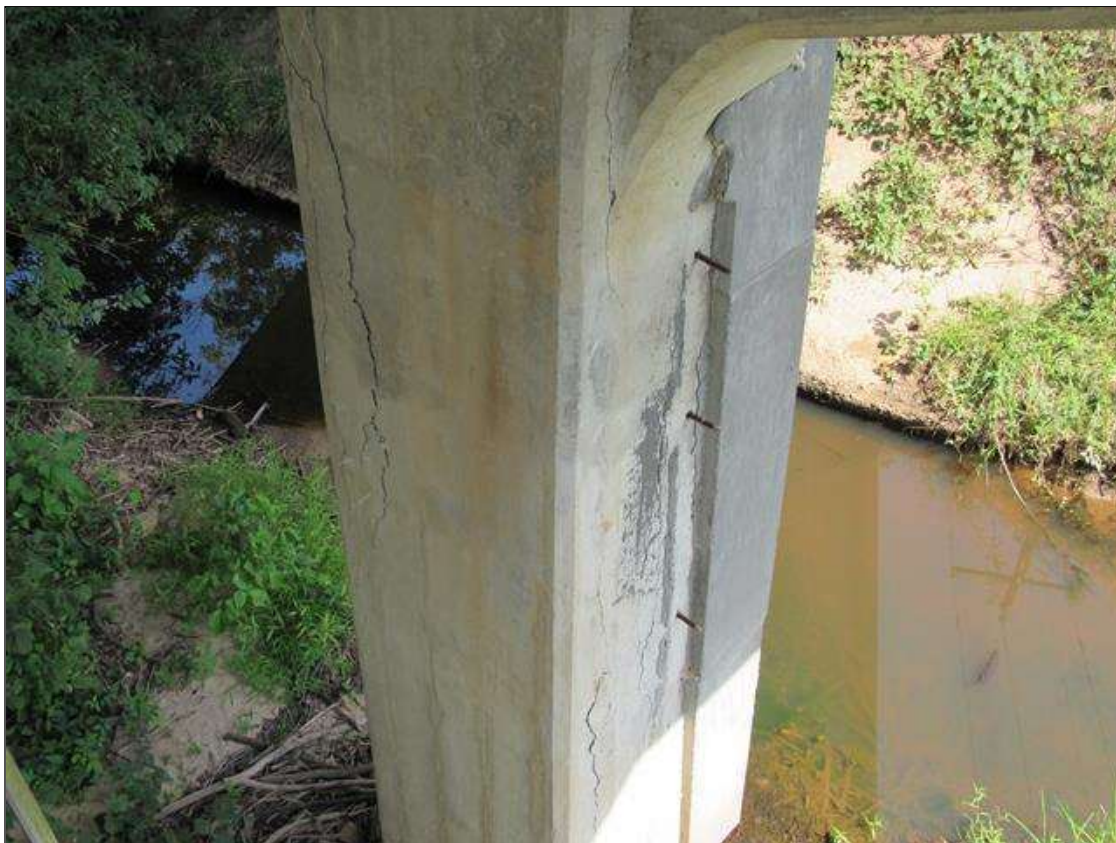
BENT 5 COLUMN 2 - DELAM (8FT X 1FT) RIGHT FACE STARTING AT TOP OF COLUMN

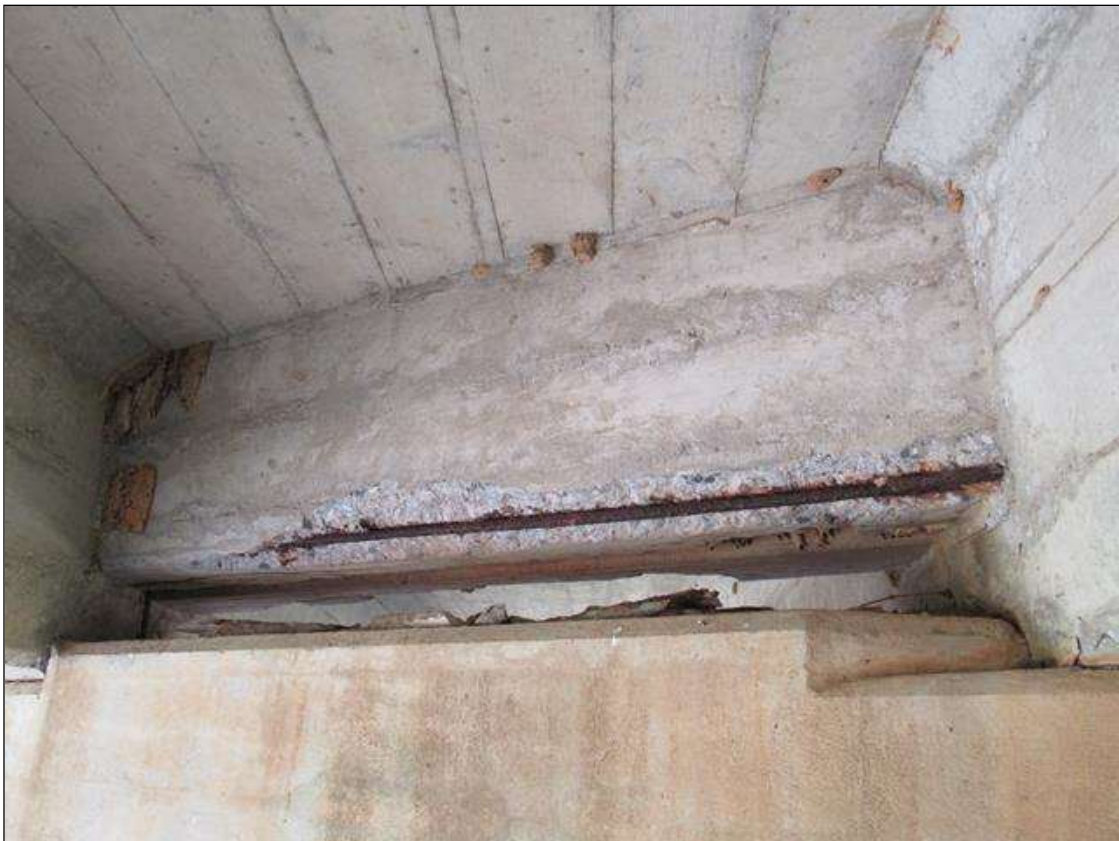
SPAN 6 NEAR END DIAPHRAGM, BAY 3 - SPALL (4FT X 6IN X 3IN) WITH EXPOSED REINFORCING

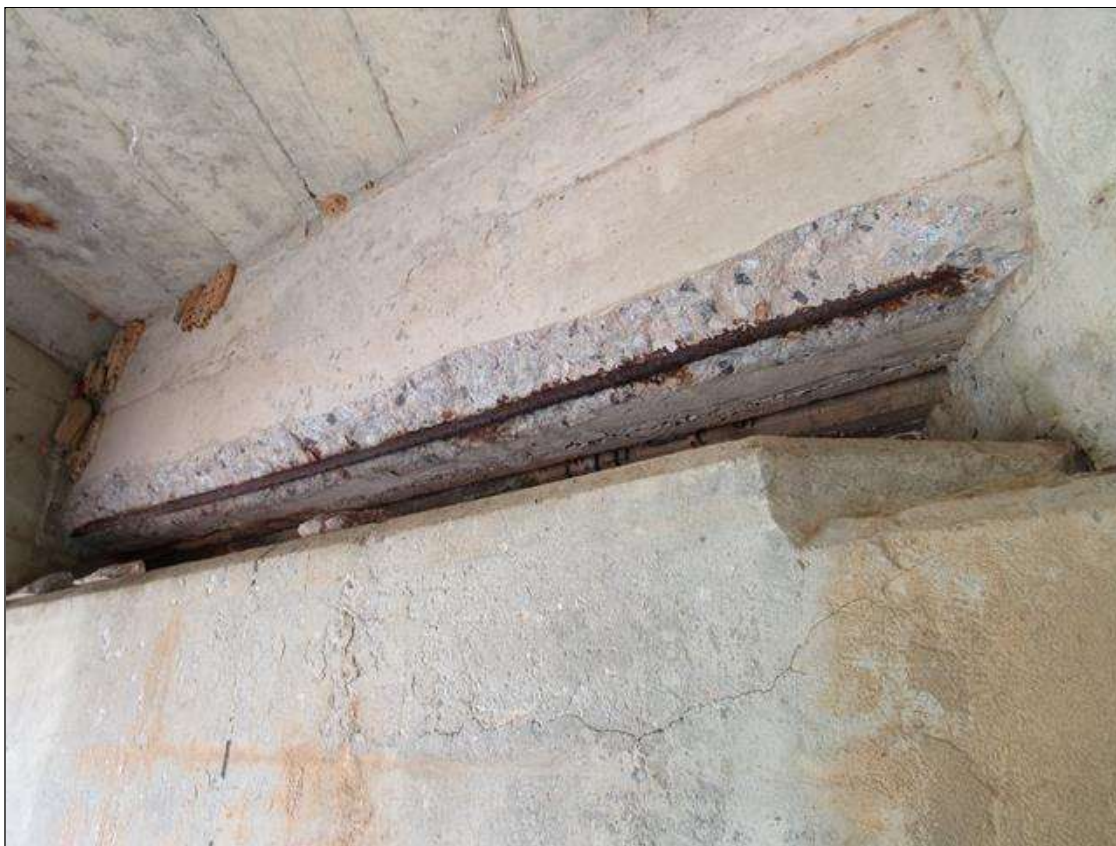
SPAN 6 NEAR END DIAPHRAGM, BAY 4 - SPALL (5FT X 6IN X 3IN) WITH EXPOSED REINFORCING

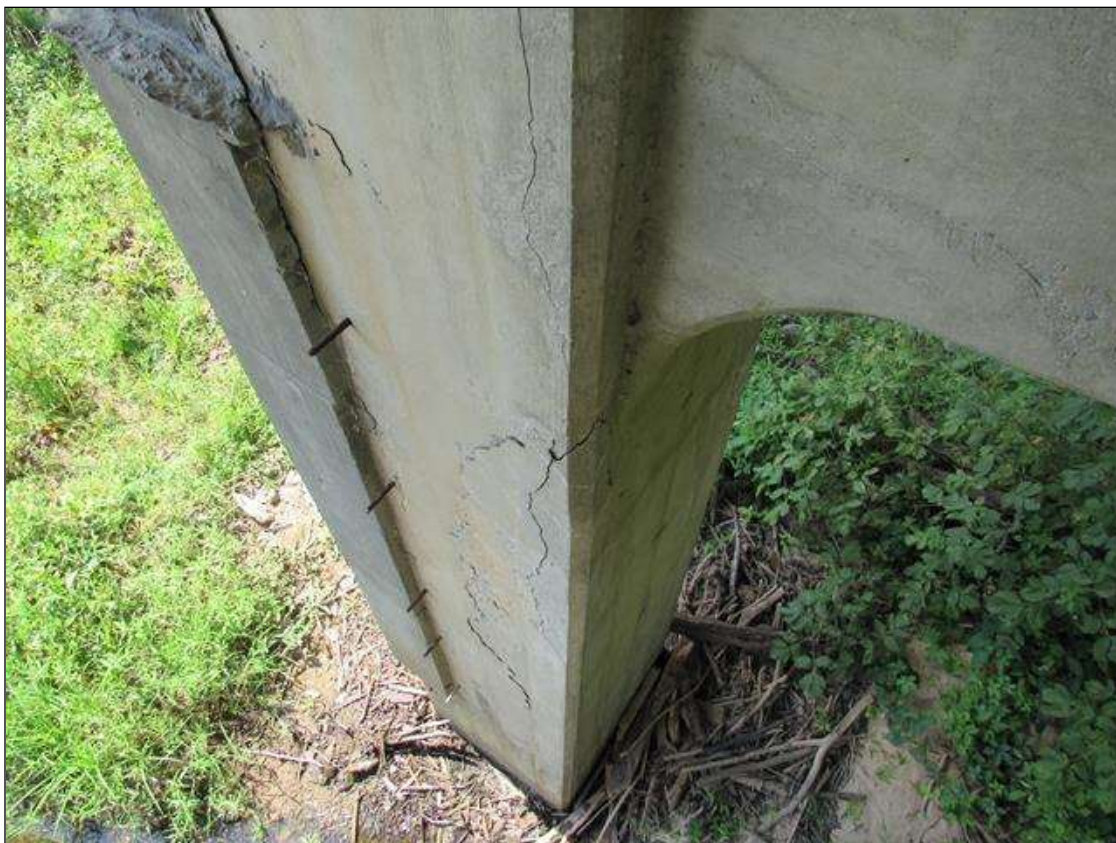
BENT 5 COLUMN 2 - DELAM (10FT X 16IN) FAR LEFT CORNER STARTING AT BOTTOM OF CAP

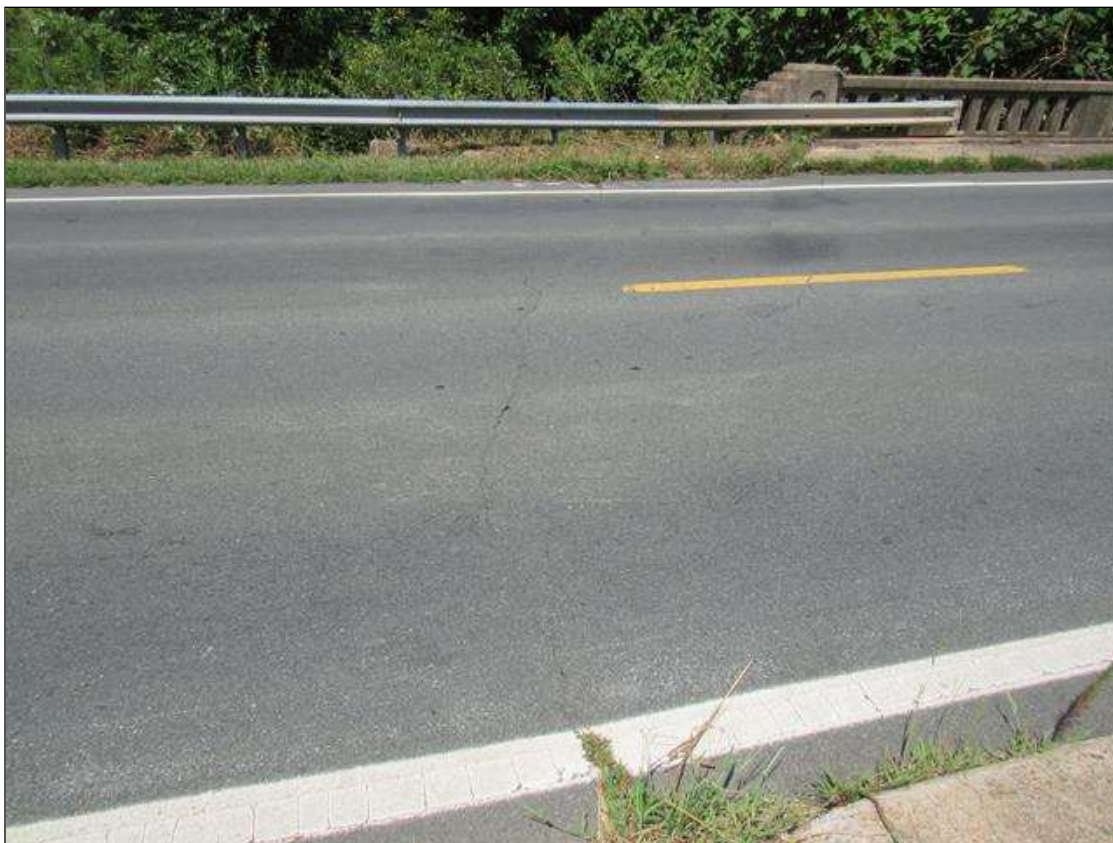
NEAR APPROACH & AWS OVER END BENT 1 - INTERMITTENT TRANSVERSE OPEN CRACKING, (UP TO 1/4IN X FULL L.) THROUGHOUT, FAR APPROACH SIMILAR

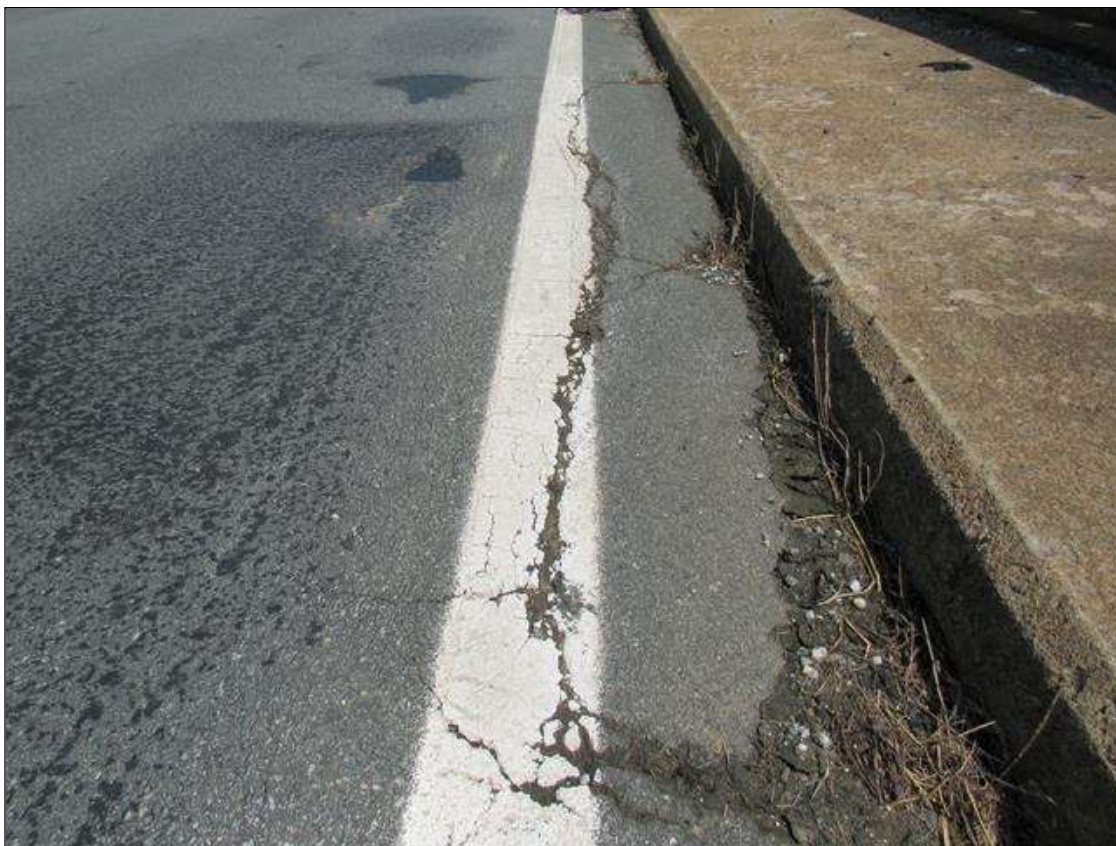
TYPICAL INTERMITTENT LONGITUDINAL OPEN CRACKING, (UP TO 1/2IN X 8FTL.) THROUGHOUT, SPAN 2 NEAR END RIGHT SIDE

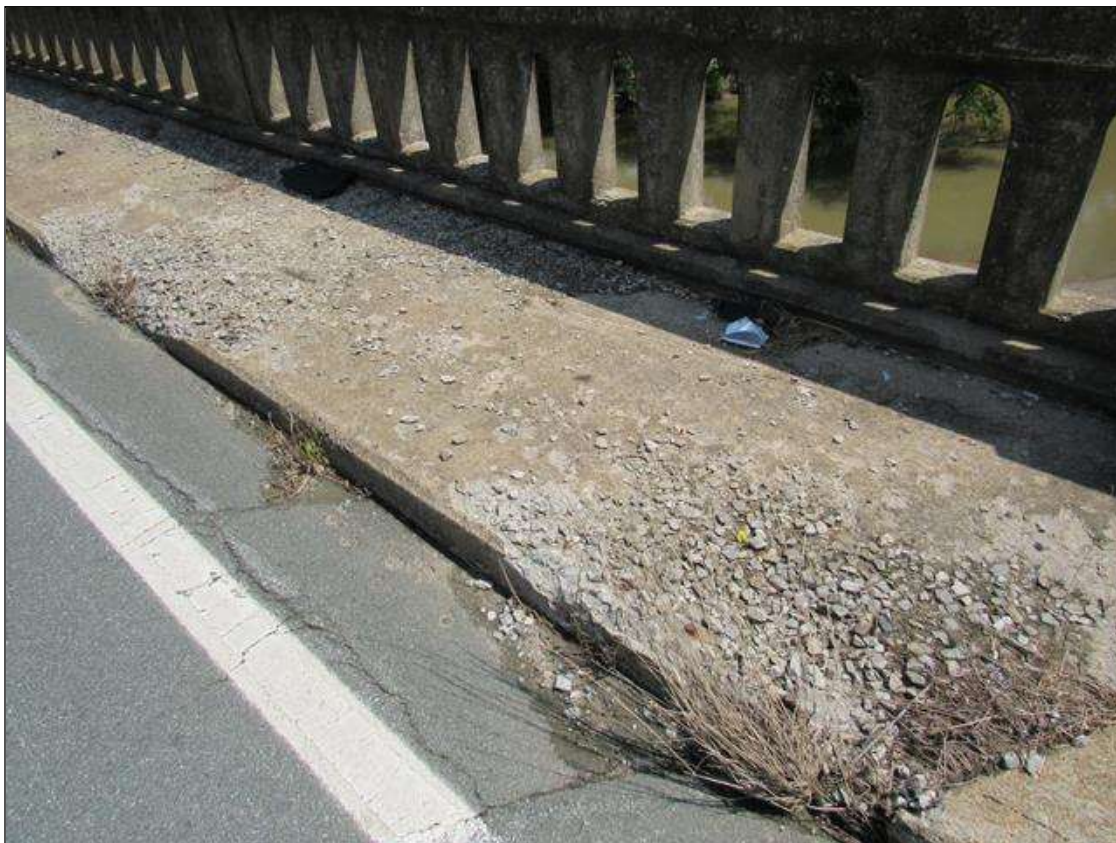
SPAN 3 SIDEWALK, RIGHT SIDE - SPALLING, (UP TO 5FT X 4FT X 4IN D.) WITH EXPOSED REINFORCING & LOOSE AGGREGATE, NEAR END. (PAR PHOTO)

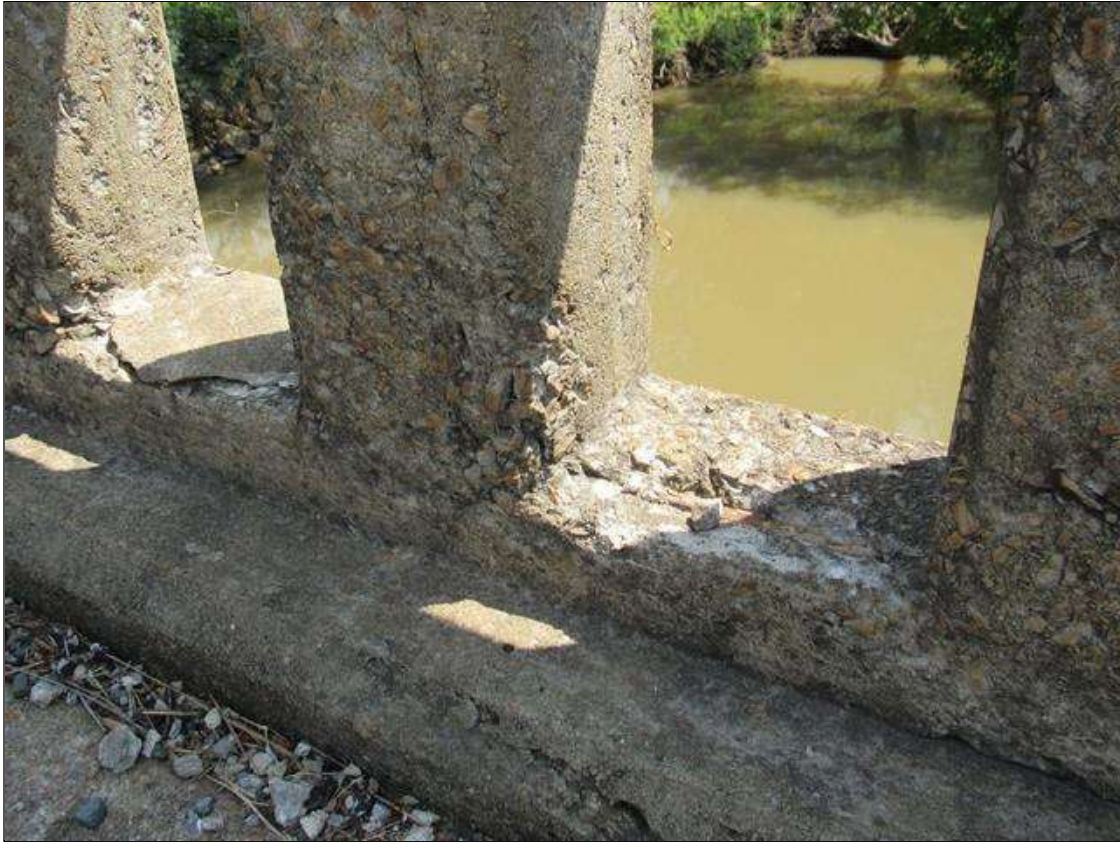
TYPICAL INTERMITTENT SPALLING, (UP TO 8IN X 2IN X 1IN) WITH EXPOSED REINFORCING & CRACKING, (UP TO 1/32IN X 2FT L.) THROUGHOUT RAIL, SPAN 3 RIGHT RAIL MID-SPAN

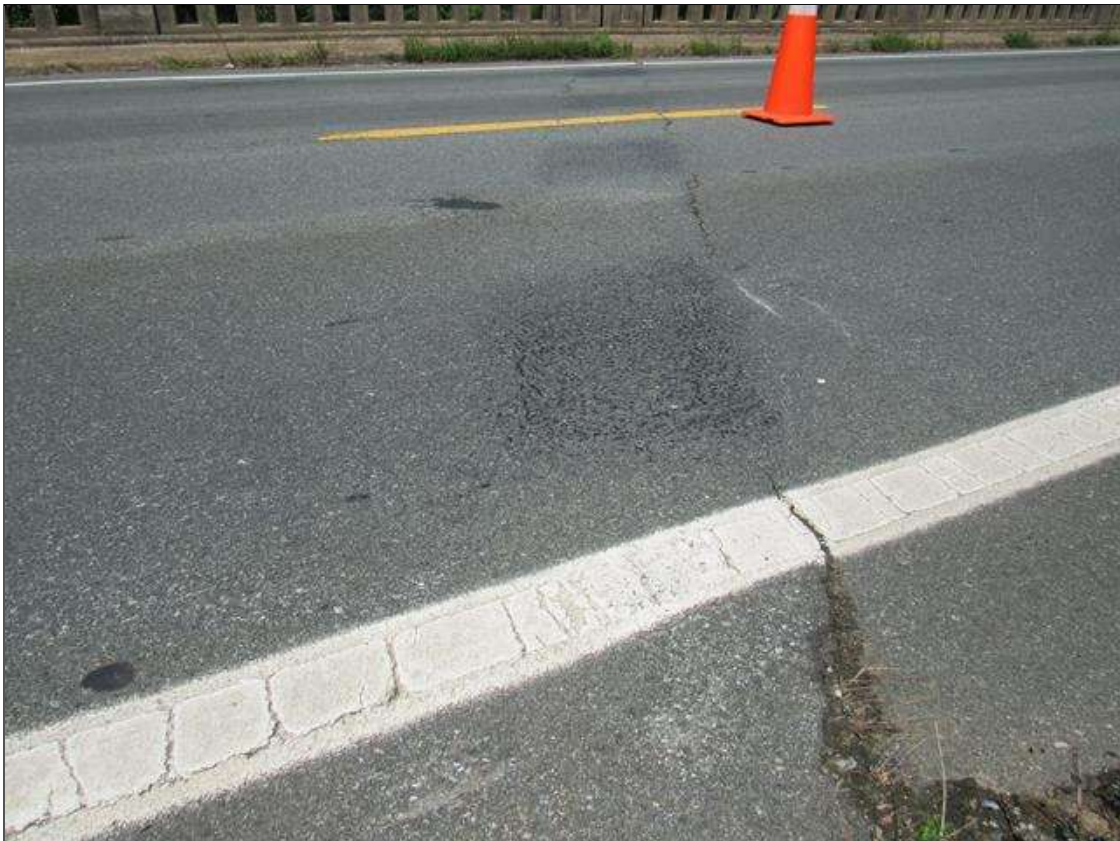
TYPICAL AWS OVER INTERIOR BENT - TRANSVERSE OPEN CRACKING, (UP TO 1/4IN X FULL W.) THROUGHOUT, AWS OVER BENT 3

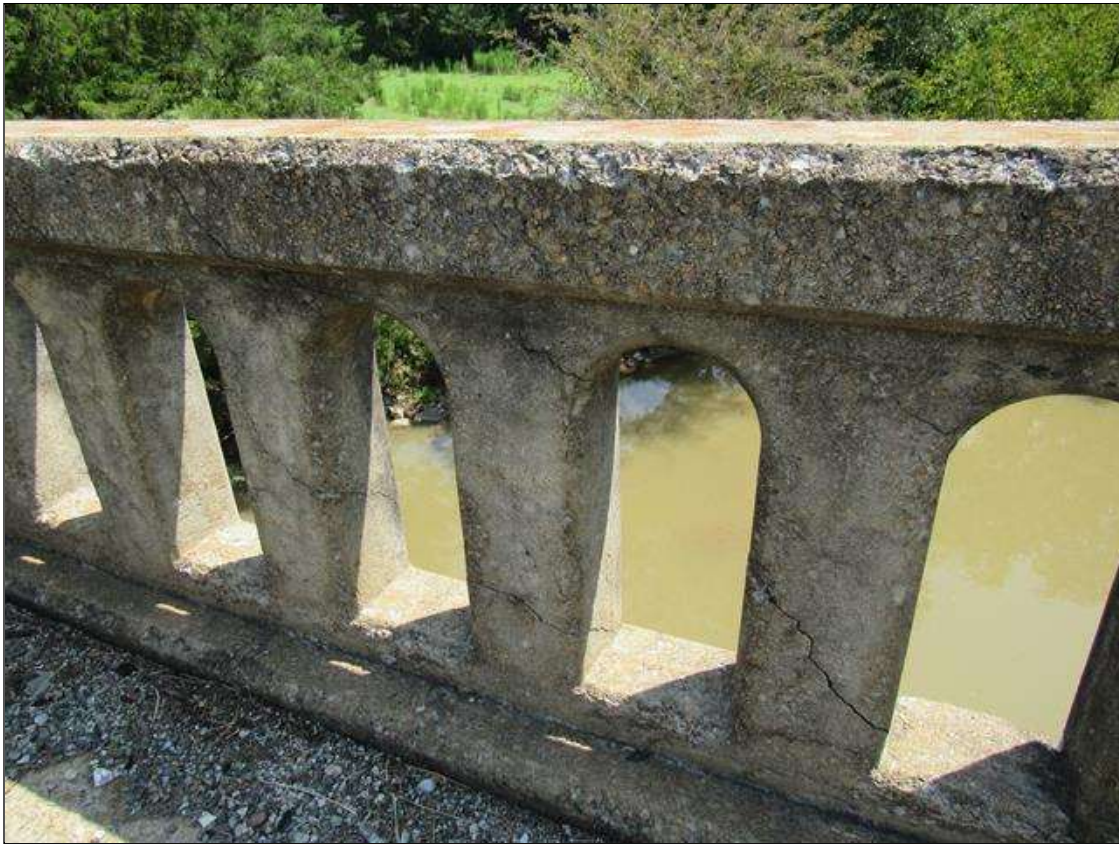
SPAN 4 RIGHT RAIL - DIAGONAL OPEN CRACKING, (UP TO 1/8IN X 4FT L.) AT 1/3 POINT

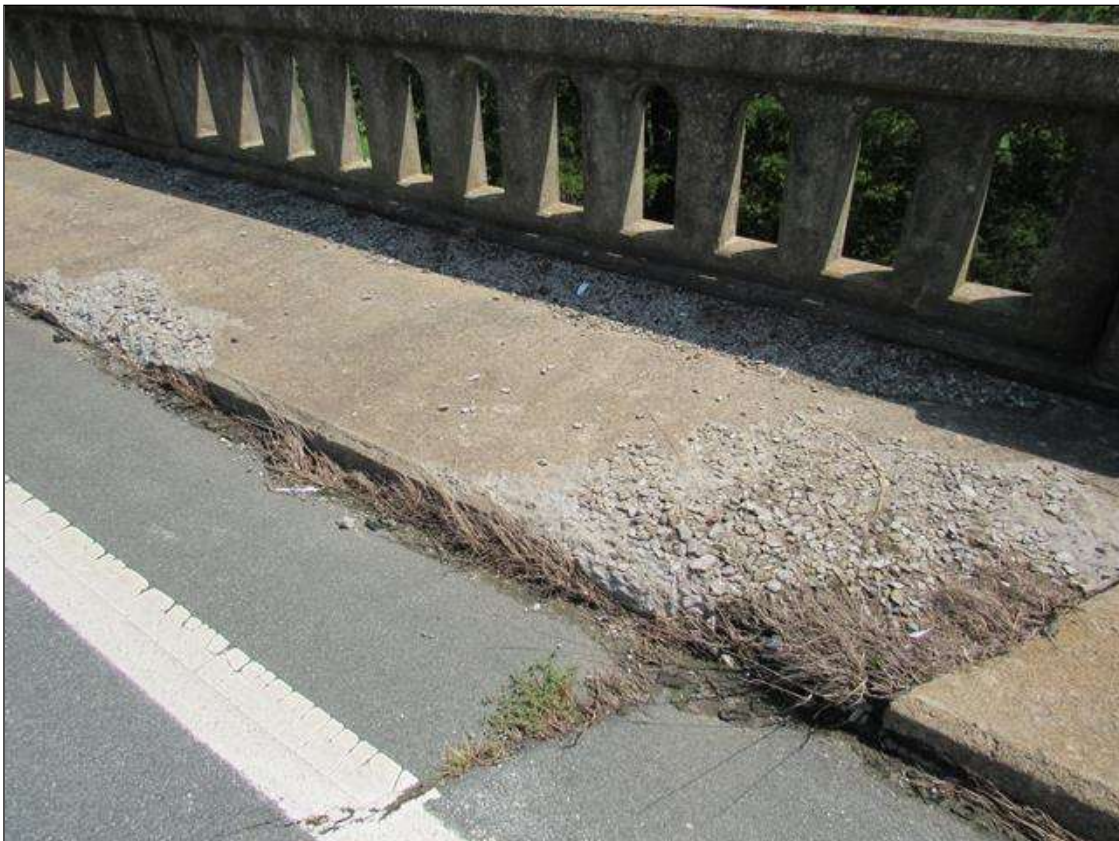
SPAN 5 SIDEWALK, RIGHT SIDE - SPALLING, (UP TO 5FT X 4FT X 3IN) WITH EXPOSED REINFORCING & LOOSE AGGREGATE, NEAR END. (PAR PHOTO)

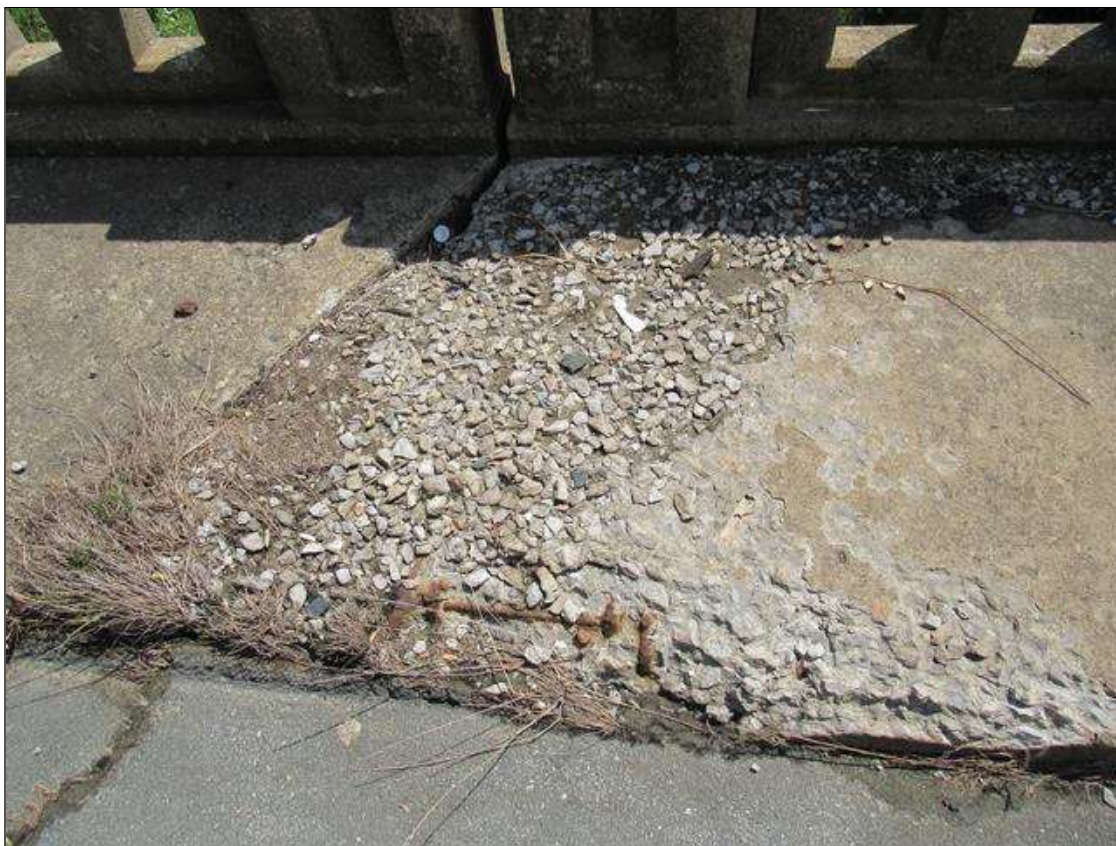
SPAN 5 SIDEWALK, RIGHT SIDE - SPALLING, (UP TO 4FT X 4FT X 4IN) WITH EXPOSED REINFORCING & LOOSE AGGREGATE, FAR END. (PAR PHOTO)

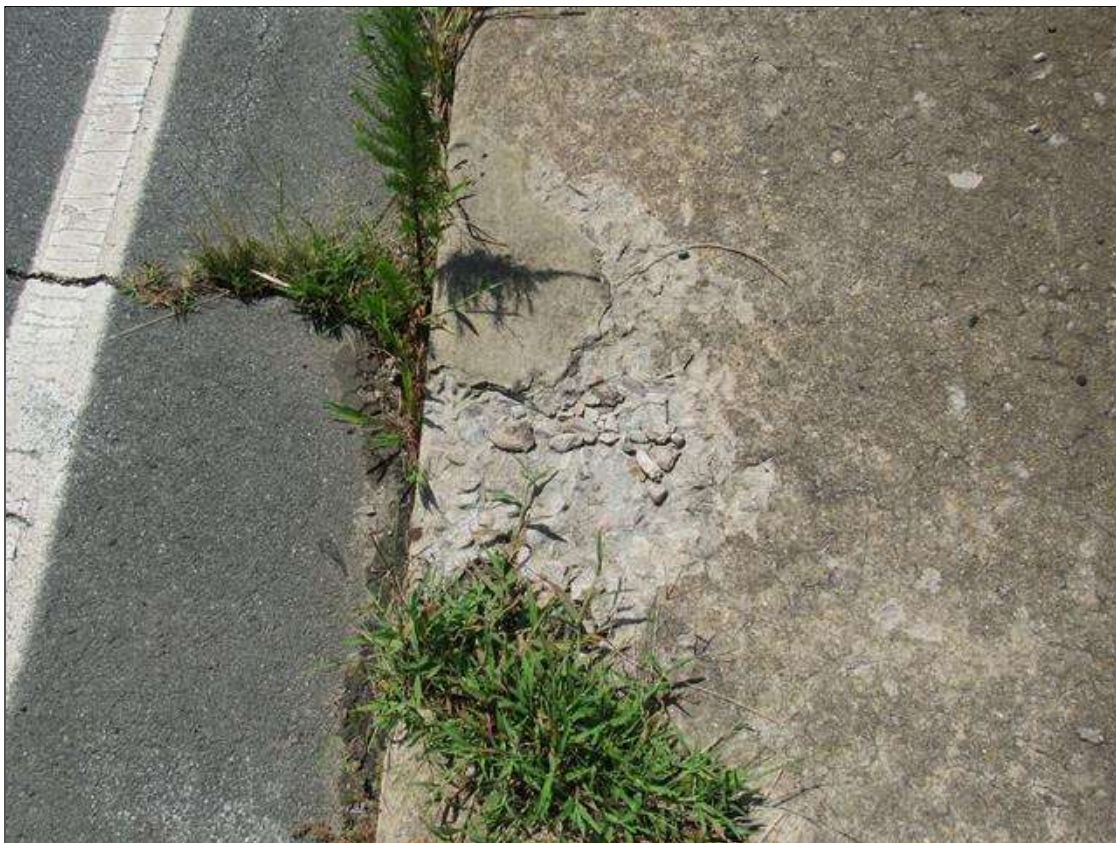
SPAN 5 SIDEWALK, LEFT SIDE - SPALLING, (3FT X 2FT X 1.5IN) WITH EXPOSED REINFORCING & LOOSE AGGREGATE, FAR END

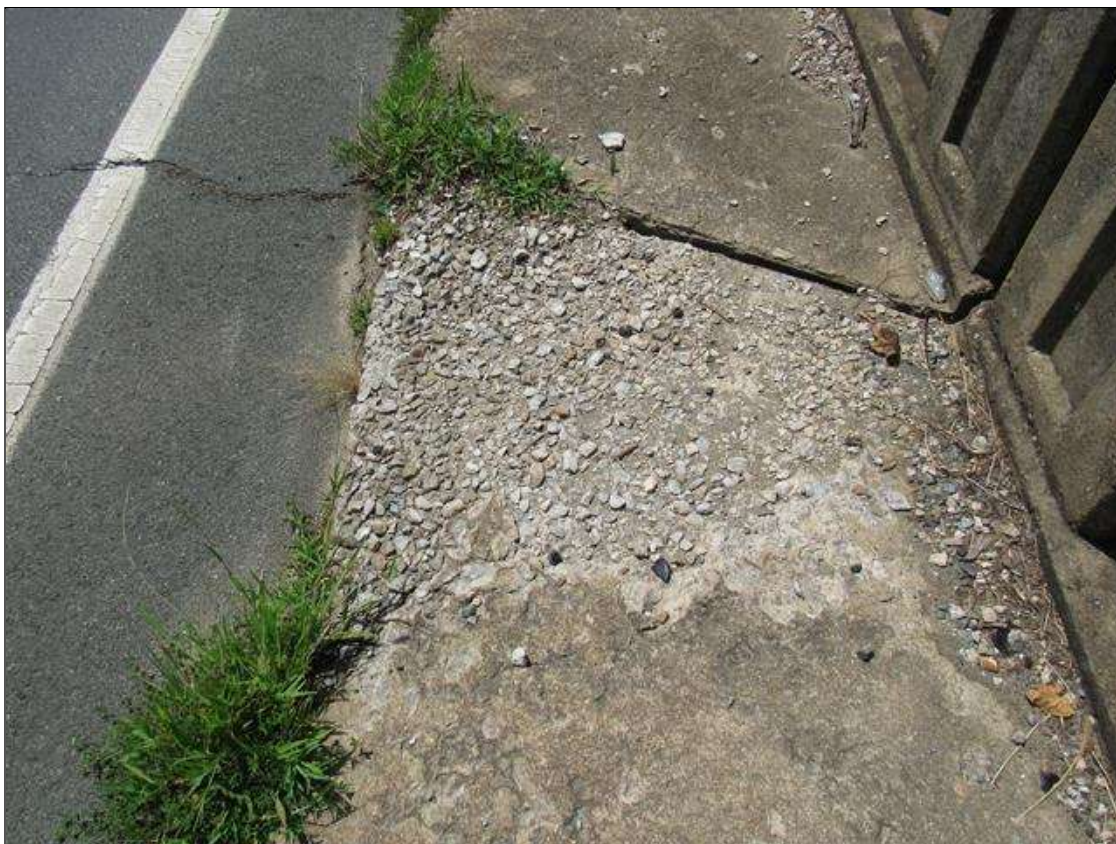
SPAN 3 SIDEWALK, LEFT SIDE - SPALLING, (4FT X 4FT X 3IN) WITH EXPOSED REINFORCING & LOOSE AGGREGATE, NEAR END. (PAR PHOTO)

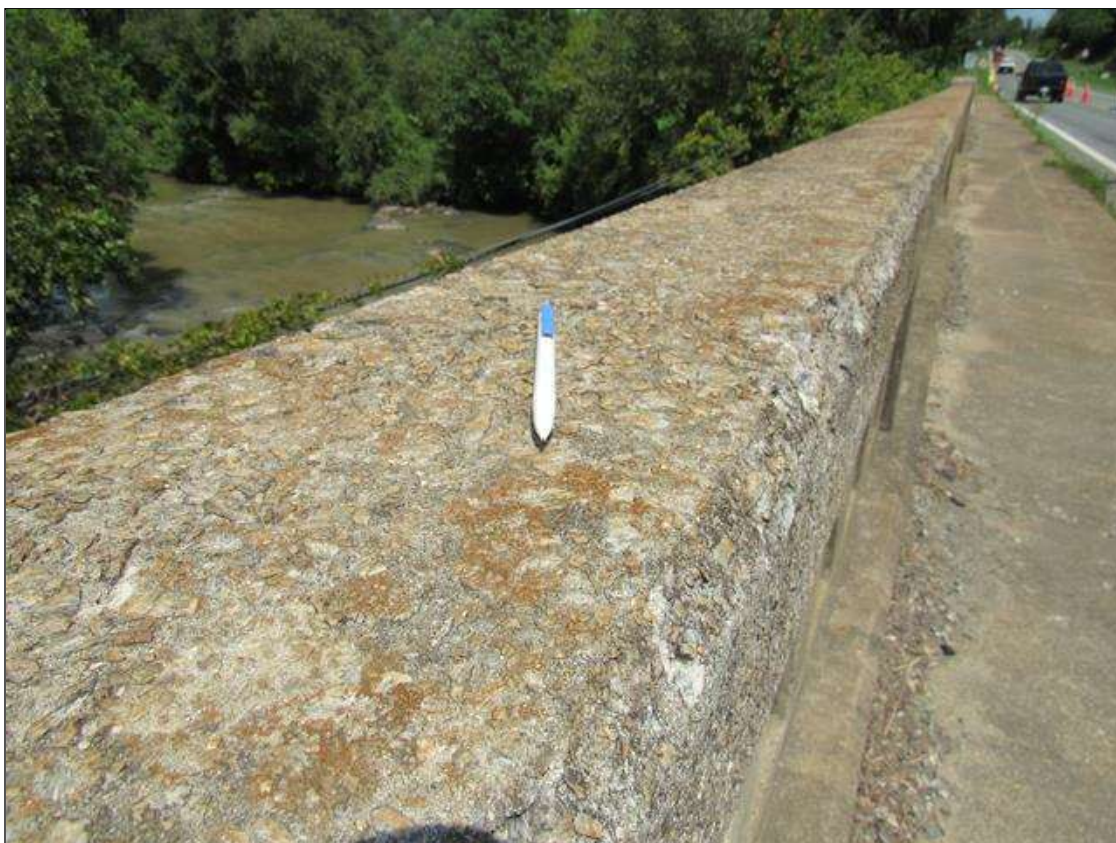
TYPICAL WEAR WITH EXPOSED AGGREGATE THROUGHOUT TOP OF RAIL, SPAN 3 LEFT RAIL

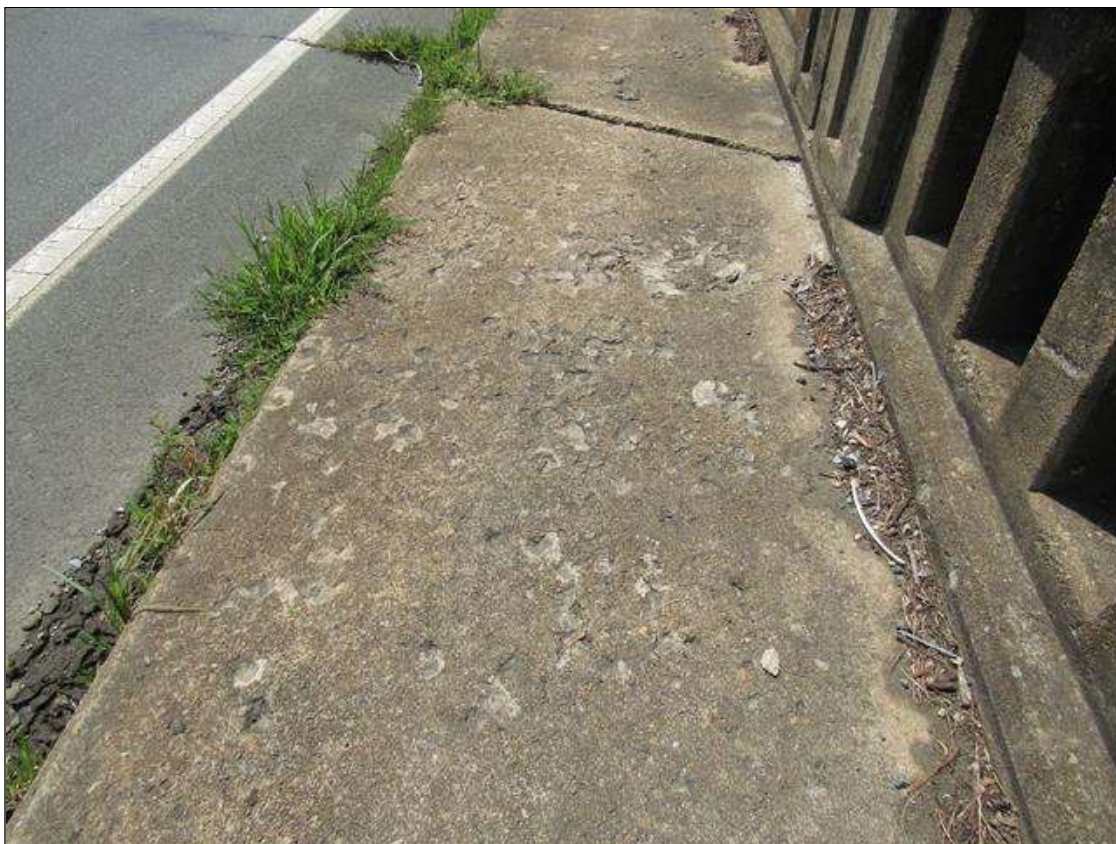
TYPICAL WEAR/SHALLOW SPALLING, (UP TO 1/2IN D.) WITH EXPOSED AGGREGATE THROUGHOUT SIDEWALK, SPAN 2 LEFT SIDE NEAR END

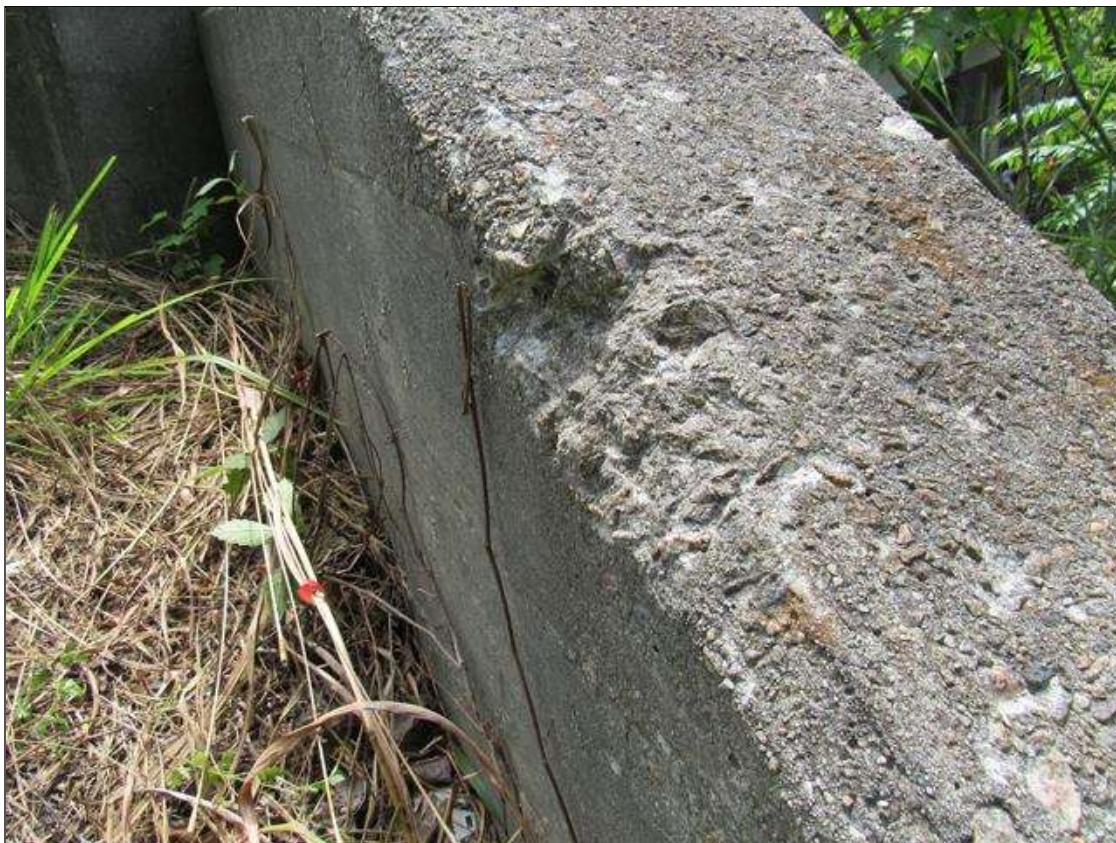
FAR LEFT WINGWALL - SPALL (7IN X 4IN X 3/4IN) NO EXPOSED REINFORCING, FAR CORNER

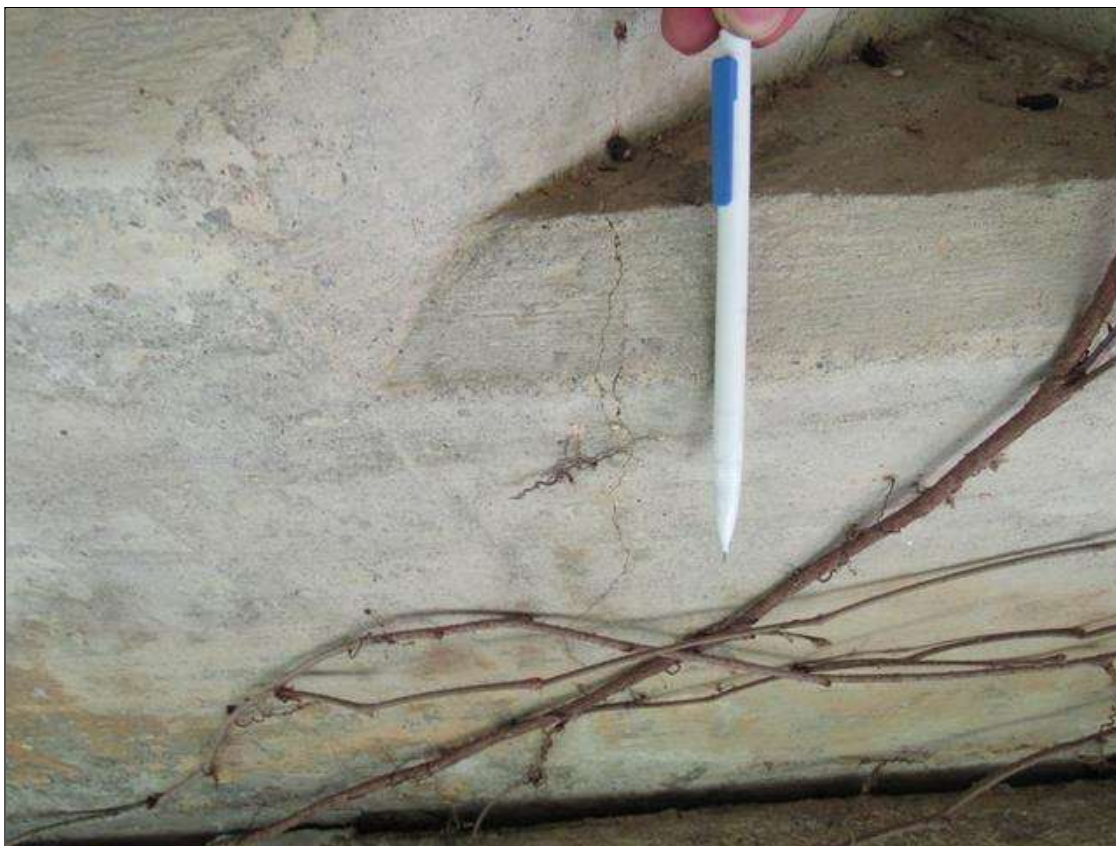
TYPICAL INTERMITTENT VERTICAL HAIRLINE CRACK, (UP TO 10IN L.) THROUGHOUT CAP, END BENT 2 BAY 1

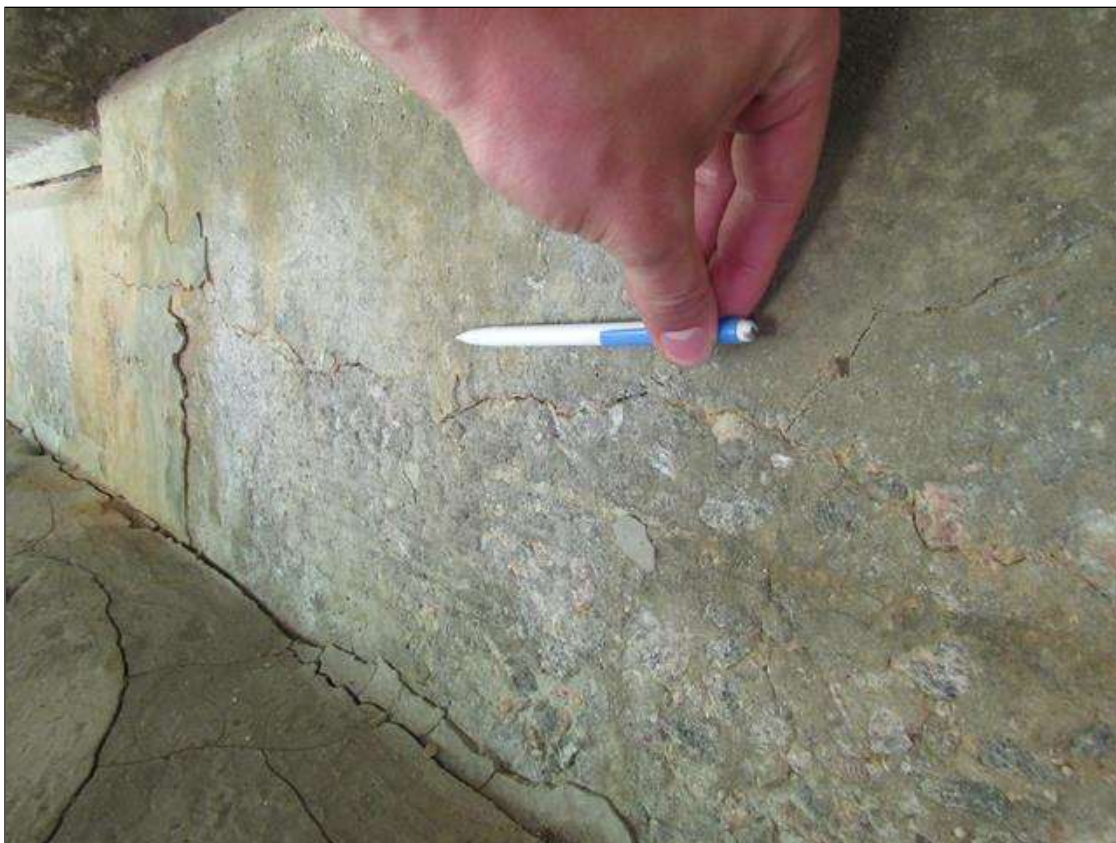
TYPICAL INTERMITTENT LONGITUDINAL HAIRLINE TO 1/32IN CRACK, (UP TO 5FT L.) THROUGHOUT CAP, END BENT 2 BAY 4
