NC DEPARTMENT OF TRANSPORTATION
 DIVISION OF HIGHWAYS
 STRUCTURE MANAGEMENT UNIT

ATTENTION: **PAR'S ISSUED: SPALLING THROUGHOUT BENTS, SIDEWALKS, BEAM & DRIFT UNDER SPAN 4. SNOOPER USED. CHANGES TO TYP. SECTION SKETCH. CHANGE TO AWS THICKNESS.**

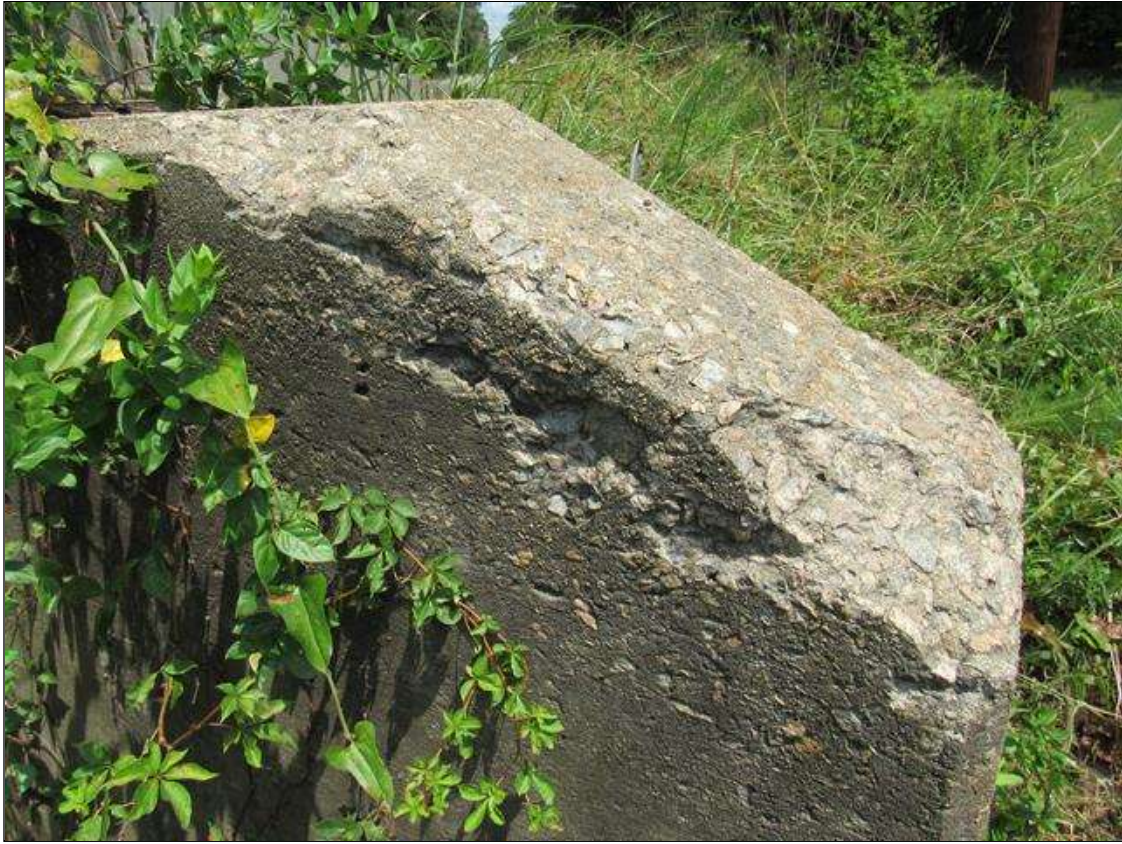
FAR RIGHT WINGWALL - SPALLING, (UP TO 2FT X 8IN X 2IN) NO EXPOSED REINFORCING, NEAR CORNER

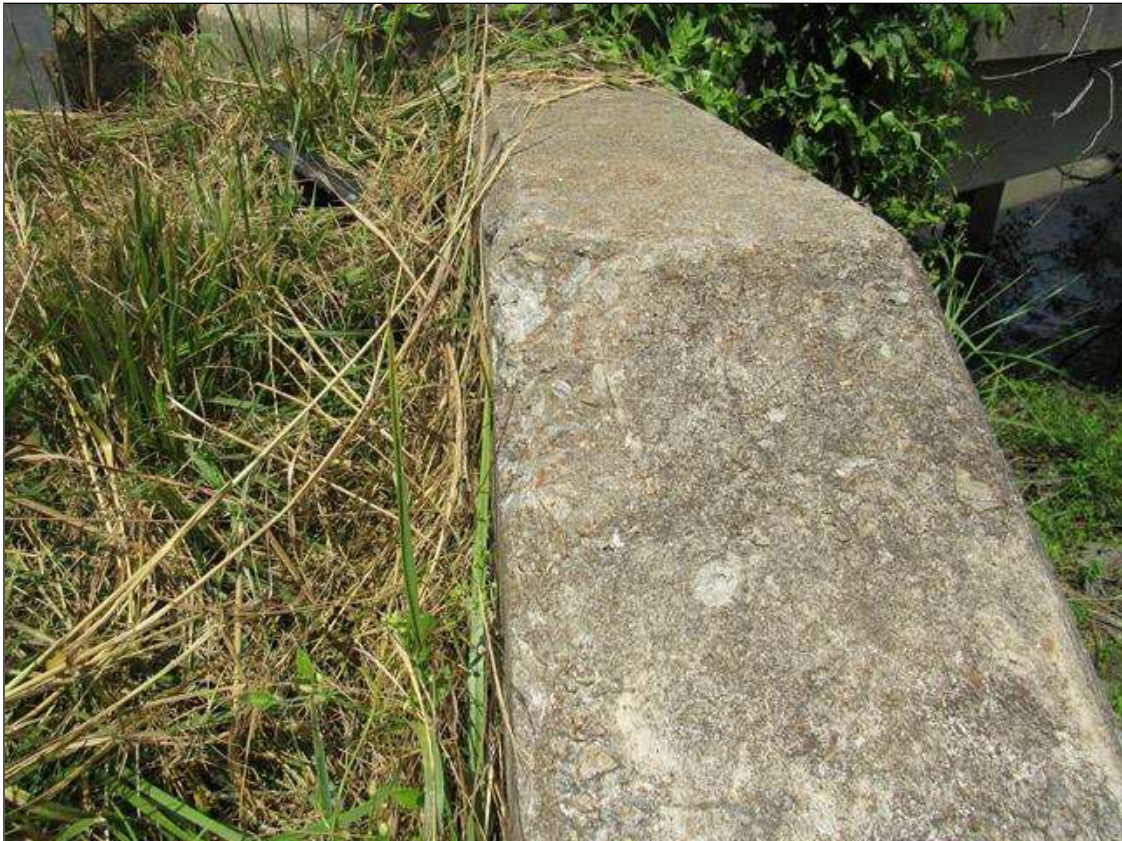
NEAR RIGHT WINGWALL - SPALL (10IN X 6IN X 1IN) NO EXPOSED REINFORCING, NEAR CORNER

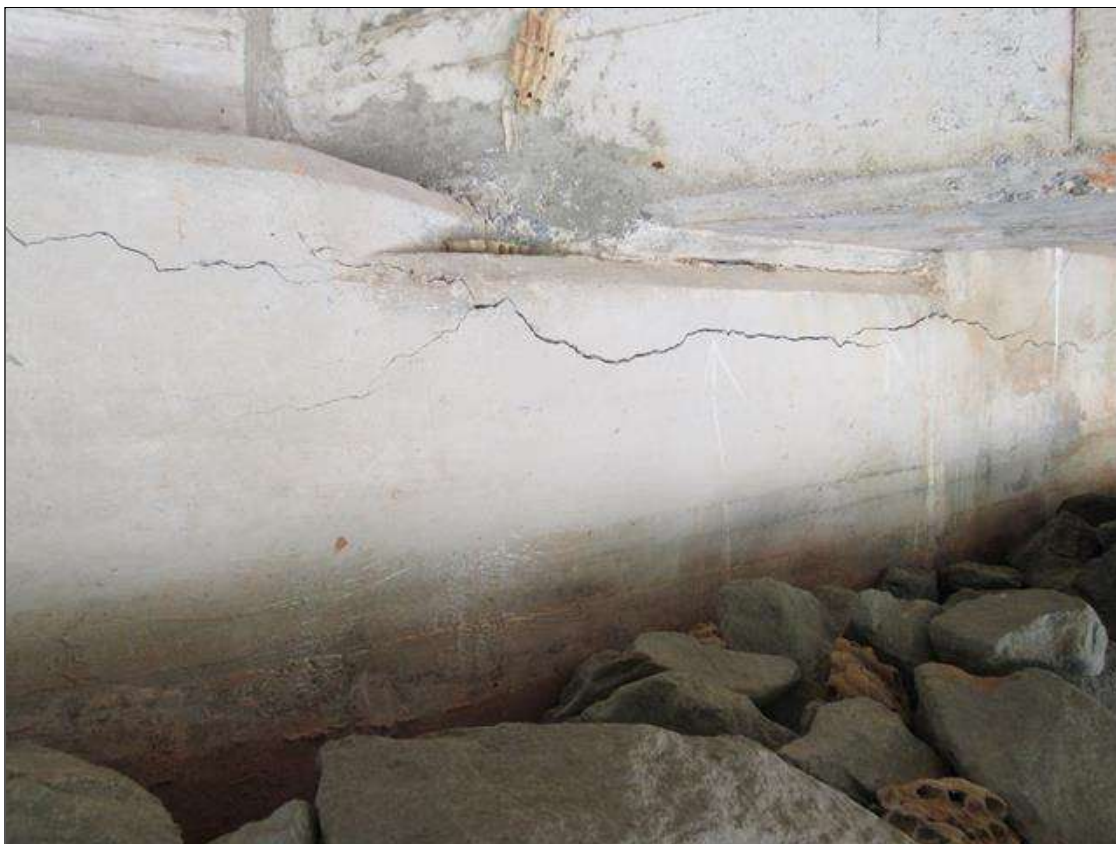
END BENT 1 CAP - LONGITUDINAL OPEN CRACK, (1/8IN X 5FT L.) UNDER BEAM 2

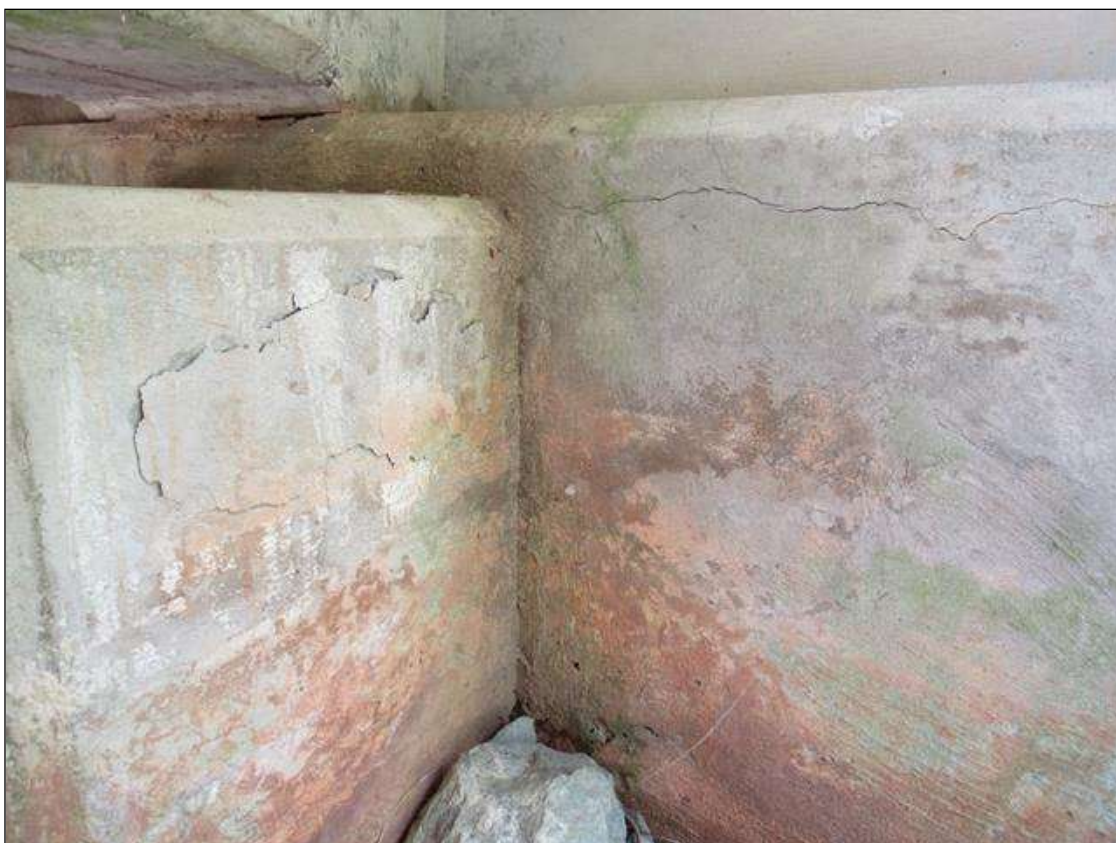
END BENT 2 CAP - DELAM (1FT X 6IN) TO LEFT END PILE CAP AT LEFT SIDE & LONGITUDINAL CRACK, (1/32IN X 2FT L.) LEFT OF BEAM 1

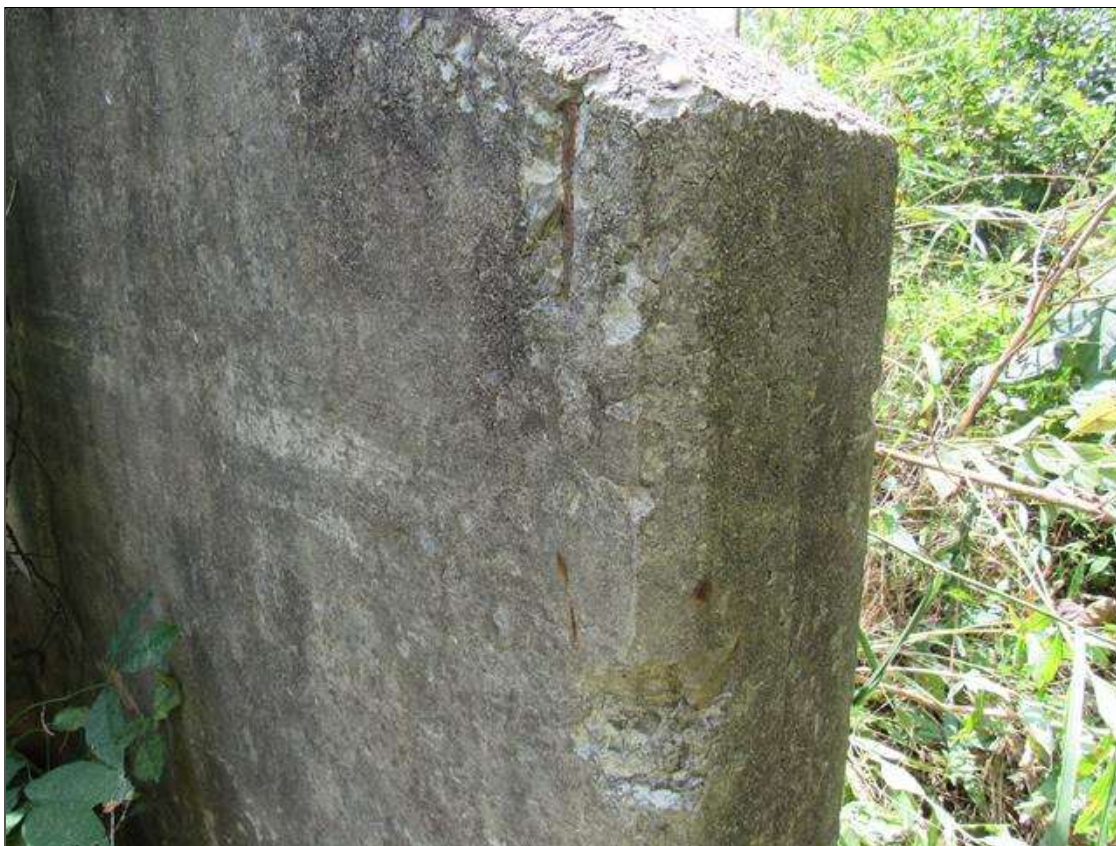
NEAR LEFT WINGWALL - SPALLING, (UP TO 6IN X 4IN X 1/2IN) WITH EXPOSED REINFORCING, FAR CORNER

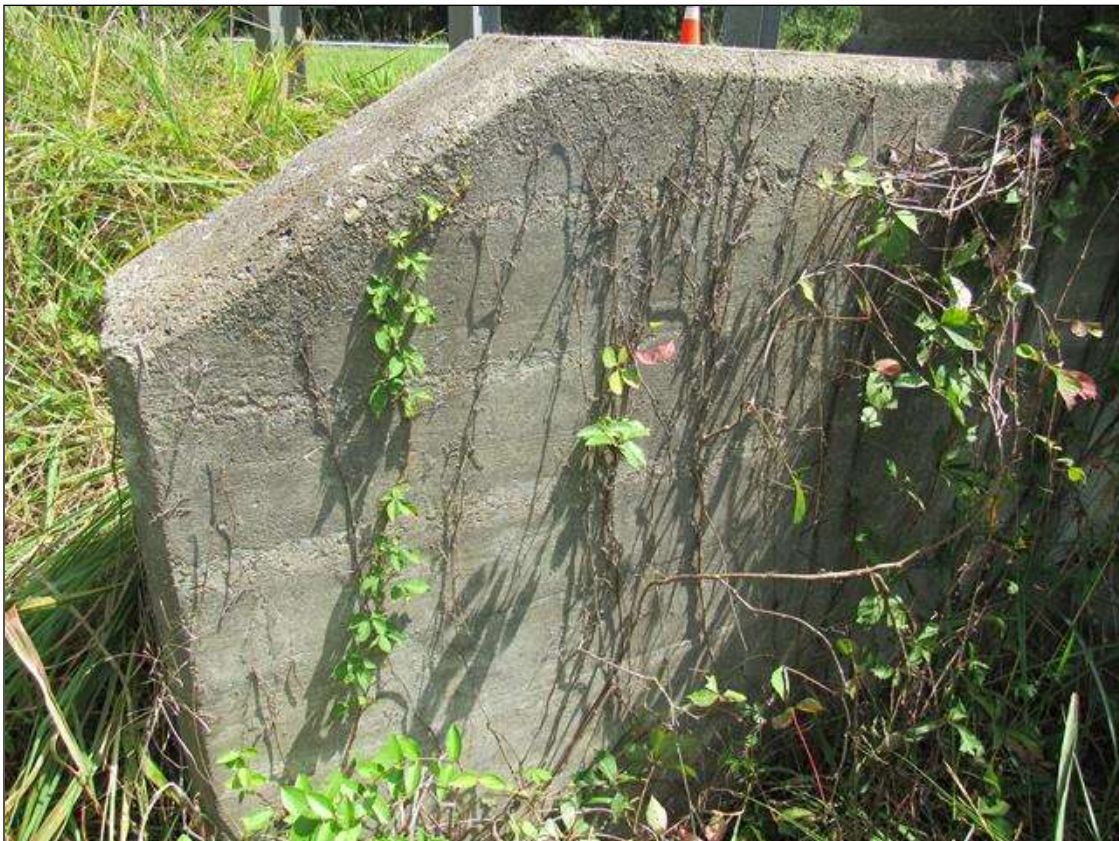
TYPICAL WINGWALL, FAR LEFT

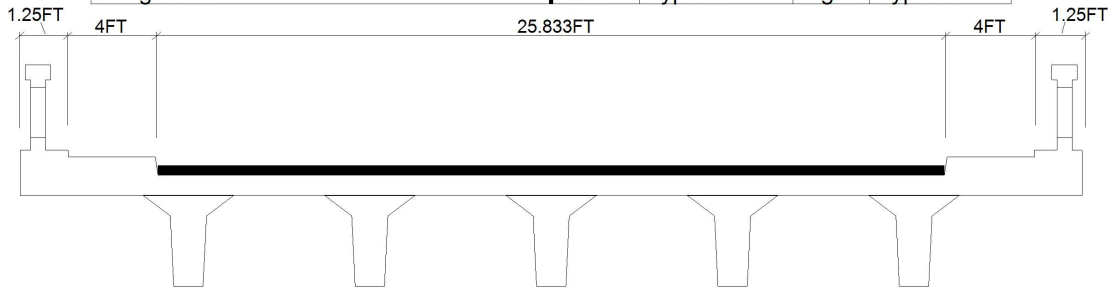
Measurements for Span #	1		
Deck Thickness	0.542	Left Overhang	4.417
Top of Rail to Bottom of Beam	6.583	Right Overhang	4.417

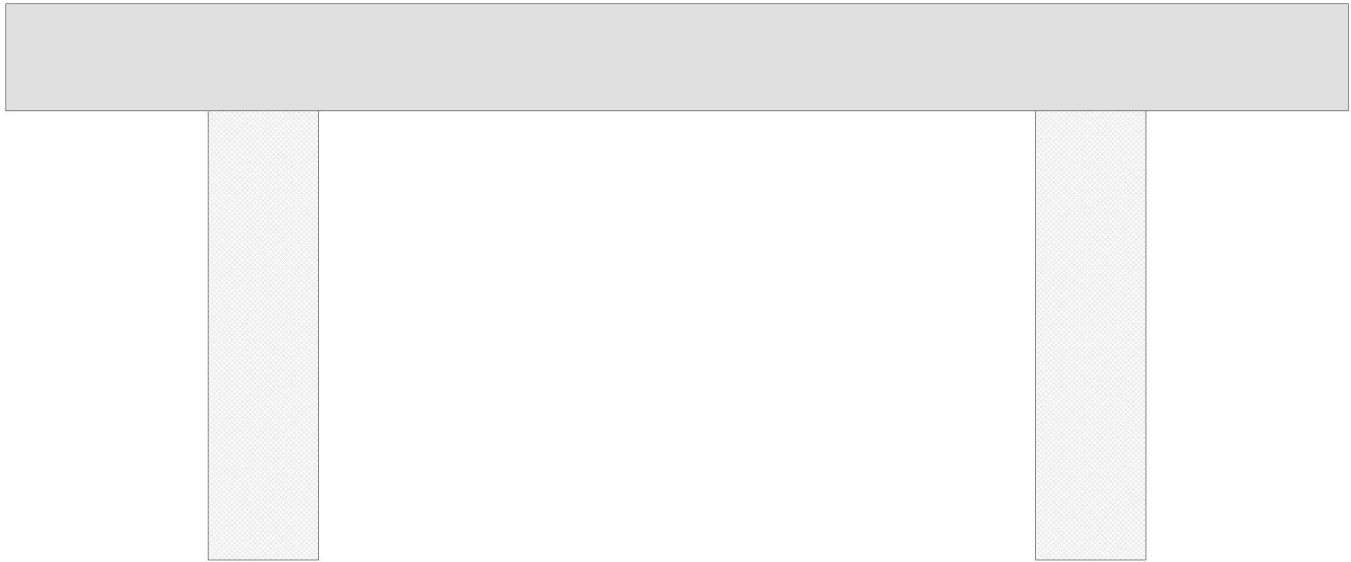
Cap Information			Material Cast-in-Place Concrete							
Length	Width	Height	Left Overhang	Right Overhang	Left Beam to End of Cap.	Right Beam to End of Cap.				
36.500 ft.	3.000 ft.	2.917 ft.	7.000 ft.	7.000 ft.	2.500 ft.	2.500 ft.				
Subcap Information			Material							
Length	Width	Height	Left Overhang	Right Overhang	Left Pile to Splice.					
Sill Information			Material							
Length	Width	Height								
Pile #	Material	Spacing	Width/Dia.	Height	Length	Orientation	Driven?	Replacement?	Removed?	Collar?
1	Concrete	22.500 ft.	3.000 ft.	2.9167 ft.			No	No	No	No
2	Concrete		3.000 ft.	2.9167 ft.			No	No	No	No
<p>VERIFIED 8/21/19 AGF & MWR MEAS. VERIFIED 8/23/2017...RFW</p>										
Bent/Abutment #: 1			Similar Bents: 2,3,4,5
