NC DEPARTMENT OF TRANSPORTATION
 DIVISION OF HIGHWAYS
 STRUCTURE MANAGEMENT UNIT

ATTENTION: **SKETCHES UPDATED**

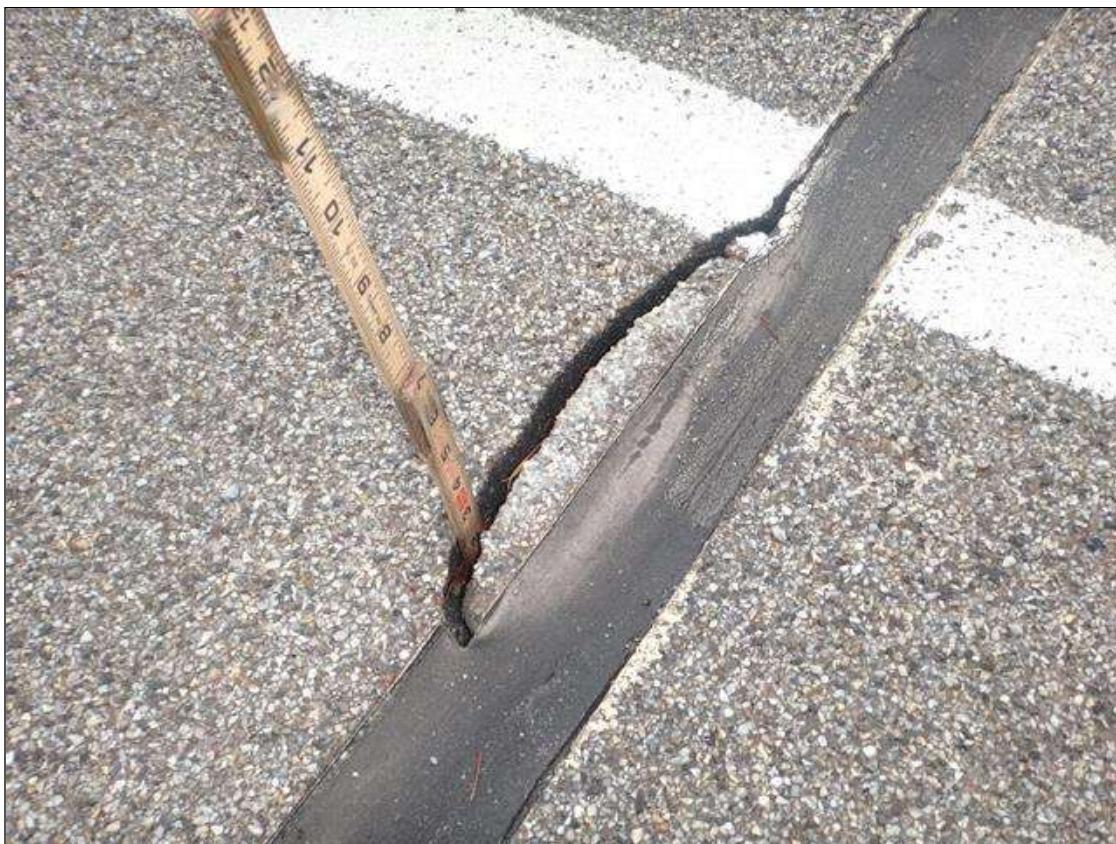
Expansion Joint 2 : west shoulder next to white line, broken section (1ft x 2in x up to 3in)

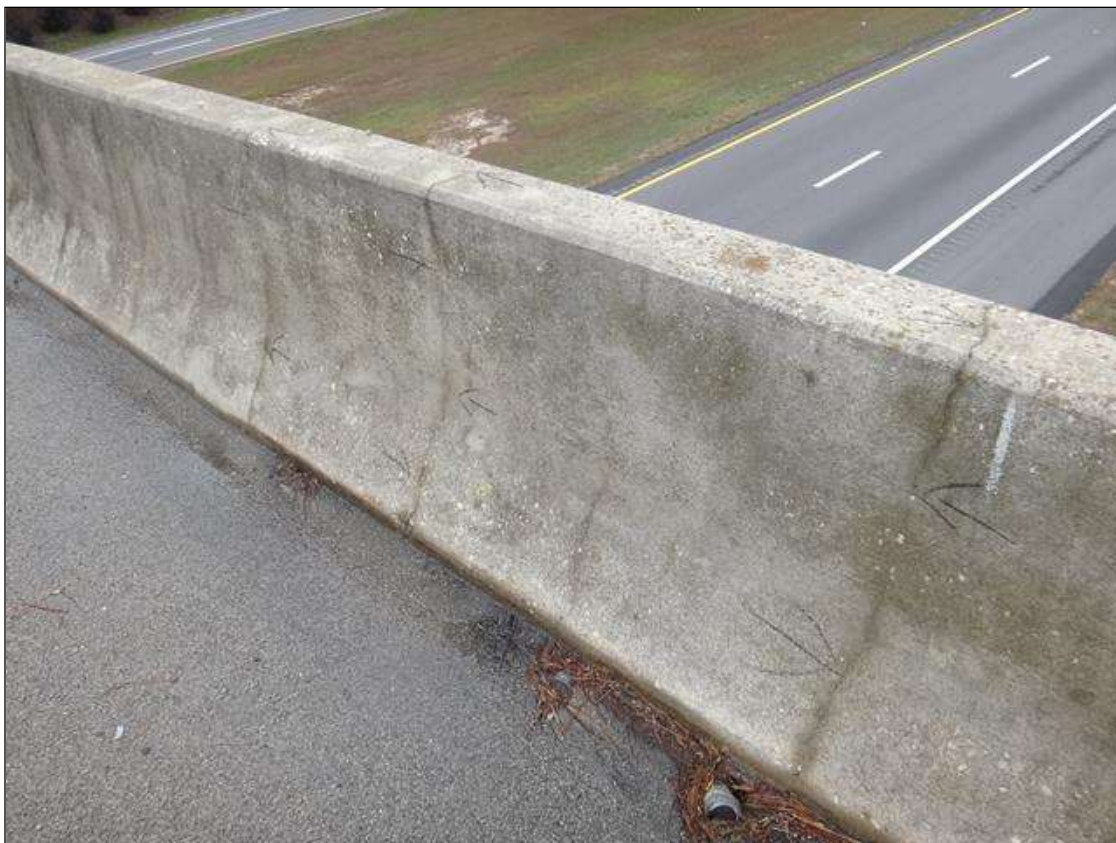
Span 2 Left Bridge Rail: scattered throughout at random, multiple vertical cracks (full height x hairline)

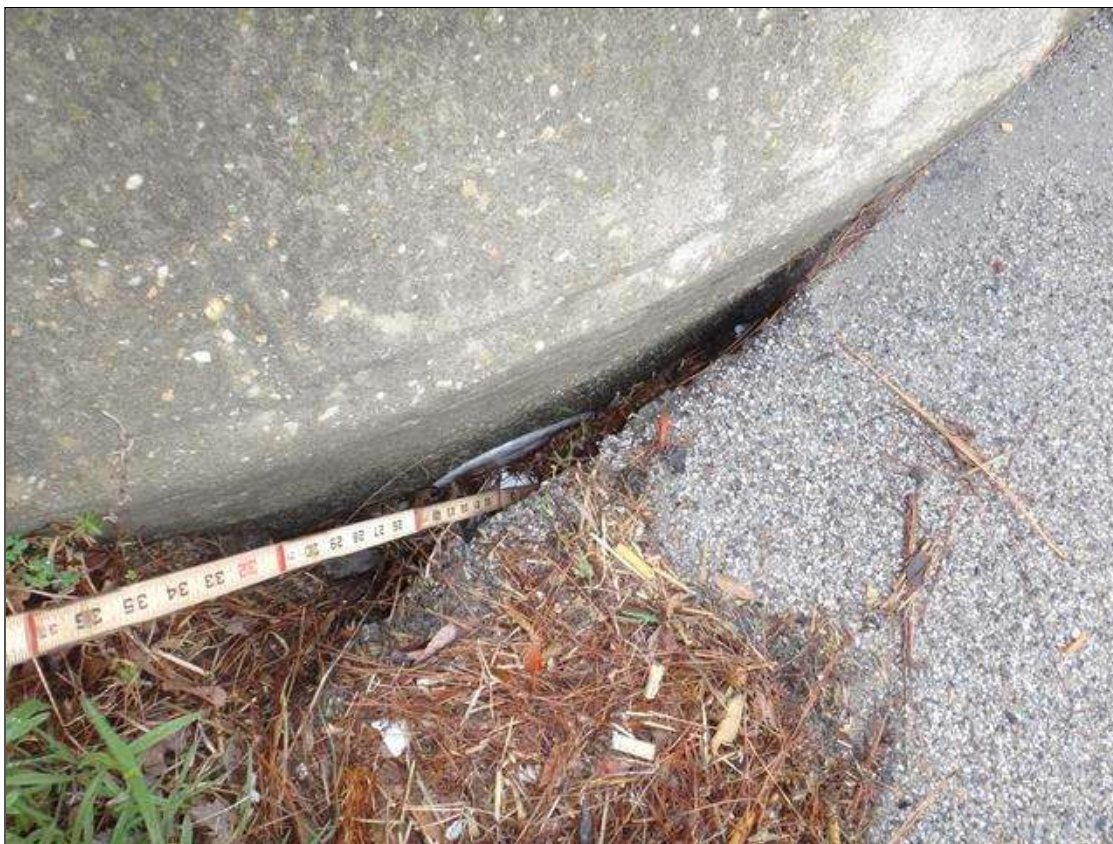
west shoulder between approach slab and left bridge rail at 2ft from end bent 1, erosion hole (2ft x up to 5in x up to 21in) (photo 1 of 2)

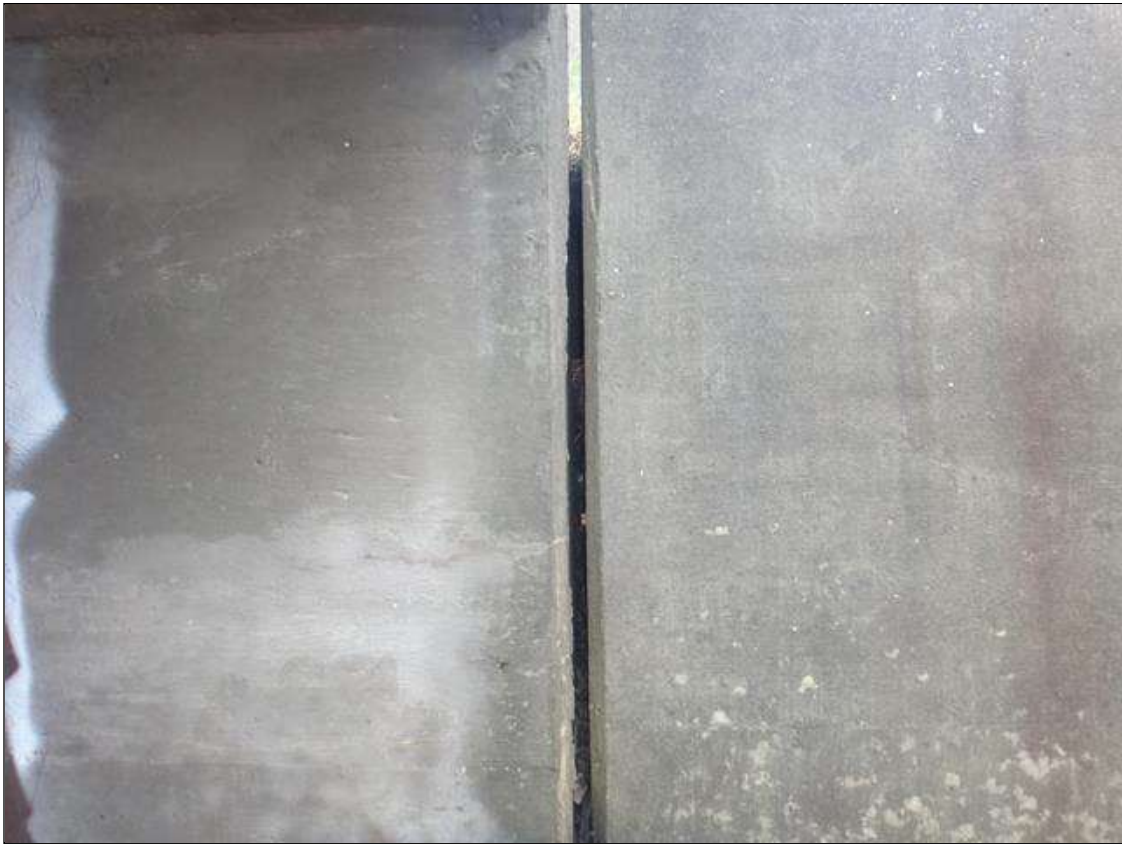
all wingwalls, missing joint material (full height)

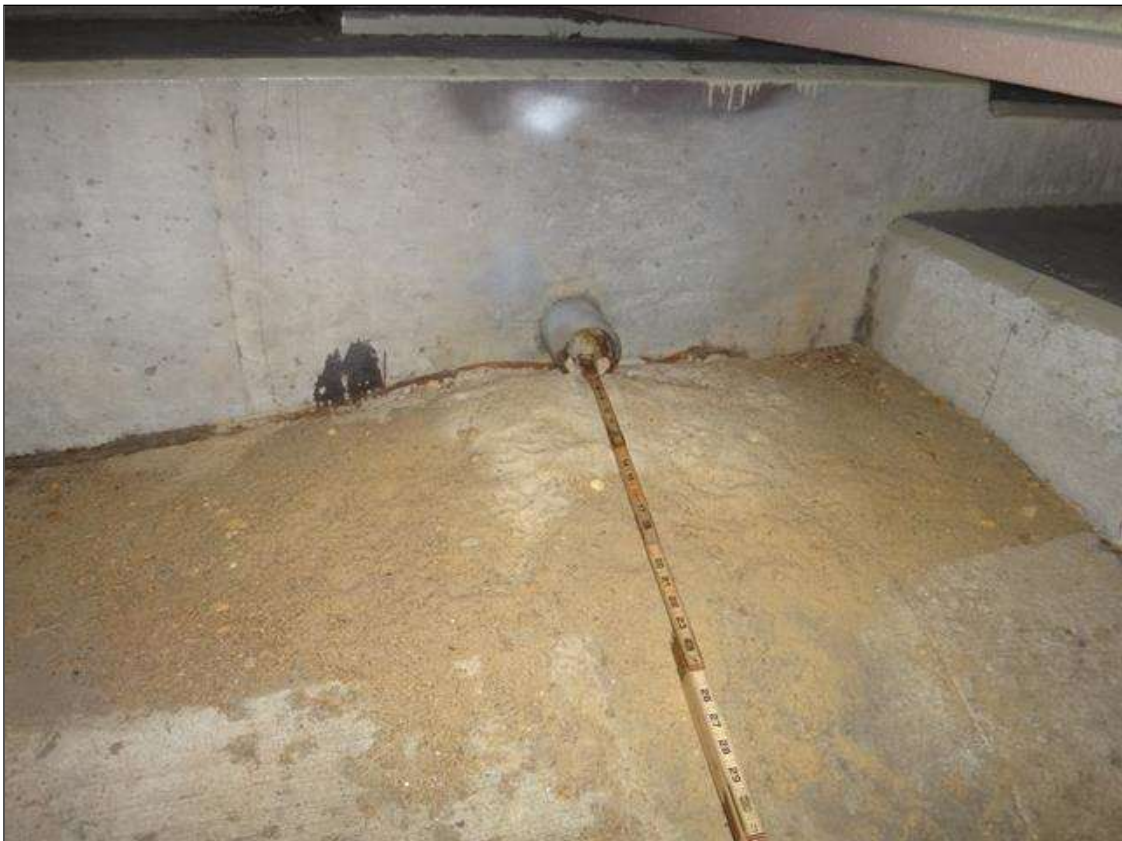
end bent 1 weepage holes under beams 4 and 5, partially blocked

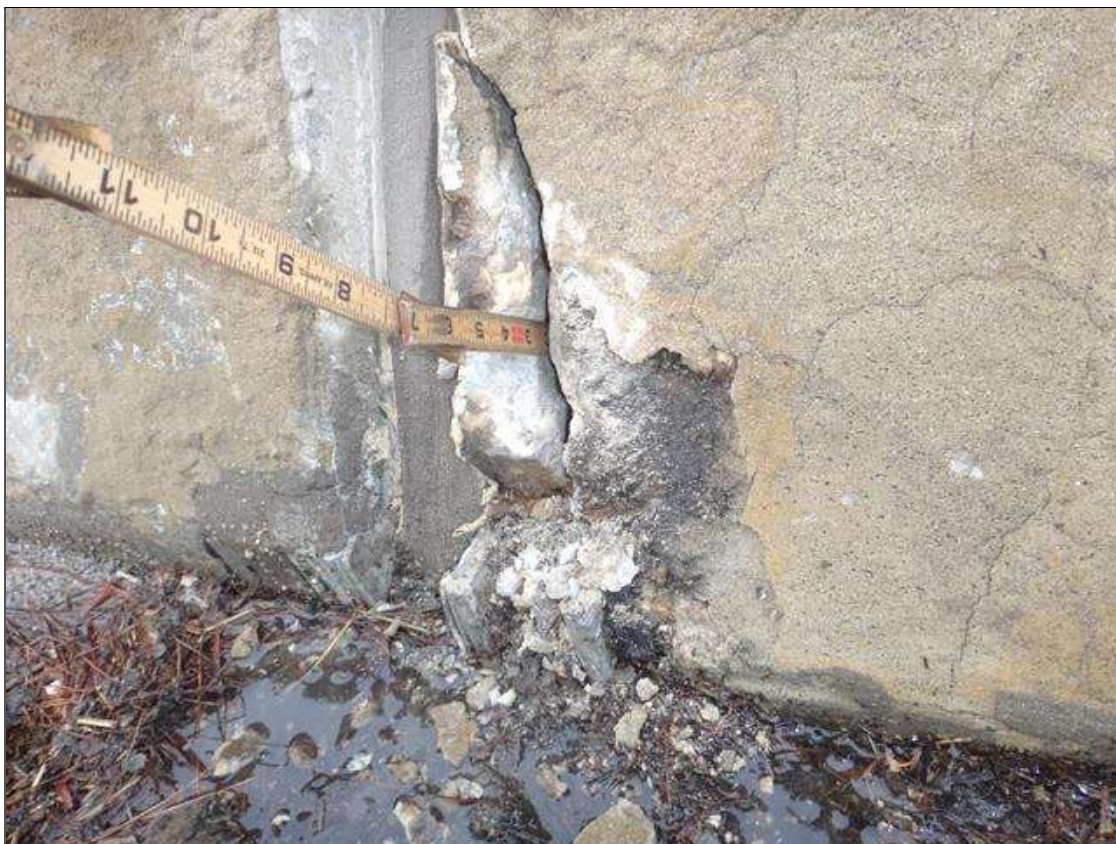
Span 1 Right Bridge Rail: base of rail at bent 1, spall (1ft x 6in x up to 3in)

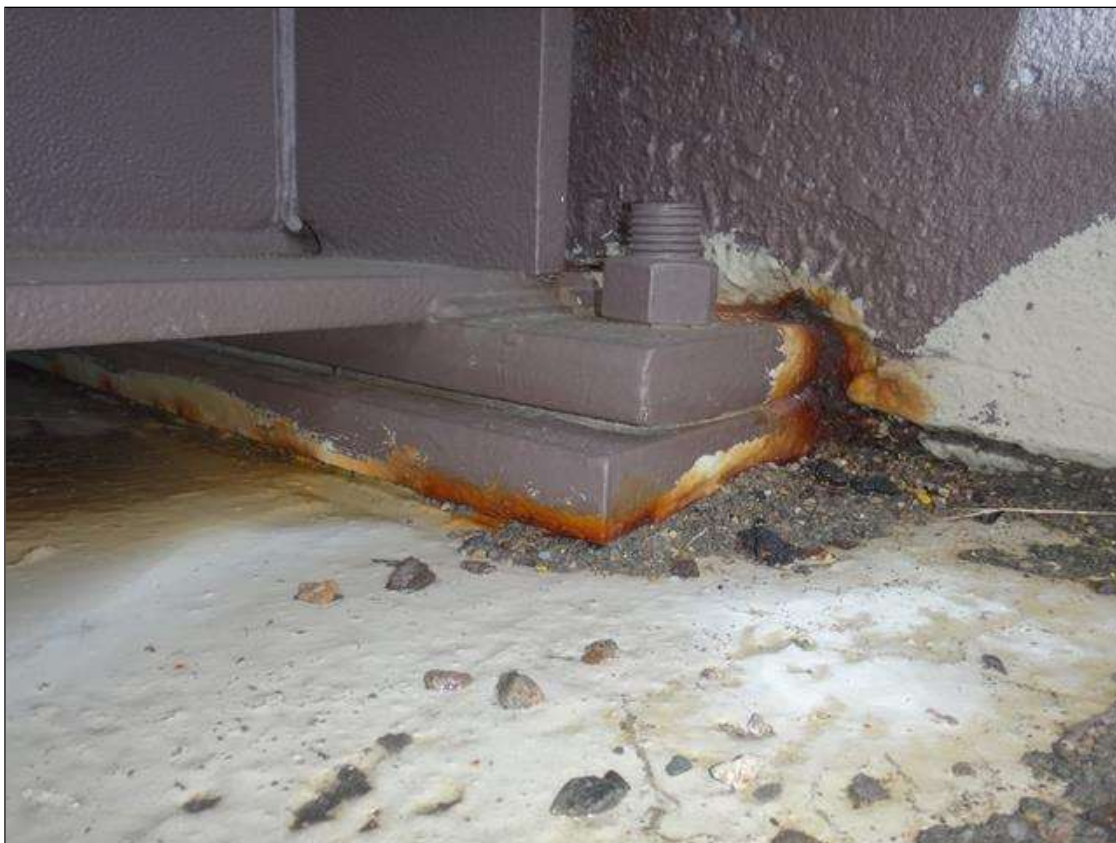
Span 2 Beam 9 Far Bearing: rust stains (3sf)

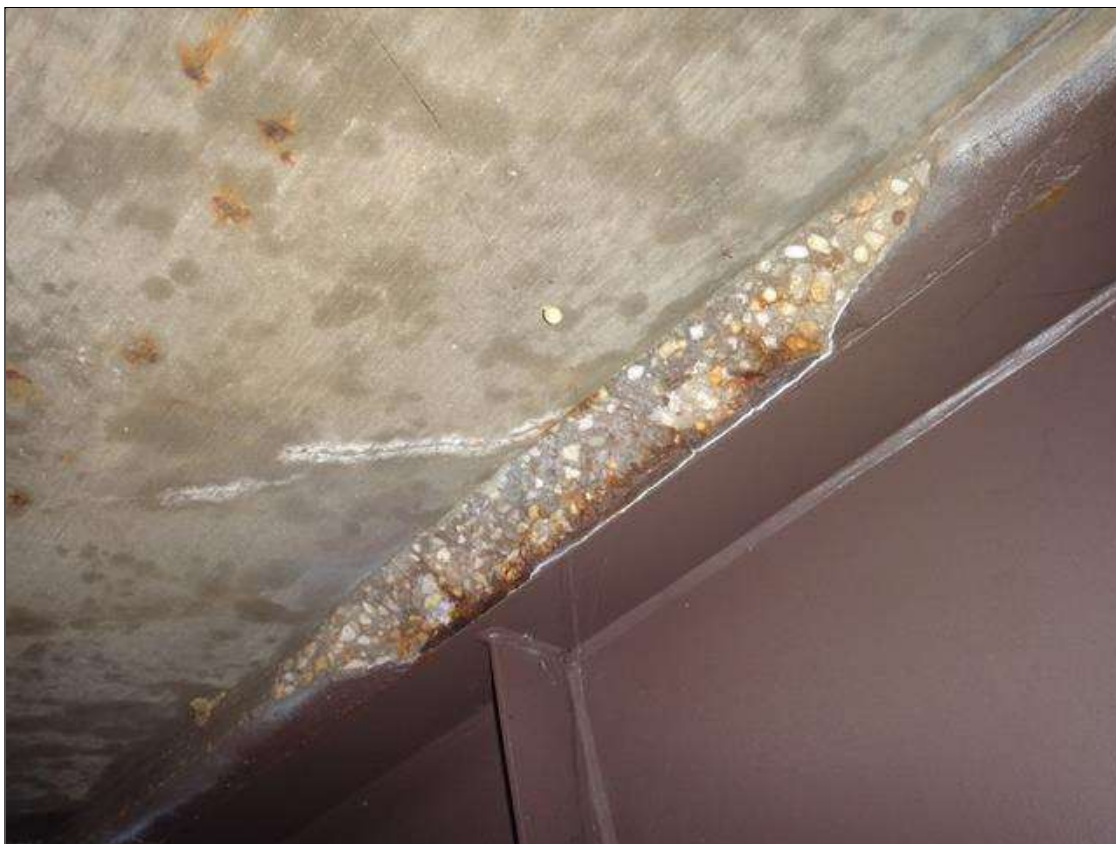
Span 2 Deck: underside bay 8 next to beam 9 at end bent 2, edge spall (30in x 4in x 1-1/2in) and adjacent diagonal crack (5-1/2ft x 1/32in) with efflorescence (photo 1 of 2)

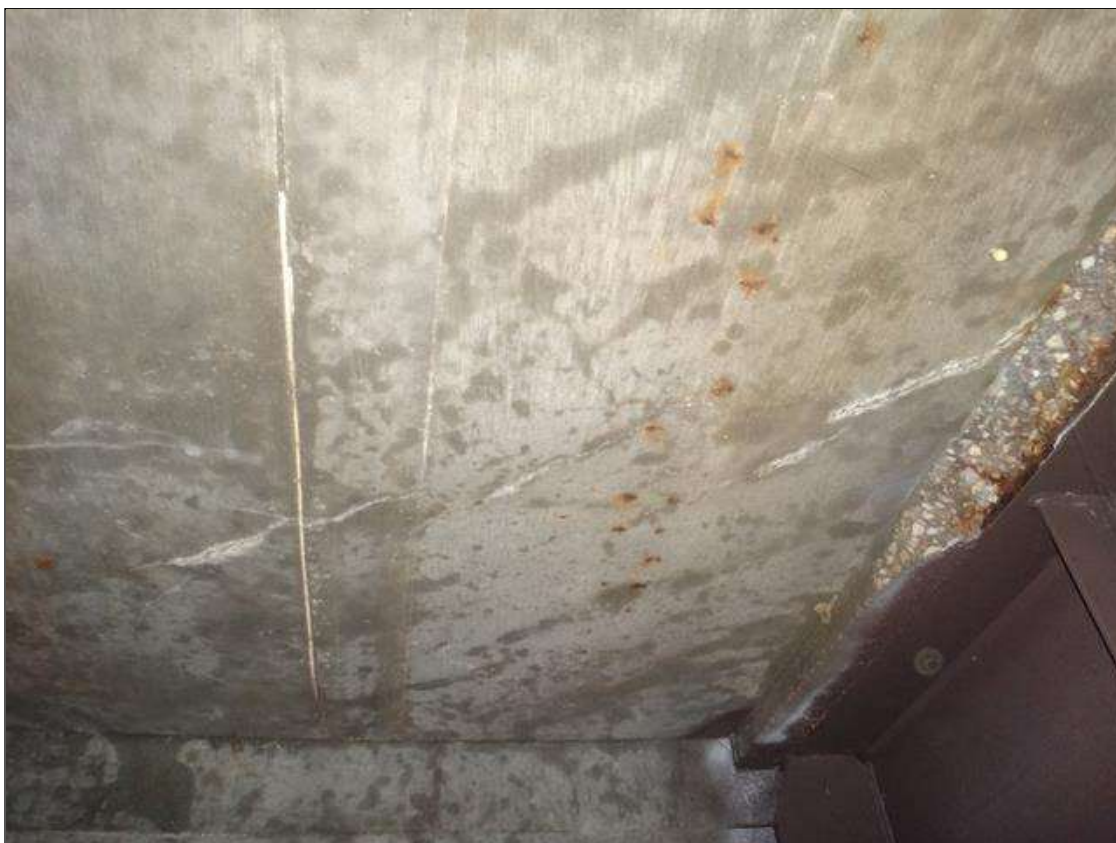
Span 2 Deck: underside bay 8 next to beam 9 at end bent 2, edge spall (30in x 4in x 1-1/2in) and adjacent diagonal crack (5-1/2ft x 1/32in) with efflorescence (photo 2 of 2)

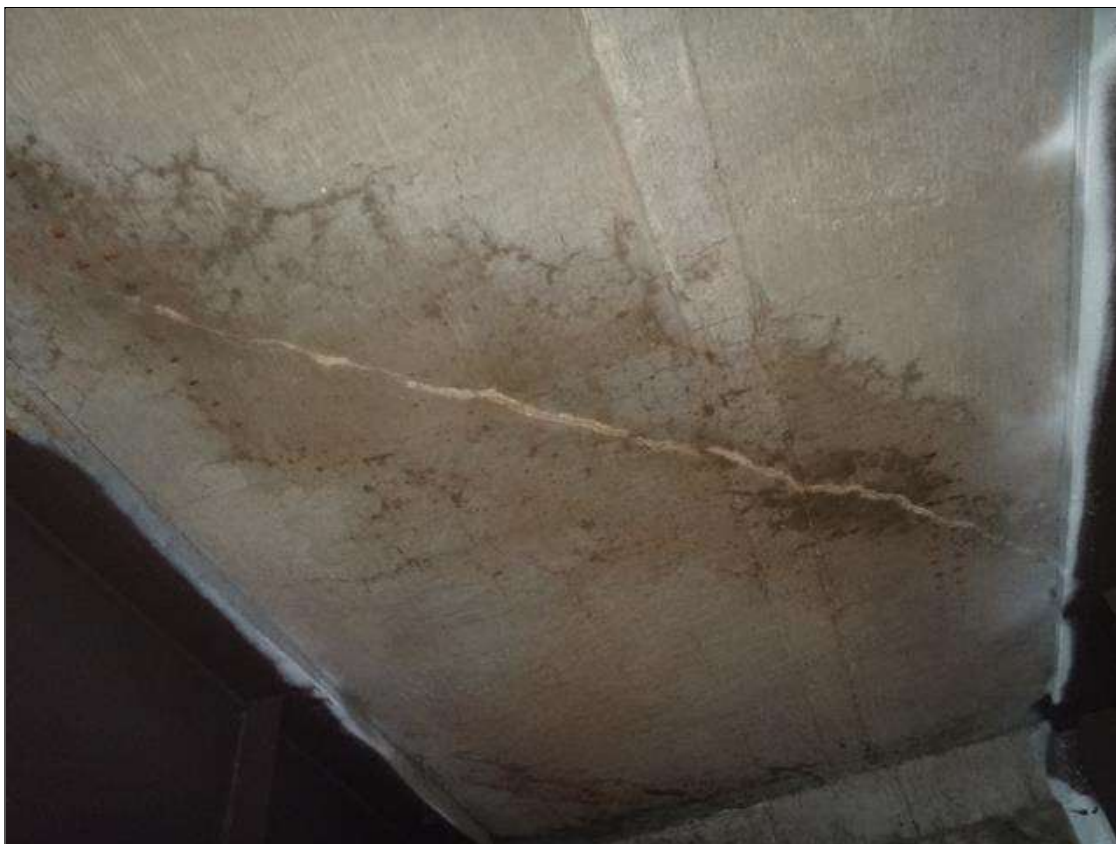
Span 2 Deck: underside bay 2 at end bent 2, diagonal crack (10ft x 1/32in) with efflorescence

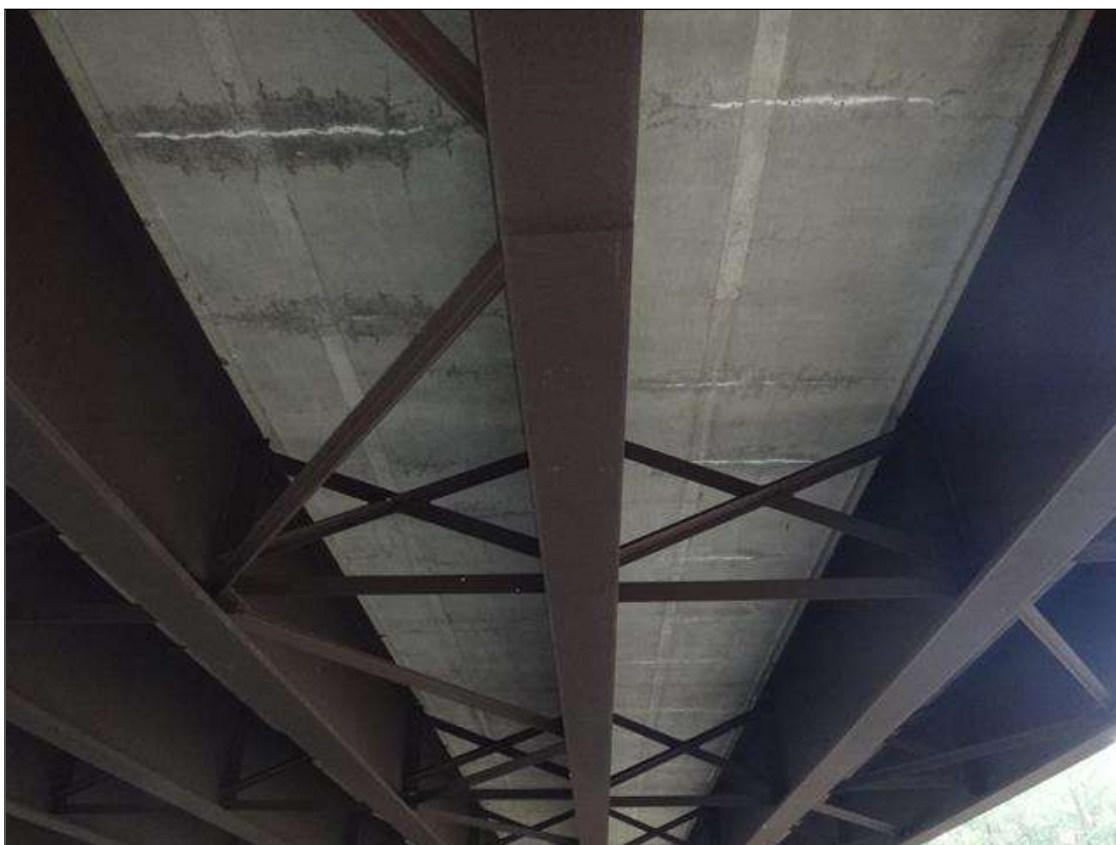
Span 2 Deck: underside scattered throughout at all bays, multiple transverse cracks (full width x hairline) with efflorescence

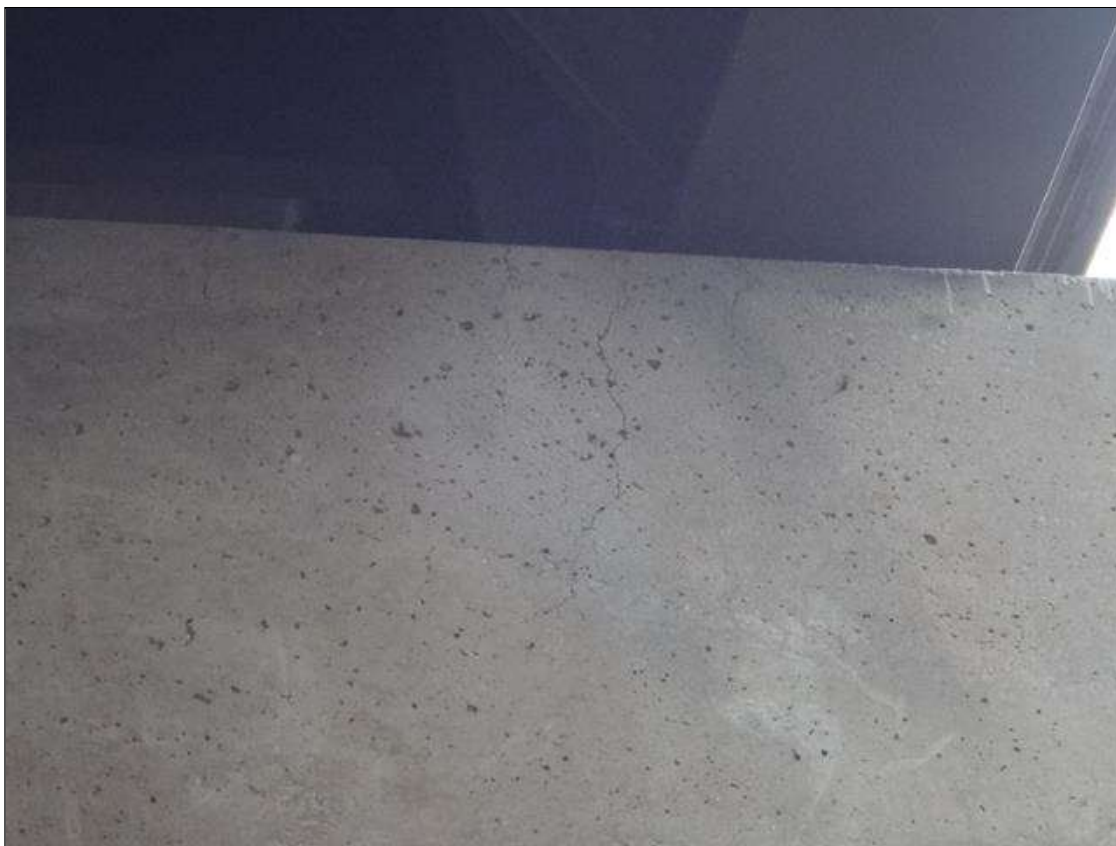
Bent 1 Cap 1: north face under beam 1, vertical crack (18in x 1/16in)

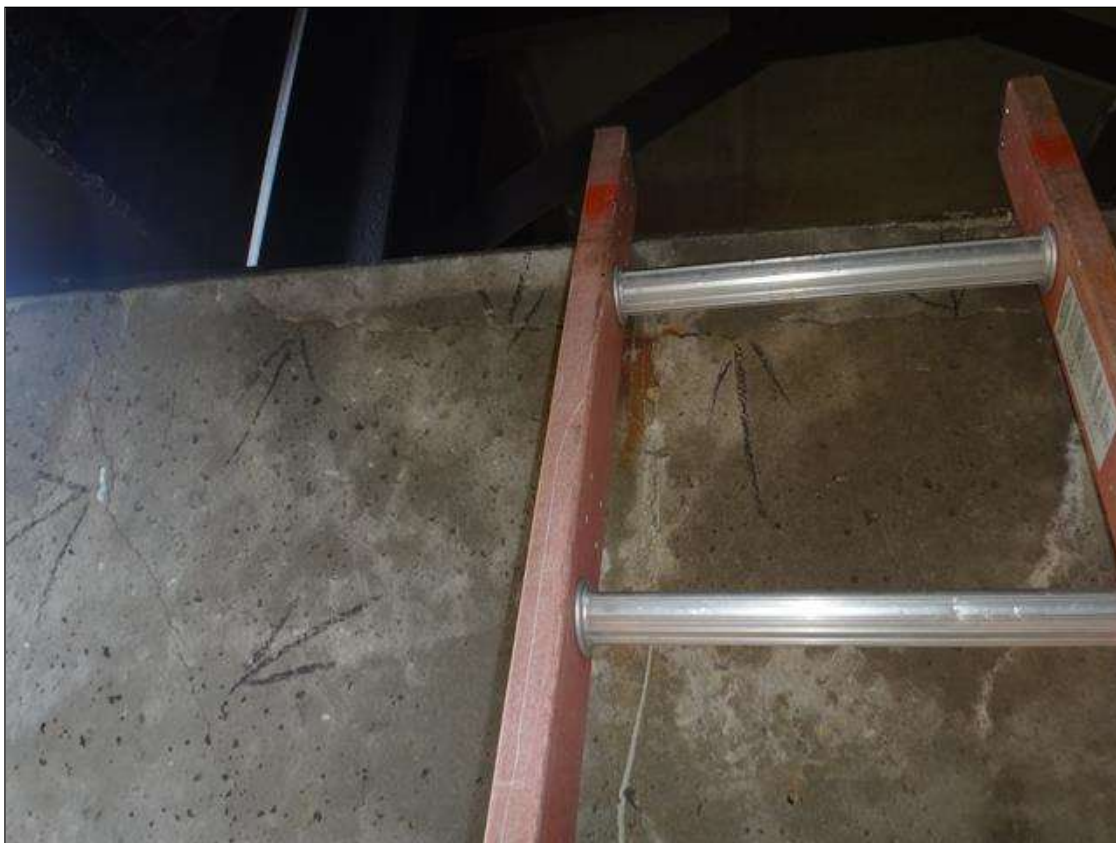
Bent 1 Cap 1: north face at bay 8, diagonal crack (18in x 1/16in) and horizontal crack (4ft x up to 1/8in)

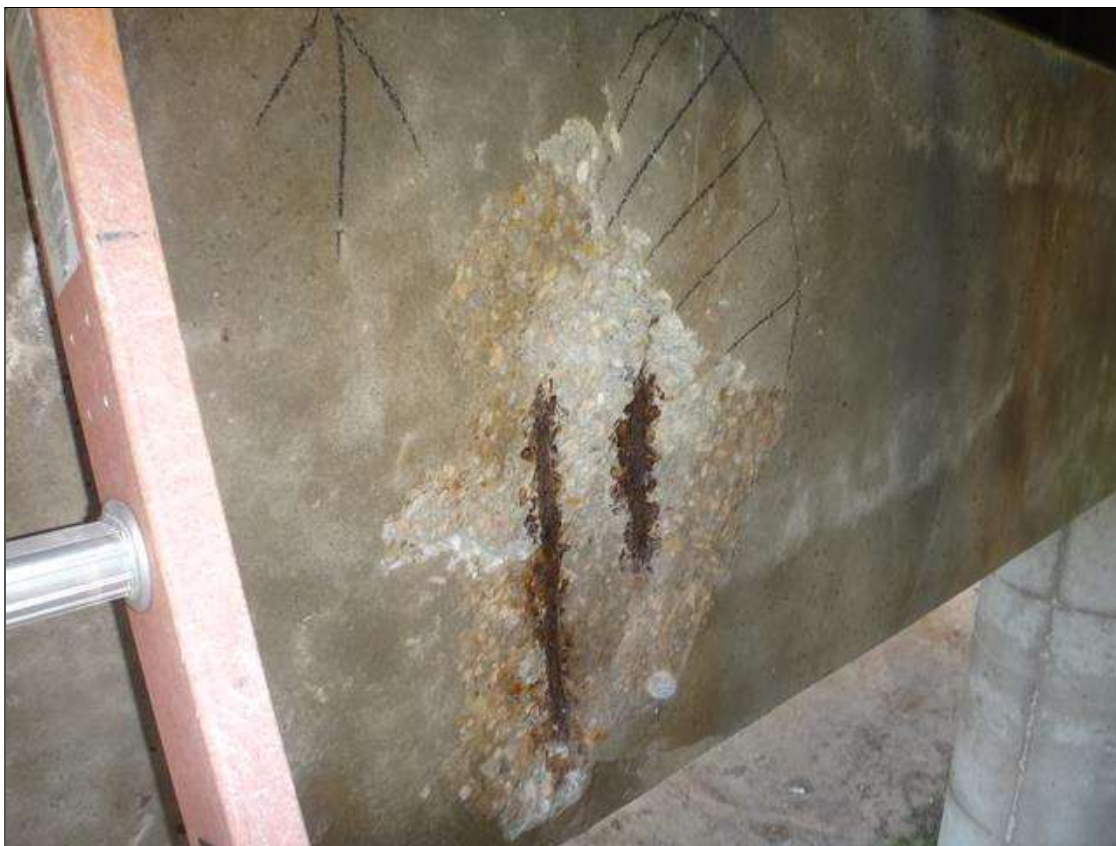
Bent 1 Cap 1: north face at bay 8, spall (2ft x 21in x up to 2in) with exposed rusted rebar and adjacent delamination (15in x 10in)

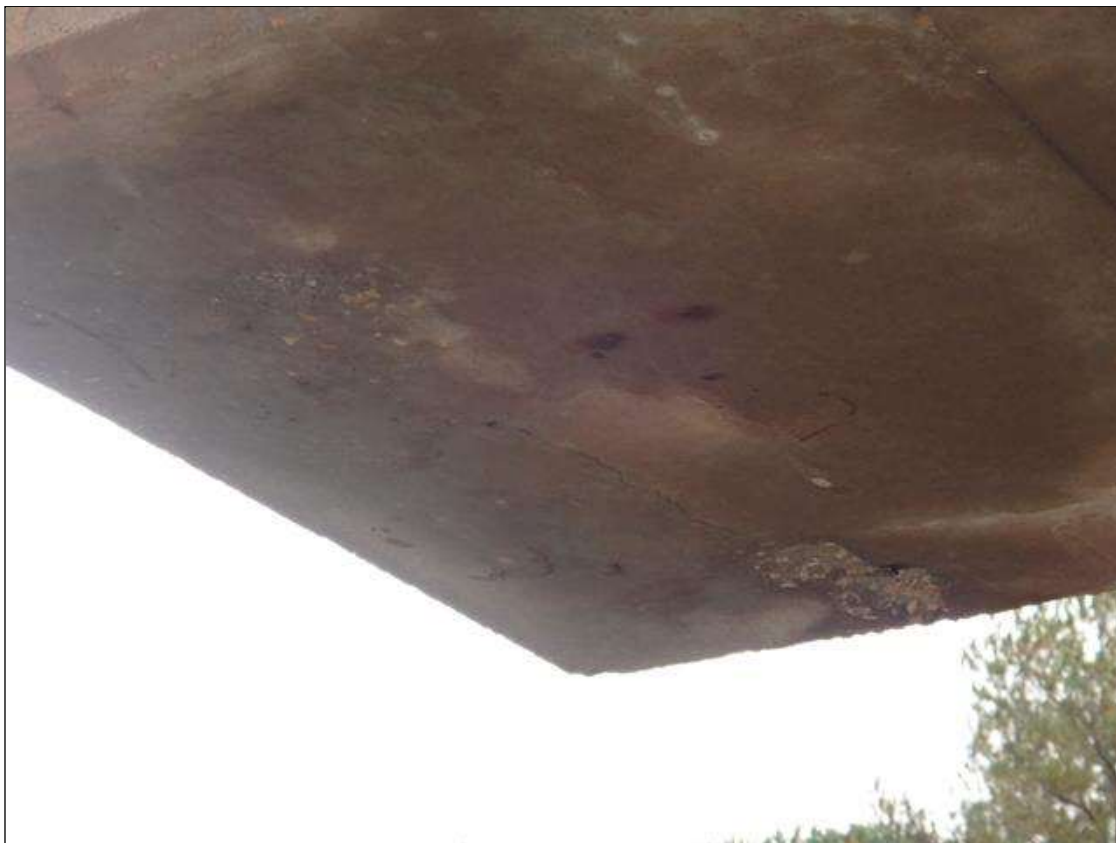
Bent 1 Cap 1: underside at east end, transverse crack (full width x 1/16in) and adjacent spall (6in x 3in x 1/4in)

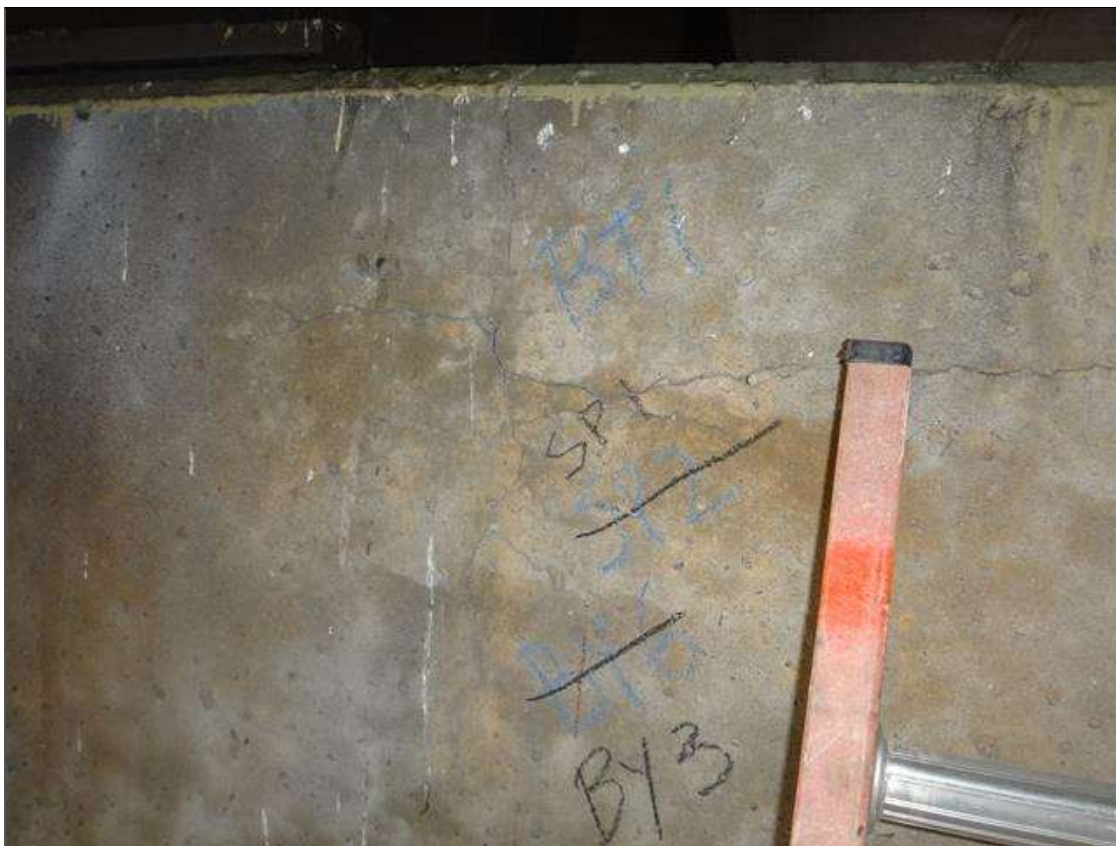
Bent 1 Cap 1: south face at bay 3, horizontal crack (30in x 1/16in) and vertical crack (15in x 1/16in)

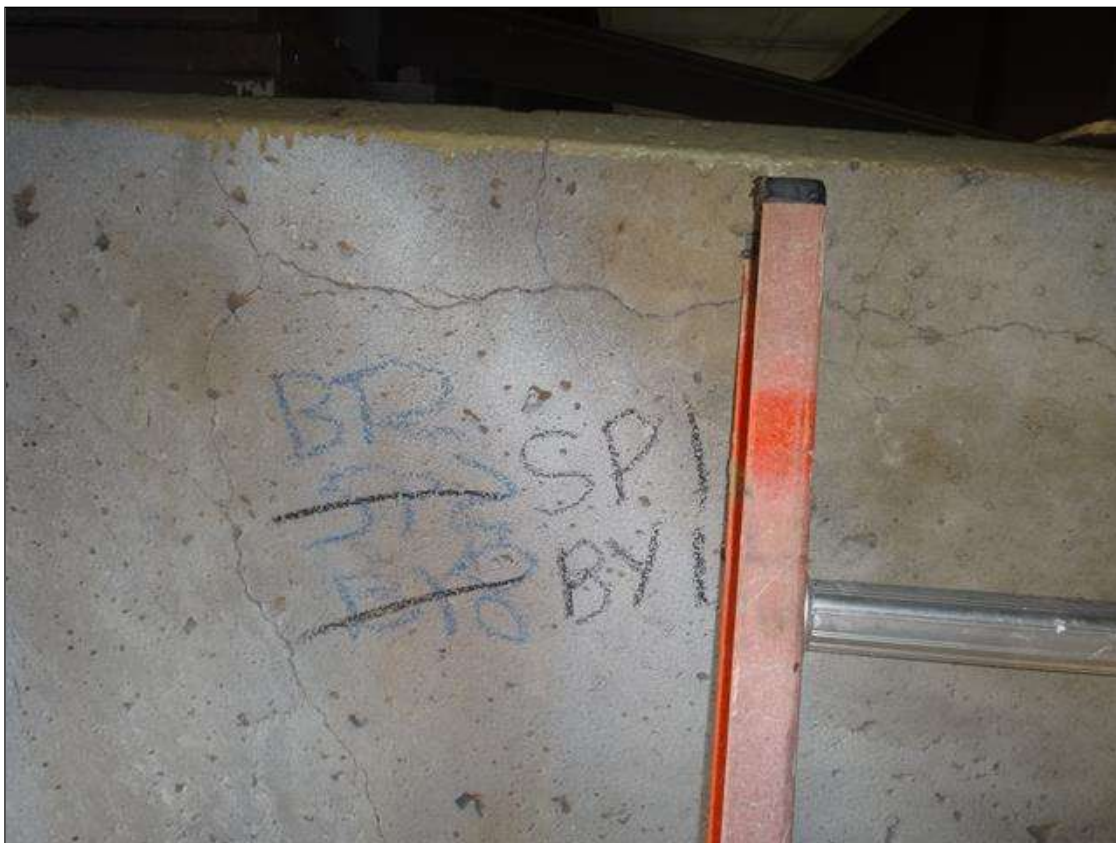
Bent 1 Cap 1: south face at bay 1, horizontal crack (2ft x 1/16in) and vertical crack (2ft x 1/16in)

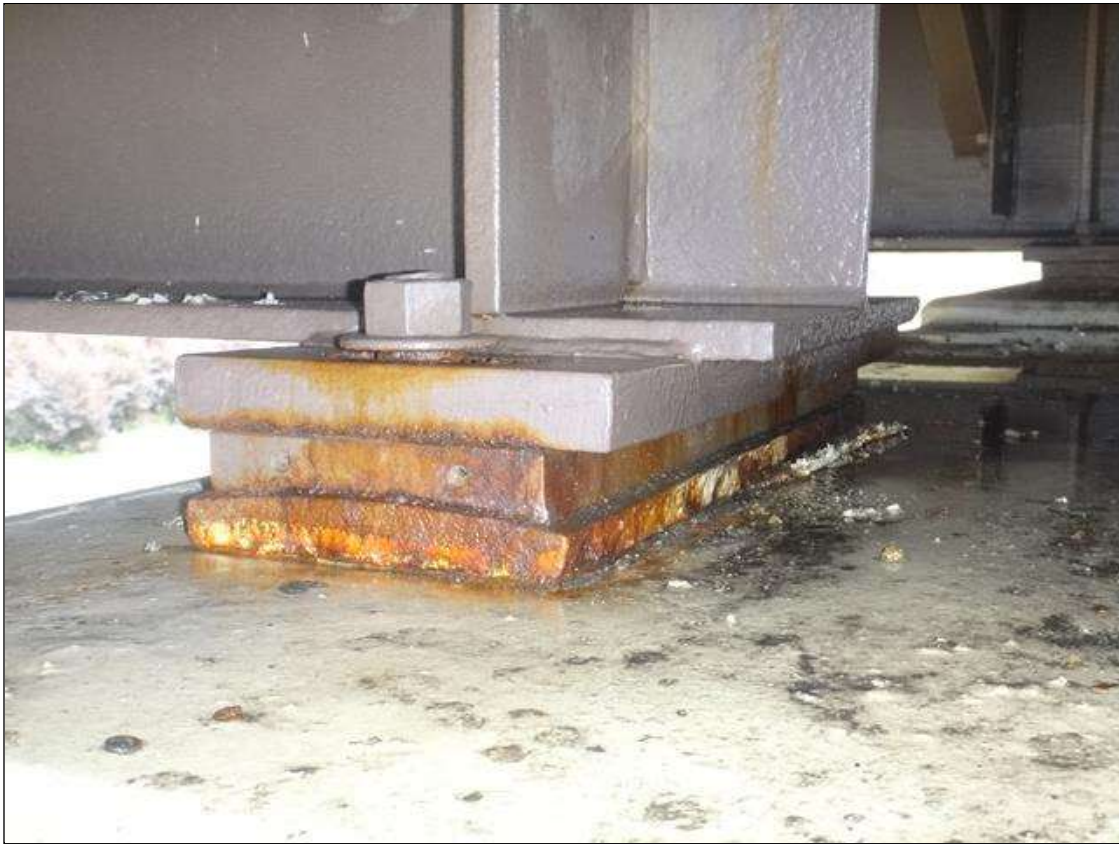
Span 2 Beam 2 Near Bearing: paint failure with surface rust

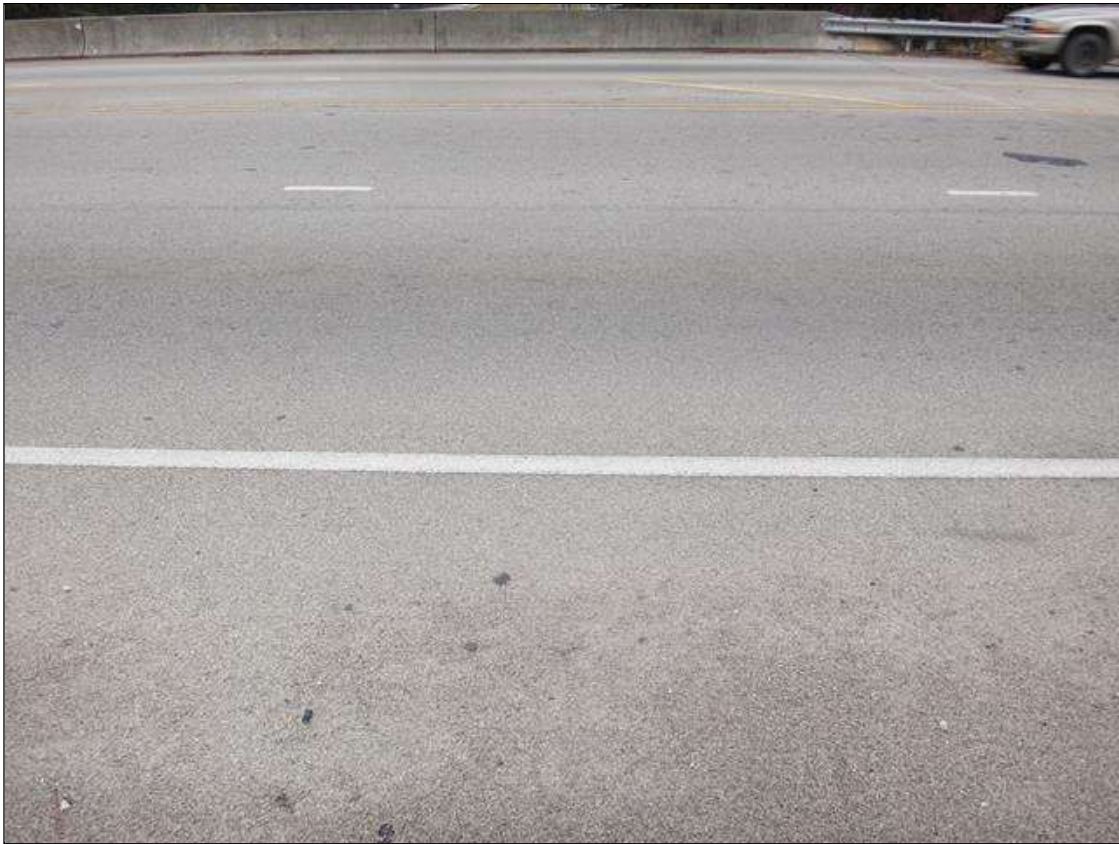
epoxy wearing surface

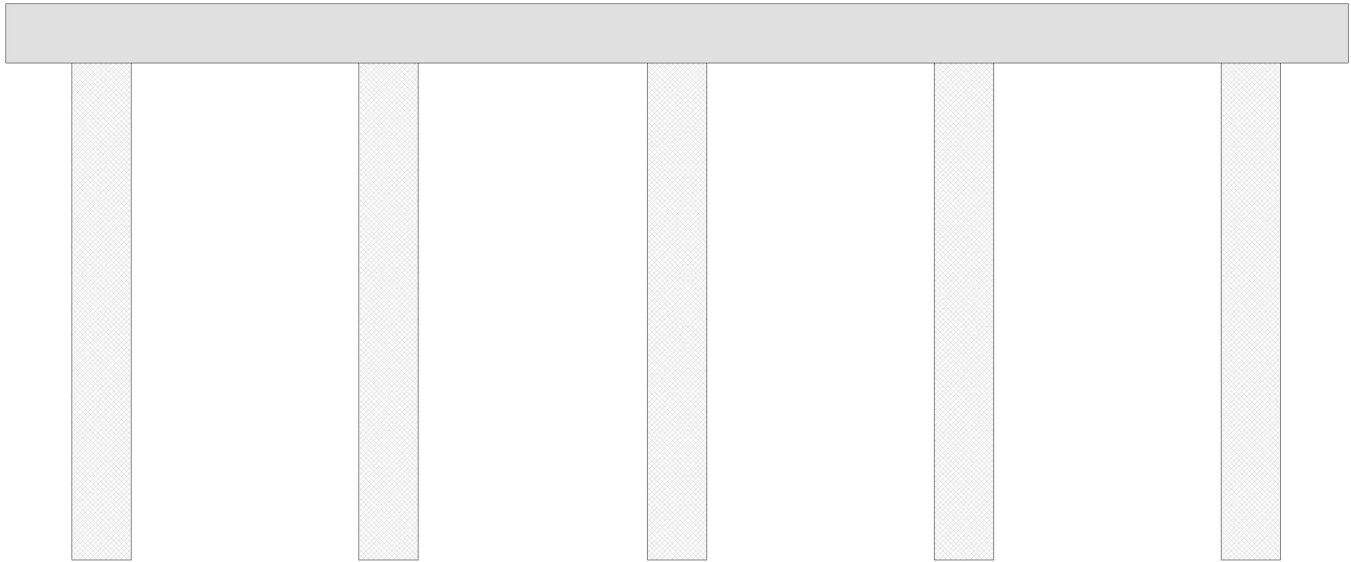
Cap Information			Material Cast-in-Place Concrete							
Length	Width	Height	Left Overhang	Right Overhang	Left Beam to End of Cap.	Right Beam to End of Cap.				
67.833 ft.	3.167 ft.	3.000 ft.	4.833 ft.	4.917 ft.	1.667 ft.	1.833 ft.				
Subcap Information			Material							
Length	Width	Height	Left Overhang	Right Overhang	Left Pile to Splice.					
Sill Information			Material							
Length	Width	Height								
Pile #	Material	Spacing	Width/Dia.	Height	Length	Orientation	Driven?	Replacement?	Removed?	Collar?
1	Concrete	14.5 ft.	3 ft.			Vertical	No	No	No	No
2	Concrete	14.583 ft.	3 ft.			Vertical	No	No	No	No
3	Concrete	14.5 ft.	3 ft.			Vertical	No	No	No	No
4	Concrete	14.5 ft.	3 ft.			Vertical	No	No	No	No
5	Concrete		3 ft.			Vertical	No	No	No	No
<p>VERIFIED BY: H. BONILLA 11/5/2018</p>										
Bent/Abutment #: 1			Similar Bents:
