NC DEPARTMENT OF TRANSPORTATION
 DIVISION OF HIGHWAYS
 STRUCTURE MANAGEMENT UNIT

ATTENTION: **SKETCHES UPDATED
 NEW EPOXY OVERLAY INSTALLED SINCE PREVIOUS
 INSPECTION
 FAYETTEVILLE/FORT BRAG/POPE AAF SIGN
 ATTACHED TO BRIDGE**

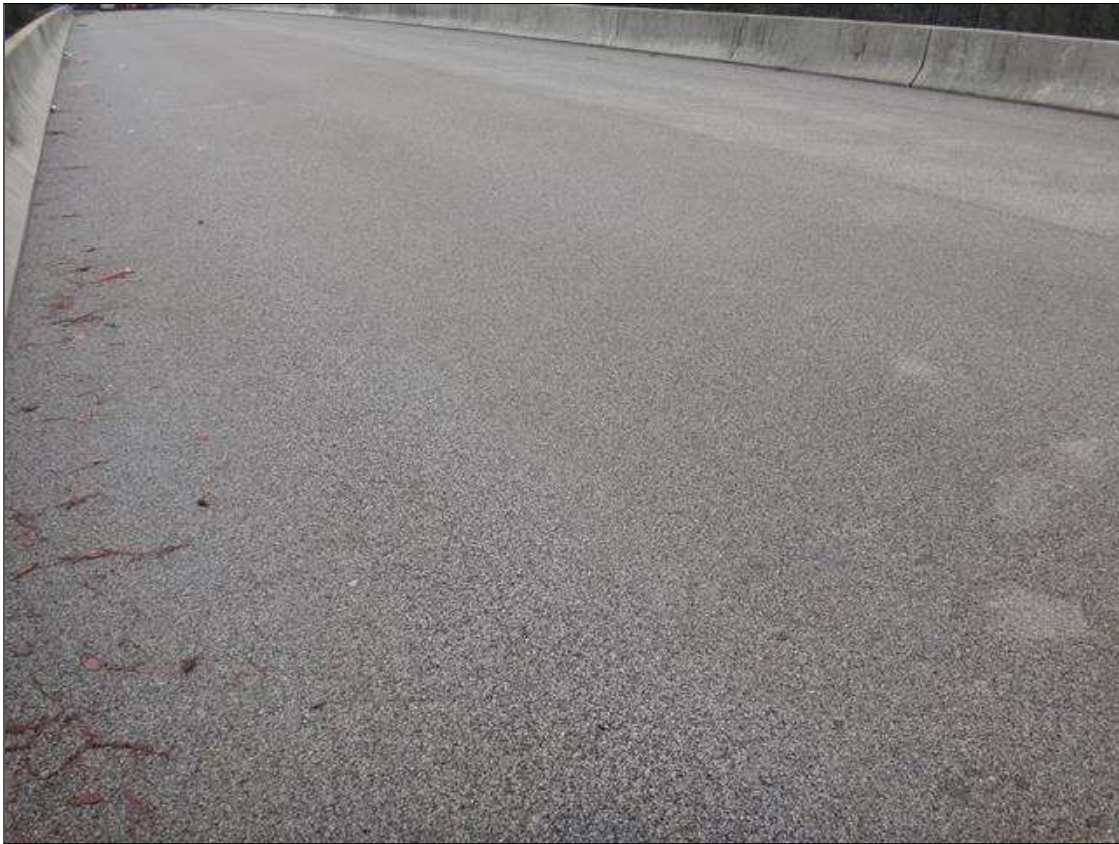
Span 1 Wearing Surface: new epoxy wearing surface installed since last inspection

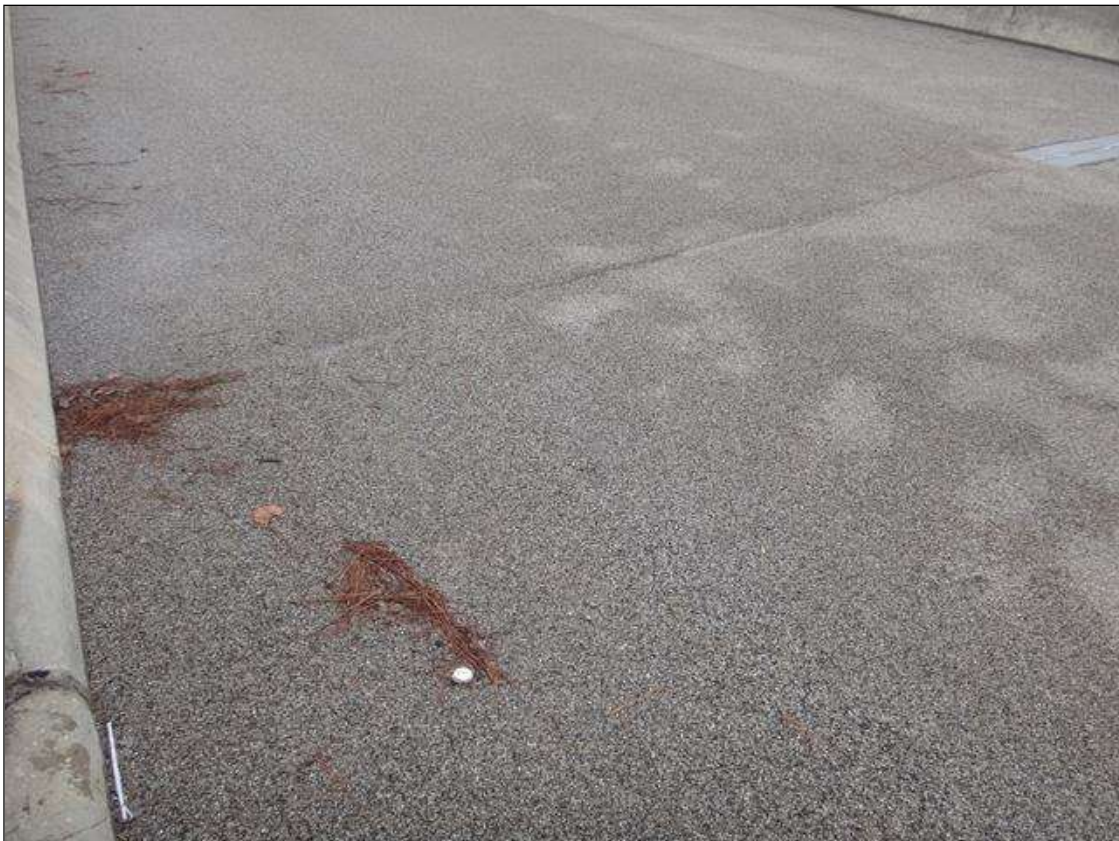
Expansion Joint 1: at north end, joint covered with epoxy overlay (17-1/2ft)

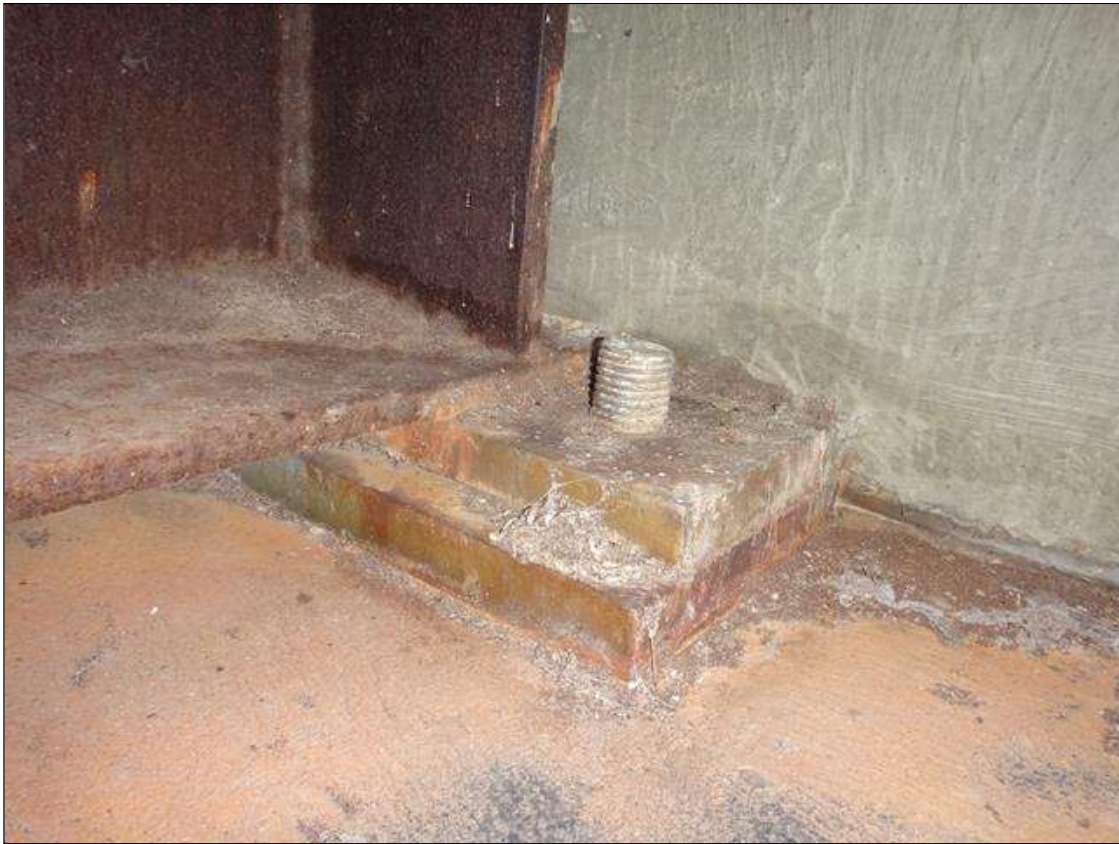
Span 2 Beam 2 Far Bearing: (2) anchor bolt nuts, missing

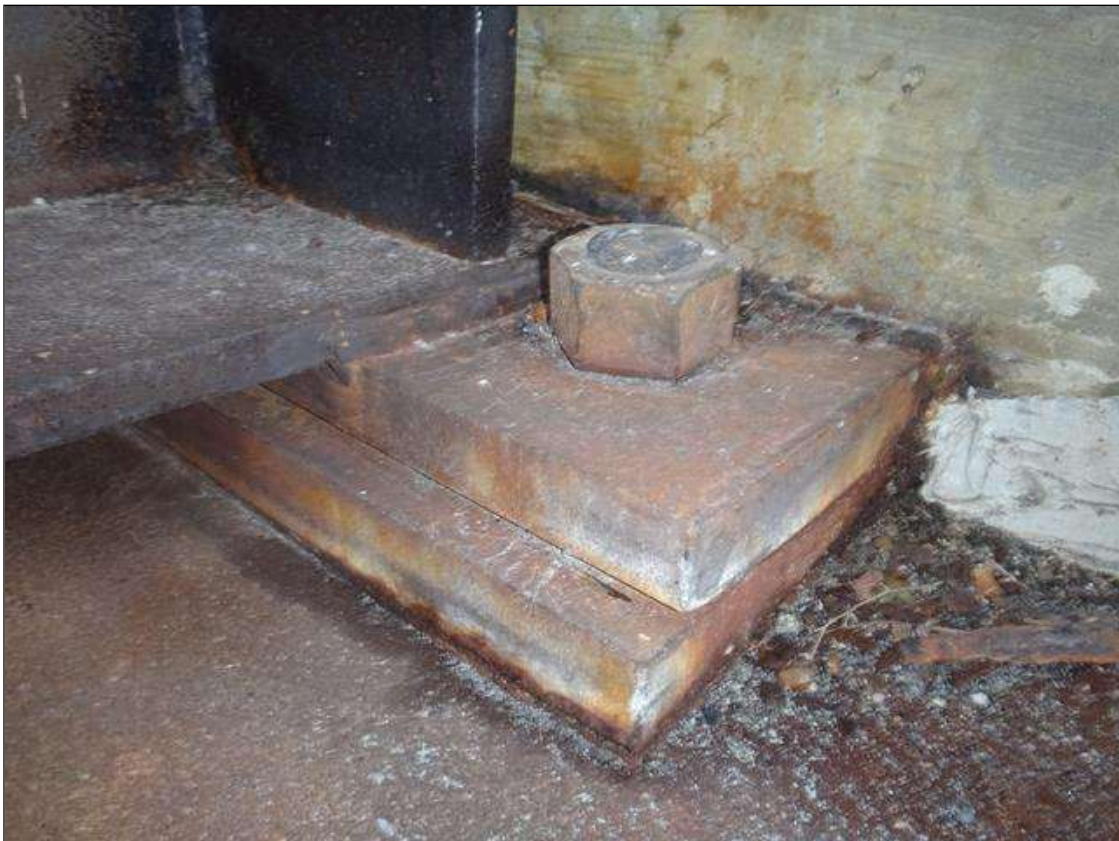
Span 2 Beam 6 Far Bearing: paint failure with surface rust

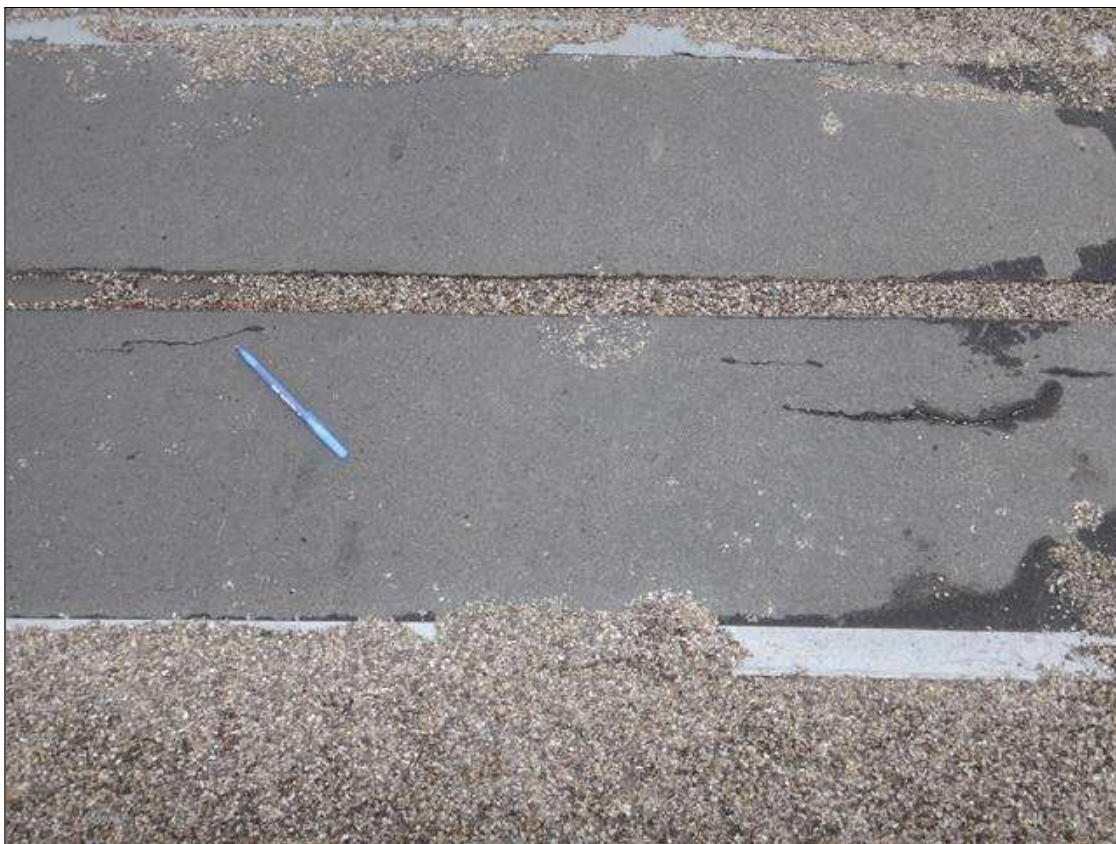
Expansion Joint 3: eastbound lane at 5ft from rail, (4) longitudinal cracks in header (up to 11in x up to 1/8in)

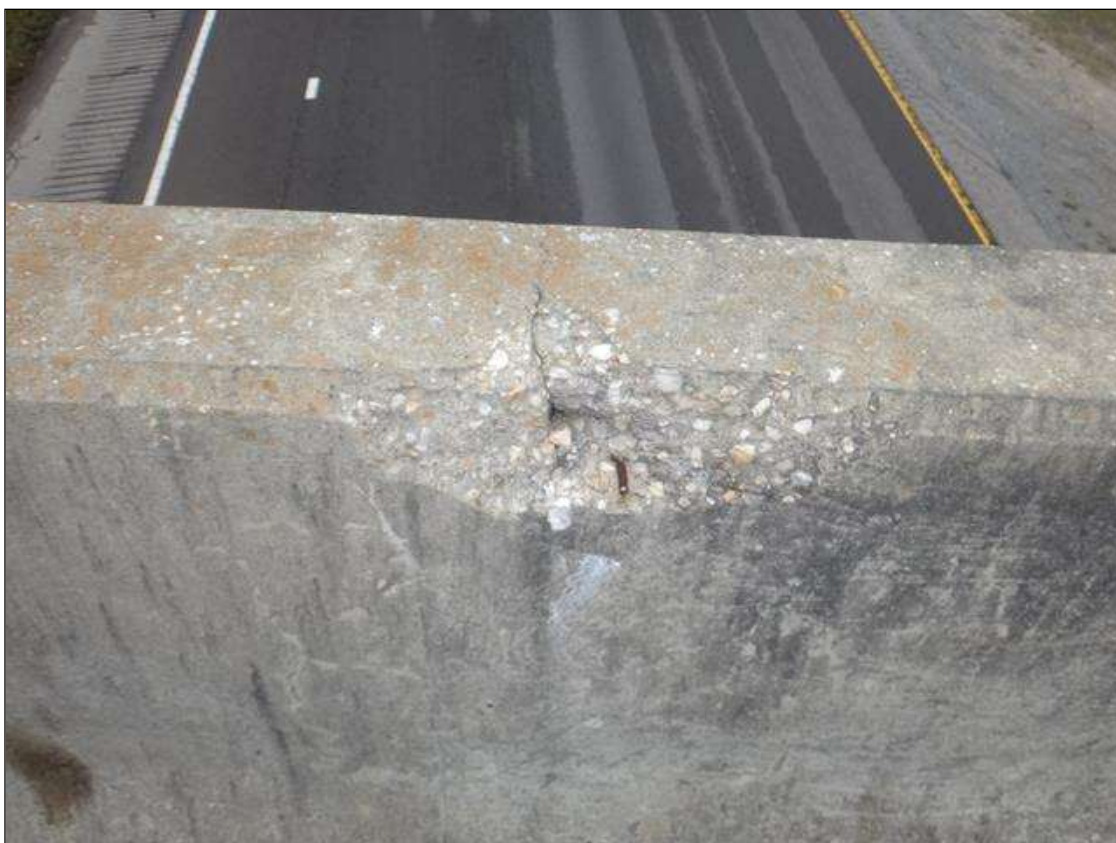
Span 1 Left Bridge Rail: top of rail at 60ft from end bent 1, spall (14in x 5in x 2-1/2in)

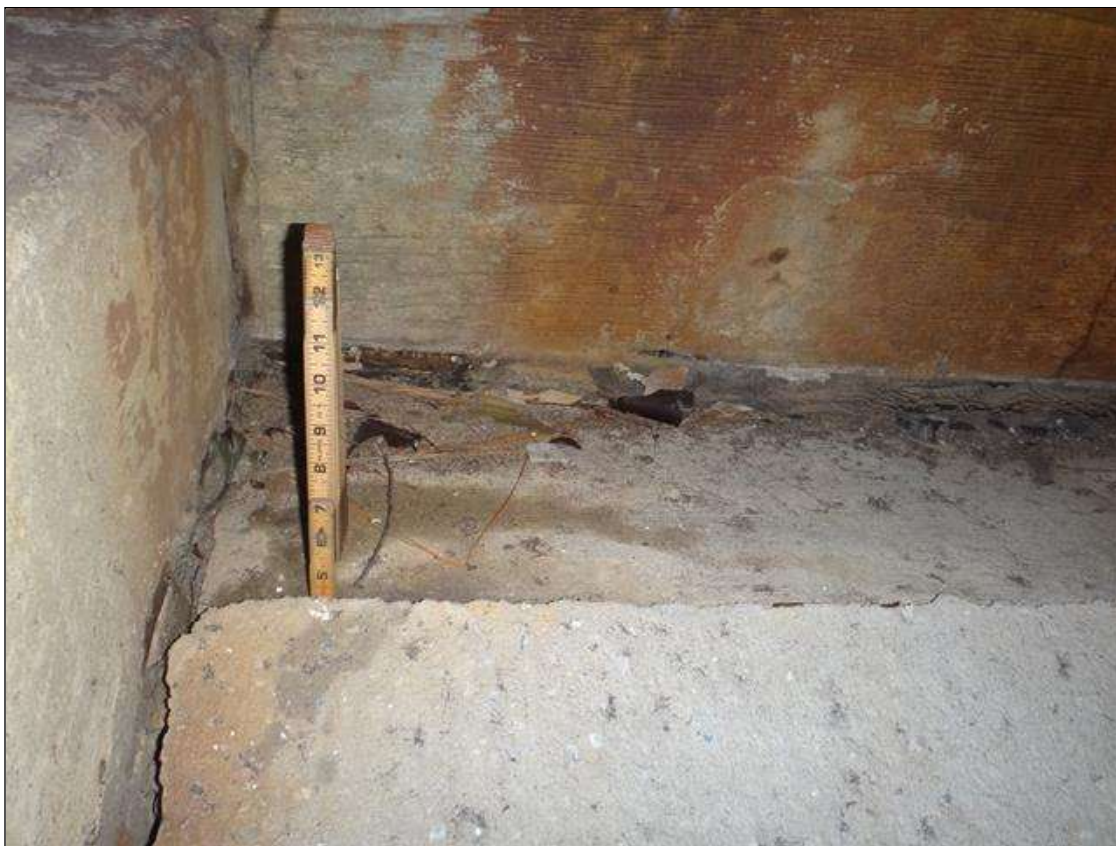
top face of slope protection below bay 5, seperated and settled (8ft x up to 3/4in x 5in) (photo 1 of 2)

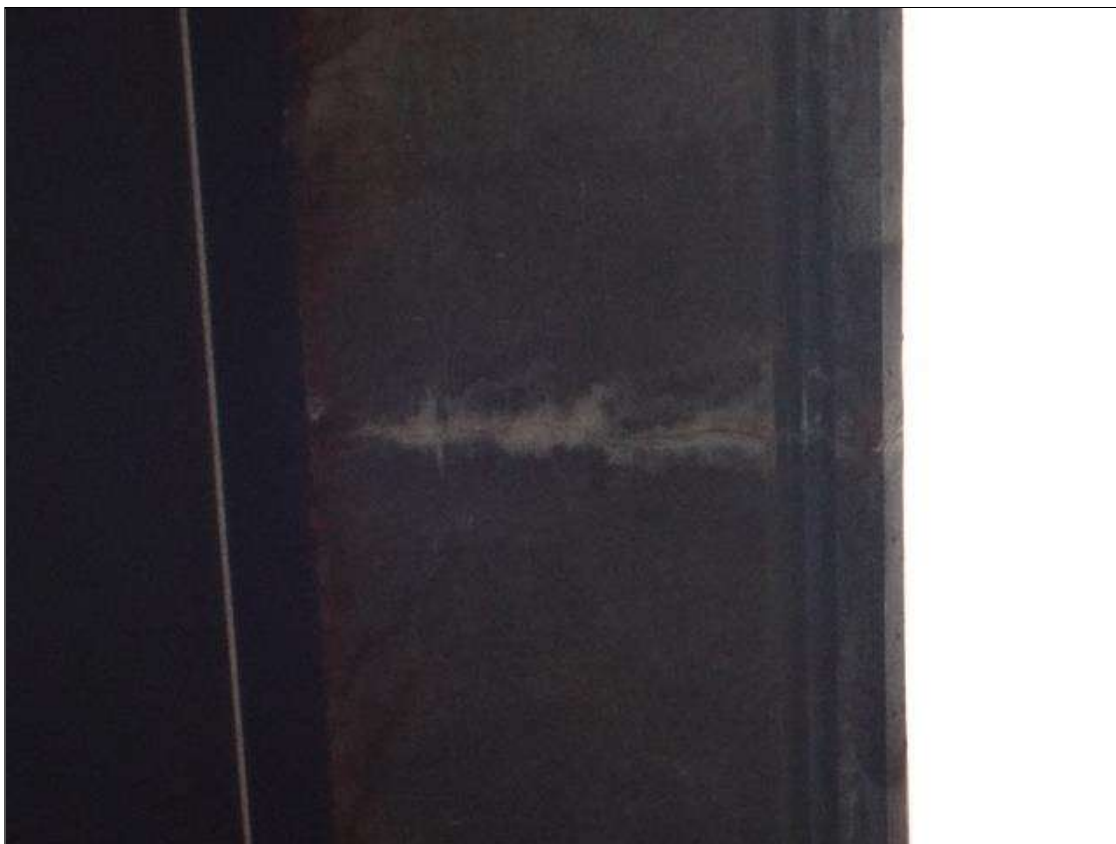
Span 1 Deck: south overhang, transverse cracks (full width x hairline) with efflorescence scattered throughout

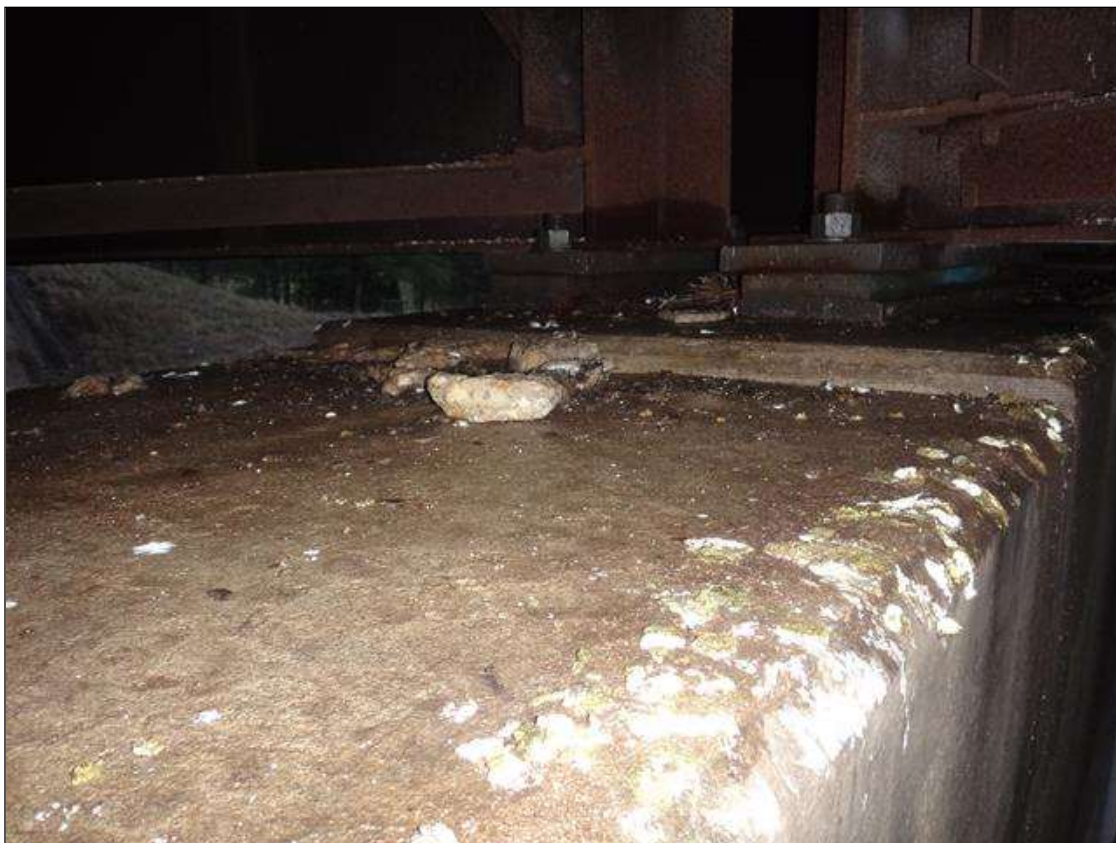
Bent 1 Cap: top of cap, debris accumulation (full length x full width)

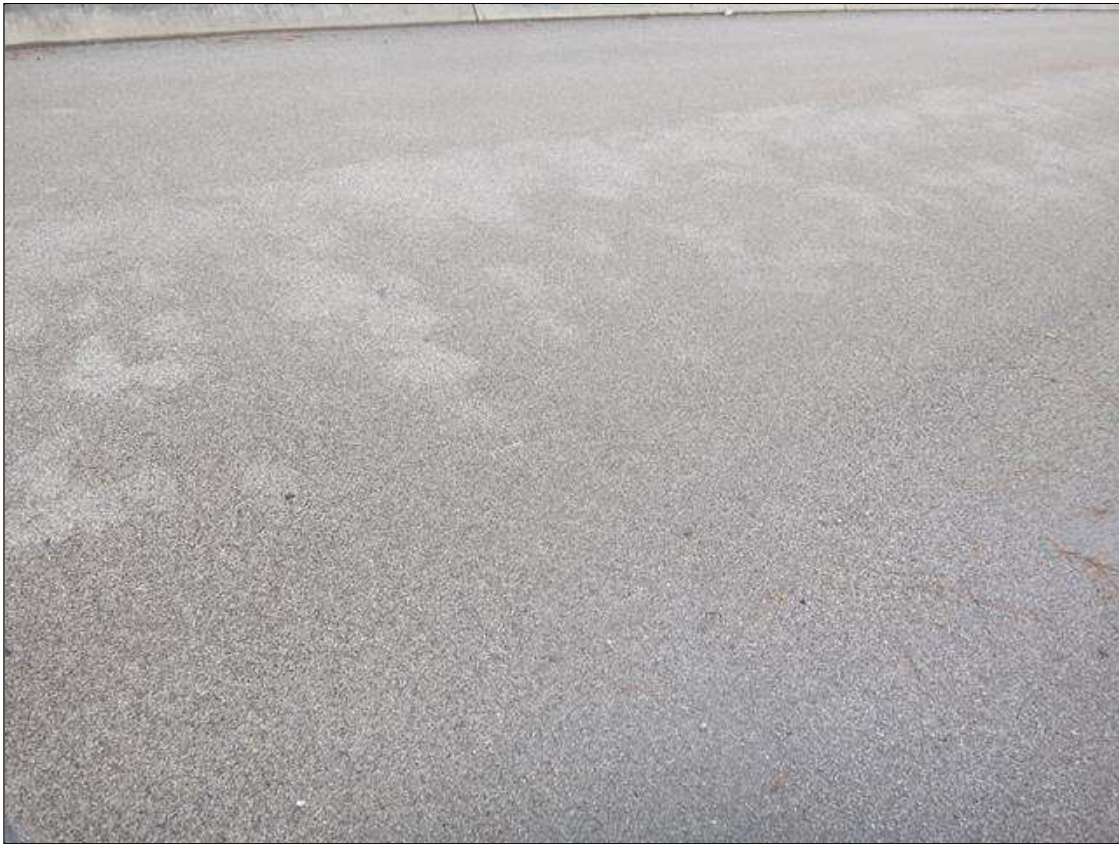
epoxy wearing surface

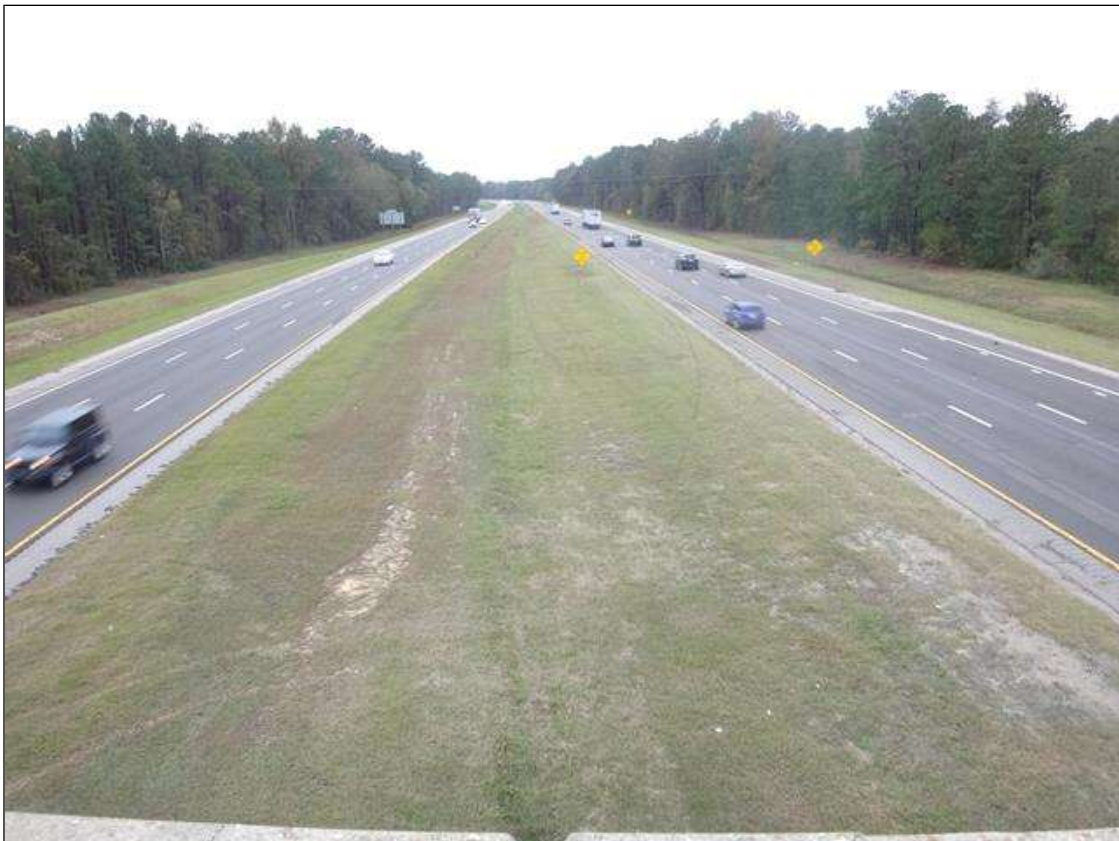
looking south from deck

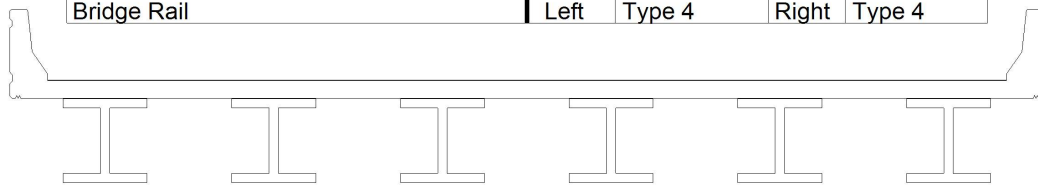
Measurements for Span #	1	SPAN 2 SIMILAR	
Deck Thickness	0.667ft	Left Overhang	2.333ft
Top of Rail to Bottom of Beam	8.583ft	Right Overhang	2.333ft

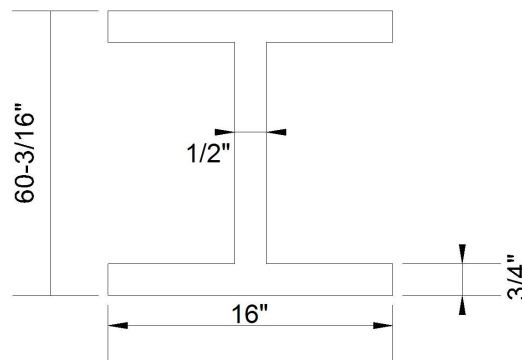
*REVISED BY: SANYAM GURME 11/05/2018

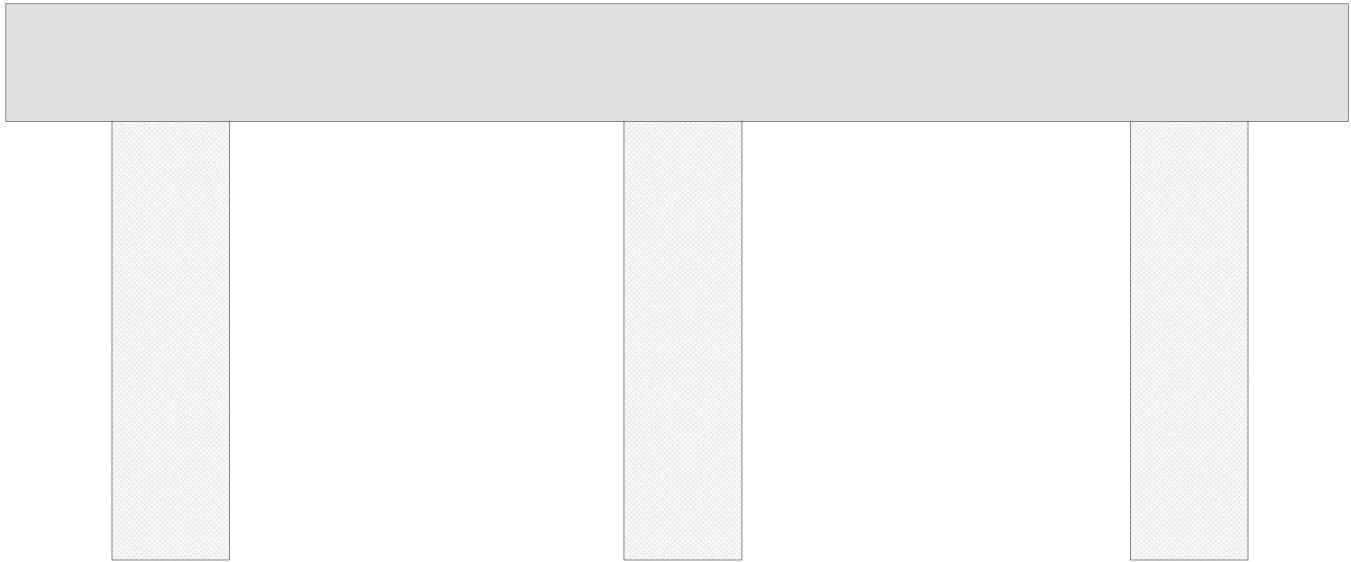
Cap Information			Material Cast-in-Place Concrete							
Length	Width	Height	Left Overhang	Right Overhang	Left Beam to End of Cap.	Right Beam to End of Cap.				
38.000 ft.	3.500 ft.	3.333 ft.	4.667 ft.	4.500 ft.	2.000 ft.	1.583 ft.				
Subcap Information			Material							
Length	Width	Height	Left Overhang	Right Overhang	Left Pile to Splice.					
Sill Information			Material							
Length	Width	Height								
Pile #	Material	Spacing	Width/Dia.	Height	Length	Orientation	Driven?	Replacement?	Removed?	Collar?
1	Concrete	14.50 ft.	3.333 ft.			Vertical	No	No	No	No
2	Concrete	14.333 ft.	3.333 ft.			Vertical	No	No	No	No
3	Concrete		3.333 ft.			Vertical	No	No	No	No
VERIFIED BY: SANYAM GURME 11/05/2018										
Bent/Abutment #: 1			Similar Bents:
