NC DEPARTMENT OF TRANSPORTATION
 DIVISION OF HIGHWAYS
 STRUCTURE MANAGEMENT UNIT

ATTENTION: **PM ISSUED**

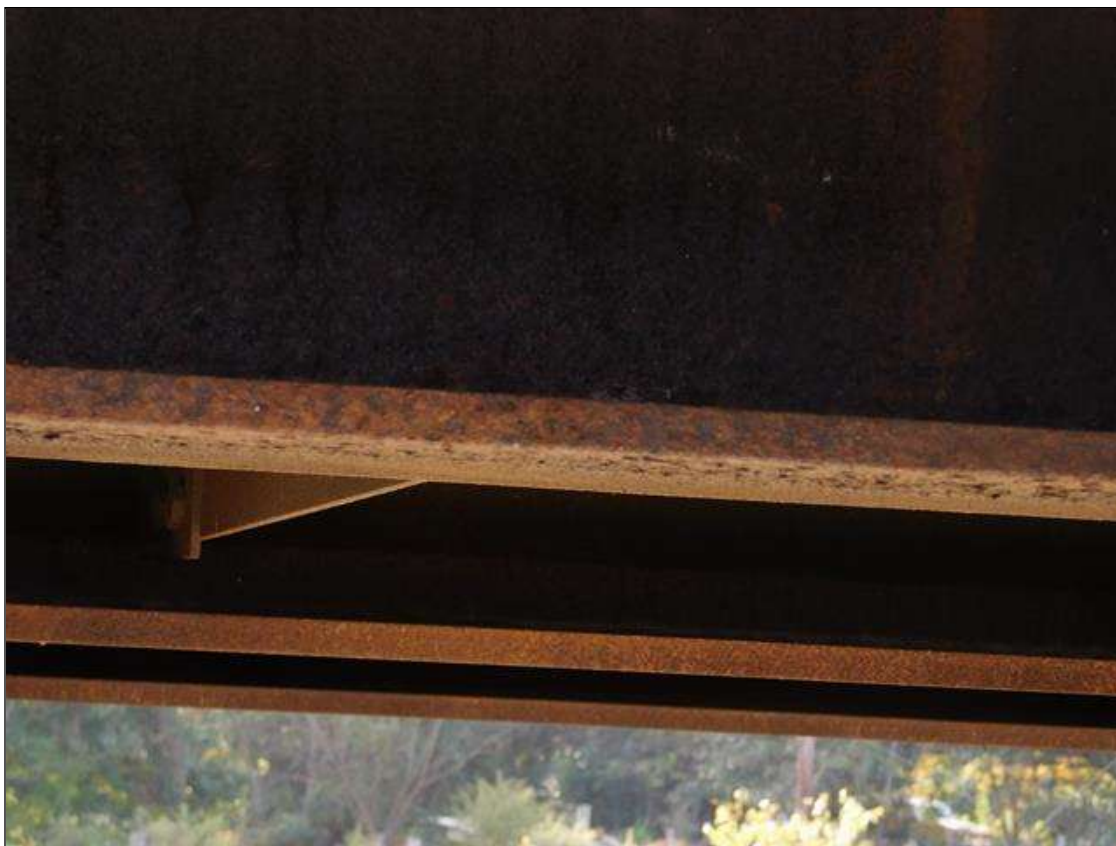
SPAN 2 BEAM 4 AT 10 FT. FROM BENT 1 SIDE VIEW OF SURFACE RUST ON BOTTOM FLANGE, NO SECTION LOSS

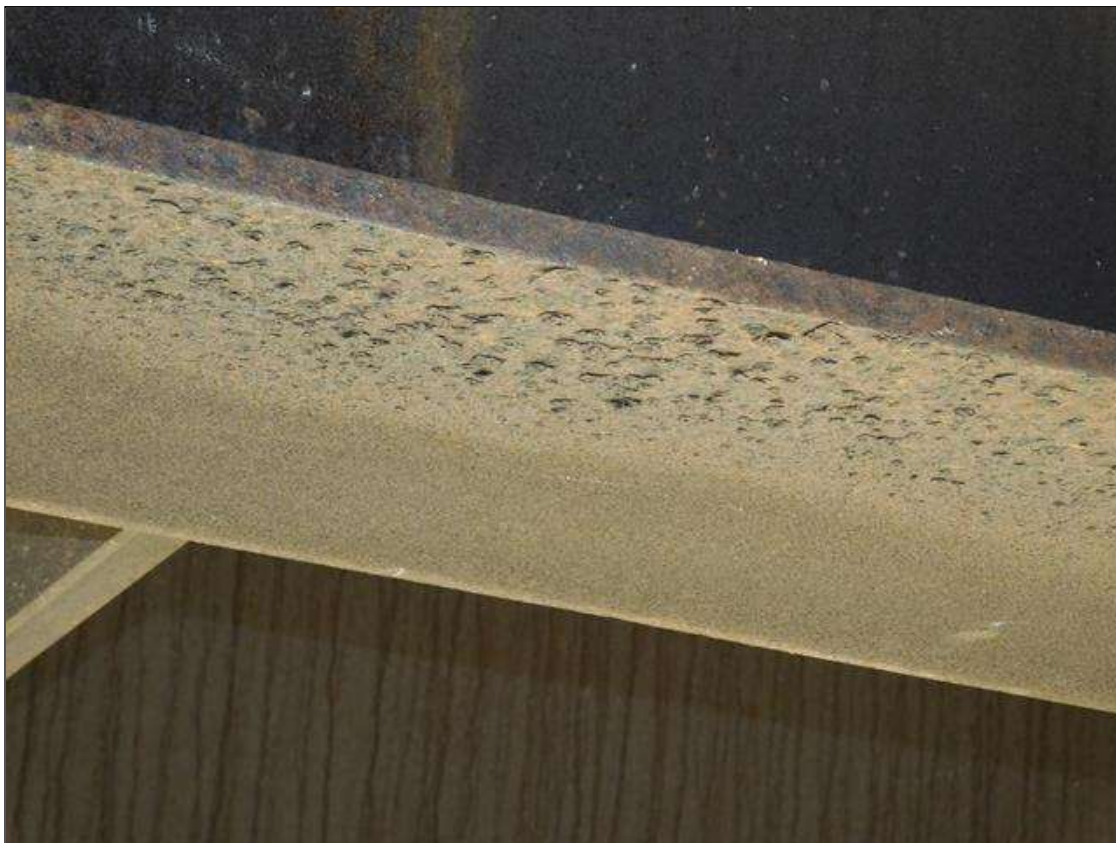
Span 2 Beam 4: SURFACE RUST ON BOTTOM FLANGE 10' LONG X 8" WIDE WITH NO SECTION LOSS AT 10' FROM BENT 1

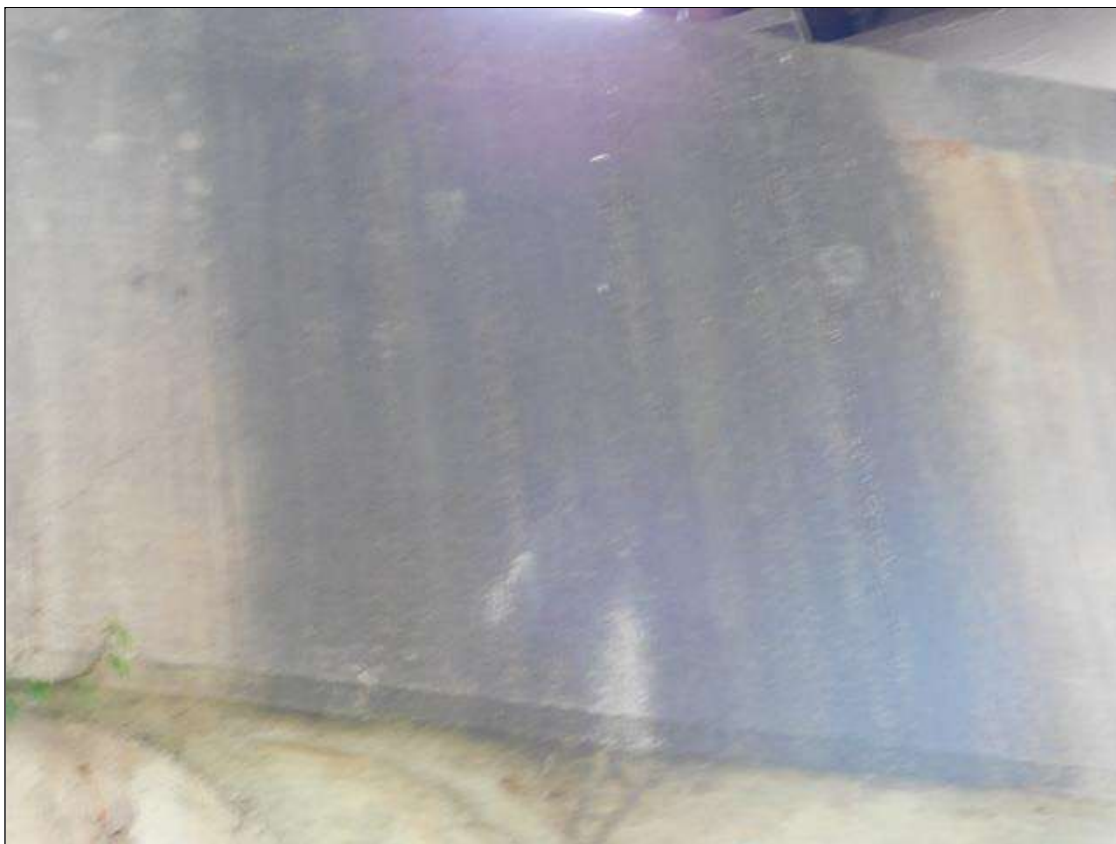
Bent 2 Cap 1: 1/32" WIDE DIAGONAL CRACK ON SPAN 2 FACE UNDER BEAM 6

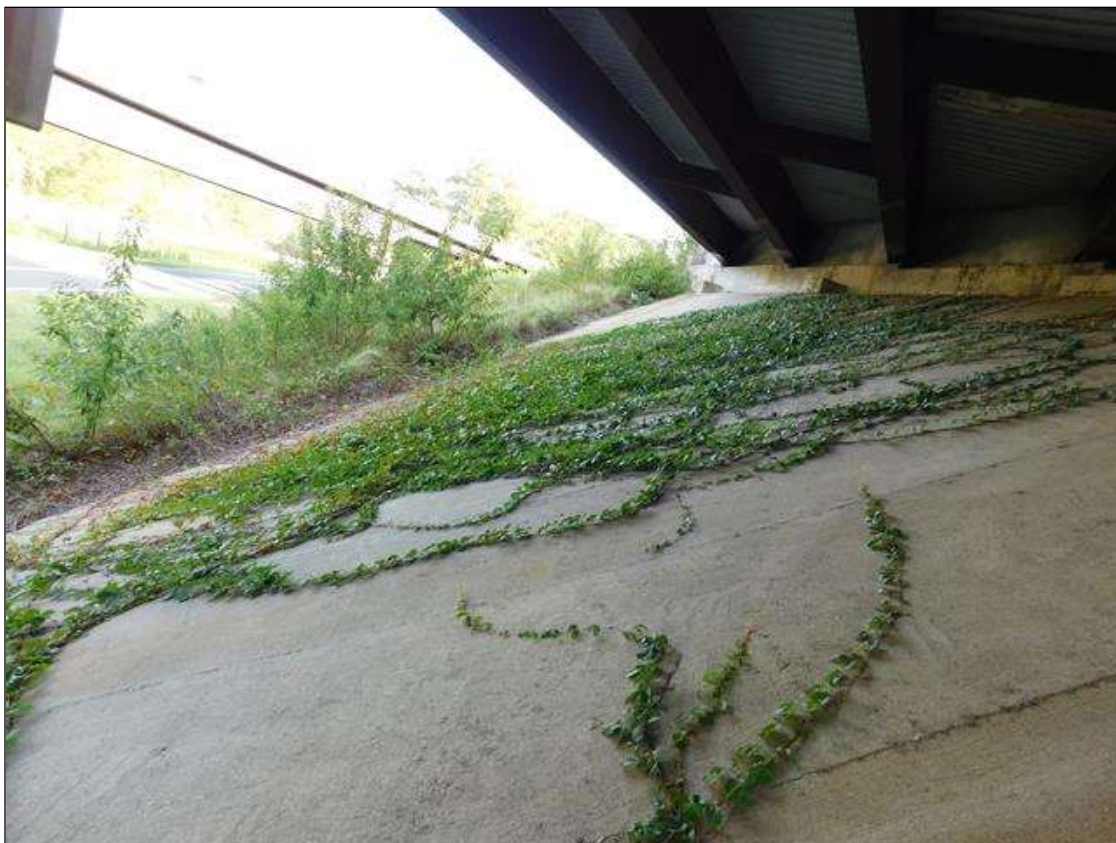
VEGETATION ON END BENT 2 SLOPE PROTECTION 100 SQUARE FOOT. FT.

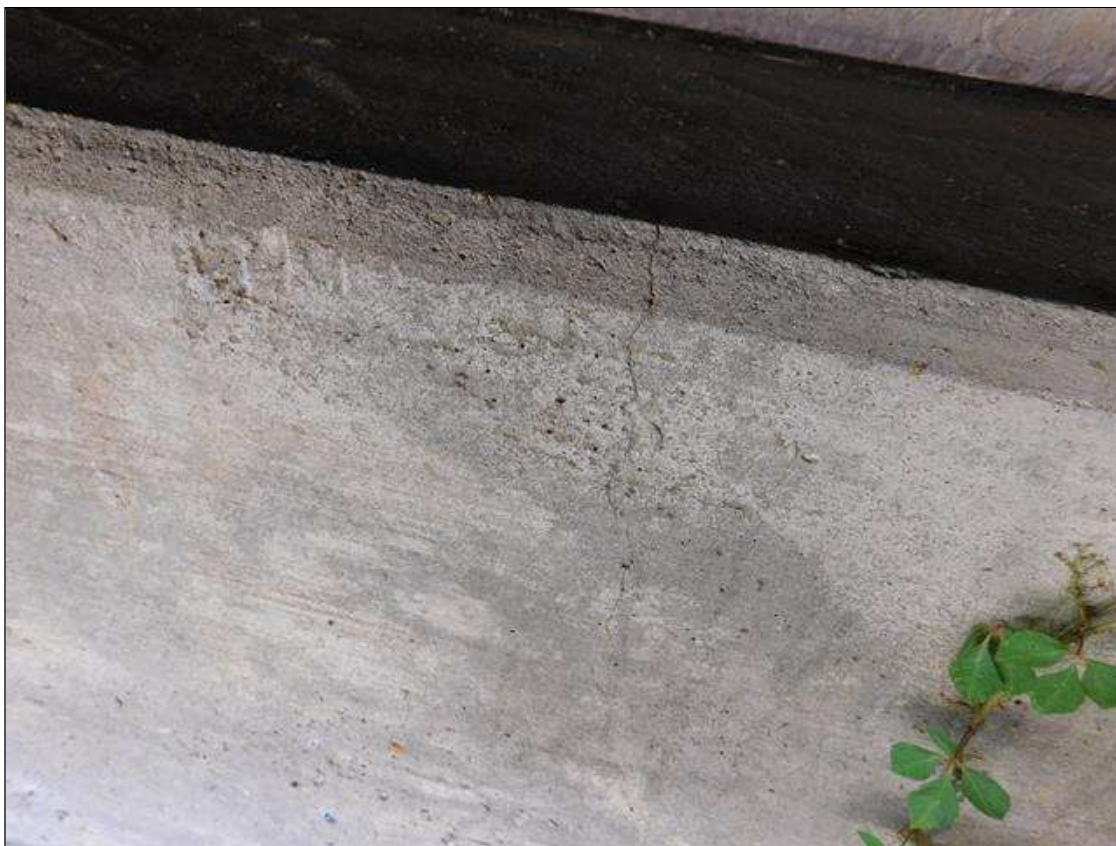
End Bent 2 Cap 1: 6 - HAIRLINE VERTICAL CRACKS AT 1' SPACING IN END BENT 2 CAP FROM BAY 1 TO BEAM
3

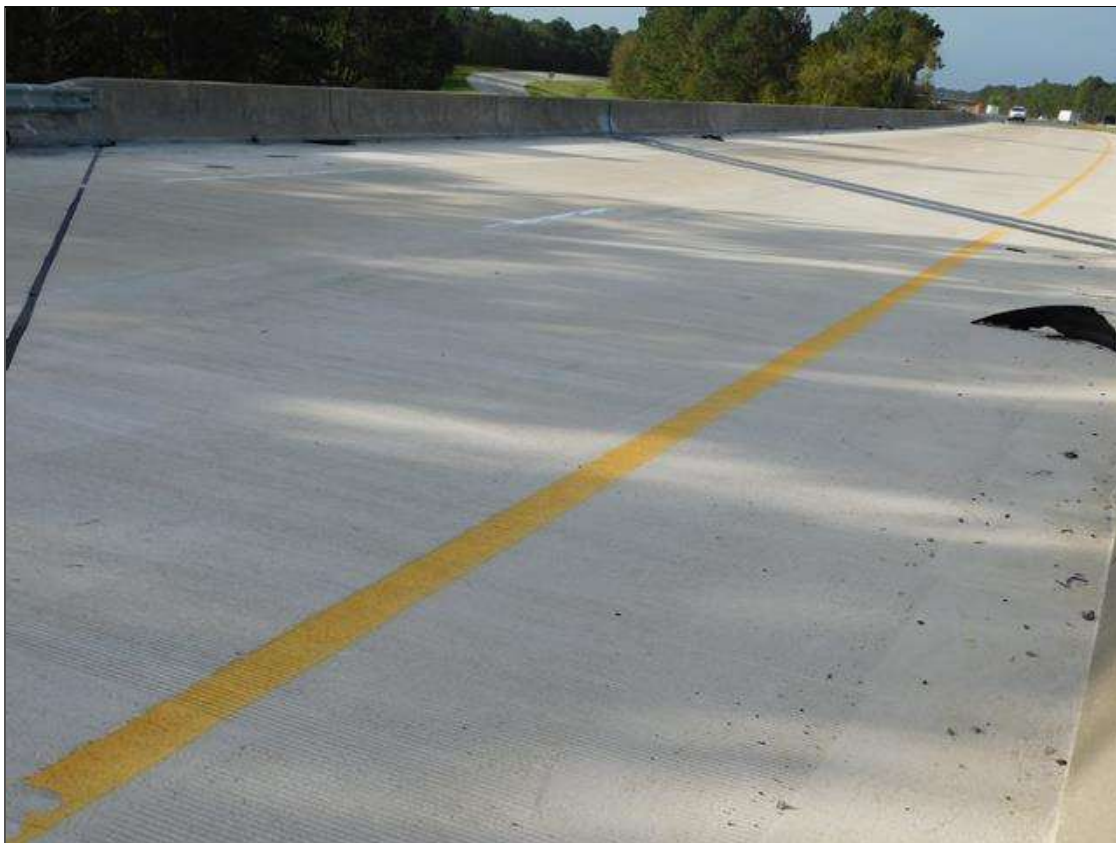
SPAN 4 DECK MILLED AND RESURFACED WITH SAME MEASUREMENTS, ALL SPANS ARE SIMILAR 2018

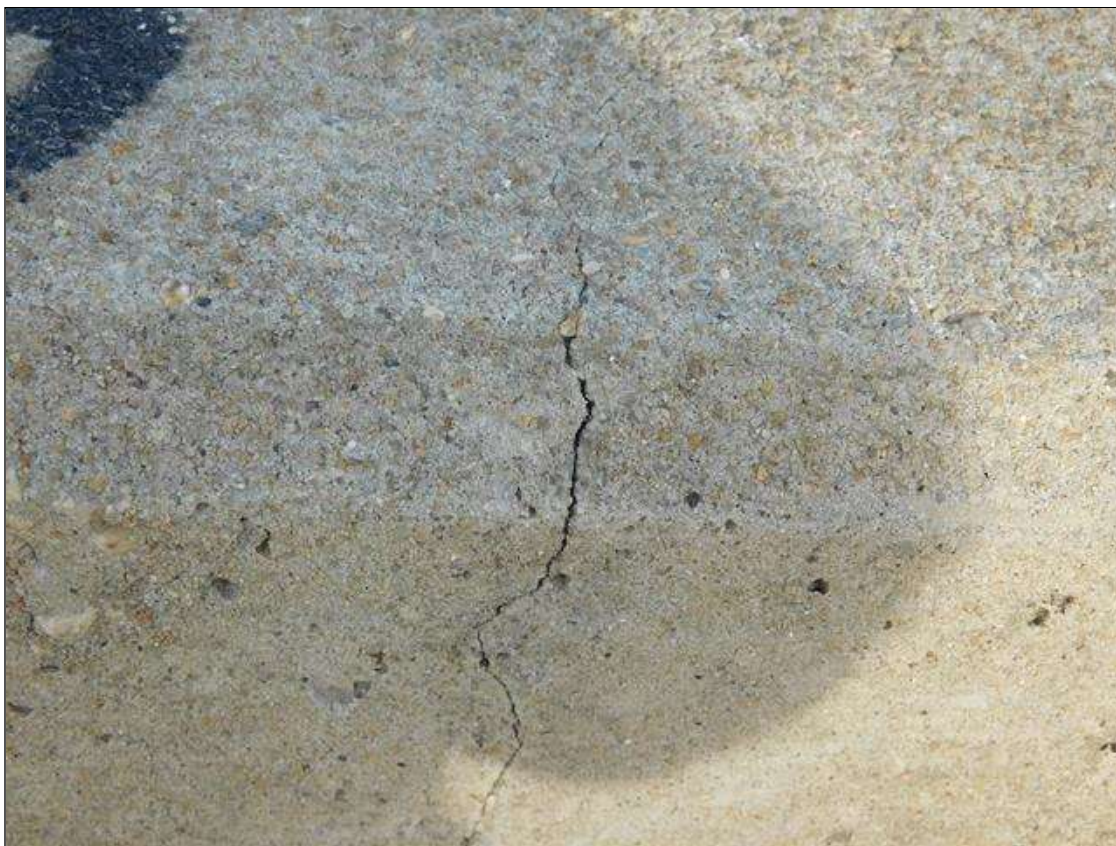
Span 4 Left Bridge Rail: HAIRLINE TRANSVERSE AND VERTICAL CRACKS AT 1-3 FT. SPACING

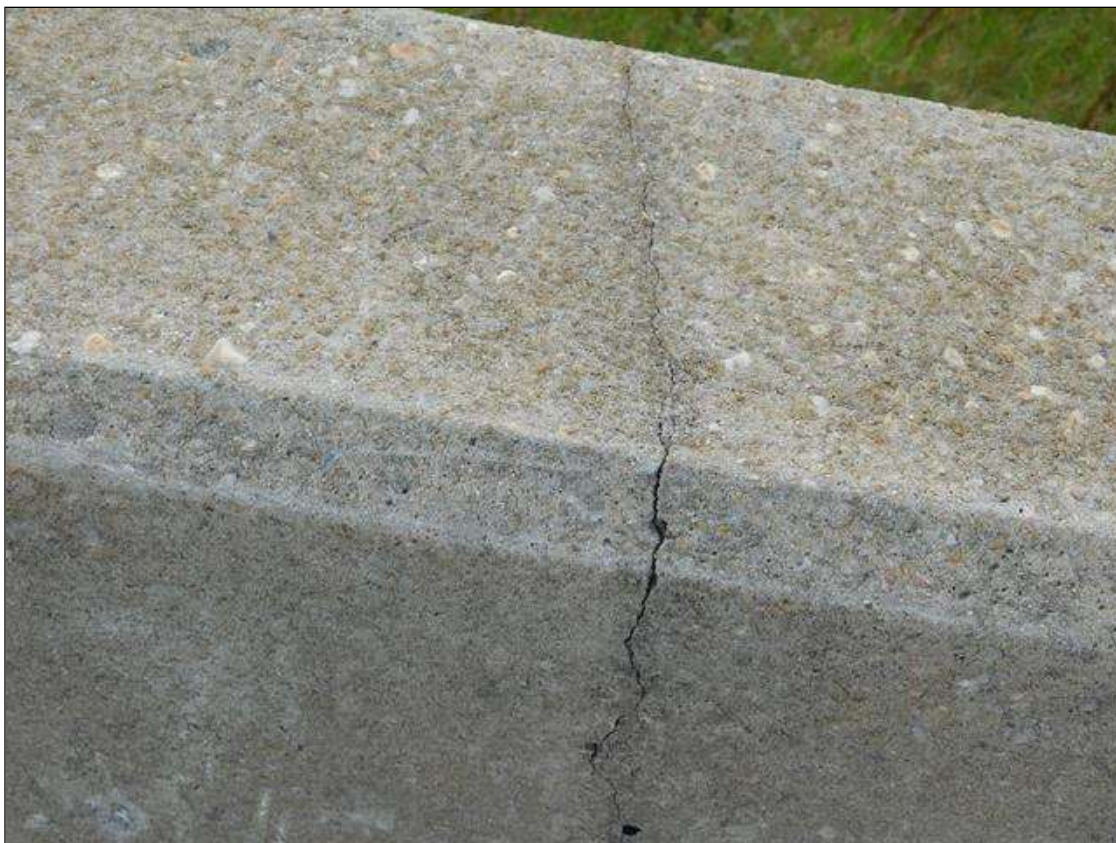
Span 4 Right Bridge Rail: HAIRLINE TRANSVERSE AND VERTICAL CRACKS AT 1-3 FT. SPACING

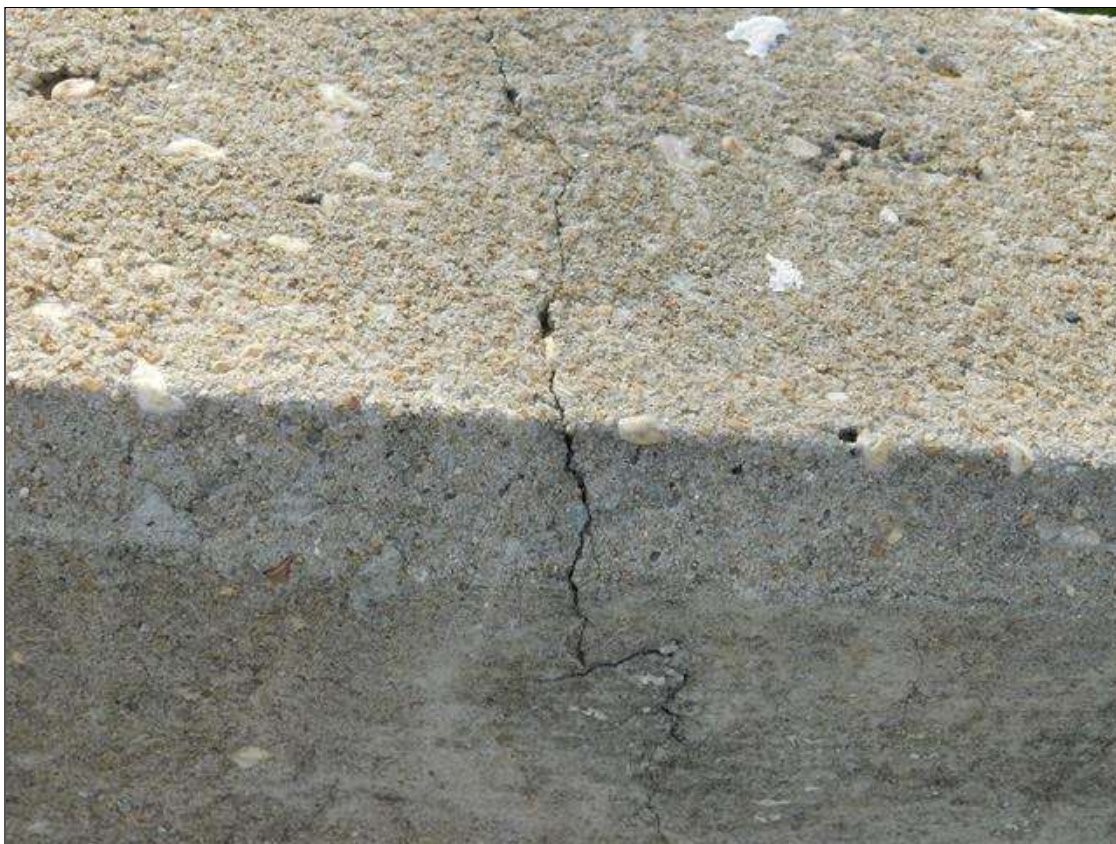
Span 3 Right Bridge Rail: HAIRLINE TRANSVERSE AND VERTICAL CRACKS AT 1-3 FT. SPACING

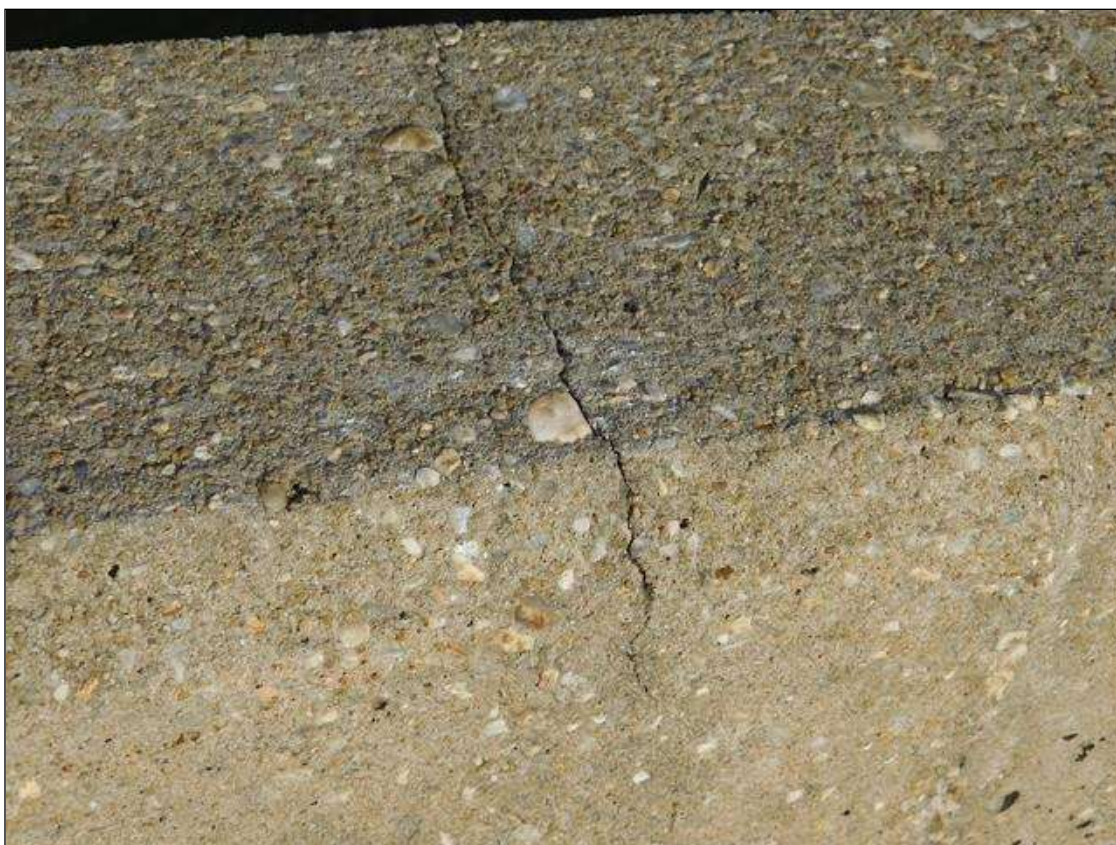
Span 3 Left Bridge Rail: HAIRLINE TRANSVERSE AND VERTICAL CRACKS AT 1-3 FT. SPACING

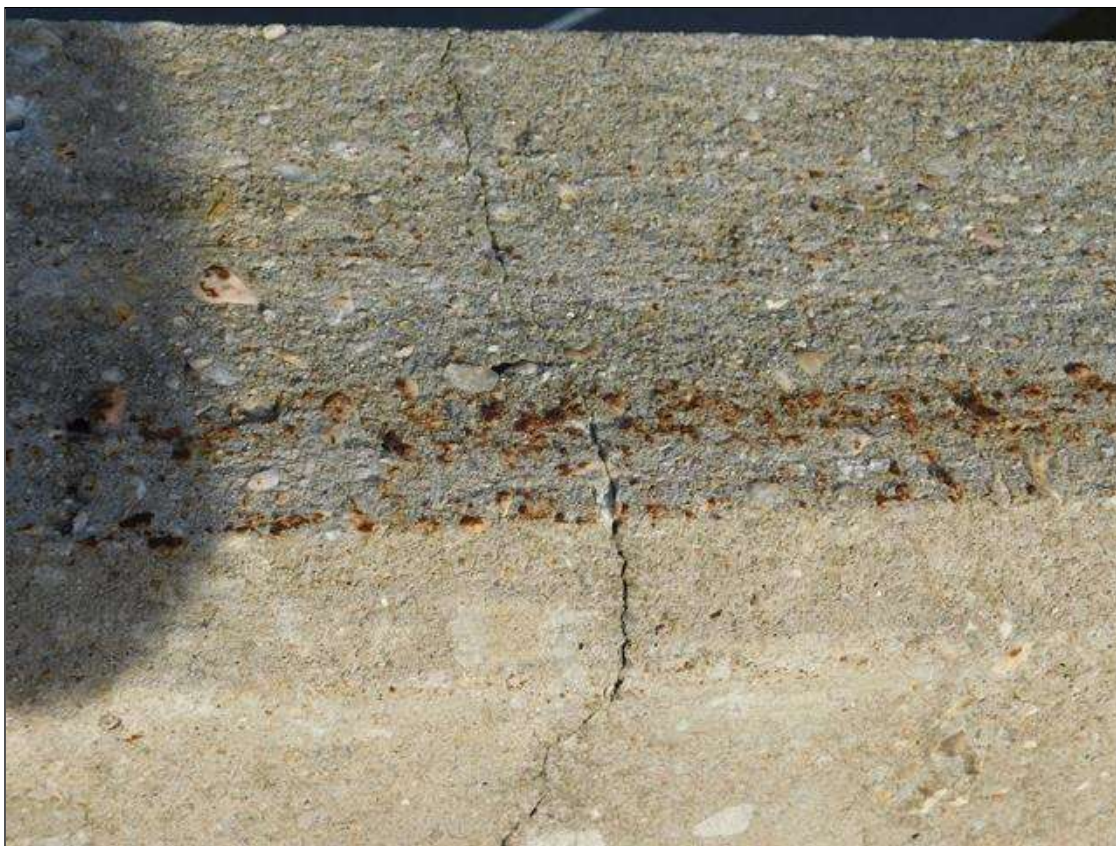
Span 2 Left Bridge Rail: HAIRLINE TRANSVERSE AND VERTICAL CRACKS AT 1-3 FT. SPACING

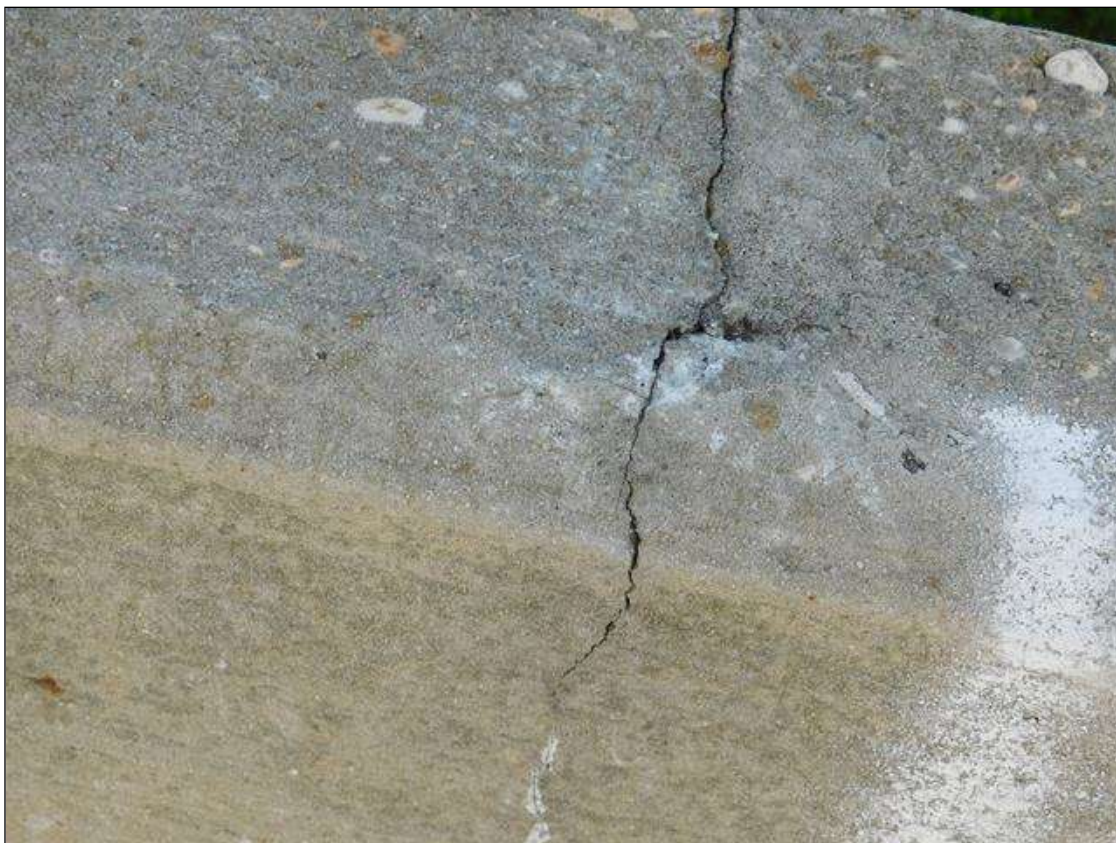
Span 2 Right Bridge Rail: HAIRLINE TRANSVERSE AND VERTICAL CRACKS AT 1-3 FT. SPACING

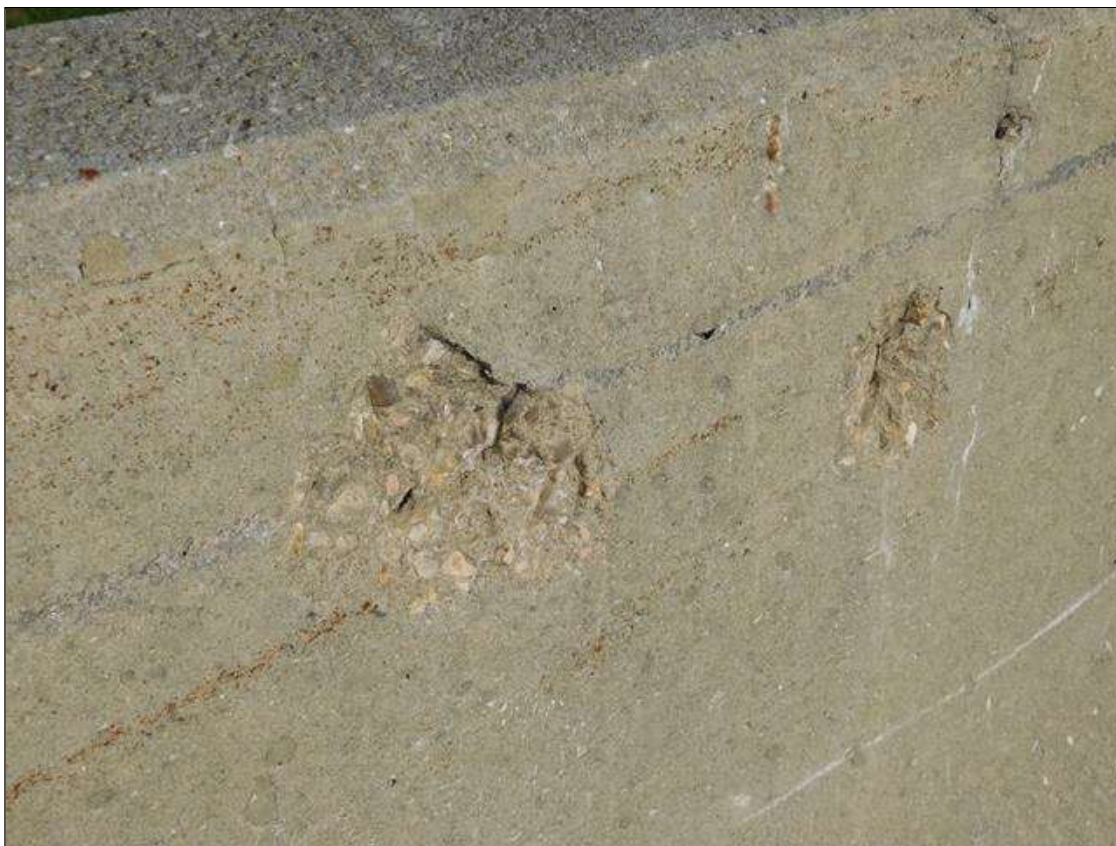
Span 2 Right Bridge Rail: 2 - 6" DIAMETER X 1" DEEP SURFACE SPALLS

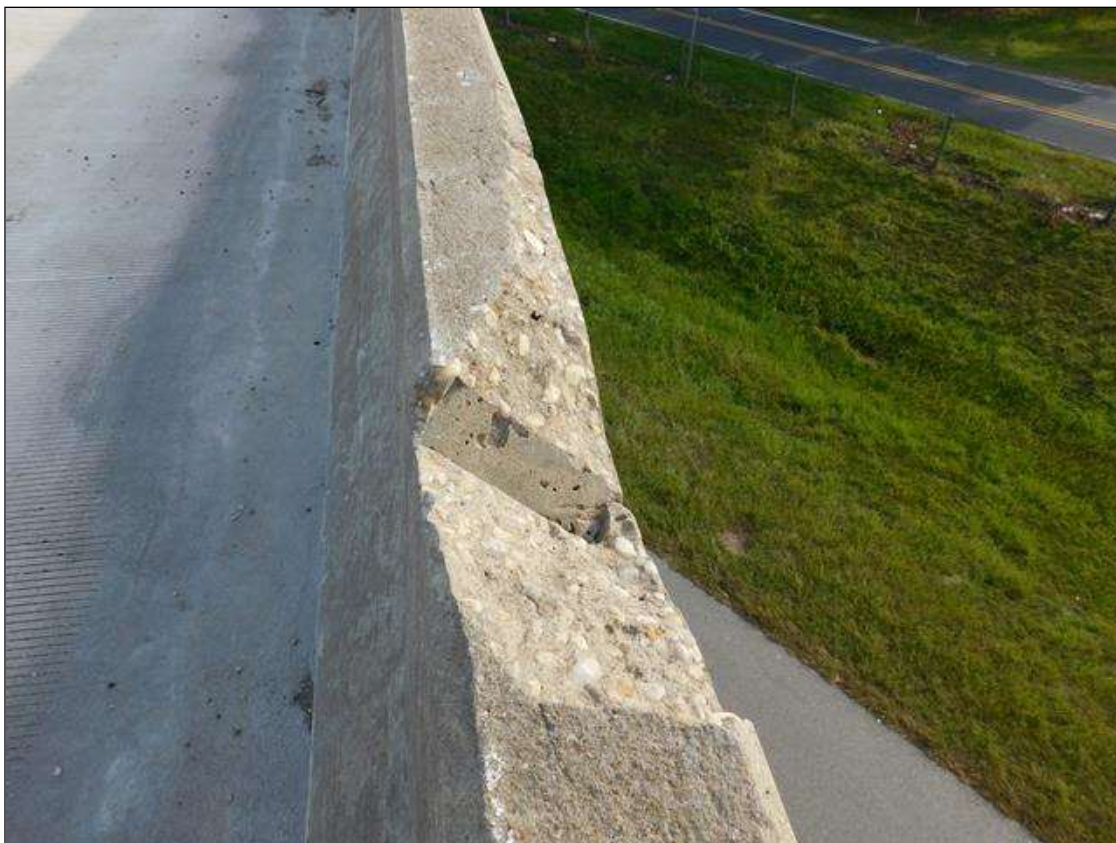
Span 2 Right Bridge Rail: SPALL 42" LONG X 7" WIDE X 6" DEEP AT MID SPAN PRIORITY MAINTENANCE ISSUED

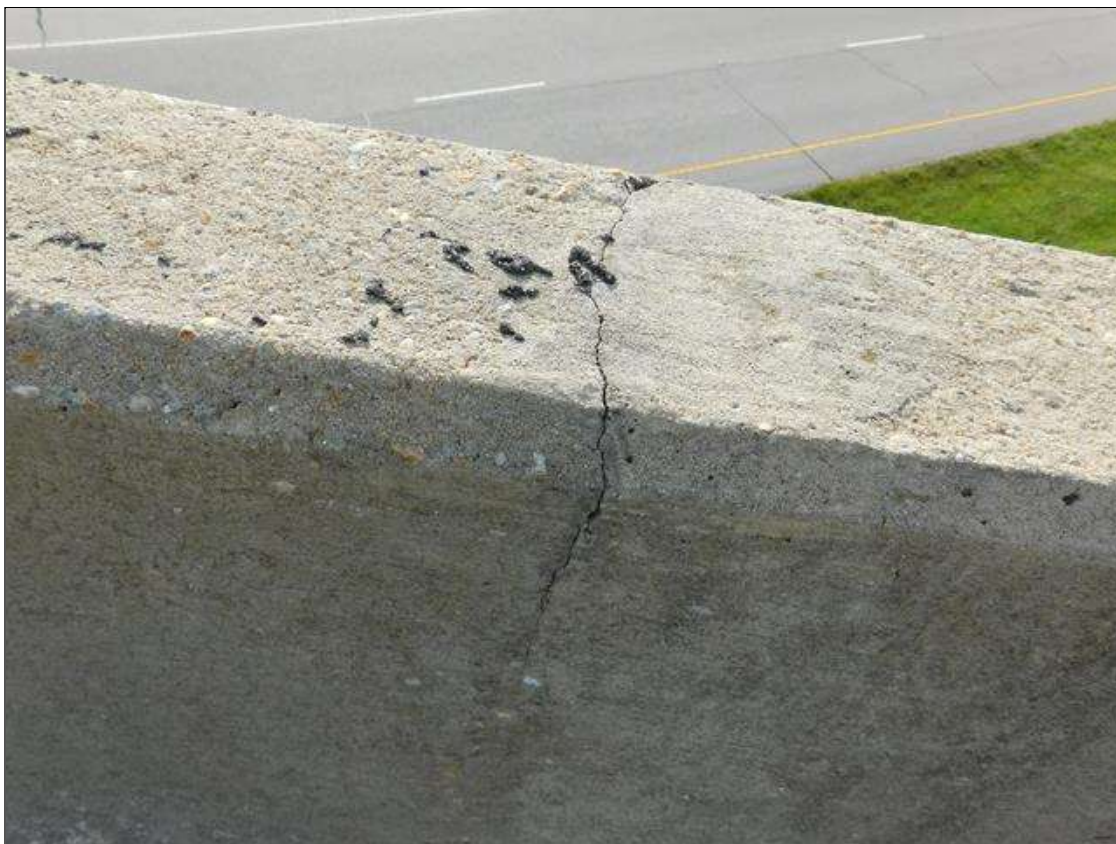
Span 1 Right Bridge Rail: HAIRLINE TRANSVERSE AND VERTICAL CRACKS AT 1-3 FT. SPACING

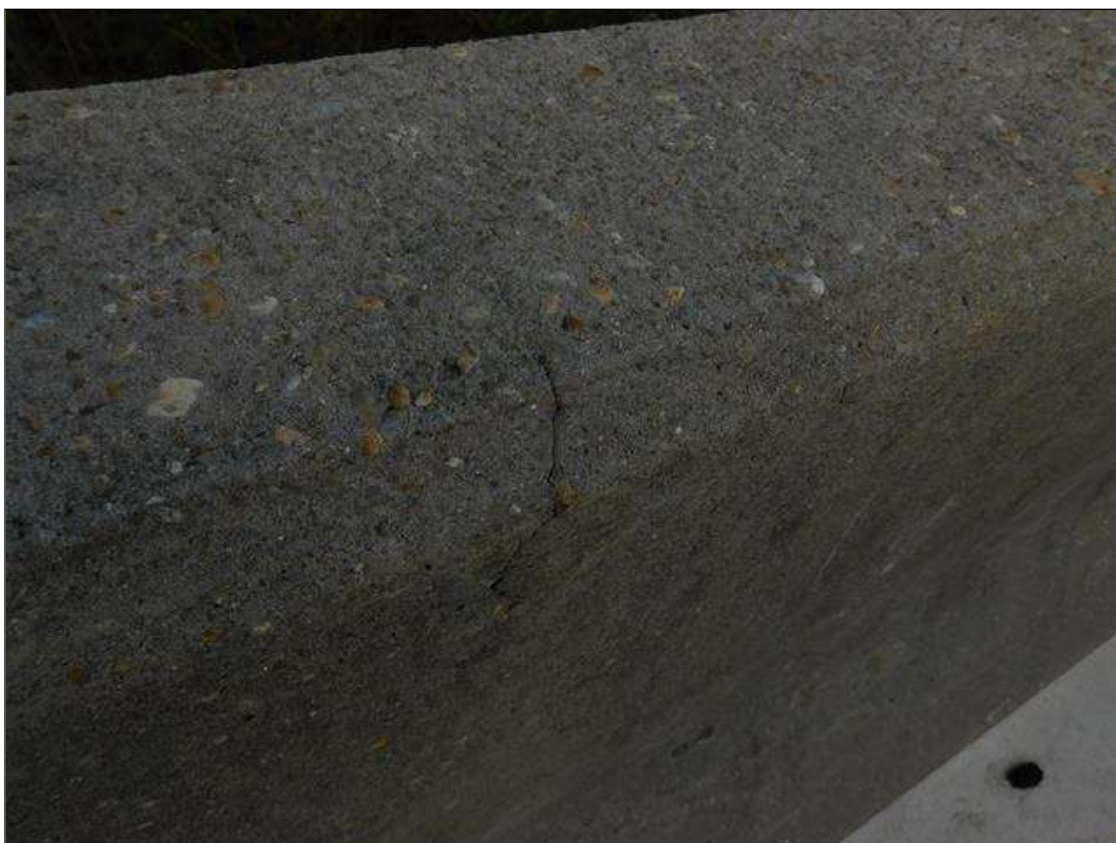
Span 1 Left Bridge Rail: HAIRLINE TRANSVERSE AND VERTICAL CRACKS AT 1-3 FT. SPACING

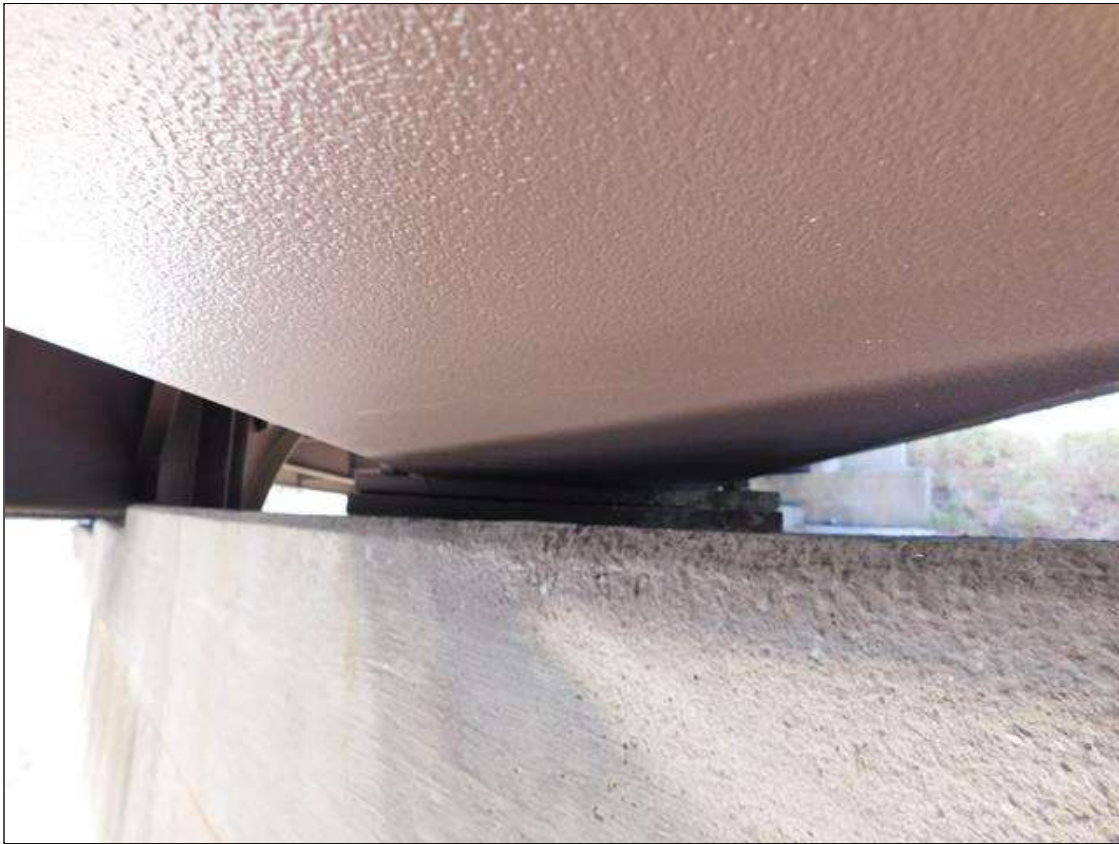
SPAN 2 BEAM 3 NEAR BEARING
