NC DEPARTMENT OF TRANSPORTATION ATTENTION:
 DIVISION OF HIGHWAYS
 STRUCTURE MANAGEMENT UNIT

Structure Safety Report

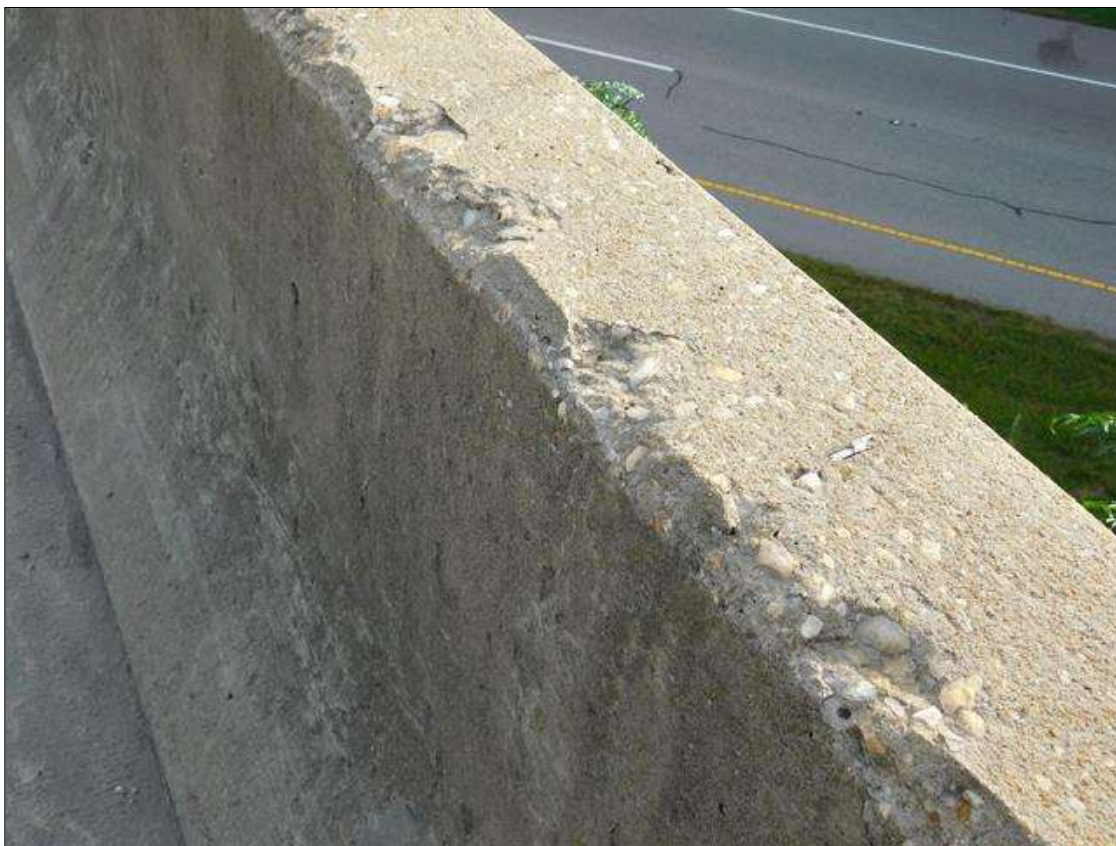
Span 1 Right Bridge Rail: SURFACE SPALL 4 FT. LONG X 2" WIDE X 1" DEEP IN TOP OF RAIL AT 20 FT. FROM END BENT 1

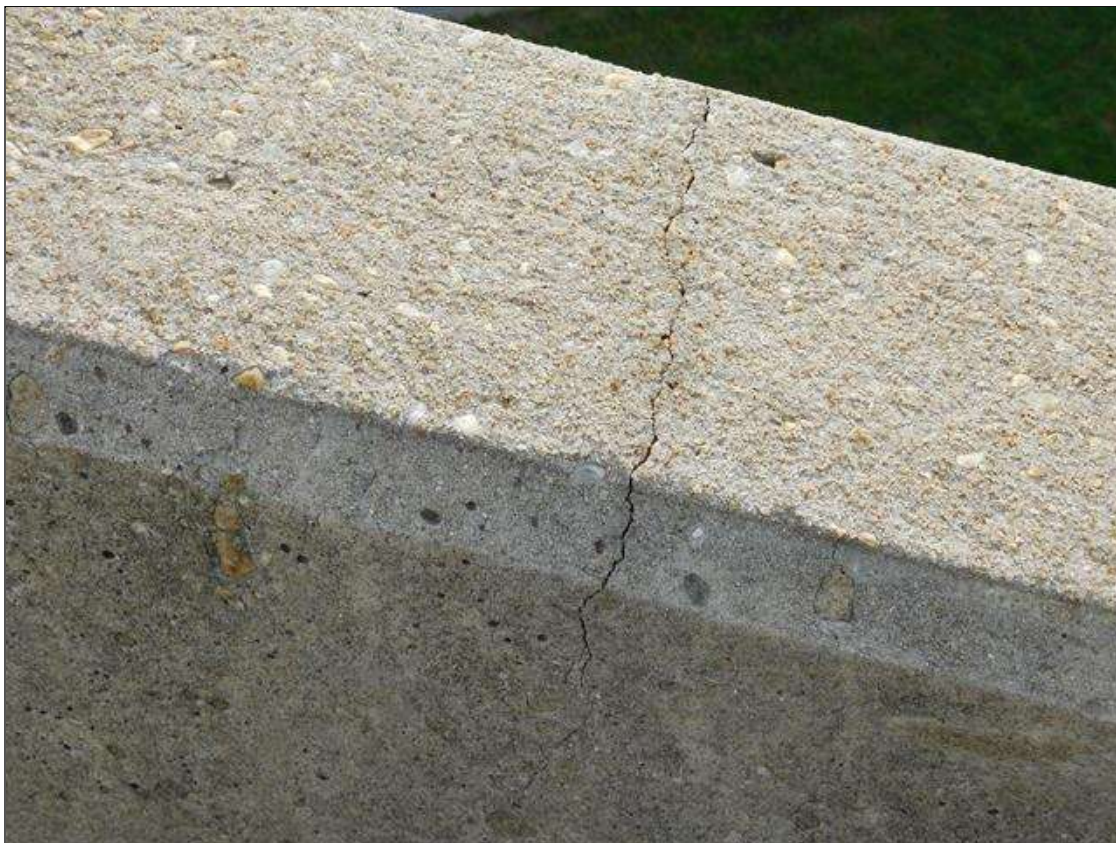
Span 1 Right Bridge Rail: HAIRLINE TRANSVERSE AND VERTICAL CRACKS AT 1-4 FT. SPACING

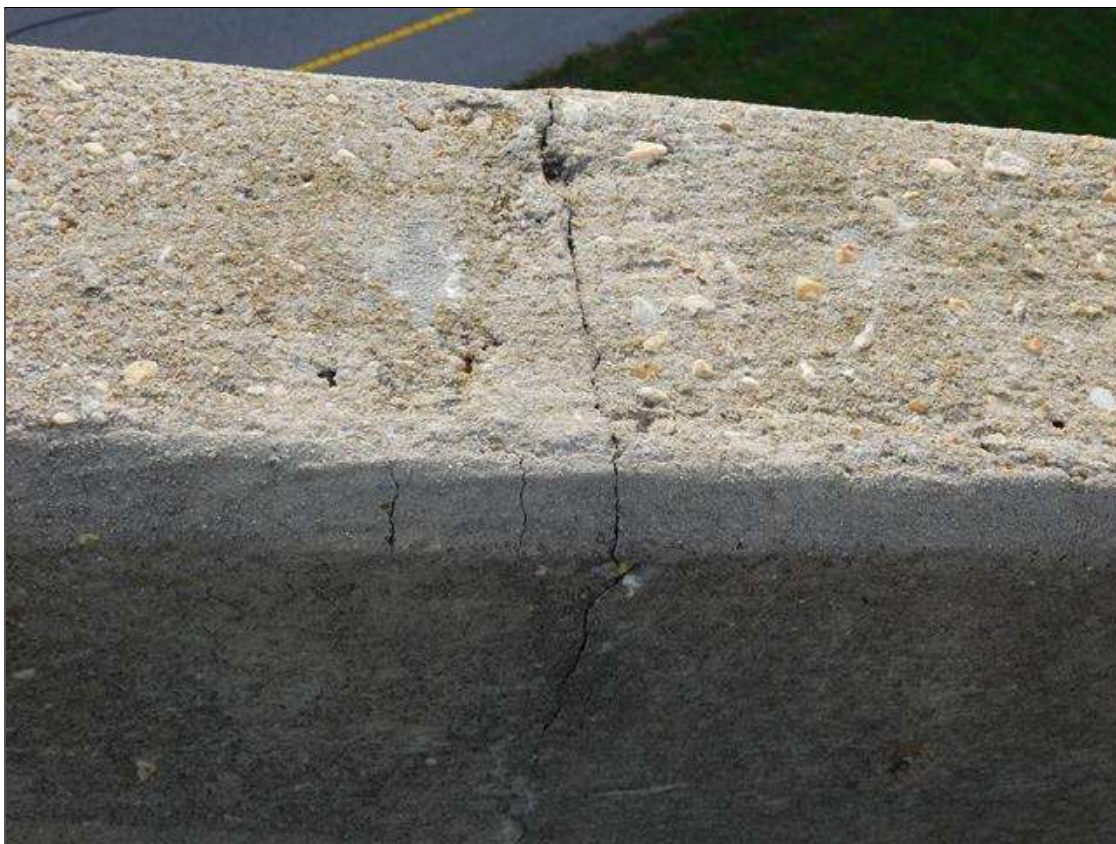
Span 2 Right Bridge Rail: HAIRLINE TRANSVERSE AND VERTICAL CRACKS AT 1-4 FT. SPACING

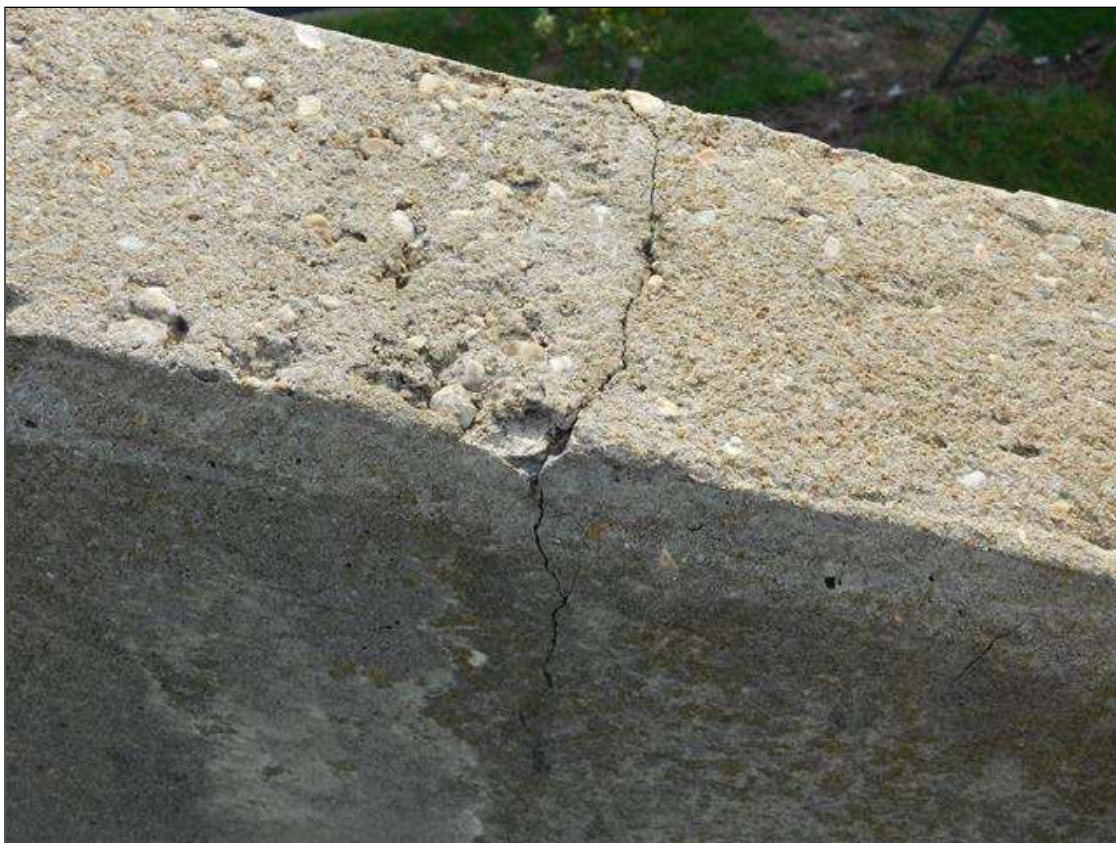
Span 3 Right Bridge Rail: HAIRLINE TRANSVERSE AND VERTICAL CRACKS AT 1-4 FT. SPACING

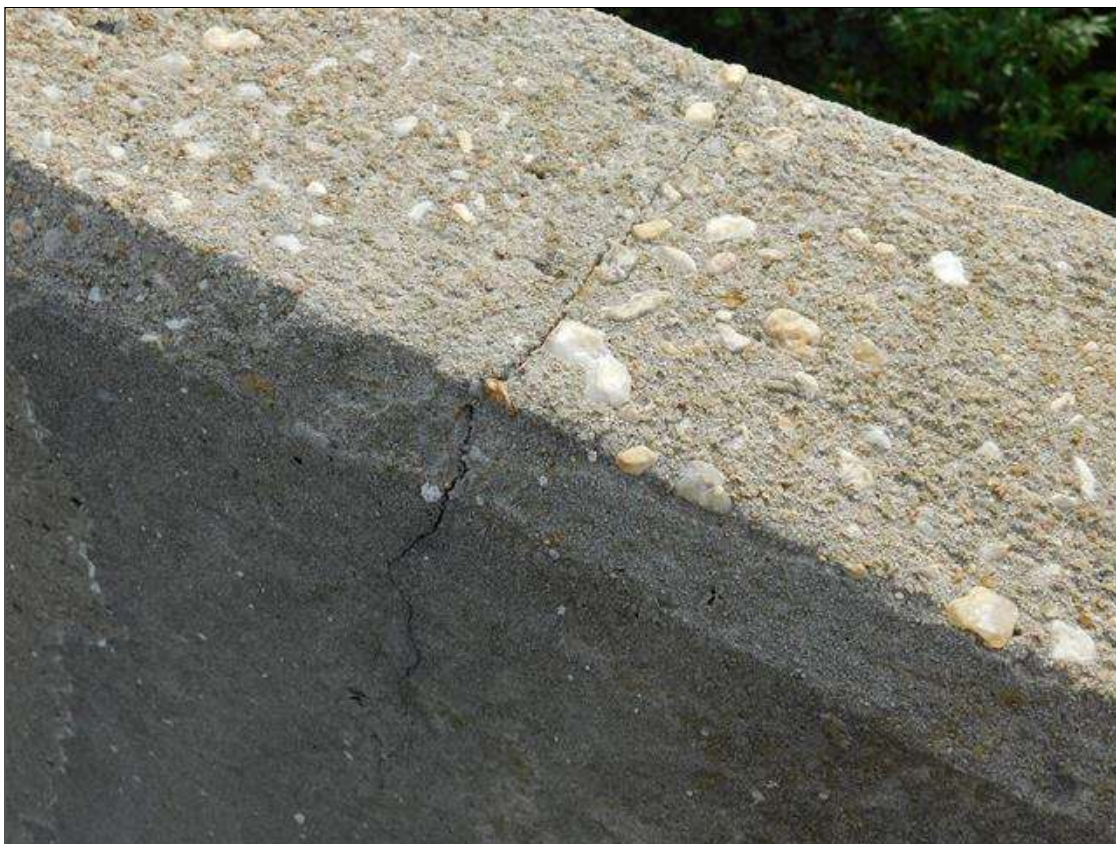
Span 4 Right Bridge Rail: HAIRLINE TRANSVERSE AND VERTICAL CRACKS AT 1-4 FT. SPACING

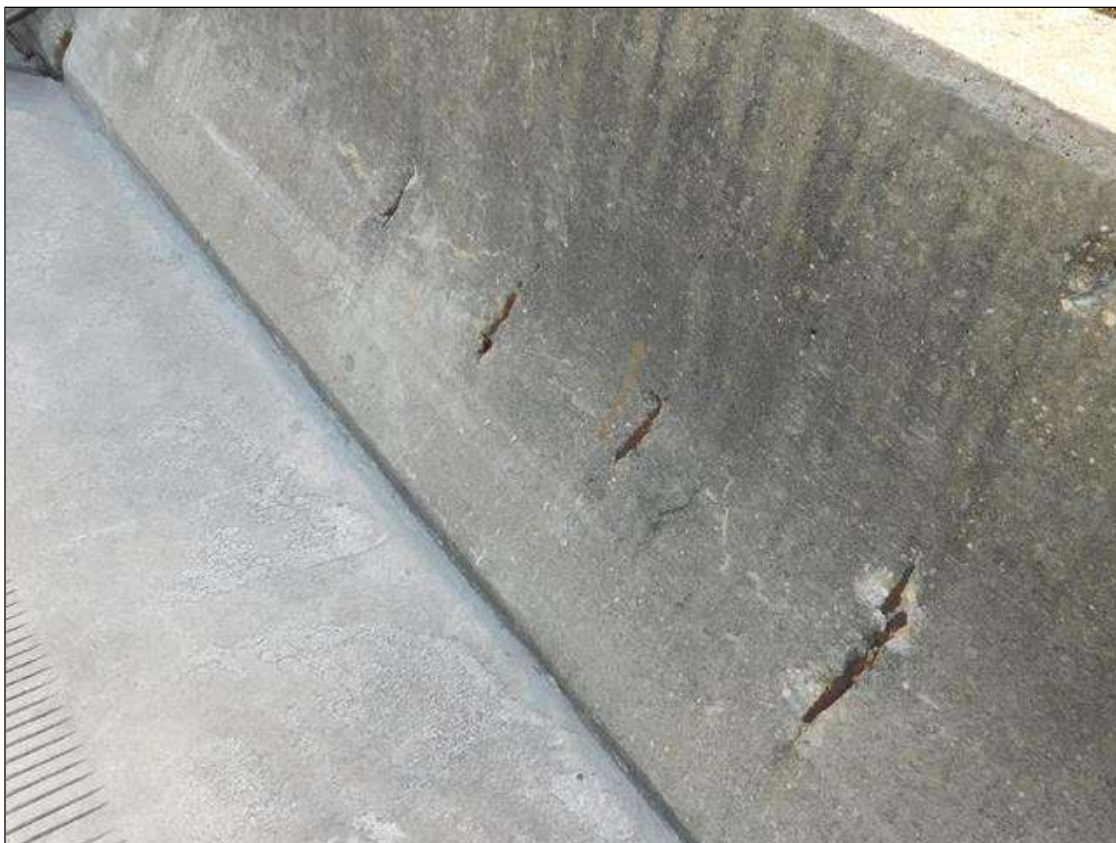
Span 4 Right Bridge Rail: 4 - 2" HIGH X 1/2" DEEP SURFACE SPALLS WITH EXPOSED REBAR NEAR END BENT 2

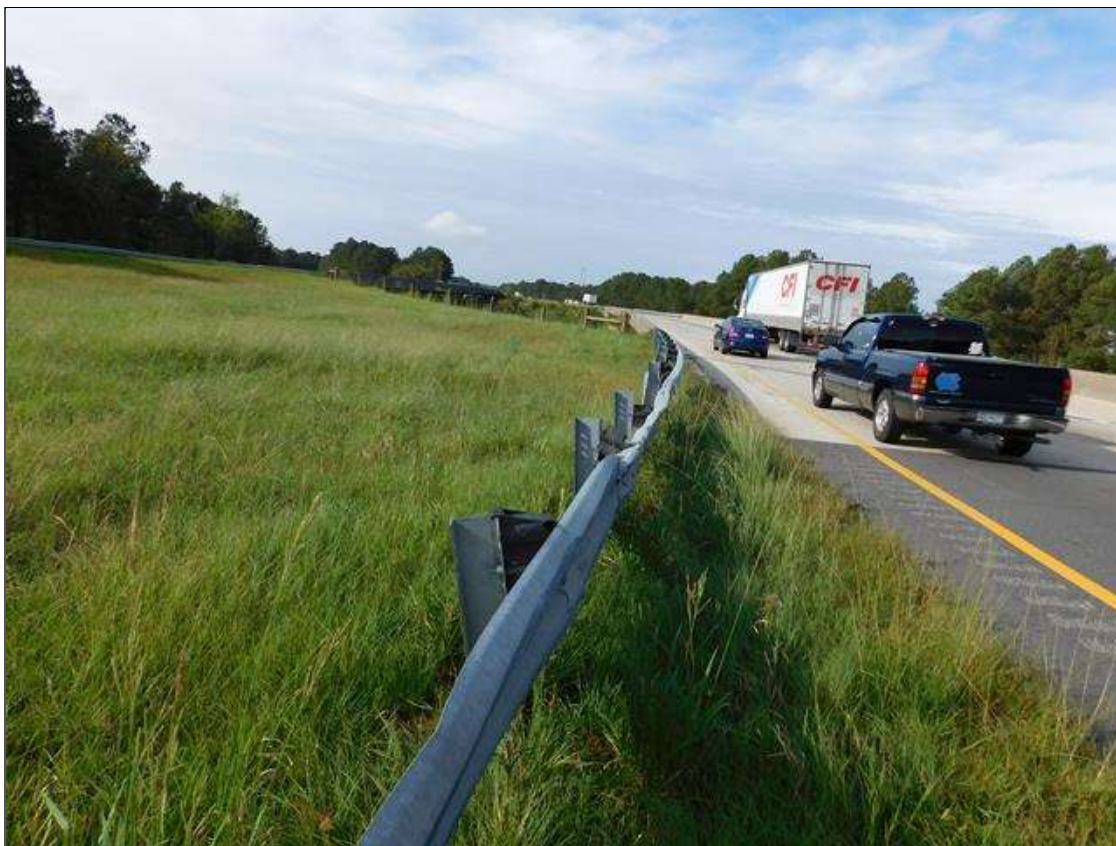
20 FT. GUARDRAIL AND 4 POSTS DAMAGED AT NORTHEAST CORNER

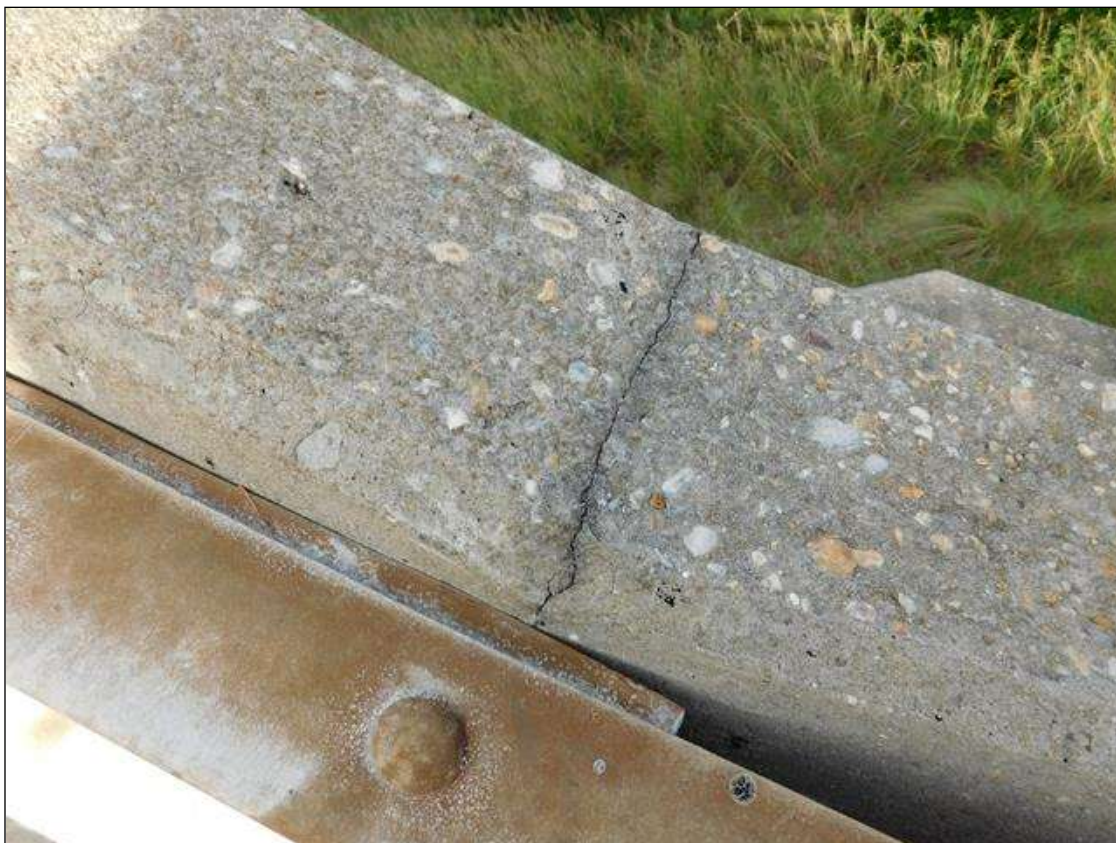
Span 4 Left Bridge Rail: HAIRLINE TRANSVERSE AND VERTICAL CRACKING

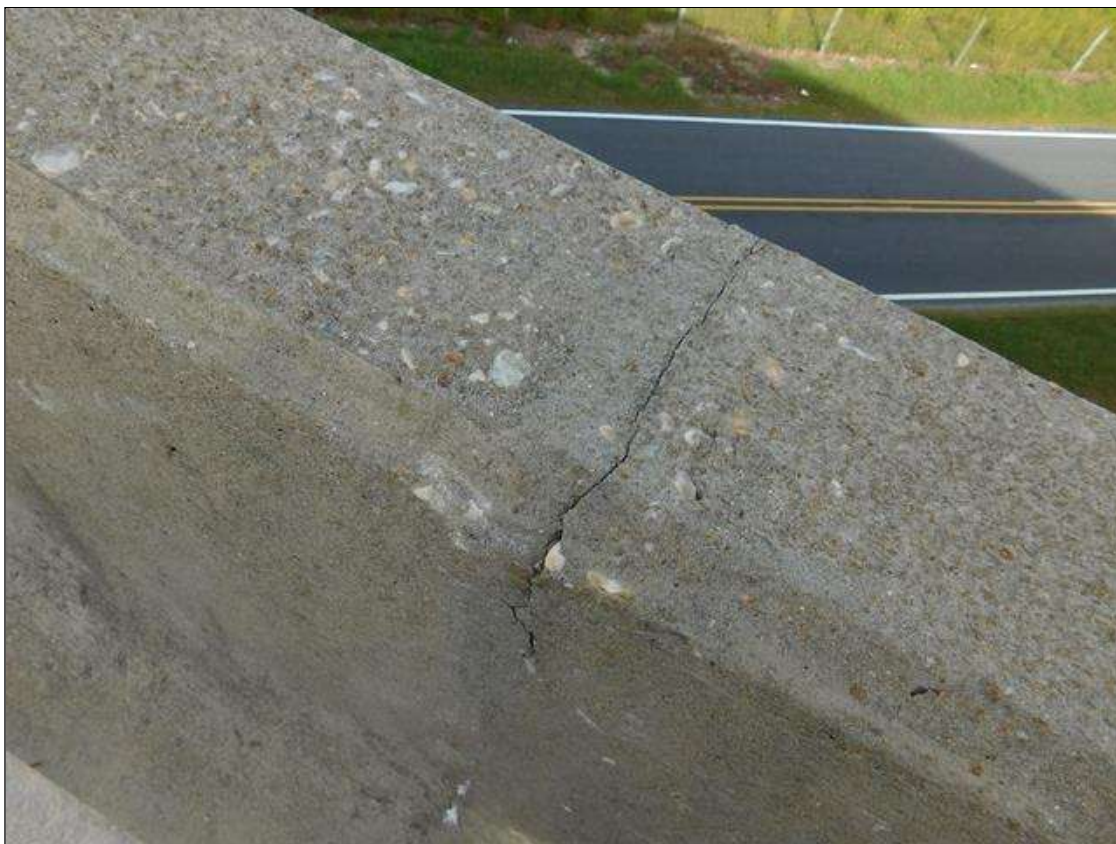
Span 3 Left Bridge Rail: HAIRLINE TRANSVERSE AND VERTICAL CRACKING

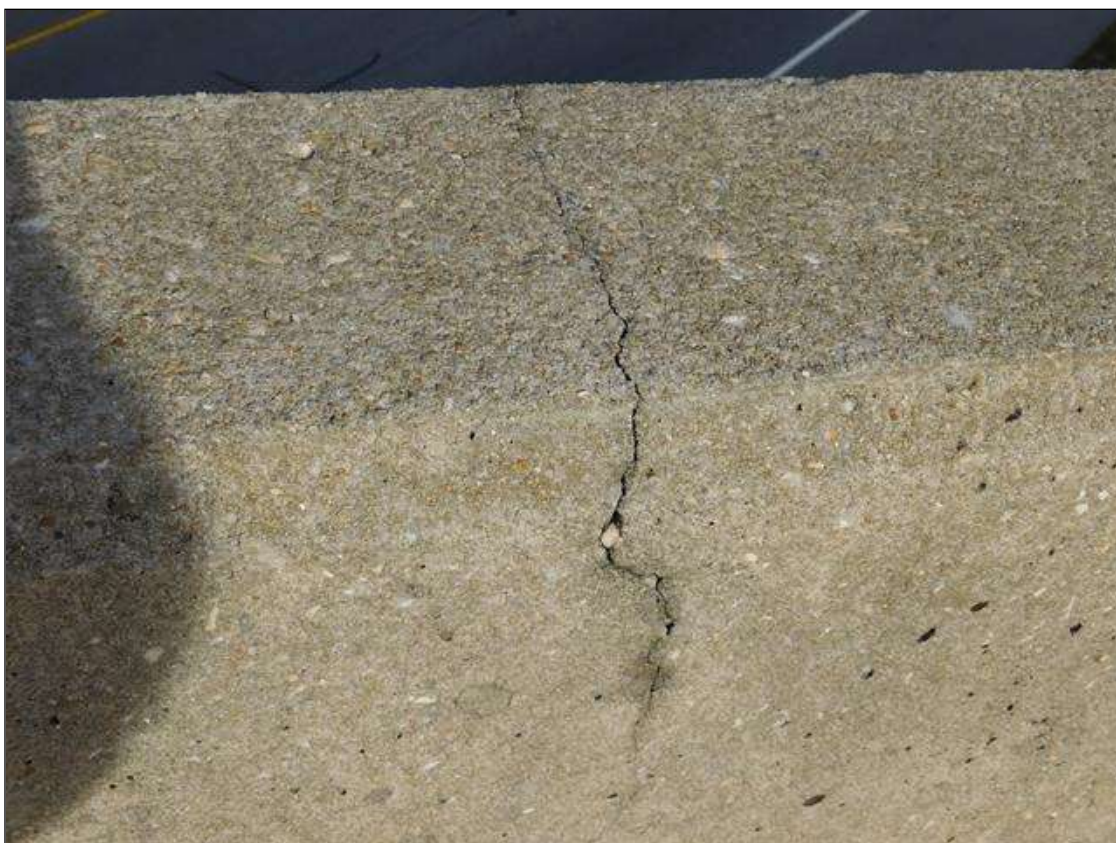
Span 2 Left Bridge Rail: HAIRLINE TRANSVERSE AND VERTICAL CRACKING

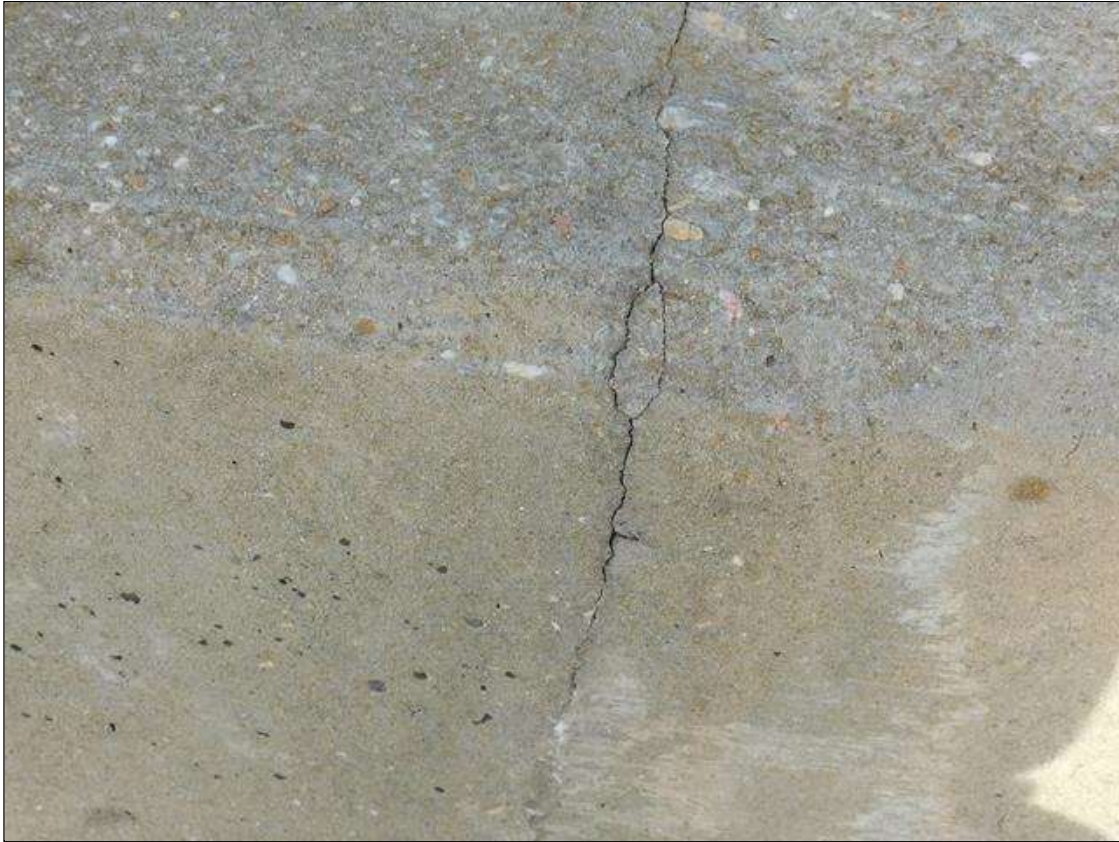
Span 1 Left Bridge Rail: HAIRLINE TRANSVERSE AND VERTICAL CRACKING

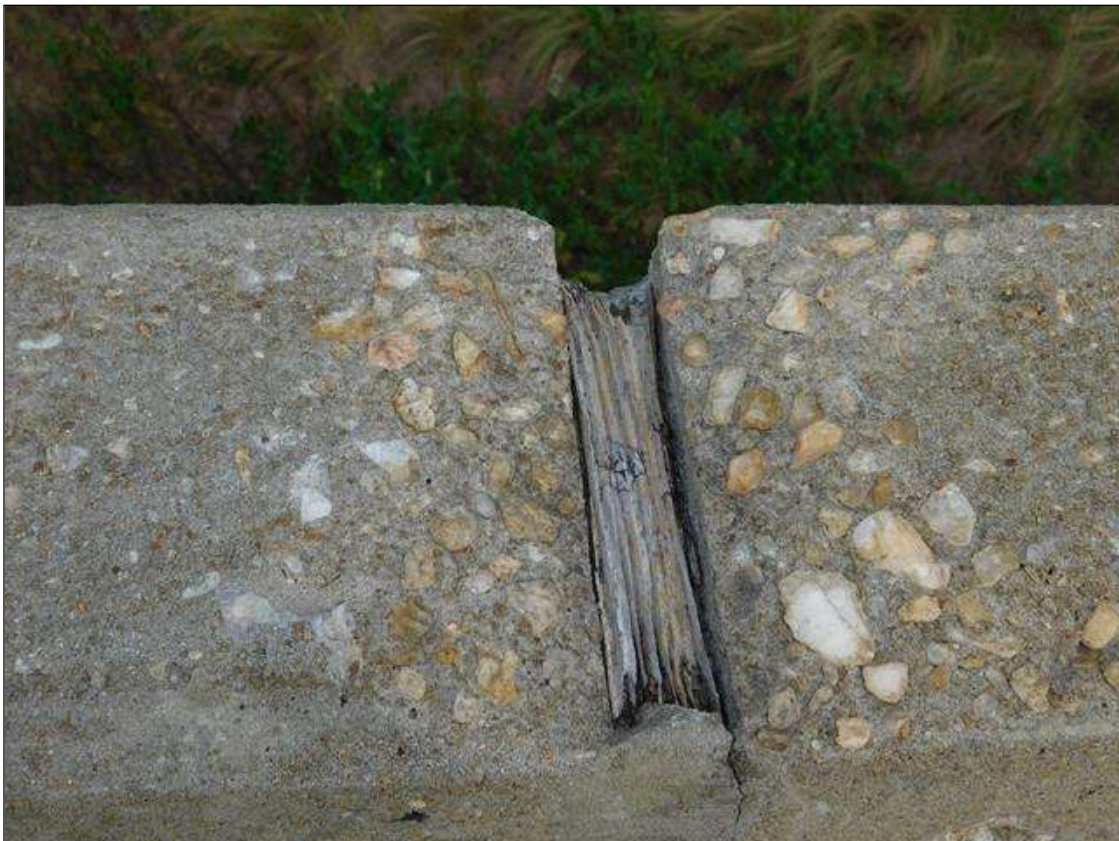
Span 1 Left Bridge Rail: SPALL 6" LONG X 2" WIDE X 1 1/2" DEEP IN TOP OF RAIL AT MID SPAN

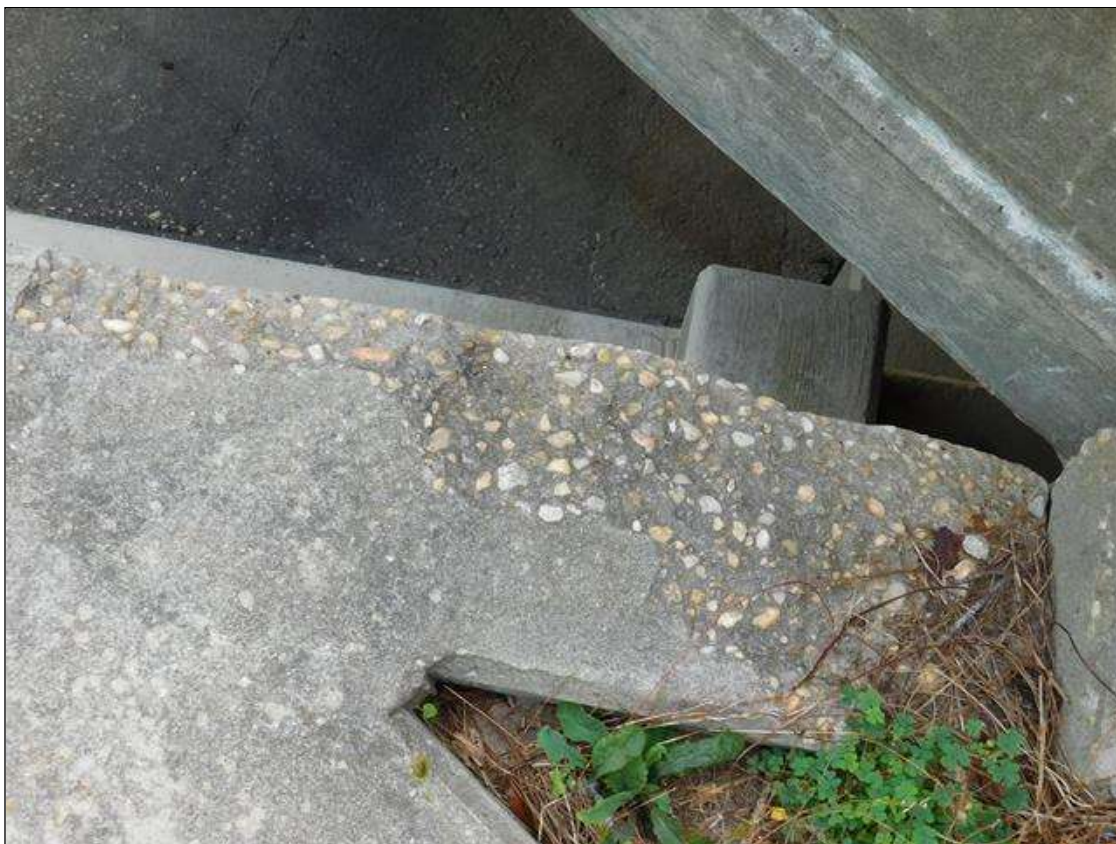
SOUTHWEST WINGWALL TOP SPALLED 4 FT. LONG X 12" WIDE X UP TO 4" DEEP

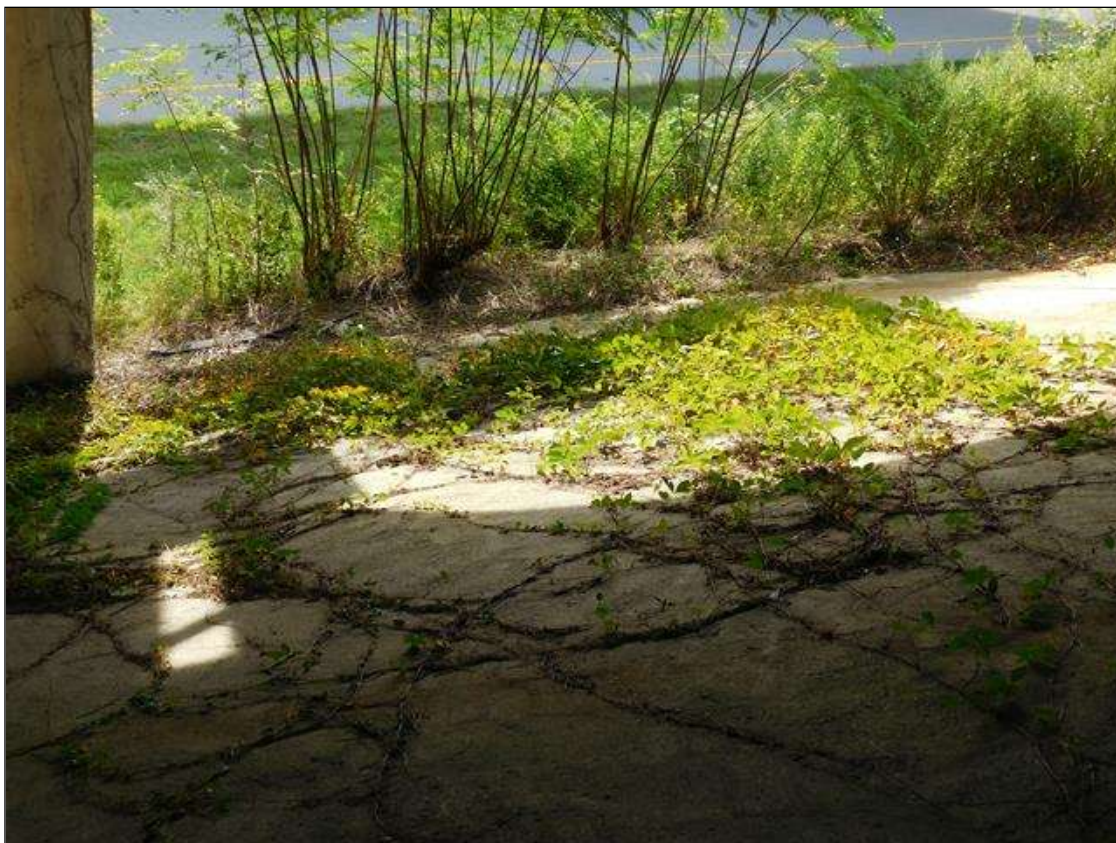
50 SQUARE FOOT. FT. VEGETATION ON END BENT 1 SLOPE

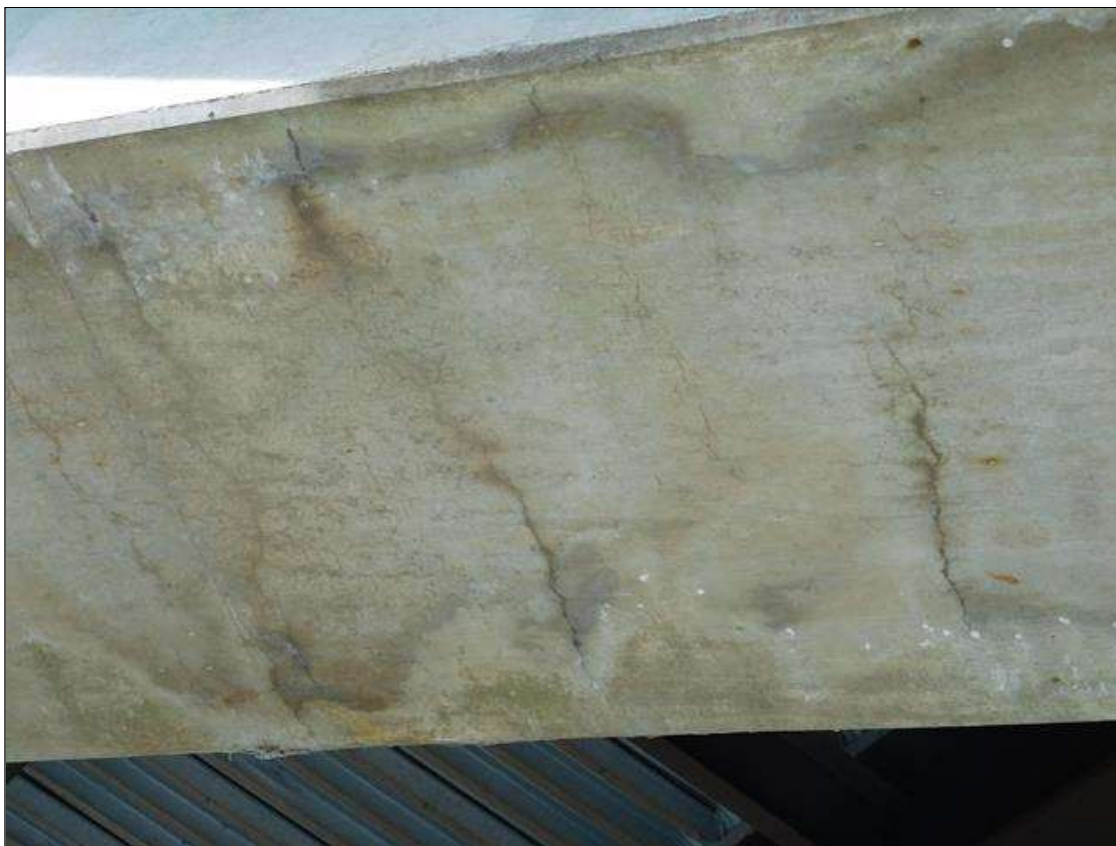
Bent 1 Cap 1: 3 - 3 FT. LONG X HAIRLINE TRANSVERSE CRACKS AT 2 FT. SPACING IN BOTTOM OF CAP BETWEEN COLUMNS 3 AND 4

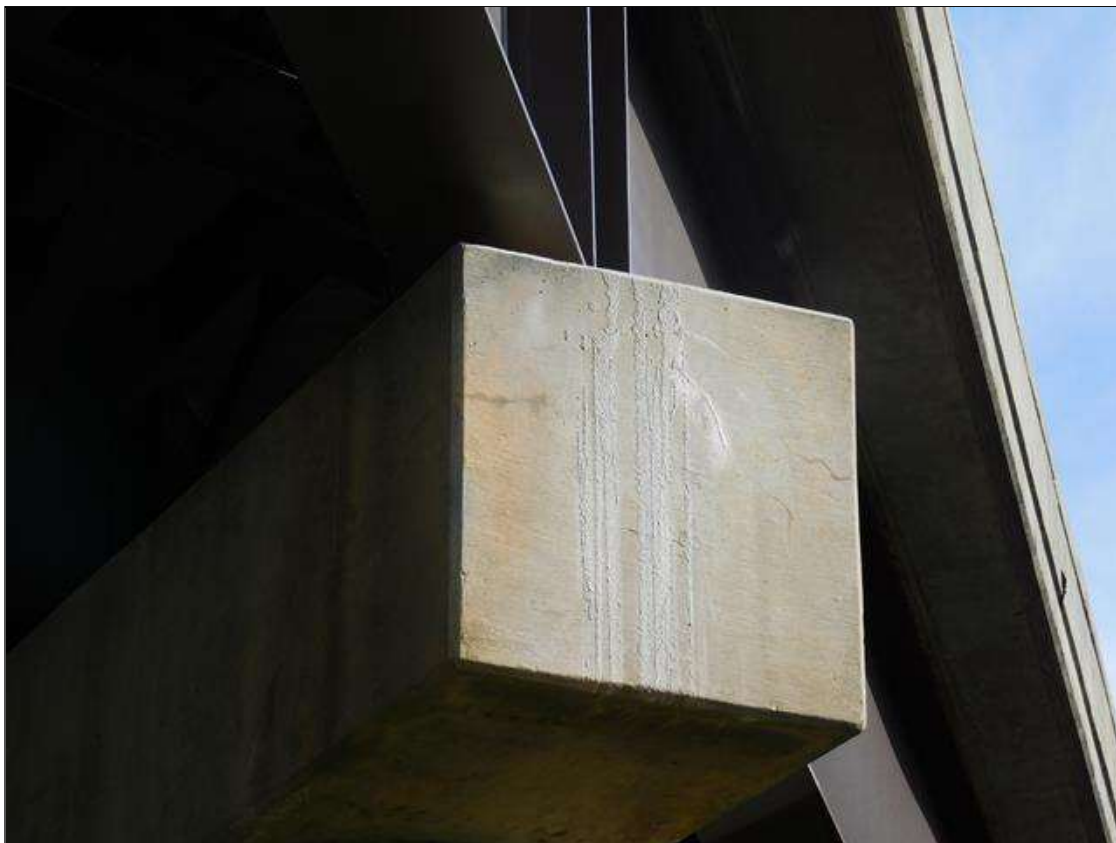
Bent 2 Cap 1: HAIRLINE MAP CRACKING WITH EFFLO ON EAST END OF CAP

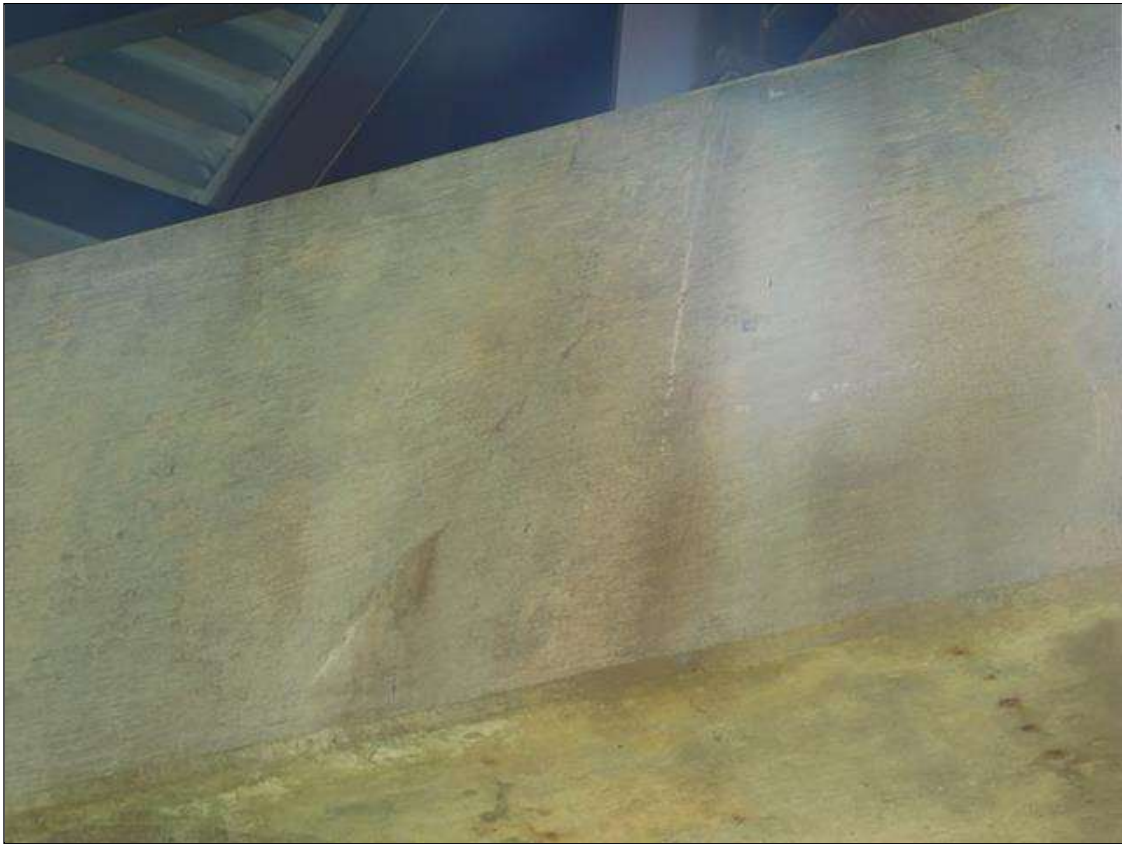
Bent 2 Cap 1: 1/32" WIDE DIAGONAL CRACK IN SPAN 2 FACE OF CAP EAST END UNDER BEAM 6

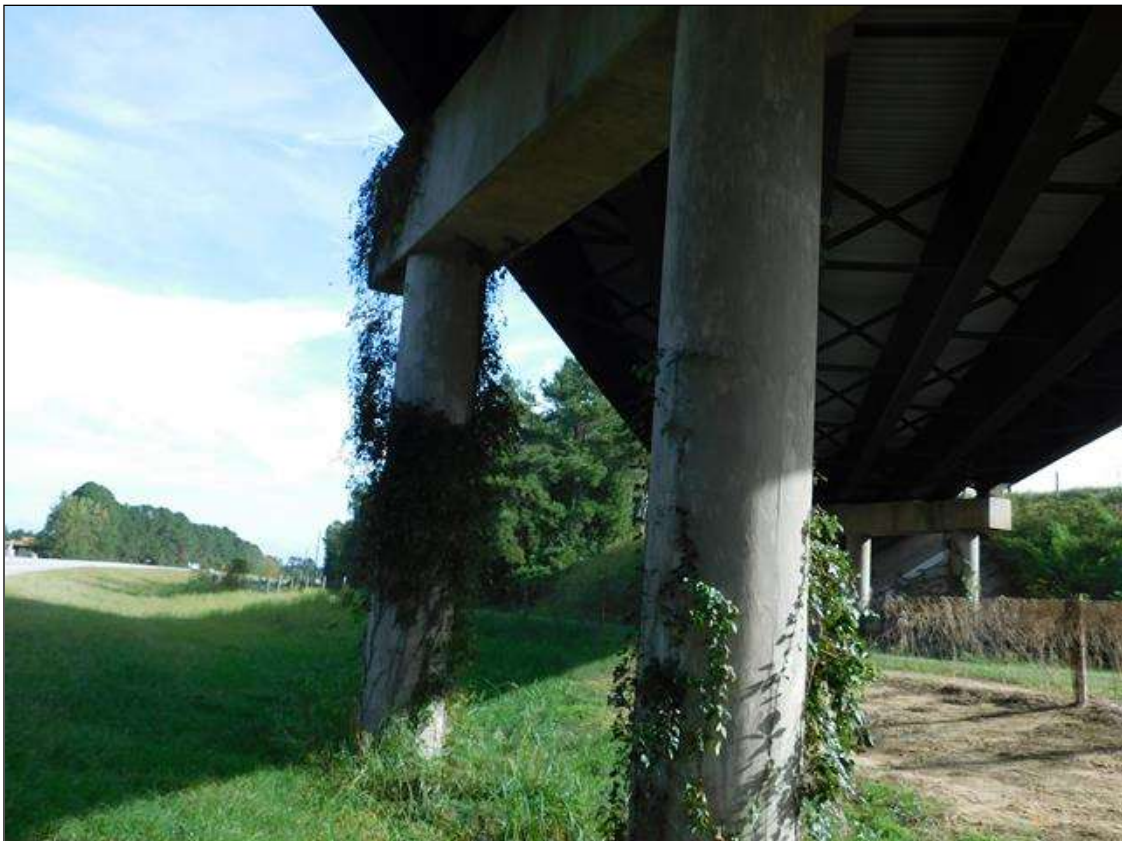
VEGETATION ON ALL COLUMNS AT BENT 2
