NC DEPARTMENT OF TRANSPORTATION ATTENTION:
 DIVISION OF HIGHWAYS
 STRUCTURE MANAGEMENT UNIT

Structure Safety Report

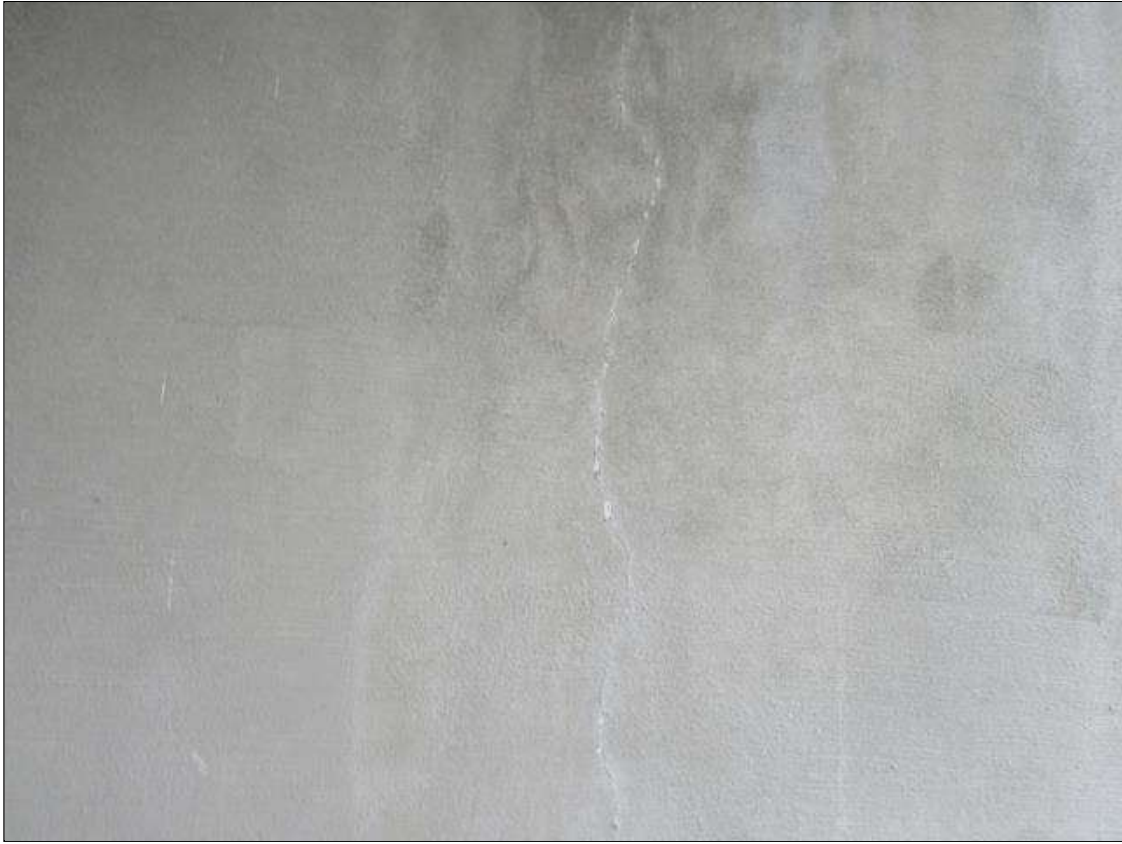
End Bent 1 Abutment/Backwall : 4' HIGH X HAIRLINE VERTICAL CRACK AT WEST END NEAR BEAM 1

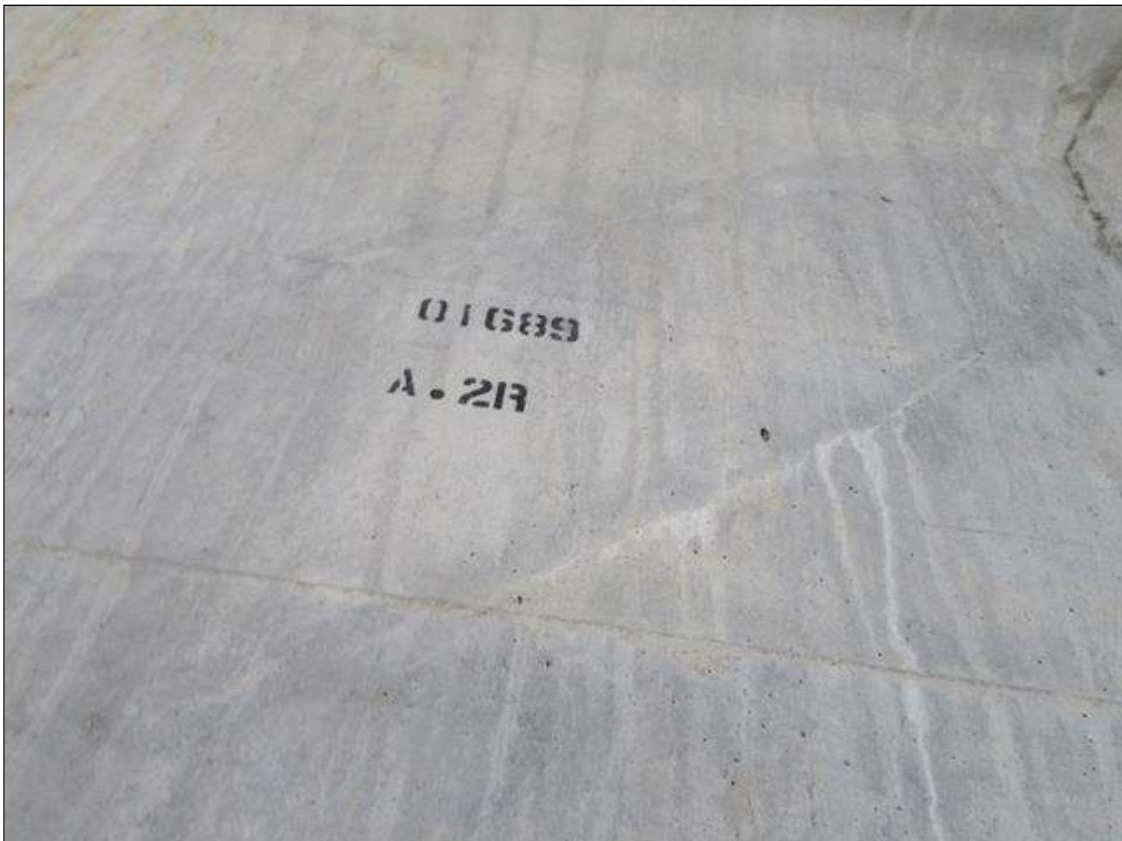
Span 1 Beam 2: 2 - 2' LONG X HAIRLINE DIAGONAL SHEER CRACKING IN WEB BAY 1 SIDE AT NEAR END

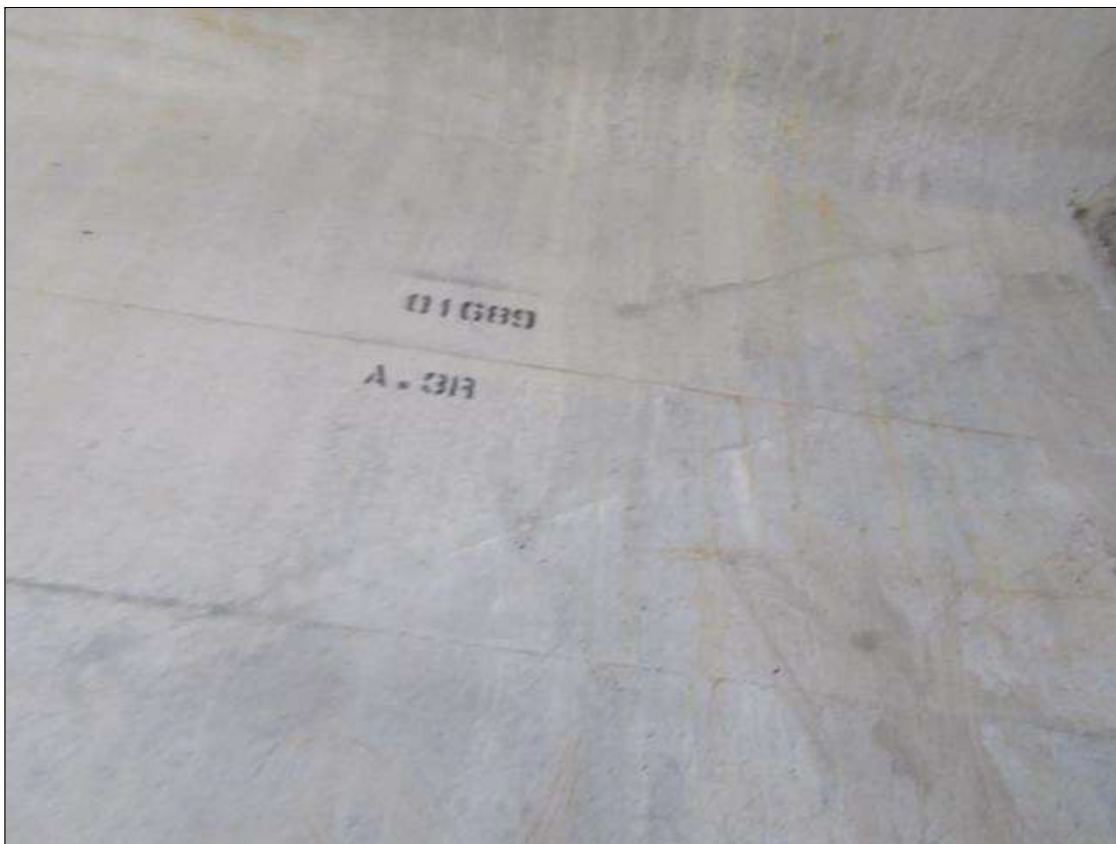
Span 1 Beam 3: 2 - 2' LONG X HAIRLINE DIAGONAL SHEER CRACKING IN WEB BAY 2 SIDE AT NEAR END

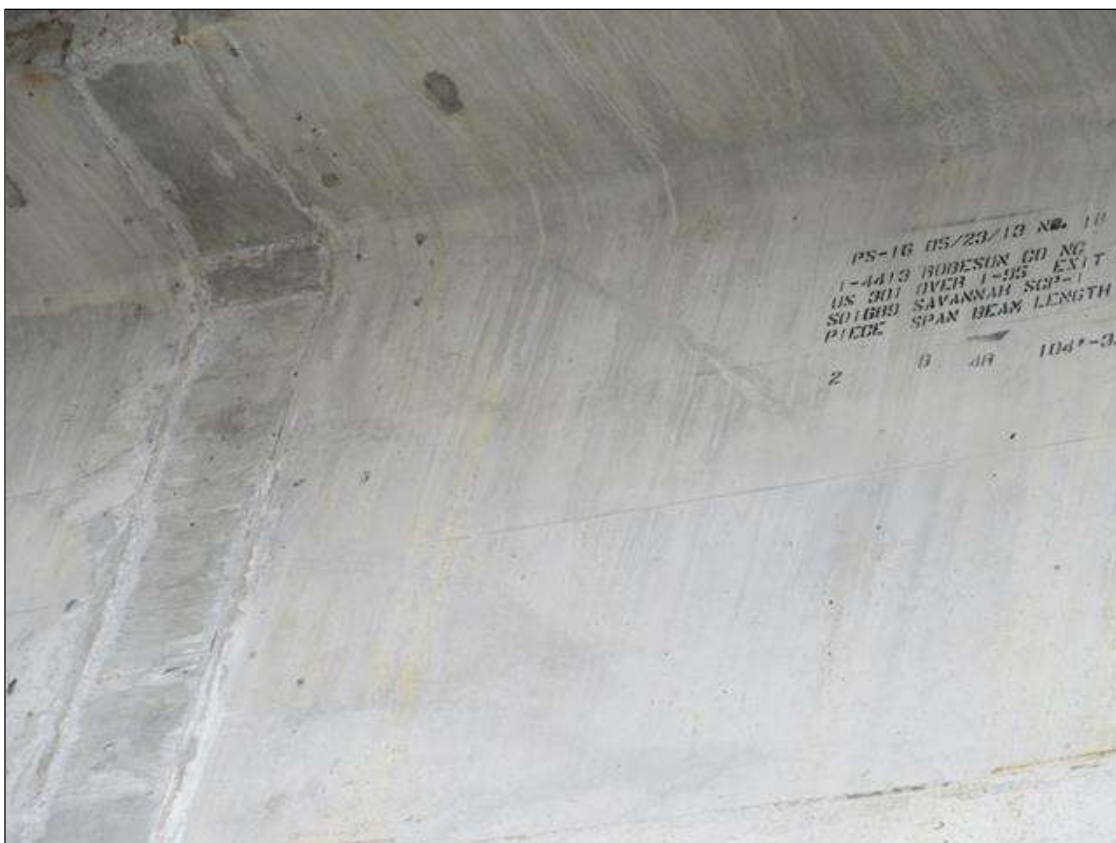
Span 2 Beam 4: 1- 2' LONG X HAIRLINE DIAGONAL SHEER CRACKING IN WEB AT RIGHT SIDE AT NEAR END.

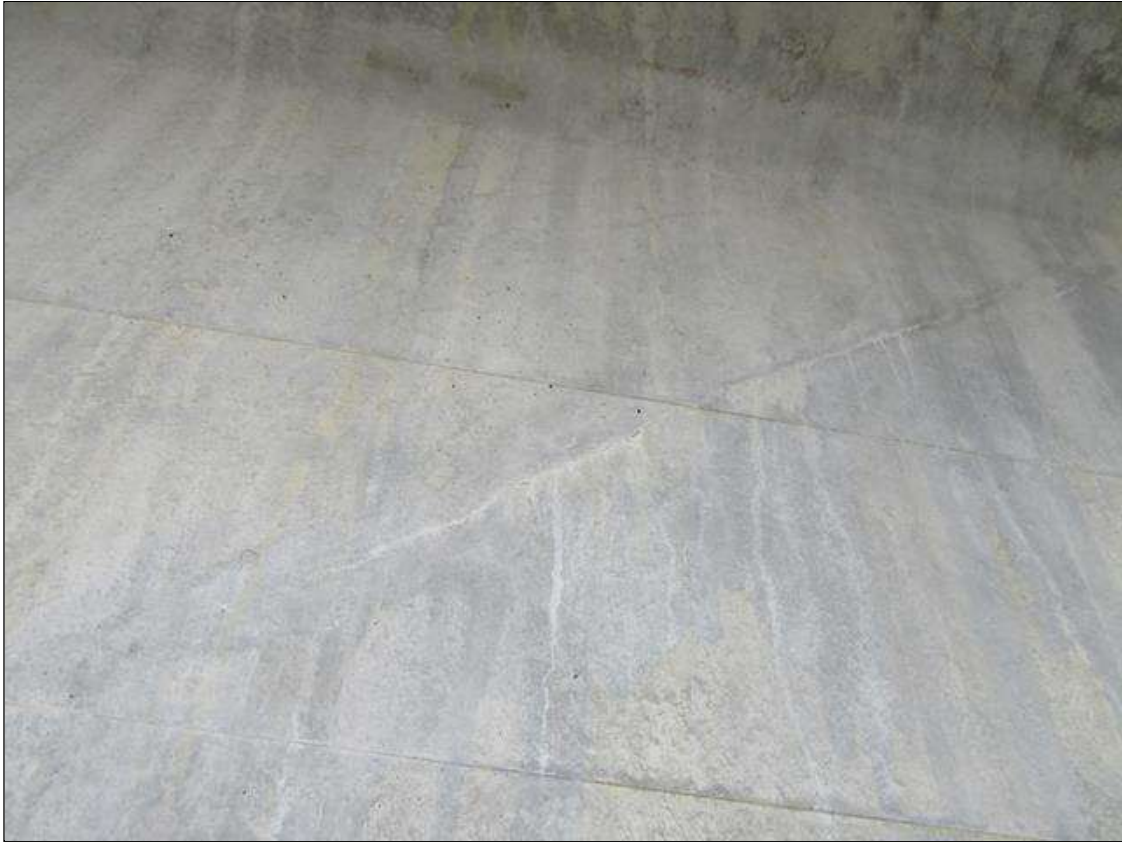
Span 2 Beam 4: 1 - 2 ' LONG X HAIRLINE DIAGONAL SHEER CRACKING IN WEB RIGHT SIDE AT FAR END

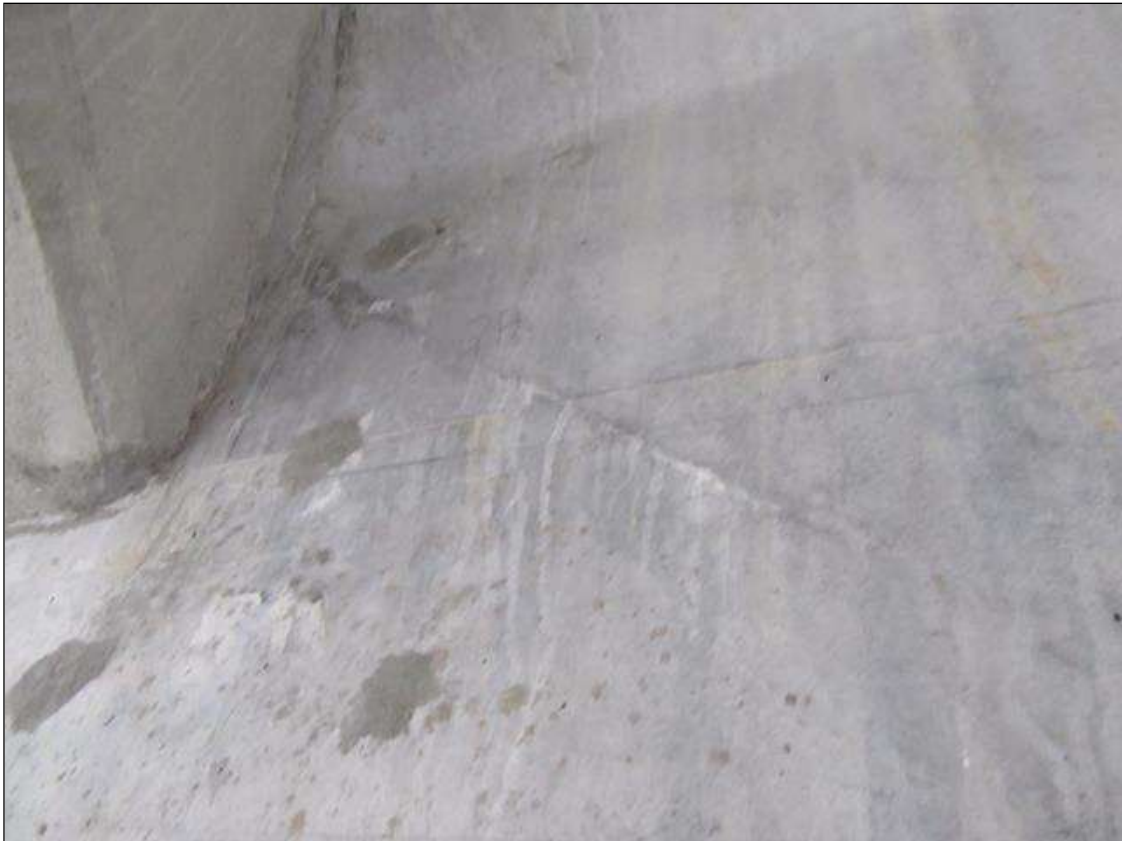
Span 2 Beam 4: 1 - 2 ' LONG X HAIRLINE DIAGONAL SHEER CRACKING IN WEB BAY 3 SIDE AT FAR END

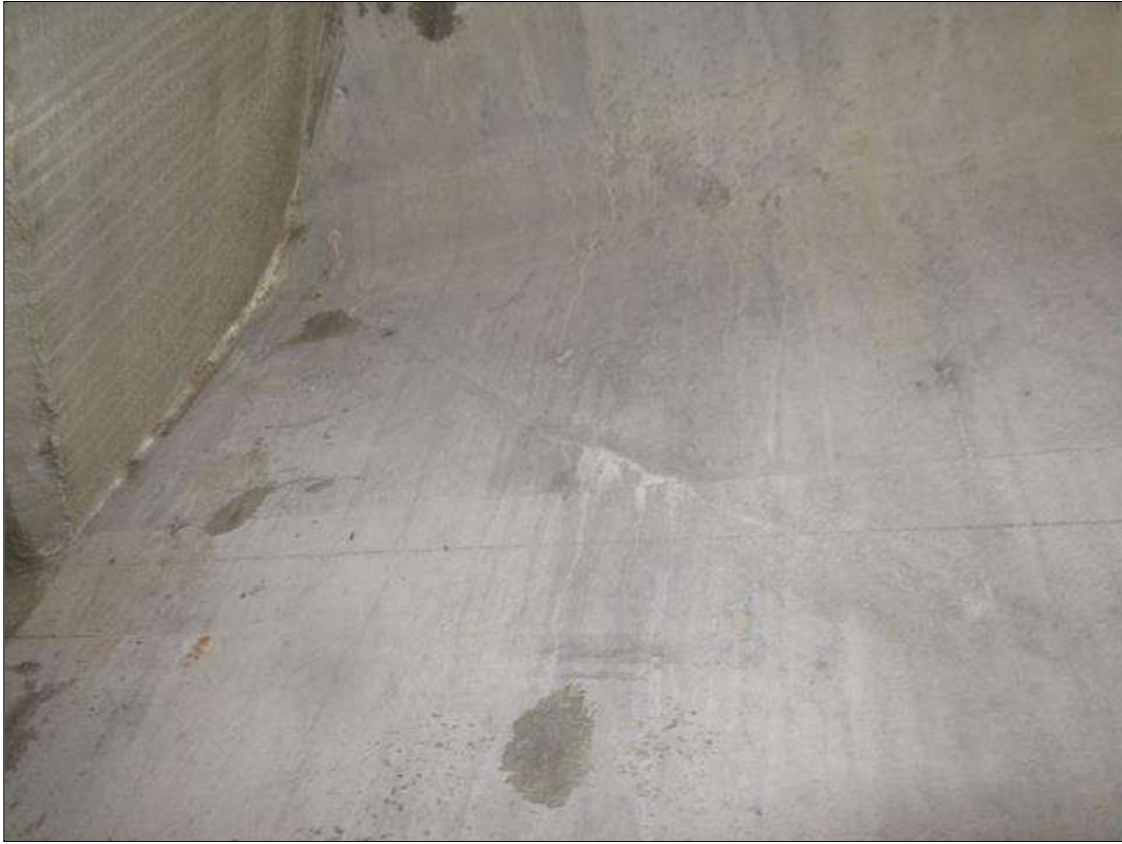
Span 2 Beam 3: 1- 2 ' LONG X HAIRLINE DIAGONAL SHEER CRACKING IN WEB BAY 2 SIDE AT FAR END

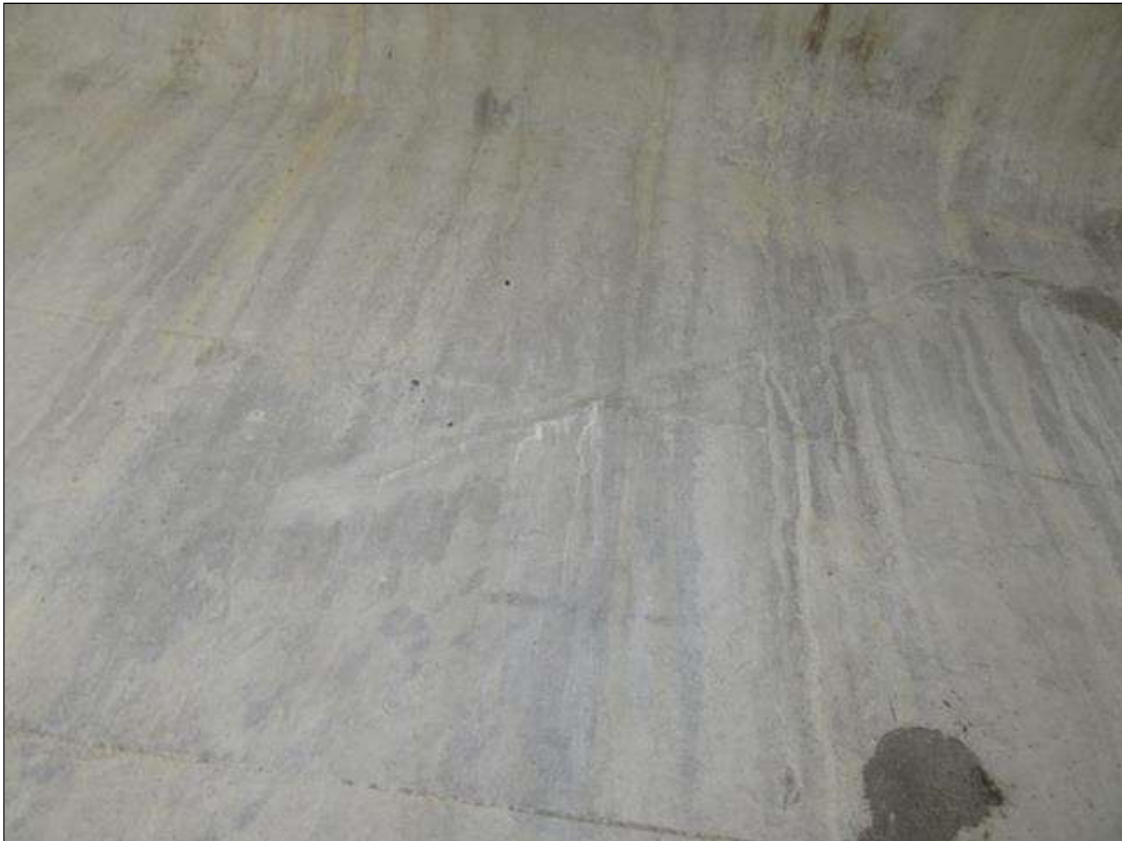
Span 2 Beam 2: 1- 2 ' LONG X HAIRLINE DIAGONAL SHEER CRACKING IN WEB BAY 2 SIDE AT FAR END

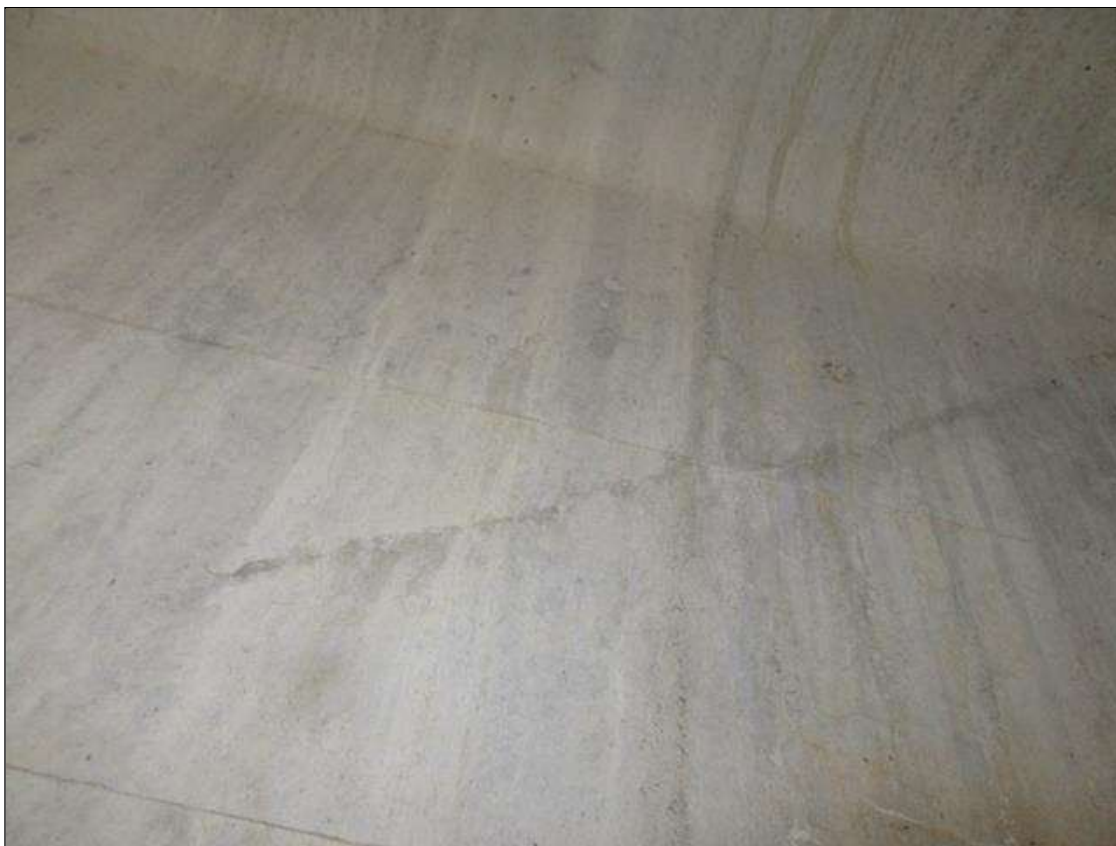
Span 2 Beam 1: 1- 2 ' LONG X HAIRLINE DIAGONAL SHEER CRACKING IN WEB BAY 1 SIDE AT FAR END

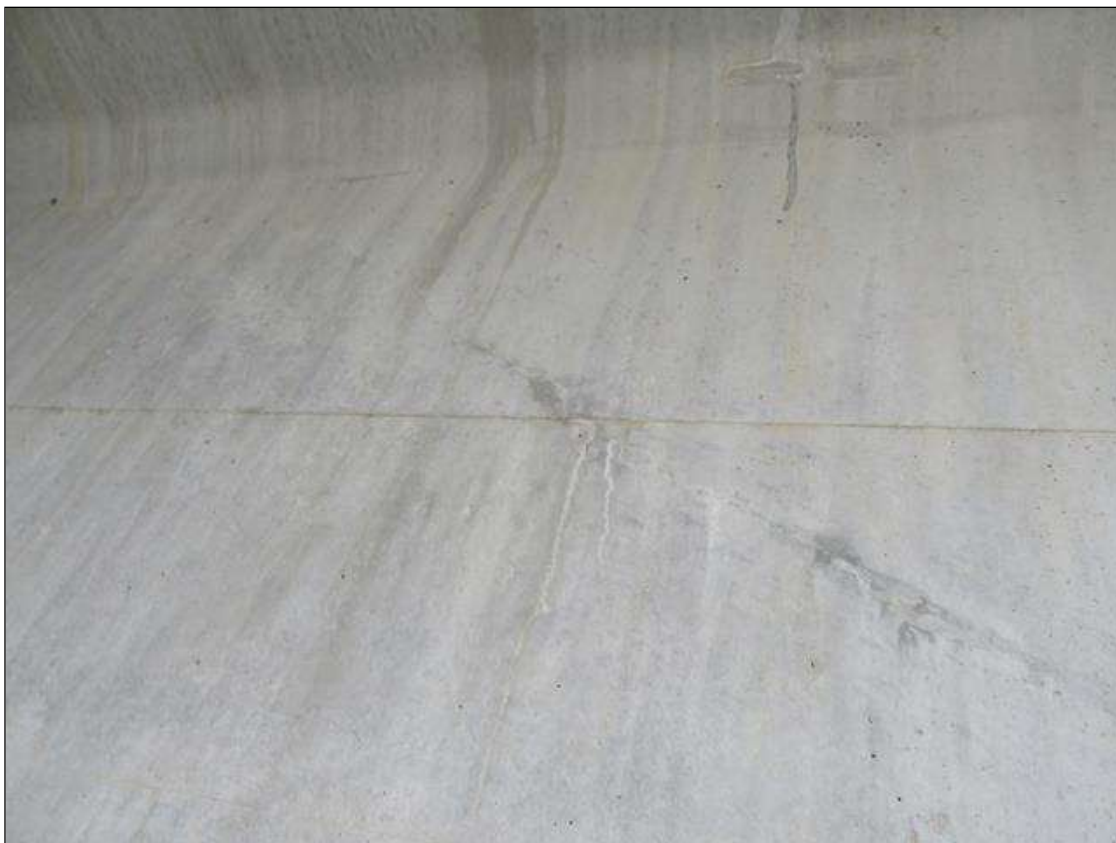
Span 2 Beam 1: 1- 2 ' LONG X HAIRLINE DIAGONAL SHEER CRACKING IN WEB LEFT SIDE AT FAR END

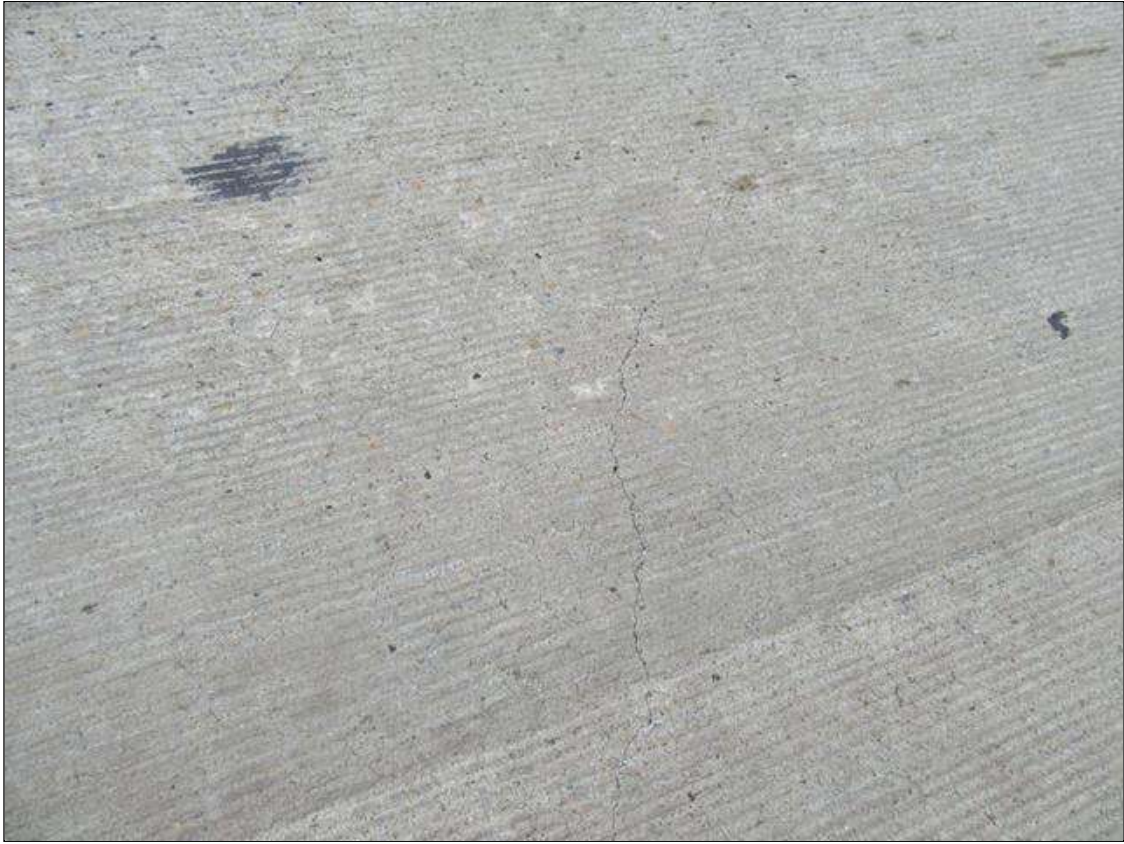
Approach 2: HAIRLINE LONGITUDINAL AND MAPCRACKING

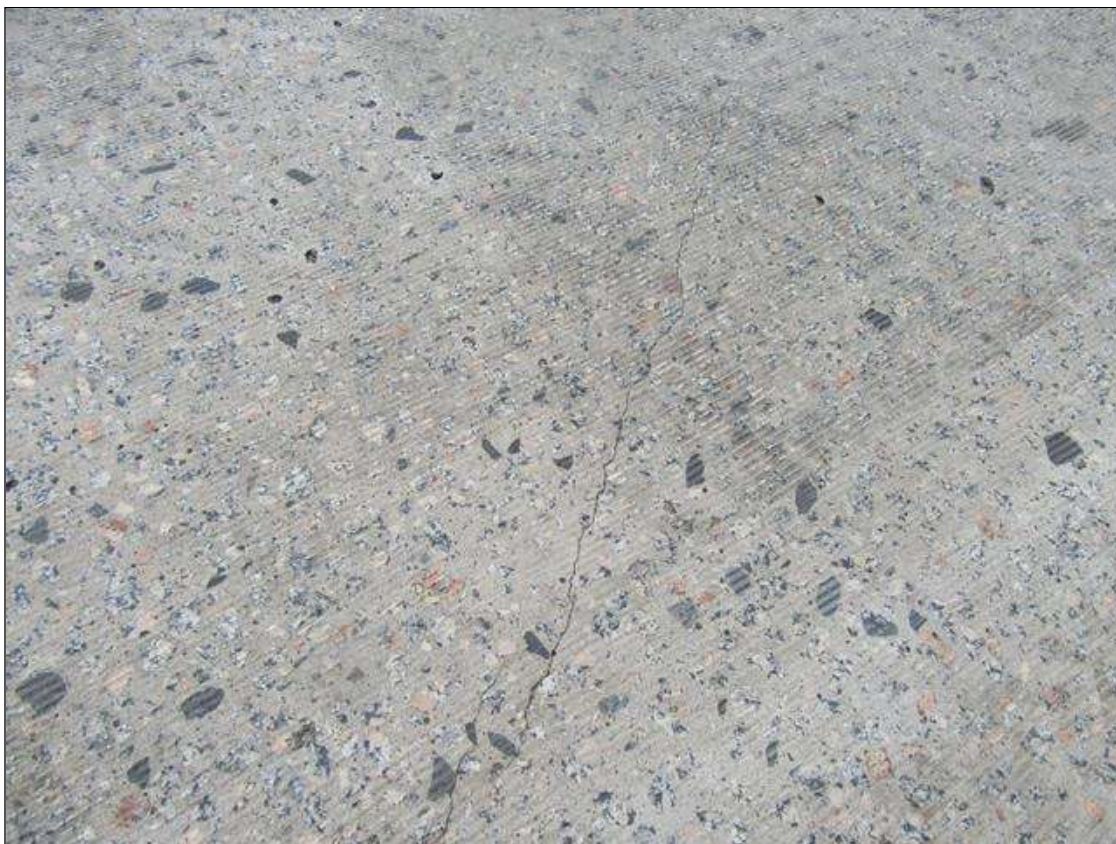
Span 2 Deck: HAIRLINE LONGITUDINAL CRACKING AT END BENT 2 END

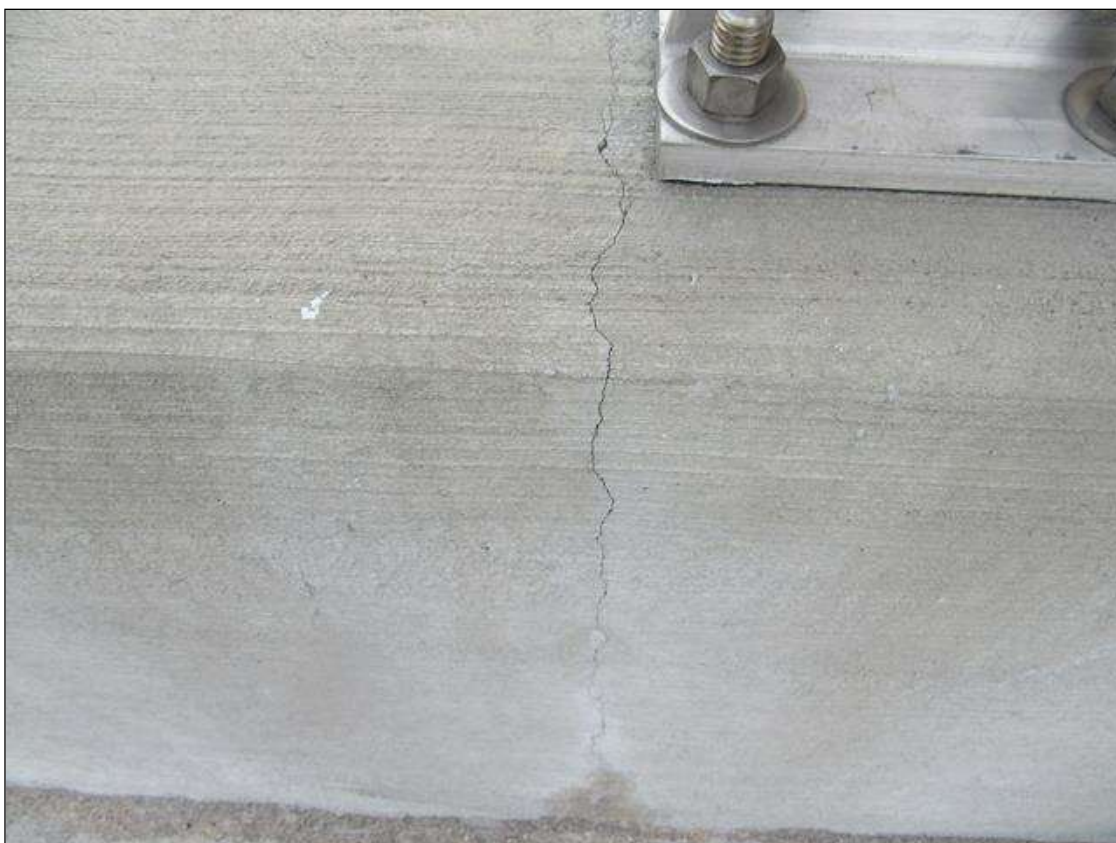
Span 2 Left Bridge Rail: HAIRLINE TRANSVERSE AND VERTICAL CRACKS AT 8- 10 FT. SPACING

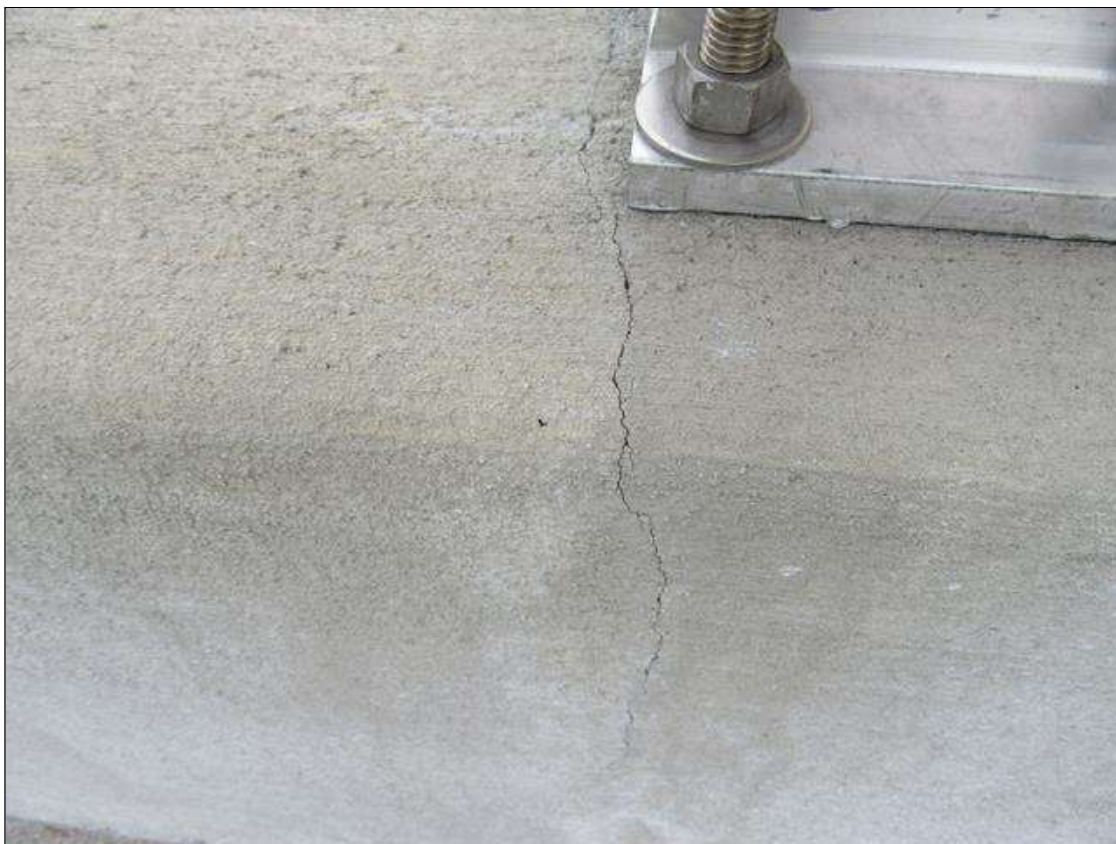
Span 1 Left Bridge Rail: HAIRLINE TRANSVERSE AND VERTICAL CRACKS AT 8- 10 FT. SPACING

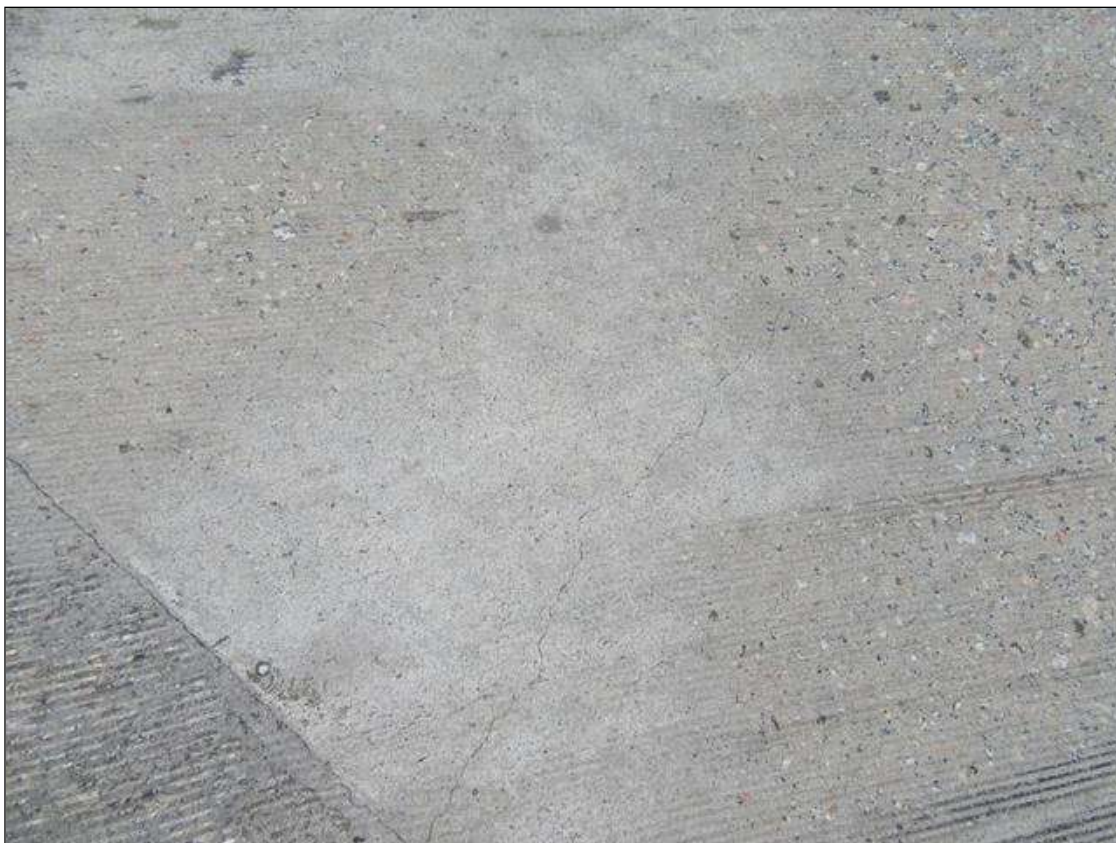
Span 1 Deck: HAIRLINE LONGITUDINAL CRACKING AT END BENT 1 END

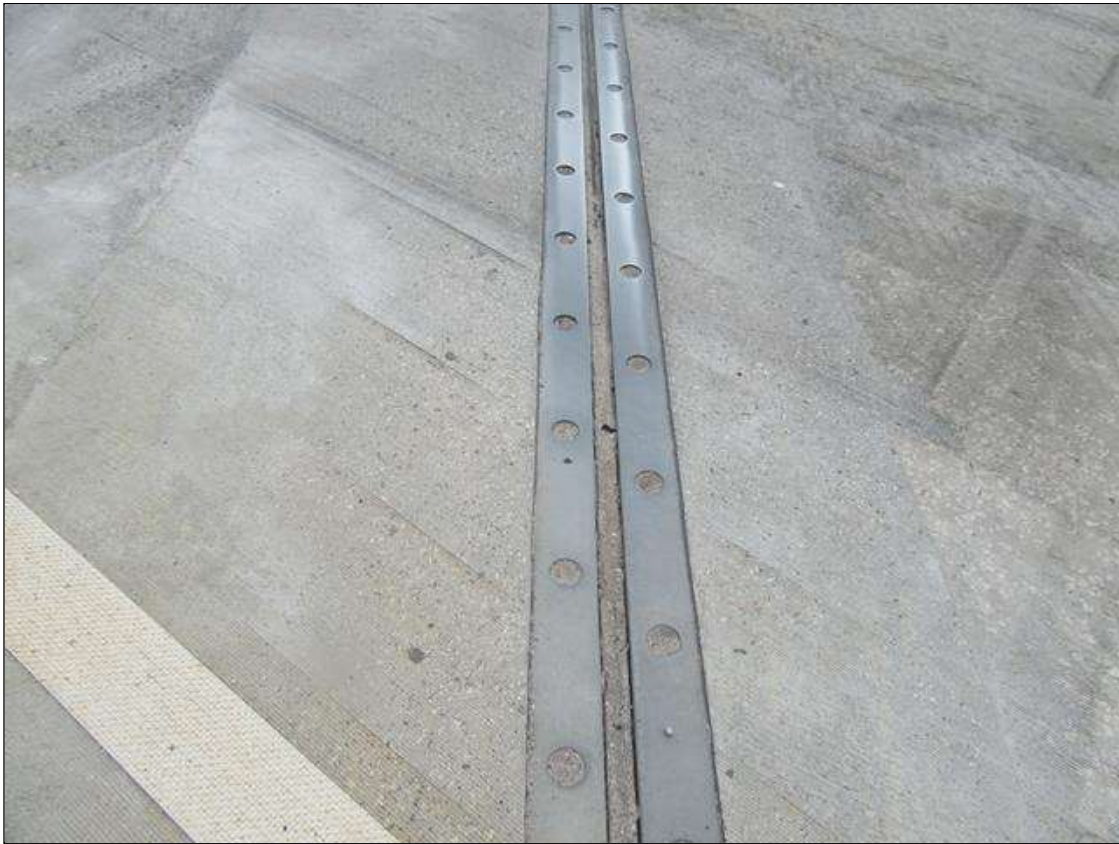
Expansion Joint : DEBRIS IN JOINT

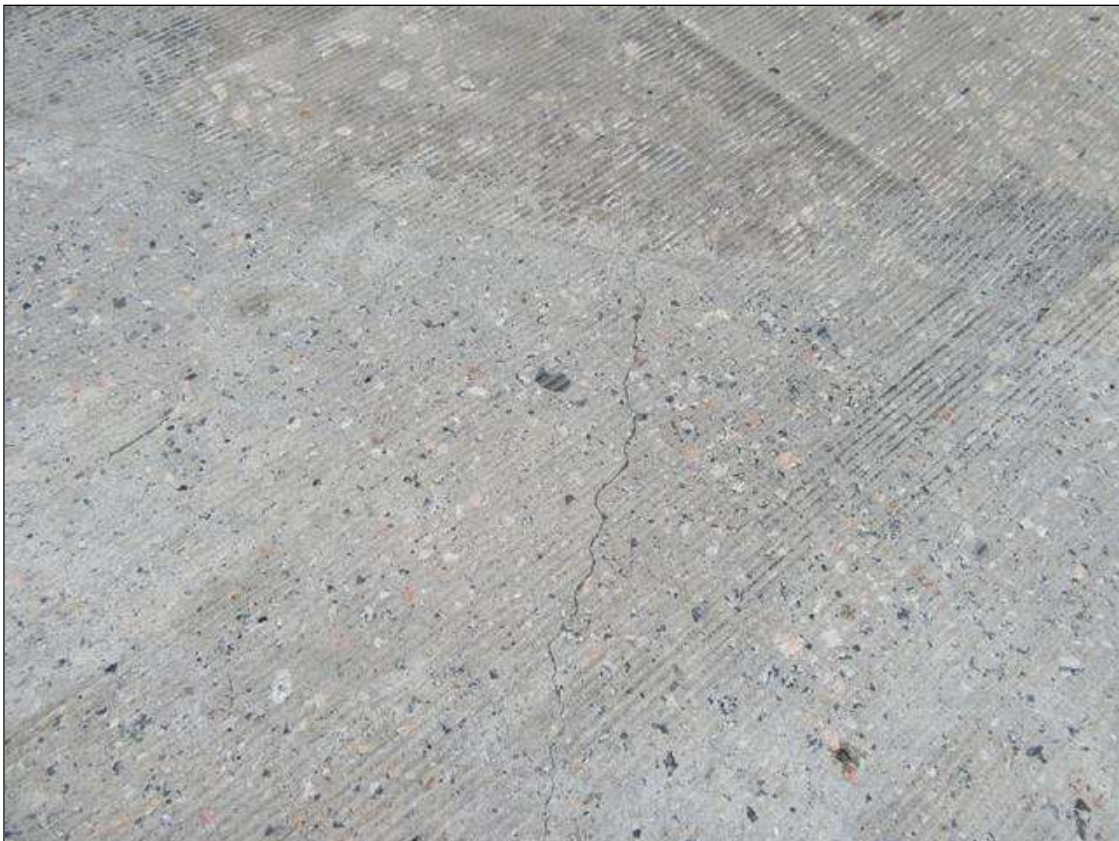
Approach 1: HAIRLINE LONGITUDINAL AND MAP CRACKING

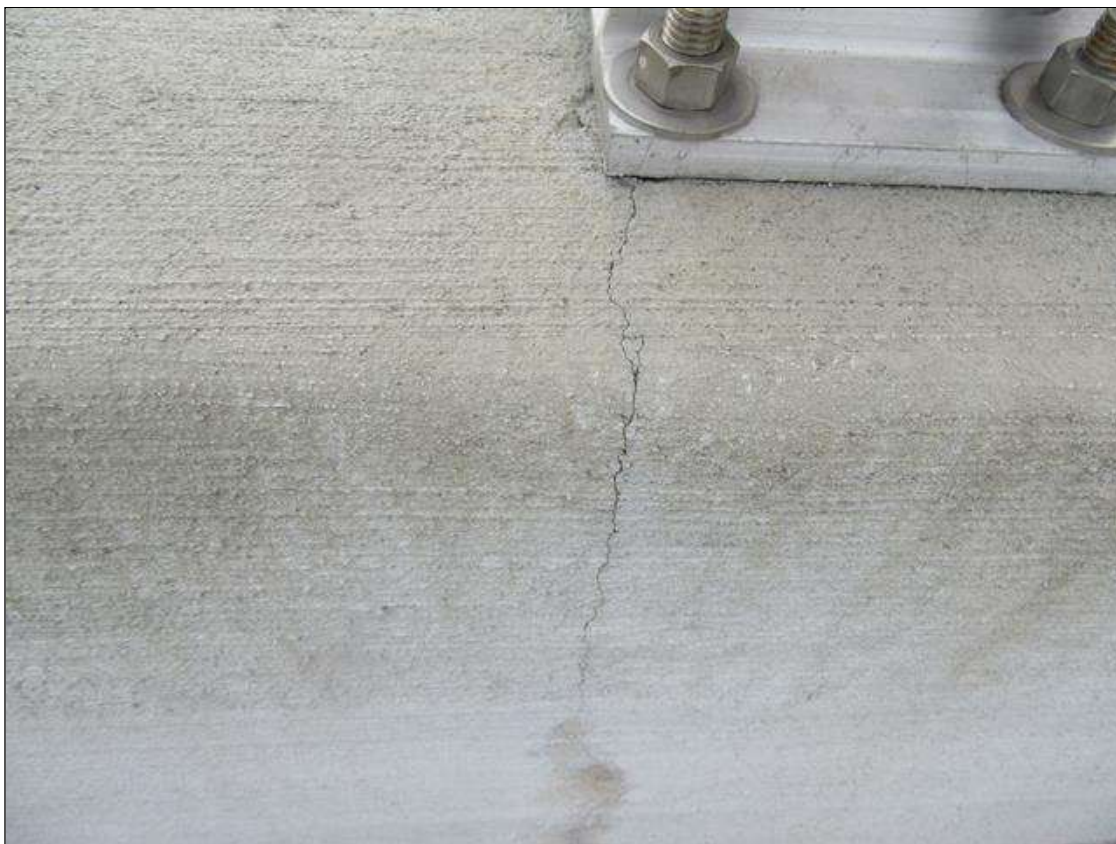
Span 1 Right Bridge Rail: HAIRLINE TRANSVERSE AND VERTICAL CRACK AT MID SPAN

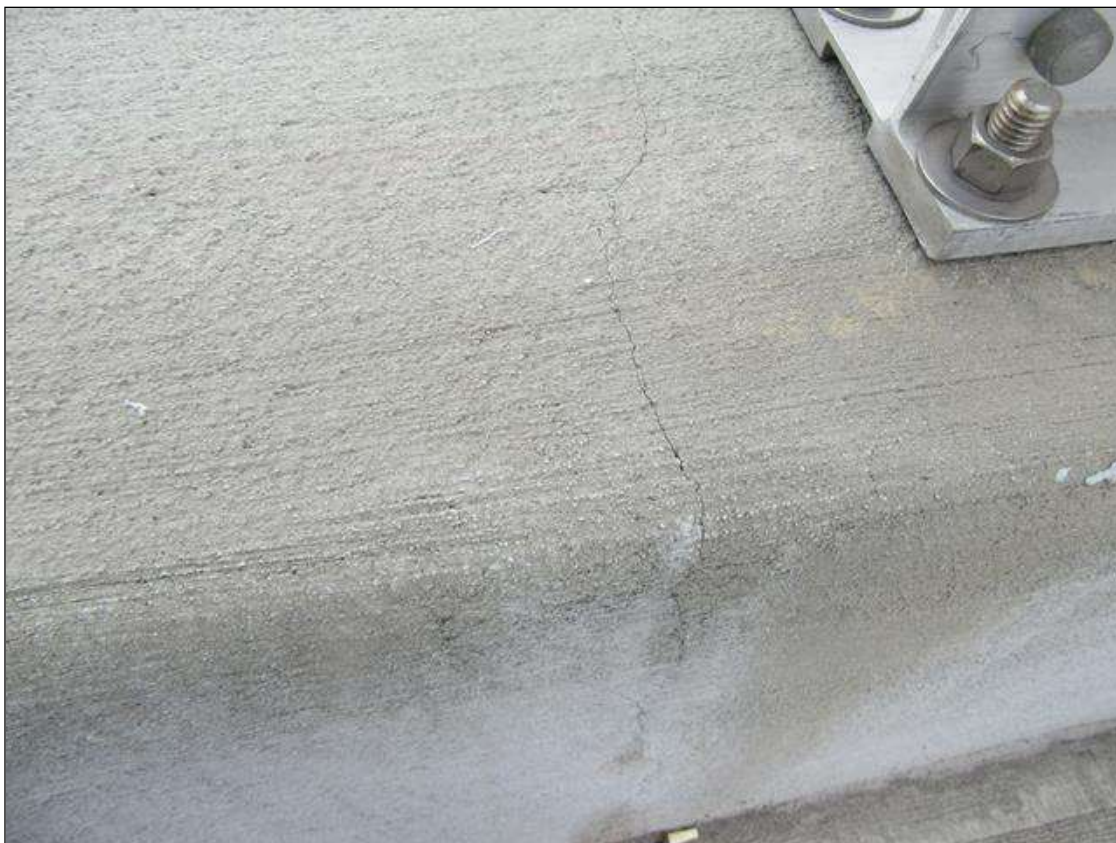
Span 2 Right Bridge Rail: HAIRLINE TRANSVERSE AND VERTICAL CRACKS AT 8- 10 FT. SPACING

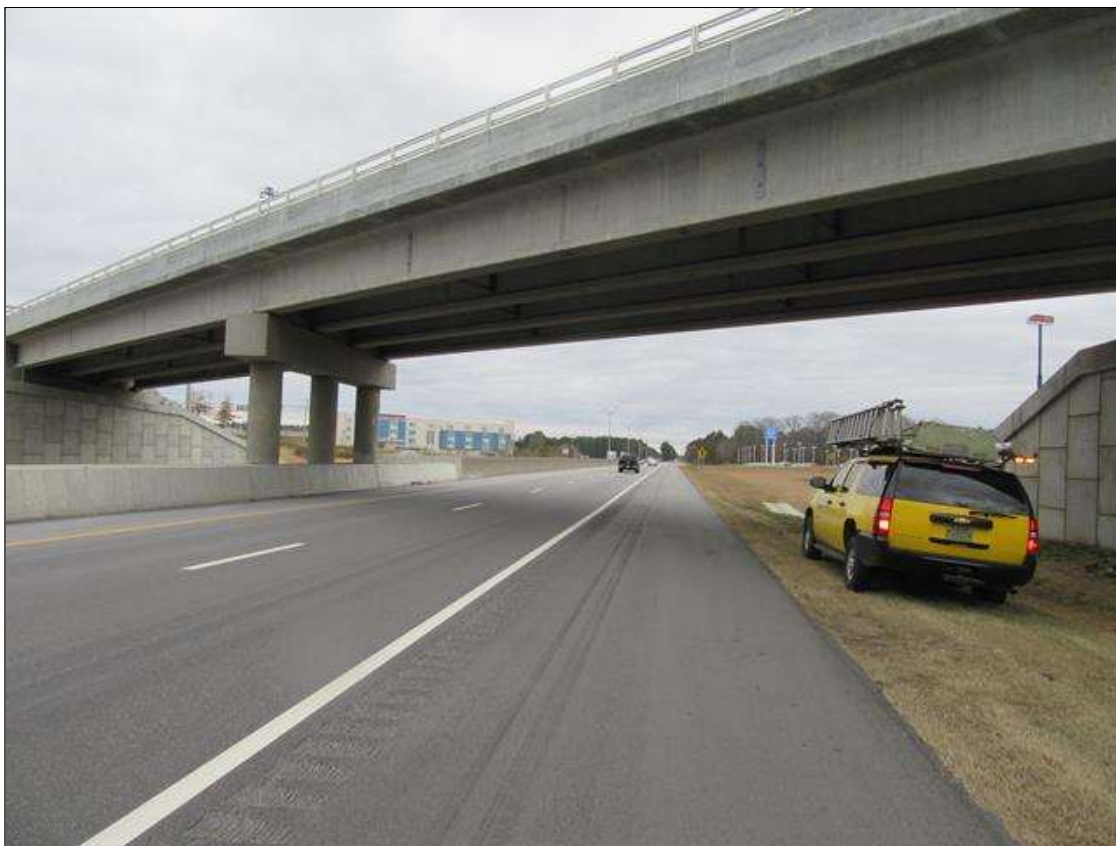
LOOKING EAST, NORTHBOUND LANE I 95 THRU SPAN 1

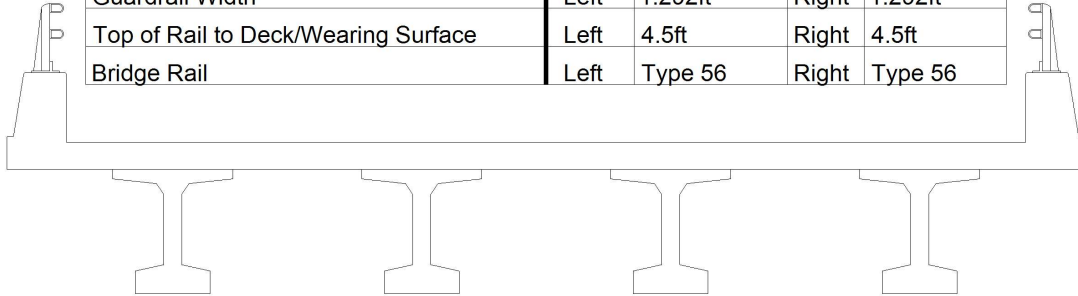
Measurements for Span #	1	SPAN 2 SIMILAR	
Deck Thickness	0.917	Left Overhang	4.042
Top of Rail to Bottom of Beam	10.25	Right Overhang	4.042

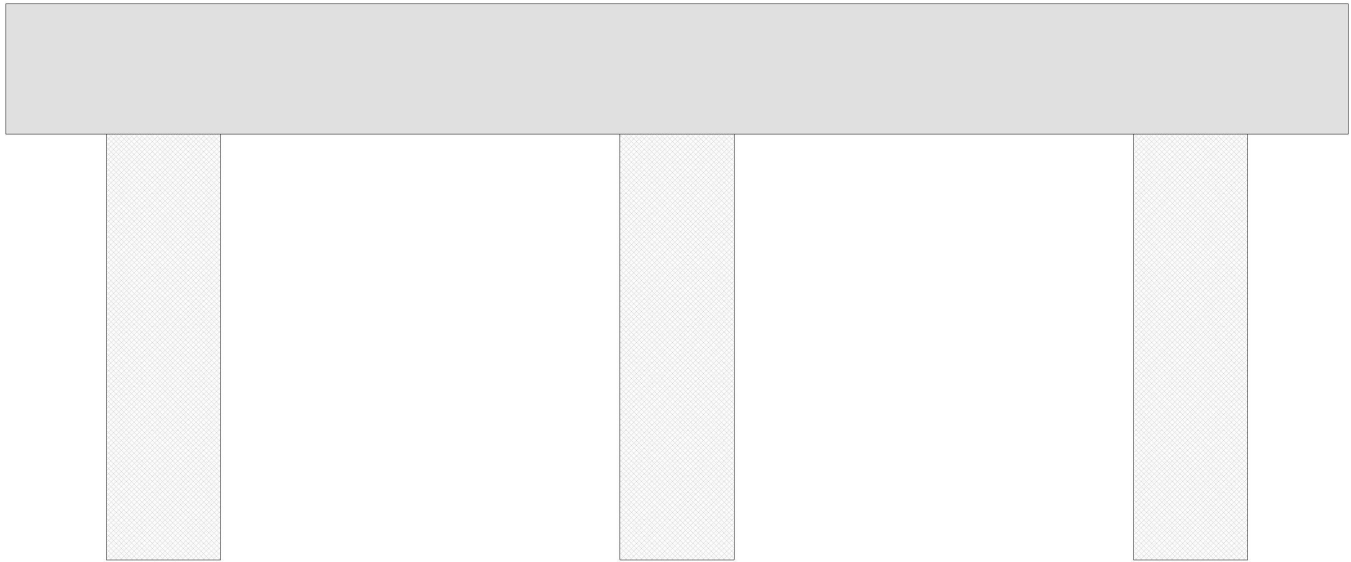
Cap Information			Material Cast-in-Place Concrete							
Length	Width	Height	Left Overhang	Right Overhang	Left Beam to End of Cap.	Right Beam to End of Cap.				
41.167 ft.	4.667 ft.	4.000 ft.	4.833 ft.	4.833 ft.	2.786 ft.	2.786 ft.				
Subcap Information			Material							
Length	Width	Height	Left Overhang	Right Overhang	Left Pile to Splice.					
Sill Information			Material							
Length	Width	Height								
Pile #	Material	Spacing	Width/Dia.	Height	Length	Orientation	Driven?	Replacement?	Removed?	Collar?
1	Concrete	15.75 ft.	3.5 ft.			Vertical	No	No	No	No
2	Concrete	15.75 ft.	3.5 ft.			Vertical	No	No	No	No
3	Concrete		3.5 ft.			Vertical	No	No	No	No
MEASUREMENTS VERIFIED BY DLK 1/3/18										
Bent/Abutment #: 1			Similar Bents:
