NC DEPARTMENT OF TRANSPORTATION      ATTENTION:  
 DIVISION OF HIGHWAYS  
 STRUCTURE MANAGEMENT UNIT

# Structure Safety Report

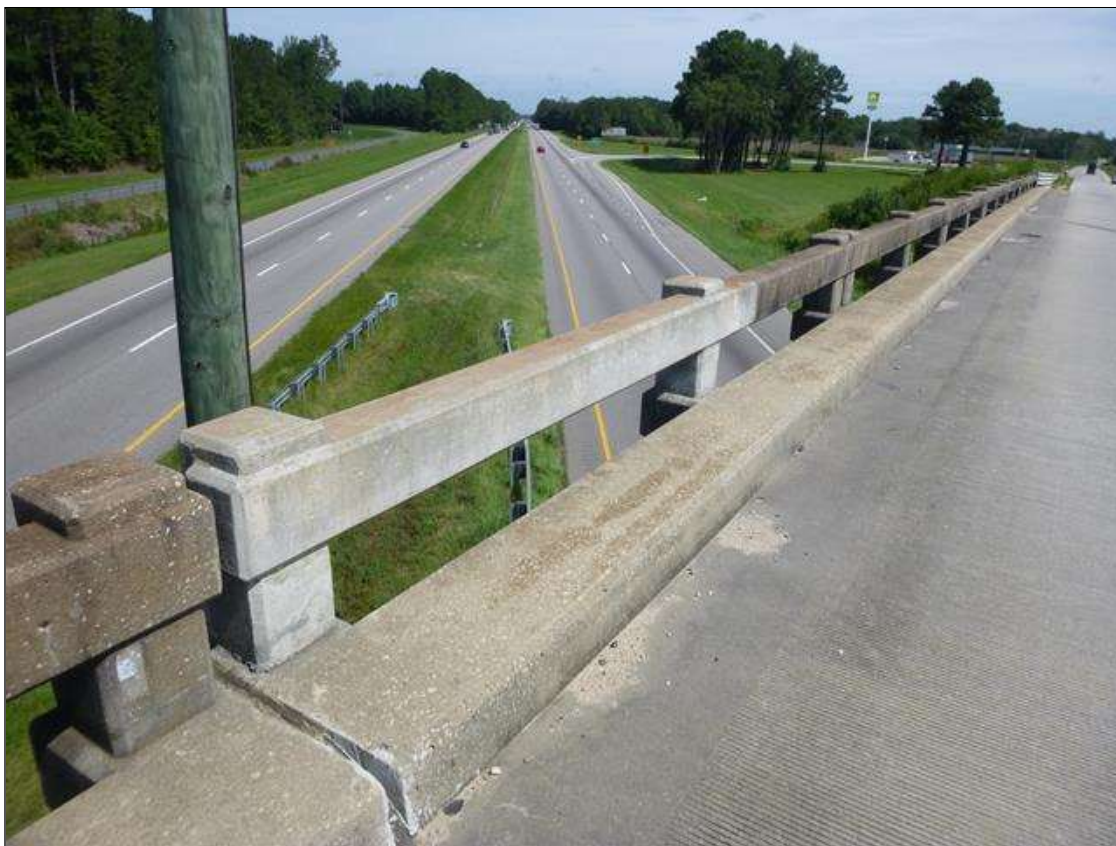
Span 4 Left Bridge Rail: 11' REPAIR TO RAIL BEGINNING AT BENT 3.

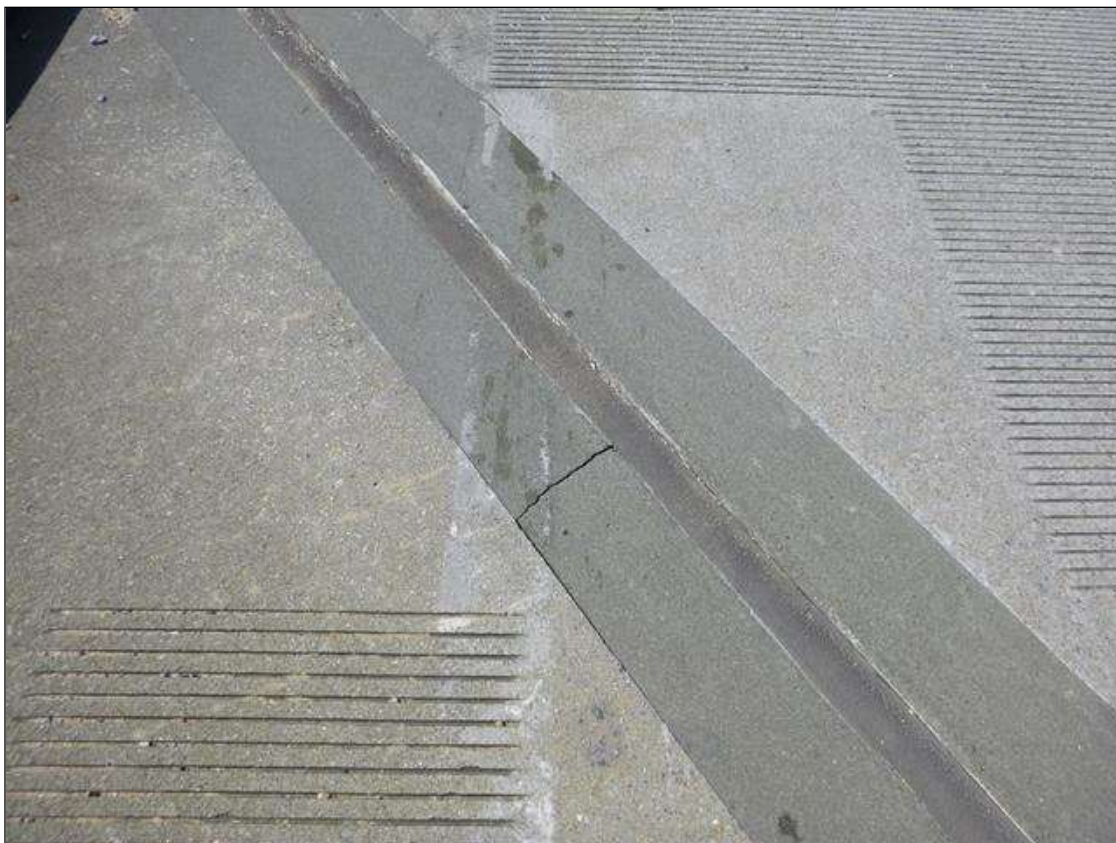
Expansion Joint, Bent 4 : EASTBOUND LANE, TRANSVERSE CRACKING IN THE ADJACENT DECK HEADER UP TO 1/32".

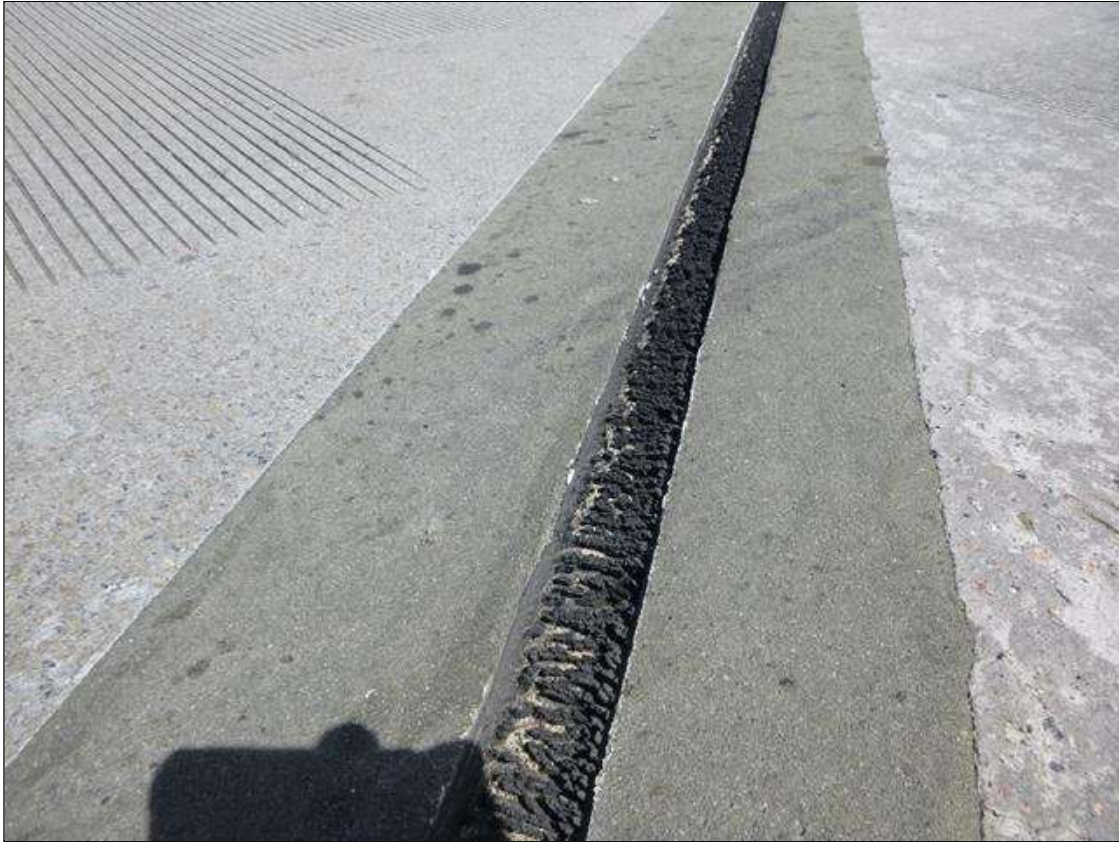
Expansion Joint, End Bent 2 : TOP OF THE SEAL, DEGRADATION AND SURFACE CRACKING ALONG THE LENGTH

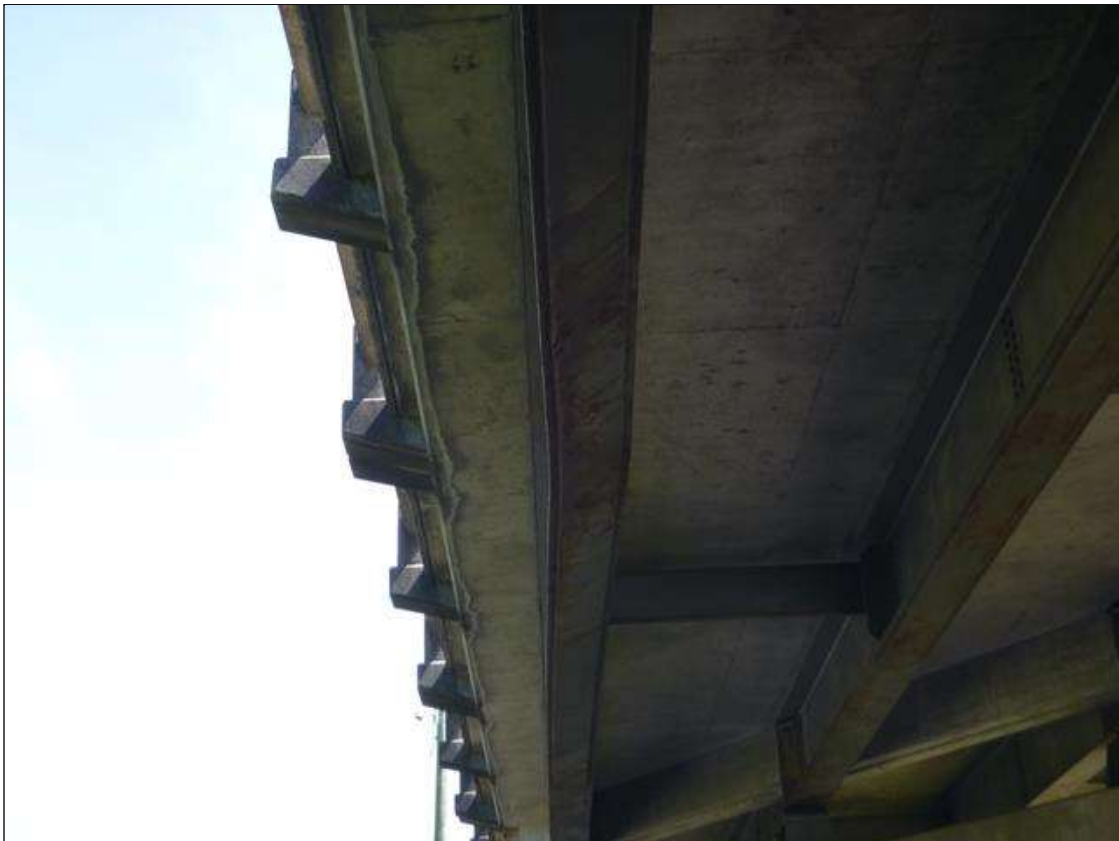
Span 2 Beam 1: 15 Feet of Damage: Bottom flange is bent 2" south over I-95 southbound lane.

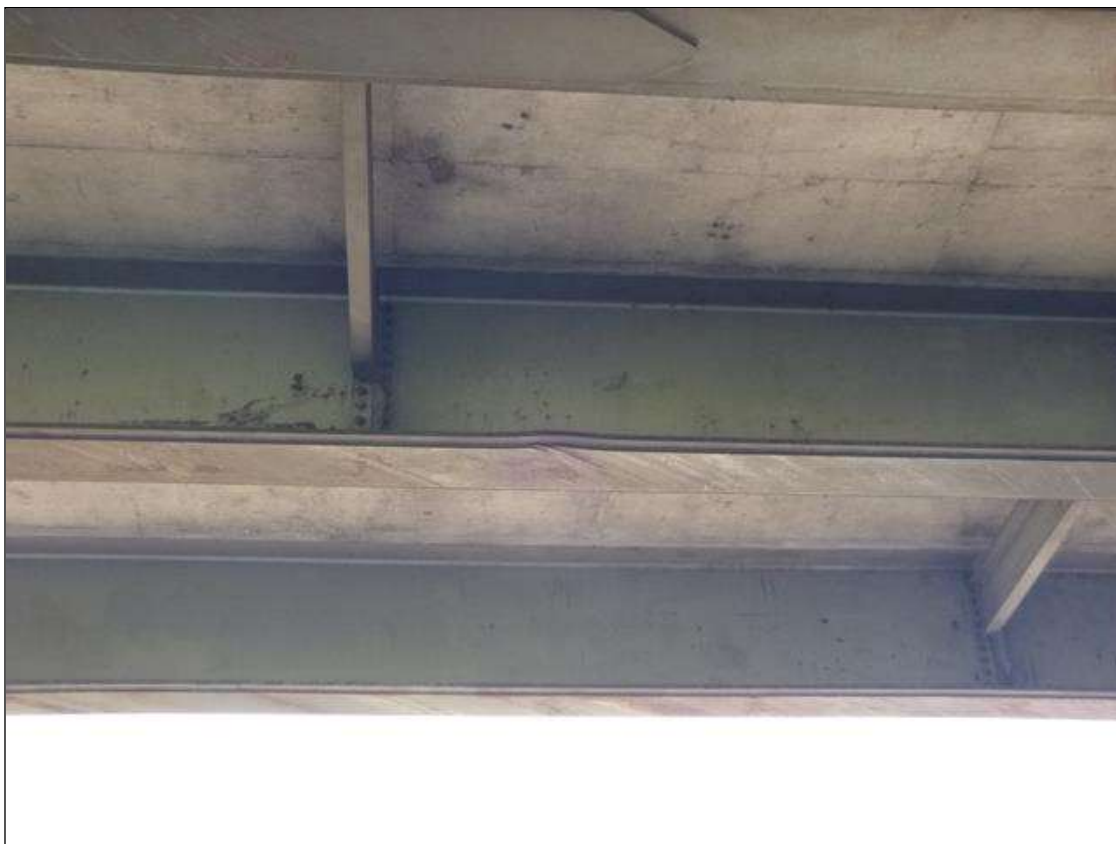
Span 2 Beam 3: (2) 2" GOUGES UP TO 1/2" DEEP, BOTTOM OF COVER PLATE, CAUSING UPWARD DEFLECTION OF BOTTOM FLANGE UP TO 1", 2' WEST OF FIRST INTERMEDIATE DIAPHRAGM.

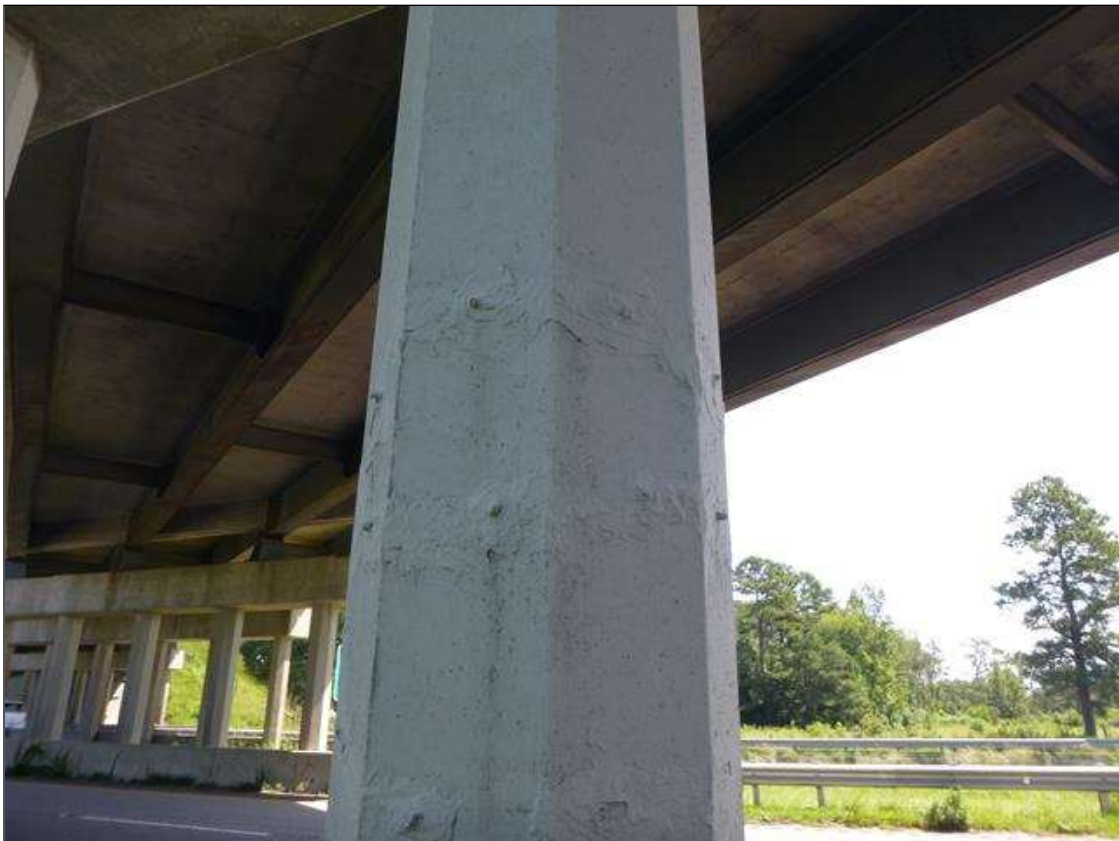
Bent 1 Pile 2: EPOXY SEALED CRACKS THROUGHOUT AT MID HEIGHT.

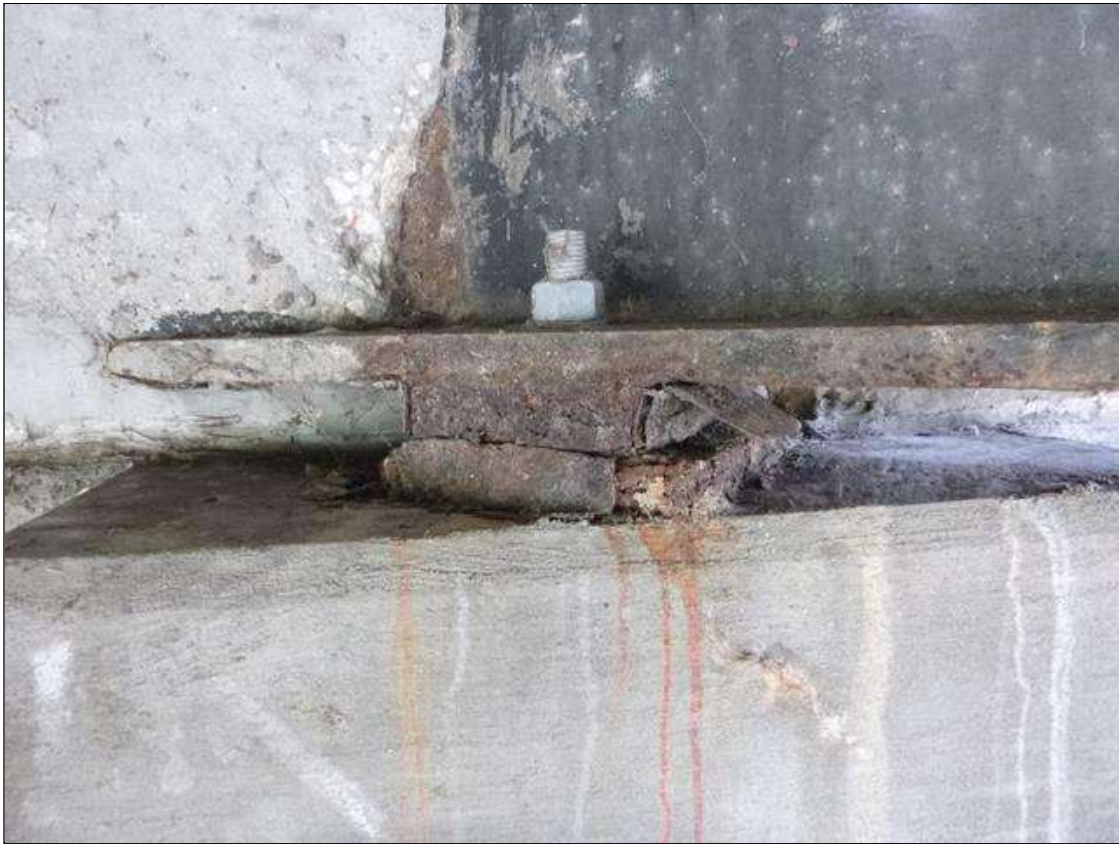
Span 1 Beam 1 Near Bearing: BEARING ASSEMBLY HAS RUST SCALE, BEAM 1.

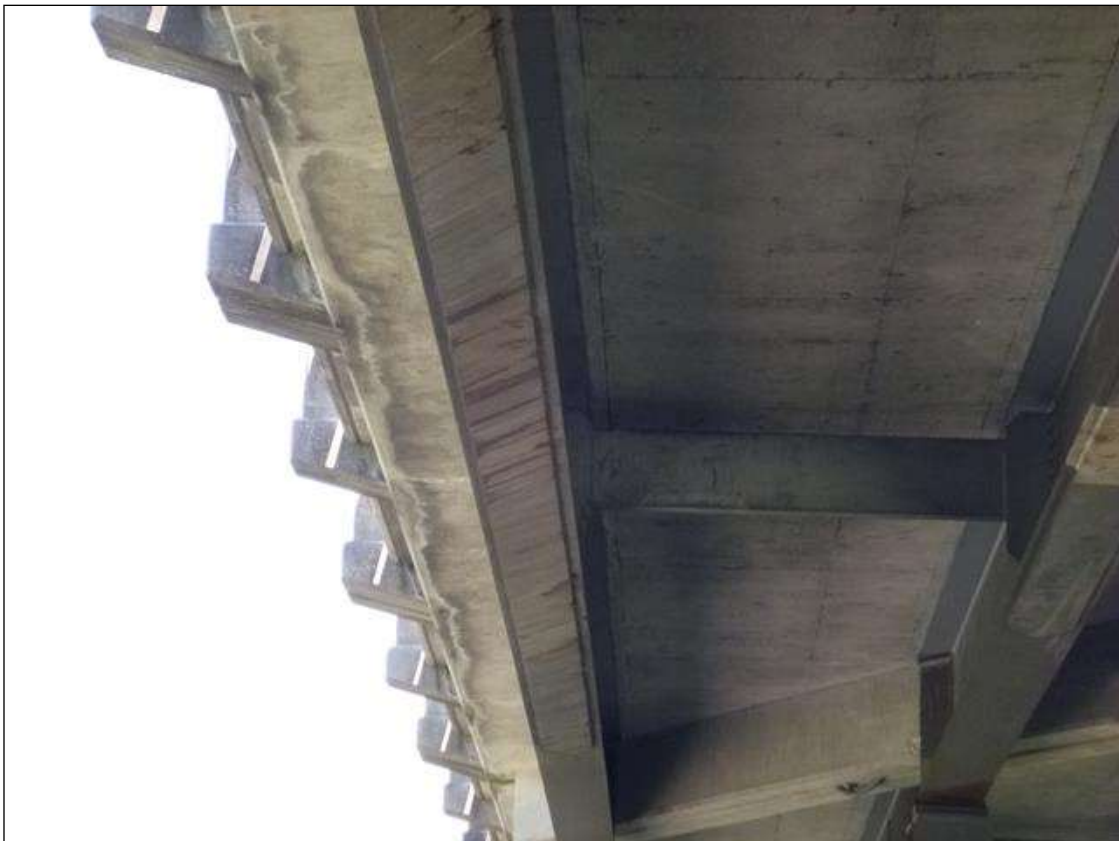
Span 4 Beam 1: 20' OF SCRAPES ALONG UNDERSIDE OF BOTTOM FLANGE, AT MIDSPAN.

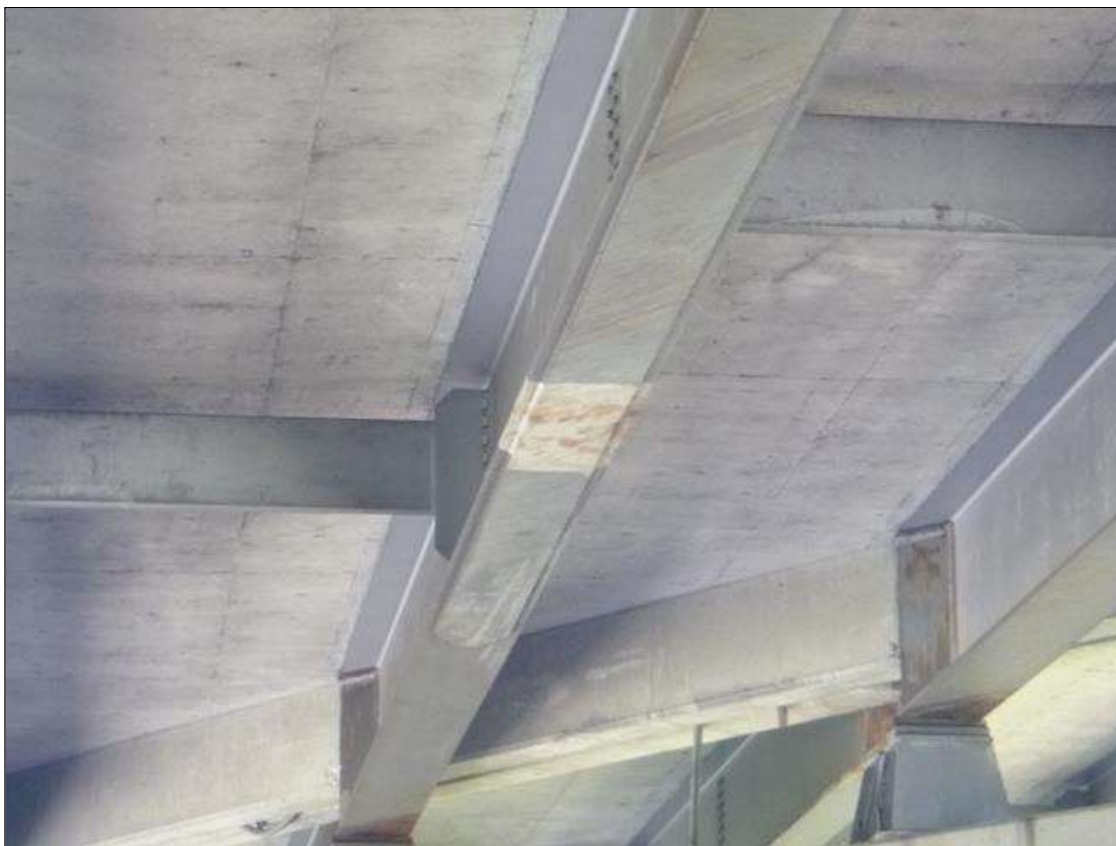
Span 4 Beam 2: NEAR MID SPAN, PAST IMPACT DAMAGE REPAIR

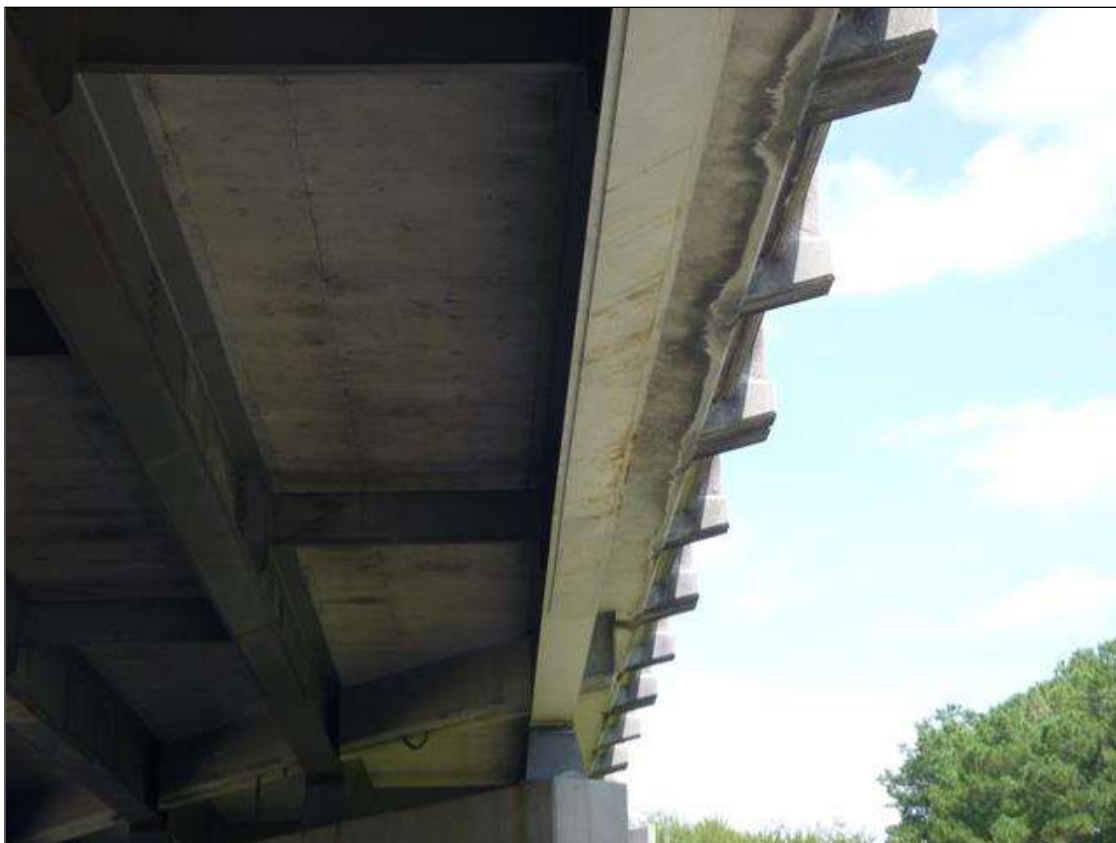
Span 4 Beam 4: 6' OF SCRAPES AND SHALLOW GOUGES ALONG UNDERSIDE OF BOTTOM FLANGE, NEAR MIDSPAN.

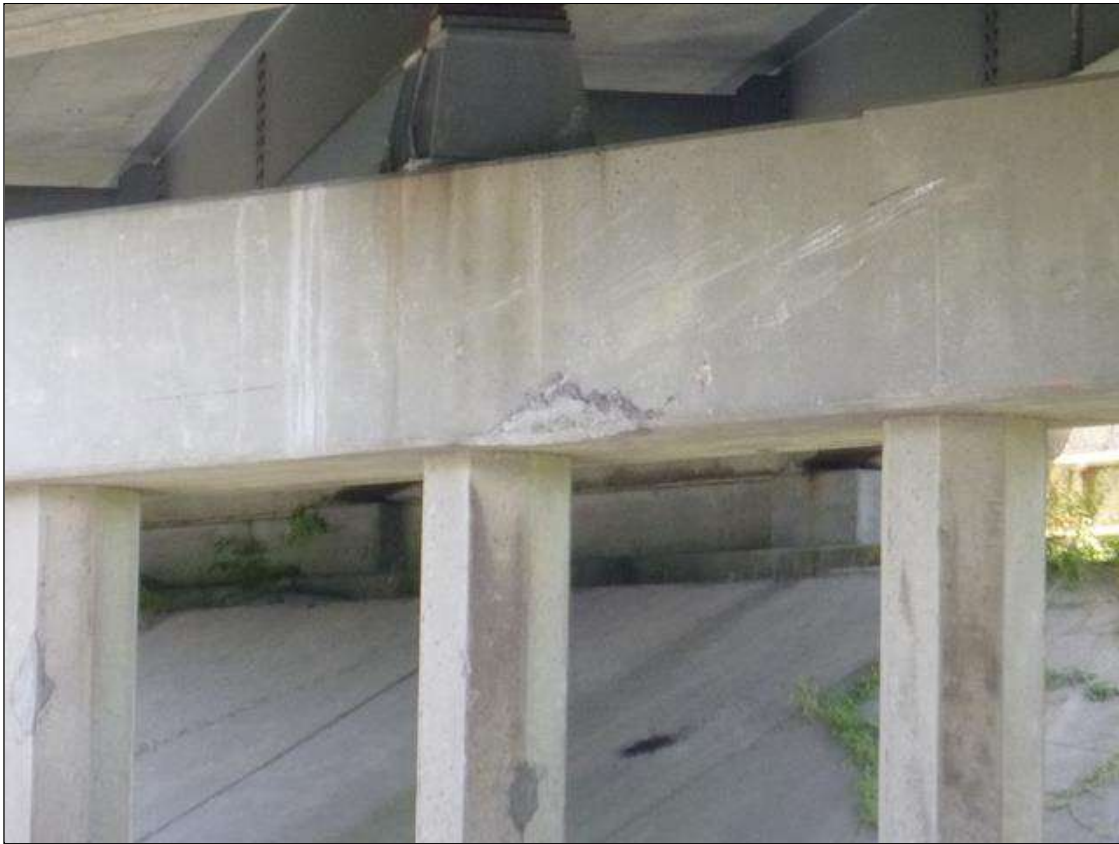
Bent 4 Cap 1: LOWER SIDE OF THE CAP BETWEEN PILES 3-4, WEST FACE, LOWER CORNER, APPROX 3SQFT UNSOUND PATCHING (HAIRLINE MAP CRACKED)

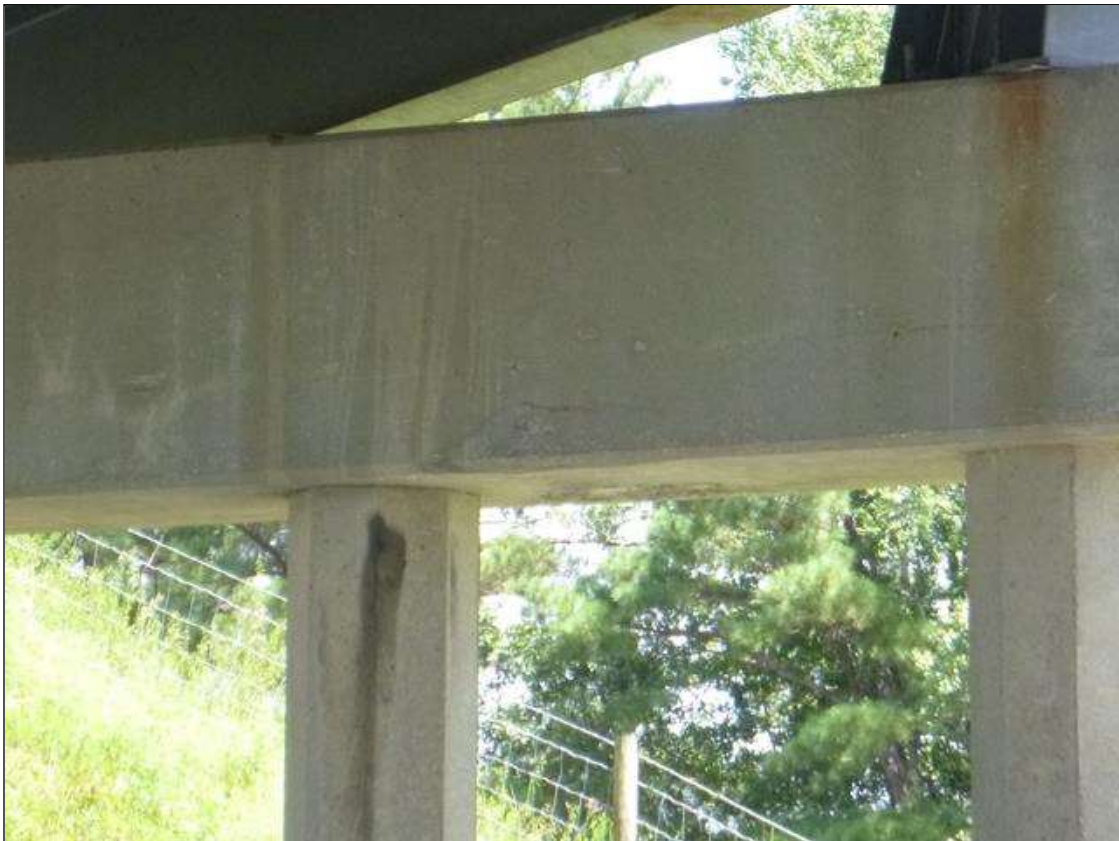
Bent 4 Cap 1: LOWER SIDE OF THE CAP BETWEEN PILES 3-4, EAST FACE, LOWER CORNER, LONGITUDINAL CRACKING UP TO 1/8"

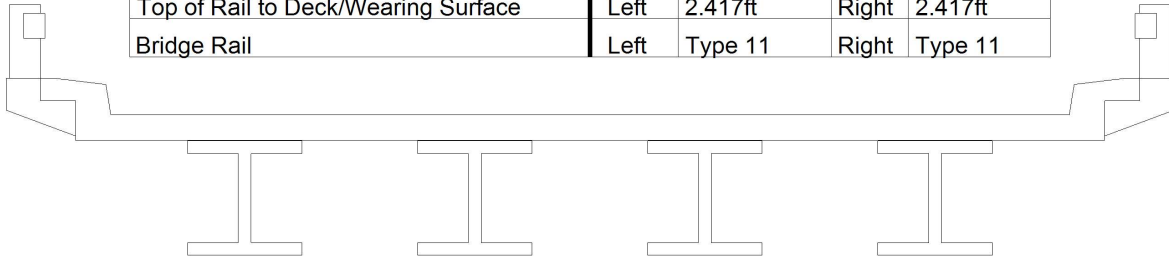
Measurements for Span #	1		
Deck Thickness	0.75	Left Overhang	4.67
Top of Rail to Bottom of Beam	6.25	Right Overhang	4.67

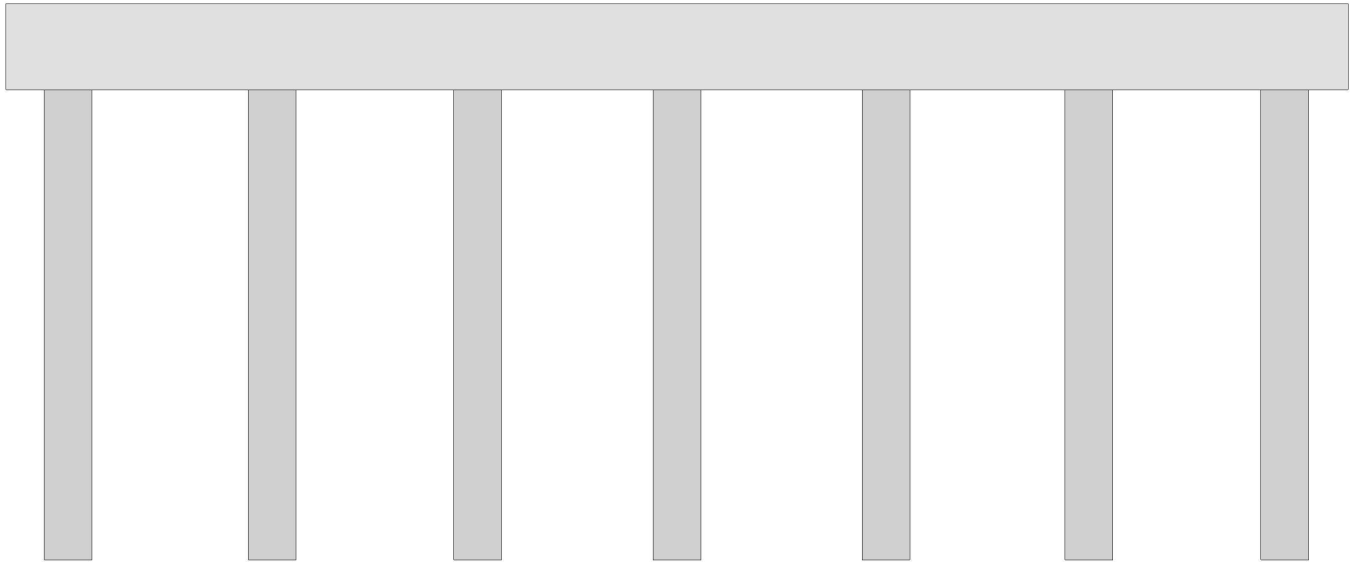
<b>Cap Information</b>			Material Cast-in-Place Concrete							
Length	Width	Height	Left Overhang	Right Overhang	Left Beam to End of Cap.	Right Beam to End of Cap.

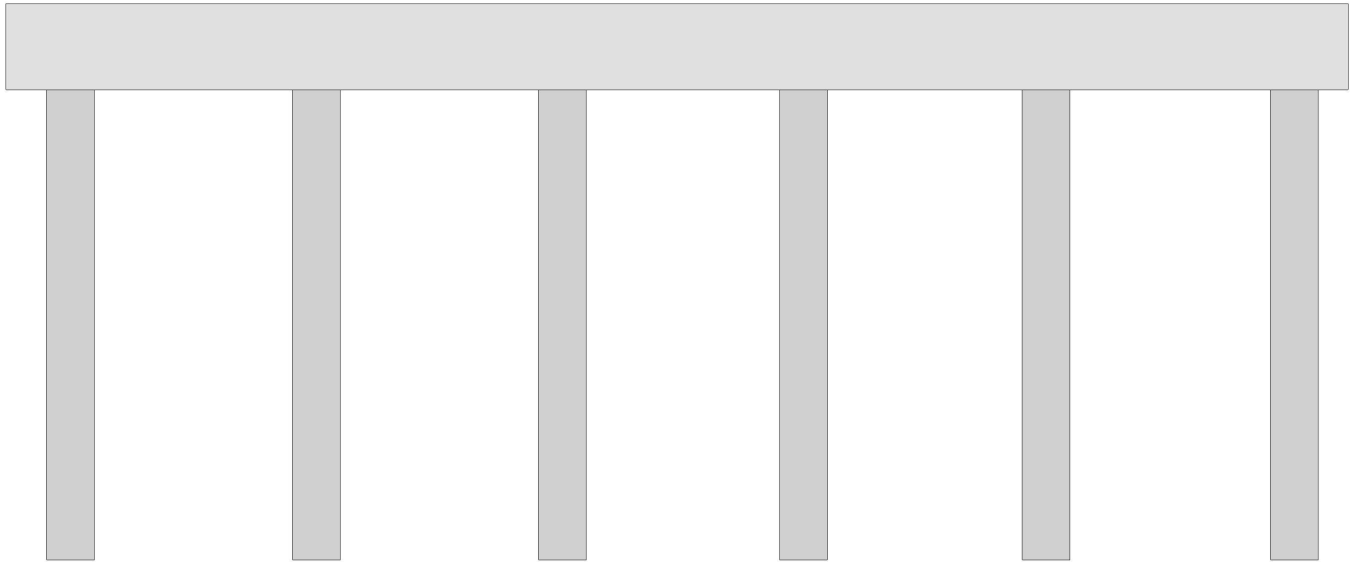
<b>Cap Information</b>			<b>Material</b> Cast-in-Place Concrete							
Length	Width	Height	Left Overhang	Right Overhang	Left Beam to End of Cap.	Right Beam to End of Cap.
