NC DEPARTMENT OF TRANSPORTATION ATTENTION:
 DIVISION OF HIGHWAYS
 STRUCTURE MANAGEMENT UNIT

Structure Safety Report

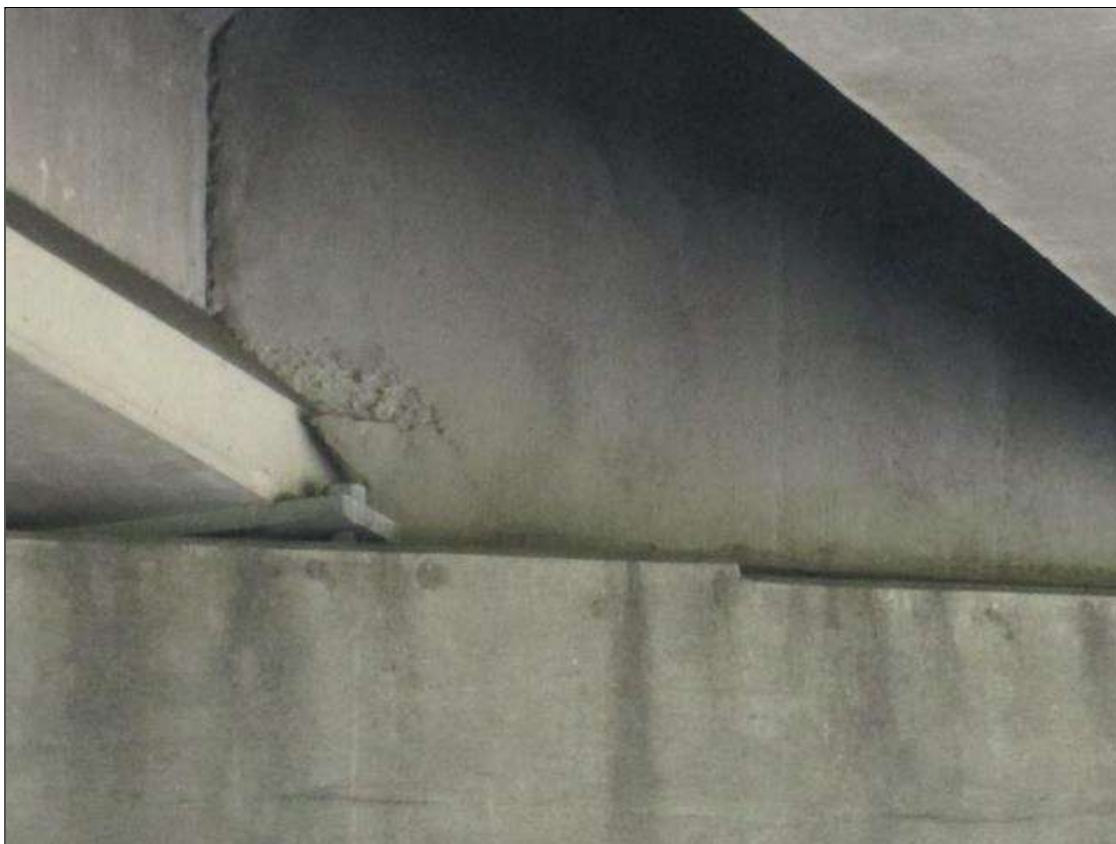
END DIAPHRAGM IN SPAN 3 OVER BENT 2 EAST FACE IN BAY 5 AT LT SIDE OF G6 HAS DELAMINATED AND SPALLED AREA 12" X 14".

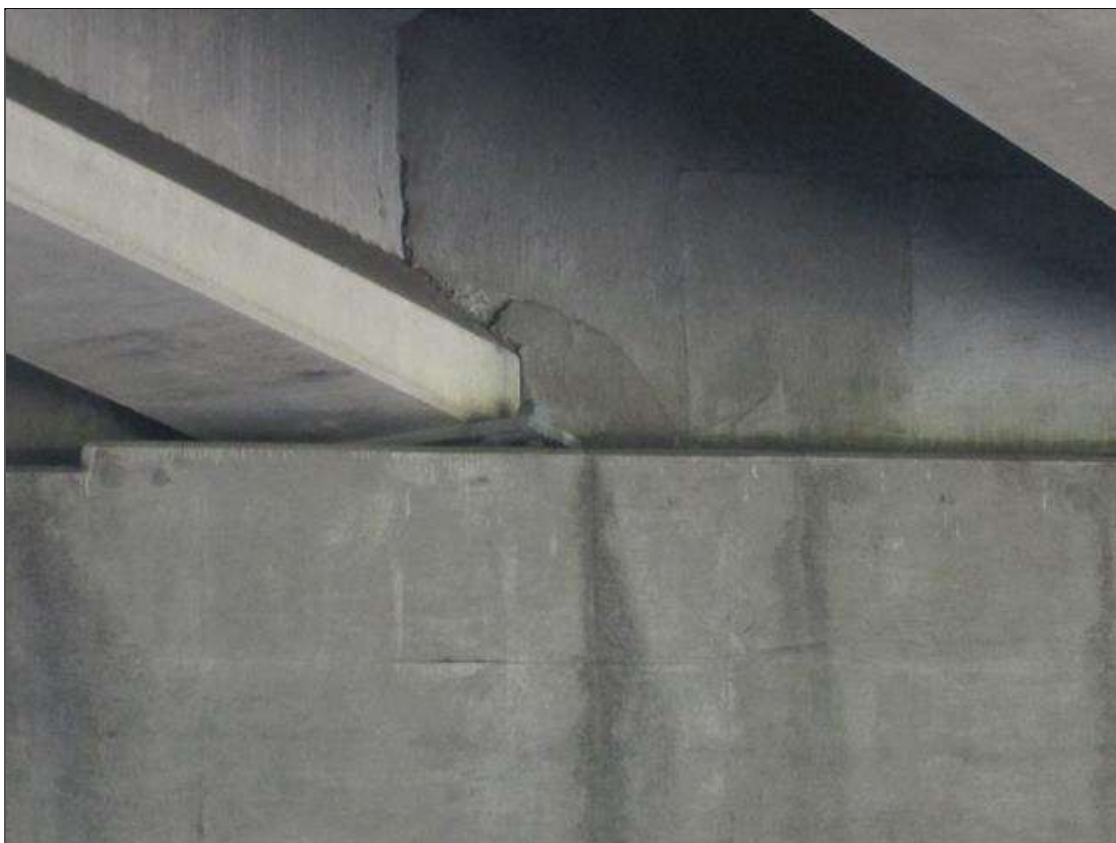
END DIAPHRAGM IN SPAN 3 OVER BENT 2 EAST FACE AT LT SIDE G7 HAS DELAMINATED AREA 12" X 16".

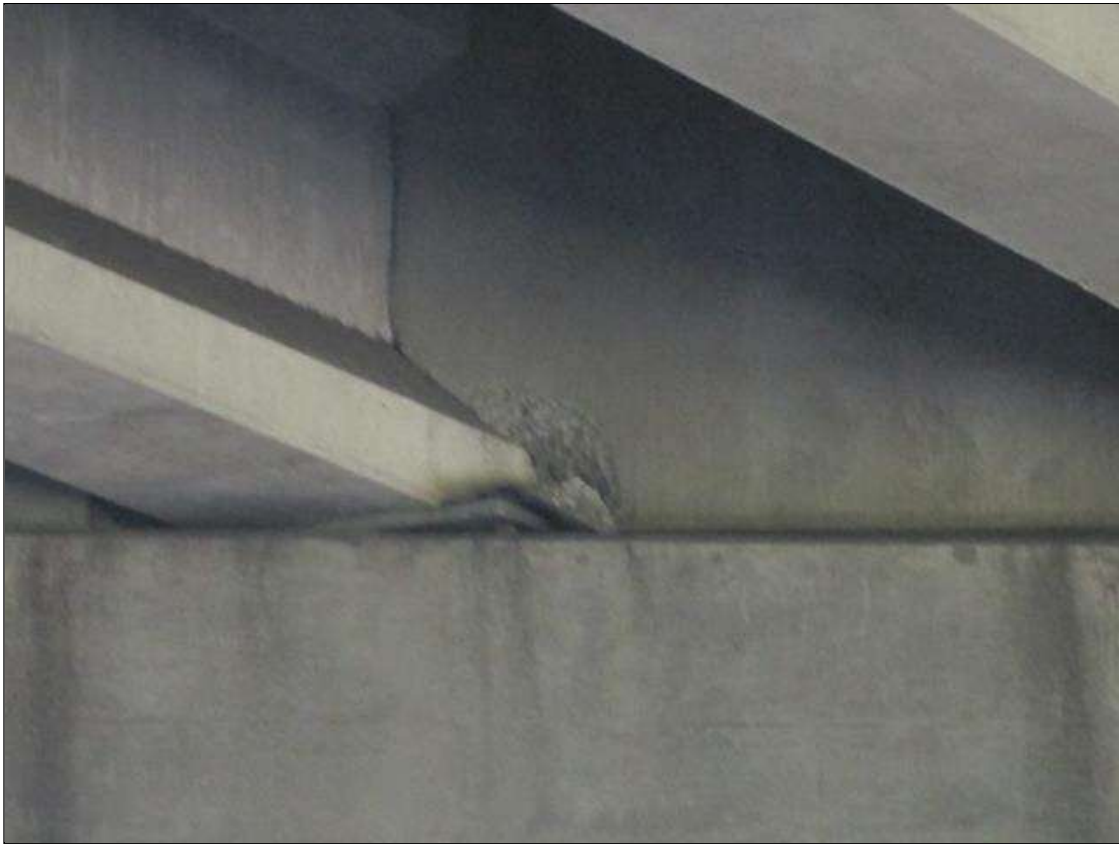
END DIAPHRAGM IN SPAN 3 OVER BENT 2 EAST FACE ON LT SIDE OF G8 HAS SPALLED AREA 8" X 12" X 2" DEEP.

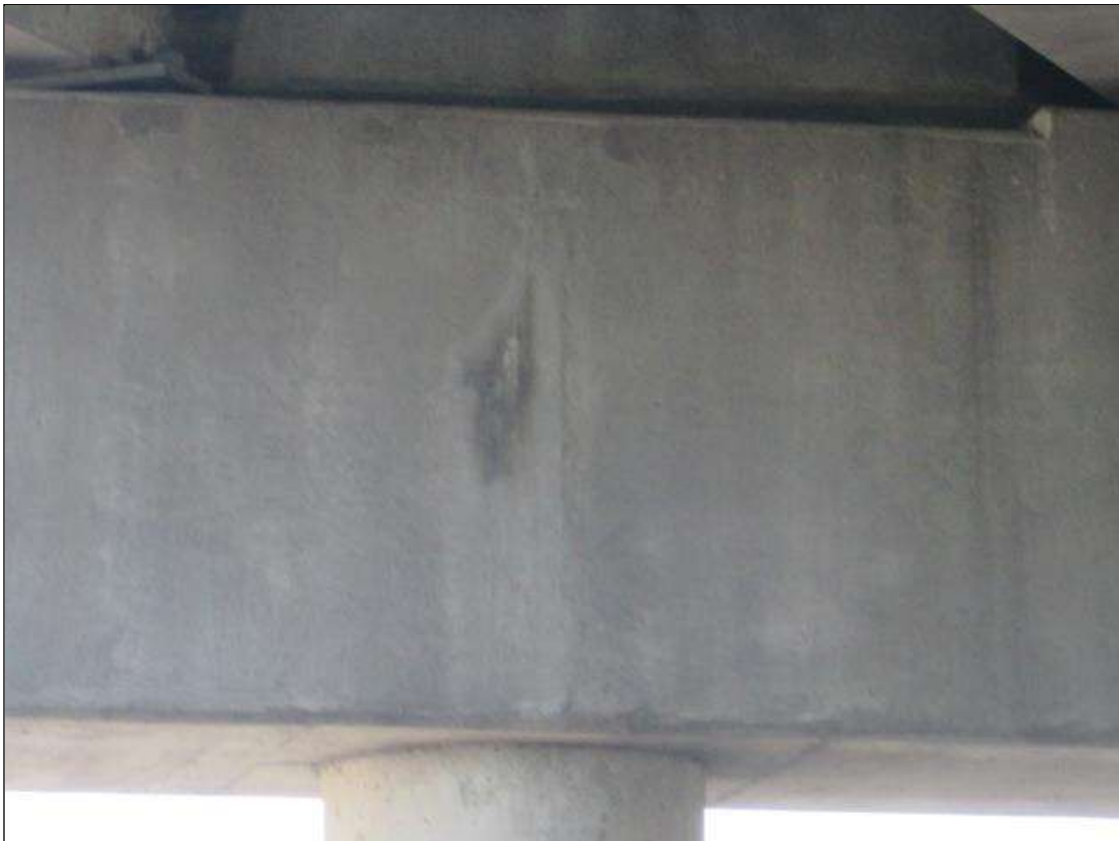
Bent 2 Cap 1: BENT 2 EAST FACE OF CAP HAS VERTICAL CRACK WITH EFFLO STAIN BETWEEN G11 AND G12.

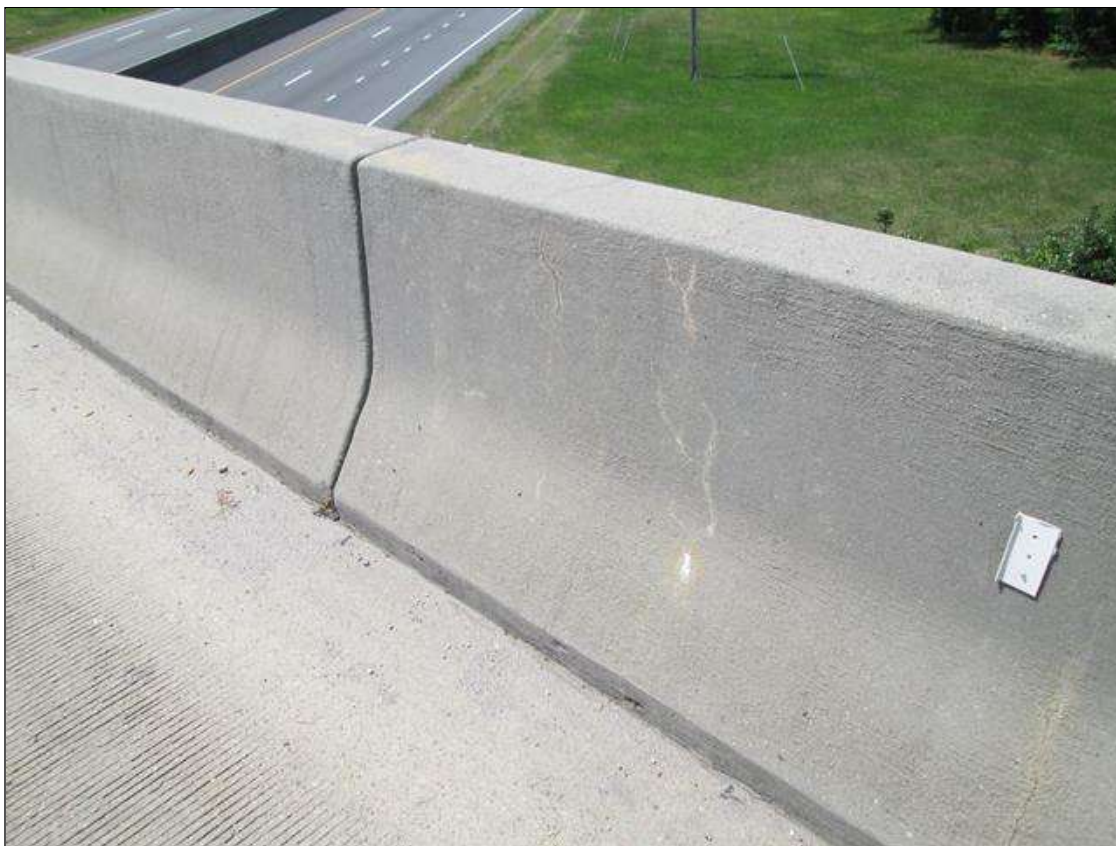
Span 1 Right Bridge Rail: SCATTERED VERTICAL CRACKS WITH EFFLO STAINS.

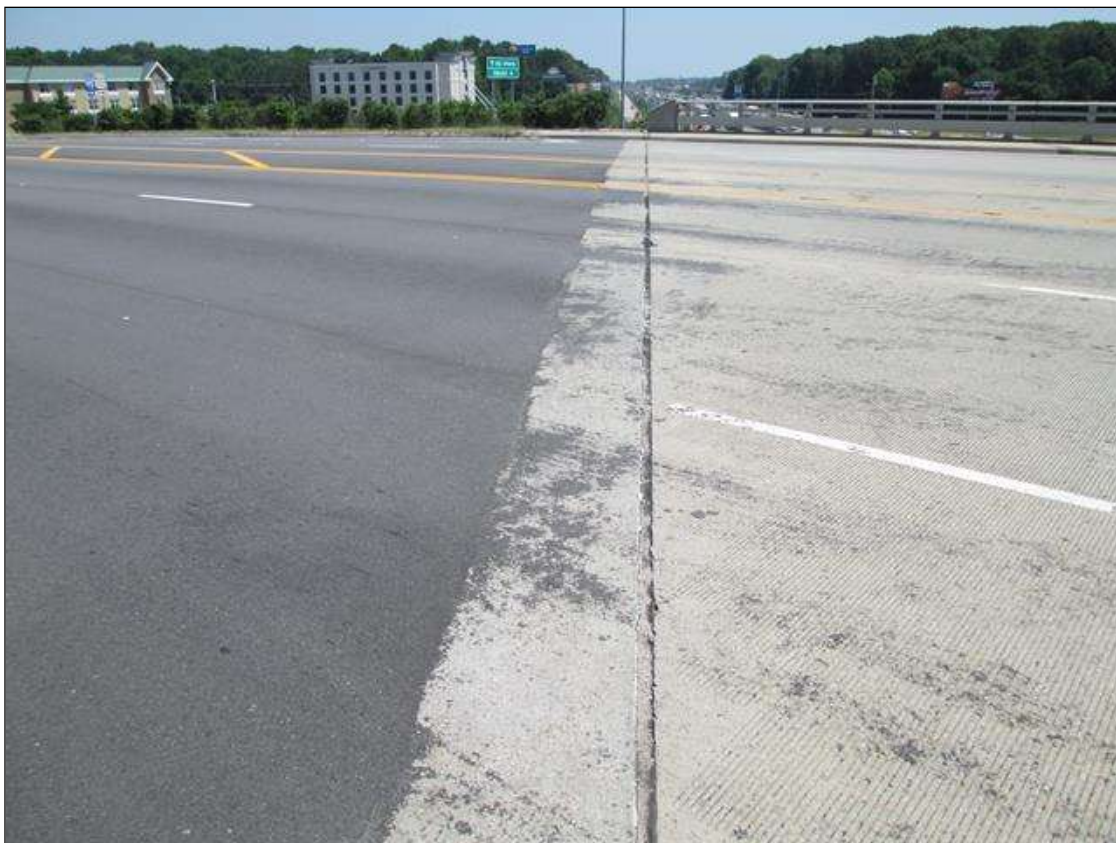
Expansion Joint : DIRT AND SMALL GRAVEL INSIDE JOINT OVER END BENT 1.

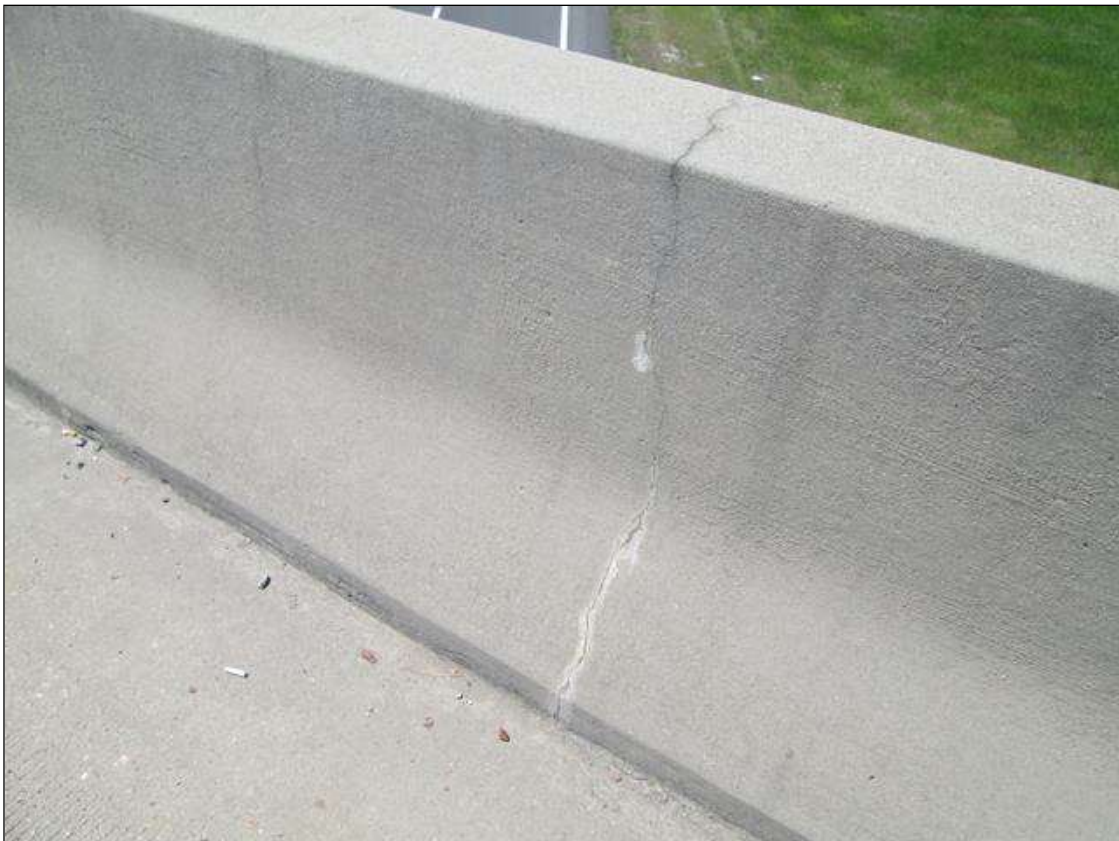
Span 2 Right Bridge Rail: SCATTERED VERTICAL CRACKS WITH EFFLO STAINS.

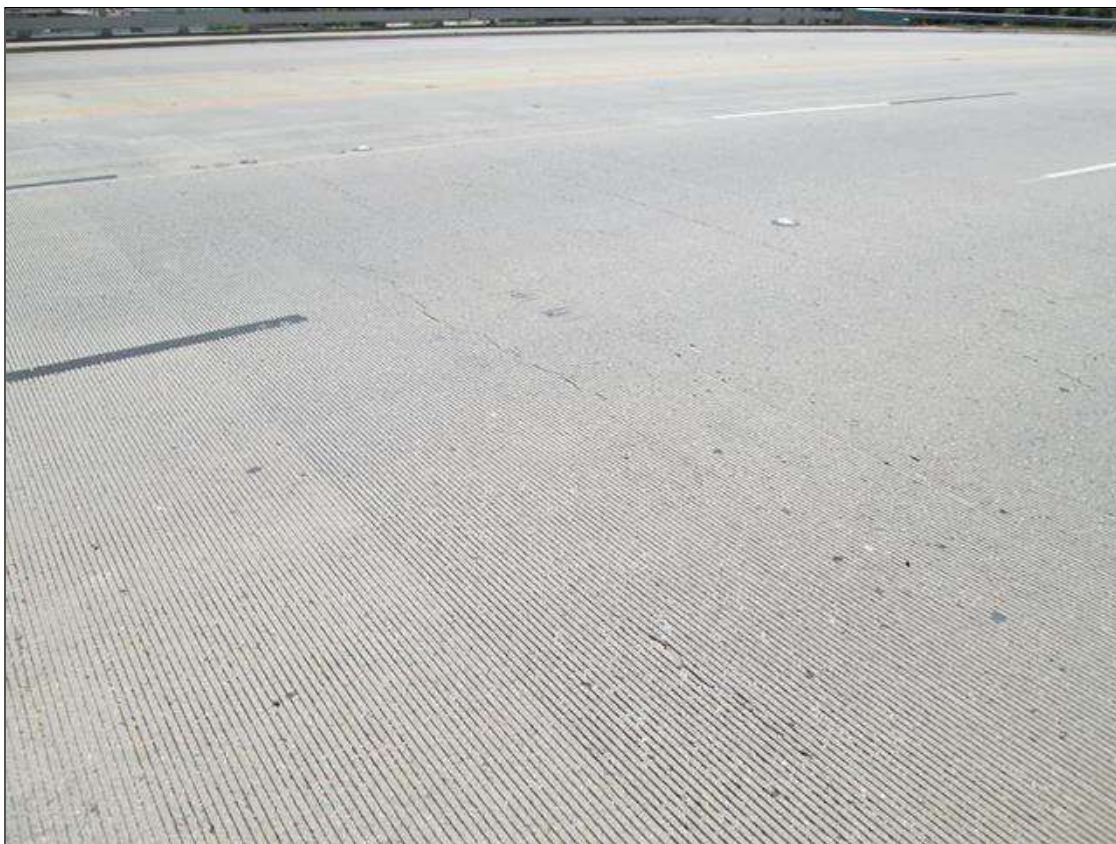
Span 2 Deck: TOP OF THE DECK IN SPAN 2 SOME MAP CRACKING AND TRANSVERSE CRACKS FROM 2' TO 5' ON CENTERS THROUGH OUT EBLs .

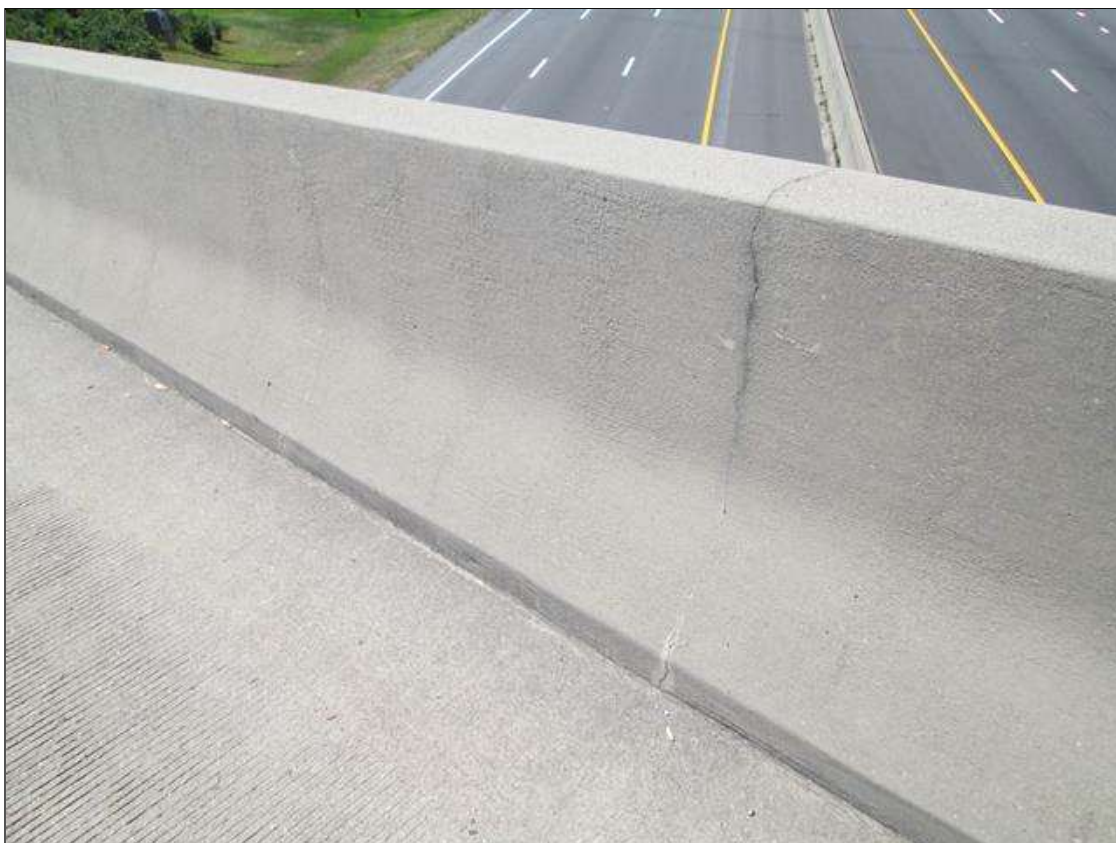
Span 3 Right Bridge Rail: SCATTERED VERTICAL CRACKS WITH EFFLO STAINS

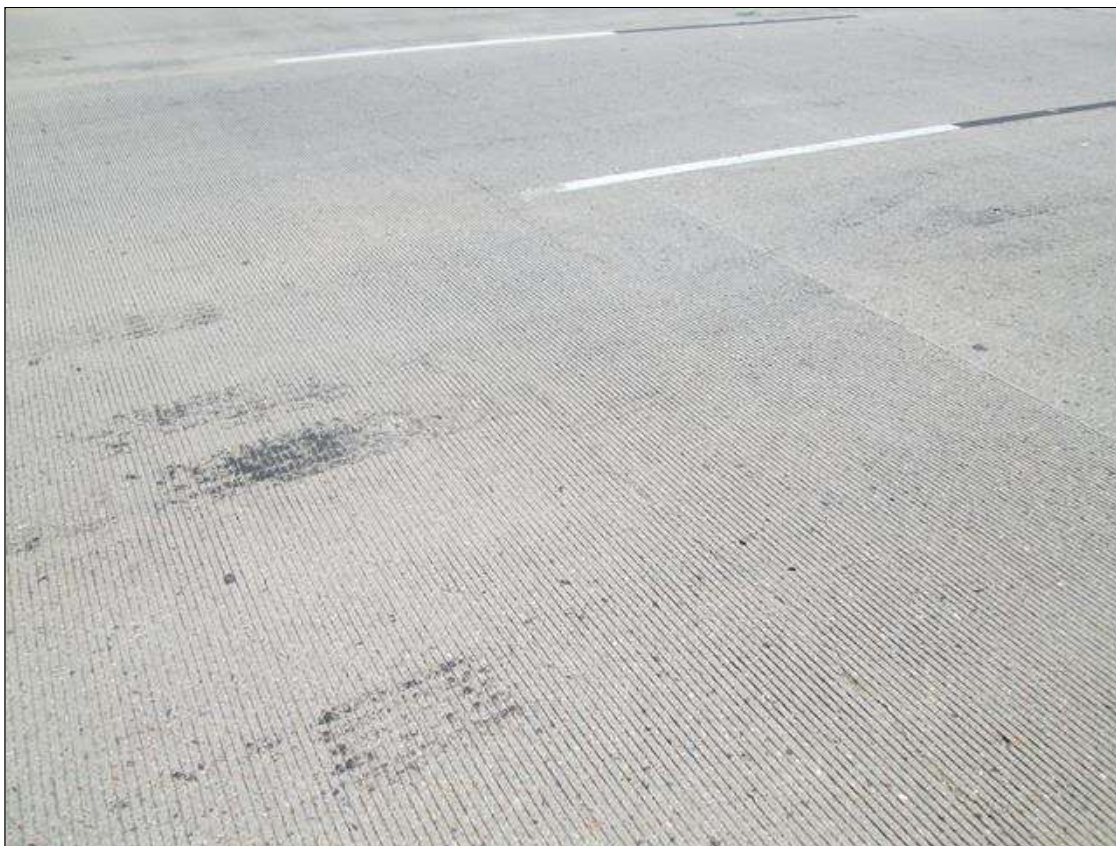
Span 3 Deck: SCATTERED TRANSVERSE CRACKS FROM 2' TO 5' CENTERS THROUGH OUT EBLs.

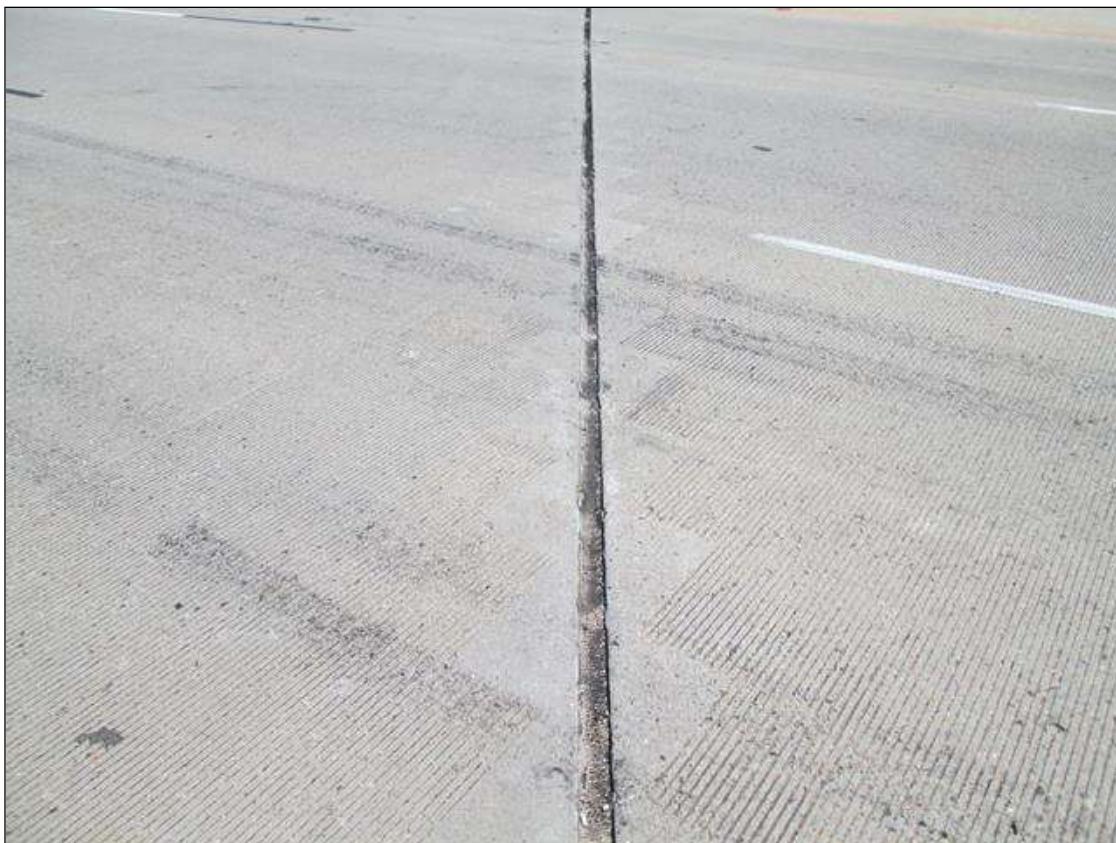
Expansion Joint : DIRT AND SMALL GRAVEL INSIDE THE JOINT OVER BENT 3.

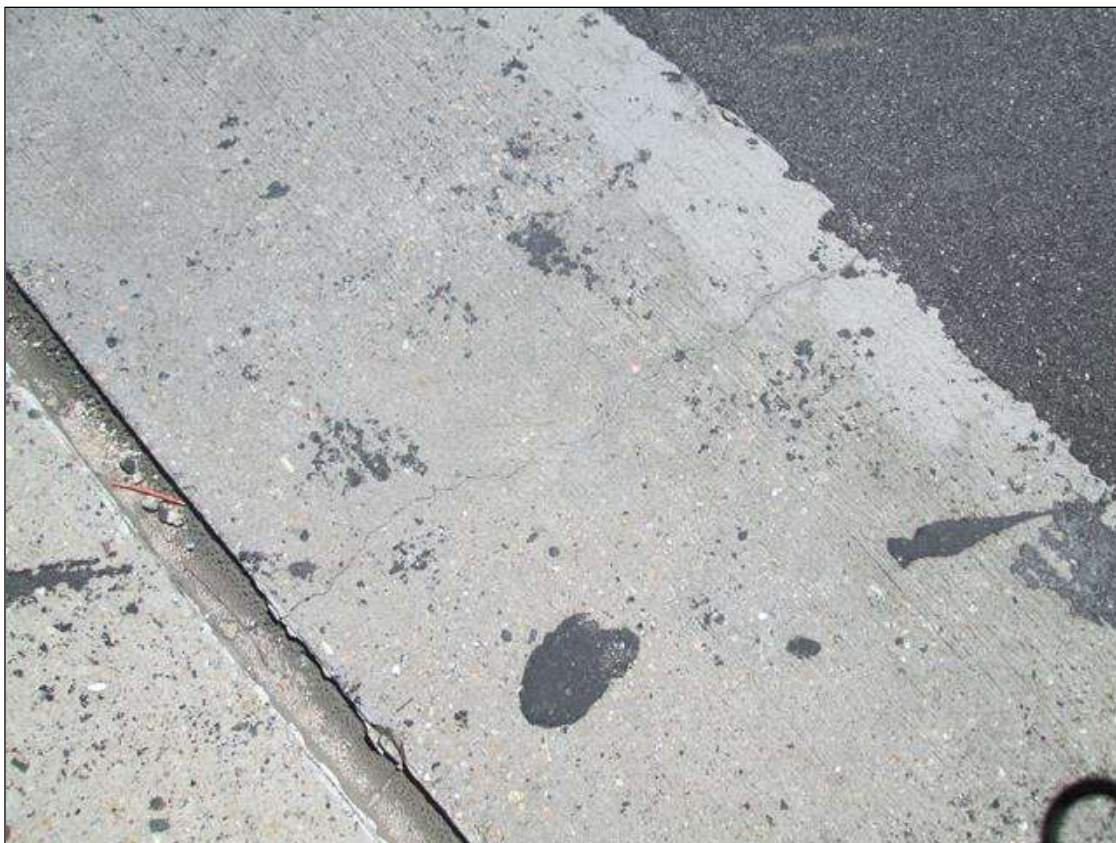
Approach 2: SCATTERED LONGITUDINAL CRACKS ACROSS APPROACH IN EBL AND WBL.

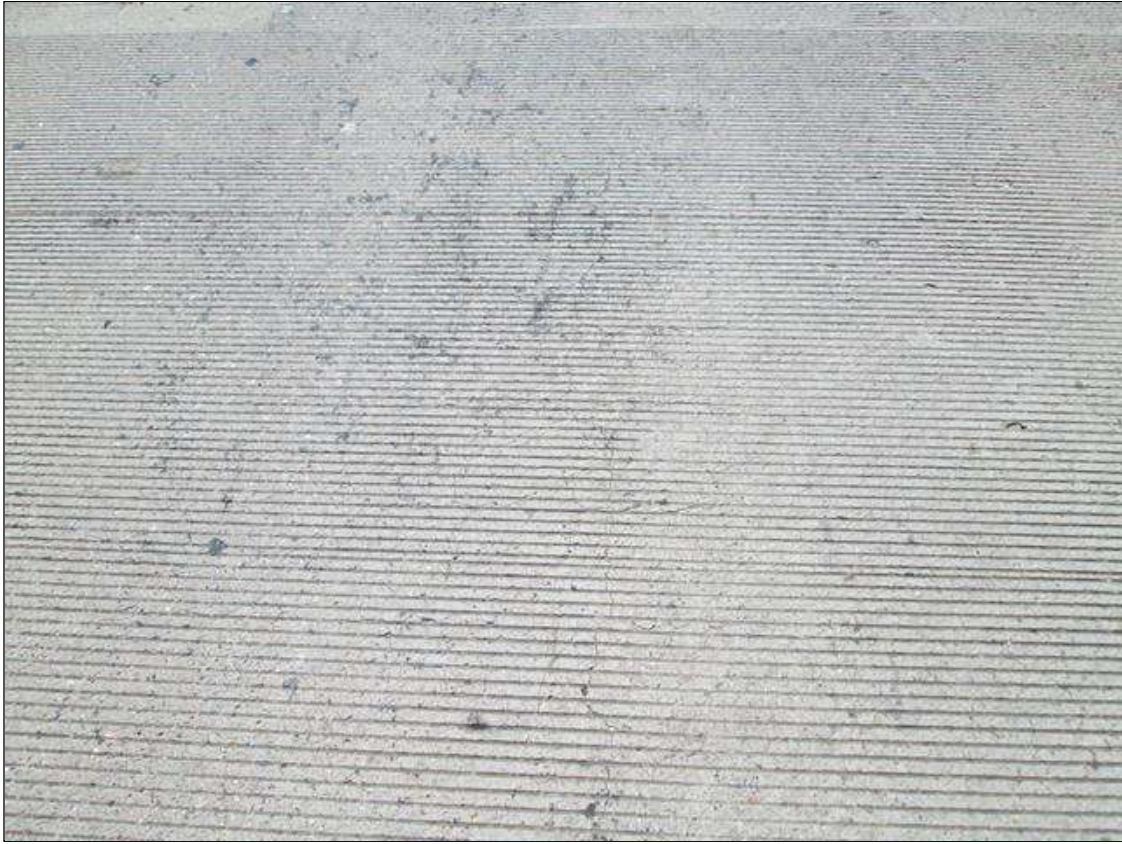
Span 4 Deck: SOME MAP CRACKING AND A FEW TRANSVERSE CRACKS ALSO SOME LONGITUDINAL CRACKS IN EBLs.

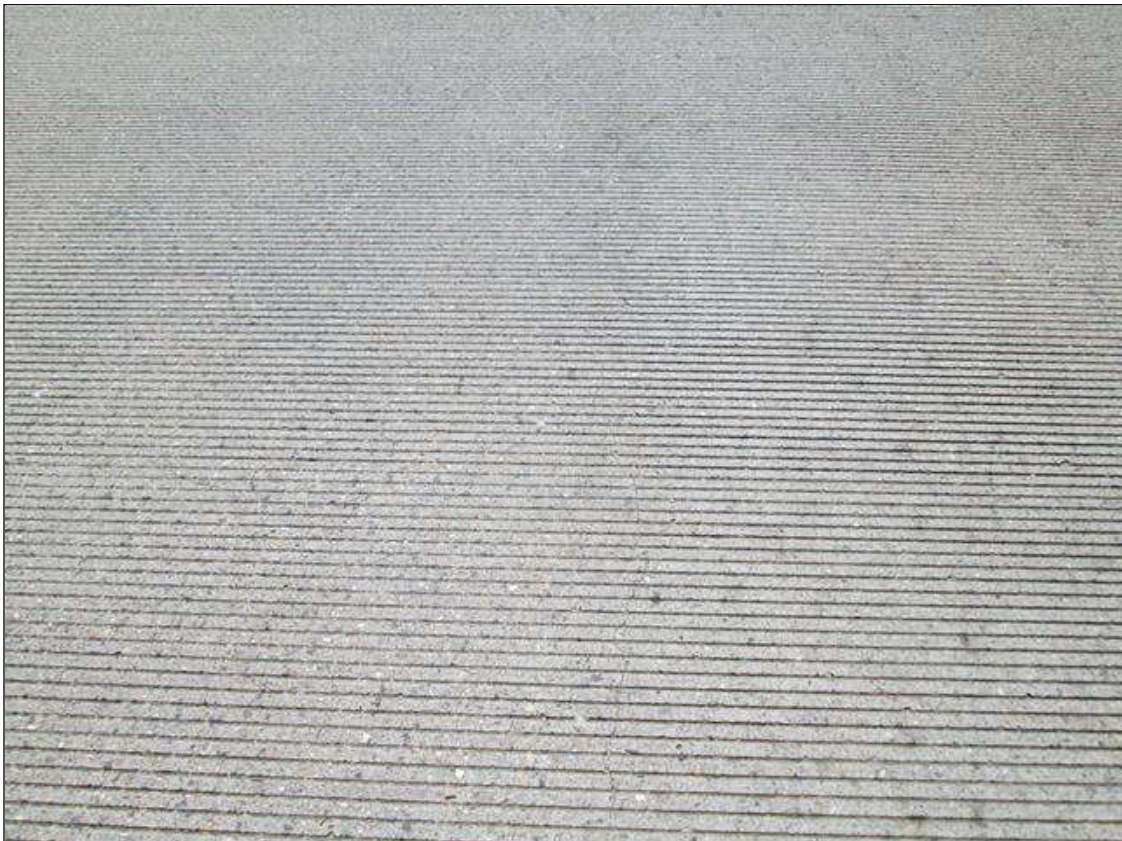
Span 2 Deck: SOME SCATTERED LONGITUDINAL CRACKS IN TOP OF DECK OF EBLs.

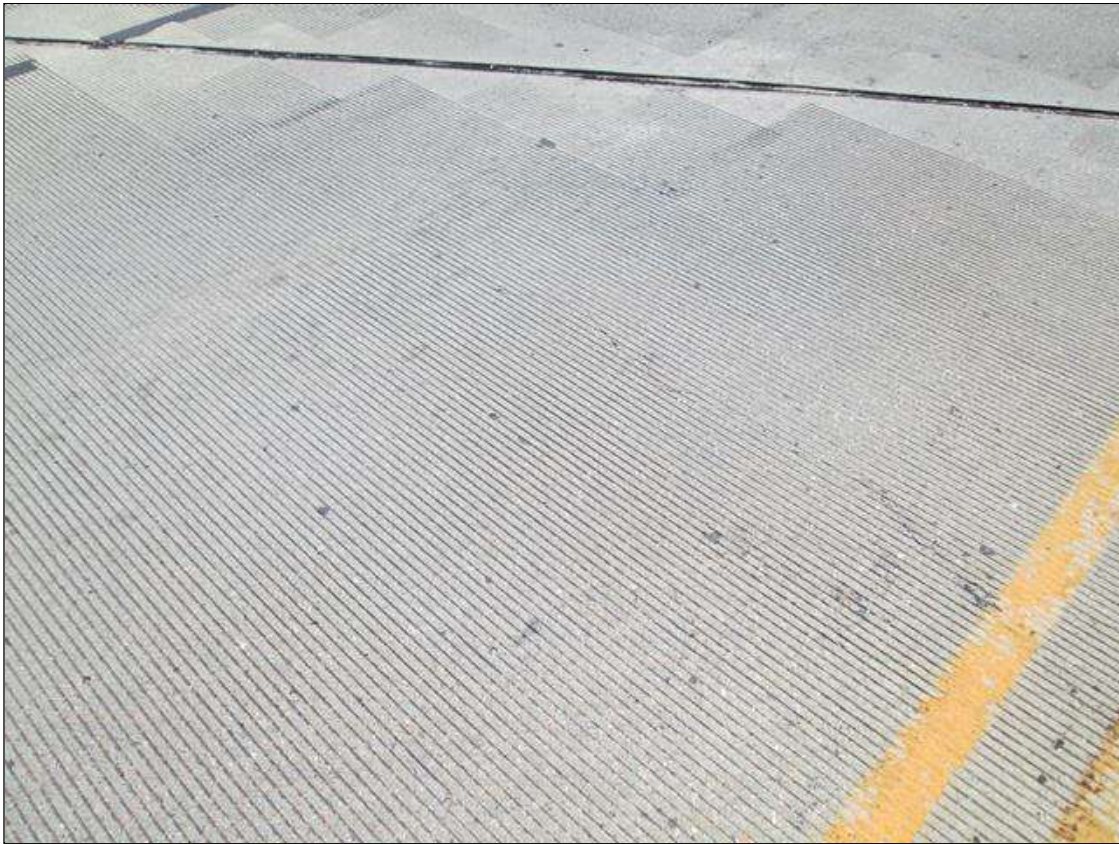
Span 1 Deck: TOP DECK IN SPAN 1 HAS SOME MAP CRACKING AND DIAGONAL CRACKS IN WBL COMING FROM JOINT AT BENT 1.

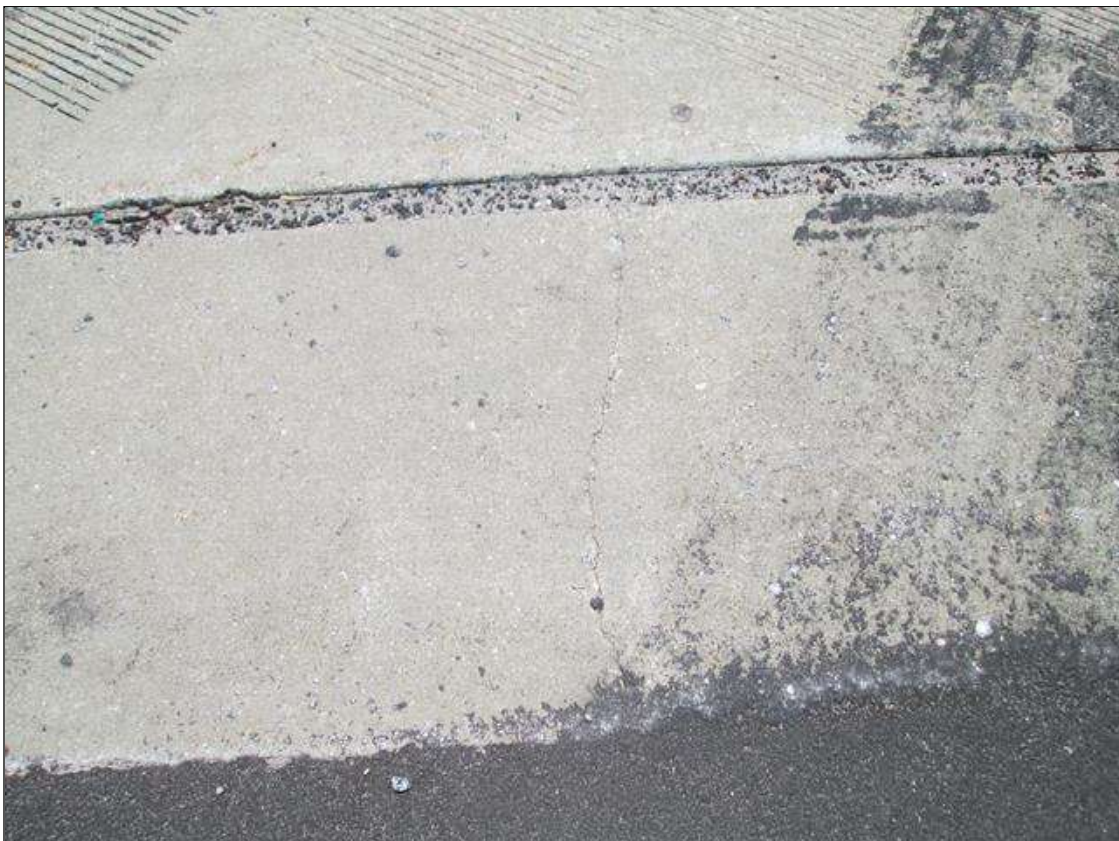
Approach 1: SCATTERED LONGITUDINAL CRACKS IN WEST APPROACH .

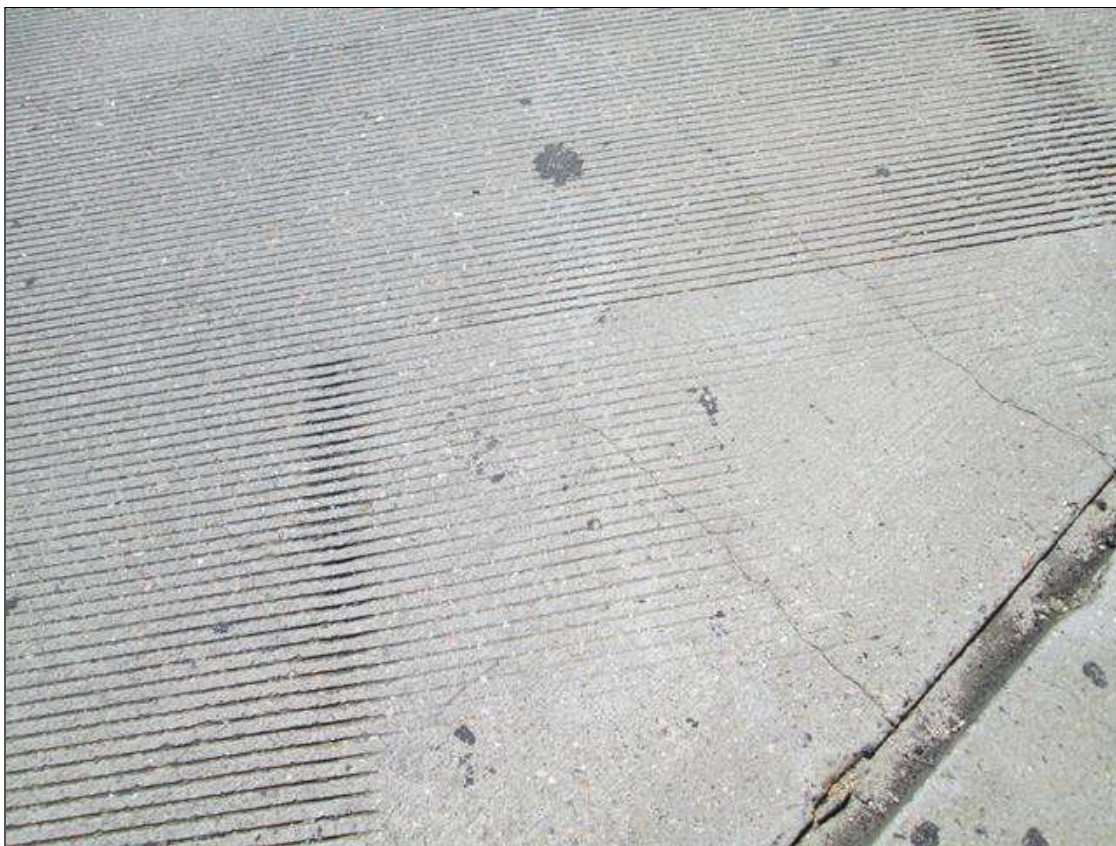
Span 1 Deck: SCATTERED LONGITUDINAL CRACKS AND SOME MAP CRACKING EXTENDING FROM END BENT
2 JOINT .

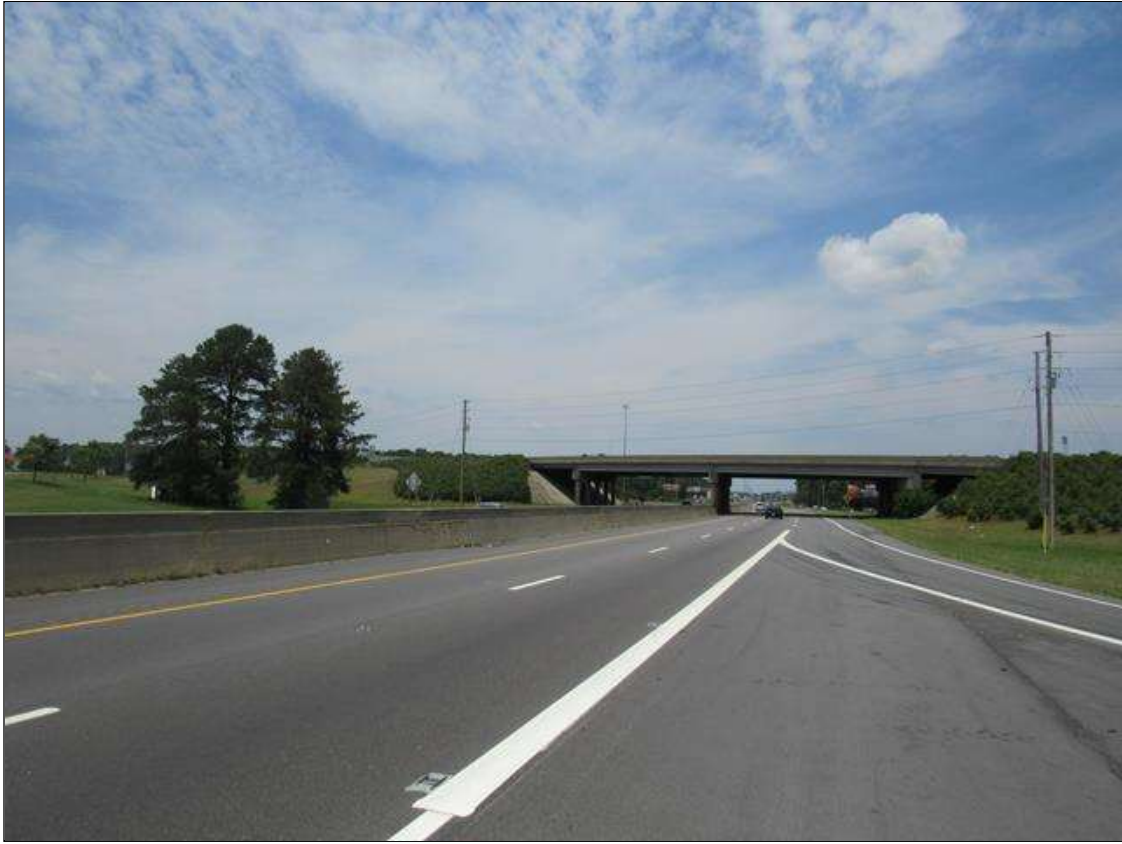
LOOKING NORTH IN NBL
