NC DEPARTMENT OF TRANSPORTATION ATTENTION:
 DIVISION OF HIGHWAYS
 STRUCTURE MANAGEMENT UNIT

Structure Safety Report

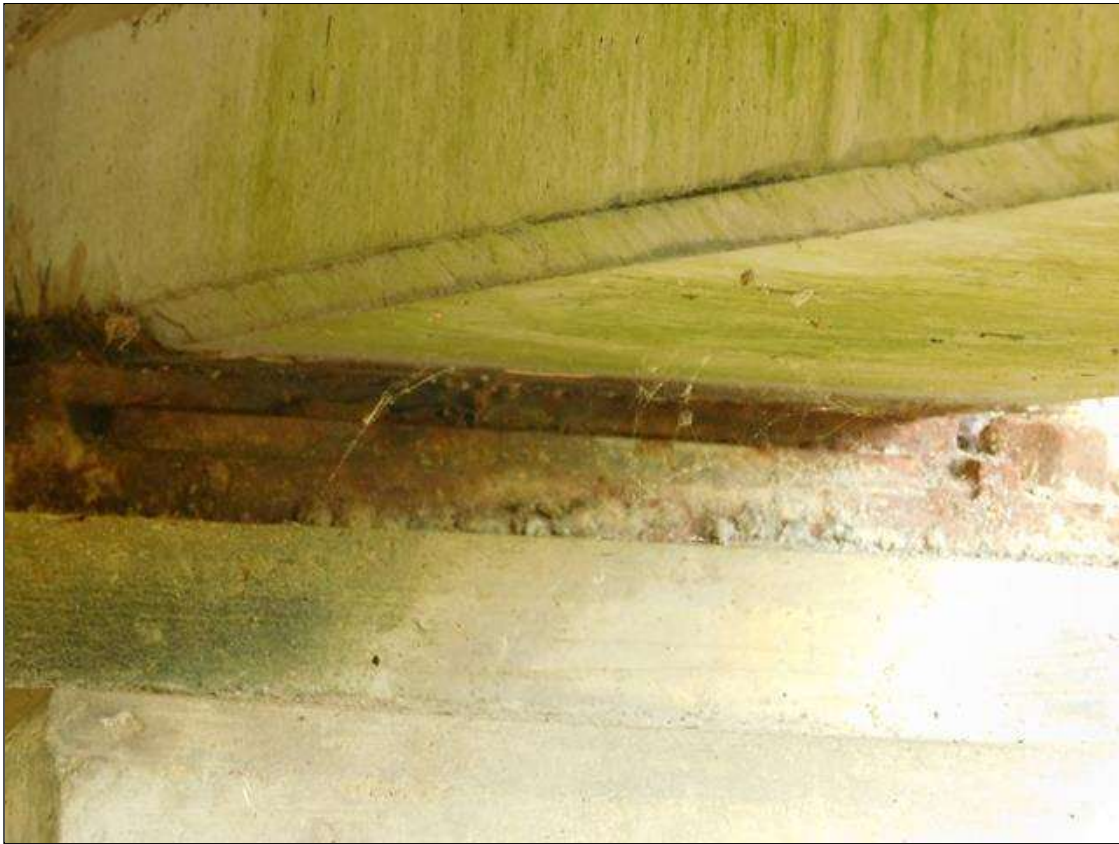
Span 1 Beam 1 Near Bearing: RUST AND FLAKING WITH NO SECTION LOSS

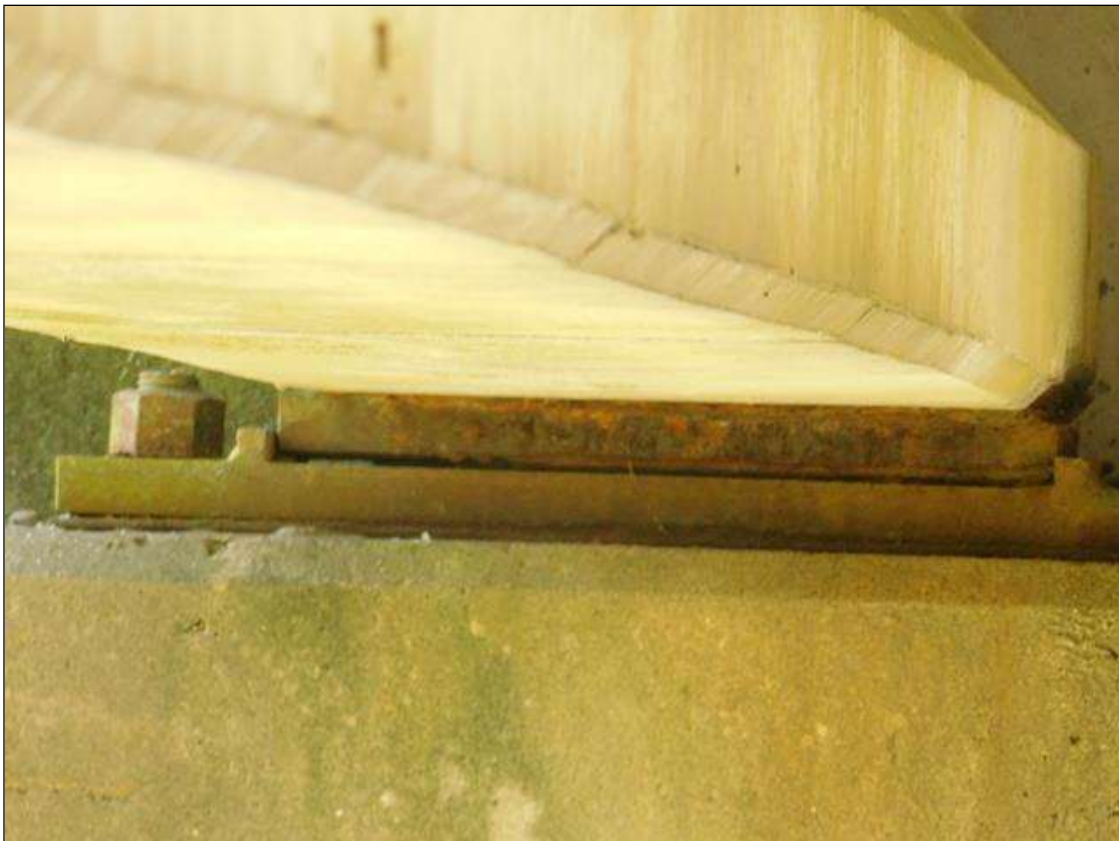
Span 1 Beam 1 Far Bearing: RUST AND FLAKING WITH NO SECTION LOSS

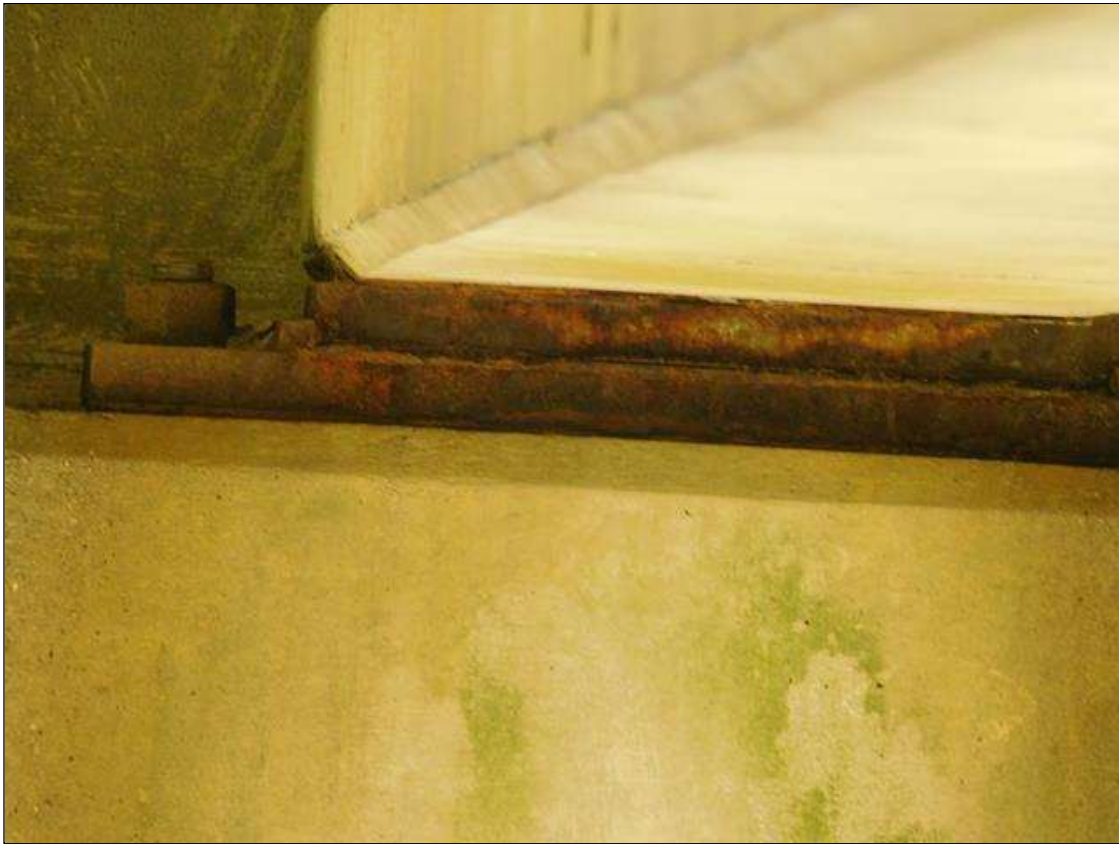
Span 1 Beam 2 Far Bearing: RUST AND FLAKING WITH NO SECTION LOSS

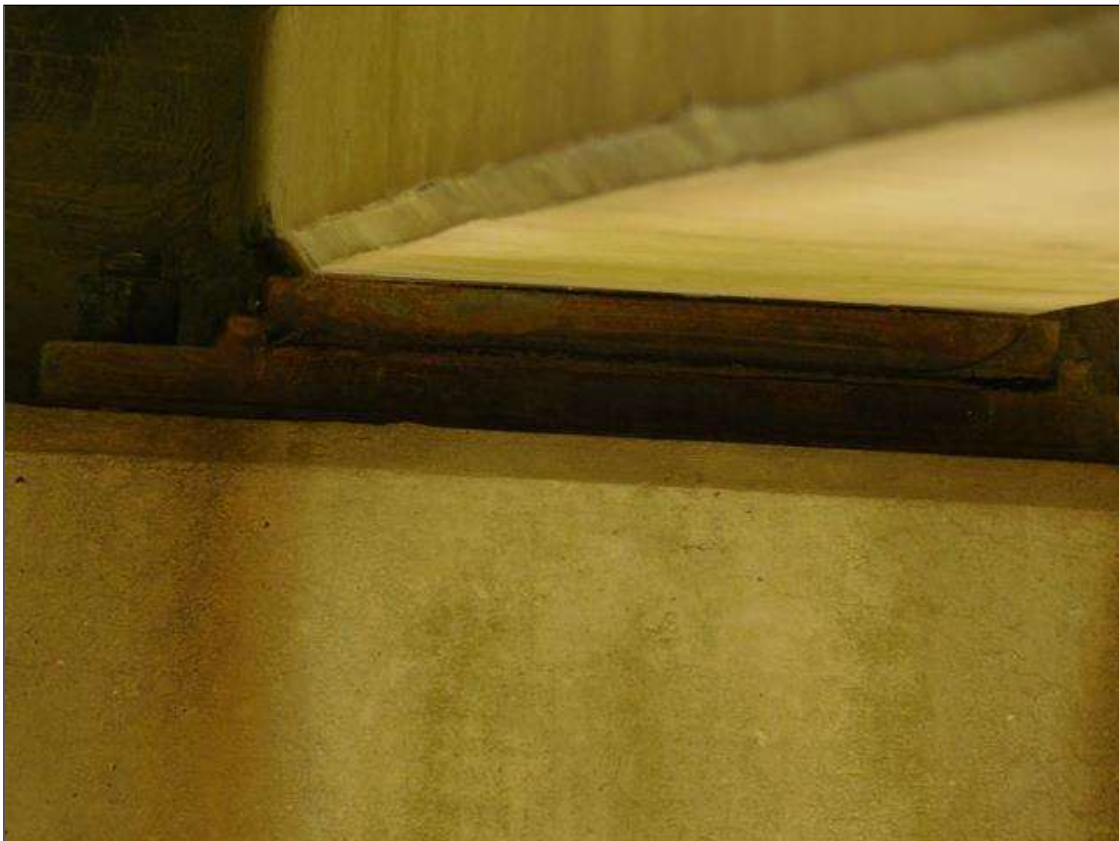
Span 1 Beam 3 Far Bearing: RUST AND FLAKING WITH NO SECTION LOSS

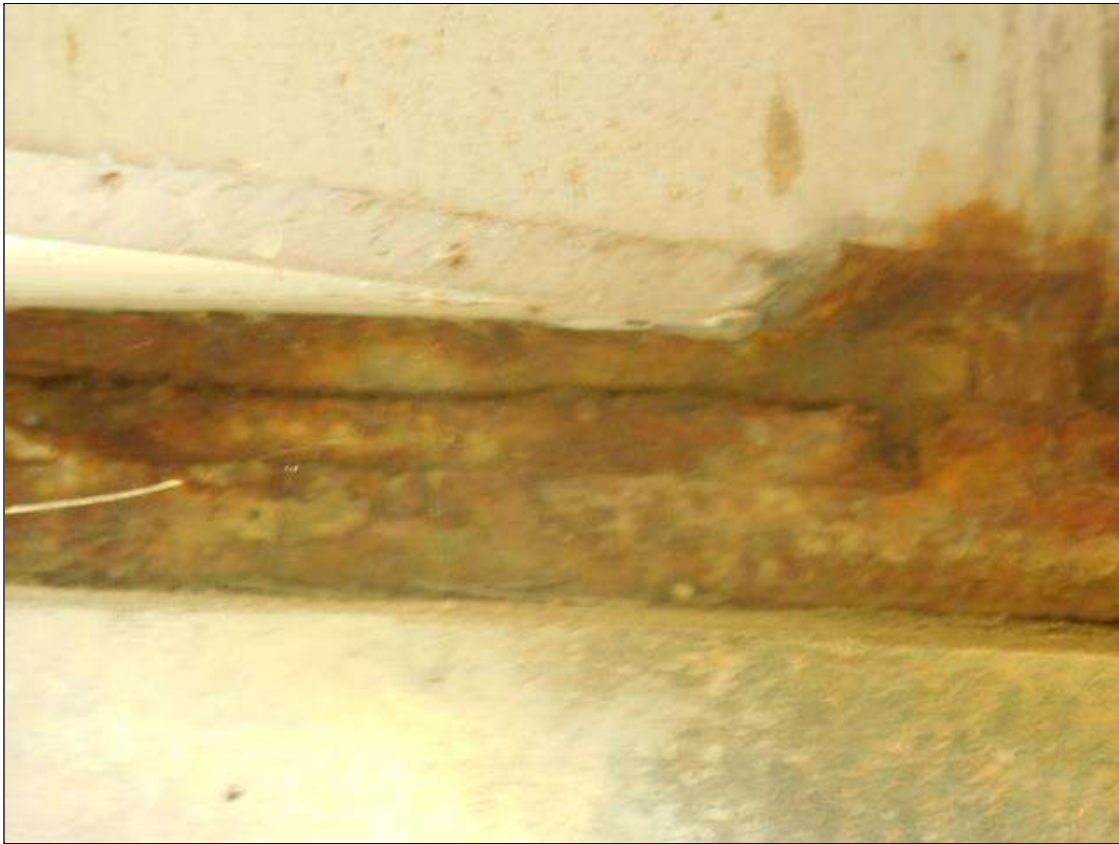
Span 1 Beam 4 Near Bearing: RUST AND FLAKING WITH NO SECTION LOSS

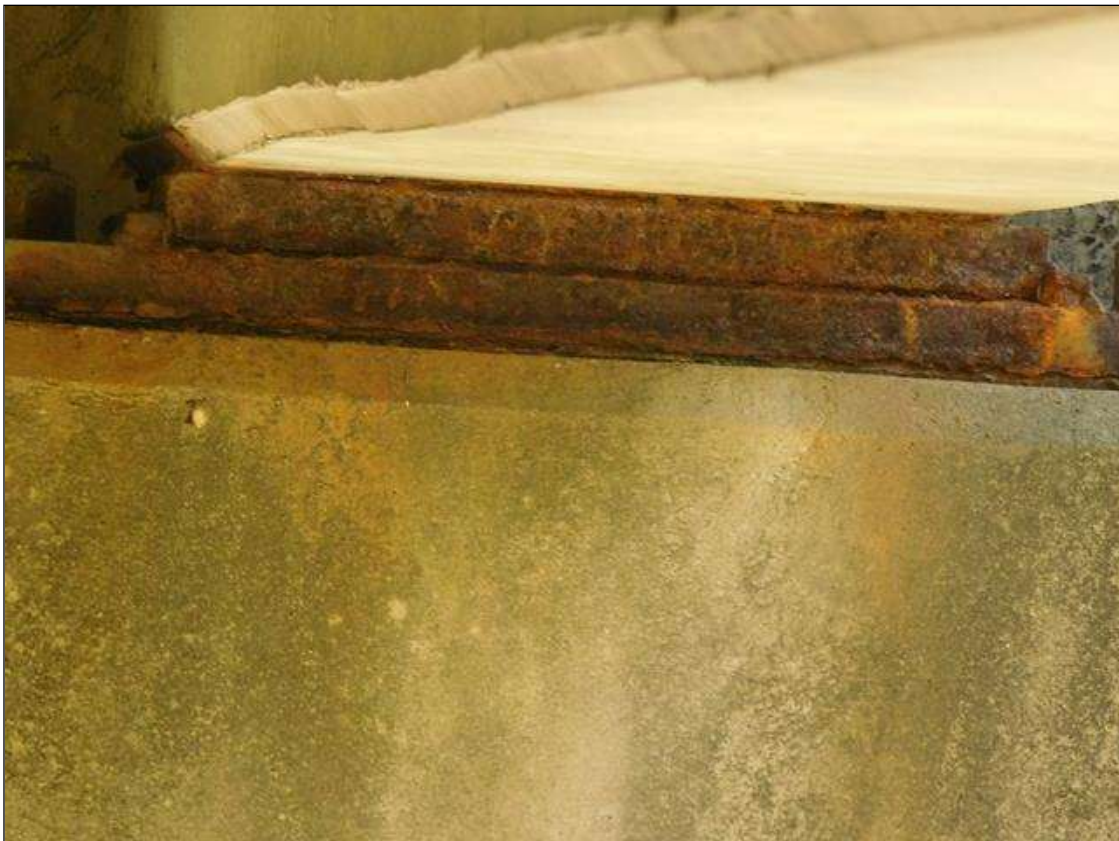
Span 1 Beam 4 Far Bearing: RUST AND FLAKING WITH NO SECTION LOSS

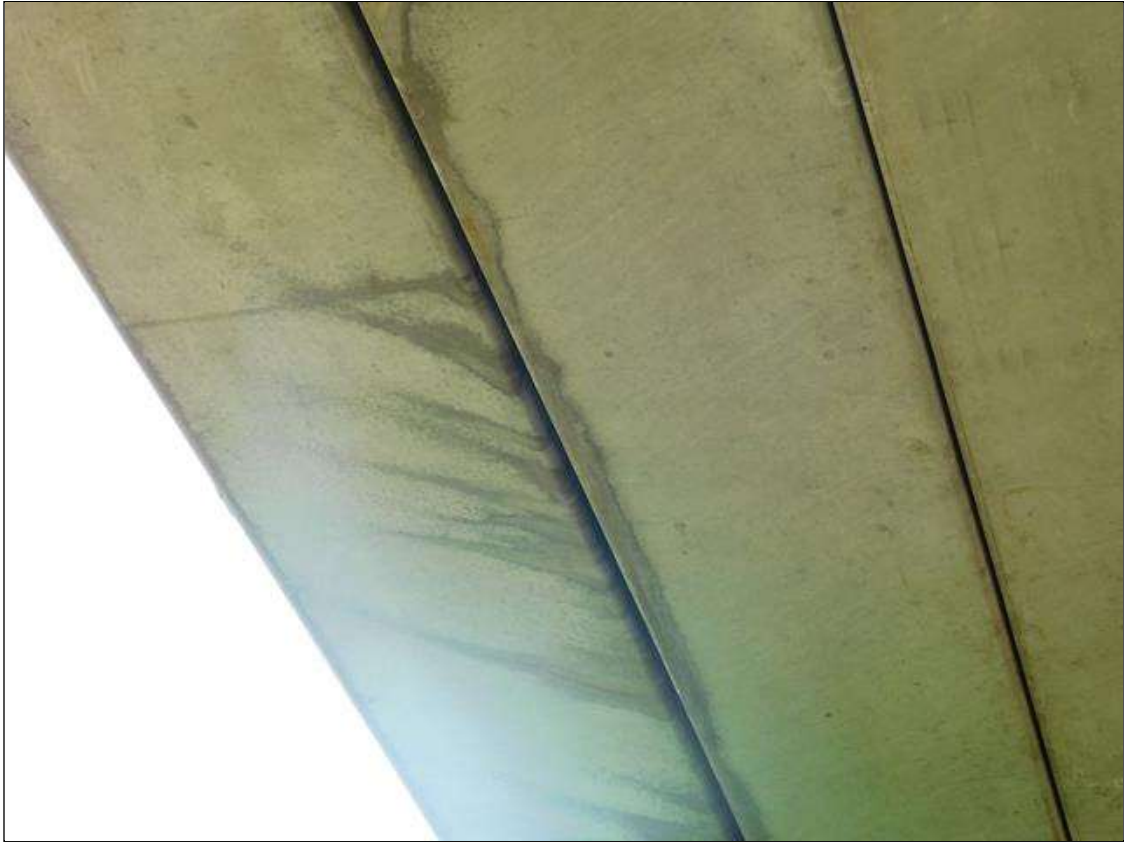
Span 2 Slab 1: 50 FT. OF EFFLORESCENCE LEAKAGE BETWEEN UNITS 1 AND 2

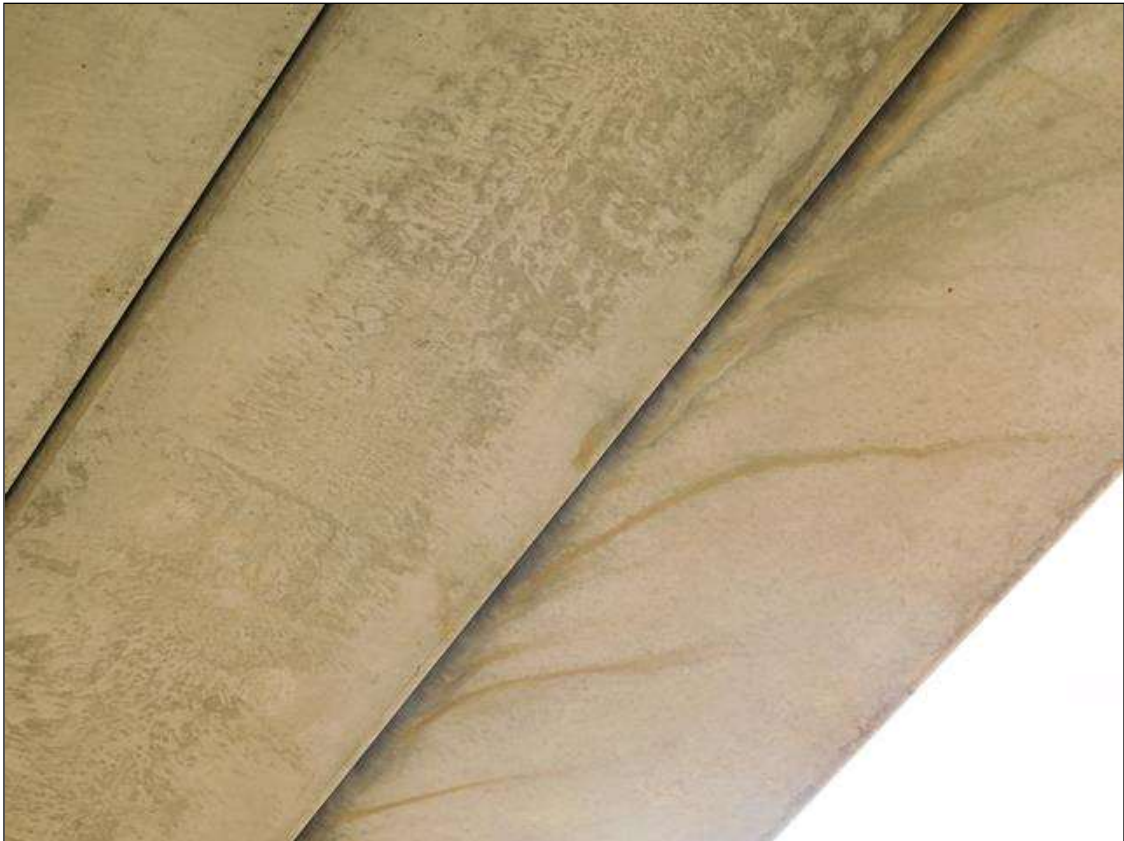
Span 2 Slab 8: 50 FT. OF EFFLORESCENCE LEAKAGE BETWEEN UNITS 8 AND 9

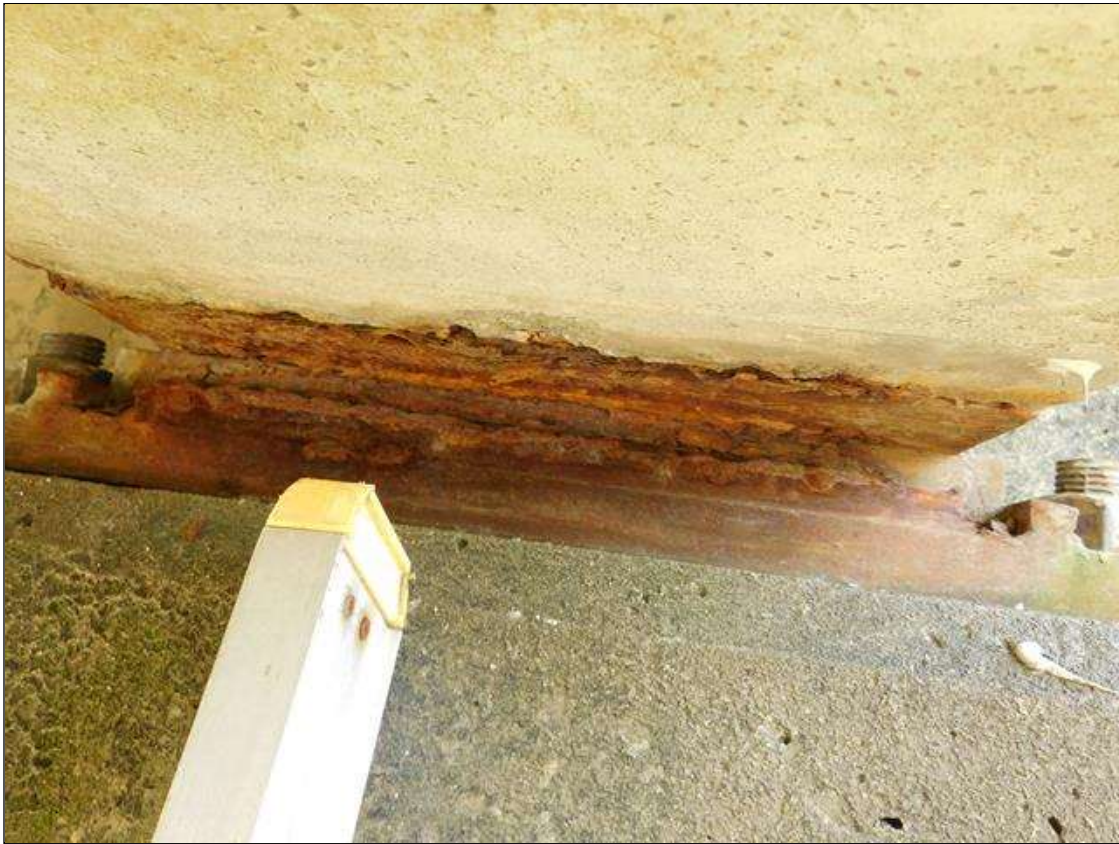
Span 3 Beam 1 Near Bearing: 1/8" OF PACK RUST

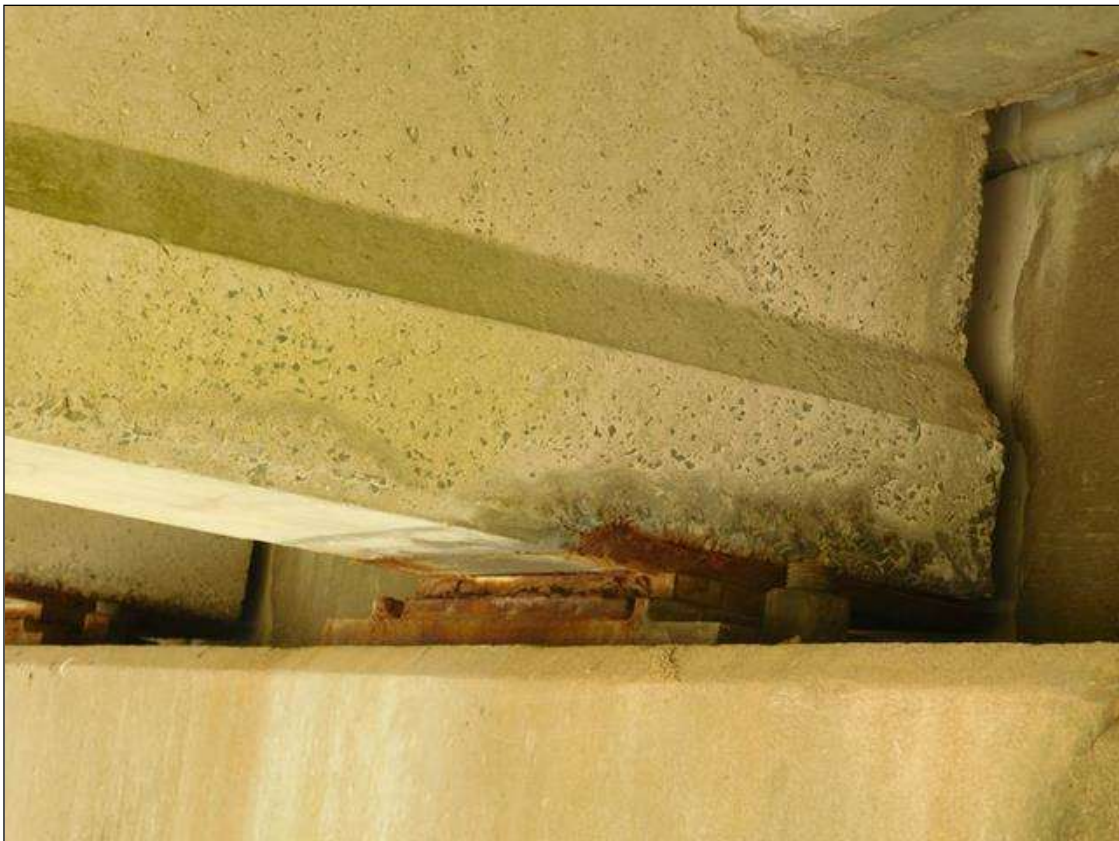
Span 3 Beam 2 Near Bearing: RUST AND FLAKING WITH NO SECTION LOSS

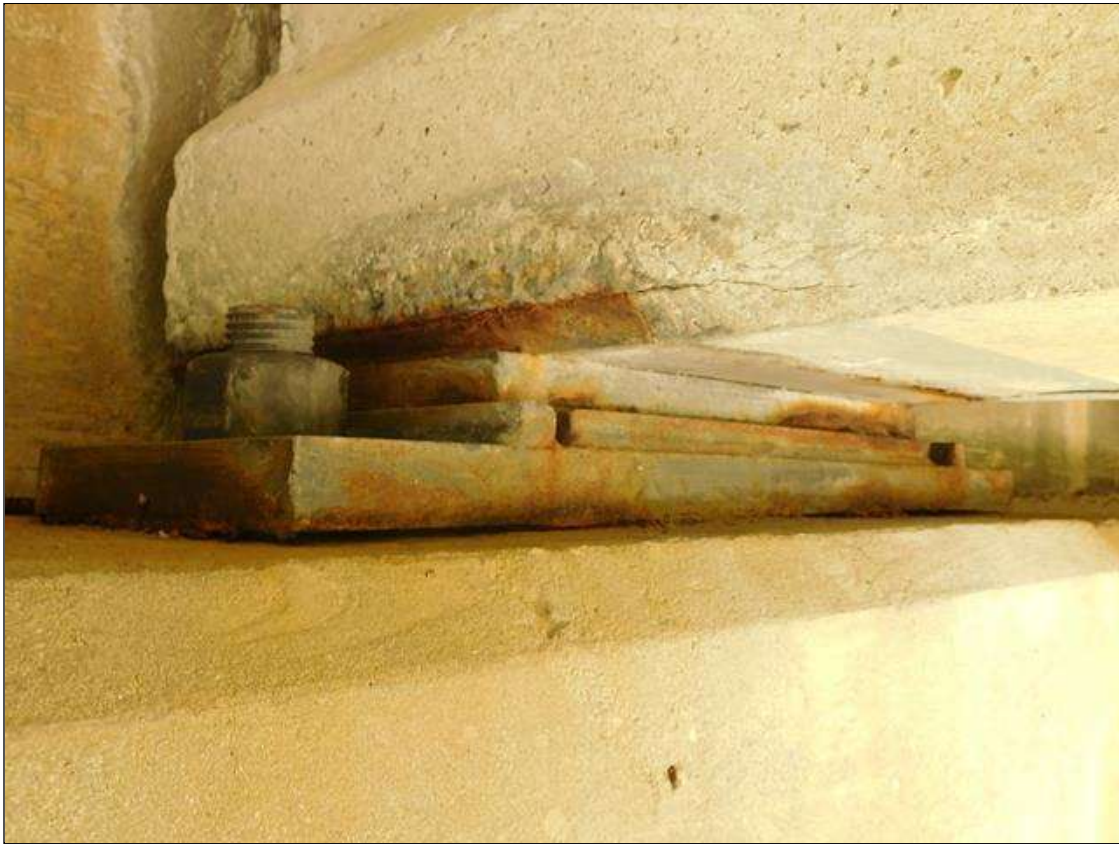
Span 3 Beam 3 Near Bearing: SURFACE CORROSION

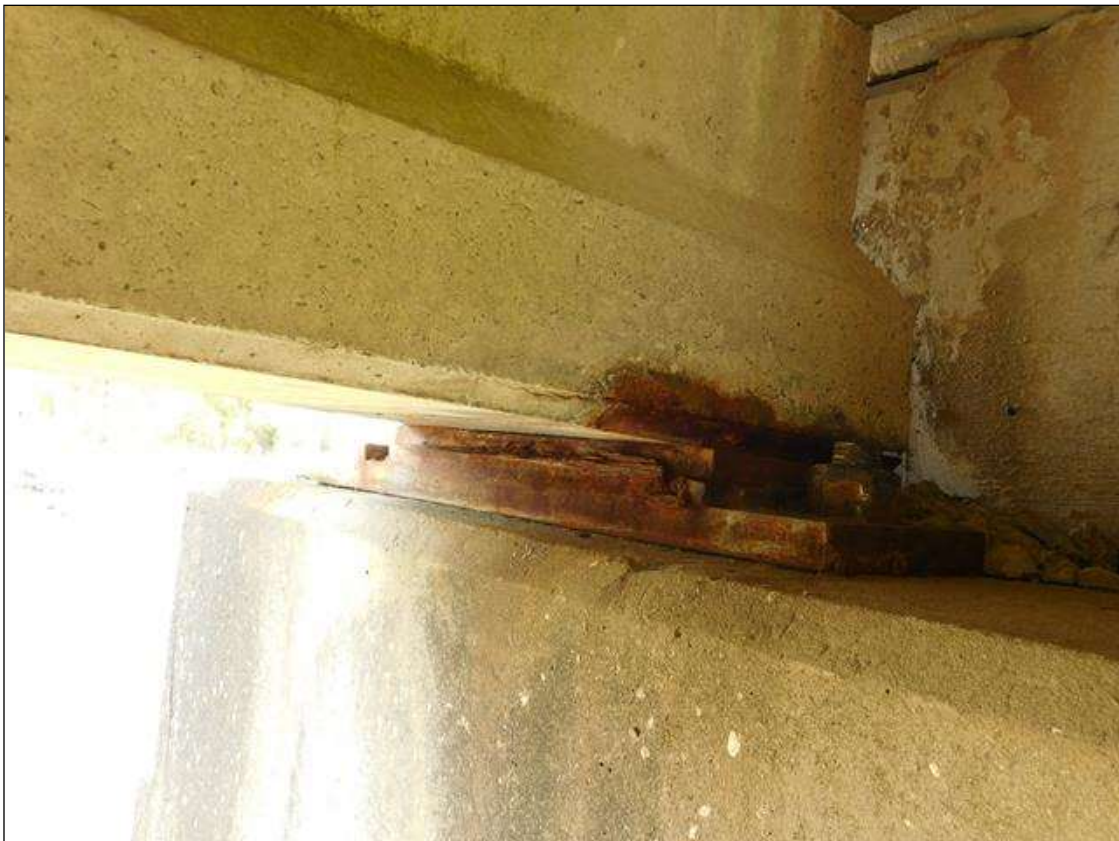
Span 3 Beam 4 Near Bearing: RUST AND FLAKING WITH NO SECTION LOSS

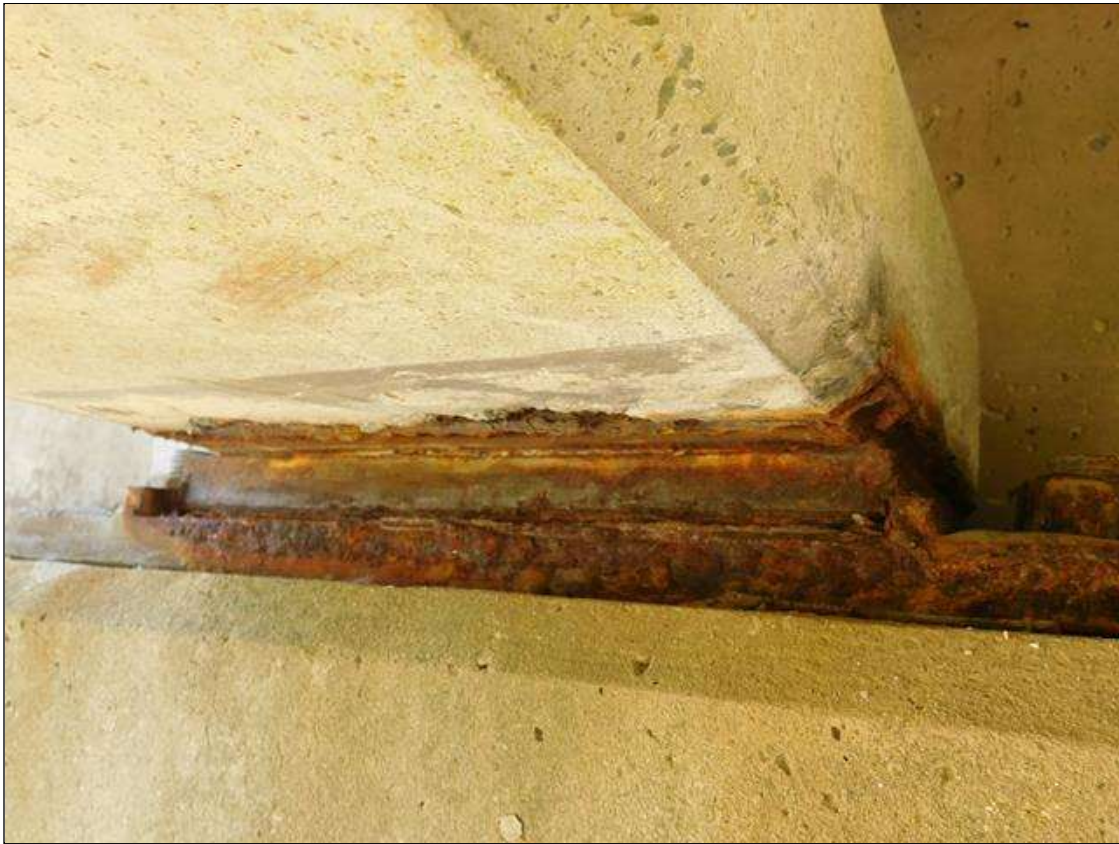
Span 3 Beam 1 Far Bearing: 1/8" OF PACK RUST

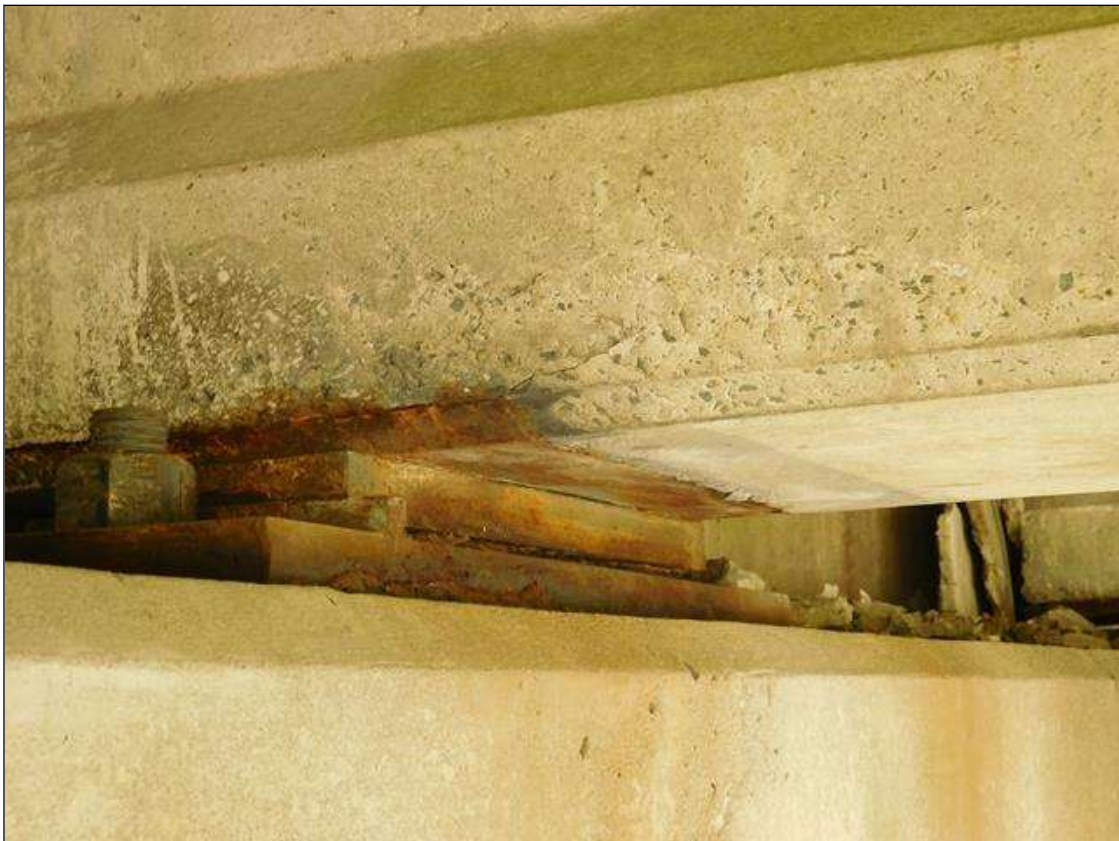
Span 3 Beam 2 Far Bearing: RUST AND FLAKING WITH NO SECTION LOSS

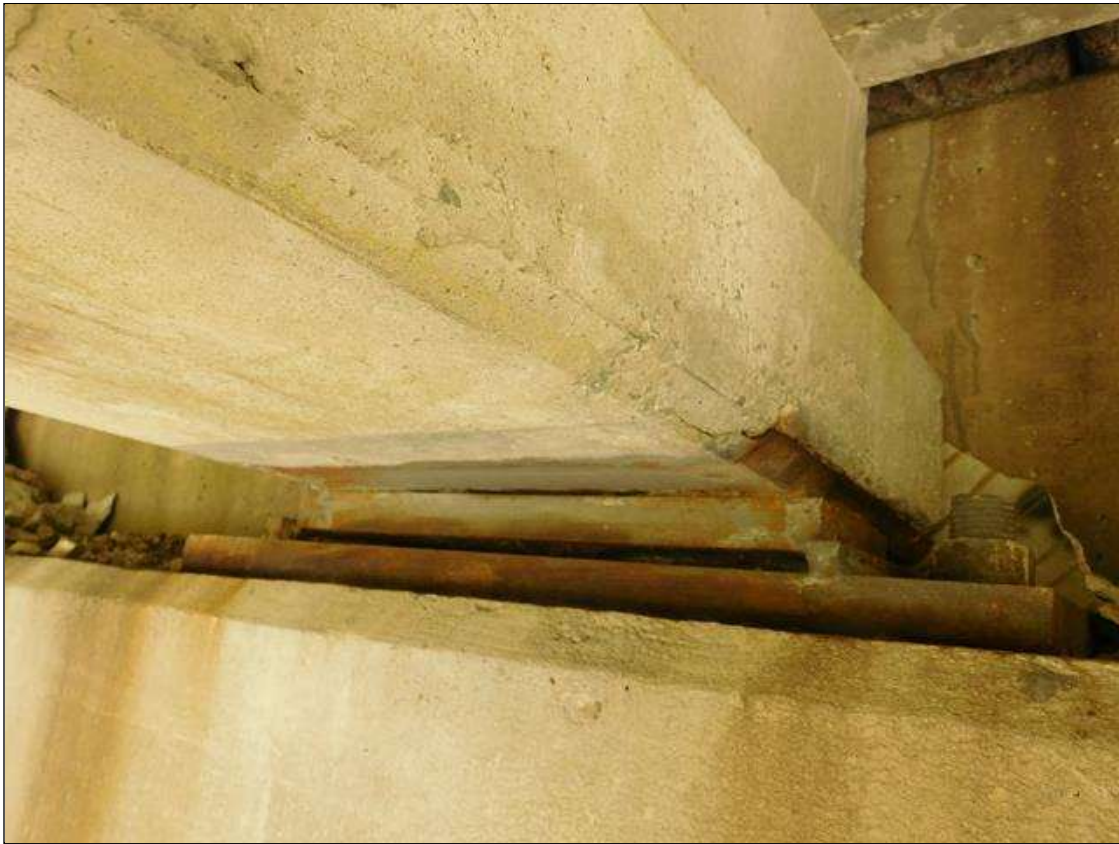
Span 3 Beam 3 Far Bearing: SURFACE CORROSION

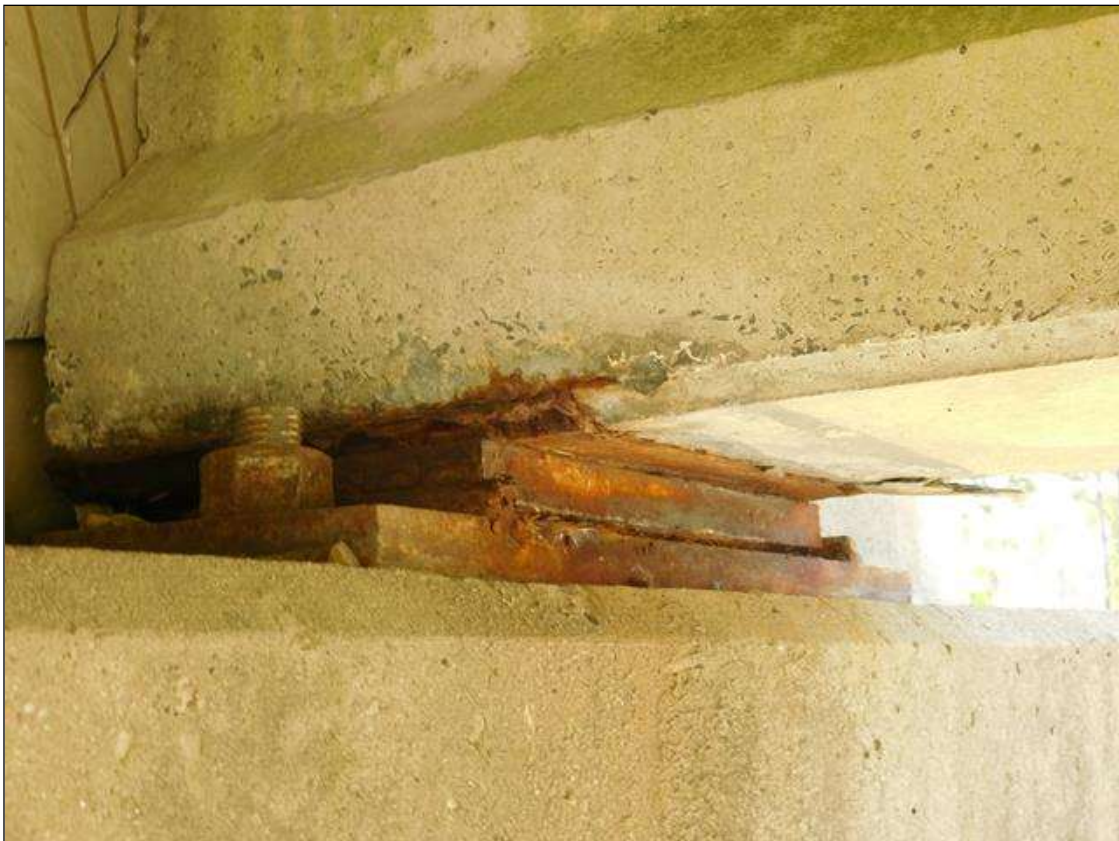
Span 3 Beam 4 Far Bearing: RUST AND FLAKING WITH NO SECTION LOSS

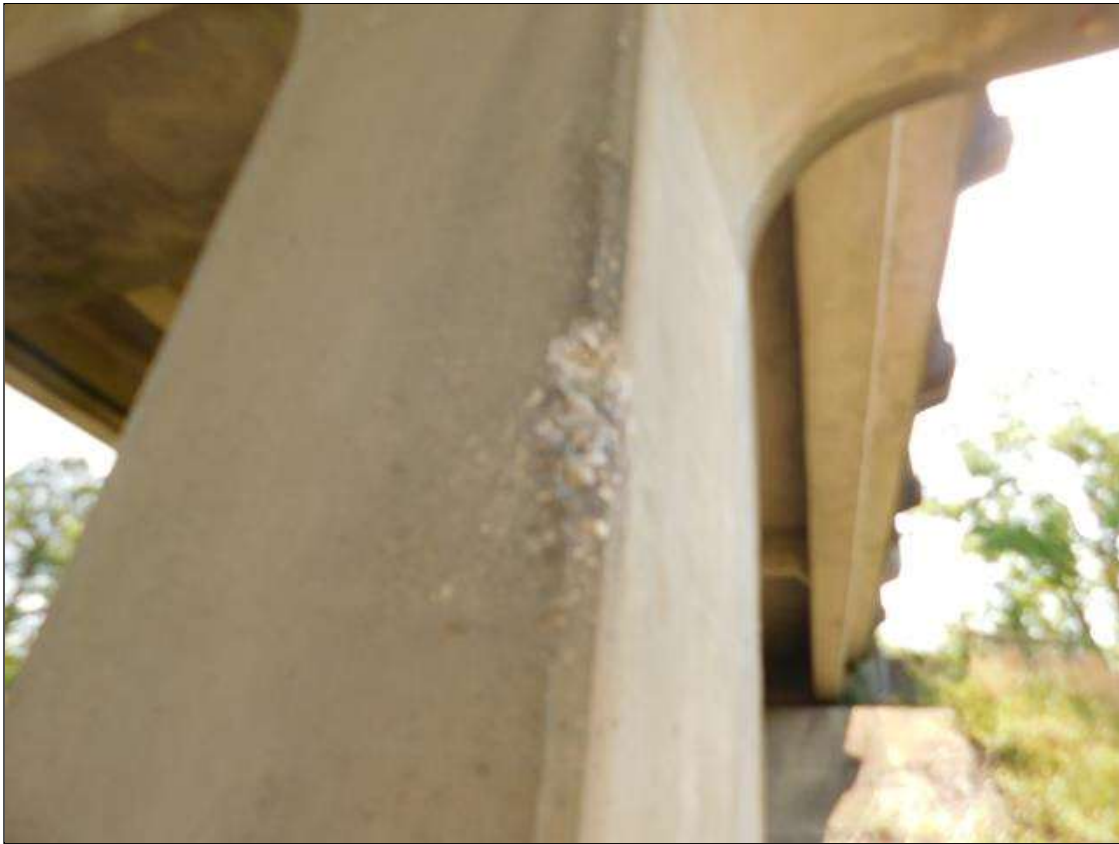
Bent 4 Pile 2: SPALL 8" HIGH X 2" WIDE X 2" DEEP AT EAST FACE 5 FT. BELOW CAP

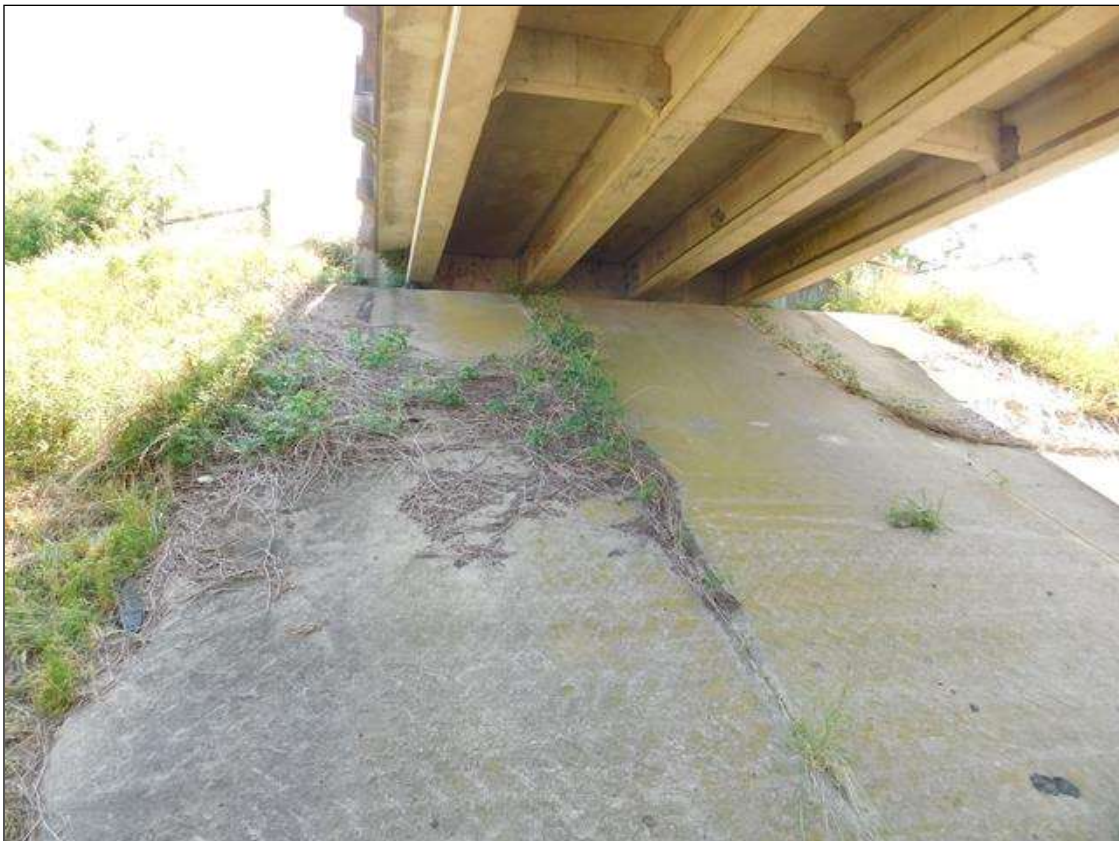
VEGETATION ON END BENT 2 SLOPE, 75 SQUARE FOOT. FT.

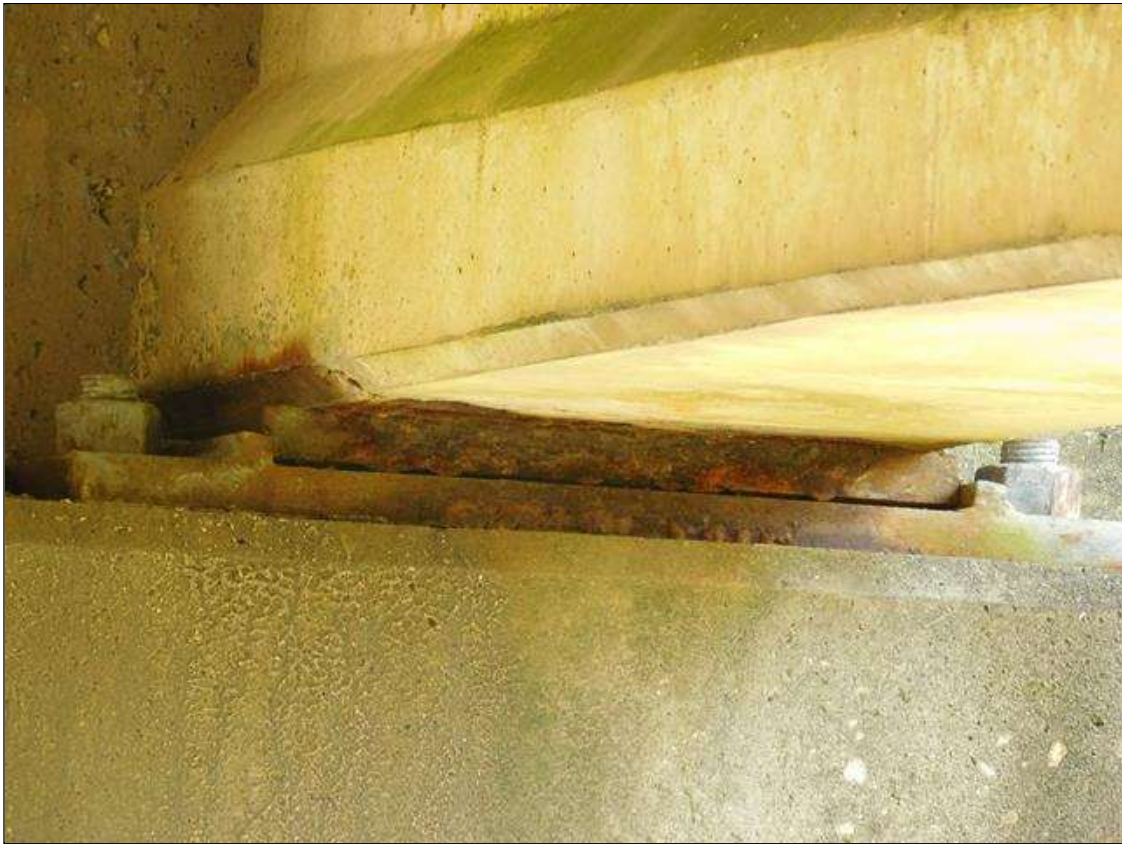
Span 5 Beam 1 Near Bearing: RUST AND FLAKING WITH NO SECTION LOSS

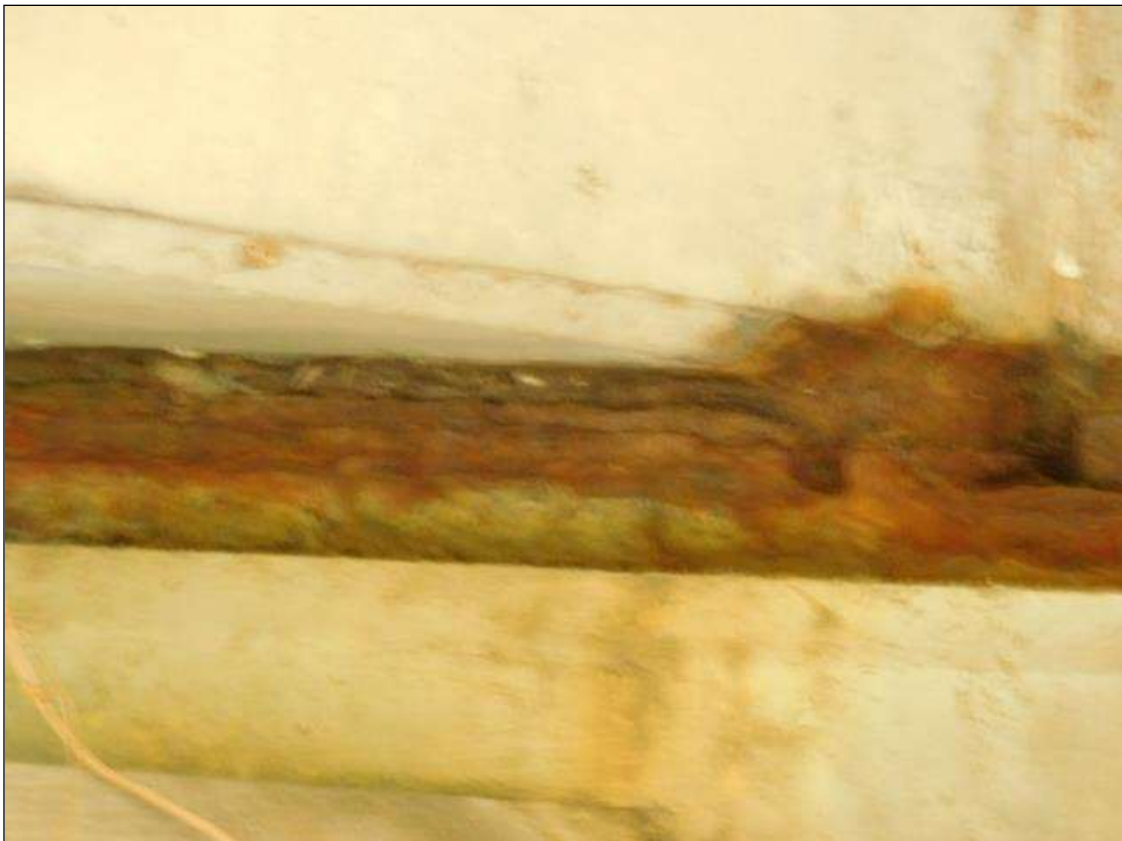
Span 5 Beam 1 Far Bearing: 1/8" OF PACK RUST

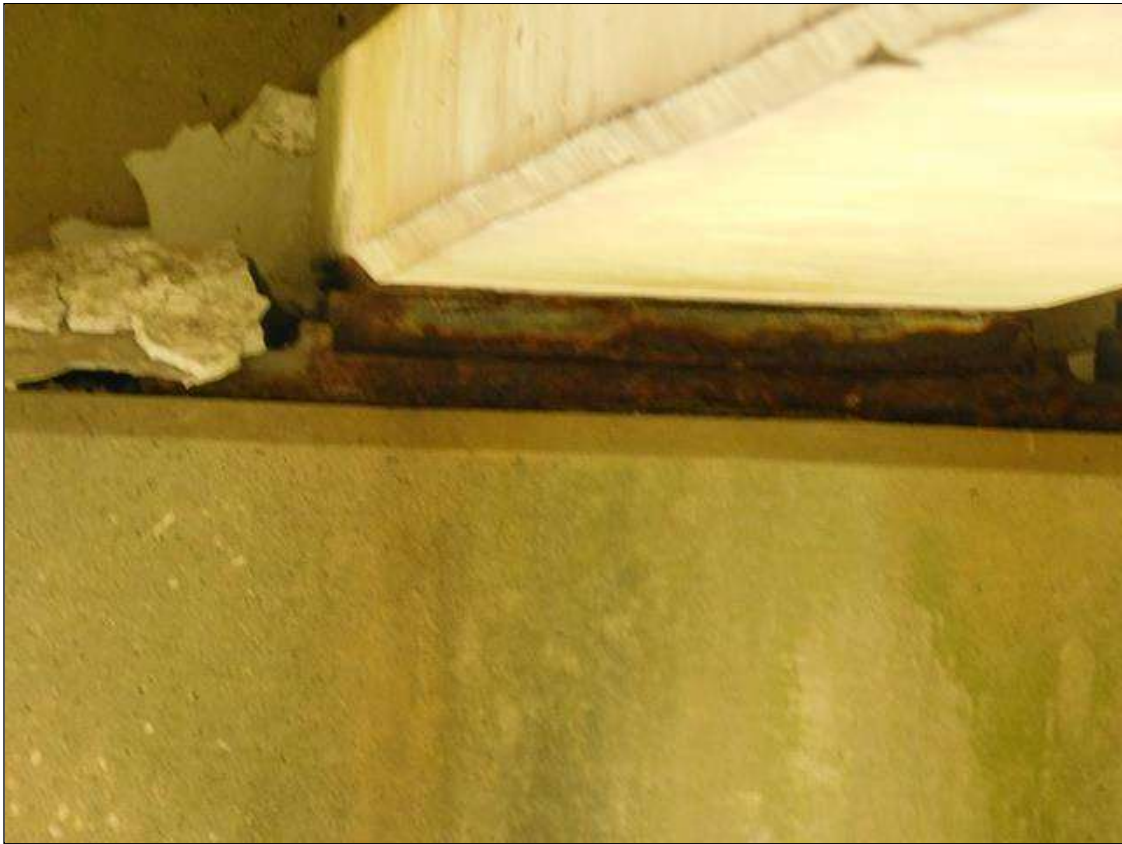
Span 5 Beam 2 Near Bearing: RUST AND FLAKING WITH NO SECTION LOSS

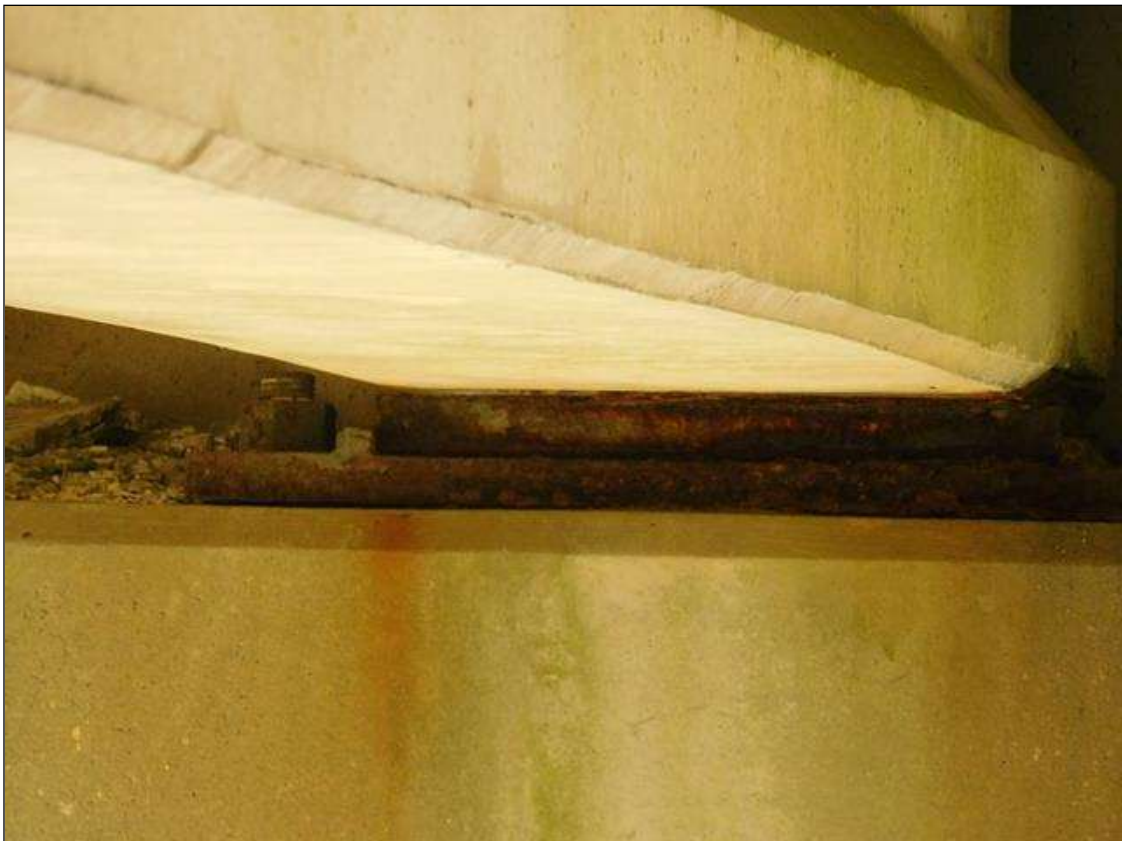
Span 5 Beam 3 Near Bearing: RUST AND FLAKING WITH NO SECTION LOSS

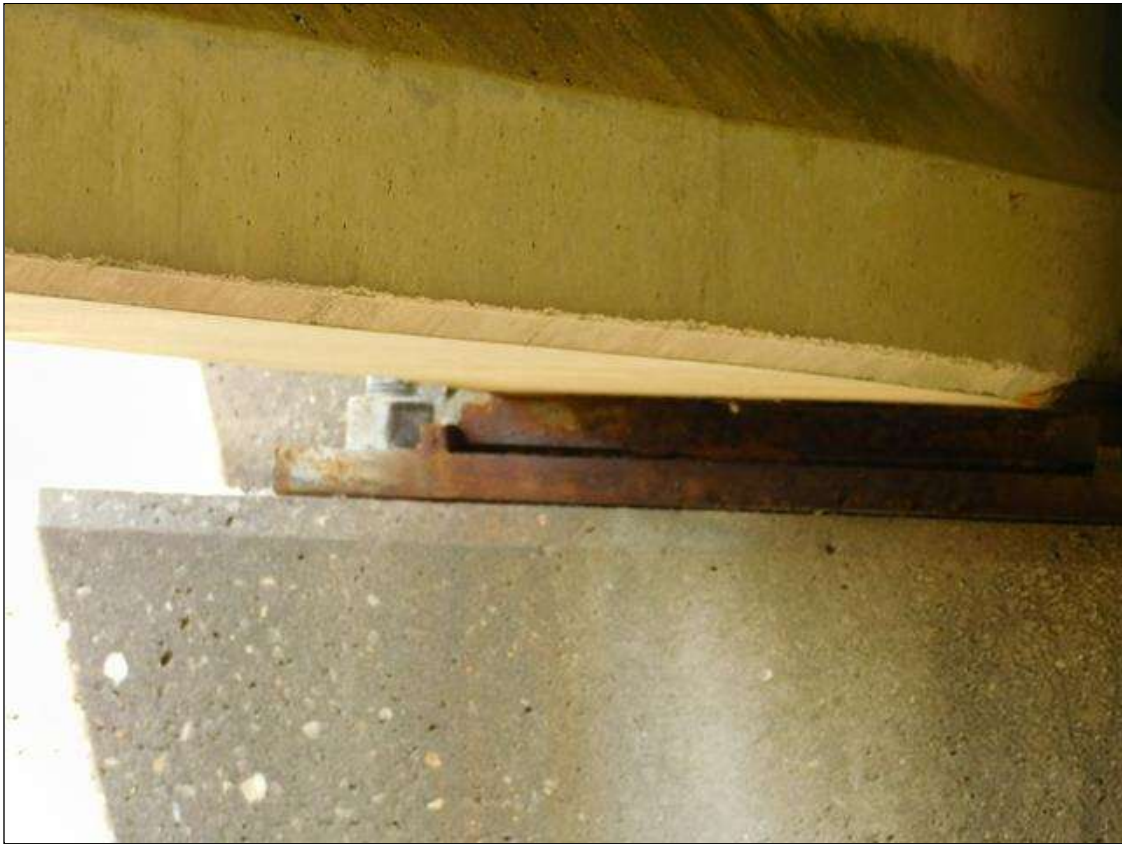
Span 5 Beam 4 Near Bearing: SURFACE CORROSION

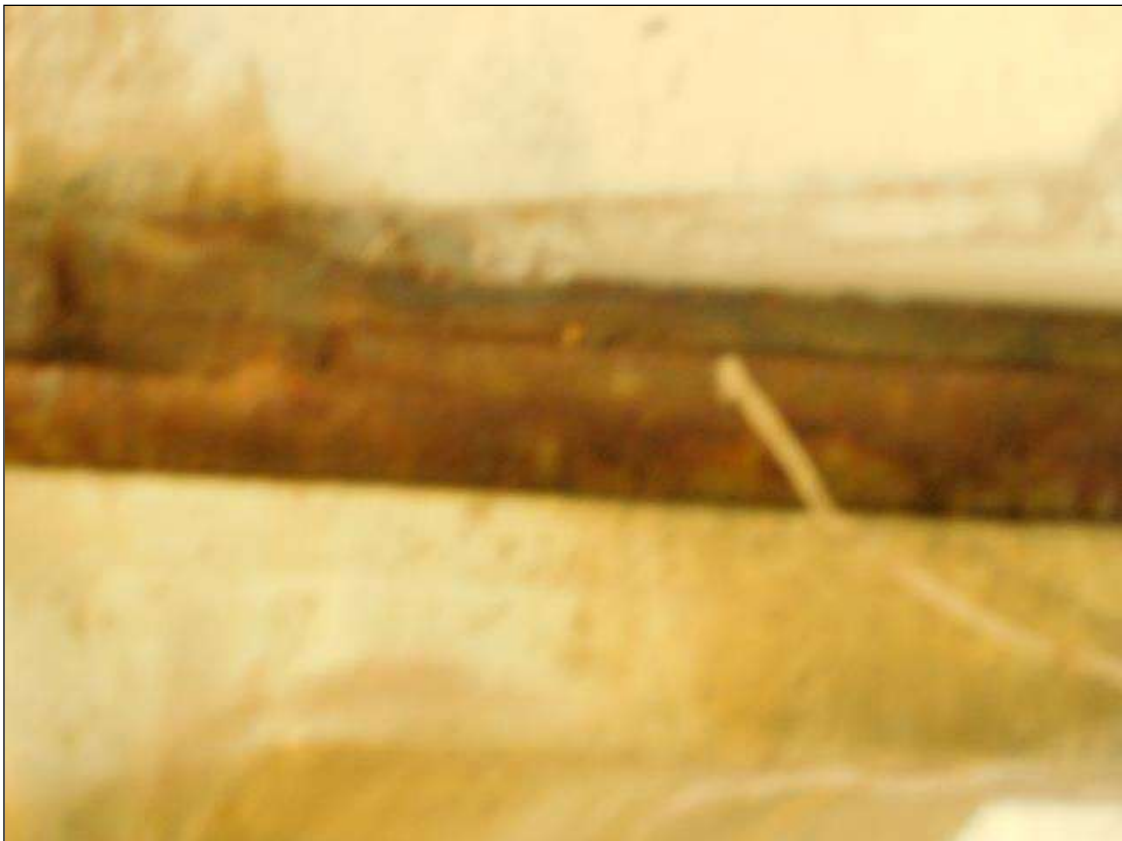
Span 5 Beam 4 Far Bearing: RUST AND FLAKING WITH NO SECTION LOSS
