NC DEPARTMENT OF TRANSPORTATION ATTENTION:
 DIVISION OF HIGHWAYS
 STRUCTURE MANAGEMENT UNIT

Structure Safety Report

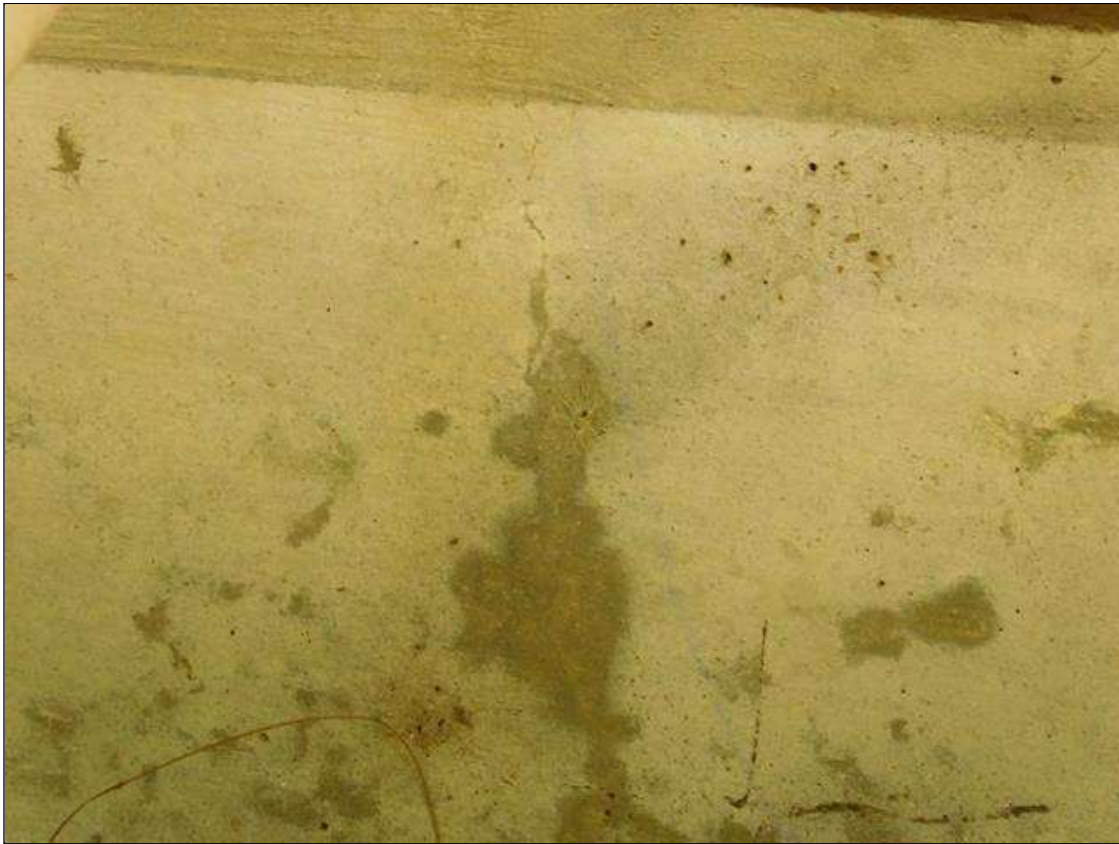
End Bent 1 Cap 1: 12" VERTICAL HAIRLINE CRACK UNDER BAY 1

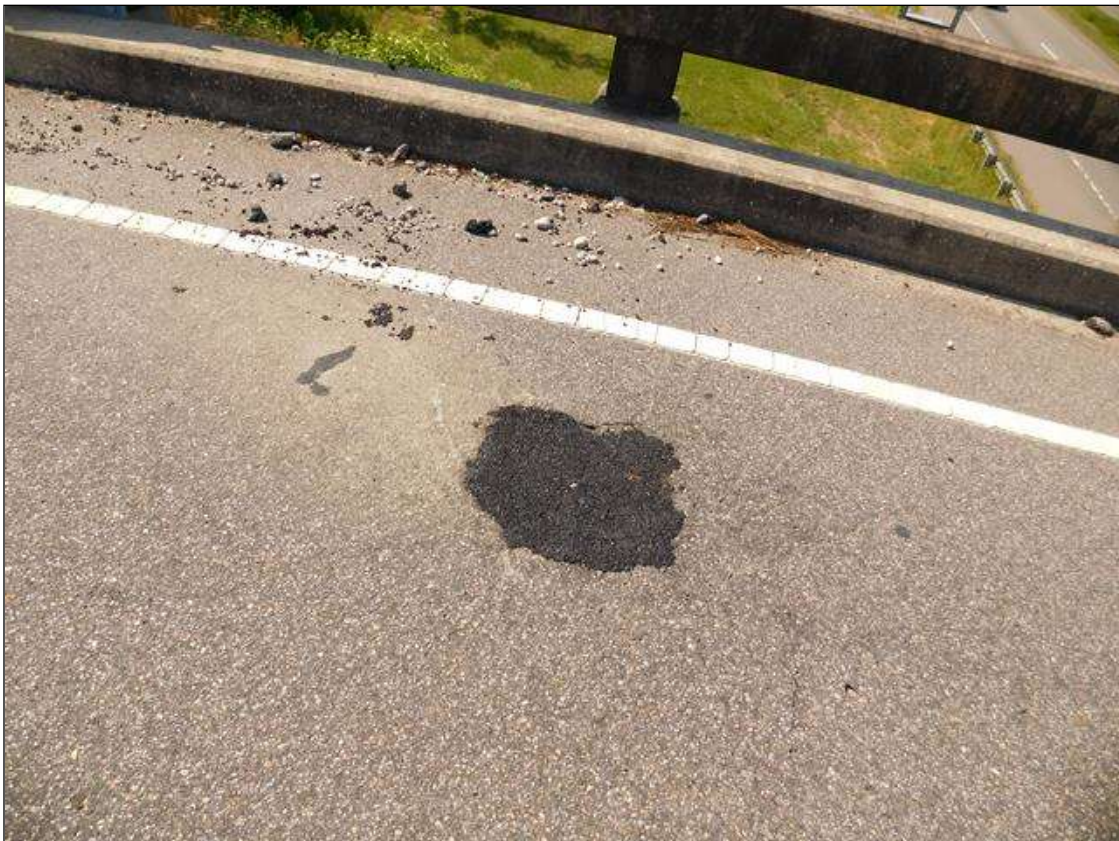
Span 5 Wearing Surface: 1 FT. PATCH IN EASTBOUND LANE AT MID SPAN

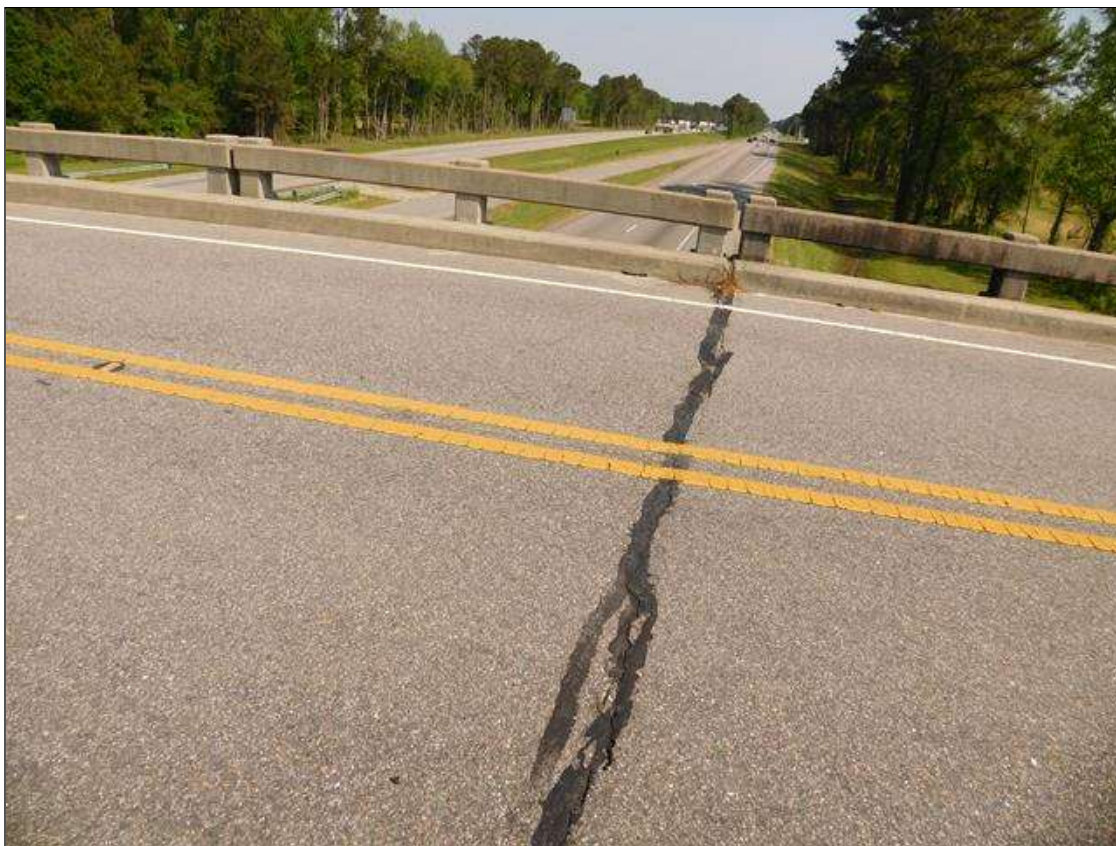
Span 5 Wearing Surface: SEALED TRANSVERSE CRACK OVER BENT 4

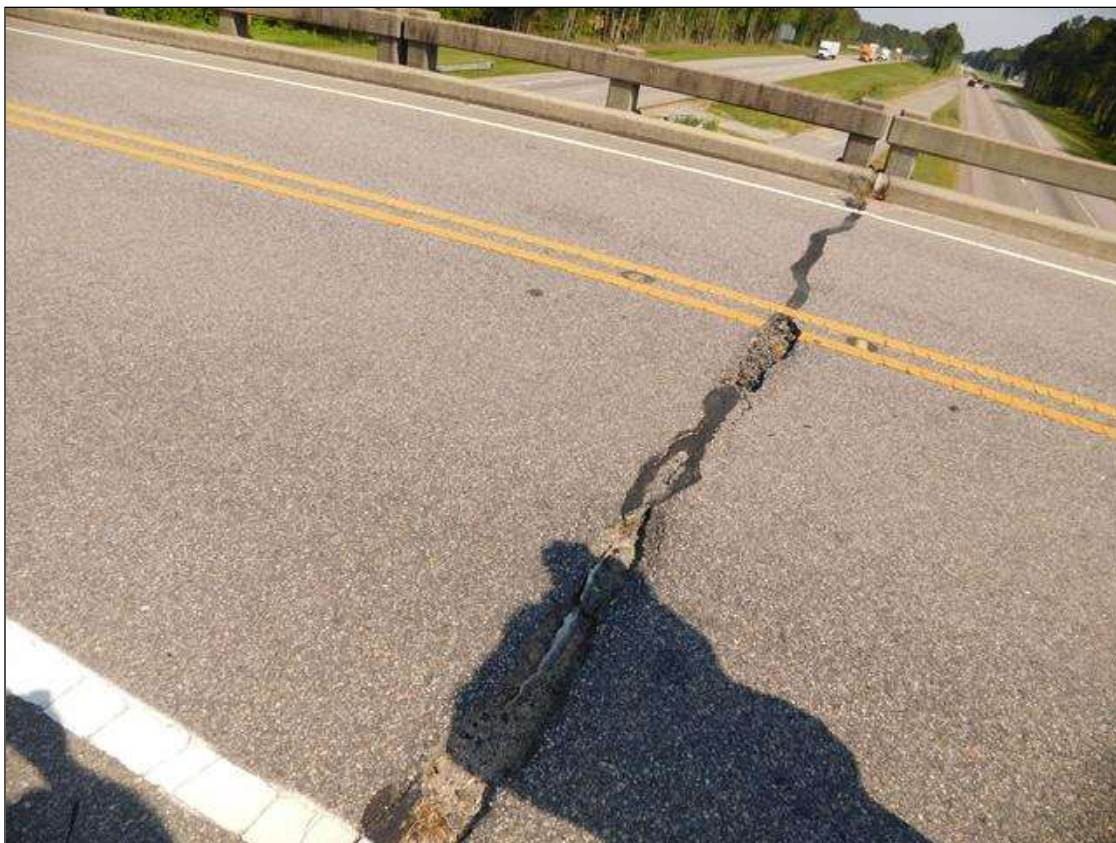
Span 4 Wearing Surface: 2 - 36" WIDE X UP TO 8" LONG X 2" DEEP POTHOLES AT BENT 3 IN THE EASTBOUND LANE

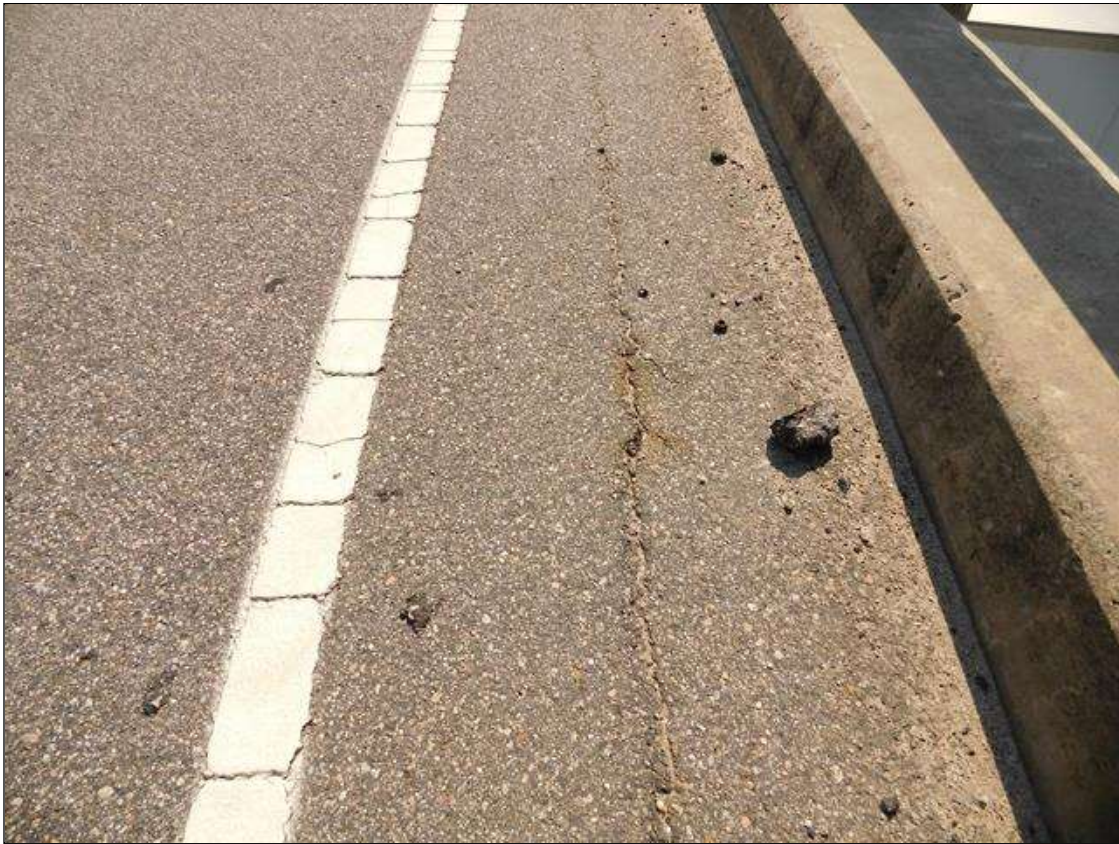
Span 4 Wearing Surface: .010 LONGITUDINAL CRACK IN THE RIGHT SHOULDER

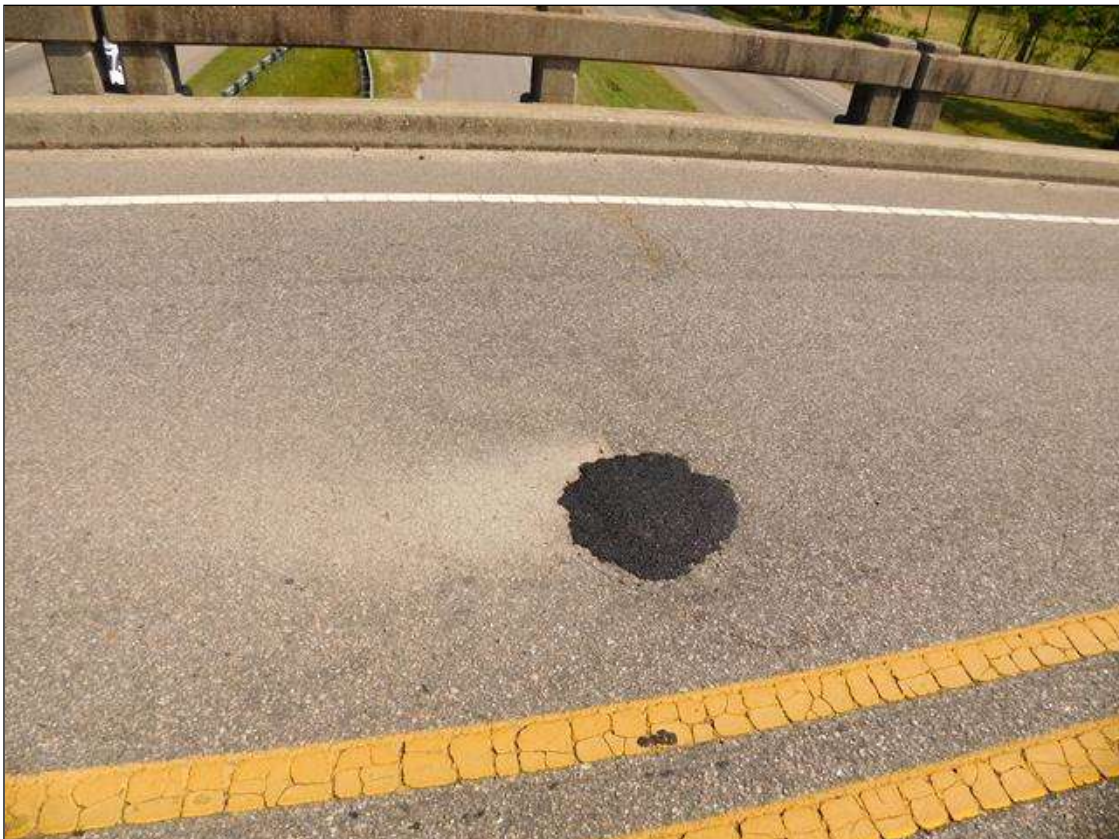
Span 3 Wearing Surface: SOUND PATCH IN WESTBOUND LANE AT MIDSPAN

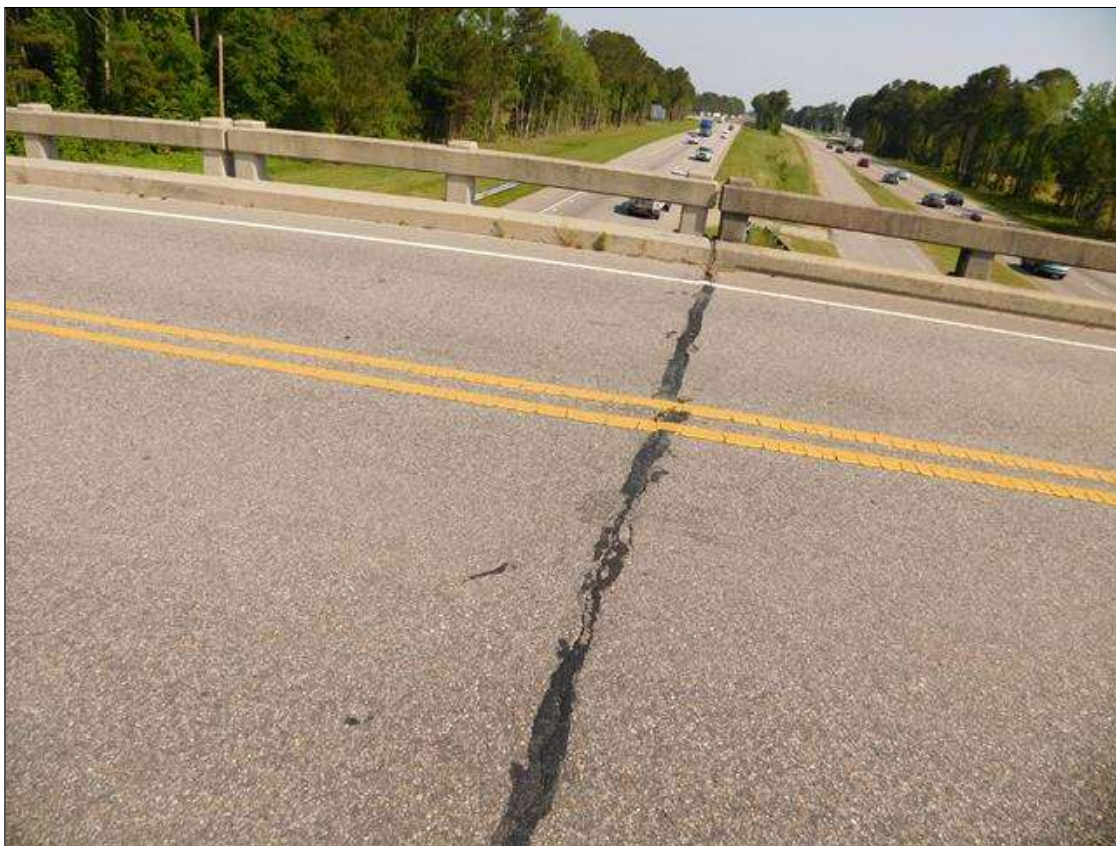
Span 3 Wearing Surface: 24 FT. SEALED TRANSVERSE CRACK OVER BENT 2

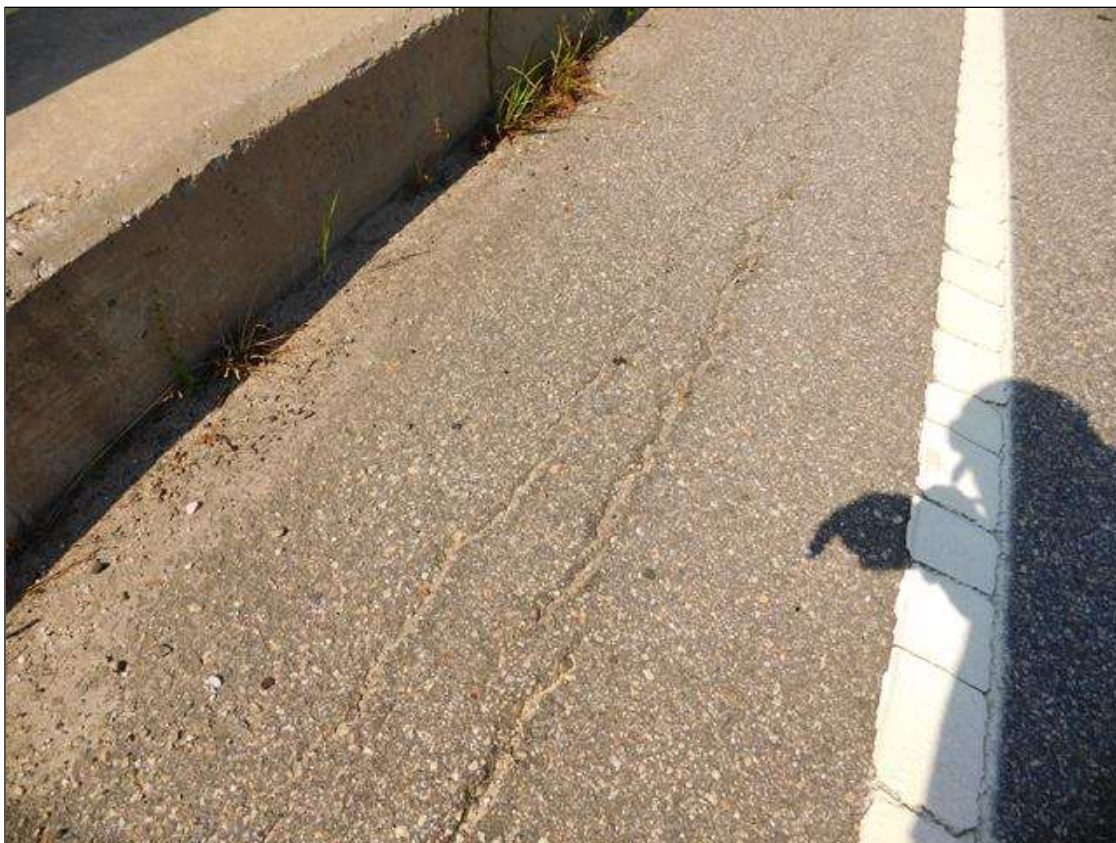
Span 2 Wearing Surface: 50 FT. LONGITUDINAL CRACK .005 WIDE IN RIGHT SHOULDER

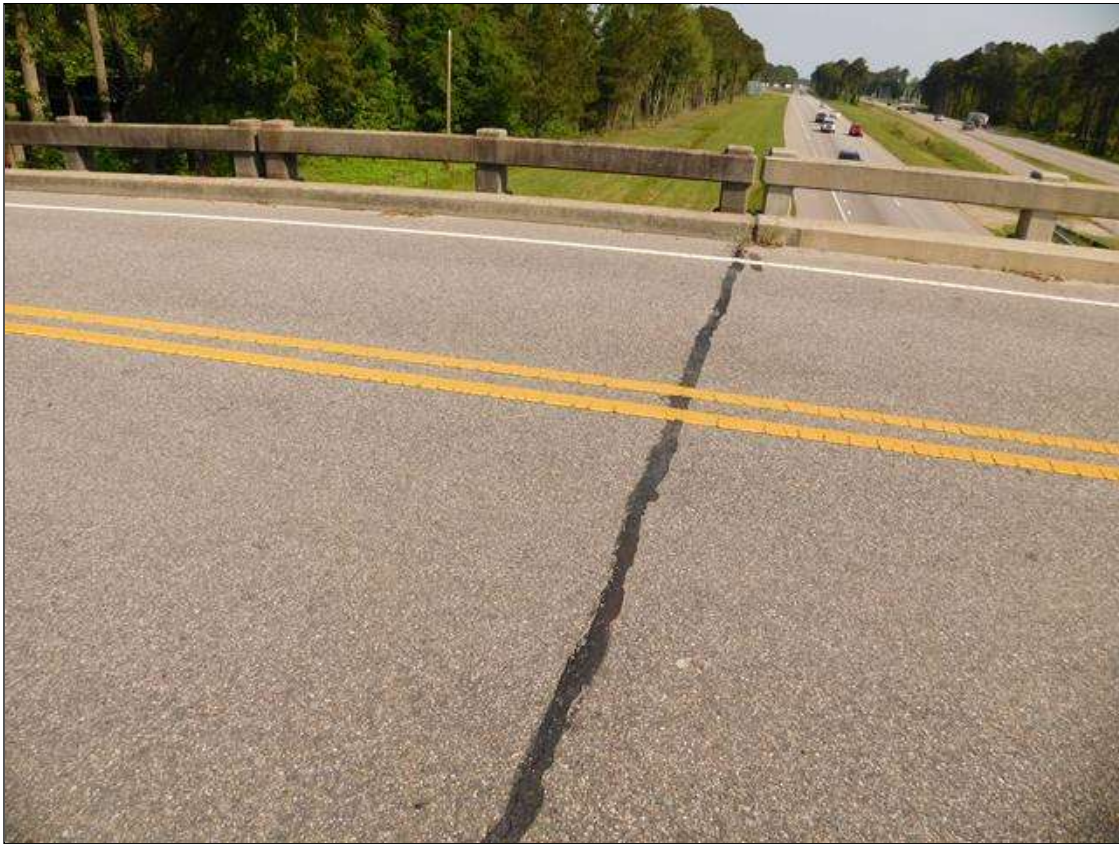
Span 2 Wearing Surface: 24 FT. SEALED TRANSVERSE CRACK OVER BENT 1

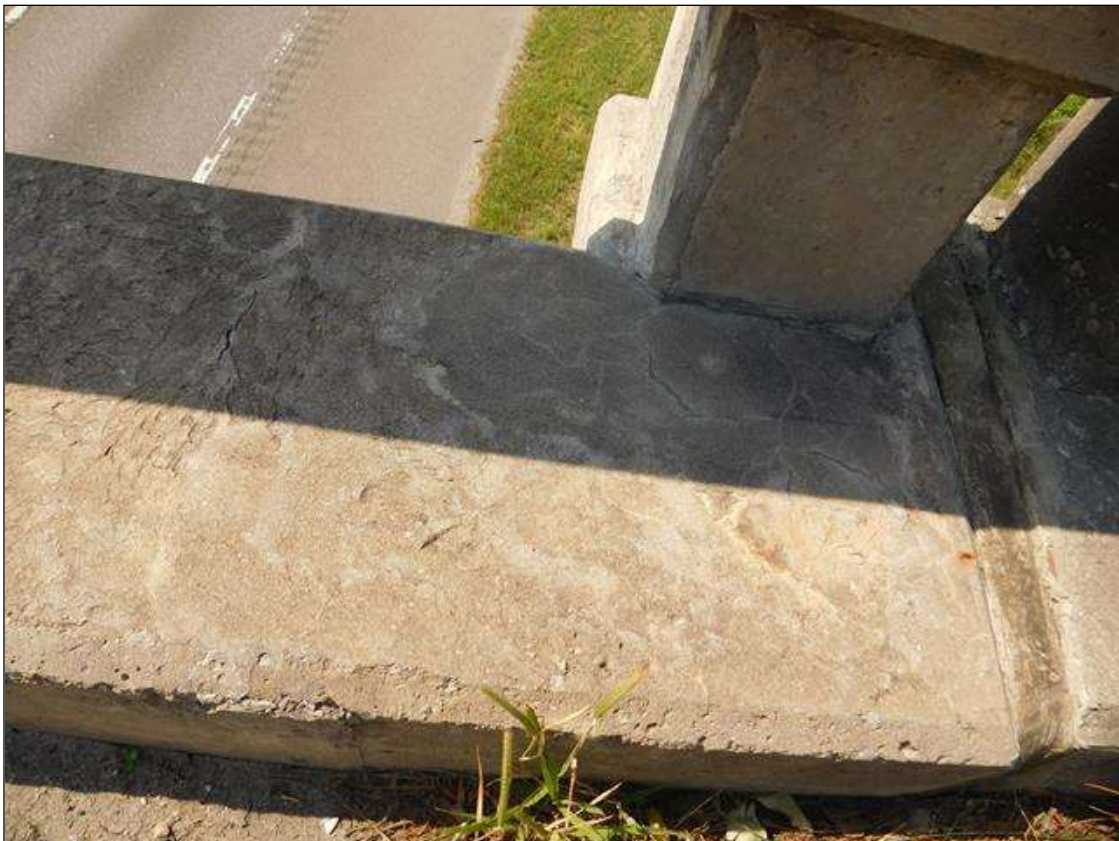
Span 2 Right Bridge Rail: 2 SF. OF HAIRLINE MAP CRACKING IN TOP OF CURB AT BENT 1

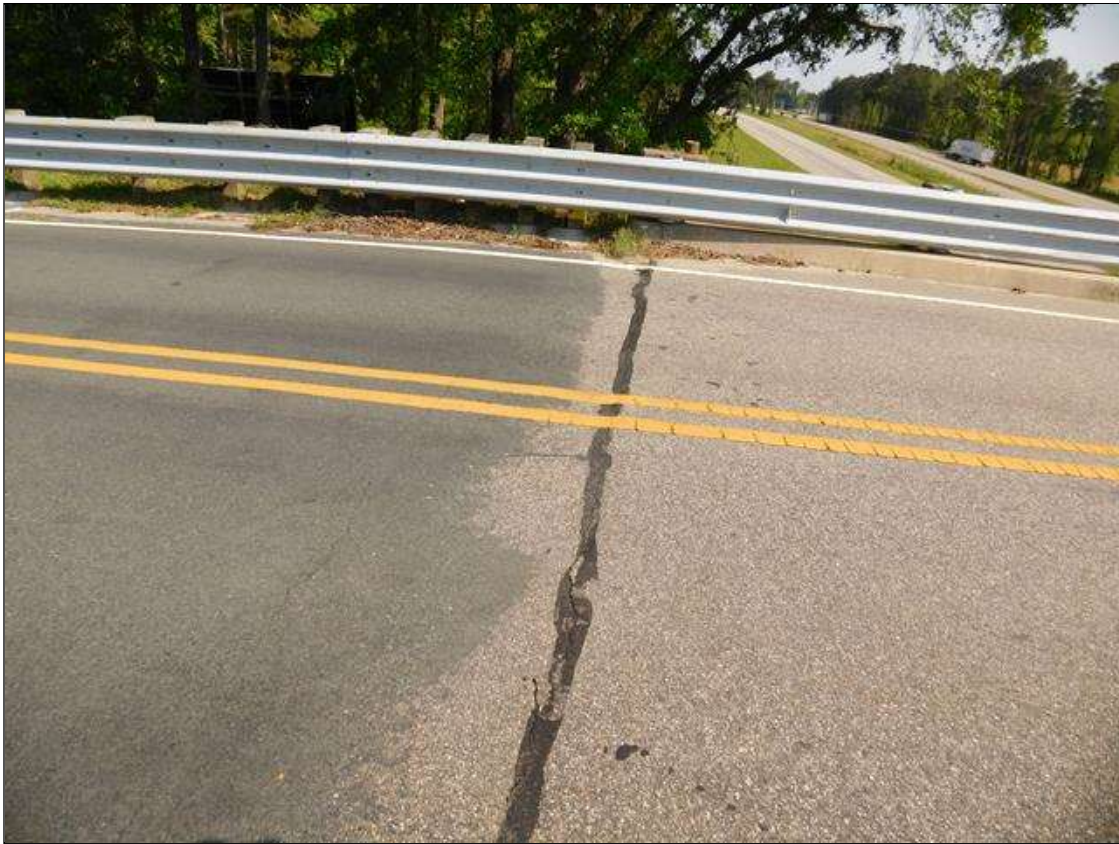
Span 1 Wearing Surface: 24 FT. LONG SEALED CRACK AT END BENT 1

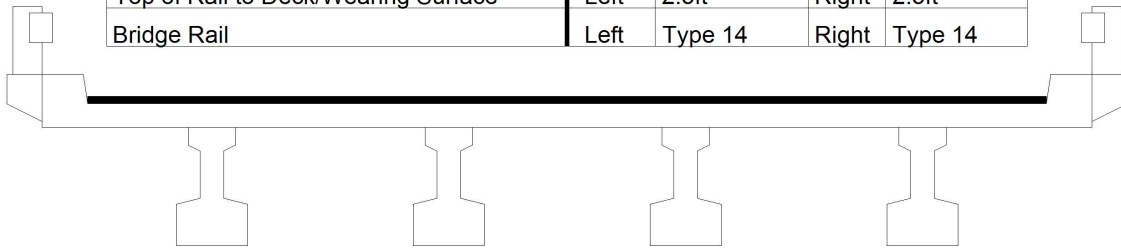
Measurements for Span #	1	SPANS 3 AND 5 SIMILAR	
Deck Thickness	0.583	Left Overhang	3.67
Top of Rail to Bottom of Beam	6.167	Right Overhang	3.67

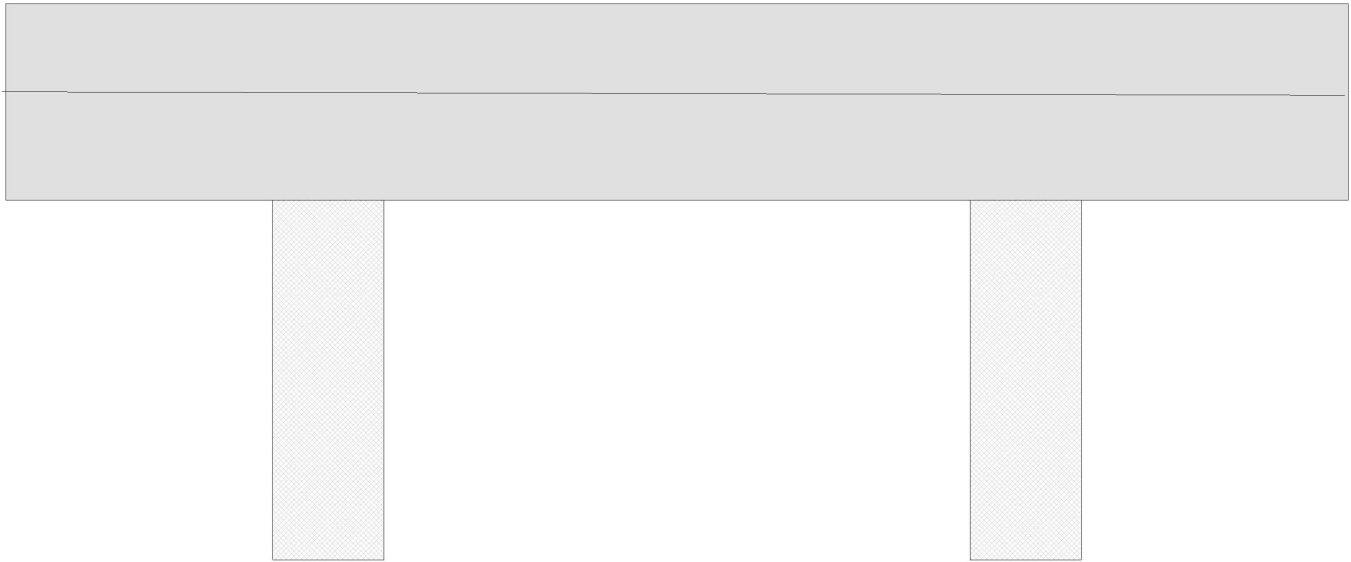
Cap Information			Material Cast-in-Place Concrete							
Length	Width	Height	Left Overhang	Right Overhang	Left Beam to End of Cap.	Right Beam to End of Cap.				
30.167 ft.	3.250 ft.	4.417 ft.	7.250 ft.	7.250 ft.	2.500 ft.	2.833 ft.				
Subcap Information			Material							
Length	Width	Height	Left Overhang	Right Overhang	Left Pile to Splice.					
Sill Information			Material							
Length	Width	Height								
Pile #	Material	Spacing	Width/Dia.	Height	Length	Orientation	Driven?	Replacement?	Removed?	Collar?
1	Concrete	15.667 ft.	2.5 ft.	3.25 ft.		Vertical	No	No	No	No
2	Concrete		2.5 ft.	3.25 ft.		Vertical	No	No	No	No
MEASUREMENTS VERIFIED BY SFS 4/29/19										
Bent/Abutment #: 1			Similar Bents: 2,3&4
