NC DEPARTMENT OF TRANSPORTATION  
 DIVISION OF HIGHWAYS  
 STRUCTURE MANAGEMENT UNIT

ATTENTION: **UPDATED NBL CLEARANCE SKETCH, SBL CLEARANCE SKETCH AND SUBSTRUCTURE SKETCH**

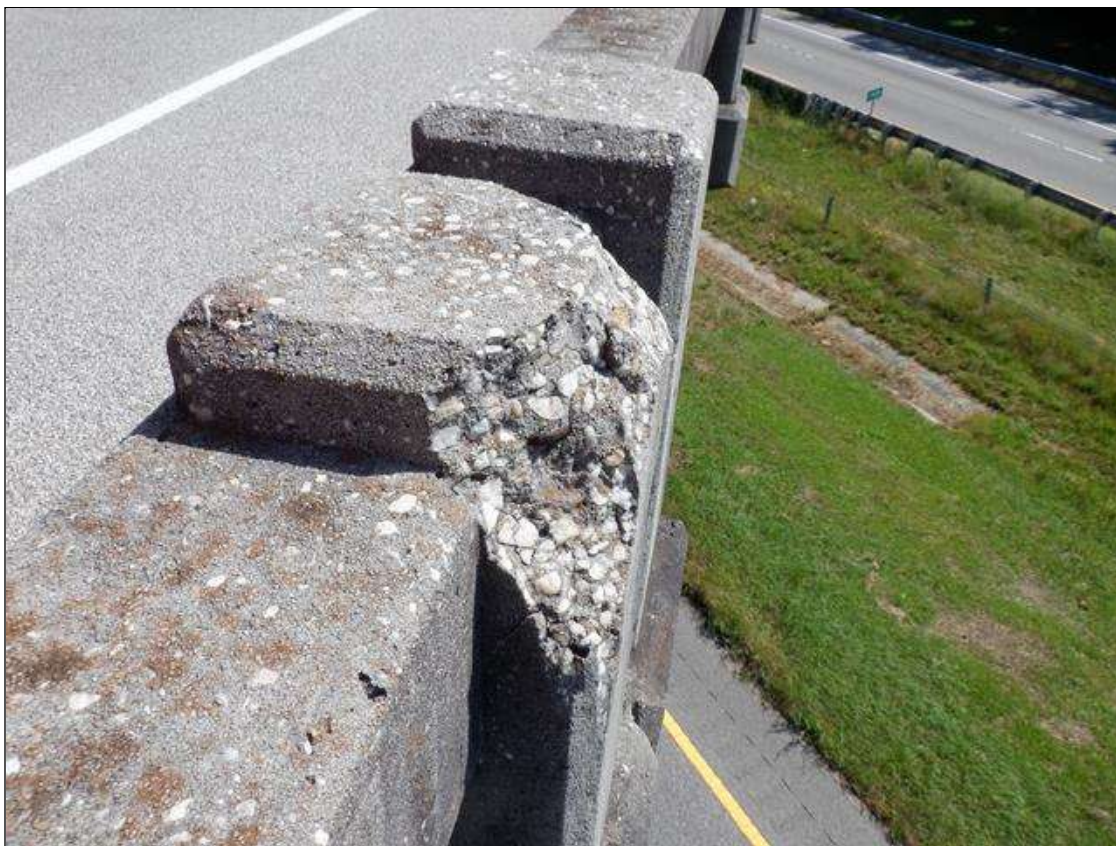
Span 2 Right Bridge Rail: RAIL POST # 4 SPALL 4" HIGH X 2" WIDE X 1" DEEP WITH EXPOSED REBAR

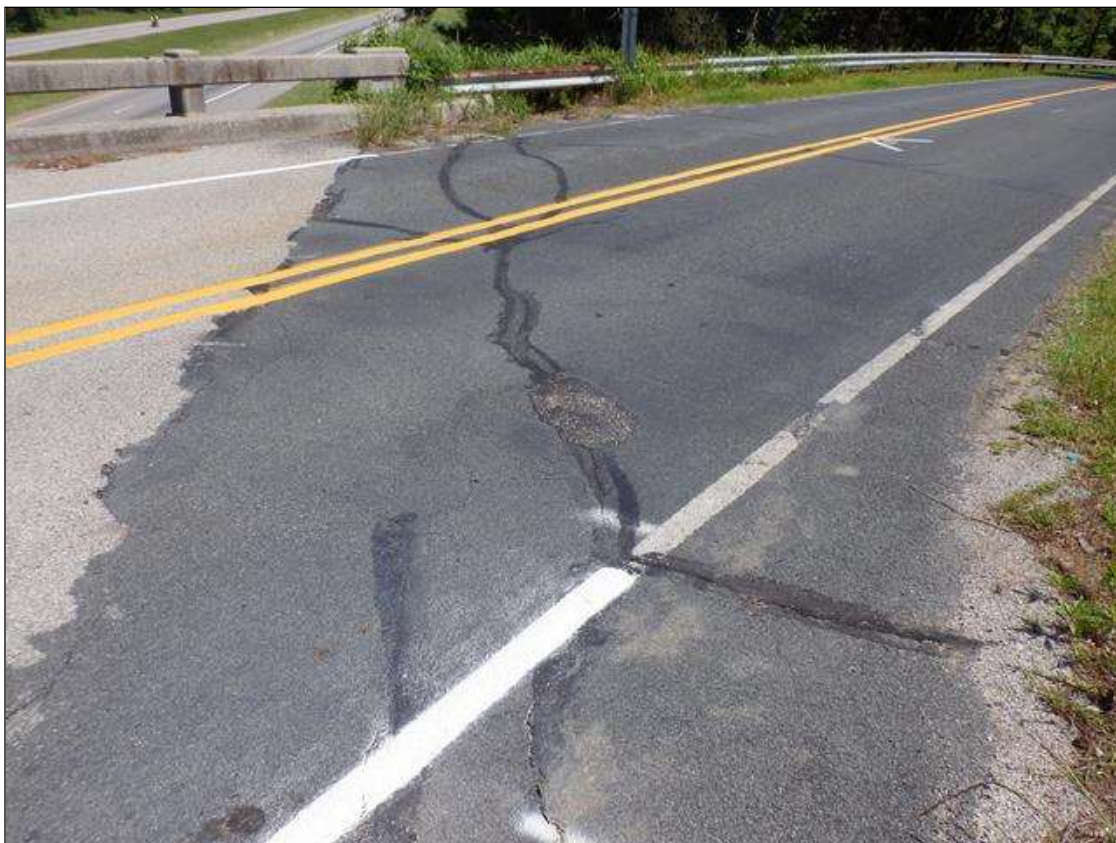
LAERAL CRACKING ACROSS ENTIRE ROADWAY 5FT EAST OF EAST APPROACH

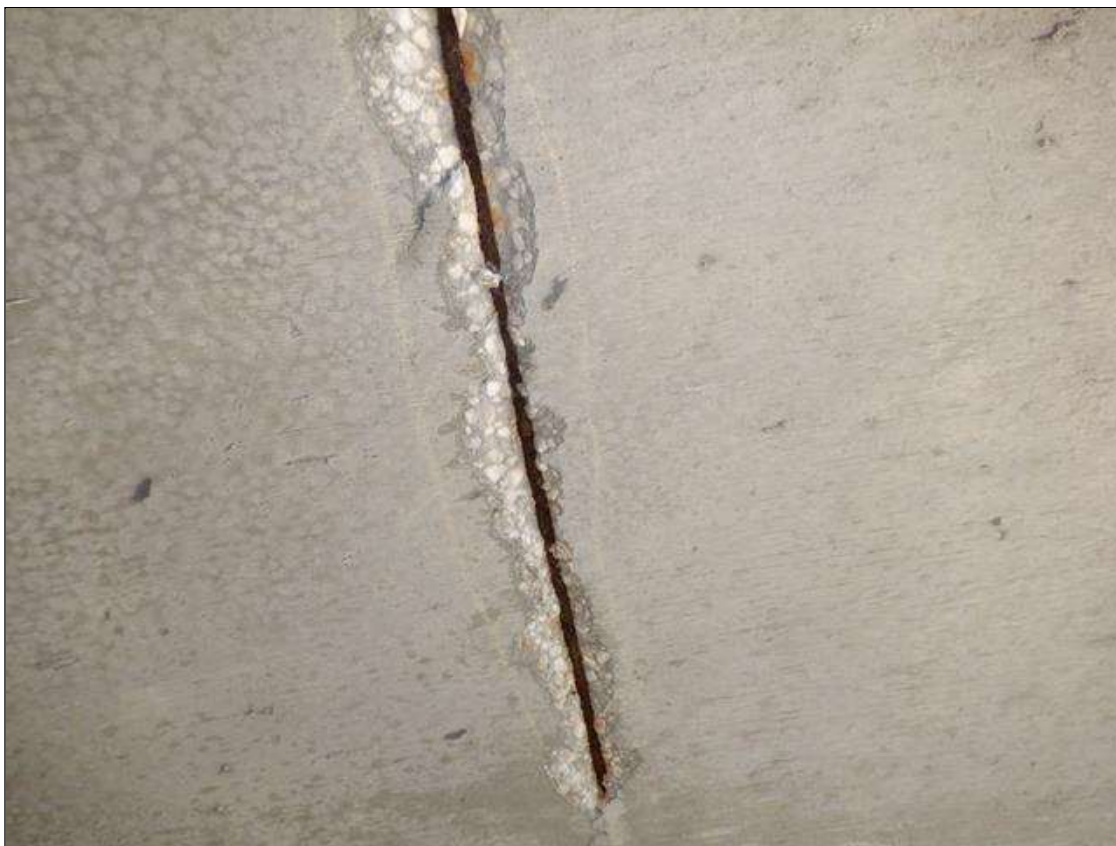
Span 5 Deck: 30" X 4" X 1" DEEP SPALL LOCATED ON BOTTOM SIDE OF DECK IN BAY 3 NEAR ENDBENT 2.  
EXPOSED REBAR

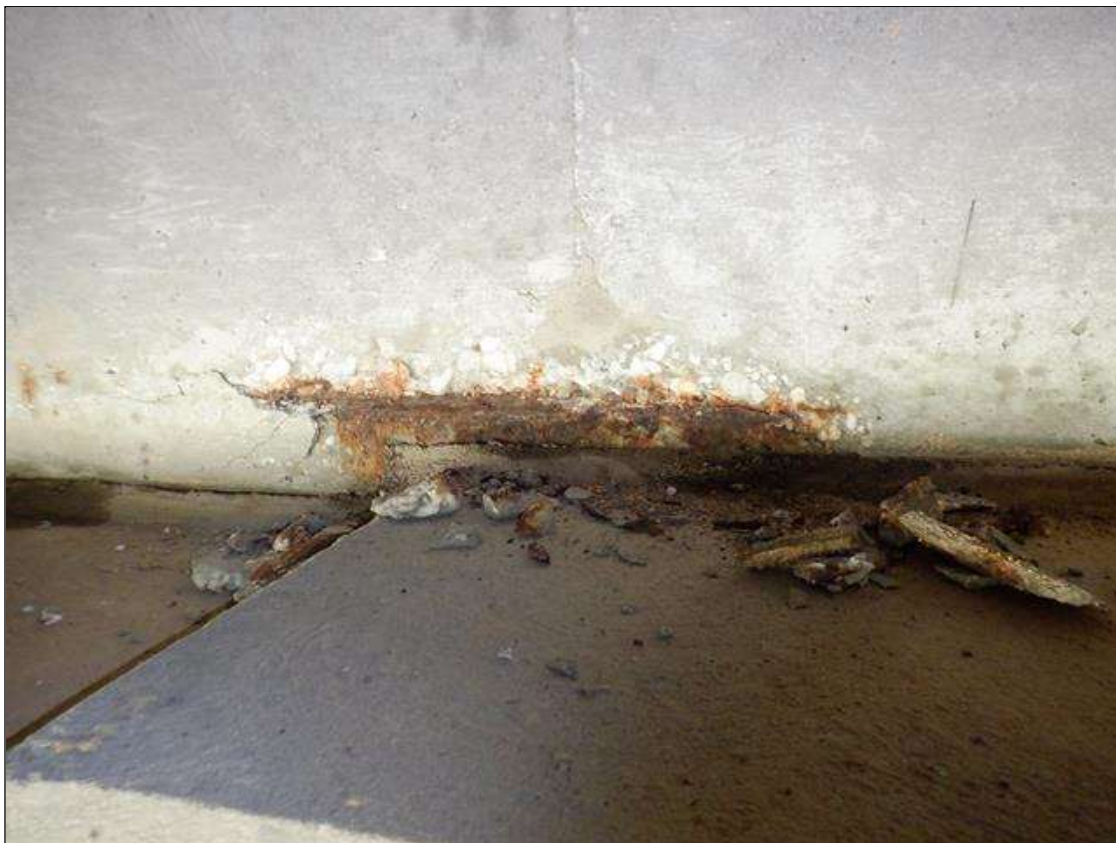
End Bent 2 Abutment/Backwall : SPALL 1.5 FT LONG X 4" WIDE X 1" DEEP LOCATED IN BAY 2

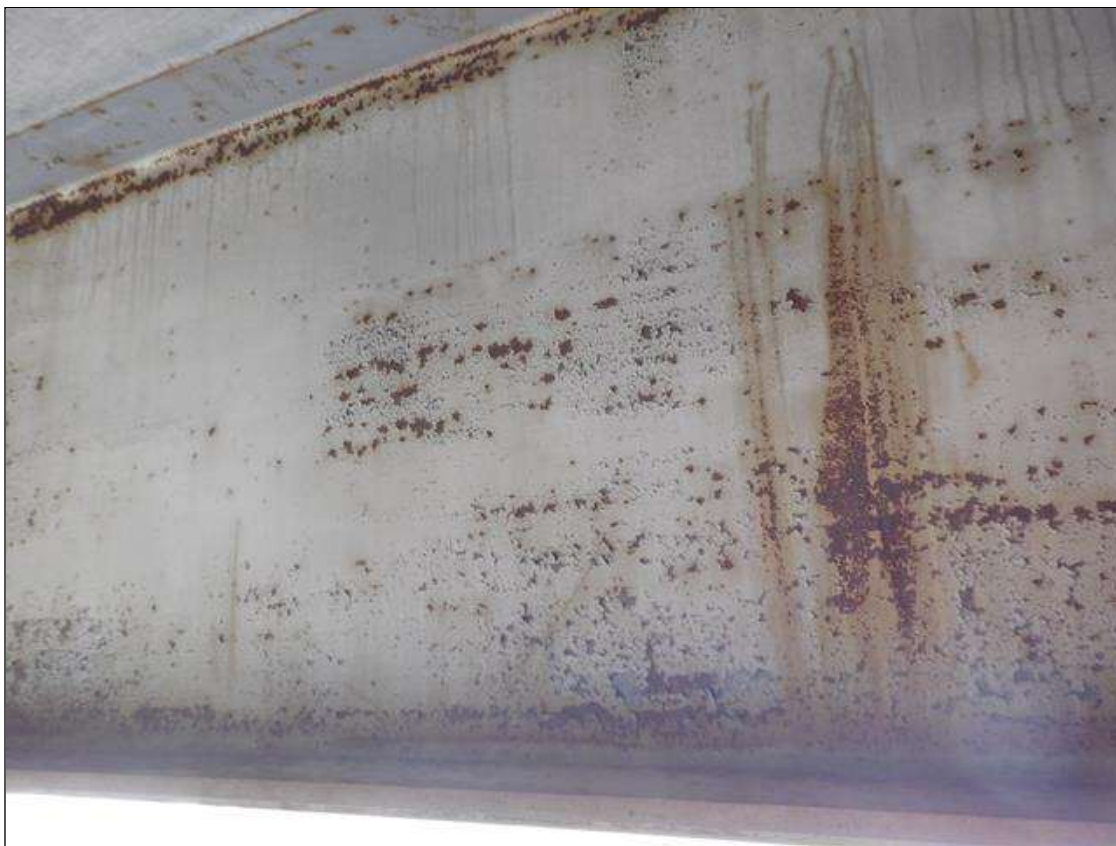
Span 5 Beam 2: PAINT PEELING AND SURFACE RUST IN FLANGES AND WEBS

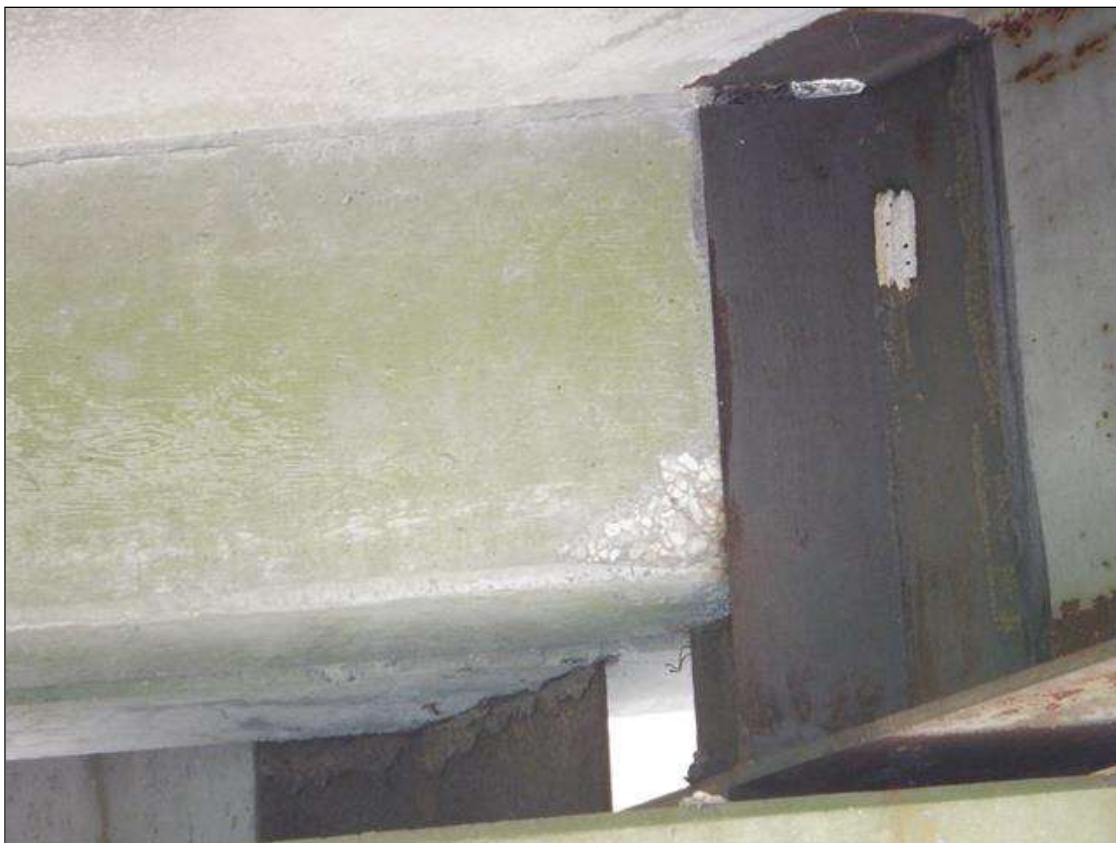
SPALL MEASURING 8" IN DIAMETER BY 1" DEEP LOCATED IN THE CONCRETE BUILD UP IN SPAN 1 BAY 2 OVER BENT 1.

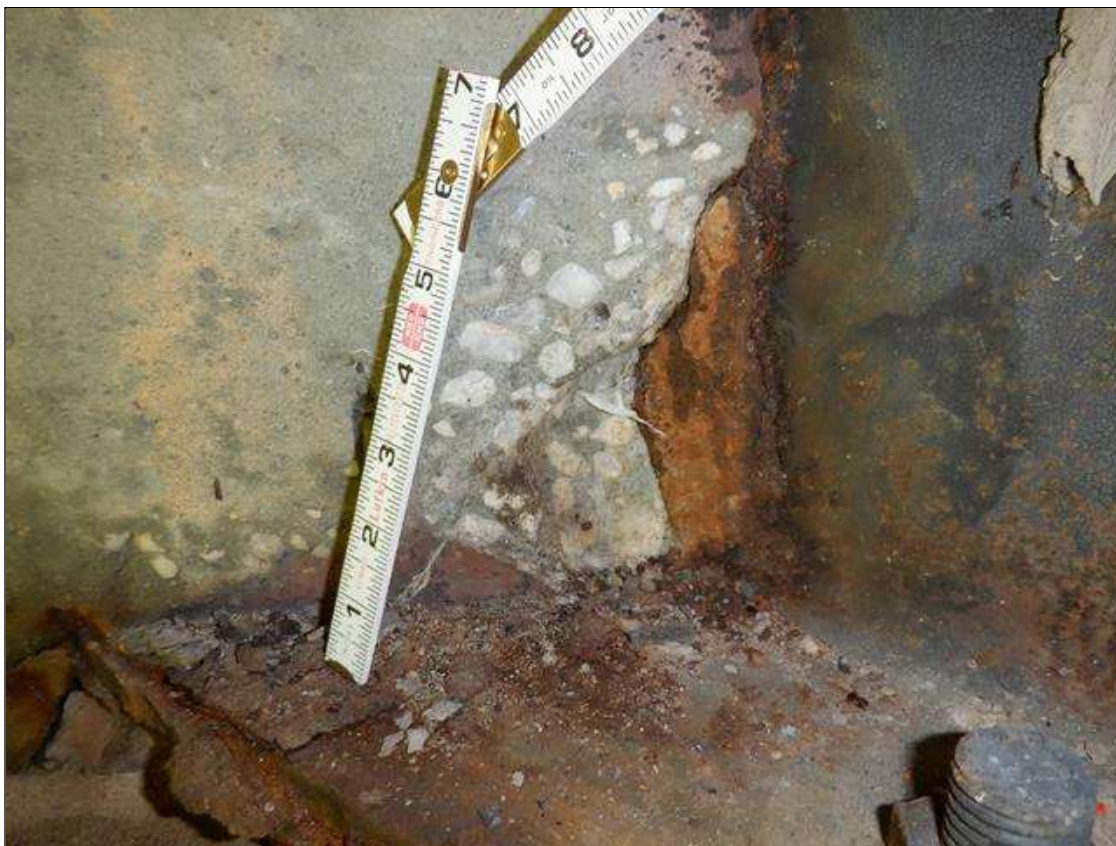
End Bent 1 Abutment/Backwall : SPALL MEASURING 7" HIGH X 4" WIDE X 1" DEEP LOCATED BAY 3 ADJACENT TO BEAM 3

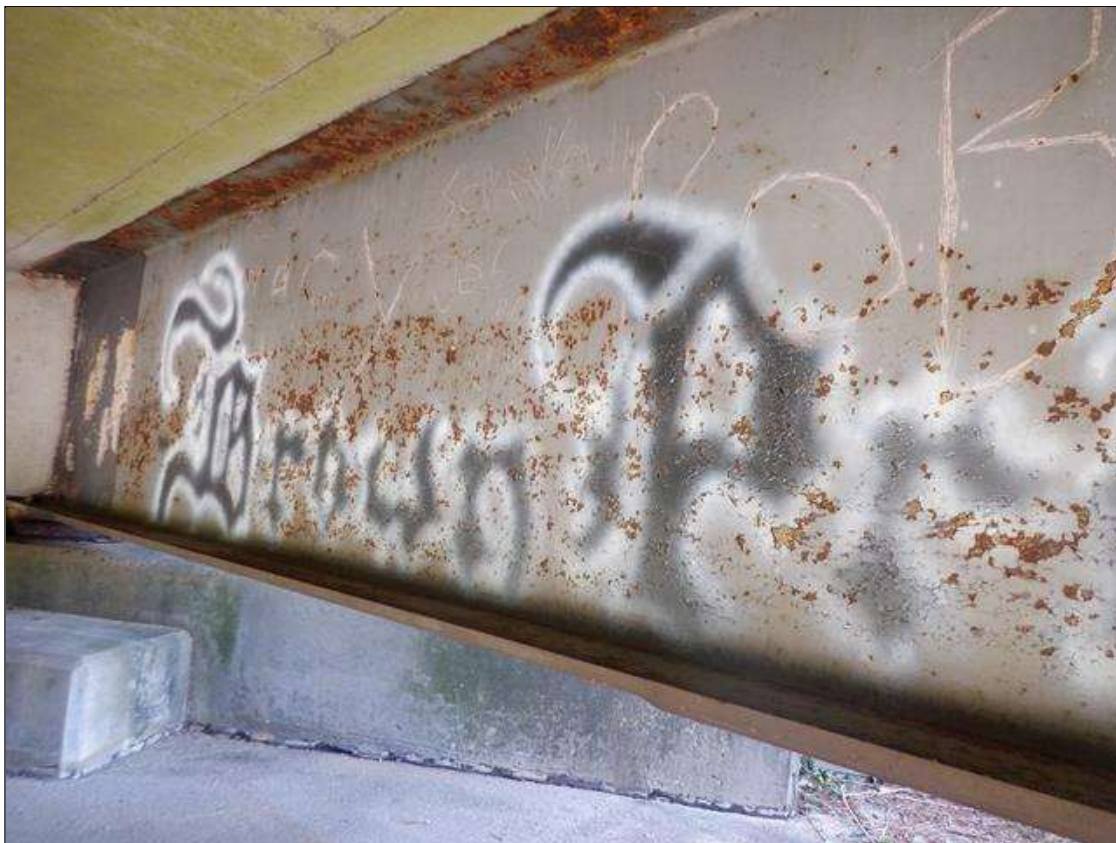
Span 1 Beam 1: PAINT PEELING WITH SURFACE RUST , NO SECTION LOSS

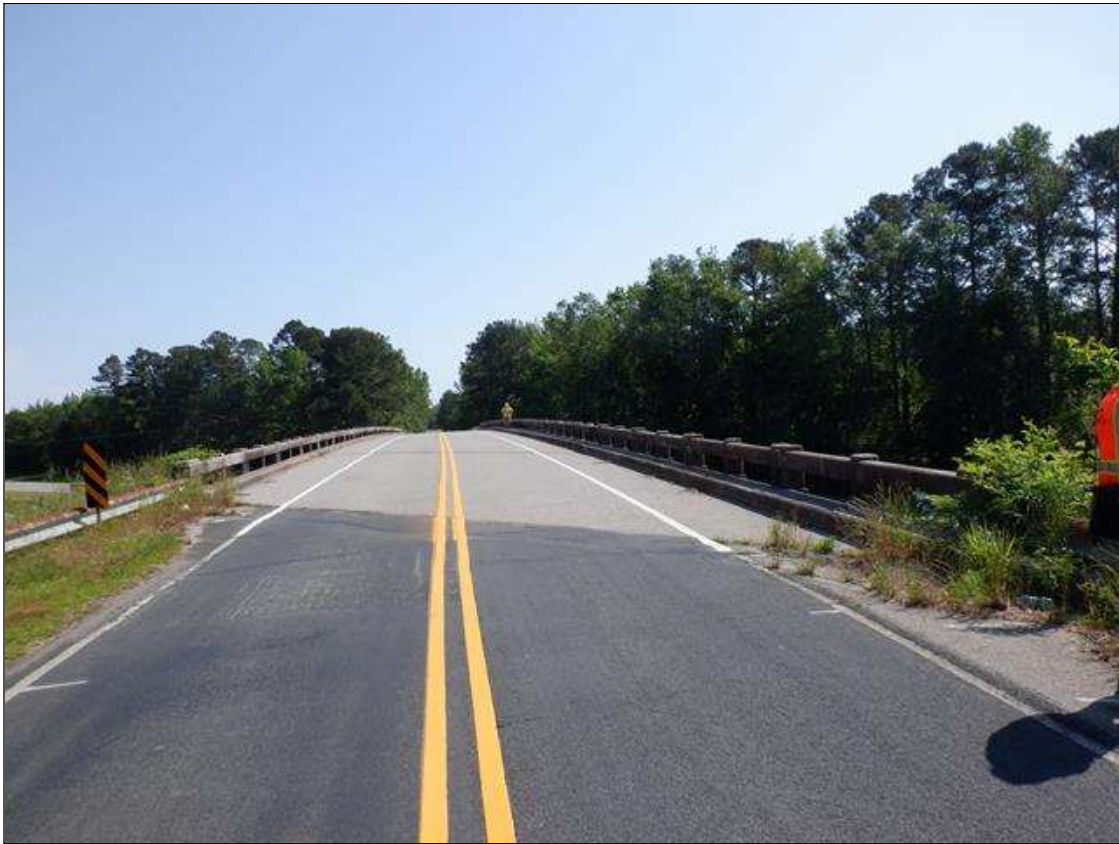
COVER PHOTO LOOKING EAST

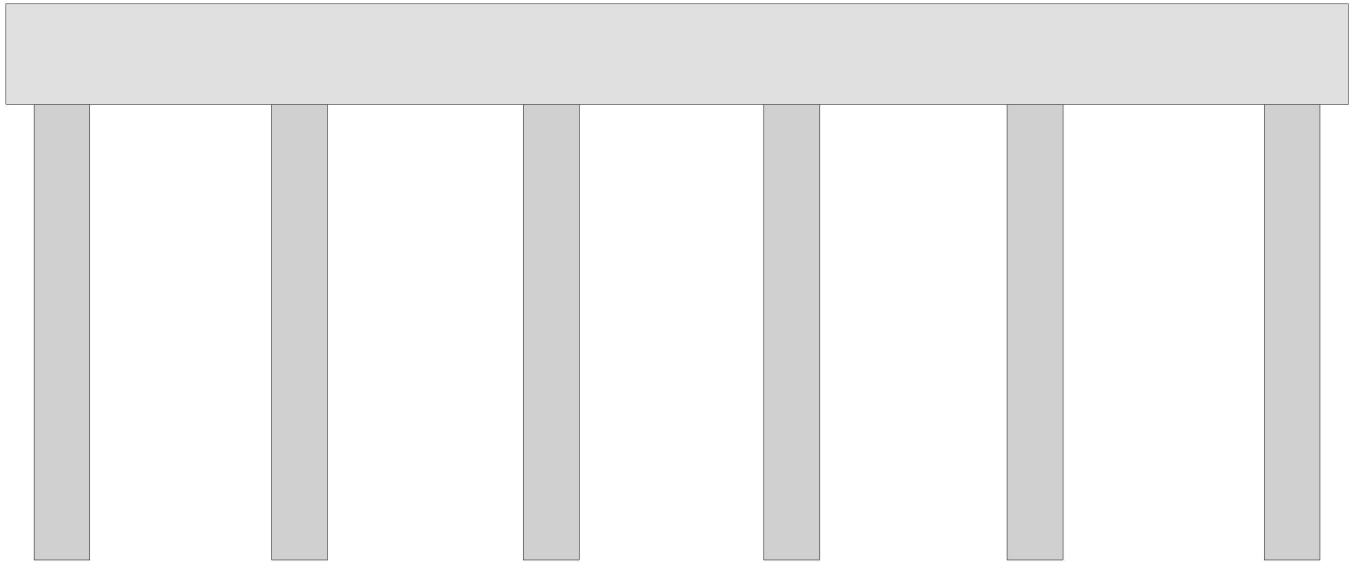
<b>Cap Information</b>			<b>Material</b> Cast-in-Place Concrete							
Length	Width	Height	Left Overhang	Right Overhang	Left Beam to End of Cap.	Right Beam to End of Cap.

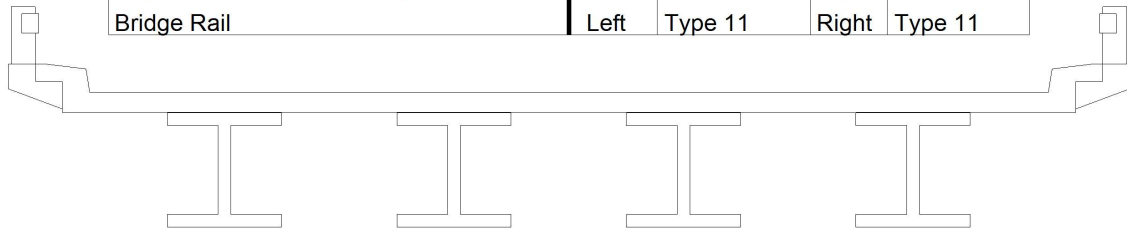
Measurements for Span #	1		
Deck Thickness	0.583	Left Overhang	4.708
Top of Rail to Bottom of Beam	6.167	Right Overhang	4.708
