NC DEPARTMENT OF TRANSPORTATION  
 DIVISION OF HIGHWAYS  
 STRUCTURE MANAGEMENT UNIT

ATTENTION: PRIORITY MAINTENANCE - SPAN 1 BEAM 1;  
 UPDATES MADE TO APPROACH ROADWAY SKETCH  
 AND UNDERCLEARANCE SKETCHES

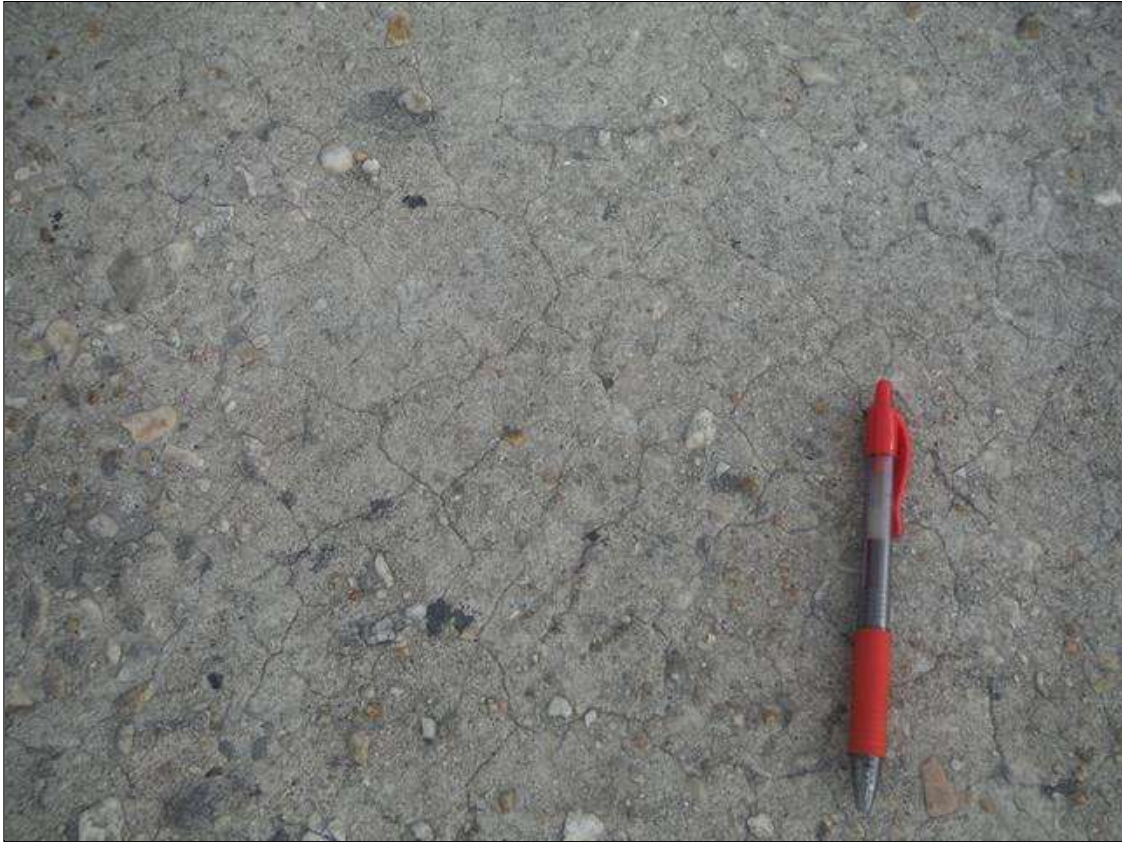
Span 1 Deck: 1376 SF. OF HAIRLINE MAP CRACKING AND TRANSVERSE AND DIAGONAL CRACKING UP TO 1/16" WIDE IN TOP OF DECK

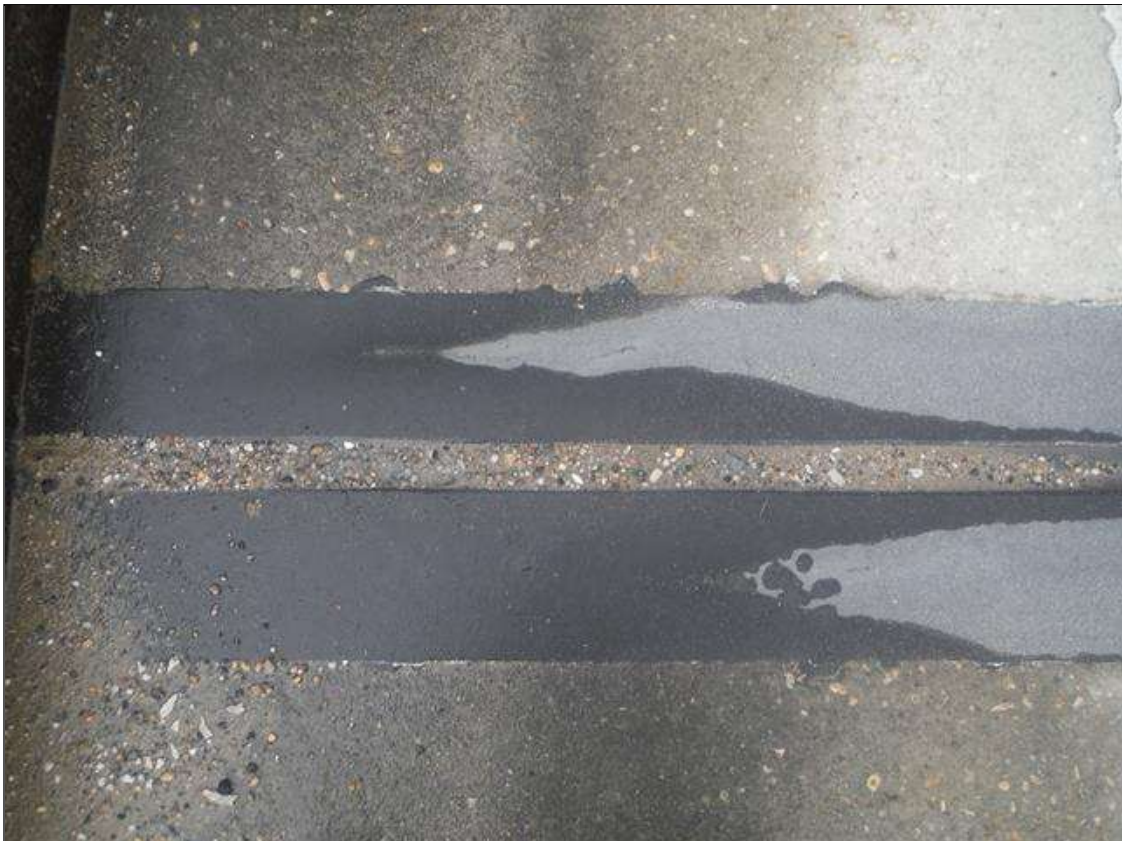
Expansion Joint : 6 FT. OF DEBRIS IMPACTION

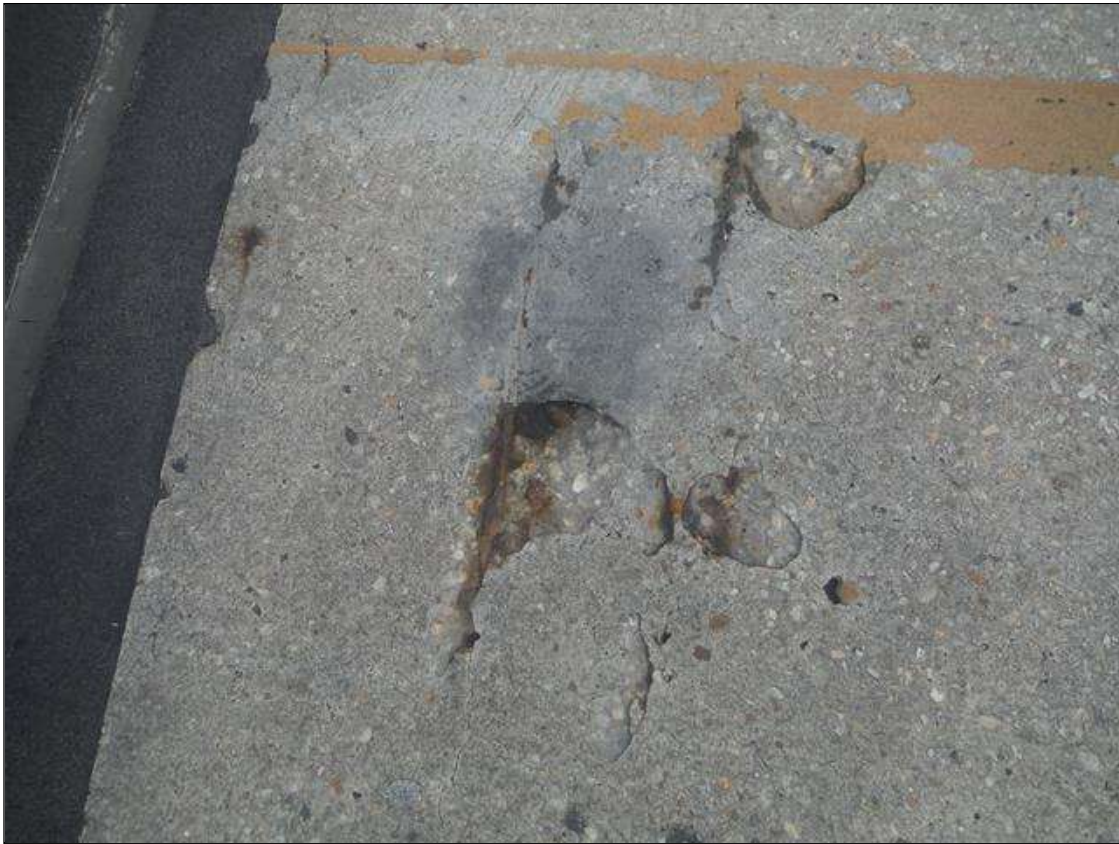
Span 2 Deck: 20" X 12" X 1/2" DEEP SPALL WITH EXPOSED REBAR IN TOP OF DECK AT BENT 1

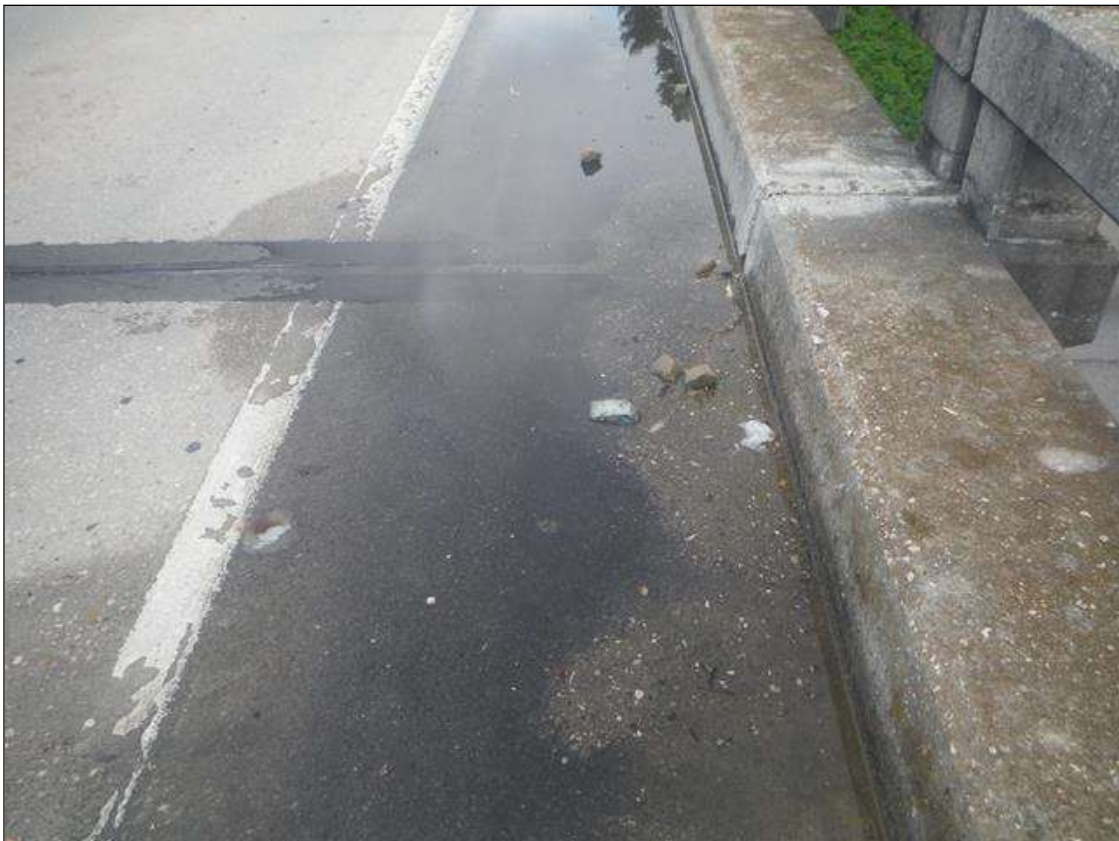
PONDING WATER ALONG NORTH AND SOUTH CURB

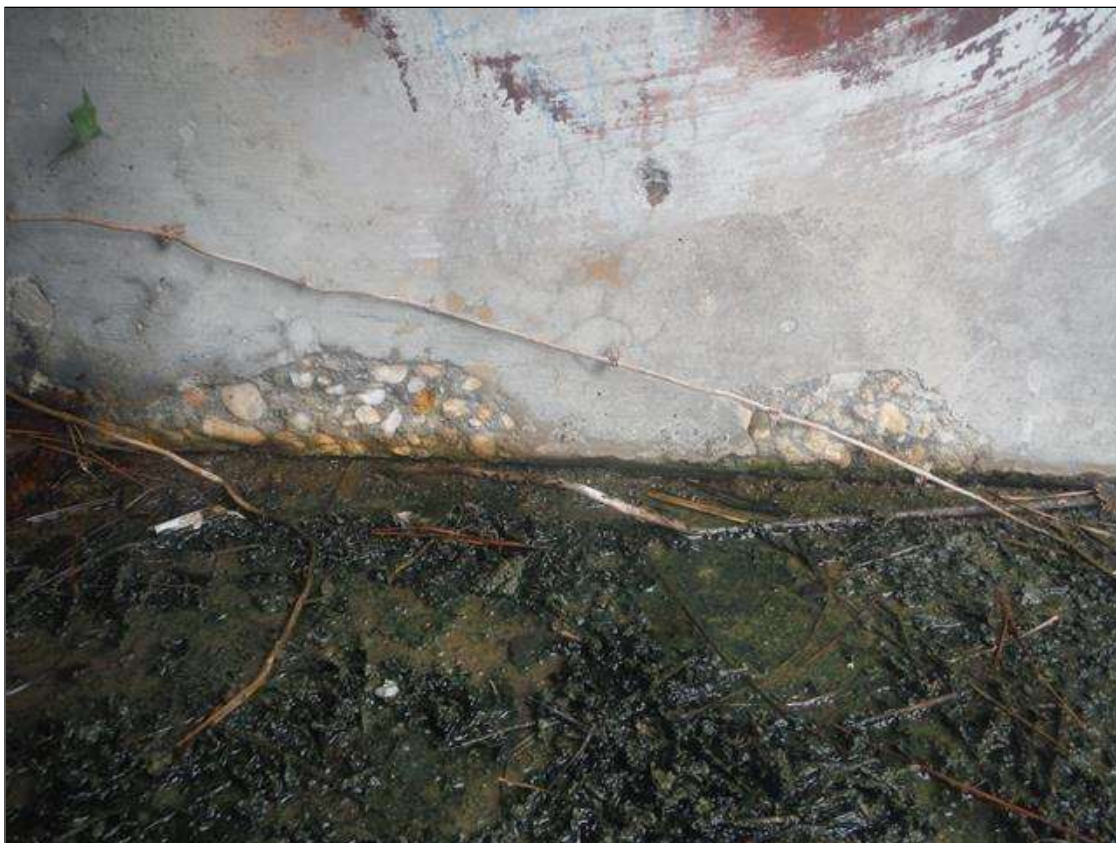
End Bent 1 Abutment/Backwall : 2 - SPALLS UP TO 12" X 4" X 1/2" DEEP AT NORTH END

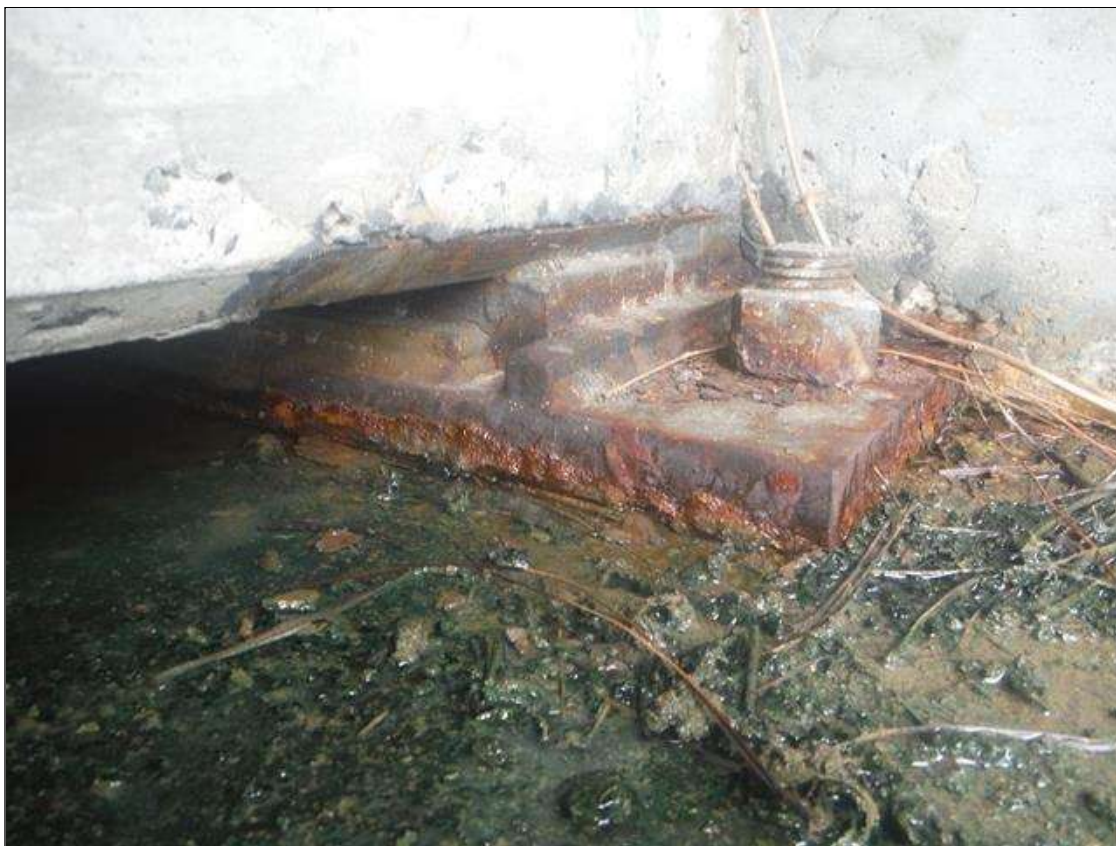
Span 1 Beam 1 Near Bearing: SURFACE CORROSION

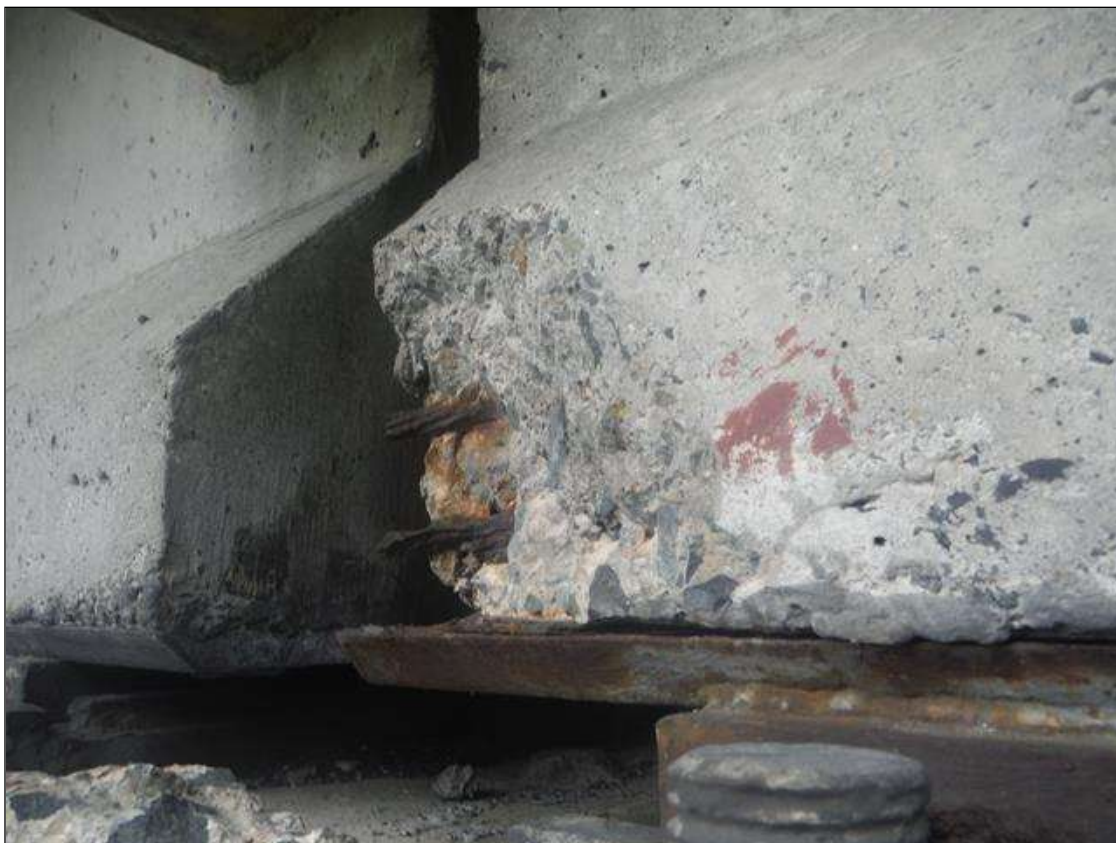
Span 1 Beam 1: 7" X 5" X 2" DEEP SPALL WITH EXPOSED STRANDS IN BOTTOM FLANGE NORTH FACE AT BENT 1 (PM)

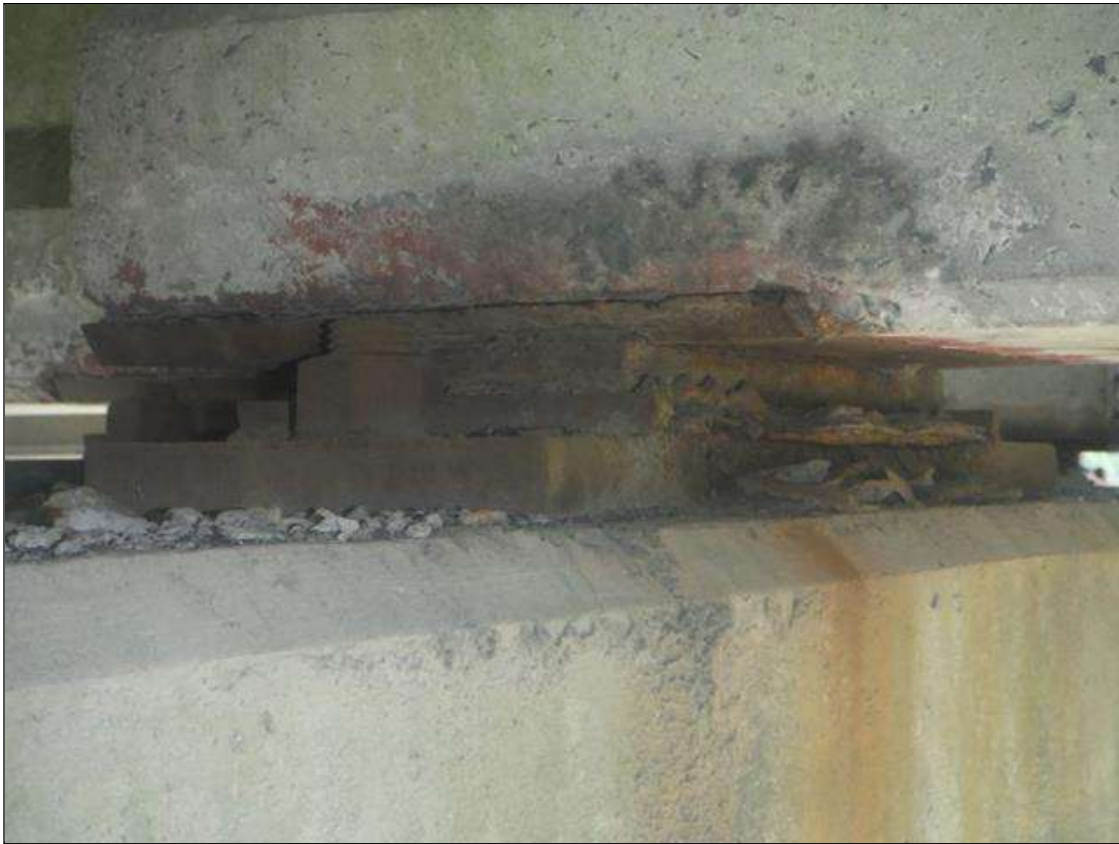
Span 1 Beam 3 Far Bearing: 1/4" OF PACK RUST

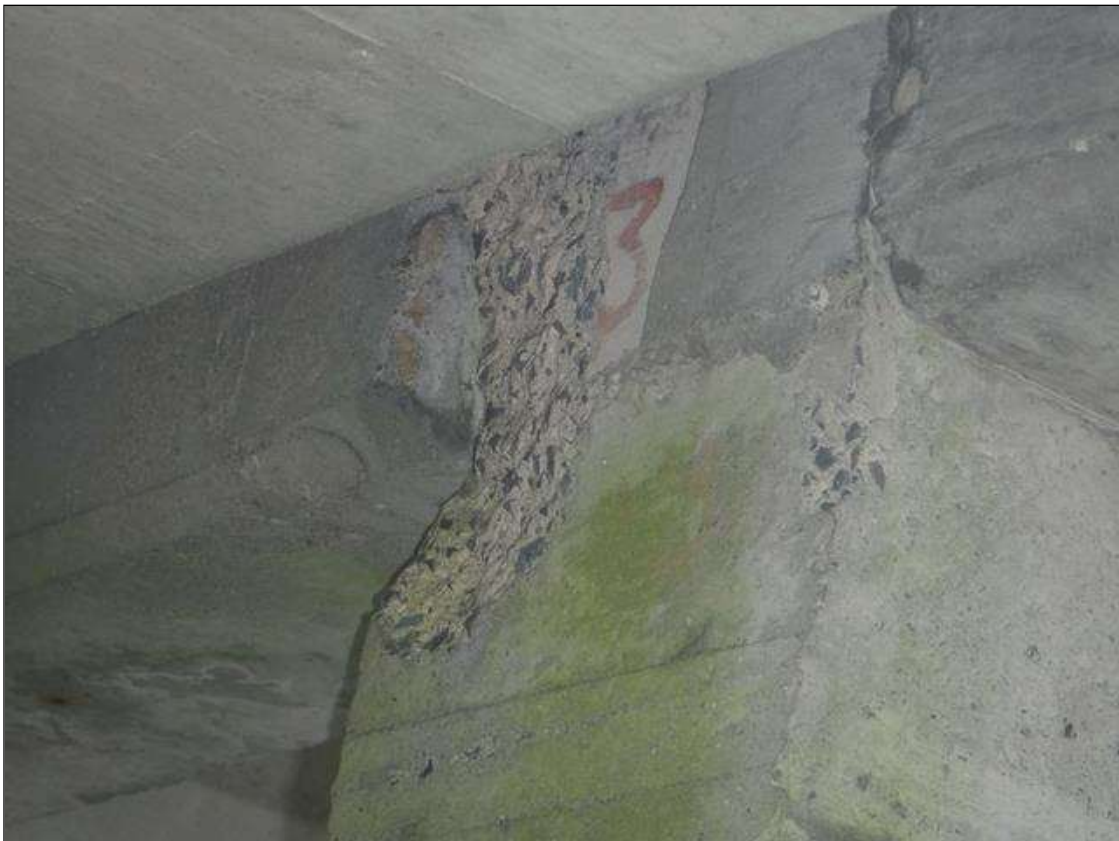
Span 2 Beam 4: 14" X 7" X 2" DEEP SPALL IN END OF BEAM AT BENT 1

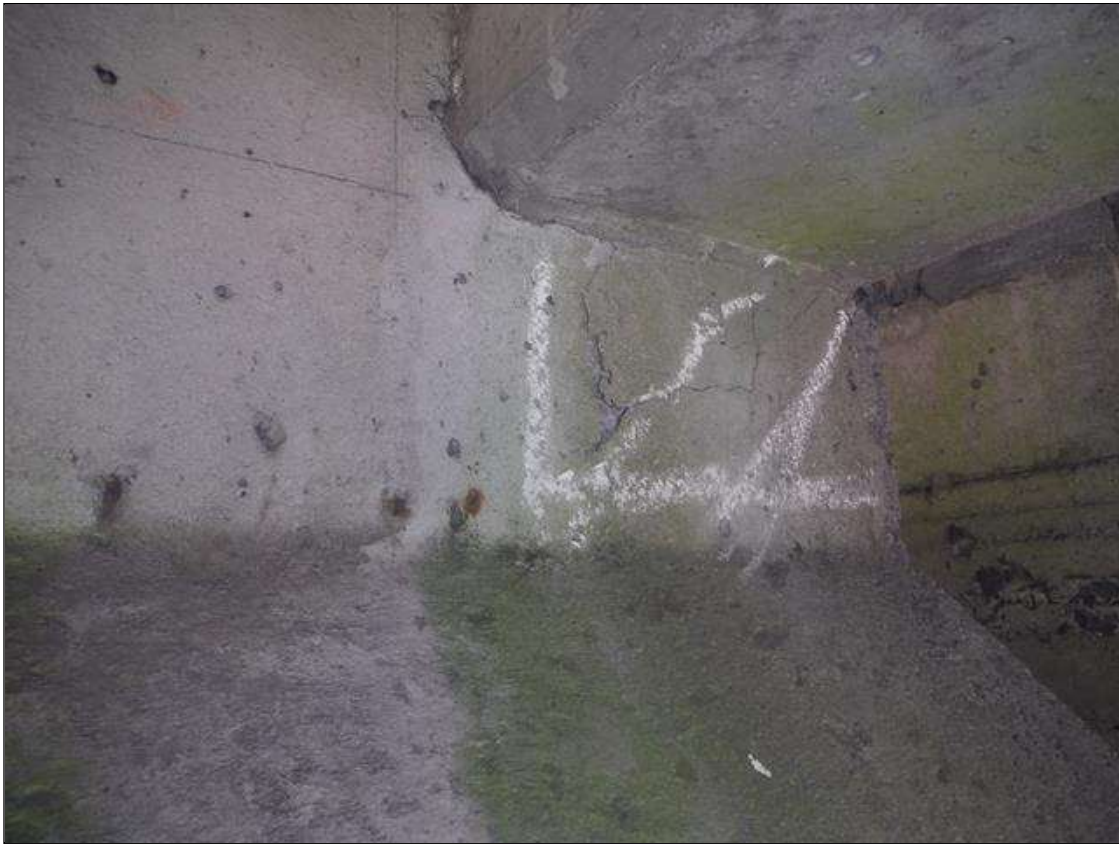
Span 2 Beam 3: 7" X 3" DELAMINATION IN WEB SOUTH FACE AT BENT 2

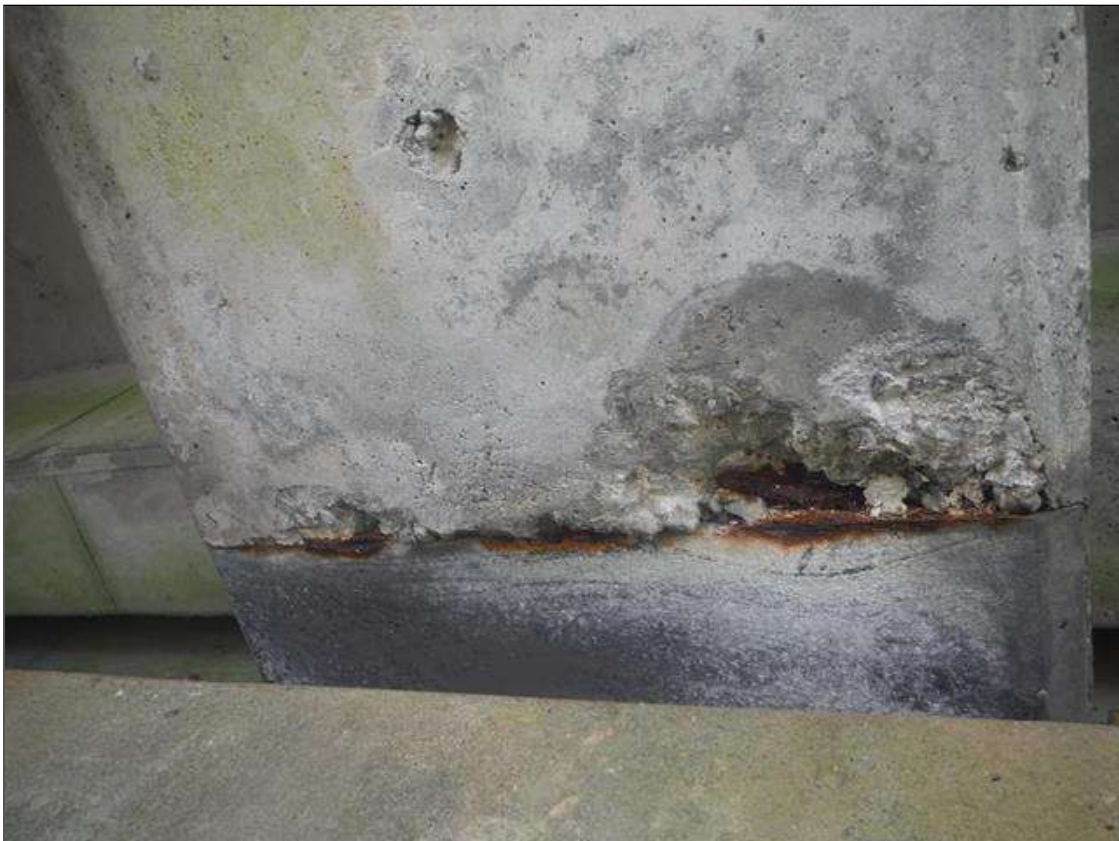
Span 2 Beam 3: 3" X 7" X 1/2" DEEP SPALL WITH EXPOSED REBAR IN BOTTOM FACE AT BENT 2

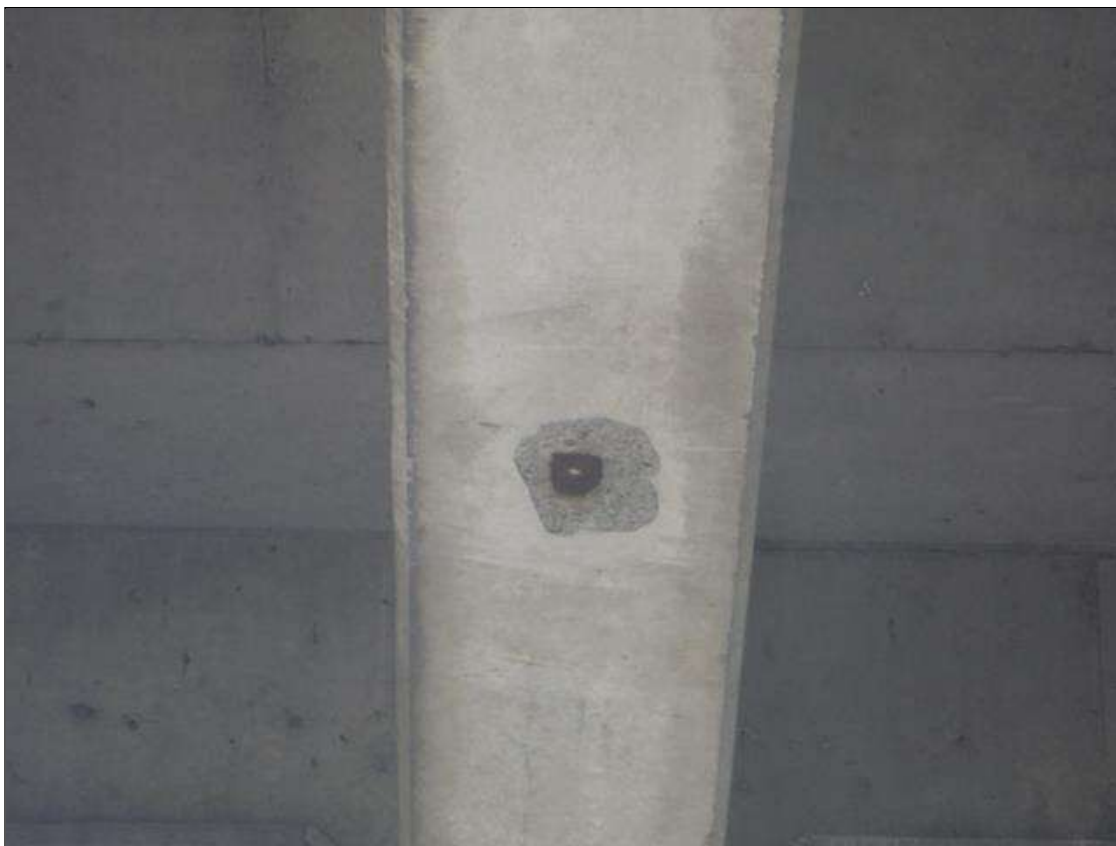
Span 3 Beam 4: 10" DIAMETER X 1/2" DEEP SPALL IN BOTTOM FACE AT TIE-DOWN POINT NEAR MIDSPAN

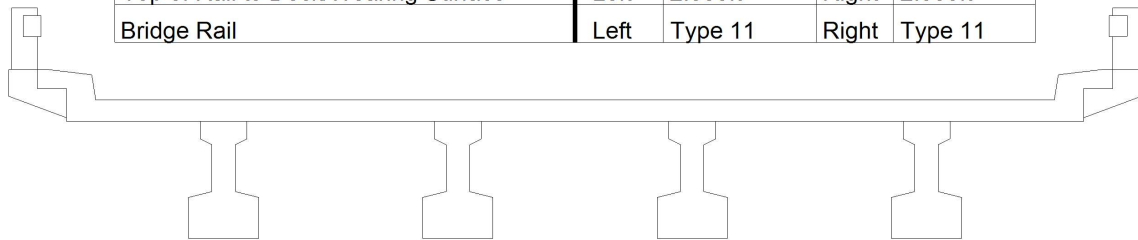
Measurements for Span #	1		
Deck Thickness	0.625	Left Overhang	4.458
Top of Rail to Bottom of Beam	6.125	Right Overhang	4.458

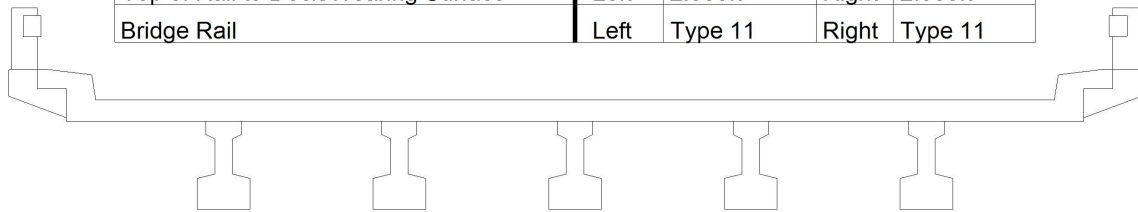
Measurements for Span #	2		
Deck Thickness	0.625	Left Overhang	4.458
Top of Rail to Bottom of Beam	6.125	Right Overhang	4.458

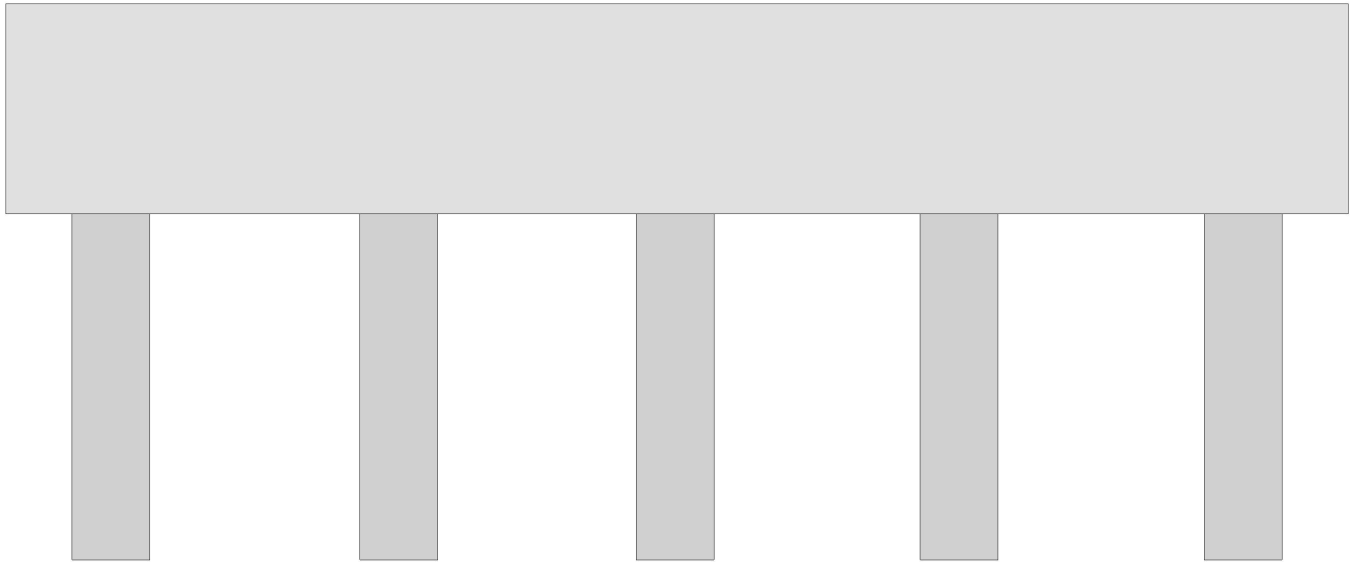
<b>Cap Information</b>			<b>Material</b> Cast-in-Place Concrete							
Length	Width	Height	Left Overhang	Right Overhang	Left Beam to End of Cap.	Right Beam to End of Cap.				
28.750 ft.	3.000 ft.	4.500 ft.	2.250 ft.	2.250 ft.	1.750 ft.	1.750 ft.				
<b>Subcap Information</b>			<b>Material</b>							
Length	Width	Height	Left Overhang	Right Overhang	Left Pile to Splice.					
<b>Sill Information</b>			<b>Material</b>							
Length	Width	Height								
Pile #	Material	Spacing	Width/Dia.	Height	Length	Orientation	Driven?	Replacement?	Removed?	Collar?
1	Concrete	6.167 ft.	1.667 ft.			Vertical	Yes	No	No	No
2	Concrete	5.917 ft.	1.667 ft.			Vertical	Yes	No	No	No
3	Concrete	6.083 ft.	1.667 ft.			Vertical	Yes	No	No	No
4	Concrete	6.083 ft.	1.667 ft.			Vertical	Yes	No	No	No
5	Concrete		1.667 ft.			Vertical	Yes	No	No	No
<b>Bent/Abutment #:</b> 1			<b>Similar Bents:</b> 3

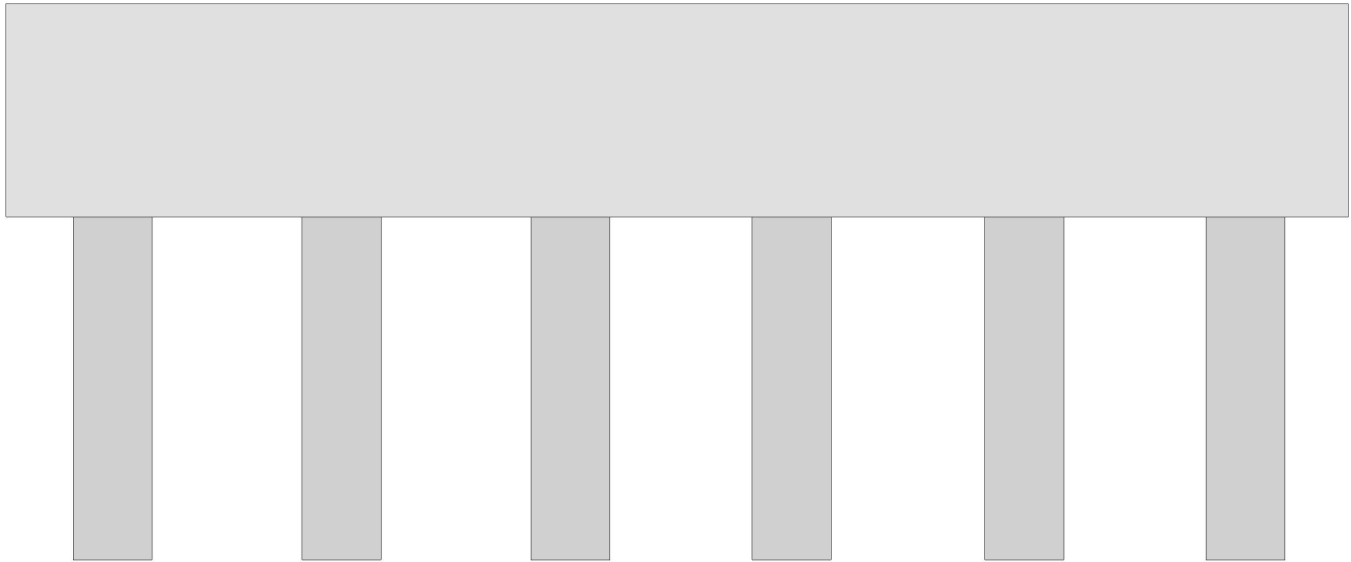
<b>Cap Information</b>			<b>Material</b> Cast-in-Place Concrete							
Length	Width	Height	Left Overhang	Right Overhang	Left Beam to End of Cap.	Right Beam to End of Cap.
