NC DEPARTMENT OF TRANSPORTATION  
 DIVISION OF HIGHWAYS  
 STRUCTURE MANAGEMENT UNIT

ATTENTION: **PM ISSUED**

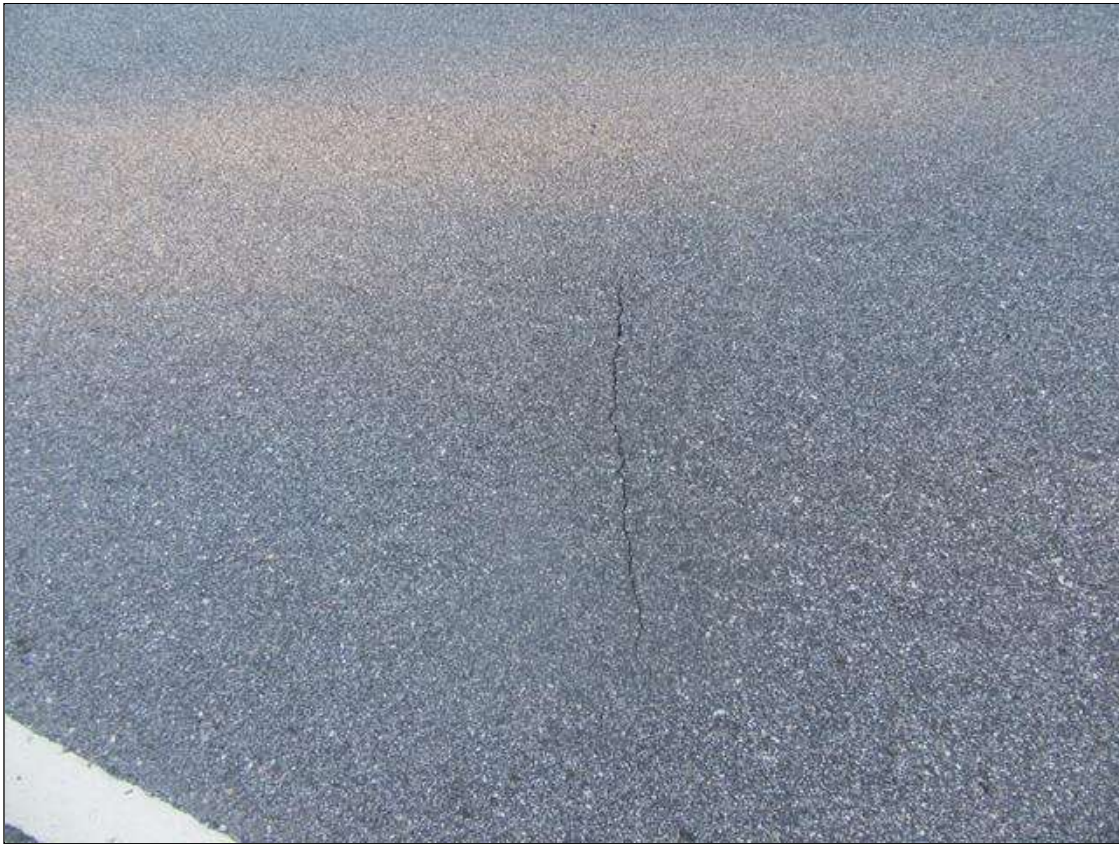
Span 5 Wearing Surface: 1/8" WIDE TRANSVERSE CRACK OVER END BENT 2

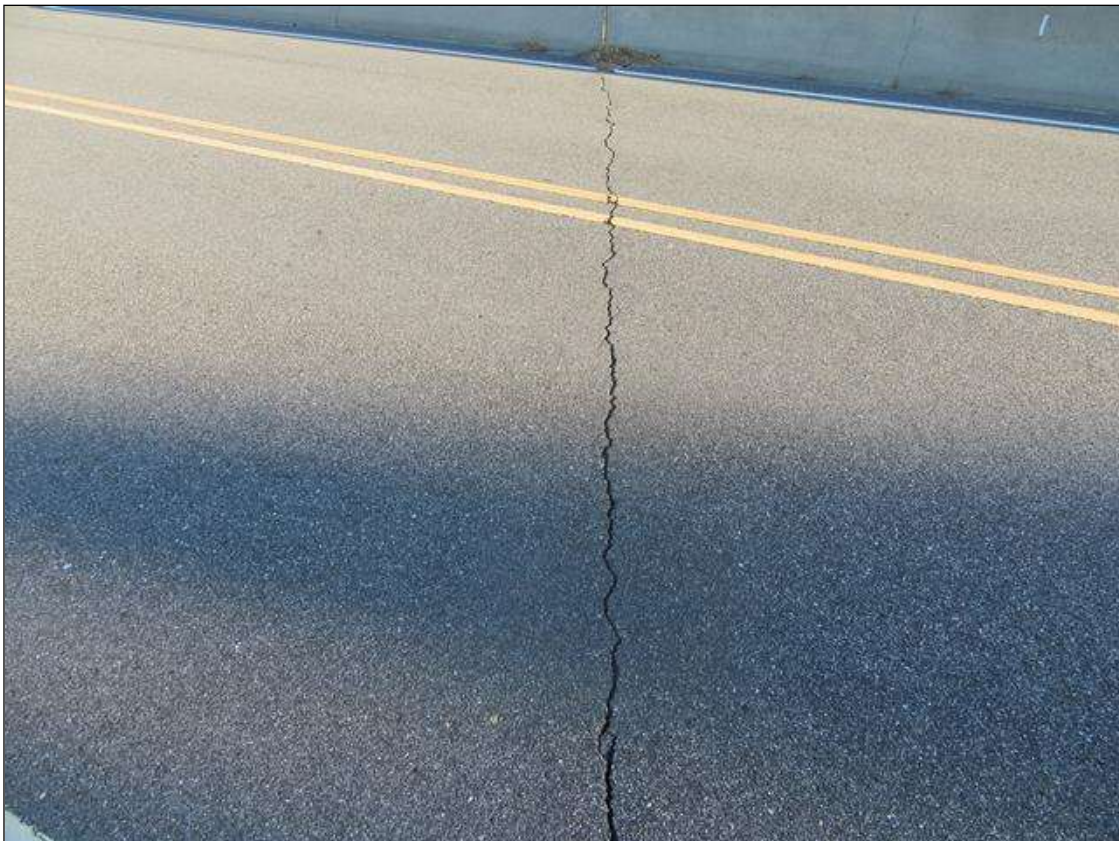
Span 5 Wearing Surface: 1/4" WIDE TRANSVERSE CRACK OVER BENT 4

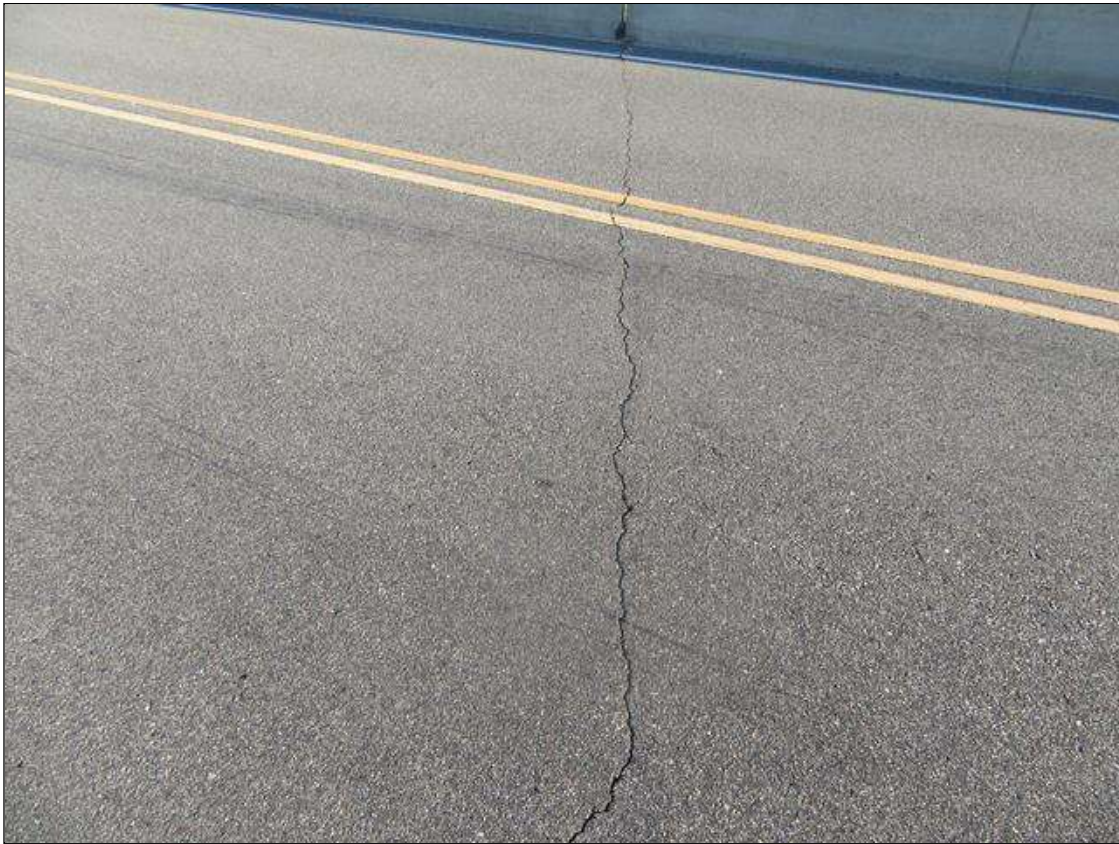
Span 4 Wearing Surface: 3/16" WIDE TRANSVERSE CRACK OVER BENT 3

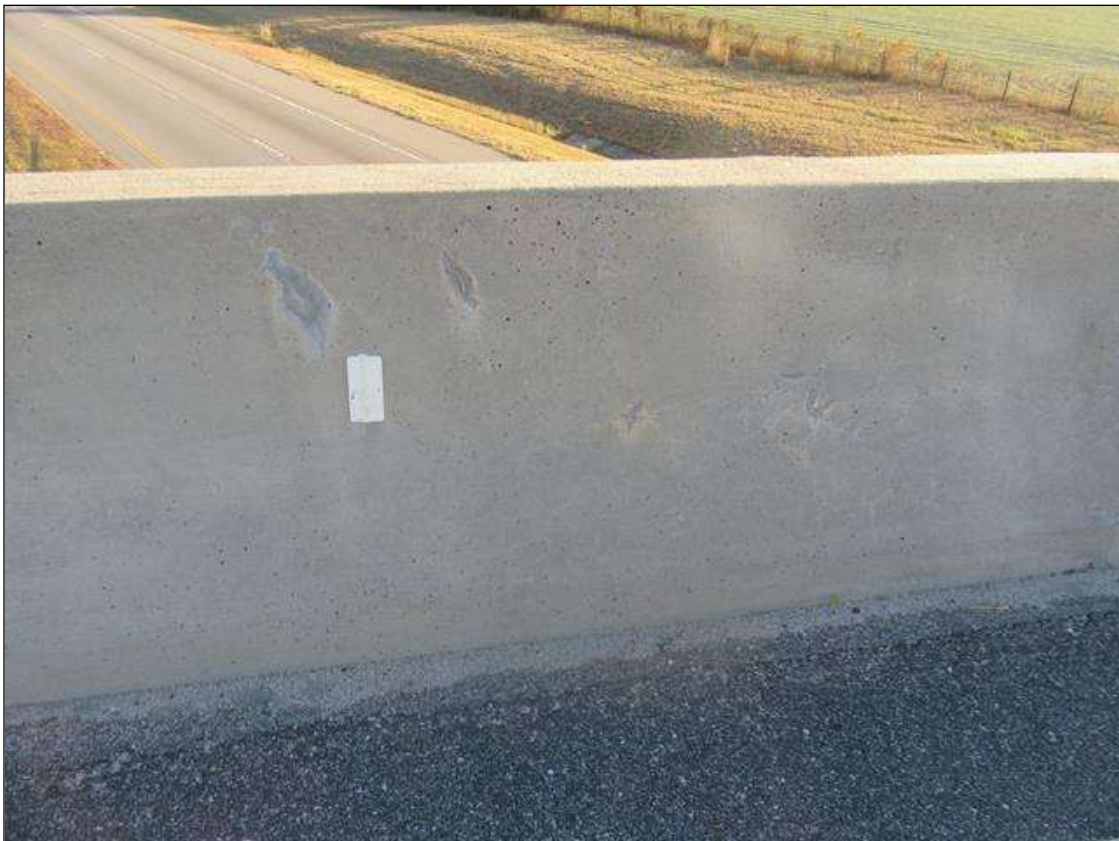
Span 4 Left Bridge Rail: HAIRLINE MAP CRACKING AT BENT 3

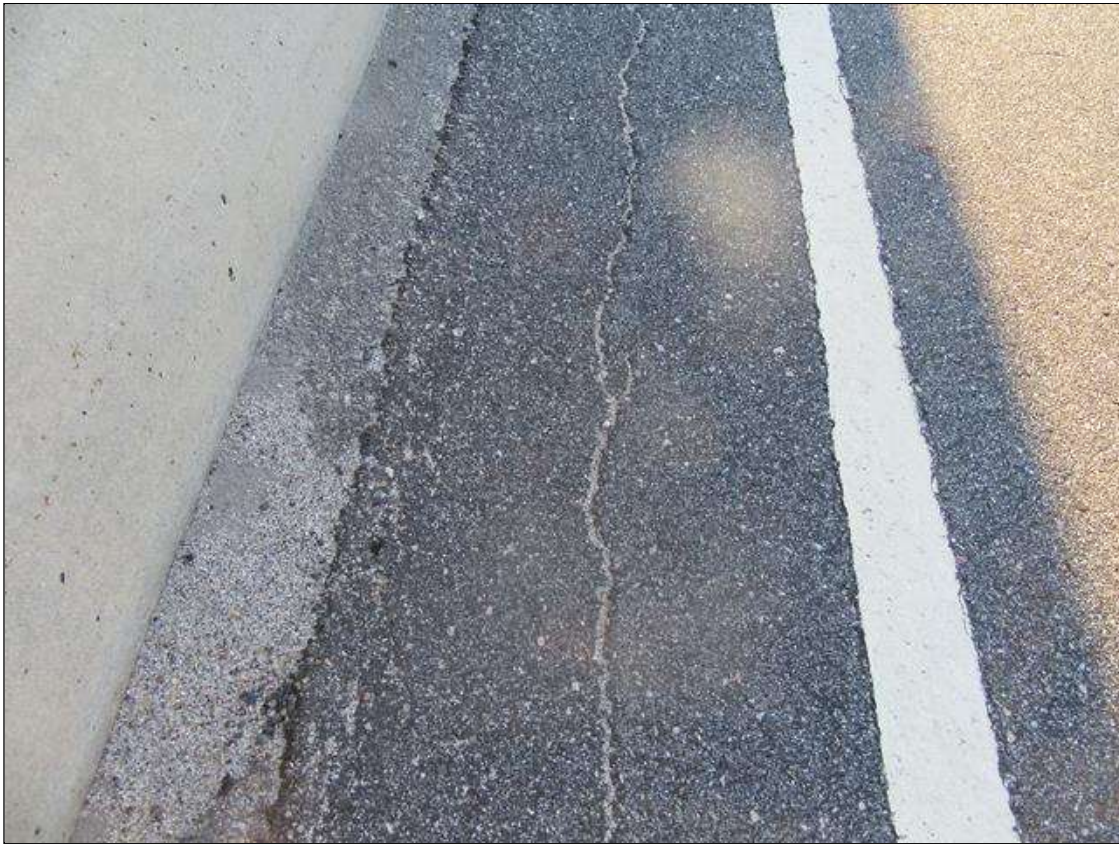
Span 3 Wearing Surface: 1/4" WIDE LONGITUDINAL CRACK IN LEFT SHOULDER AT BENT 2

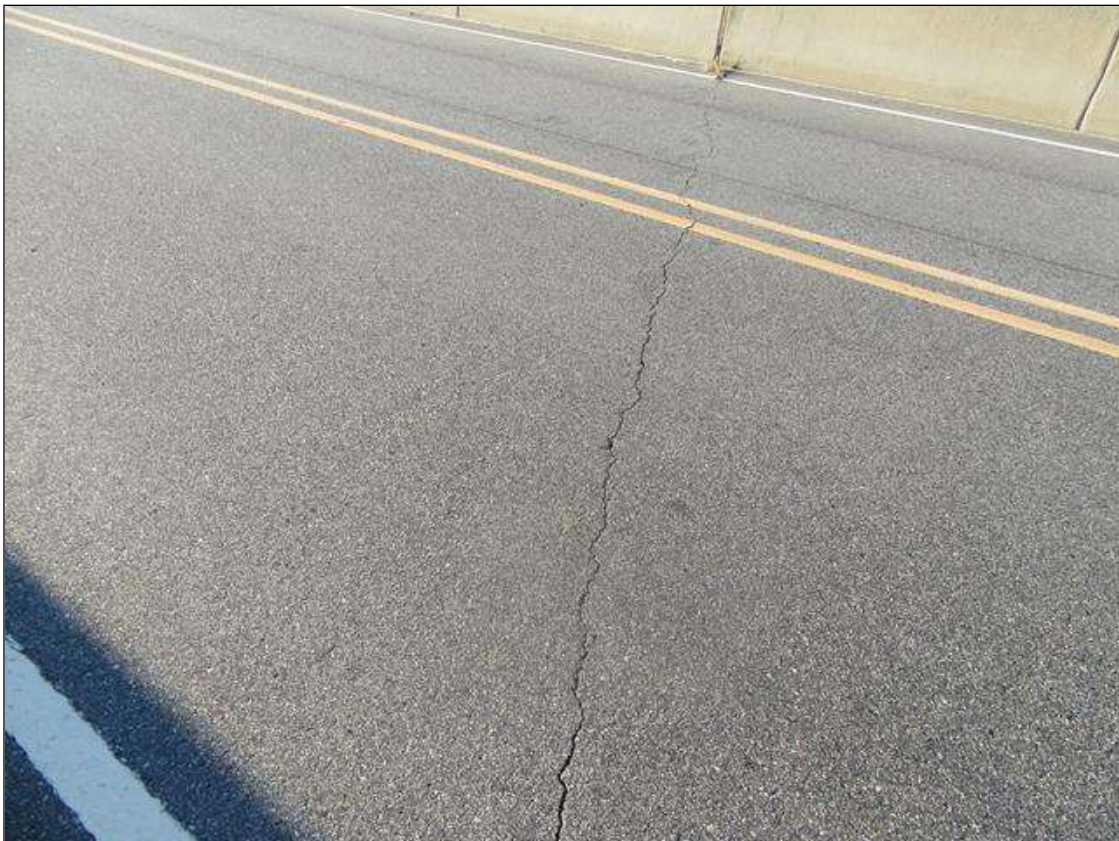
Span 3 Wearing Surface: 3/16" WIDE TRANSVERSE CRACK OVER BENT 2

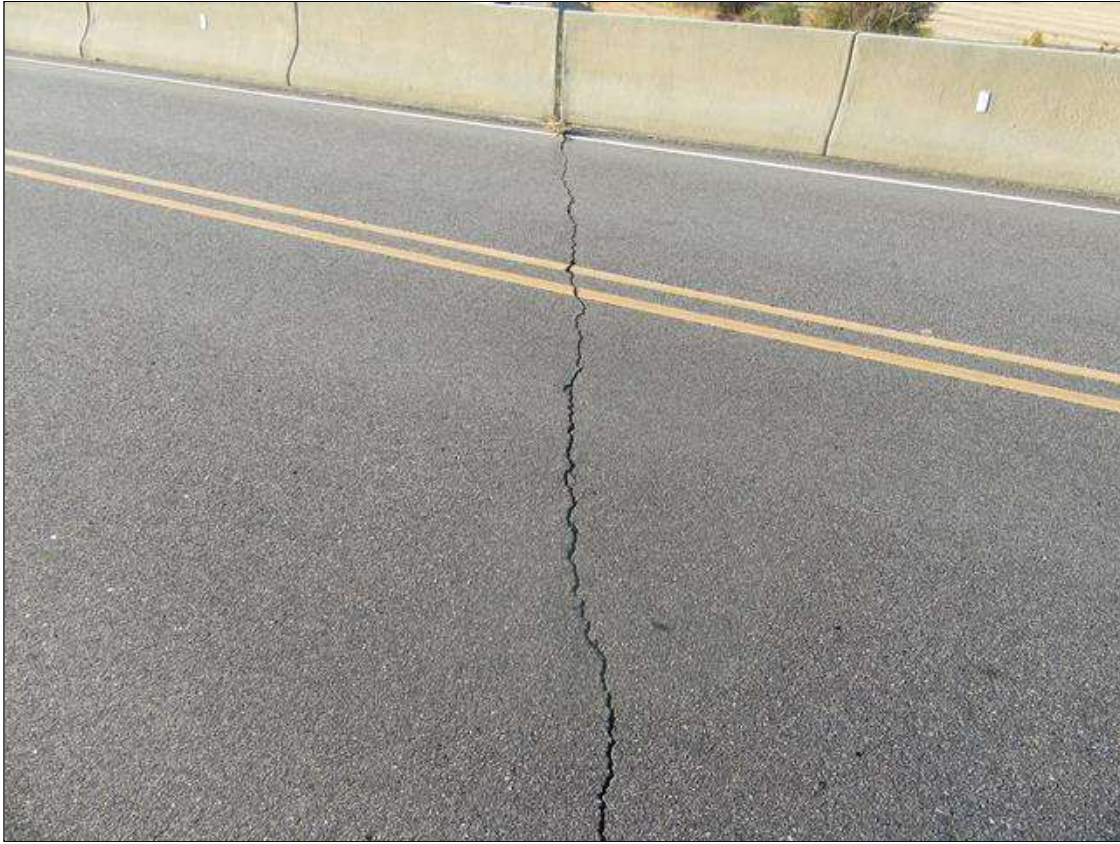
Span 2 Wearing Surface: 1/4" WIDE TRANSVERSE CRACK OVER BENT 1

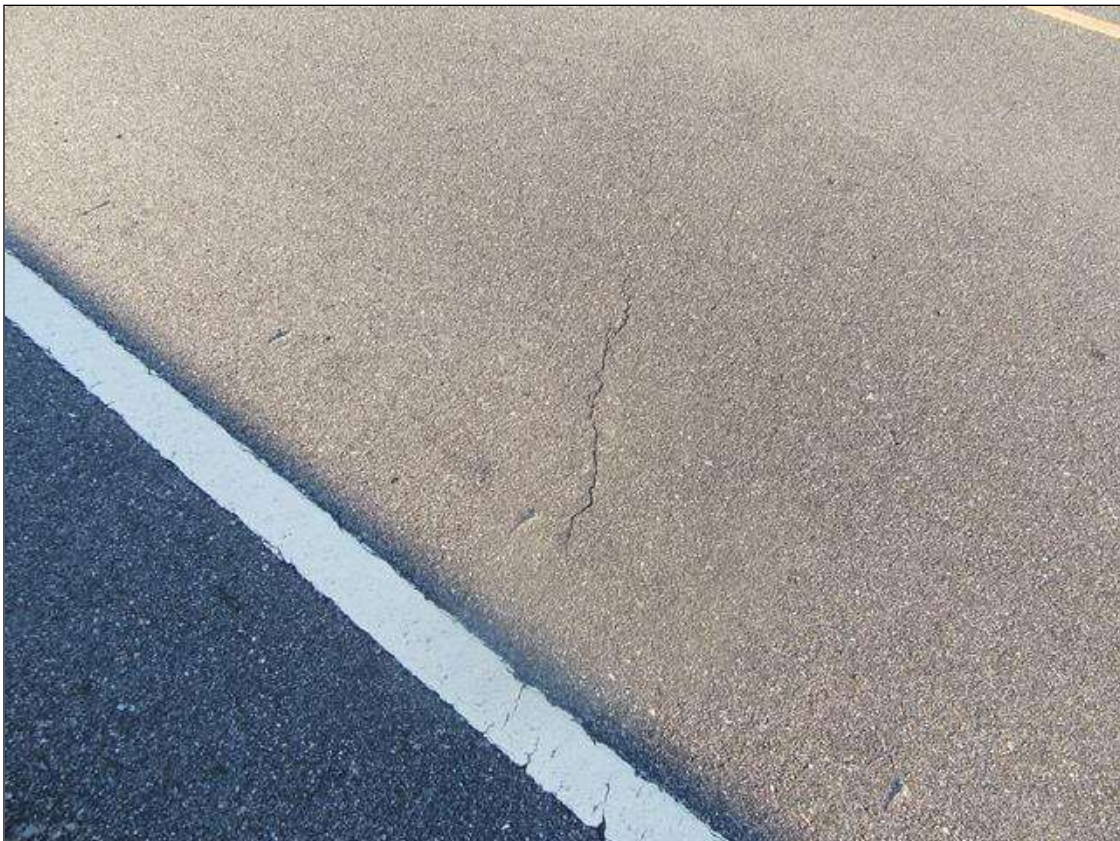
Span 1 Wearing Surface: 1/8" WIDE TRANSVERSE CRACK OVER END BENT 1 IN WESTBOUND LANE

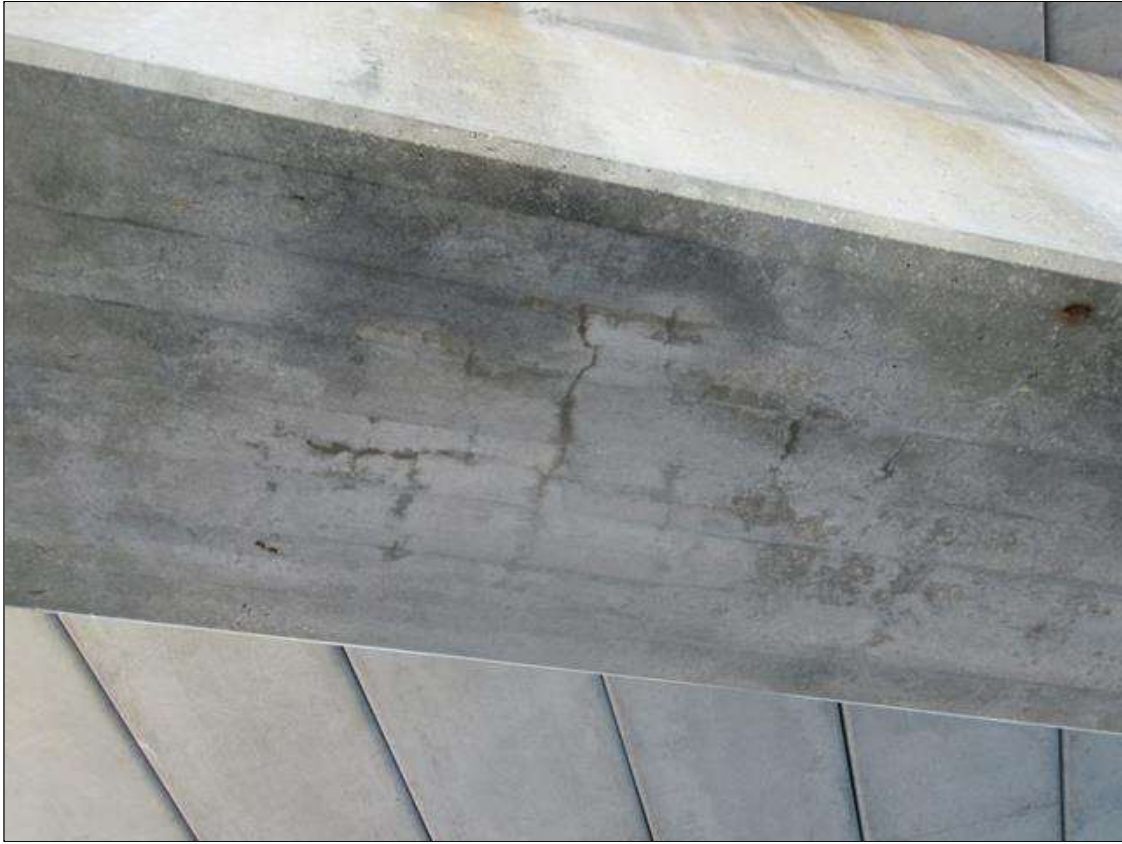
Bent 4 Cap 1: HAIRLINE TRANSVERSE CRACKS AT 1' SPACING IN BOTTOM OF CAP BETWEEN COLUMNS

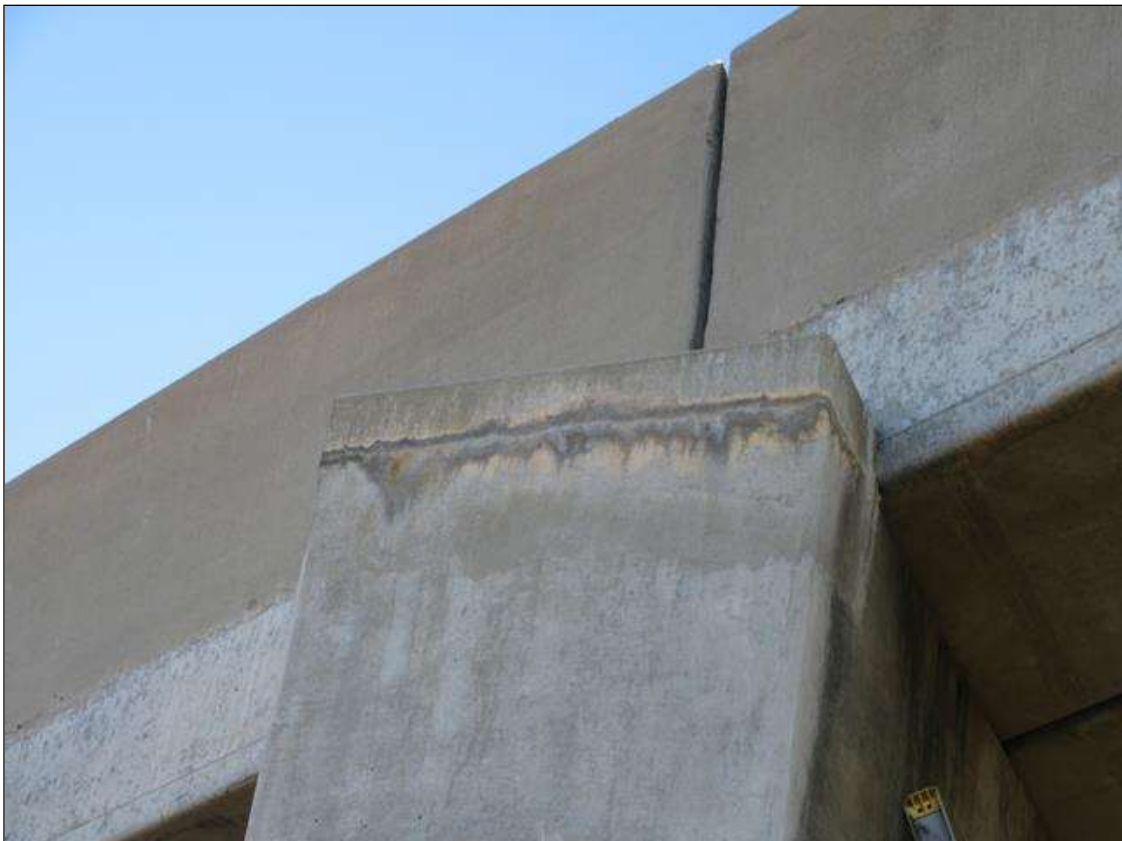
EFFLORESCENCE LEAKAGE AT BENT 2 LATERAL GUIDE

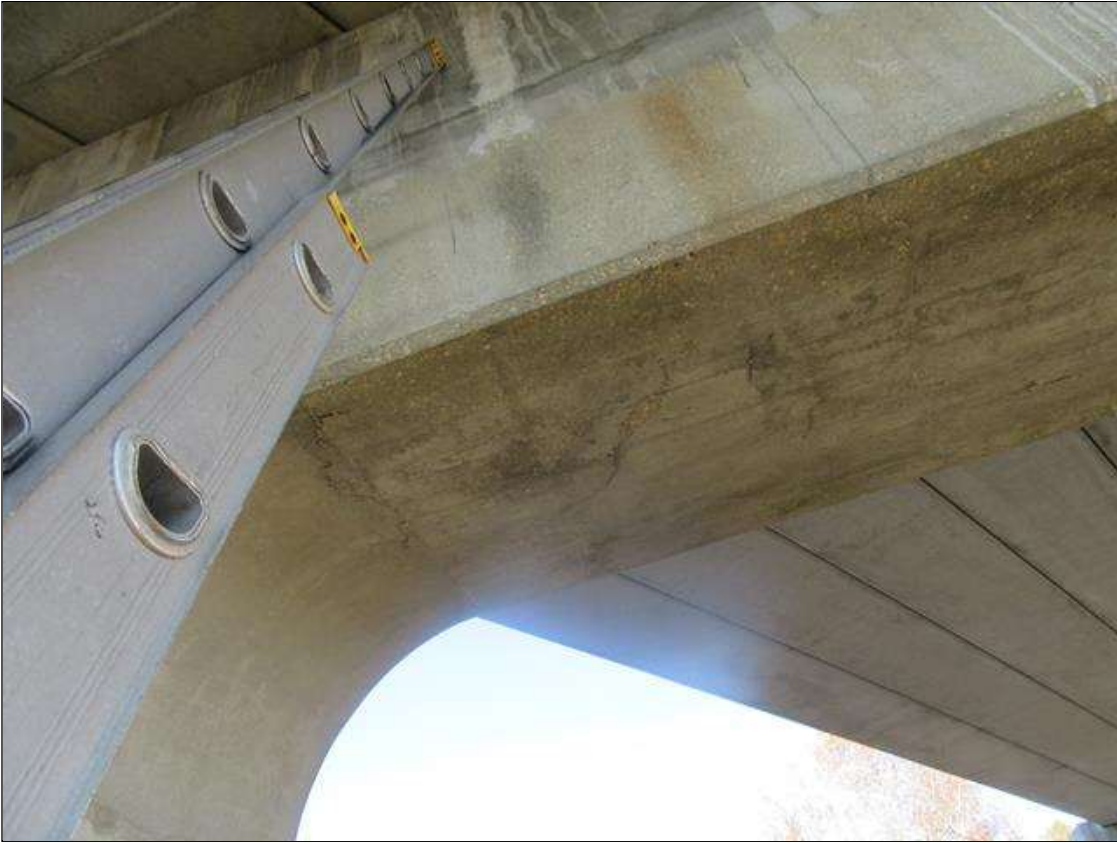
Bent 2 Cap 1: 2 FT. DIAMETER DELAMINATION IN BOTTOM OF CAP AT 2 FT. FROM COLUMN 2

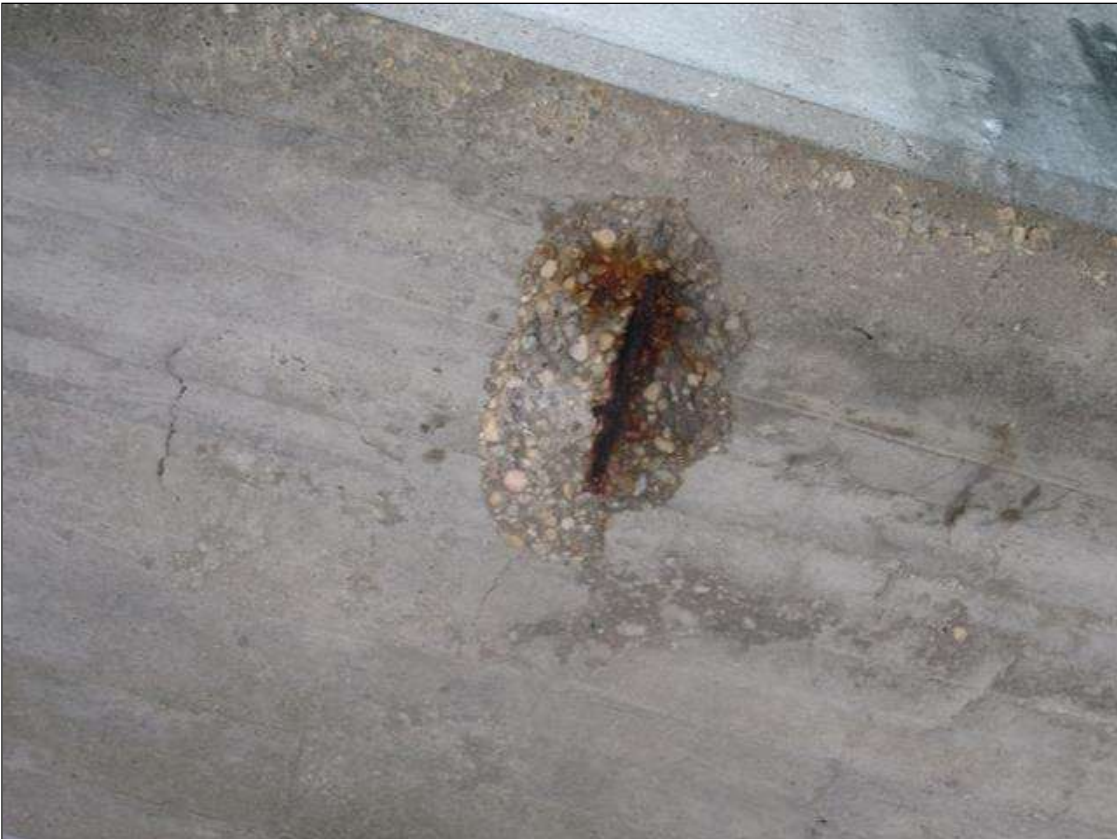
Bent 1 Cap 1: SPALL 14" LONG X 8" WIDE X 1.25" DEEP WITH 8" EXPOSED RUSTED REBAR. PRIORITY MAINTENANCE ISSUED

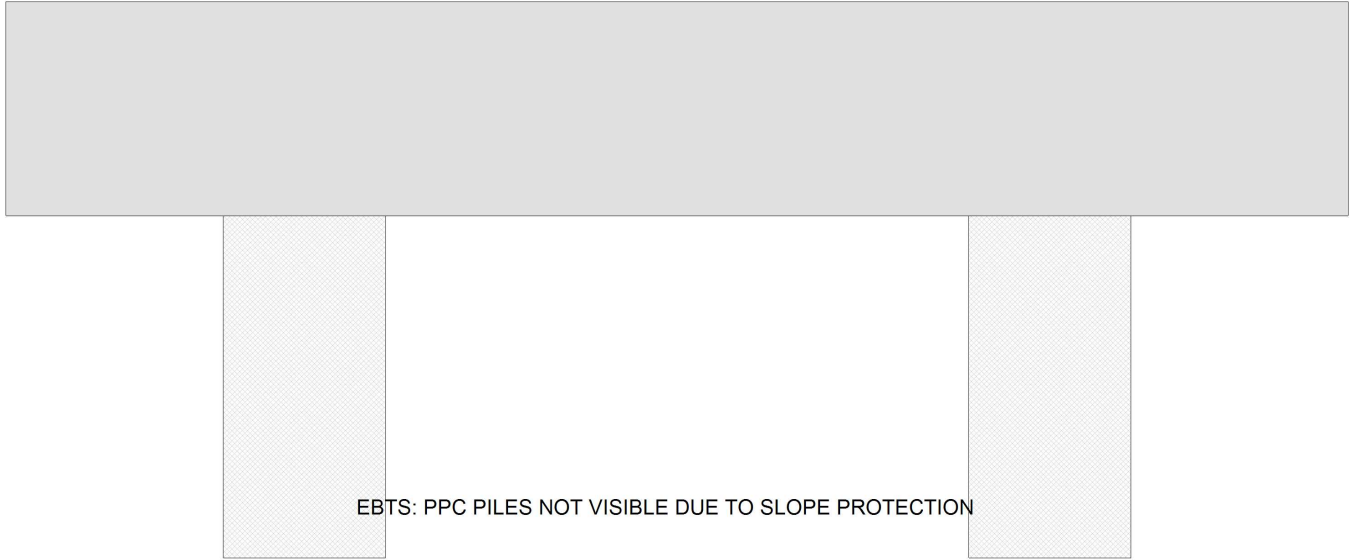
EBTS: PPC PILES NOT VISIBLE DUE TO SLOPE PROTECTION
