NC DEPARTMENT OF TRANSPORTATION  
 DIVISION OF HIGHWAYS  
 STRUCTURE MANAGEMENT UNIT

ATTENTION: **Changes to Structure Data, Temporary Shoring**

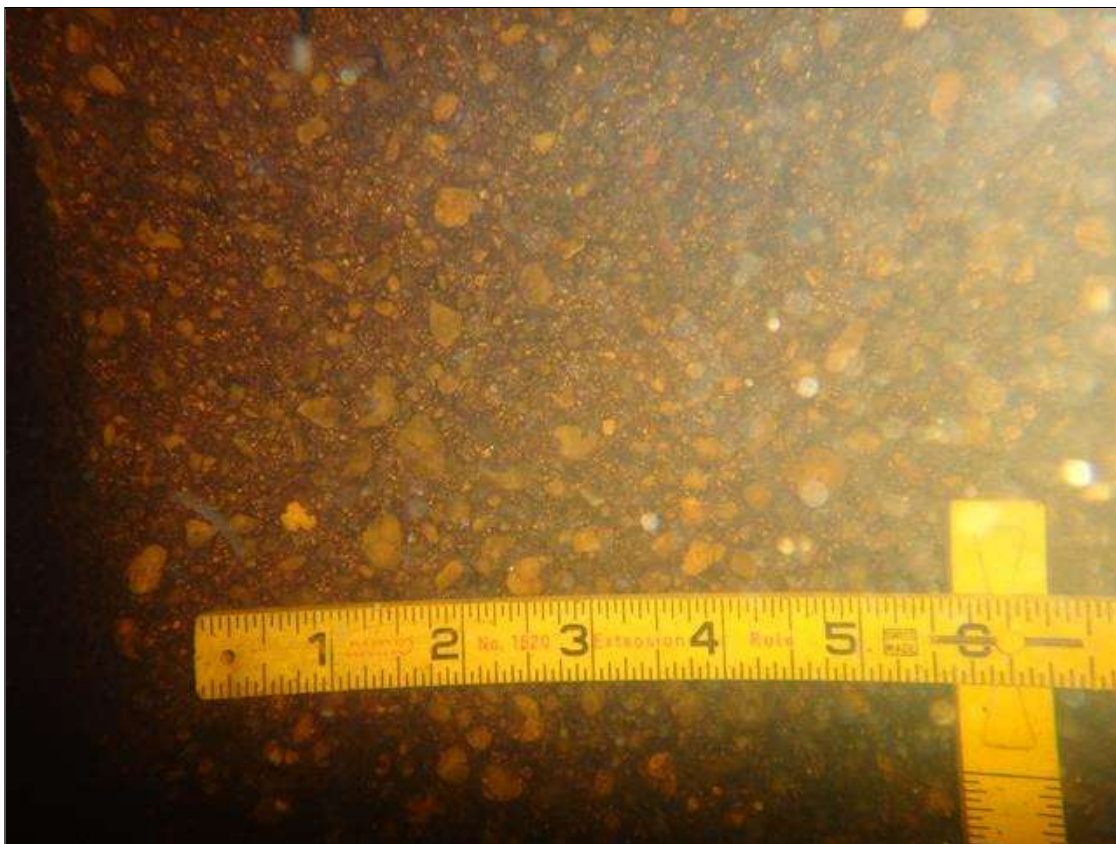
Bent 3 Pile 1: waterline down 24in, abrasion [up to 1/16in]

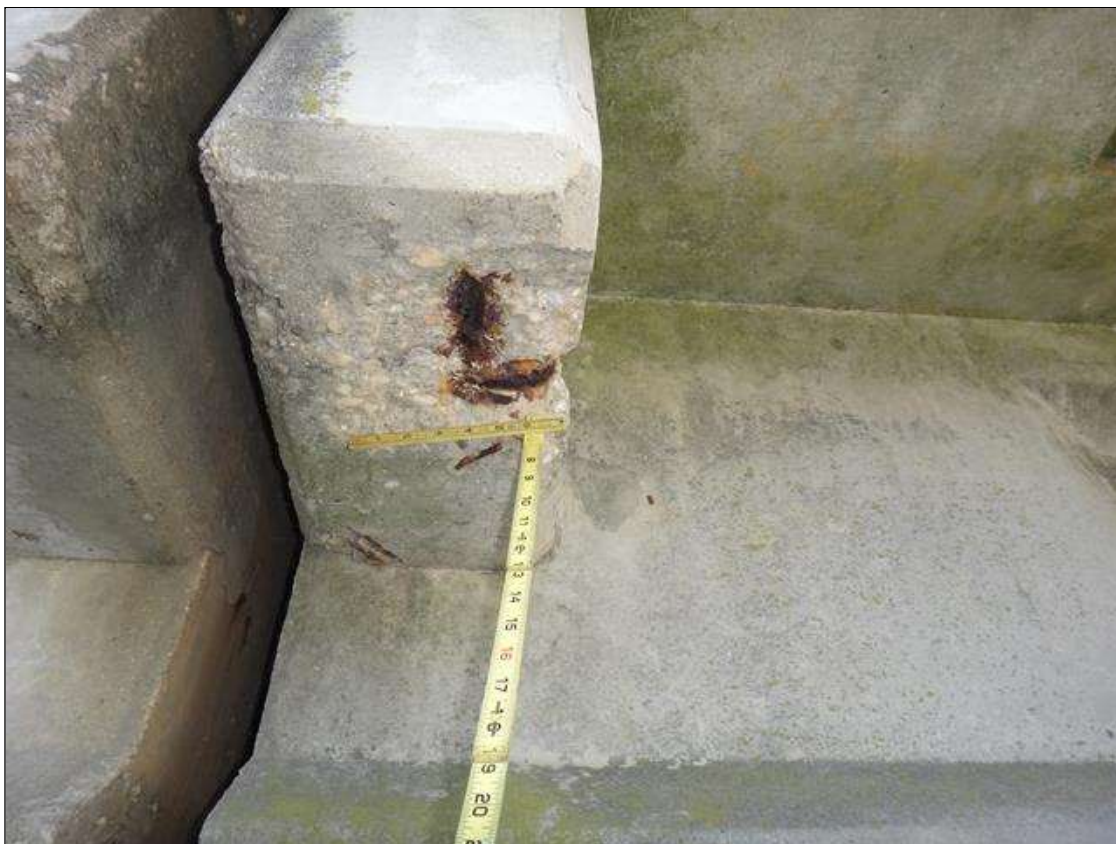
Span 4 Deck: diaphragm at right overhang over bent 3, spall/delamination [10in x 10in x 3in deep] with one [1] exposed longitudinal rebar and one [1] exposed vertical stirrup [section loss up to 1/16in]

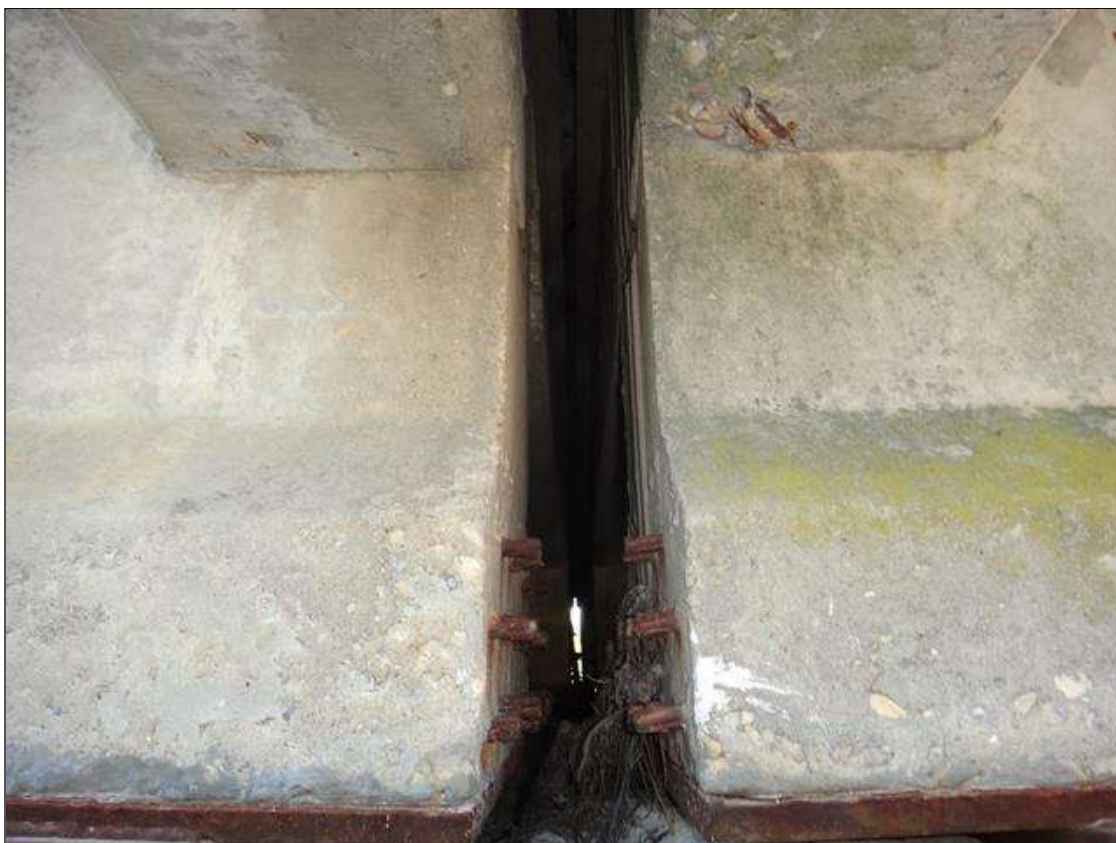
exposed strand ends over interior bents [similar at all beams]

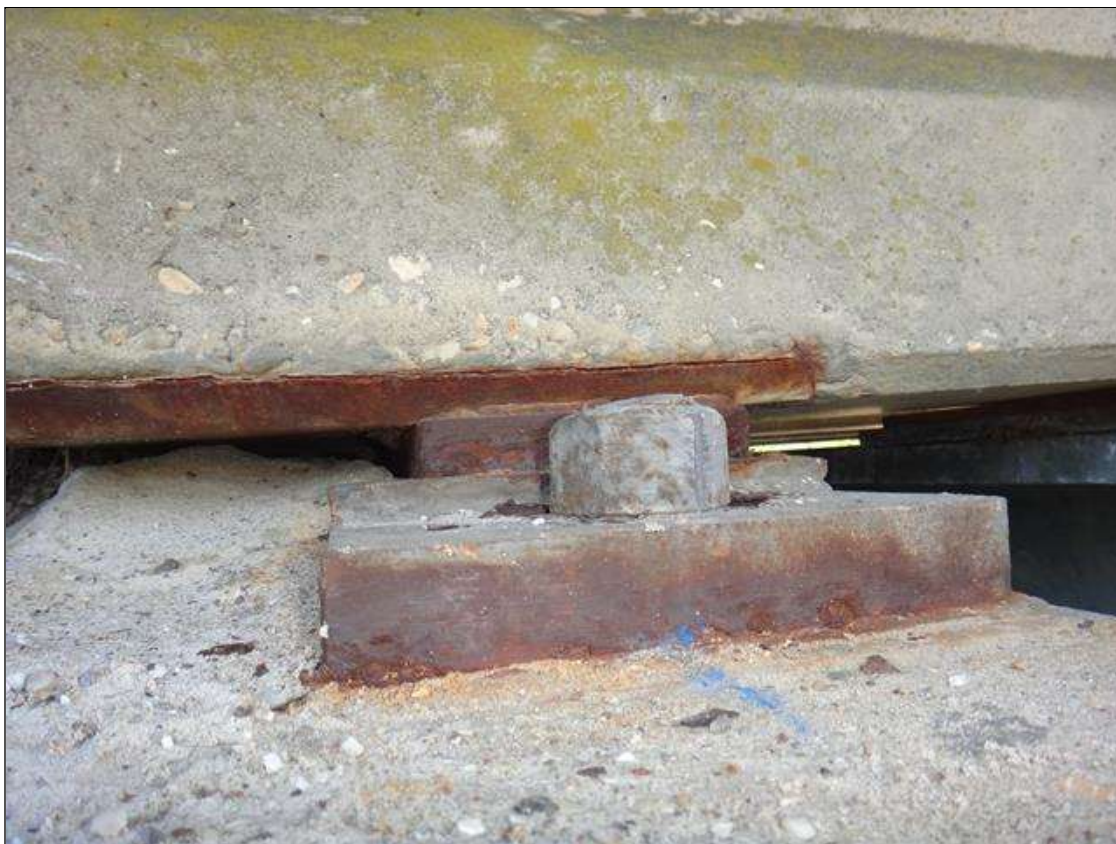
Span 4 Beam 4 Near Bearing: active surface corrosion [no section loss noted]

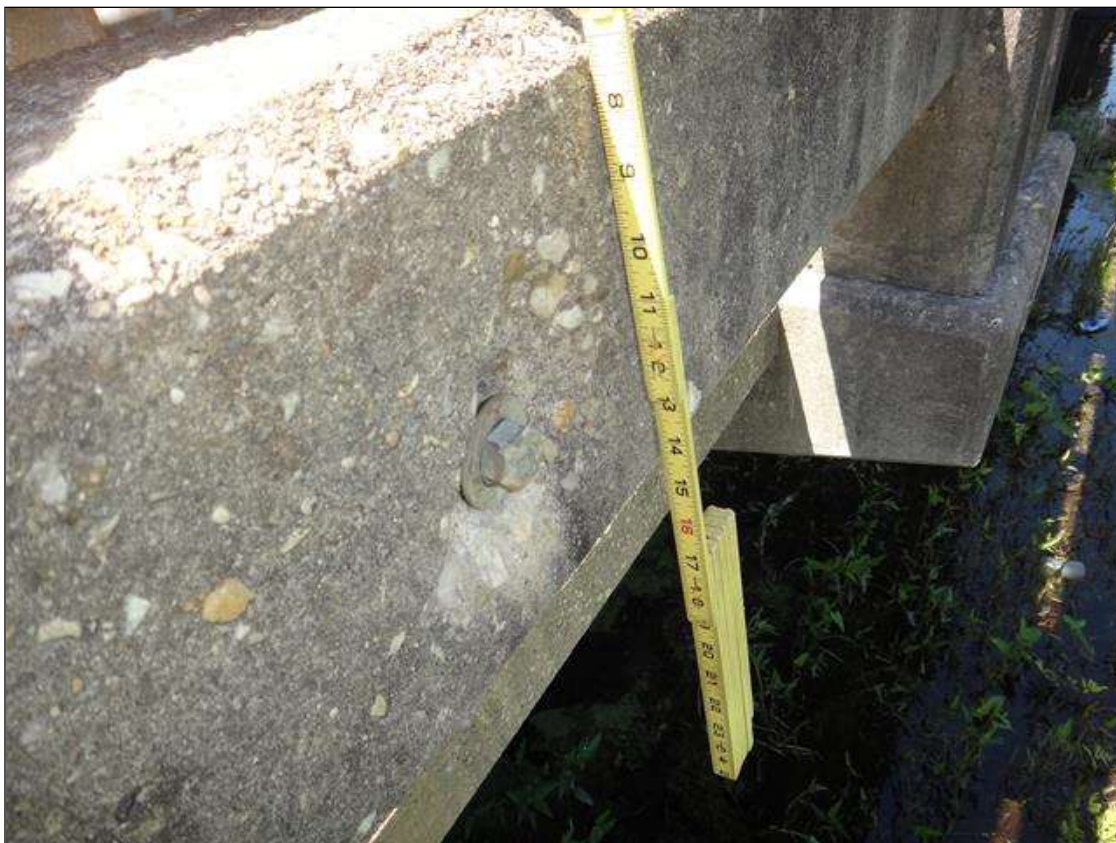
Span 1 Right Bridge Rail: along length of rail at guardrail connections, multiple spalls [up to 5in diameter x up to 1in deep]

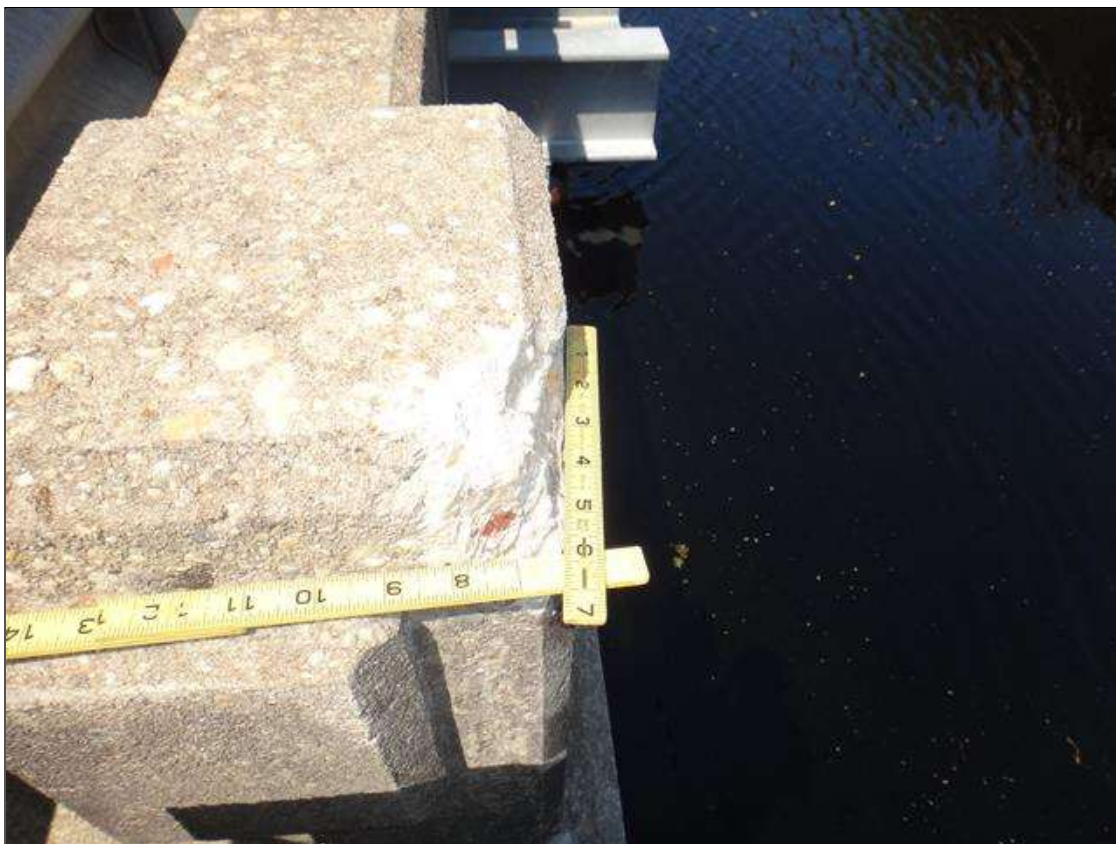
Span 3 Right Bridge Rail: at rail post 4, spall [7in x 5in x 1in deep] [similar at rail post 6]

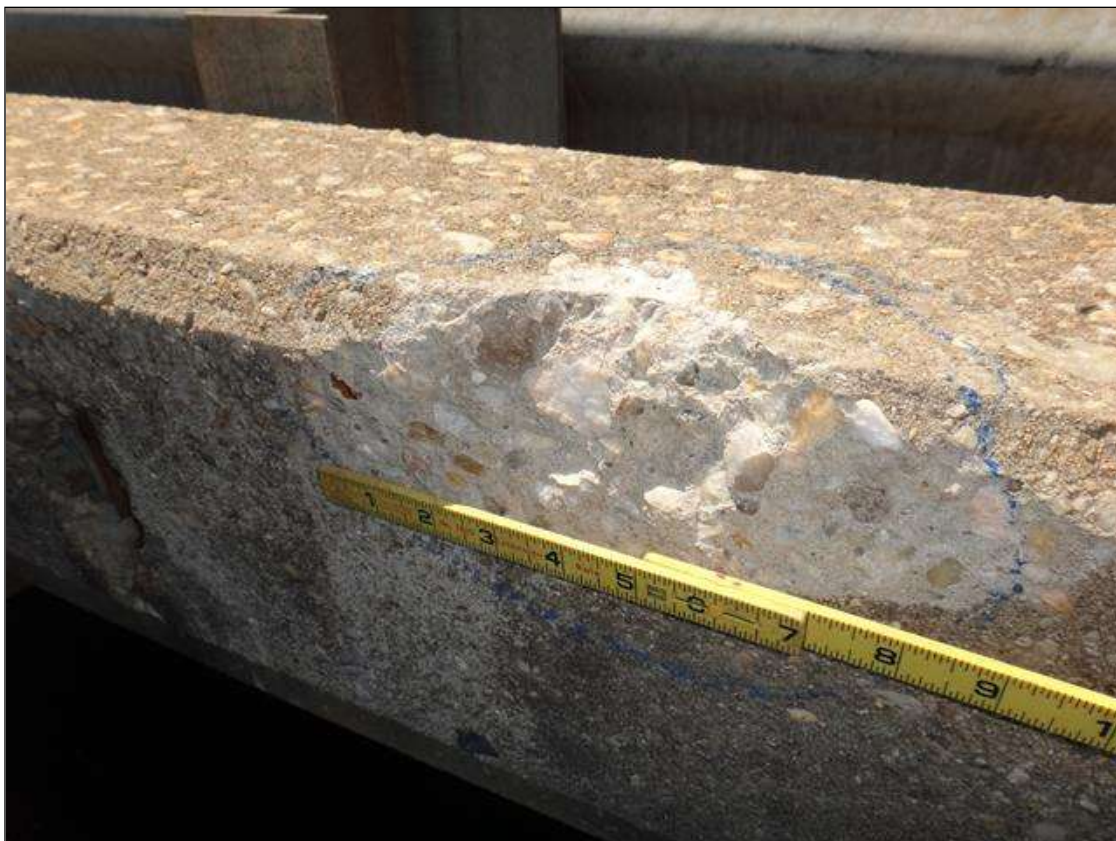
Span 3 Right Bridge Rail: at far third, spall [8in x 4in x 1in deep]

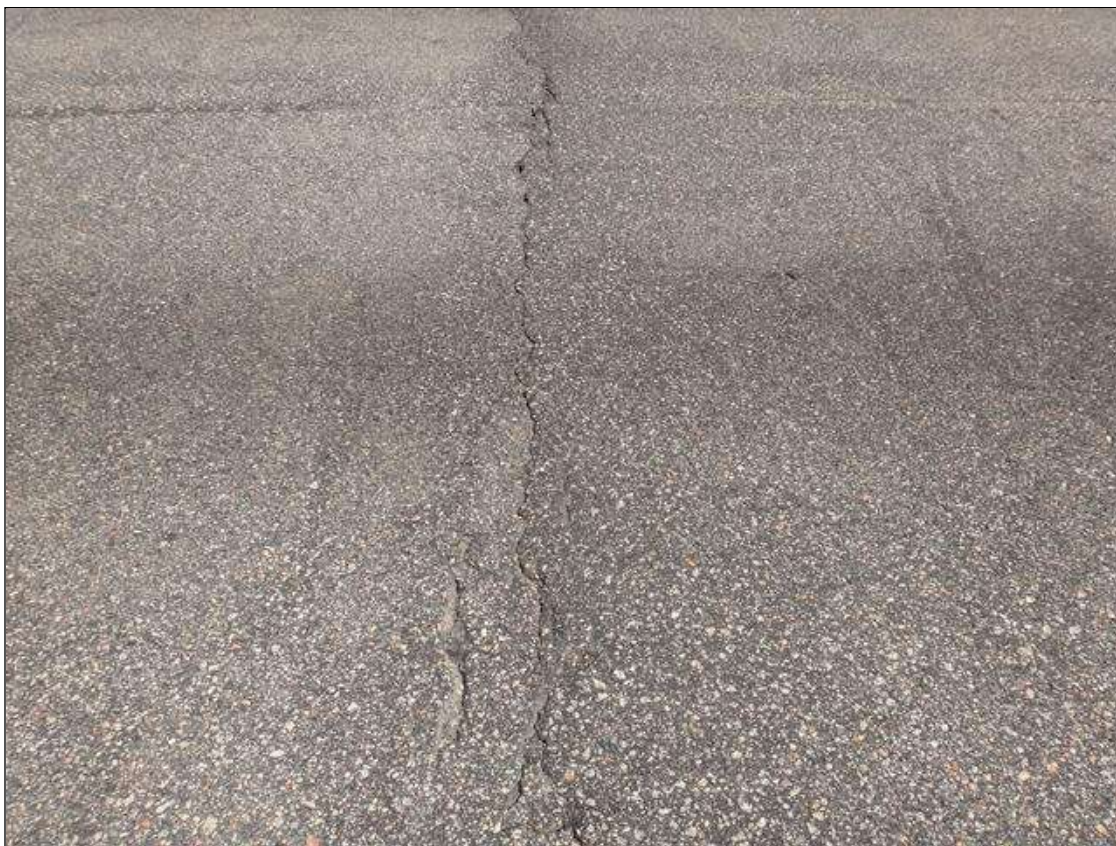
Span 4 Wearing Surface: asphalt over end bent 2, multiple transverse cracks [up to full width x up to 1/2in] with edge spalling [up to 1in]

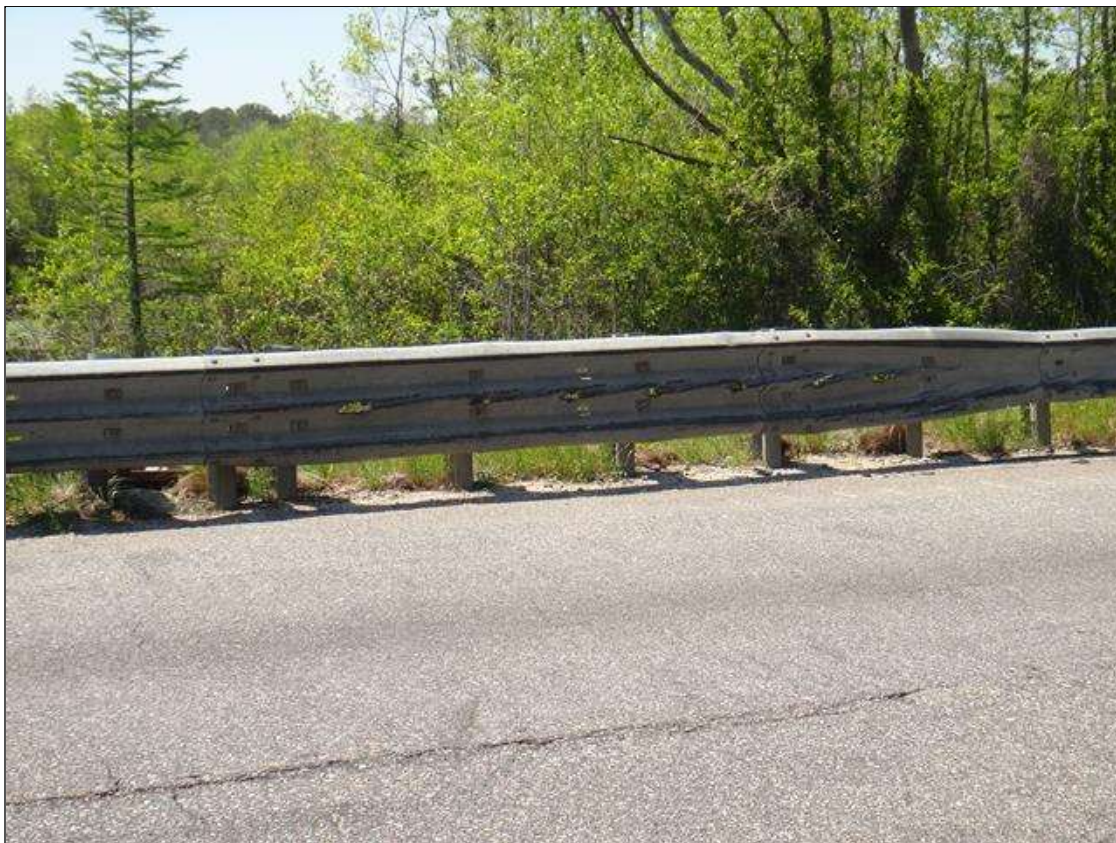
Northwest guardrail: at North approach, vehicular impact damage [25ft long] with multiple gouges [up to 5in x 3in]

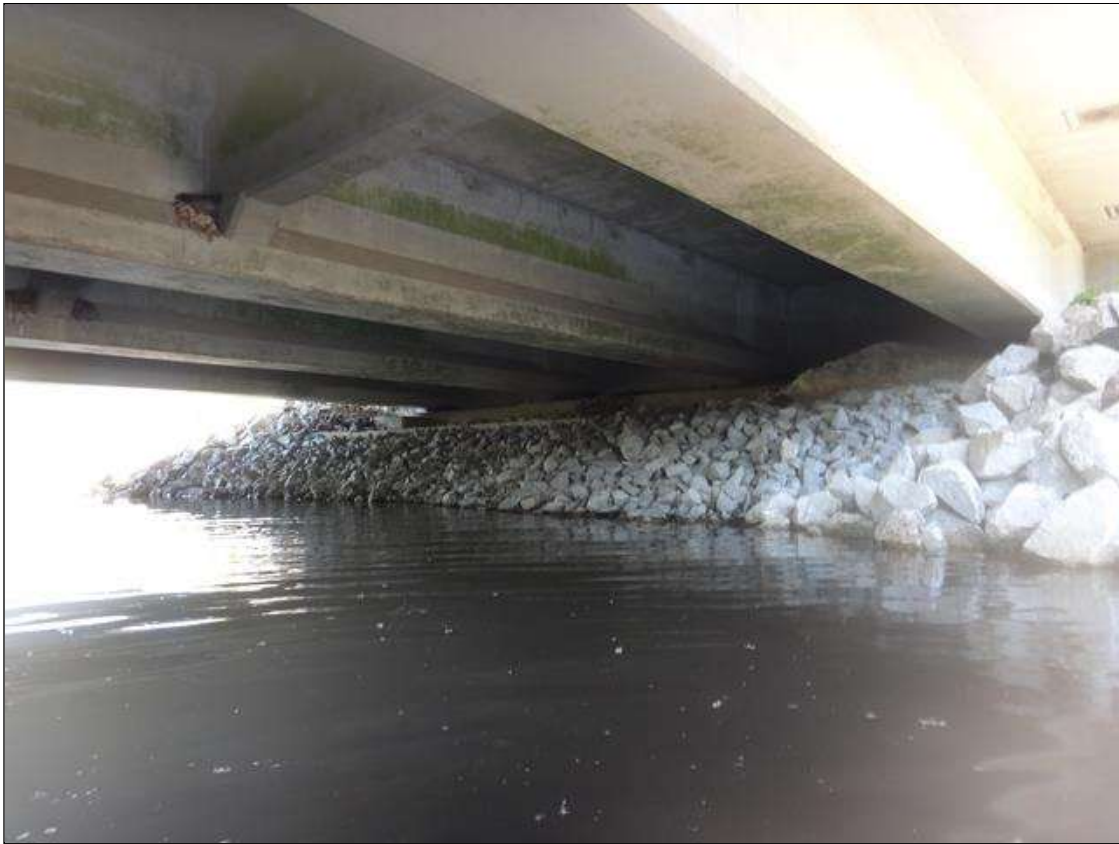
end bent 2 and slope protection

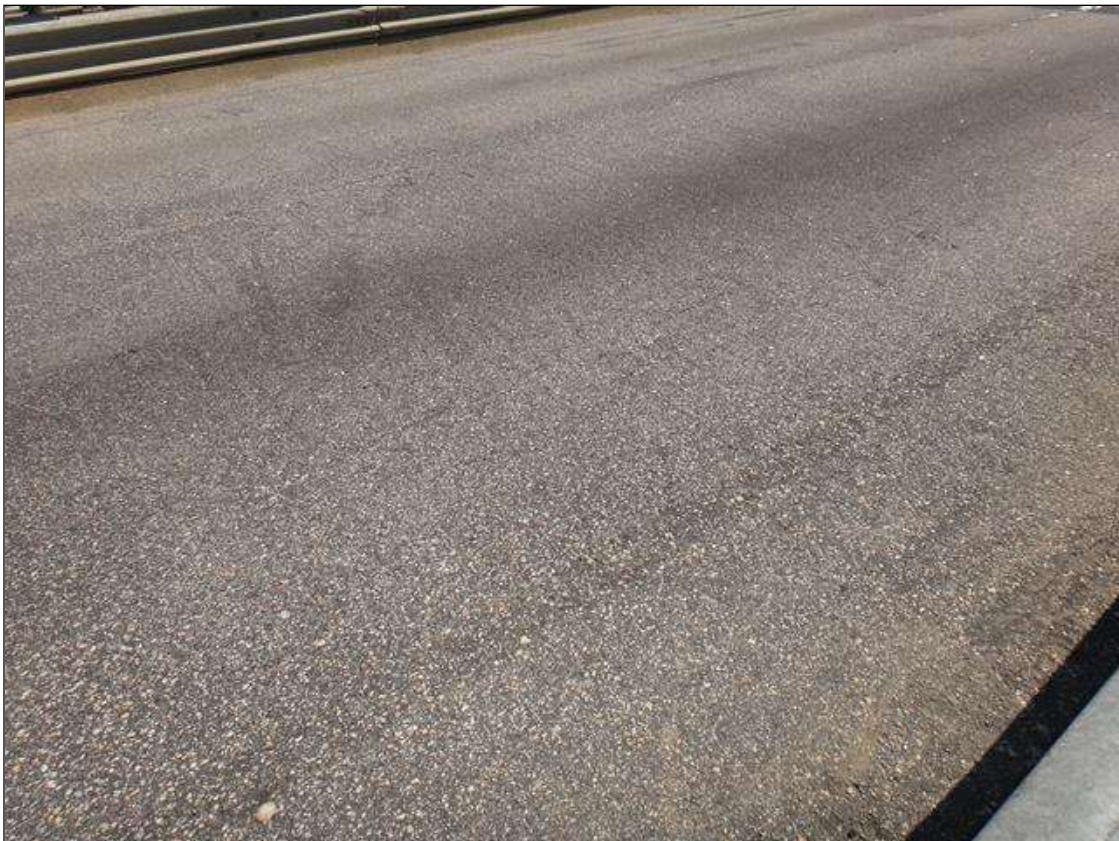
typical wearing surface

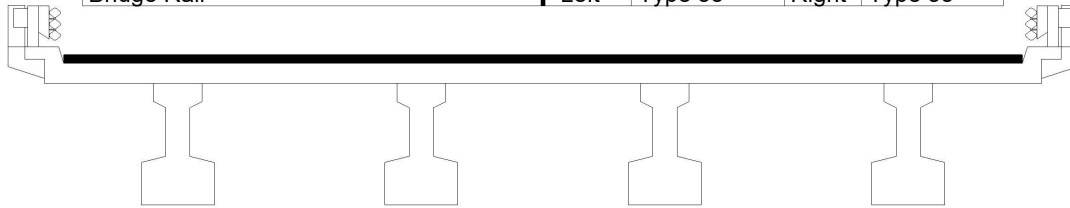
Measurements for Span #	1		
Deck Thickness	0.583ft	Left Overhang	3.75ft*
Top of Rail to Bottom of Beam	6.083ft	Right Overhang	3.75ft*

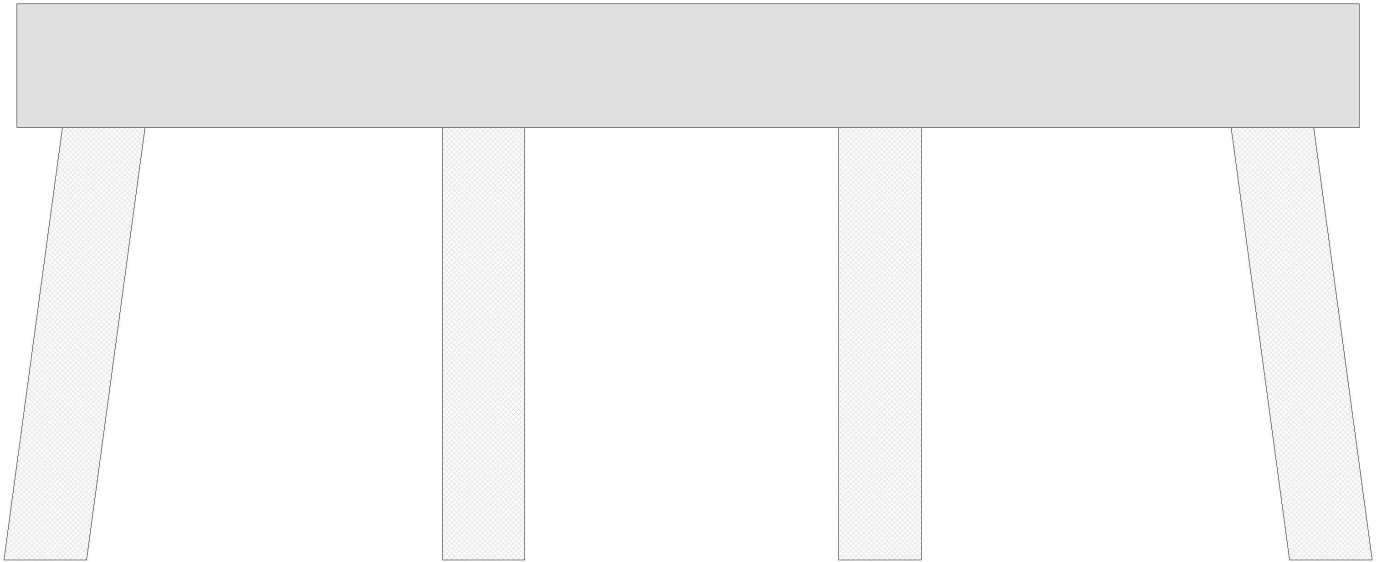
<b>Cap Information</b>			<b>Material</b> Cast-in-Place Concrete							
Length	Width	Height	Left Overhang	Right Overhang	Left Beam to End of Cap.	Right Beam to End of Cap.				
27.083 ft.	3.000 ft.	2.500 ft.	1.750 ft.	1.750 ft.	1.917 ft.	1.833 ft.				
<b>Subcap Information</b>			<b>Material</b>							
Length	Width	Height	Left Overhang	Right Overhang	Left Pile to Splice.					
<b>Sill Information</b>			<b>Material</b>							
Length	Width	Height								
Pile #	Material	Spacing	Width/Dia.	Height	Length	Orientation	Driven?	Replacement?	Removed?	Collar?
1	Concrete	7.667 ft.	1.667 ft.			Battered	Yes	No	No	No
2	Concrete	8 ft.	1.667 ft.			Vertical	Yes	No	No	No
3	Concrete	7.917 ft.	1.667 ft.			Vertical	Yes	No	No	No
4	Concrete		1.667 ft.			Battered	Yes	No	No	No
<b>Bent #:</b> 1

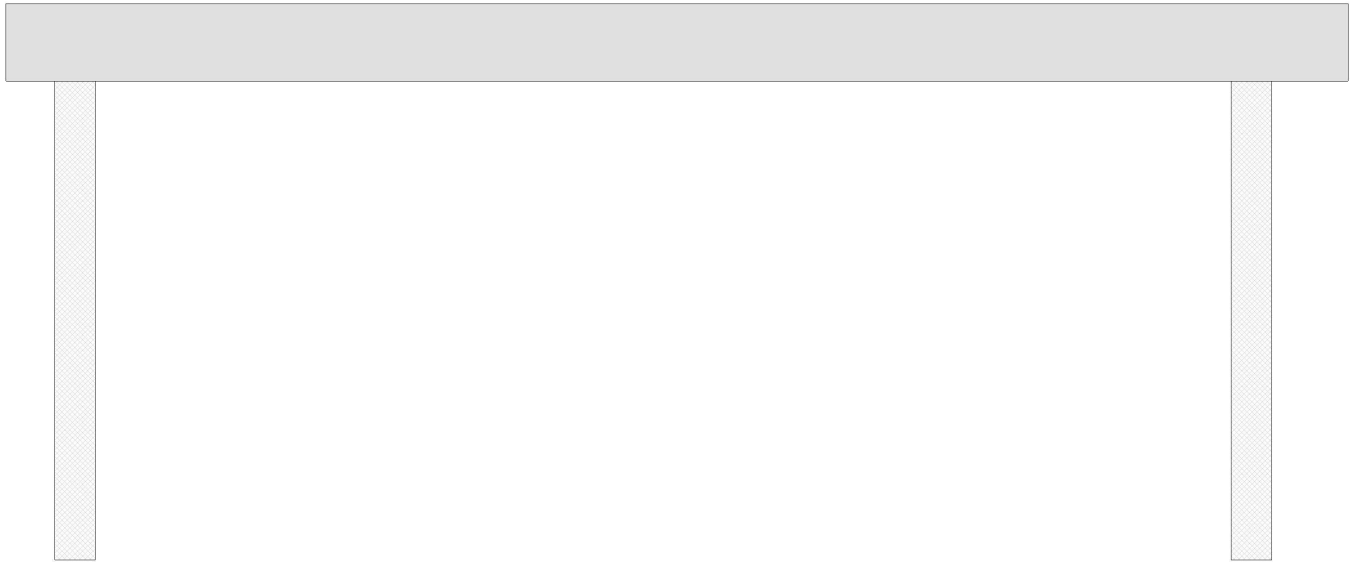
<b>Cap Information</b>			<b>Material</b> Steel							
Length	Width	Height	Left Overhang	Right Overhang	Left Beam to End of Cap.	Right Beam to End of Cap.				
40.500 ft.	1.188 ft.	2.334 ft.	2.084 ft.	2.917 ft.						
<b>Subcap Information</b>			<b>Material</b>							
Length	Width	Height	Left Overhang	Right Overhang	Left Pile to Splice.					
<b>Sill Information</b>			<b>Material</b>							
Length	Width	Height								
Pile #	Material	Spacing	Width/Dia.	Height	Length	Orientation	Driven?	Replacement?	Removed?	Collar?
1	Steel	35.5 ft.	1.15 ft.			Vertical	Yes	No	No	No
2	Steel		1.15 ft.			Vertical	Yes	No	No	No
<b>Crutch Bent #: 1</b>		<b>Similar Crutch Bents: 2, 3, and 4</b>
