NC DEPARTMENT OF TRANSPORTATION      ATTENTION:  
 DIVISION OF HIGHWAYS  
 STRUCTURE MANAGEMENT UNIT

## Structure Safety Report

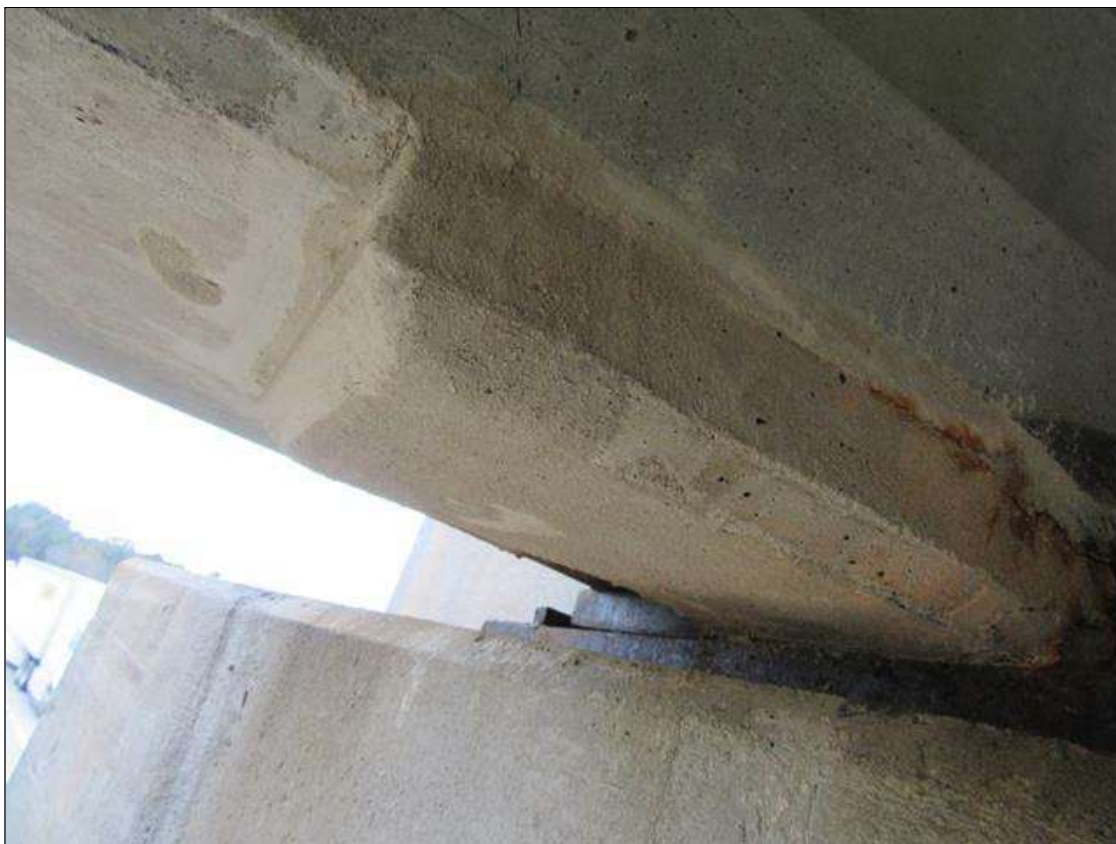
Span 4 Beam 4: SOUND PATCH IN BOTTOM FLANGE NEAR END AT BENT 3, PRIORITY MAINTENANCE REPAIR.

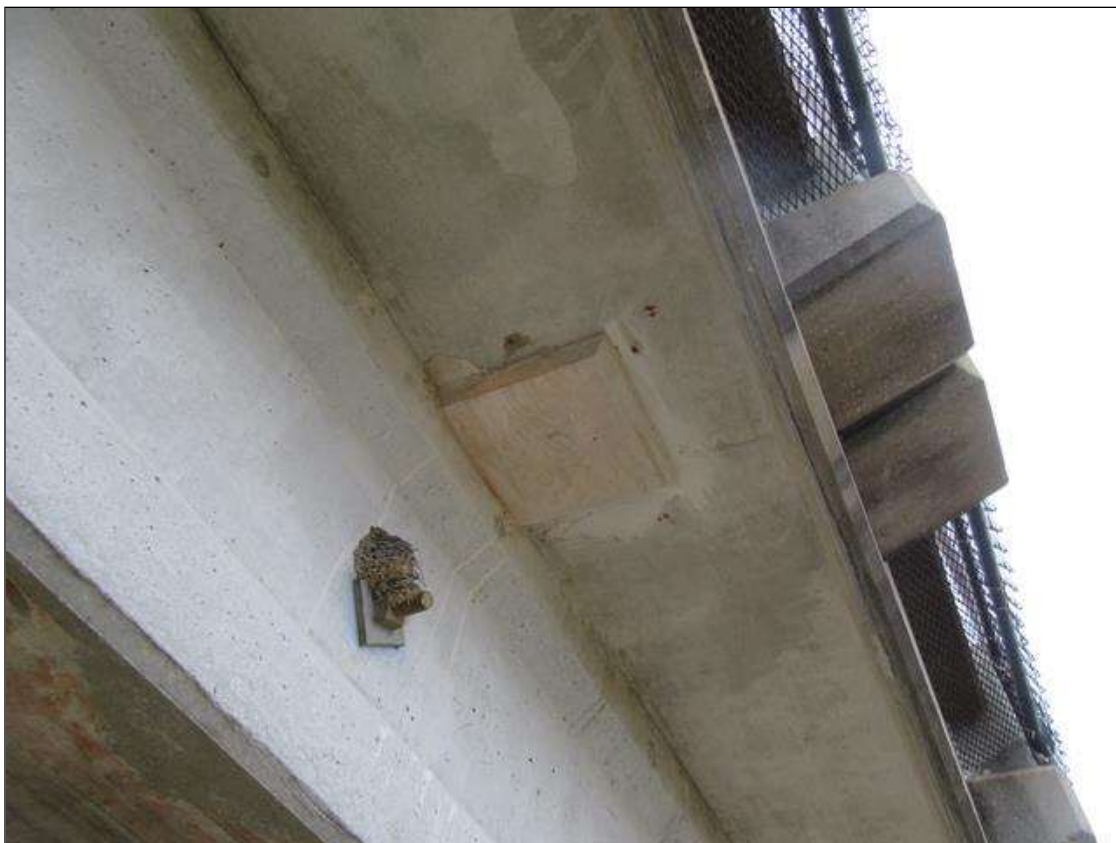
Span 1 Deck: RIGHT DECK OVERHANG SOUND PATCH AT MID SPAN

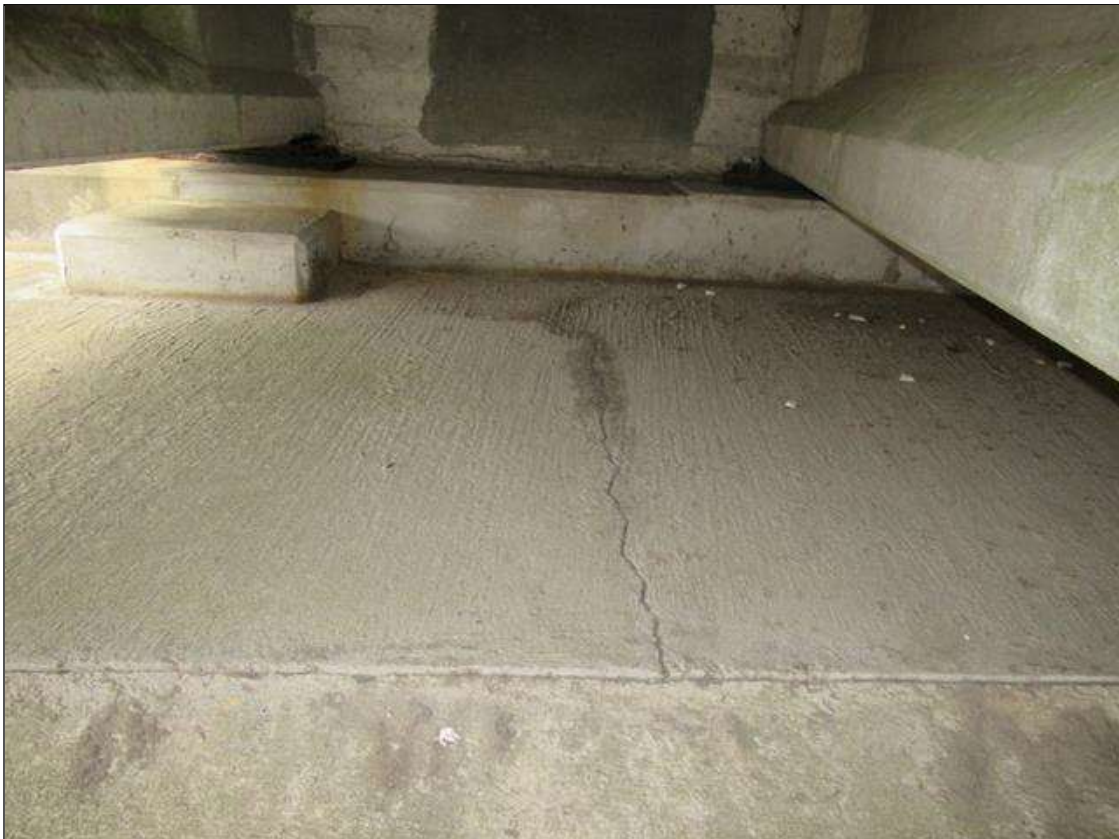
END BENT 1 TOP OF SLOPE AT BAY 1 6 FT. LONG X 1/4" WIDE LONGITUDINAL CRACK

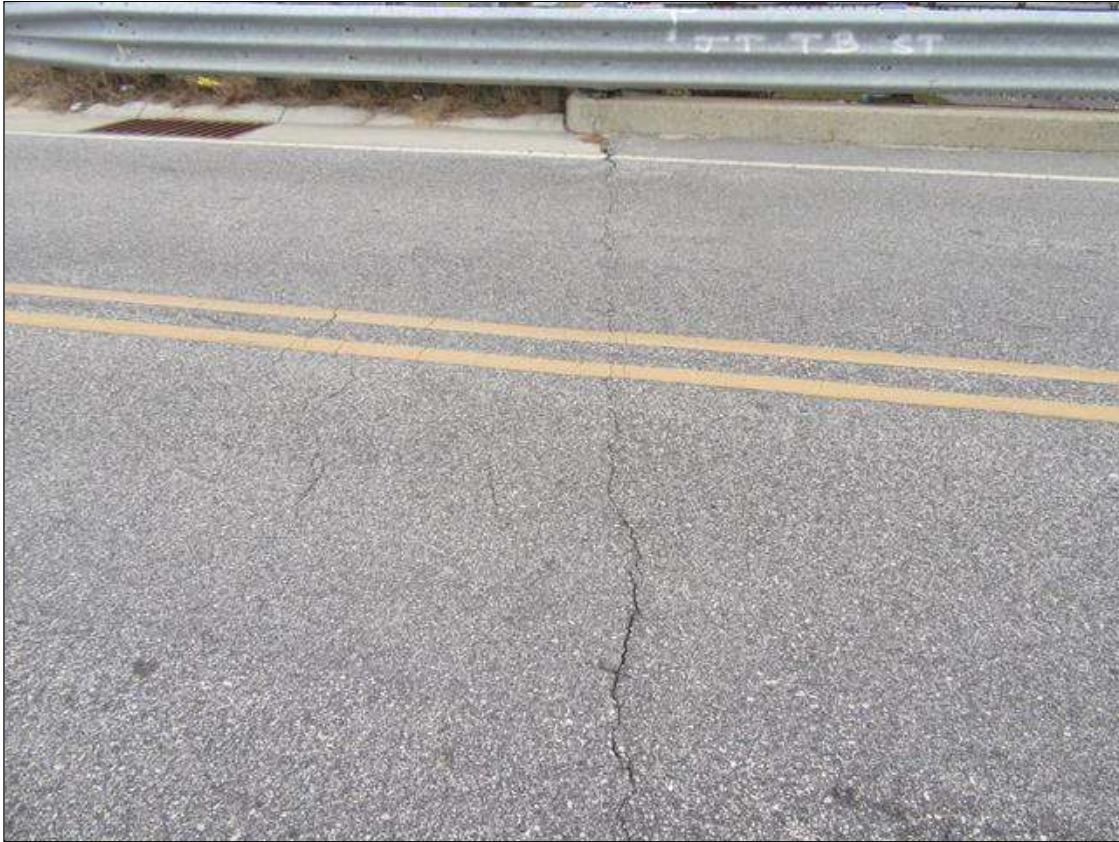
Span 1 Wearing Surface: 1/8" WIDE TRANSVERSE CRACK OVER END BENT 1

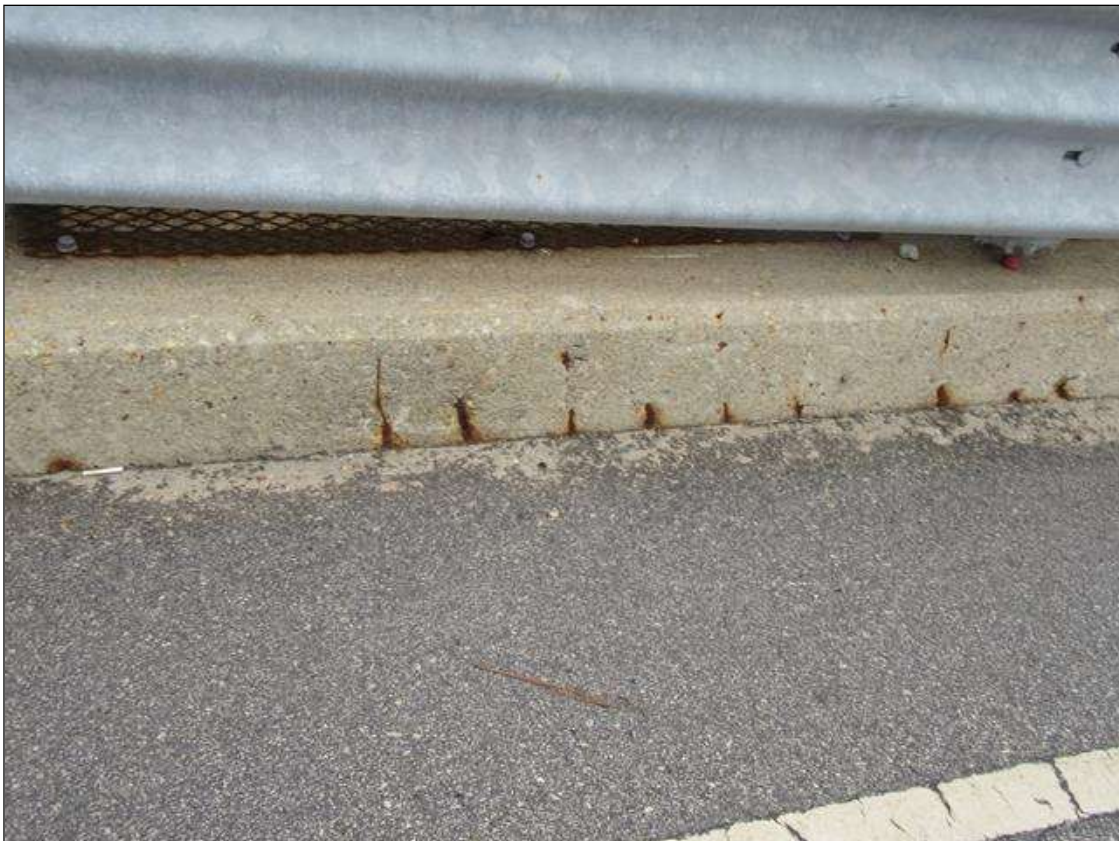
Span 1 Right Bridge Rail: SURFACE SPALLS 18 WITH EXPOSED REBAR IN RIGHT CURB

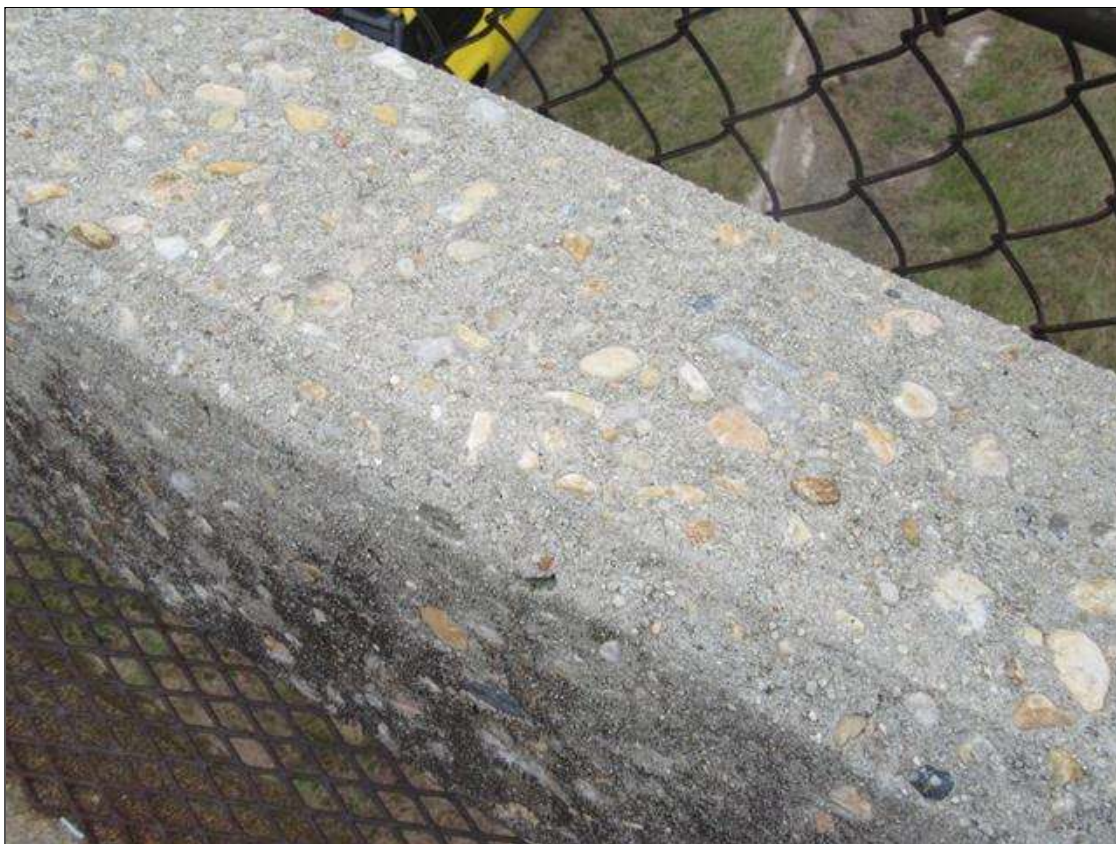
SPAN 1 RIGHT RAIL 35 FT OF EXPOSED AGGREGATE

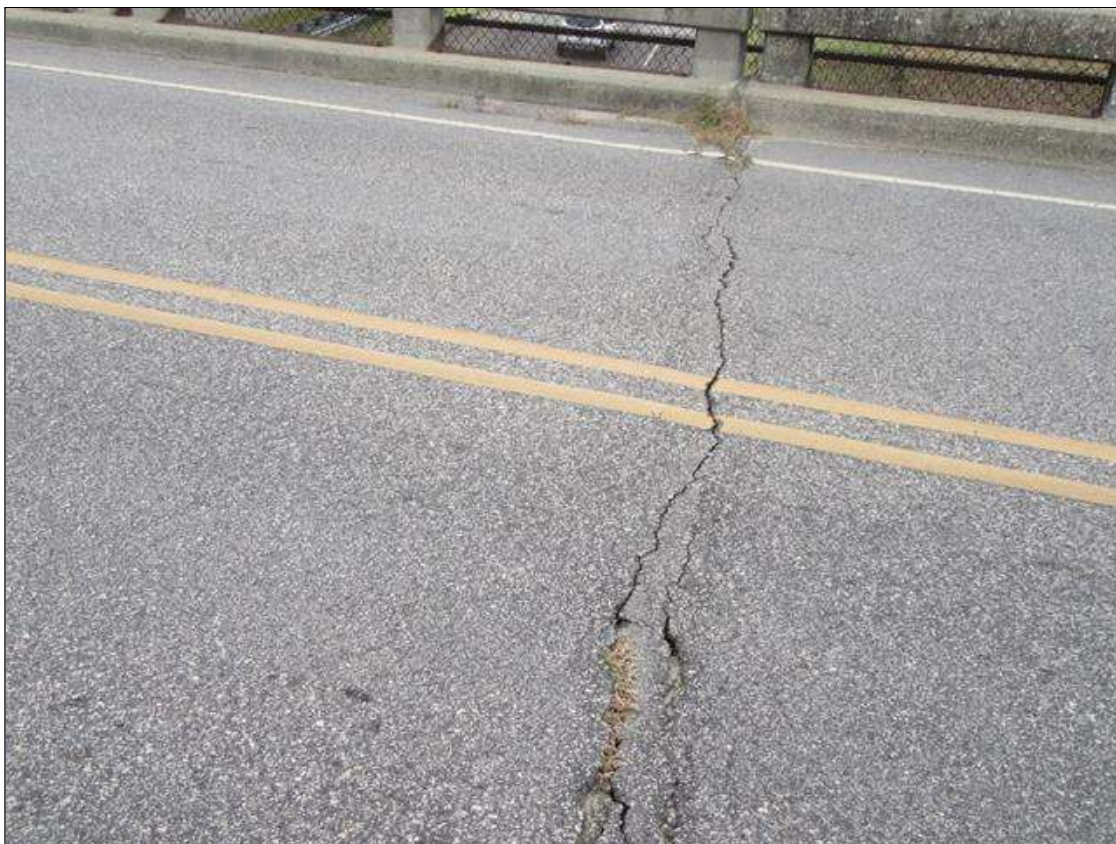
Span 1 Wearing Surface: 1/4" WIDE TRANSVERSE CRACK OVER BENT 1

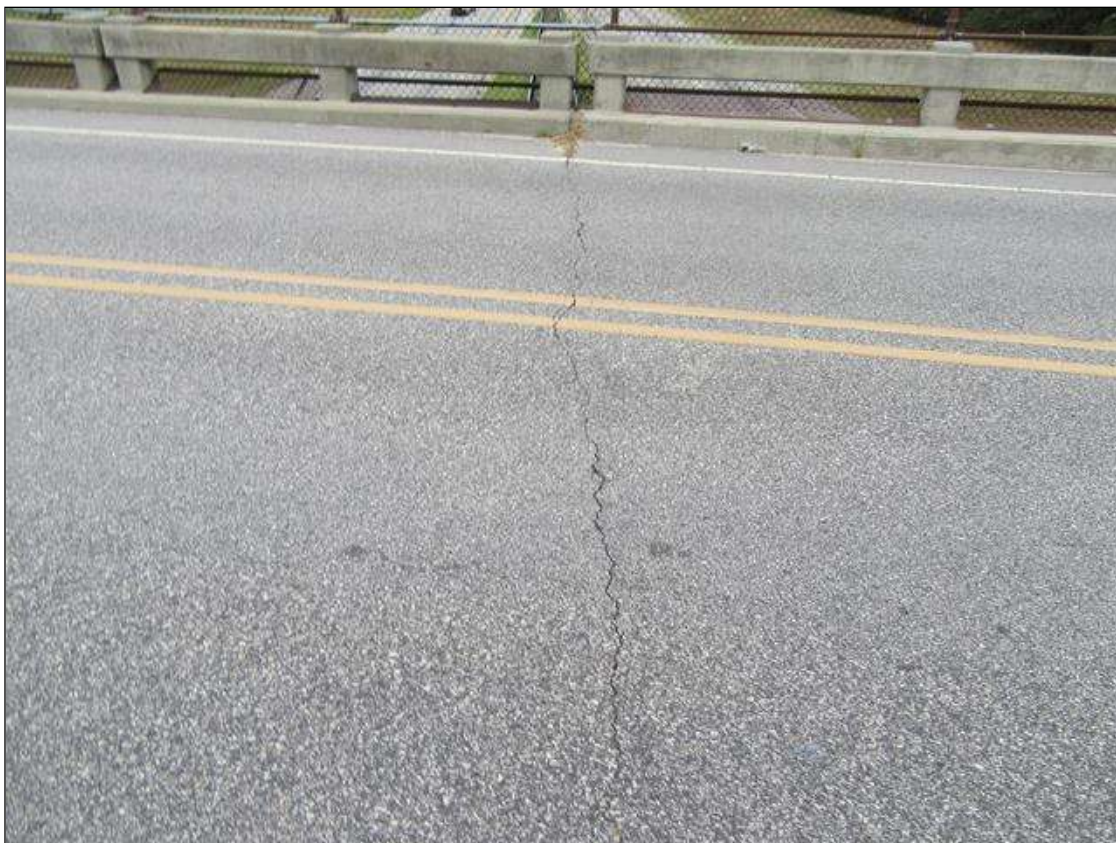
Span 2 Wearing Surface: 1/8" WIDE TRANSVERSE CRACK OVER BENT 2

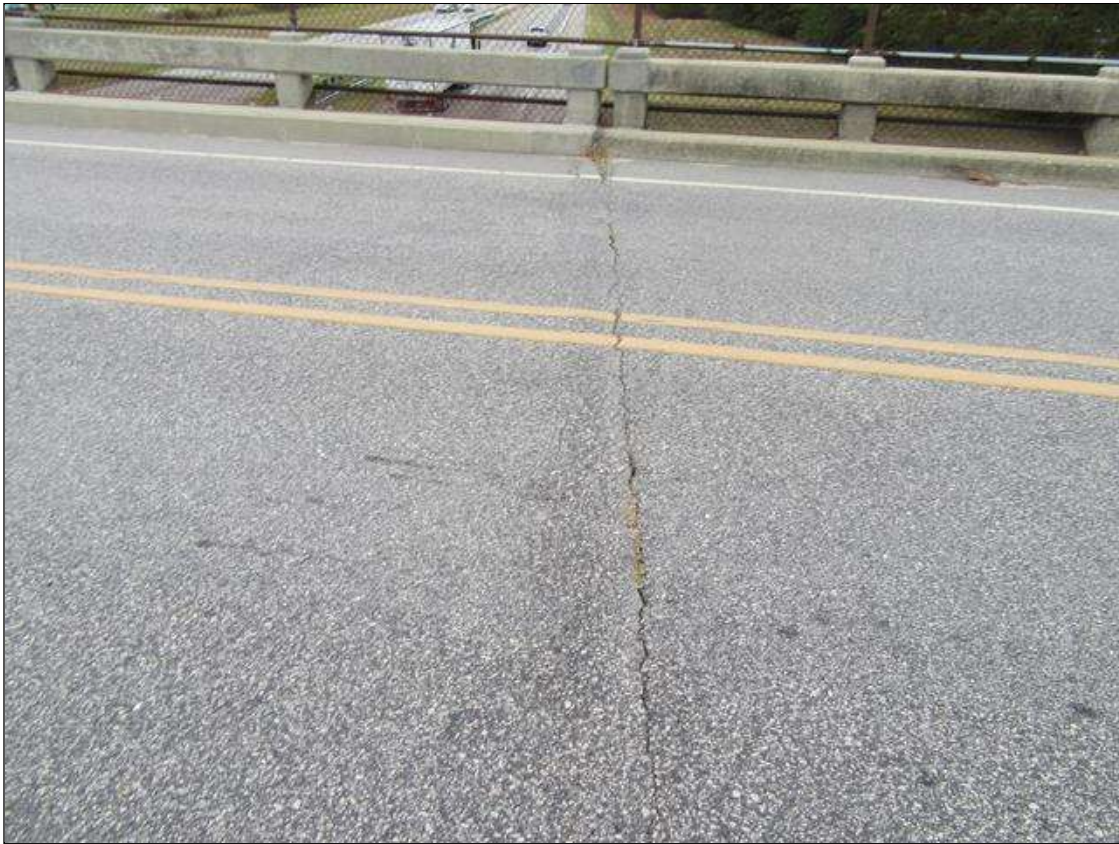
Span 3 Wearing Surface: 3/16" WIDE TRANSVERSE CRACK OVER BENT 3

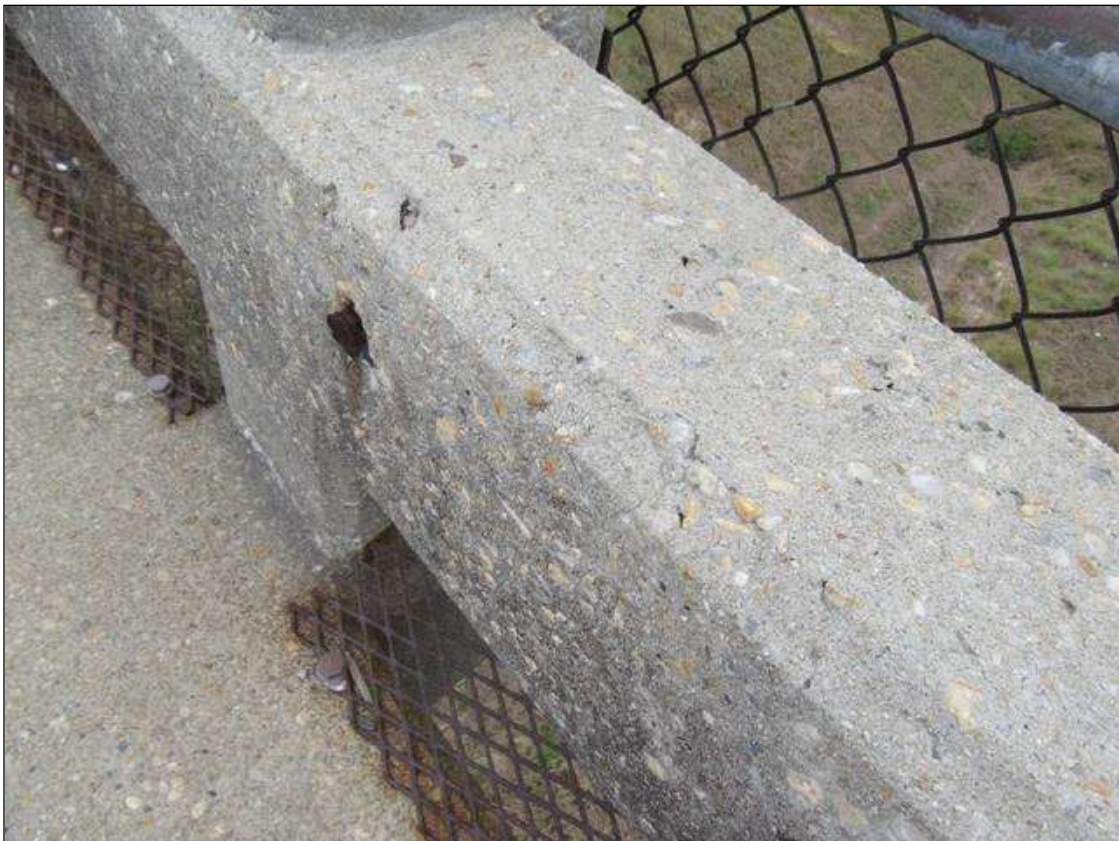
SPAN 4 RIGHT RAIL HAS EXPOSED AGGREGATE

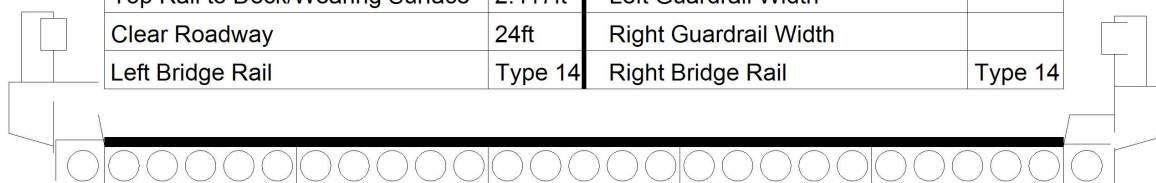
Measurements for Span #	2	SPAN 3 SIMILAR	
Deck Thickness	1.5	Left Overhang	1
Top of Rail to Bottom of Beam	4.083	Right Overhang	1

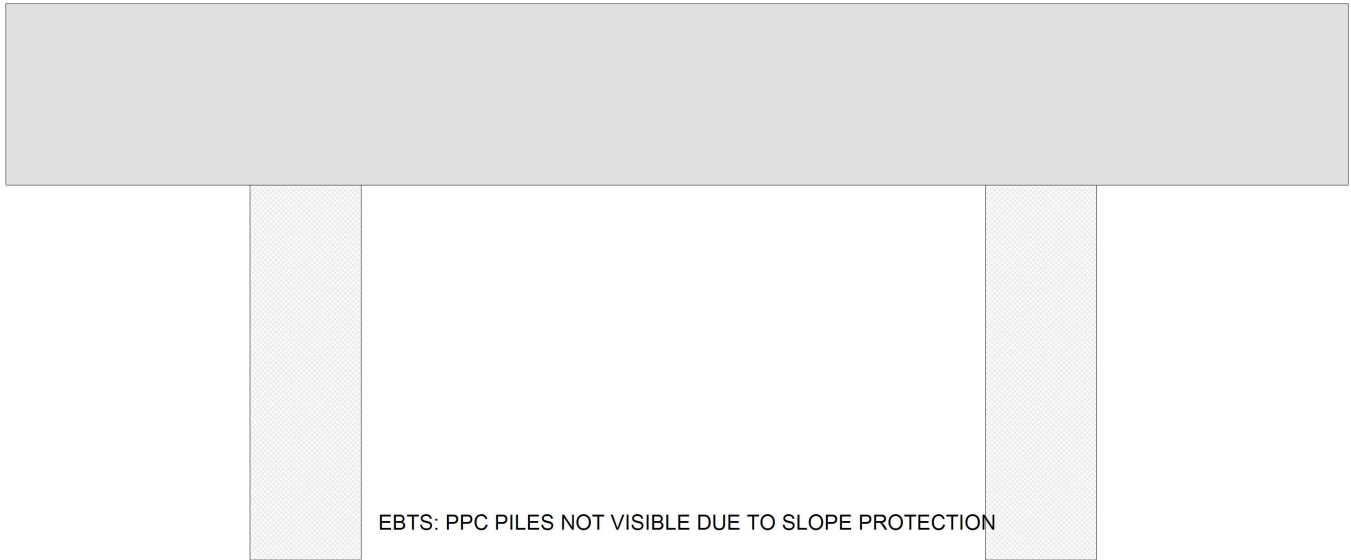
EBTS: PPC PILES NOT VISIBLE DUE TO SLOPE PROTECTION

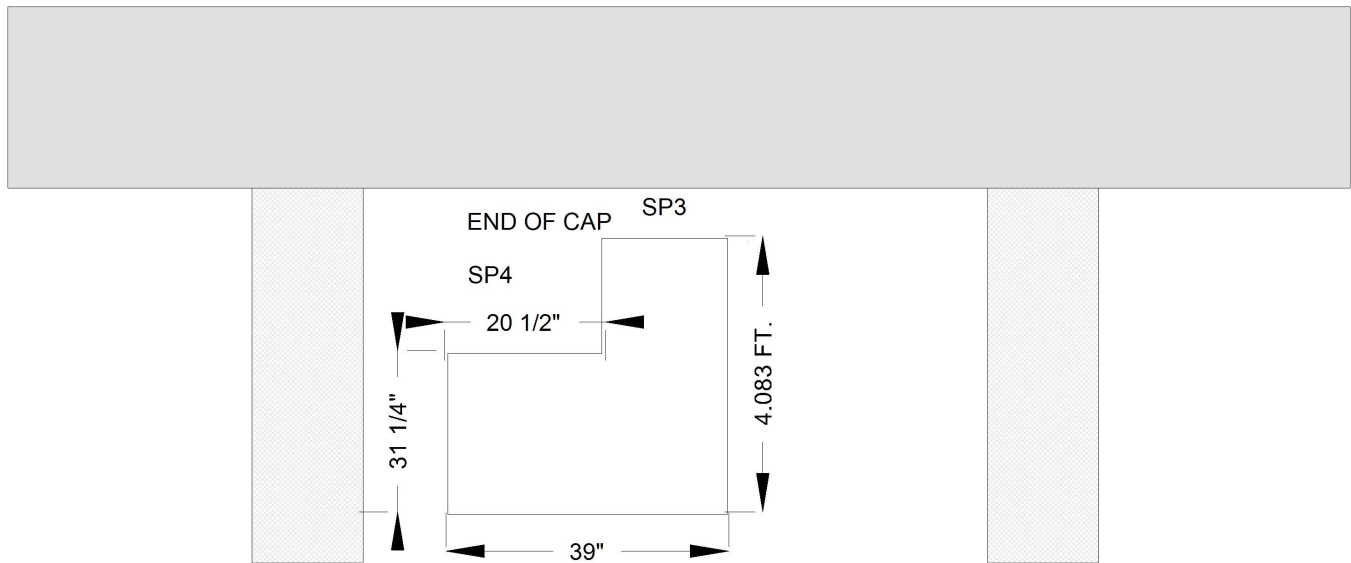
<b>Cap Information</b>			Material Cast-in-Place Concrete							
Length	Width	Height	Left Overhang	Right Overhang	Left Beam to End of Cap.	Right Beam to End of Cap.				
30.250 ft.	2.250 ft.	4.083 ft.	6.750 ft.	6.917 ft.	4.333 ft.	4.167 ft.				
<b>Subcap Information</b>			Material							
Length	Width	Height	Left Overhang	Right Overhang	Left Pile to Splice.					
<b>Sill Information</b>			Material							
Length	Width	Height								
Pile #	Material	Spacing	Width/Dia.	Height	Length	Orientation	Driven?	Replacement?	Removed?	Collar?
1	Concrete		2.5 ft.			Vertical	No	No	No	No
2	Concrete	16.583 ft.	2.5 ft.			Vertical	No	No	No	No
MEASUREMENTS VERIFIED BY RLK 12/13/11 MEASUREMENTS VERIFIED BY RLK 11/6/13 MEASUREMENTS VERIFIED BY RLK 11/16/15 MEASUREMENTS VERIFIED BY RLK 11/08/17										
<b>Bent/Abutment #:</b> 3			<b>Similar Bents:</b> BENT 1
