NC DEPARTMENT OF TRANSPORTATION      ATTENTION:  
 DIVISION OF HIGHWAYS  
 STRUCTURE MANAGEMENT UNIT

# Structure Safety Report

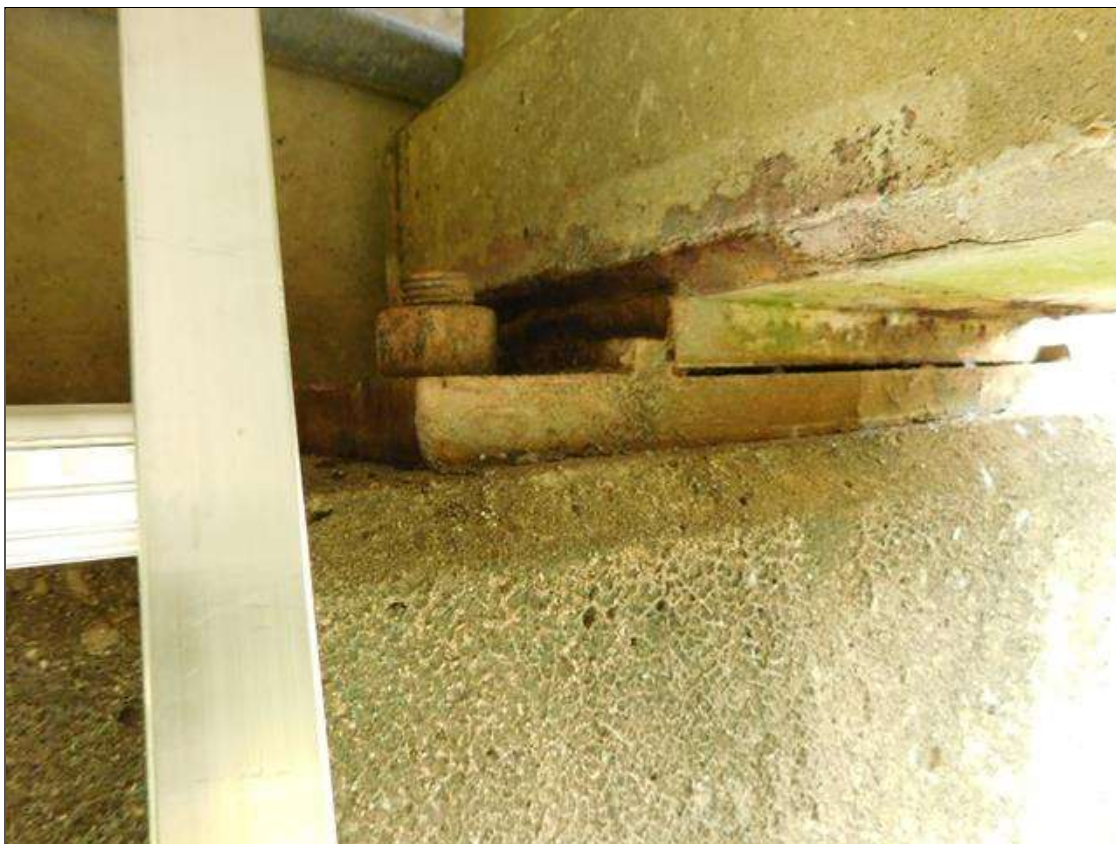
Span 4 Beam 1 Near Bearing: FRECKLED CORROSION

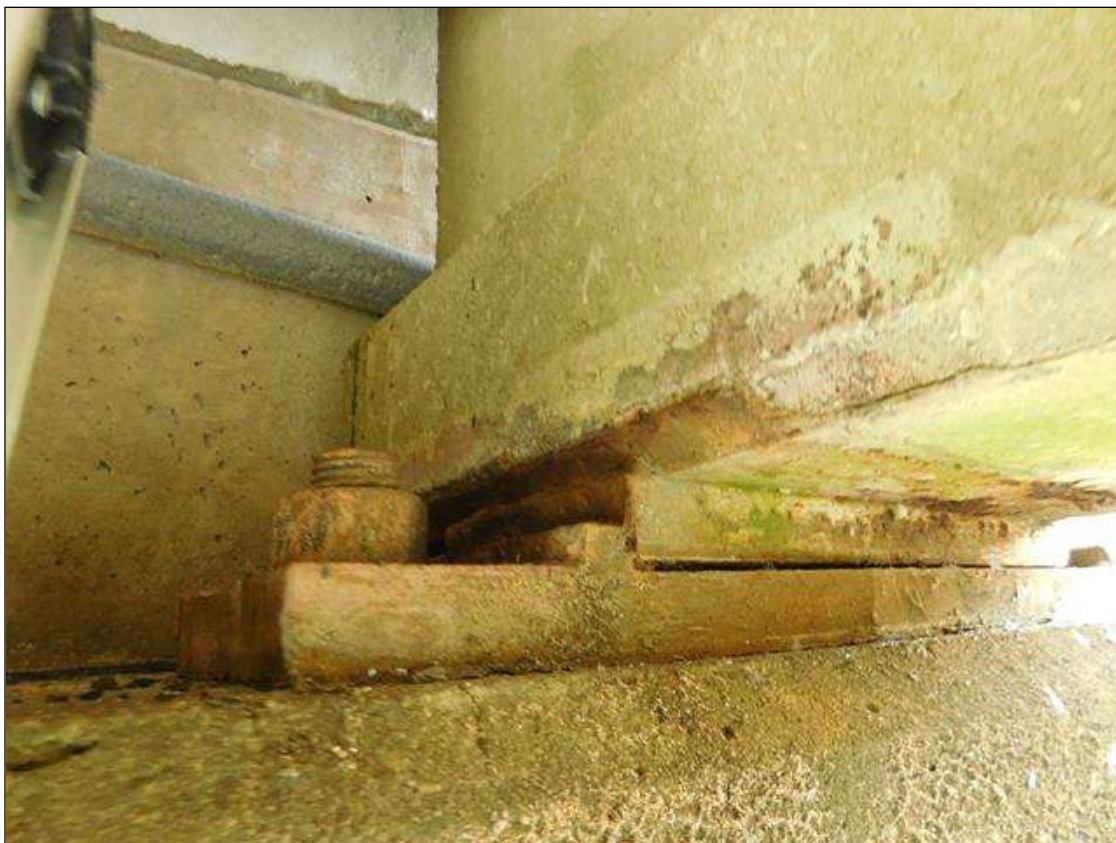
Span 4 Beam 1 Near Bearing: FRECKLED CORROSION

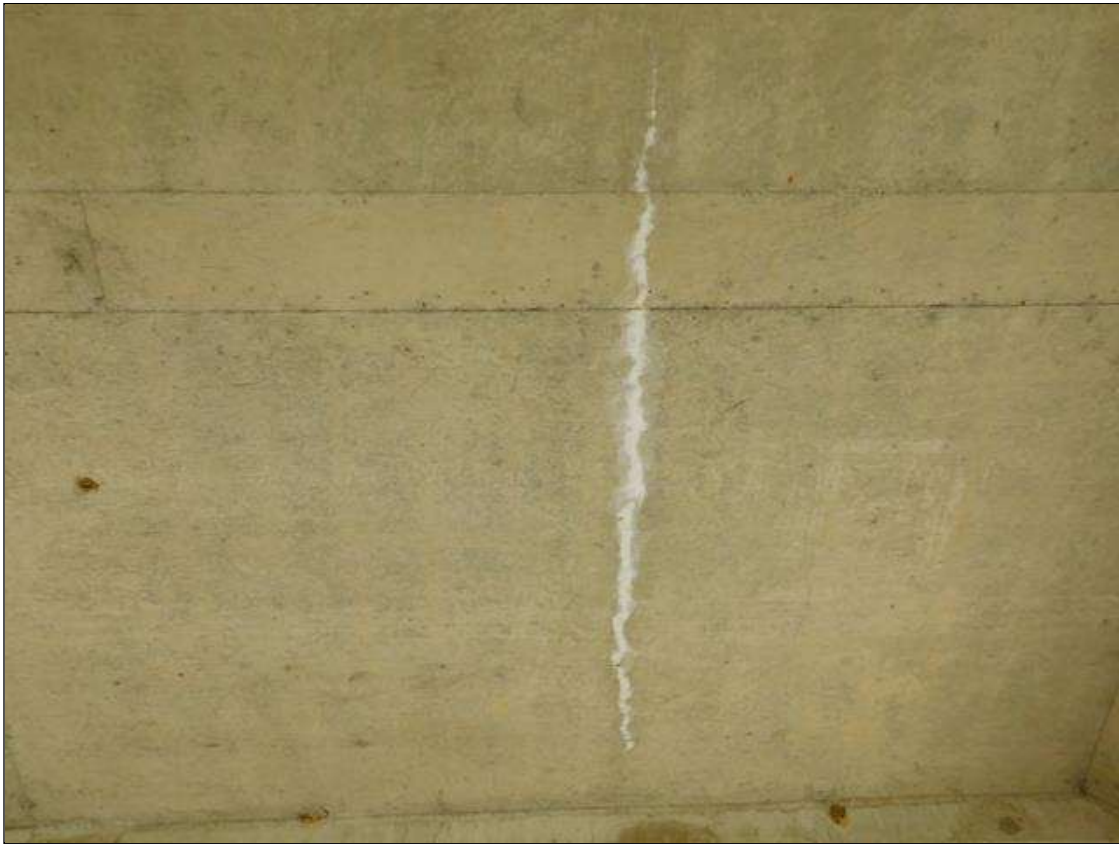
Span 4 Deck: 60 Square Feet of transverse Cracking (RC and Other): Width up to 1/32" with efflorescence near mid-span ON UNDERSIDE OF DECK

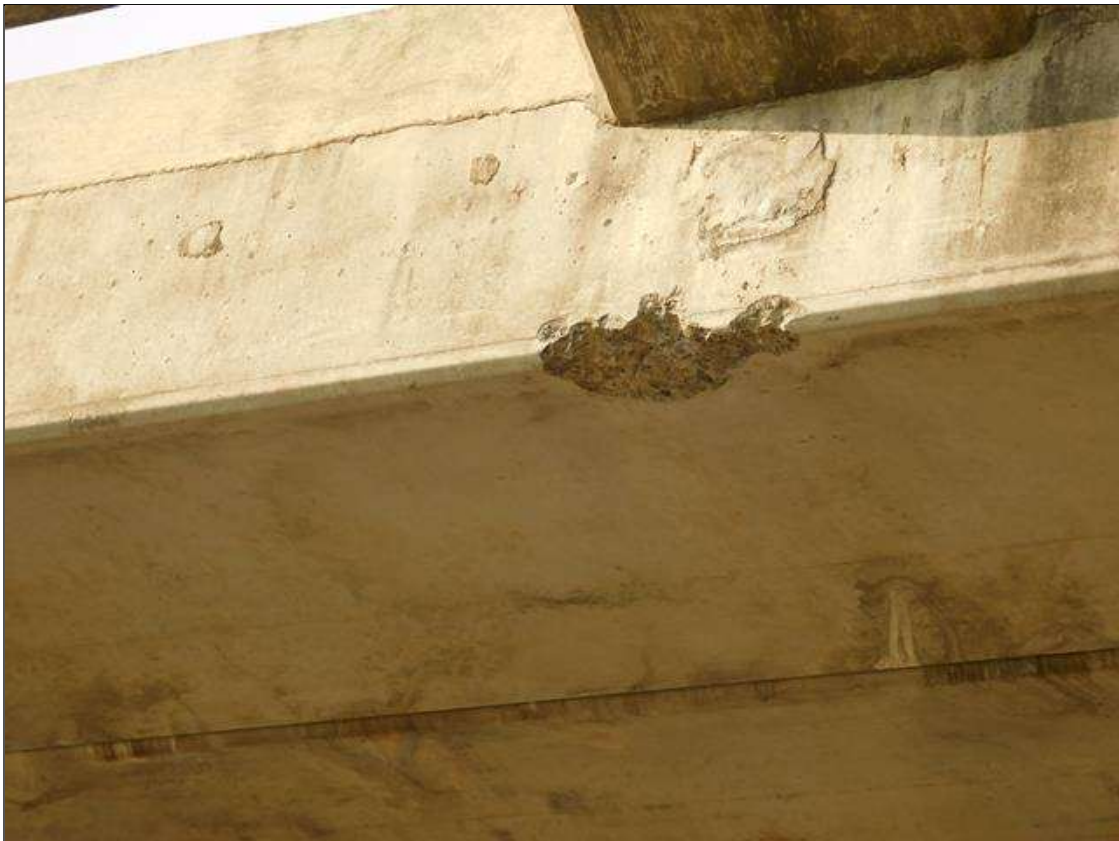
Span 2 Slab 1: OUTBOARD LOWER SIDE OF THE SLAB HAS PAST IMPACT DAMAGE, APPROX 1'L X UP TO 5"W X UP TO 2"D, CENTERED OVER THE RT SOUTHBOUND LANE

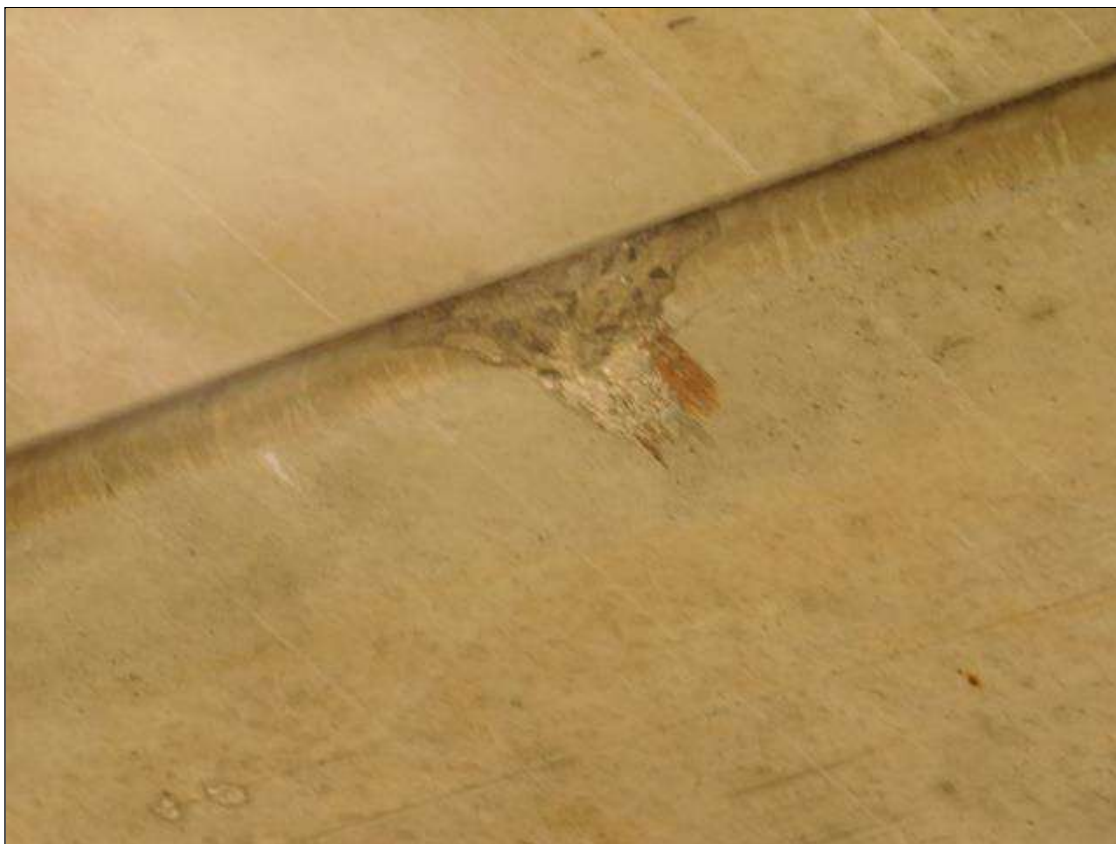
Span 2 Slab 5: LOWER SIDE OF THE SLAB AT THE LEADING CORNER HAS PAST IMPACT DAMAGE, APPROX 2"LINE X UP TO 4"W X UP TO 1"D CENTERED OVER THE RT SOUTHBOUND LANE

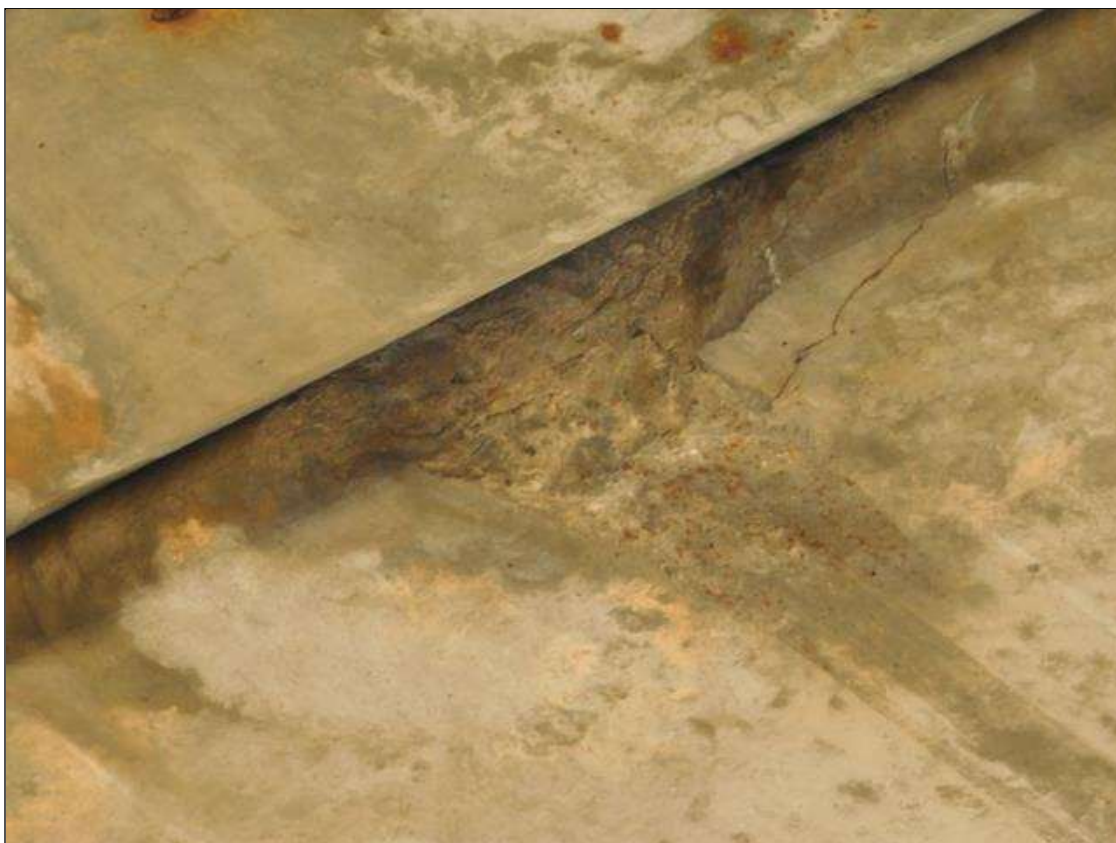
Span 2 Slab 9: LOWER SIDE OF THE SLAB AT THE LEADING CORNER HAS PAST IMPACT DAMAGE, APPROX 4"LINE X UP TO 4"W X UP TO 1"D CENTERED OVER THE RT SOUTHBOUND LANE

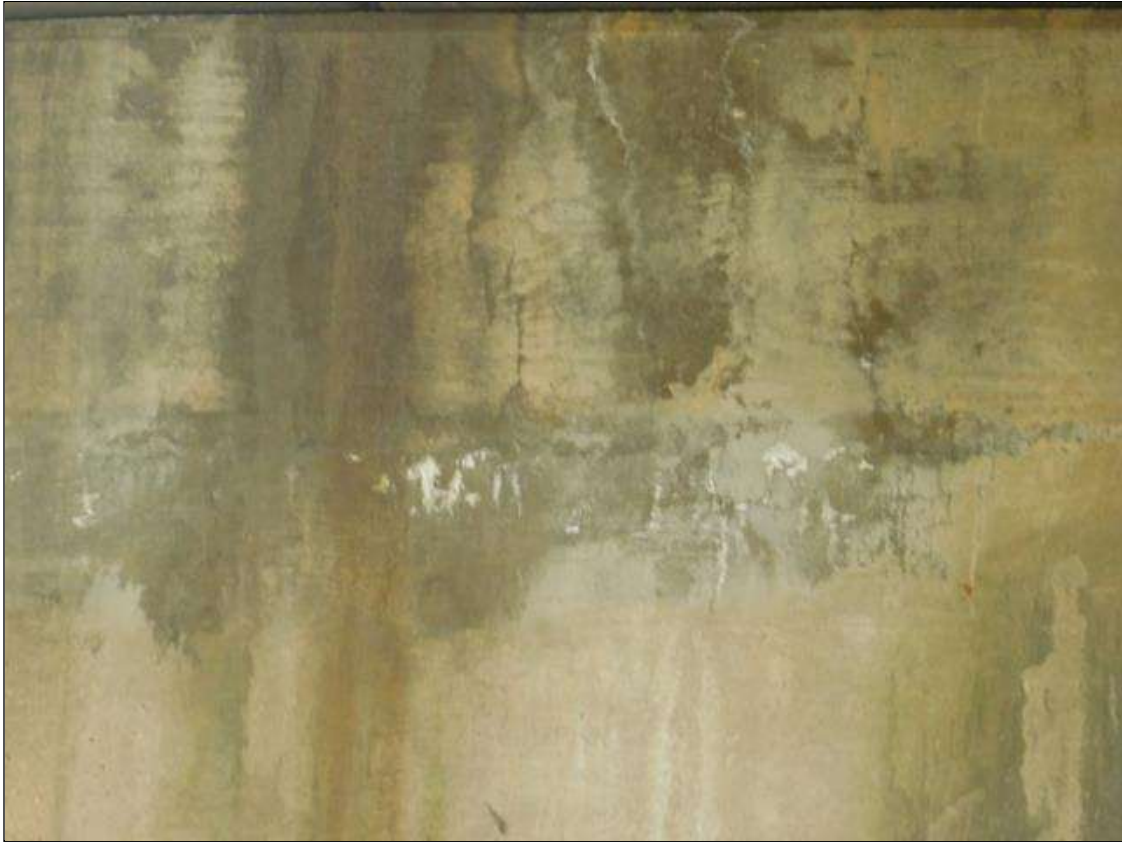
Bent 2 Cap 1: 1 Feet of longitudinal Cracking (RC and Other): Width .005 open on bottom face under slabs 4 and 5.

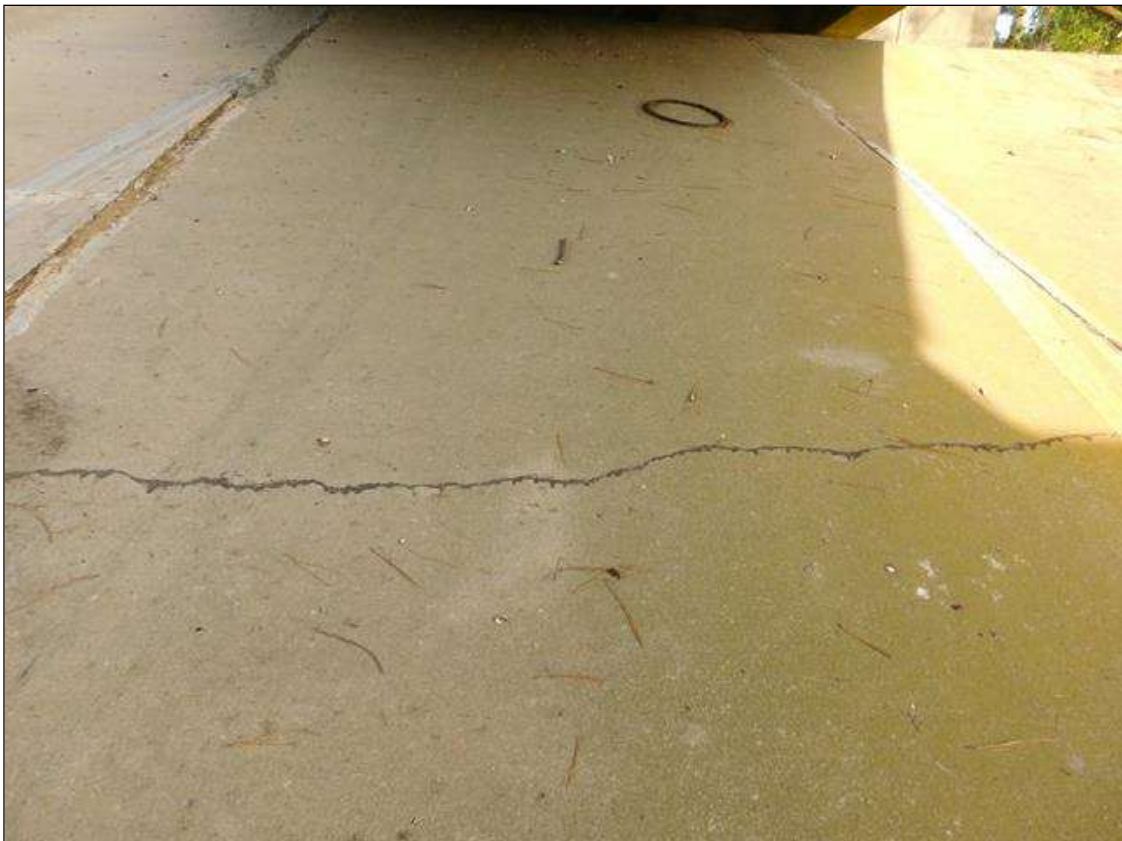
END BENT 1 SLOPE PROTECTION .010 WIDE TRANSVERSE CRACKING 45 FT.

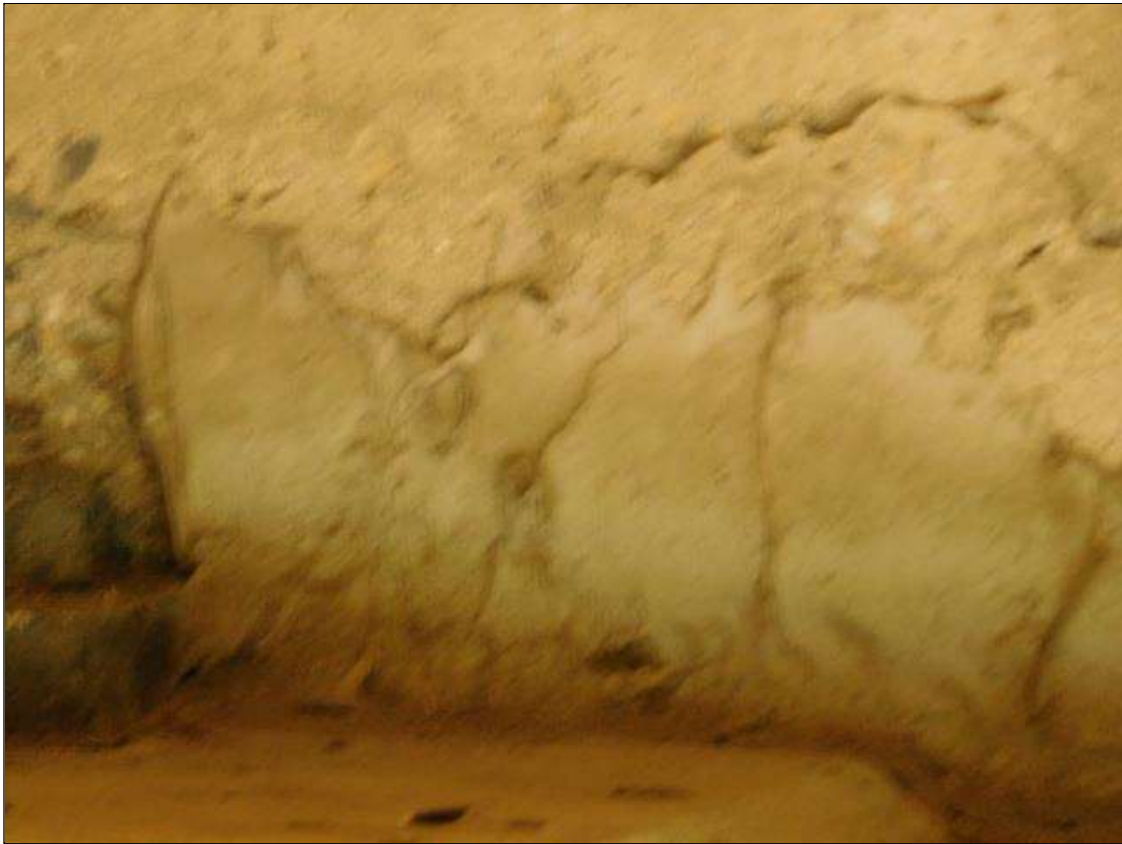
End Bent 1 Abutment/Backwall : BAY 1, SOUND PATCH AT LOWER SIDE AT GIRDER 2

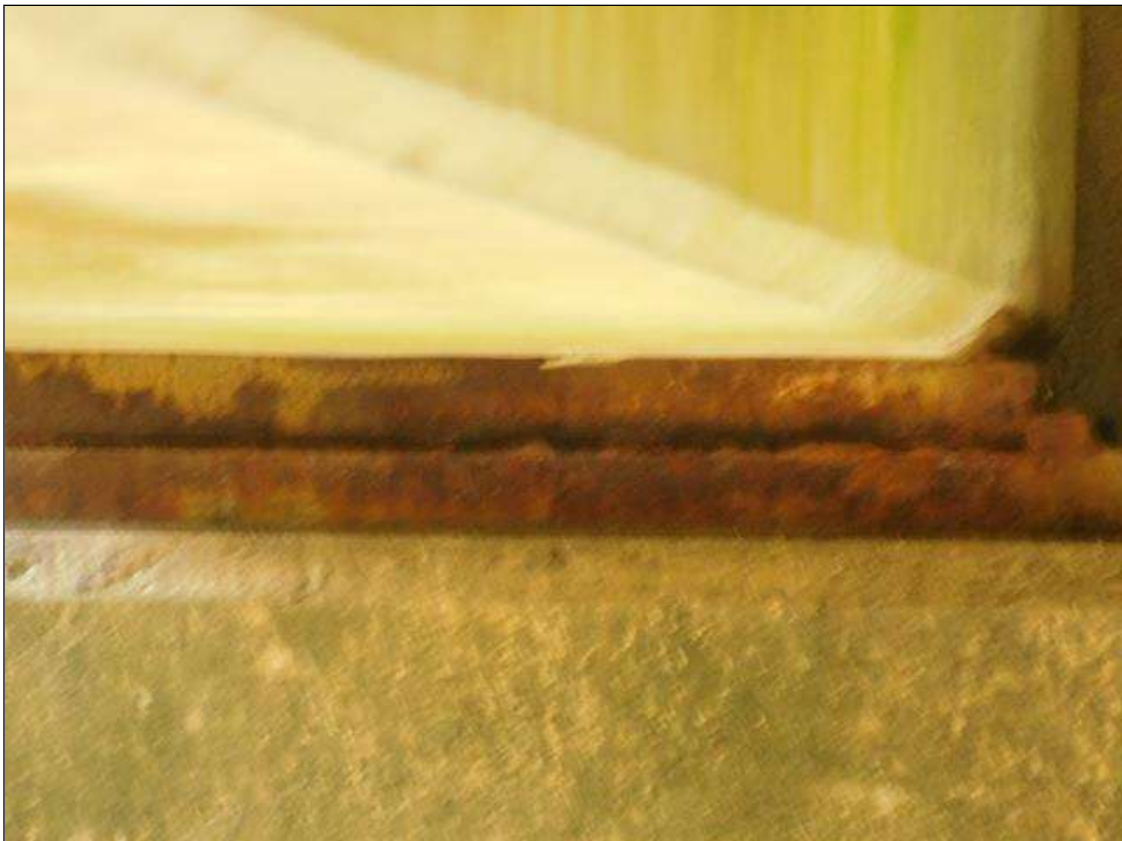
Span 1 Beam 1 Far Bearing: FRECKLED CORROSION

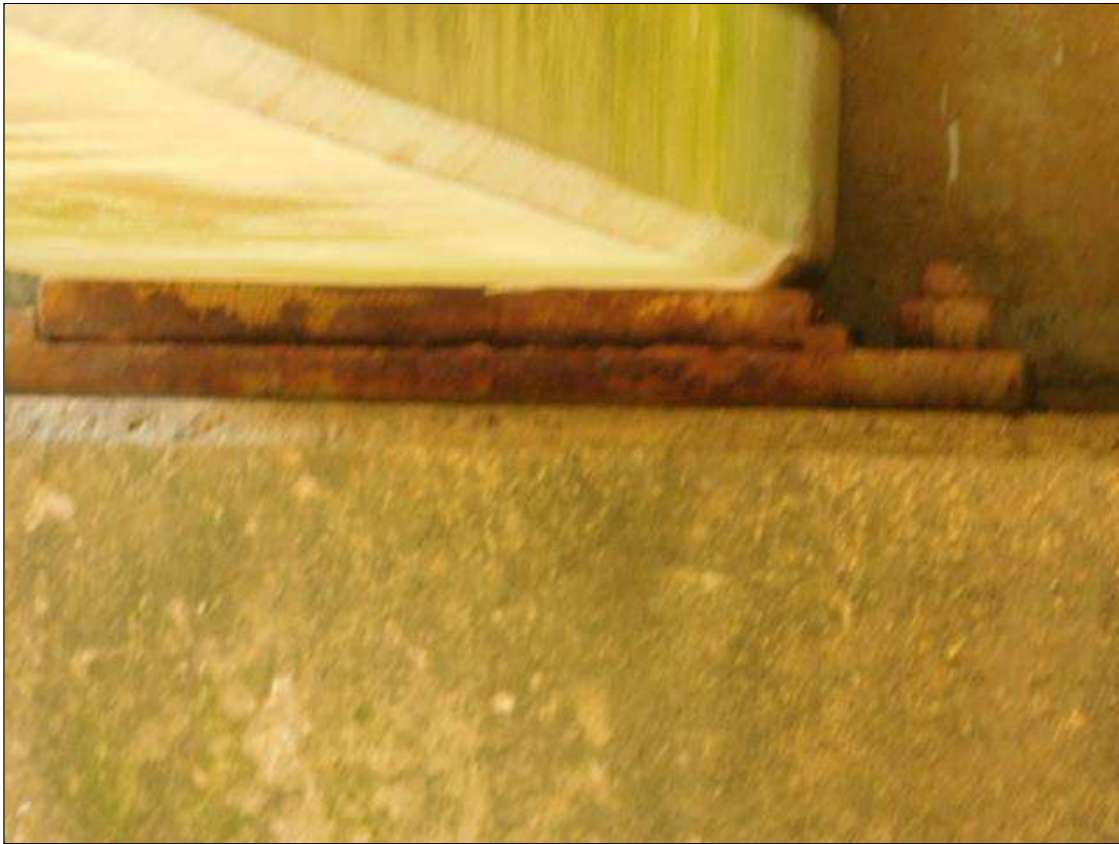
Span 1 Beam 1 Far Bearing: FRECKLED CORROSION

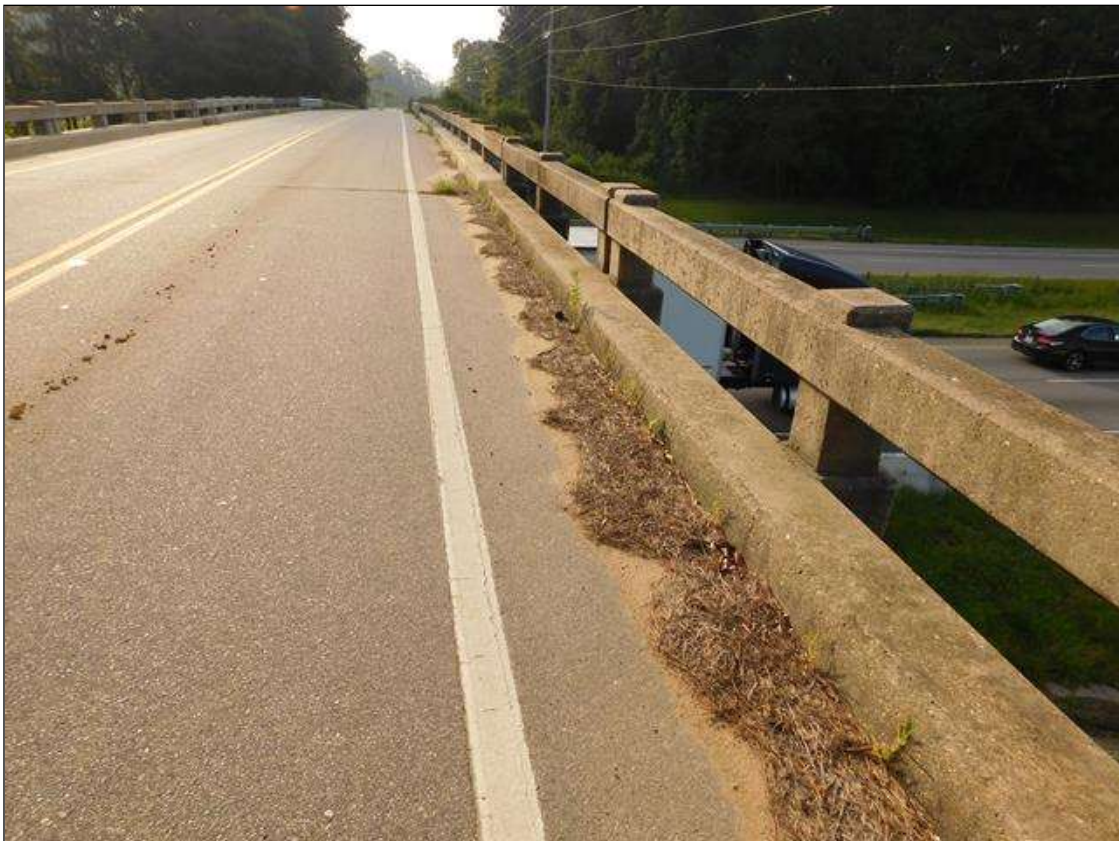
DECK DEBRIS ALONG BOTH CURBS

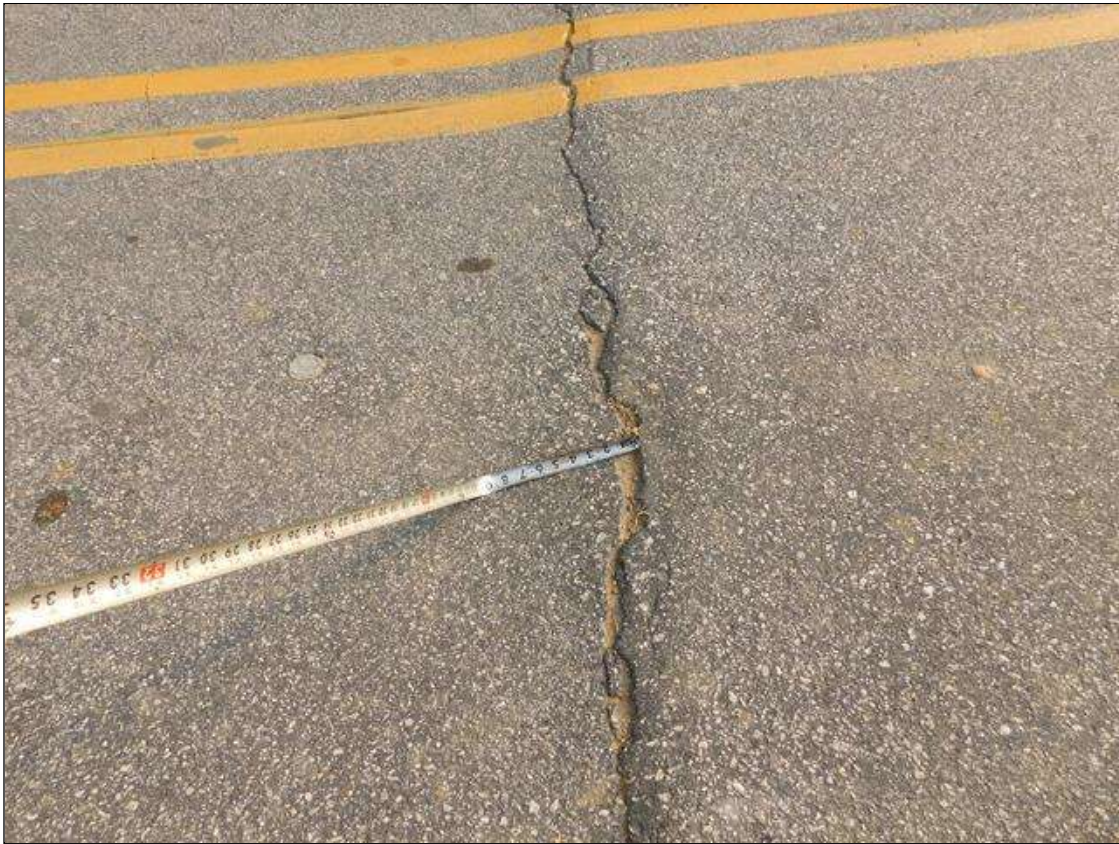
Span 1 Wearing Surface: UP TO .103 FT. WIDE TRANSVERSE CRACK OVER END BENT 1

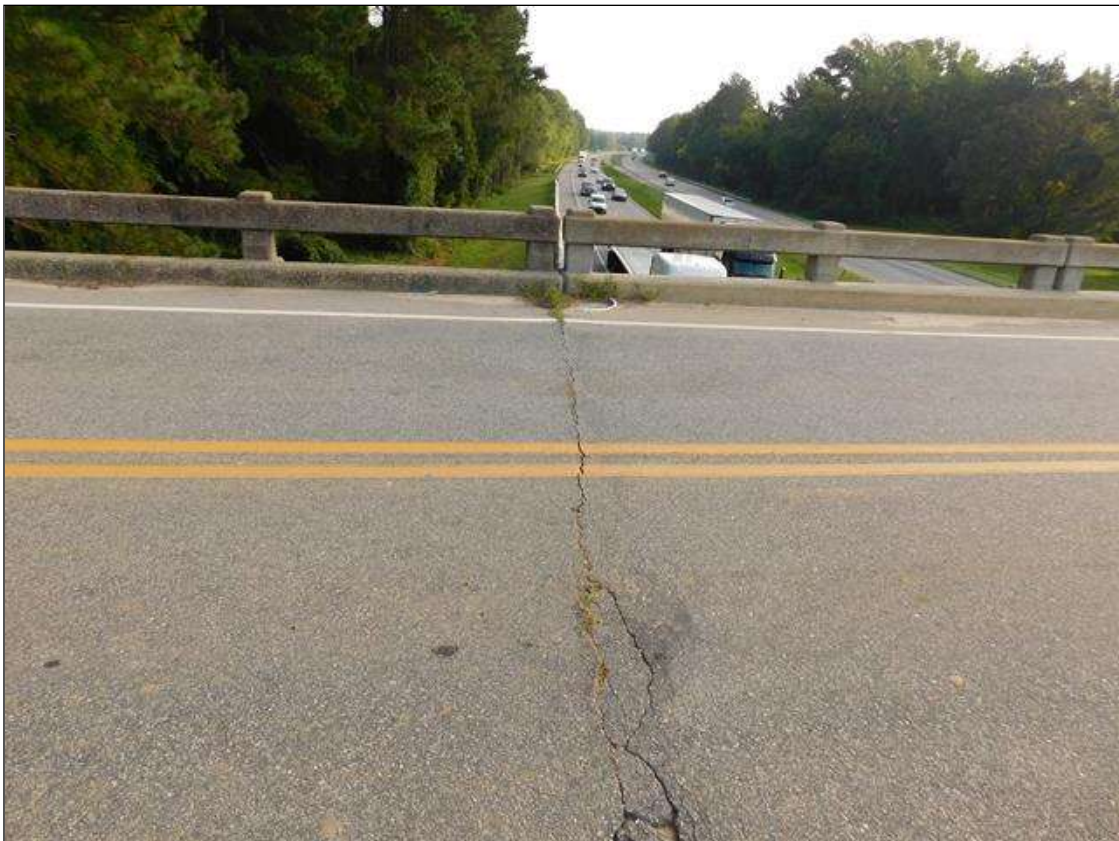
Span 1 Wearing Surface: .005 WIDE TRANSVERSE CRACK OVER BENT 1

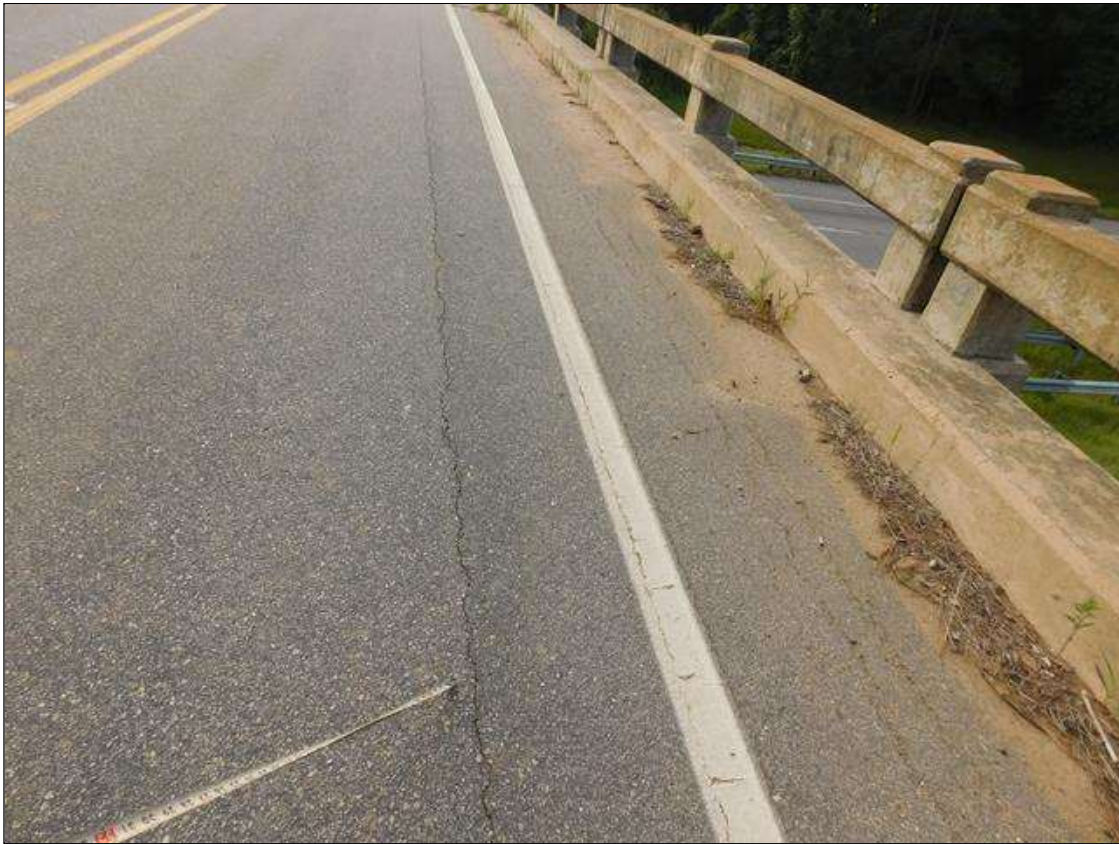
Span 2 Wearing Surface: LONGITUDINAL REFLECTIVE CRACKING UP TO .010 WIDE, RT LANE, LT SHOULDER AND RIGHT SHOULDER

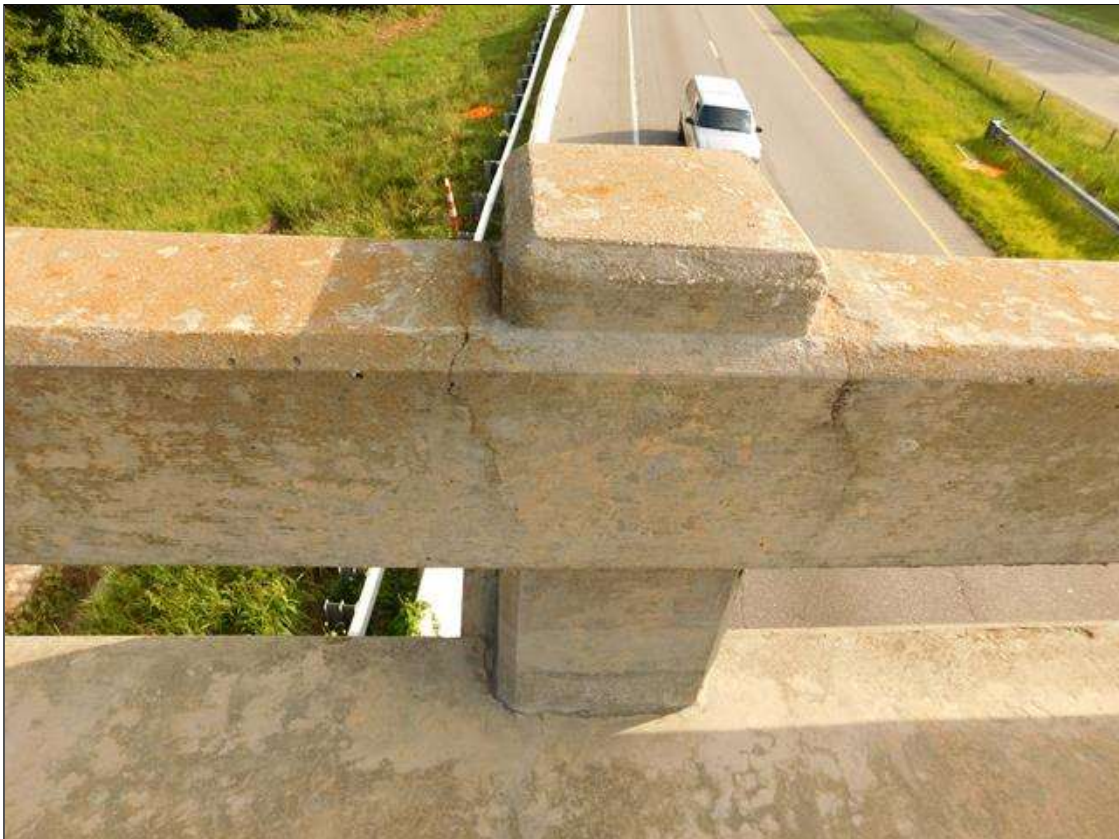
Span 2 Left Bridge Rail: 2 HAIRLINE VERTICAL CRACKS AT POST 2 AND 2 HAIRLINE VERTICAL CRACKS AT POST 8

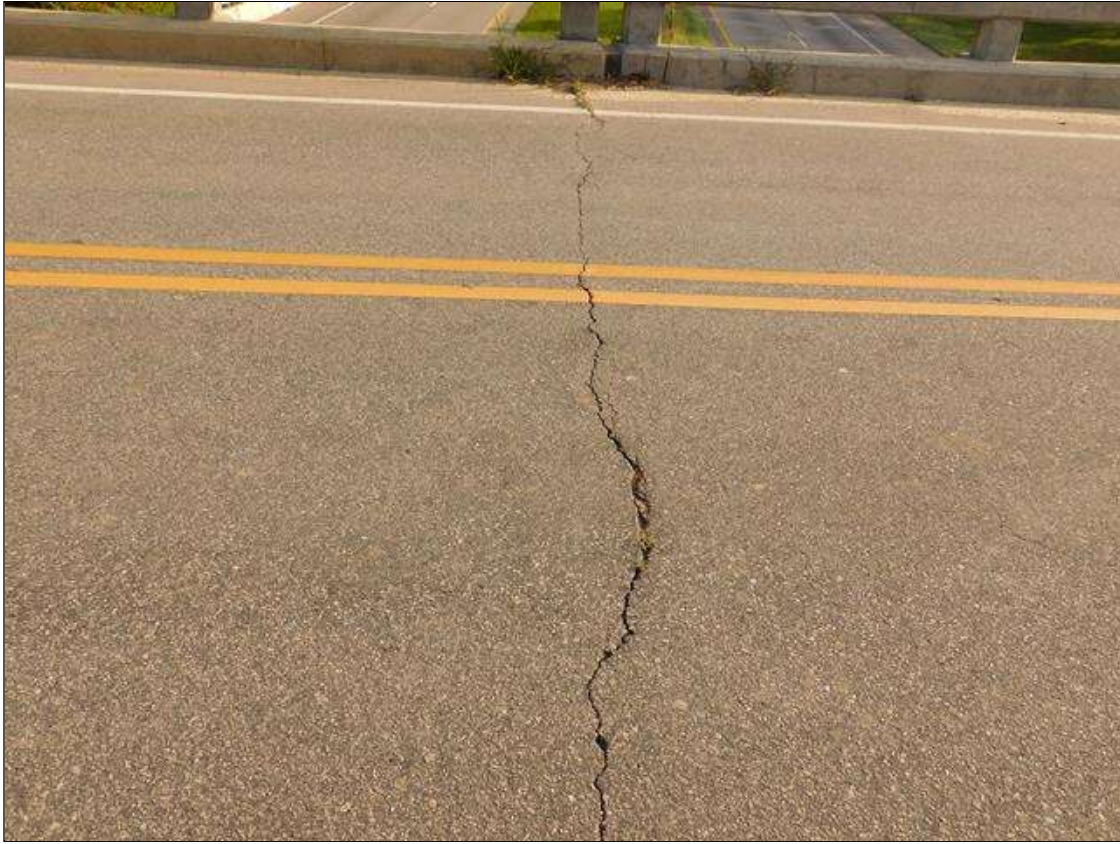
Span 3 Wearing Surface: .005 WIDE TRANSVERSE CRACK OVER BENT 2

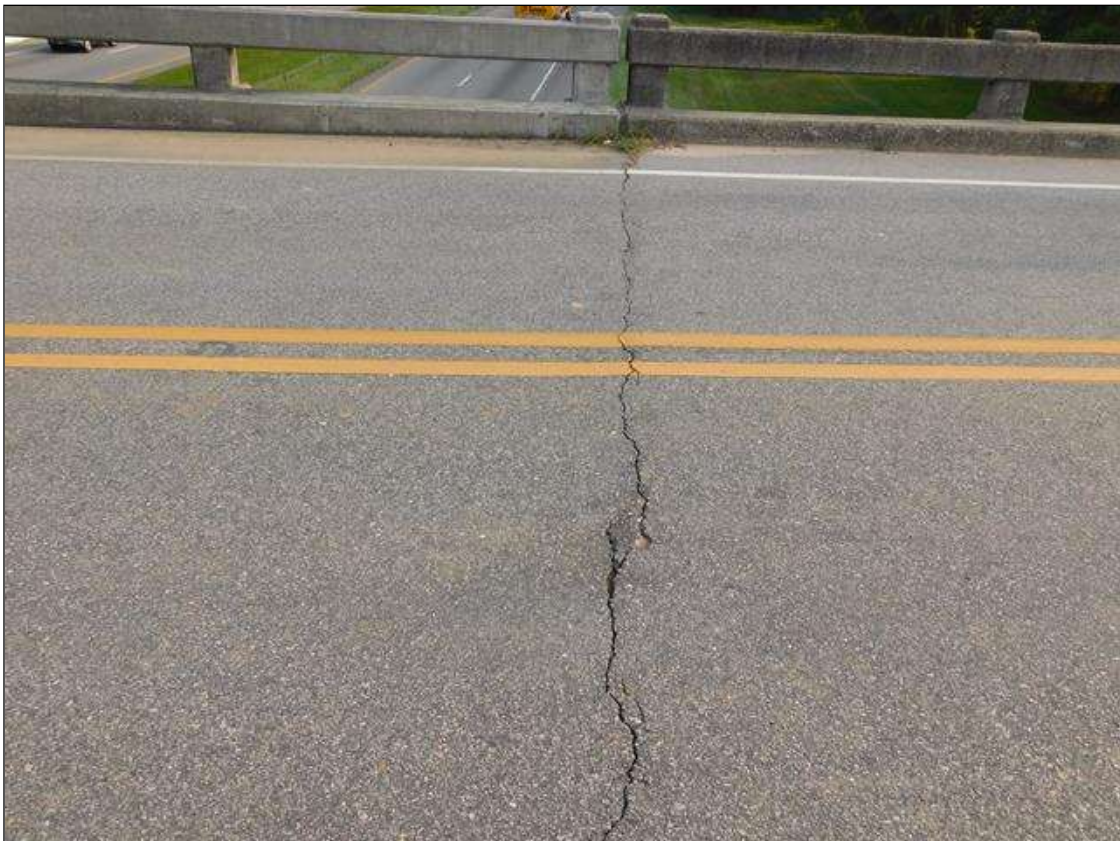
Span 3 Wearing Surface: OVER BENT 3, FULL WIDTH TRANSVERSE CRACKING UP TO .042 WIDE WITH IMPENDING POPOUTS

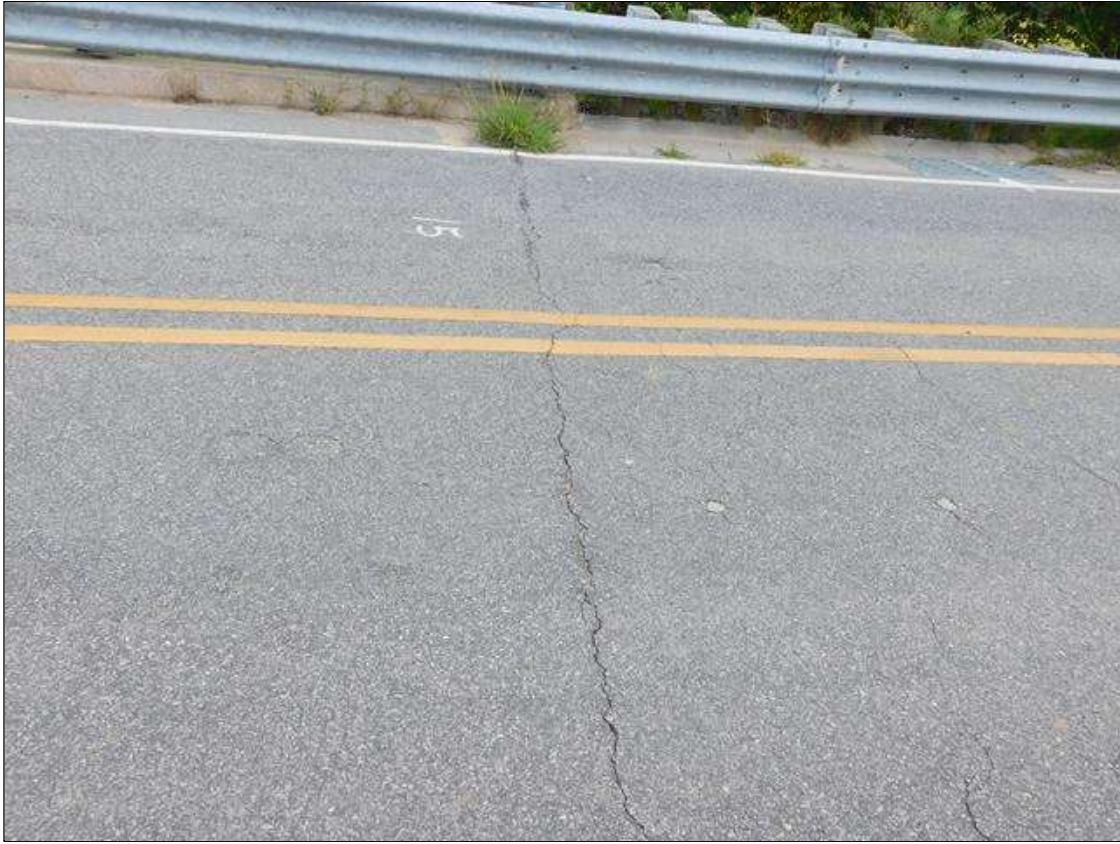
Span 4 Wearing Surface: .005 TO .020 WIDE TRANSVERSE CRACK OVER END BENT 2

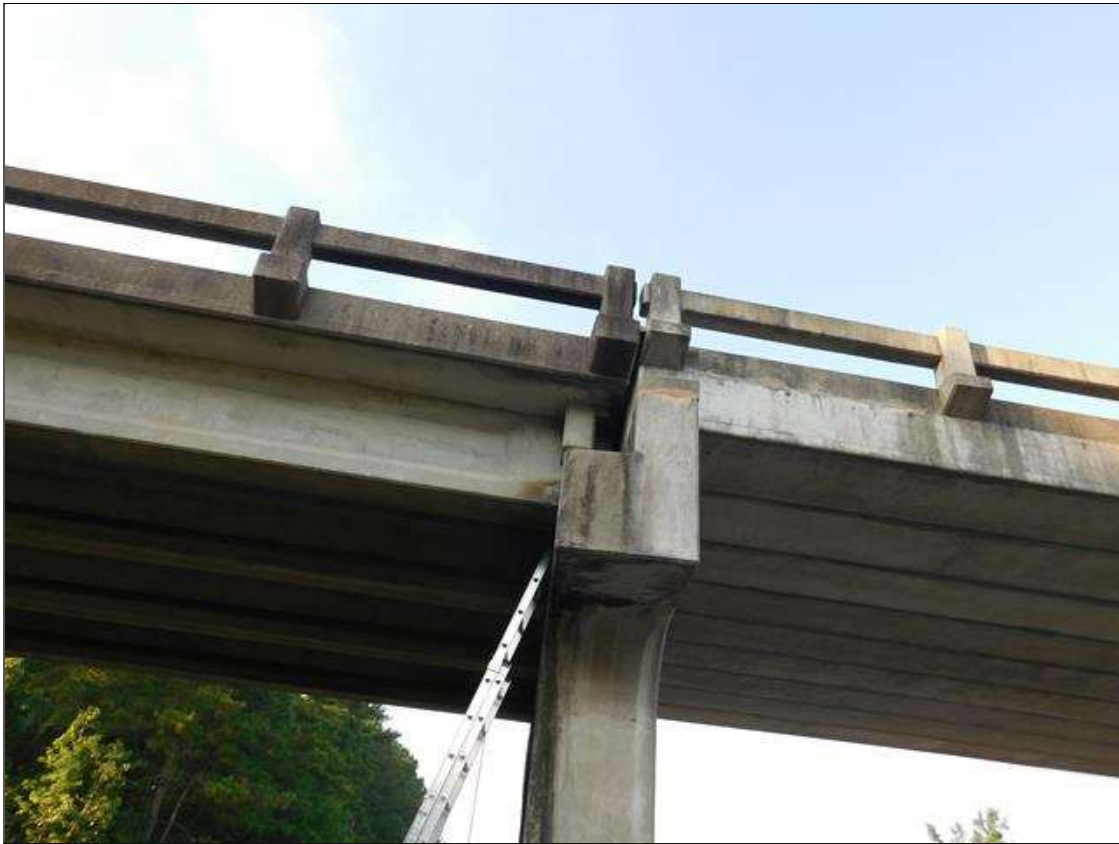
NORTH END OF BENT 3 CAP

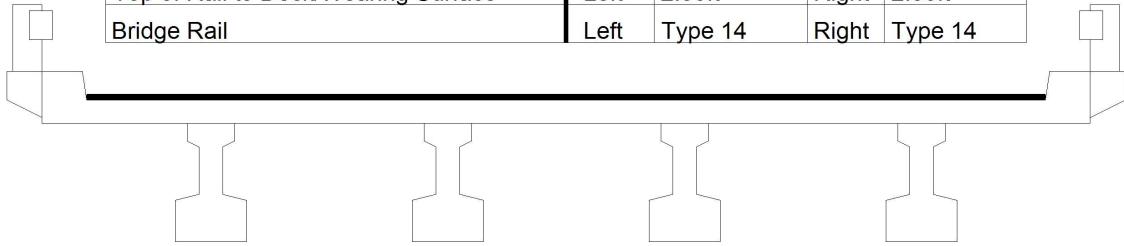
Measurements for Span #	1	SPAN 4 SIMILAR	
Deck Thickness	.58	Left Overhang	3.67
Top of Rail to Bottom of Beam	6.167	Right Overhang	3.67

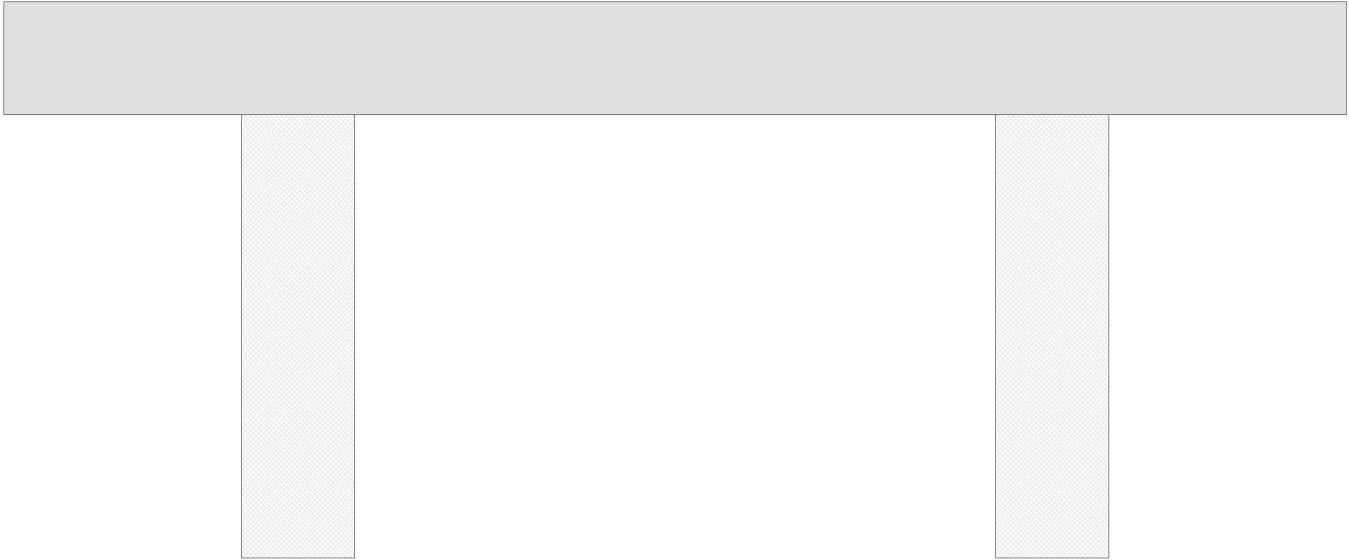
<b>Cap Information</b>			<b>Material</b> Cast-in-Place Concrete							
Length	Width	Height	Left Overhang	Right Overhang	Left Beam to End of Cap.	Right Beam to End of Cap.				
29.667 ft.	3.000 ft.	2.500 ft.*	6.500 ft.	6.500 ft.	4.500 ft.	4.500 ft.				
<b>Subcap Information</b>			<b>Material</b>							
Length	Width	Height	Left Overhang	Right Overhang	Left Pile to Splice.					
<b>Sill Information</b>			<b>Material</b>							
Length	Width	Height								
Pile #	Material	Spacing	Width/Dia.	Height	Length	Orientation	Driven?	Replacement?	Removed?	Collar?
1	Concrete	16.67 ft.	2.5 ft.	3 ft.		Vertical	No	No	No	No
2	Concrete		2.5 ft.	3 ft.		Vertical	No	No	No	No
REVISED BY KEITH PROCTOR ON 8-14-2017 (* DENOTES CHANGE) MEASUREMENTS VERIFIED BY SFS 8/7/19										
<b>Bent/Abutment #:</b> 1			<b>Similar Bents:</b> 3

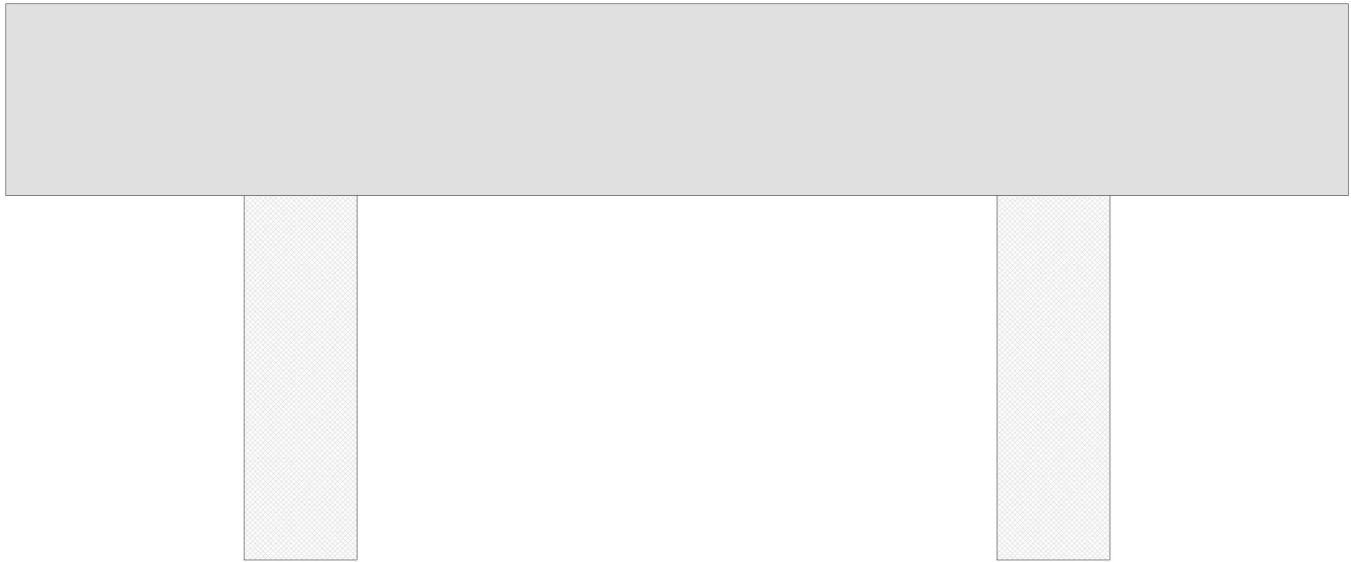
<b>Cap Information</b>			Material Cast-in-Place Concrete							
Length	Width	Height	Left Overhang	Right Overhang	Left Beam to End of Cap.	Right Beam to End of Cap.				
29.709 ft.	3.000 ft.	4.250 ft.	6.520 ft.	6.520 ft.	2.792 ft.	2.917 ft.				
<b>Subcap Information</b>			Material							
Length	Width	Height	Left Overhang	Right Overhang	Left Pile to Splice.					
<b>Sill Information</b>			Material							
Length	Width	Height								
Pile #	Material	Spacing	Width/Dia.	Height	Length	Orientation	Driven?	Replacement?	Removed?	Collar?
1	Concrete	16.667 ft.	2.5 ft.*	3 ft.*		Vertical	No	No	No	No
2	Concrete		2.5 ft.*	3 ft.*		Vertical	No	No	No	No
REVISED BY KEITH PROCTOR ON 8-14-2017 (* DENOTES CHANGE) MEASUREMENTS VERIFIED BY SFS 8/7/19										
<b>Bent/Abutment #:</b> 2			<b>Similar Bents:</b>
