NC DEPARTMENT OF TRANSPORTATION
 DIVISION OF HIGHWAYS
 BRIDGE MANAGEMENT UNIT

PRIORITY MAINTENANCE ISSUED

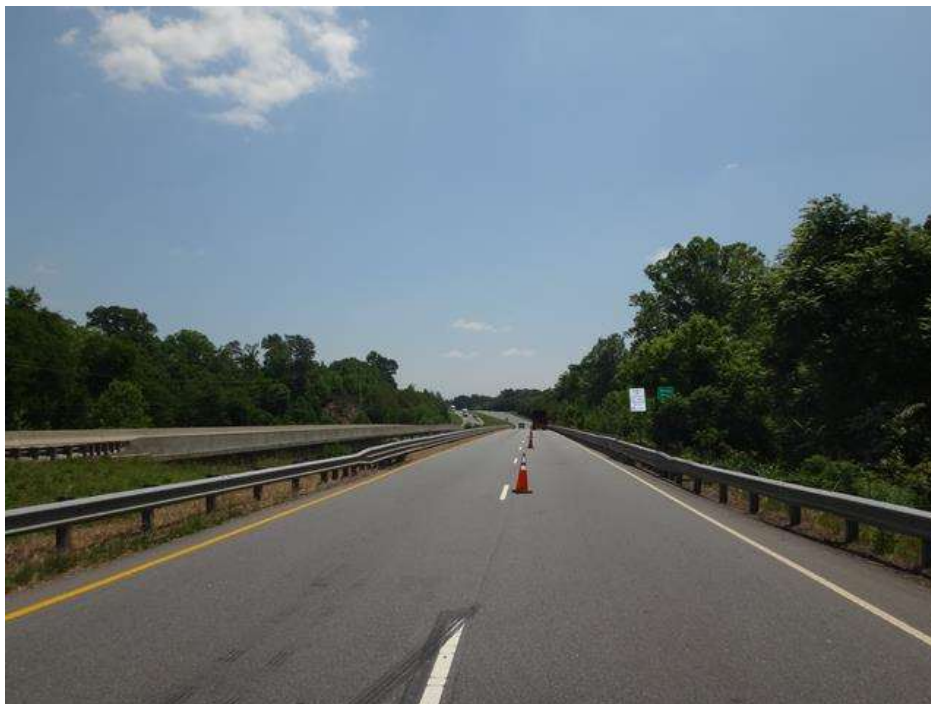
WEST APPROACH LOOKING EAST

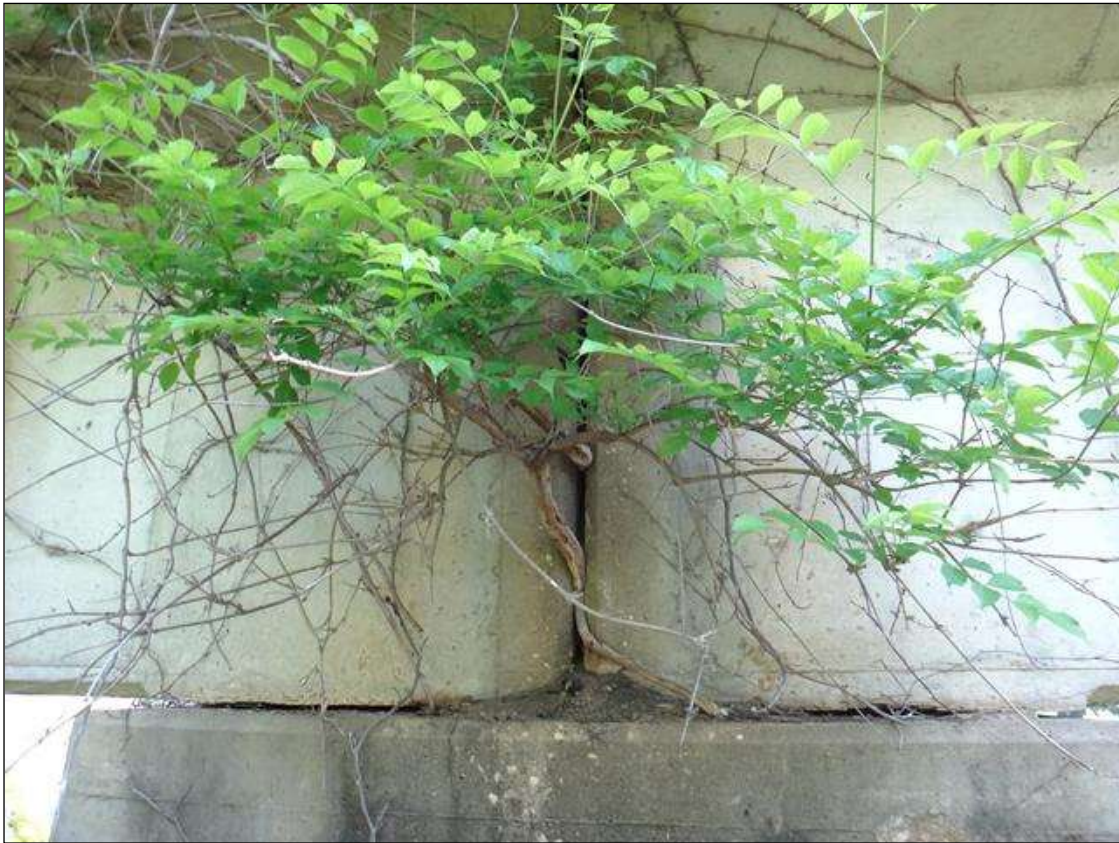
BENT 1 CAP SOUTH FACE, VEGETATION GROWTH (1CF) WITH DEBRIS ACCUMULATION (1CF)

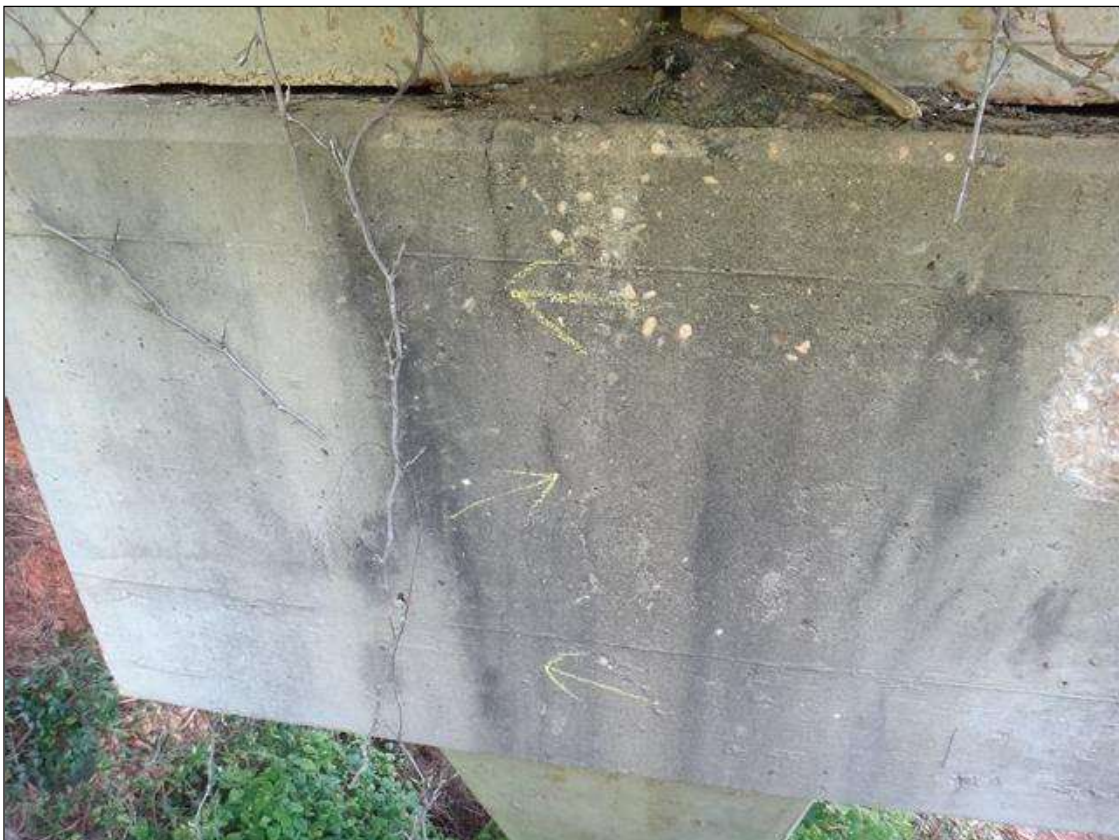
BENT 1 CAP SOUTH FACE, VERTICAL CRACK (FULL HEIGHT X HAIRLINE)

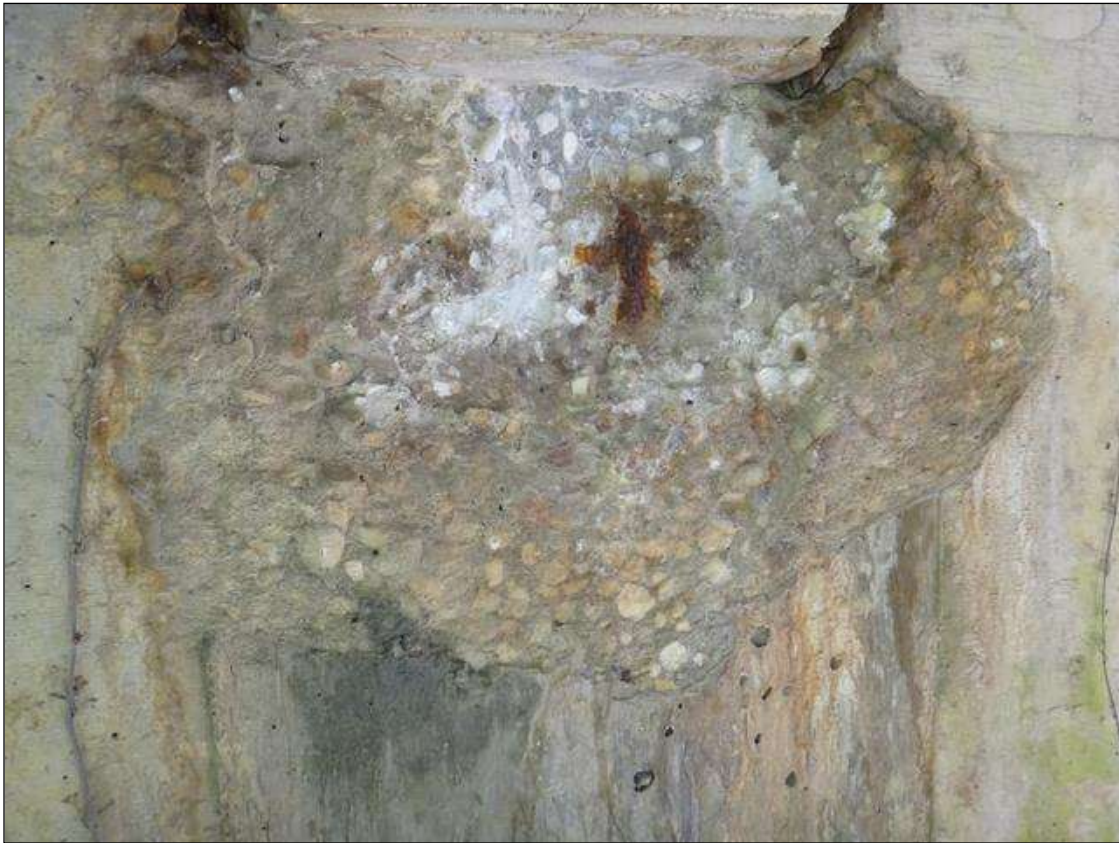
(PM) BENT 1 CAP EAST FACE BELOW BEAM 4, SPALL (18IN X 30IN X 3-1/2IN DEEP) WITH EXPOSED RUSTED REBAR

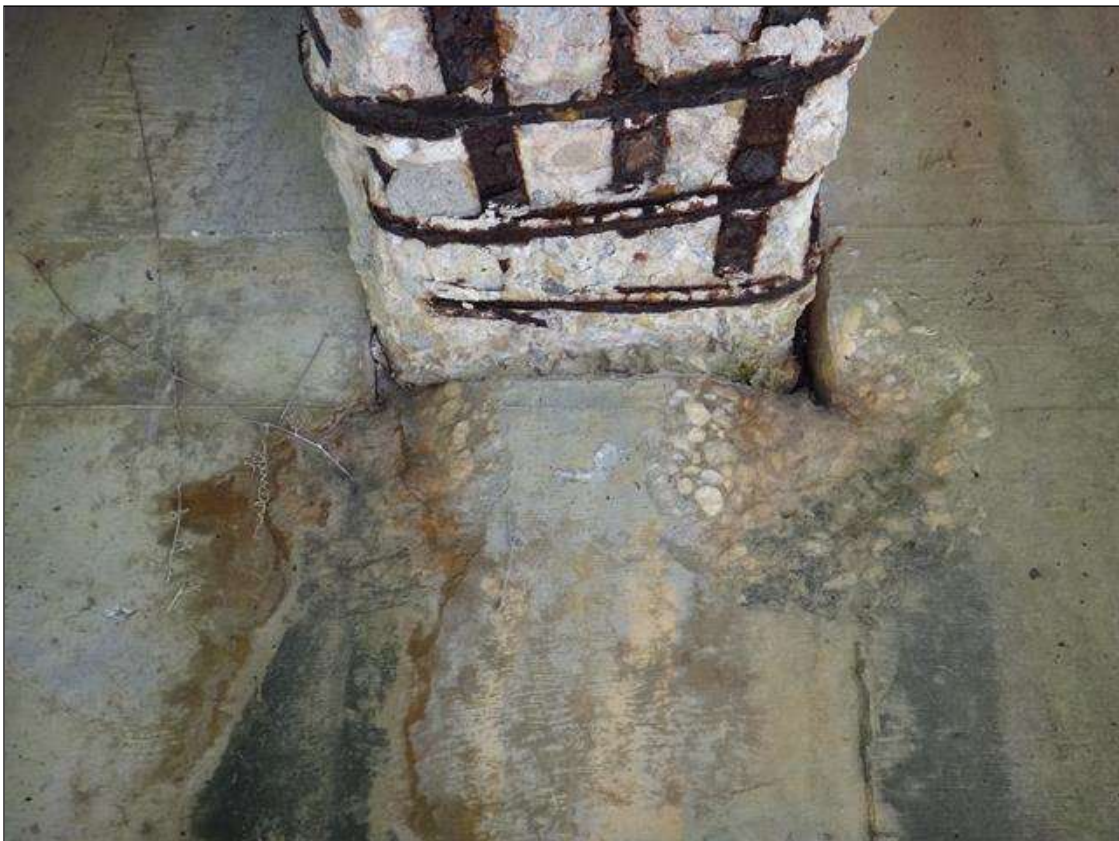
BENT 1 CAP EAST FACE BELOW BEAM 3, TWO (2) SPALLS (UP TO 14IN DIAMETER X 2IN DEEP)

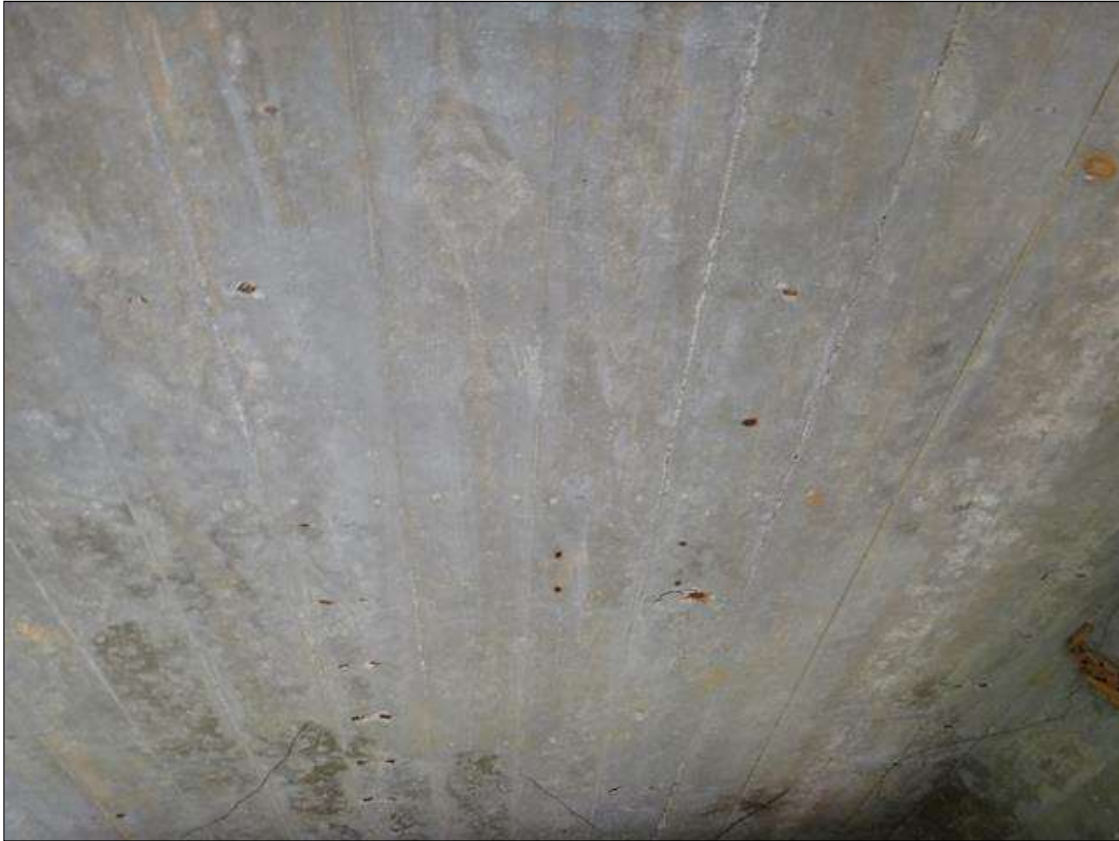
SPAN 2 UNDERSIDE OF DECK AT BAY 3, MULTIPLE POPOUTS/DELAMINATION (UP TO 1IN DIAMETER) WITH EXPOSED RUSTED REBAR (ALL BAYS SIMILAR)

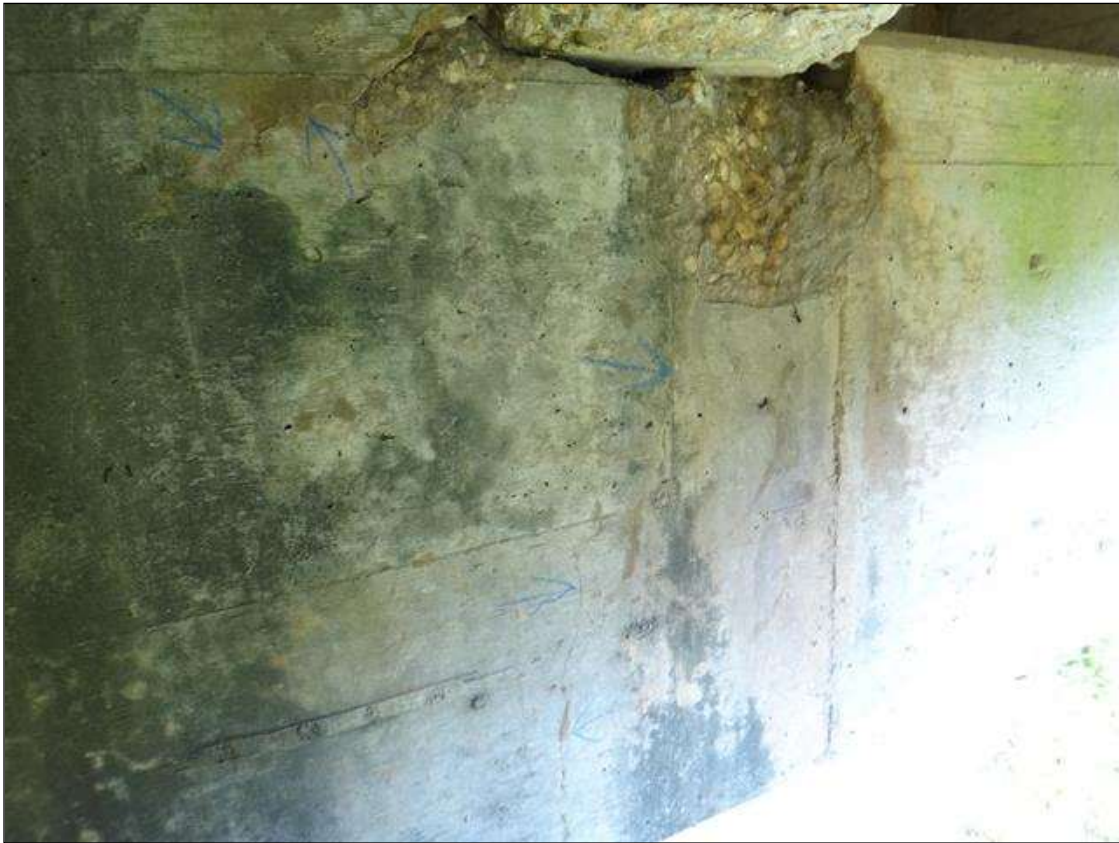
BENT 1 CAP EAST FACE BELOW BEAM 2, TWO (2) SPALLS (UP TO 15IN X 11IN X 2IN DEEP) WITH VERTICAL CRACKS (UP TO FULL HEIGHT X HAIRLINE)

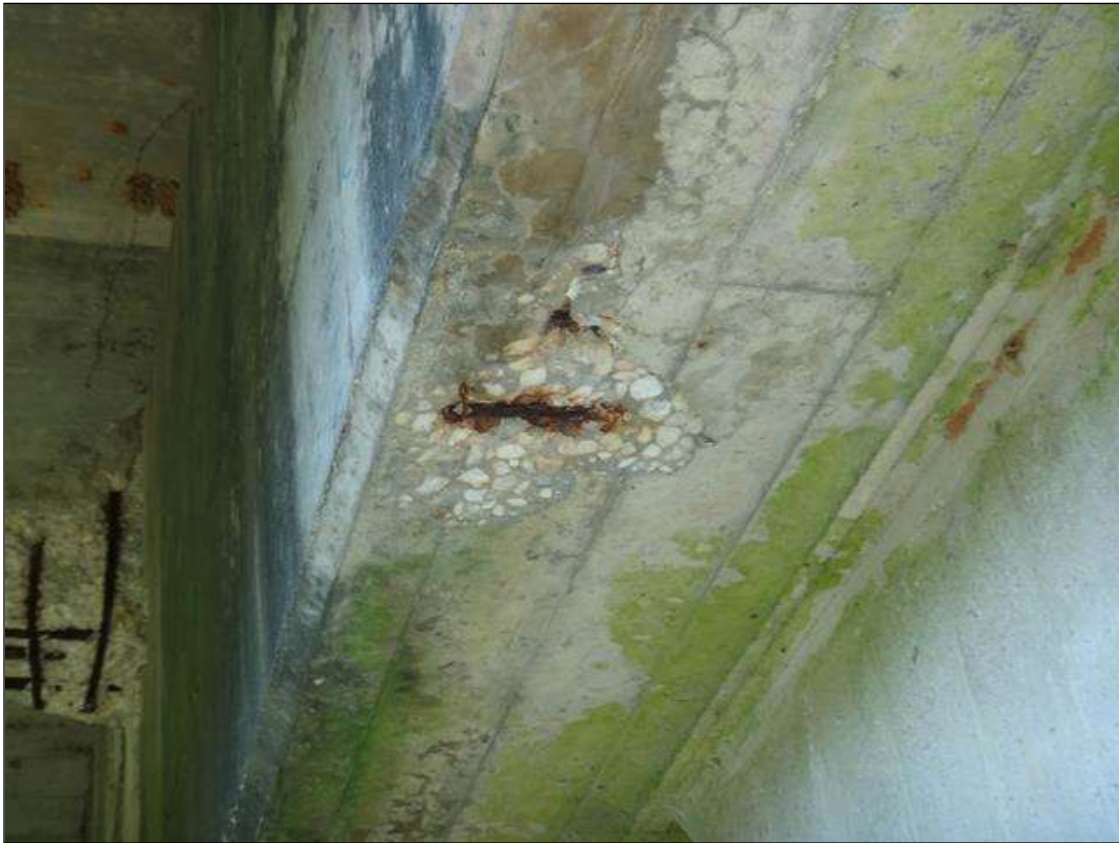
(PM) BENT 1 CAP UNDERSIDE BELOW BEAM 2, SPALL (12IN X 12IN X 1IN DEEP) WITH EXPOSED RUSTED REBAR

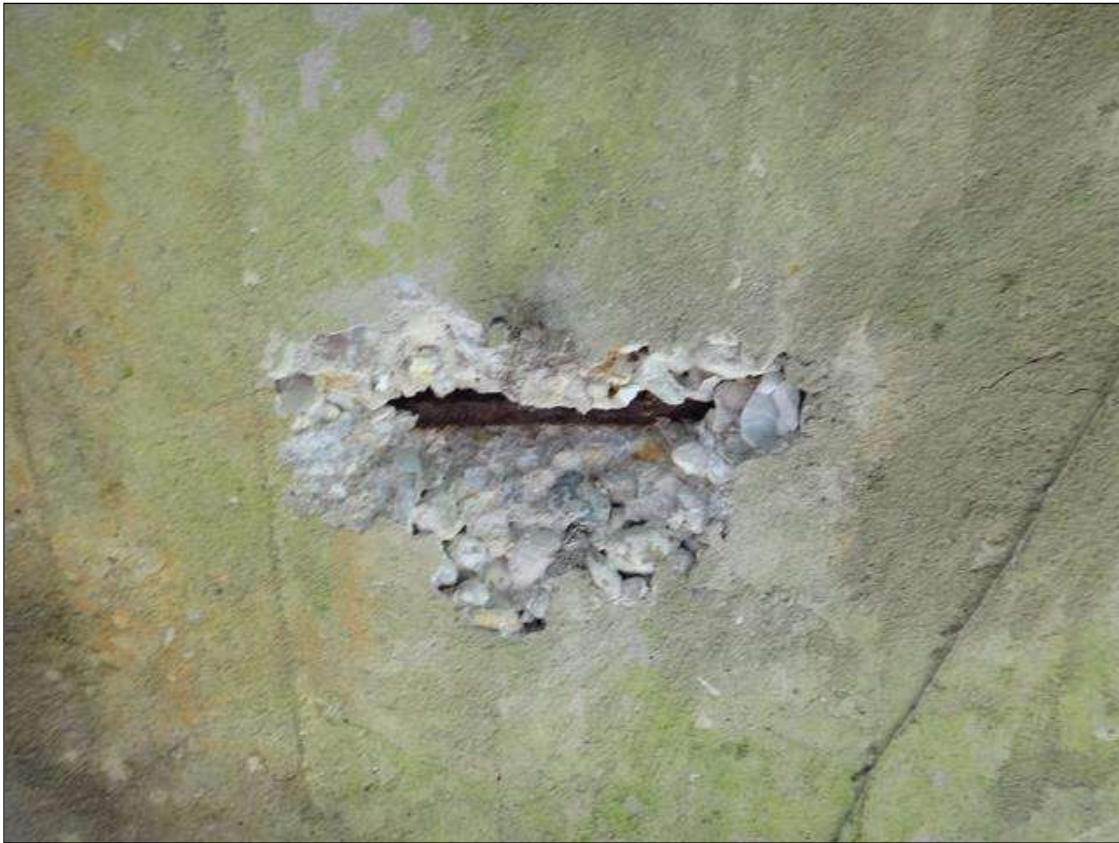
(PM) BENT 1 CAP UNDERSIDE BETWEEN COLUMNS 1 AND 2, SPALL (10IN X 7IN X 2IN DEEP) WITH EXPOSED RUSTED REBAR

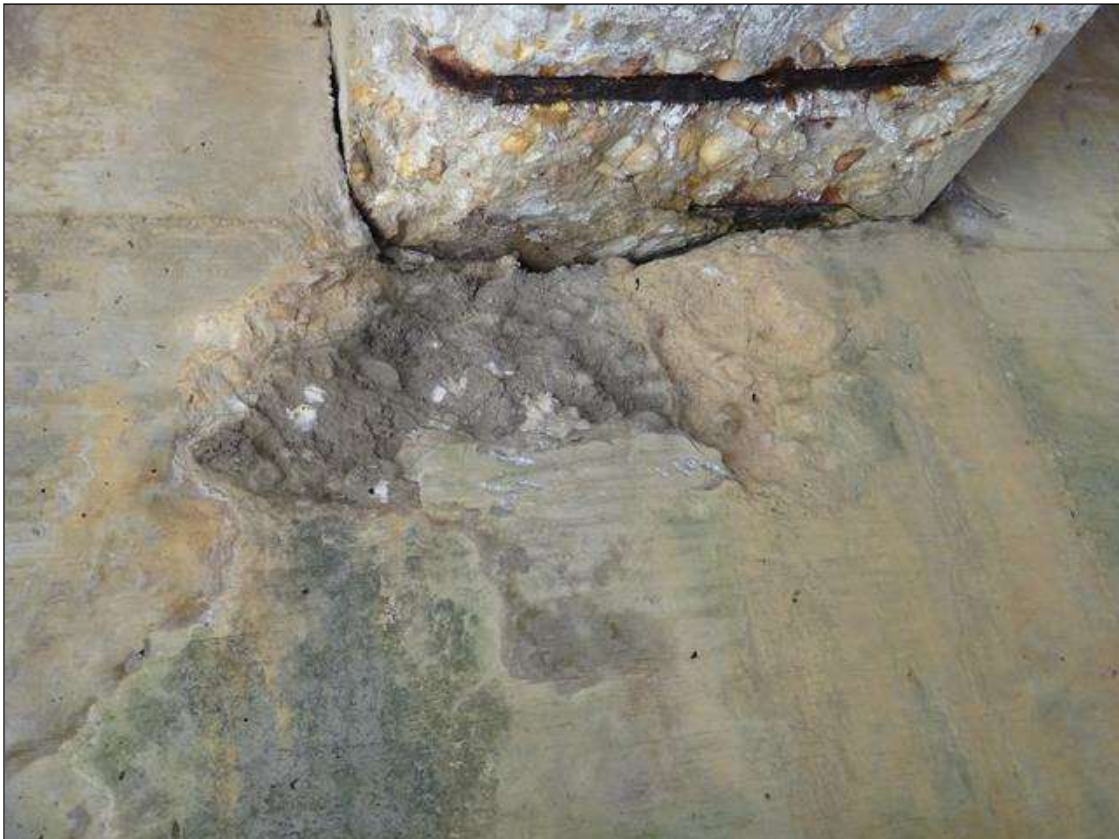
BENT 1 CAP WEST FACE BELOW BENT 3, SPALL (20IN X 9IN X 2-1/2IN DEEP)

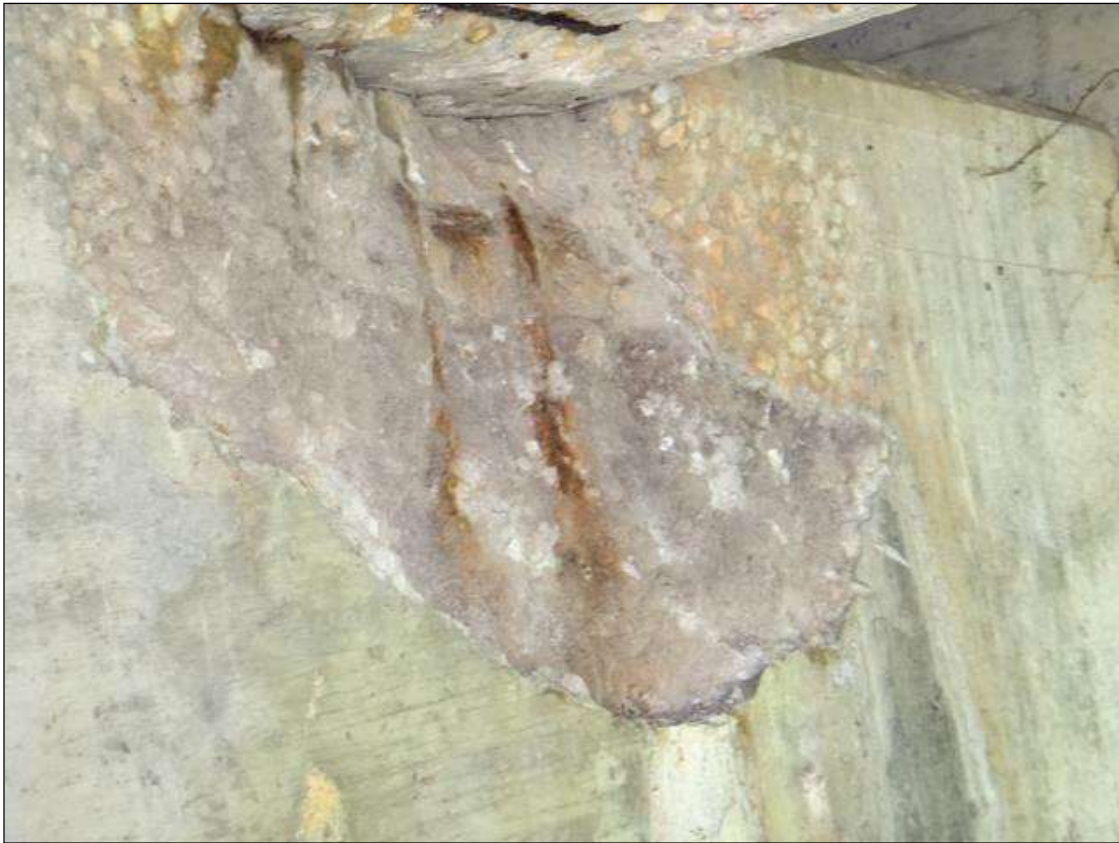
(PM) BENT 1 CAP WEST FACE BELOW BENT 4, SPALL (3FT X 20IN X 4IN DEEP) WITH EXPOSED RUSTED REBAR

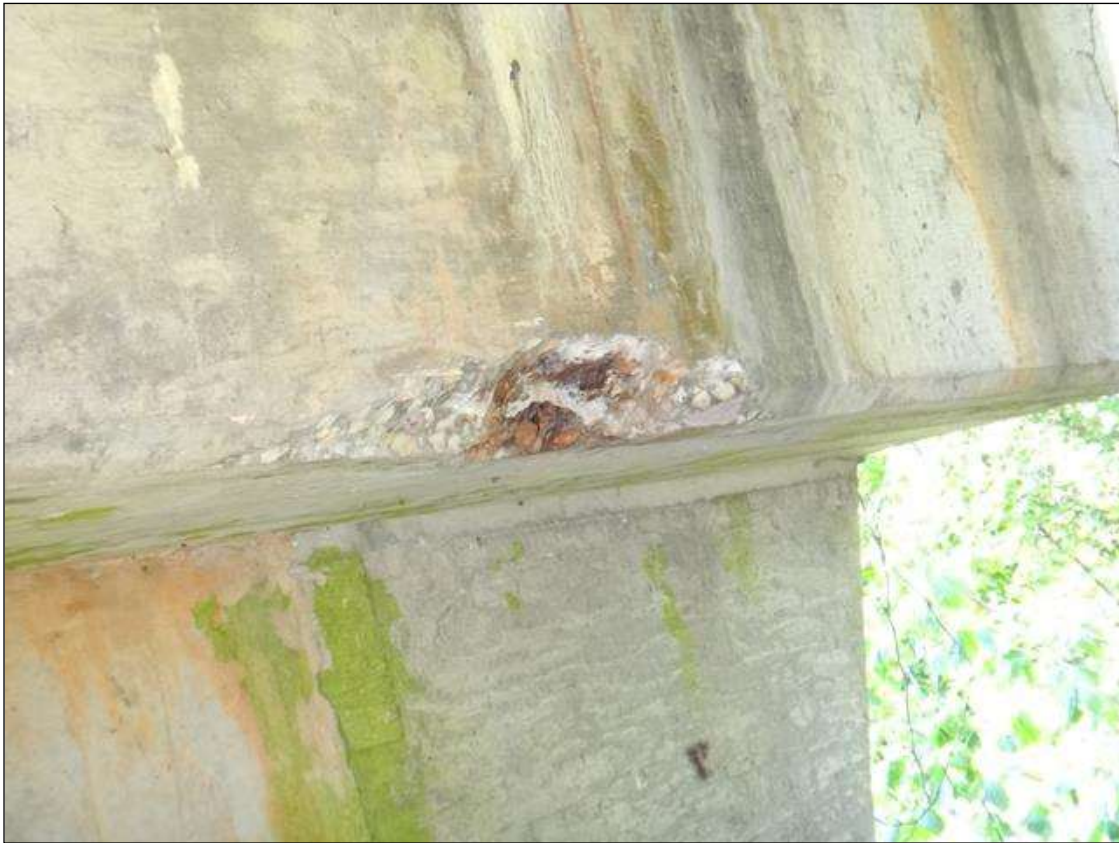
(PM) BENT 1 CAP WEST FACE BELOW BENT 4, SPALL (20IN X 6IN X 3IN DEEP) WITH EXPOSED RUSTED REBAR

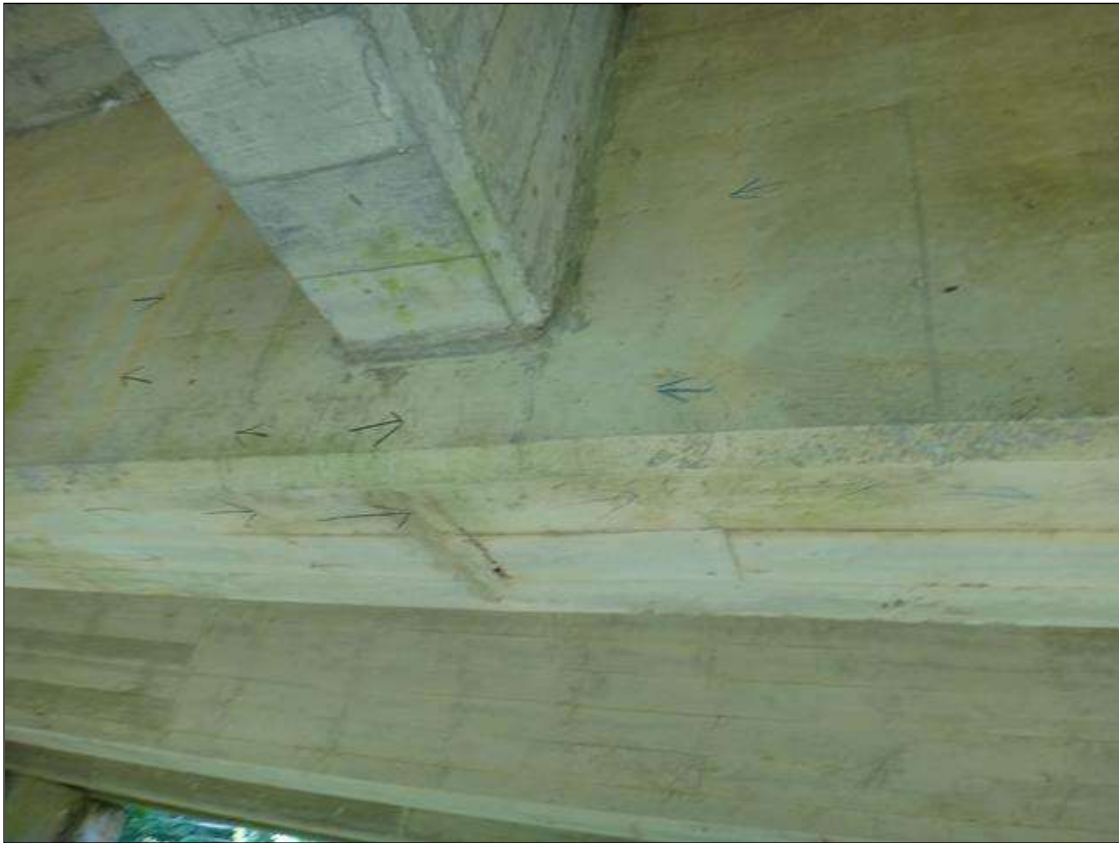
SPAN 2 BEAM 2 AT MIDSPAN, MULTIPLE TRANSVERSE CRACKS (FULL WIDTH X HAIRLINE) EXTEND UP BOTH SIDES WITH ADJACENT MAP CRACKING

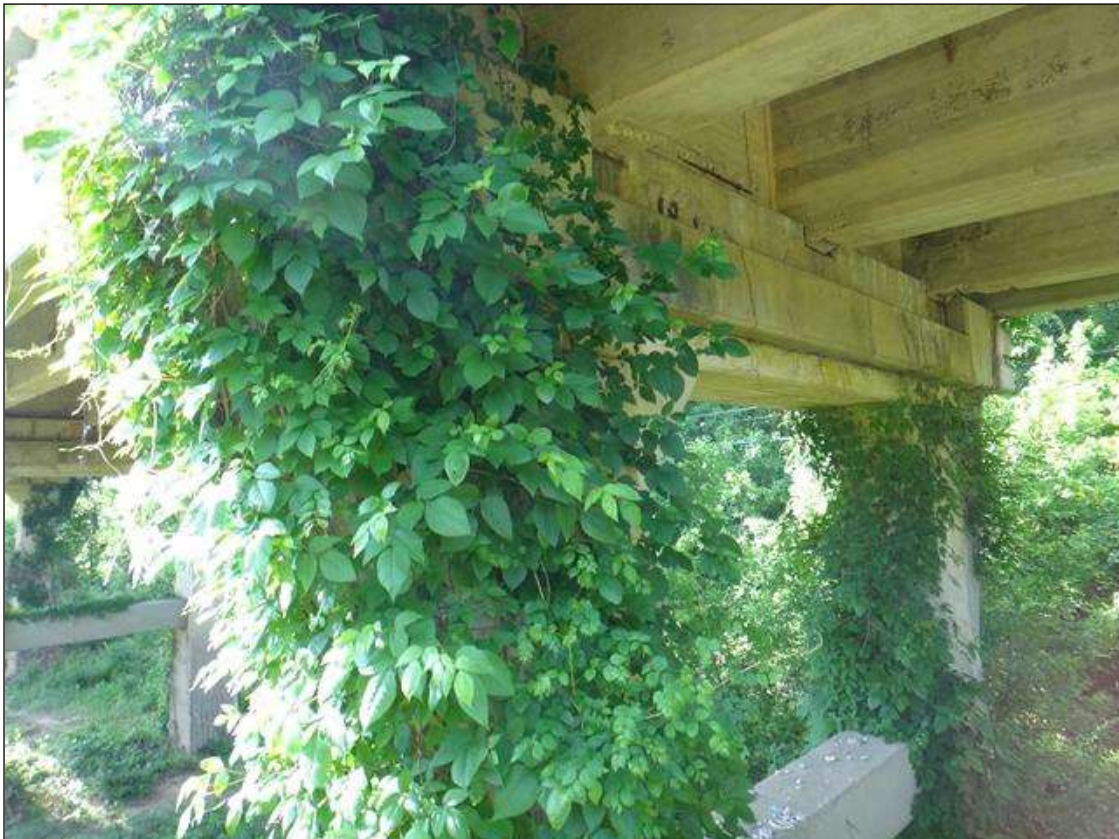
BENT 2 CAP AND COLUMN, VEGETATION GROWTH

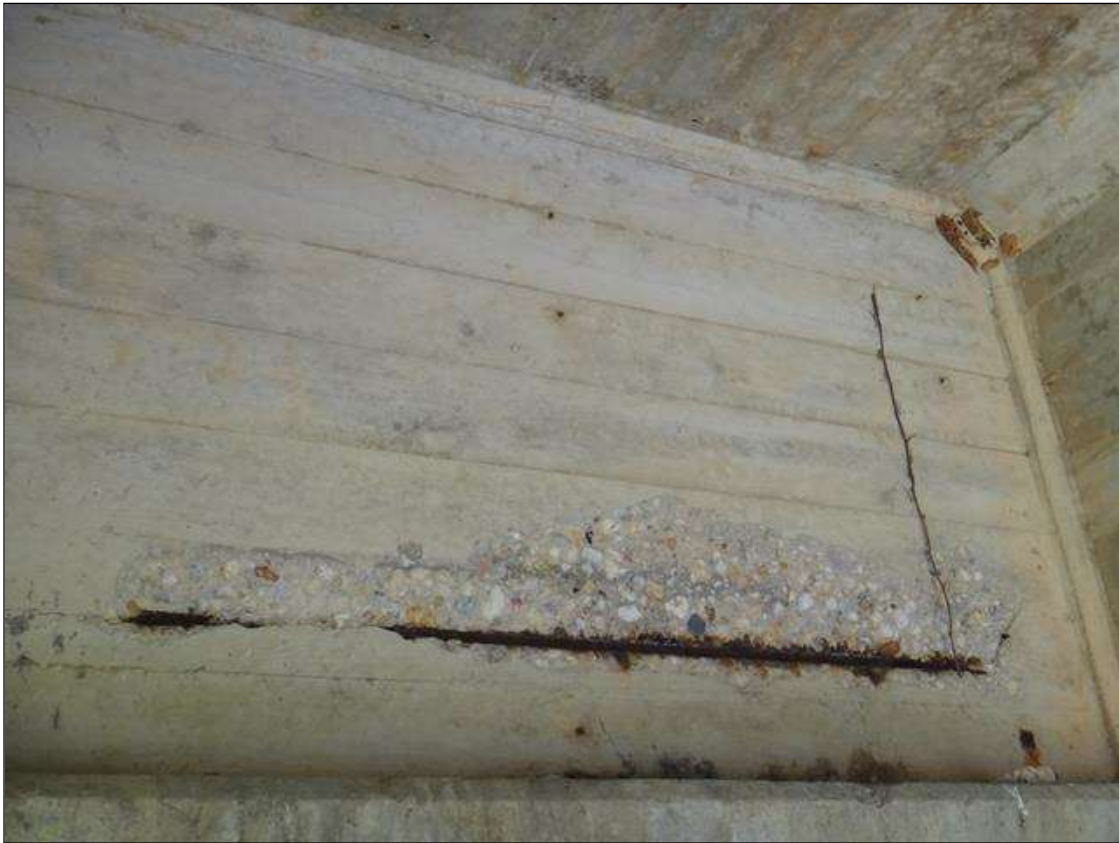
SPAN 2 BENT 2 BACKWALL AT BAY 2, SPALL (14IN X 6IN X 2IN DEEP) WITH EXPOSED RUSTED REBAR

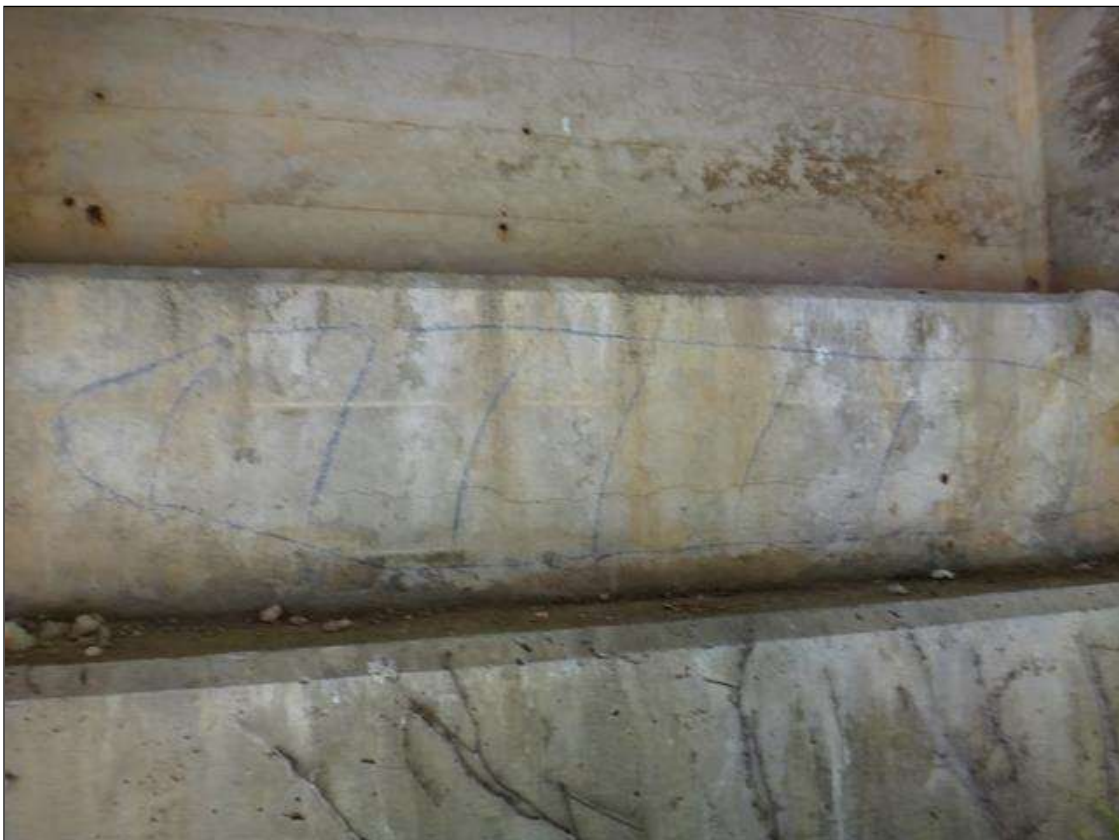
BENT 2 CAP WEST FACE AT BAY 3, DELAMINATION (6FT X 18IN)

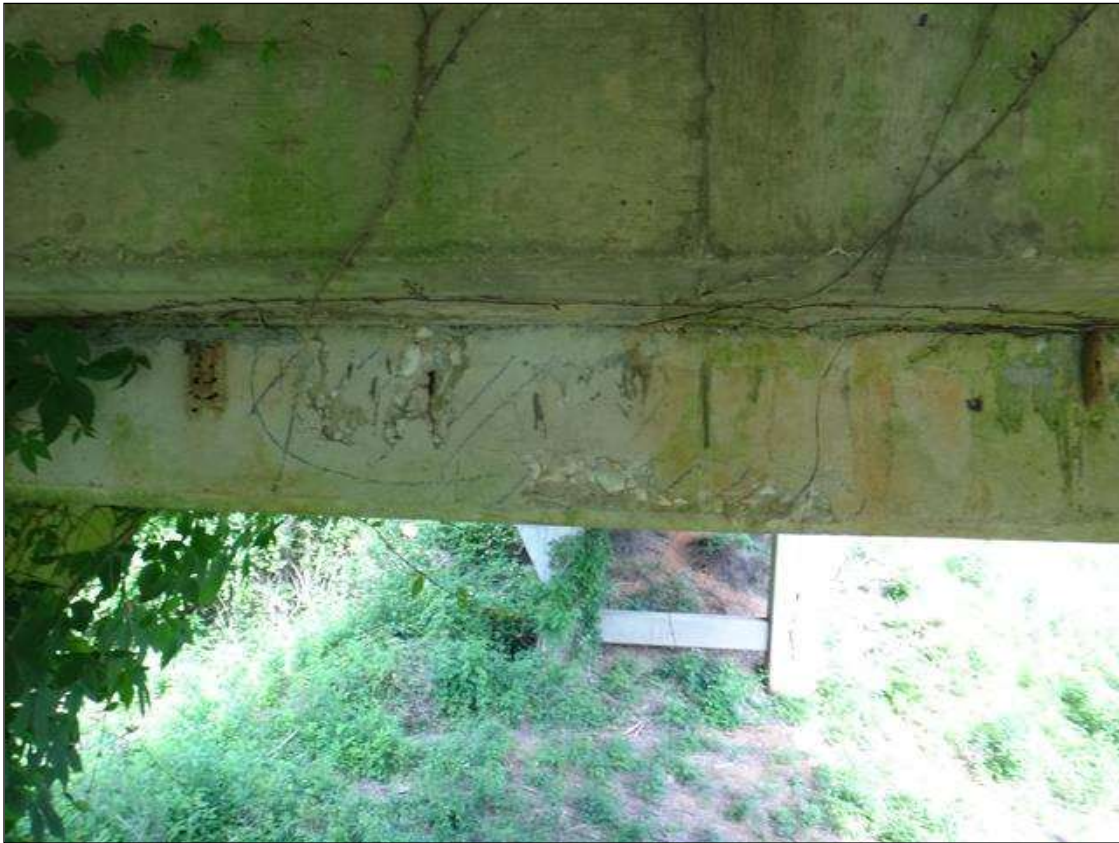
BENT 2 CAP EAST FACE BELOW BEAM 3, DELAMINATION/SPALL (30IN X 8IN X 1IN DEEP) WITH EXPOSED RUSTED REBAR

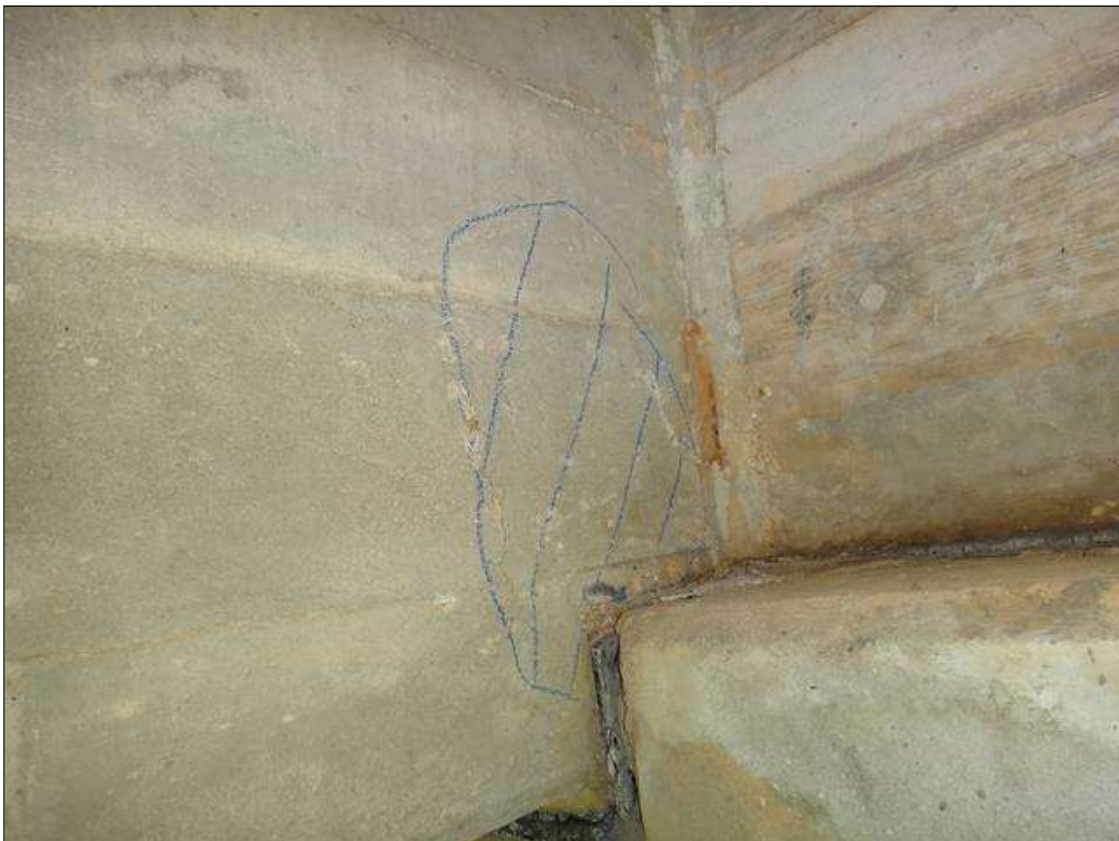
SPAN 3 BEAM 3 NORTH FACE AT BENT 2, DELAMINATION (14IN X 10IN)

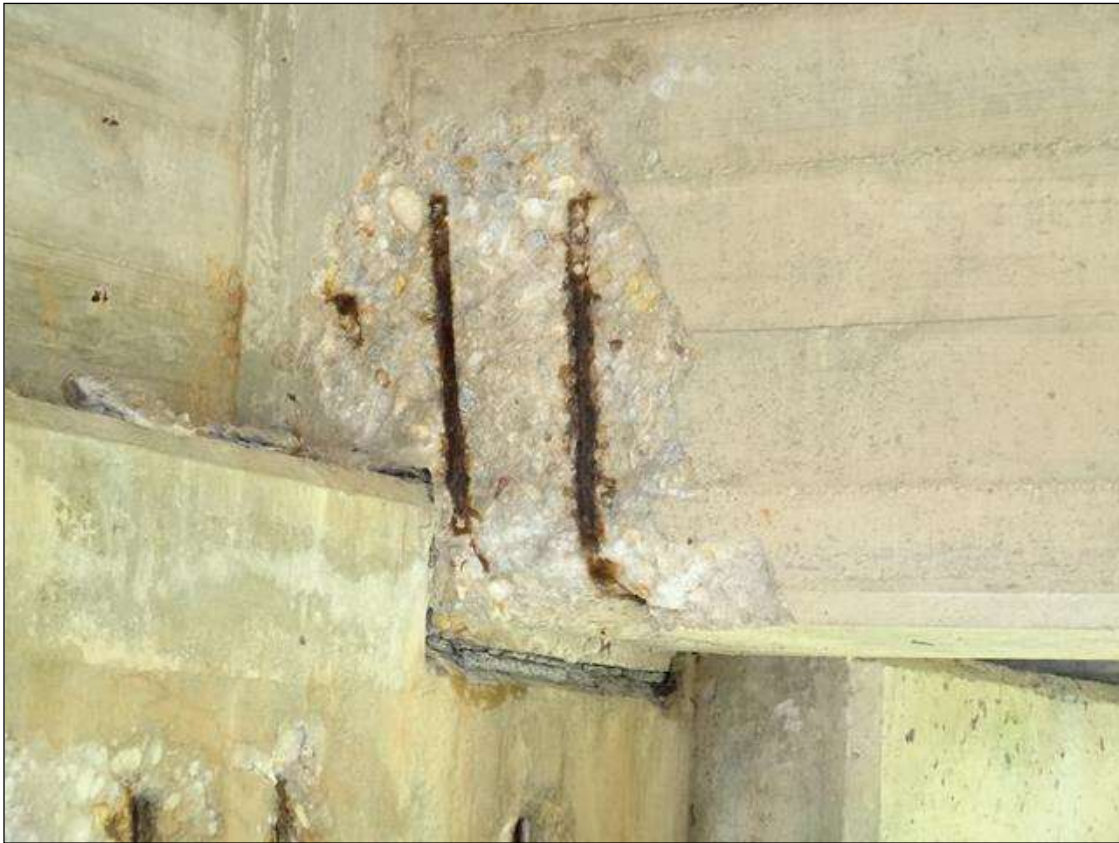
(PM) SPAN 3 BEAM 4 AT BENT 3, SPALL (20IN X 20IN X 2IN DEEP) WITH EXPOSED RUSTED REBAR, SECTION LOSS (NO MEASURABLE LOSS)

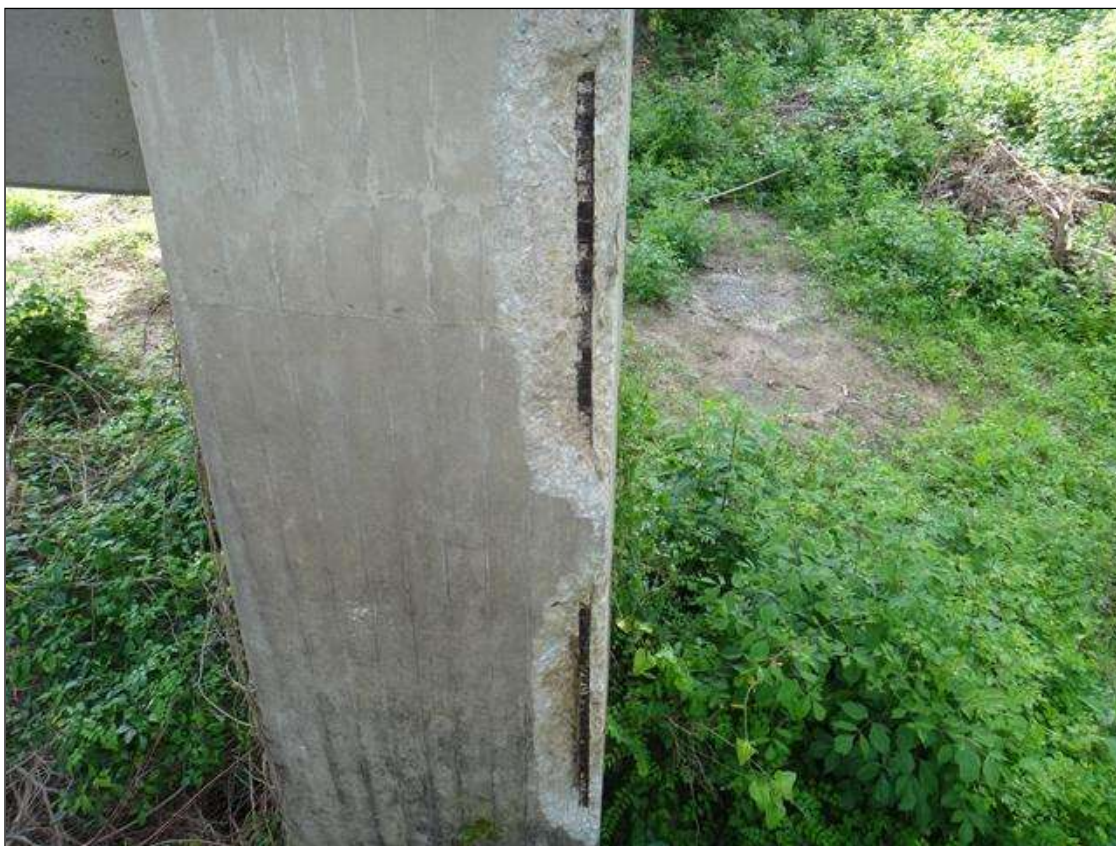
(PM) BENT 3 COLUMN 2 SOUTHWEST CORNER, TWO (2) SPALLS (UP TO 4FT X 15IN X 4IN DEEP) WITH EXPOSED RUSTED REBAR, SECTION LOSS (NO MEASURABLE LOSS)

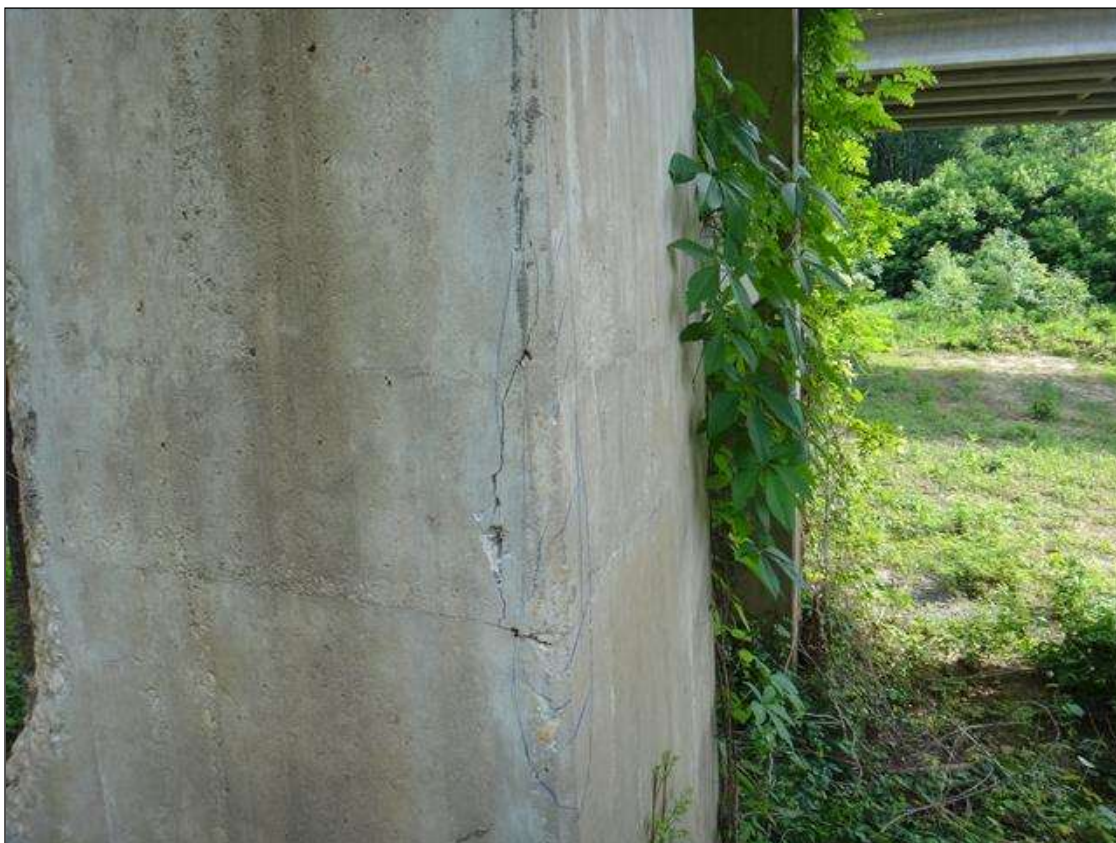
BENT 3 COLUMN 2 SOUTHEAST CORNER, DELAMINATION (2FT X 4IN)

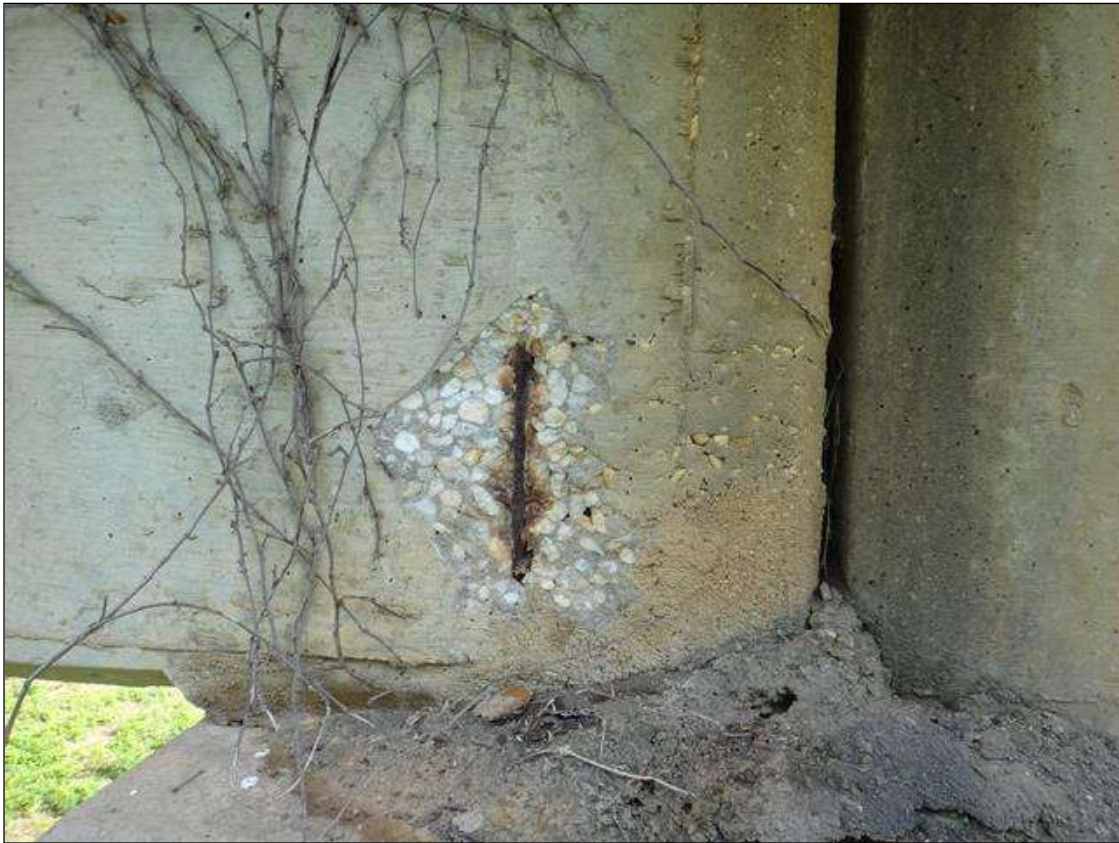
(PM) SPAN 3 BEAM 5 AT BENT 3, SPALL (10IN X 8IN X 1IN DEEP) WITH EXPOSED RUSTED REBAR

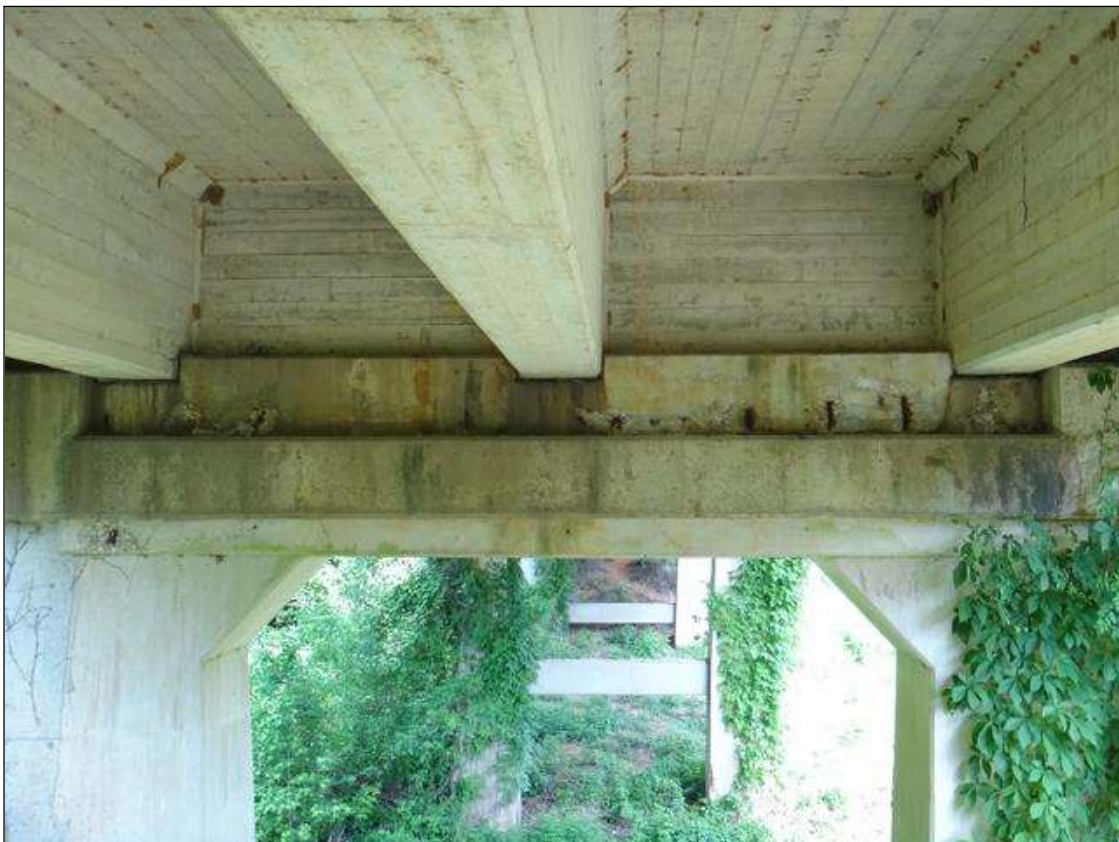
(PM) BENT 3 CAP EAST FACE, MULTIPLES SPALLS (UP TO 3FT X 10IN X 2IN DEEP) WITH EXPOSED RUSTED REBAR, SECTION LOSS (NO MEASURABLE LOSS)

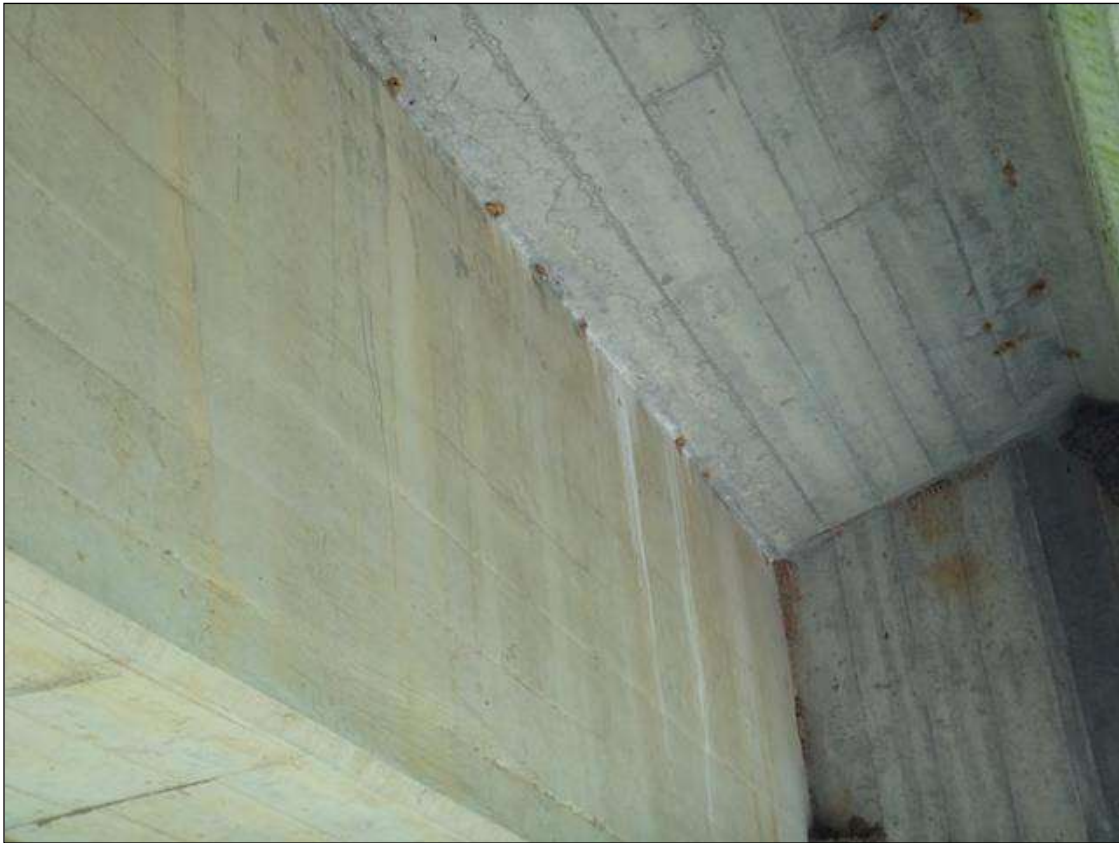
SPAN 4 UNDERSIDE OF DECK AT BAY 1, EFFLORESCENCE ALONG BENT 2 (ALL SPANS SIMILAR)
