NC DEPARTMENT OF TRANSPORTATION
 DIVISION OF HIGHWAYS
 BRIDGE MANAGEMENT UNIT

PRIORITY MAINTENANCE ISSUED

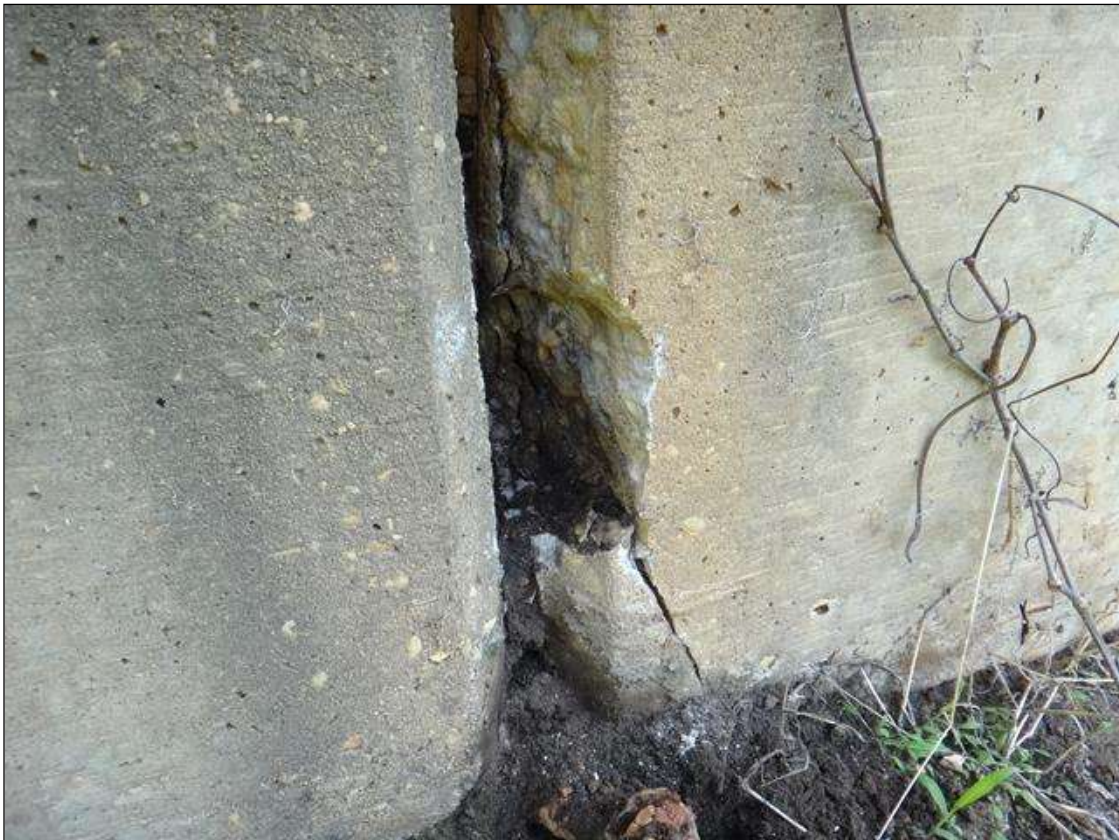
SPAN 5 BEAM 5 SOUTH FACE AT BENT 5, SPALL (12IN X 4IN X 2IN DEEP) WITH ADJACENT DELAMINATION

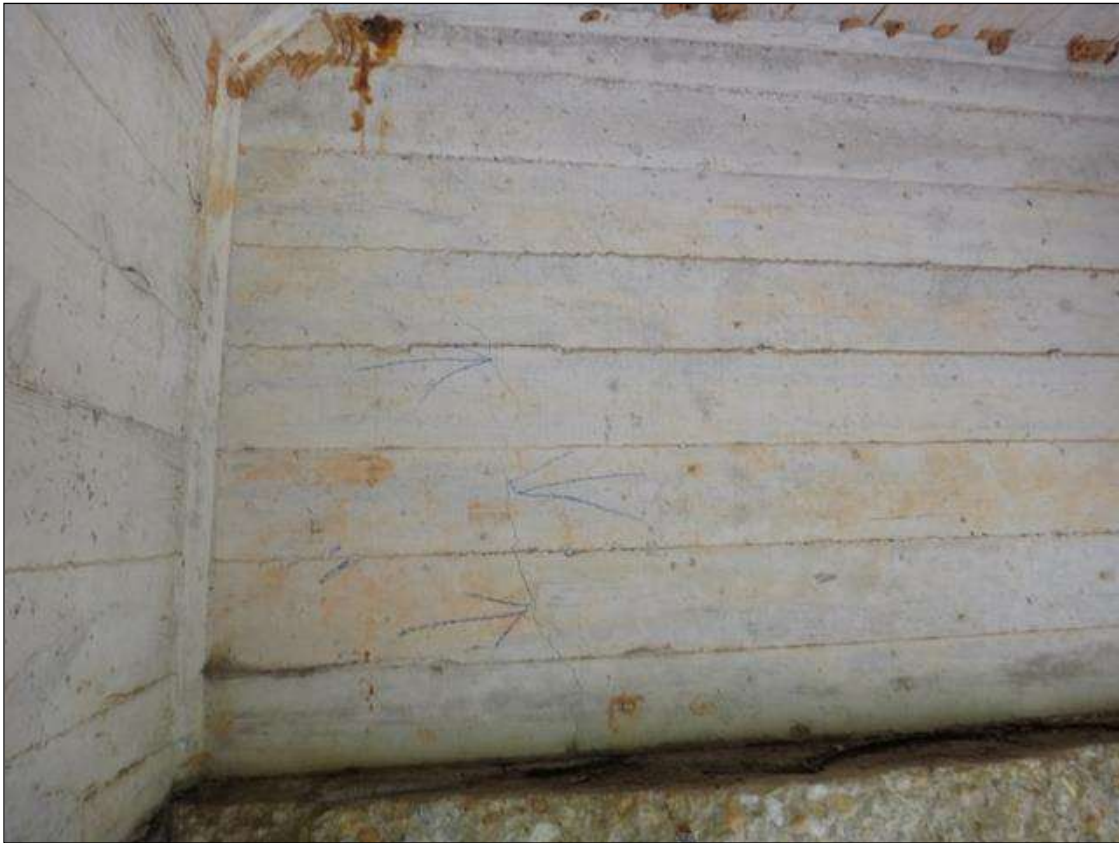
SPAN 5 BENT 4 BACKWALL AT BAY 2, VERTICAL CRACK (FULL HEIGHT X HAIRLINE)

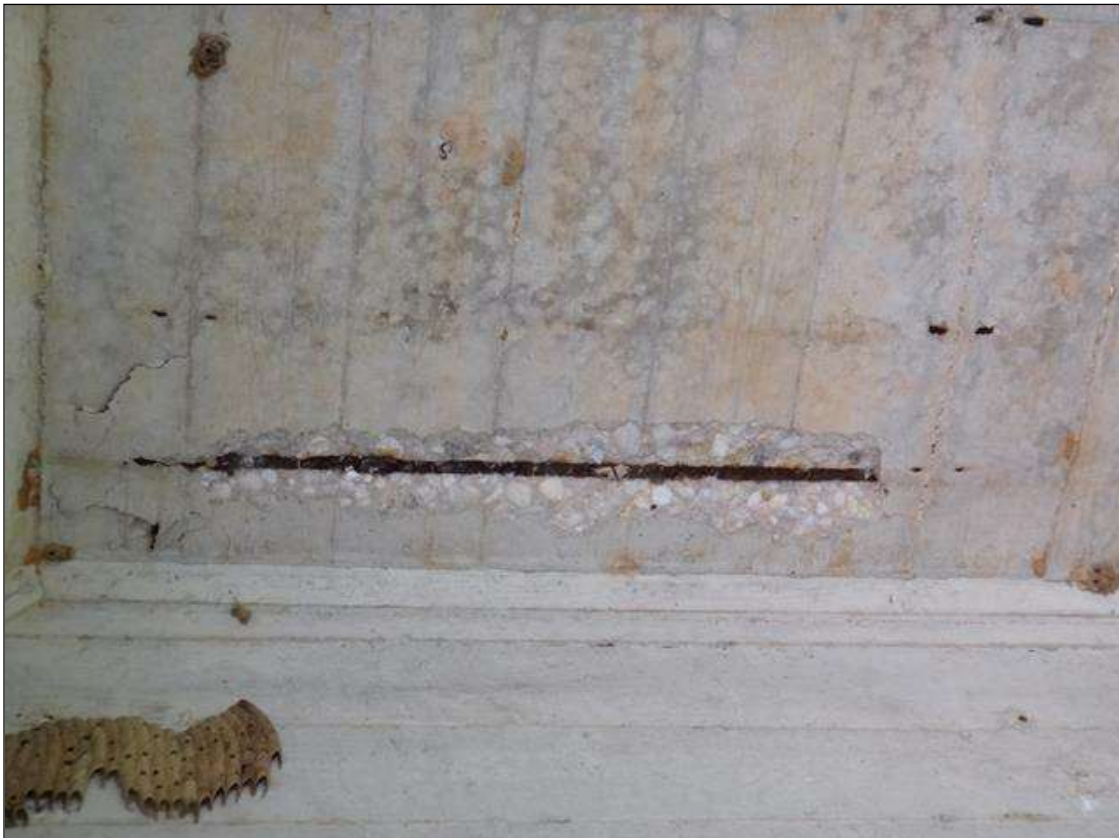
SPAN 5 BENT 5 UNDERSIDE OF DECK AT BAY 2, SPALL (3FT X 4IN X 1IN DEEP) WITH EXPOSED RUSTED REBAR AND ADJACENT DELAMINATION

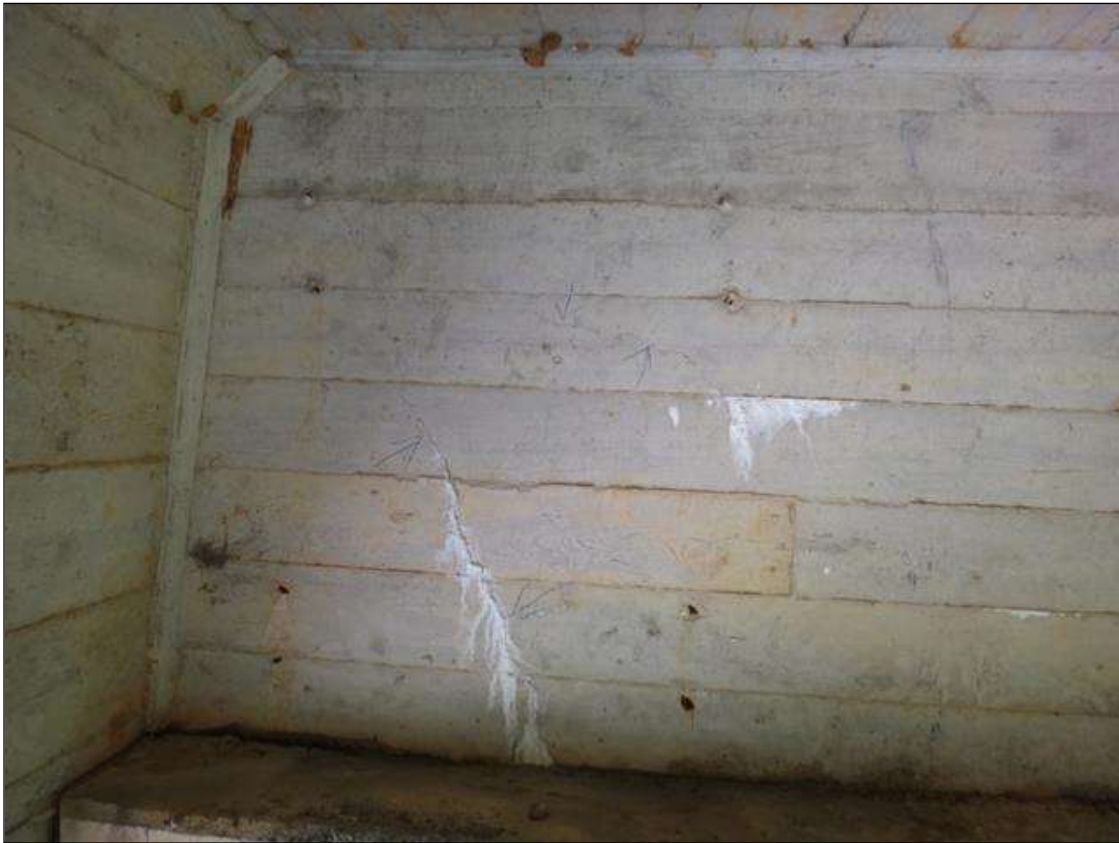
SPAN 5 BENT 5 BACKWALL AT BAY 3, TWO (2) DIAGONAL CRACKS (UP TO FULL HEIGHT X HAIRLINE) WITH EFFLORESCENCE

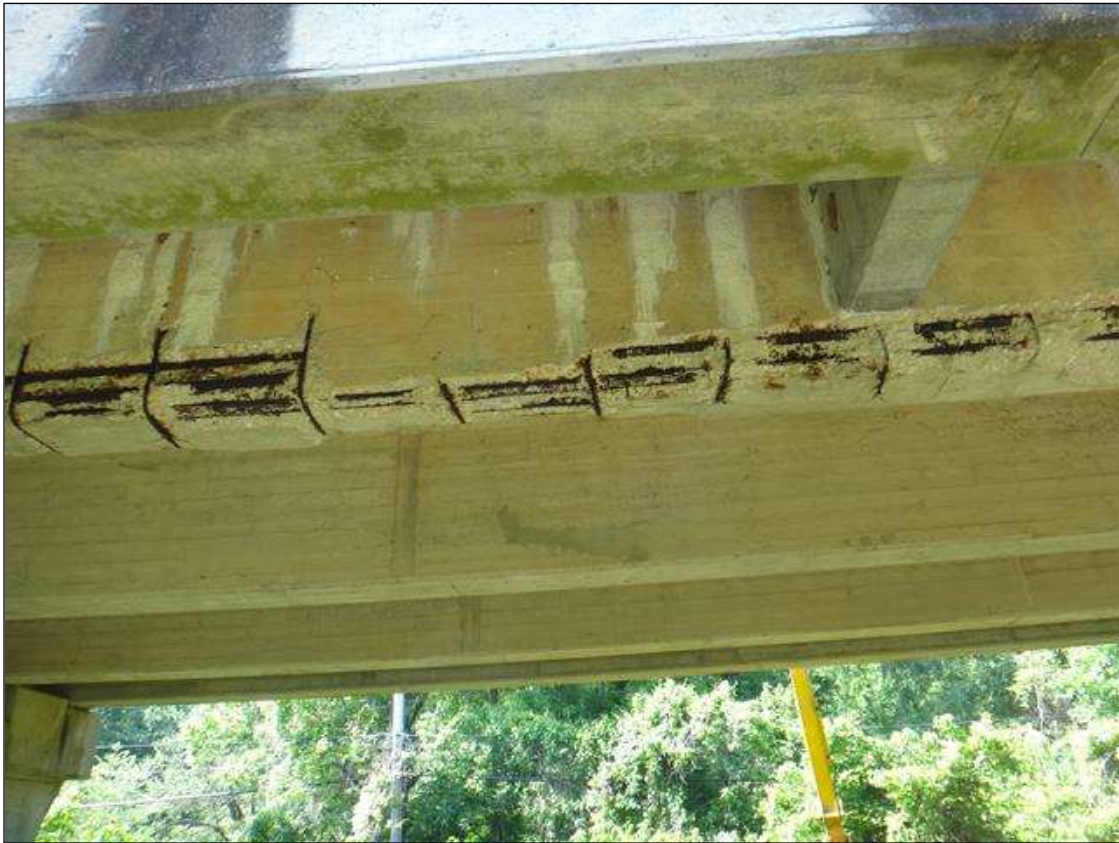
(PM) SPAN 6 BEAM 2 AT MIDSPAN, SPALL (26FT X 20IN X 2IN) WITH EXPOSED RUSTED REBAR, SECTION LOSS ON PRIMARY (NO MEASURABLE LOSS) AND SECONDARY (100%)

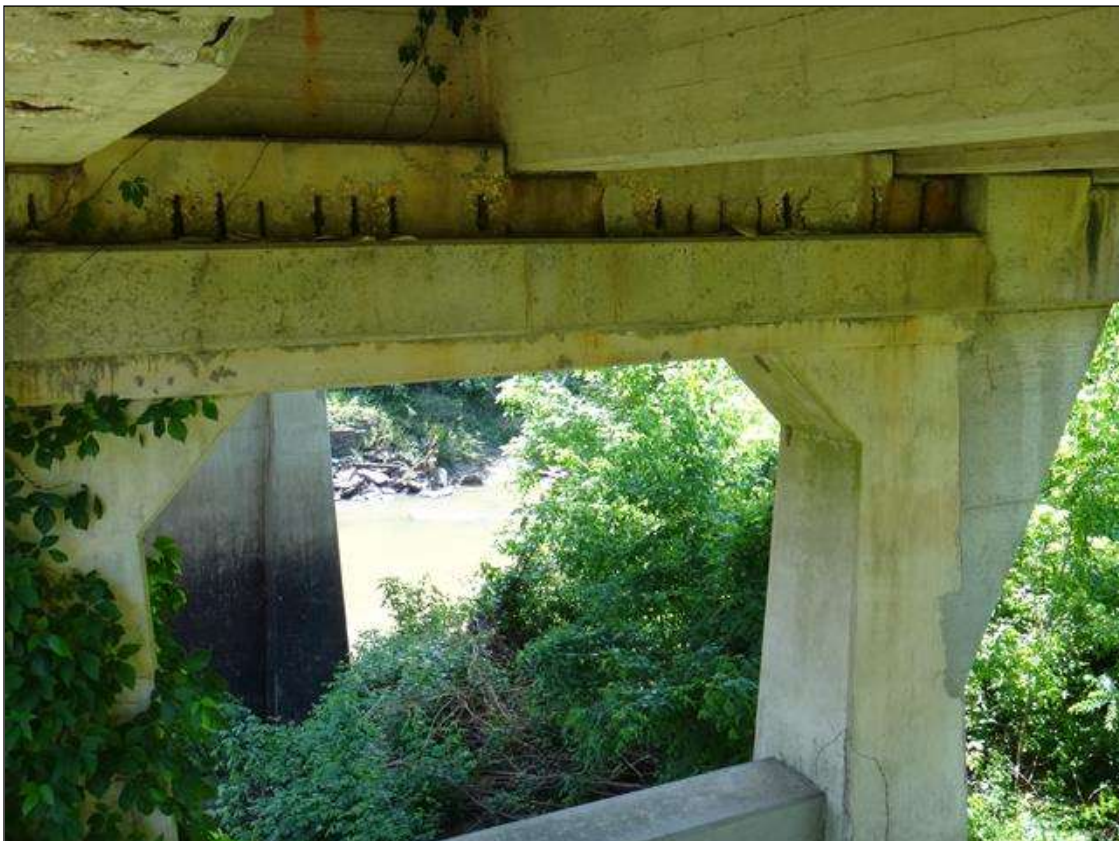
(PM) BENT 6 CAP WEST FACE, MULTIPLE SPALLS (UP TO 20IN X 12IN)

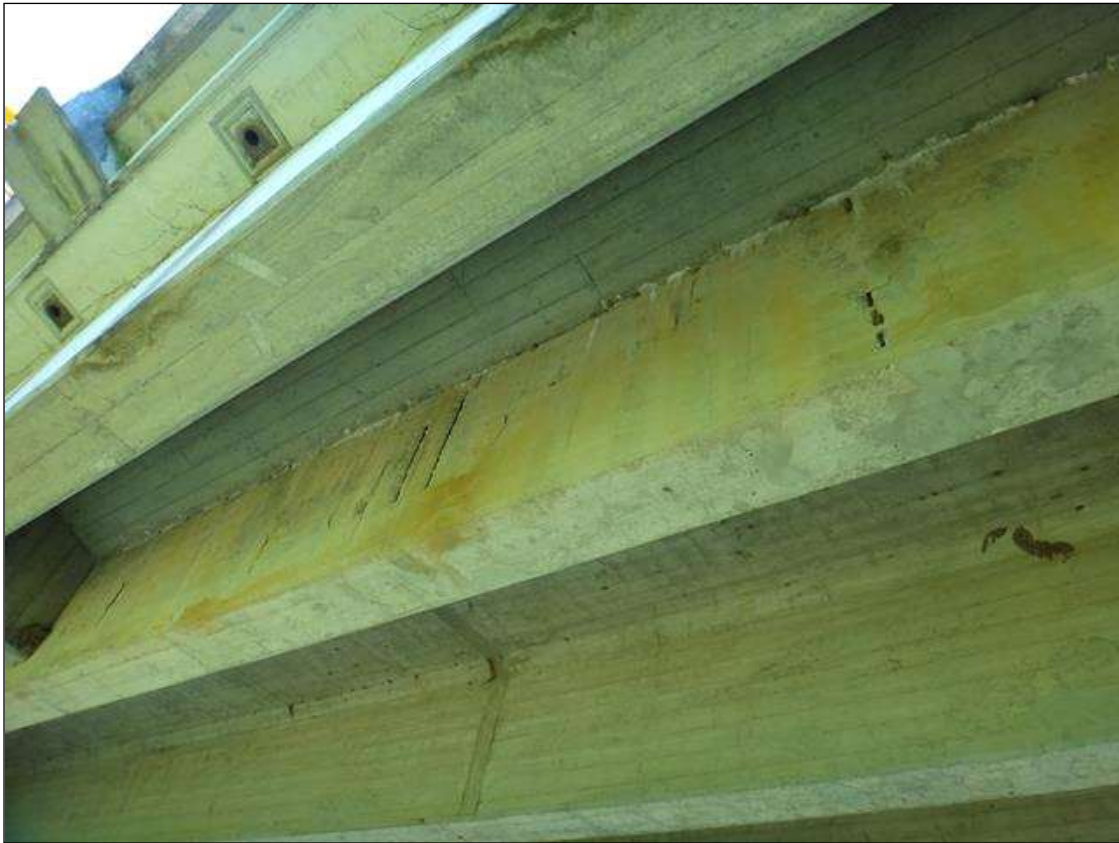
(PM) SPAN 6 BEAM 4 SOUTH FACE, MULTIPLE SPALLS (3FT X 4IN X 1IN) WITH EXPOSED RUSTED REBAR, MULTIPLE DELAMINATIONS (3FT X 3IN)

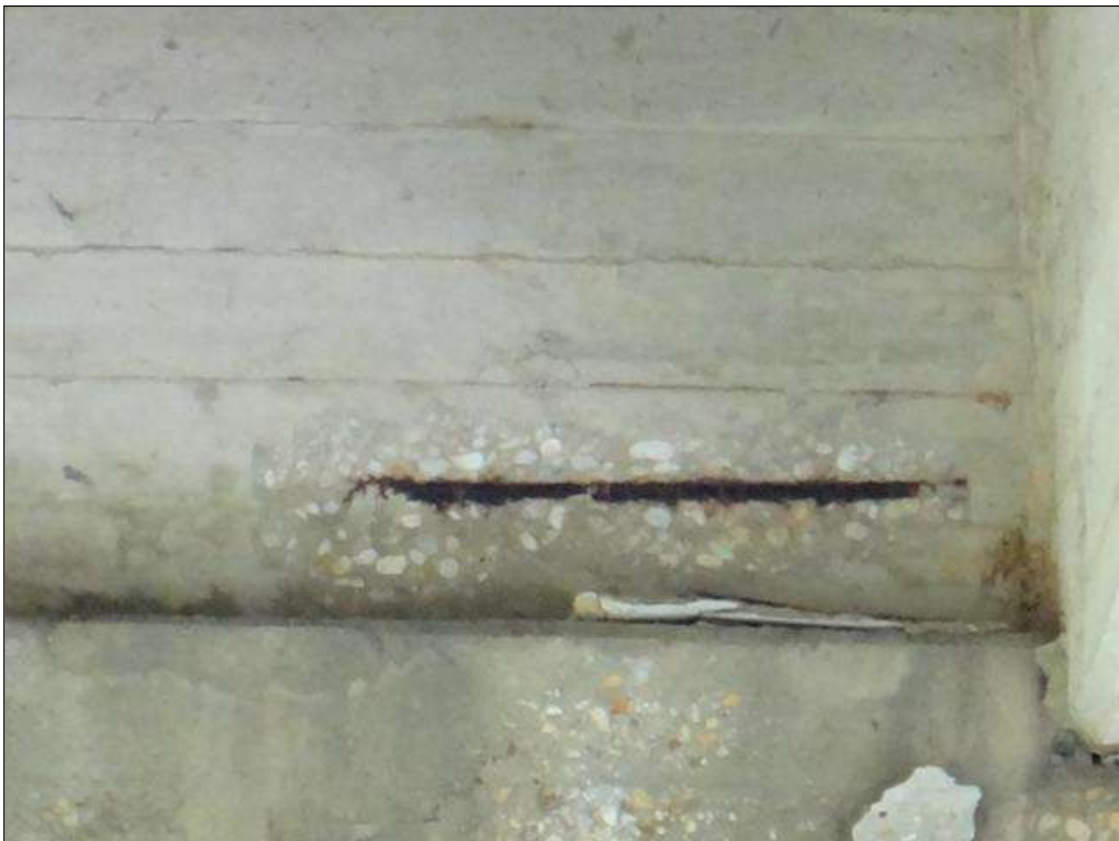
SPAN 6 BENT 5 END DIAPHRAGM AT BAY 4, SPALL (20IN X 5IN X 1IN DEEP) WITH EXPOSED RUSTED REBAR

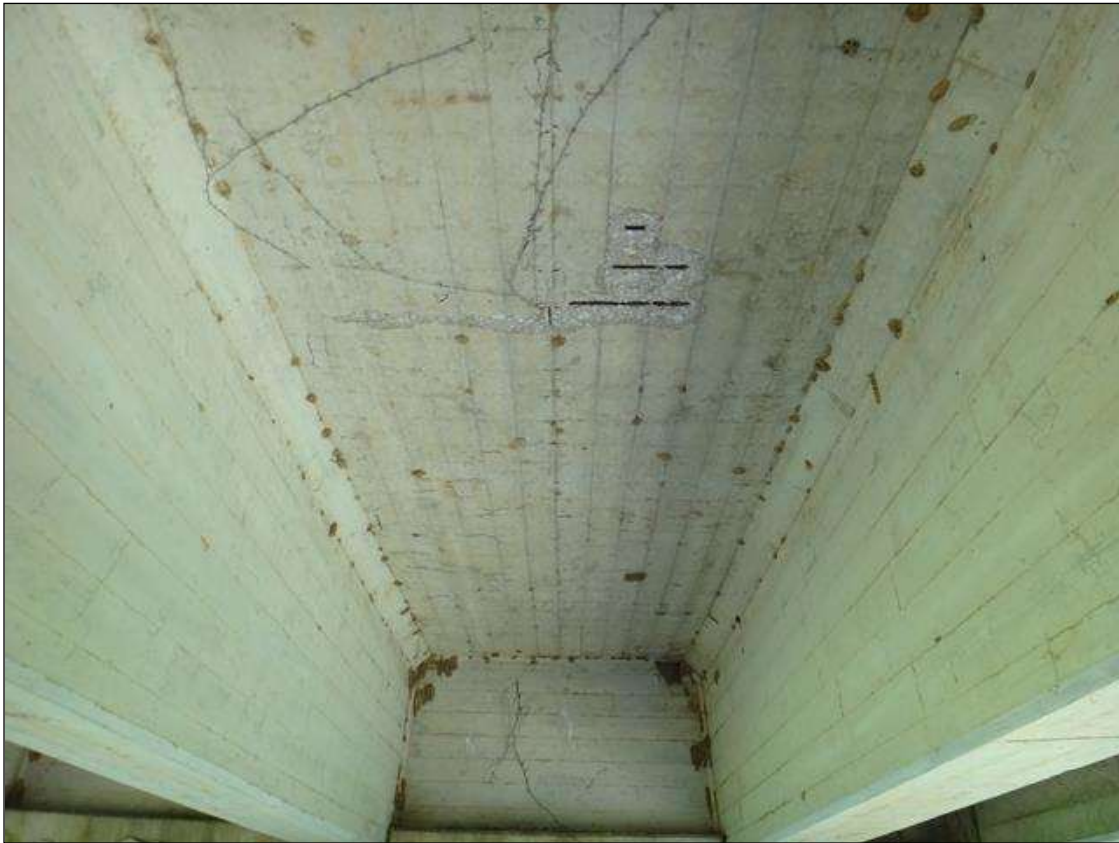
SPAN 7 UNDERSIDE OF DECK AT BAY 2, MULTIPLE SPALLS (UP TO 4FT X 2FT X 2IN DEEP) WITH EXPOSED RUSTED REBAR, SECTION LOSS (NO MEASURABLE LOSS)

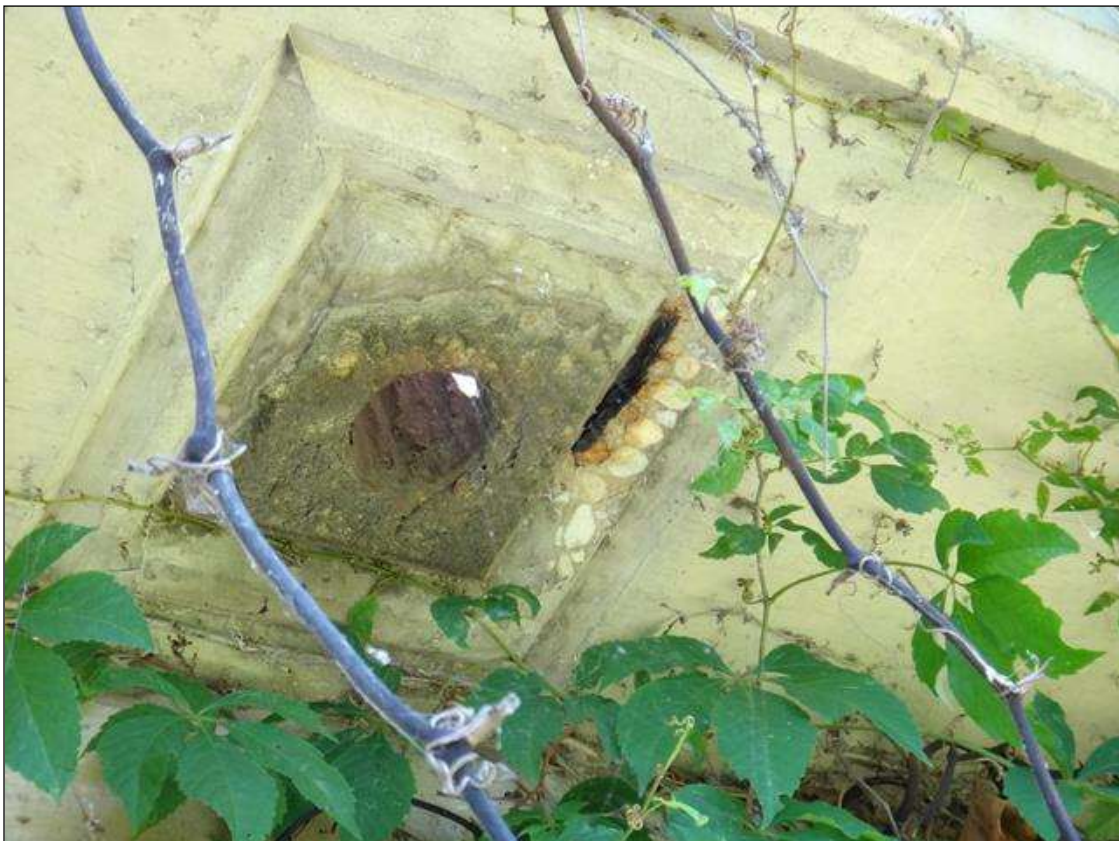
SPAN 7 NORTH OVERHANG AT SCUPPER 1, SPALL (12IN X 4IN X 1IN DEEP) WITH EXPOSED RUSTED REBAR

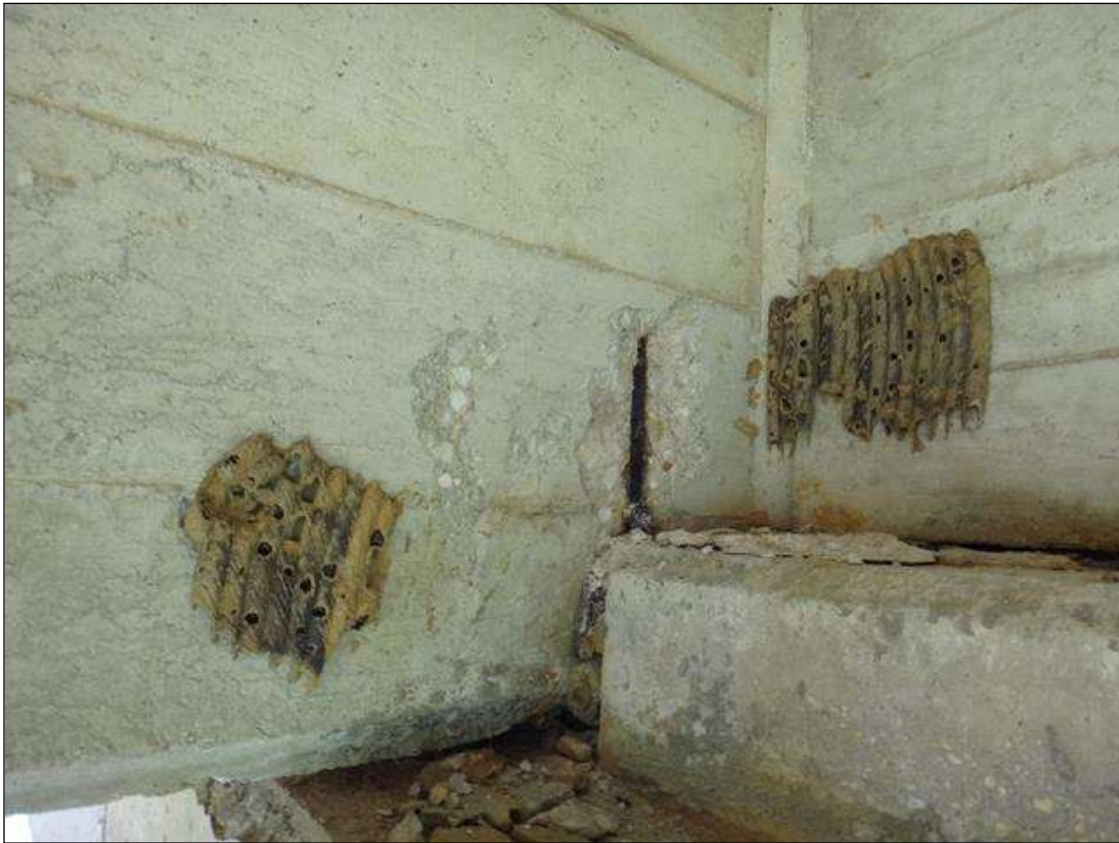
(PM) SPAN 7 BEAM 3 AT BENT 7, SPALL (10IN X 5IN X 1IN DEEP) WITH EXPOSED RUSTED REBAR AND ADJACENT DELAMINATION

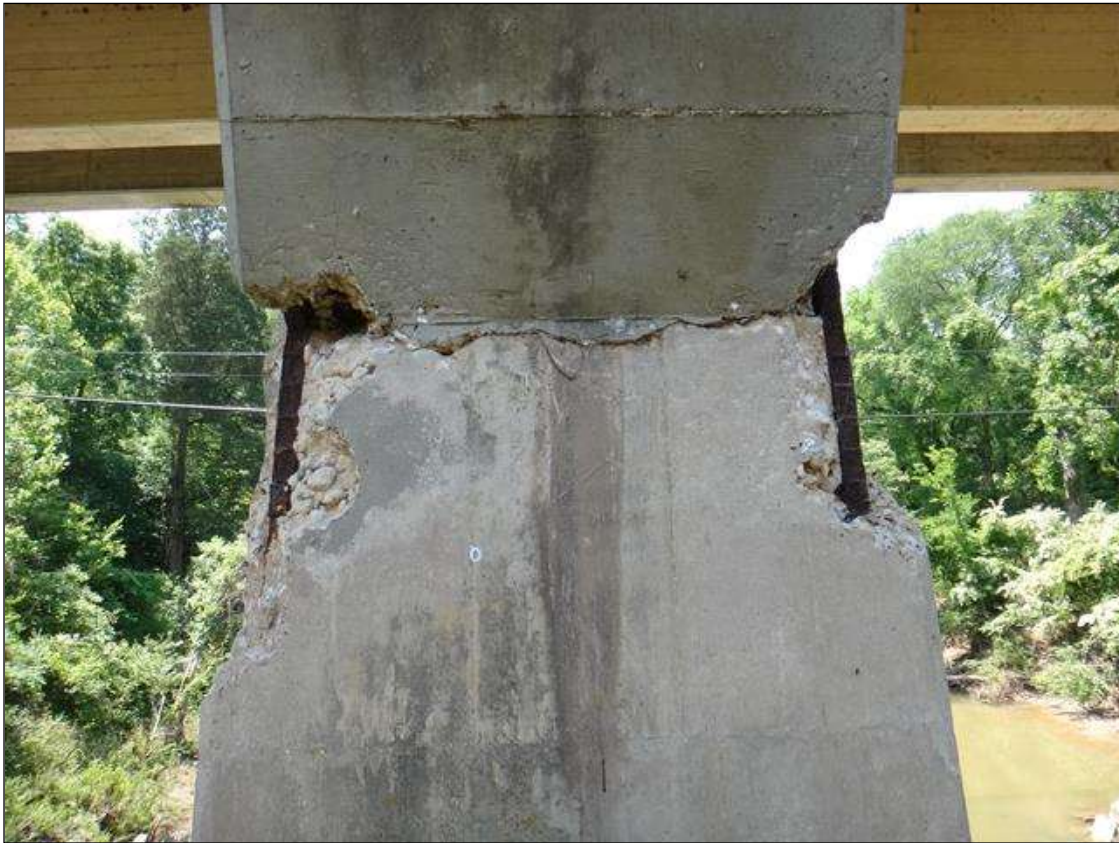
(PM) BENT 8 COLUMN 1 NORTH FACE, TWO (2) SPALLS (2FT X 8IN X 4IN DEEP) WITH EXPOSED RUSTED REBAR, SECTION LOSS (NO MEASURABLE LOSS) AND DEBONDED REBAR

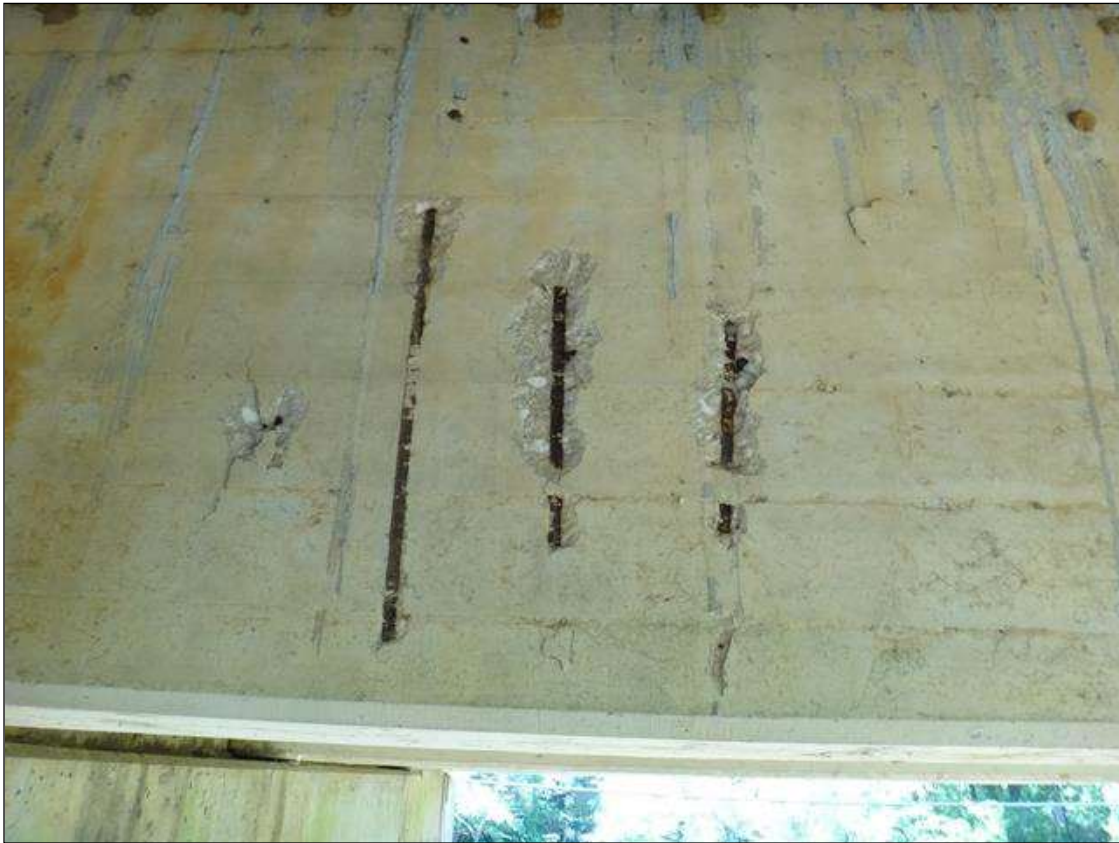
(PM) SPAN 8 BEAM 2 AT 6FT FROM BENT 8, MULTIPLE SPALLS (UP TO 2FT X 5IN X 1IN DEEP) WITH EXPOSED RUSTED REBAR

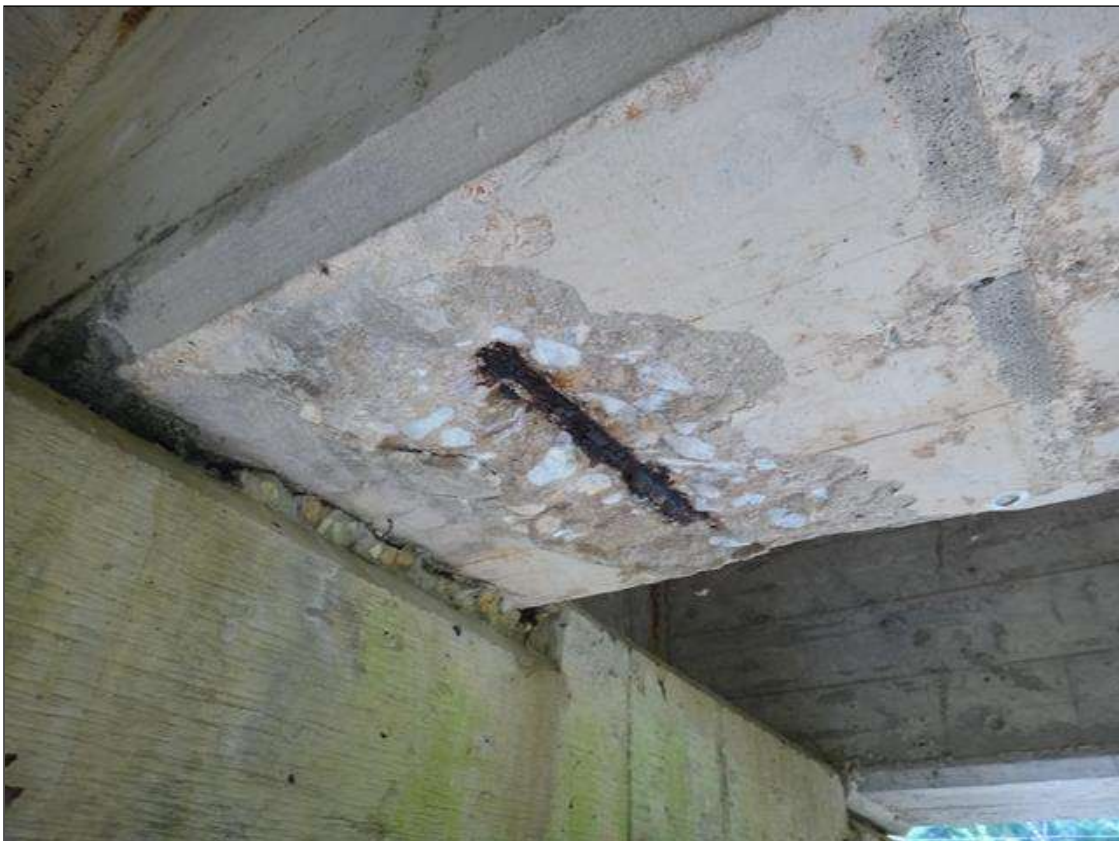
(PM) SPAN 8 BEAM 4 AT BENT 8, SPALL (16IN X 8IN X 1-1/2IN DEEP) WITH EXPOSED RUSTED REBAR

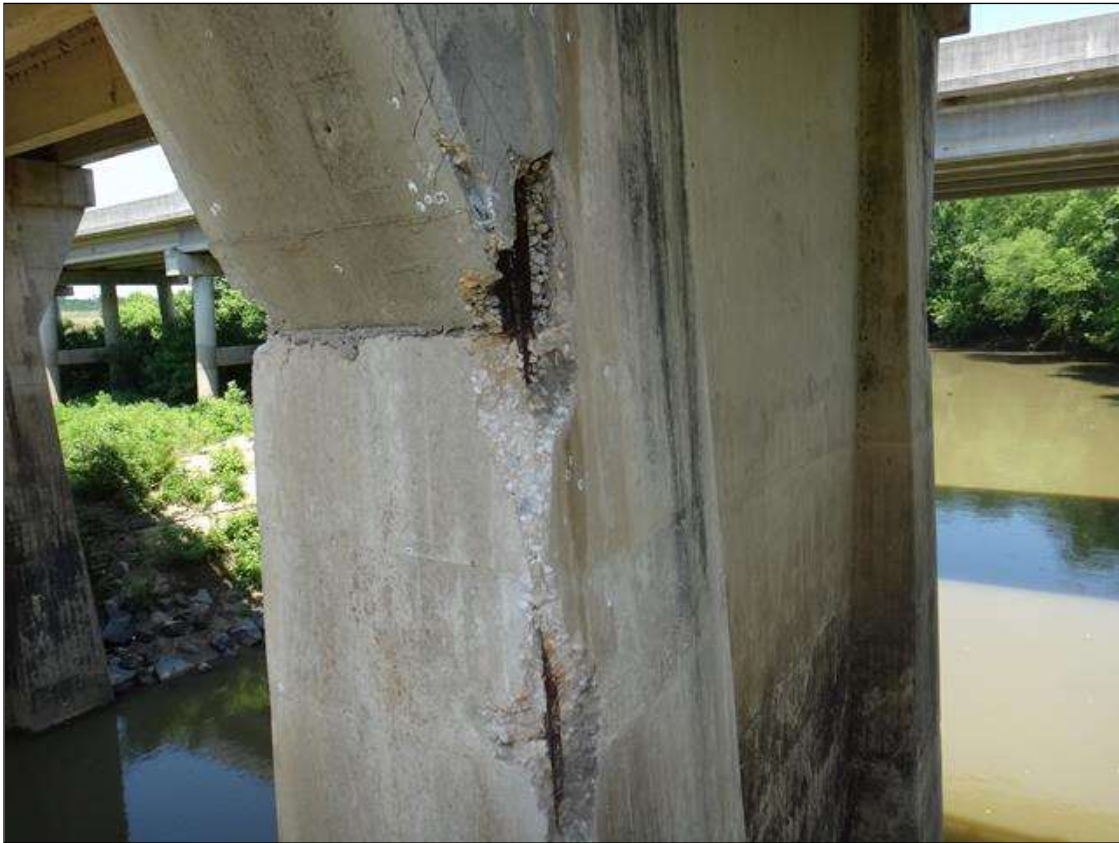
(PM) BENT 8 COLUMN 2 SOUTHEAST CORNER AT 10FT BELOW CAP, SPALL (6FT X 1FT X 5IN DEEP) WITH EXPOSED RUSTED REBAR, SECTION LOSS (NO MEASURABLE LOSS)

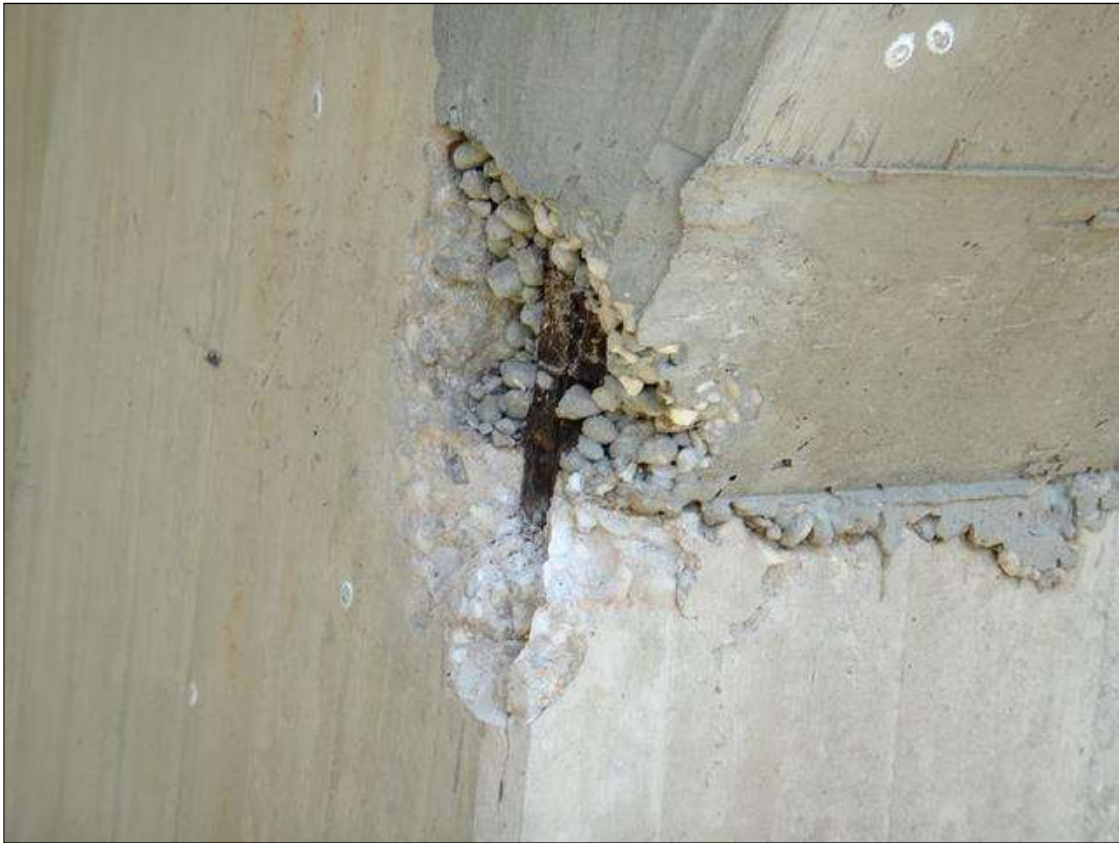
(PM) BENT 8 COLUMN 2 SOUTHWEST CORNER, SPALL (16IN X 8IN X 3IN DEEP) WITH EXPOSED RUSTED REBAR, SECTION LOSS (NO MEASURABLE LOSS)

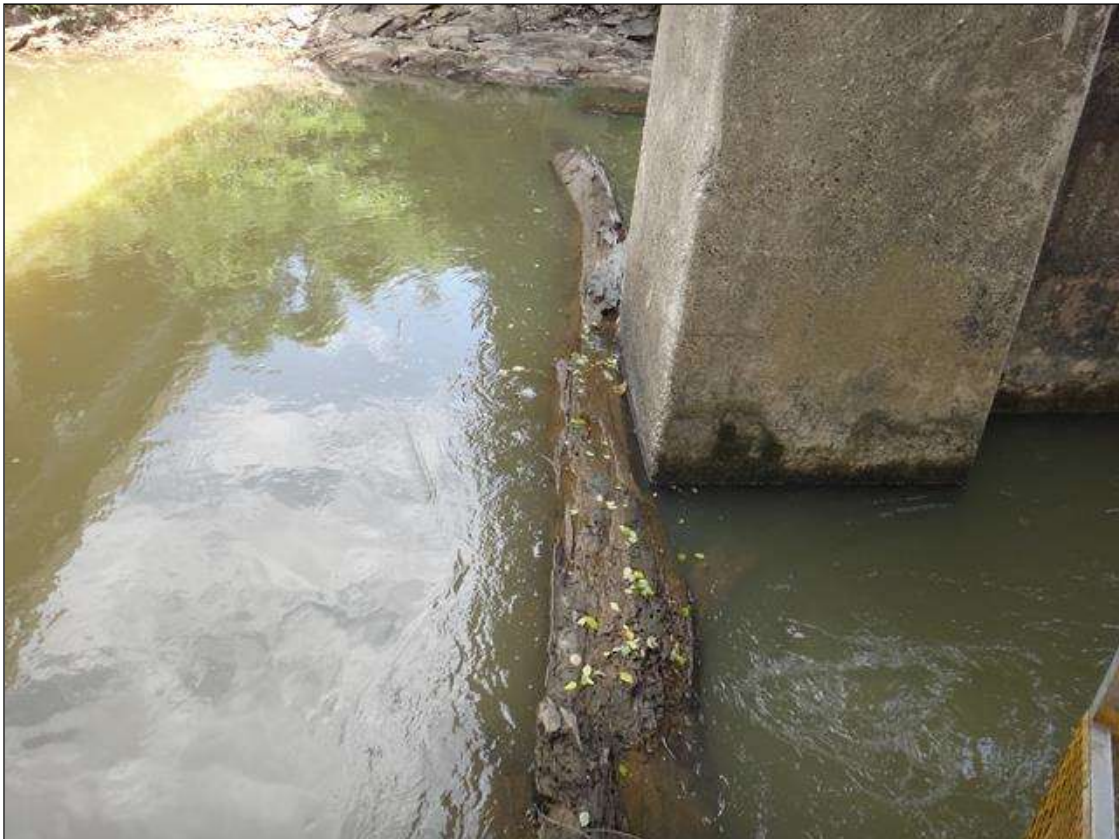
BENT 8, DRIFT ACCUMULATION WITH TREE (30FT X 24IN DIAMETER)

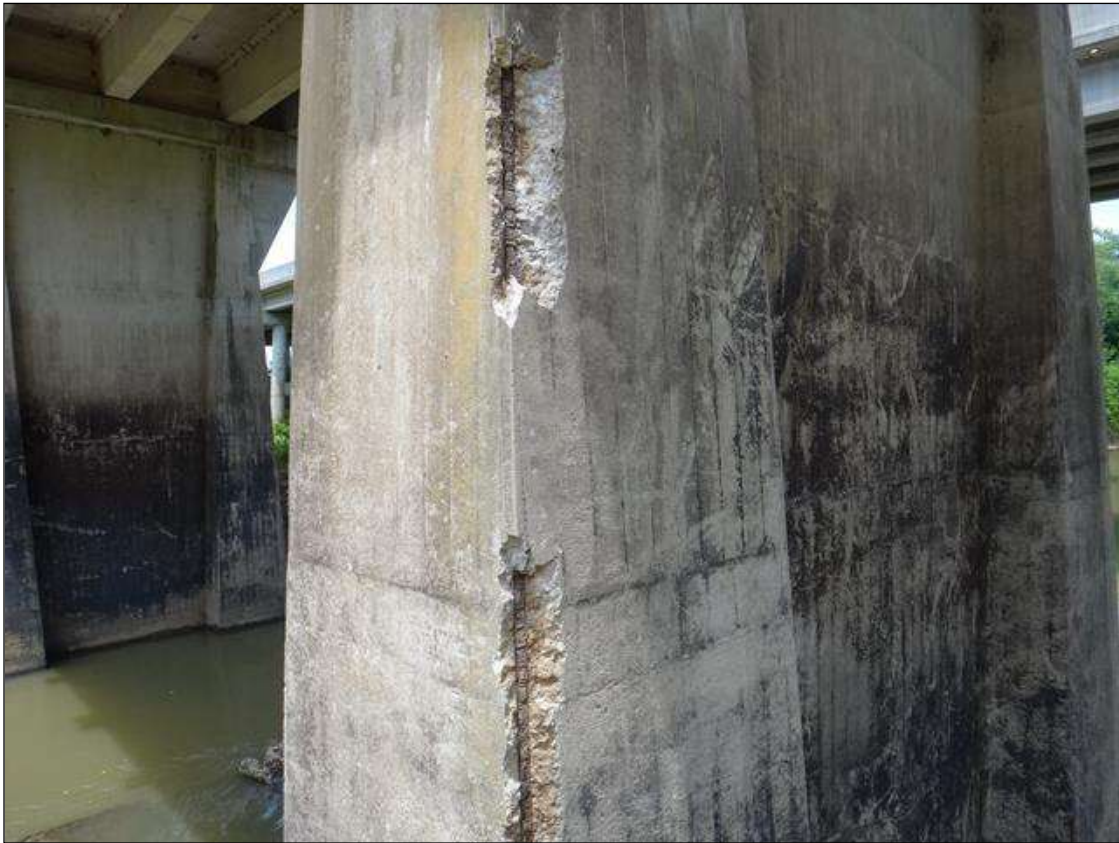
(PM) BENT 8 COLUMN 2 SOUTHEAST CORNER AT 10FT ABOVE WATERLINE, TWO (2) SPALLS (UP TO 4FT X 6IN X 2IN) WITH EXPOSED RUSTED REBAR AND SECTION LOSS

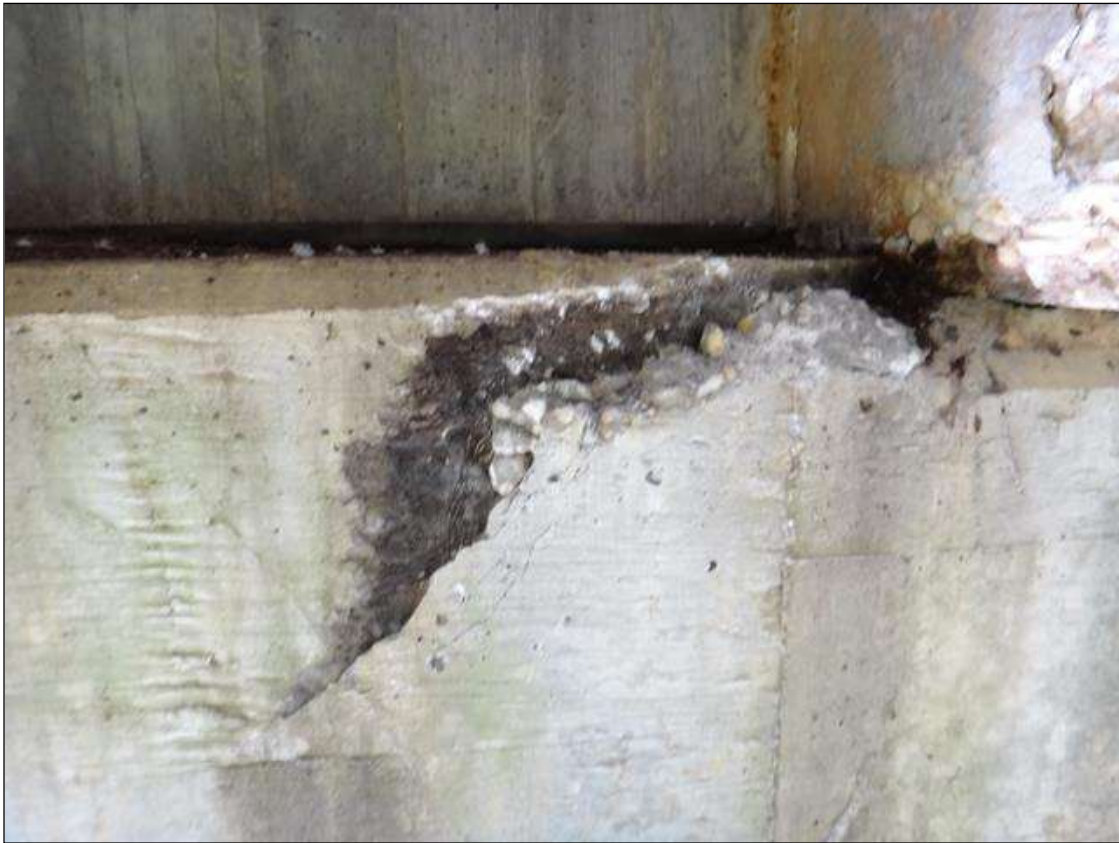
(PM) BENT 8 CAP EAST FACE BELOW BEAM 4, SPALL (2FT X 4IN X 2-1/2IN DEEP) WITH ADJACENT DELAMINATION

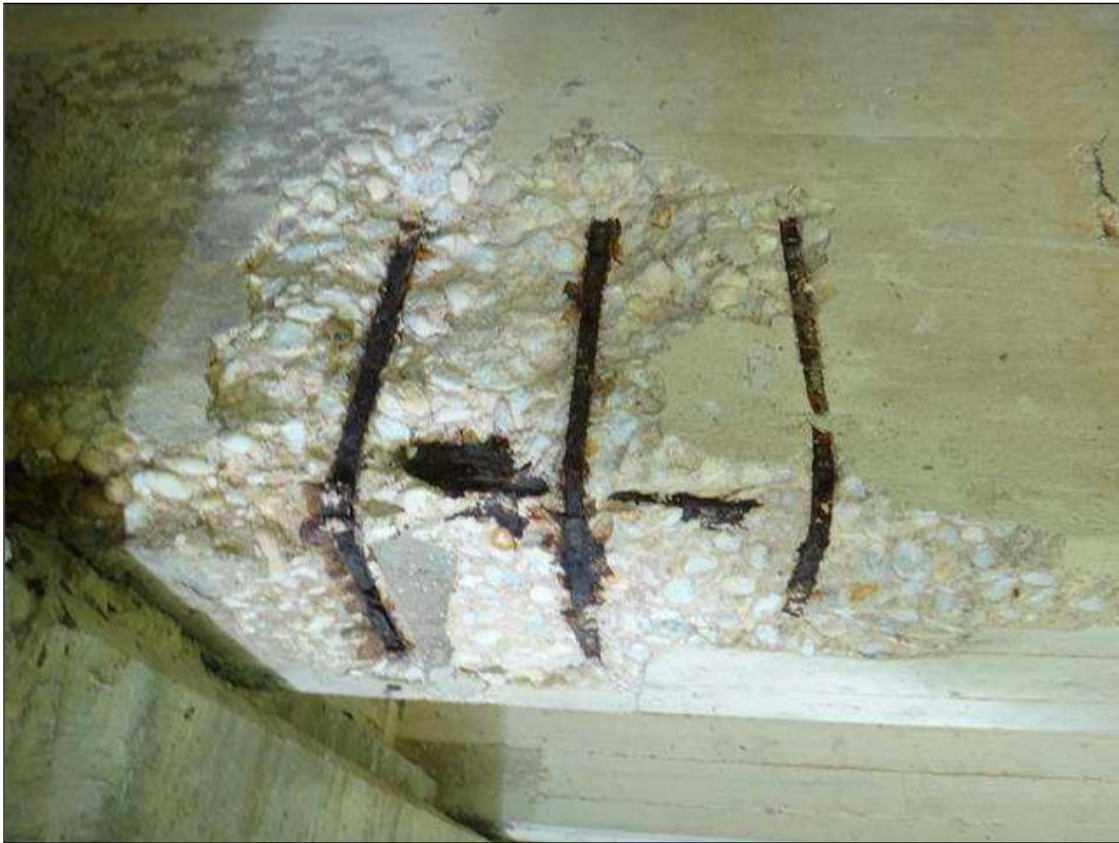
(PM) SPAN 9 BEAM 4 AT BENT 8, SPALL (2FT X 4IN X 2-1/2IN DEEP) WITH EXPOSED RUSTED REBAR, SECTION LOSS (NO MEASURABLE LOSS)

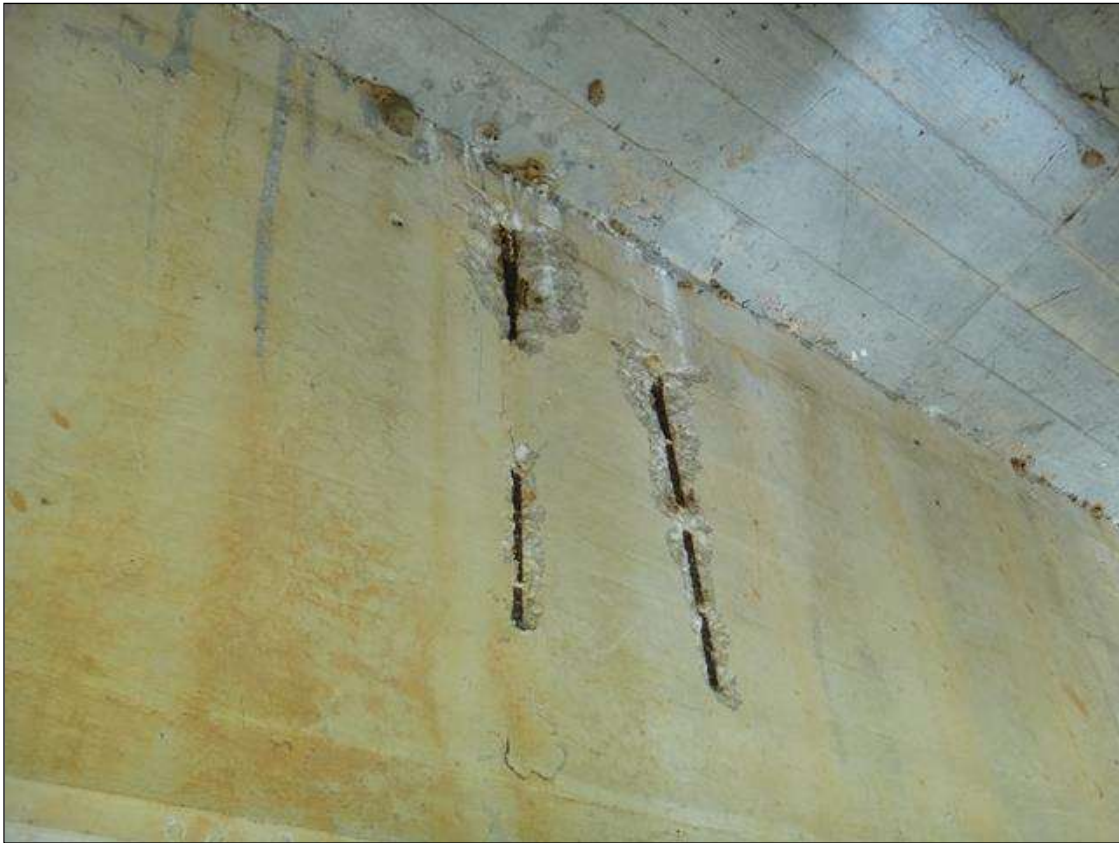
(PM) SPAN 9 BEAM 4 AT 12FT FROM BENT 8, MULTIPLE SPALLS/DELAMINATIONS (UP TO 26IN X 5IN X 1IN DEEP) WITH EXPOSED RUSTED REBAR

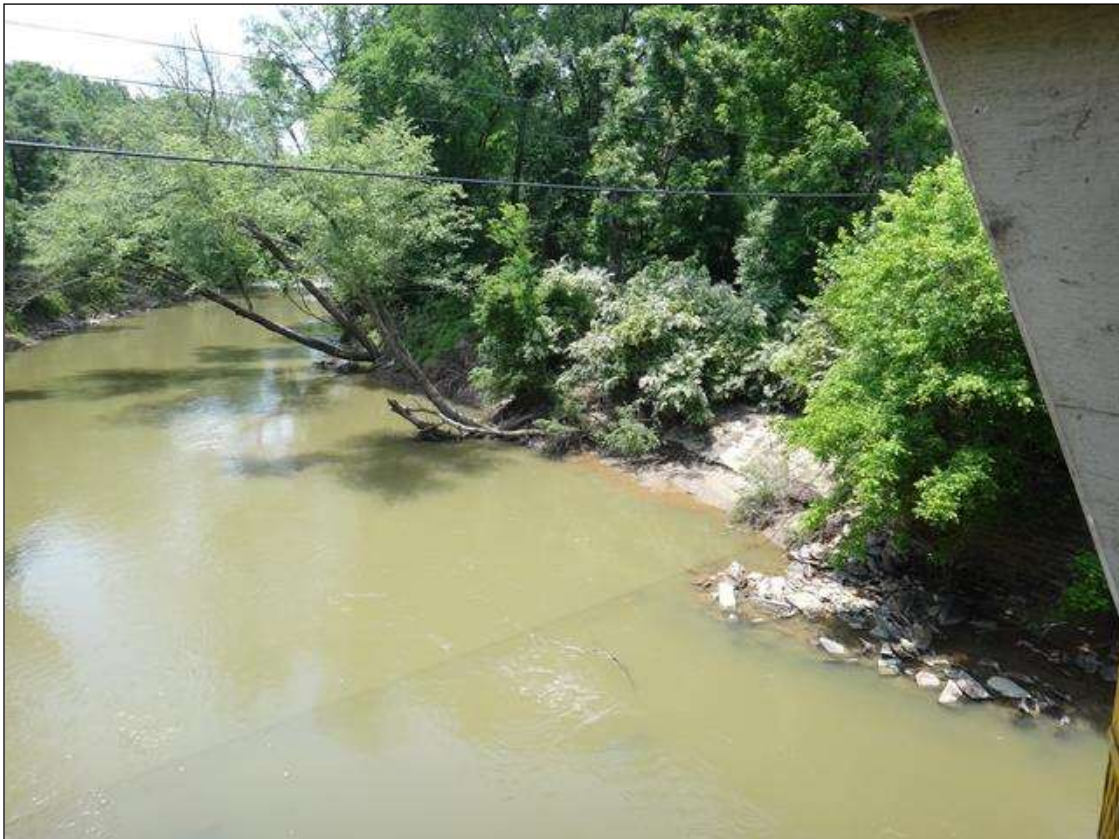
SOUTHWEST STREAMBANK, EROSION WITH DISPLACED SLOPE PROTECTION AND EXPOSED TREE ROOTS

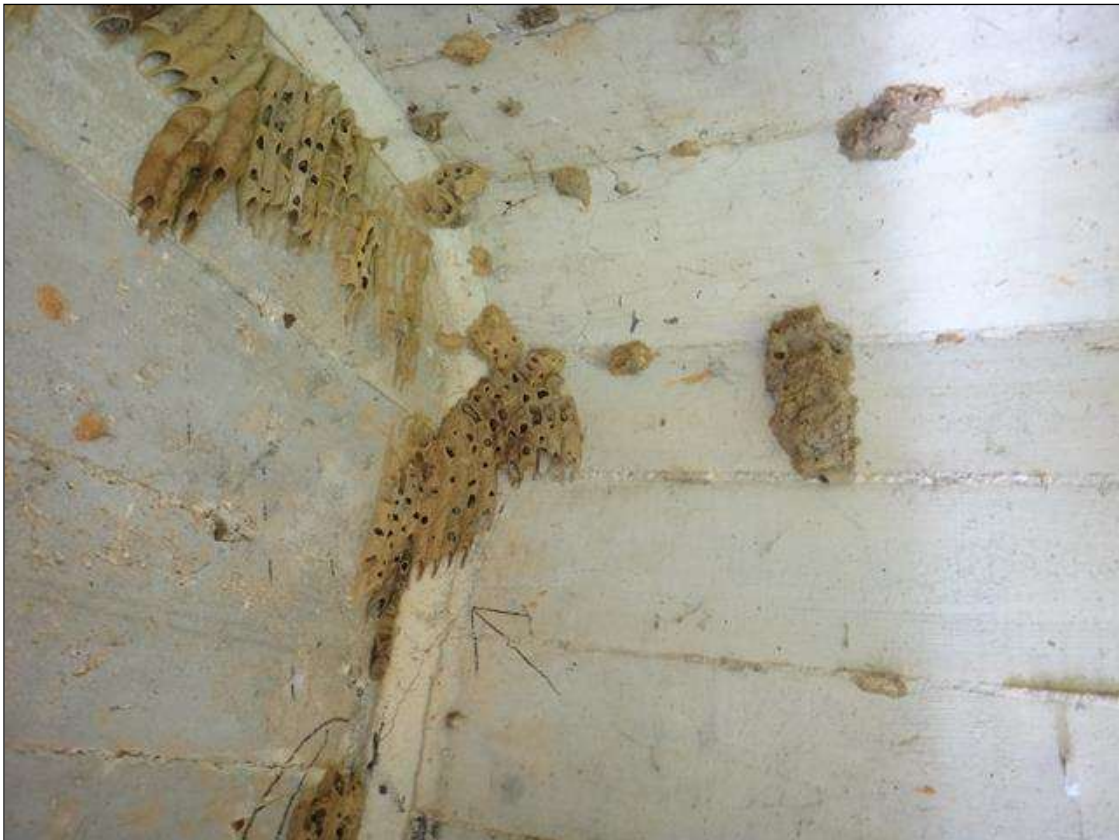
SPAN 9 BEAM 3 AT BENT 8, DIAGONAL CRACK (24IN X 1/64IN) EXTENDS INTO DECK (2FT)

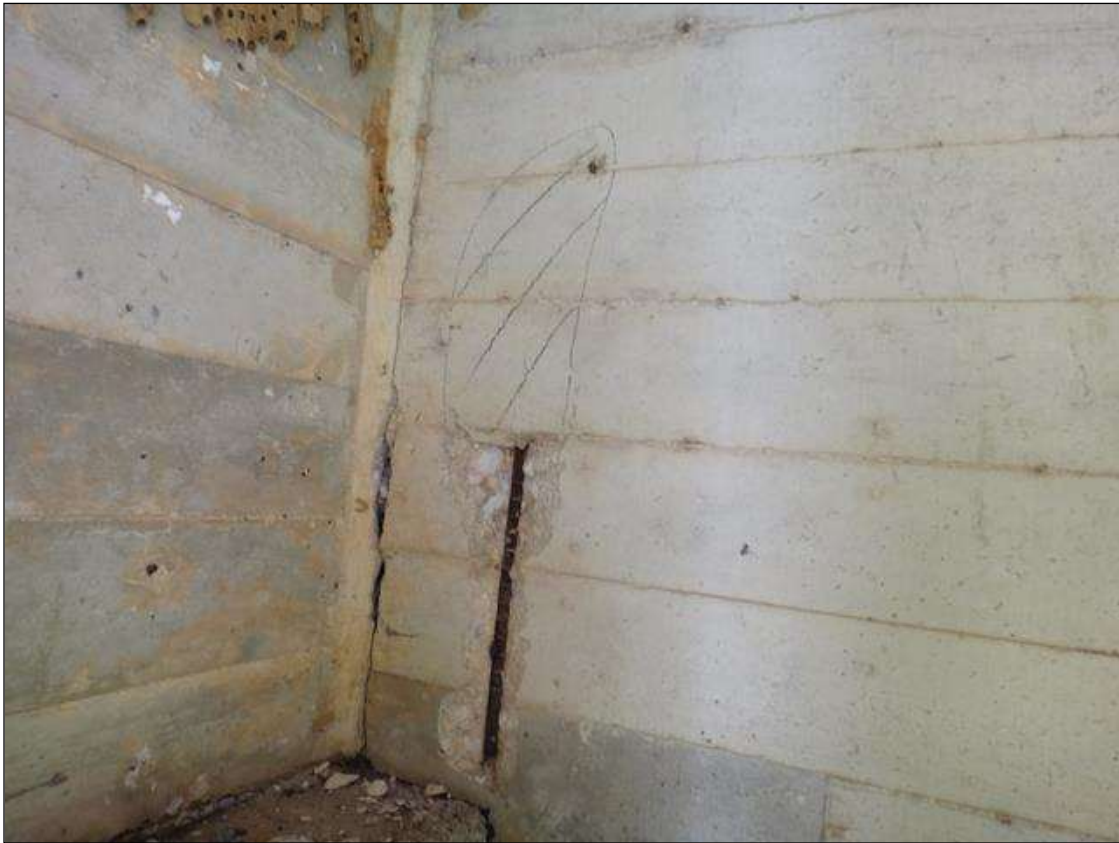
(PM) SPAN 9 BEAM 2 AT BENT 8, SPALL (16IN X 6IN X 1-1/2IN DEEP) WITH EXPOSED RUSTED REBAR, SECTION LOSS (NO MEASURABLE LOSS), ADJACENT DELAMINATION
