NC DEPARTMENT OF TRANSPORTATION
 DIVISION OF HIGHWAYS
 BRIDGE MANAGEMENT UNIT

PRIORITY MAINTENANCE ISSUED

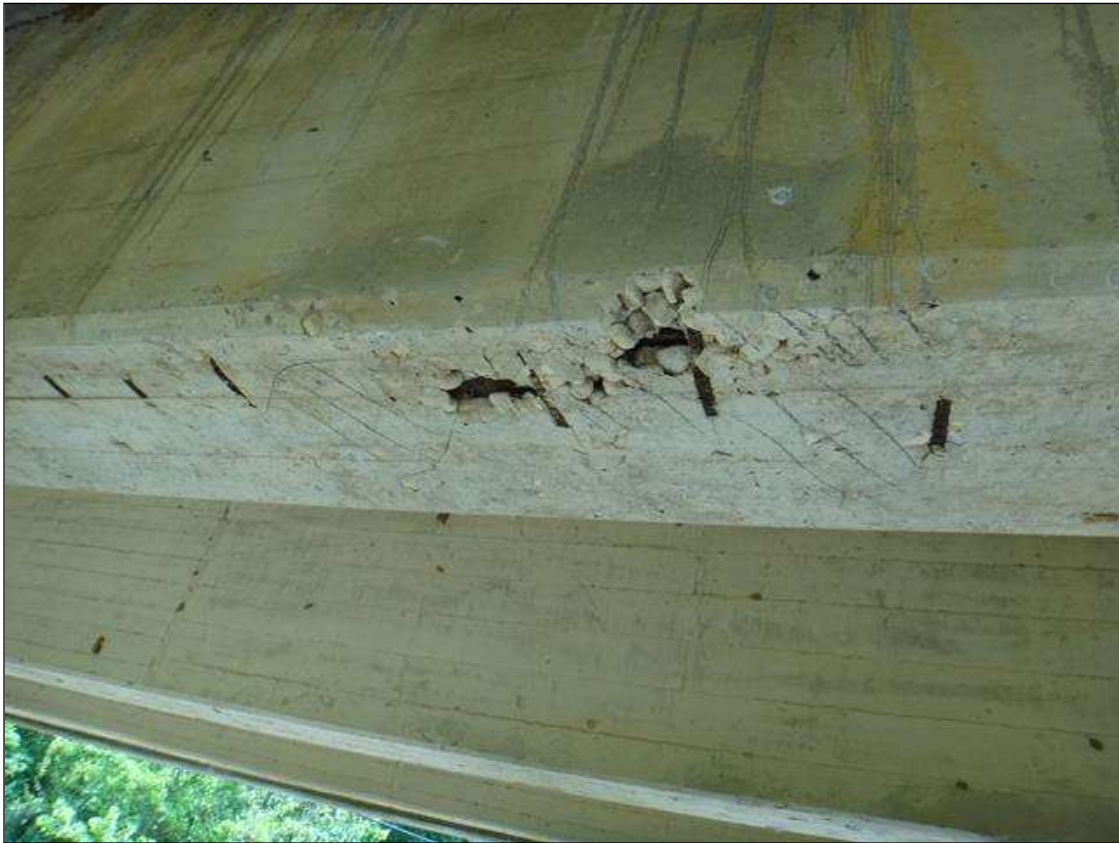
(PM) SPAN 9 BEAM 2 AT 5FT FROM BENT 8, SPALL (2FT X5INX 2IN) WITH EXPOSED RUSTED REBAR, HONEYCOMB, AND DELAMINATION, SECTION LOSS (NO MEASURABLE LOSS)

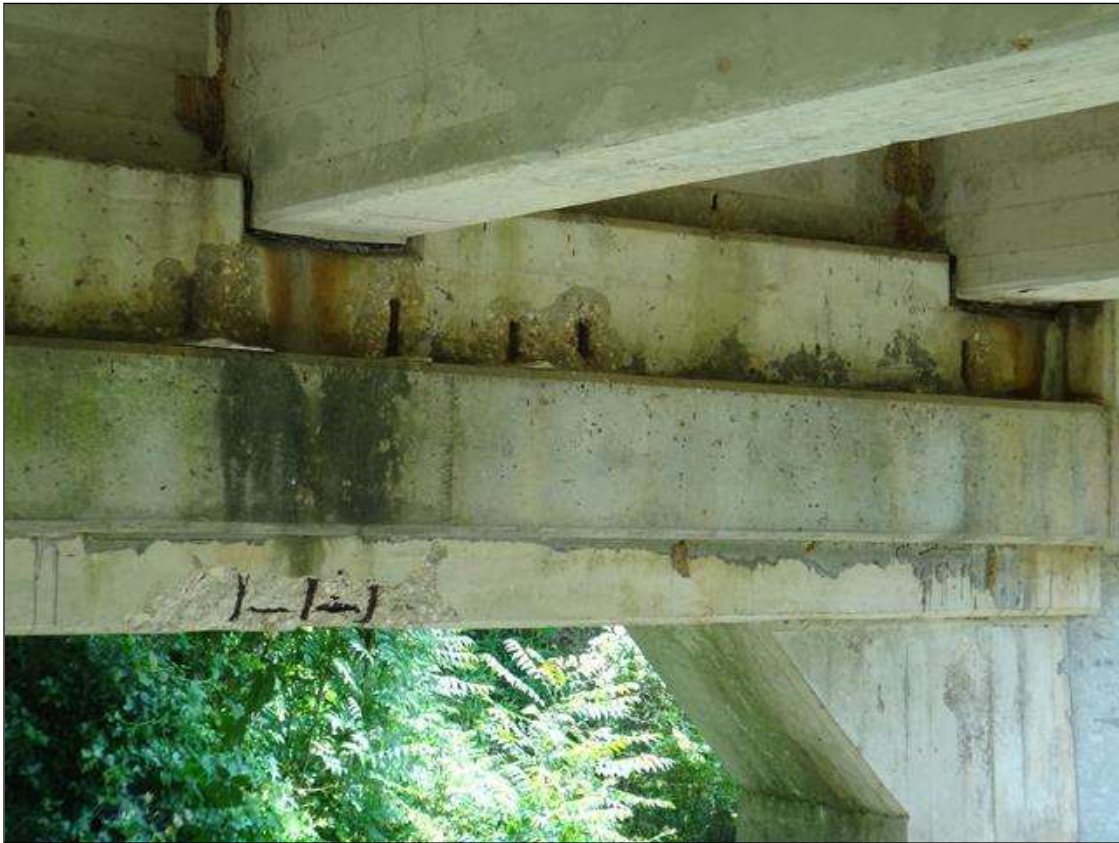
(PM) BENT 9 CAP WEST FACE, MULTIPLE SPALLS (UP TO 3-1/2FT X 12IN X 4IN DEEP) WITH EXPOSED RUSTED REBAR, SECTION LOSS (NO MEASURABLE LOSS)

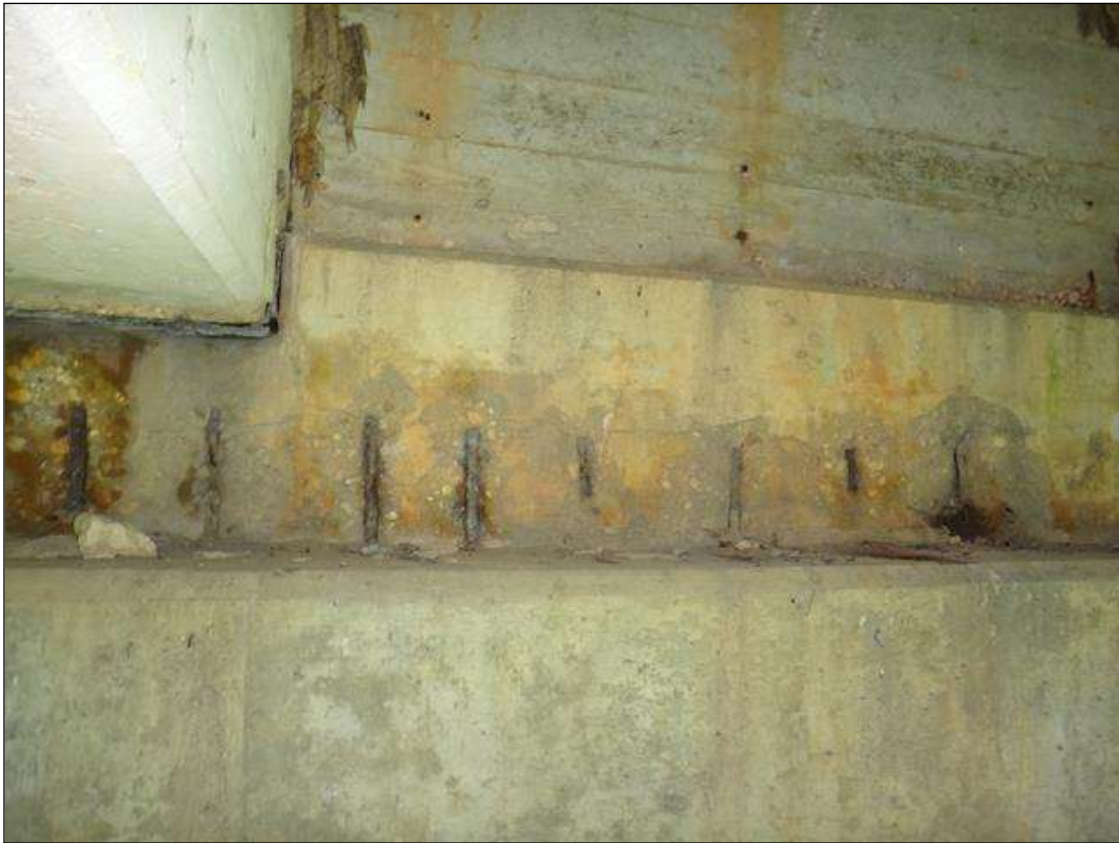
(PM) BENT 9 CAP EAST FACE, MULTIPLE SPALLS (UP TO 15FT X 13IN X 1-1/2IN DEEP) WITH EXPOSED RUSTED REBAR, SECTION LOSS (NO MEASURABLE LOSS)

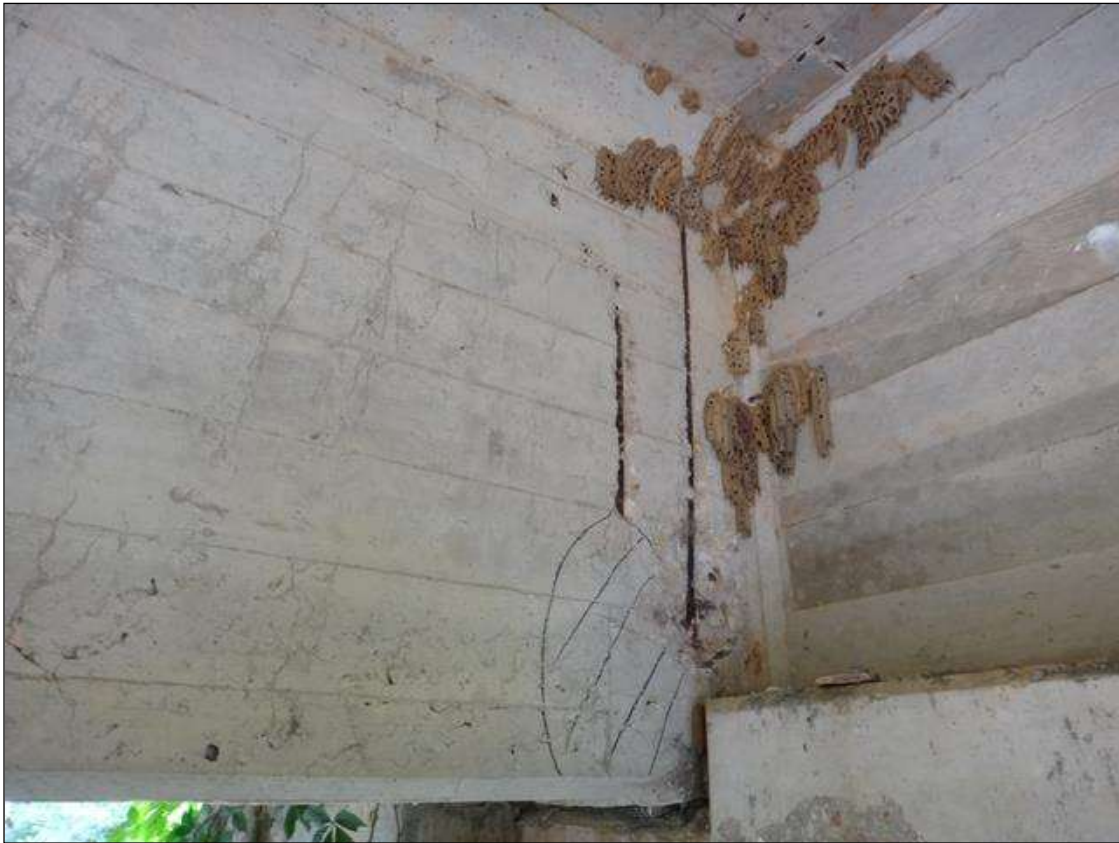
(PM) SPAN 9 BEAM 2 AT BENT 9, TWO (2) SPALLS (UP TO 40IN X 8IN X 1-1/2IN) WITH EXPOSED RUSTED REBAR, SECTION LOSS (NO MEASURABLE LOSS), DELAMINATION

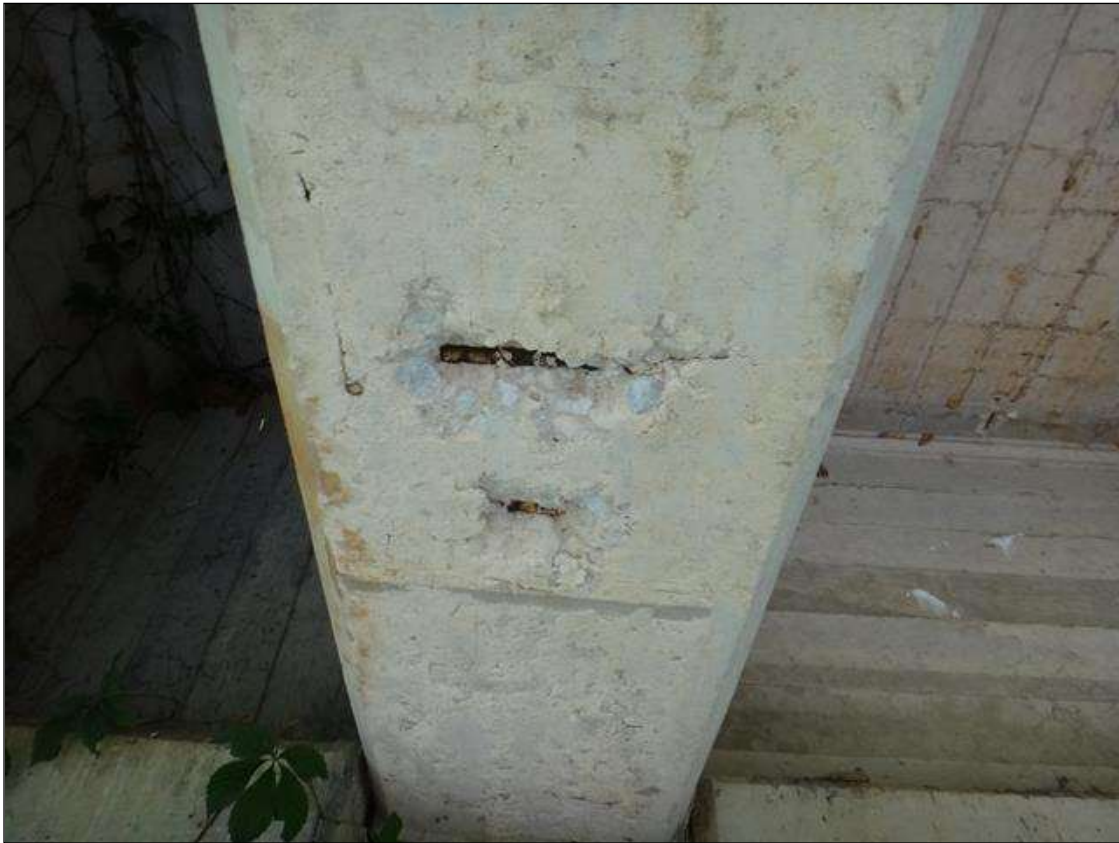
(PM) SPAN 9 BEAM 2 AT BENT 9, TWO (2) SPALLS (5IN DIAMETER X 1IN DEEP) WITH EXPOSED RUSTED REBAR

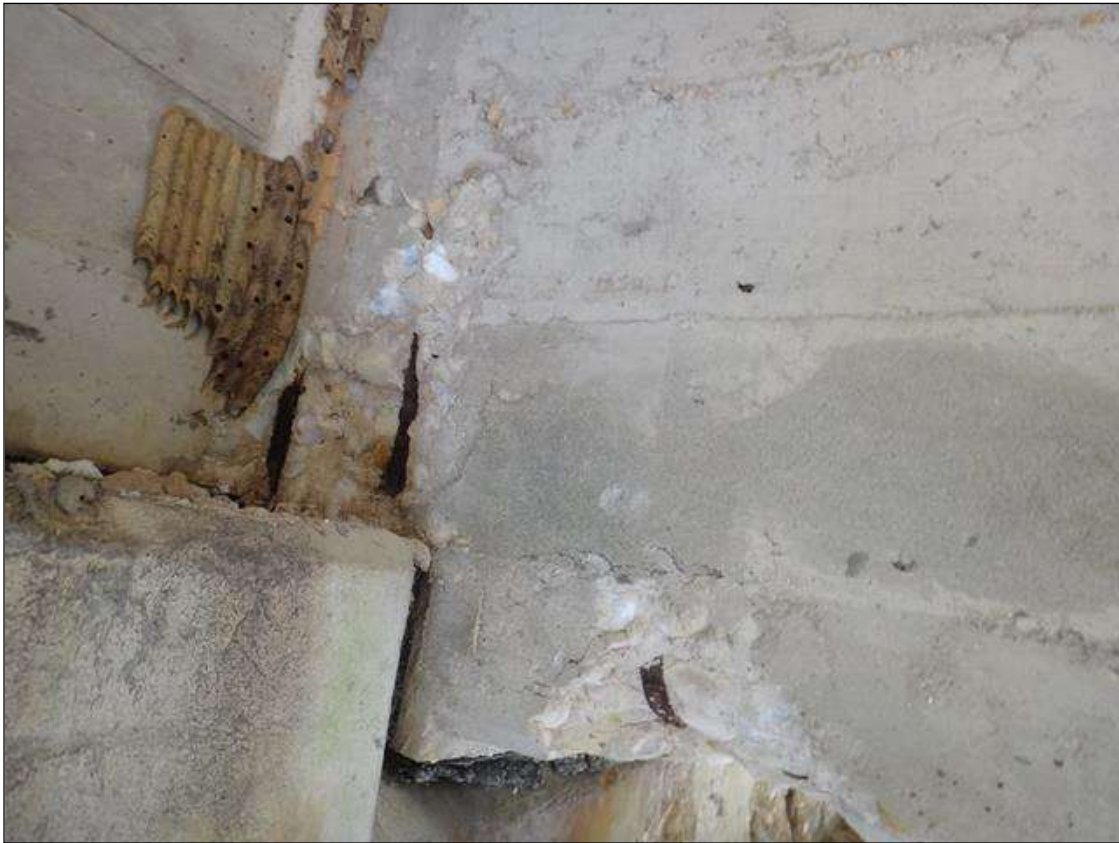
(PM) SPAN 9 BEAM 3 NORTH FACE AT BENT 9, TWO (2) SPALLS (UP TO 12IN X 6IN X 2IN DEEP) WITH EXPOSED RUSTED REBAR

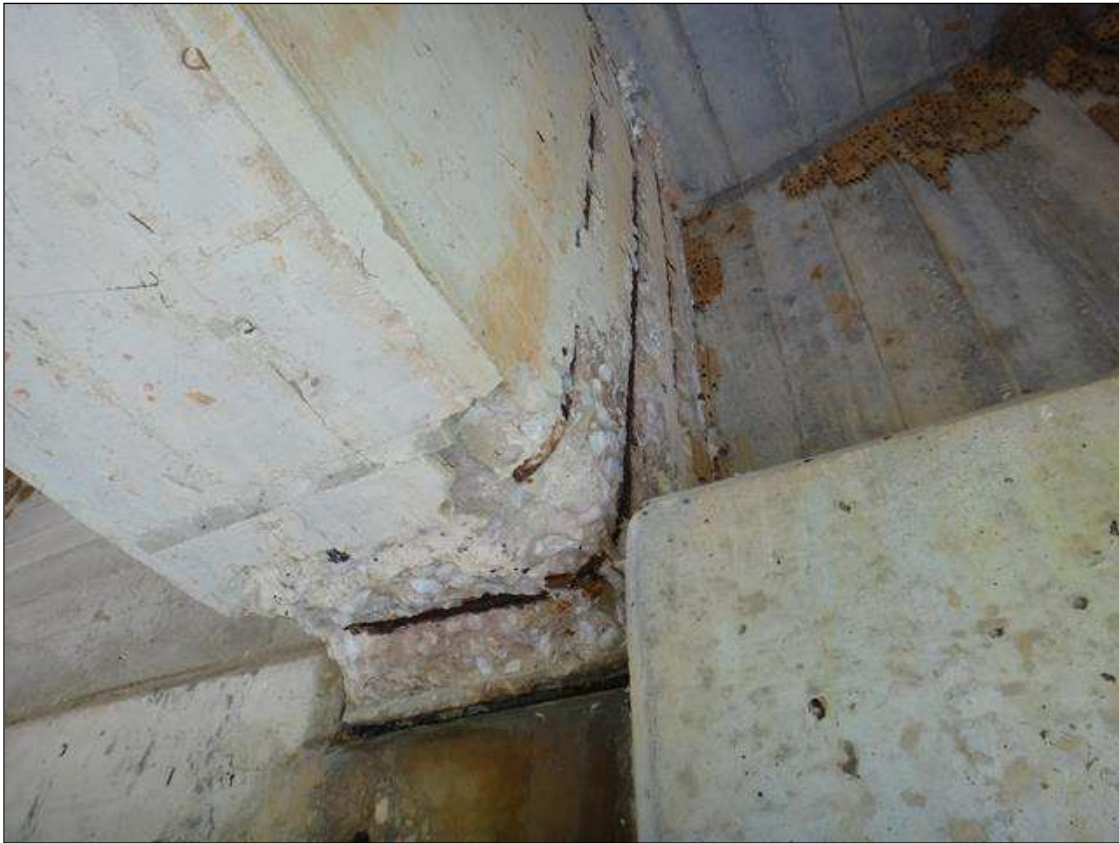
(PM) SPAN 9 BEAM 4 AT BENT 9, SPALL (18IN X 48IN X 3-1/2IN DEEP) WITH EXPOSED RUSTED REBAR, SECTION LOSS (NO MEASURABLE LOSS)

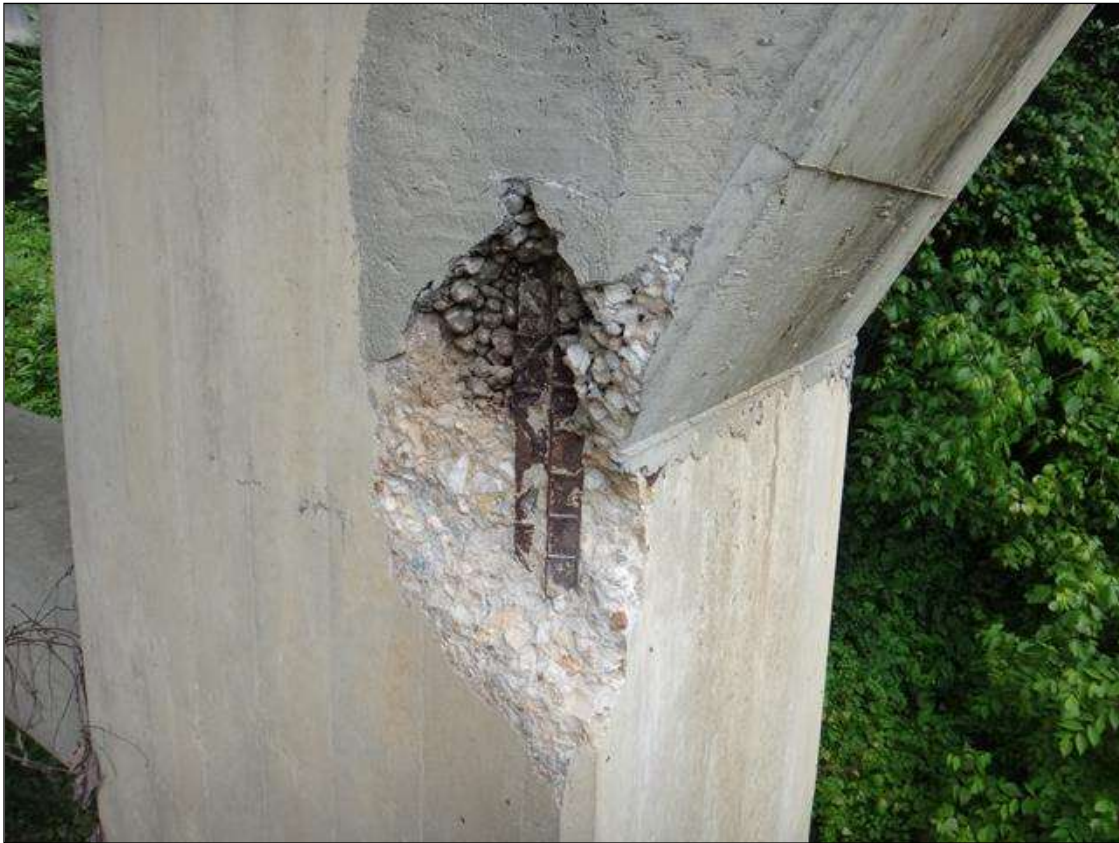
(PM) BENT 9 COLUMN 2 SOUTHWEST CORNER, SPALL (20IN X 12IN X 4IN DEEP) WITH EXPOSED RUSTED REBAR

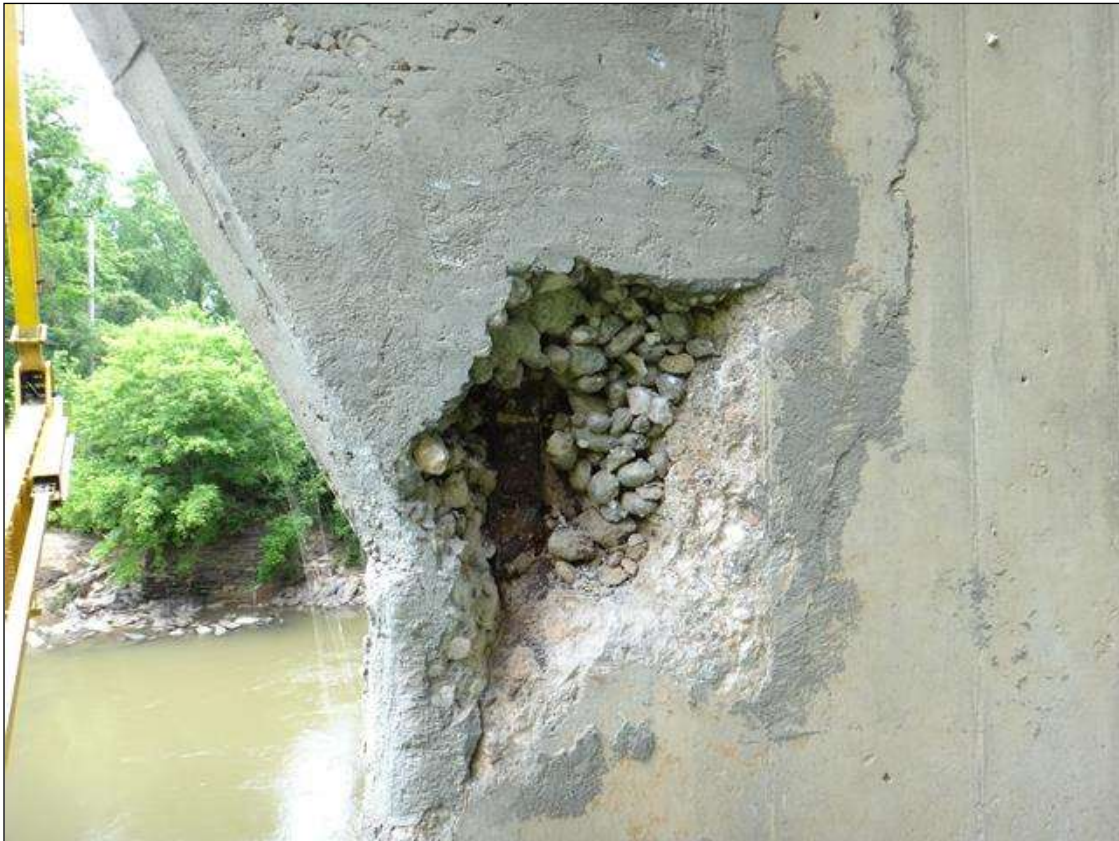
(PM) BENT 9 COLUMN 2 SOUTHEAST CORNER, SPALL (11IN X 8IN X 3IN DEEP) WITH EXPOSED RUSTED REBAR

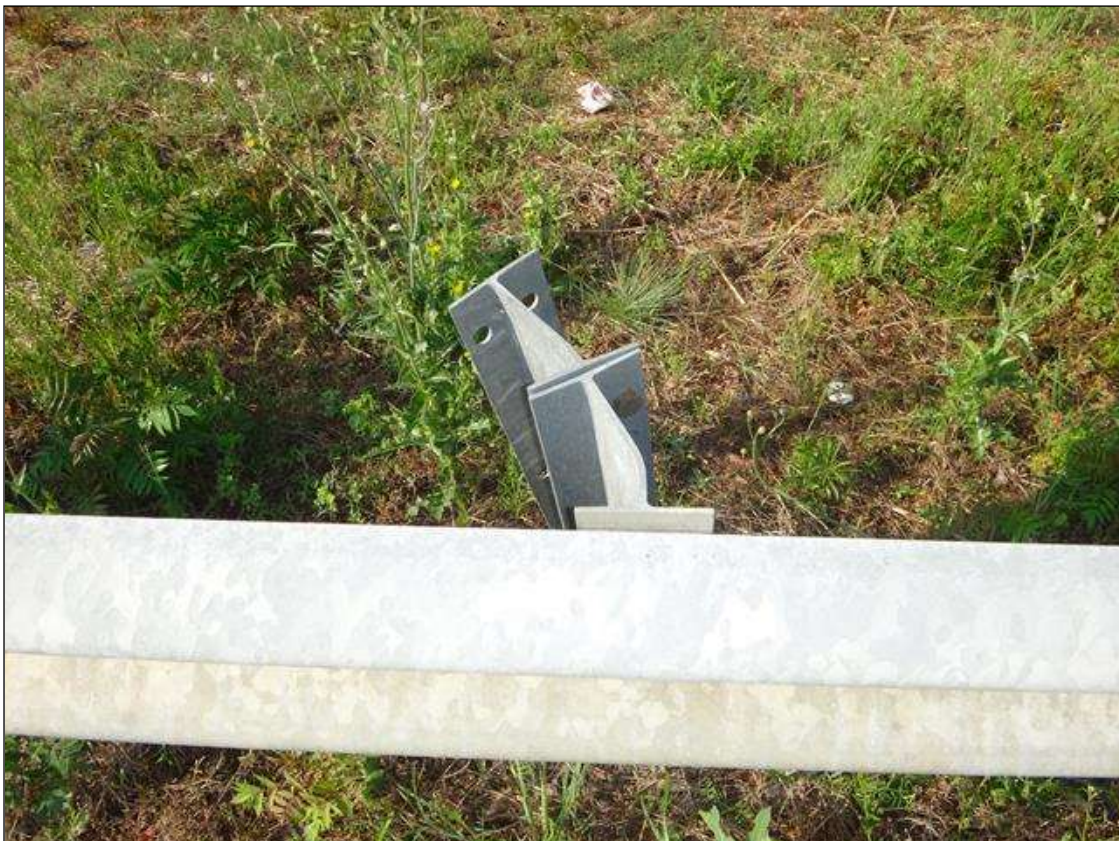
SOUTHWEST GUARDRAIL POST AT 100FT FROM END BENT 1, BENT/ROTATED (45 DEGREES)

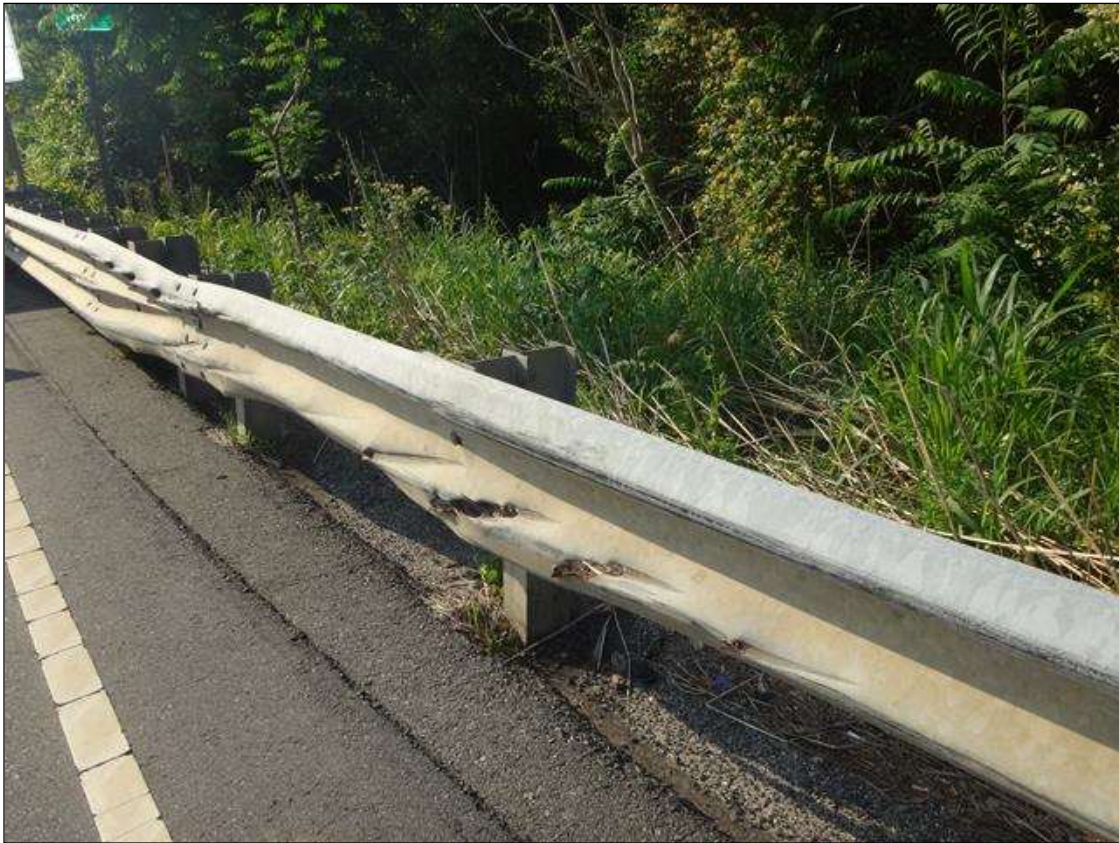
SOUTHWEST GUARDRAIL AT 20FT FROM END BENT 1, IMPACT DAMAGE (17FT)

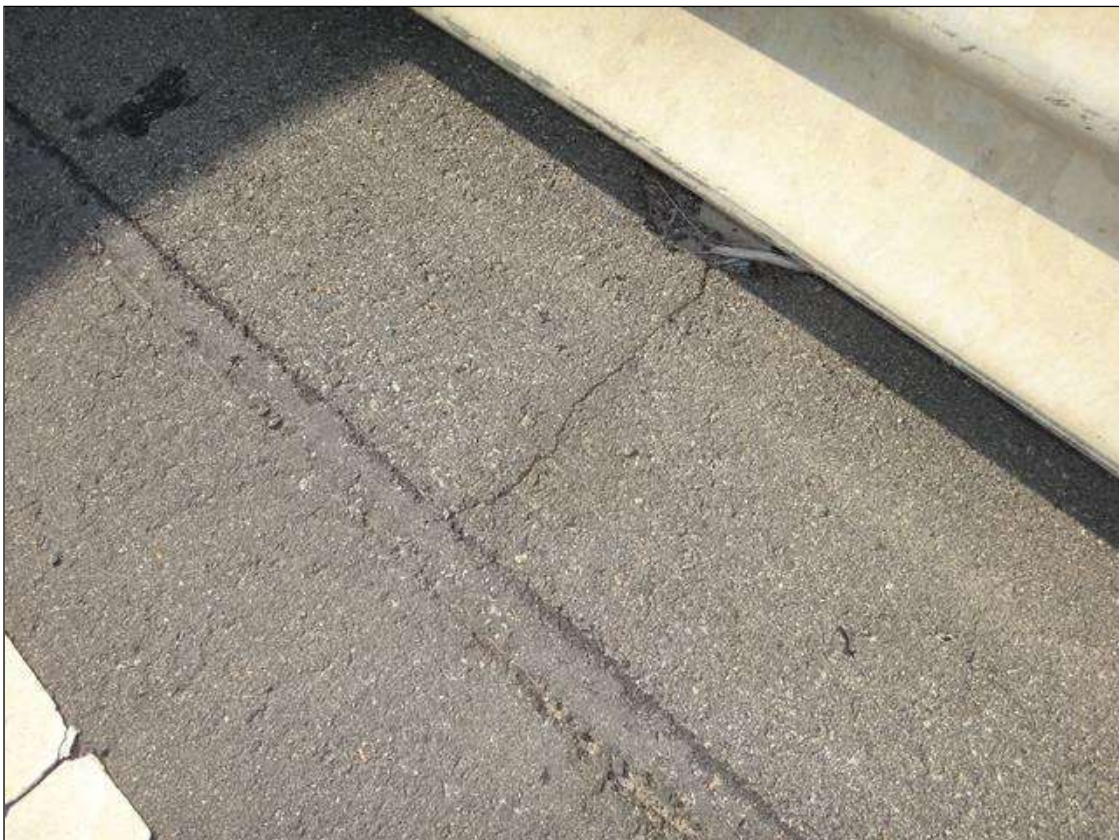
WEST APPROACH SOUTH SHOULDER ASPHALT WEARING SURFACE AT 15FT FROM END BENT 1,
TRANSVERSE CRACK (1-1/2FT X 1/8IN)

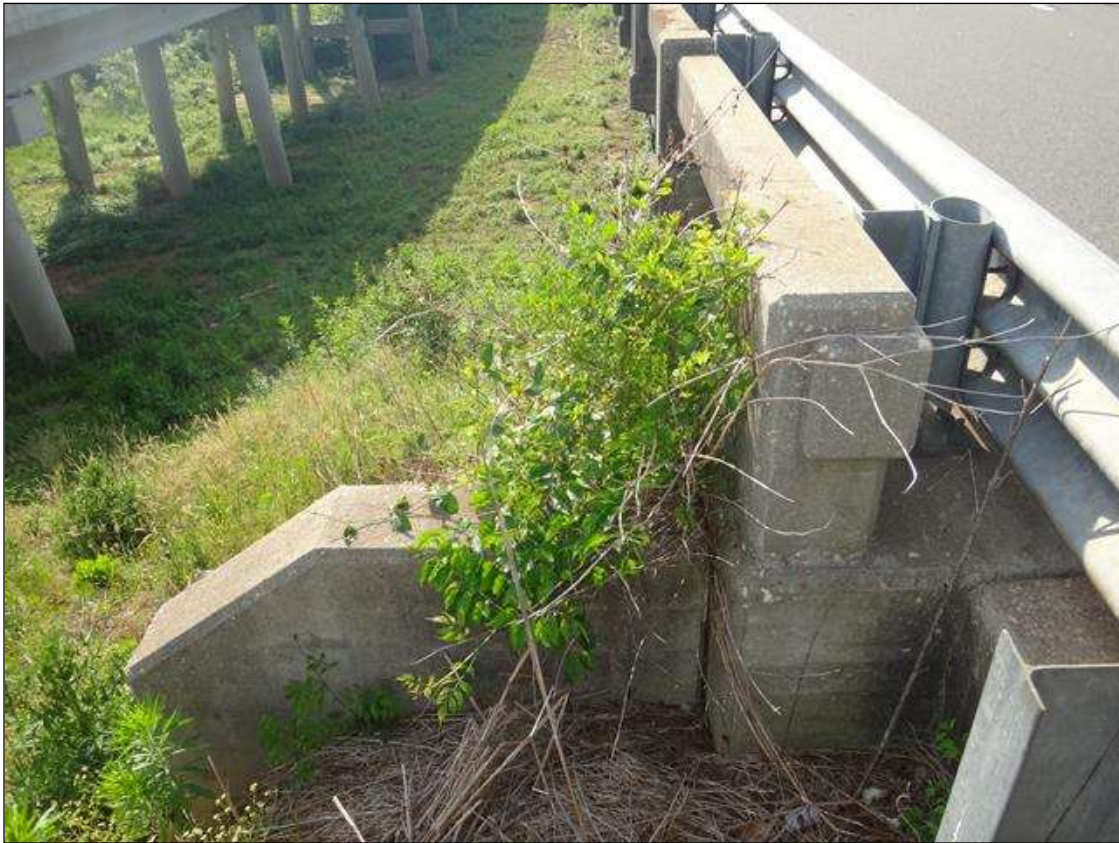
NORTH RAIL AND NORTHWEST EARWALL AT END BENT 1, VEGETATION GROWTH (5FT X 3FT X 5FT)

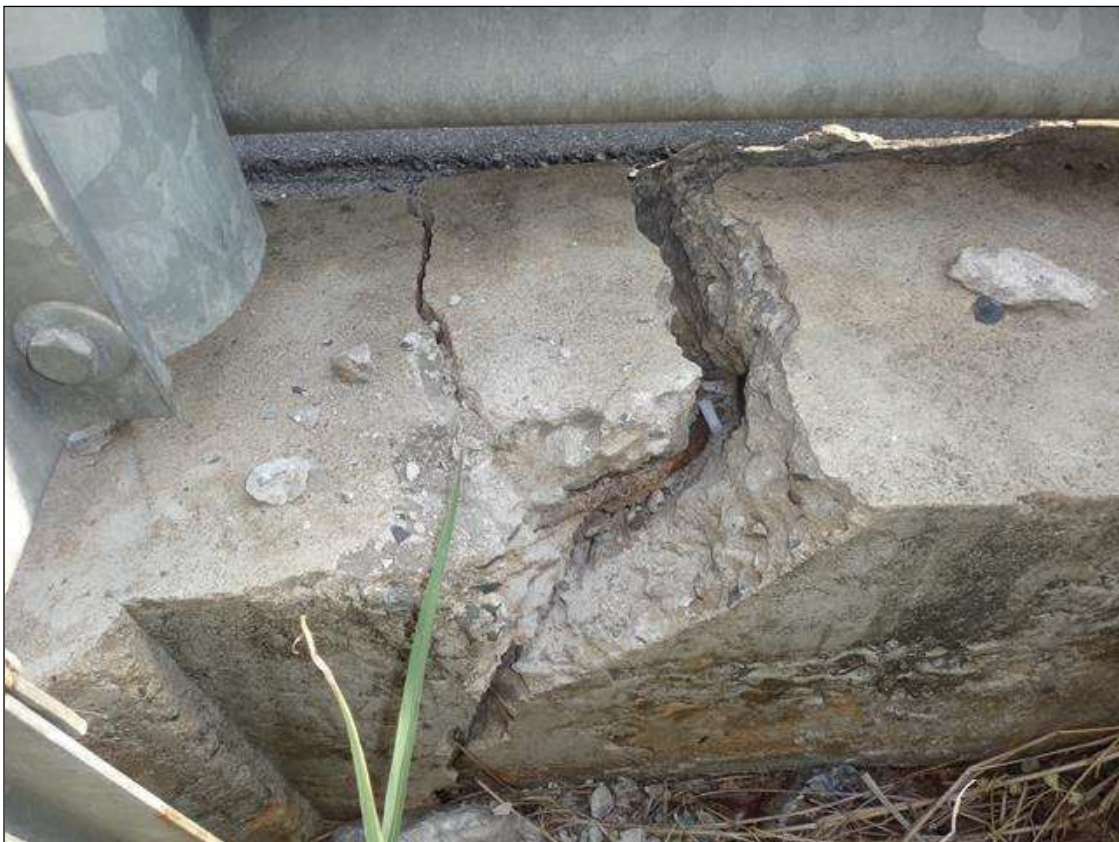
WEST APPROACH SOUTH CURB AT END BENT 1, BROKEN WITH SPALL (4IN X 8IN X 6IN DEEP) WITH EXPOSED RUSTED REBAR

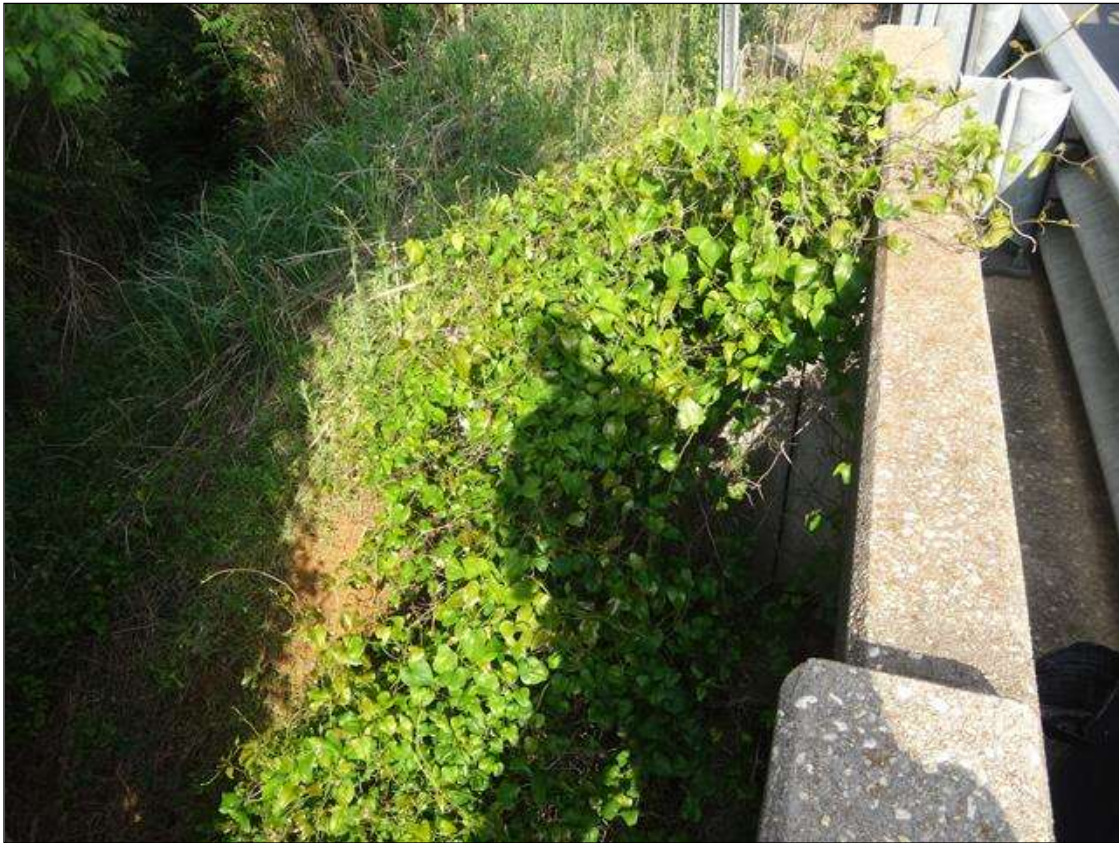
SOUTH RAIL AND SOUTHWEST EARWALL AT END BENT 1, VEGETATION GROWTH (15FT X 10FT X 3FT)

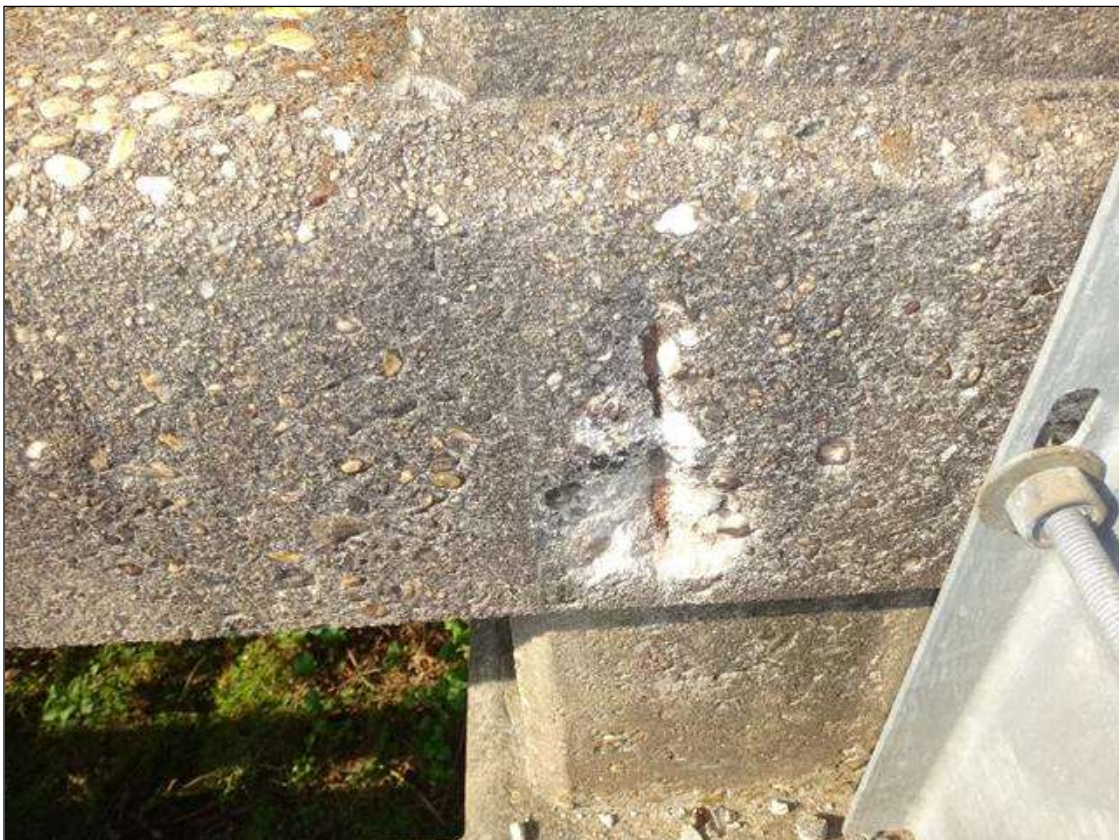
SPAN 1 SOUTH RAIL AT 20FT FROM END BENT 1, SPALL (6IN X 3IN X 1/2IN DEEP)

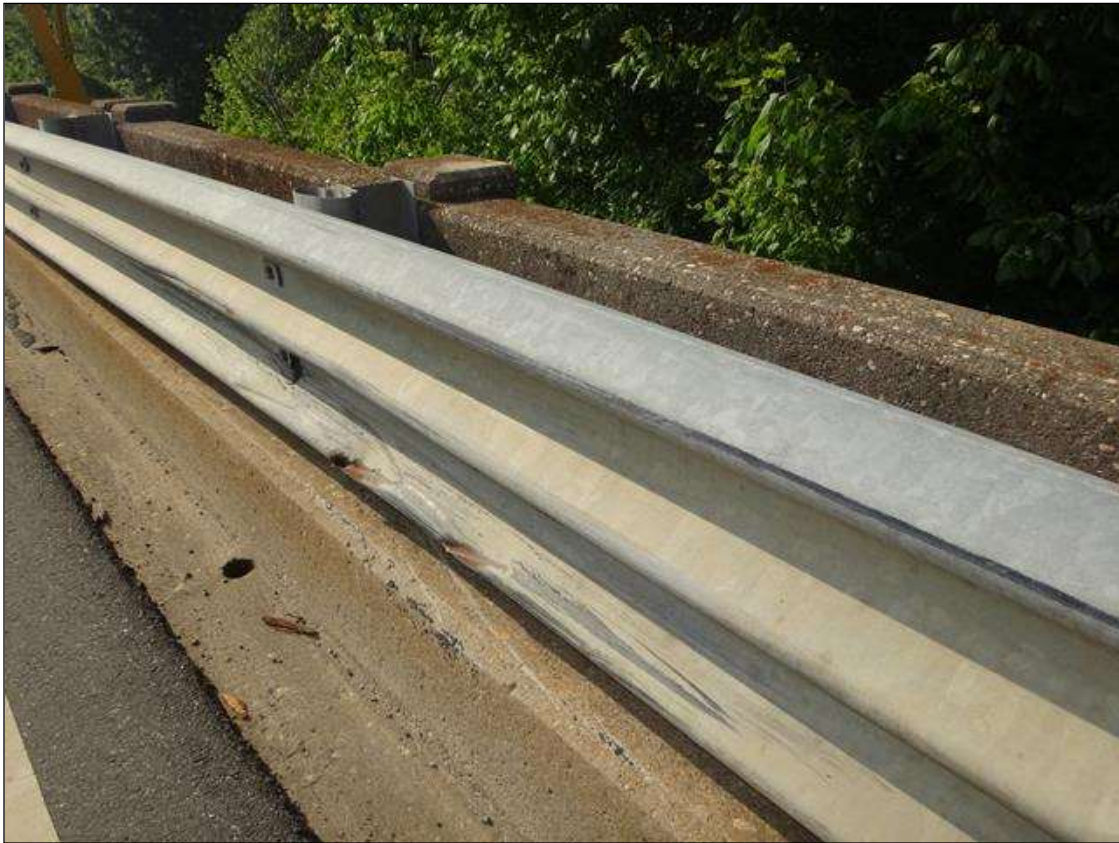
SPAN 1 SOUTH RAIL AT 25FT FROM END BENT 1, IMPACT DAMAGE (8FT)

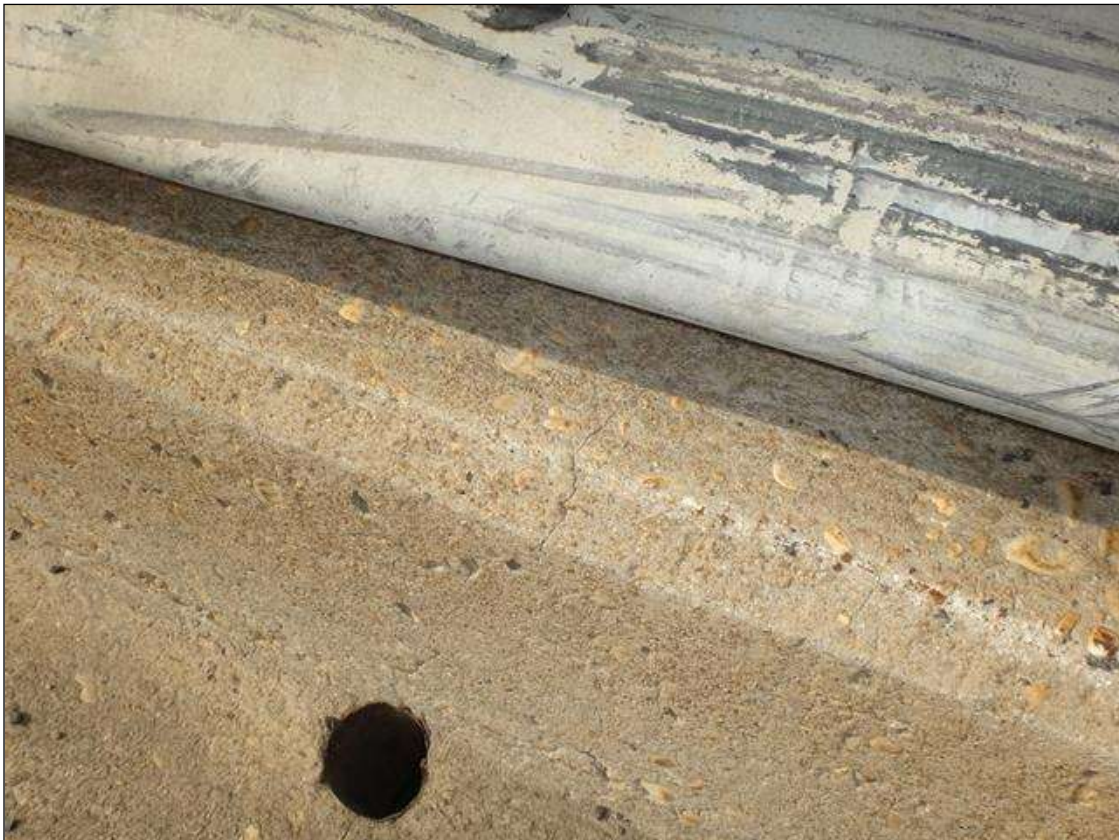
SPAN 1 SOUTH RAIL PARAPET AT 25FT FROM END BENT 1, TRANSVERSE CRACK (2FT X HAIRLINE)

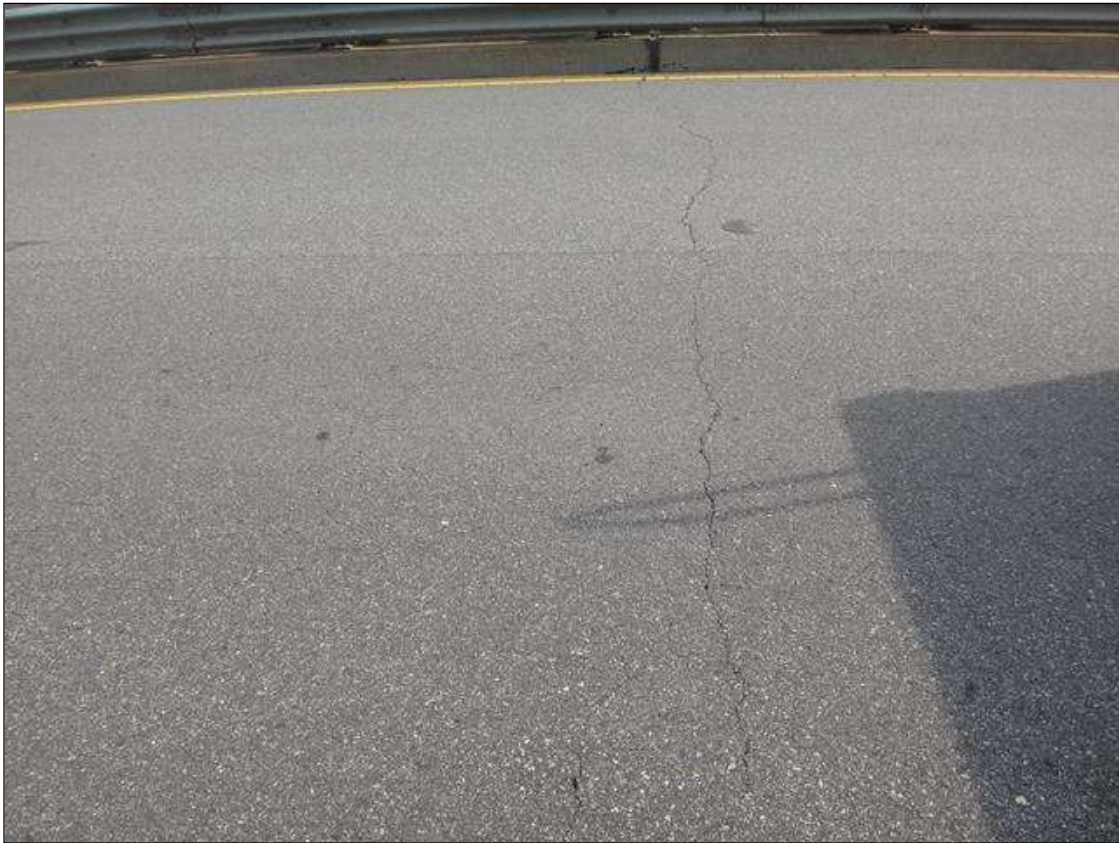
ASPHALT WEARING SURFACE OVER BENT 1, TRANSVERSE CRACK (FULL WIDTH X UP TO 1/4IN)

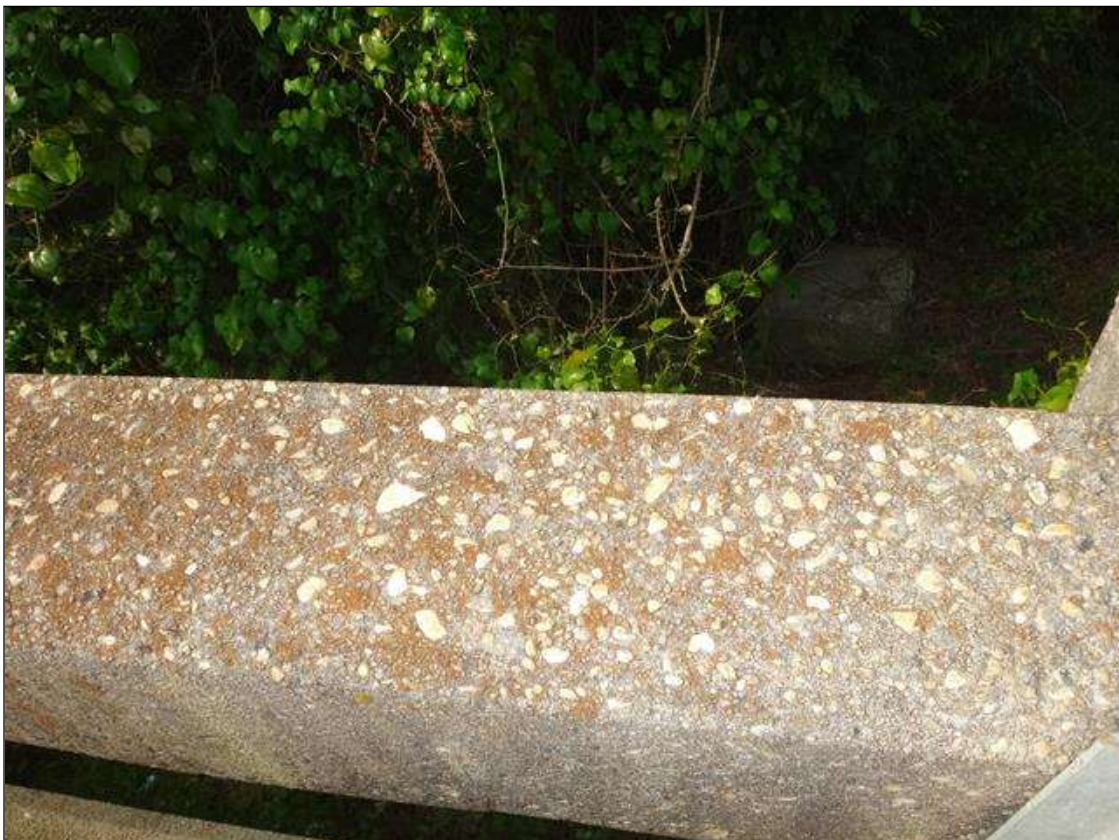
SOUTH RAIL, SCALING WITH EXPOSED AGGREGATE

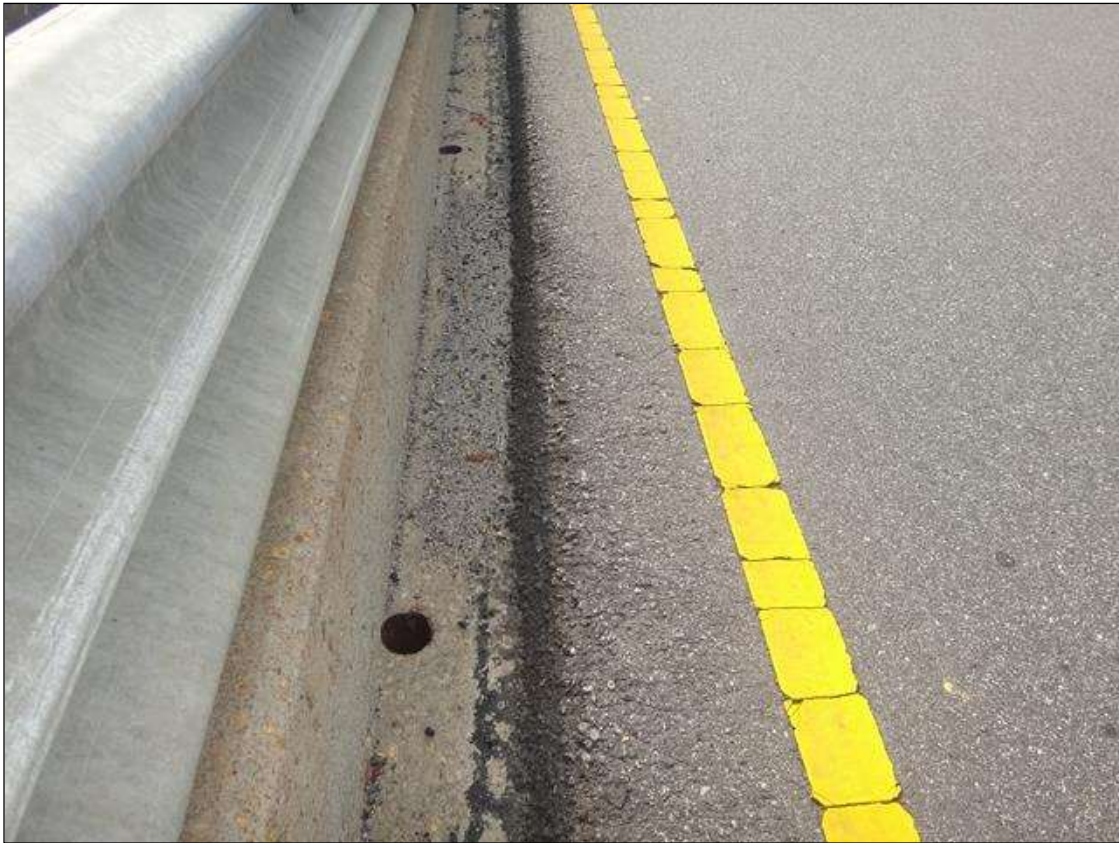
NORTH CURB, DROPOFF (UP TO 4IN) FROM ASPHALT WEARING SURFACE

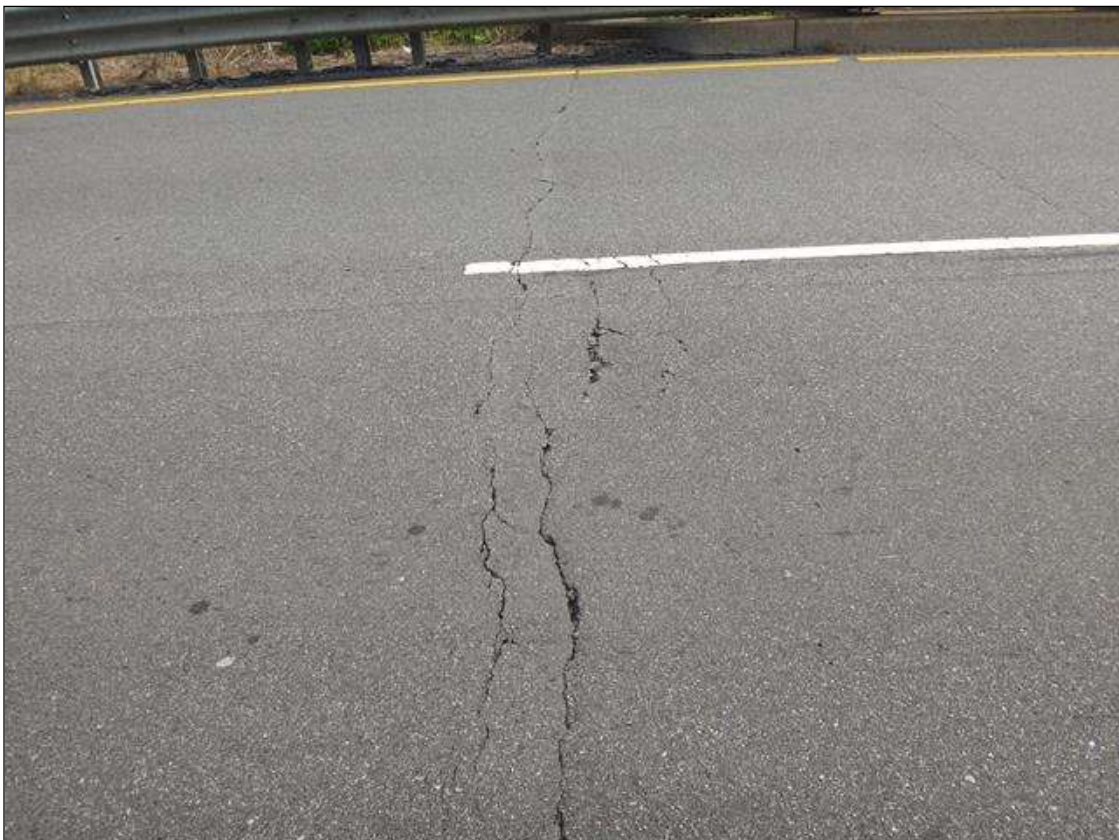
WEST APPROACH ASPHALT WEARING SURFACE AT 5FT FROM END BENT 1, FOUR (4) TRANSVERSE CRACKS (UP TO FULL WIDTH X UP TO 1/2IN)

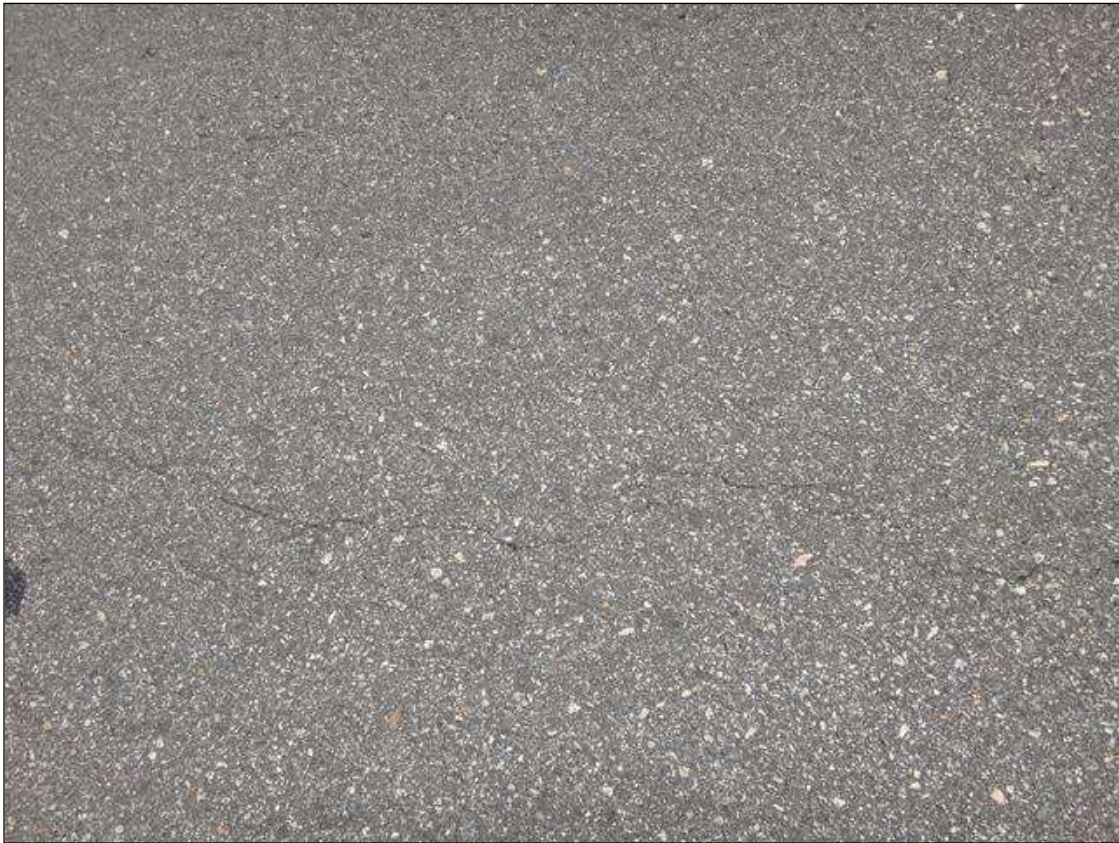
WEST APPROACH ASPHALT WEARING SURFACE AT END BENT 1, LONGITUDINAL CRACK (4FT X 1/16IN)

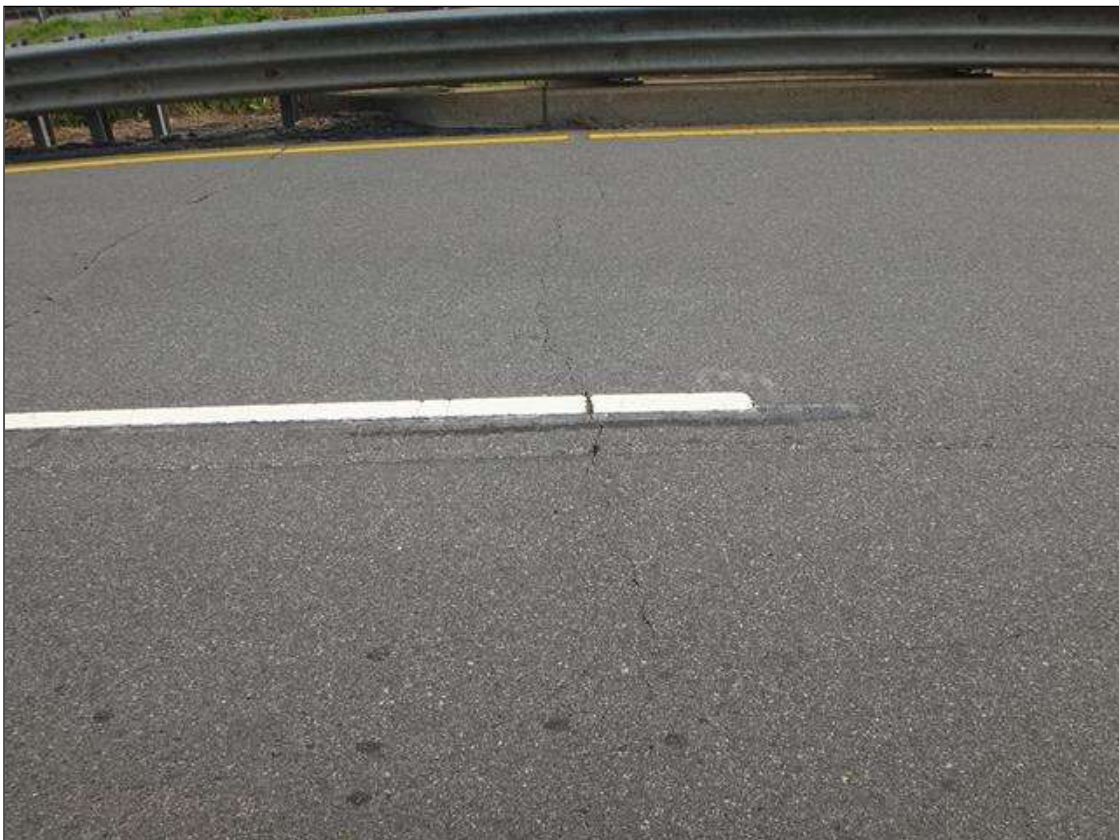
ASPHALT WEARING SURFACE OVER END BENT 1, TRANSVERSE CRACK (FULL WIDTH X UP TO 1/4IN)
