NC DEPARTMENT OF TRANSPORTATION
 DIVISION OF HIGHWAYS
 BRIDGE MANAGEMENT UNIT

PRIORITY MAINTENANCE ISSUED

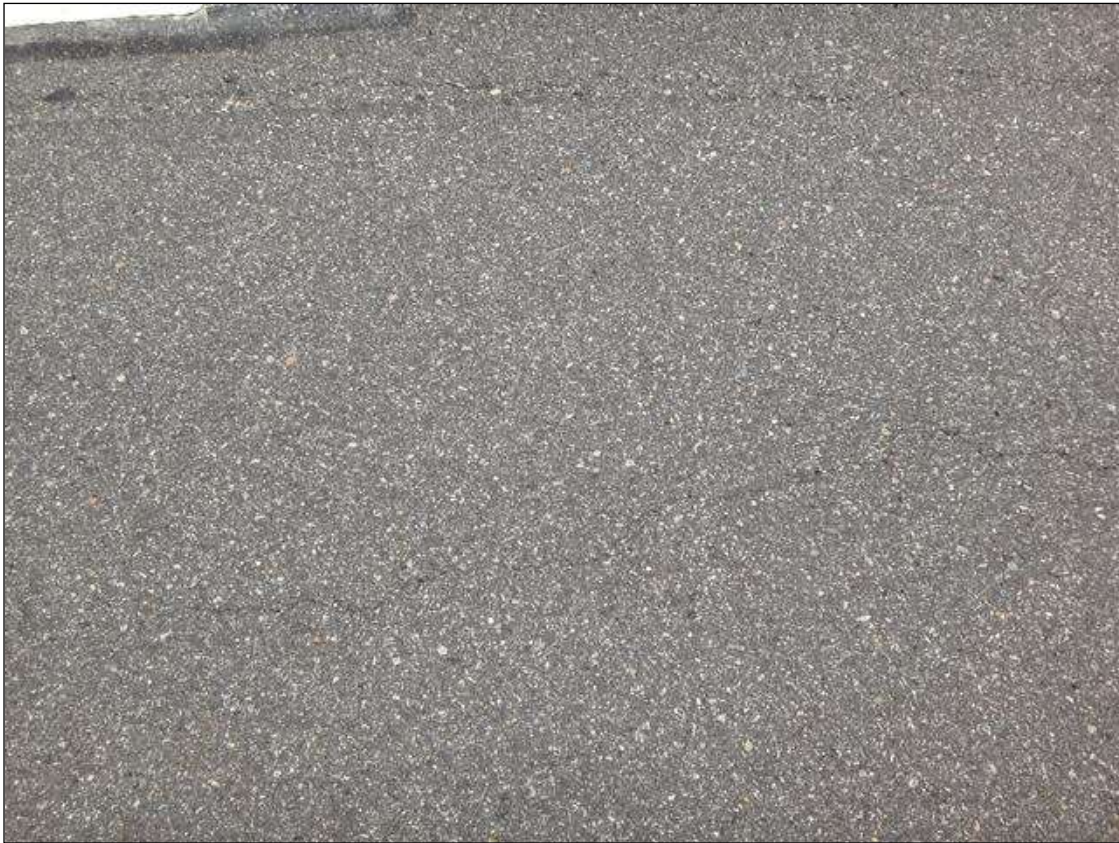
SPAN 1 ASPHALT WEARING SURFACE RIGHT LANE AT END BENT 1, LONGITUDINAL CRACK (6FT X 1/16IN)

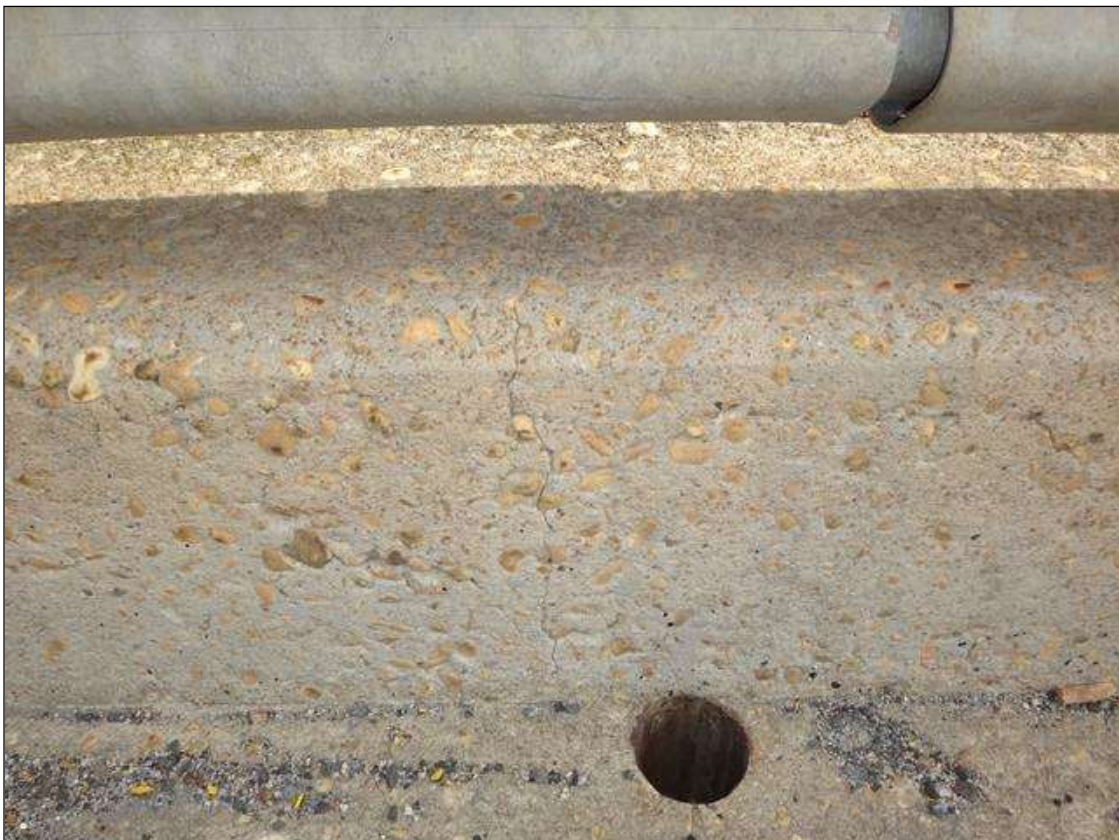
SPAN 1 NORTH RAIL PARAPET NEAR MIDSPAN, VERTICAL CRACK (3FT X 1/16IN) EXTENDS TO TOP SIDE

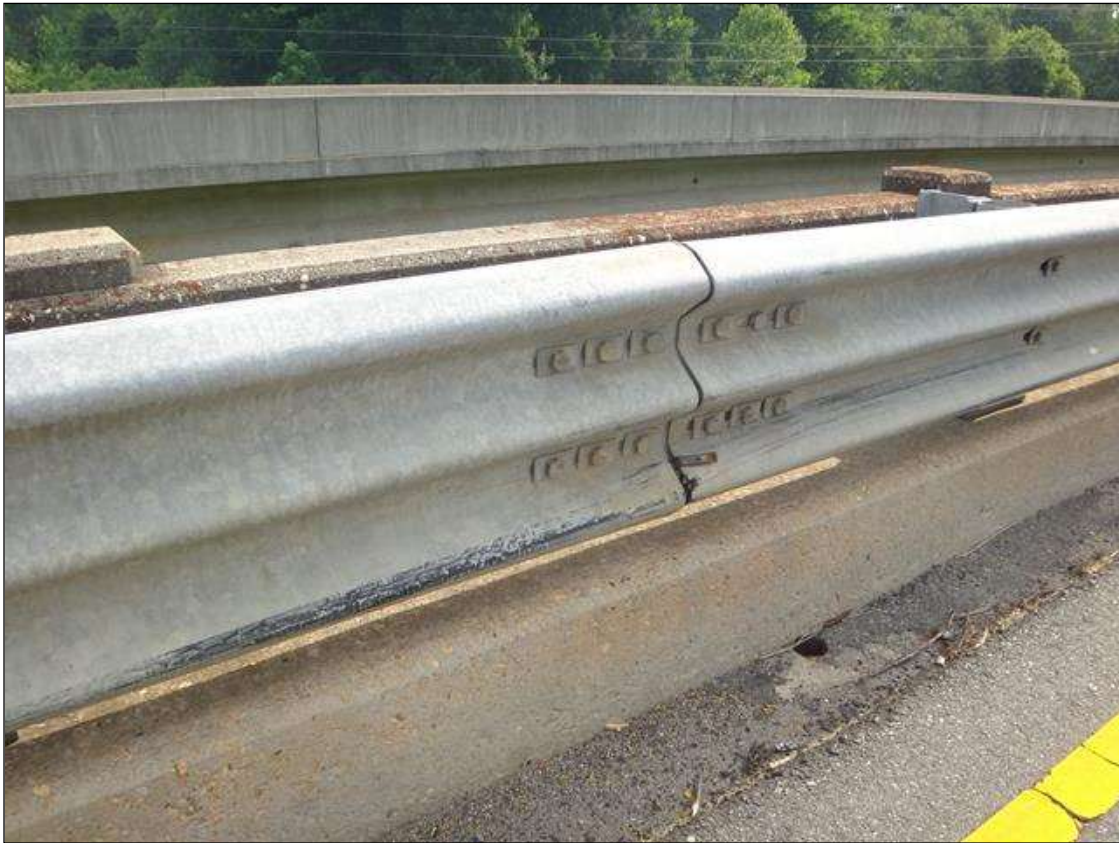
SPAN 1 NORTH RAIL AT 10FT FROM BENT 1, IMPACT SCRAPES (8FT)

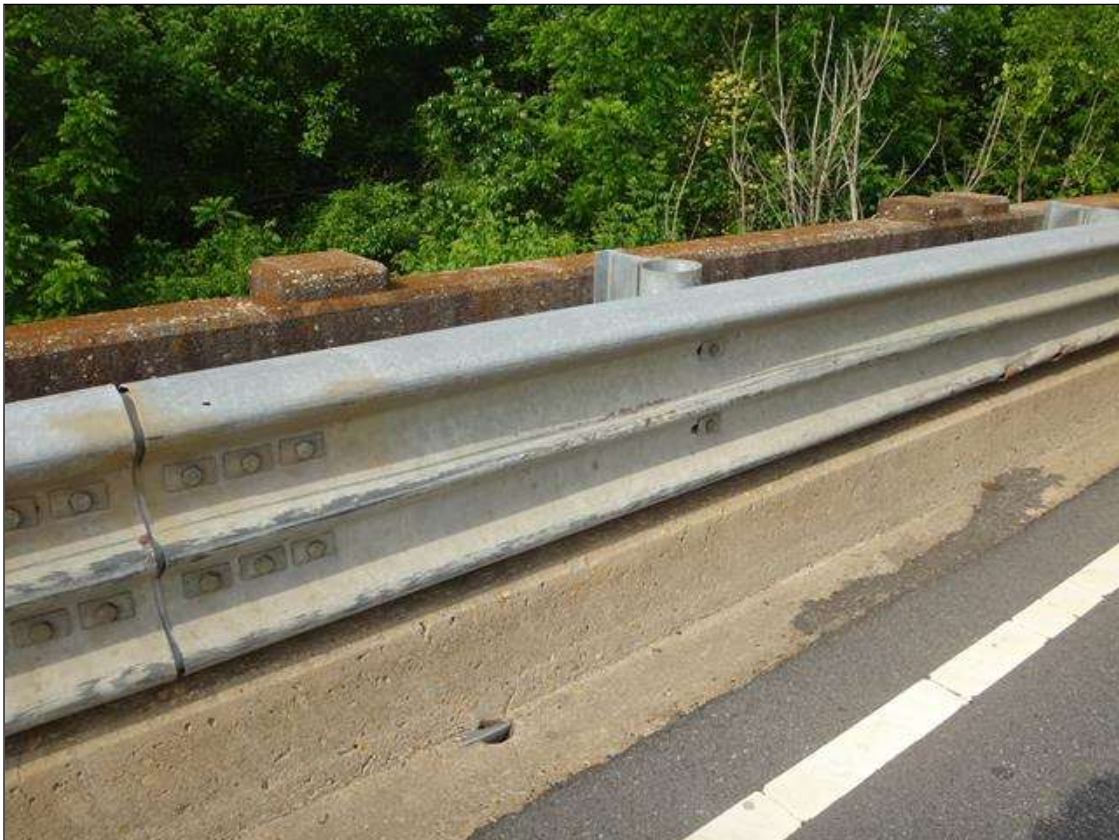
SPAN 2 SOUTH RAIL NEAR MIDSPAN, IMPACT DAMAGE/SCRAPES (20FT)

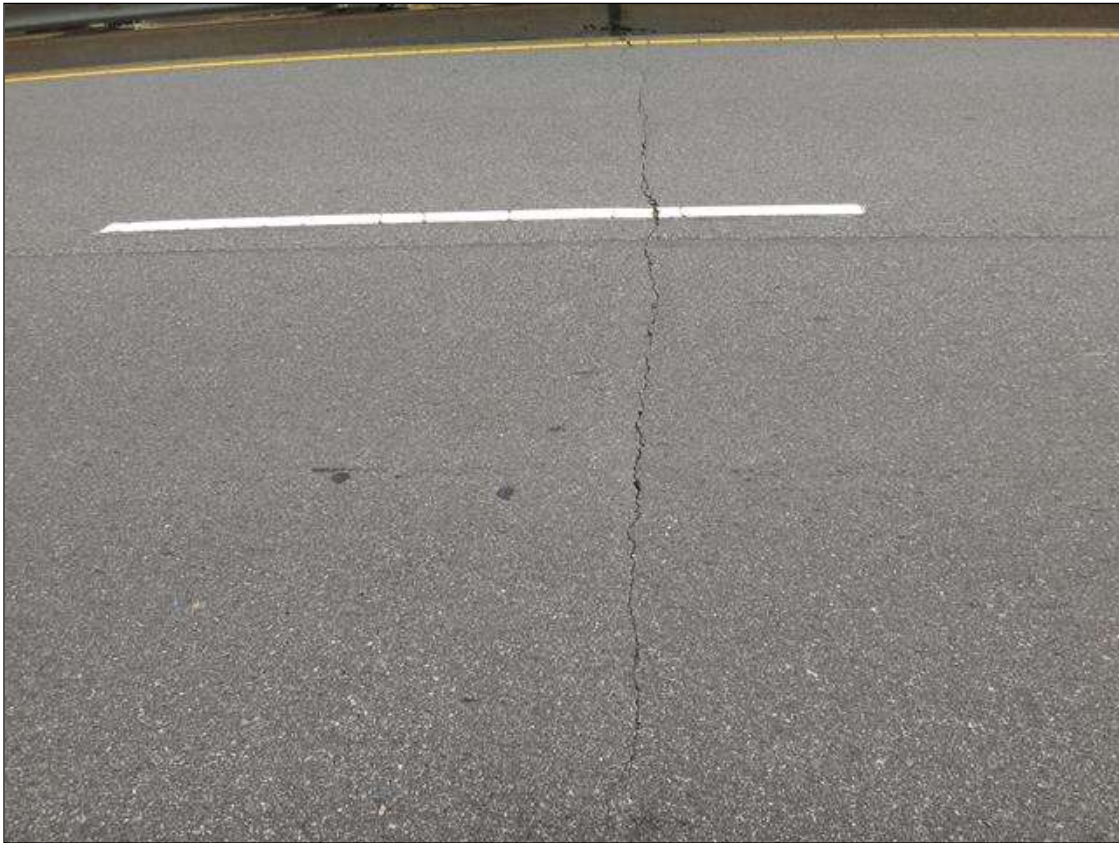
ASPHALT WEARING SURFACE OVER BENT 3, TRANSVERSE CRACK (FULL WIDTH X UP TO 1/4IN)

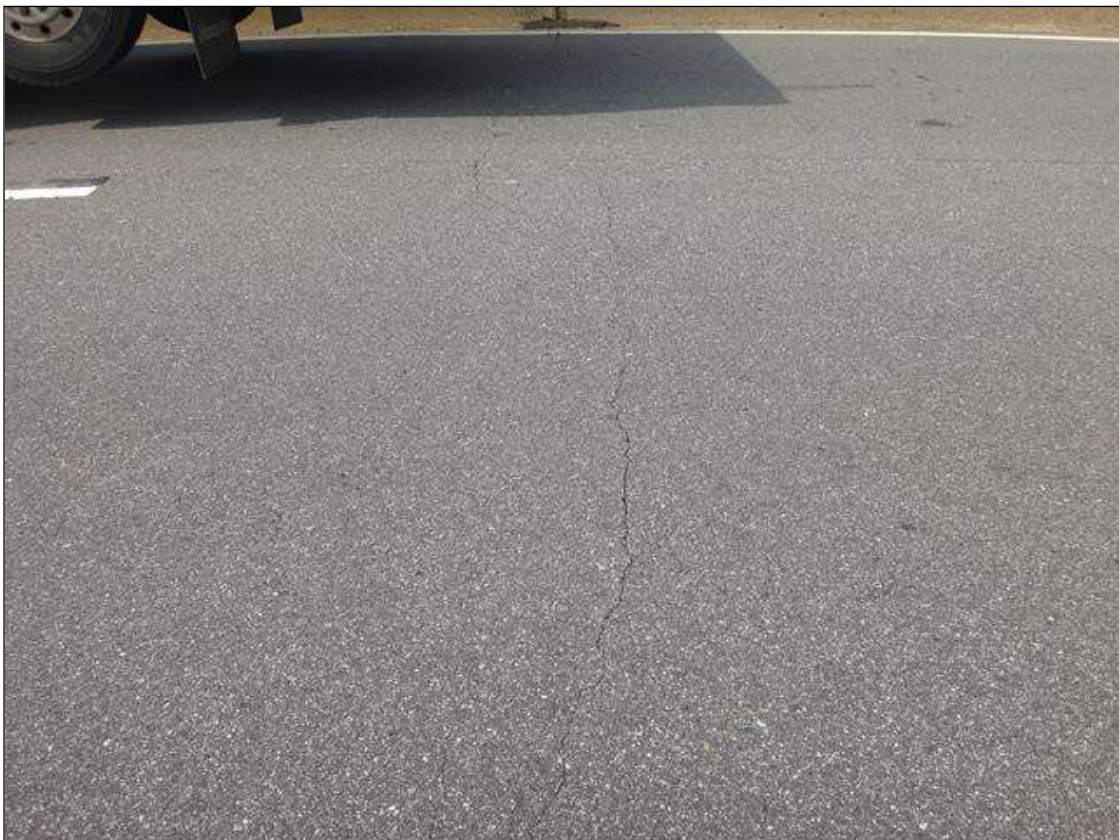
ASPHALT WEARING SURFACE OVER BENT 2, TWO (2) TRANSVERSE CRACKS (12FT X UP TO 1/4IN)

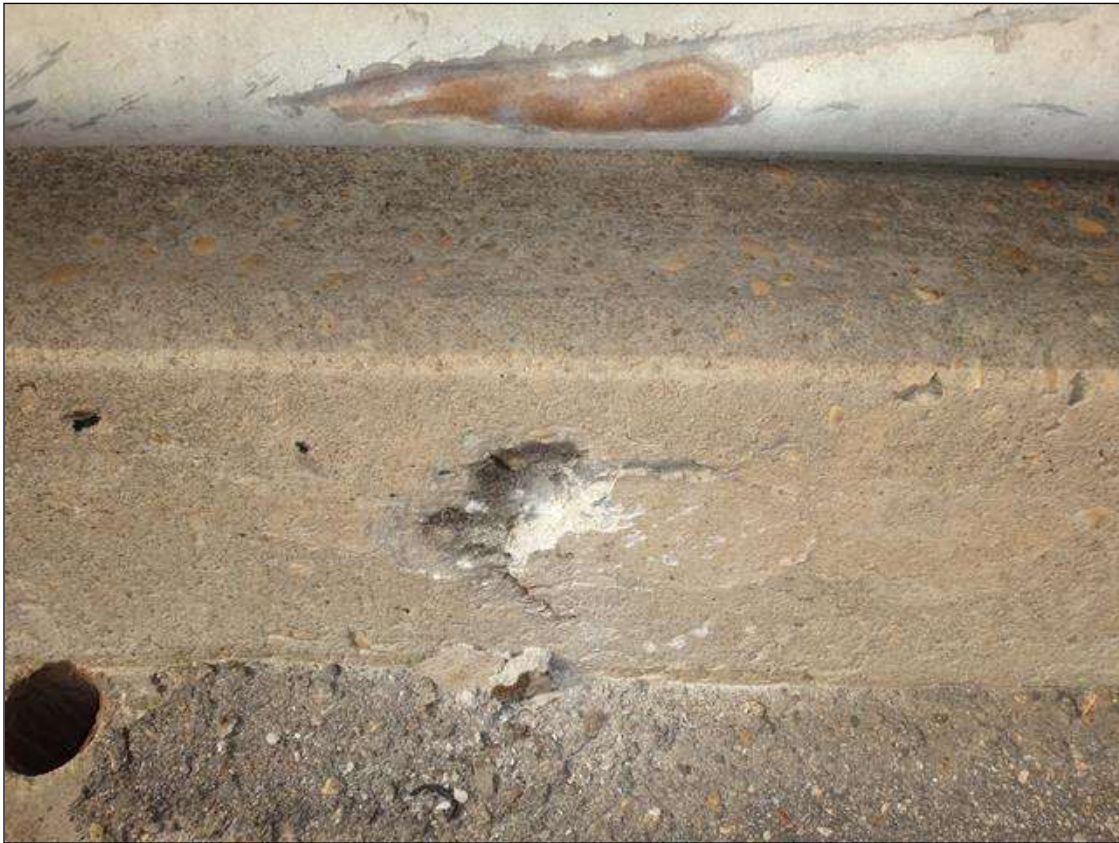
SPAN 3 SOUTH RAIL PARAPET, SPALL (3IN X 3IN X 1/4IN DEEP) WITH DELAMINATION (6IN X 3IN)

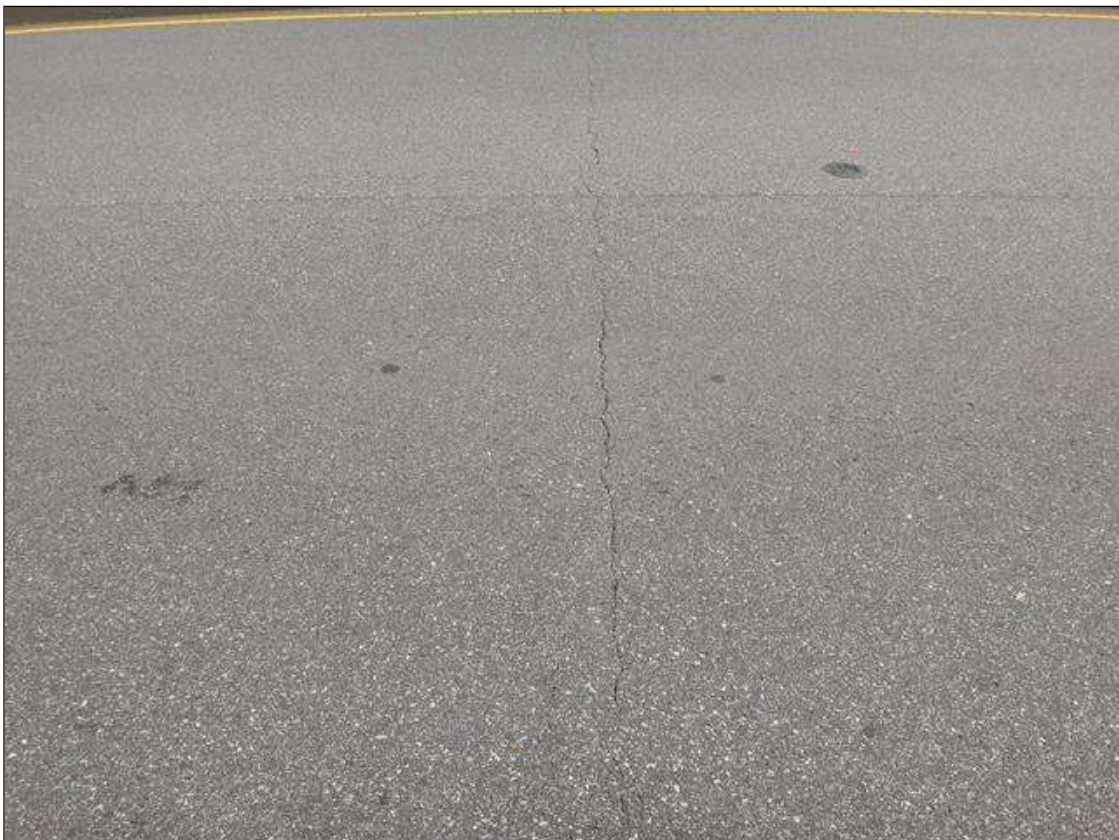
ASPHALT WEARING SURFACE OVER BENT 4, TRANSVERSE CRACK (FULL WIDTH X 1/8IN)

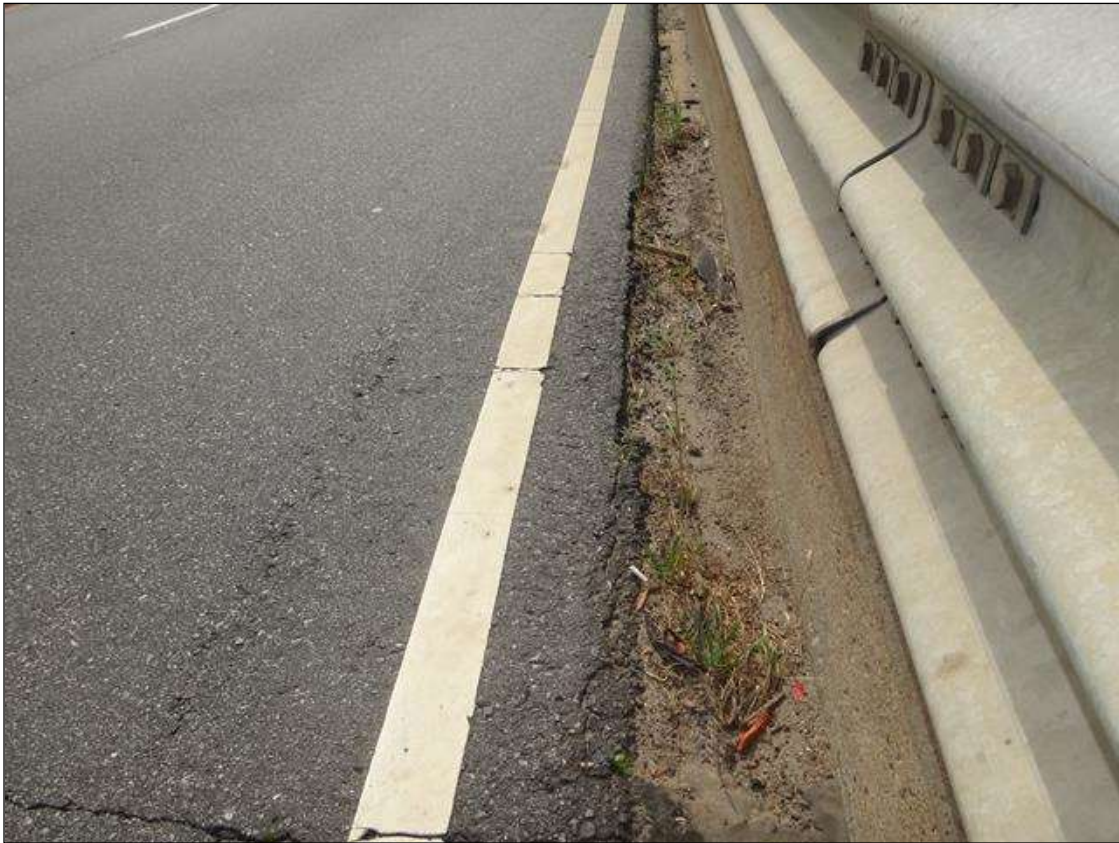
SPAN 4 SOUTH CURB, DEBRIS ACCUMULATION WITH VEGETATION GROWTH (FULL LENGTH X 1FT)

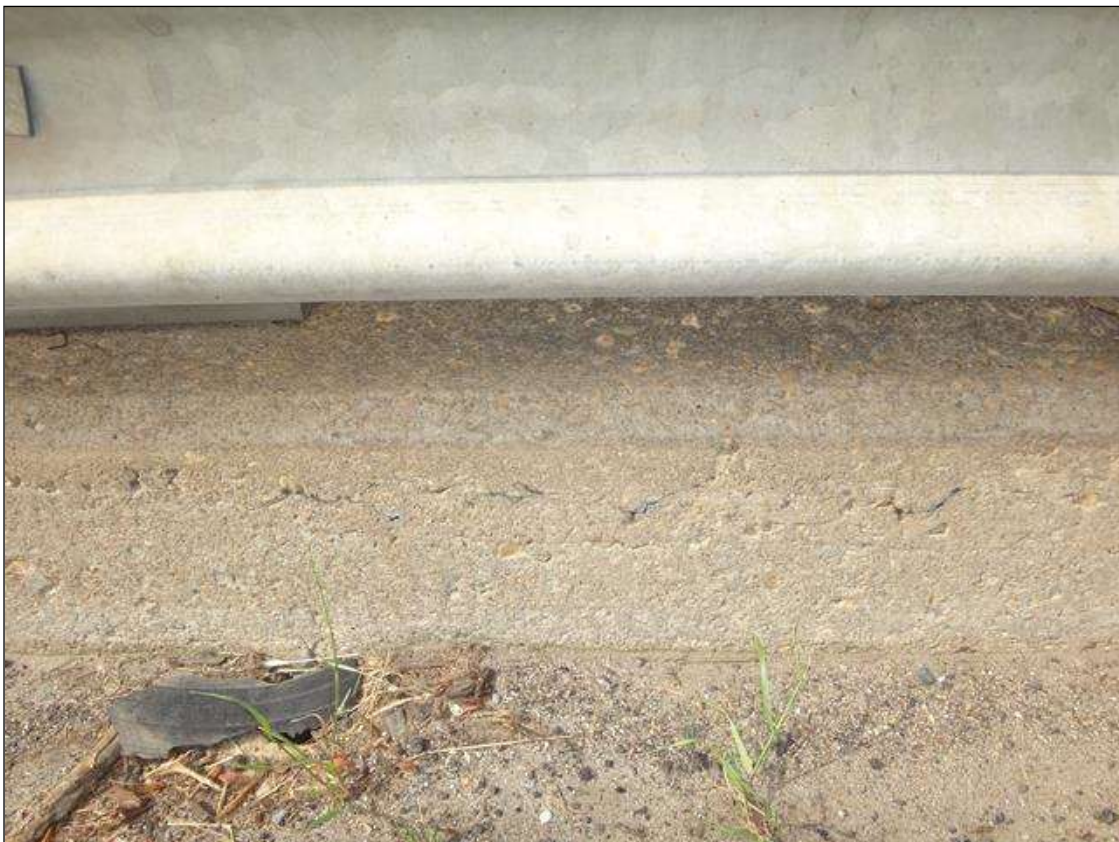
SPAN 5 SOUTH RAIL PARAPET, HORIZONTAL CRACK (3FT X 1/16IN)

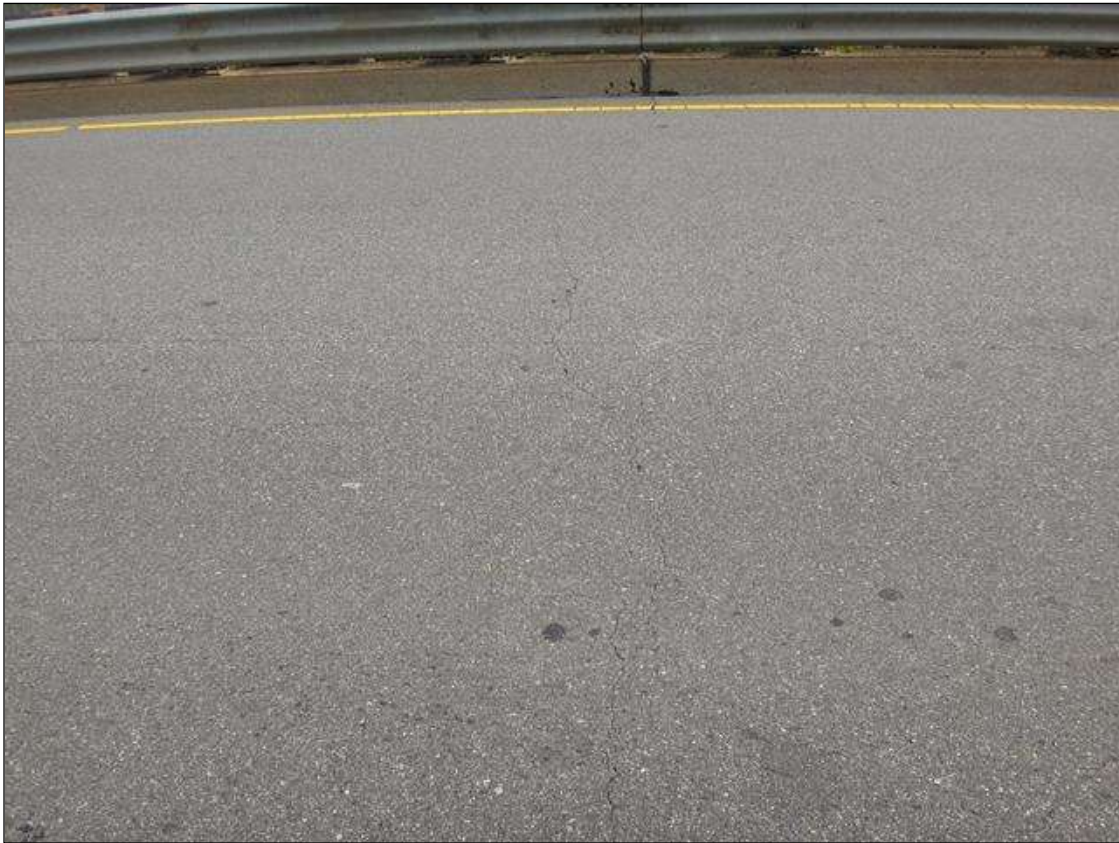
ASPHALT WEARING SURFACE OVER BENT 5, TRANSVERSE CRACK (FULL WIDTH X 1/8IN)

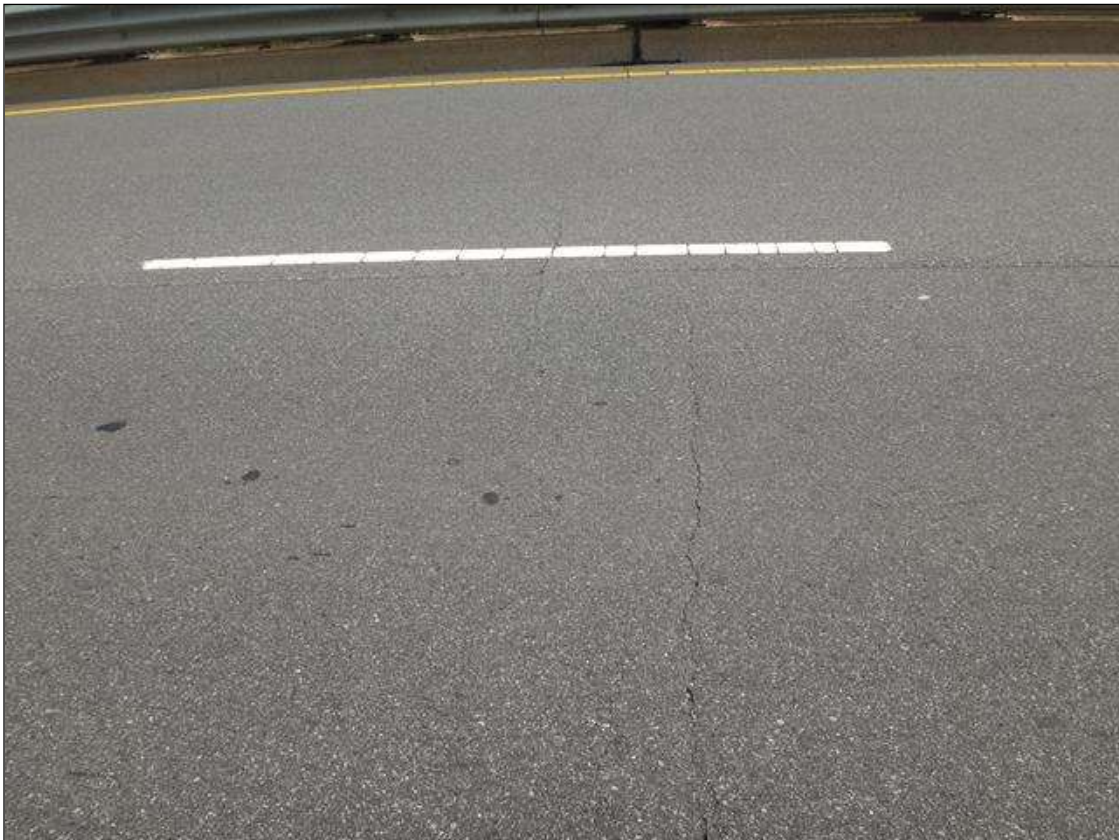
ASPHALT WEARING SURFACE OVER BENT 6, TWO (2) TRANSVERSE CRACKS (13FT X 1/8IN)

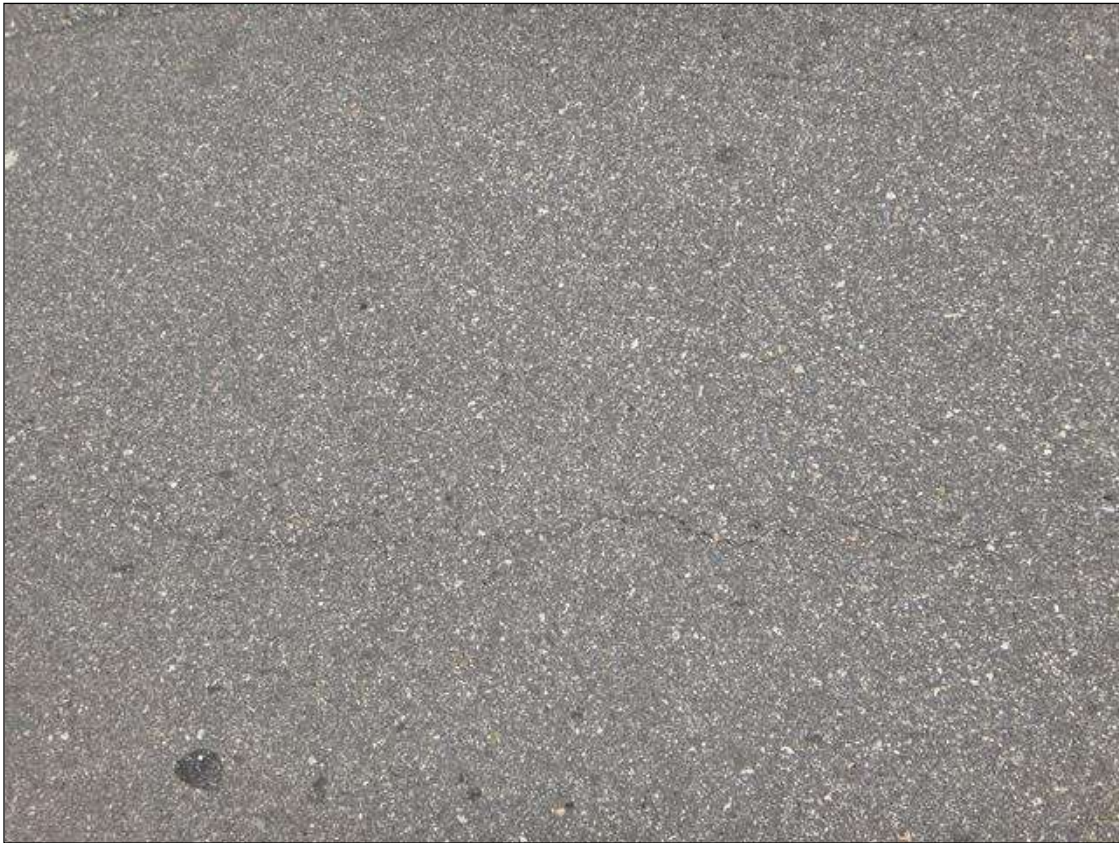
SPAN 7 ASPHALT WEARING SURFACE RIGHT LANE AT 3FT FROM BENT 6, LONGITUDINAL CRACK (4FT X 1/16IN)

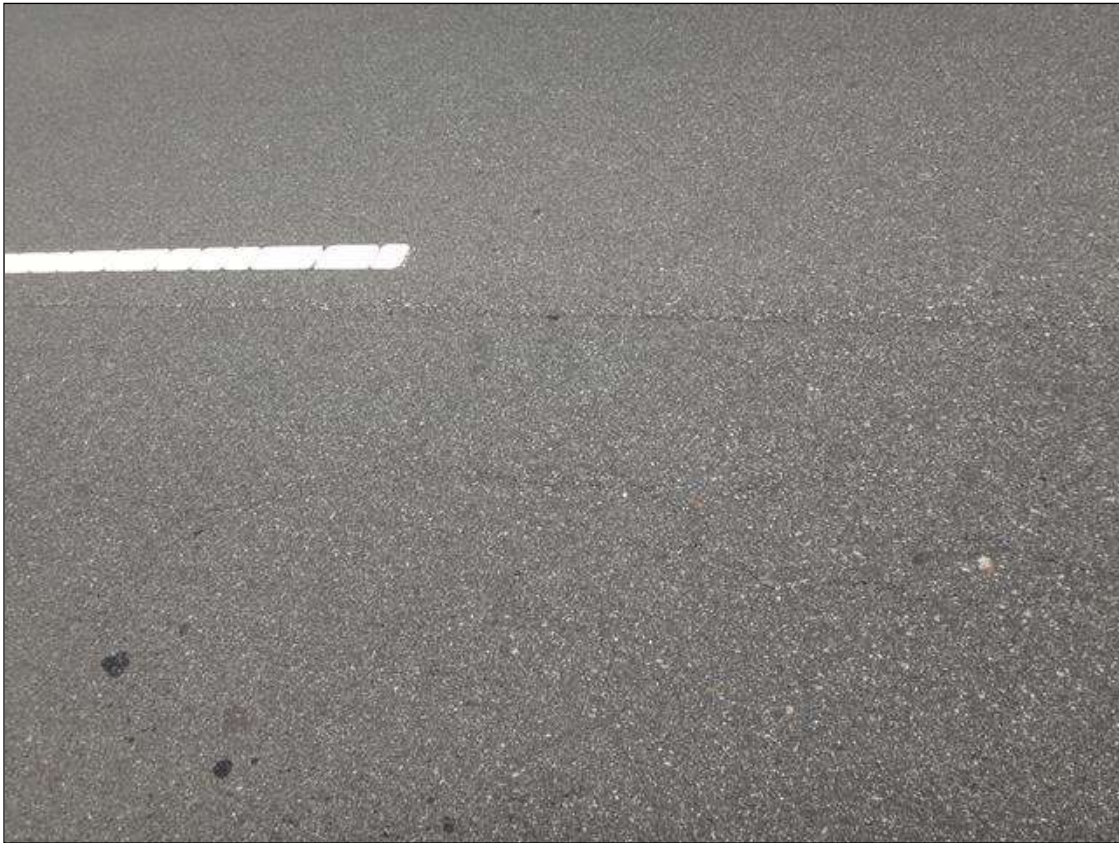
SPAN 7 ASPHALT WEARING SURFACE RIGHT LANE AT 3FT FROM BENT 7, LONGITUDINAL CRACK (10FT X 1/16IN)

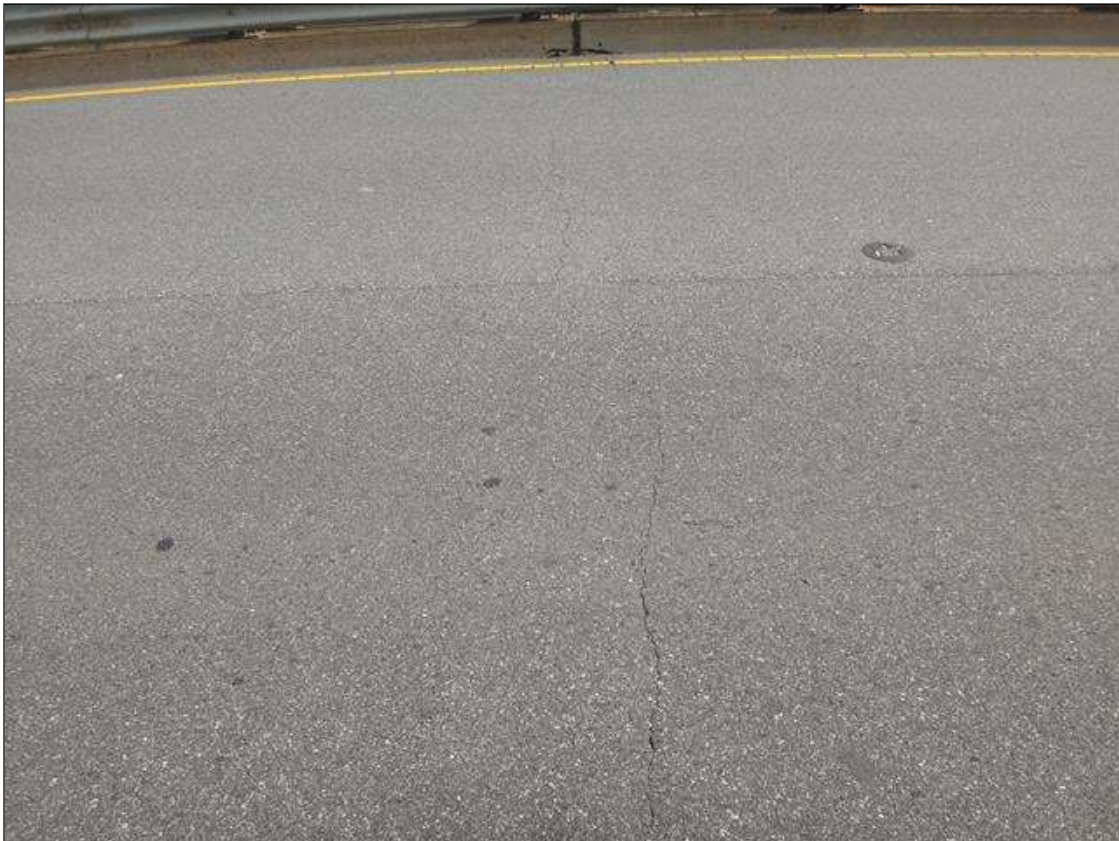
ASPHALT WEARING SURFACE OVER BENT 7, TWO (2) TRANSVERSE CRACKS (12FT X 1/8IN)

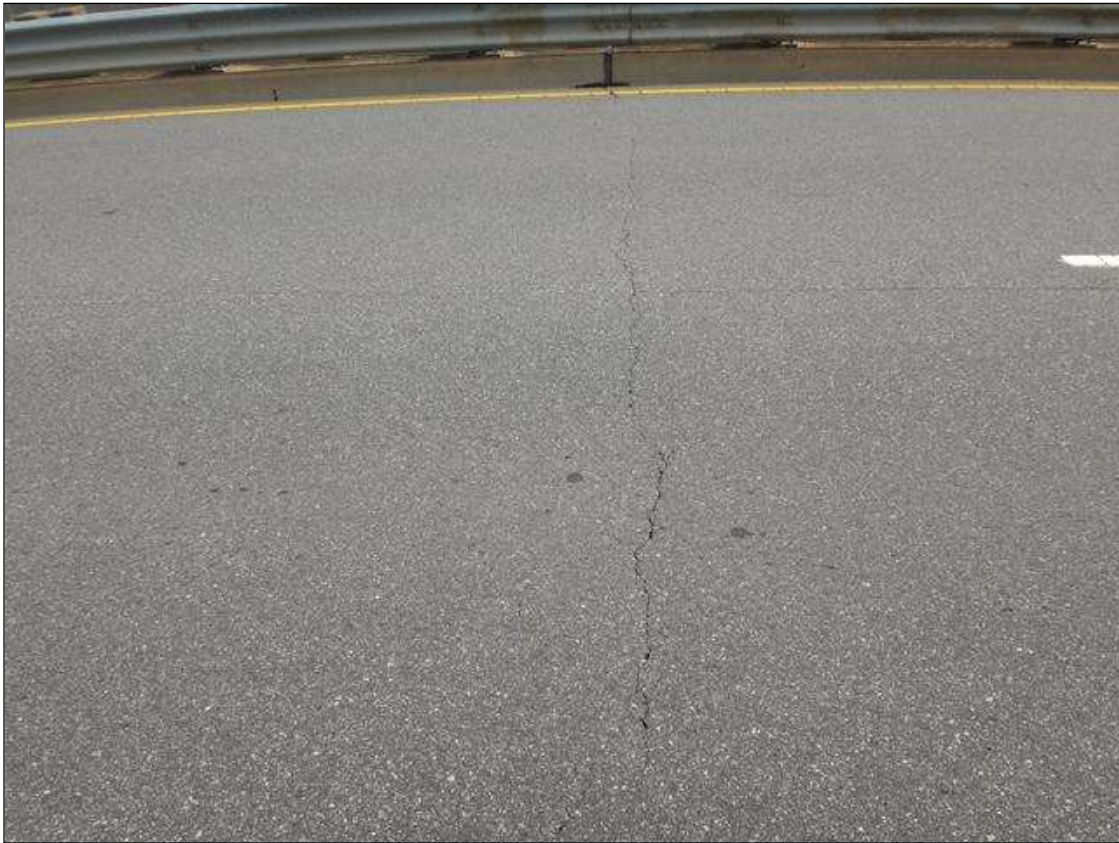
ASPHALT WEARING SURFACE OVER BENT 8, TRANSVERSE CRACK (FULL WIDTH X 1/8IN)

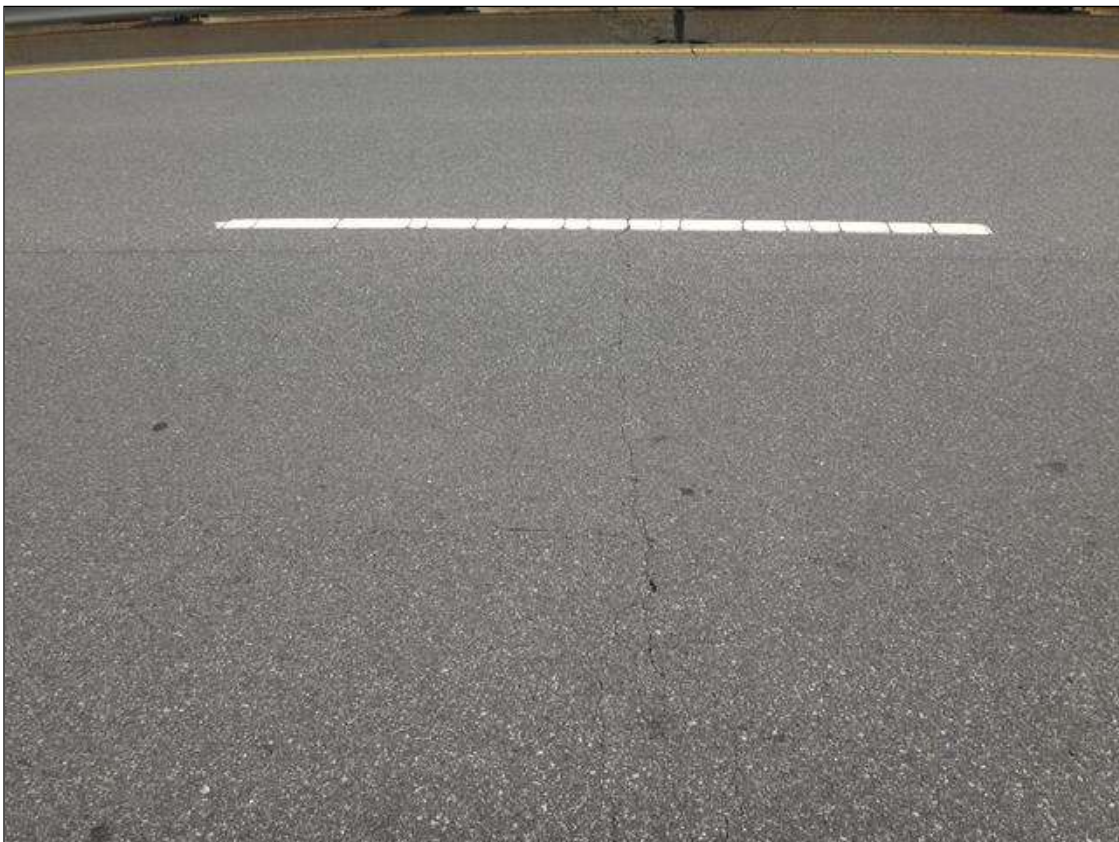
ASPHALT WEARING SURFACE OVER BENT 9, TRANSVERSE CRACK (FULL WIDTH X 1/8IN)

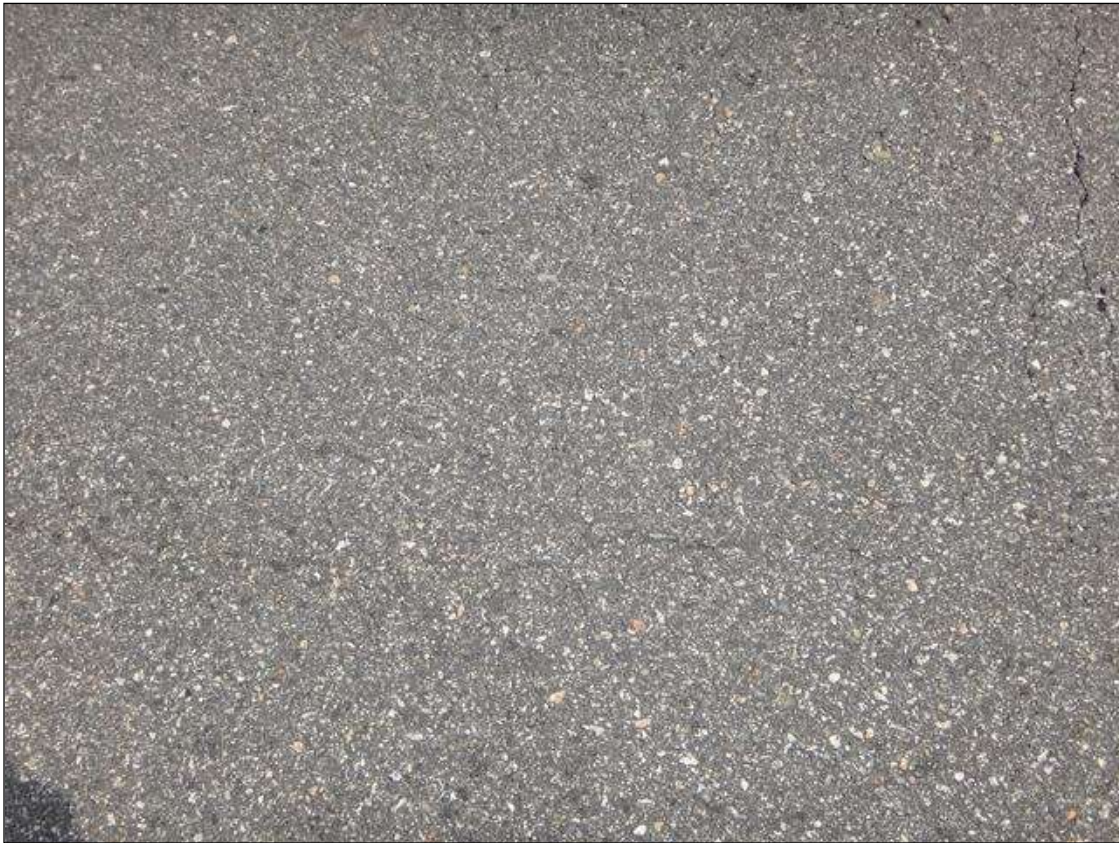
SPAN 10 ASPHALT WEARING SURFACE RIGHT LANE AT END BENT 2, LONGITUDINAL CRACK (3FT X 1/16IN)

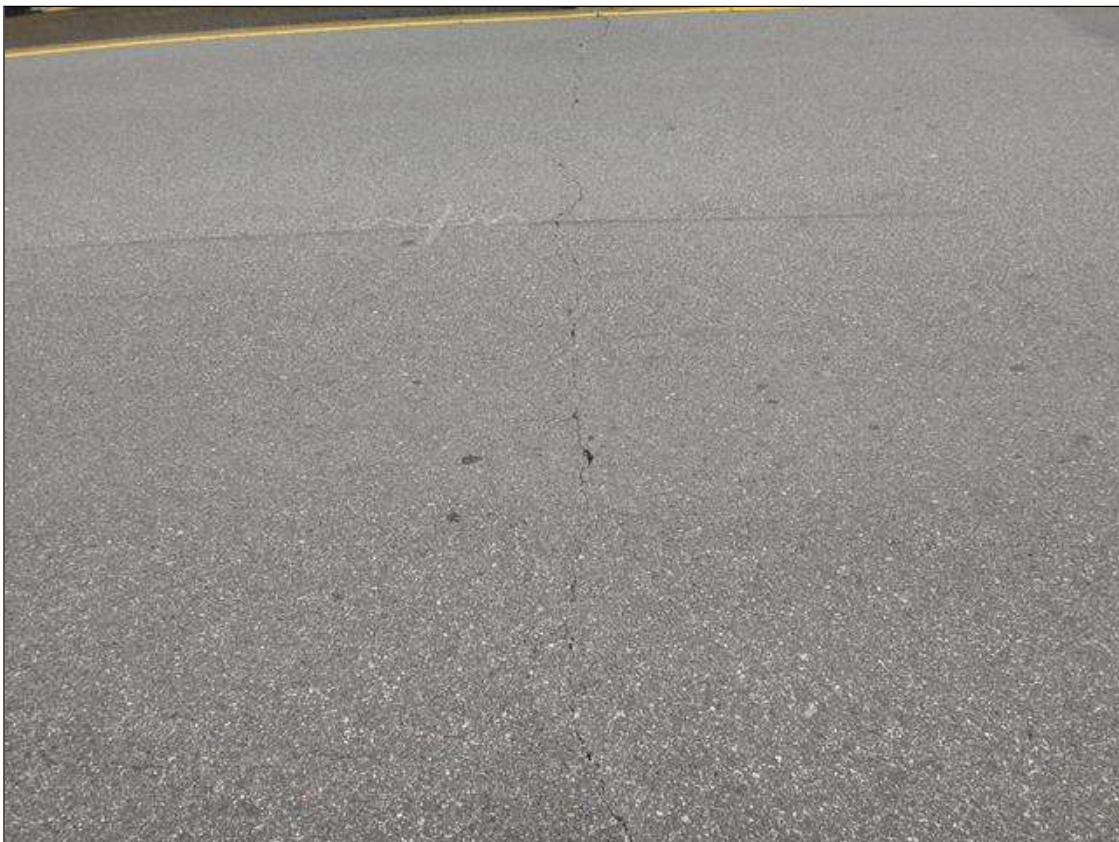
ASPHALT WEARING SURFACE OVER END BENT 2, TRANSVERSE CRACK (FULL WIDTH X UP TO 1/4IN)

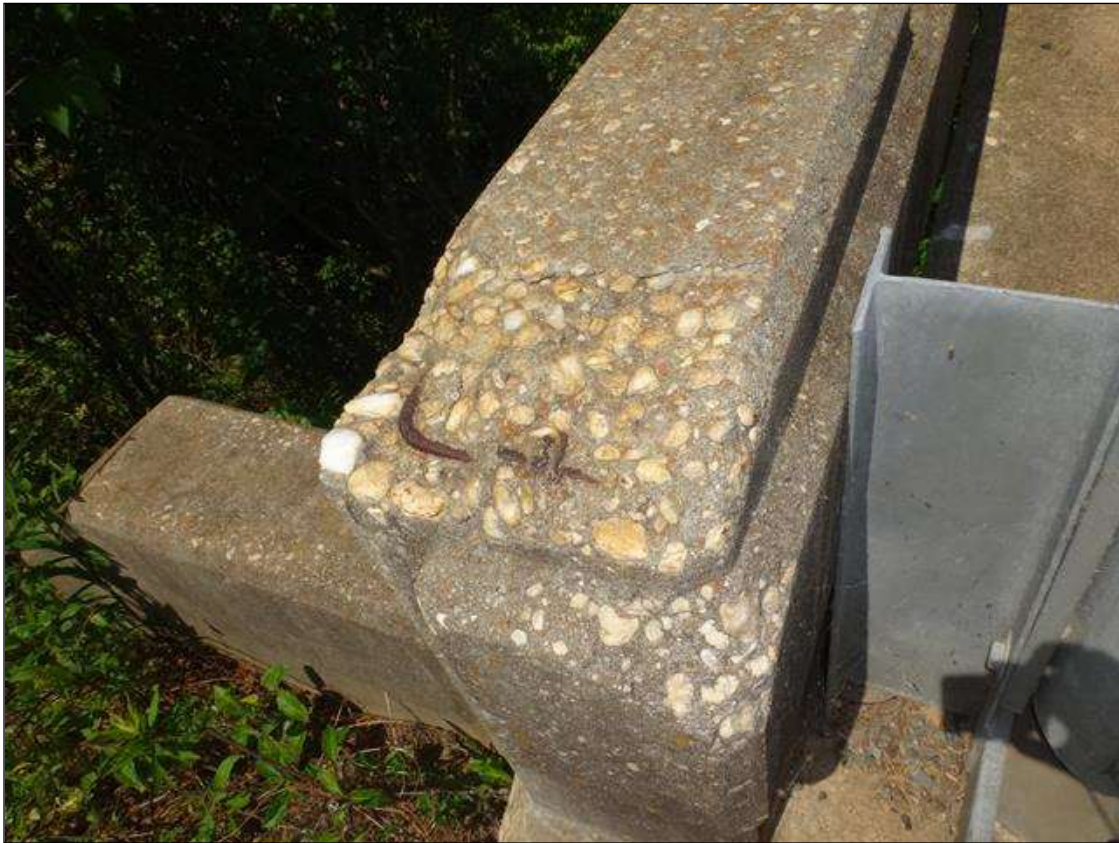
SOUTH RAIL END POST AT END BENT 2, SPALL (10IN X 8IN X 1IN DEEP) WITH EXPOSED RUSTED REBAR

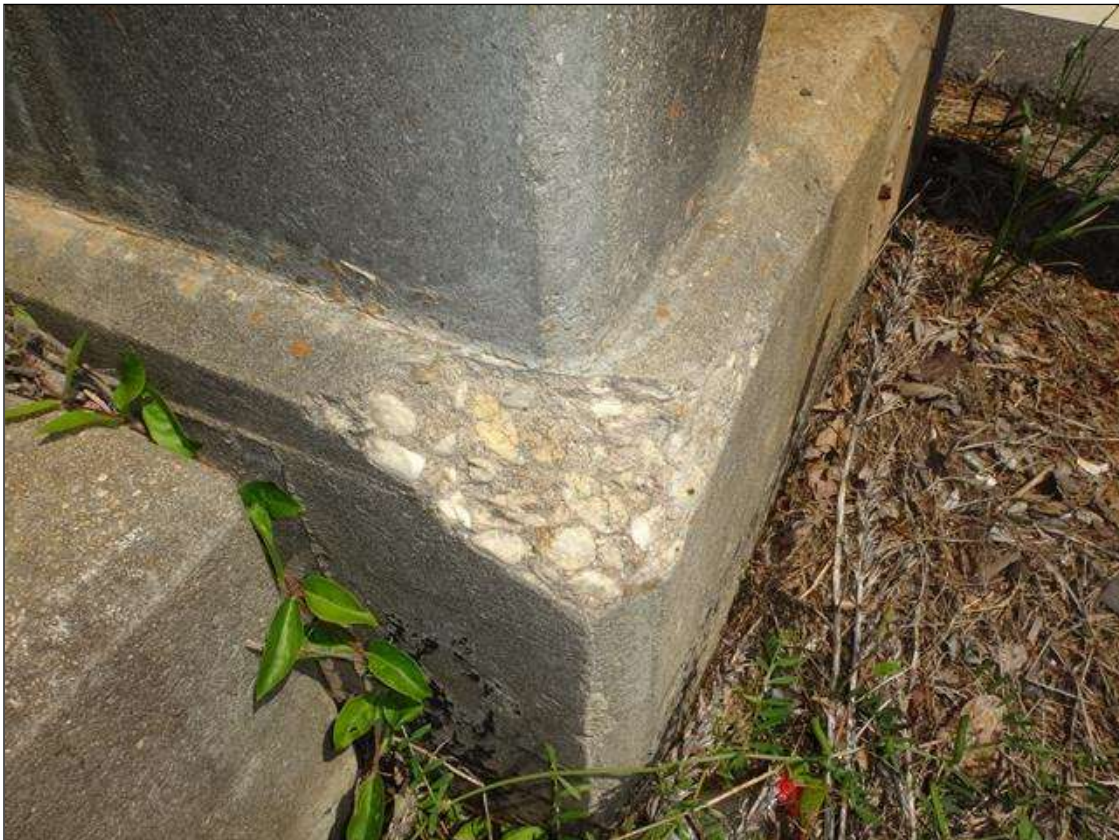
SOUTH RAIL END POST BASE AT END BENT 2, SPALL (6IN X 4IN X 1IN DEEP)

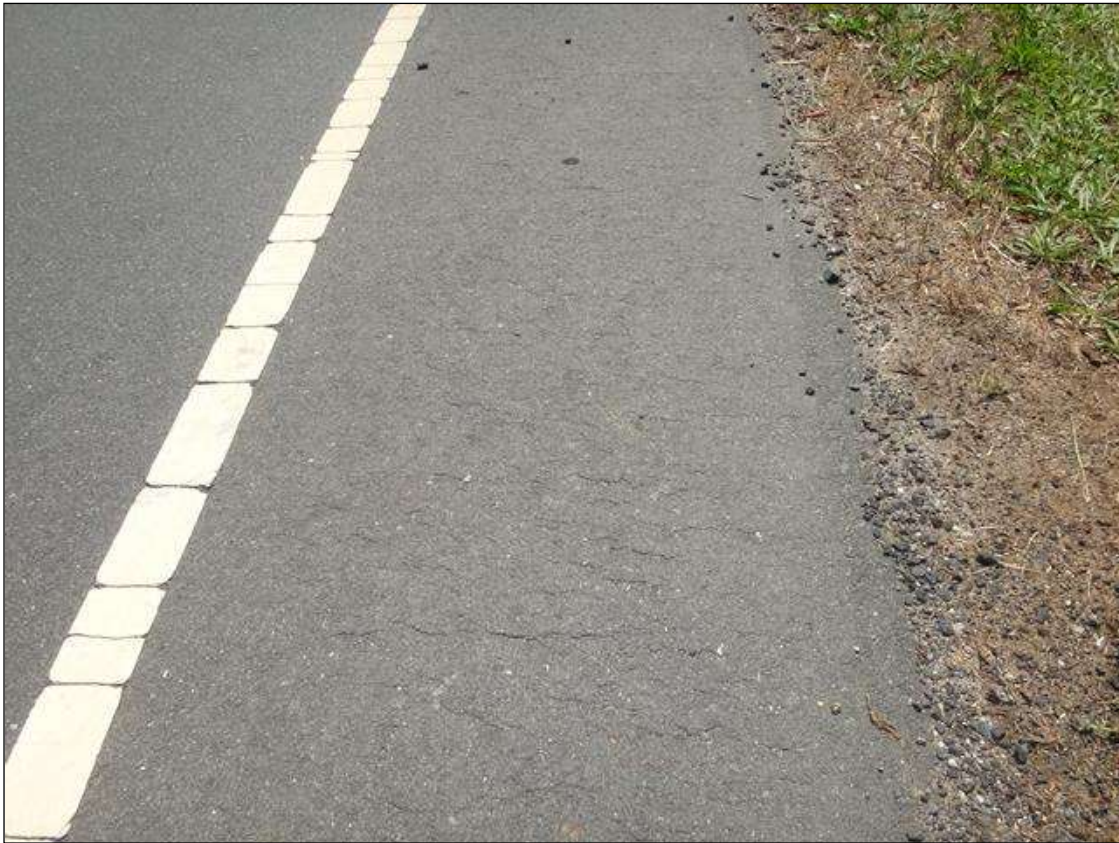
EAST APPROACH SOUTH SHOULDER ASPHALT WEARING SURFACE, ASPHALT RAVELING (25FT X 3FT)

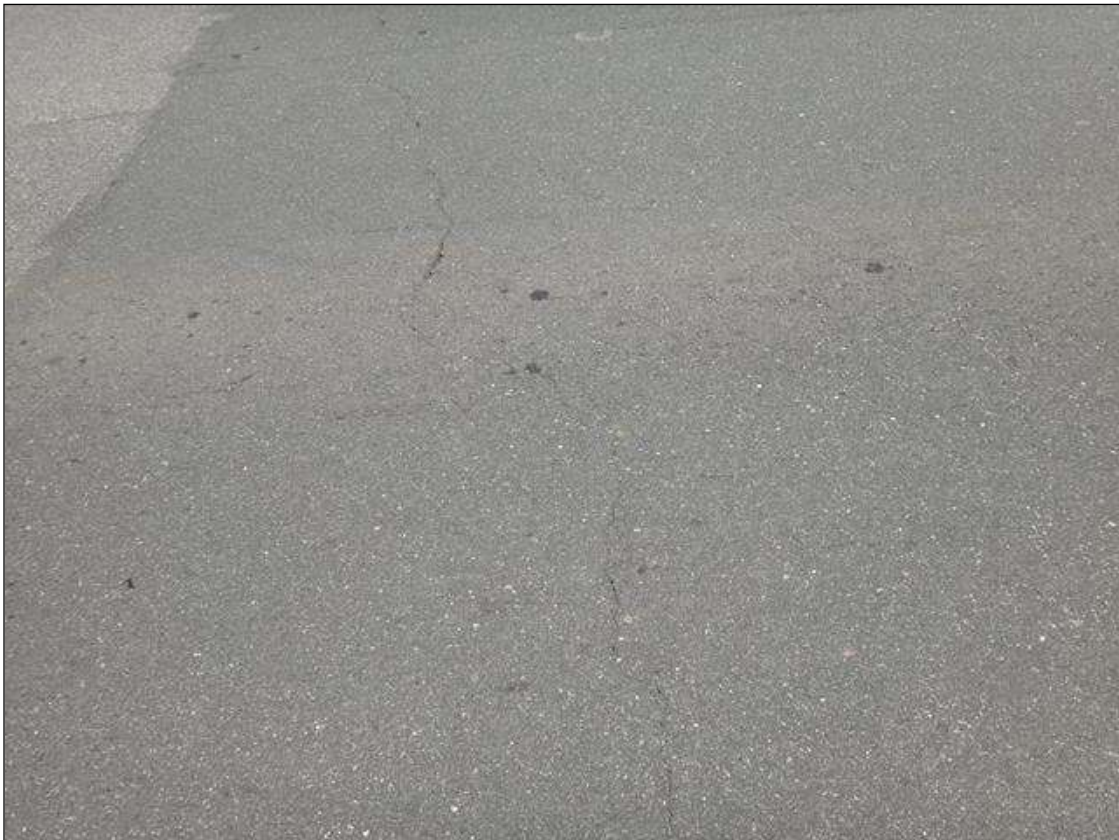
EAST APPROACH ASPHALT WEARING SURFACE AT 3FT FROM END BENT 2, TRANSVERSE CRACK (20FT X UP TO 1/4IN)

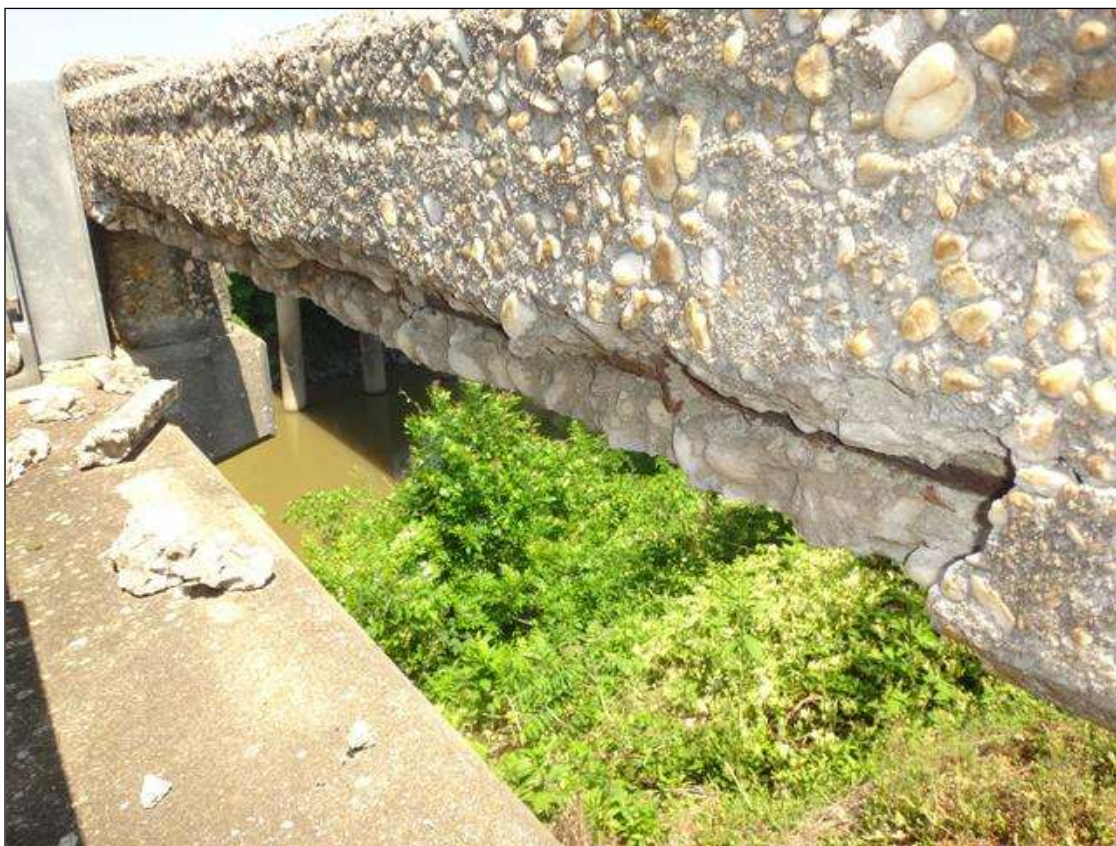
NORTH RAIL AT END BENT 2, SPALL (6FT X 5IN X 2IN DEEP) WITH EXPOSED RUSTED REBAR
